**ALBERTA TRANSPORTATION
GEOHAZARD ASSESSMENT PROGRAM
PEACE REGION – PEACE-HIGH LEVEL
2020 INSPECTION**

Site Number	Location	Name	Hwy	km
PH001-2	Dunvegan	Dunvegan North	2:68	12.60
Legal Description		UTM Co-ordinates		
NE¼ 08-080-04 W6M		11U E 400694	N 6198867

Date	PF	CF	Total
Previous Inspection:	June 6, 2019	15	4	60
Current Inspection:	June 12, 2020	16	4	64
Road AADT:	2,680		Year:	2019
Inspected By:	Ken Szmata, TRANS Ed Szmata, TRANS Rocky Wang, TRANS		Don Proudfoot, Thurber José Pineda, Thurber	
Report Attachments:	<input checked="" type="checkbox"/> Photographs <input checked="" type="checkbox"/> Plans <input checked="" type="checkbox"/> Maintenance Items

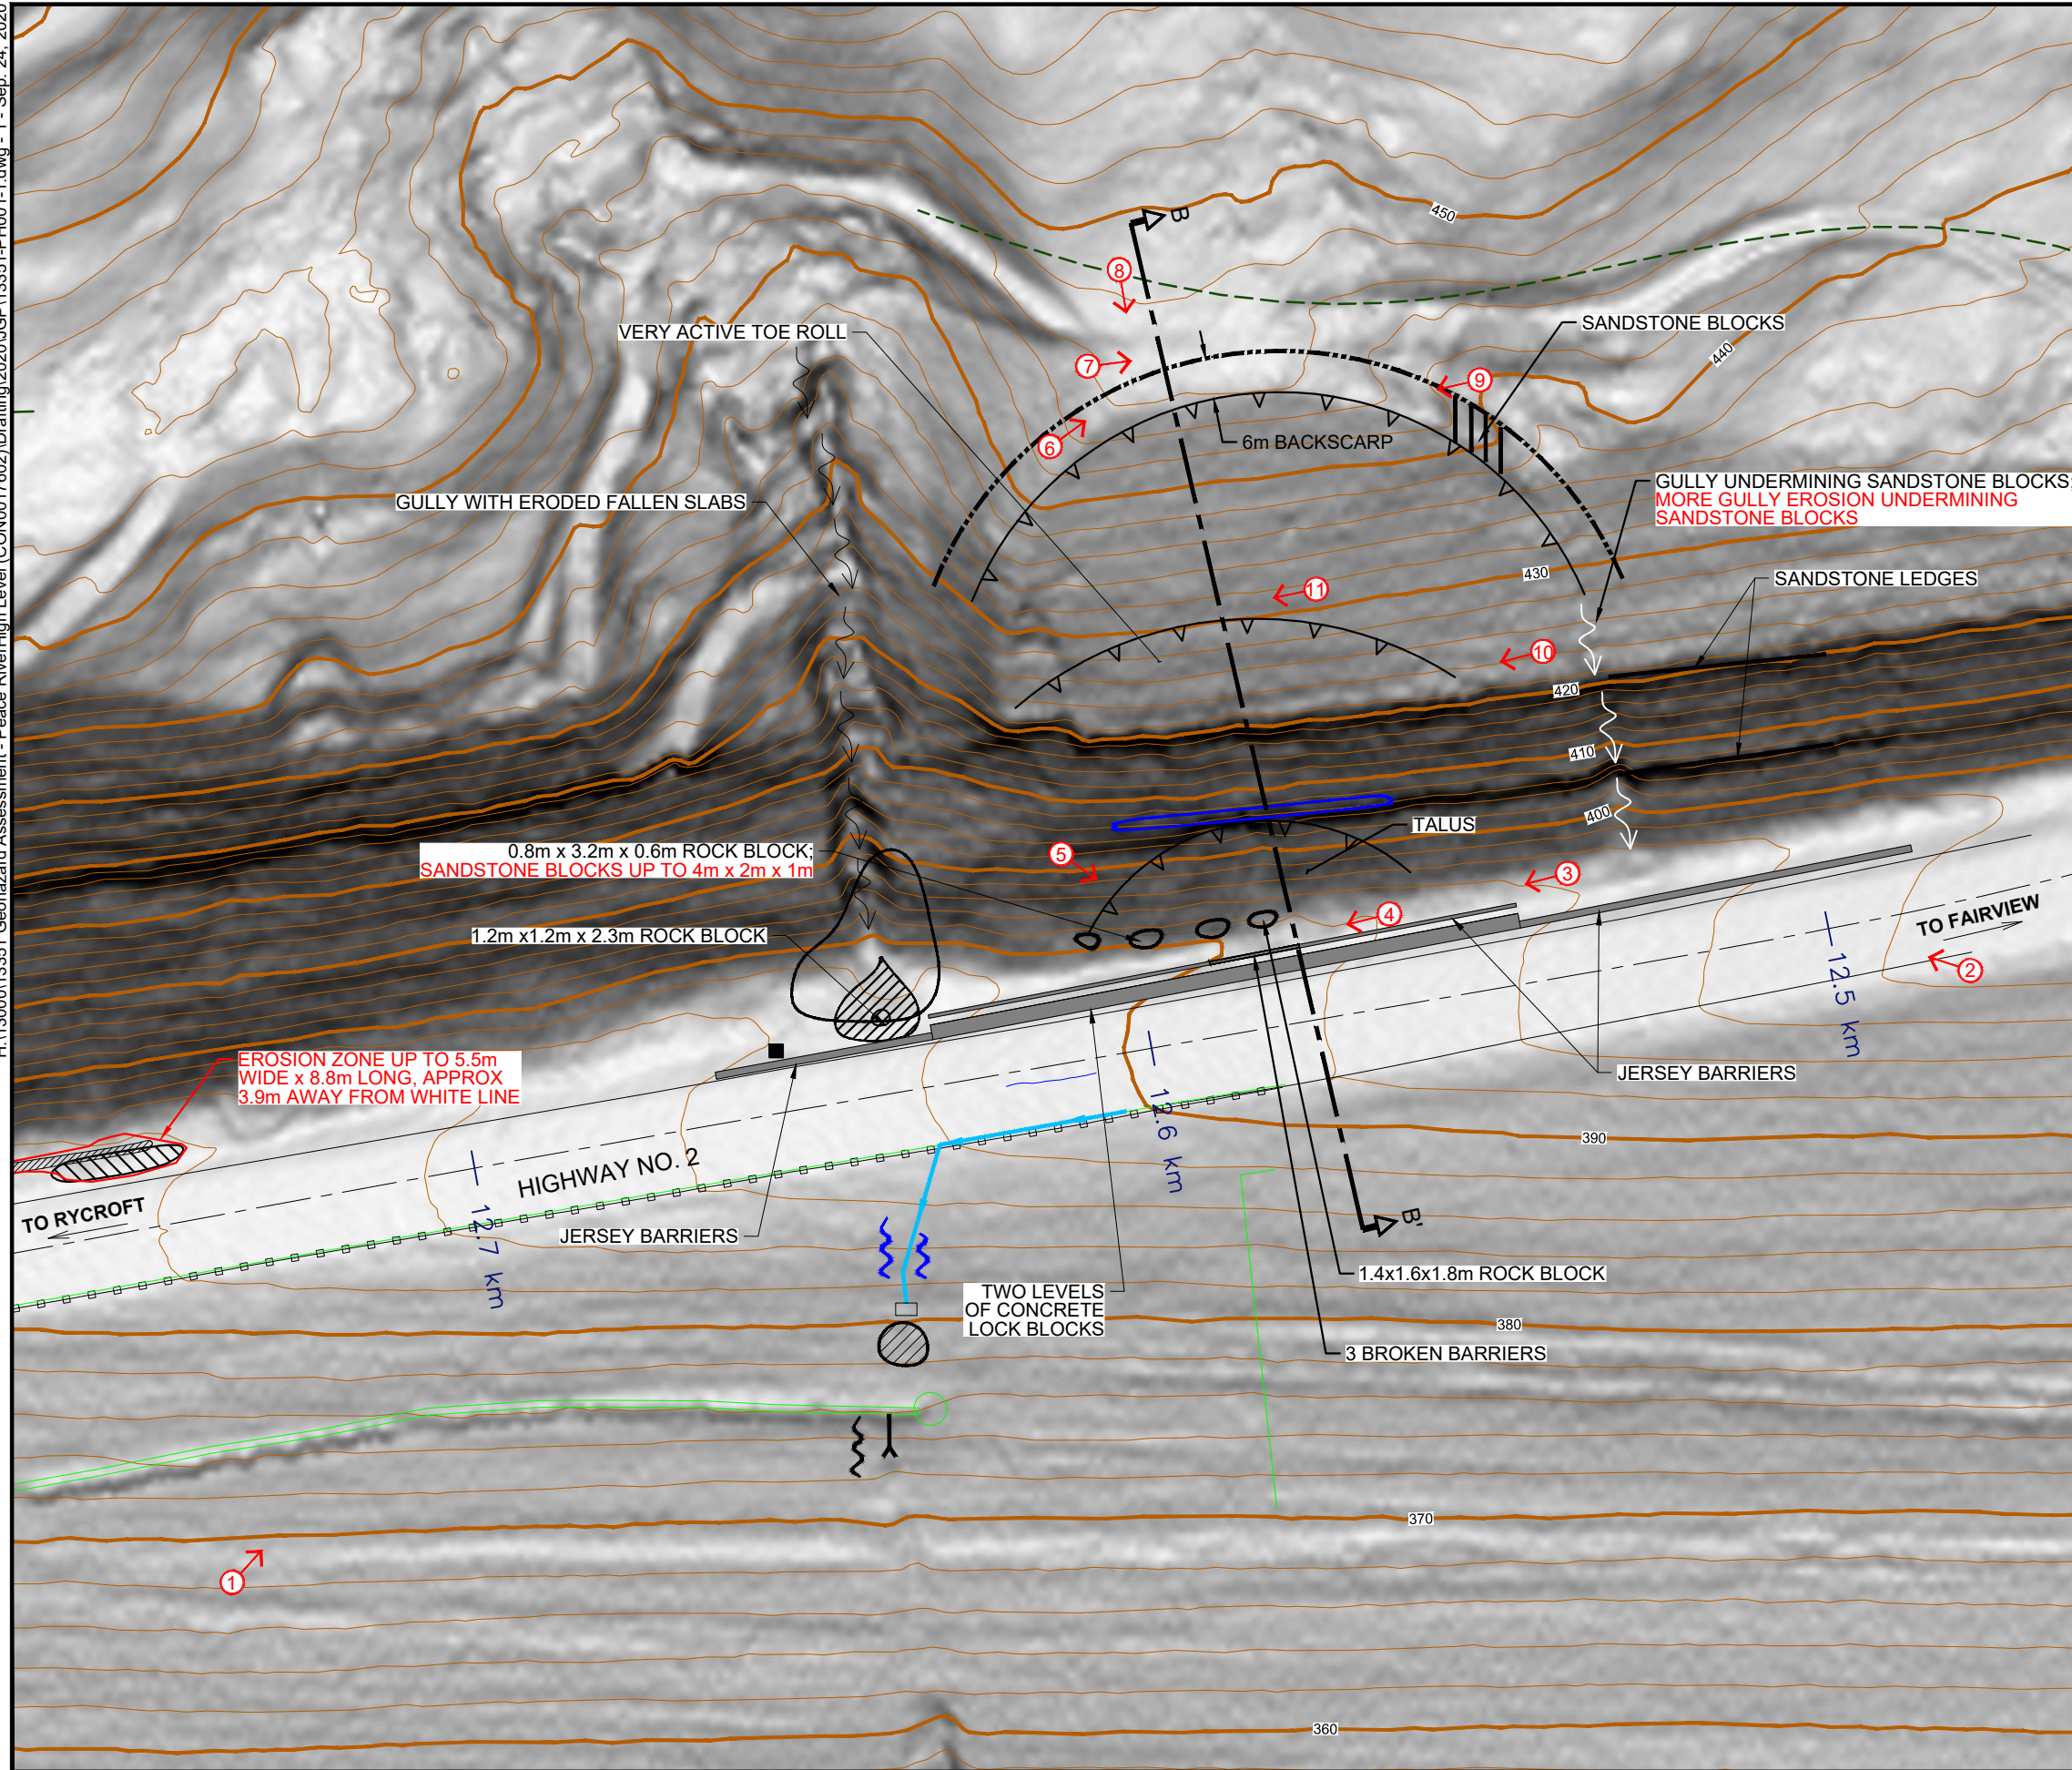
2020 PH001 INSPECTION PLAN

Primary Site Issue:	A landslide in the highway backslope. Upslope debris flow/rock fall hazard		
Dimensions:	Extends 90 m wide and 90 m north from the highway into the backslope. The lower 30 m of the backslope, where bedrock is exposed is inclined at 1H:1V. The upper 25 m of the backslope where the landslide is located in the colluvium, is inclined at 2H:1V.		
Maintenance:	Debris from upslope slides was removed from the highway surface and north side ditches and shoulders in July 2018.		
Observations:	Description	Worsened?	
<input checked="" type="checkbox"/> Slope Movement	<p>The approximate plan outline of the landslide is shown on Dwg. 13351-PH001-1. The exposed backscarp height at the center of the landslide was about 6 m (Photos 6 and 9).</p> <p>A graben had formed along the base of the scarp. The soil exposed in the backscarp and slide mass appears to consist mainly of silty sand, with some clay and hard/strong sandstone pieces embedded within it (Photos 10 and 11).</p>	<input checked="" type="checkbox"/>

<input checked="" type="checkbox"/> Other	<p>Currently, the slide material is toppling over the edge of the steep bedrock slope at a slow enough rate that regular ditch cleaning has managed to keep pace with slide debris accumulation. The landslide debris accumulated in the SBL ditch consisted primarily of small chunks and small to large sized slabs of silty weathered sandstone bedrock and colluvium mixed with organics. Some of the landslide debris broke and bounced over the Jersey barrier and accumulated between the Jersey Barriers and the two-level of concrete lock blocks</p>	<input checked="" type="checkbox"/>	
Instrumentation:	There are no available records of previous geotechnical investigations and there are currently no instruments installed at the site.

In the past, similar landslides and debris flows in this area have typically occurred in the gullies due to the concentration of surface runoff water from heavy rain fall events. The inferred slip surface for this landslide is likely to be along the top of the upper sandstone bedrock layer at an approximate elevation 423 m.

This landslide is considered to have been triggered by either a temporary rise in groundwater perched in the colluvium or a concentration of surface water runoff at this location. The primary concern for this site is the potential for further colluvium and weathered sandstone bedrock debris accumulating along the edge of the upper sandstone ledge debris to continue to fall onto the highway causing a risk to public safety. Furthermore, there is also a risk that the cascading landslide debris can dislodge undermined sandstone slabs from the two sandstone layers below that might travel faster and further out into the highway and possibly strike a vehicle.

The maintenance contractor has erected concrete lock blocks and jersey barriers to help contain the debris to keep it off the highway. However, there is still a risk that the remainder of the slide debris volume (about 20,000 m³) could fall catastrophically onto the highway in a fast-moving mudslide if it gets saturated during a heavy precipitation event. If the slide material came down in a big single event it could dislodge the concrete barriers and flow out onto and close the highway.

The provision of the concrete barriers has reduced but not eliminated the risk of further rock falls to the travelling public.

A warning sign should be posted at the top and bottom of the hill to warn of higher risk of rockfall and mudslide activity particularly during wet weather conditions.

If possible, the remaining slide mass should be carefully removed from the top of the slope to reduce the potential for further debris to fall onto the highway below. Due to the possibility of crumbling of the edge of the sandstone bedrock layer, equipment should be kept back at a minimum distance of 3 m from the crest of the steep backslope. This could be accomplished using a long reach excavator that would access the site from privately owned land to the north of the landslide. The excavator would push the failed material over the crest of the slope. This would need to be monitored with spotters equipped with two-way radios positioned at the top of the steep backslope section and along the highway. Once the outer 15 m of the landslide debris has been removed, the backscarp should be flattened to an inclination of 2.5H:1V and the remaining slide debris should be cut-down and flattened as a buttress with a slope angle of 5H:1V. Depending on the extent of the backscarp, this may require the acquisition of privately-owned land above the current landslide.

An alternate plan would be to leave the landslide mass to tumble down the backslope at its own rate and complete regular maintenance to remove the fallen debris during dry weather conditions to maintain a storage capacity behind the barriers and allow the ditch to pass runoff drainage. This option carries a higher risk of injury to the public.

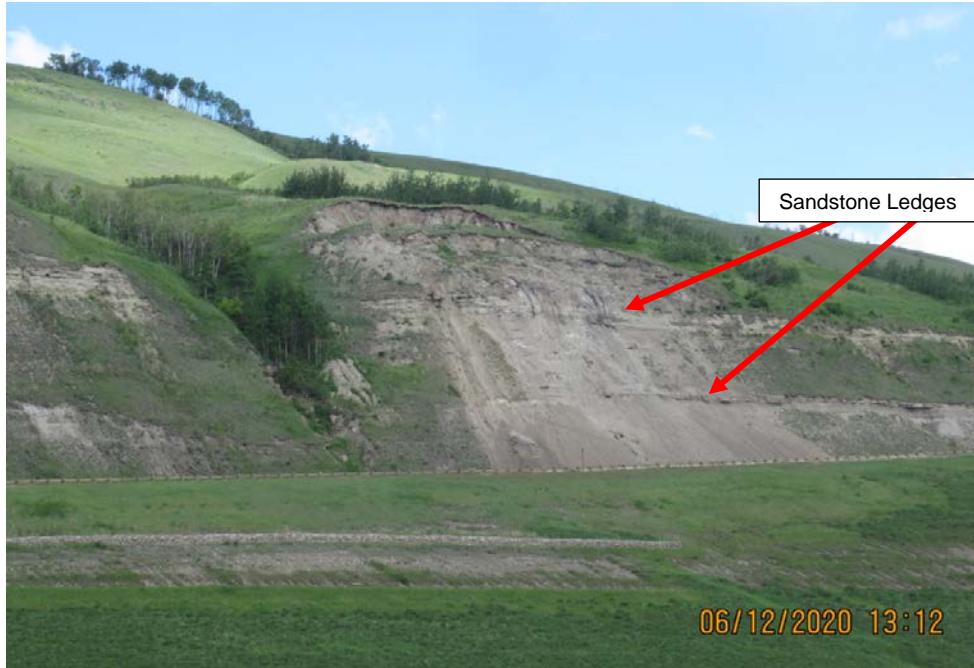
Photo 1: Looking northeast at the landslide site from the north terrace of the Peace River

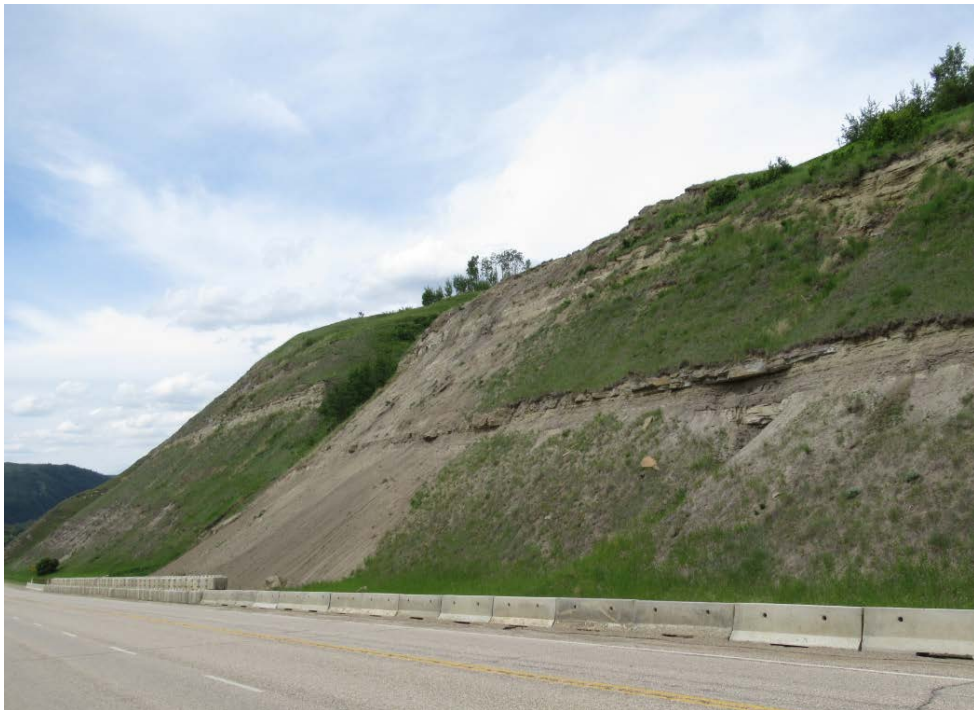
Photo 2: Looking northwest at the highway backslope below the landslide and concrete barriers

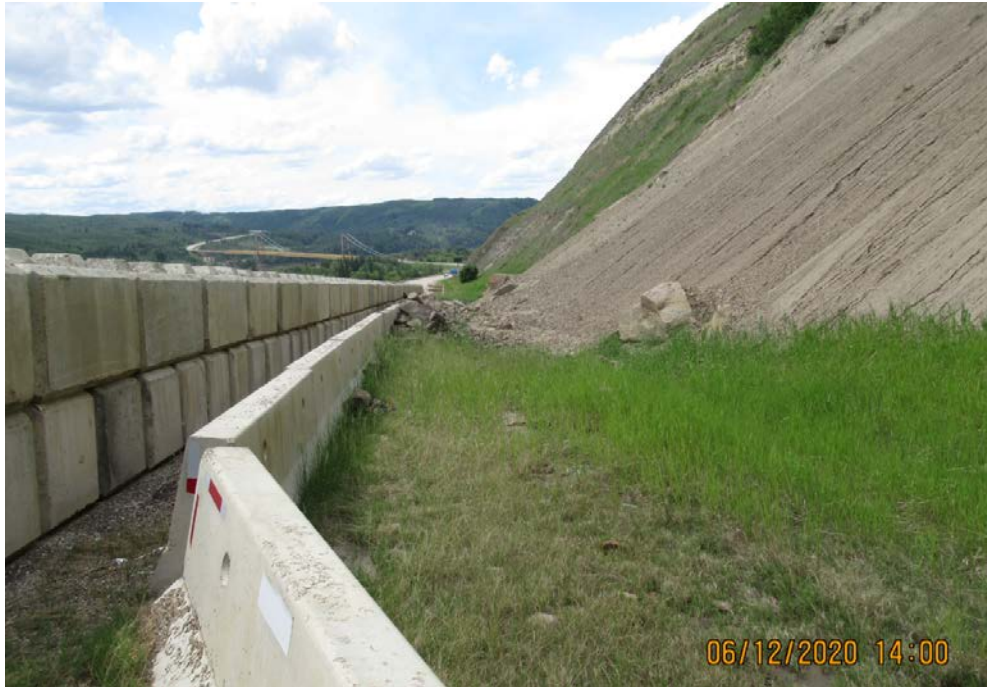
Photo 3: Looking west at accumulated debris from the SBL ditch of Hwy 2:68 at the highway backslope below the landslide

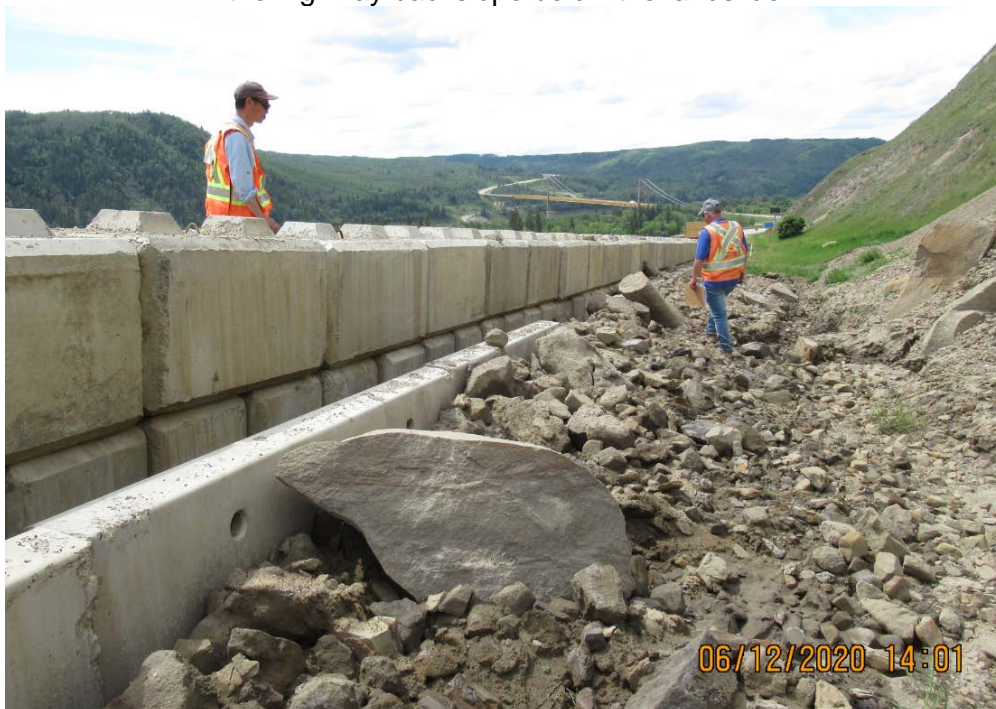
Photo 4: Looking west from SBL ditch of Hwy 2:68 at sandstone slabs, talus, boulders, and soil chunks that have accumulated between the ditch below the landslide and the Jersey Barrier

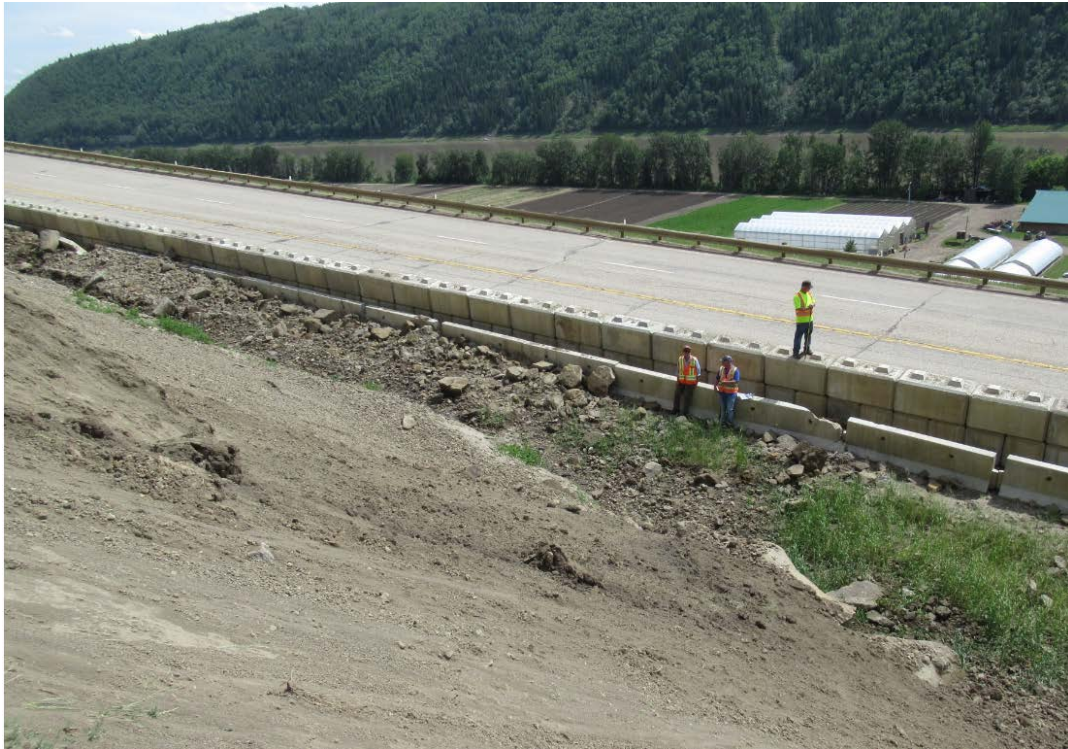
Photo 5: Looking southeast at landslide debris; note talus, boulders, and soil chunks that have accumulated in the ditch below the landslide

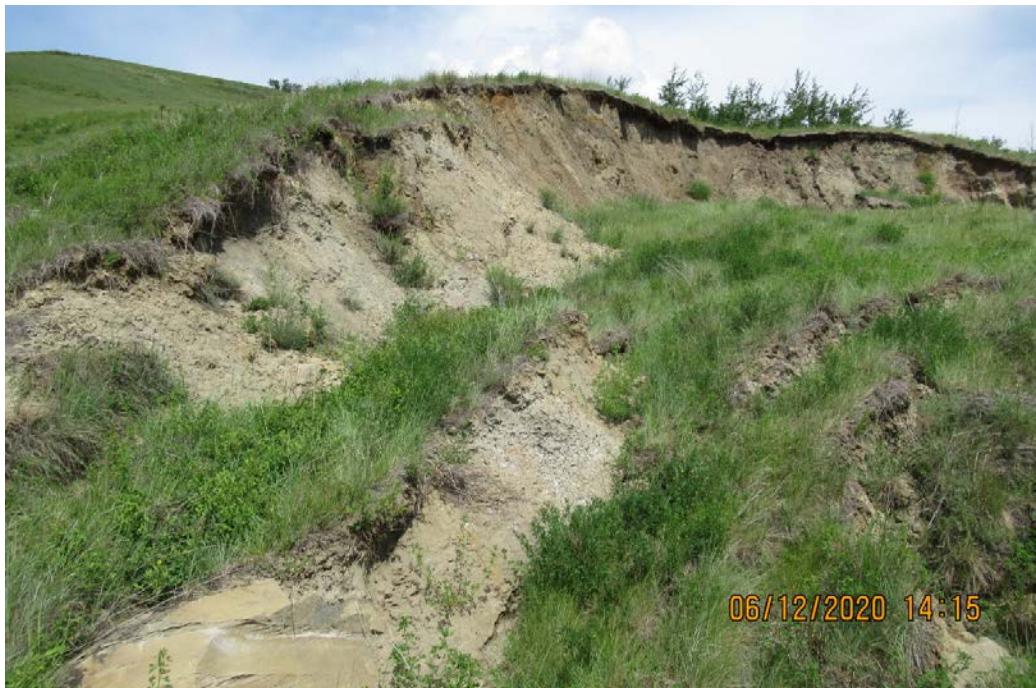
Photo 6: Looking northeast along backscarp of the landslide

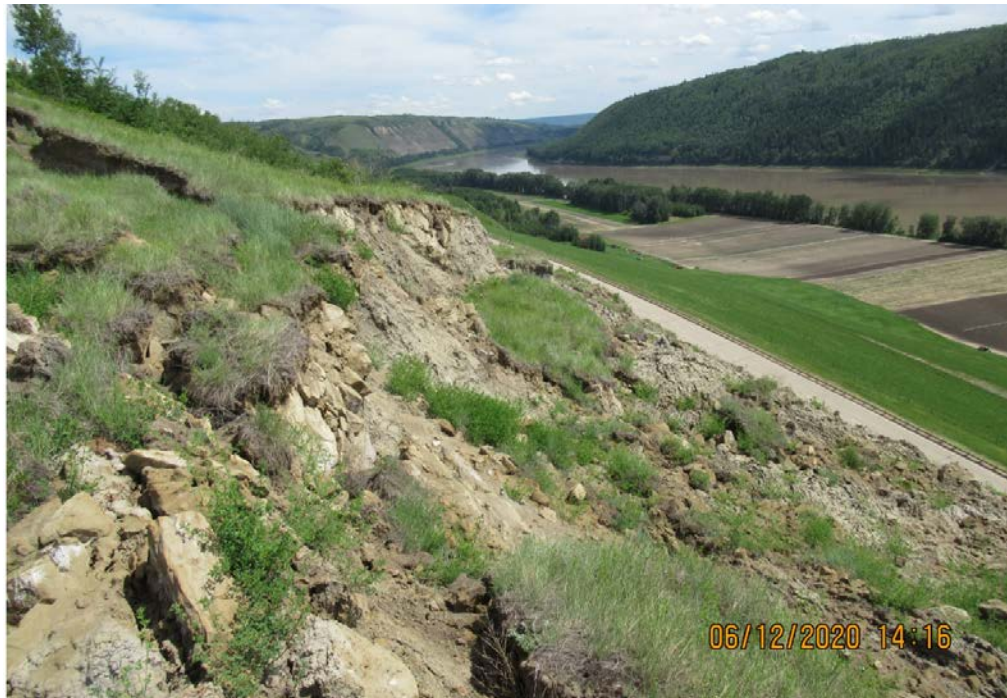
Photo 7: Looking east from landslide backscarp

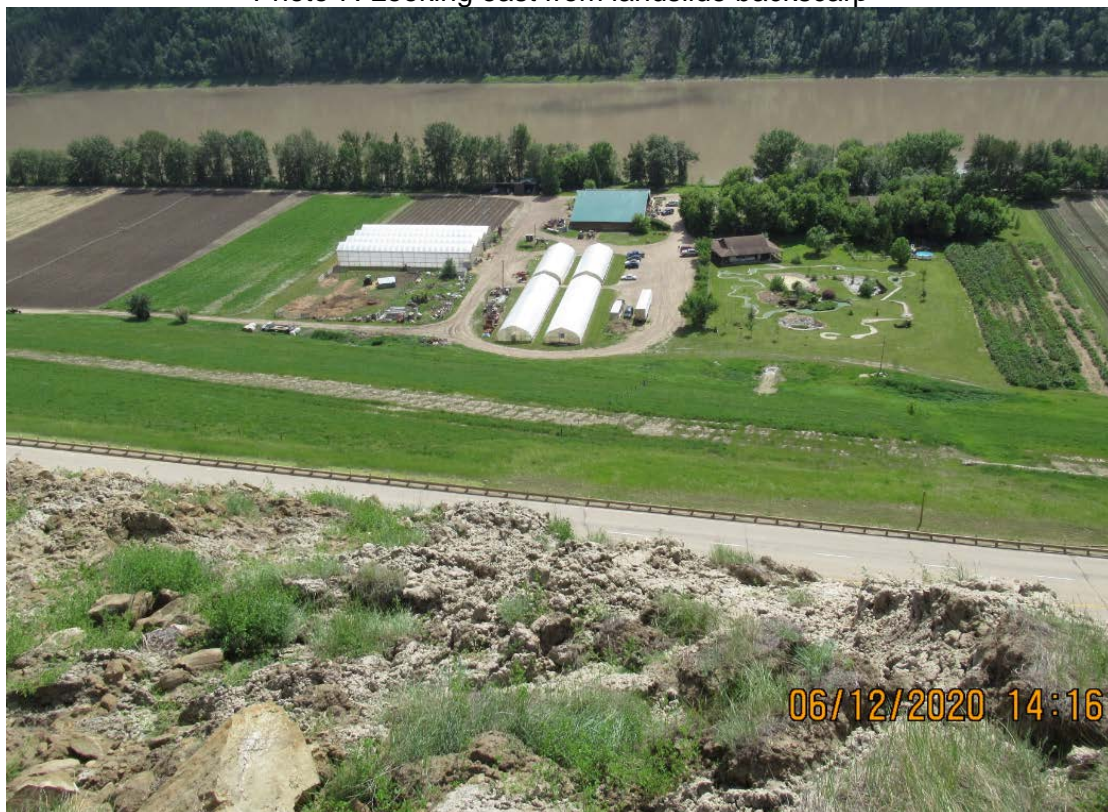
Photo 8: Looking south from the middle of the backscarp of the slide

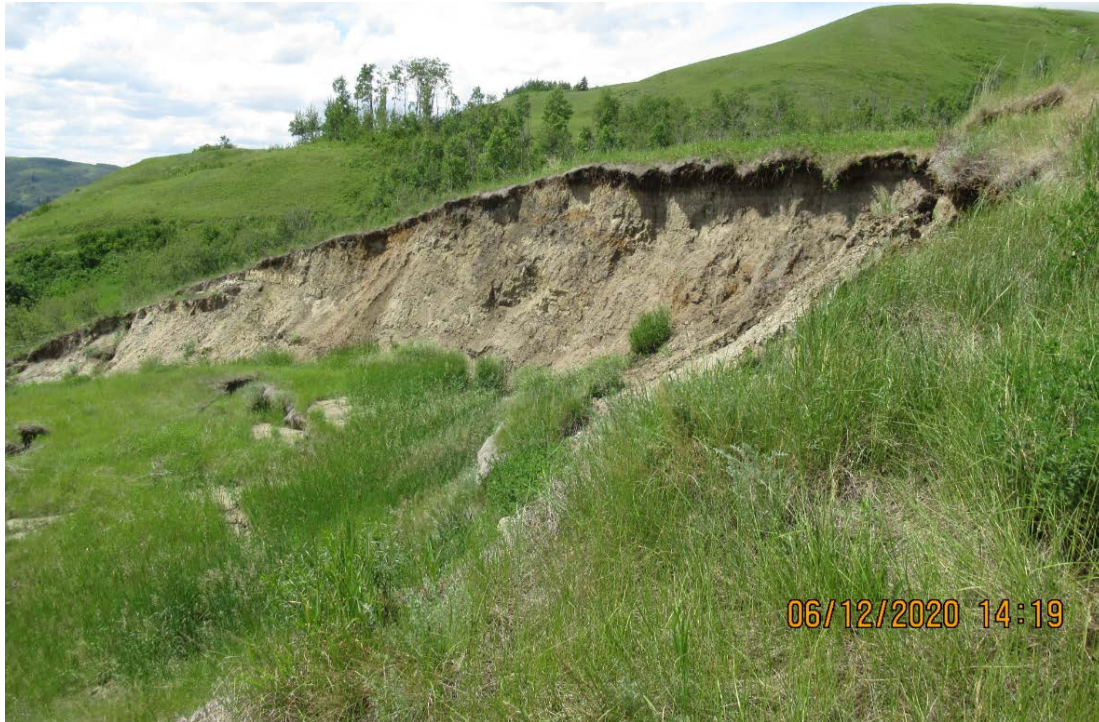
Photo 9: Looking west along the backscarp

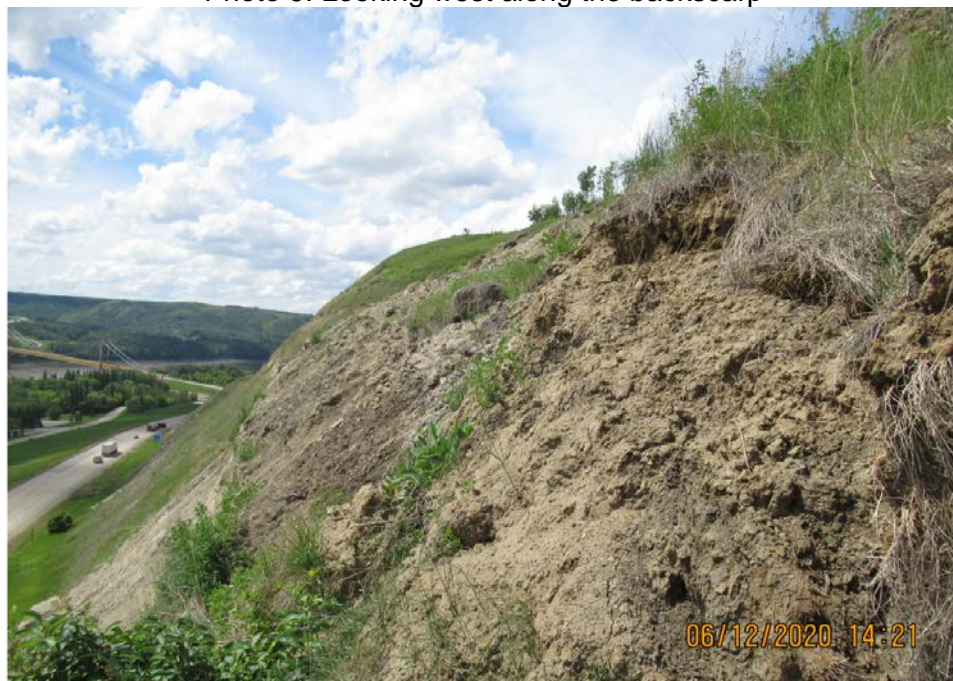
Photo 10: Looking west along the toe of the slide

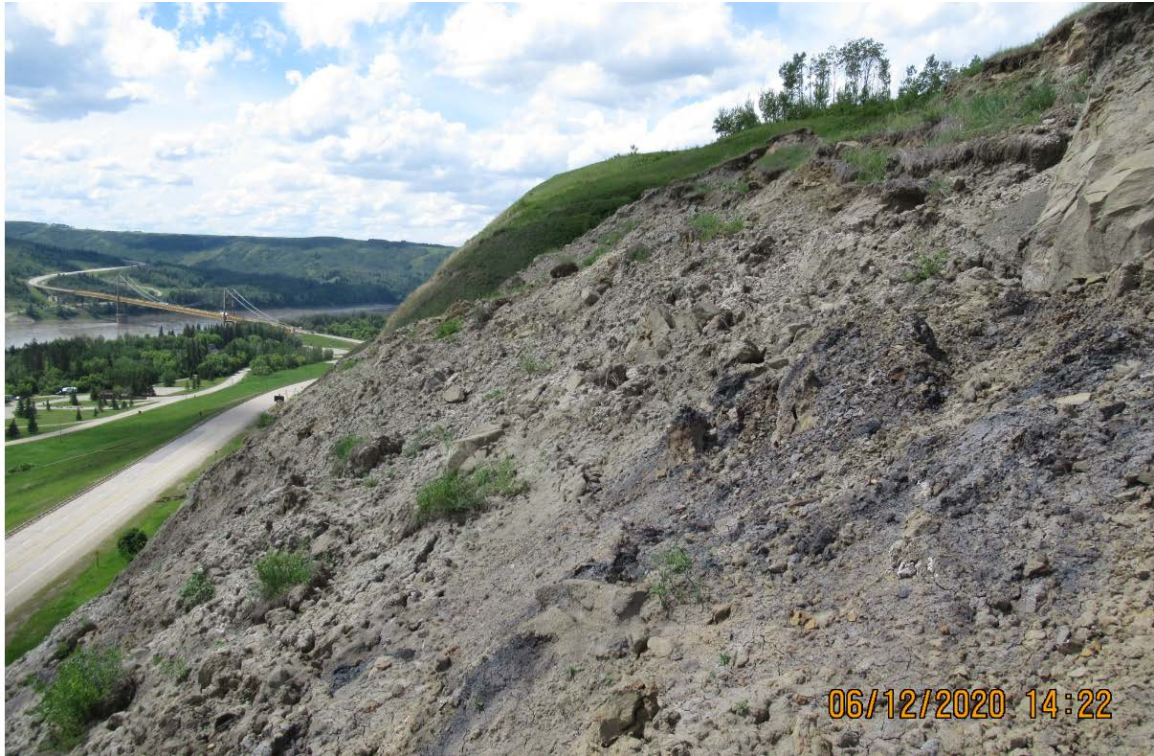
Photo 11: Looking southwest within the landside mass; note active toe roll
