**ALBERTA TRANSPORTATION  
GEOHAZARD ASSESSMENT PROGRAM  
PEACE REGION –  
GRANDE PRAIRIE DISTRICT - NORTH  
2021 INSPECTION**

<b>Site Number</b>	<b>Location</b>	<b>Name</b>	<b>Hwy</b>	<b>km</b>
PH001	Dunvegan	Dunvegan Hill, North	2:68	12.60
<b>Legal Description</b>		<b>UTM Co-ordinates</b>		
NE¼ 08-080-04 W6M		11U E 400694	N 6198867

<b>Date</b>	<b>PF</b>	<b>CF</b>	<b>Total</b>
<b>Previous Inspection:</b>	June 12, 2020	16	4	64
<b>Current Inspection:</b>	July 15, 2021	6	5	30
<b>Road WAADT:</b>	2,380		<b>Year:</b>	2020
<b>Inspected By:</b>	Rocky Wang, TRANS Ed Szmata, TRANS Roger Skirrow, TRANS Max Shannon, TRANS Jason Parr, TRANS		Don Proudfoot, Thurber José Pineda, Thurber	
<b>Report Attachments:</b>	<input checked="" type="checkbox"/> Photographs	<input checked="" type="checkbox"/> Plans	<input checked="" type="checkbox"/> Maintenance Items

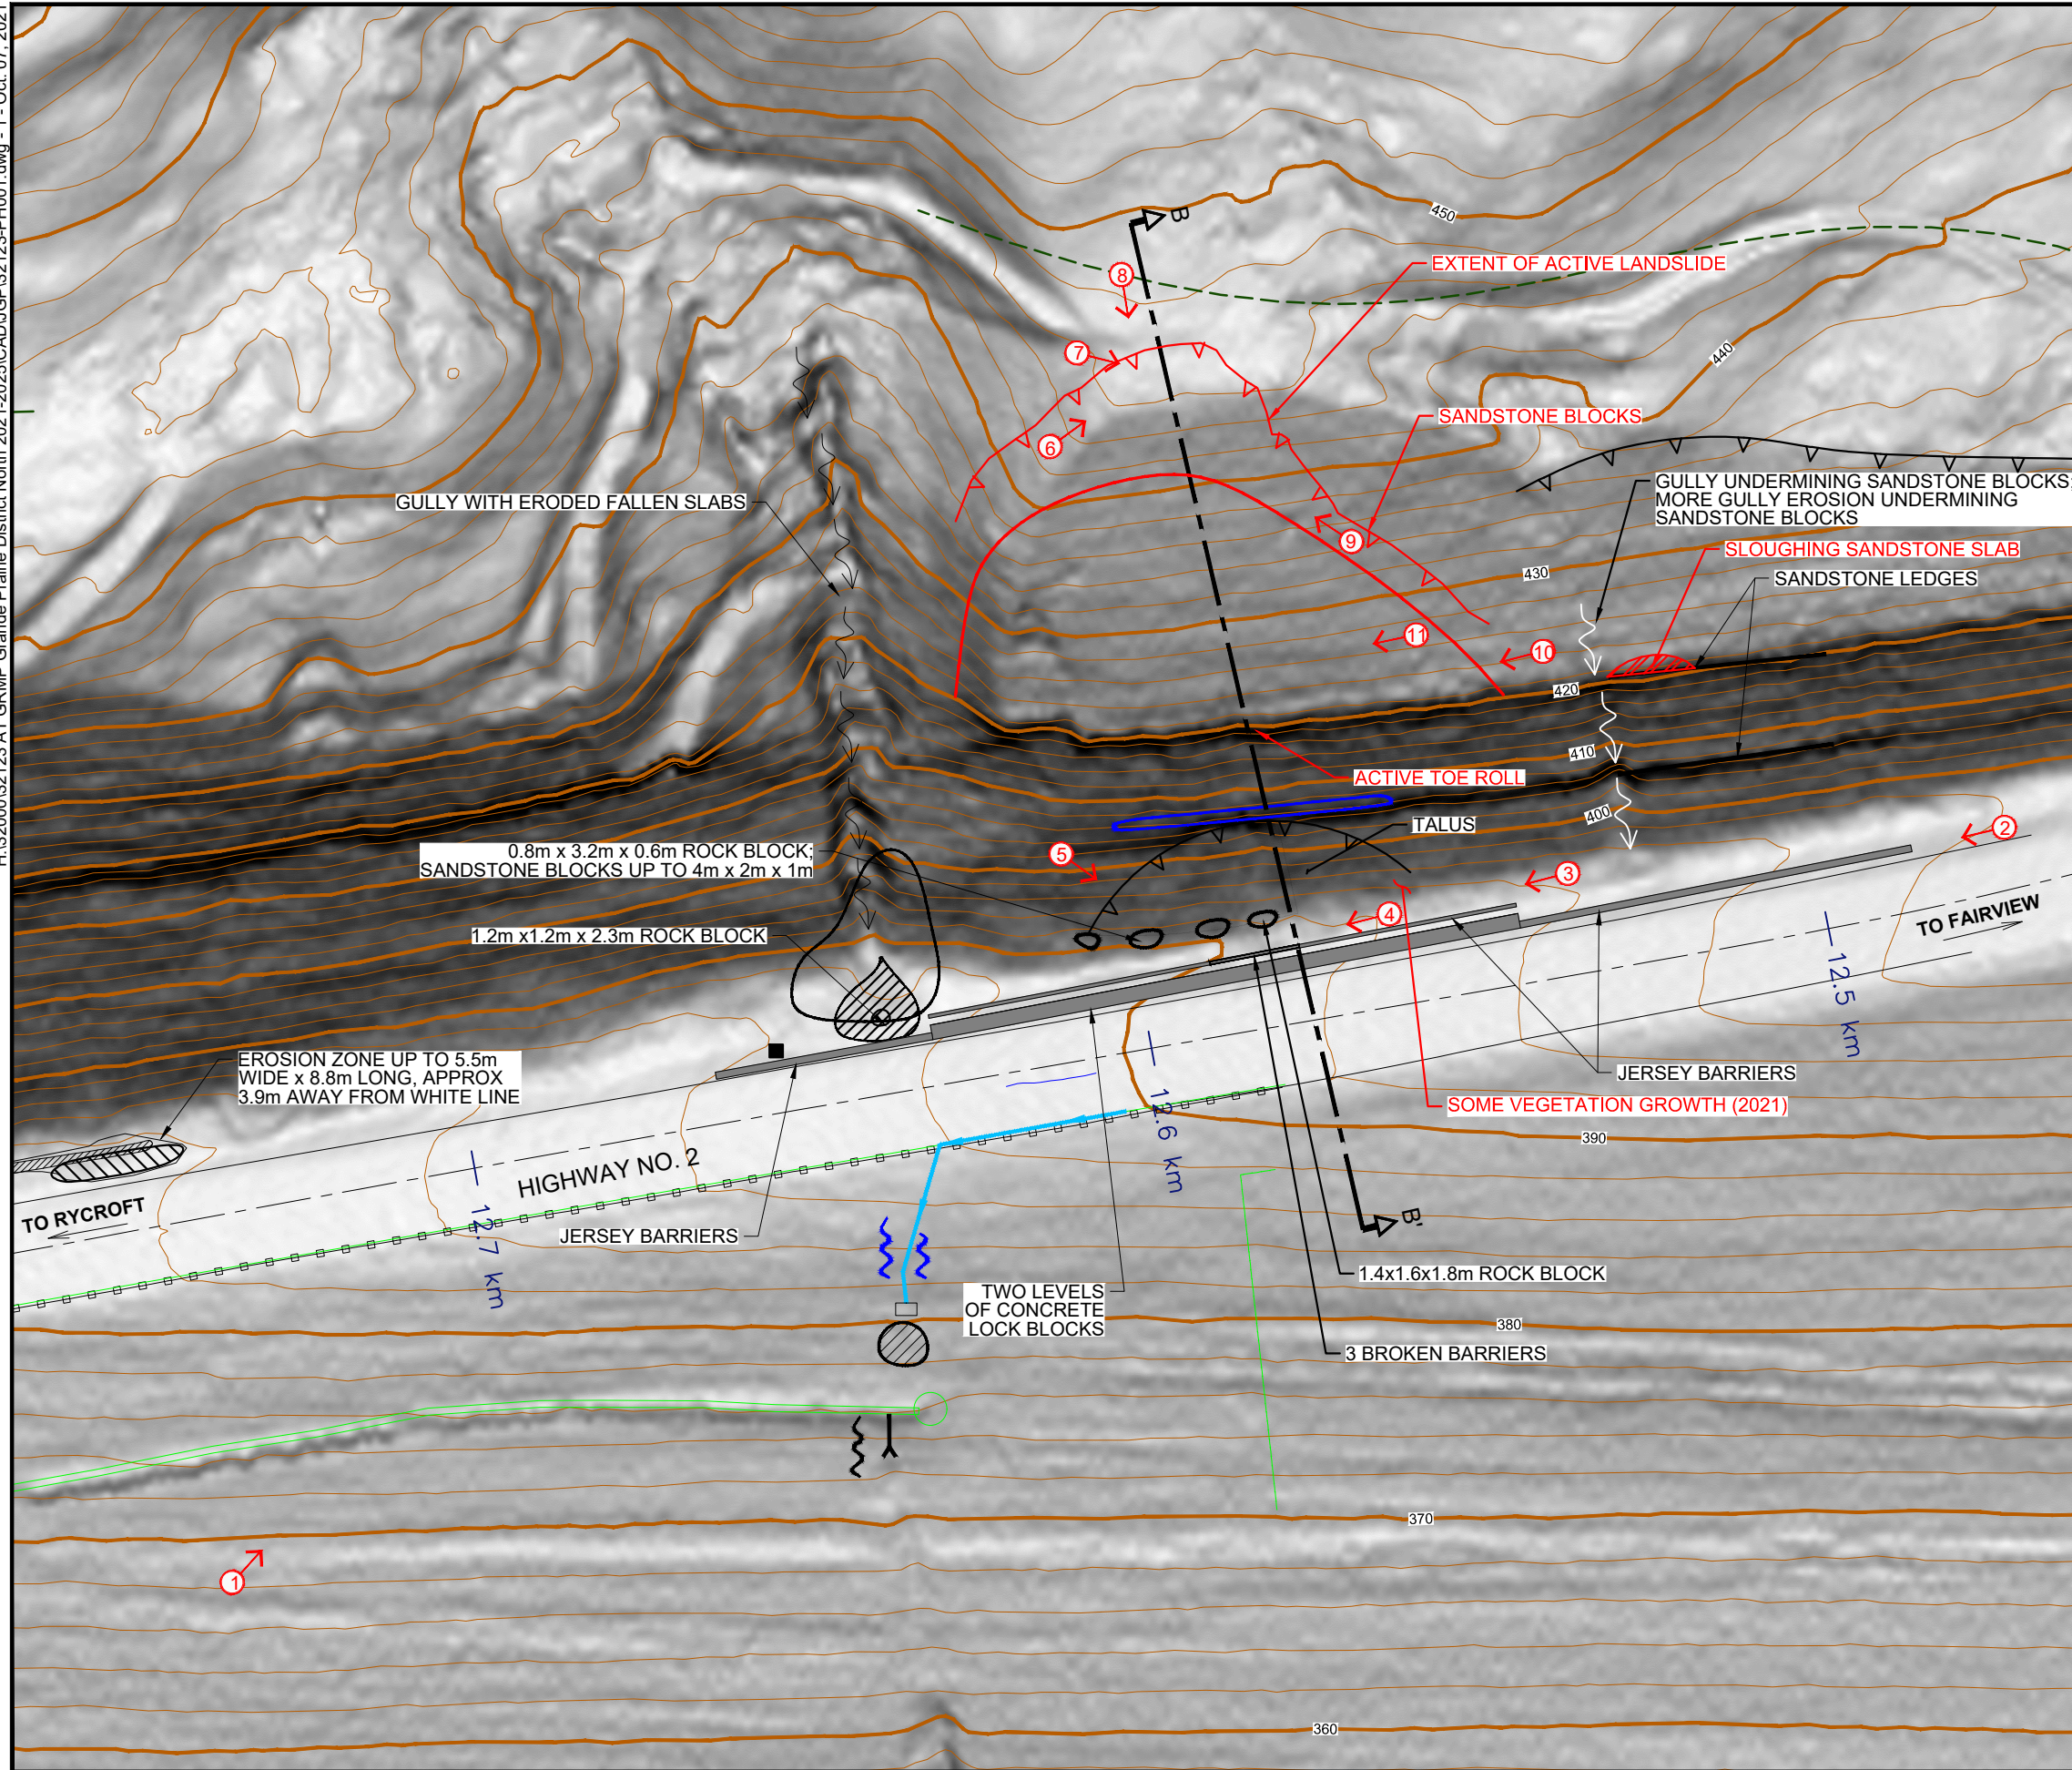
FIGURE 1

2021 PH001 INSPECTION PLAN

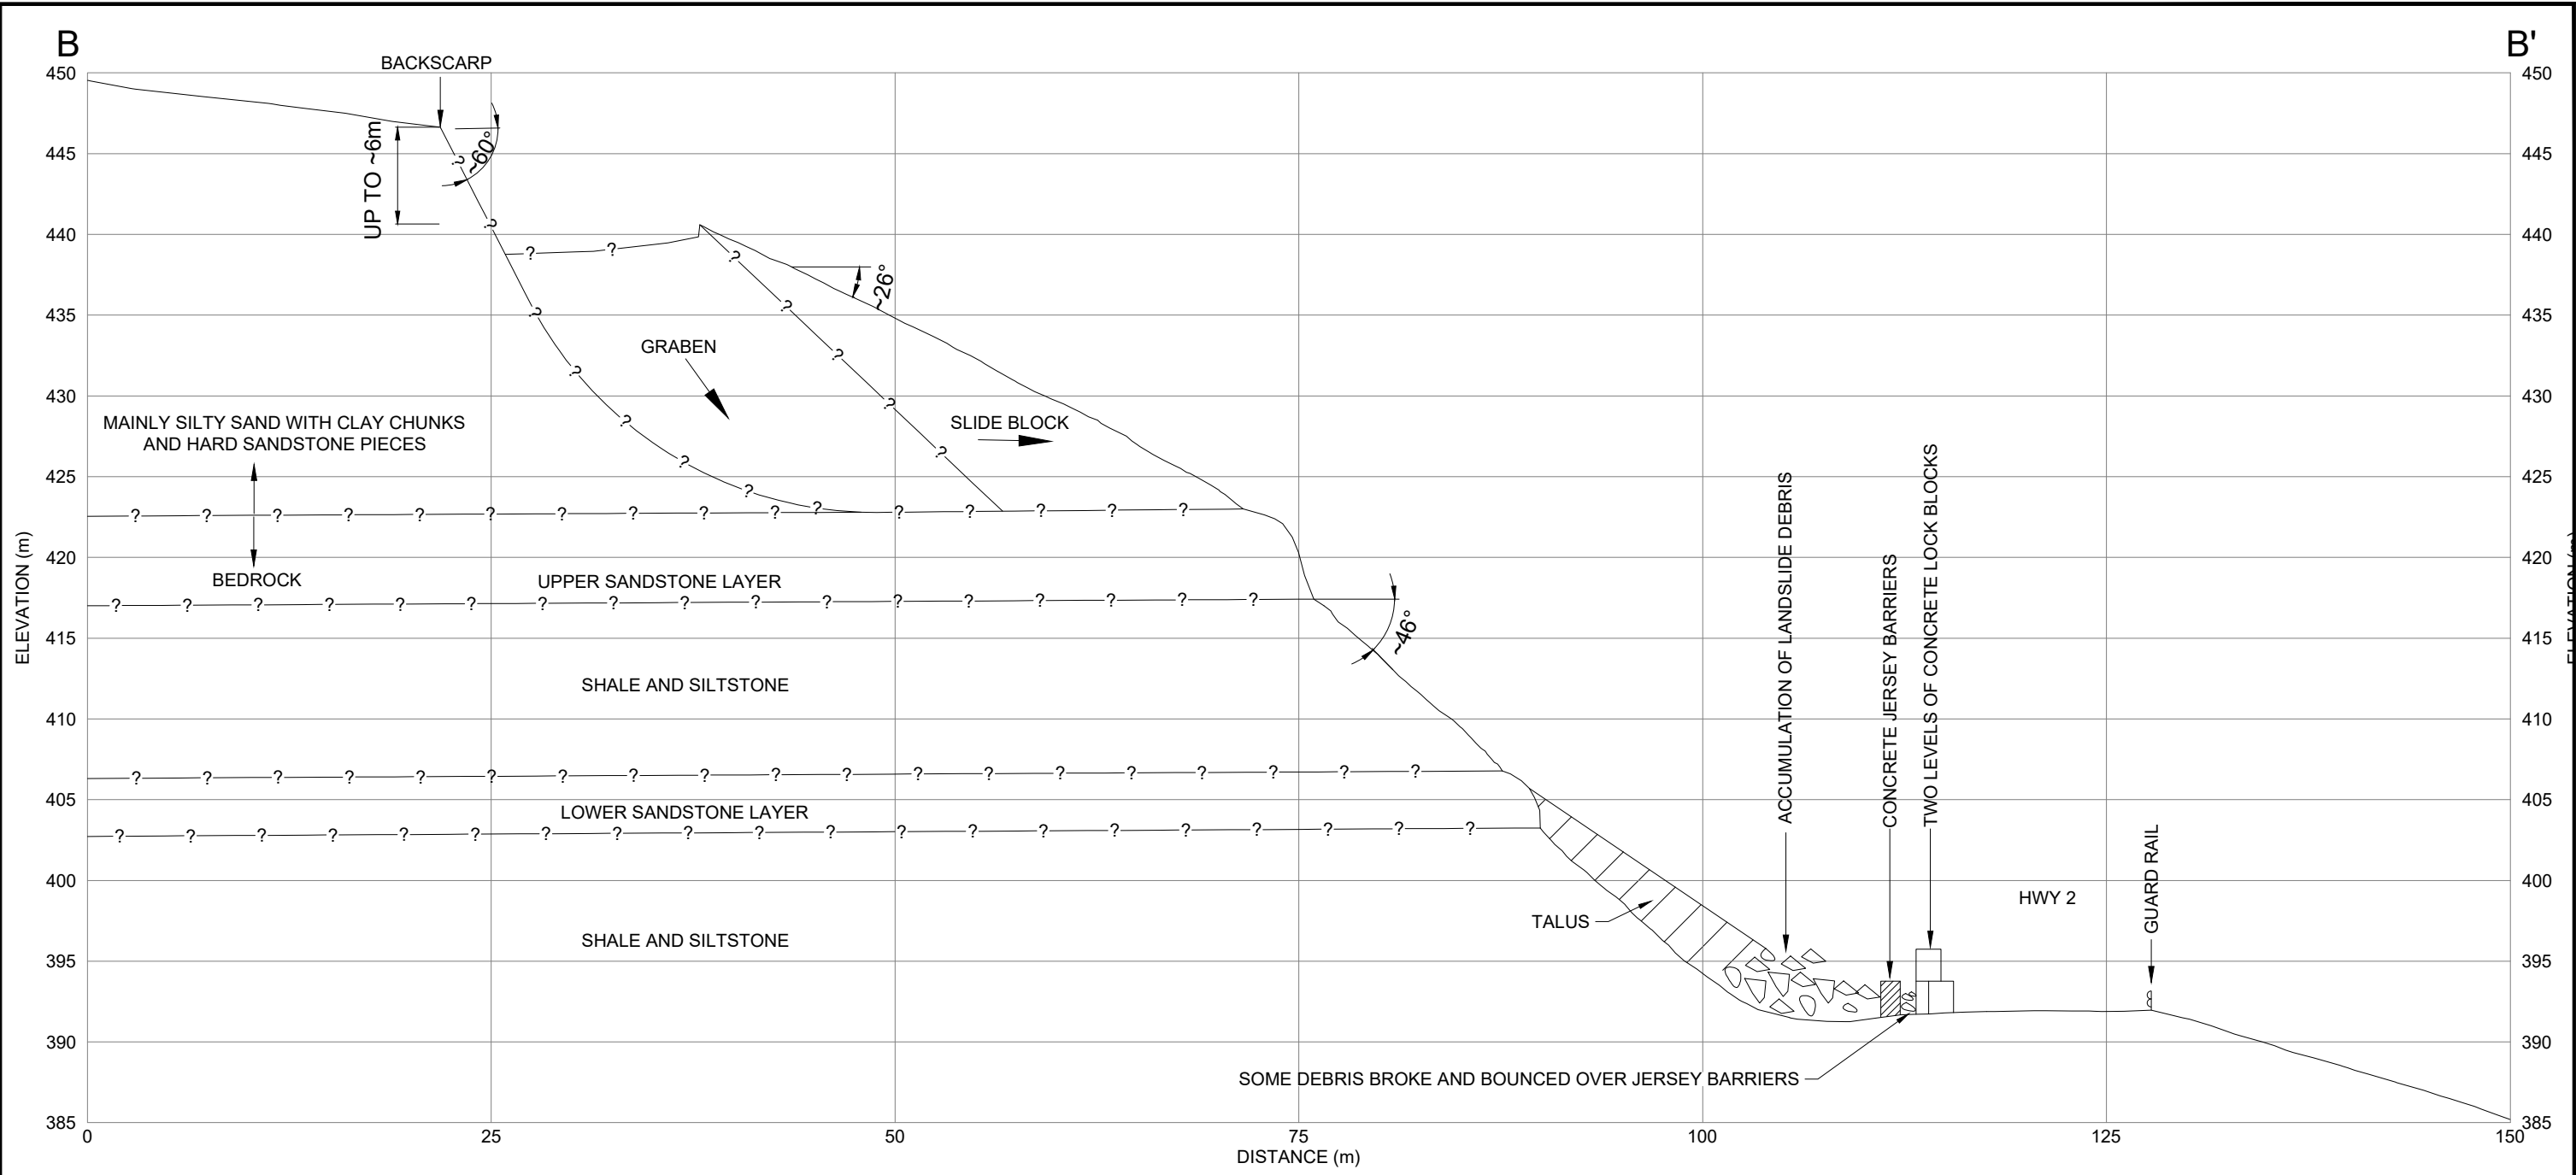
**FIGURE 2**

In the past, similar landslides and debris flows in this area have typically occurred in the gullies due to the concentration of surface runoff water from heavy rain fall events. The inferred slip surface for this landslide is along the top of the upper sandstone bedrock layer at an approximate elevation 423 m (Refer to Figure 2).

**CROSS - SECTION B - B'**

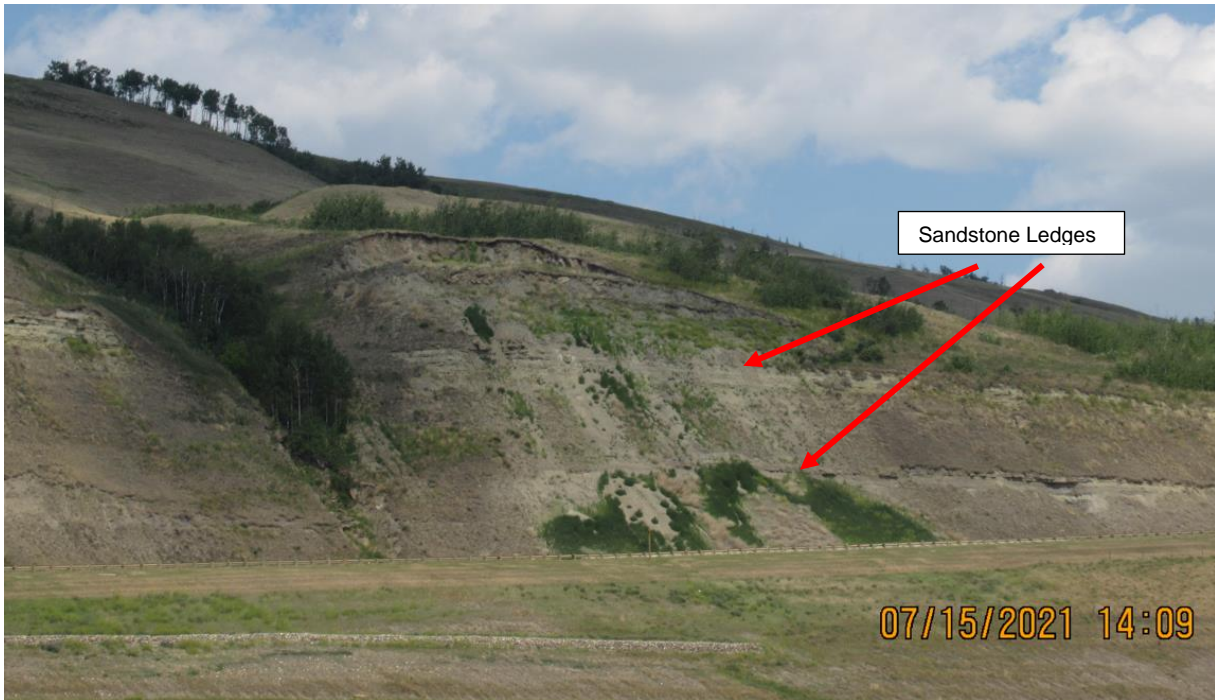
Photo 1: Looking northeast at the landslide site from the north terrace of the Peace River

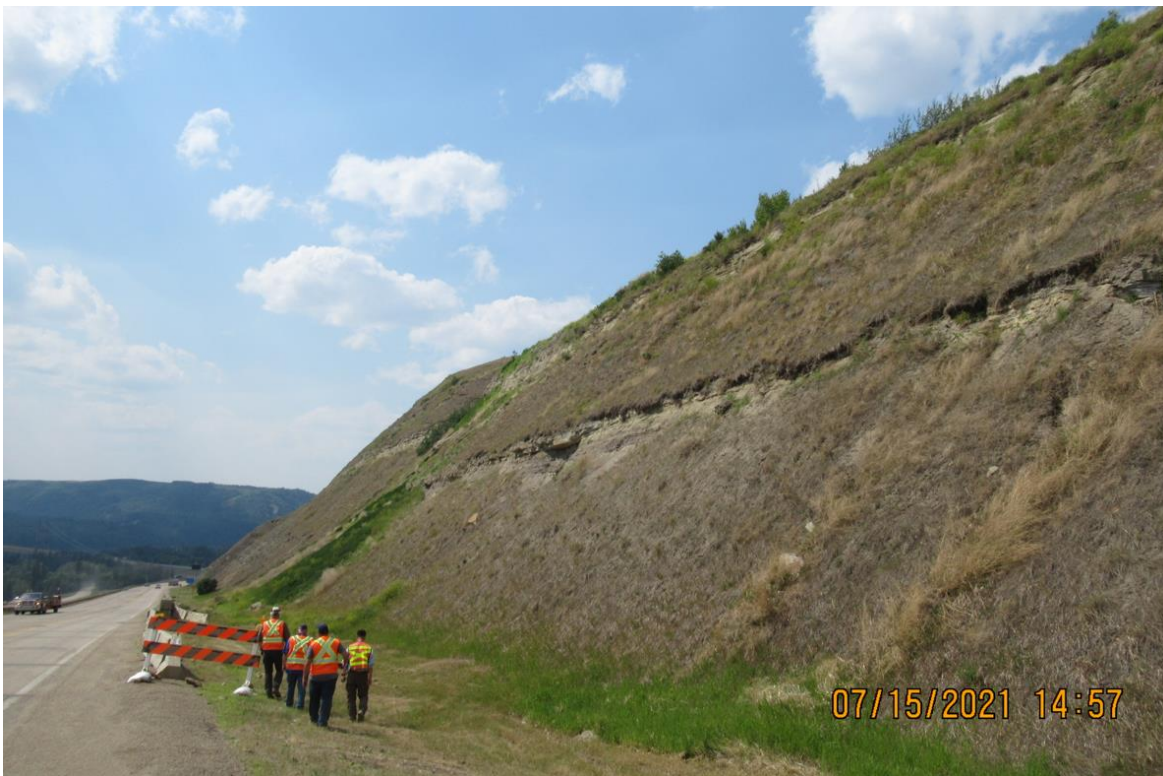
The maintenance contractor has erected concrete lock blocks and jersey barriers to help contain the debris to keep it off the highway. However, there is still a risk that the remainder of the slide debris volume (about 20,000 m<sup>3</sup>) could fall catastrophically onto the highway in a fast-moving mudslide if it gets saturated during a heavy precipitation event. If the slide material came down in a big single event it could dislodge the concrete barriers and flow out onto and close the highway.

The provision of the concrete barriers has reduced but not eliminated the risk of further rock falls to the travelling public.

Photo 2: Looking west at the highway backslope below the landslide and concrete barriers

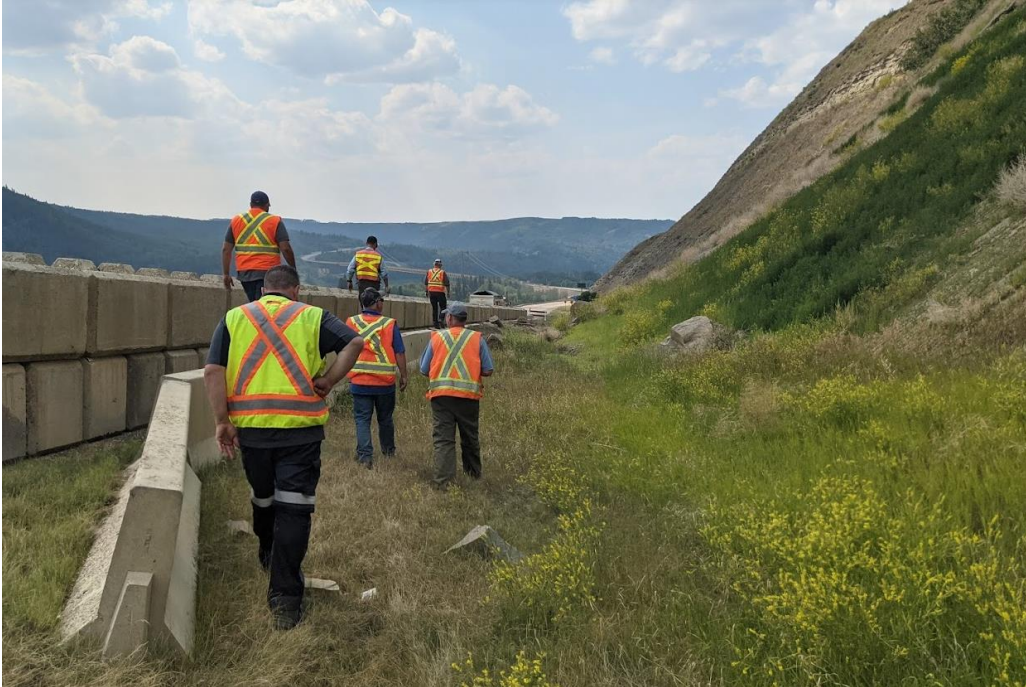
Photo 3: Looking west at accumulated debris in the ditch below the landslide. Note vegetation starting to grow on the backslope

An alternate plan would be to leave the landslide mass to tumble down the backslope at its own rate and complete regular maintenance to remove the fallen debris during dry weather conditions to maintain a storage capacity behind the barriers and allow the ditch to pass runoff drainage. This option carries a higher risk of injury to the public.

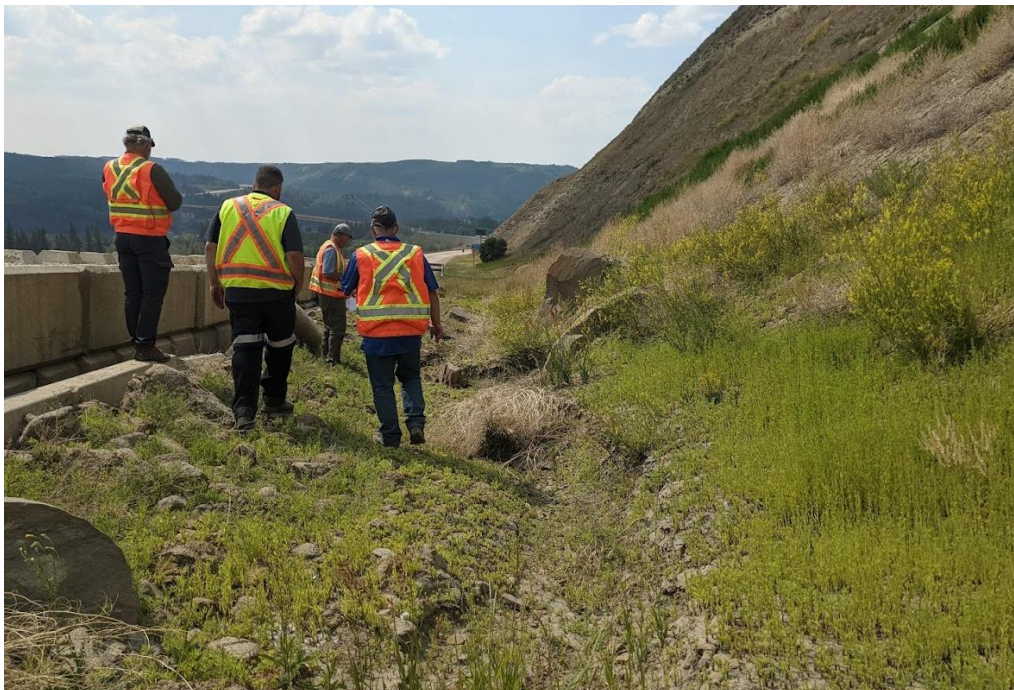
Photo 4: Looking west at the accumulated sandstone slabs, talus, boulders, and soil chunks appears to be approximately the same as 2020. But, with some vegetation growing

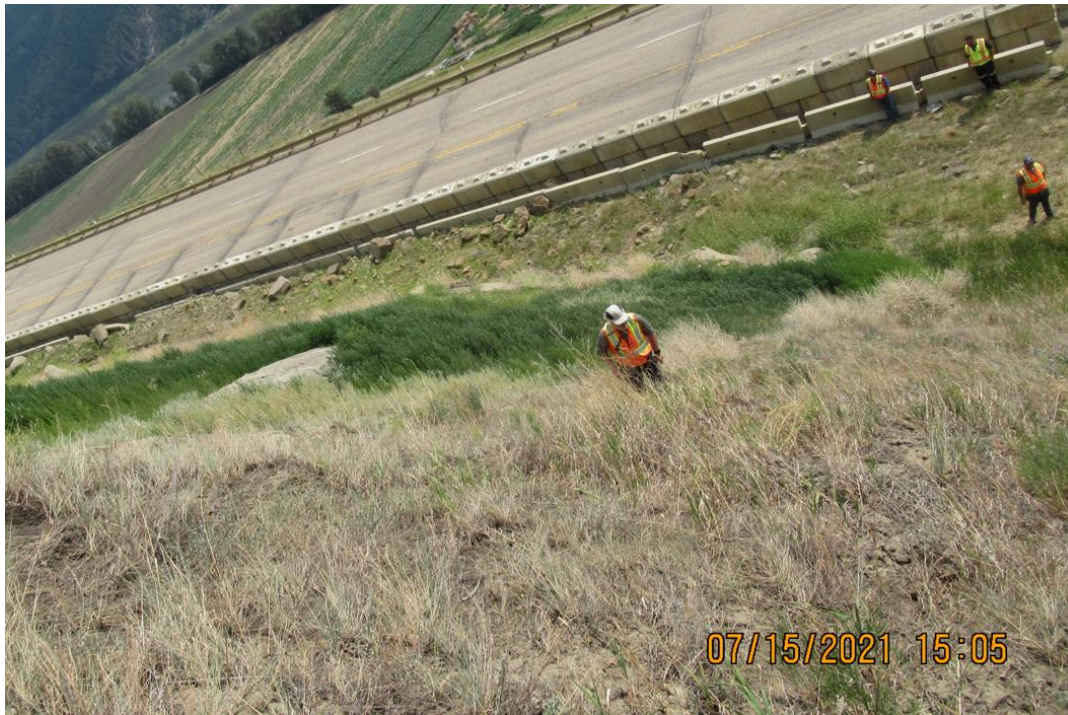
Photo 5: Looking southeast at landslide debris; note talus, boulders, and soil chunks that have accumulated in the ditch below the landslide

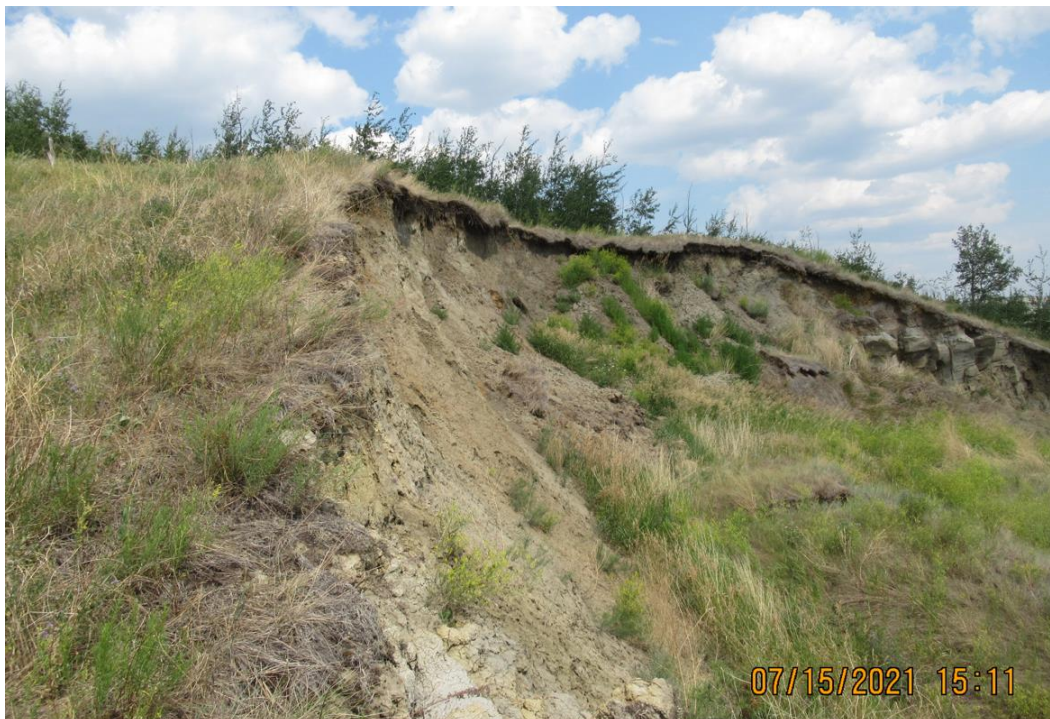
Photo 6: Looking northeast along backscarp of the landslide

If possible, the remaining slide mass should be carefully removed from the top of the slope to reduce the potential for further debris to fall onto the highway below. Due to the possibility of crumbling of the edge of the sandstone bedrock layer, equipment should be kept back at a minimum distance of 3 m from the crest of the steep backslope. This could be accomplished using a long reach excavator that would access the site from privately owned land to the north of the landslide. The excavator would push the failed material over the crest of the slope. This would need to be monitored with spotters equipped with two-way radios positioned at the top of the steep backslope section and along the highway. Once the outer 15 m of the landslide debris has been removed, the backscarp should be flattened to an inclination of 2.5H:1V and the remaining slide debris should be cut-down and flattened as a buttress with a slope angle of 5H:1V. Depending on the extent of the backscarp, this may require the acquisition of privately-owned land above the current landslide.

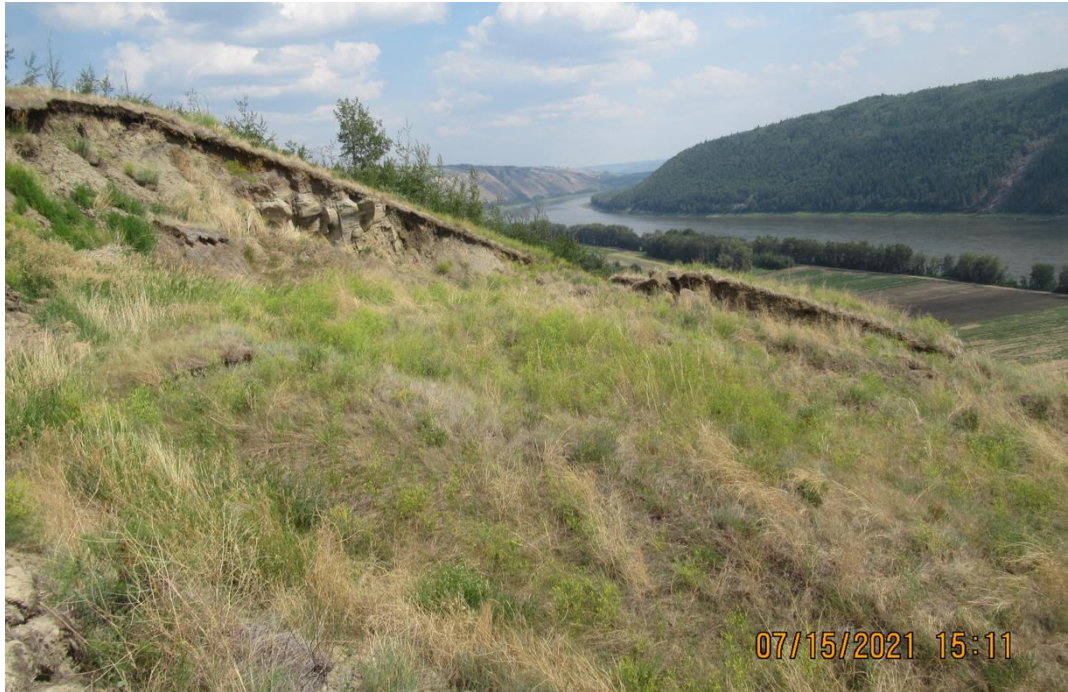
Photo 7: Looking east from landslide backscarp

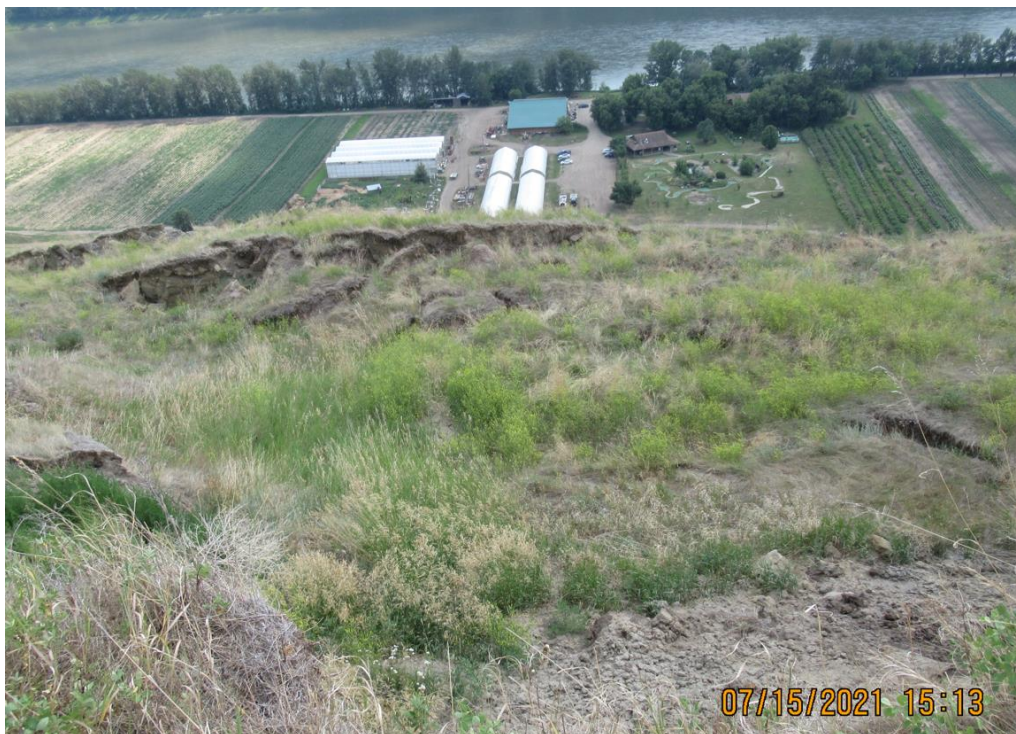
Photo 8: Looking south from the middle of the backscarp of the slide

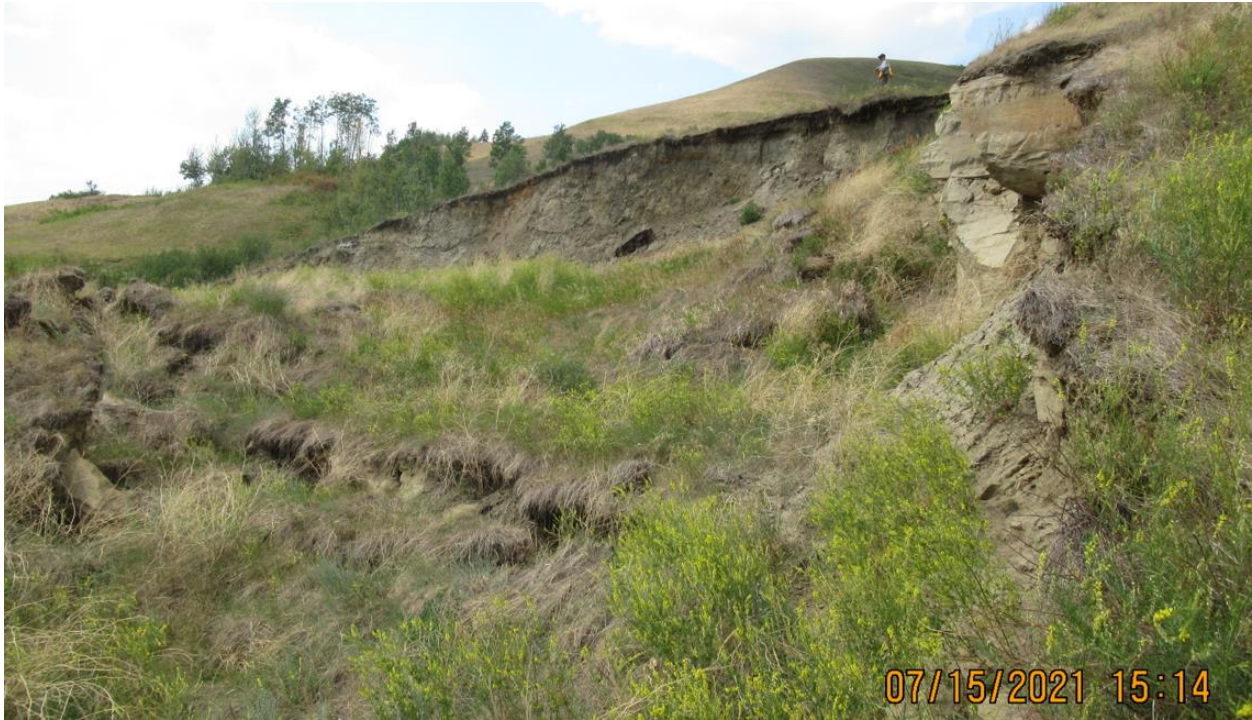
Photo 9: Looking west along the backscarp

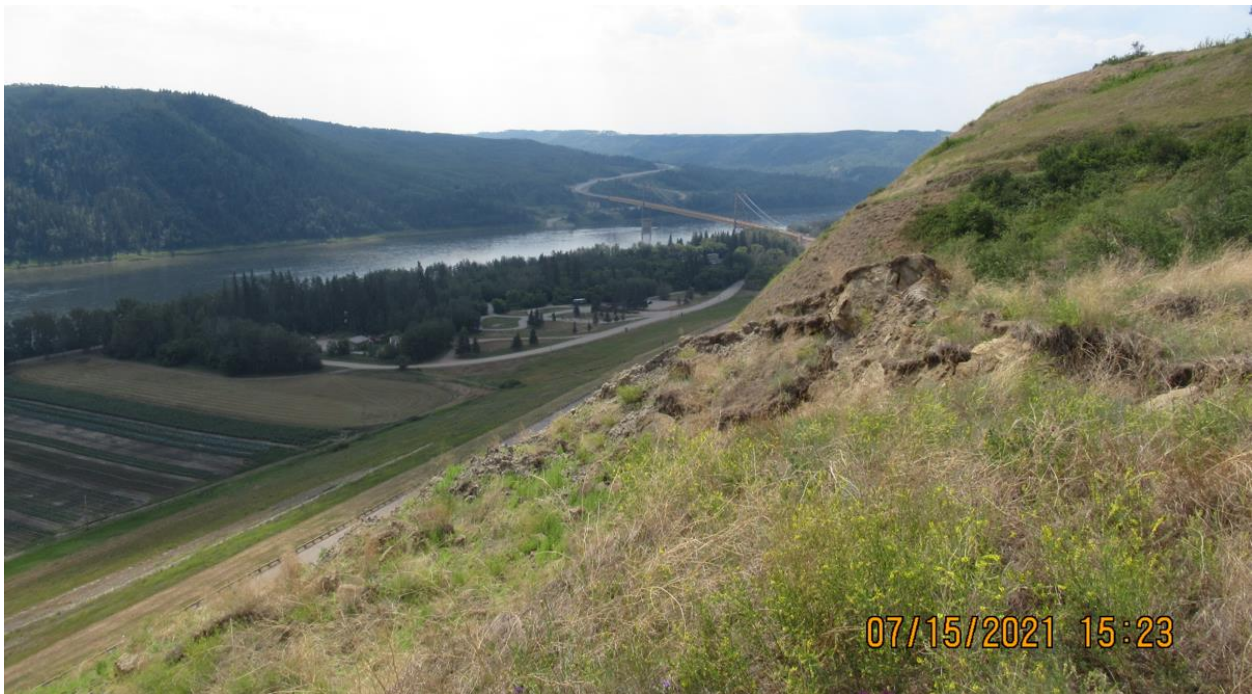
Photo 10: Looking west along the toe of the slide

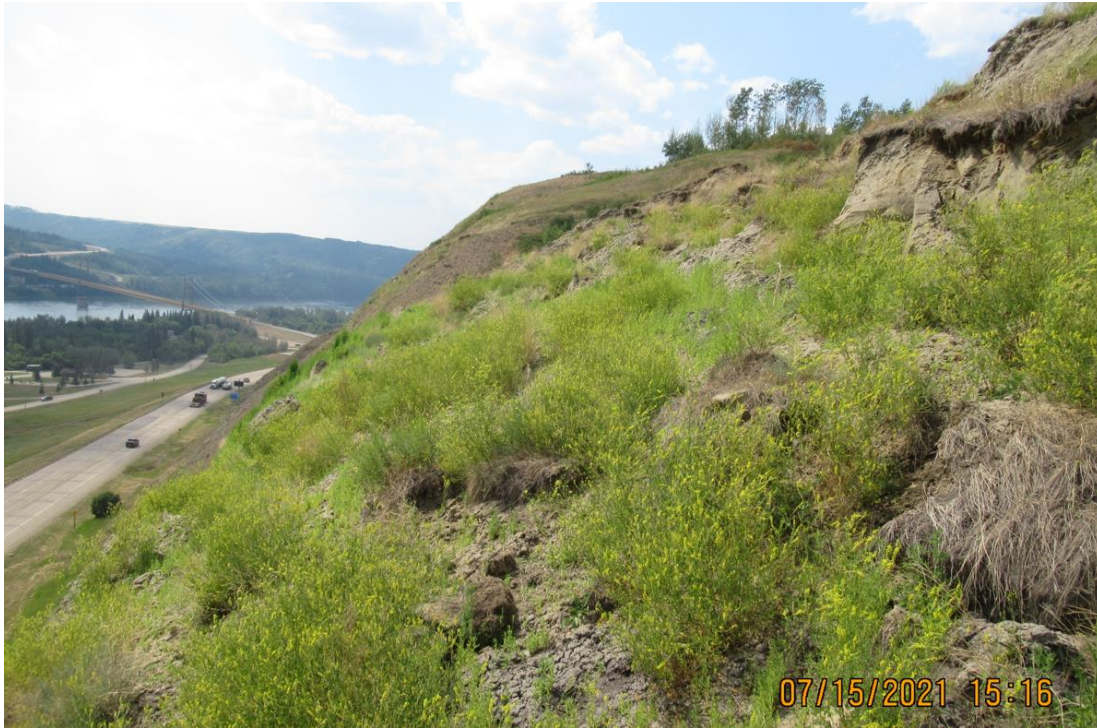
Photo 11: Looking southwest within the landside mass; note active toe roll
