**ALBERTA TRANSPORTATION
AND ECONOMIC CORRIDORS
GEOHAZARD ASSESSMENT PROGRAM
PEACE REGION –
GRANDE PRAIRIE DISTRICT - NORTH
2025 INSPECTION**

Site Number	Location	Name	Hwy	km
PH001	Dunvegan	Dunvegan Hill, North	2:68	12.60
Legal Description		UTM Co-ordinates		
NE¼ 08-080-04 W6M		11U E 400694	N 6198867

PH001: DUNVEGAN HILL - NORTH
2025 PH001 INSPECTION PLAN

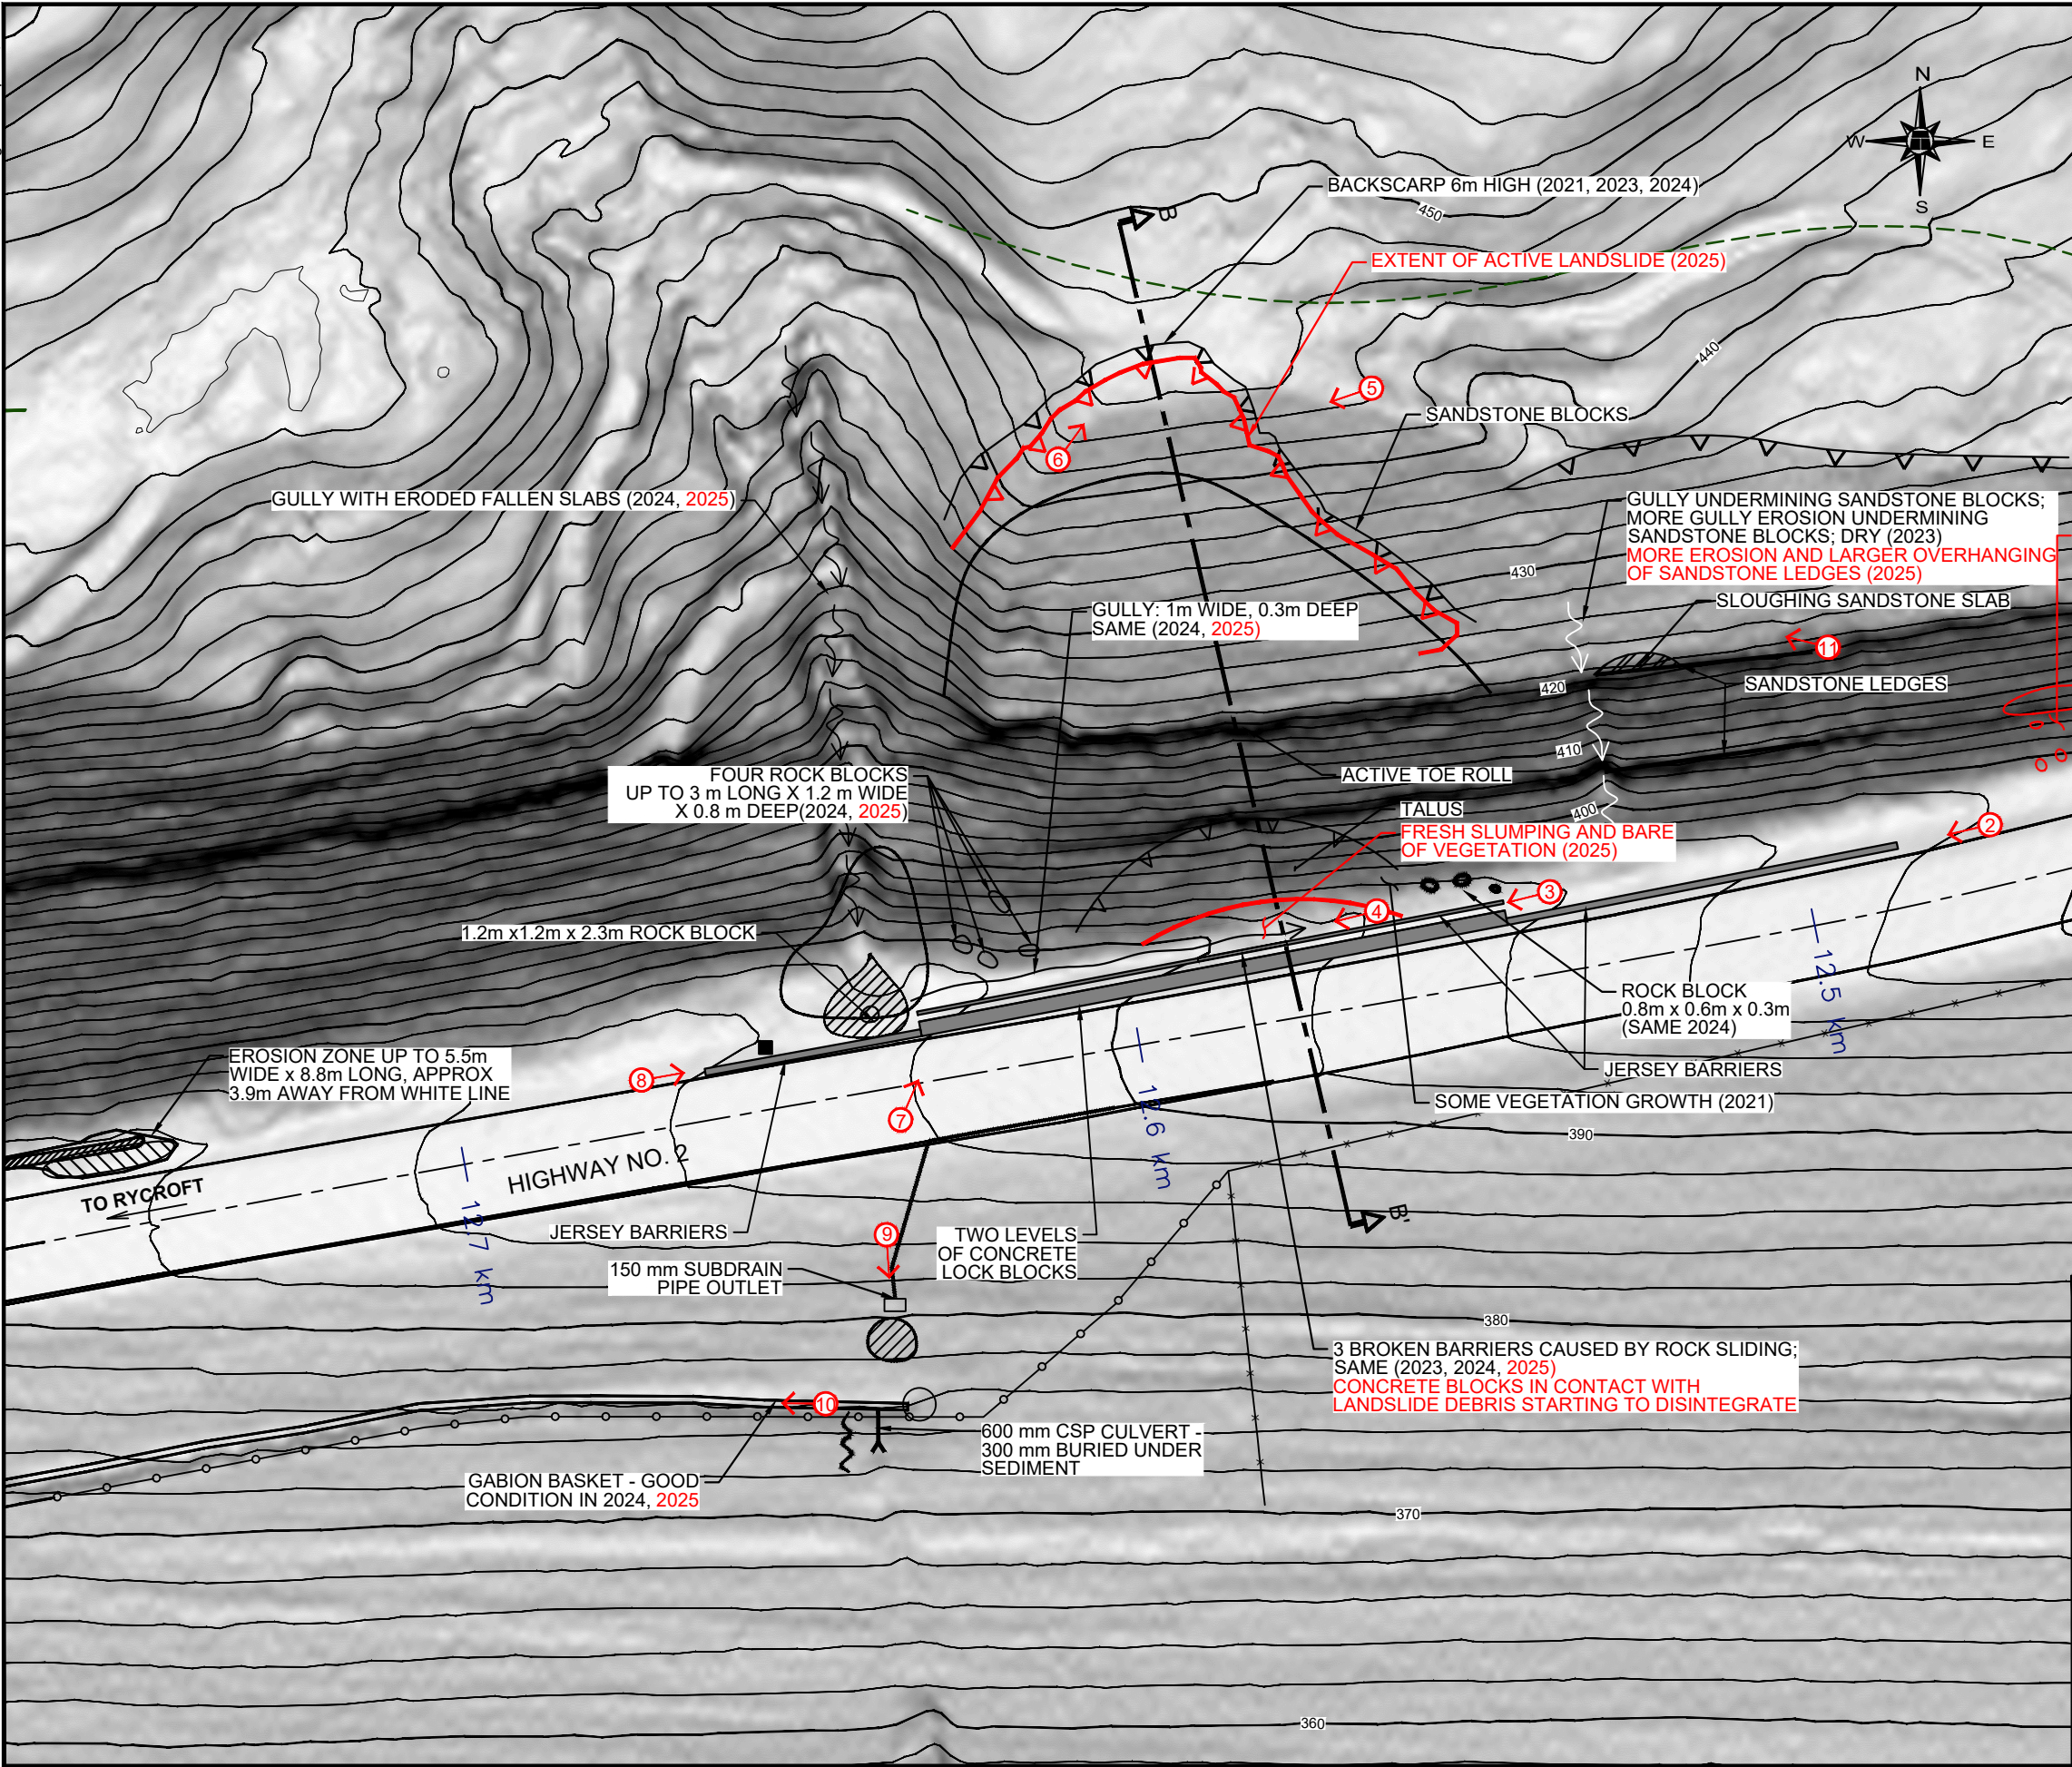
FIGURE 1

<input checked="" type="checkbox"/> Slope Movement	The approximate plan outline of the landslide is shown on Figure 1. The exposed backscarp height at the center of the landslide was about 6 m. A graben had formed along the base of the scarp. The soil exposed in the backscarp, and slide mass appears to consist mainly of silty sand, with some clay and hard/strong sandstone pieces embedded within it.	<input type="checkbox"/>	
<input checked="" type="checkbox"/> Other	Currently, the slide material is toppling over the edge of the steep bedrock slope at a relatively slow rate. Broken pieces of sandstone ledge continue to accumulate between the toe of the backslope and the concrete blocks. Concrete blocks in contact with landslide debris are disintegrating. Larger overhanging sandstone ledges noted in 2025. Lower sandstone ledge starting to crumble 20 m east of the jersey barrier resulting in sandstone blocks (0.9 m diameter by 0.15 m thick) accumulating on the backslope and ditch.	<input checked="" type="checkbox"/>

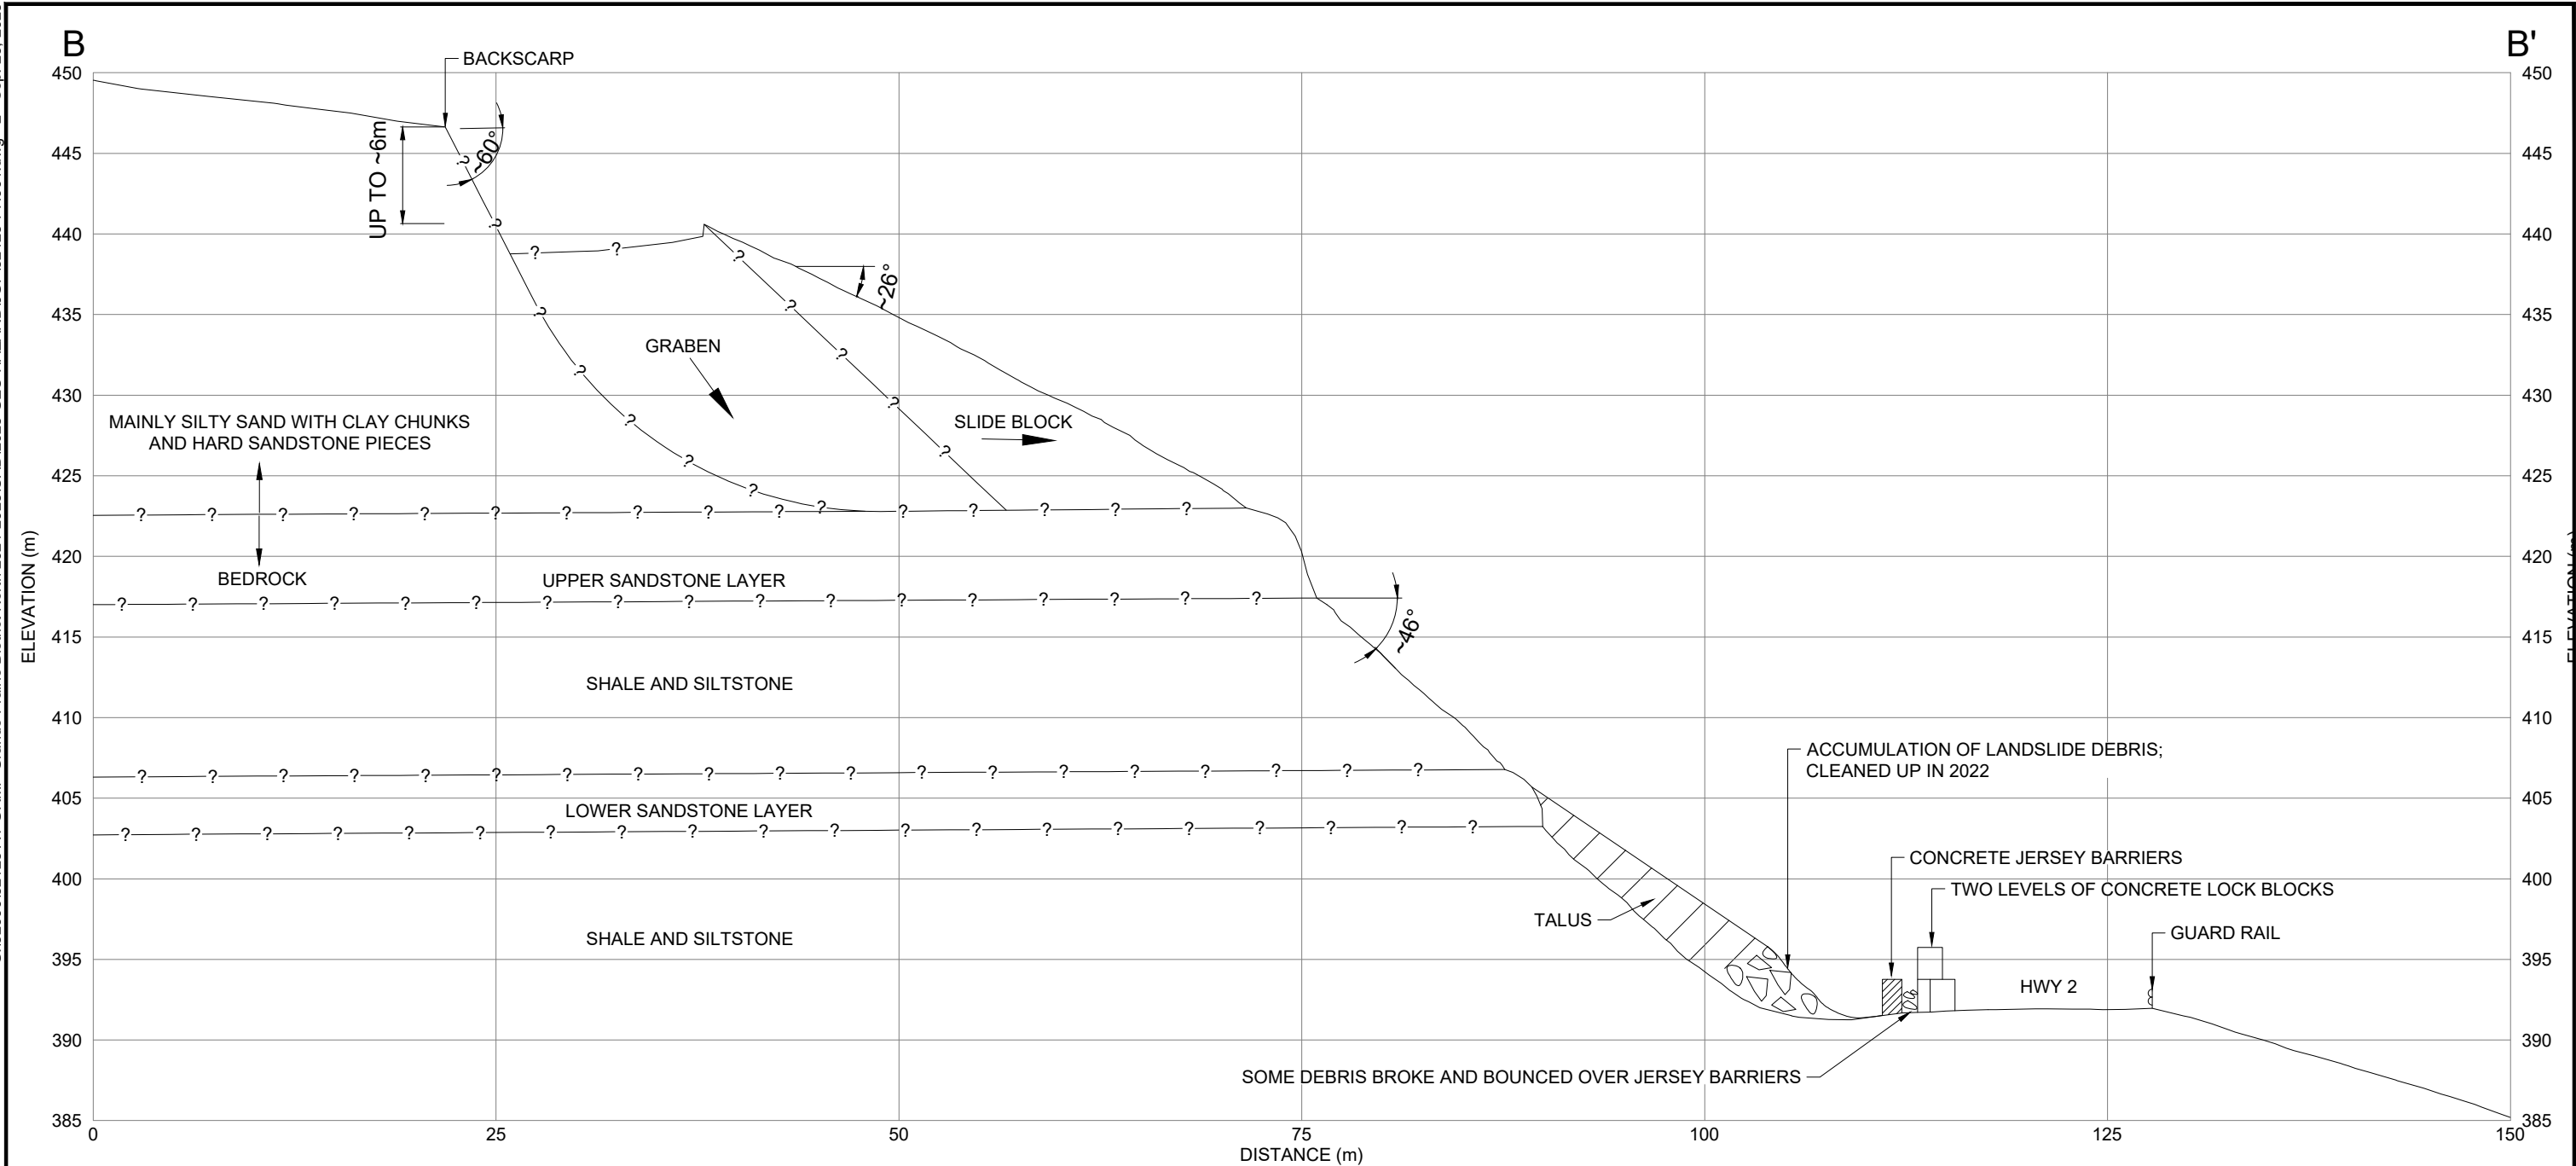
FIGURE 2

The inferred slip surface for the landslide is in the base of the soil colluvium layer, just above the upper sandstone bedrock layer at an approximate elevation 423 m (Refer to Figure 2). This landslide is considered to have been triggered by either a temporary rise in groundwater perched in the colluvium or a concentration of surface water runoff at this location. The primary concern for this site is the potential for further colluvium and weathered sandstone bedrock debris accumulating along the edge of the upper sandstone ledge debris to continue to fall onto the highway causing a risk to public safety. Furthermore, there is also a risk that the cascading landslide debris can dislodge undermined sandstone slabs from the two sandstone layers below that might travel faster and further out into the highway and possibly strike a vehicle.

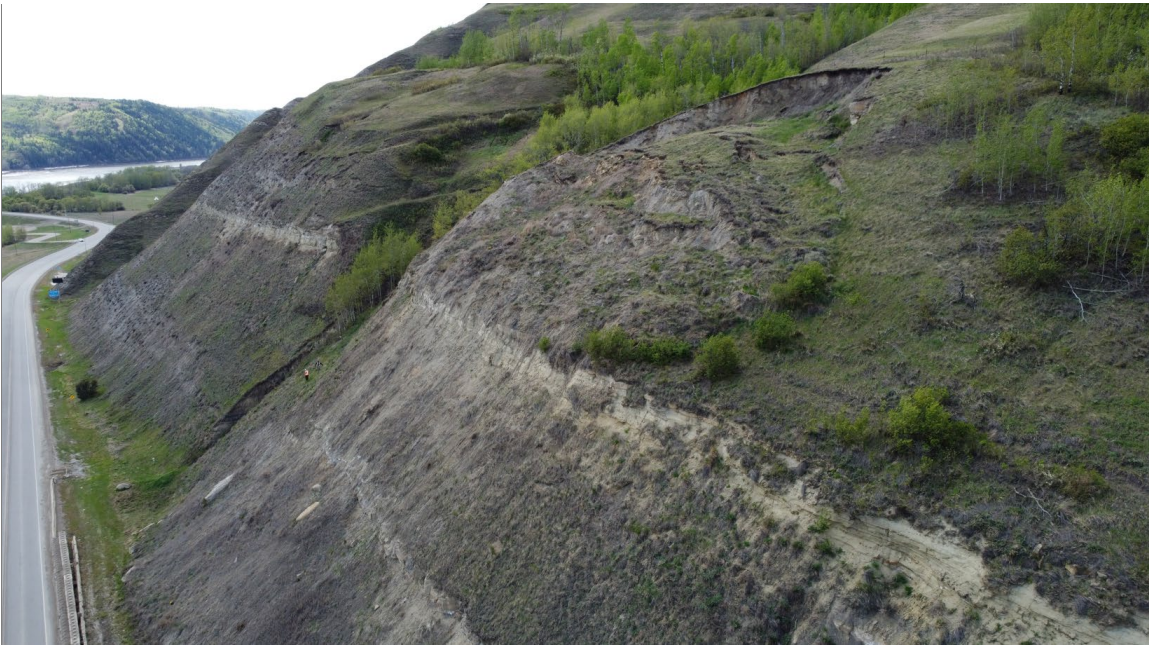
Aerial Photo 1: Looking west at the landslide site and surrounding area

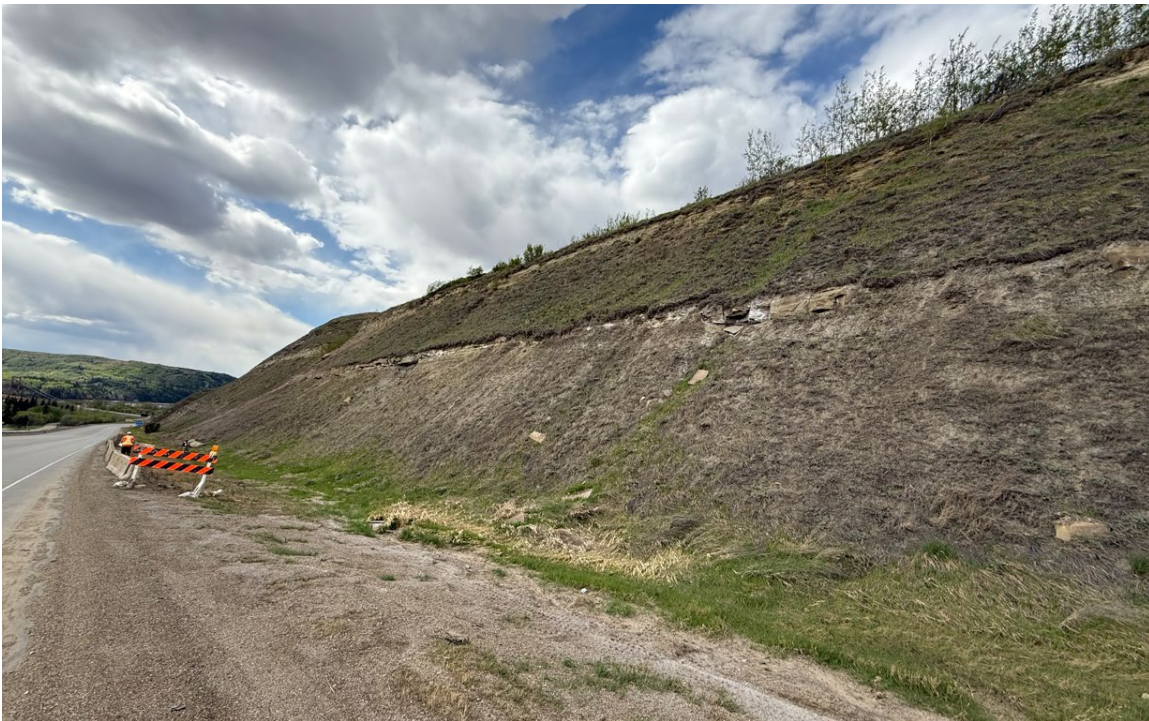
Photo 2: Looking west at the highway backslope and concrete barriers below the landslide

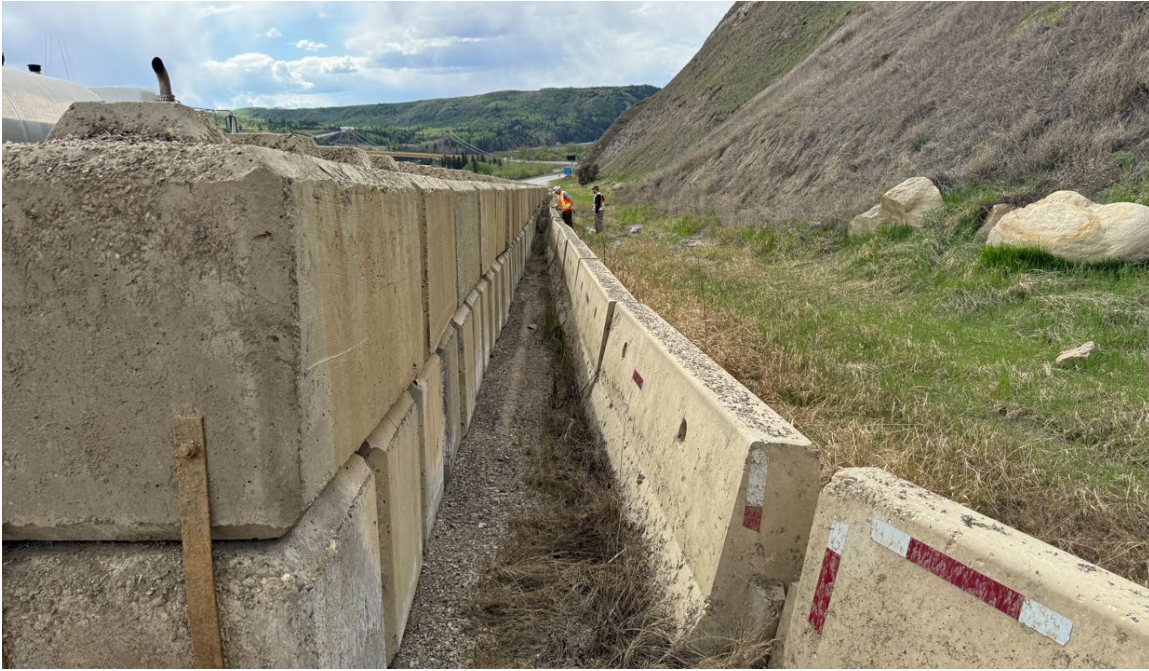
Photo 3: Looking west at accumulated debris in the ditch below the landslide.

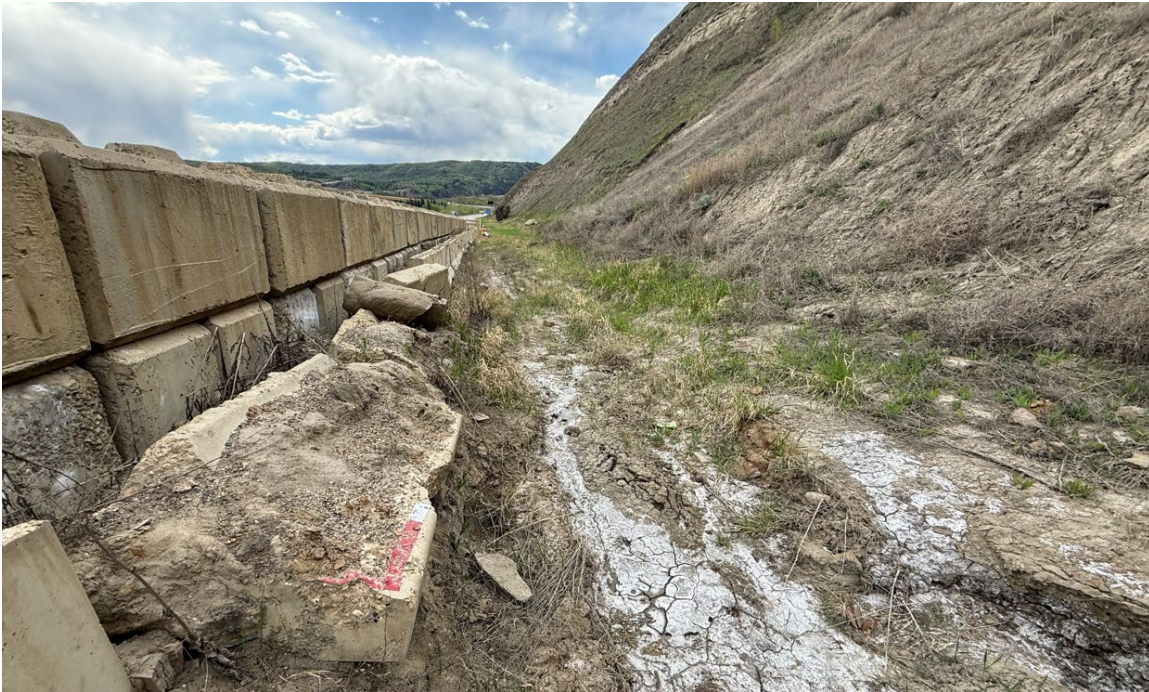
Photo 4: Area where sandstone slabs, talus, boulders accumulated the most prior to the 2022 clean up. Note fresh slumping on the lower backslope on the right of the photo. Concrete blocks that are in contact with landslide debris are starting to disintegrate.

The slide material in contact with the concrete lock blocks should be removed and disposed of offsite. Any lock blocks that have deteriorated should be replaced with new ones. Additionally, the coverage of the concrete lock blocks should be extended to align with the observed rockfall area beyond the eastern end of the existing jersey barrier.

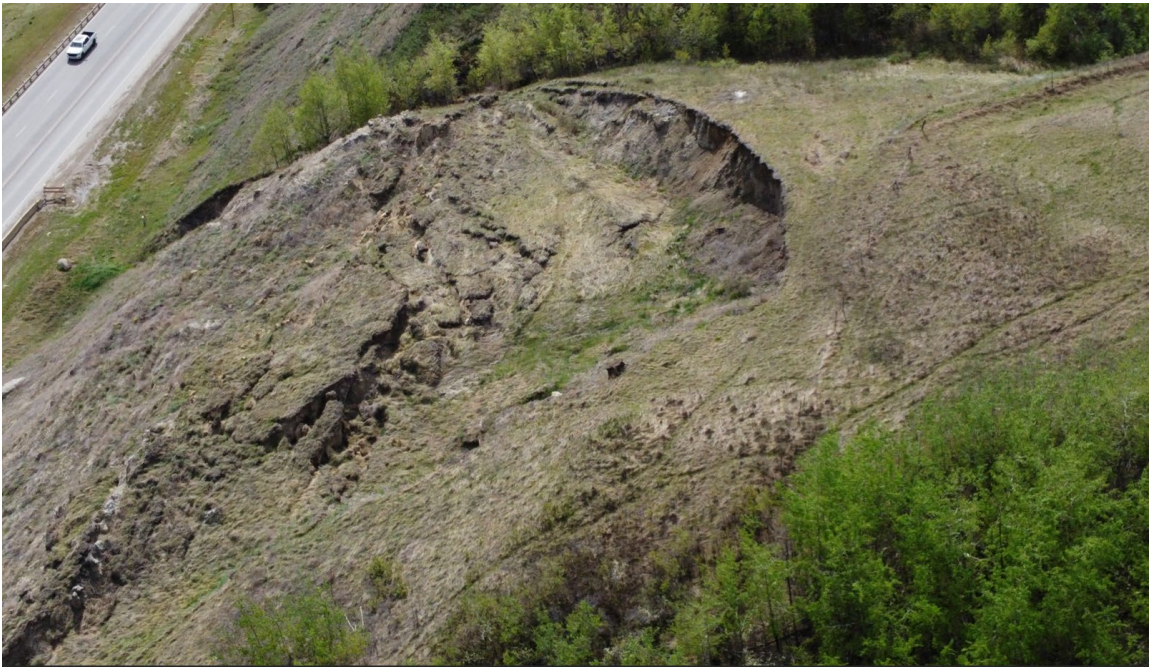
Aerial Photo 5: Looking northwest where landslide debris has been toppling over the edge of the steep bedrock slope

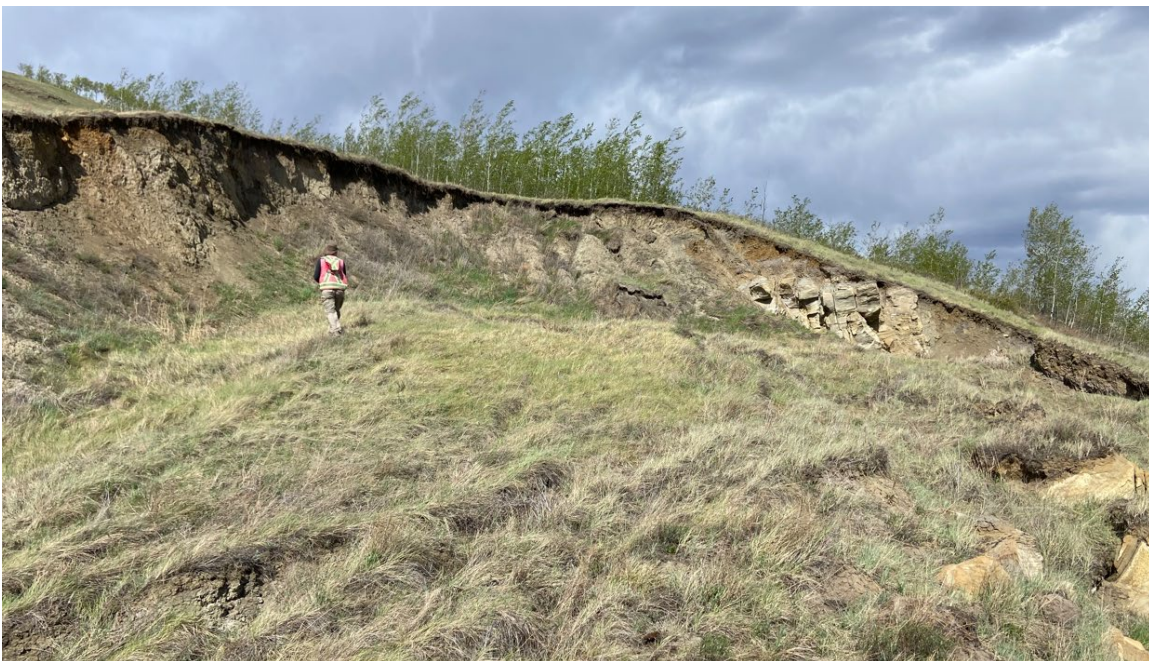
Photo 6: Landslide backscarp showing movements since 2023.

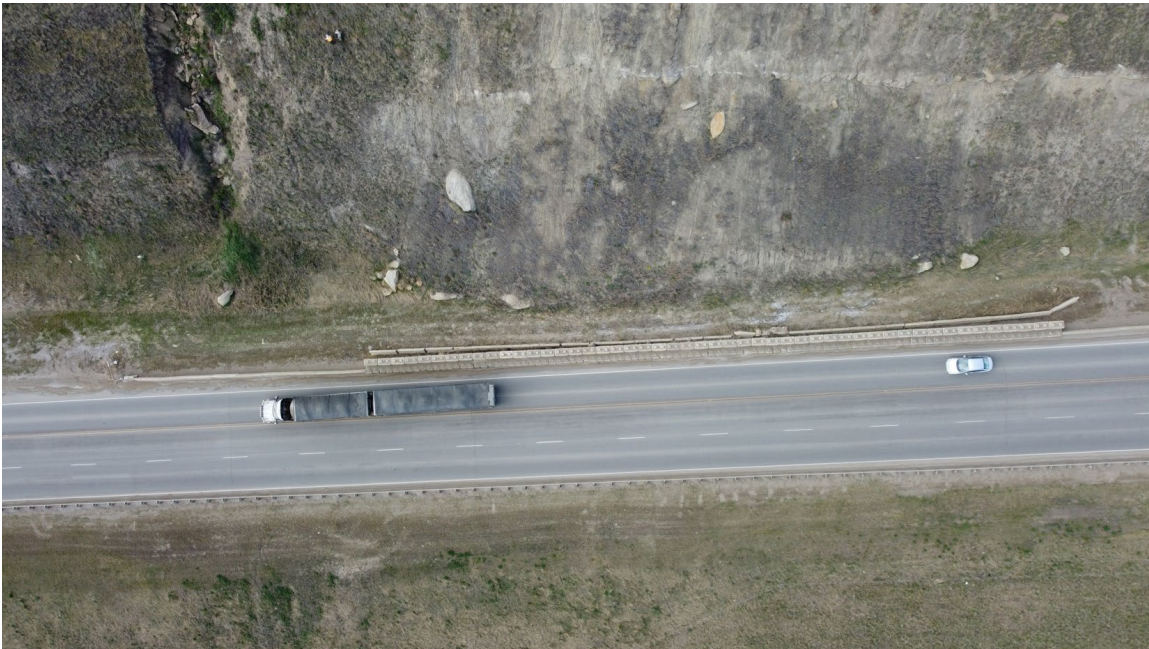
Aerial Photo 7: Few sandstone rock slabs accumulating behind the Concrete Jersey Barrier

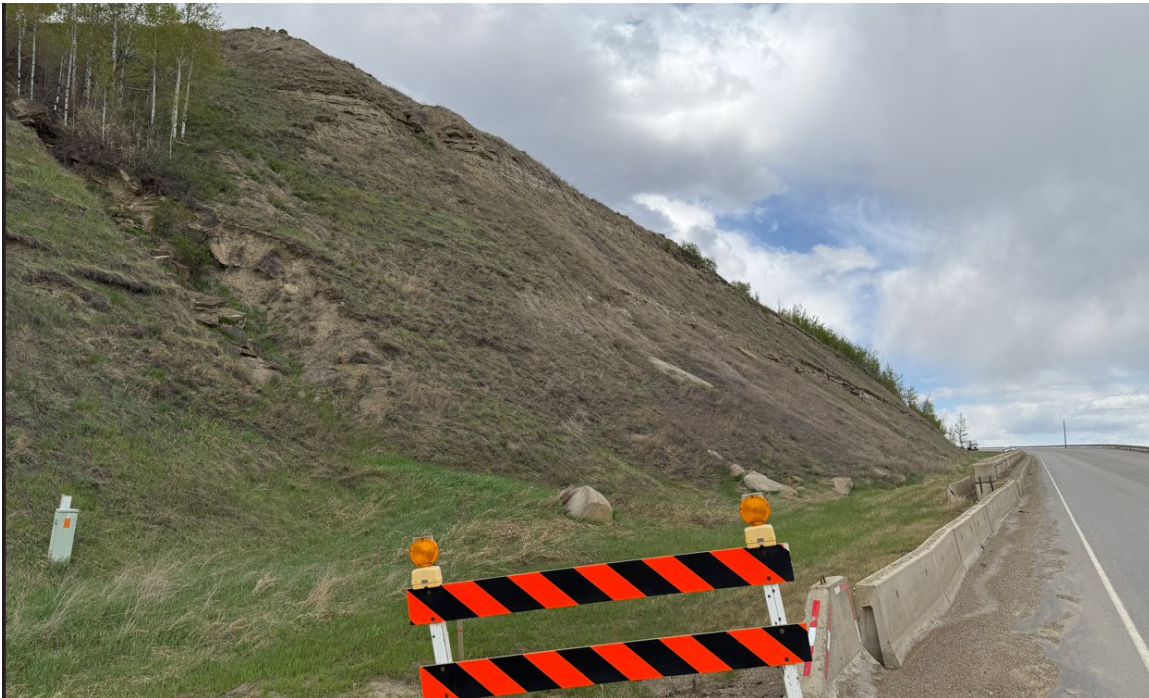
Photo 8: Looking east at steep rock backslope and a few sandstone blocks accumulating behind the Concrete Jersey Barrier

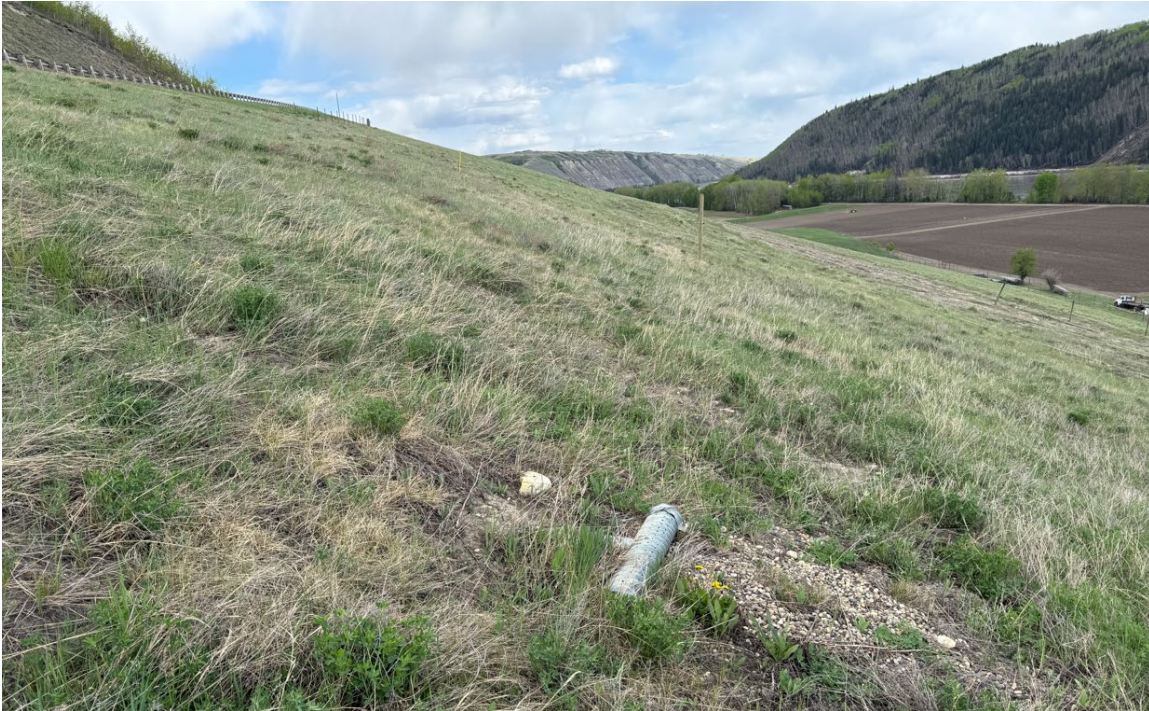
Photo 9: Subdrain outlet located upslope from gabion basket. Dry in 2025

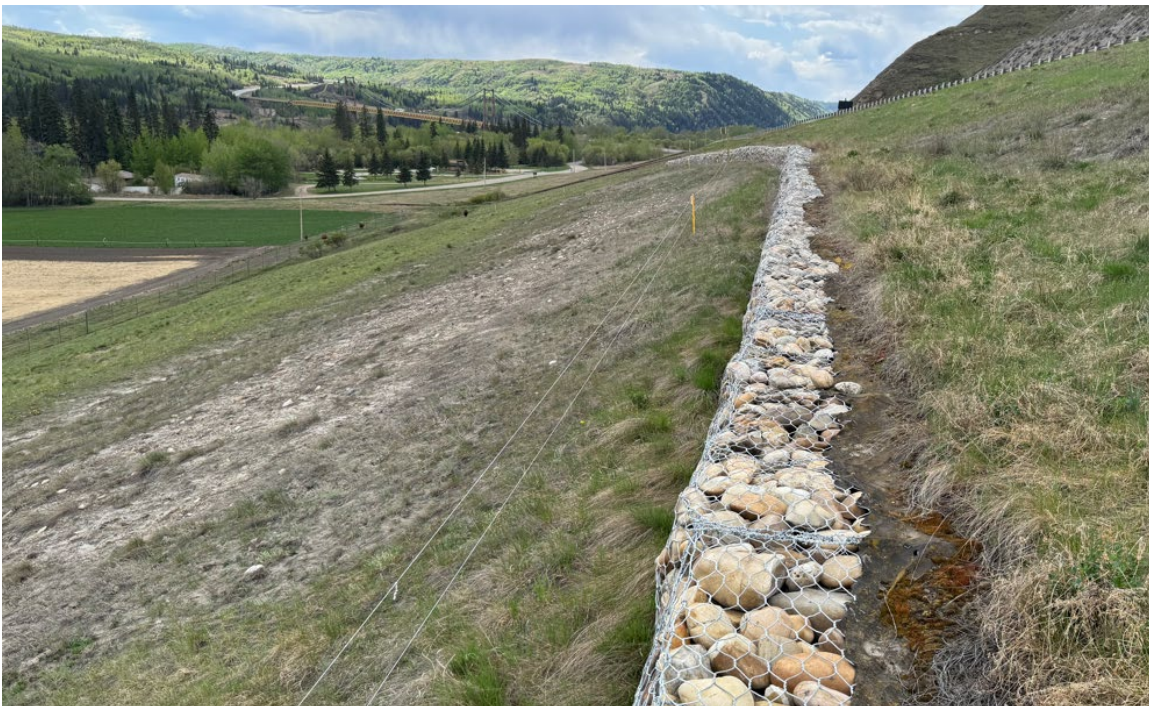
Photo 10: Gabion Basket. Acceptable condition in 2024

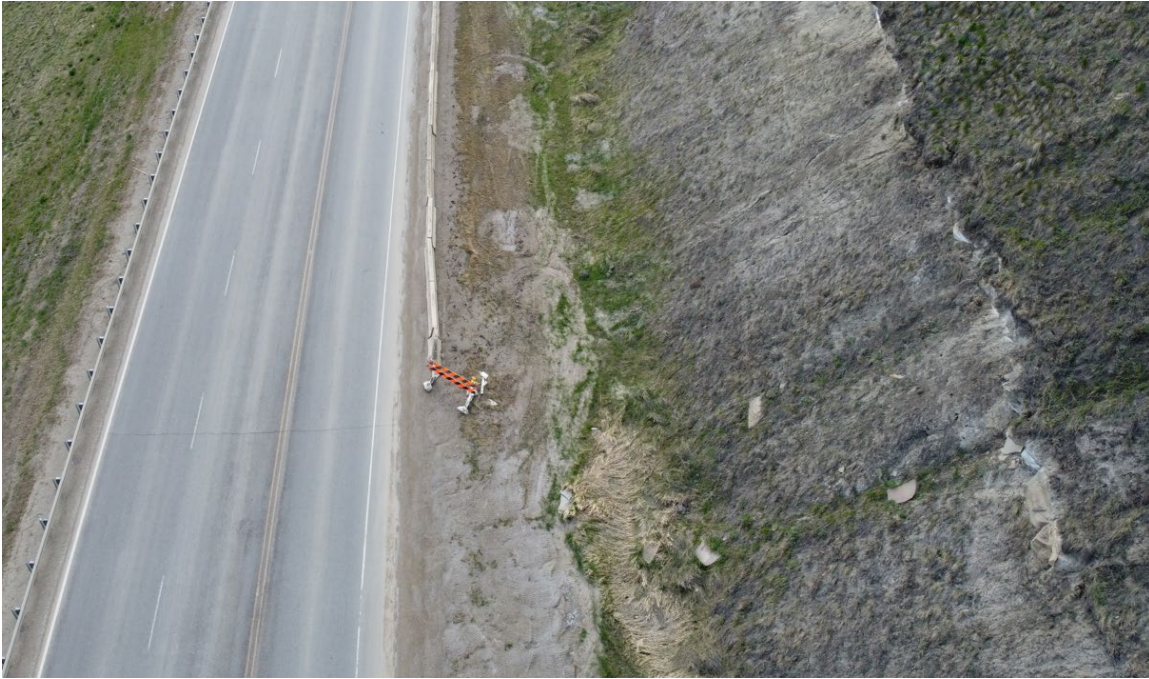
Photo 11: Lower sandstone ledge starting to crumble 20 m east of Jersey barrier.
