**ALBERTA TRANSPORTATION
GEOHAZARD ASSESSMENT PROGRAM
PEACE REGION –
GRANDE PRAIRIE DISTRICT – NORTH
2021 INSPECTION**

Site Number	Location	Name	Hwy	km
PH036	Dunvegan	Dunvegan South Elephant Trunk	2:68	16.216
Legal Description		UTM Co-ordinates		
NW¼ 06-080-04 W6M		11U E 398549	N 6196741

Date	PF	CF	Total
Previous Inspection:	12-June-2020	16	3	48
Current Inspection:	July 15, 2021	10	4	40
Road WAADT:	2,380		Year:	2020
Inspected By:	Rocky Wang, TRANS Ed Szmata, TRANS Roger Skirrow, TRANS Max Shannon, TRANS Jason Parr, TRANS		Don Proudfoot, Thurber José Pineda, Thurber	
Report Attachments:	<input checked="" type="checkbox"/> Photographs <input checked="" type="checkbox"/> Plans <input checked="" type="checkbox"/> Maintenance Items

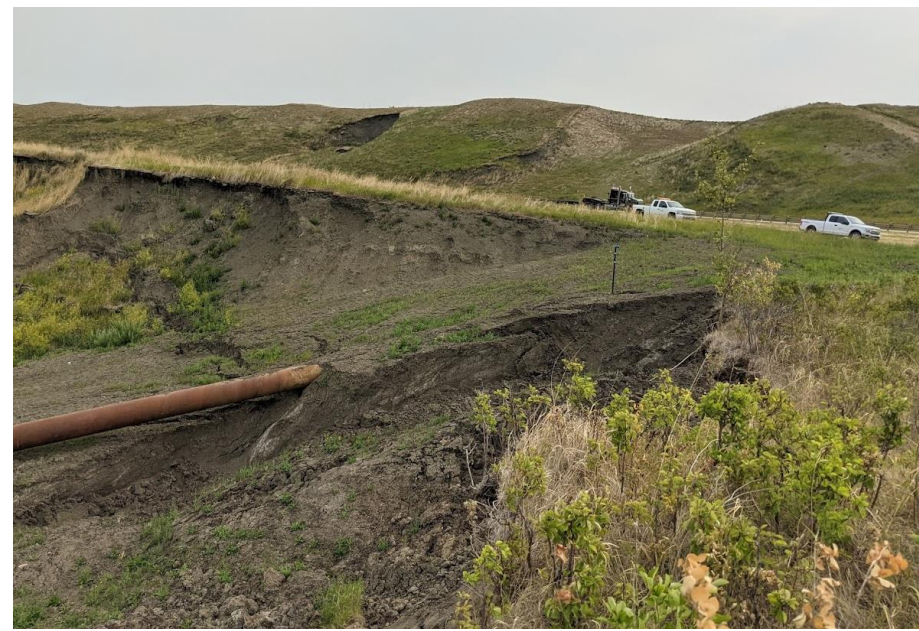
Photo 1.
Looking northeast from Sta. 2+320 towards the Dunvegan Elephant Trunk consisting of a 760 mm diameter smooth wall steel pipe installed in 2020. Note vent pipe near the scarp crack.

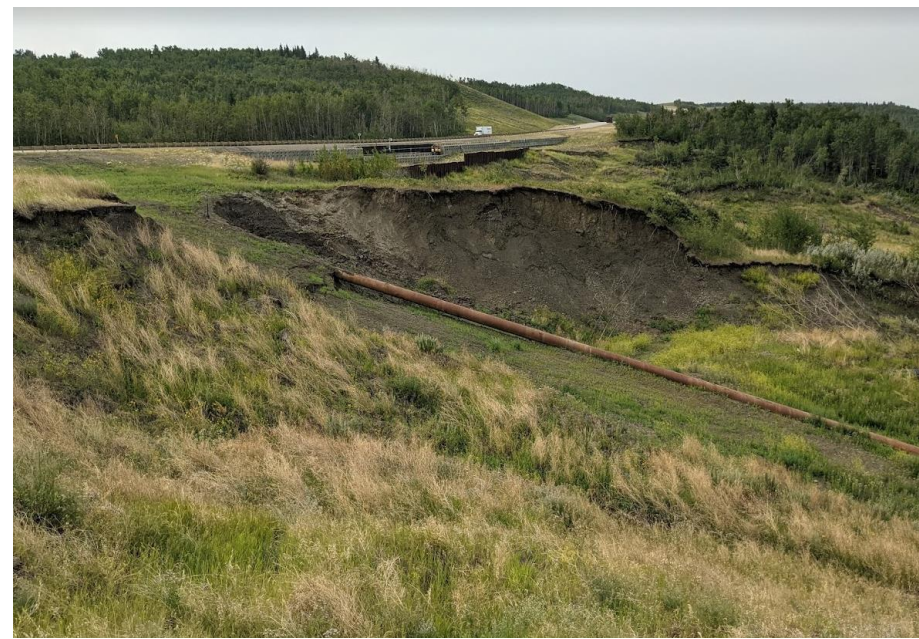
Observations:	Description	Worsened?
<input type="checkbox"/> Pavement Distress		<input type="checkbox"/>
<input checked="" type="checkbox"/> Slope Movement	There is continuing shallow and deep slide movement through the gully along which the Elephant Trunk was routed. Slope movements extend to near the head of the gully, with a significant scarp as shown in Photo 1. Scarps continue to develop across the head of the gully, with additional scarps extending south towards the 2+500 slide – The backscarp of the larger slide area is now up to 10 m high (Photo 3).	<input checked="" type="checkbox"/>

The landslide mass that the new SWSP drainpipe alignment crosses is still moving and has removed some of the subgrade support below the pipe.	
<input checked="" type="checkbox"/> Erosion	There is ongoing erosion of the bare landslide debris due to precipitation that is not related to the flow that is now contained within the pipe.	<input checked="" type="checkbox"/>
<input type="checkbox"/> Seepage		<input type="checkbox"/>
<input checked="" type="checkbox"/> Bridge/Culvert Distress	No signs of structural damage were noted in the new SWSP. However, the steel pipe shows signs of lateral movement up to 120 mm due to thermal effects. In addition, vertical gaps under the SWSP up to 1.8 m gap were also noted in the 2021 inspection due to ongoing movement of the landslide mass. Ongoing creek bank erosion at the big O pipe outlet resulted in multiple dislocations.	<input checked="" type="checkbox"/>

Photo 3.
Looking south from 2+200, about 110m west of Hwy 2:68. Overall increase in slide activity along the backscarp in the upper portion of the Elephant Trunk drainpipe since 2020. Note up to 1.8 m of settlement of slide mass under the SWSP downslope of where it exits the fill cover.

Recommendations:		
<p>The surface of the trench backfill over the SWSP alignment between the highway and the backscarp should be track packed, smoothed out and re-seeded.</p> <p>Local regrading of the subgrade along/under the section of the pipe that descends the valley slope over the landslide mass should be carried out when required to maintain support to the pipe to avoid long unsupported gaps that could overstress the pipe. There is a piece of old big o pipe that was used to drain a gully under the new SWSP. This section of big o and the gully channel leading to and from it should also be improved while doing the subgrade repairs.</p> <p>In the future, consideration should be given to using screw piles with crossbeams to support the portions of the SWSP that have been developing gaps under the pipe, if the required grading repairs become too significant.</p>

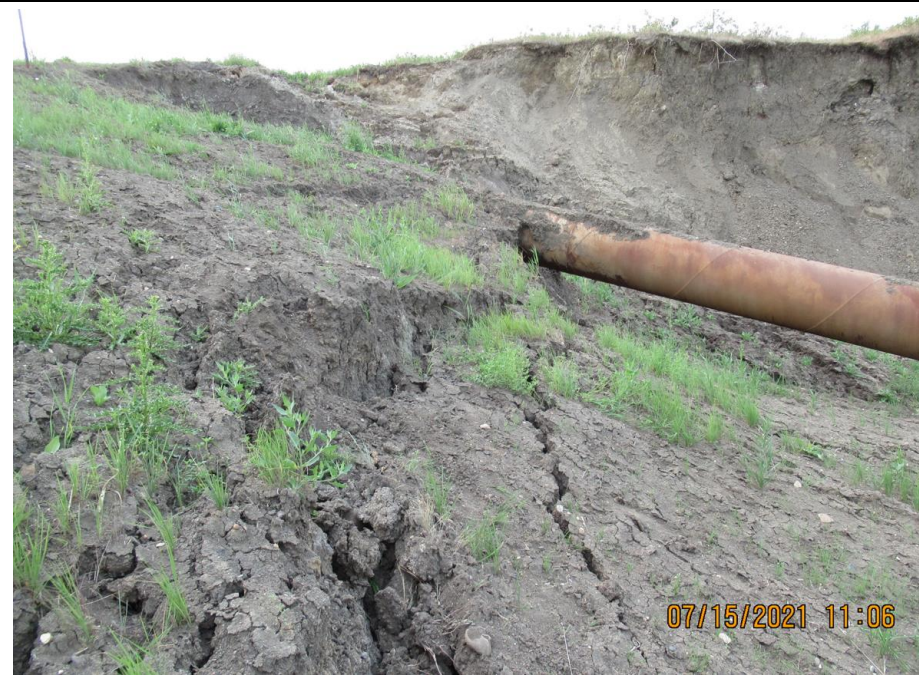
Photo 4.
Close up of the settlement gap mentioned in Photo 3.

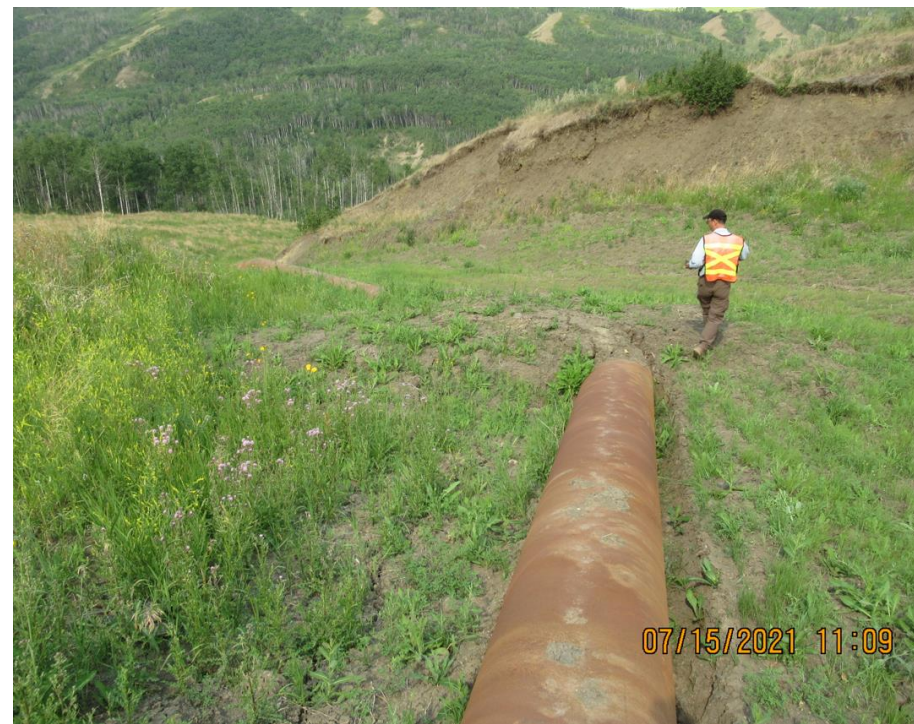
Photo 5.
Looking west at the upper most pipe bend. Note the pipe shifted by about 250 mm at this location due to thermal effects

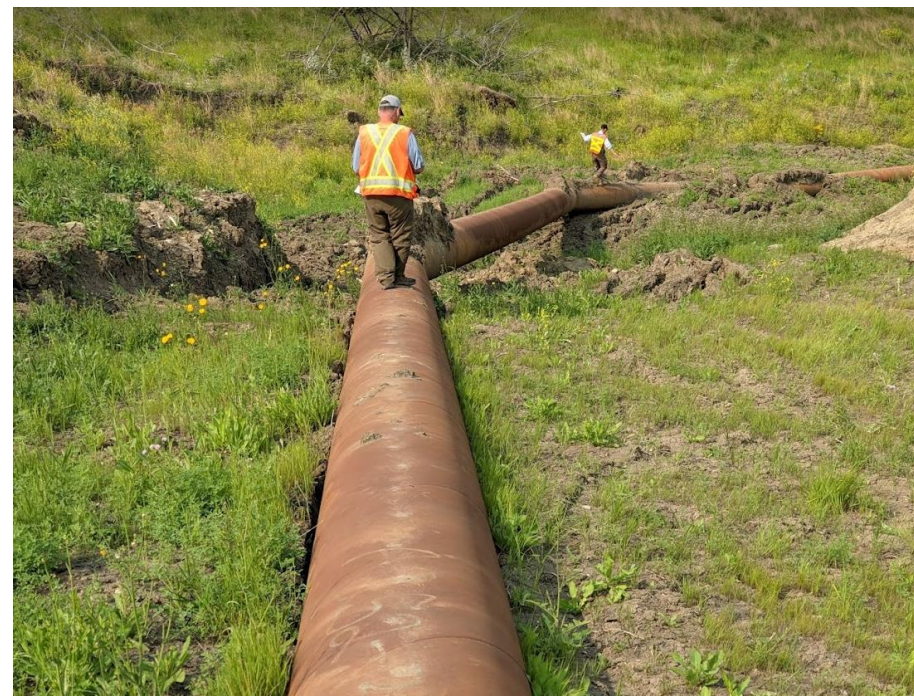
Photo 6.
Looking west at the middle pipe bend. Note how the movement of the landslide under the pipe results in a gap approximately 1 m high.

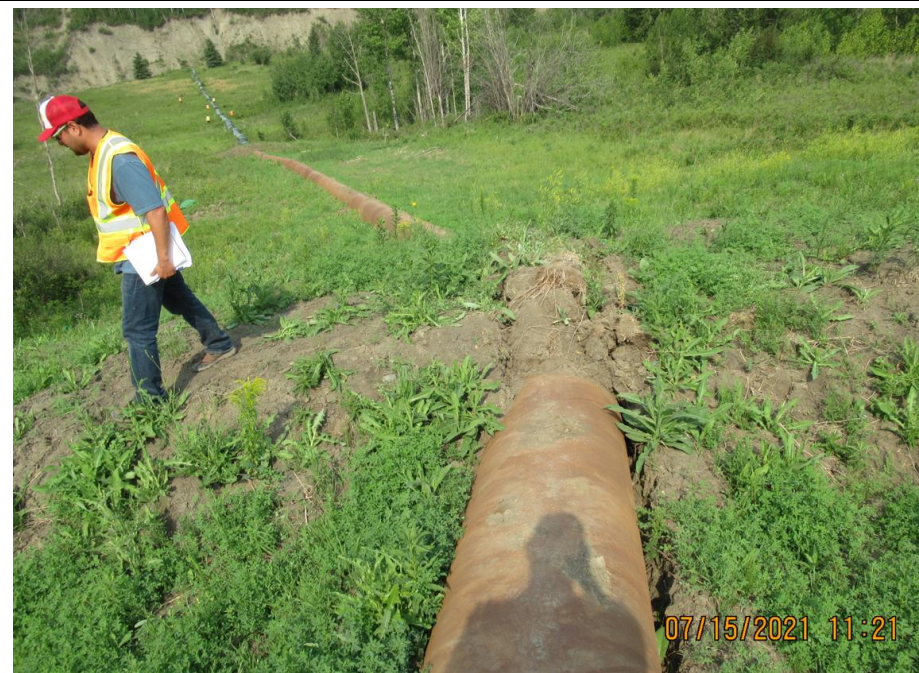
Photo 8.
Looking downslope
at SWSP lower
bend and soil berm.
Note how the pipe
thermal movement
resulted in 120 mm
shift horizontal and
some vertical
cracks in the soil
berm.

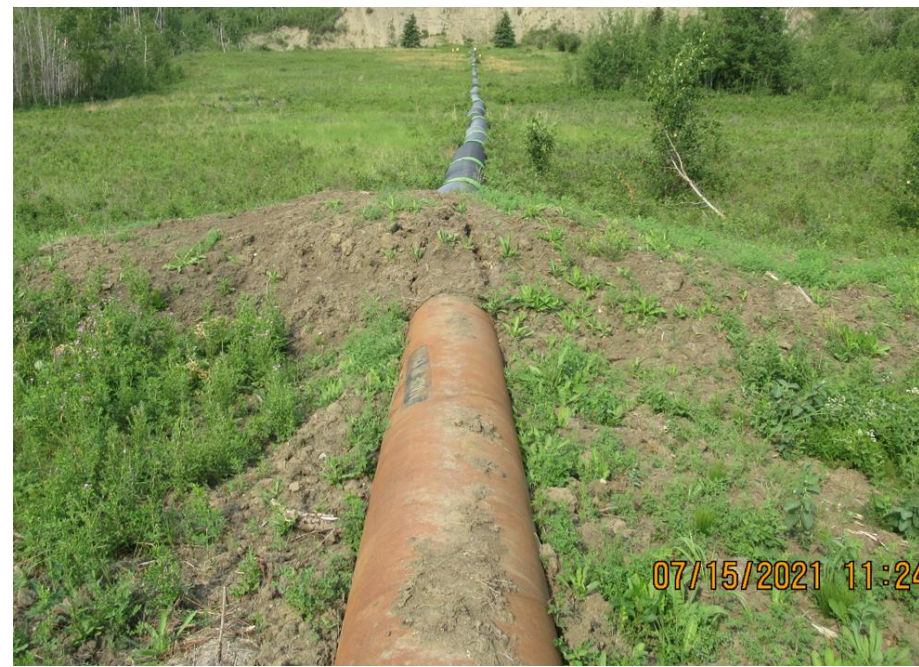
Photo 9.
Looking downslope at SWSP connection into O pipe under a soil berm. Note how the pipe thermal movement resulted in 120 mm shift horizontal and some vertical cracks in the soil berm.

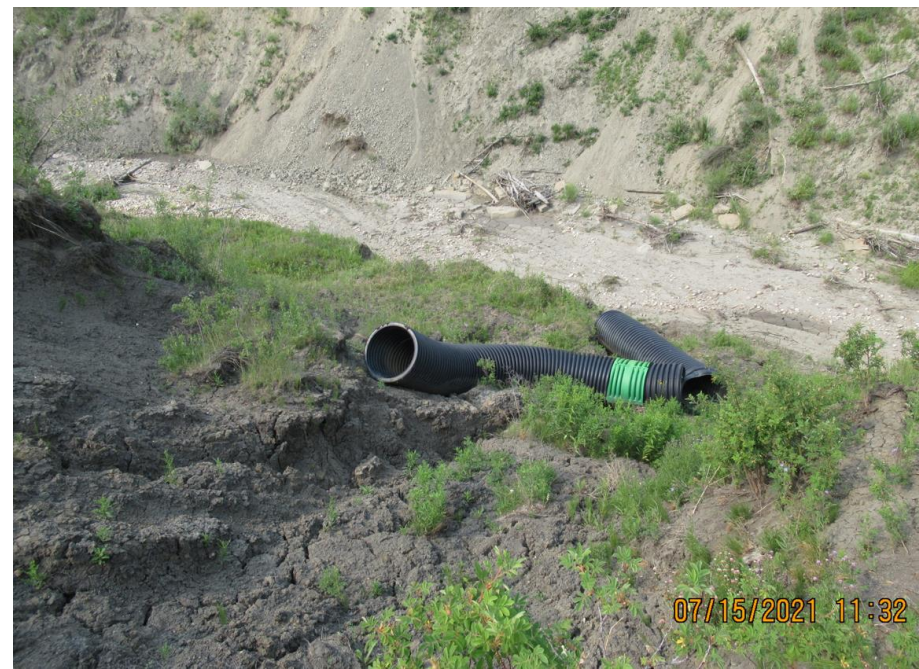
Photo 11.
On going erosion along the Creek's bank has resulted in multiple dislocation of the big O pipe outlet.

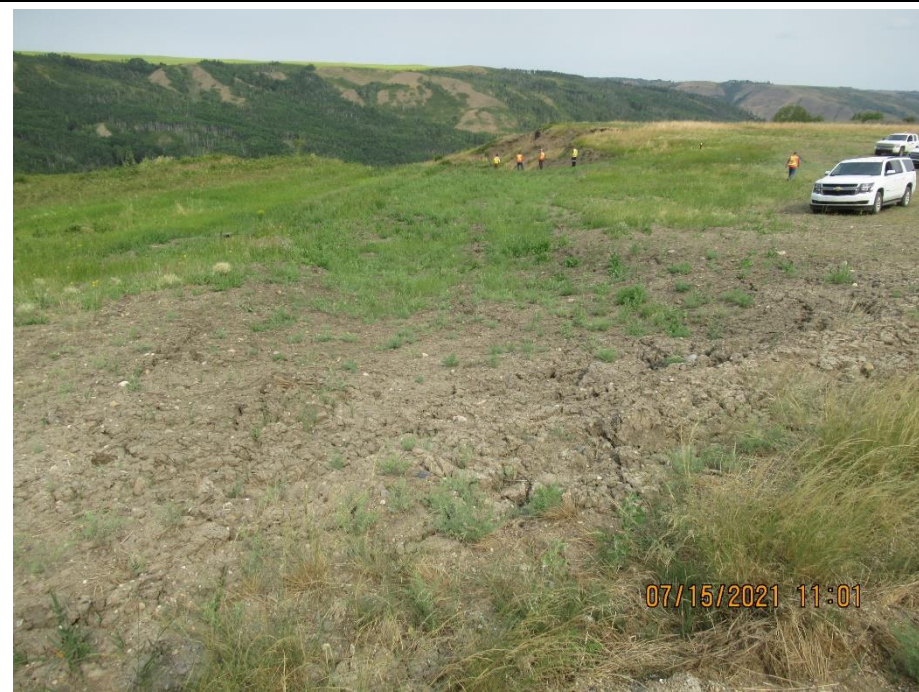
<input checked="" type="checkbox"/> Other	The trench backfill over the portion of the SWSP extending between the highway has settled.	<input checked="" type="checkbox"/>
Instrumentation:		
SI-30A	Installed near the Elephant Trunk at 2+300 and shows creep movement rates ranging from 0 to 3.5 mm/year over 5 m to 10 m depth and over 17 m to 22 m depth with 98 mm of overall cumulative downslope movement. The overall downslope movement has increased by 10 mm/yr since the fall 2020 readings.	
SI-30B	Installed near the crest of the slope above the original Dunvegan Slide, near the head of the gully with the Elephant Trunk, shows ongoing creep movement ranging from 1 mm/yr to 8 mm/yr at 12.1 m to 17 m depth. The overall downslope movement has decreased by up to 9.0 mm/yr since the fall 2020 readings.	
Assessment:		
<p>Surficial soil at this location is very sensitive to moisture content and the rupture of the old elephant trunk resulted in all upslope drainage flowing into the head of the gully. This excessive water flowing in an uncontrolled manner had been soaking and eroding the valley slope which in turn resulted in accelerated slide movement.</p> <p>Flow slide movement has expanded to the south, with the development of a scarp running between the Elephant Trunk and the 2+500 slide. The newly installed SWSP can now transfer runoff from the east ditch of the highway down to the big O pipe section located on the flat ground below the valley slope, without leaking water onto the slope. This should allow the slope to dry out a bit and should significantly reduce the amount of erosion compared to the condition prior to replacing the elephant trunk. However, the ongoing flow slide movements have created vertical gaps up to 1.8 m below the SWSP which may lead to structural stress and damage to the recently installed pipe unless additional maintenance and erosion control measures are implemented at this location.</p>

Photo 12.
The trench backfill over the new SWSP has settled. The fill was placed in winter conditions.
