**ALBERTA TRANSPORTATION
GEOHAZARD ASSESSMENT PROGRAM
PEACE REGION –
GRANDE PRAIRIE DISTRICT – NORTH
2021 INSPECTION**

Site Number	Location	Name	Hwy	km
PH037	Dunvegan	Dunvegan South 1+250 to 2+000	2:68	15.674
Legal Description		UTM Co-ordinates		
NW¼ 06-080-04 W6M		11U E 398514	N 6197340

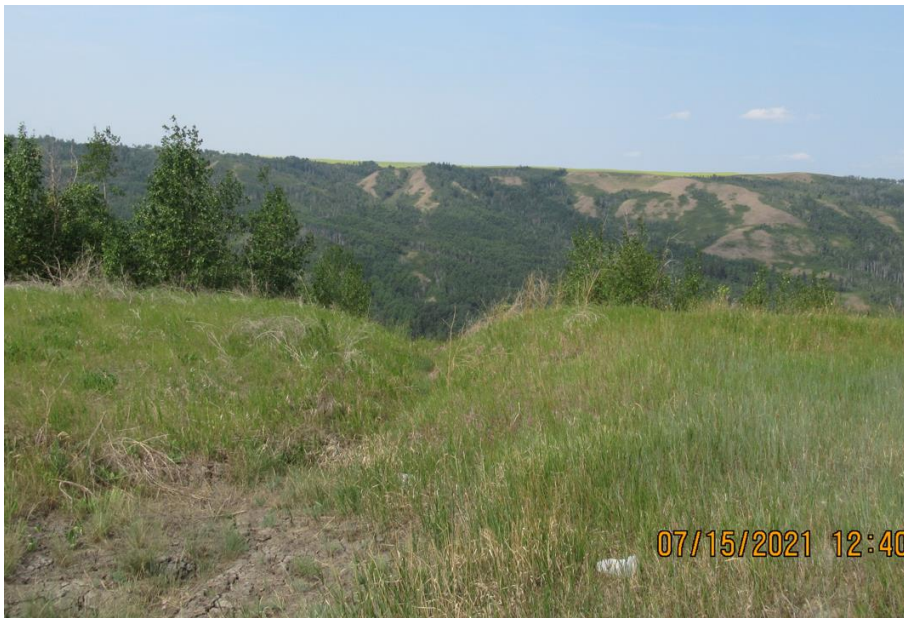
Erosion and slope movement downslope of the highway near Sta. 2+000 are a function of water flows in the ditch and are expected to worsen.

Photo 1.
Looking northwest from Sta. 2+000 at erosion gully in SBL ditch south of ditch block

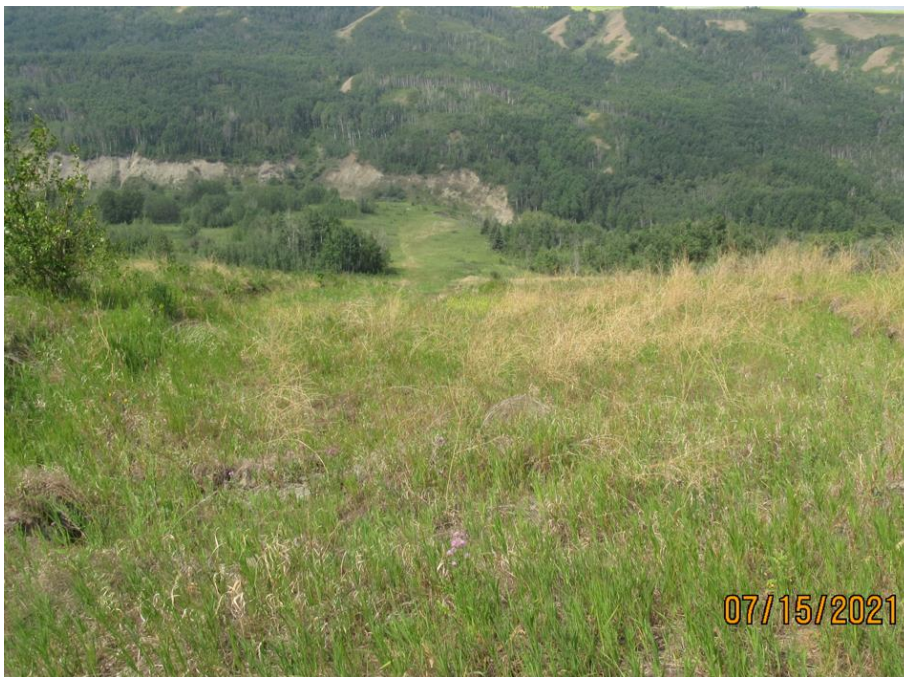
Photo 2.
Looking west from Sta. 1+980 below the SBL highway

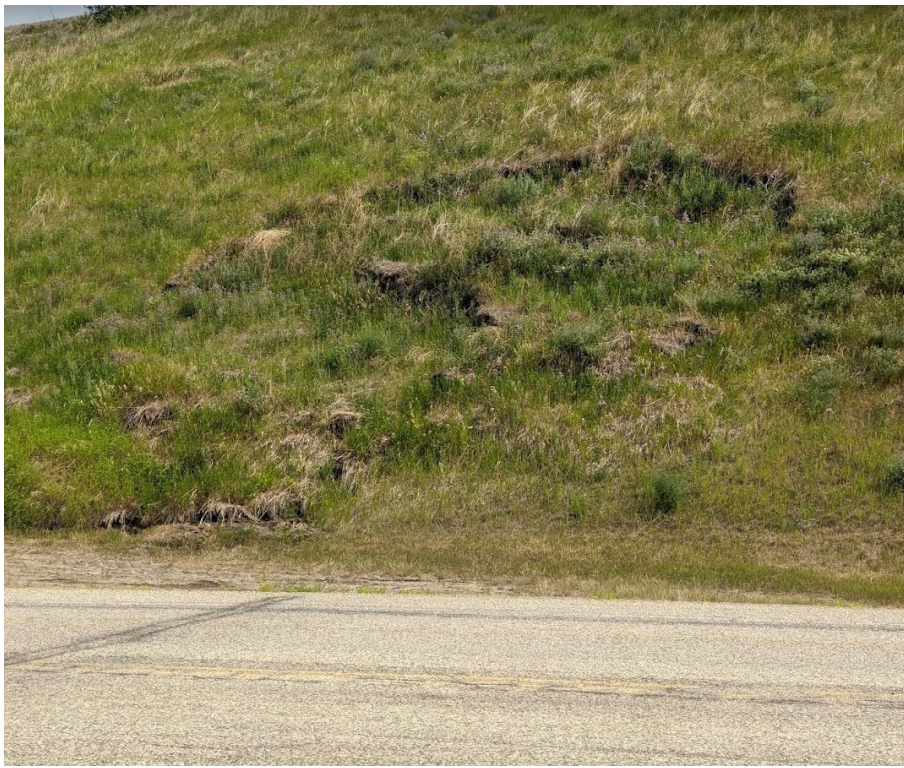
Photo 3.
Looking east at
backslope skin
failure at Sta.
1+900 (More
movement since
2020).

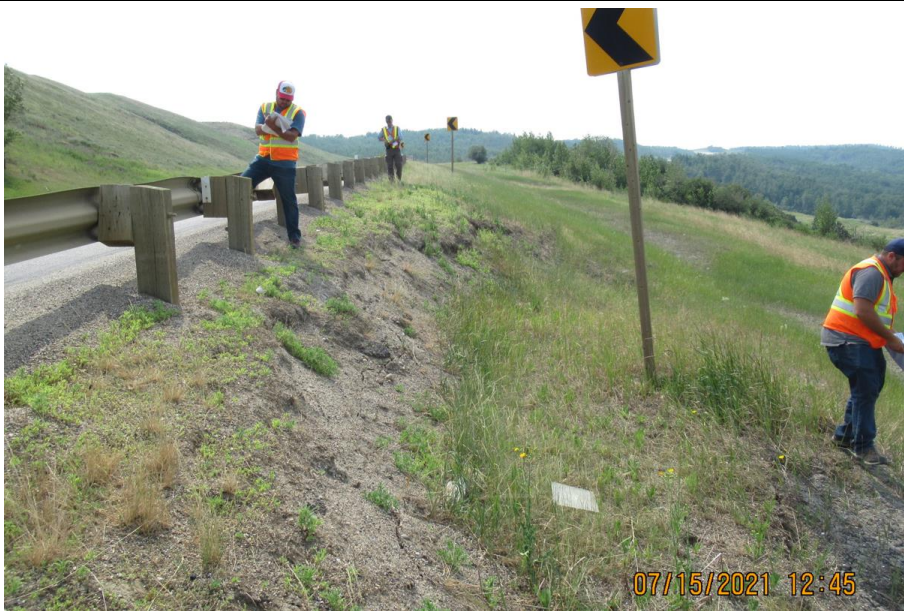
Photo 4.
Looking south
from Sta. 1+890
at the slump in
the sideslope of
the SBL. The
scarp is 1.1 m
high and
0.8 m from the
guardrail.

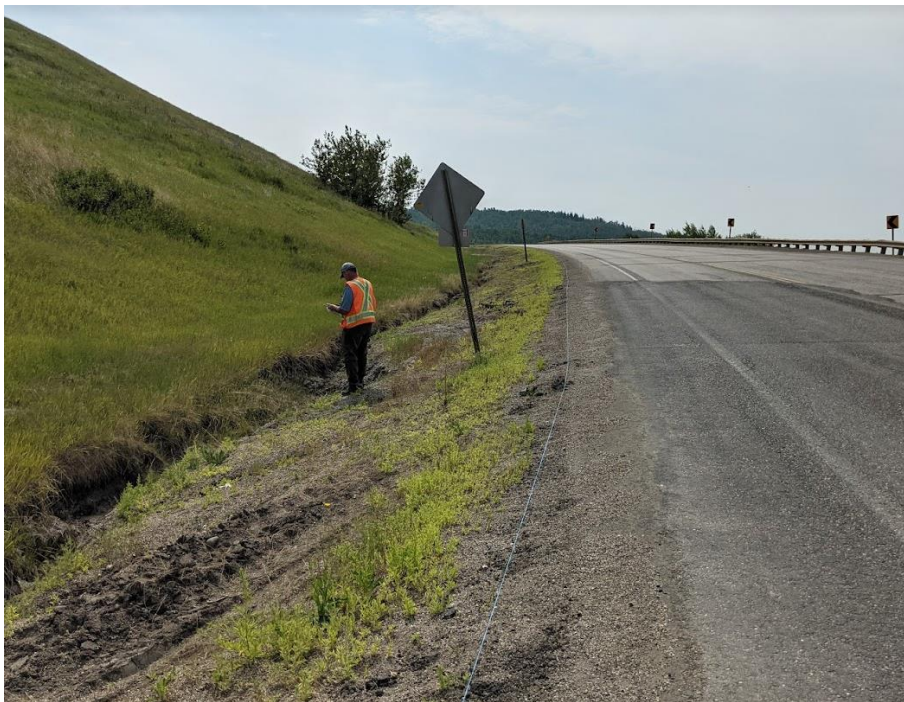
Photo 5.
Looking south from Sta. 1+800 at the new ACP patch placed in 2020 and the erosion gully developed on the ditch up to 1.6 m wide and 0.6 m deep.

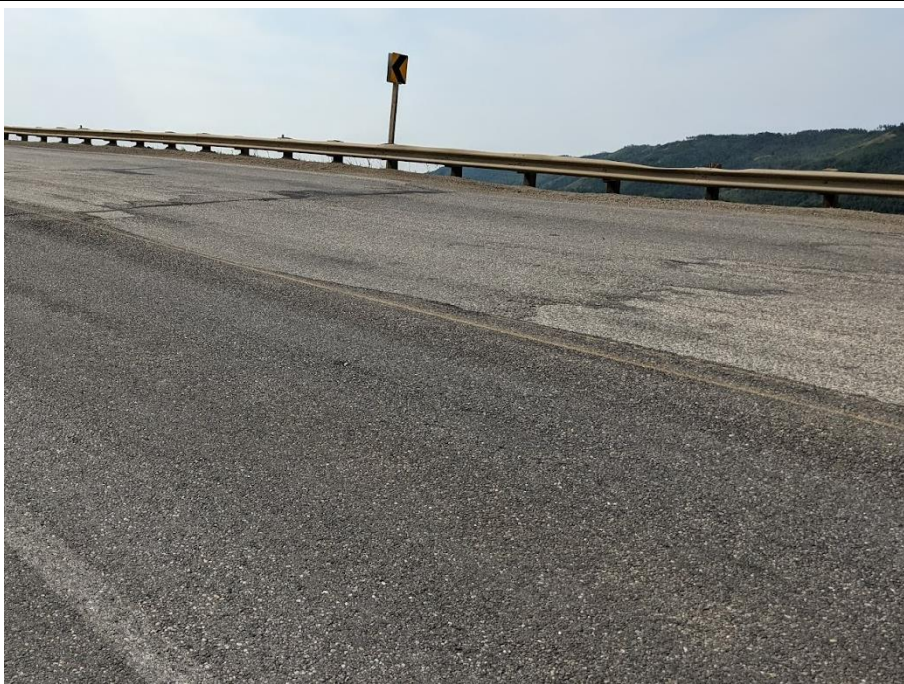
The 1+800 slide is a deep-seated slide that is currently affecting all three lanes of the highway over a 200 m length with the backscarp likely within the NBL ditch bottom. Based on the ongoing slope inclinometer monitoring, the 1+800 slide plane depth varies within the embankment of the highway from about 18 m near the SBL shoulder to a depth of 28 m below the NBL shoulder with the toe of the landslide likely situated some 300 m further downslope towards Dunvegan Creek. Rates of movement in the 1+800 slide SI's typically vary from small creep movements to 6 mm/yr. and have accelerated to about 20 mm/yr. in recent years. The 1+800 slide continues to exhibit moderate rates of movement up to 9 mm/yr; however, its footprint currently affects the entire highway embankment whereby a complete closure of the highway could result from a sudden increase in slide activity.

Photo 6.
Looking northeast across the dip in the highway at the south end of the 1+800 slide.

Continue to monitor visually for sign of activity at both slides and close the outer SBL at the 1+400 slide should tension cracks or dips appear in the roadway surface. Apply small asphalt patches at each end of the 1+800 slide to smooth out the dip when required for traffic safety.

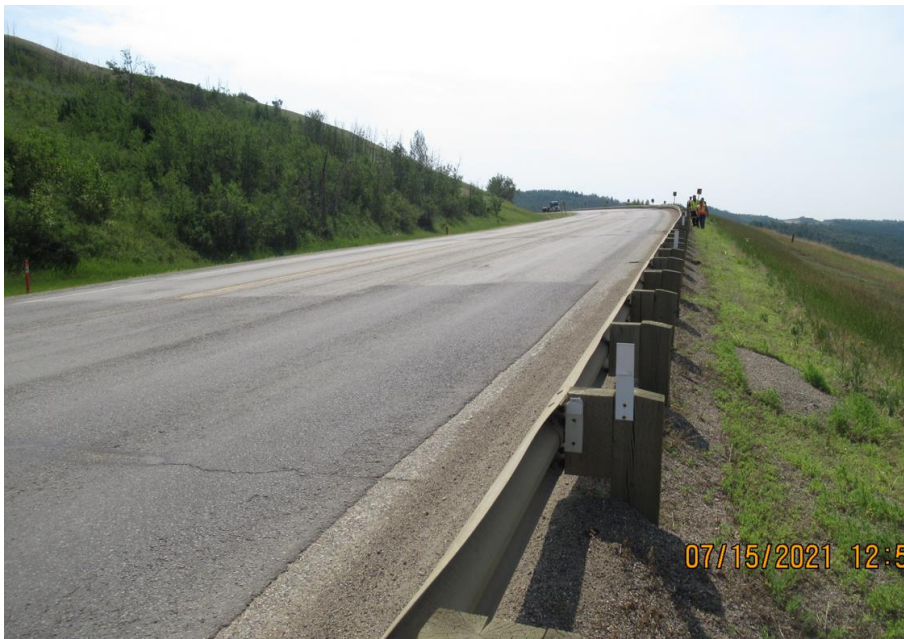
Photo 7.
Looking from the shoulder of the SBL at Sta. 1+660 across the dip in the highway at the north end of the 1+800 slide.

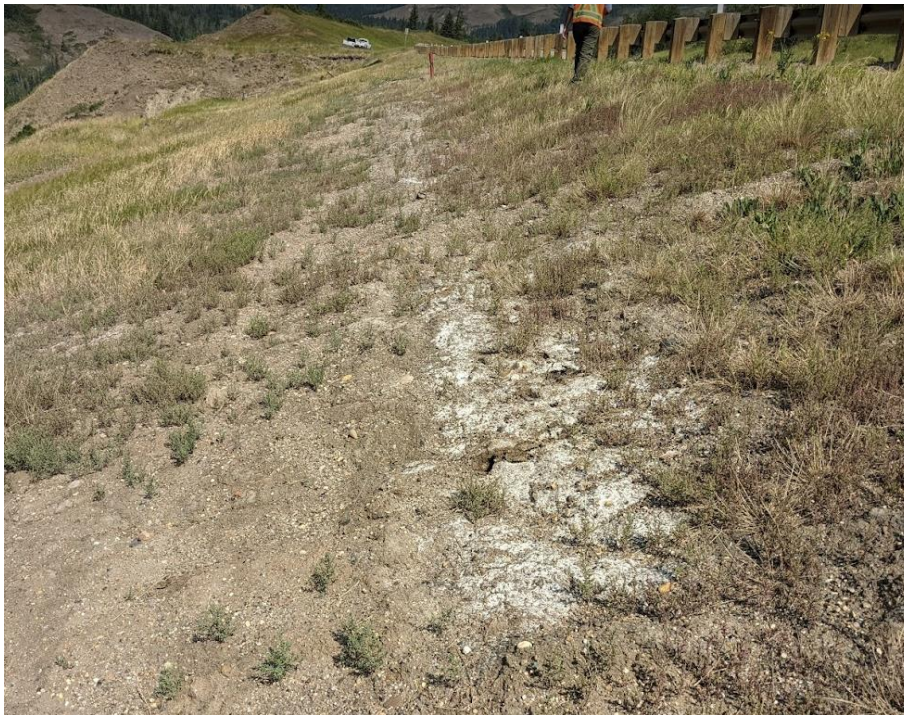
Photo 8.
Looking north near Sta. 1+550 at rough area (drill access bench) with some seepage and tension cracks

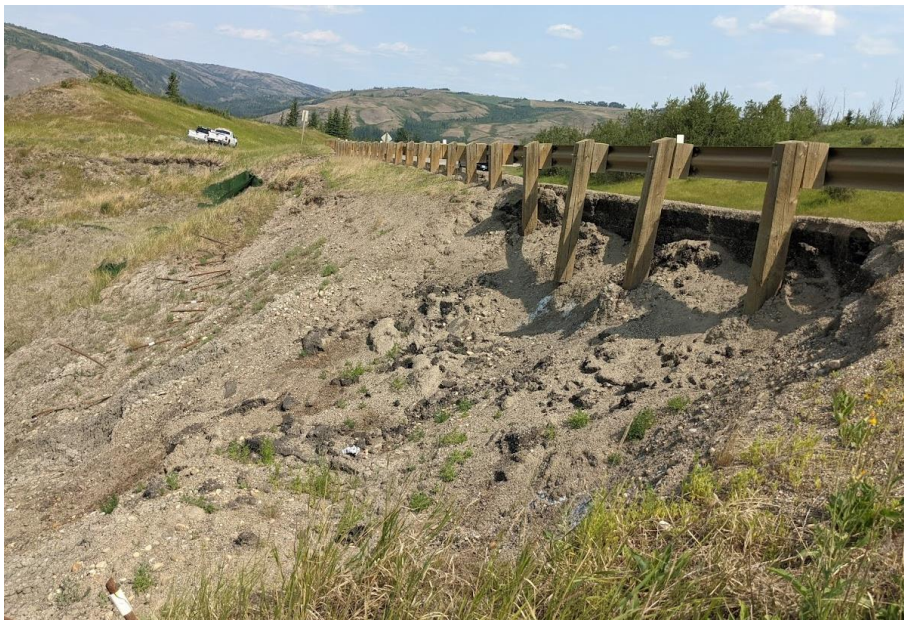
Ongoing slide activity was observed at the Sta. 1+400 slide in 2016 right through 2021. Soil below the matting and around the soil nails, installed in 2010, has failed superficially, with more substantial failure extents below the surface treated area. It is anticipated that the rate of retrogression will likely accelerate above the areas where the soil nails have been bent downward due to a combination of confining soil loss and slope movement. The backscarp located at the shoulder of the SBL ranges between 5 to 7 m high. The SI's installed within the footprint of the 1+400 slide had rapid rates of movement in the spring and summer of 2018 (50 to 700 mm/yr.) and sheared off at a depth of 2 m as a result of mud flow after the fall of 2018.

Photo 9.
Looking northwest across soil matting and nails which were installed in August 2010 at Sta. 1+450 slide. Backscarp (5 m to 7.5 m high) continues to retrogress and is now impacting the highway. Two guardrail posts are hanging and other two posts are partially exposed.

Install driven steel pile walls at the Sta. 1+400 landslide location to temporarily maintain the climbing lane until a more permanent repair is implemented.

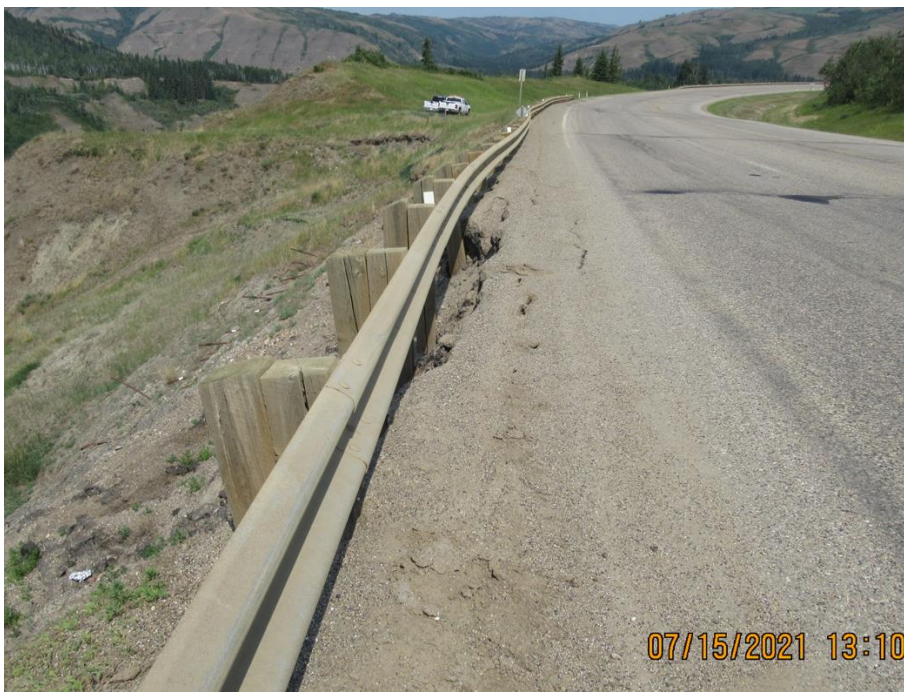
Photo 10.
Looking north from Sta. 1+450 backscarp. The slide scarp has retrogressed since 2020 and cracks are now 0.1 m west of the white line.

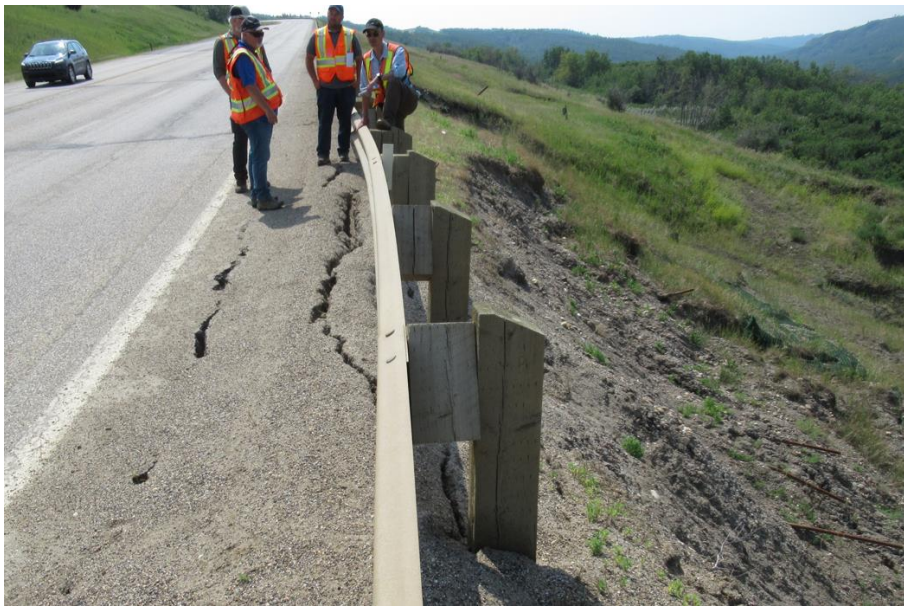
The 1+400 slide is retrogressing rapidly and was recently noted to be impacting the SBL shoulder. When considering the existing smaller slide features to the south, this suggests that the expansion of this slide further to the south should be anticipated.

Photo 11. Looking south from Sta. 1+390 at the backscarp of the 1+400 slide which is impacting the highway shoulder. Slide crack is 60 mm wide and is 0.3 m from white line plus two other cracks closer to the guardrail

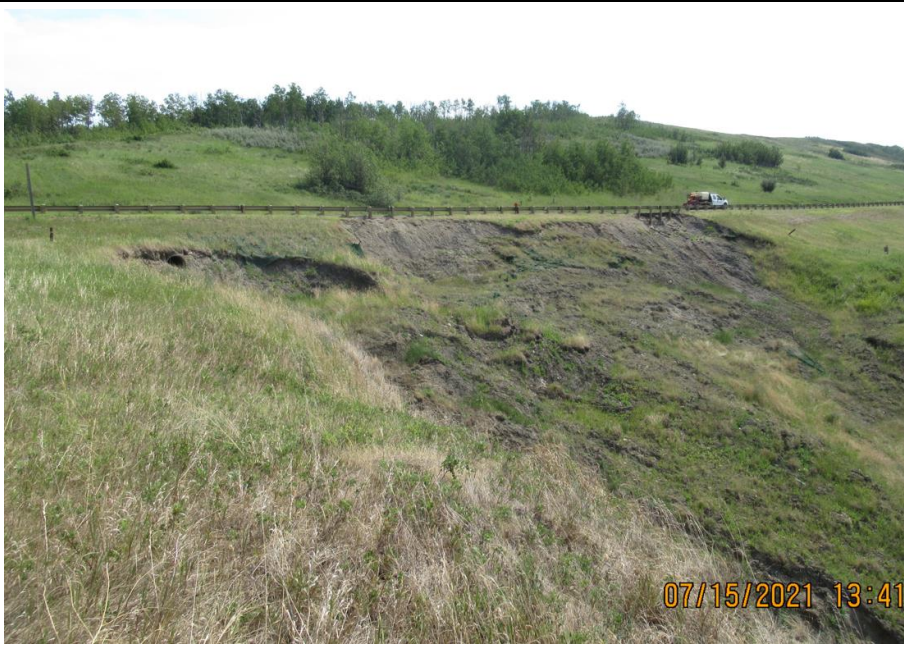
Photo 12. Looking southeast towards the 1+400 slide. The slide has further retrogressed towards the highway, is wider than in 2020 and there is a 5 m to 7.5 m drop below the guardrail.

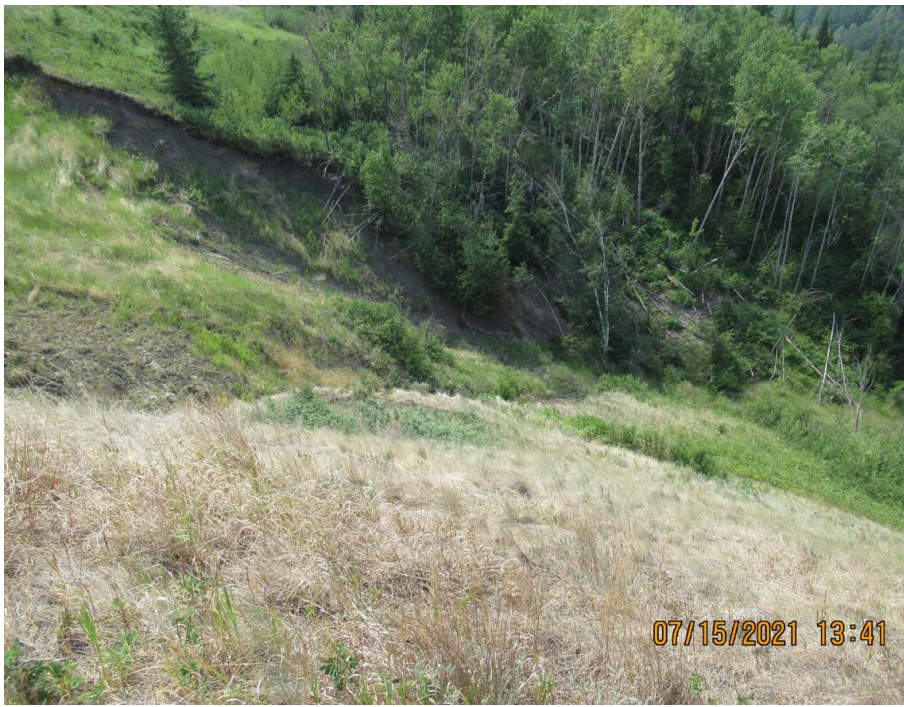
Photo 13.
Looking south at
the fresh slump
slide that is
impacting the
highway at Sta.
1+400.
