**THURBER** ENGINEERING LTD.

**ALBERTA TRANSPORTATION GRMP (CON0022165)  
PEACE REGION (GRANDE PRAIRIE DISTRICT – NORTH)  
INSTRUMENTATION MONITORING RESULTS – FALL 2022**

**SECTION C**

**SITE PH037: HWY 2:68, DUNVEGAN SOUTH**

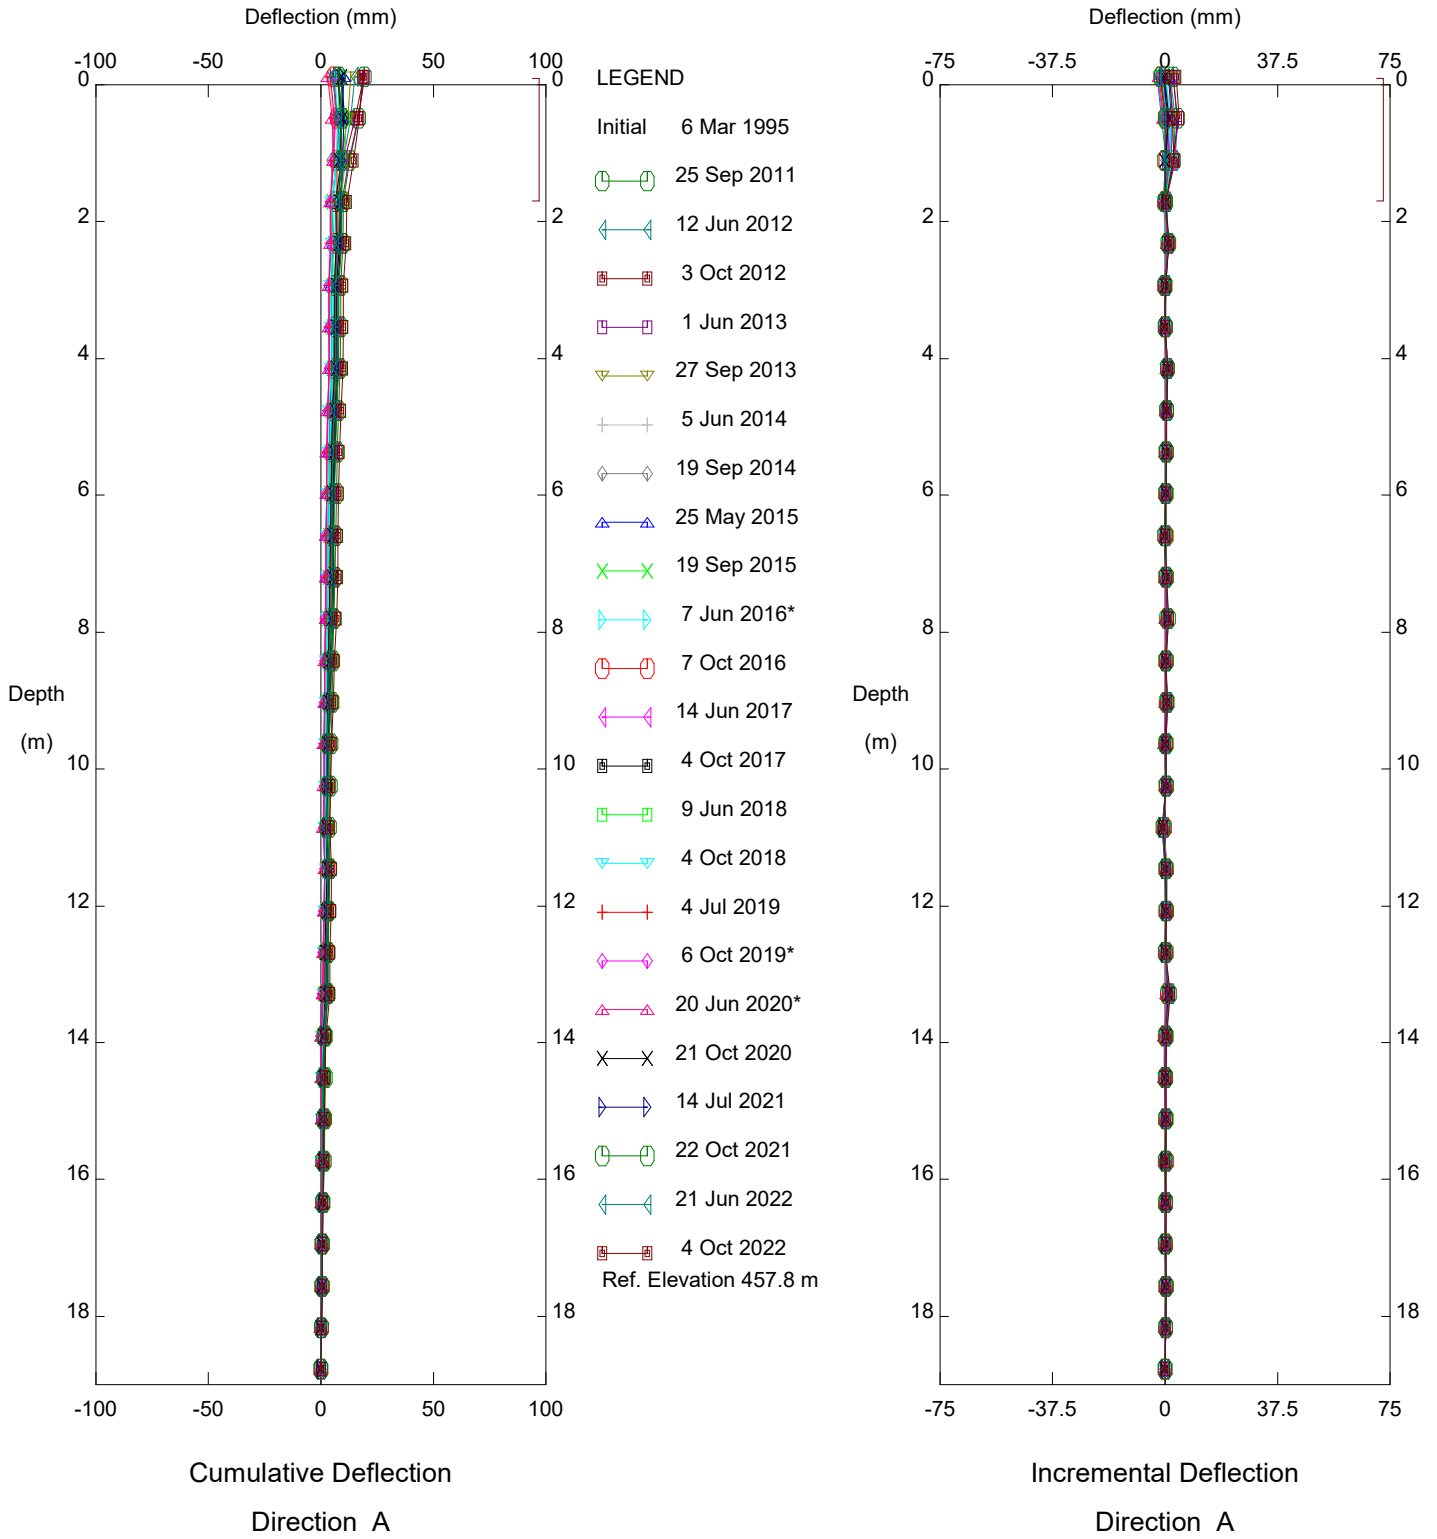
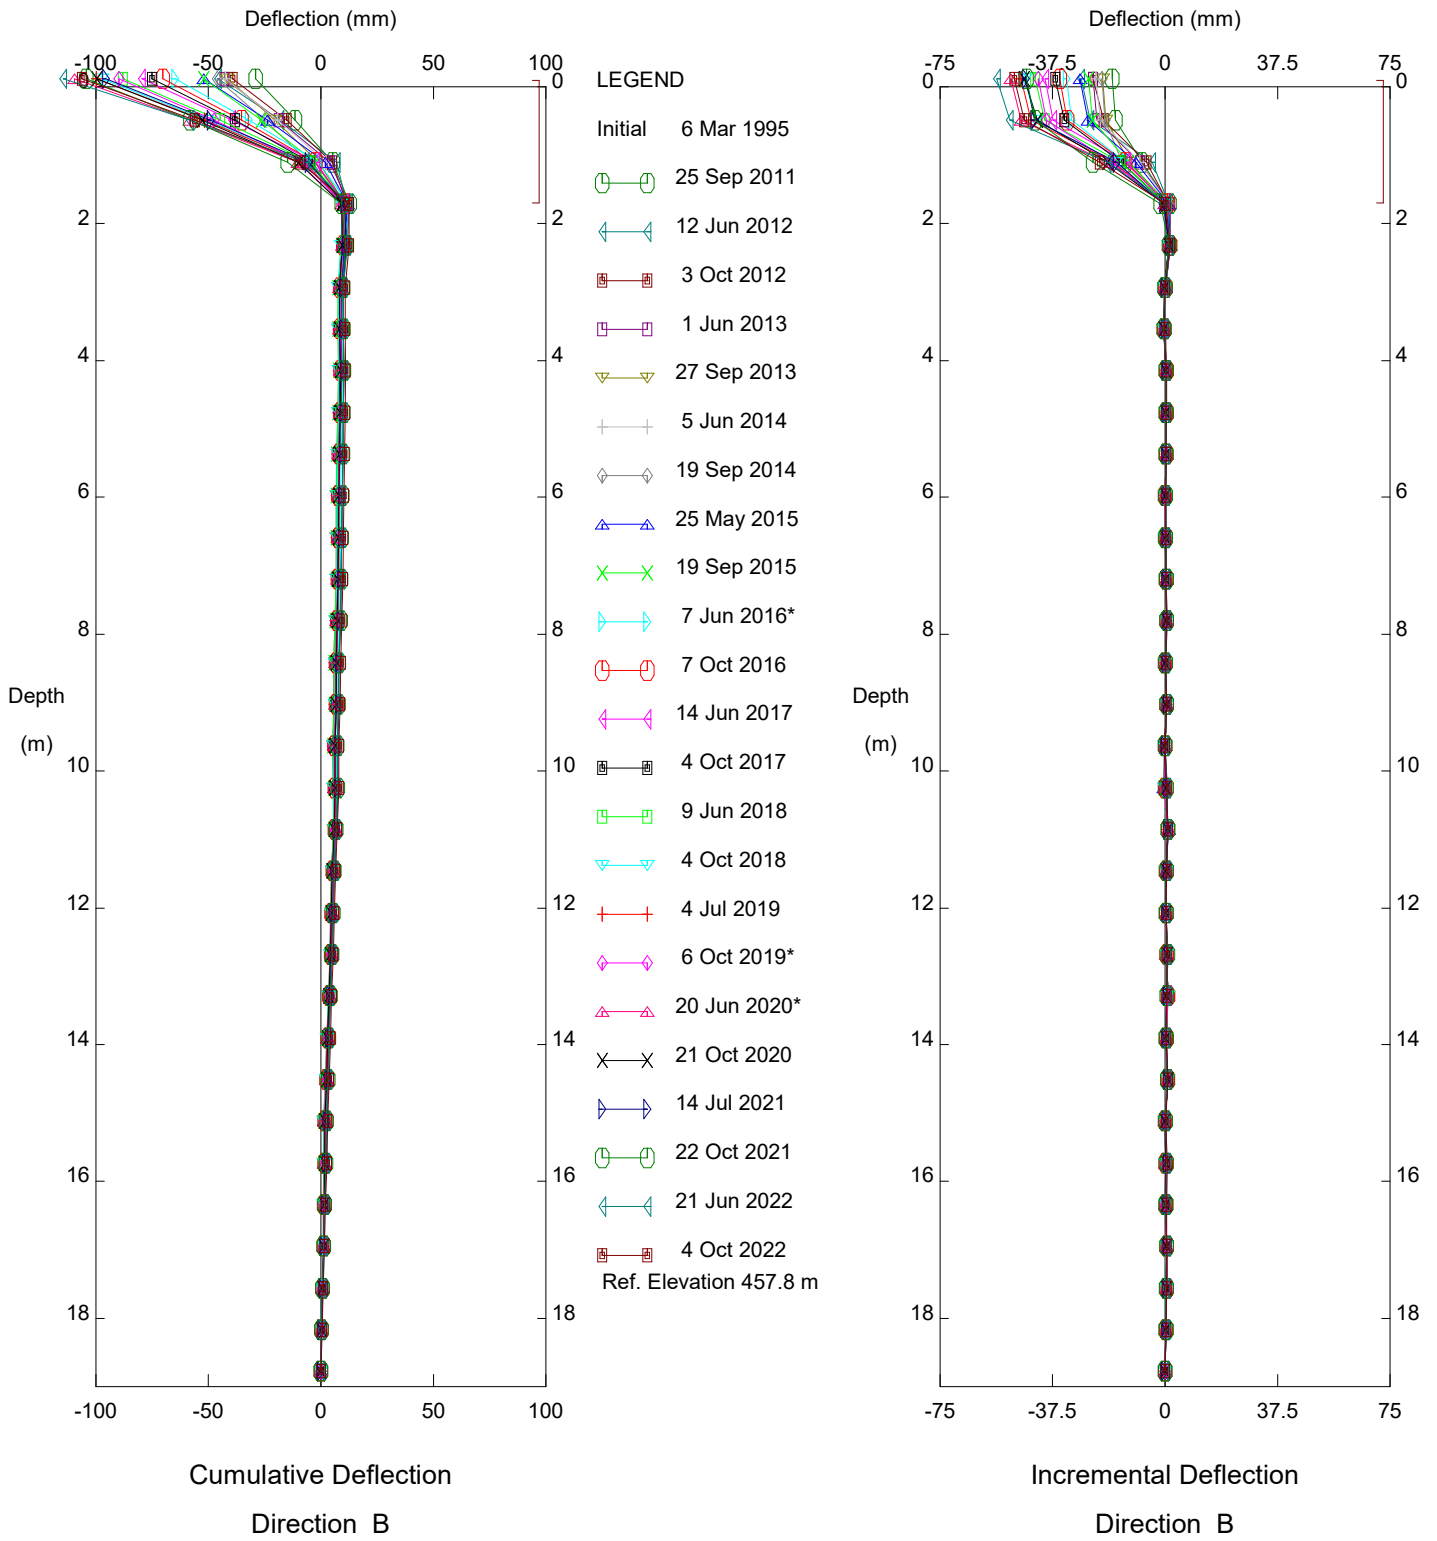
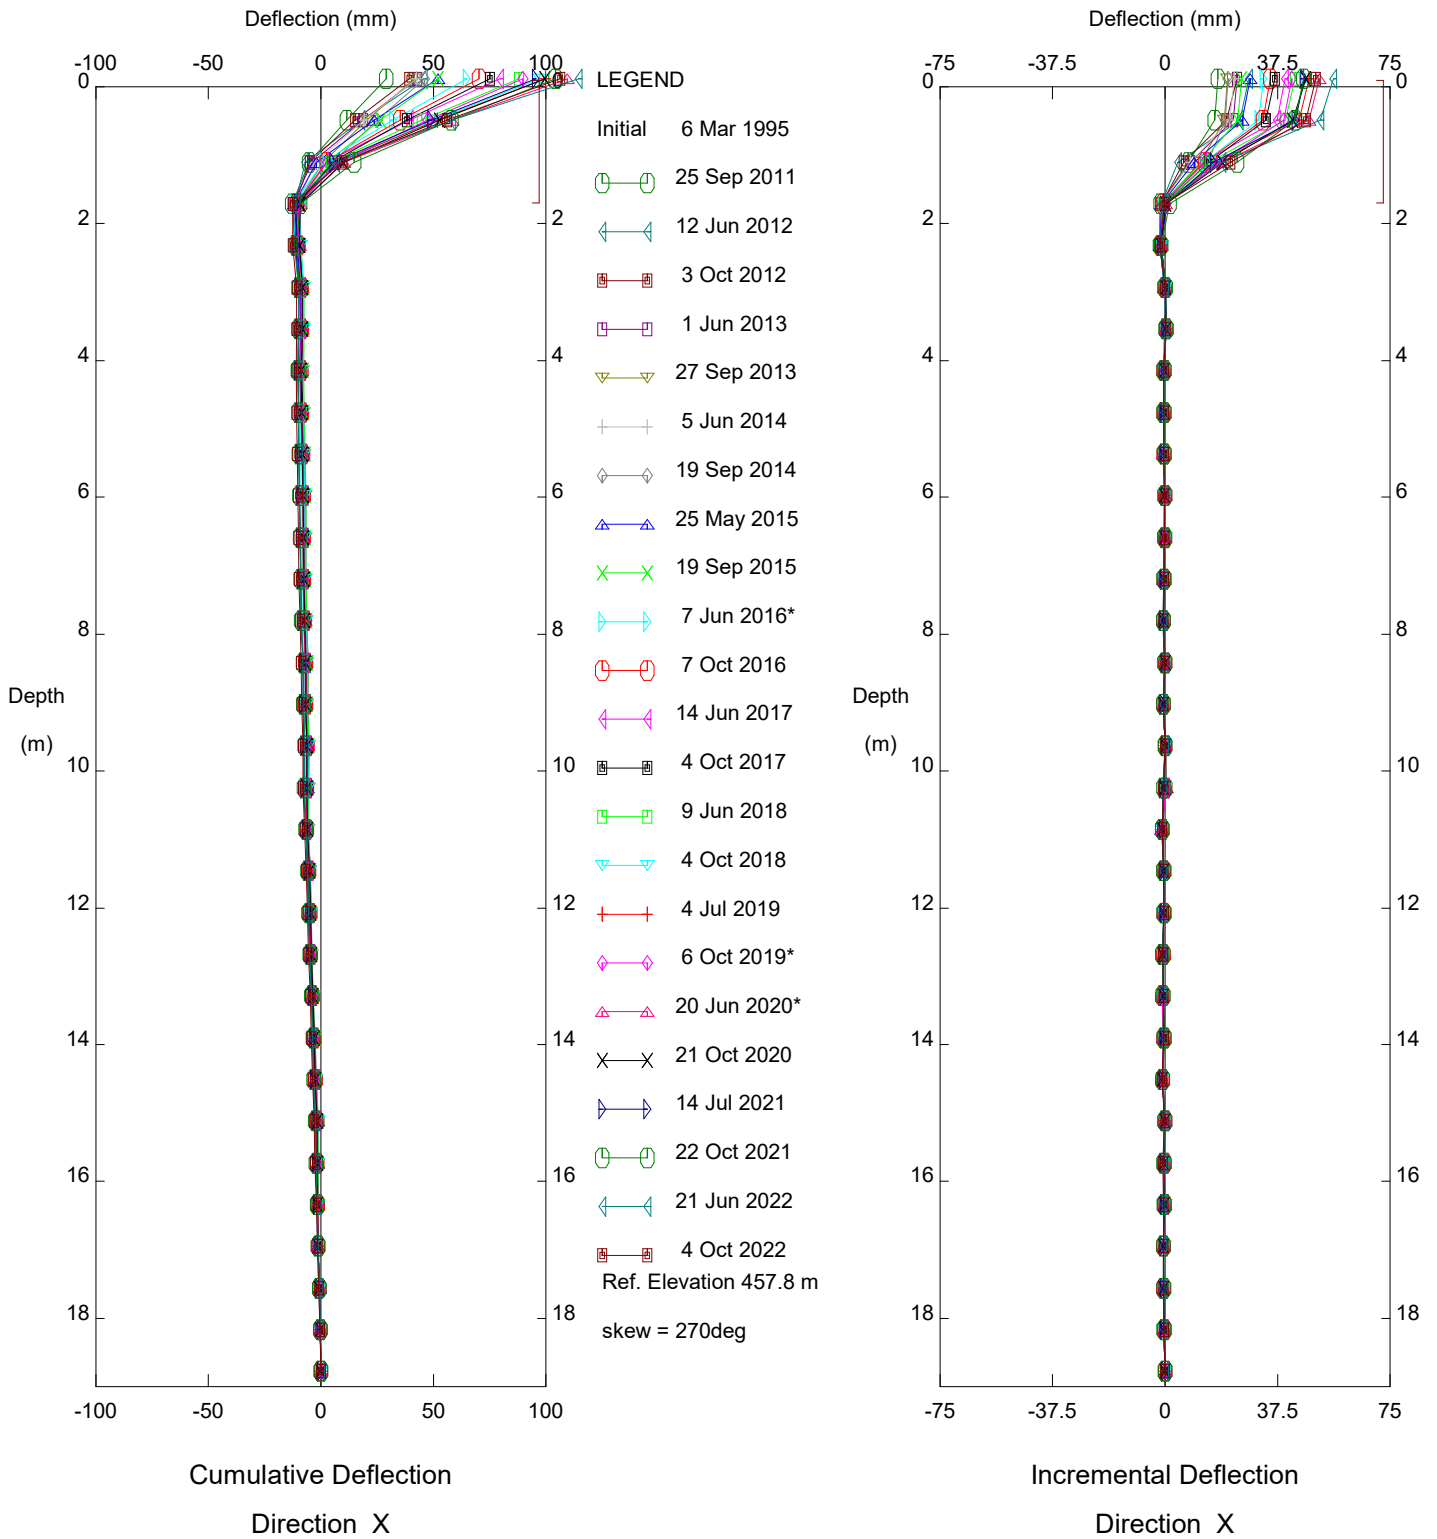
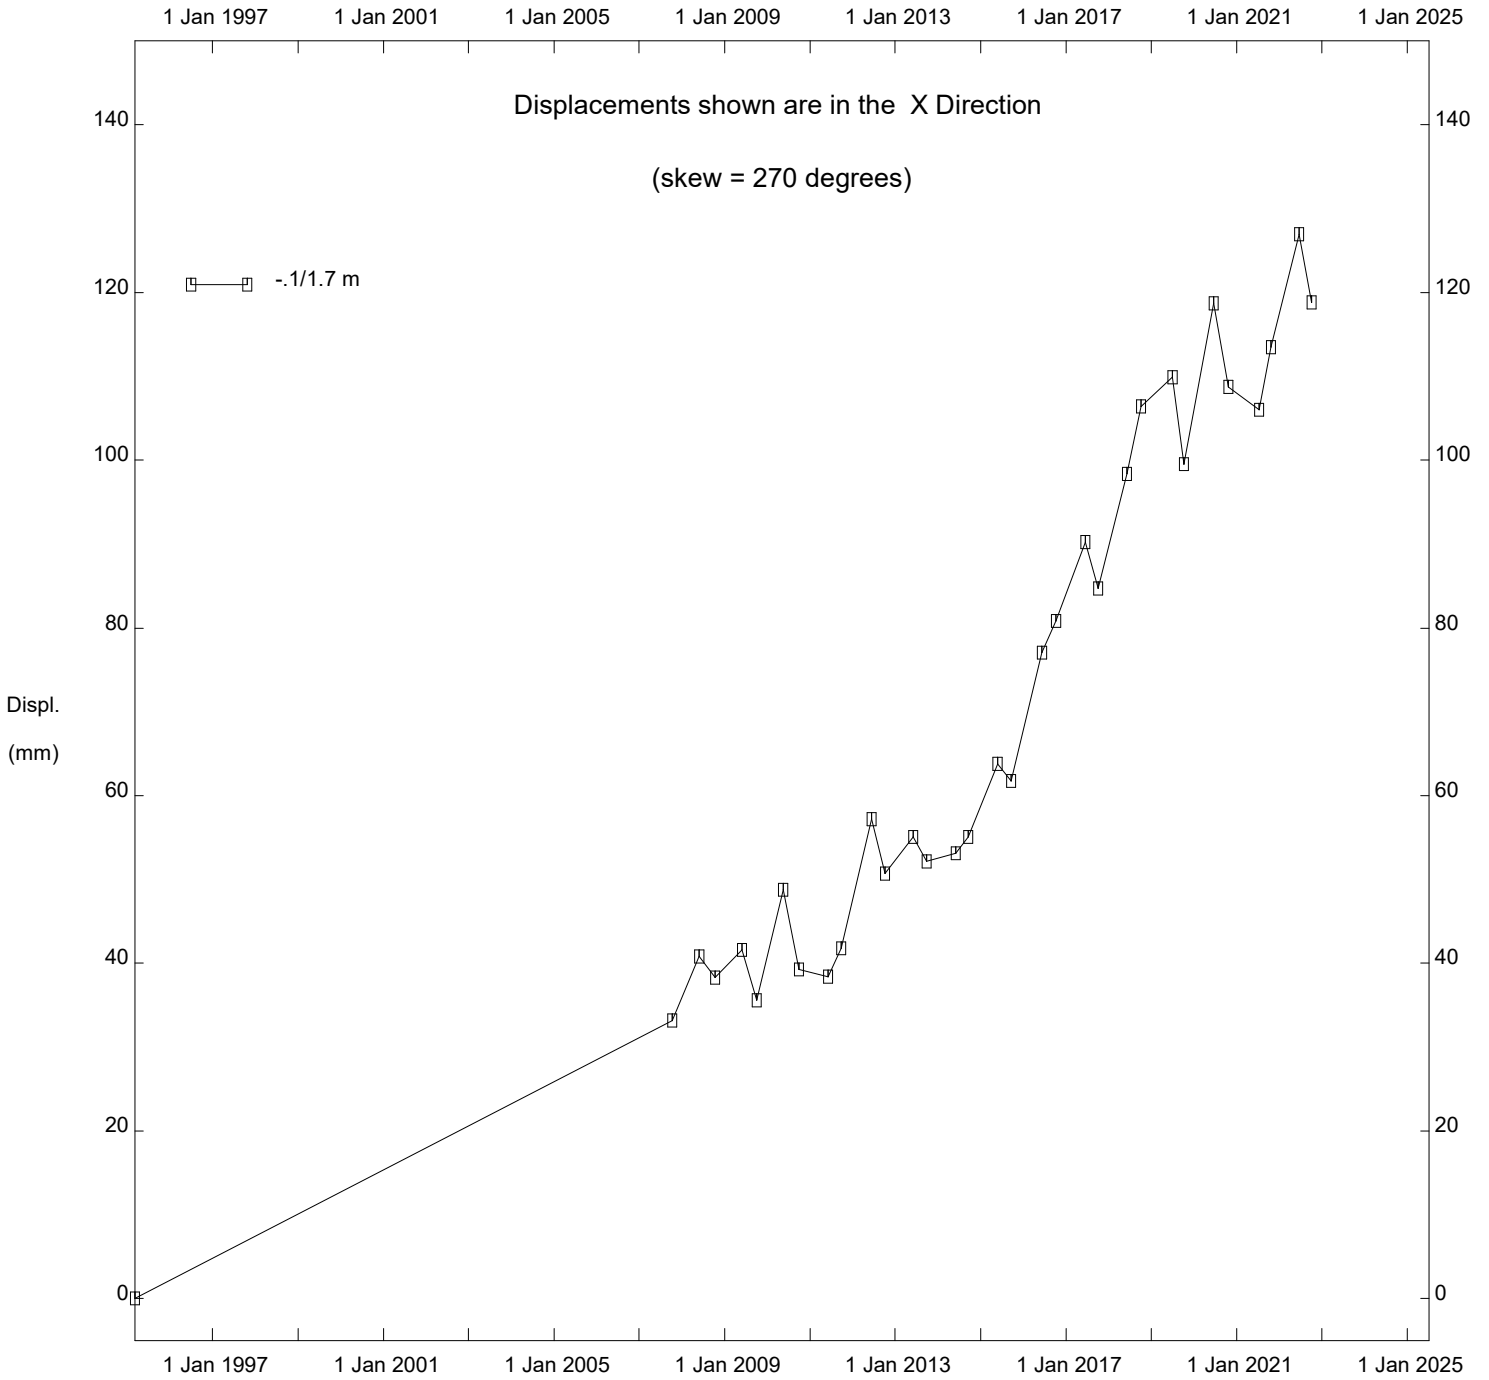
HWY 2:68 (PH037), Inclinometer SI-54

Slope inclinometer SI-54 had no discernible movement over 0 m to 1.7 m depth since the spring of 2022 readings. SI-55 showed a rate of movement of 0.9 mm/yr over 1.3 m to 4.3 m depth. SI-56 showed a rate of movement of 5.1 mm/yr over 0 m to 2.7 m depth. SI-58 showed a rate of movement of 10.0 mm/yr over 0.5 m to 3.6 m depth. SI-59 showed a rate of movement of 4.0 mm/yr over 1.0 m to 7.1 m depth. This SI is in the highway ditch near the assumed backscarp of the landslide that is affecting the highway and has moved 169.1 mm over this depth zone, since it was first installed in 1994. SI-61 showed a rate of movement of 0.4 mm/yr over 3.6 m to 10.3 m depth.

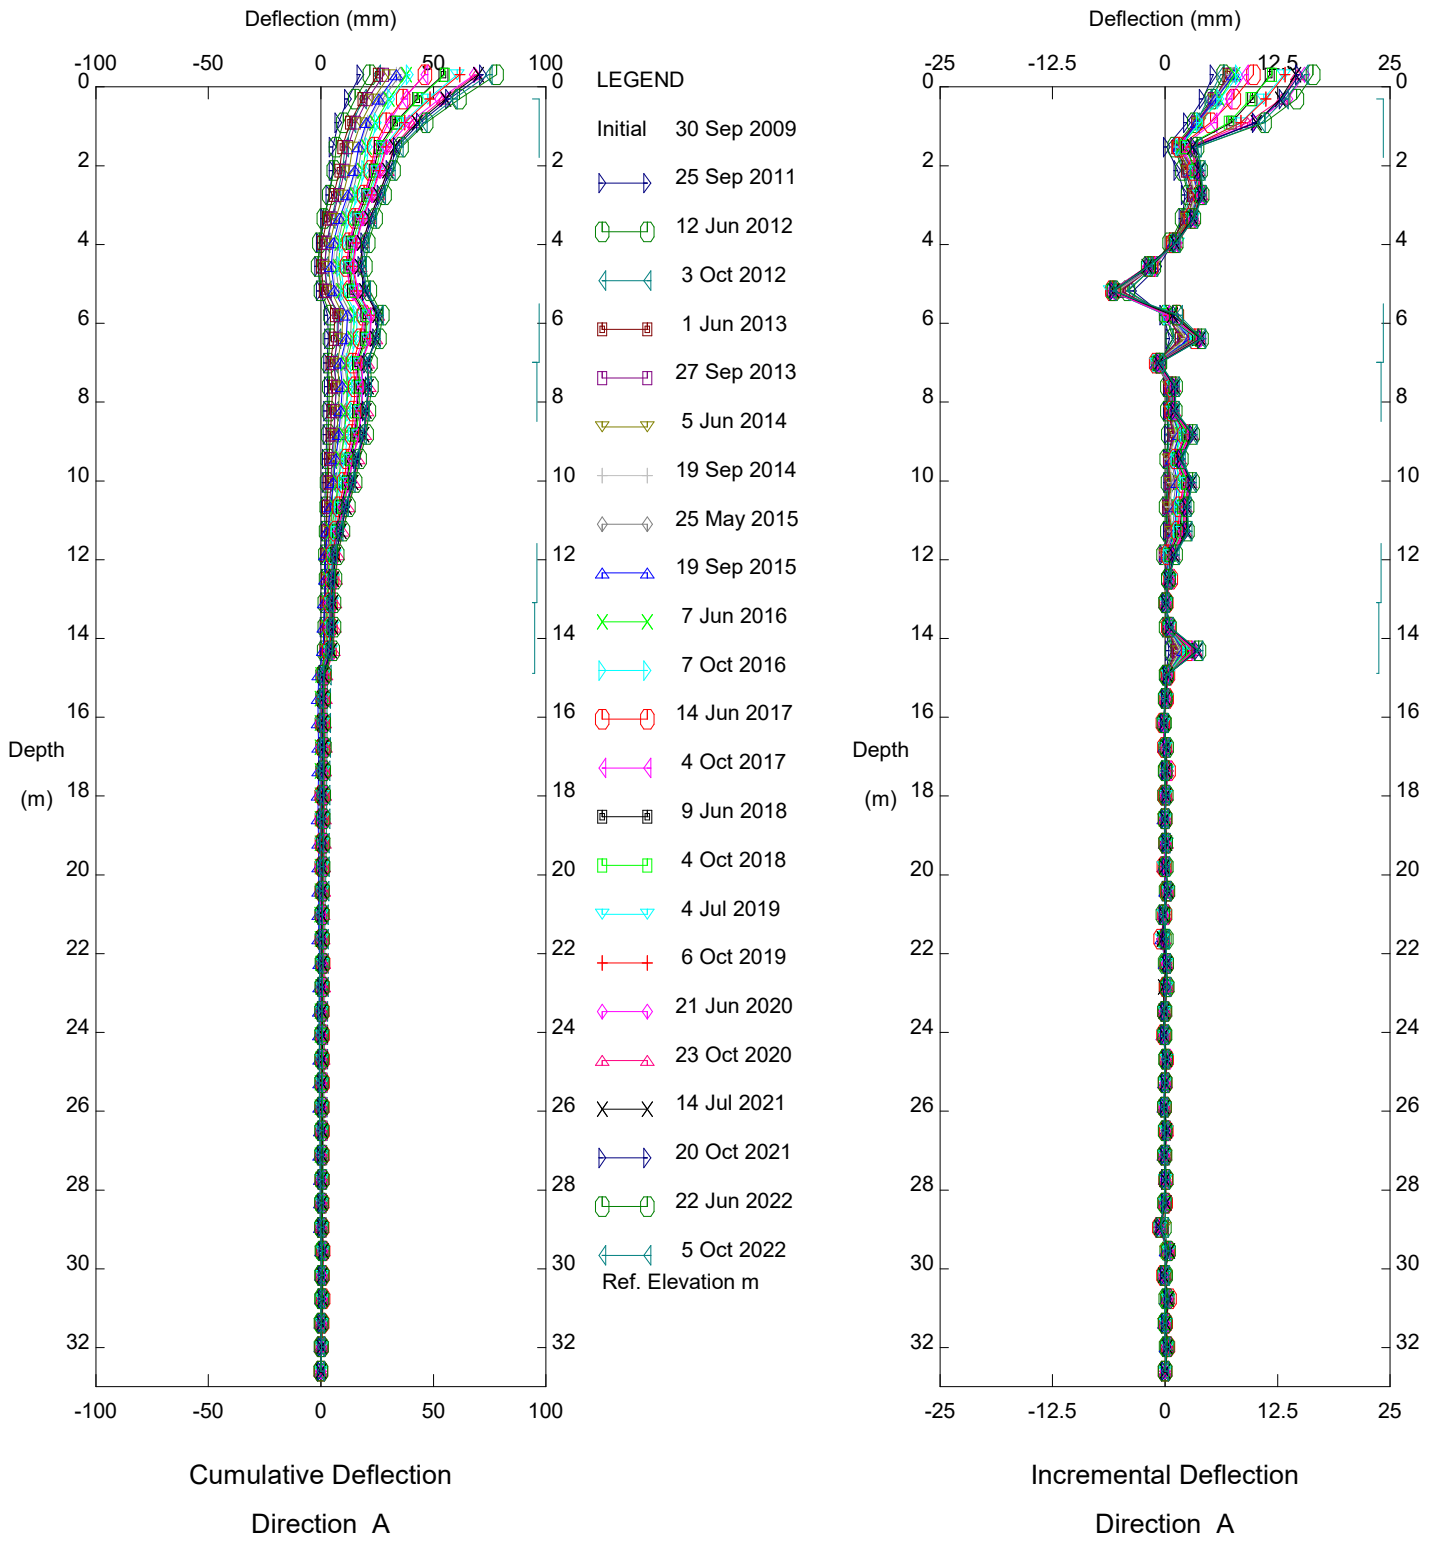
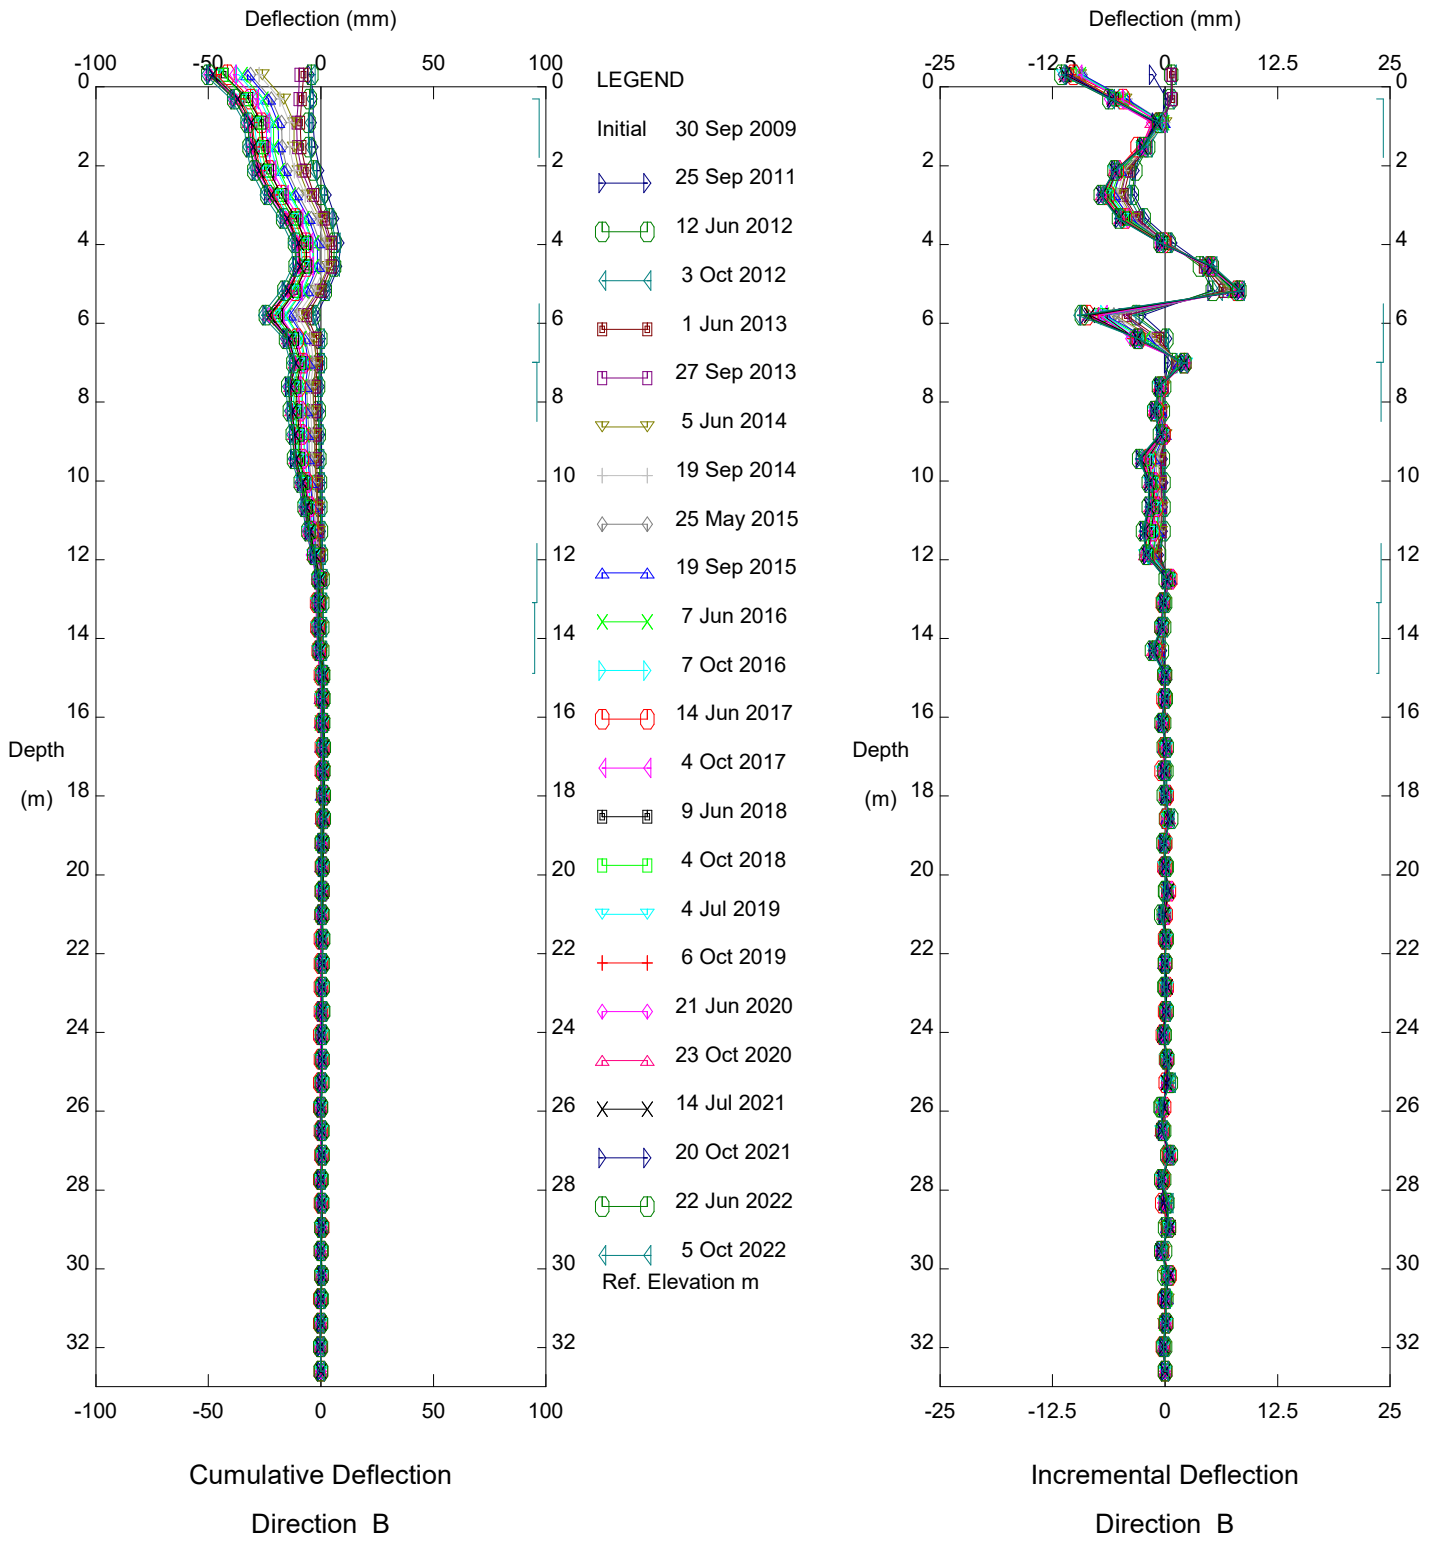
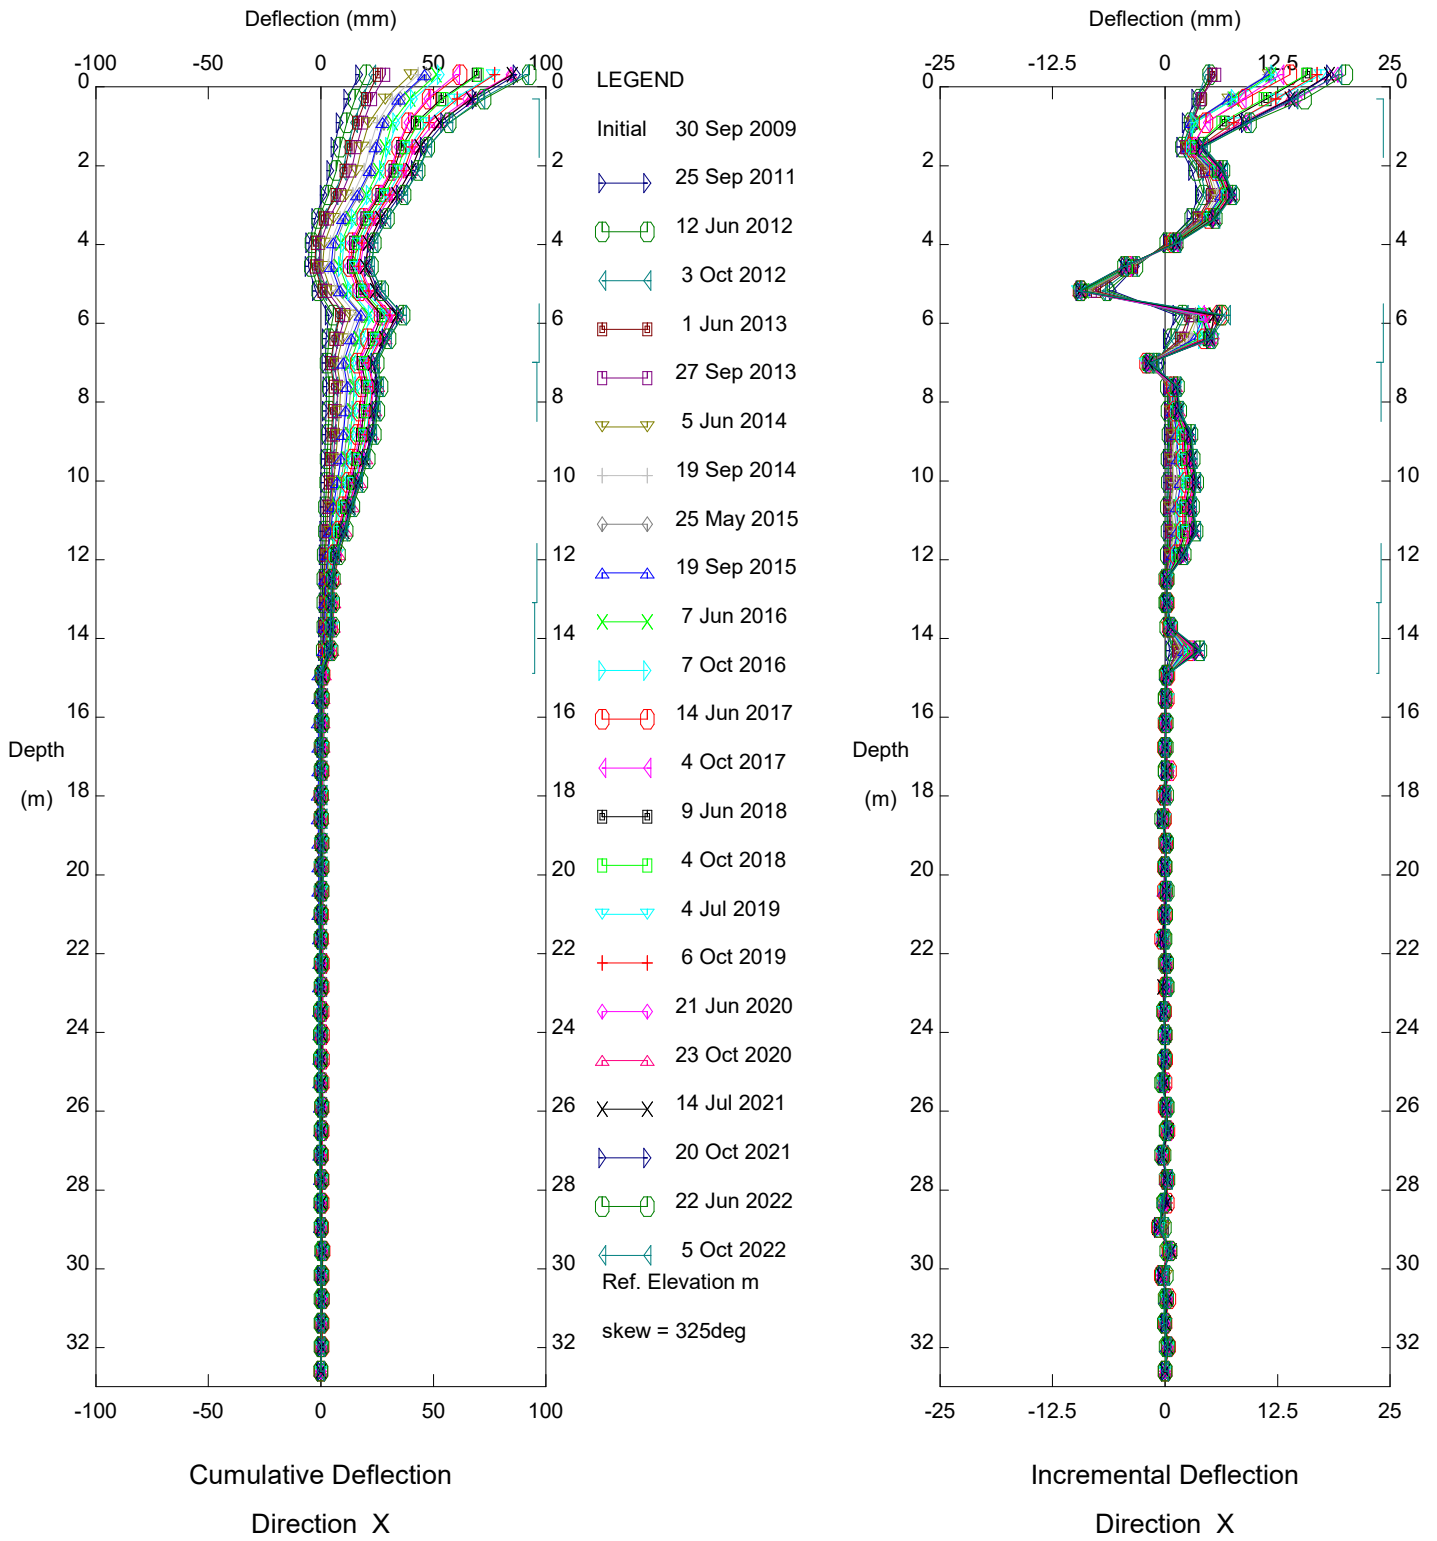
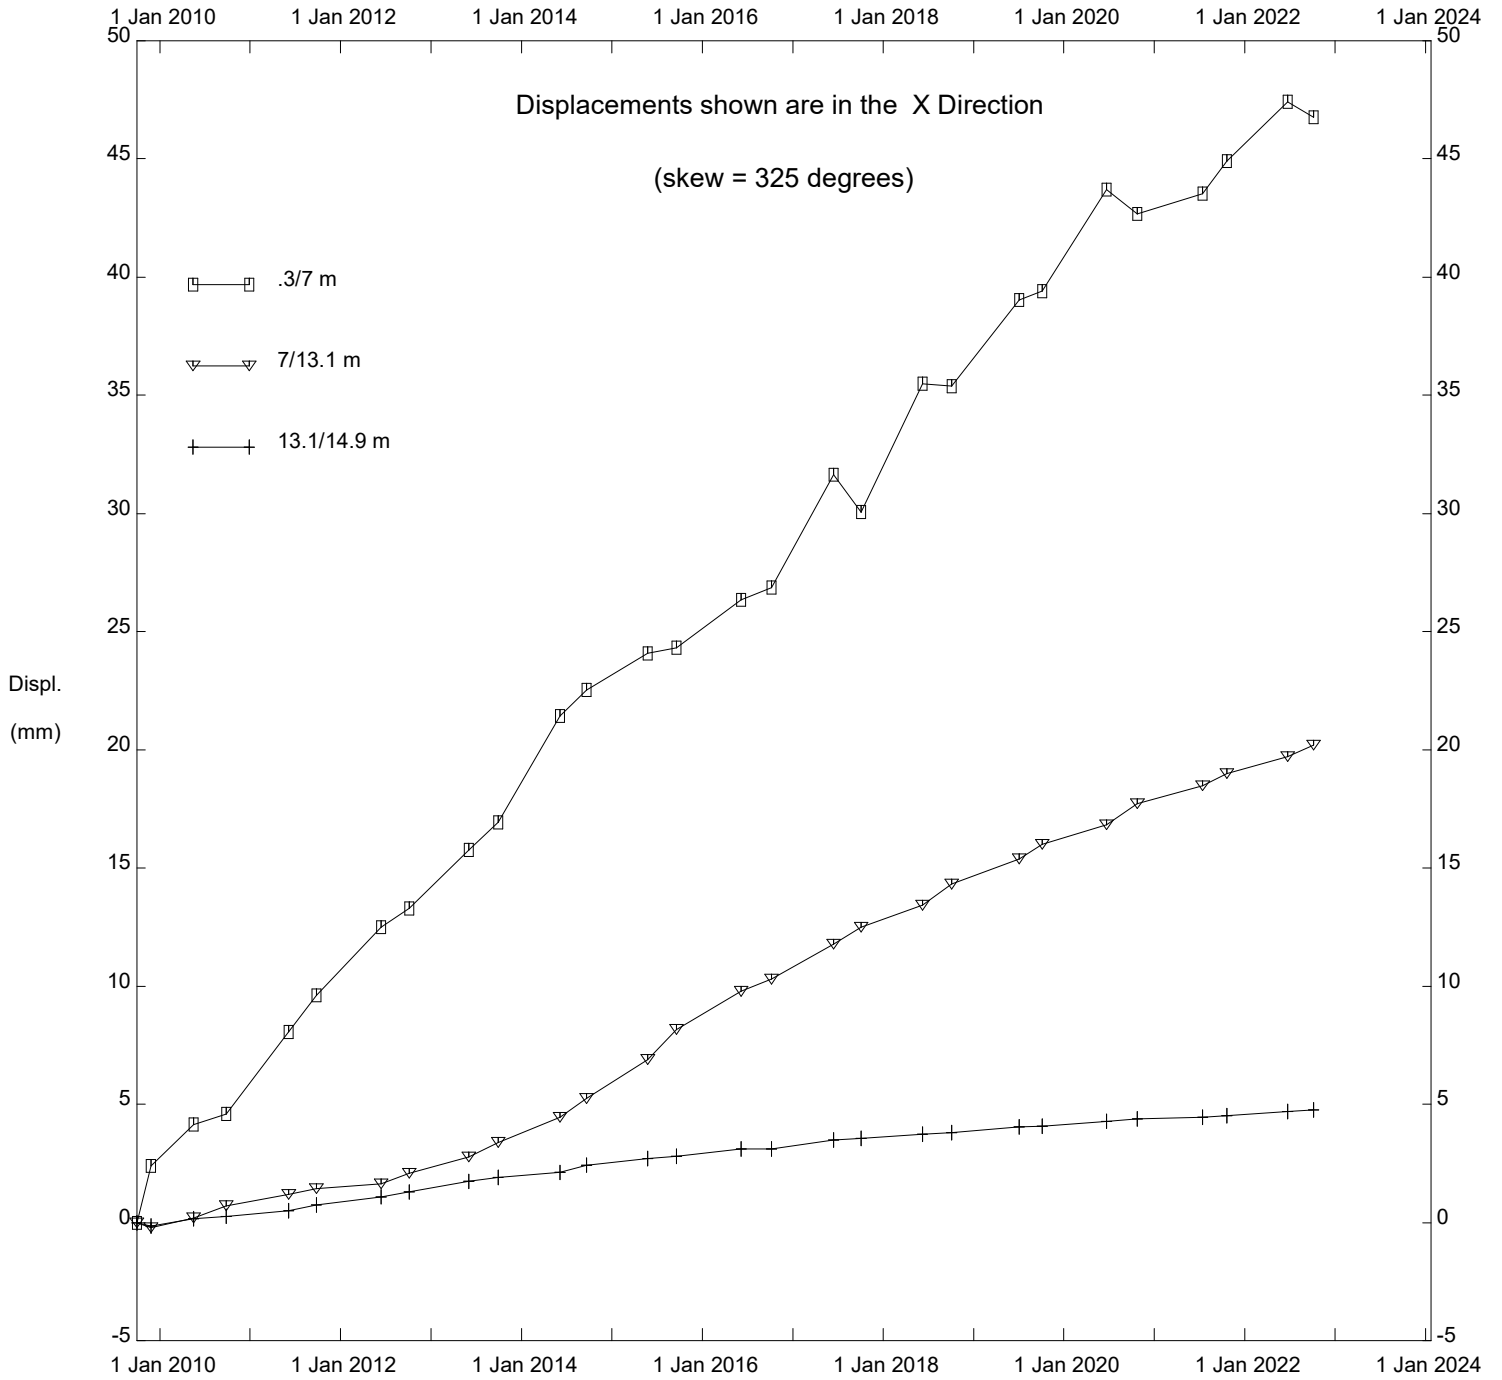
HWY 2:68 (PH037), Inclinometer SI09-1

SI09-1 showed no discernible movement, a rate of movement of 1.7 mm/yr and a rate of movement of 0.3 mm/yr over 0.3 m to 7.0 m depth, 7.0 m to 13.1 m depth and 13.1 m to 14.9 m depth, respectively, since the spring of 2022 readings. SI09-7 showed a rate of movement of 1.0 mm/yr over 3.9 m to 6.3 m depth and a rate of movement of 0.5 mm/yr over 18.5 m to 20.3 m depth.

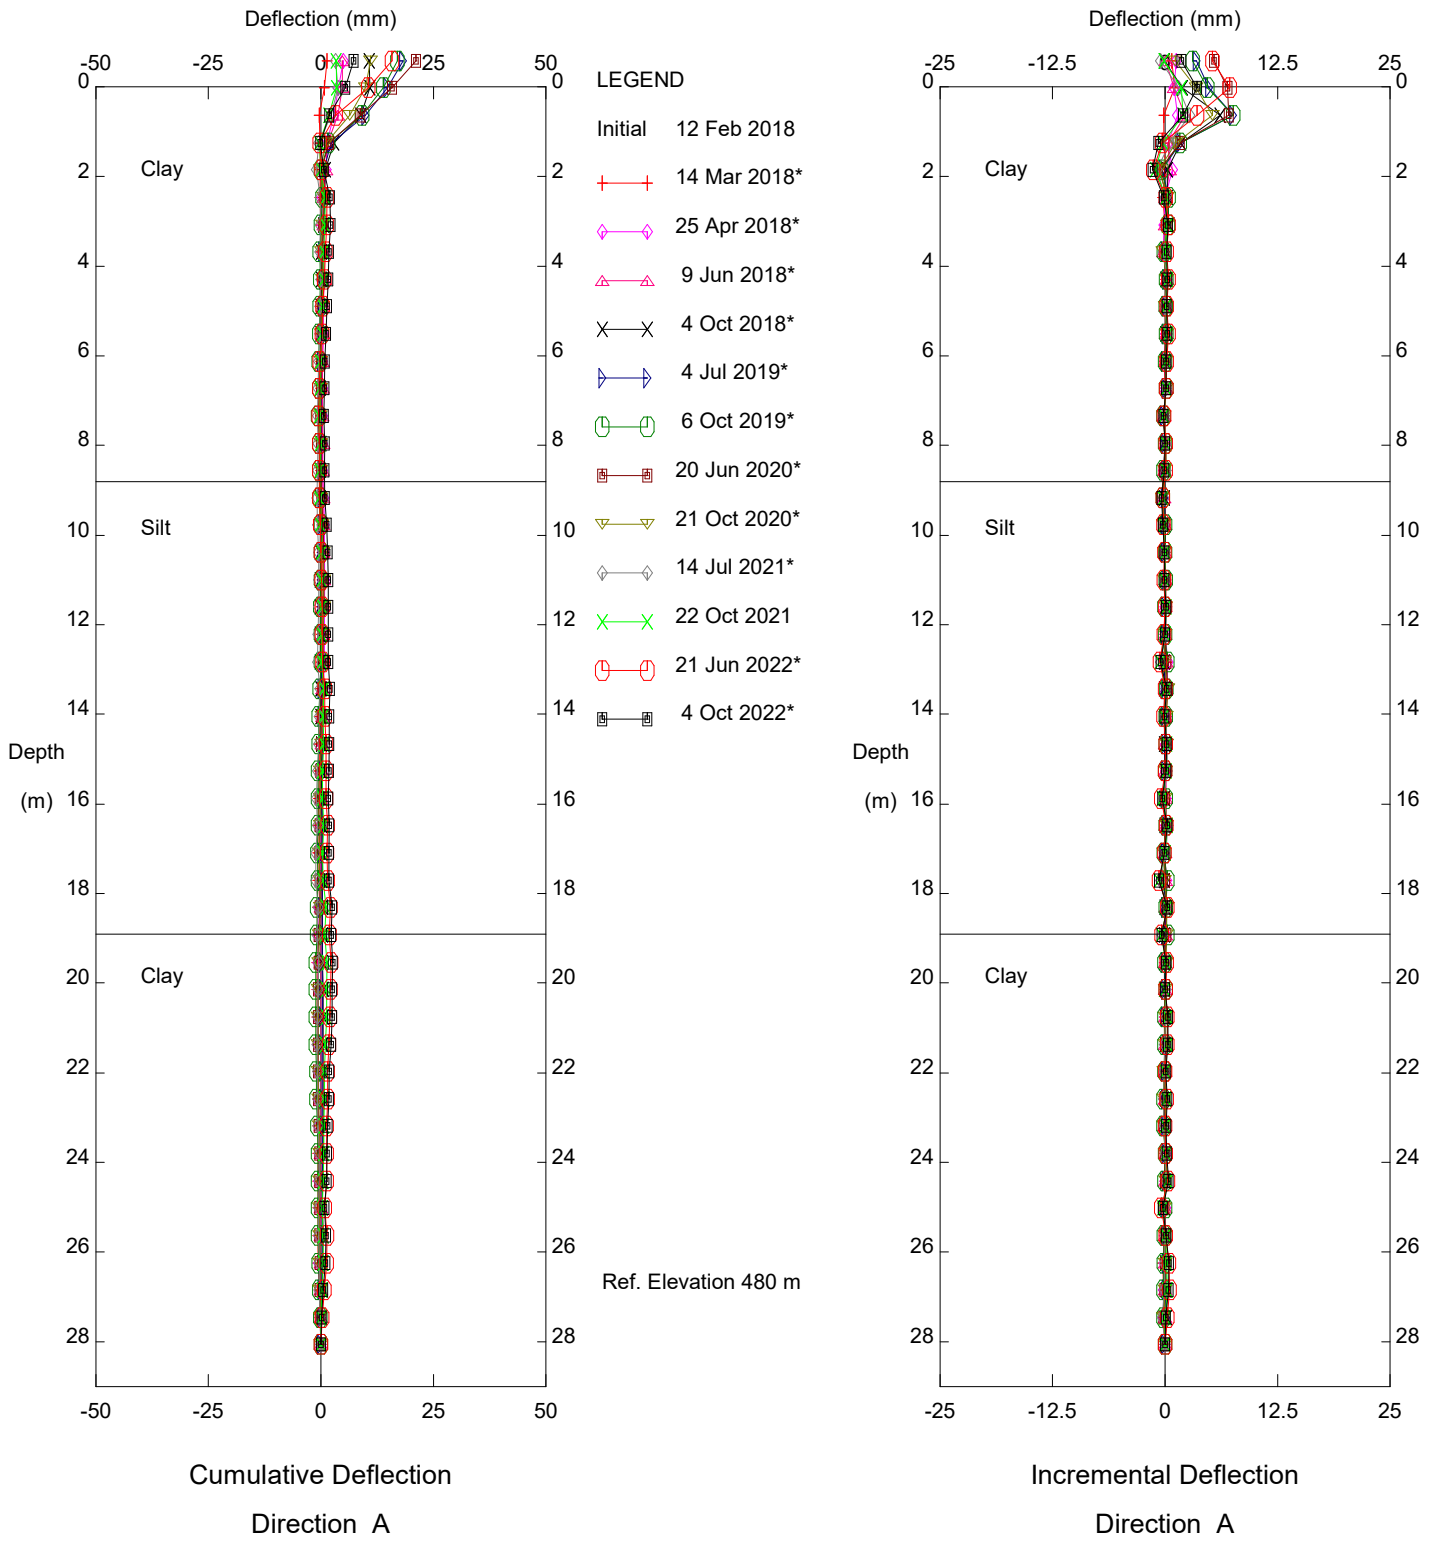
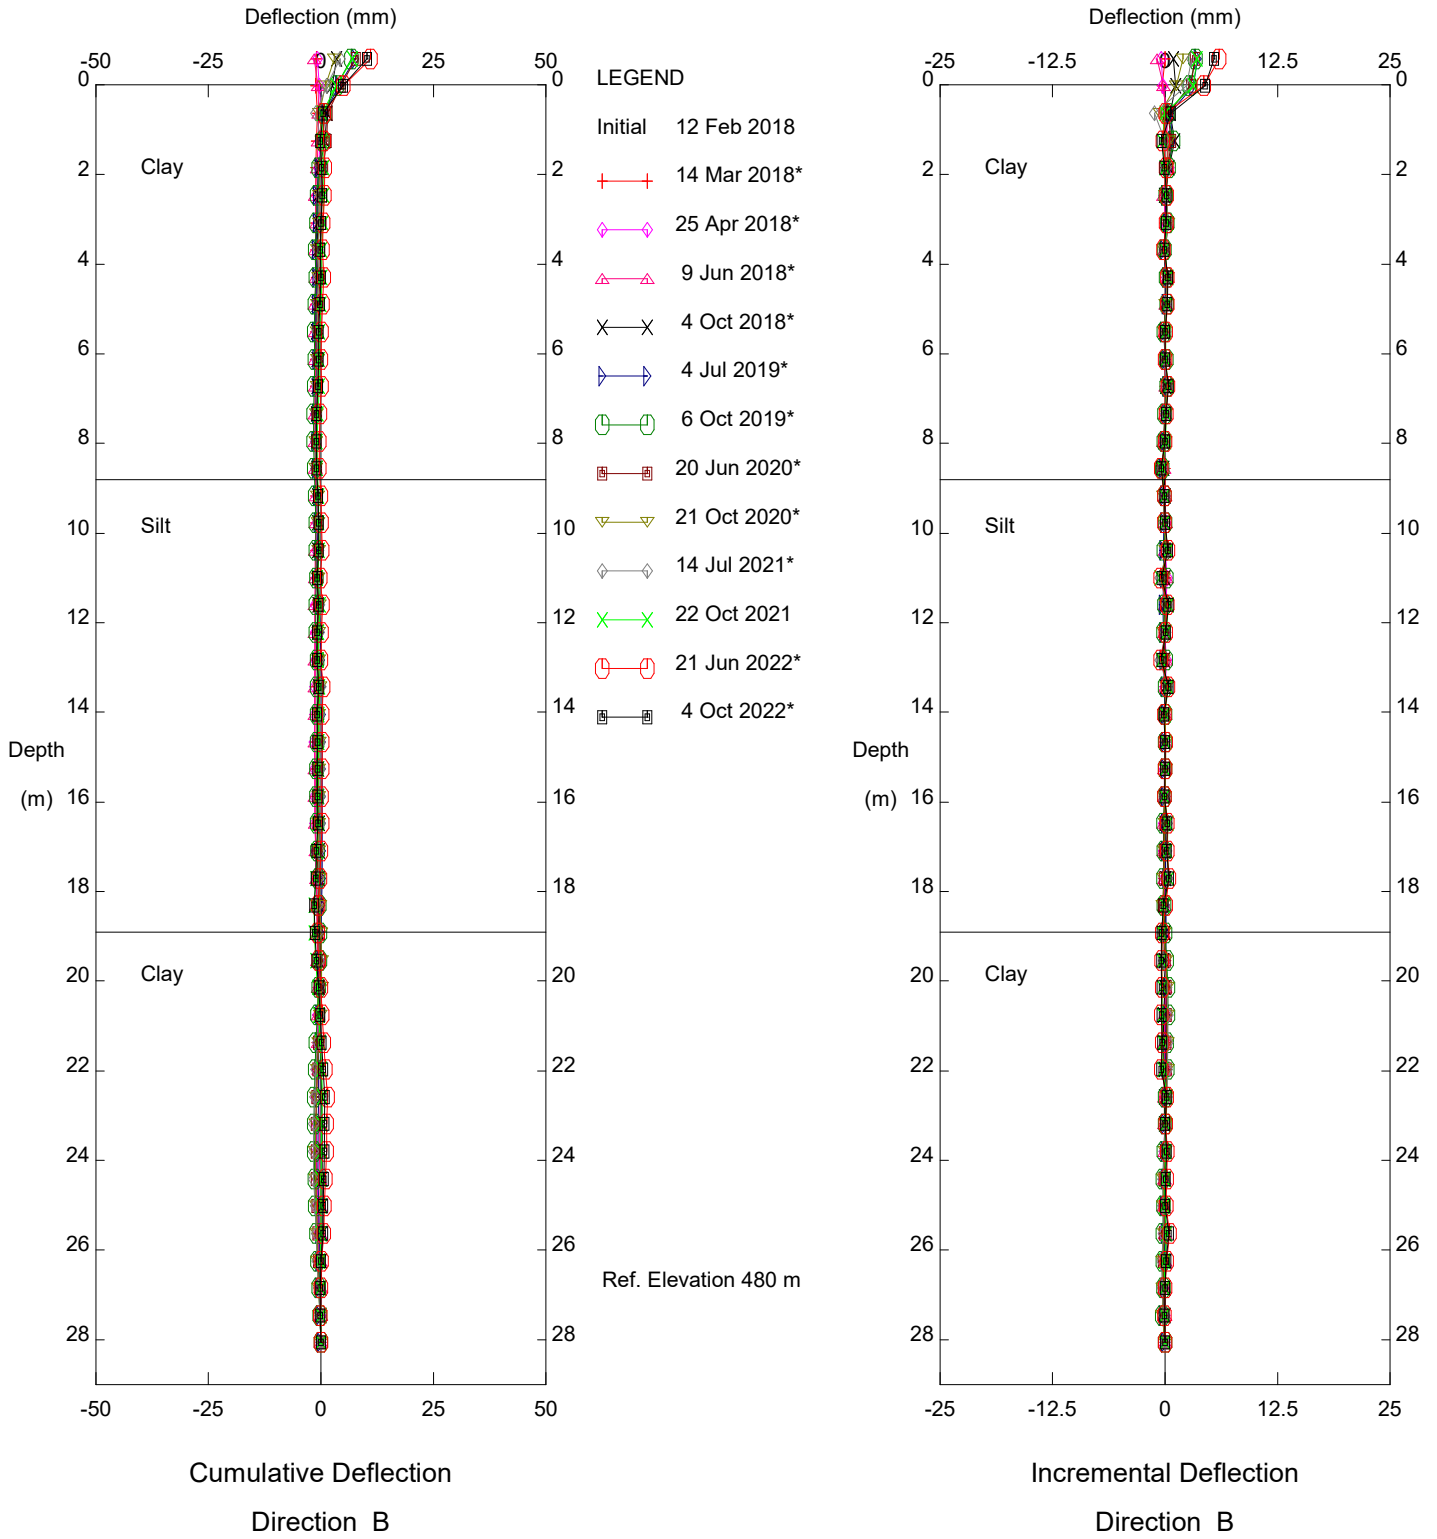
HWY 2:68 (PH037), Inclinometer SI18-4

The zone of movement over 0.0 m to 1.9 m in SI18-4 was determined during the previous readings cycle to not represent an actual zone of movement. As such, this zone of movement has been removed.

SI18-4 continued to show no discernible movement. SI18-5 indicates a well-defined landslide shear zone showing a rate of movement of 4.5 mm/yr over 17.2 m to 20.3 m depth. SI18-6 also indicates a well-defined shear plane showing a rate of movement of 1.9 mm/yr over 32.1 m to 35.1 m depth. SI18-7 showed a rate of movement of 10.6 mm/yr along a shear plane over 9.1 m to 11.6 m depth. SI18-8 showed a rate of movement of 3.6 mm/yr along a well-defined shear plane over 14.5 m to 16.3 m depth. SI18-9 showed a rate of movement of 2.6 mm/yr along a well-defined shear plane over 20.1 m to 22.0 m depth. SI18-10 showed a rate of movement of 8.8 mm/yr over 0 m to 3.0 m depth and a rate of movement of 2.0 mm/yr over 21.3 m to 23.2 m depth.
