**THURBER** ENGINEERING LTD.

**ALBERTA TRANSPORTATION GRMP (CON0022165)  
PEACE REGION (GRANDE PRAIRIE DISTRICT – NORTH)  
INSTRUMENTATION MONITORING RESULTS – FALL 2022**

**SECTION C**

**SITE PH037: HWY 2:68, DUNVEGAN SOUTH**

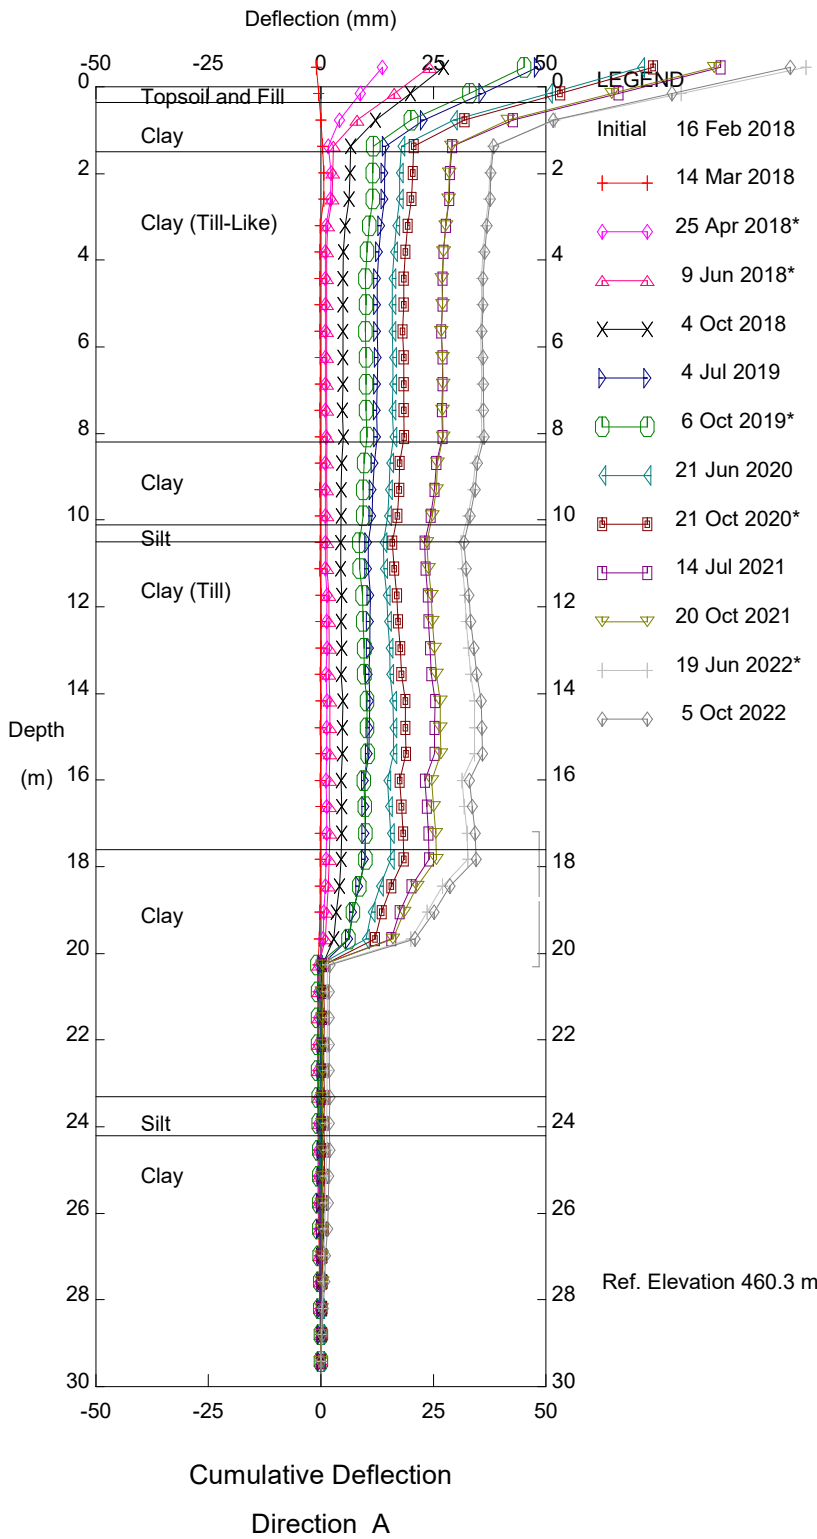
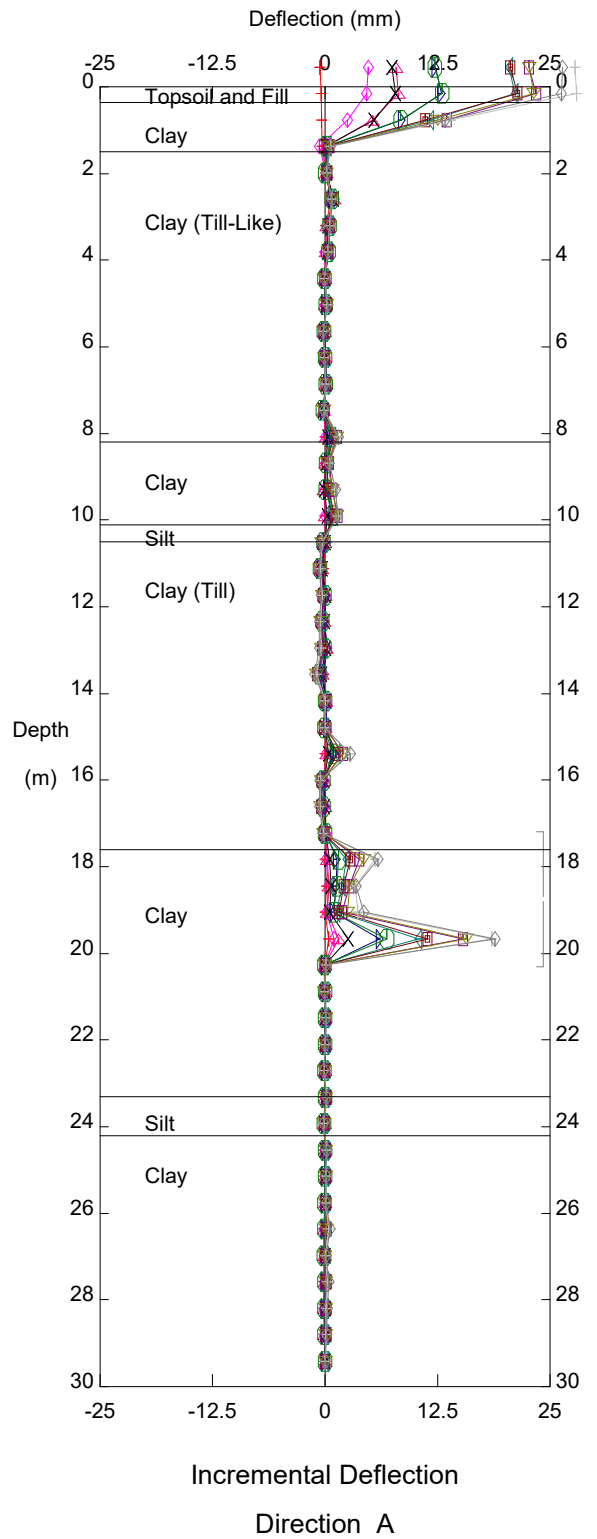
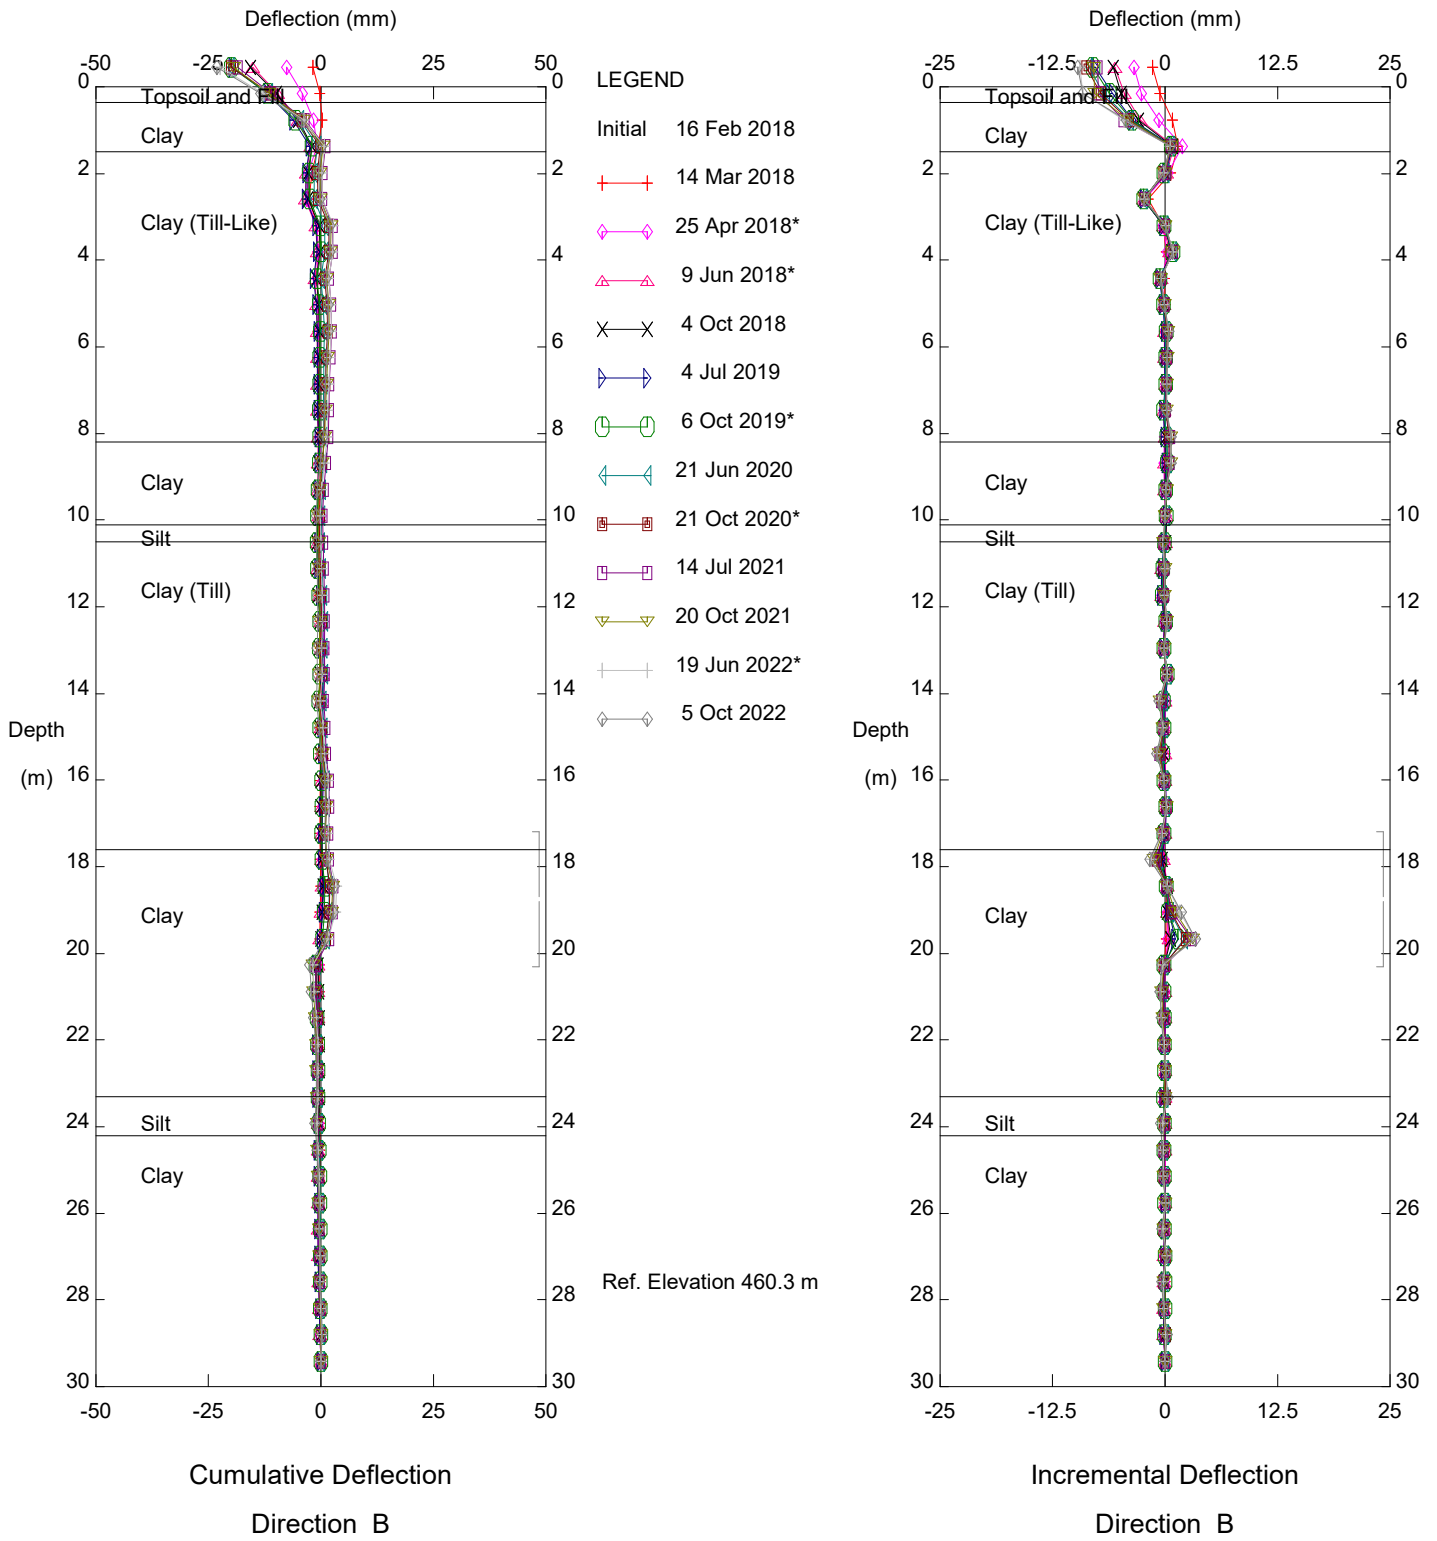
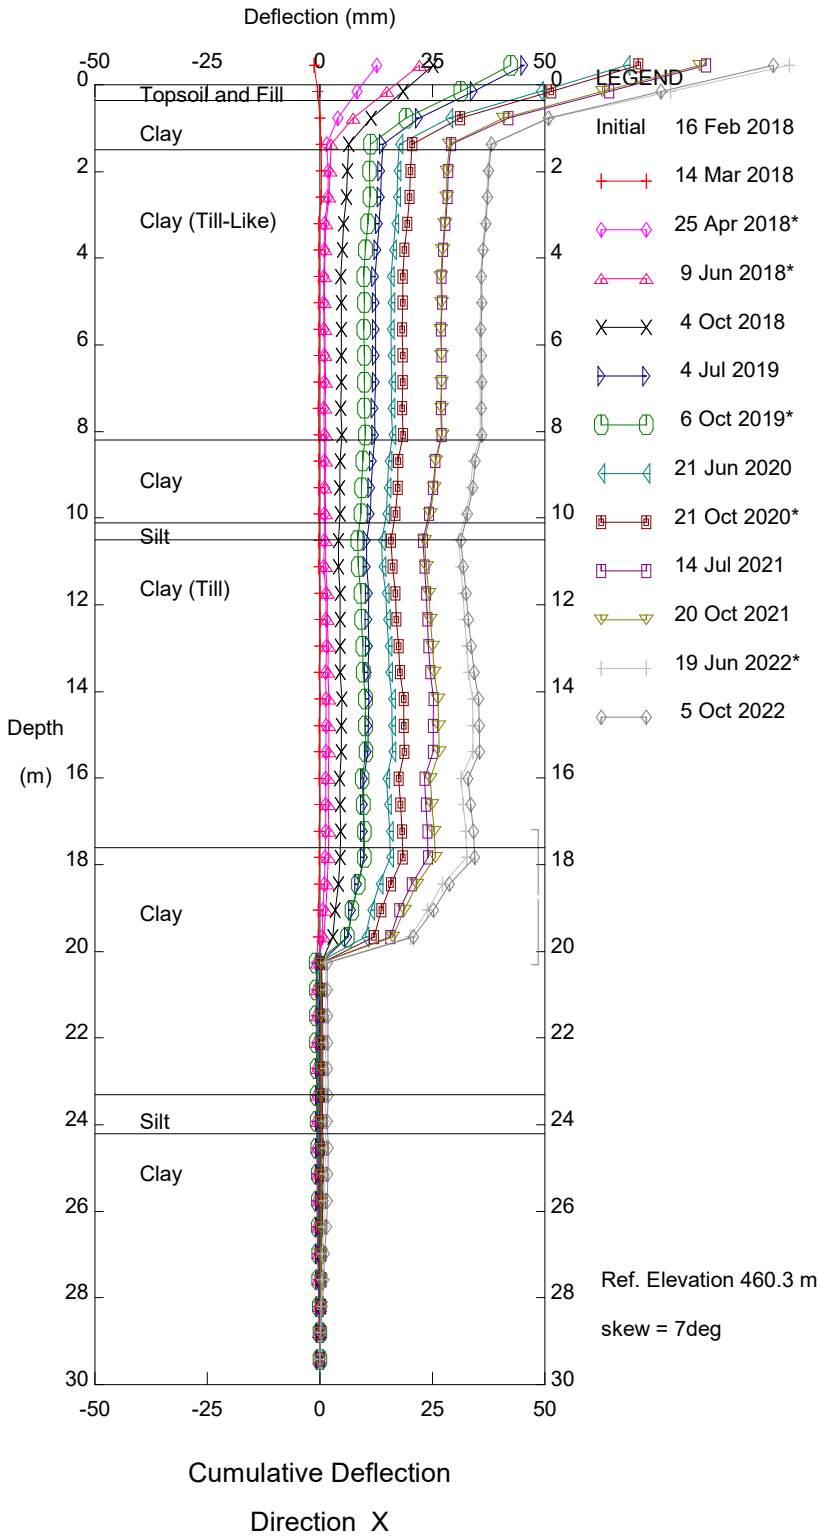
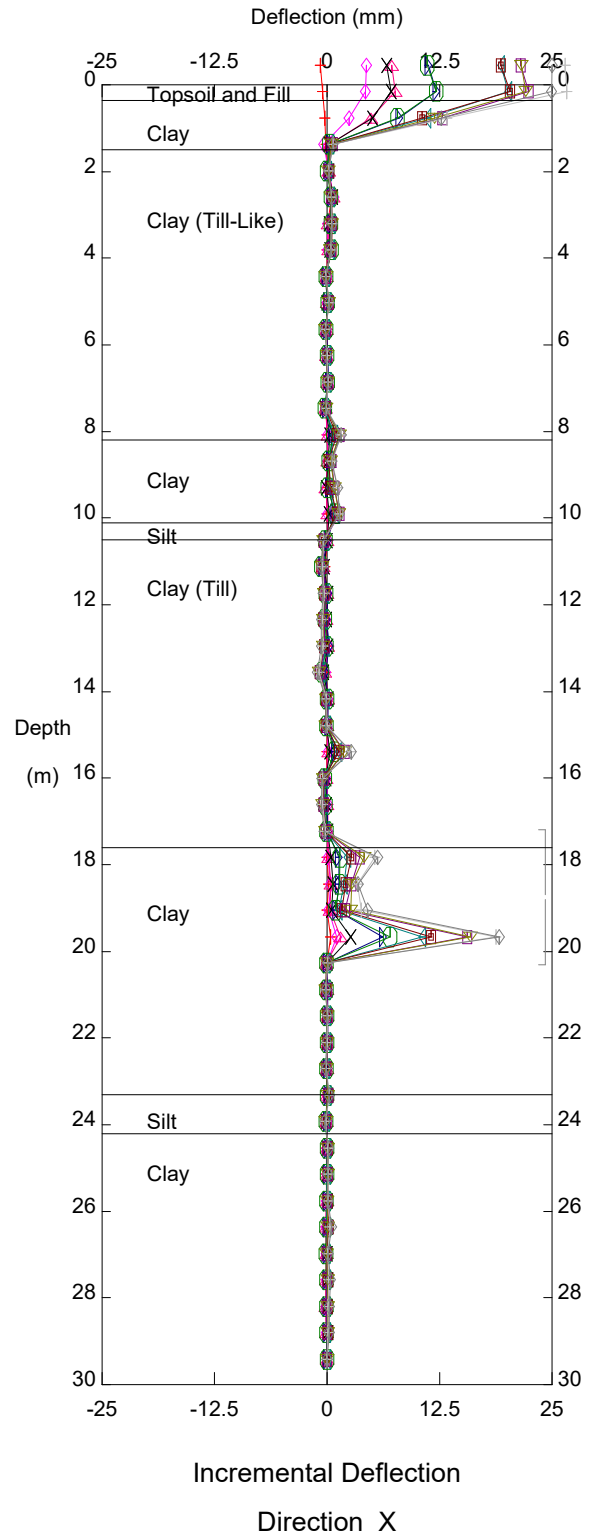
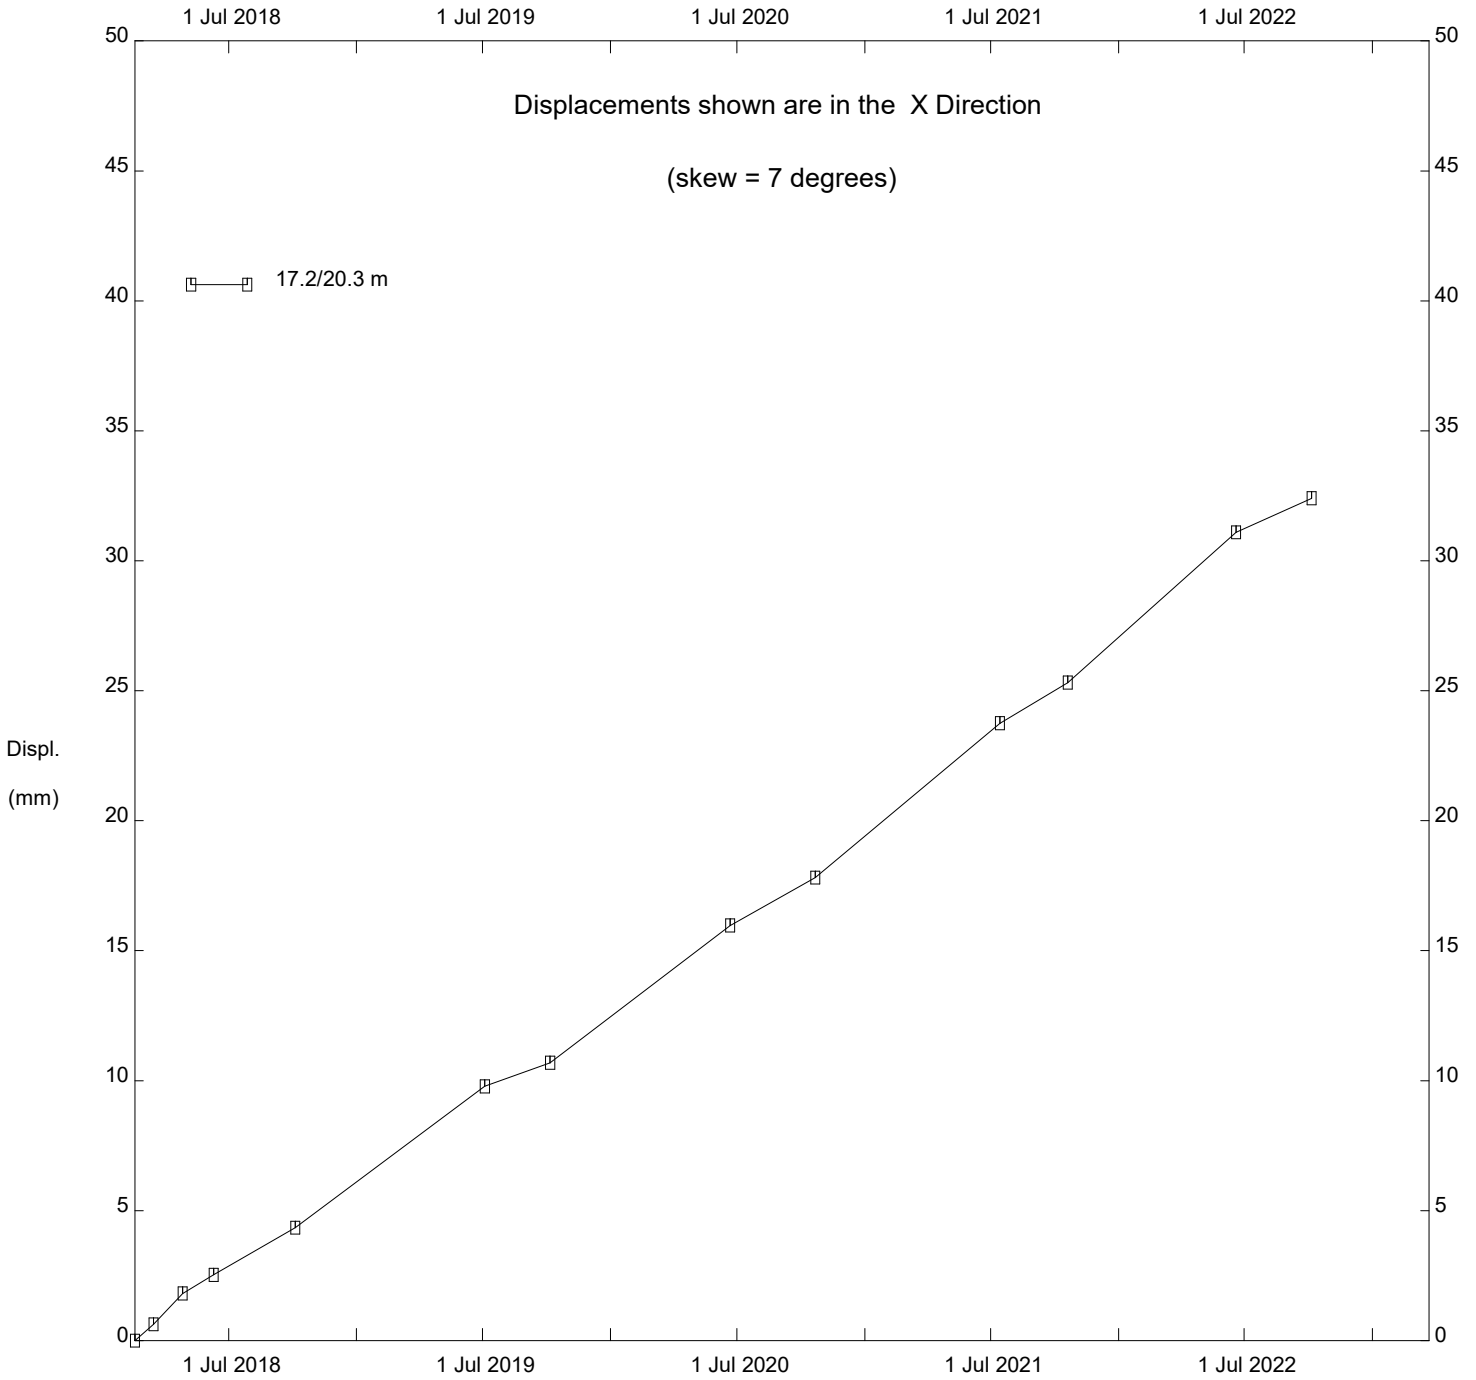
HWY 2:68 (PH037), Inclinometer SI18-5

SI18-4 continued to show no discernible movement. SI18-5 indicates a well-defined landslide shear zone showing a rate of movement of 4.5 mm/yr over 17.2 m to 20.3 m depth. SI18-6 also indicates a well-defined shear plane showing a rate of movement of 1.9 mm/yr over 32.1 m to 35.1 m depth. SI18-7 showed a rate of movement of 10.6 mm/yr along a shear plane over 9.1 m to 11.6 m depth. SI18-8 showed a rate of movement of 3.6 mm/yr along a well-defined shear plane over 14.5 m to 16.3 m depth. SI18-9 showed a rate of movement of 2.6 mm/yr along a well-defined shear plane over 20.1 m to 22.0 m depth. SI18-10 showed a rate of movement of 8.8 mm/yr over 0 m to 3.0 m depth and a rate of movement of 2.0 mm/yr over 21.3 m to 23.2 m depth.
