**ALBERTA TRANSPORTATION  
GEOHAZARD ASSESSMENT PROGRAM  
PEACE REGION –  
GRANDE PRAIRIE DISTRICT – NORTH  
2022 INSPECTION**

Site Number	Location	Name	Hwy	km
PH037	Dunvegan	Dunvegan South 1+250 to 2+000	2:68	15.674
Legal Description		UTM Co-ordinates		
NW¼ 06-080-04 W6M		11U E 398514	N 6197340

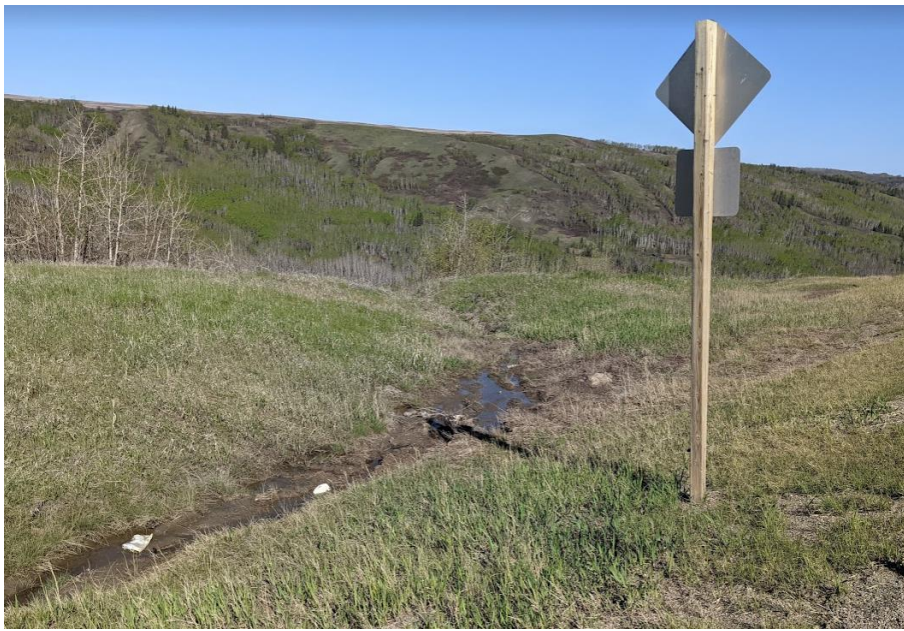
Erosion and slope movement downslope of the highway near Sta. 2+000 are a function of water flows in the ditch and are expected to worsen.

**Photo 1.**  
Looking northwest from Sta. 2+000 at erosion gully in SBL ditch south of ditch block

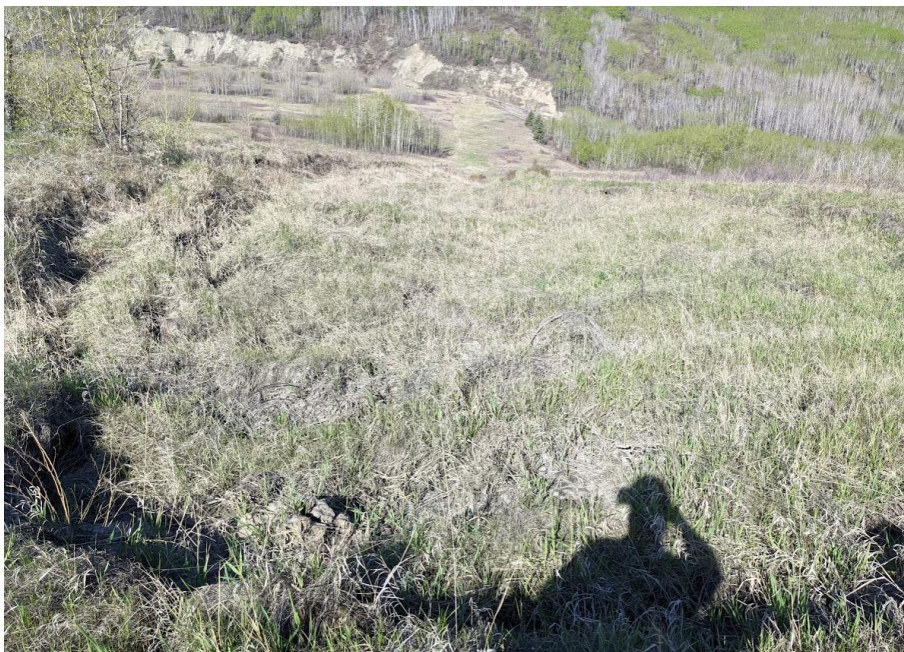
**Photo 2.**  
Looking west from Sta. 1+980 below the SBL highway. More movement noted in 2022

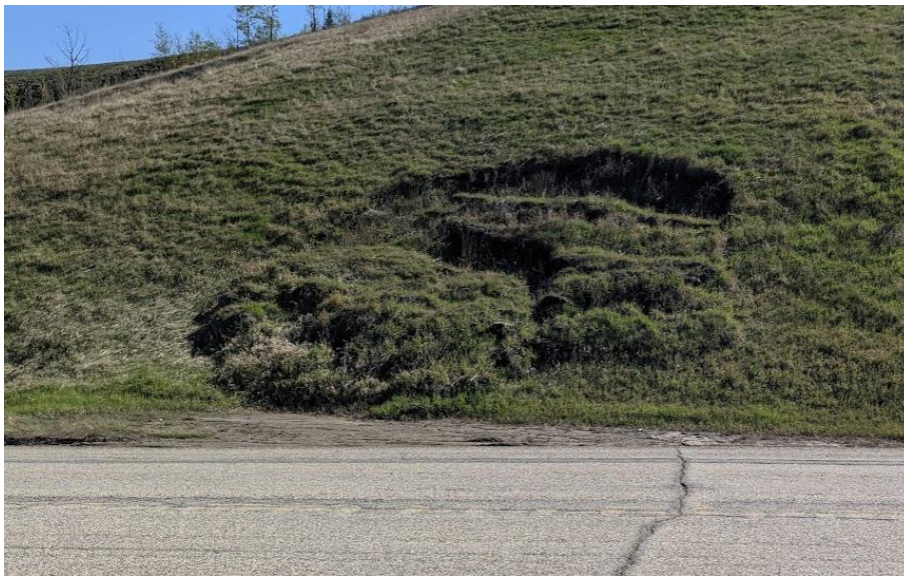
**Photo 3.**  
Looking east at  
backslope skin  
failure at Sta.  
1+900 (More  
movement since  
2021).

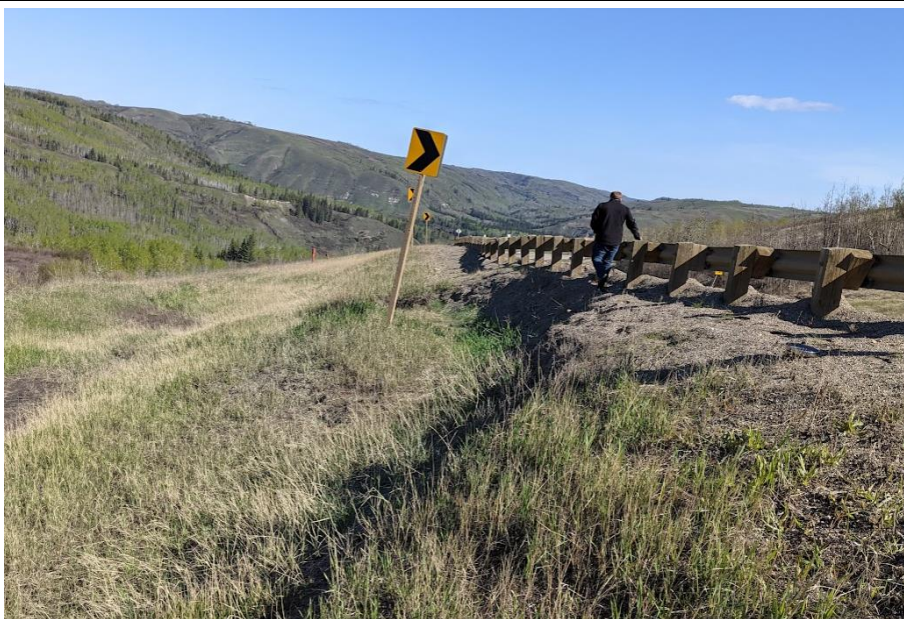
**Photo 4.**  
Looking north  
from Sta. 1+890  
at the slump in  
the sideslope of  
the SBL. The  
scarp is 1.1 m  
high and  
0.8 m from the  
guardrail.

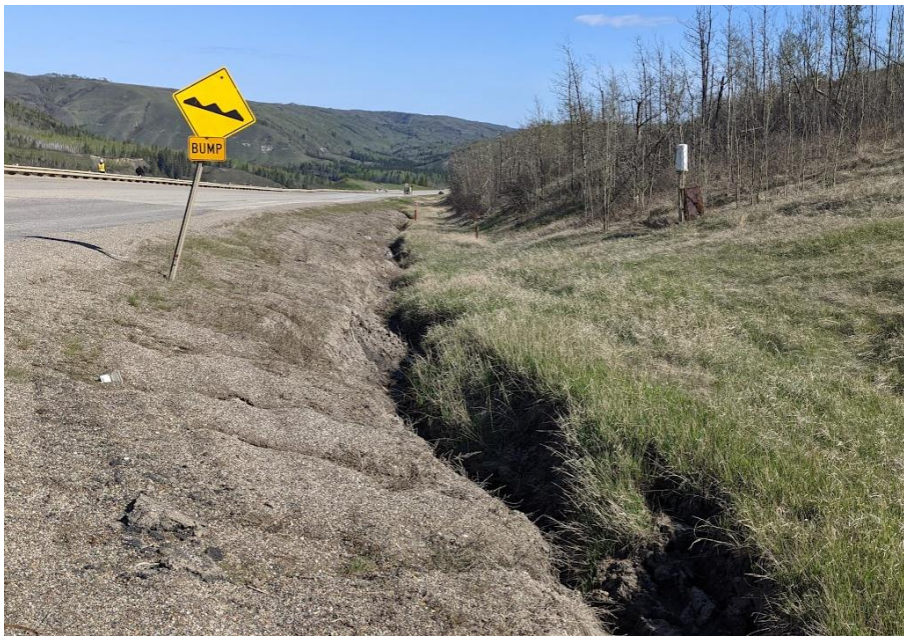
**Photo 5.**  
Looking north from Sta. 1+800 at the erosion gully developed on the ditch up to 3.3 m wide and 0.8 m deep. Erosion gully wider and deeper than noted at the 2021 inspection

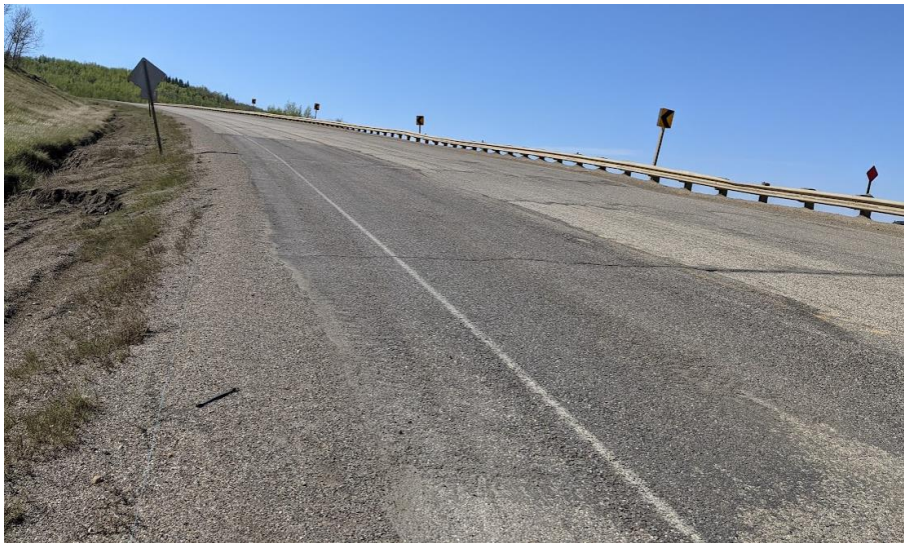
<table><tr> <th>Description</th> <th>Worsened?</th> </tr><tr> <td>Dips across road at 1+690 and 1+820 associated with both ends of slide.</td> <td></td> </tr></table>

**Photo 6.**  
Looking northeast across the dip in the highway at the south end of the 1+800 slide.

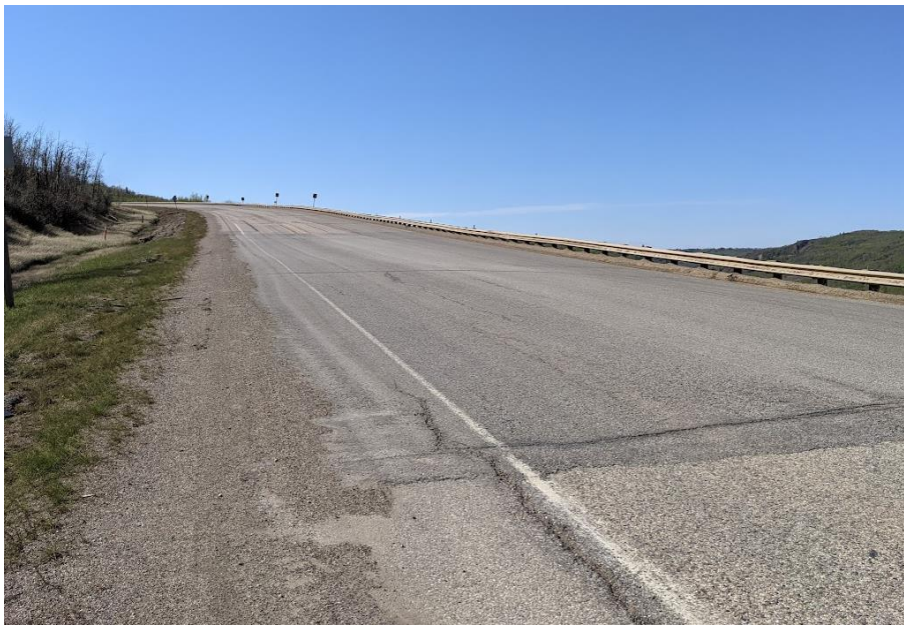
**Photo 7.**  
Looking from the shoulder of the SBL at Sta. 1+660 across the dip in the highway at the north end of the 1+800 slide.

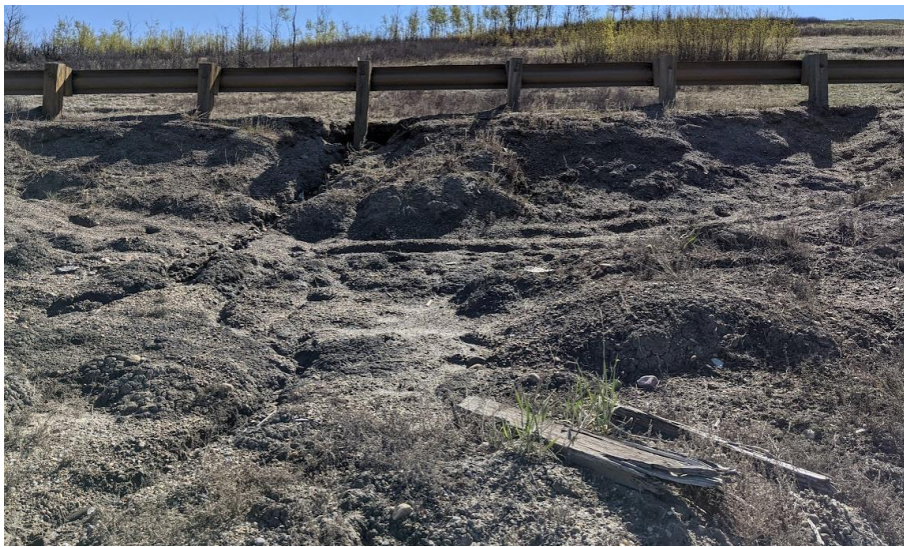
**Photo 9.** Looking west across soil matting and nails which were installed in August 2010 at Sta. 1+450 slide. Backscarp (5 m to 7.5 m high) continues to retrogress and is now impacting the highway. Two guardrail posts are hanging and other two posts are partially exposed.

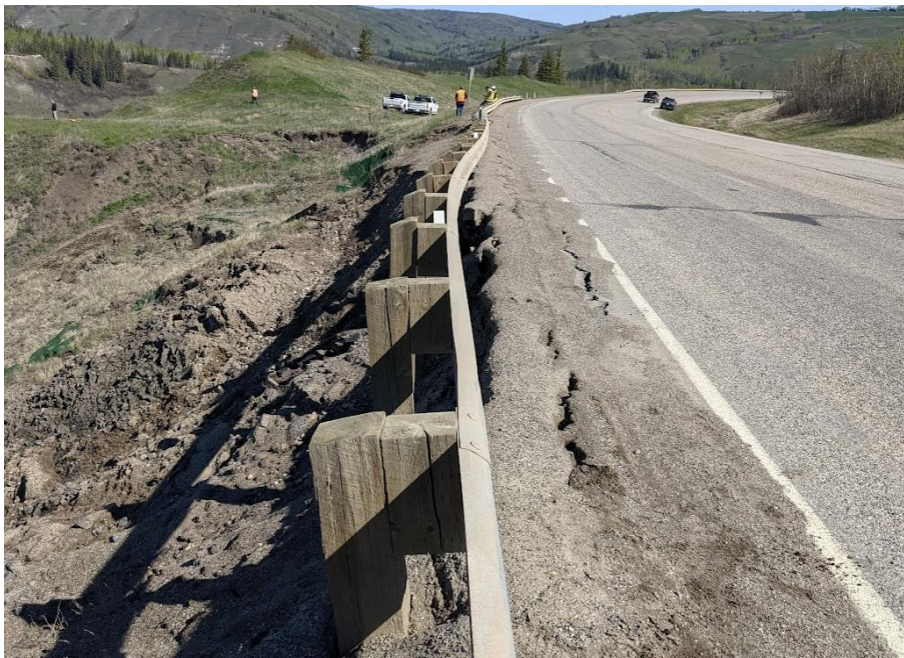
**Photo 10.** Looking north from Sta. 1+450 backscarp. The slide scarp cracks up to 200 mm wide just west of the white line.

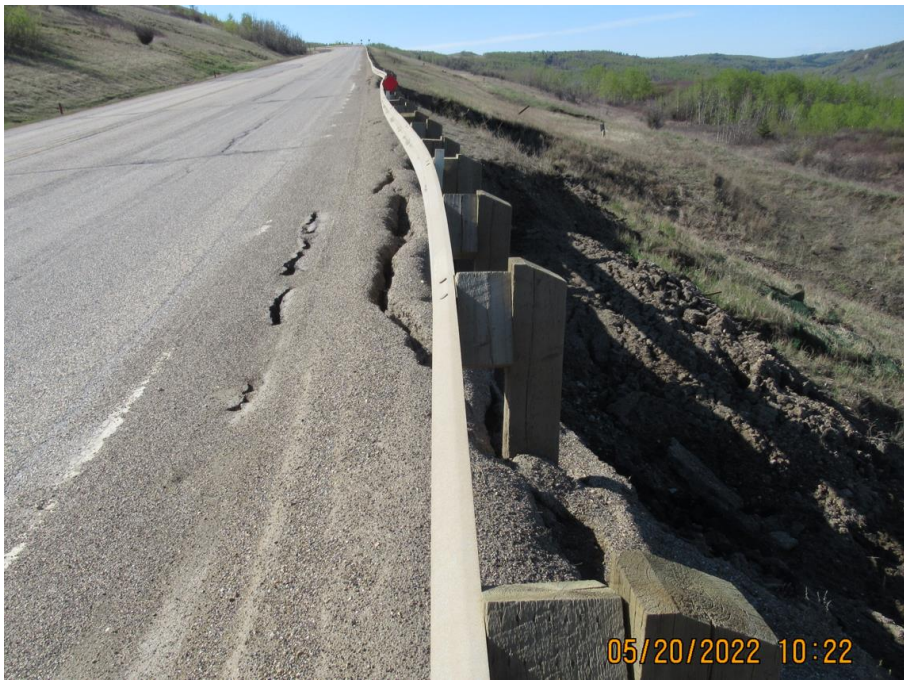
The 1+400 slide is retrogressing rapidly and is impacting the SBL shoulder. When considering the existing smaller slide features to the south, this suggests that the expansion of this slide further to the south should be anticipated.

**Photo 11.**  
Looking south from Sta. 1+390 at the backscarp of the 1+400 slide which is impacting the highway shoulder. Slide cracks are wider and closer to the white line

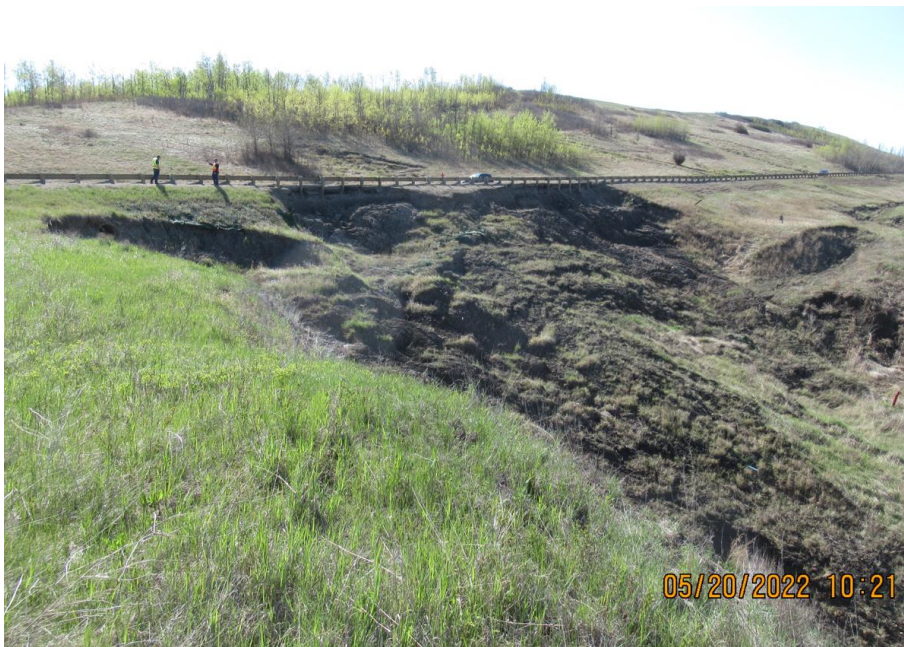
**Photo 12.**  
Looking southeast towards the 1+400 slide. The slide has further retrogressed towards the highway, is wider than in 2021 and there is a 5 m to 7.5 m drop below the guardrail.

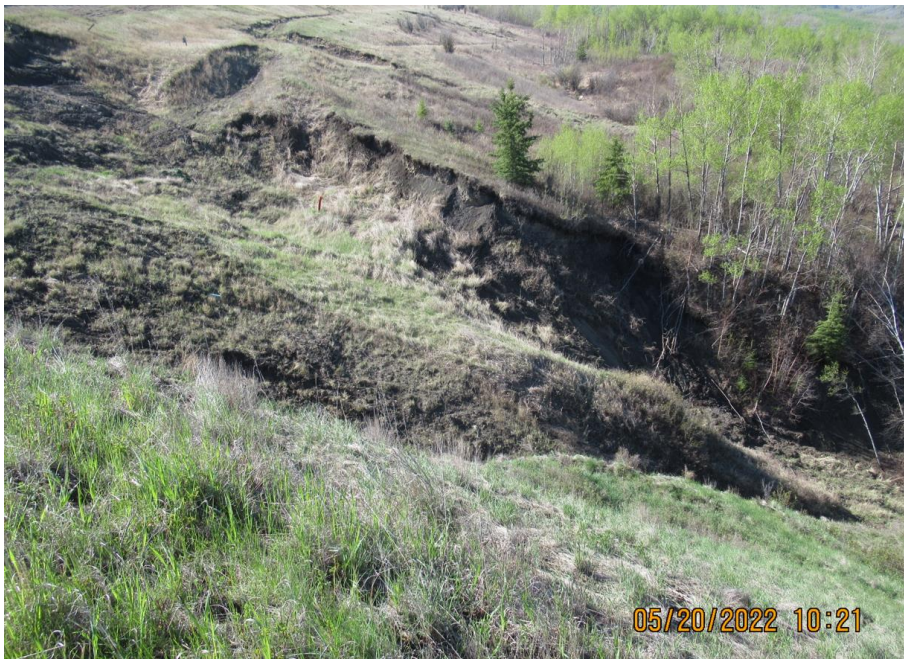
**Photo 13.**  
Looking south at  
the fresh slump  
slide that is  
impacting the  
highway at Sta.  
1+400.

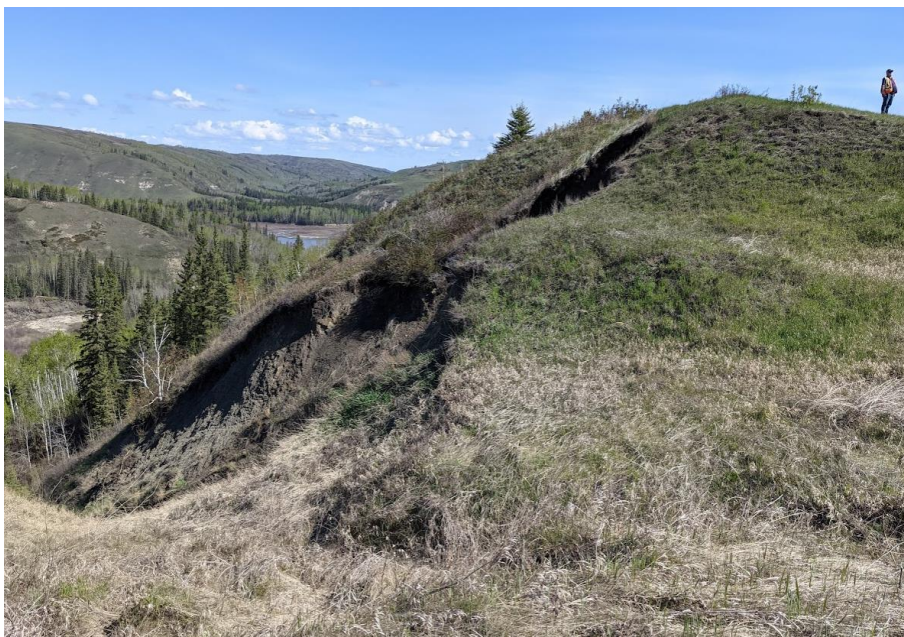
**Photo 14.**  
Looking  
northwest from  
the north side of  
the erosion gully  
at Sta. 1+360

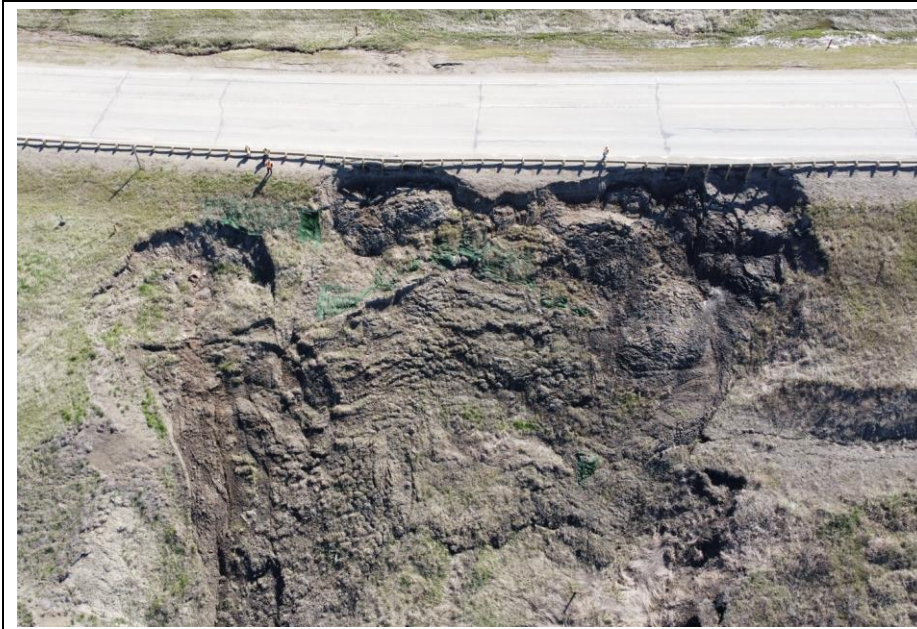
**Photo 15.**  
Drone photo of  
the backscarp of  
the 1+400 slide  
impacting the  
highway  
shoulder.
