ALBERTA TRANSPORTATION AND  
ECONOMIC CORRIDORS GRMP  
PEACE REGION  
(GRANDE PRAIRIE DISTRICT - NORTH)  
INSTRUMENTATION MONITORING - FALL 2025

| Site Number | Location | Name | Hwy | km |
|---|---|---|---|---|
| PH037 | Station 1+250 to 2+000 | Dunvegan South | 2:68 | Km 15.7 |

| <b>Current Monitoring:</b> | 02-Oct-2025 | <b>Previous Monitoring</b> | 18~19-June-2025 |

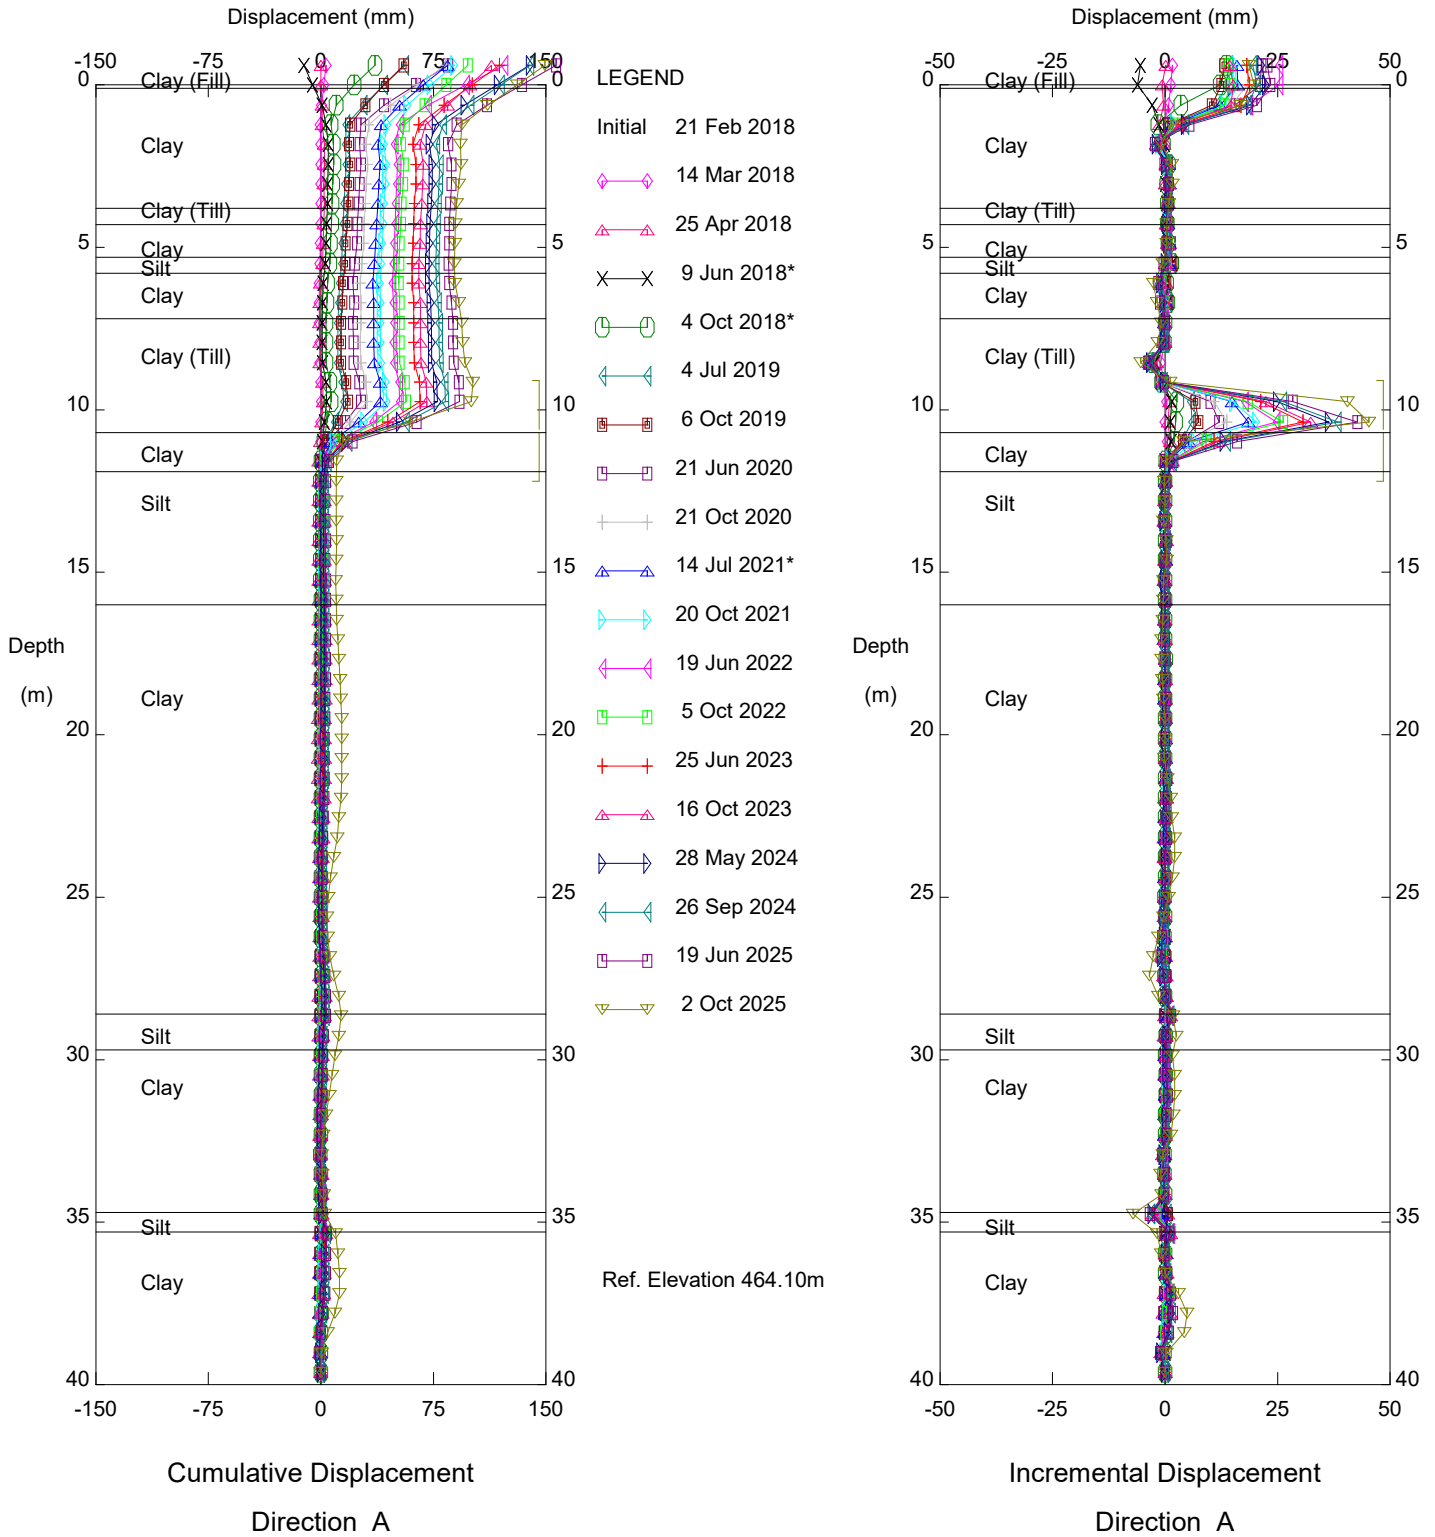
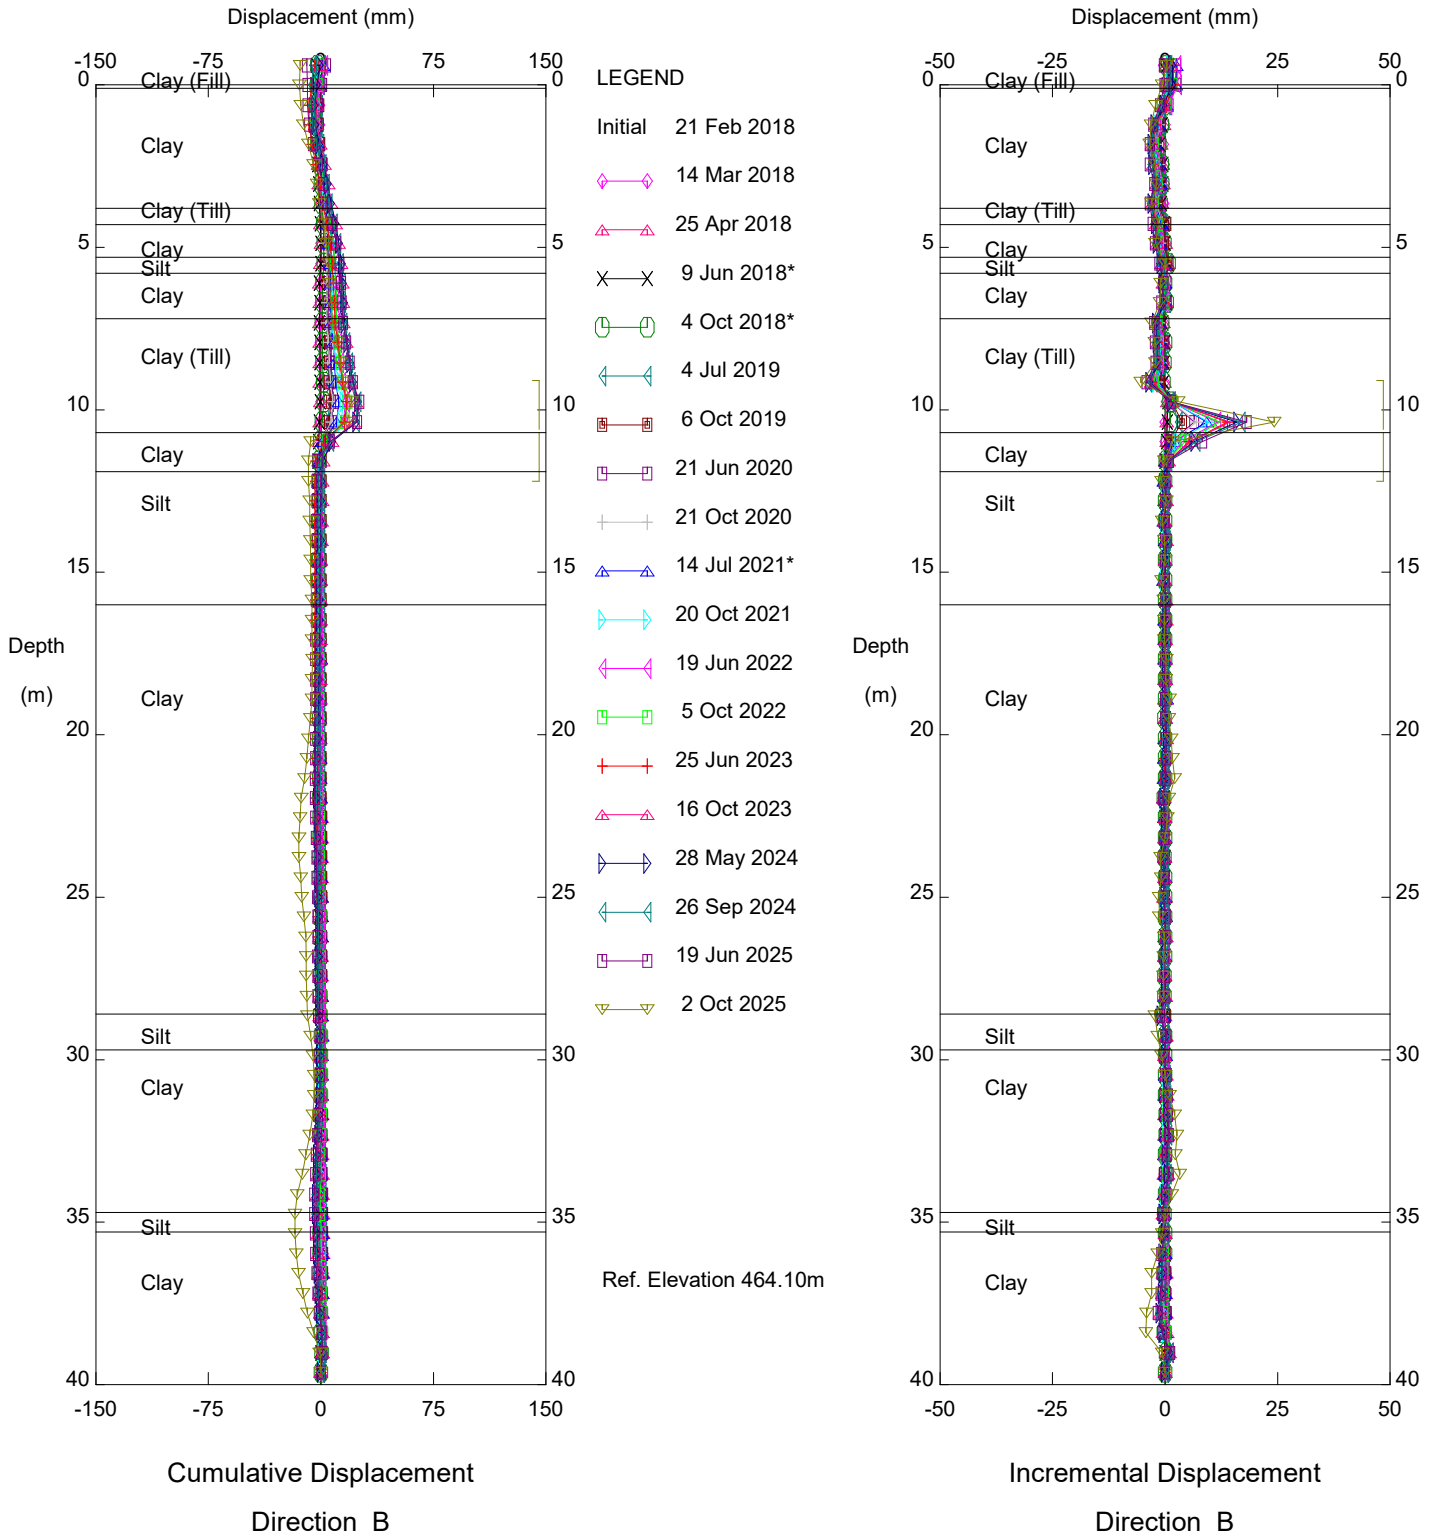
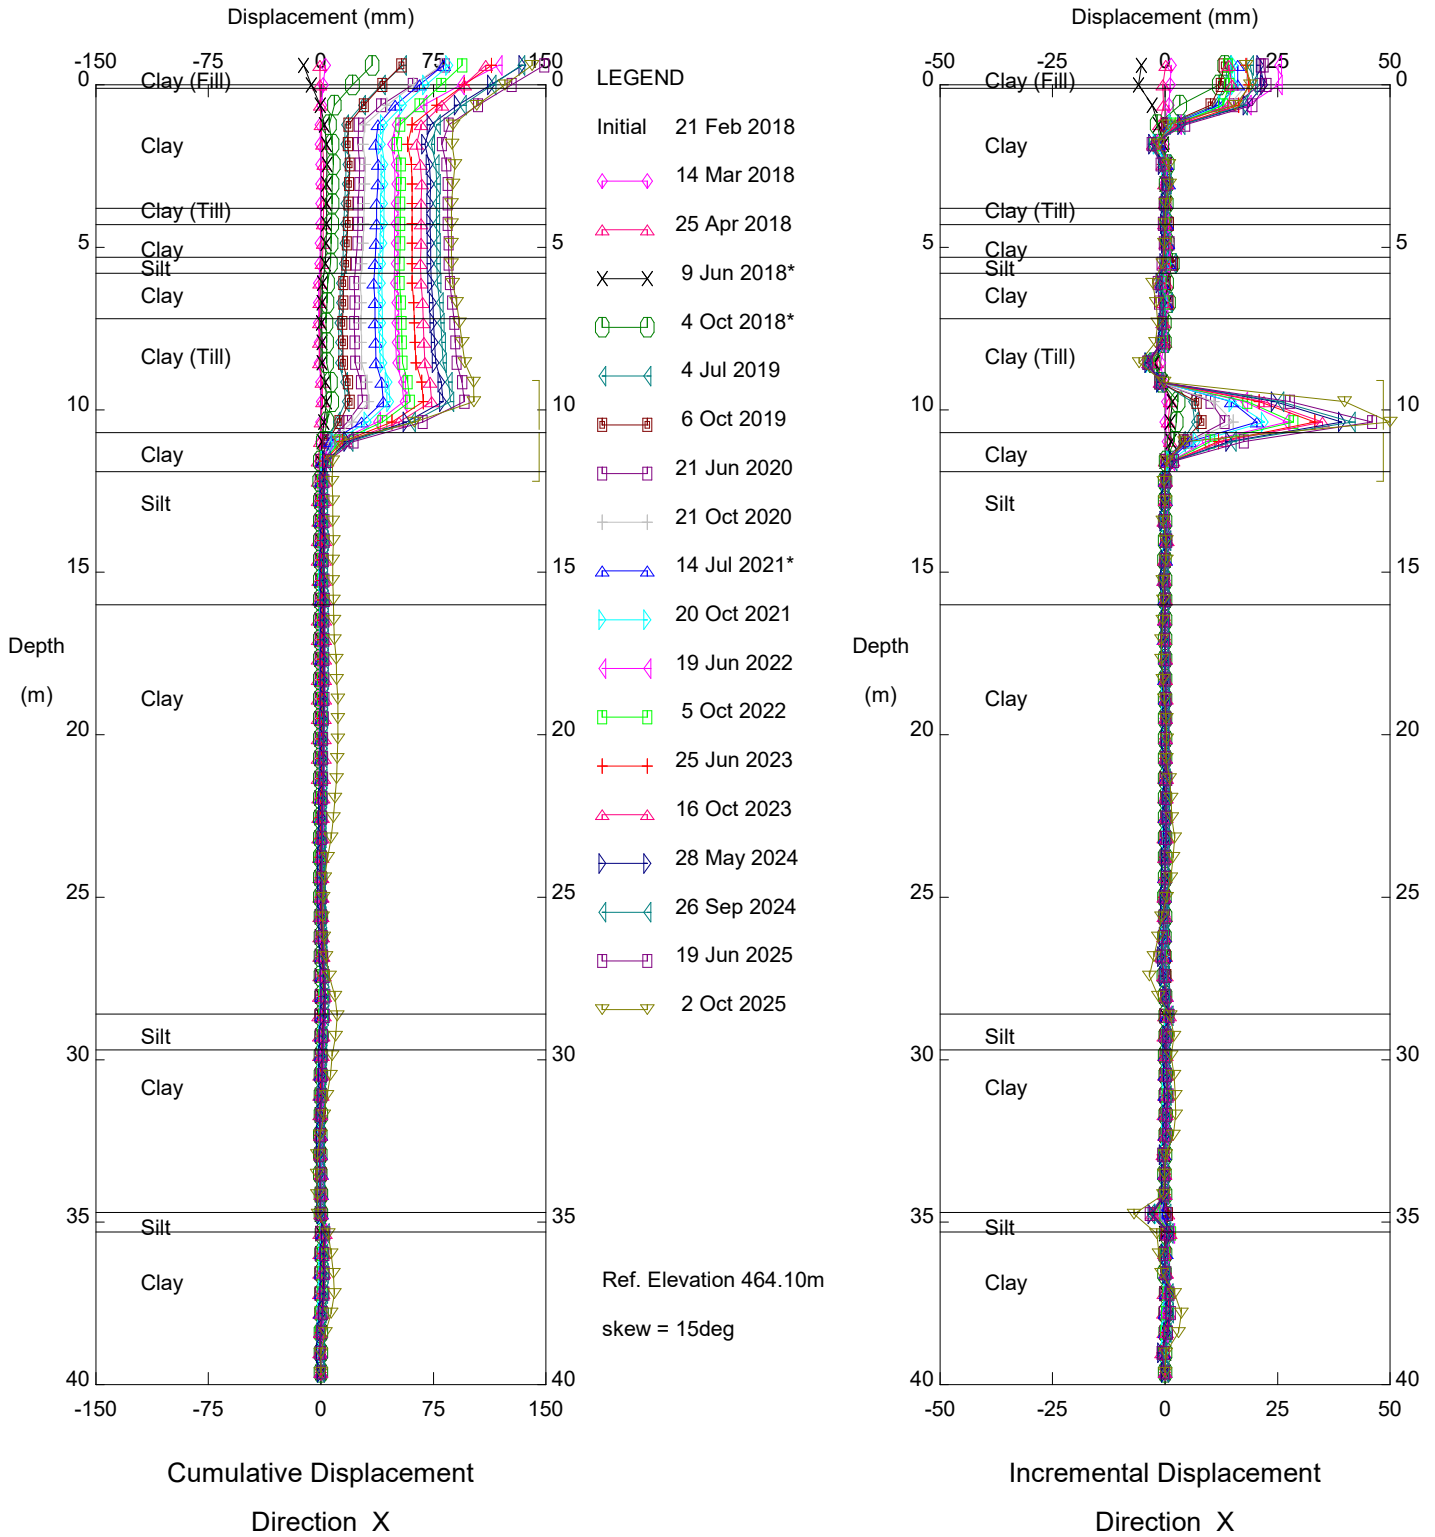
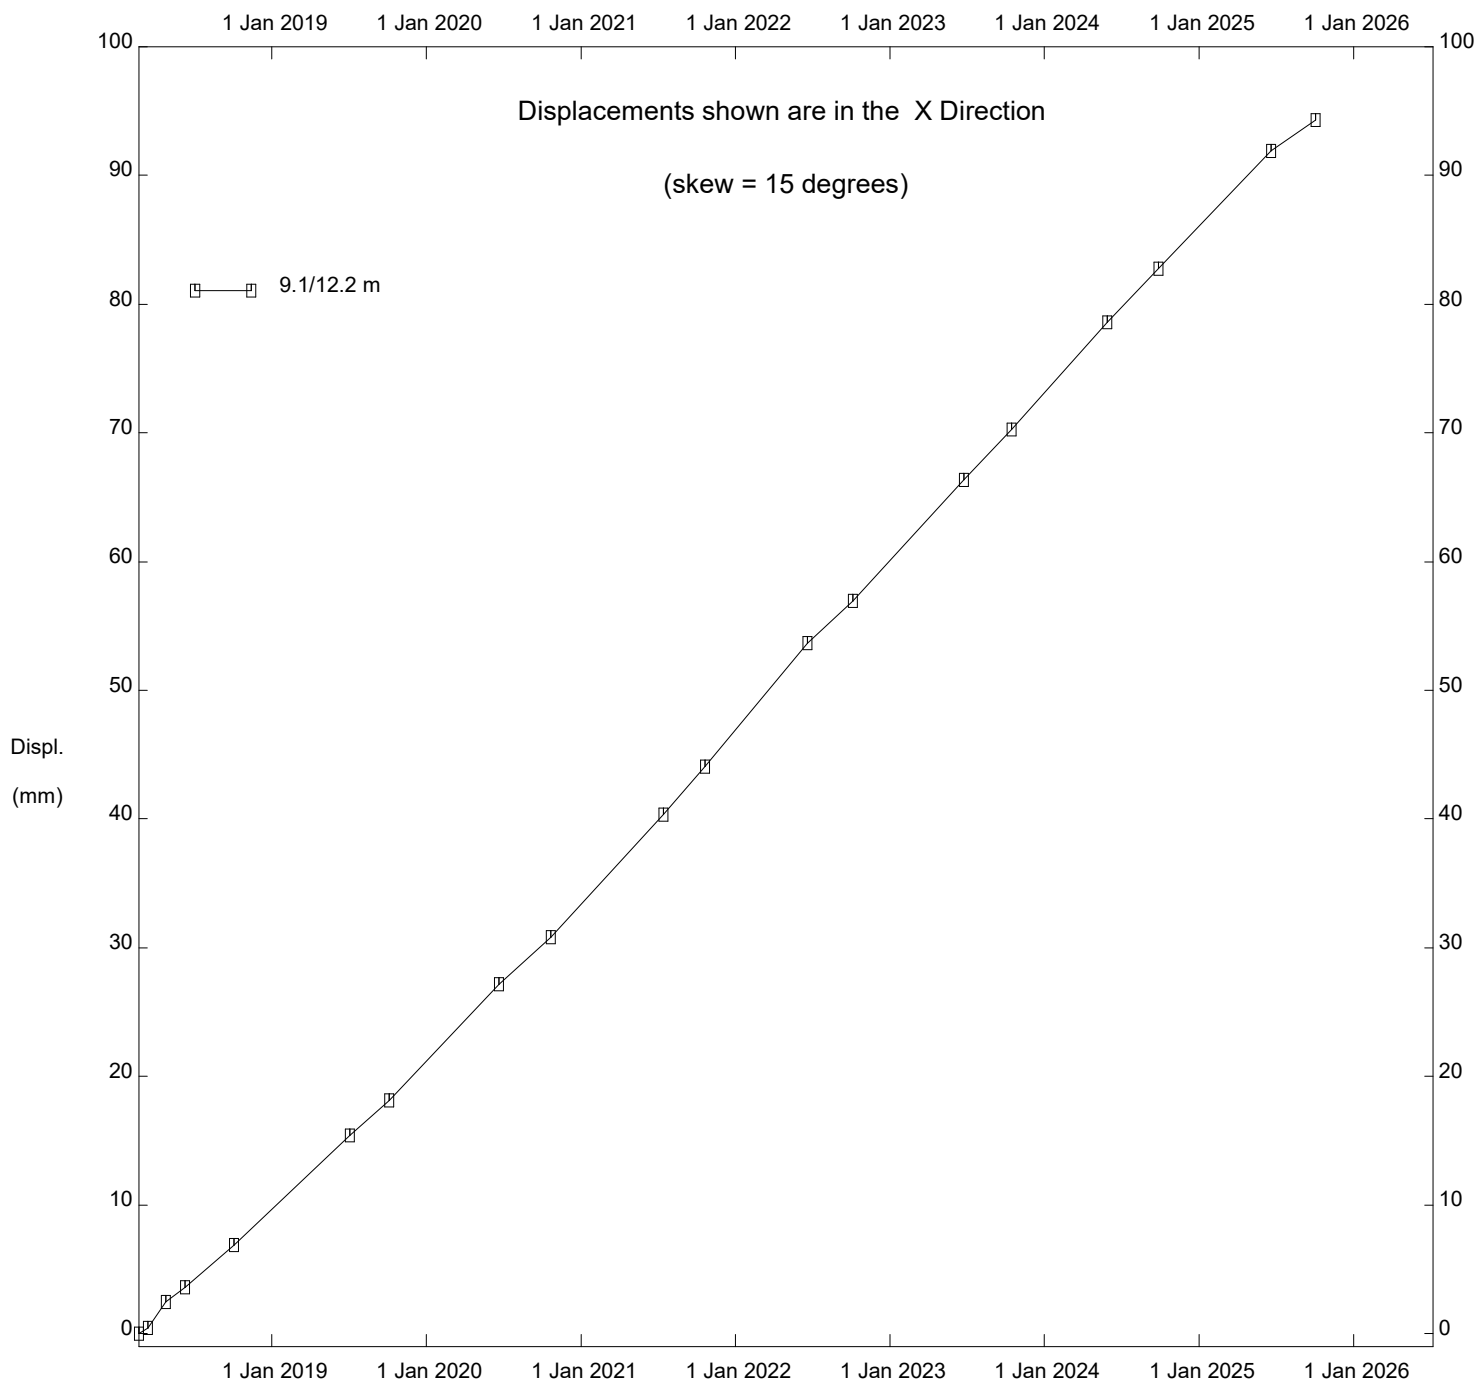
HWY 2:68 (PH037), Inclinometer SI18-7

| INSTRUMENT # | DATE INITIALIZED | TOTAL CUMULATIVE RESULTANT MOVEMENT AT NOTED DEPTH SINCE INITIAL READING (mm) | MAXIMUM RATE OF MOVEMENT (mm/yr) | CURRENT STATUS | DATE OF PREVIOUS READING | INCREMENTAL MOVEMENT SINCE PREVIOUS READING (mm) | RATE OF MOVEMENT (mm/yr) | CHANGE IN RATE OF MOVEMENT SINCE PREVIOUS READING (mm/yr) |
|---|---|---|---|---|---|---|---|---|
| SI18-7 | February 21, 2018 | 94.3 mm over 9.1 m to 12.2 m depth in 269° direction | 17.5 mm/yr in April 2018 | Operational | June 18, 2025 | 2.4 | 8.2 | -4.4 |

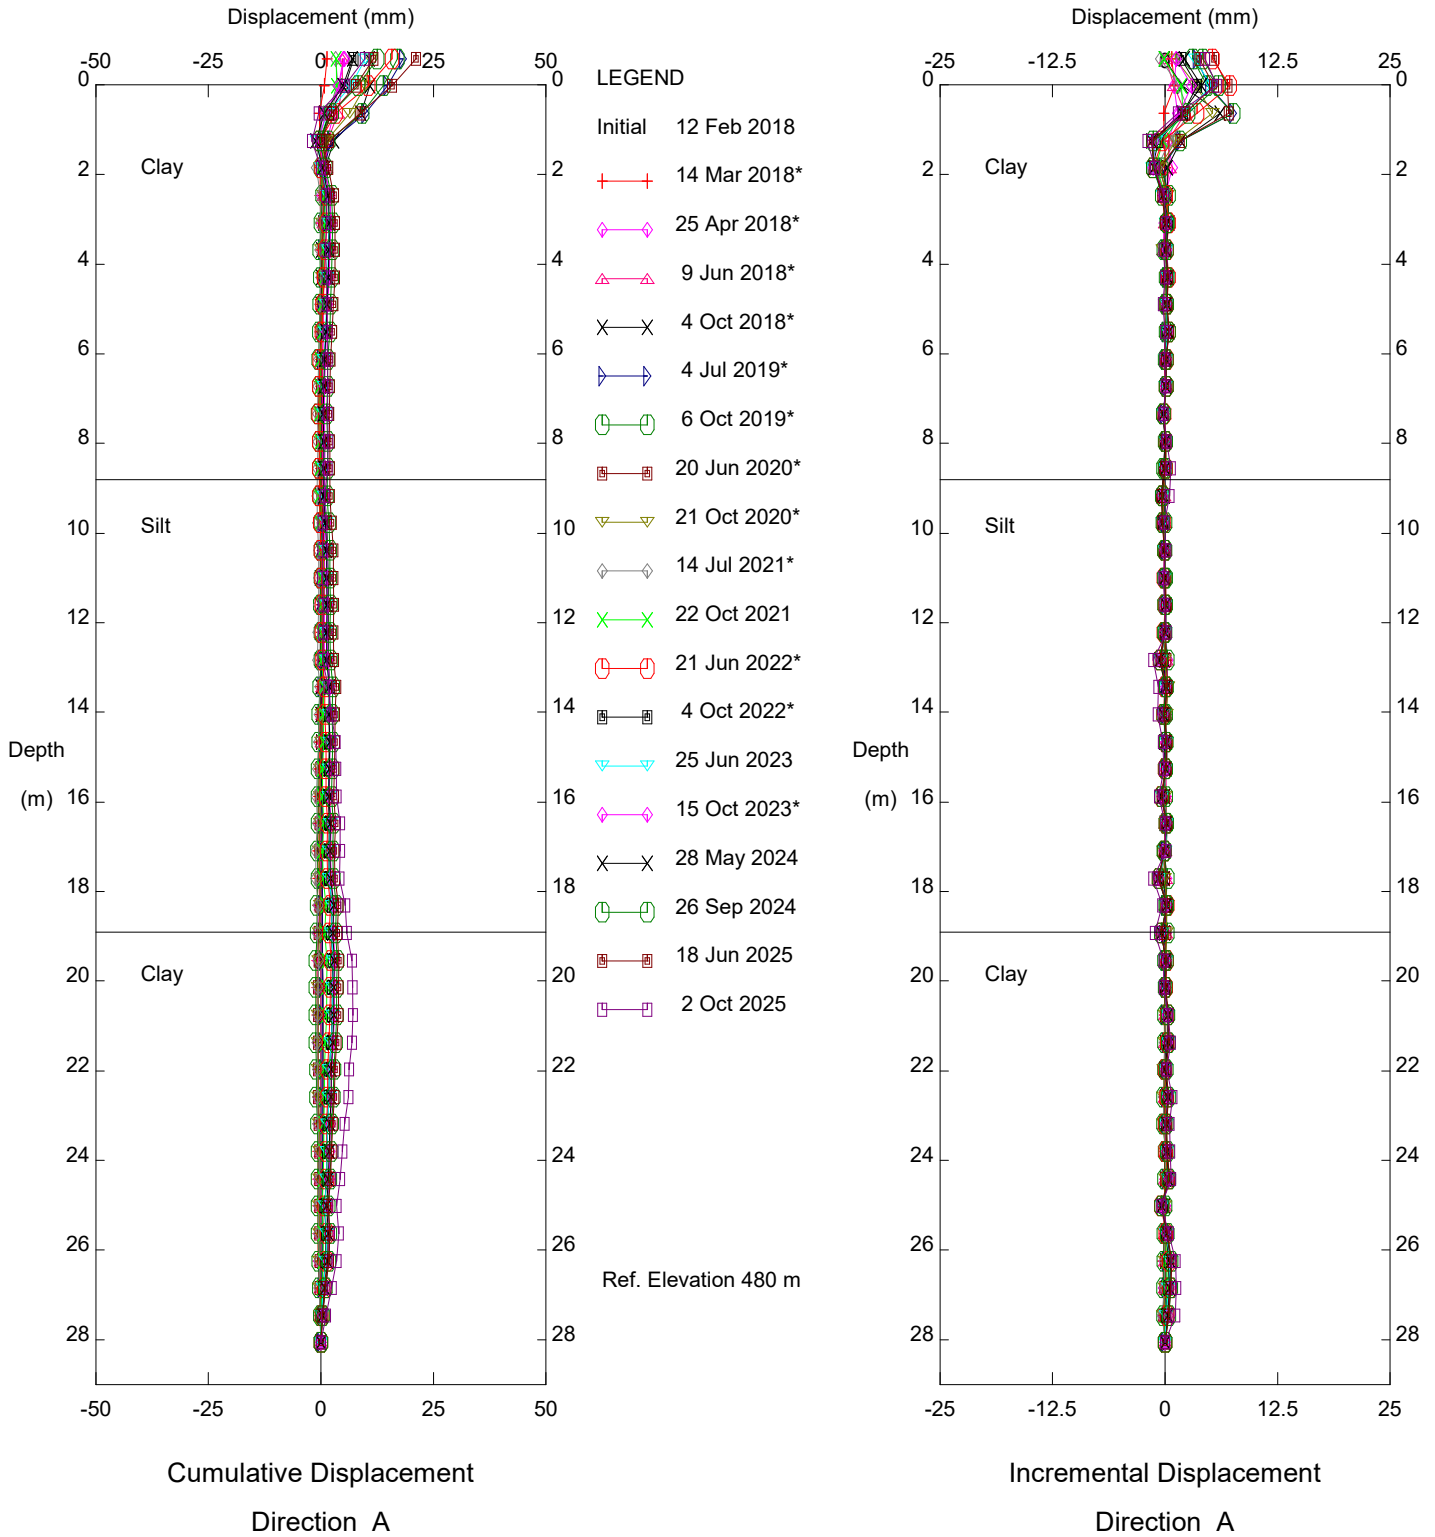
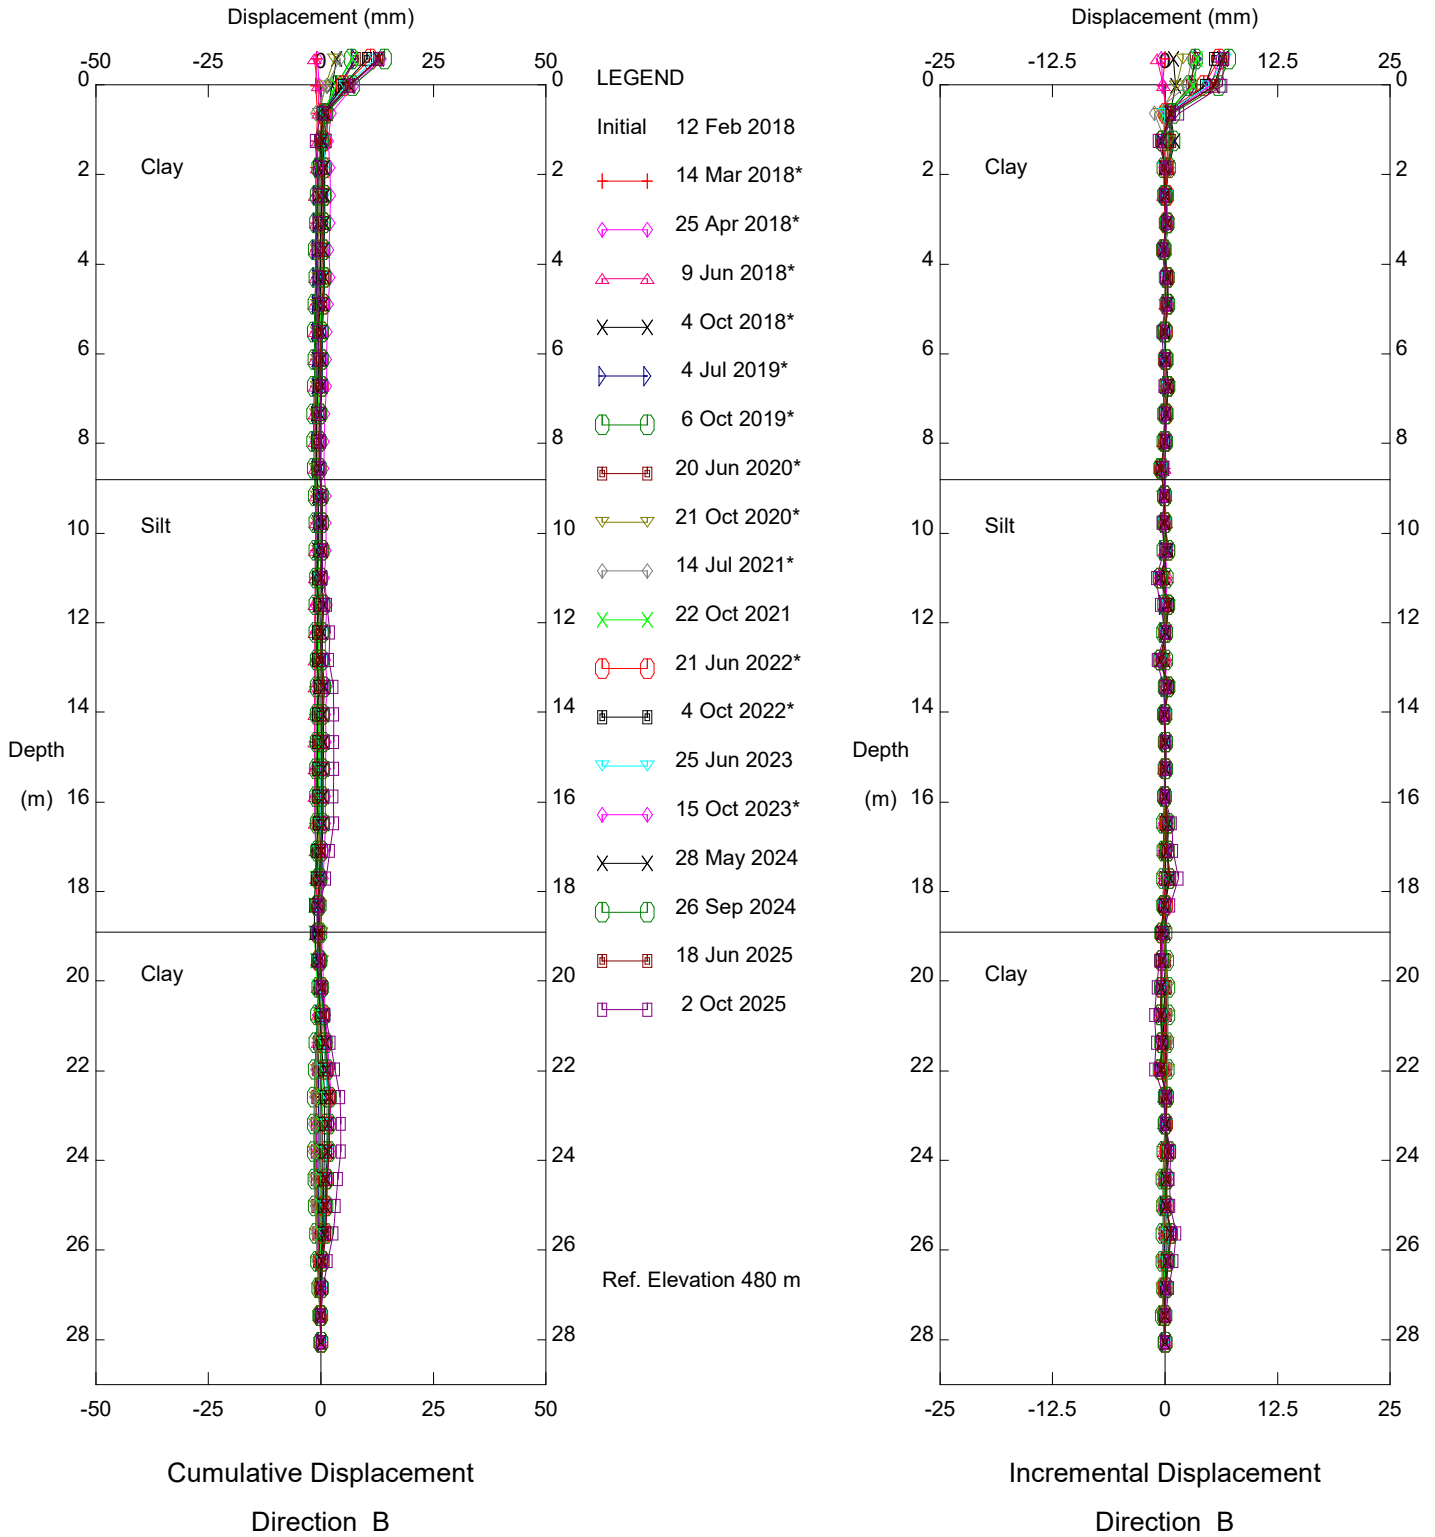
HWY 2:68 (PH037), Inclinometer SI18-4

| INSTRUMENT # | DATE INITIALIZED | TOTAL CUMULATIVE RESULTANT MOVEMENT AT NOTED DEPTH SINCE INITIAL READING (mm) | MAXIMUM RATE OF MOVEMENT (mm/yr) | CURRENT STATUS | DATE OF PREVIOUS READING | INCREMENTAL MOVEMENT SINCE PREVIOUS READING (mm) | RATE OF MOVEMENT (mm/yr) | CHANGE IN RATE OF MOVEMENT SINCE PREVIOUS READING (mm/yr) |
|---|---|---|---|---|---|---|---|---|
| SI18-4 | February 12, 2018 | No discernible movement | N/A | Operational | June 18, 2025 | N/A | N/A | N/A |

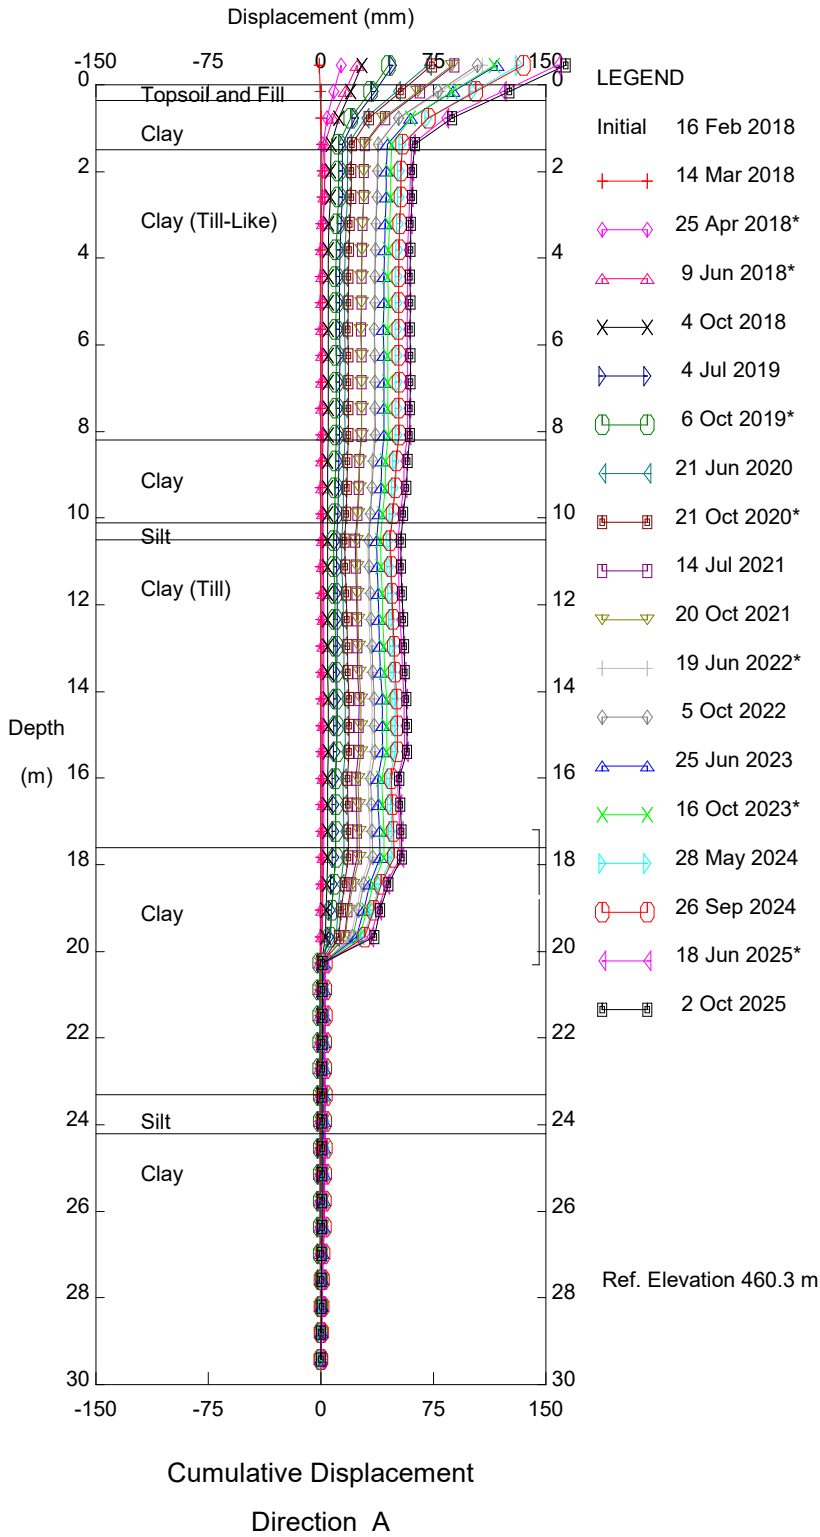
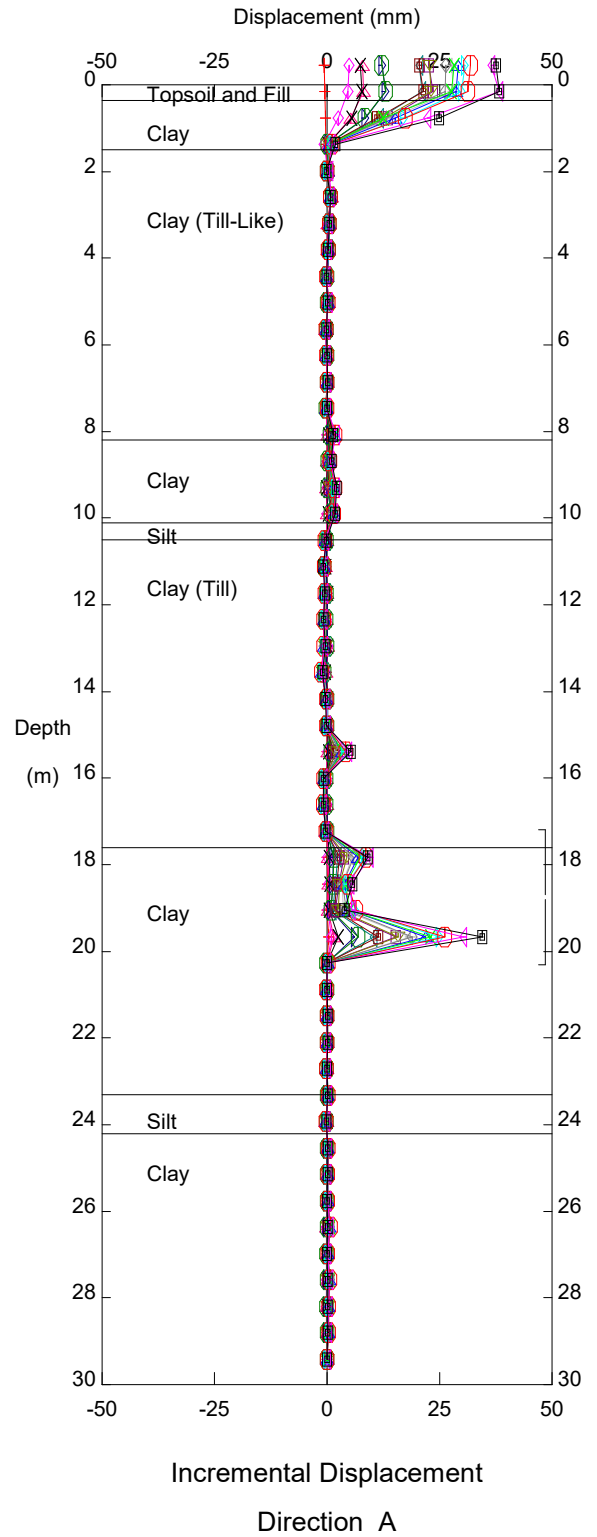
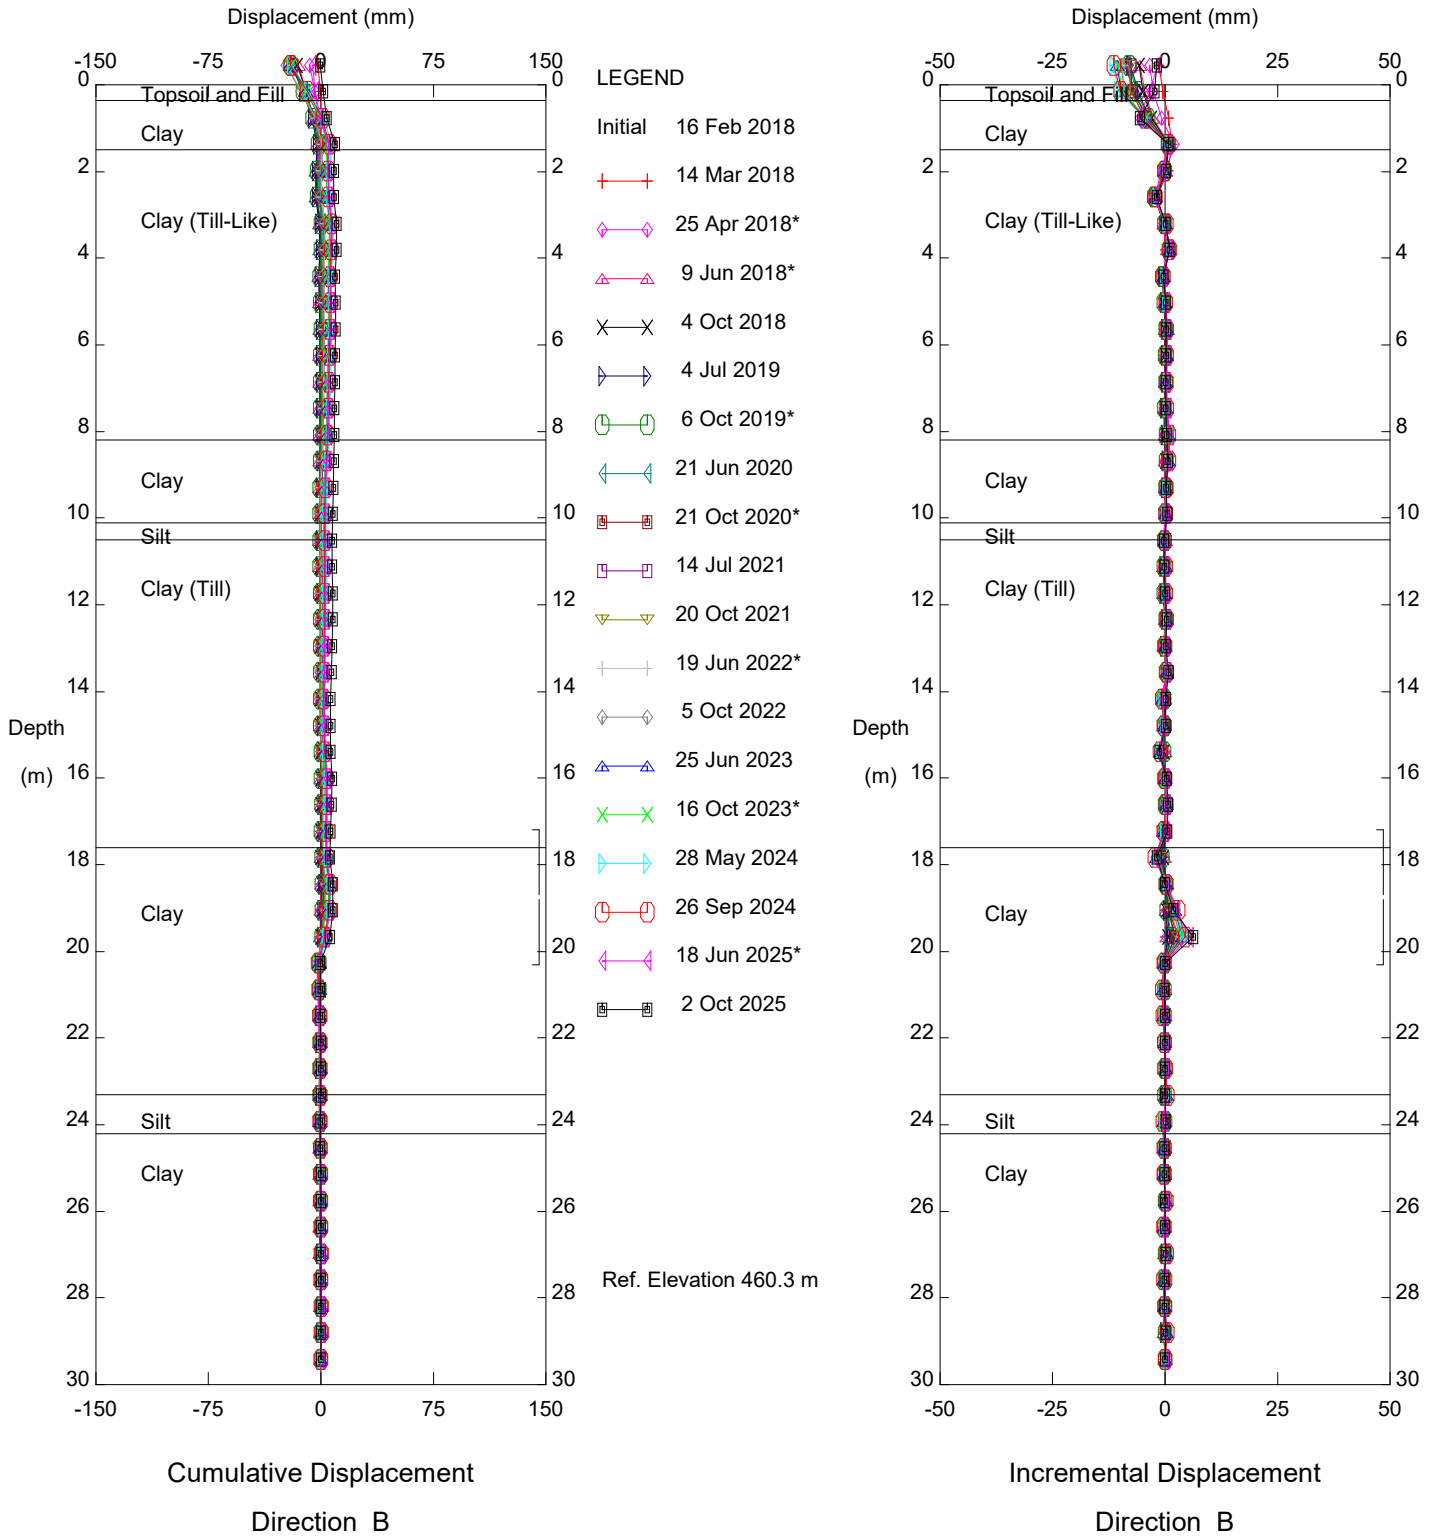
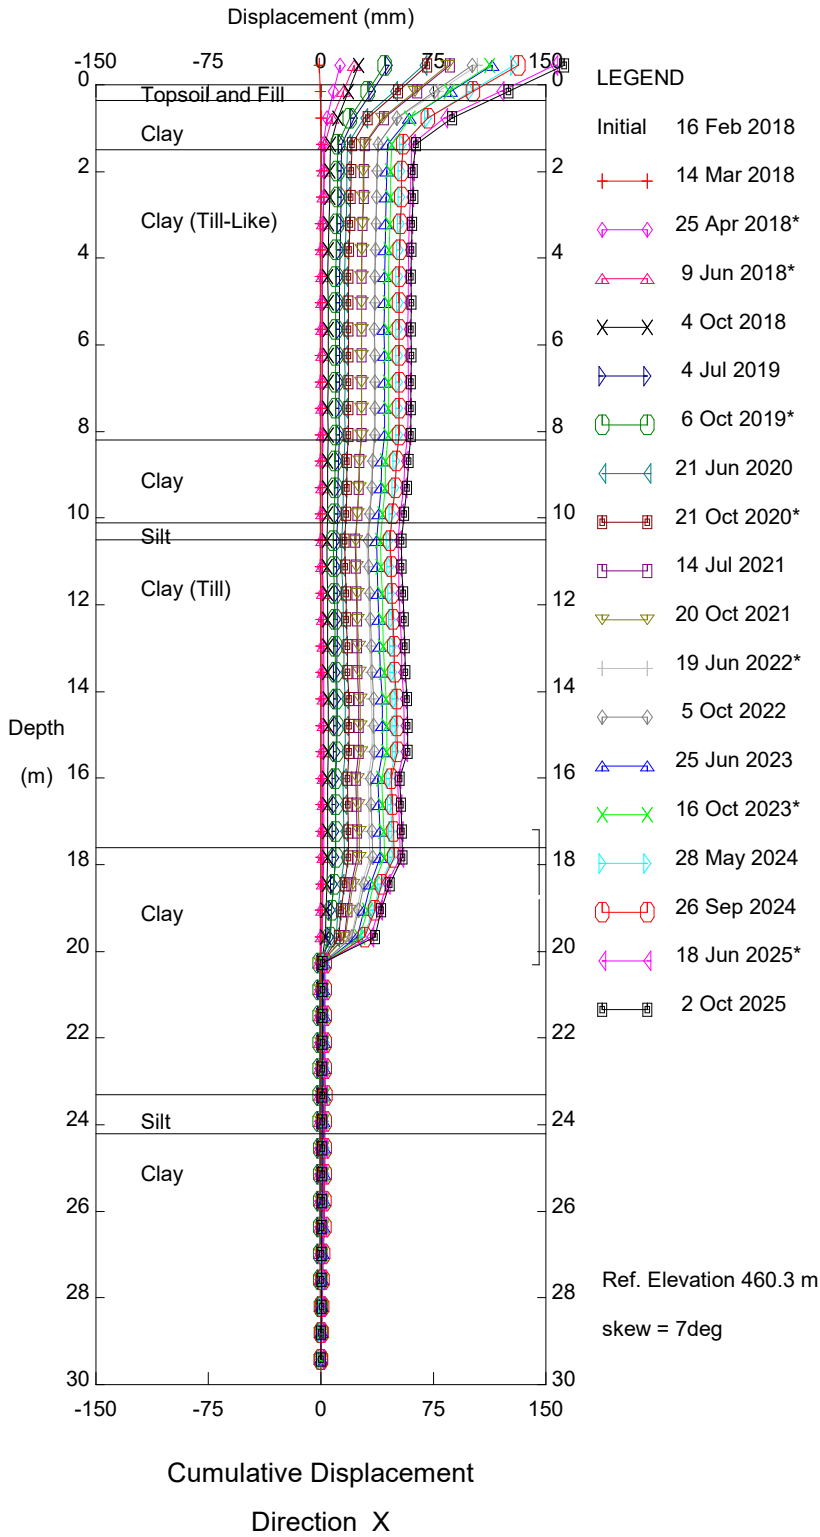
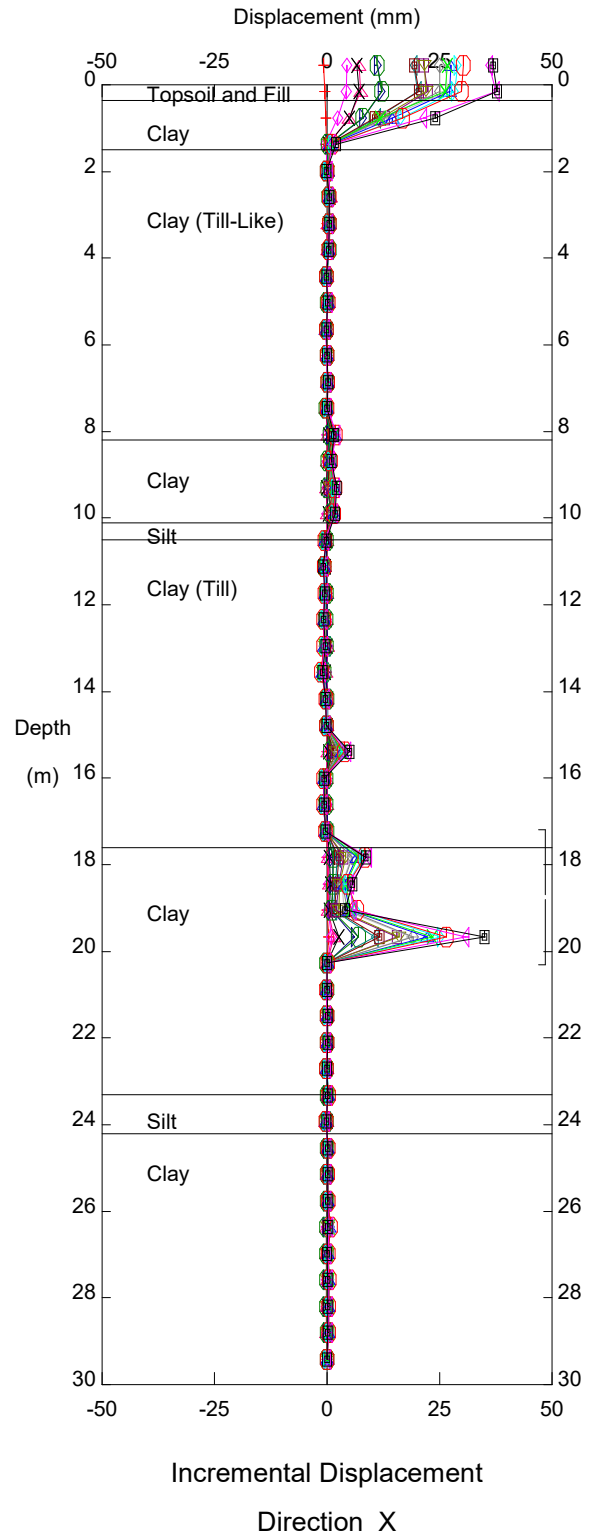
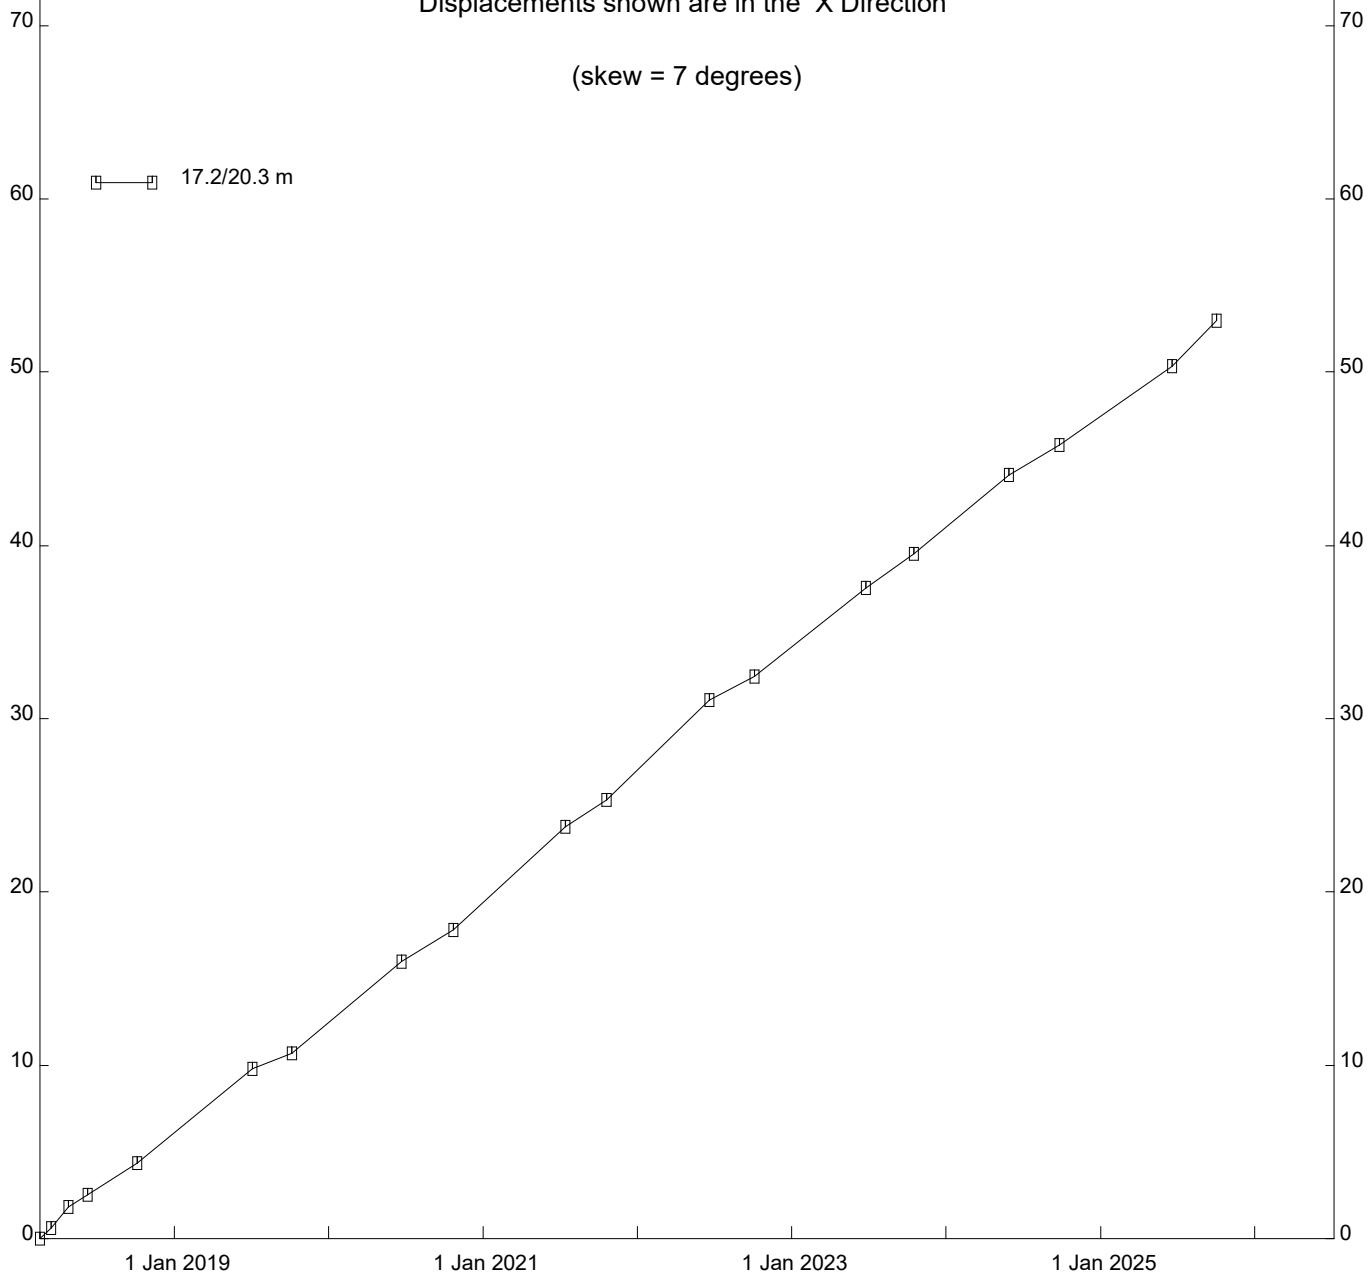
HWY 2:68 (PH037), Inclinometer SI18-5

| INSTRUMENT # | DATE INITIALIZED | TOTAL CUMULATIVE RESULTANT MOVEMENT AT NOTED DEPTH SINCE INITIAL READING (mm) | MAXIMUM RATE OF MOVEMENT (mm/yr) | CURRENT STATUS | DATE OF PREVIOUS READING | INCREMENTAL MOVEMENT SINCE PREVIOUS READING (mm) | RATE OF MOVEMENT (mm/yr) | CHANGE IN RATE OF MOVEMENT SINCE PREVIOUS READING (mm/yr) |
|---|---|---|---|---|---|---|---|---|
| SI18-5 | February 16, 2018 | 53.0 mm over 17.2 m to 20.3 m depth in 303° direction | 10.5 mm/yr in April 2018 | Operational | June 18, 2025 | 2.6 | 8.9 | 2.7 |
