ALBERTA TRANSPORTATION AND  
ECONOMIC CORRIDORS GRMP  
PEACE REGION  
(GRANDE PRAIRIE DISTRICT - NORTH)  
INSTRUMENTATION MONITORING - FALL 2025

| Site Number | Location | Name | Hwy | km |
|---|---|---|---|---|
| PH037 | Station 1+250 to 2+000 | Dunvegan South | 2:68 | Km 15.7 |

| <b>Current Monitoring:</b> | 02-Oct-2025 | <b>Previous Monitoring</b> | 18~19-June-2025 |

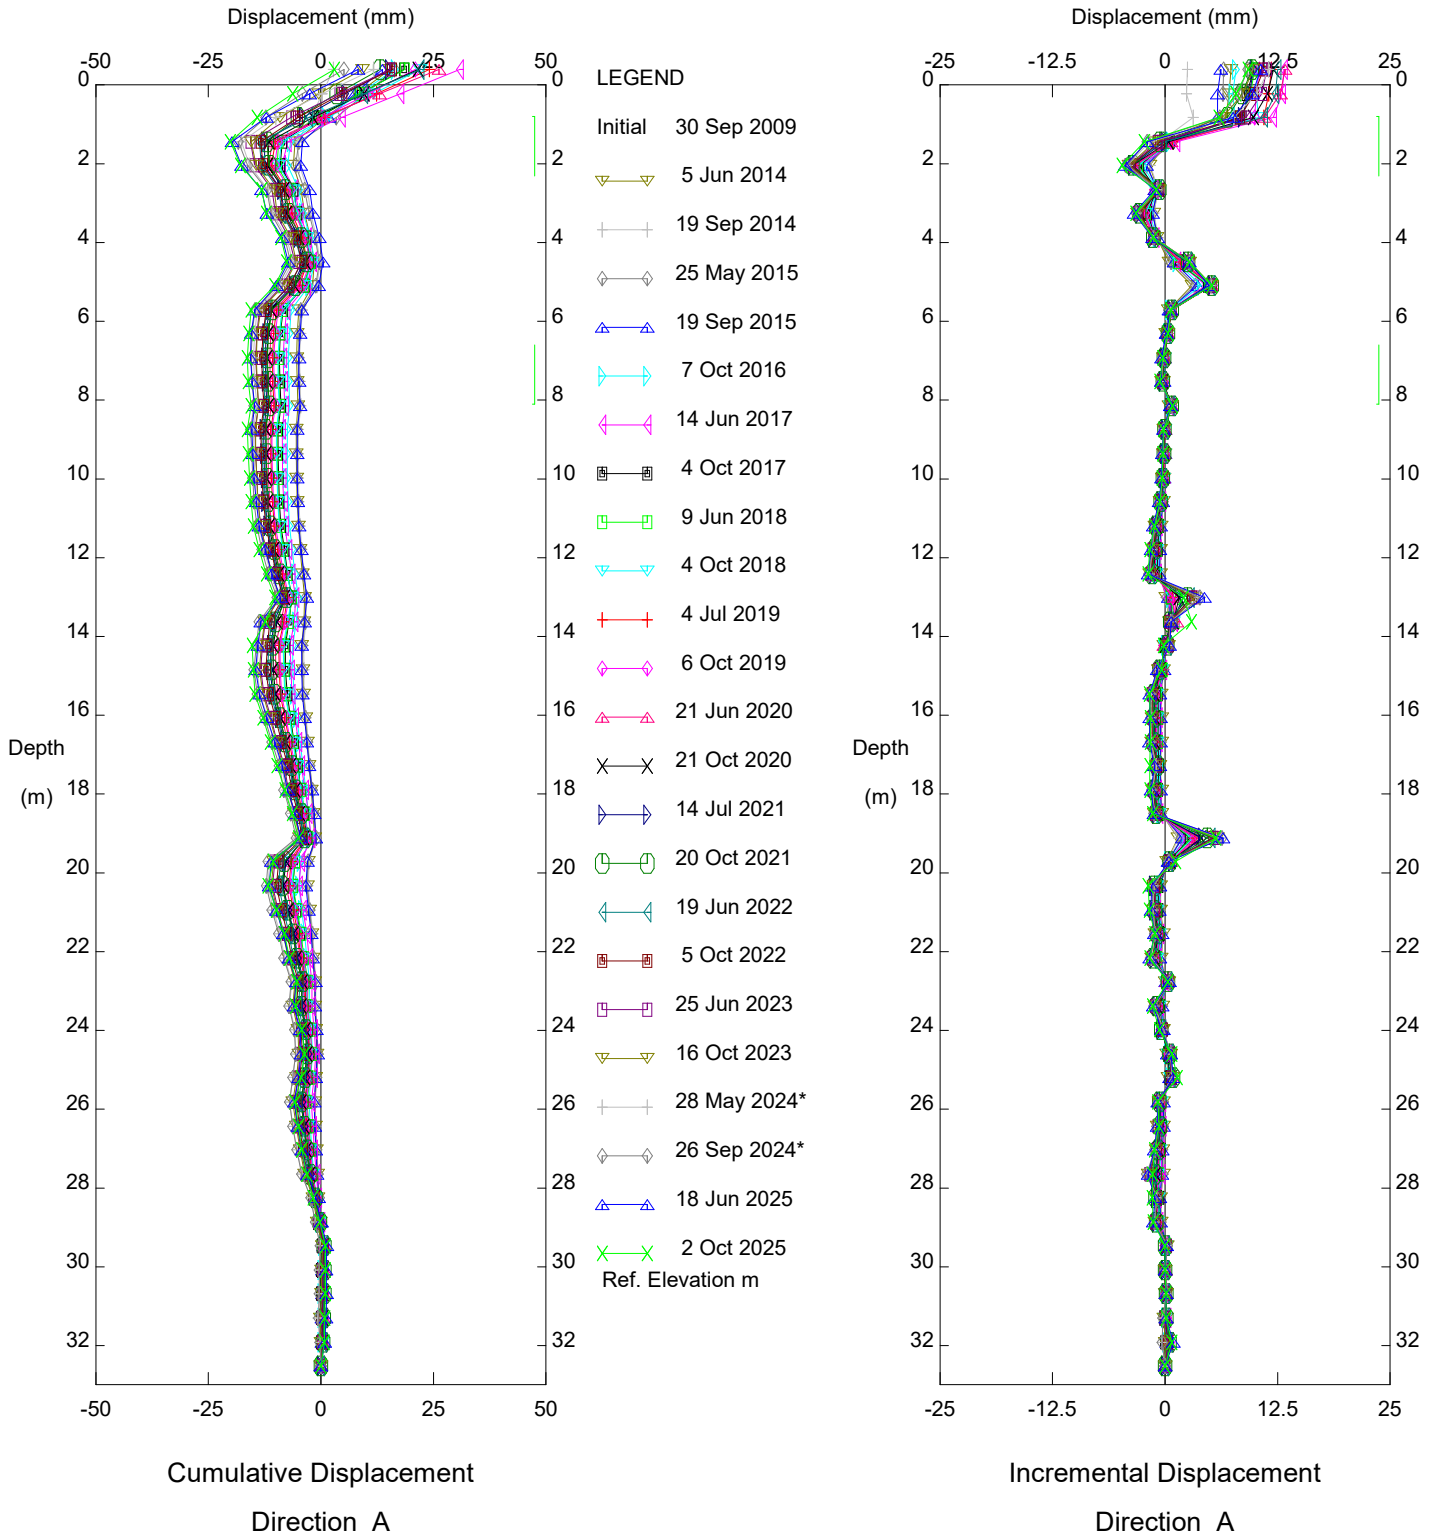
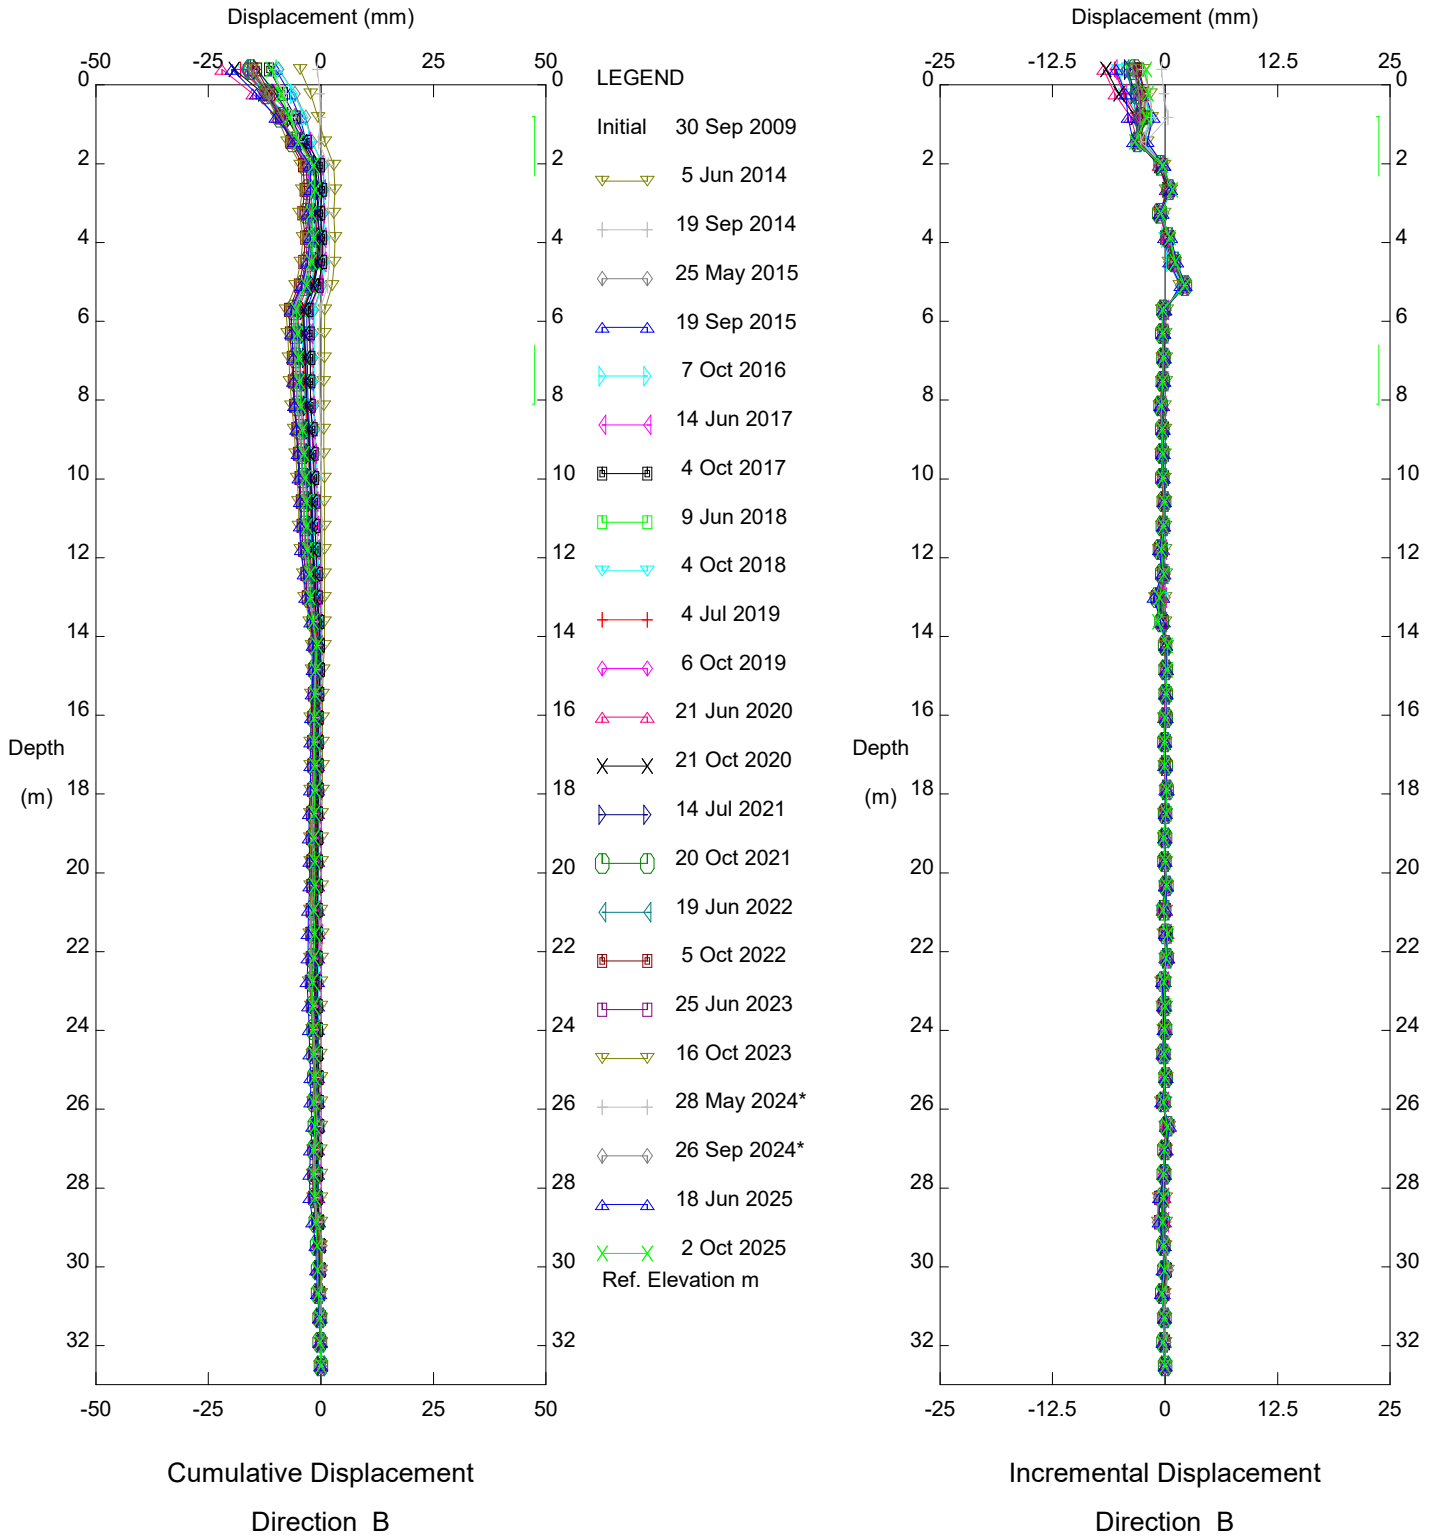
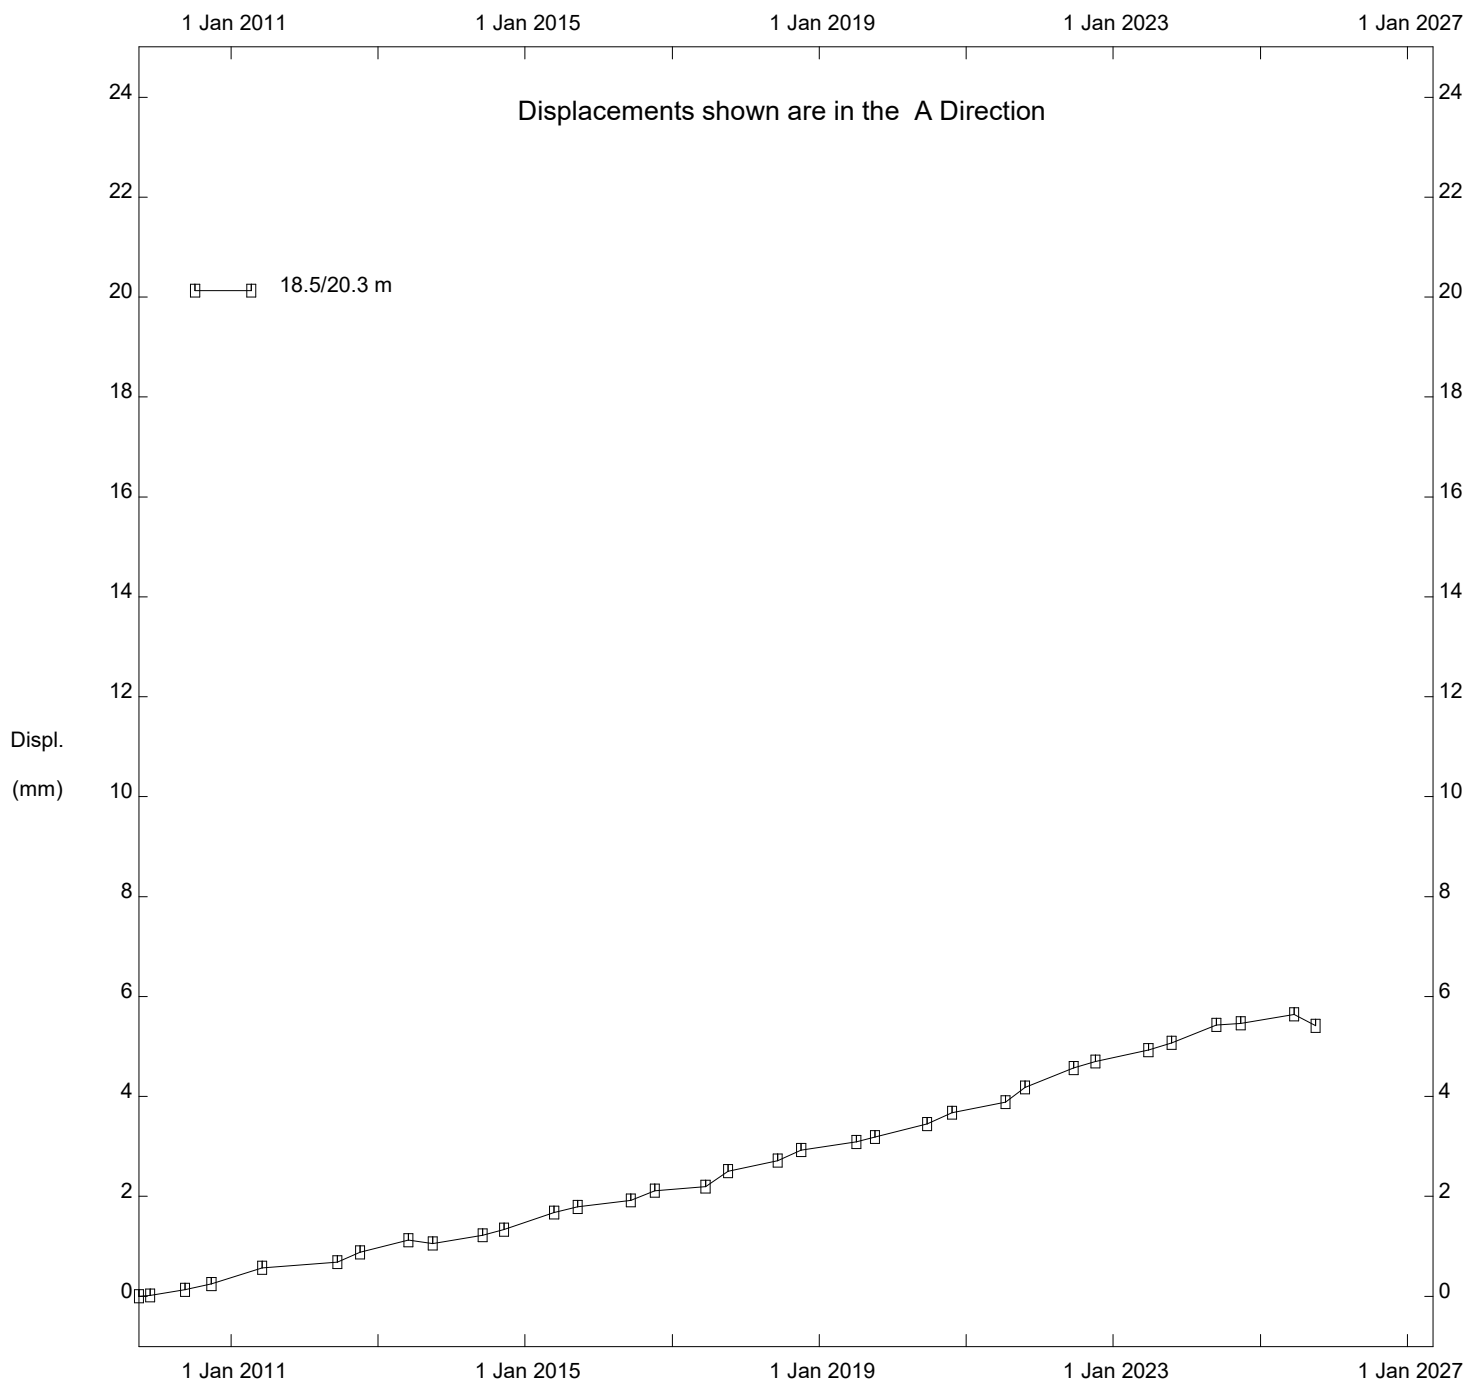
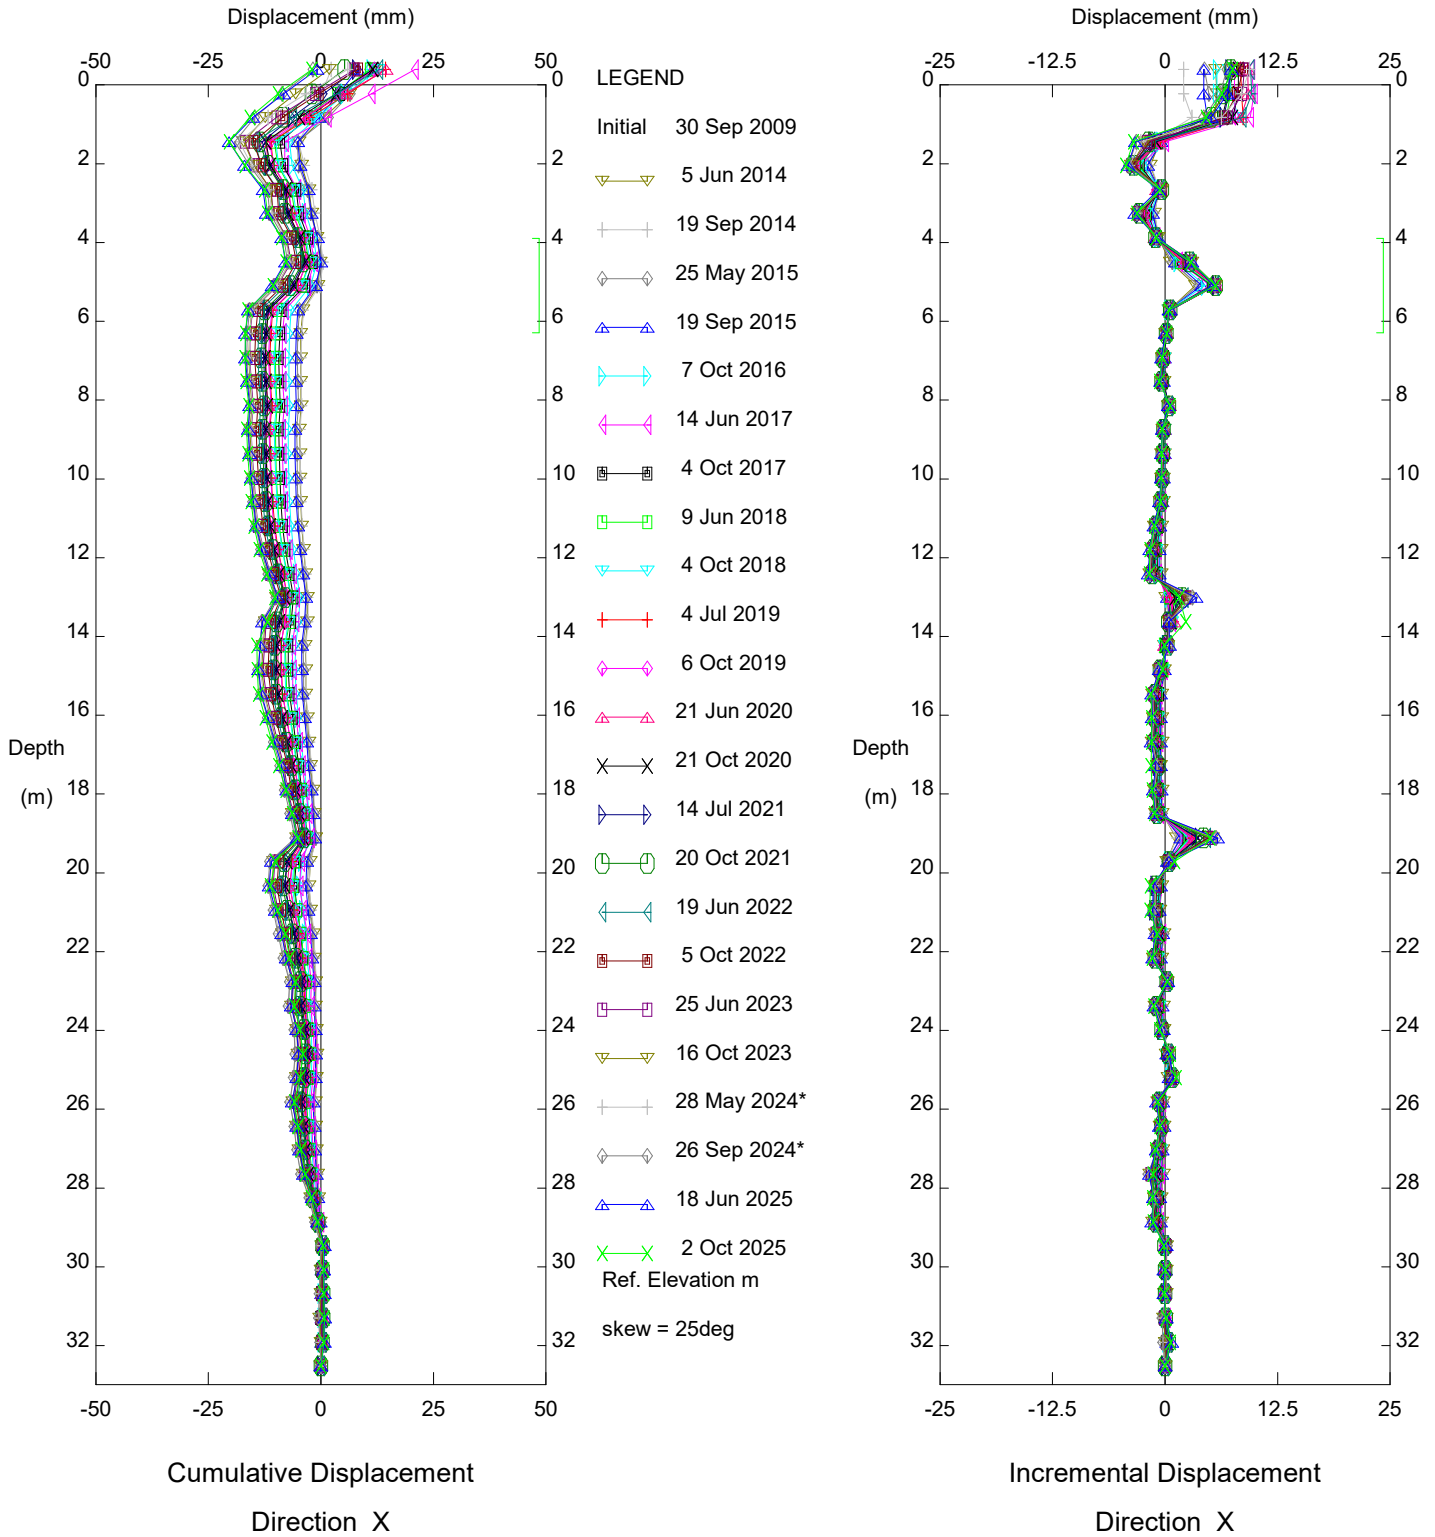
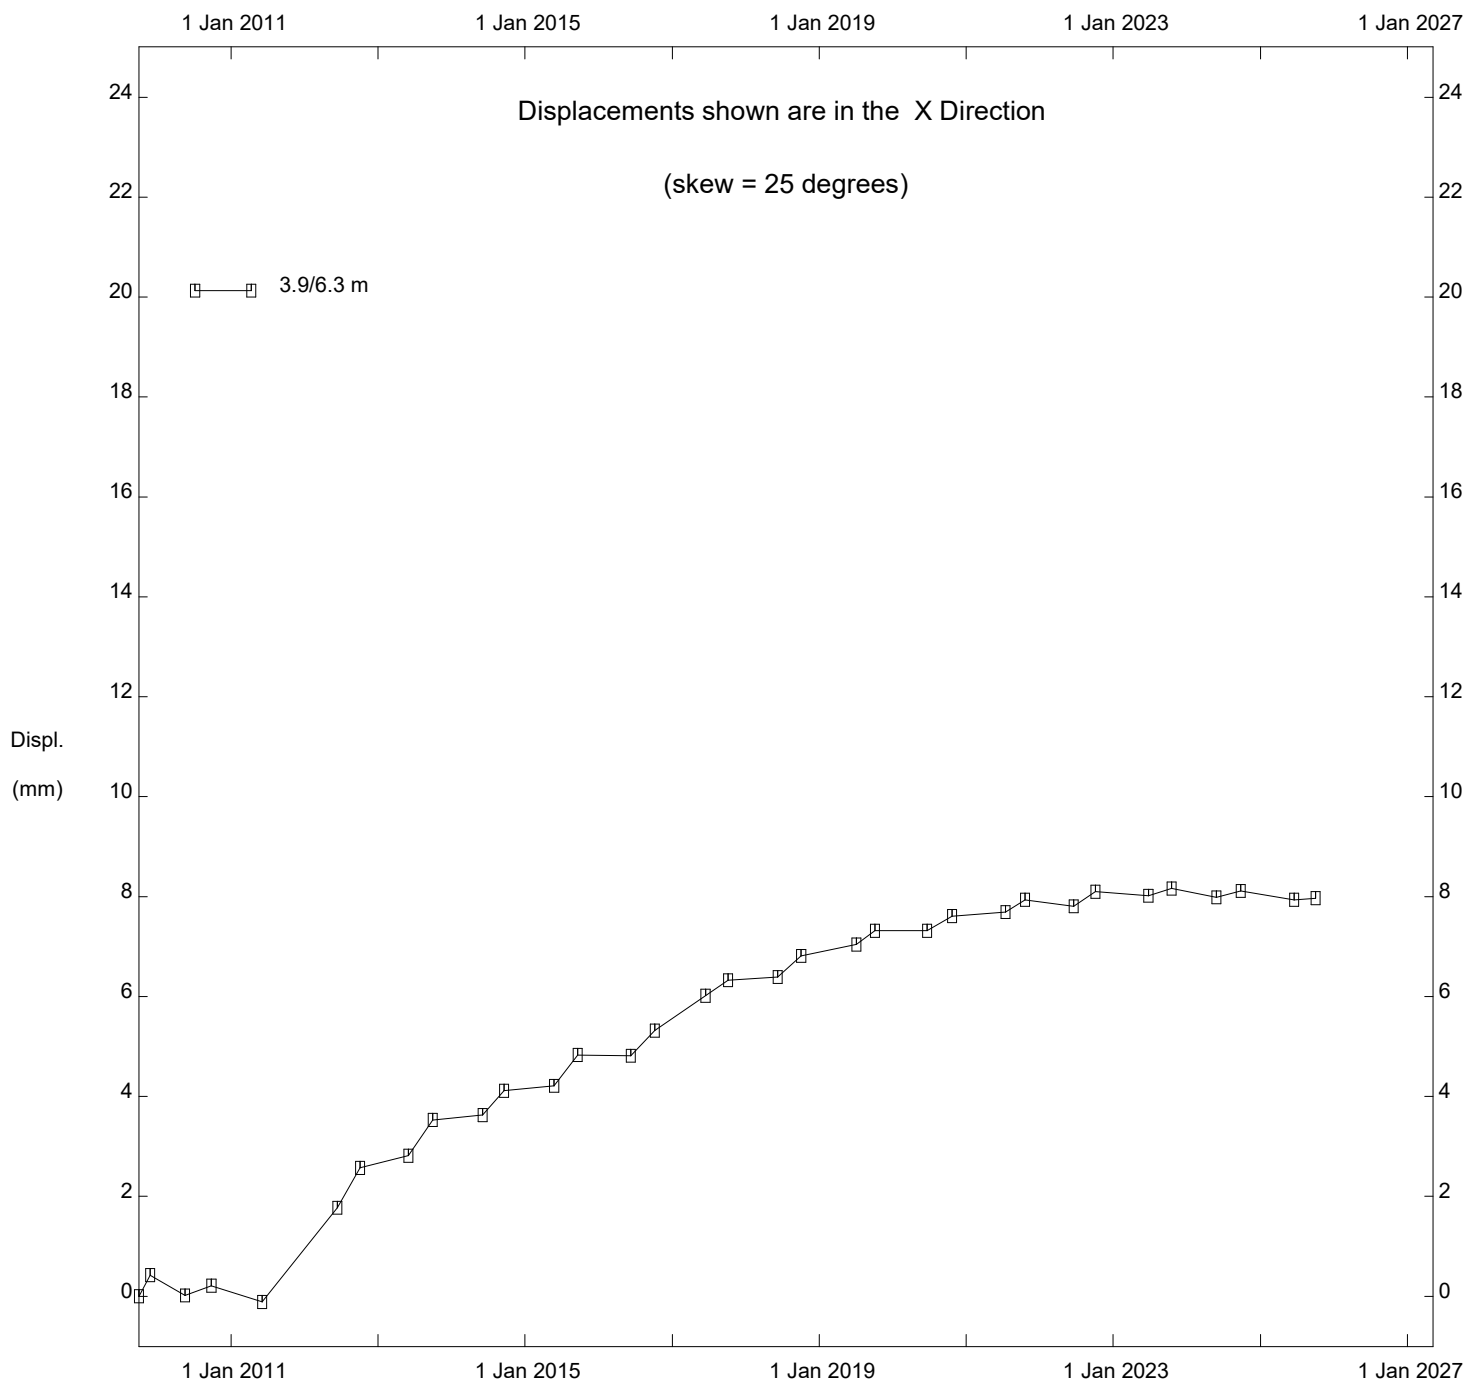
HWY 2:68 (PH037), Inclinator SI09-7

| INSTRUMENT # | DATE INITIALIZED | TOTAL CUMULATIVE RESULTANT MOVEMENT AT NOTED DEPTH SINCE INITIAL READING (mm) | MAXIMUM RATE OF MOVEMENT (mm/yr) | CURRENT STATUS | DATE OF PREVIOUS READING | INCREMENTAL MOVEMENT SINCE PREVIOUS READING (mm) | RATE OF MOVEMENT (mm/yr) | CHANGE IN RATE OF MOVEMENT SINCE PREVIOUS READING (mm/yr) |
|---|---|---|---|---|---|---|---|---|
| SI09-7 | Sept. 30, 2009 | 8.0 mm over 3.9 m to 6.3 m depth in 311° direction | 5.3 mm/yr in September 2011 | Operational | June 18, 2025 | No discernible movement | N/A | 0.4 |
| | | 5.4 mm over 18.5 m to 20.3 m depth in 286° direction | 1.1 mm/y in October 2017 | | | -0.2 | -0.7 | -1 |

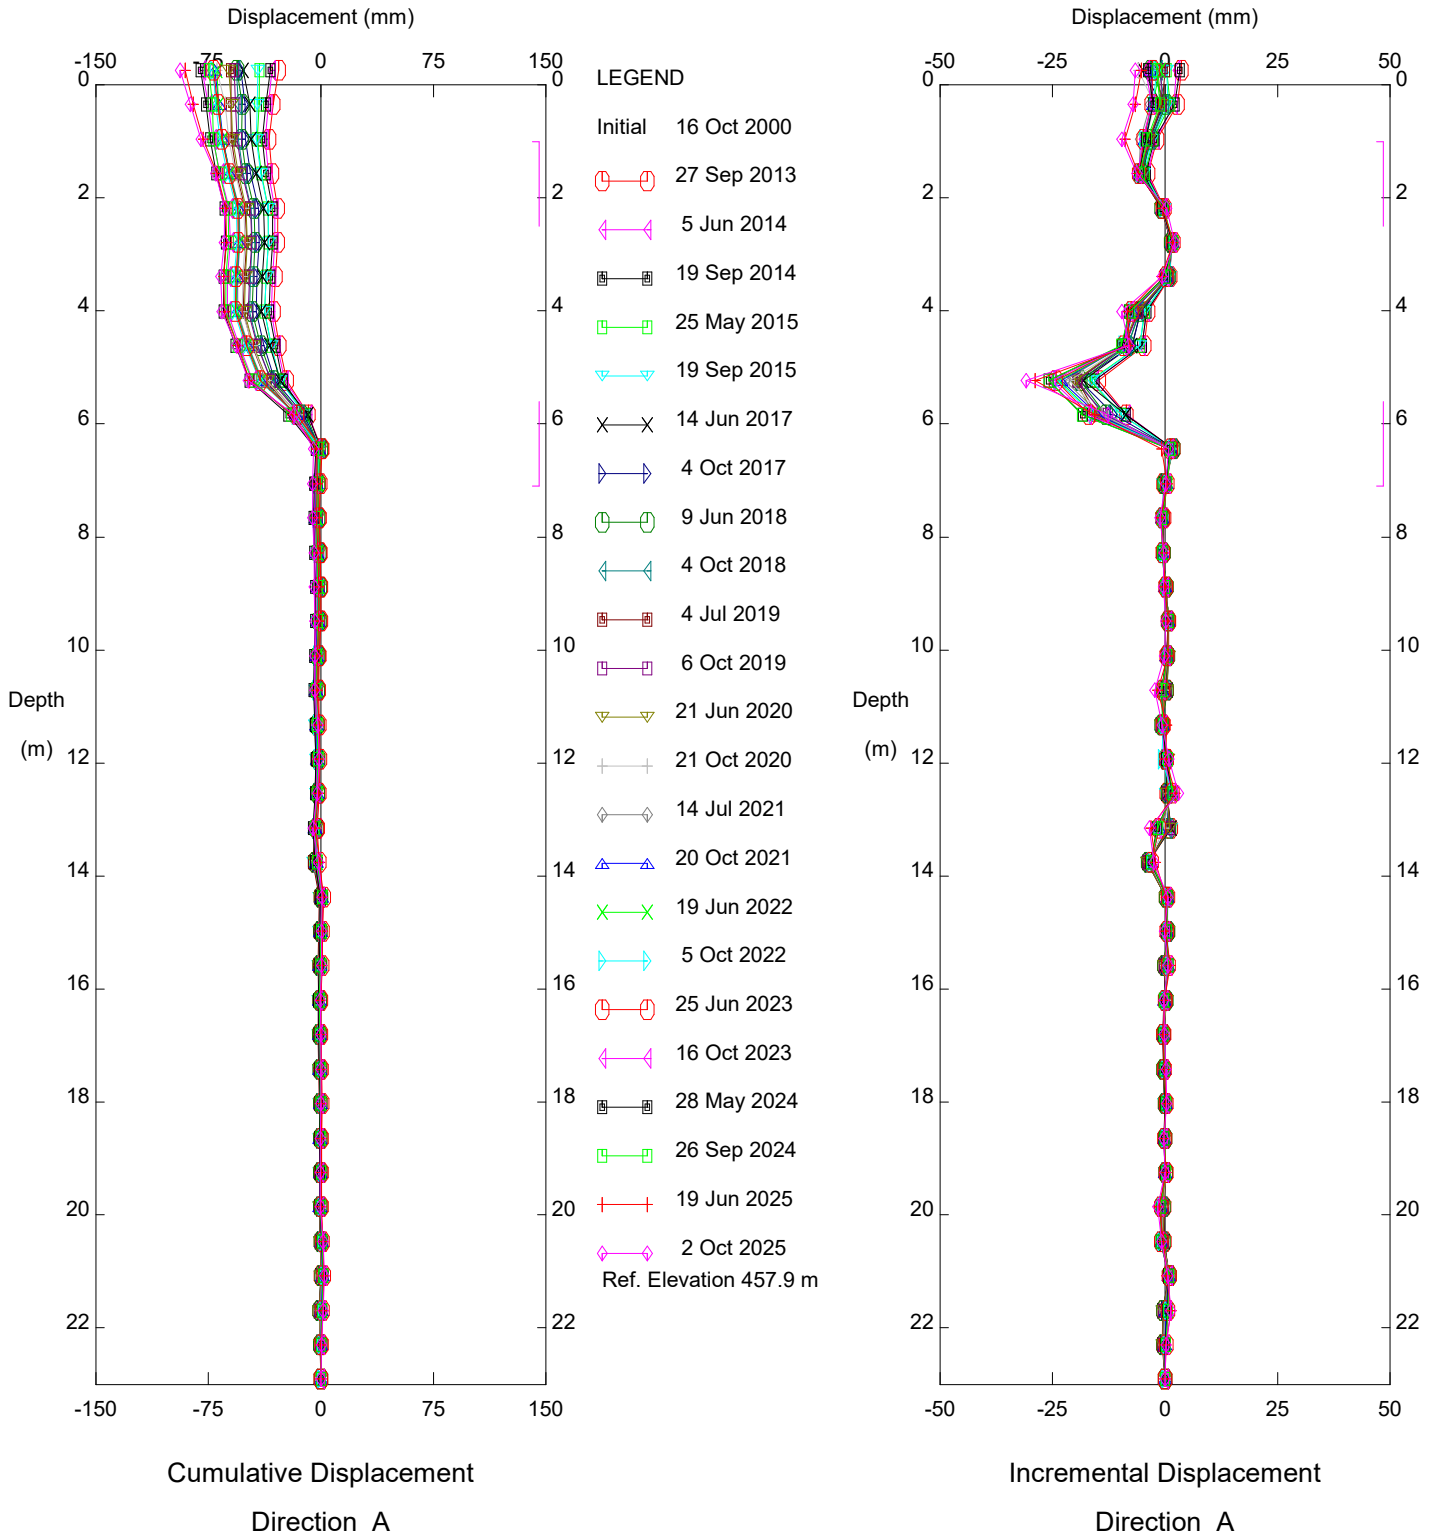
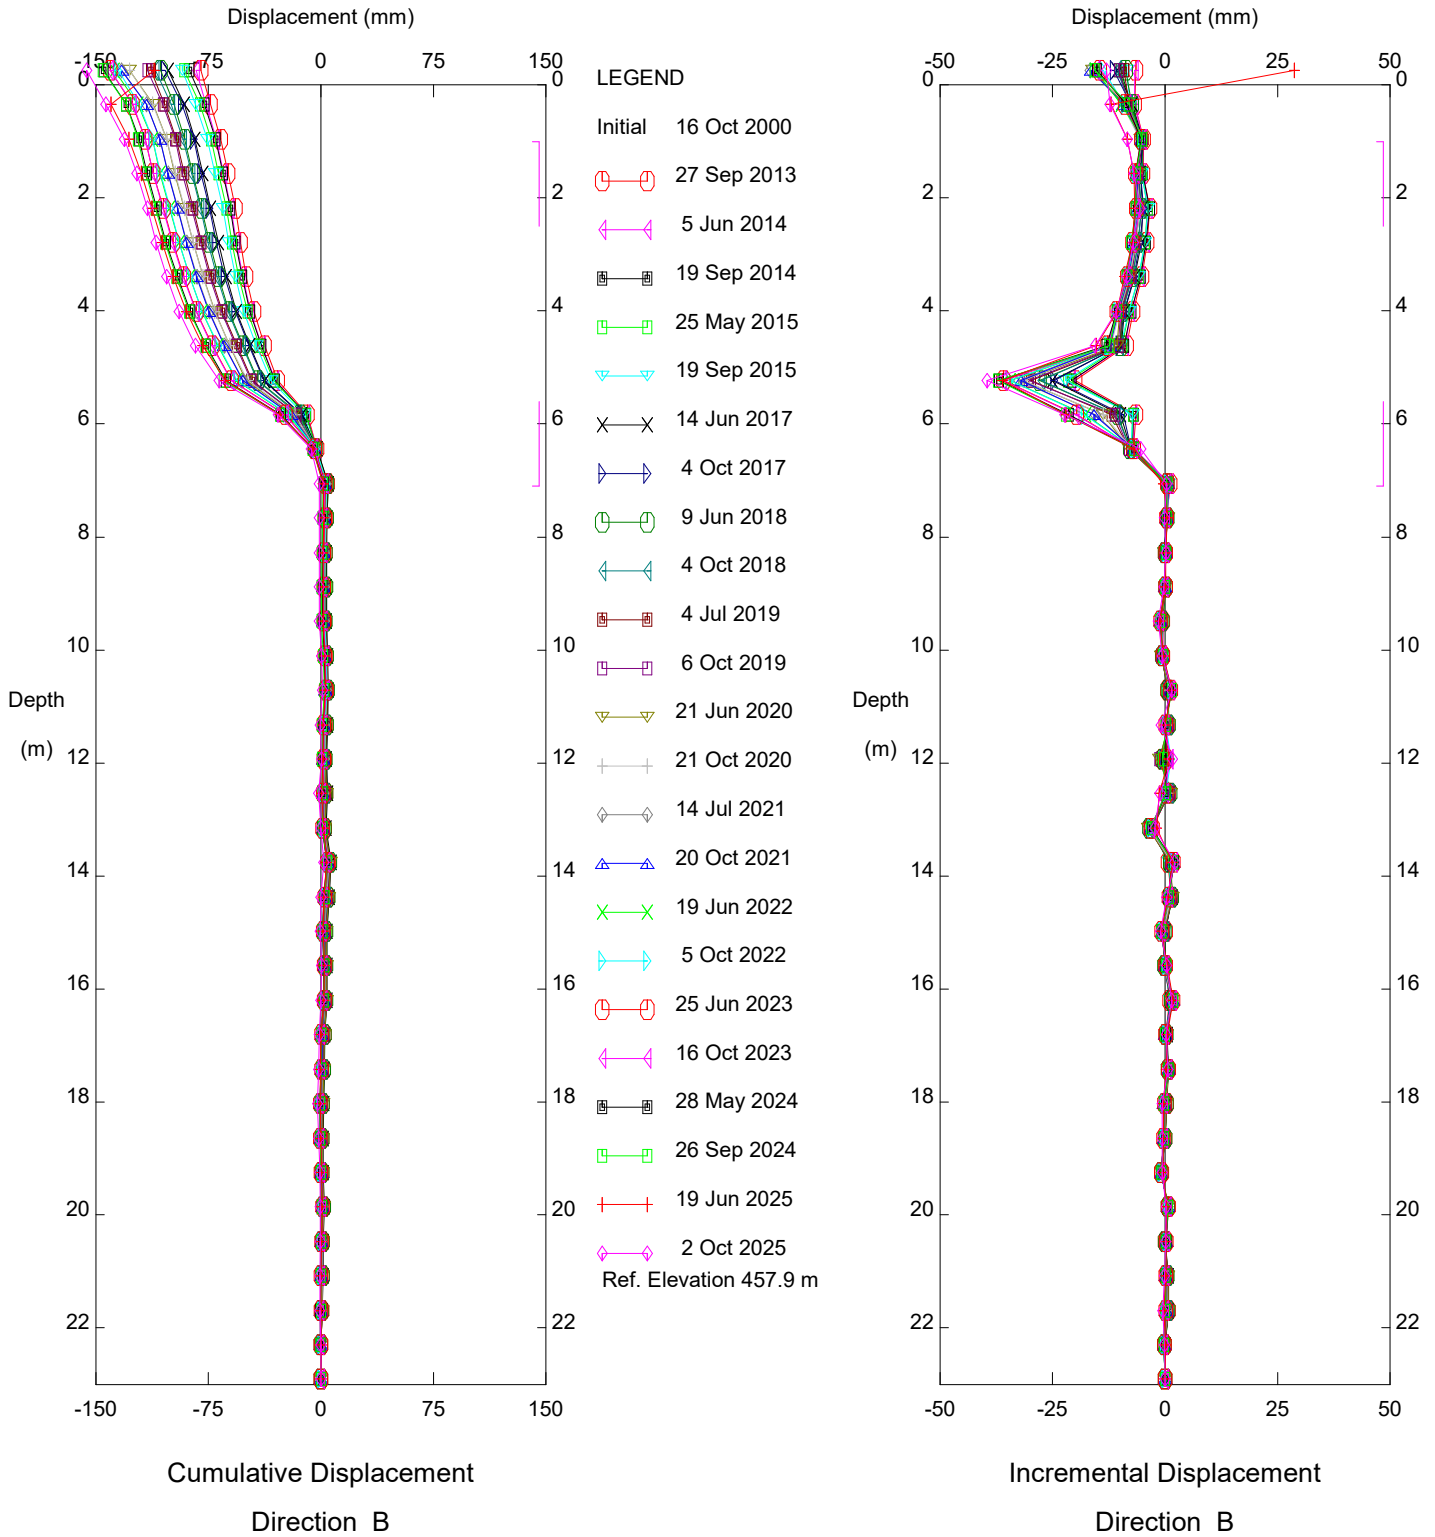
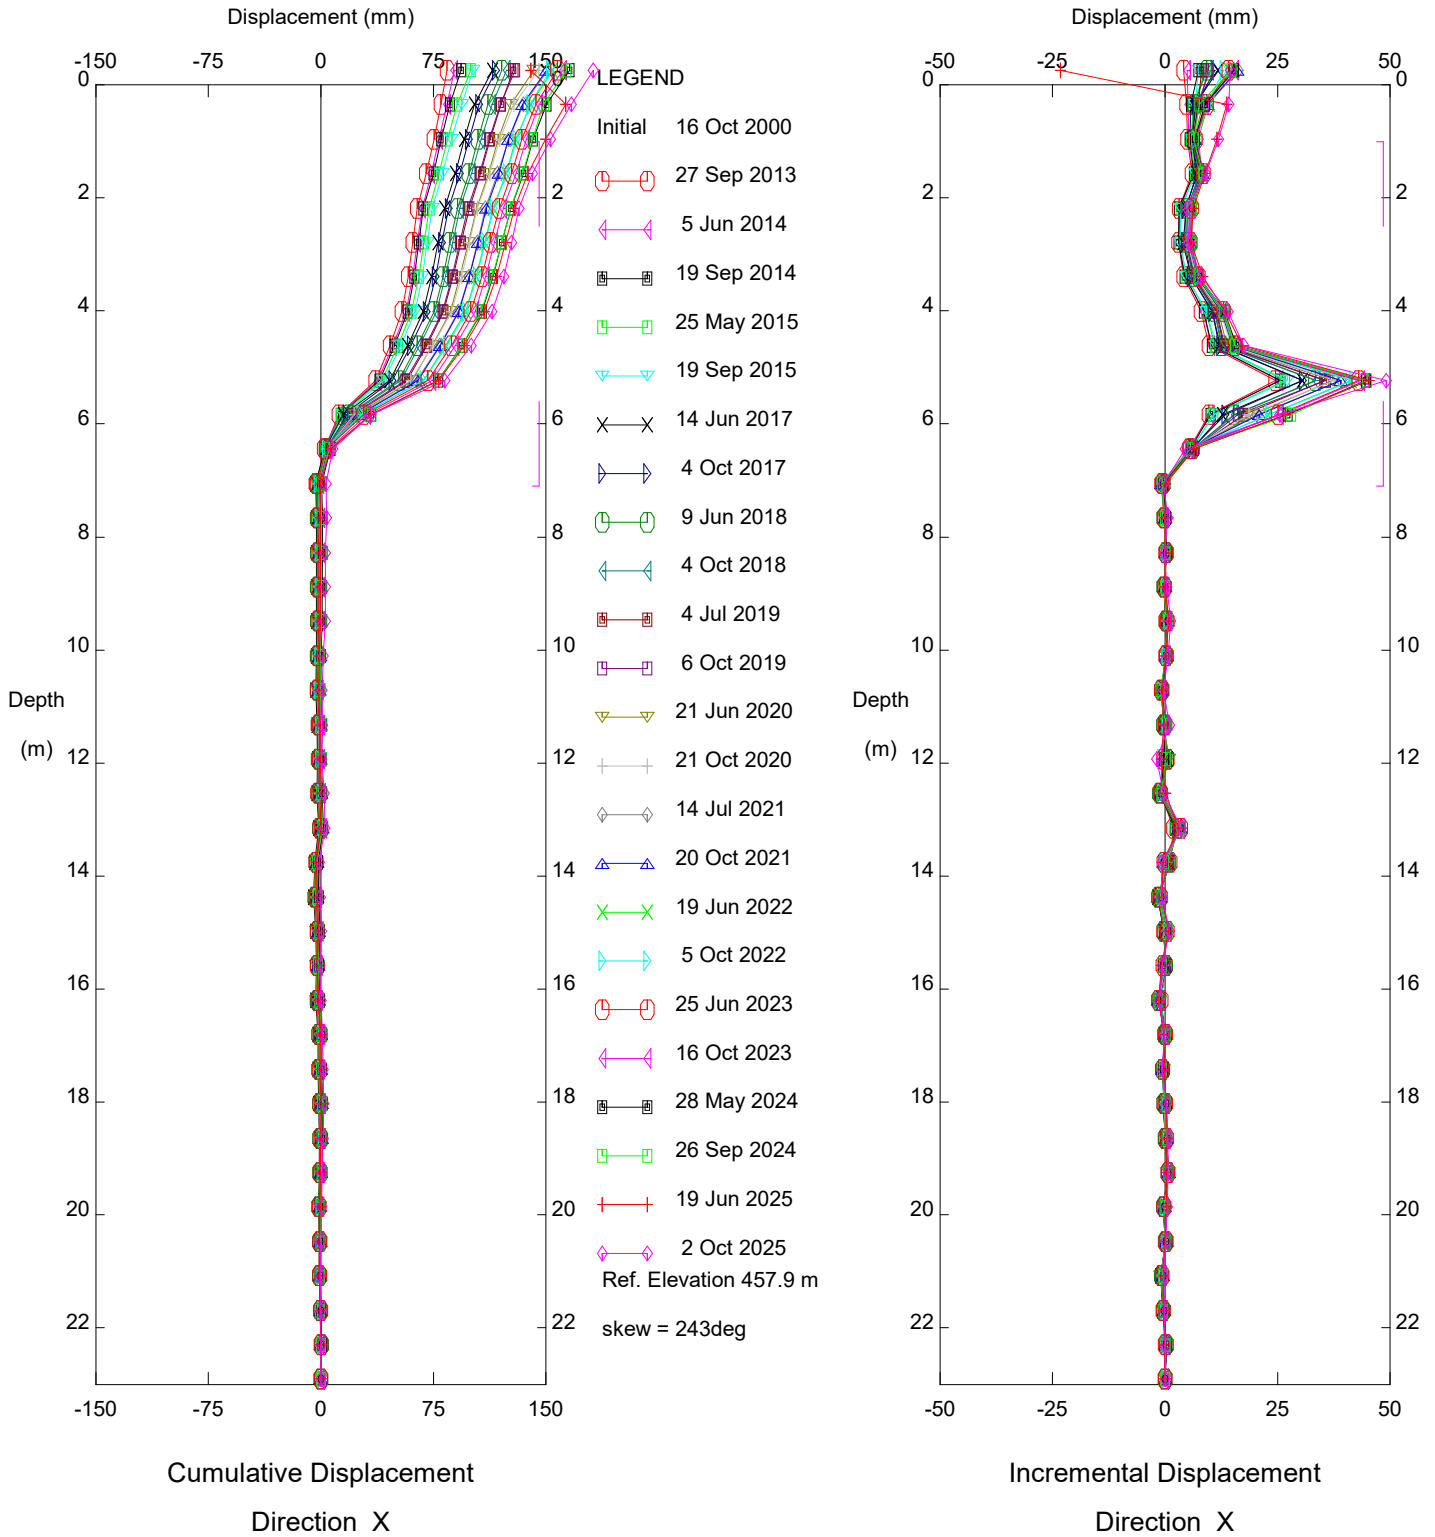
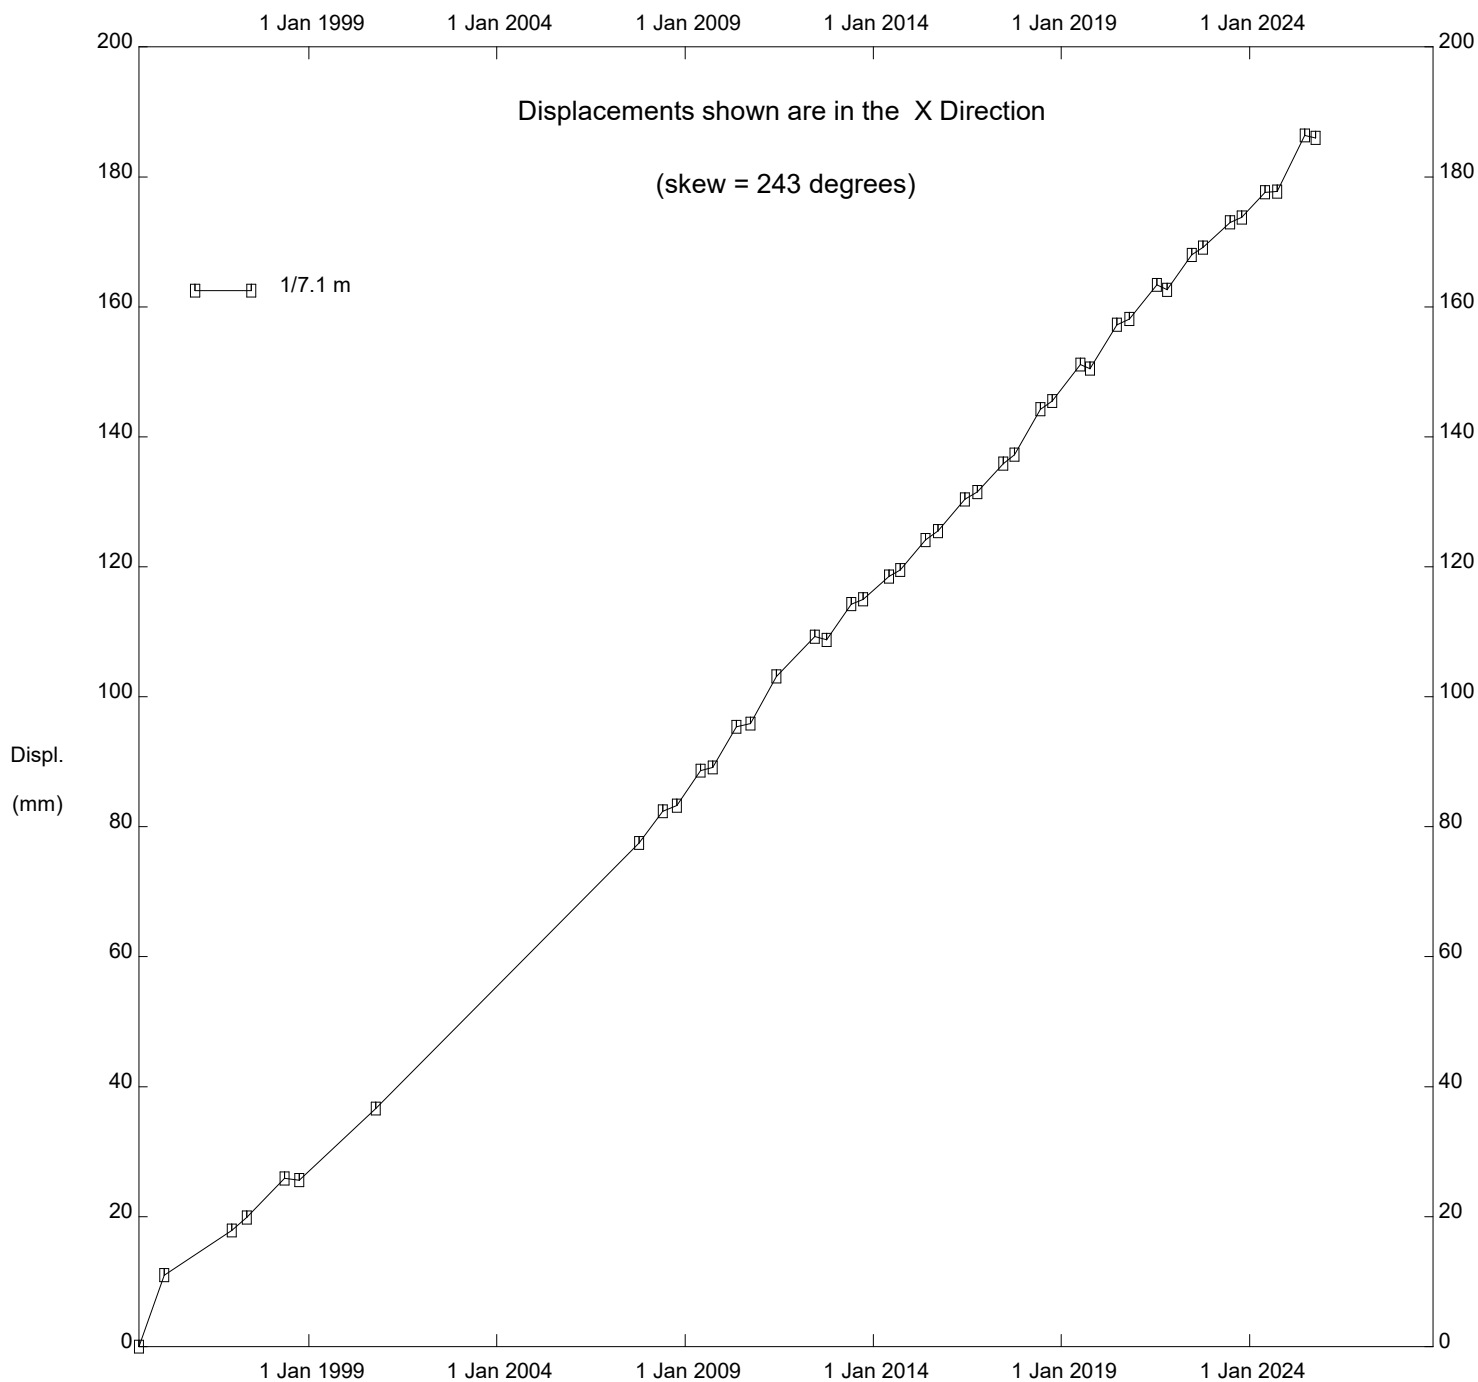
HWY 2:68 (PH037), Inclinometer SI-59

| INSTRUMENT # | DATE INITIALIZED | TOTAL CUMULATIVE RESULTANT MOVEMENT AT NOTED DEPTH SINCE INITIAL READING (mm) | MAXIMUM RATE OF MOVEMENT (mm/yr) | CURRENT STATUS | DATE OF PREVIOUS READING | INCREMENTAL MOVEMENT SINCE PREVIOUS READING (mm) | RATE OF MOVEMENT (mm/yr) | CHANGE IN RATE OF MOVEMENT SINCE PREVIOUS READING (mm/yr) |
|---|---|---|---|---|---|---|---|---|
| SI-59 | June 28, 1994 | 186.1 mm over 1.0 m to 7.1 m depth in 299° direction | 16.4 mm/yr in March 1995 | Operational | June 18, 2025 | -0.3 | -1.1 | -13.0 |

| SI -59 Damaged during construction broken about 2.0ft from top of casing, can be repaired without mechanical : |

| <b>Instrumentation Repairs:</b> | SI-55 and SI-59 are both damaged and should be repaired. Both instruments are damaged near the ground surface and can be repaired by hand. |
