ALBERTA TRANSPORTATION AND  
ECONOMIC CORRIDORS GRMP  
PEACE REGION  
(GRANDE PRAIRIE DISTRICT - NORTH)  
INSTRUMENTATION MONITORING - FALL 2025

| Site Number | Location | Name | Hwy | km |
|---|---|---|---|---|
| PH037 | Station 1+250 to 2+000 | Dunvegan South | 2:68 | Km 15.7 |

| <b>Current Monitoring:</b> | 02-Oct-2025 | <b>Previous Monitoring</b> | 18~19-June-2025 |

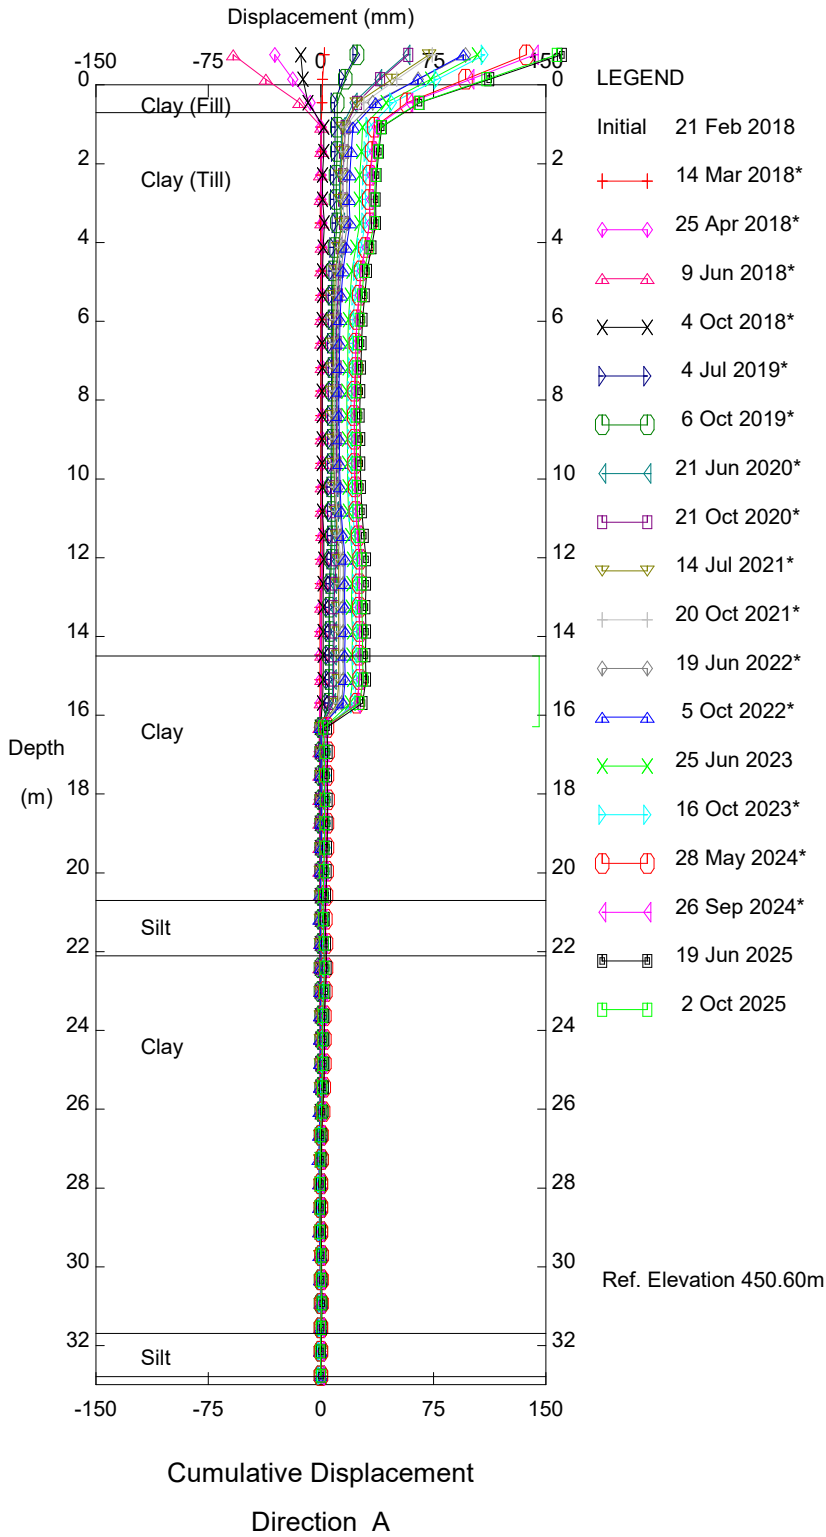
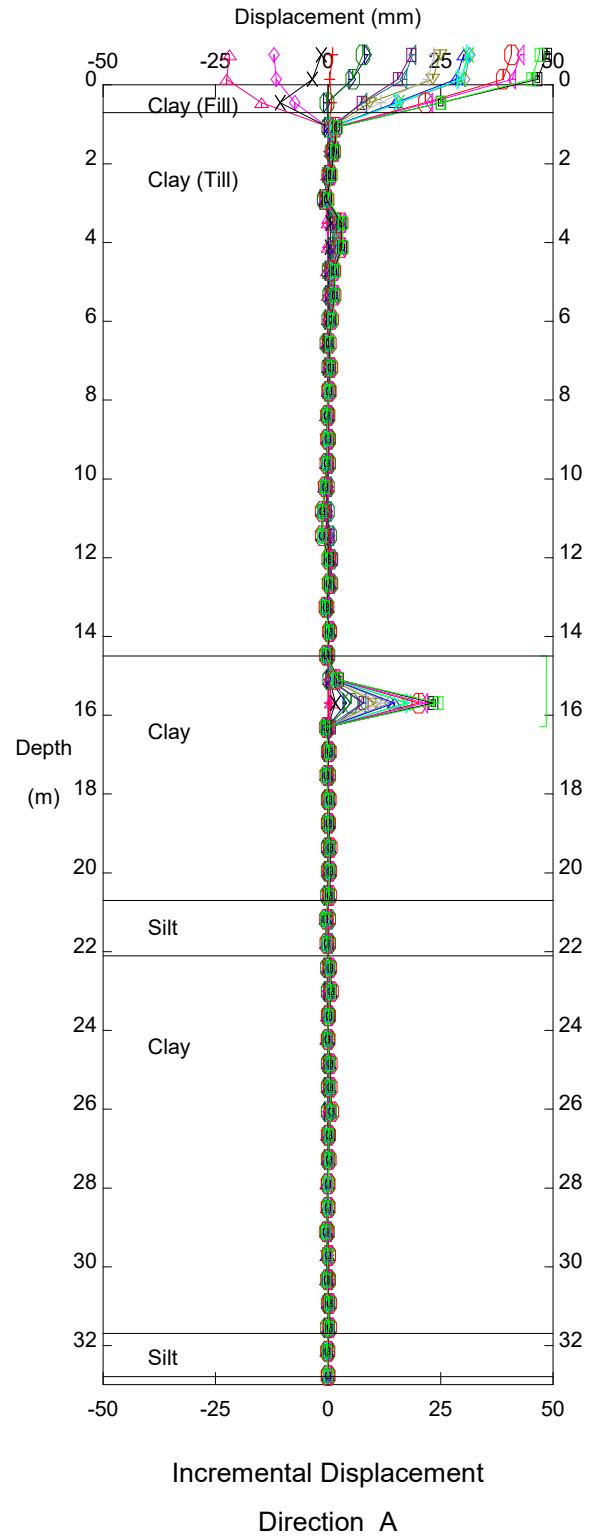
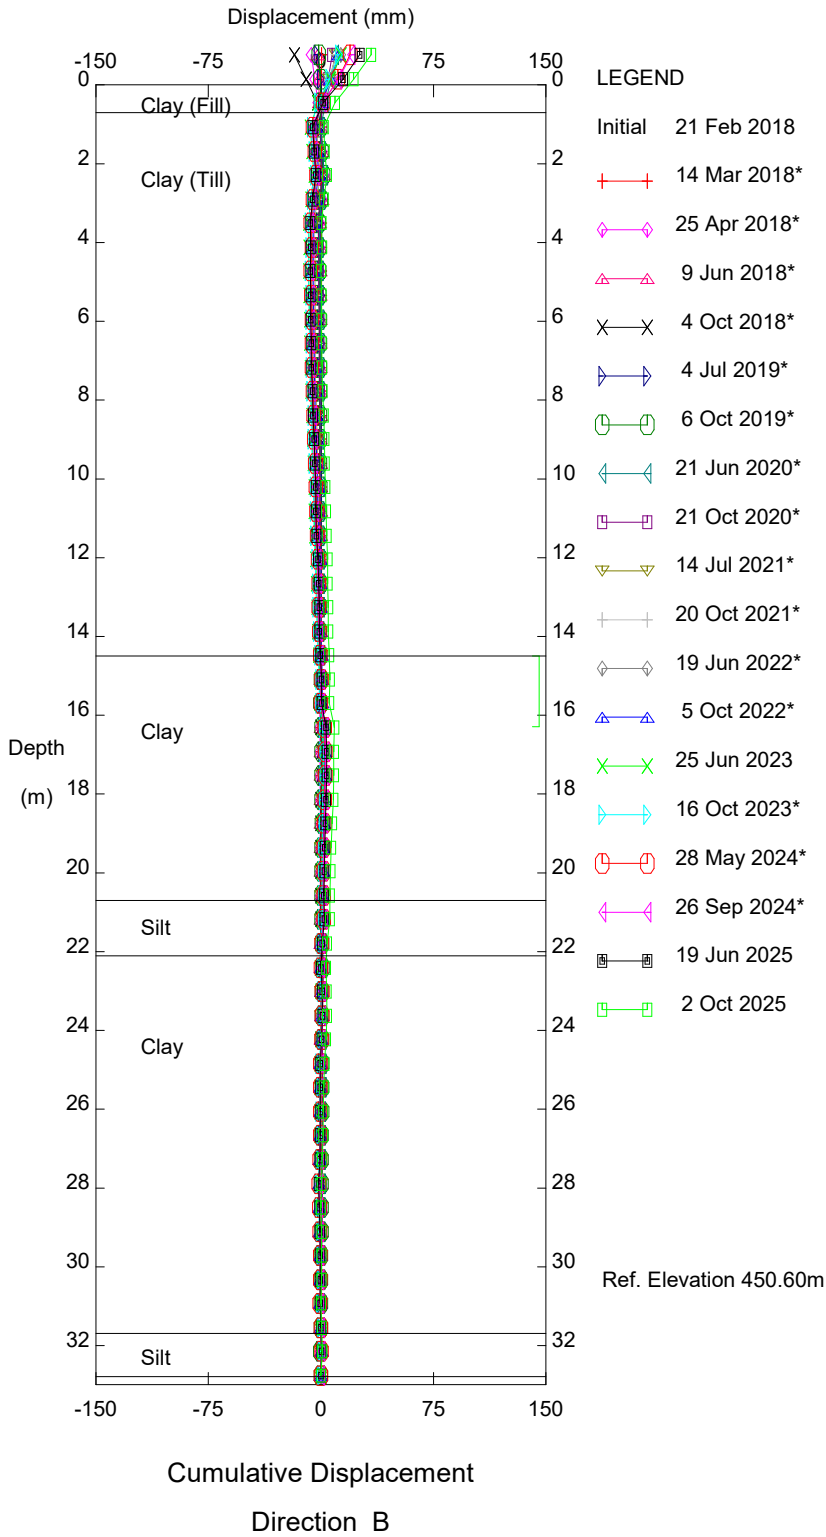
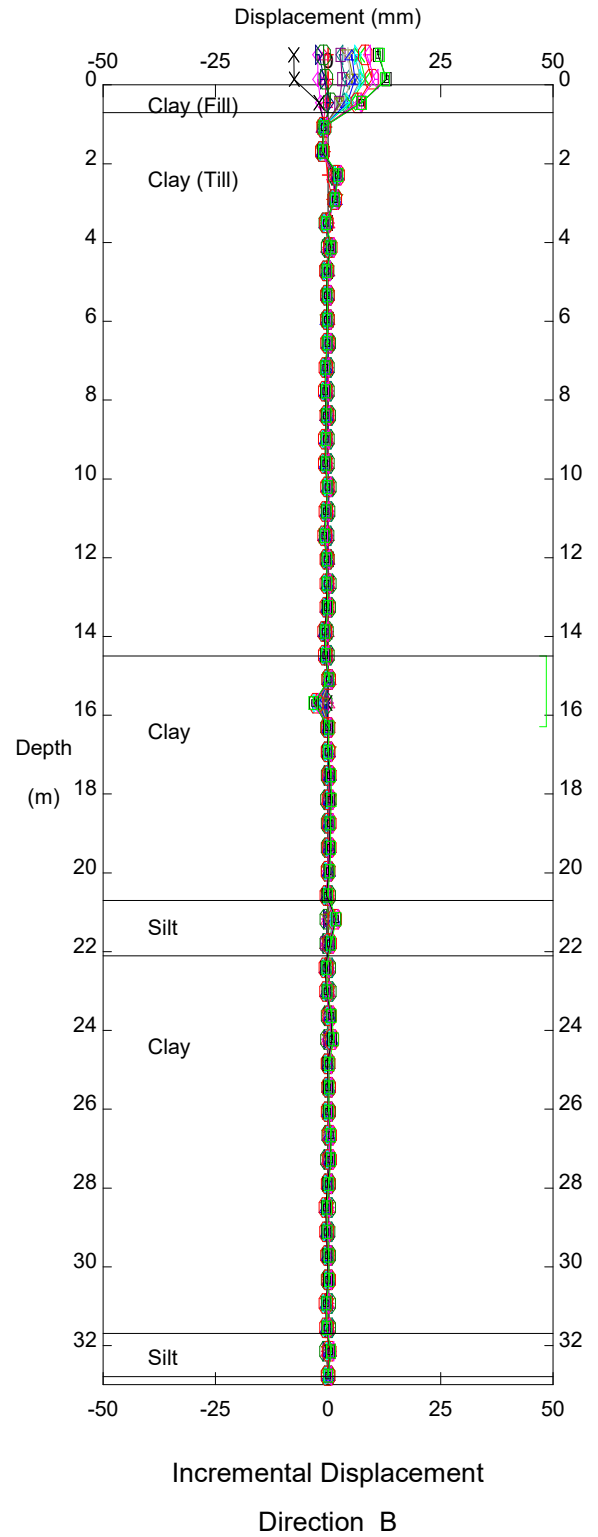
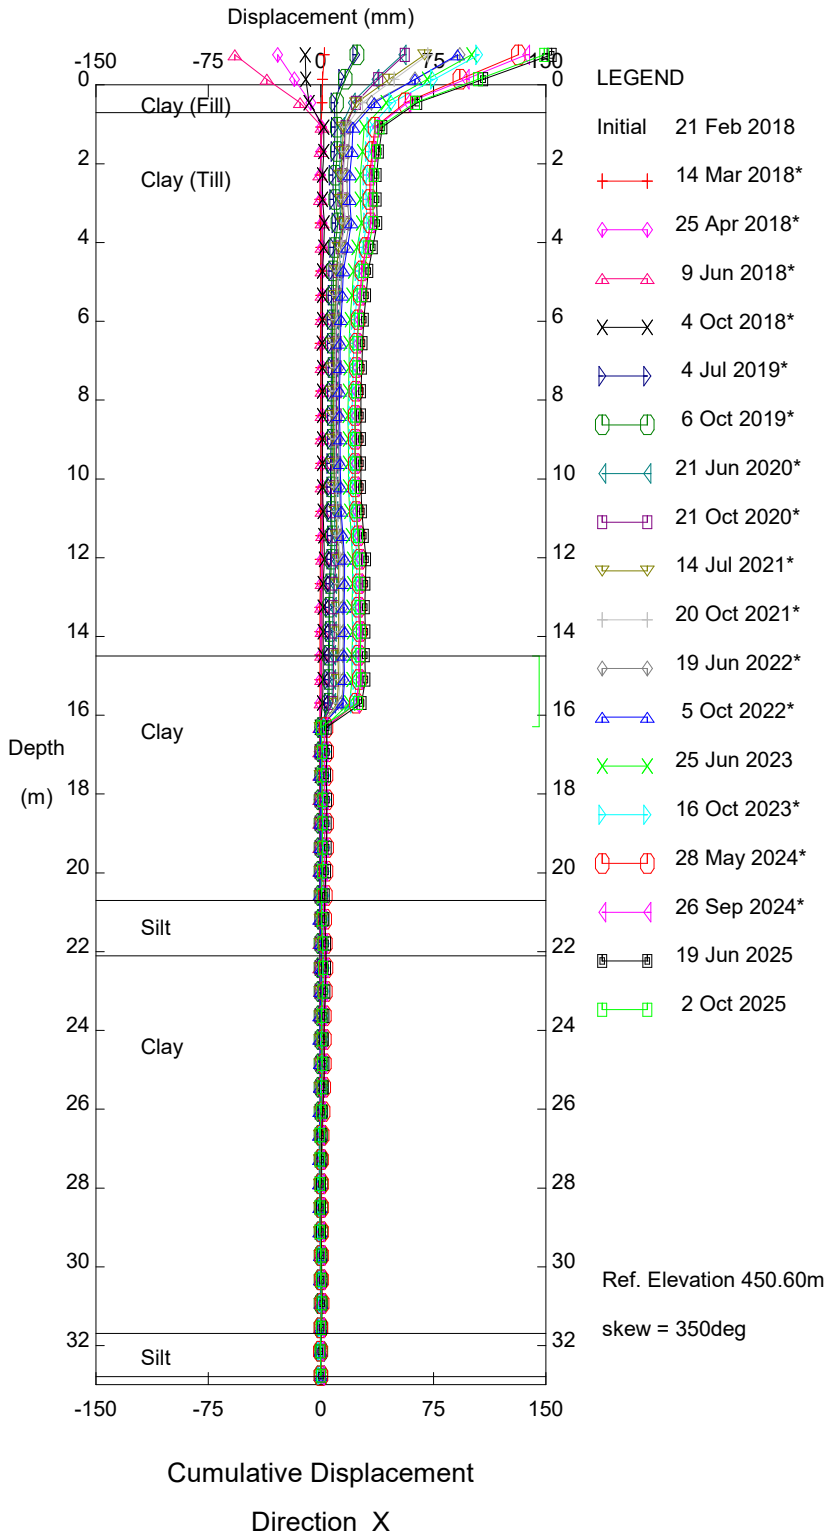
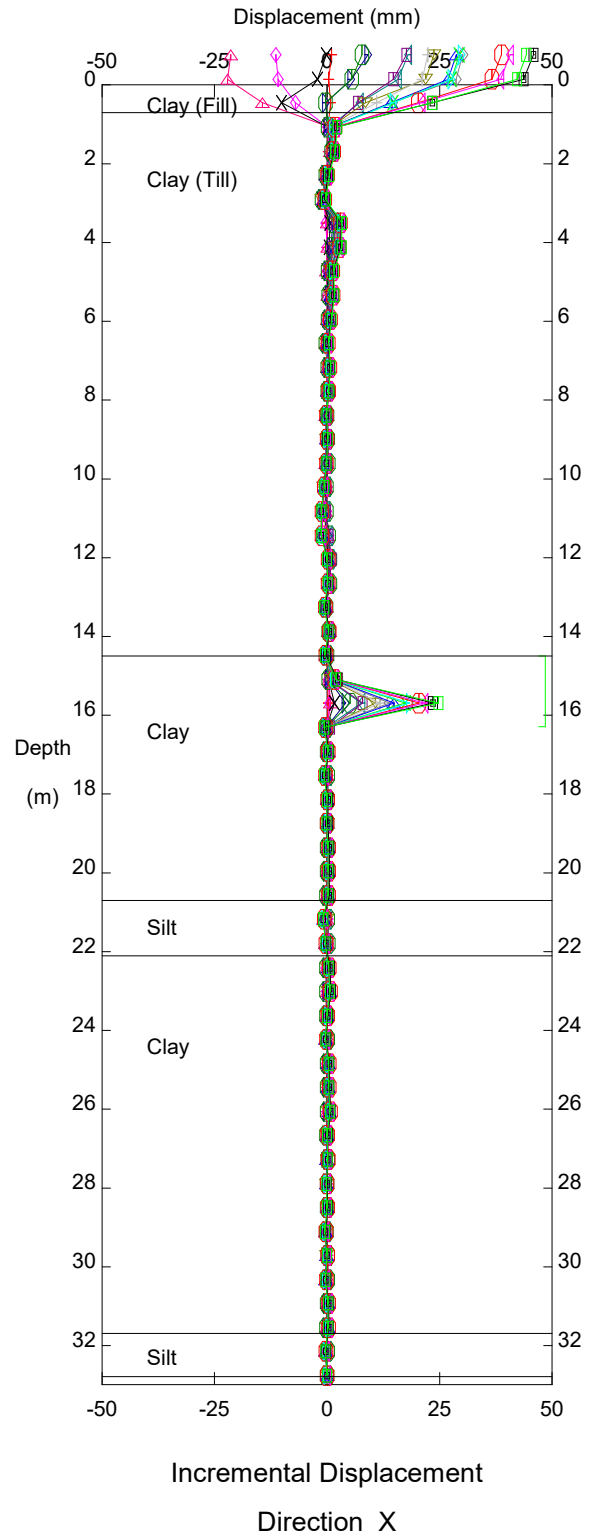
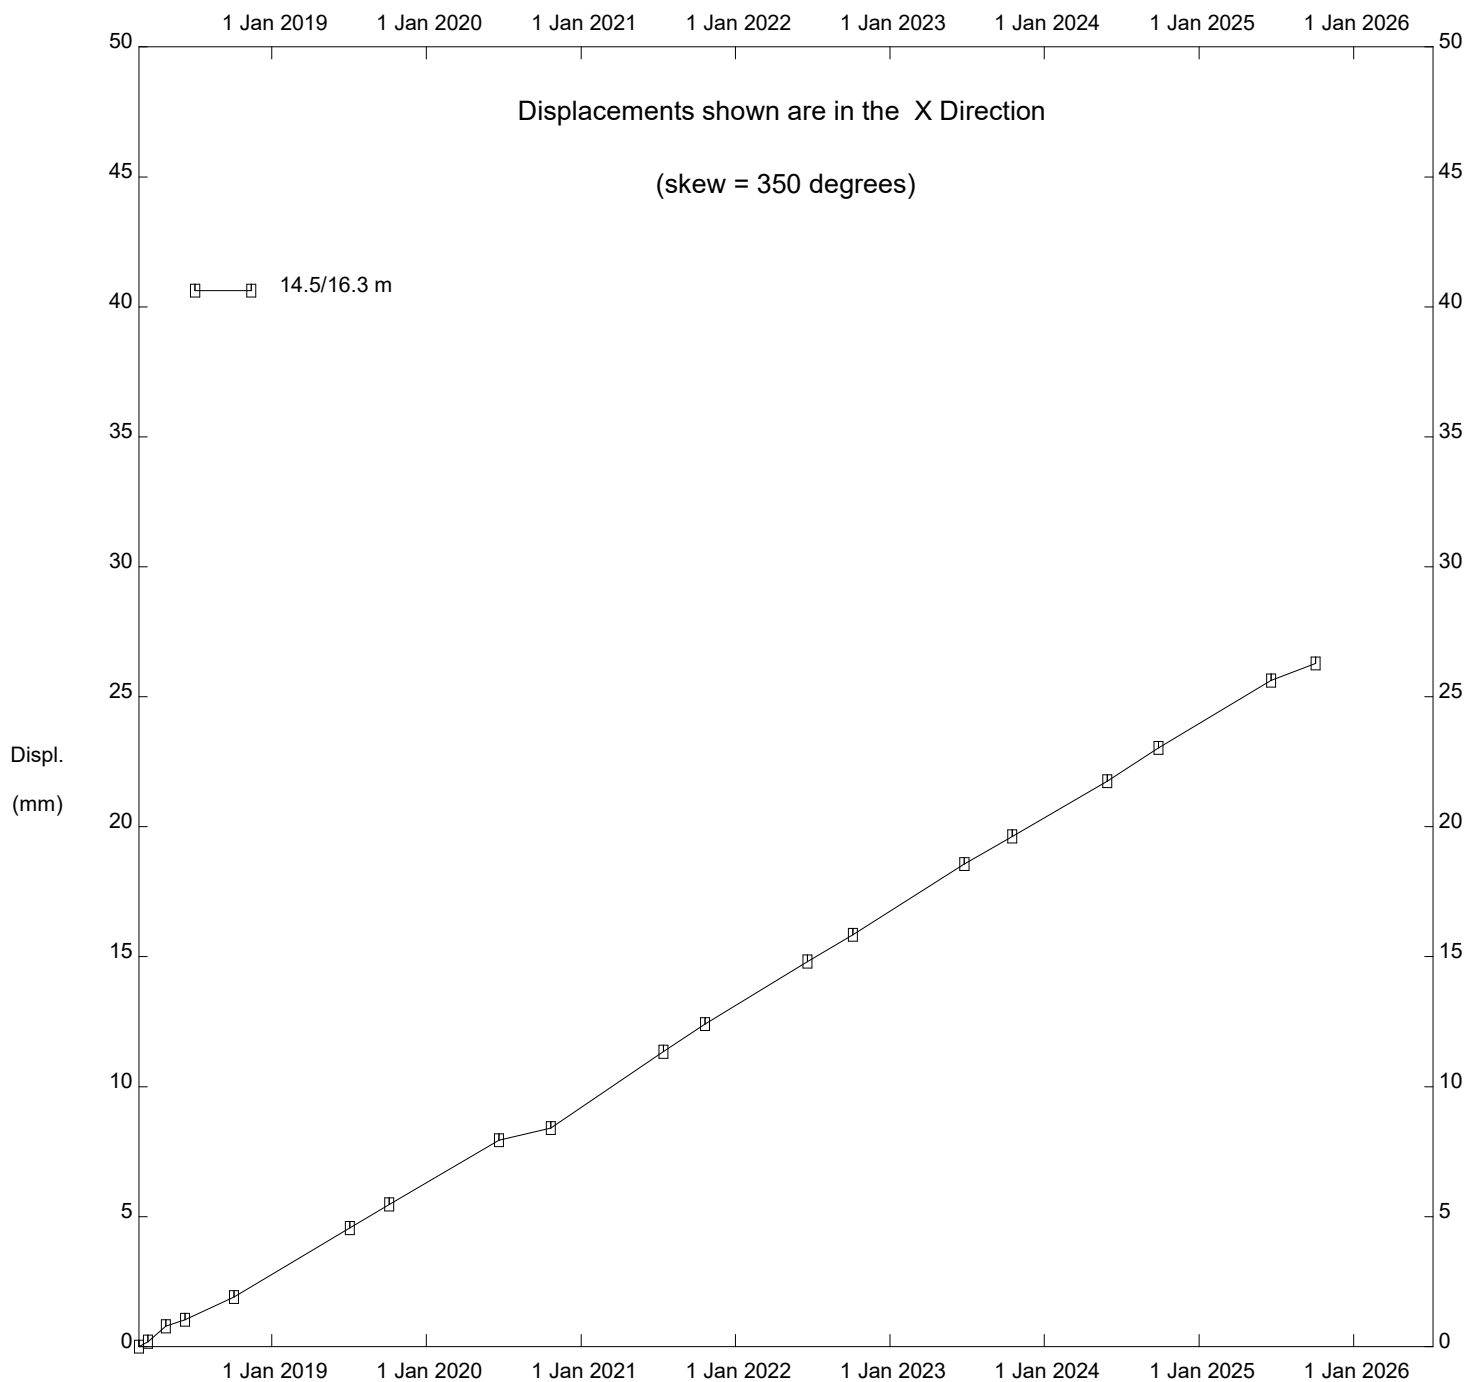
HWY 2:68 (PH037), Inclinometer SI18-8

| INSTRUMENT # | DATE INITIALIZED | TOTAL CUMULATIVE RESULTANT MOVEMENT AT NOTED DEPTH SINCE INITIAL READING (mm) | MAXIMUM RATE OF MOVEMENT (mm/yr) | CURRENT STATUS | DATE OF PREVIOUS READING | INCREMENTAL MOVEMENT SINCE PREVIOUS READING (mm) | RATE OF MOVEMENT (mm/yr) | CHANGE IN RATE OF MOVEMENT SINCE PREVIOUS READING (mm/yr) |
|---|---|---|---|---|---|---|---|---|
| SI18-8 | February 12, 2018 | 26.3 mm over 14.5 m to 16.3 m depth in 266° direction | 5.1 mm/yr in April 2018 | Operational | September 26, 2024 | 0.7 | 2.3 | -1.3 |

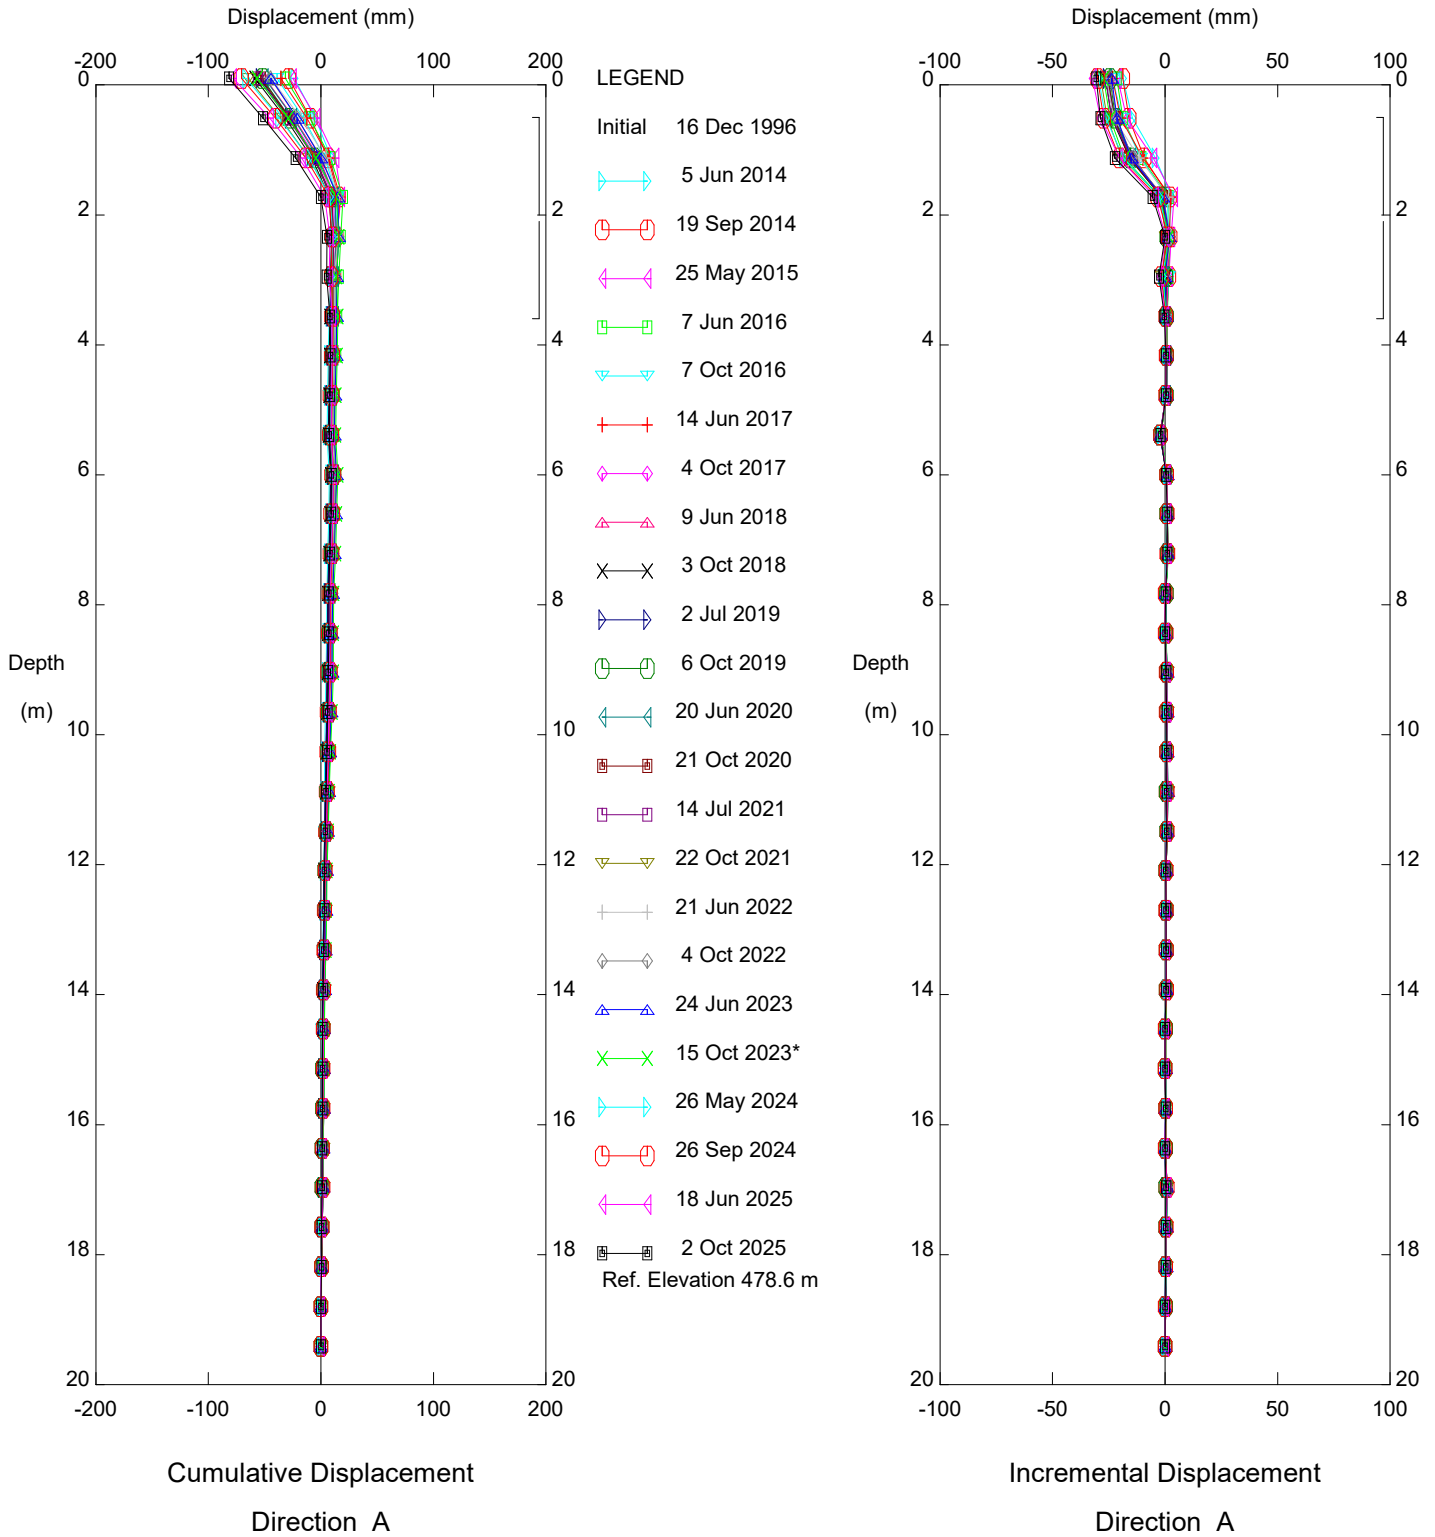
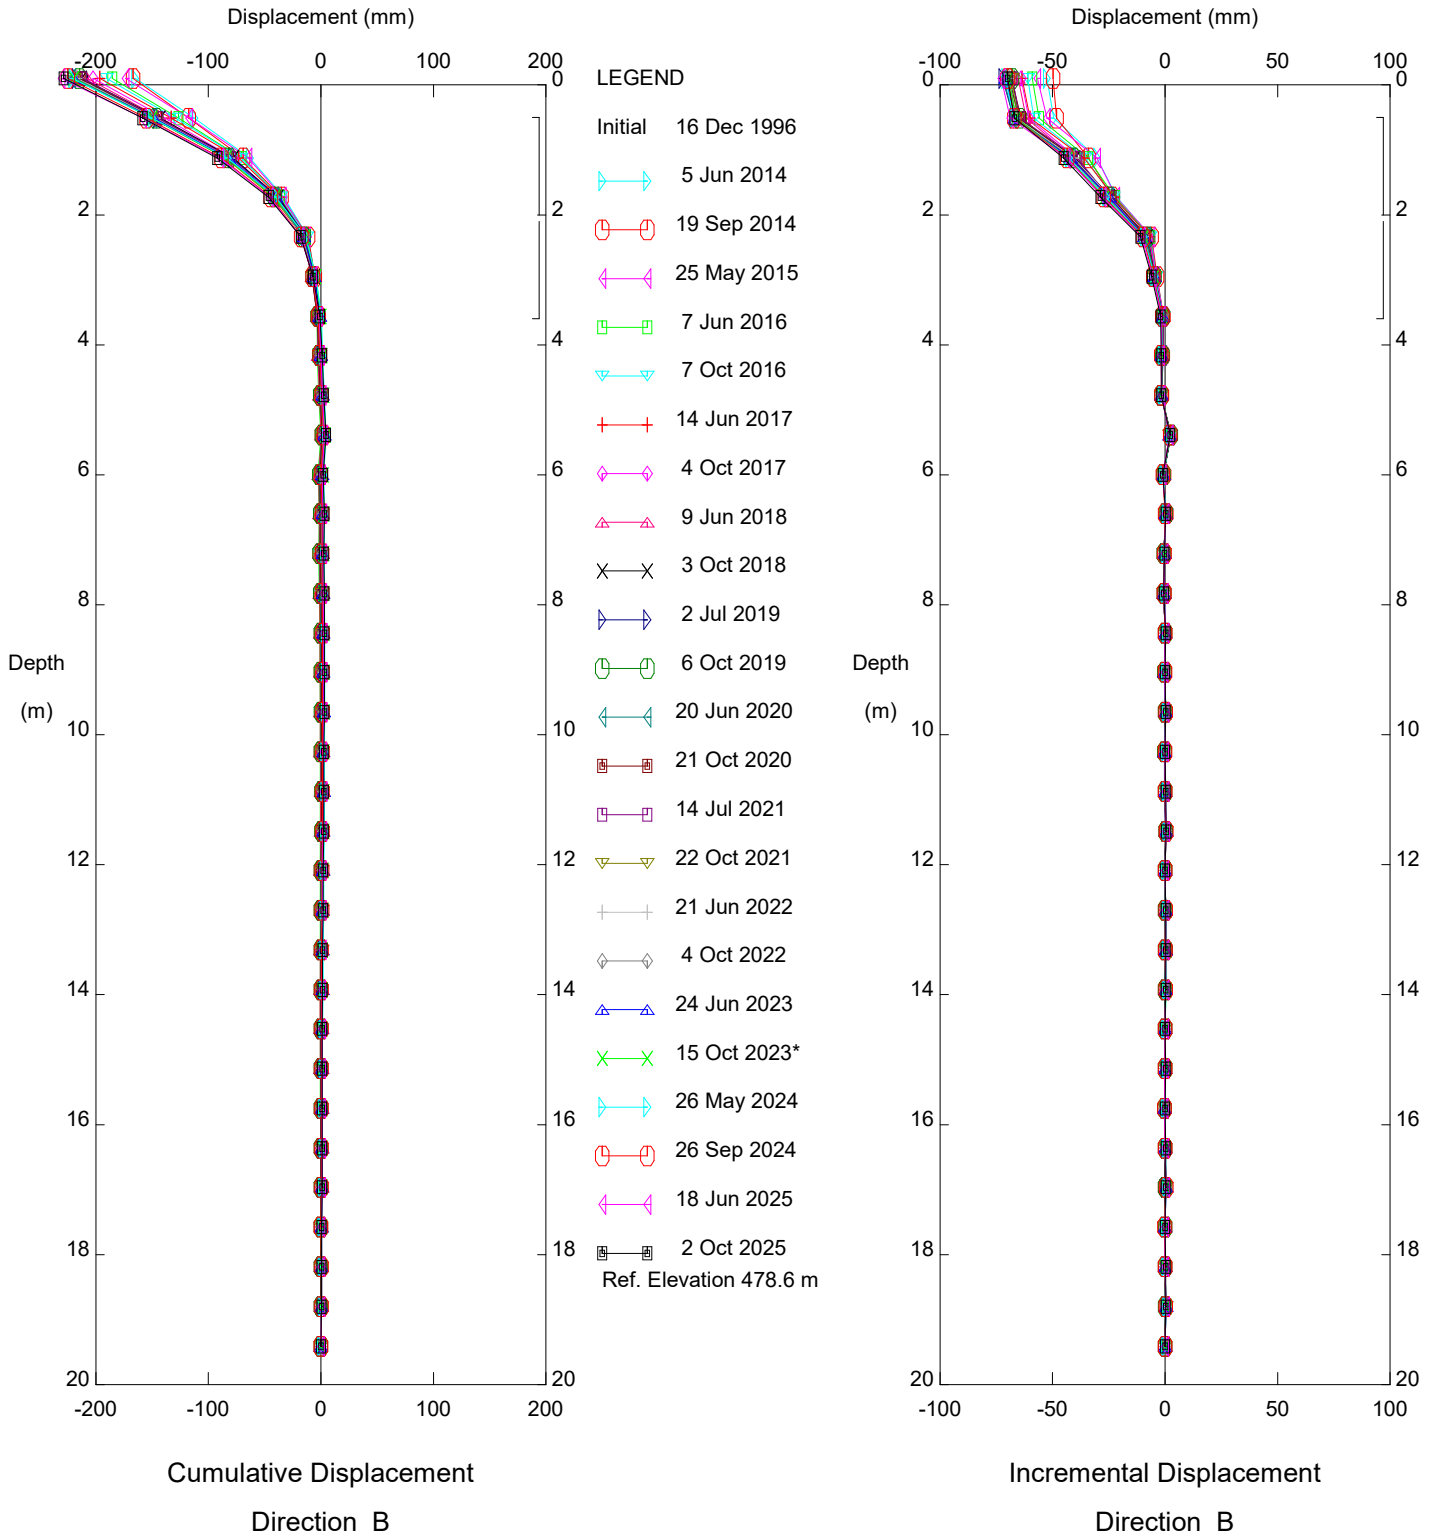
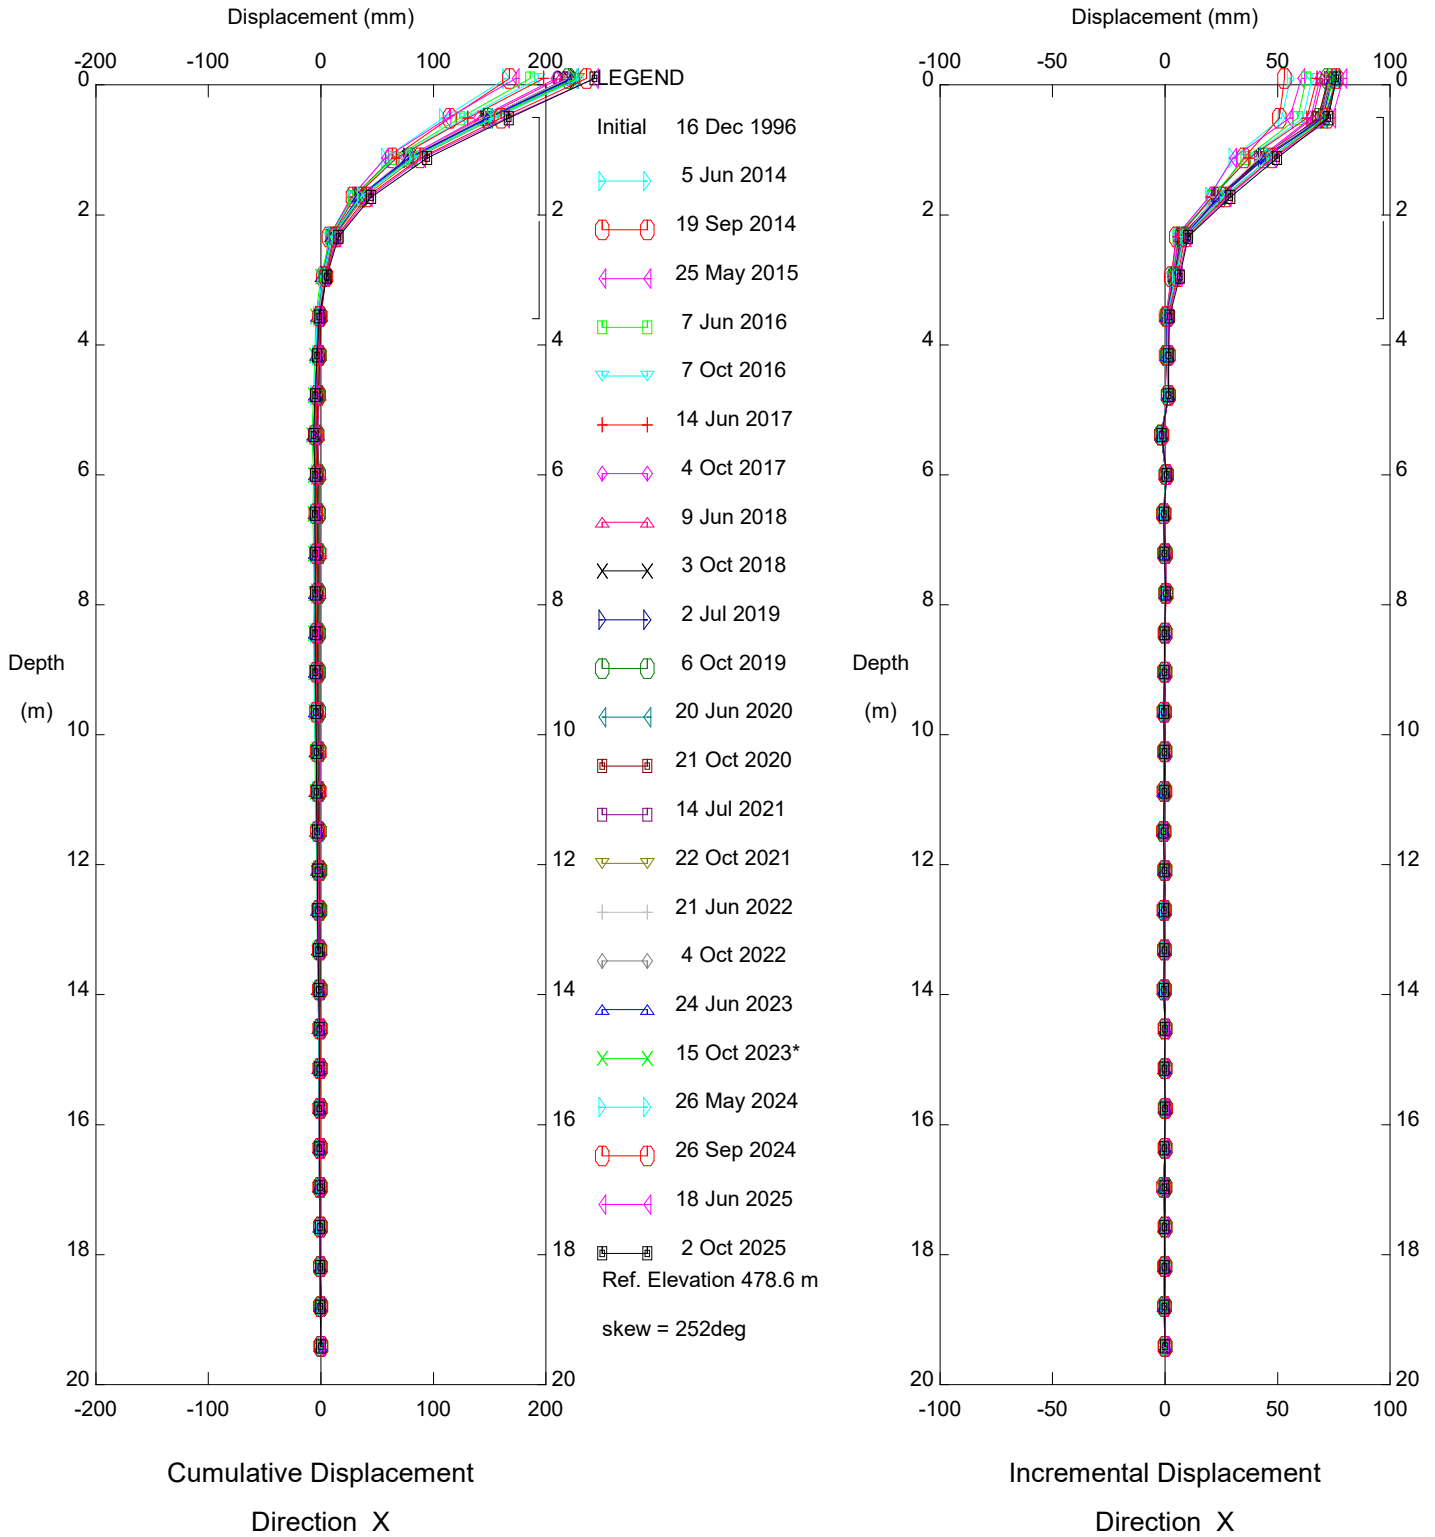
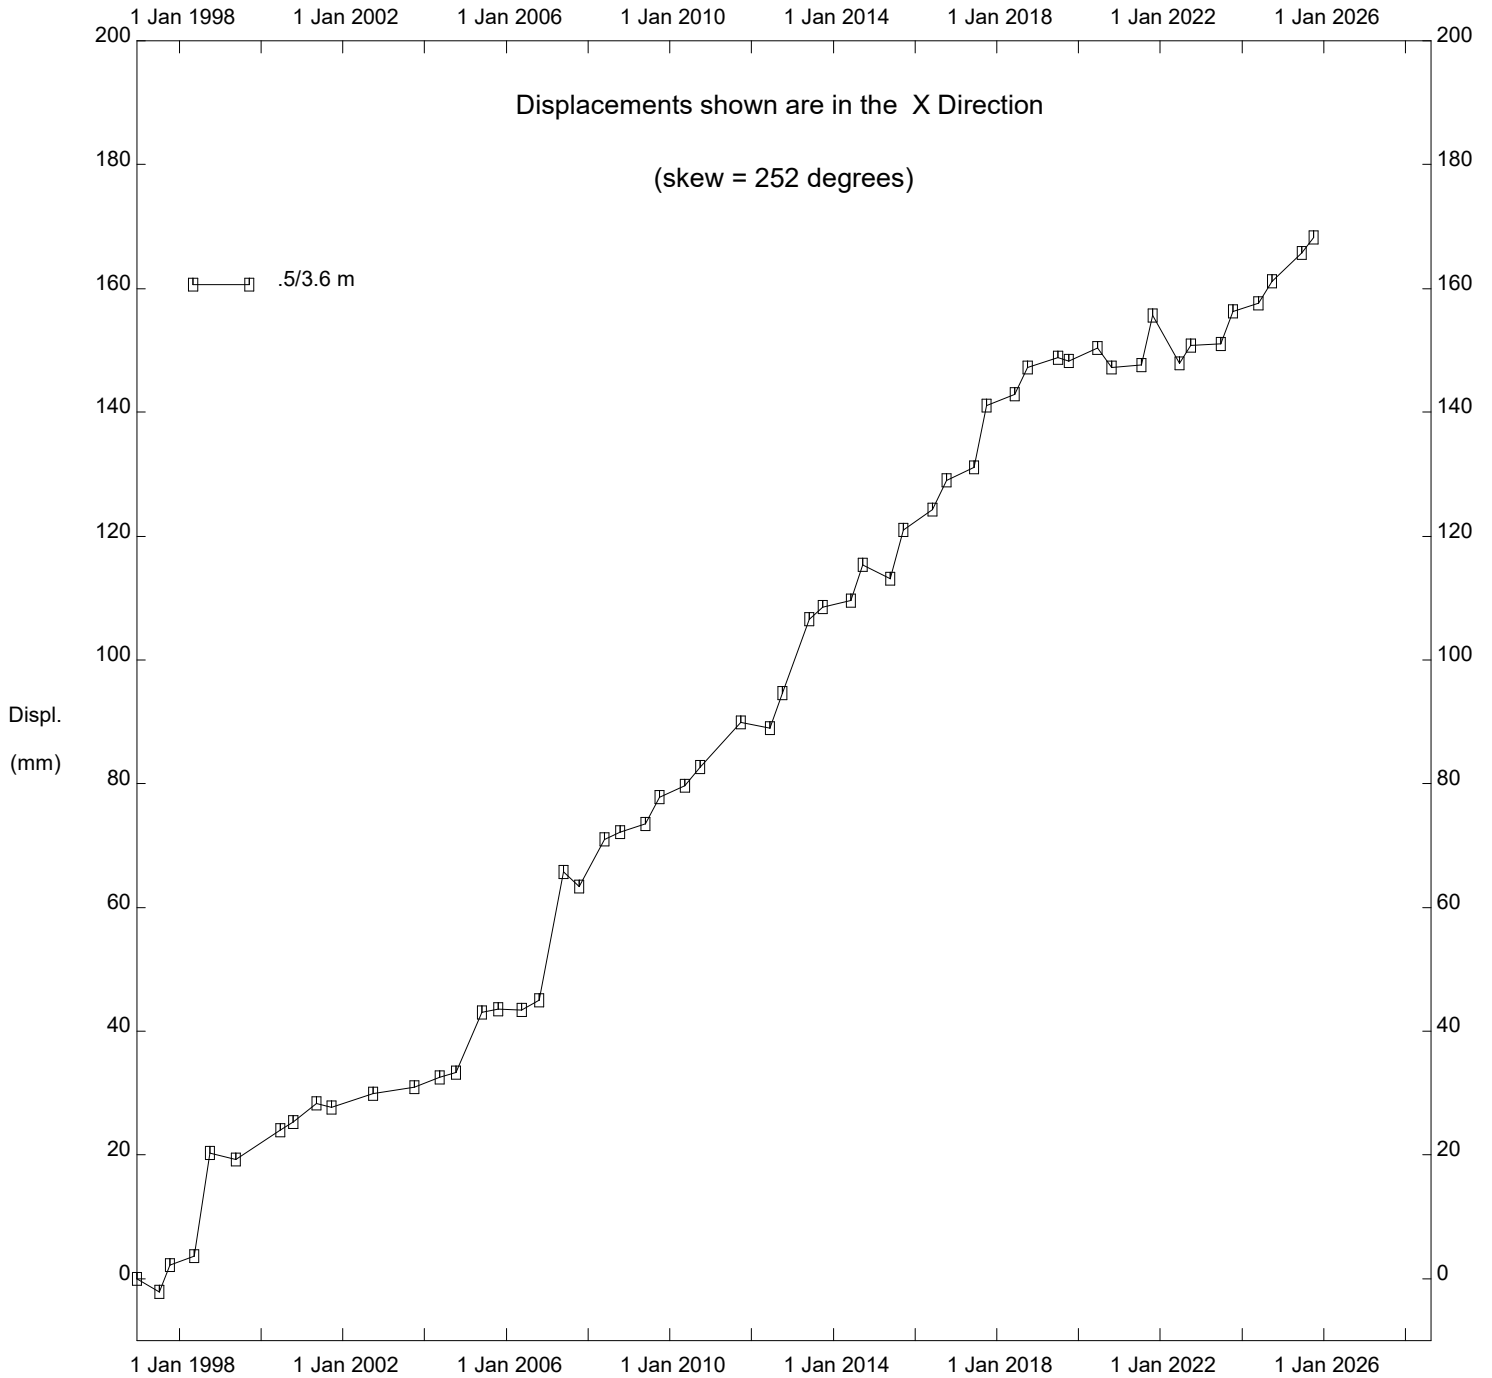
HWY 2:68 (PH037), Inclinometer SI-58

| INSTRUMENT # | DATE INITIALIZED | TOTAL CUMULATIVE RESULTANT MOVEMENT AT NOTED DEPTH SINCE INITIAL READING (mm) | MAXIMUM RATE OF MOVEMENT (mm/yr) | CURRENT STATUS | DATE OF PREVIOUS READING | INCREMENTAL MOVEMENT SINCE PREVIOUS READING (mm) | RATE OF MOVEMENT (mm/yr) | CHANGE IN RATE OF MOVEMENT SINCE PREVIOUS READING (mm/yr) |
|---|---|---|---|---|---|---|---|---|
| SI-58 | Aug. 26, 1992 | 168.3 mm over 0.5 m to 3.6 m depth in 270° direction | 41.7 mm/yr in October 1998 | Operational | June 18, 2025 | 2.5 | 8.7 | 2.4 |
