ALBERTA TRANSPORTATION AND  
ECONOMIC CORRIDORS GRMP  
PEACE REGION  
(GRANDE PRAIRIE DISTRICT - NORTH)  
INSTRUMENTATION MONITORING - FALL 2025

| Site Number | Location | Name | Hwy | km |
|---|---|---|---|---|
| PH037 | Station 1+250 to 2+000 | Dunvegan South | 2:68 | Km 15.7 |

| <b>Current Monitoring:</b> | 02-Oct-2025 | <b>Previous Monitoring</b> | 18~19-June-2025 |

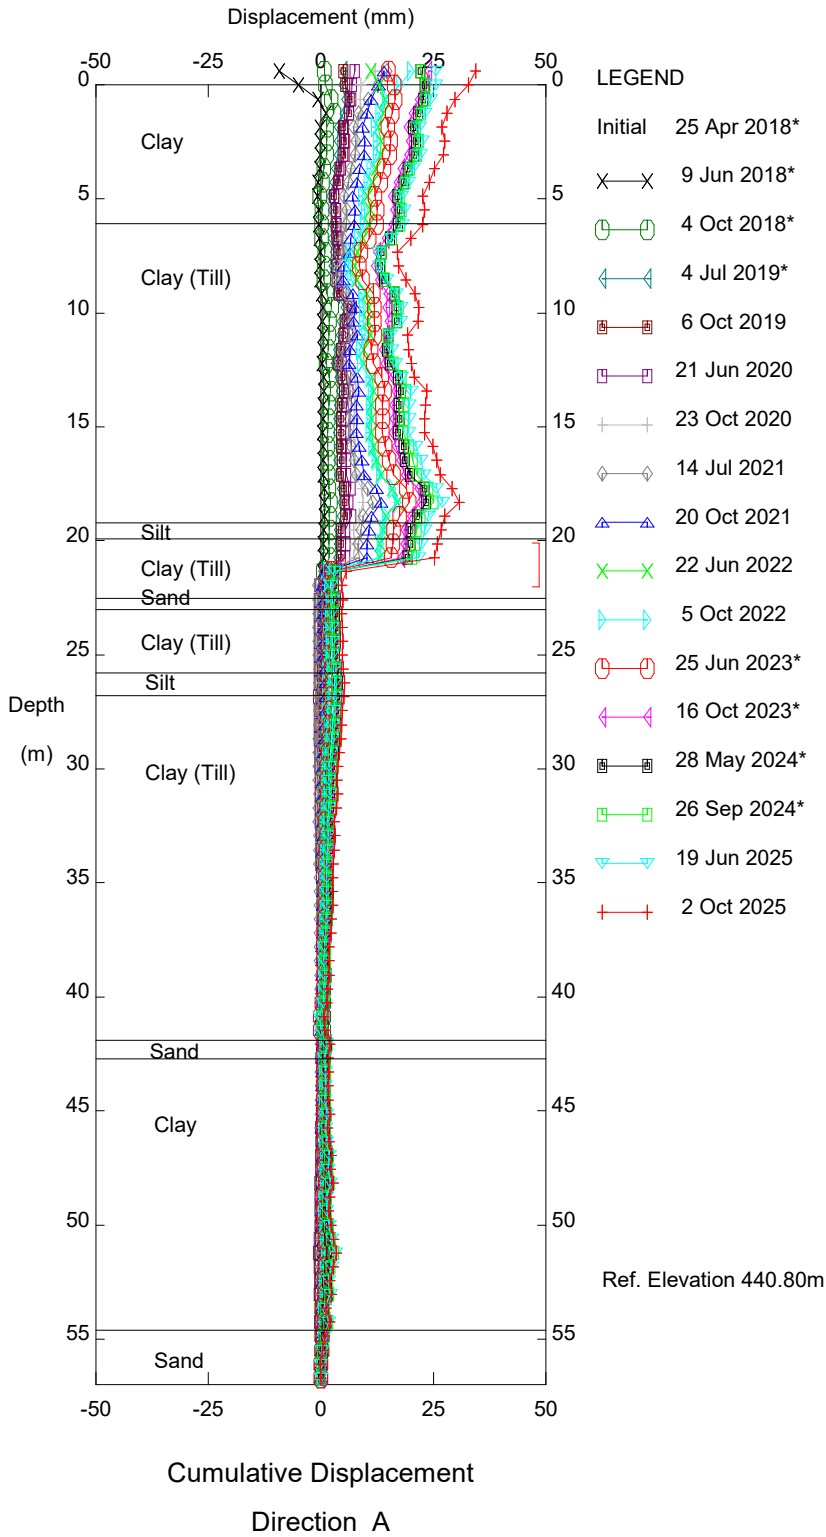
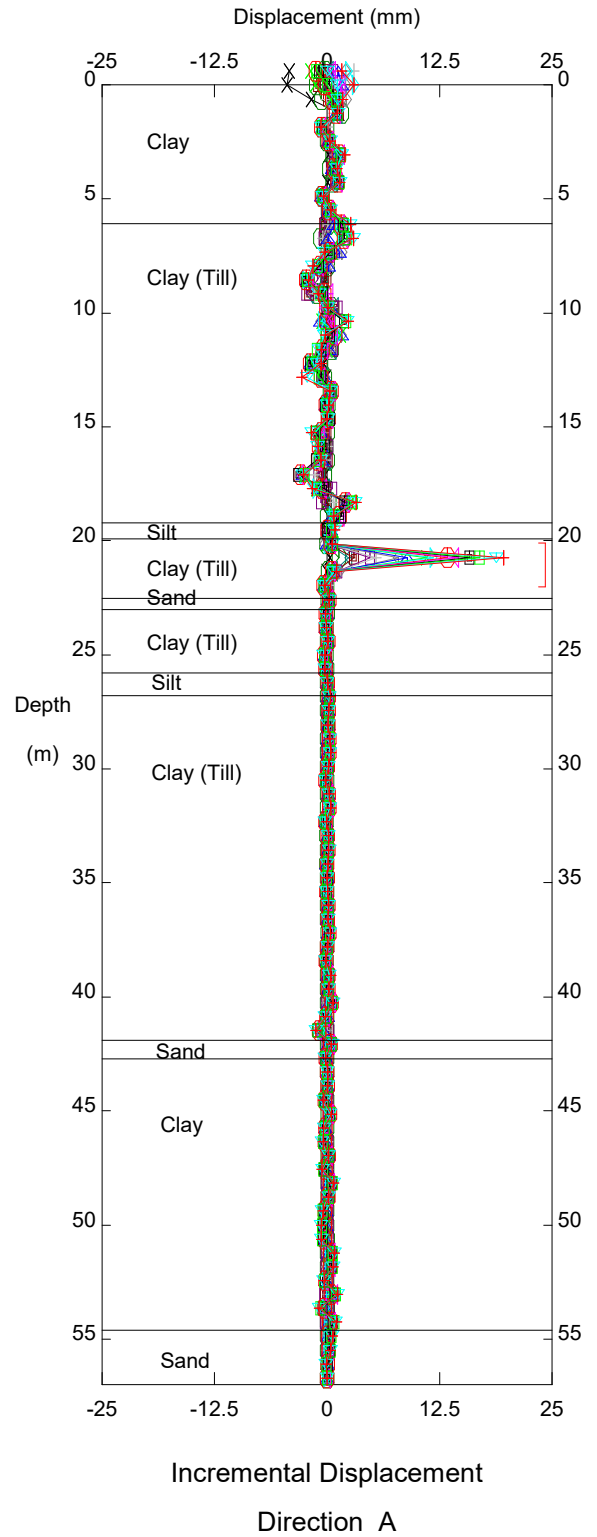
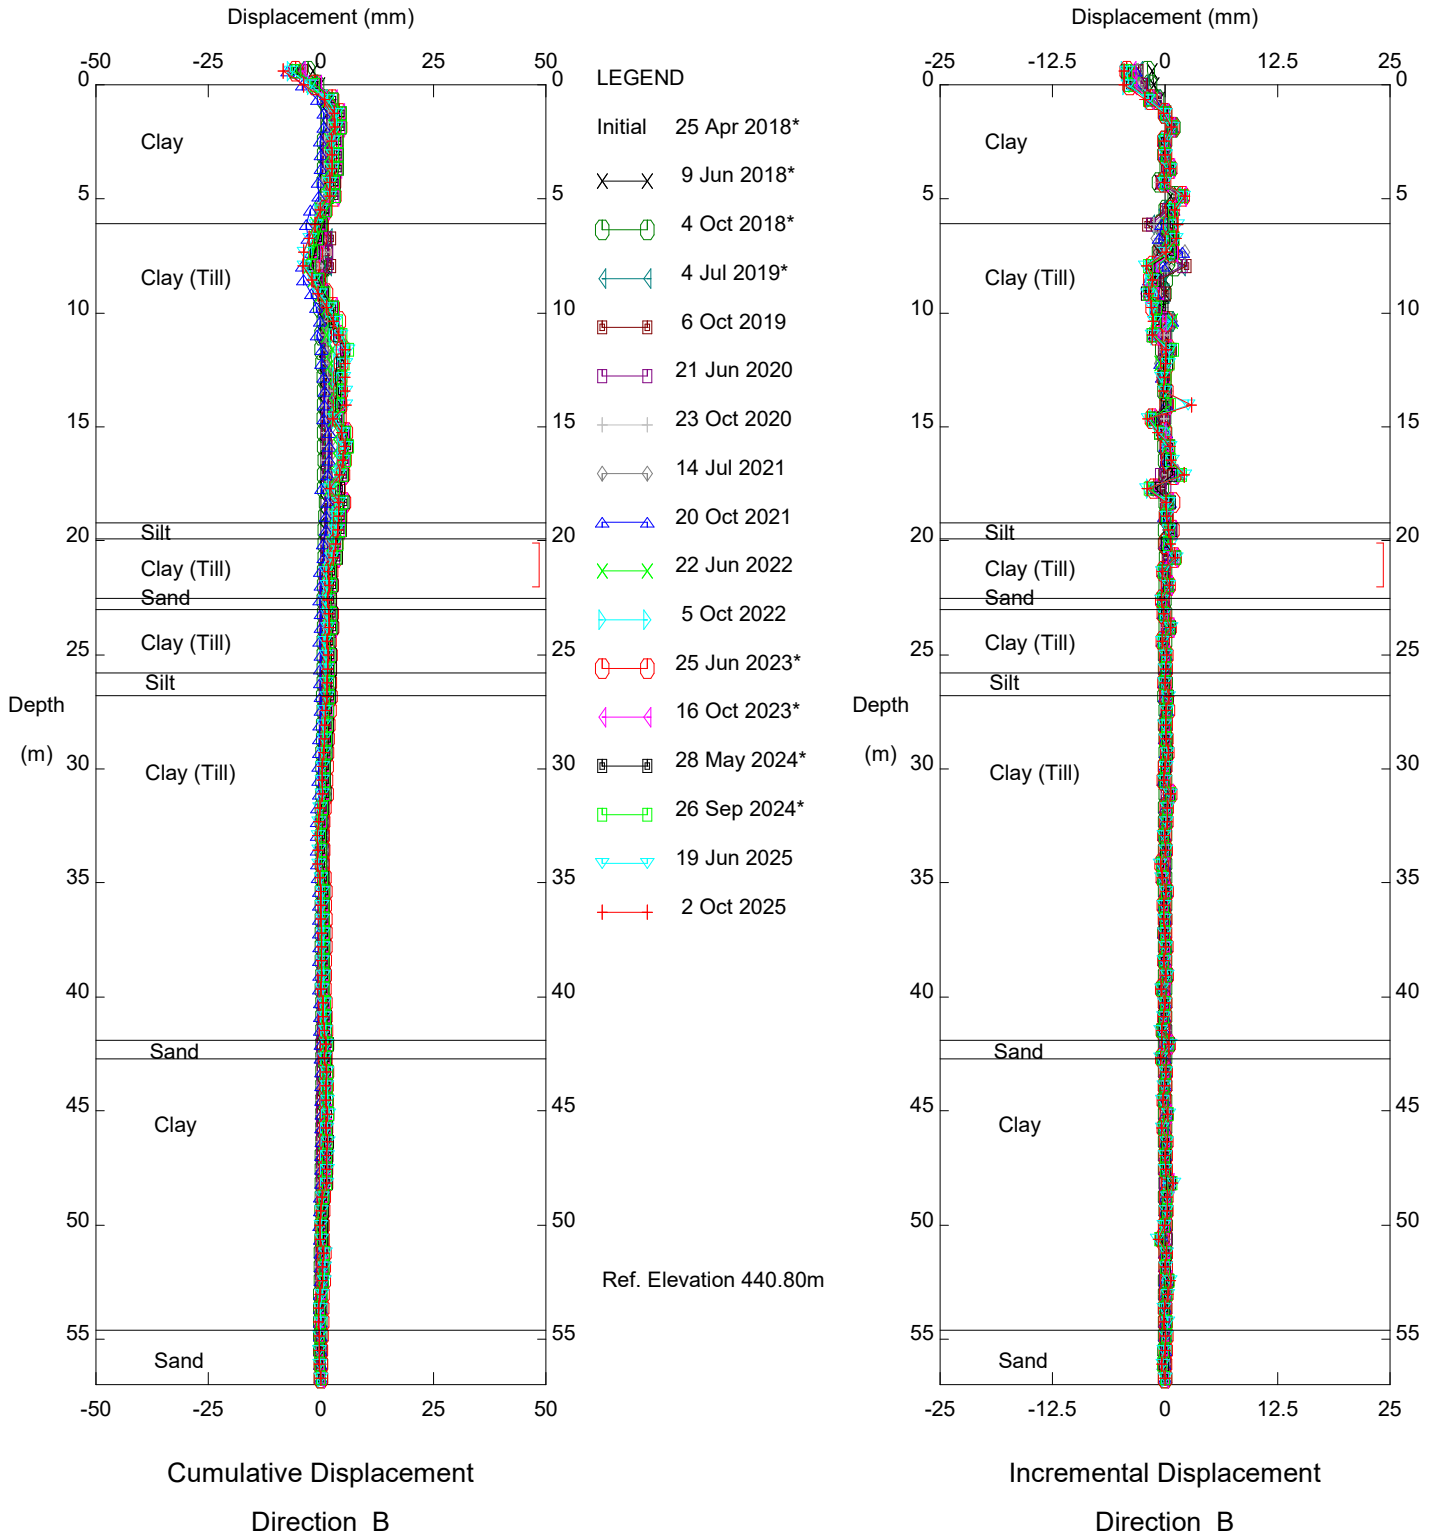
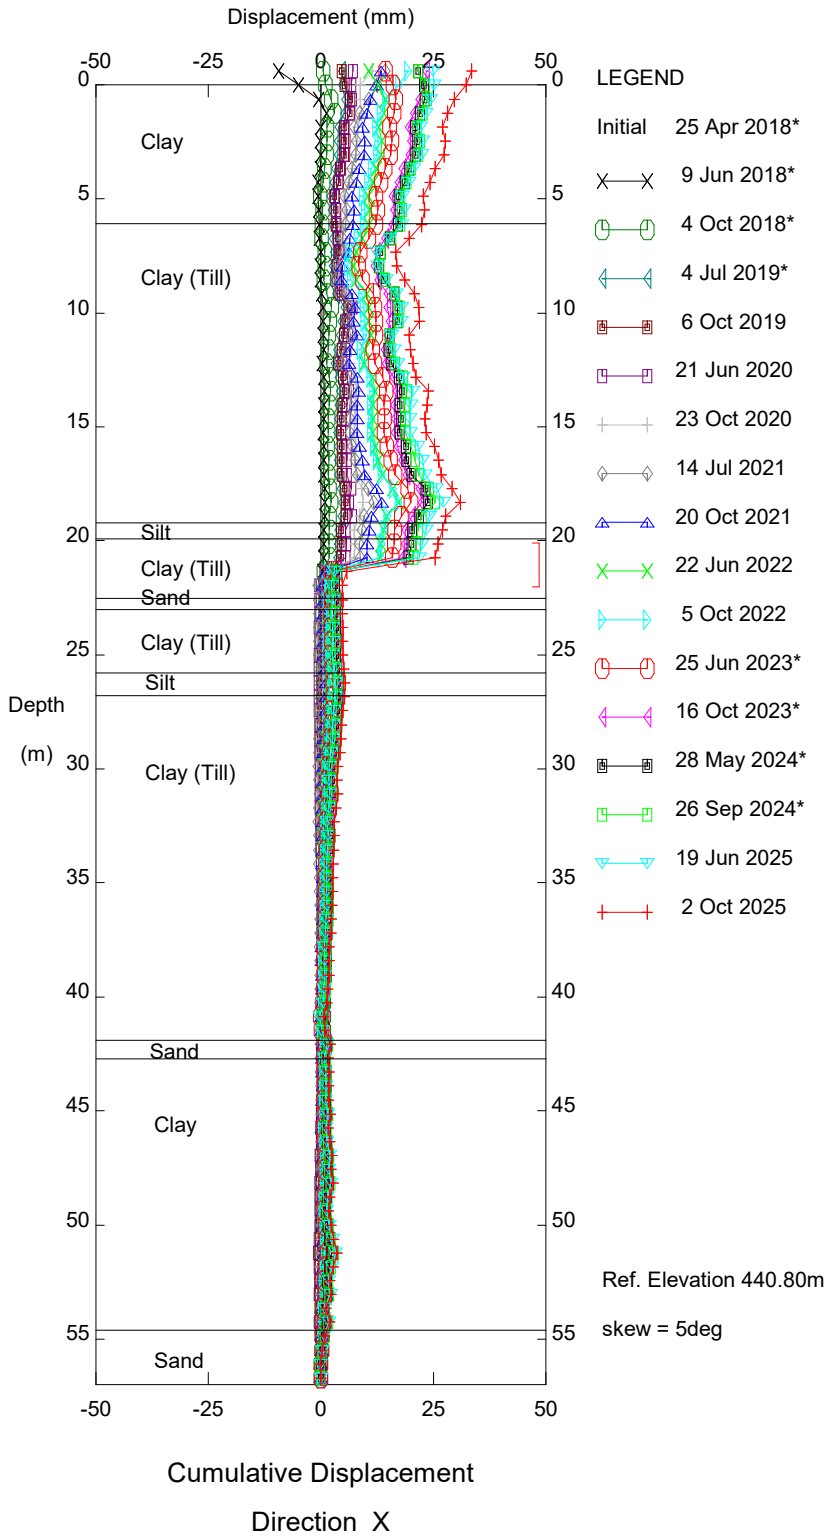
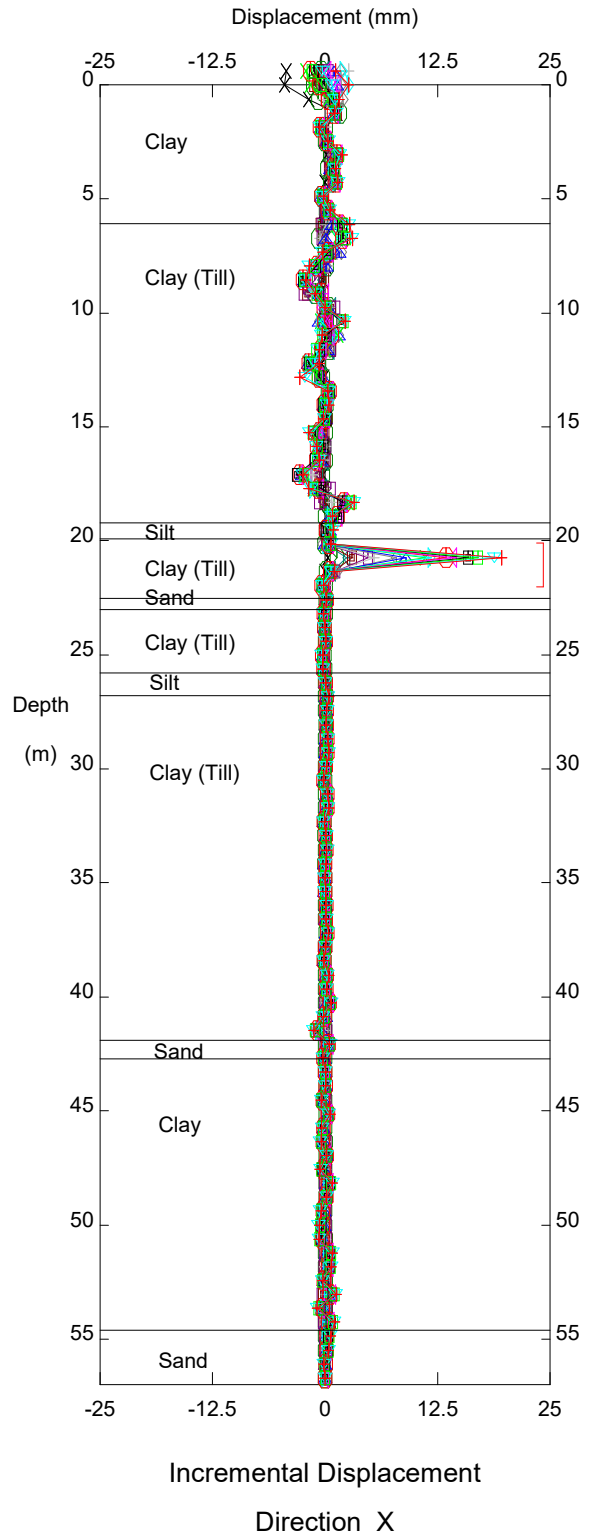
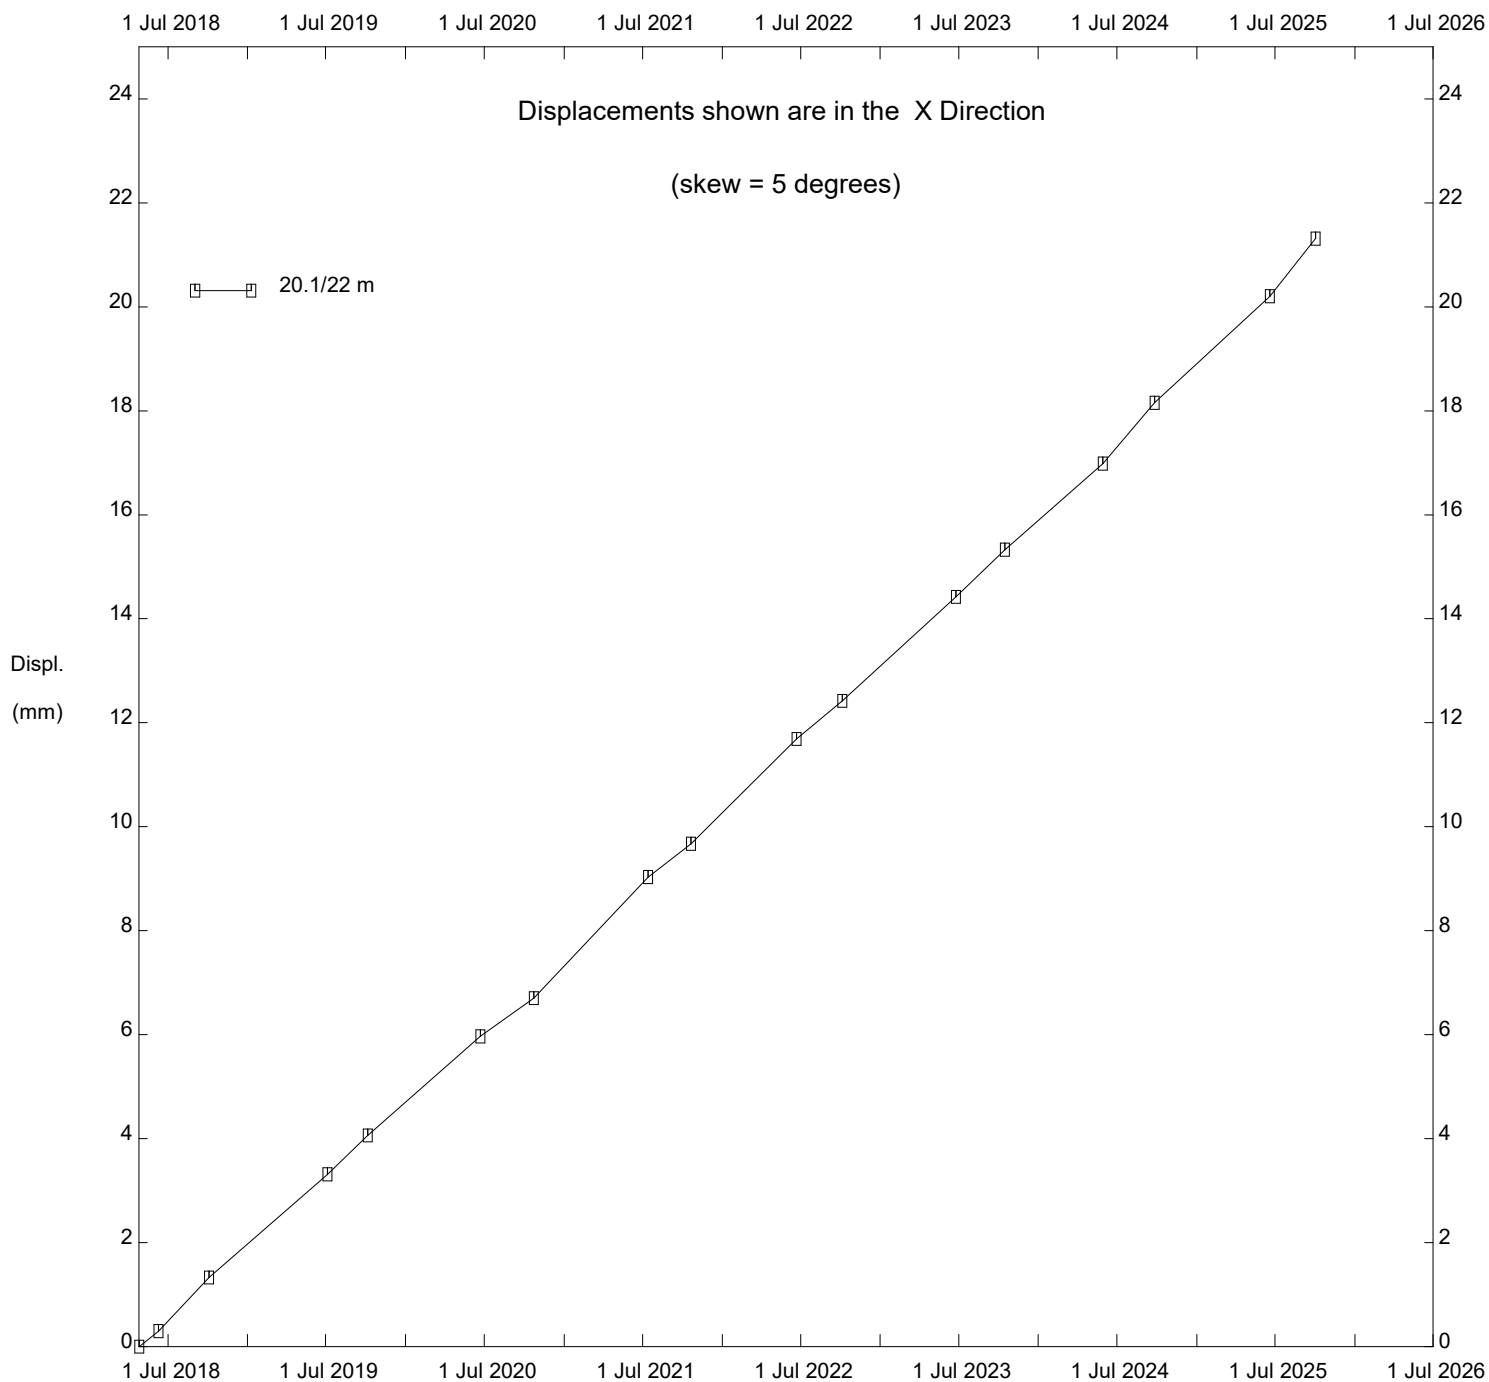
HWY 2:68 (PH037), Inclinometer SI18-9

| INSTRUMENT # | DATE INITIALIZED | TOTAL CUMULATIVE RESULTANT MOVEMENT AT NOTED DEPTH SINCE INITIAL READING (mm) | MAXIMUM RATE OF MOVEMENT (mm/yr) | CURRENT STATUS | DATE OF PREVIOUS READING | INCREMENTAL MOVEMENT SINCE PREVIOUS READING (mm) | RATE OF MOVEMENT (mm/yr) | CHANGE IN RATE OF MOVEMENT SINCE PREVIOUS READING (mm/yr) |
|---|---|---|---|---|---|---|---|---|
| SI18-9 | April 25, 2018 | 21.3 mm over 20.1 m to 22.0 m depth in 287° direction | 3.2 mm/yr in October 2018 | Operational | September 26, 2024 | 1.1 | 3.8 | 1.0 |

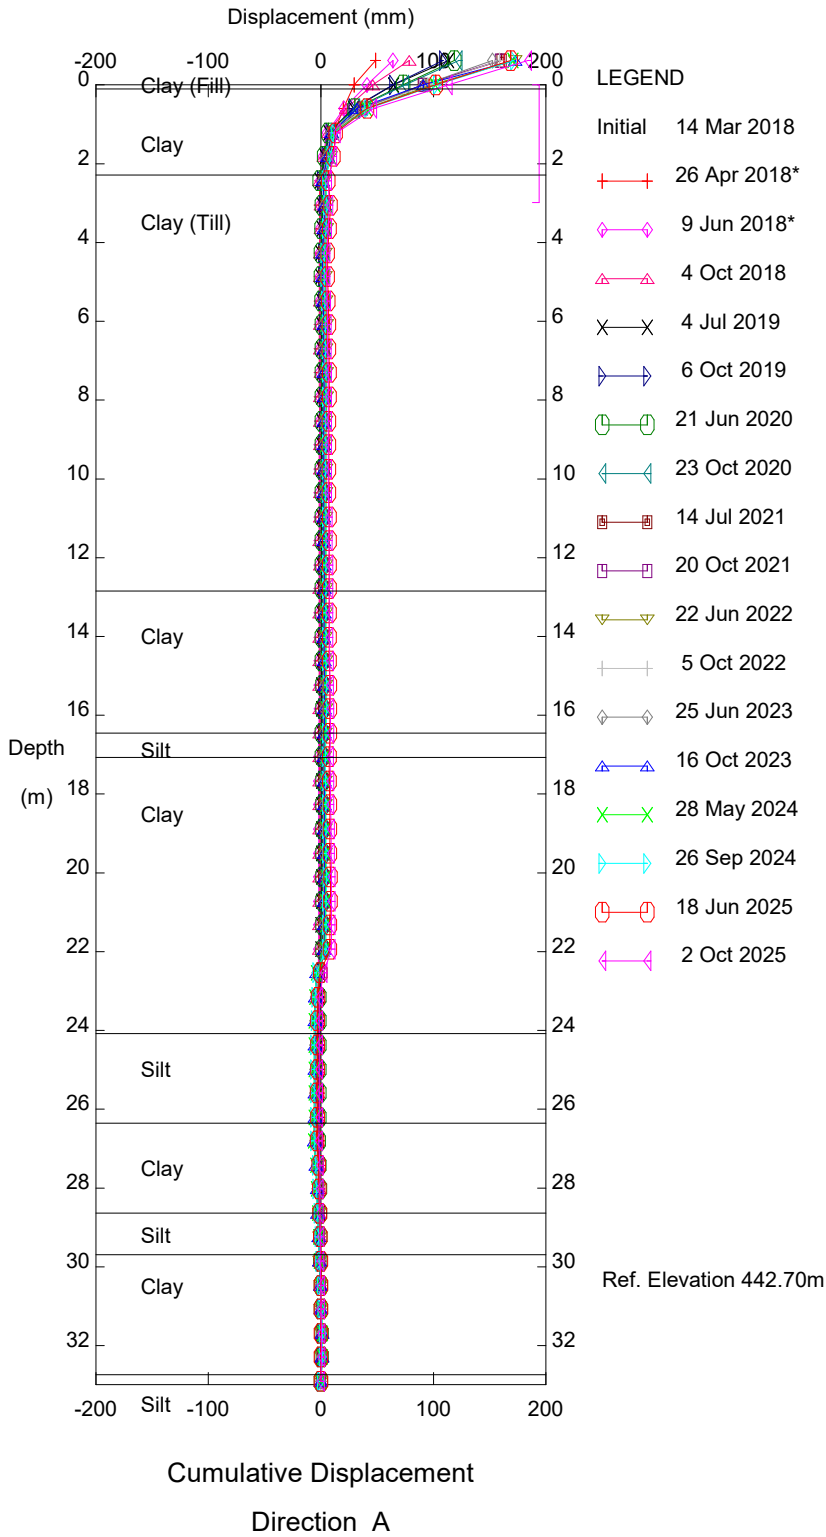
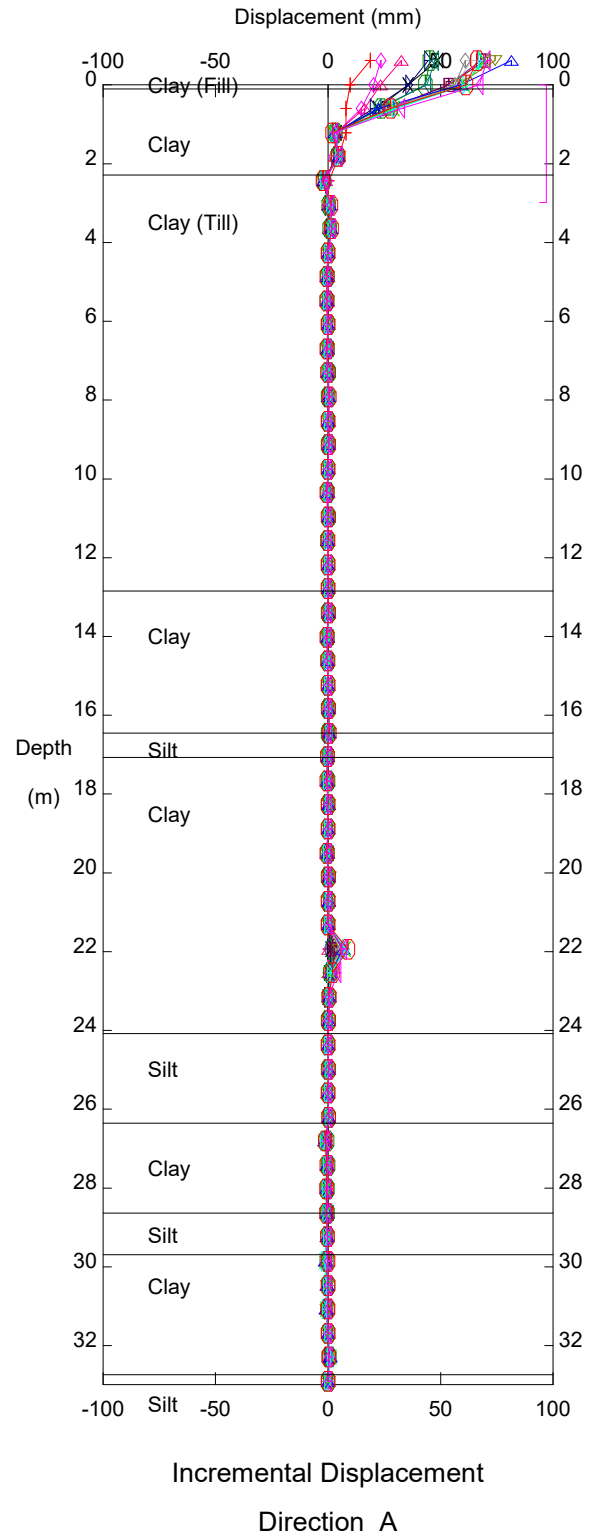
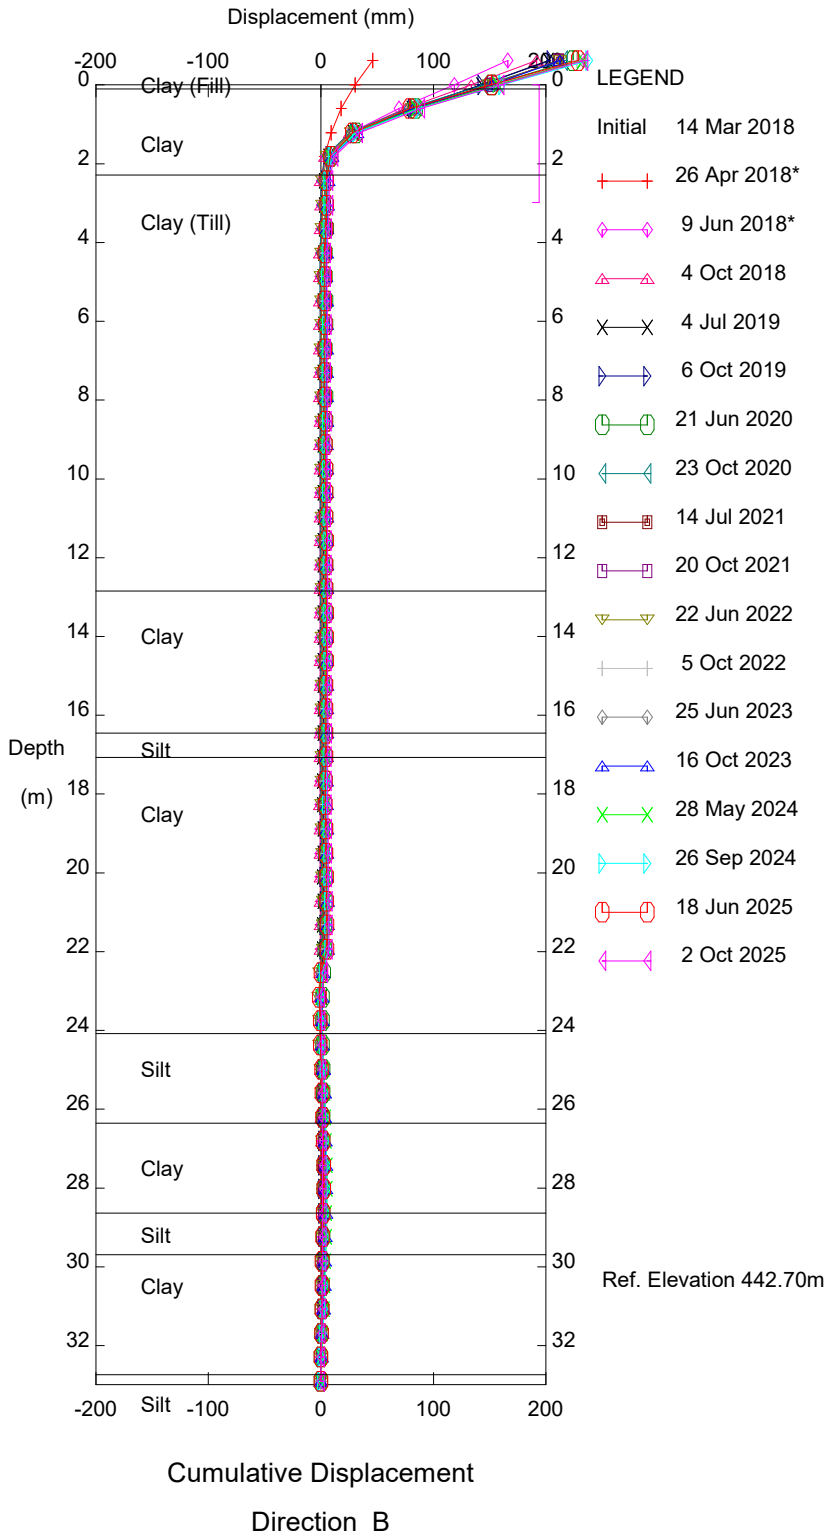
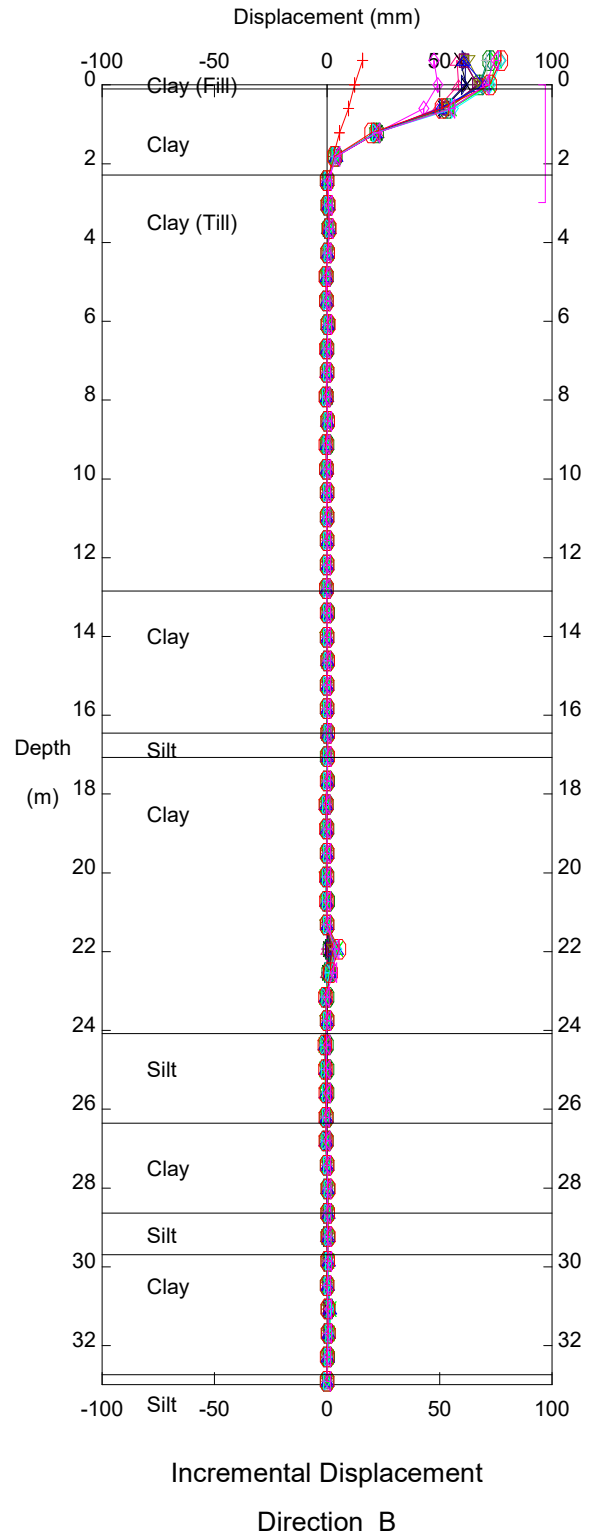
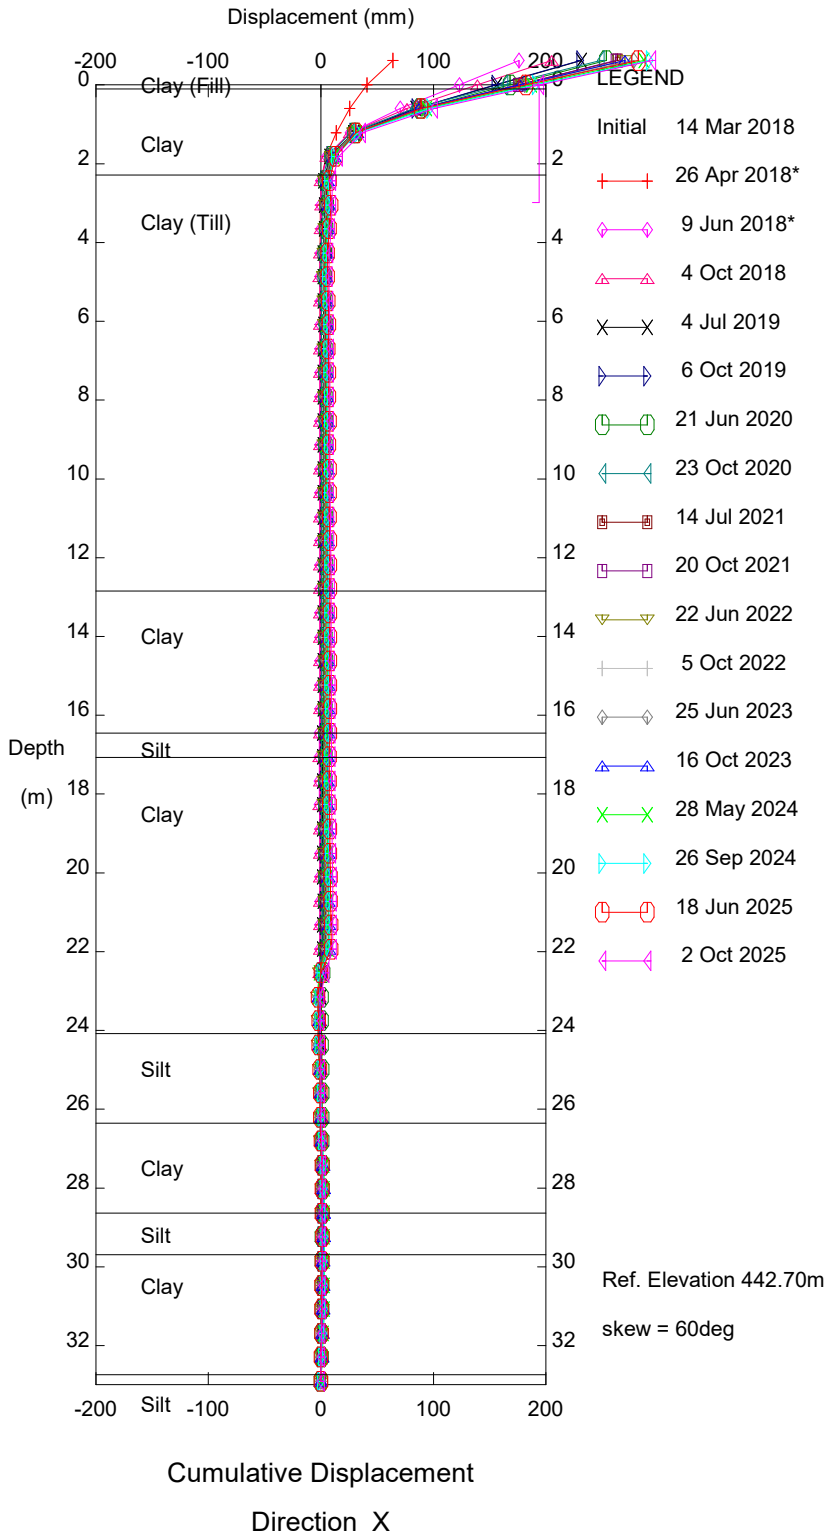
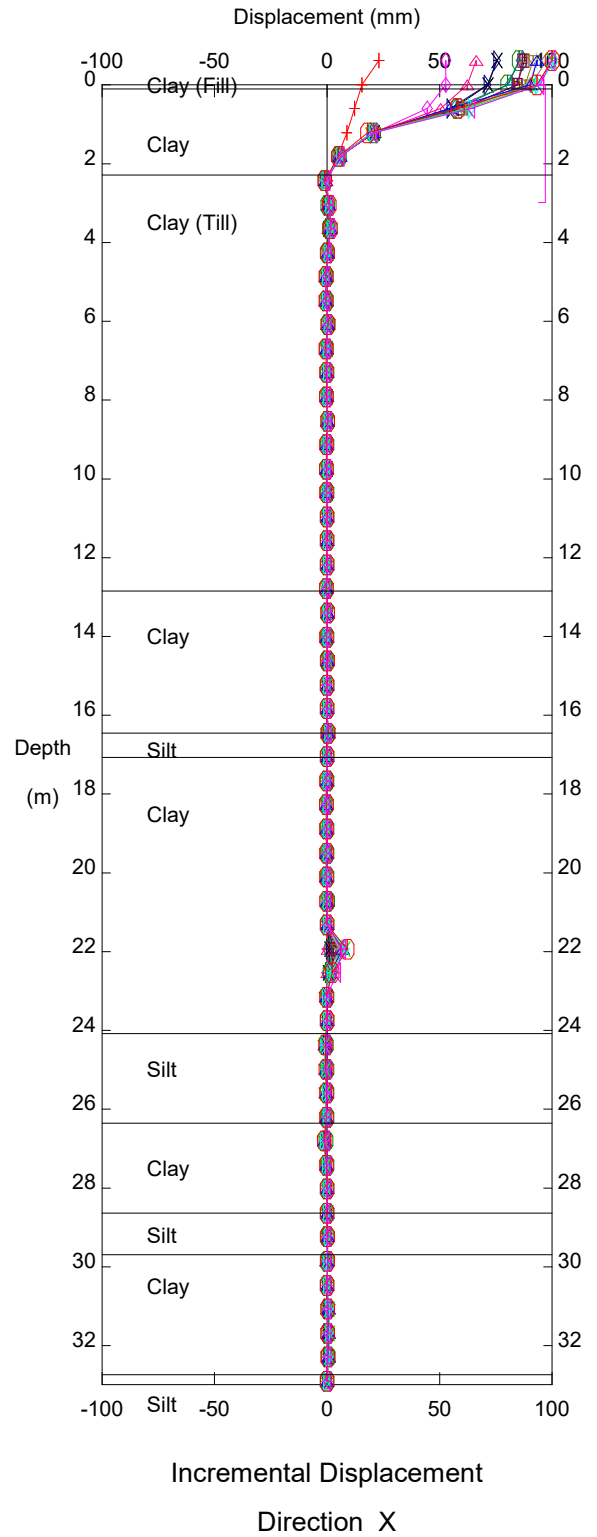
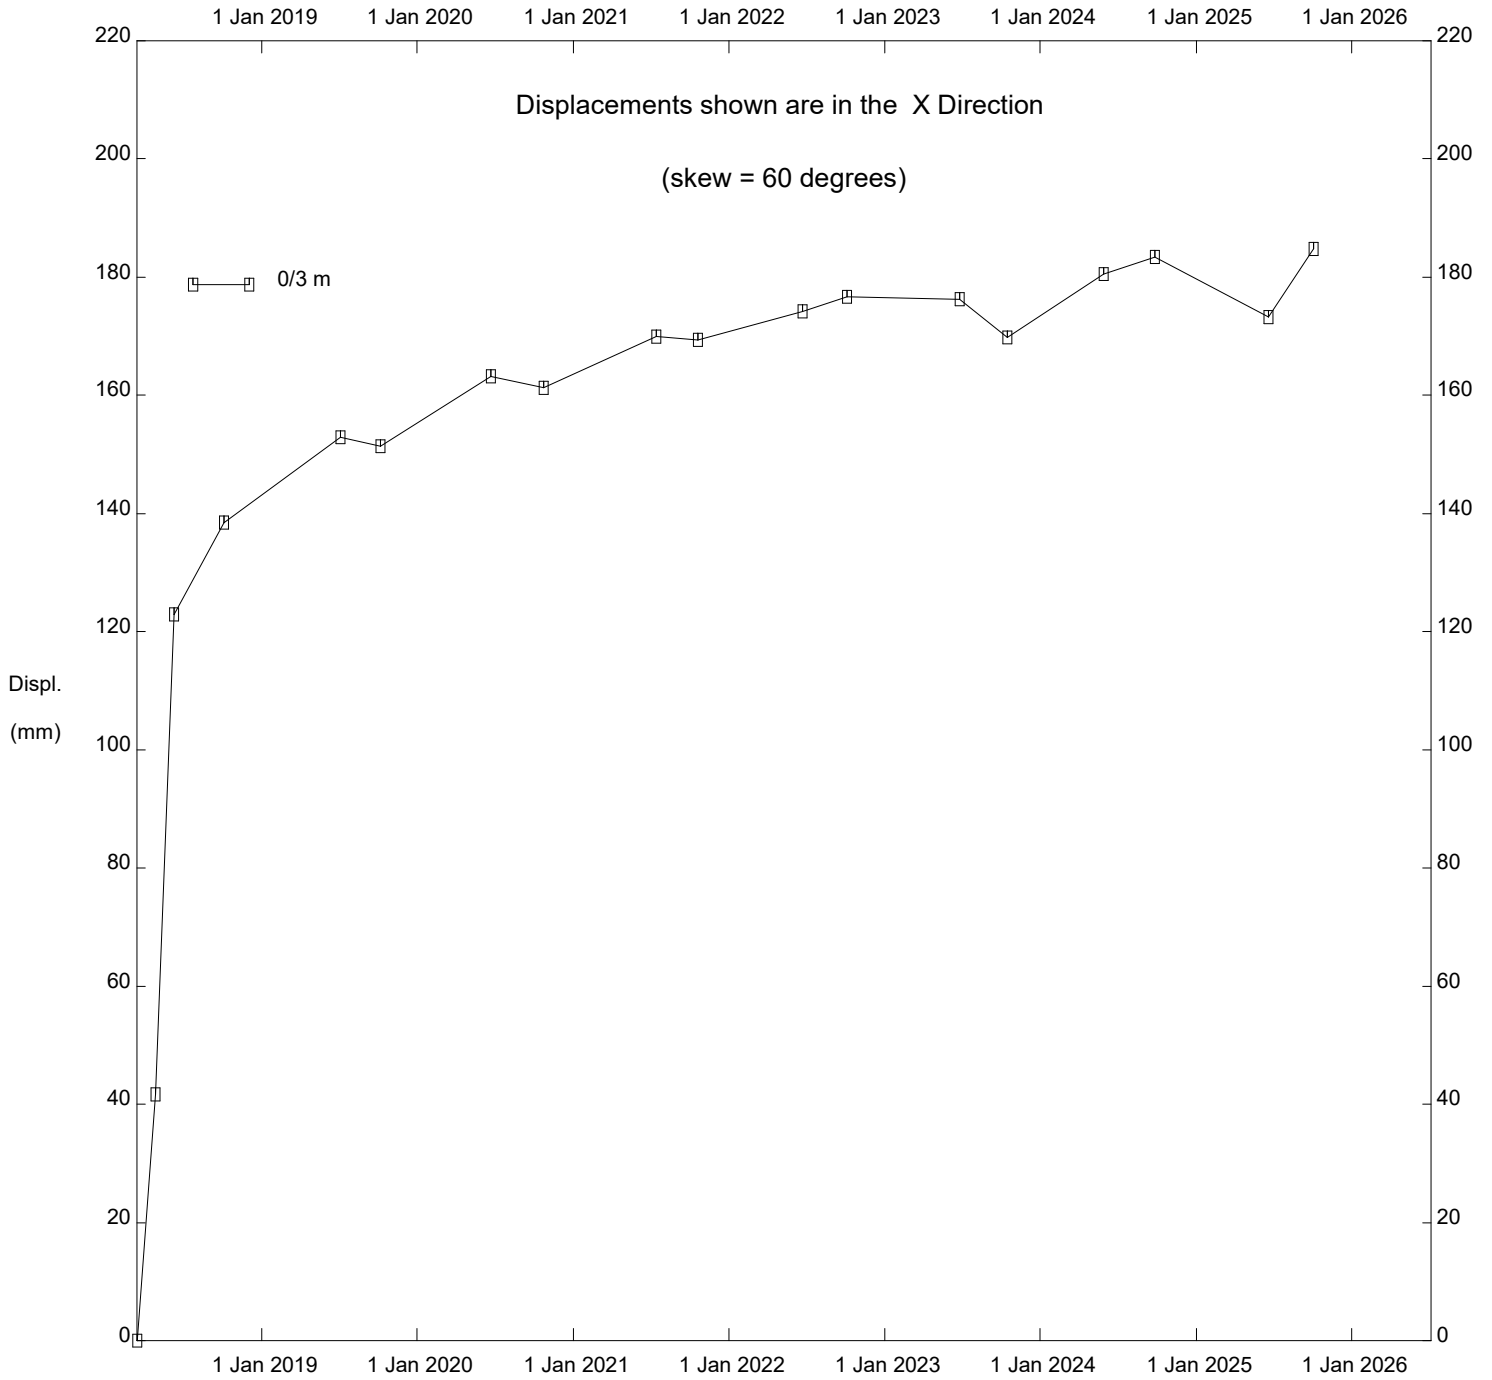
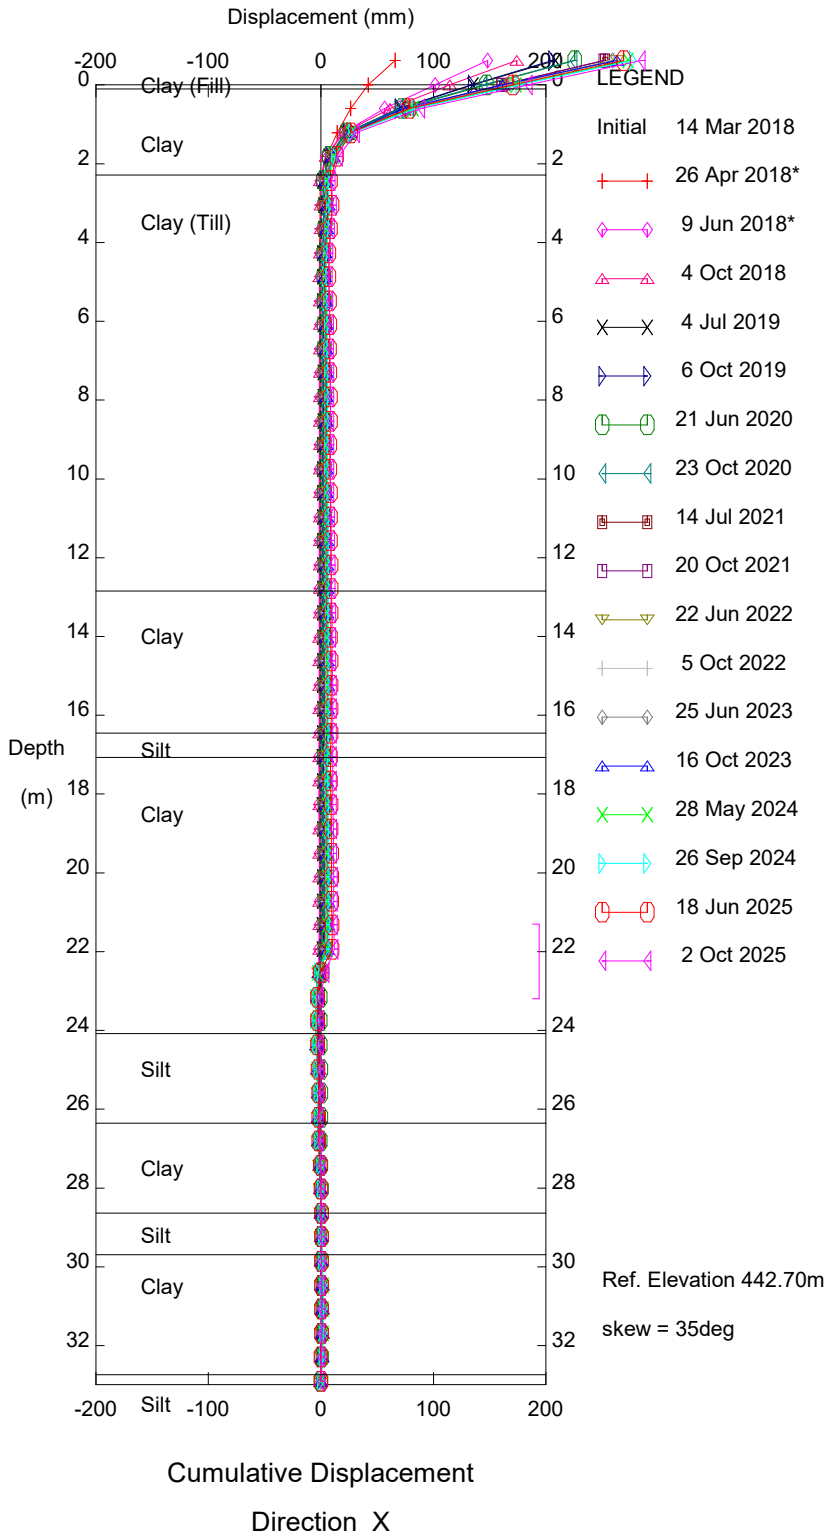
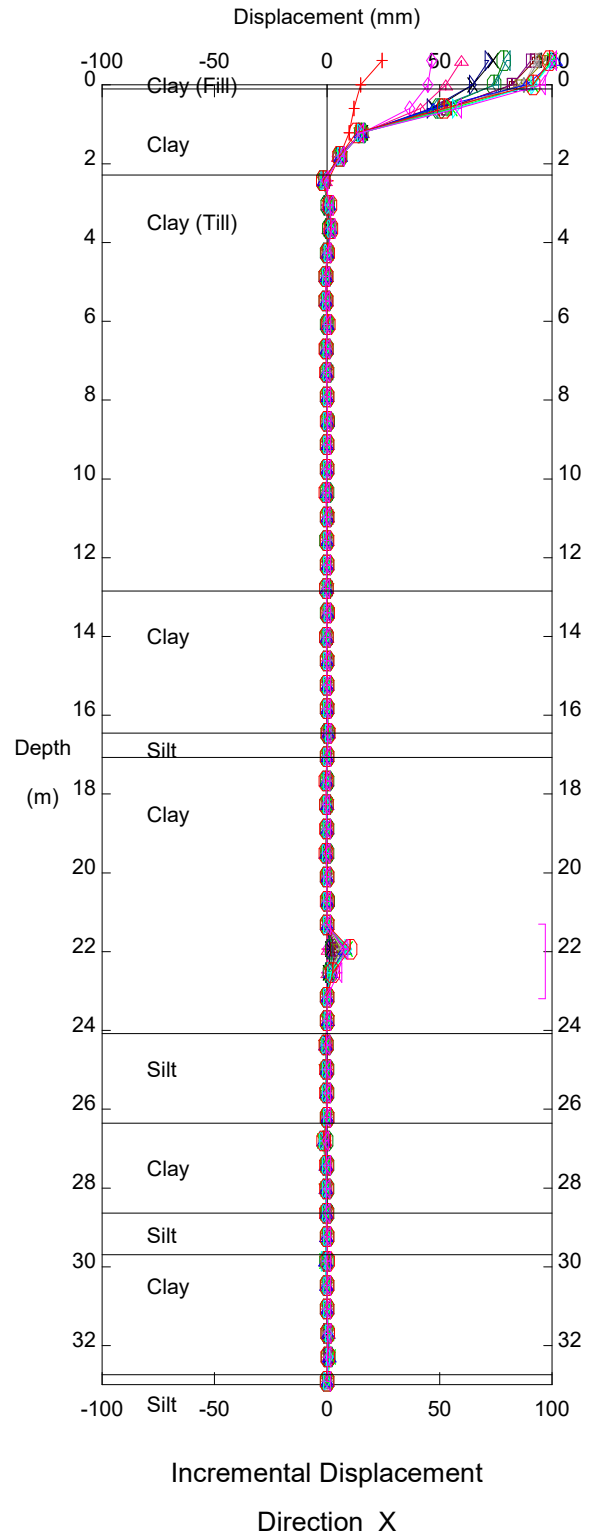
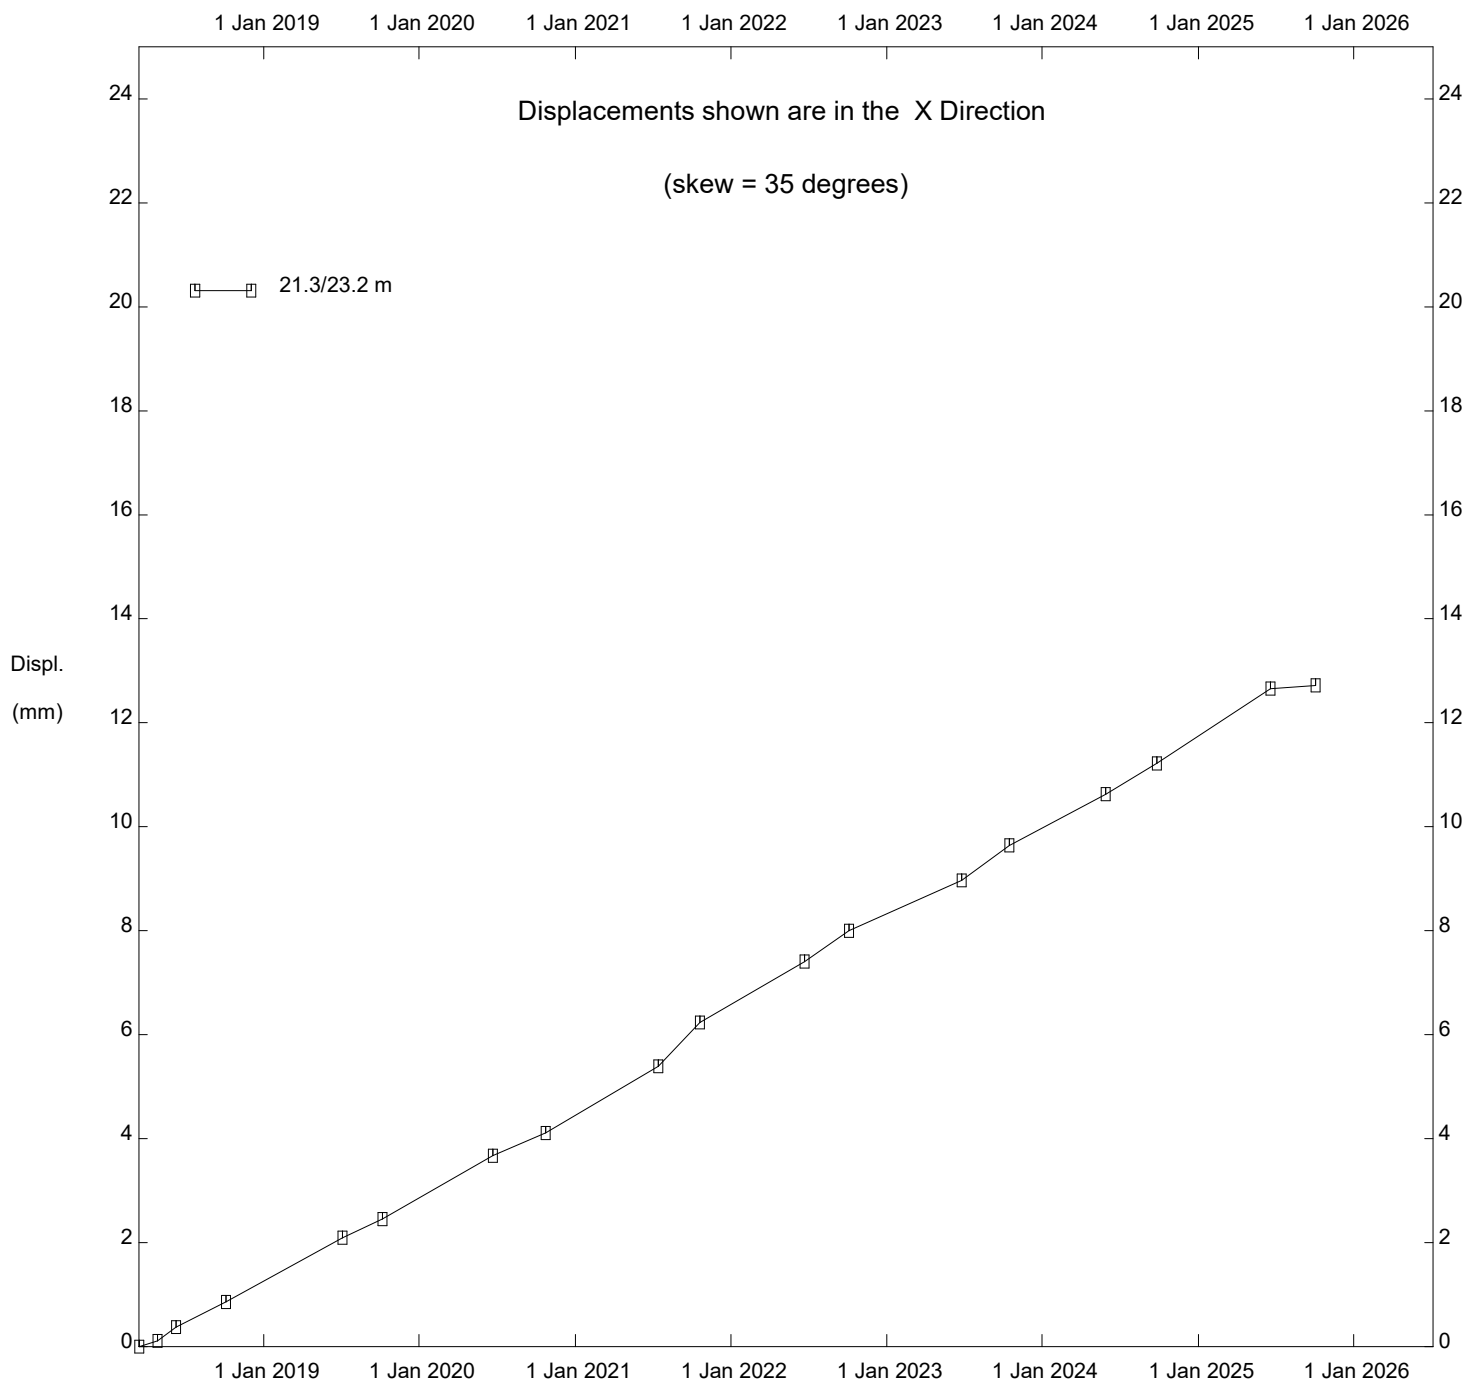
HWY 2:68 (PH037), Inclinator SI18-10

| INSTRUMENT # | DATE INITIALIZED | TOTAL CUMULATIVE RESULTANT MOVEMENT AT NOTED DEPTH SINCE INITIAL READING (mm) | MAXIMUM RATE OF MOVEMENT (mm/yr) | CURRENT STATUS | DATE OF PREVIOUS READING | INCREMENTAL MOVEMENT SINCE PREVIOUS READING (mm) | RATE OF MOVEMENT (mm/yr) | CHANGE IN RATE OF MOVEMENT SINCE PREVIOUS READING (mm/yr) |
|---|---|---|---|---|---|---|---|---|
| SI18-10 | March 14, 2018 | 184.8 mm over 0.0 m to 3.0 m depth in 344° direction | 675.3 mm/yr in June 2018 | Operational | June 18, 2025 | 11.6 | 39.9 | 53.9 |
| | | 12.7 mm over 21.3 m to 23.2 m depth in 319° direction | 3.1 mm/yr in October 2021 | | | 0.1 | 0.2 | -1.8 |
