ALBERTA TRANSPORTATION AND  
ECONOMIC CORRIDORS GRMP  
PEACE REGION  
(GRANDE PRAIRIE DISTRICT - NORTH)  
INSTRUMENTATION MONITORING - FALL 2025

| Site Number | Location | Name | Hwy | km |
|---|---|---|---|---|
| PH037 | Station 1+250 to 2+000 | Dunvegan South | 2:68 | Km 15.7 |

| <b>Current Monitoring:</b> | 02-Oct-2025 | <b>Previous Monitoring</b> | 18~19-June-2025 |

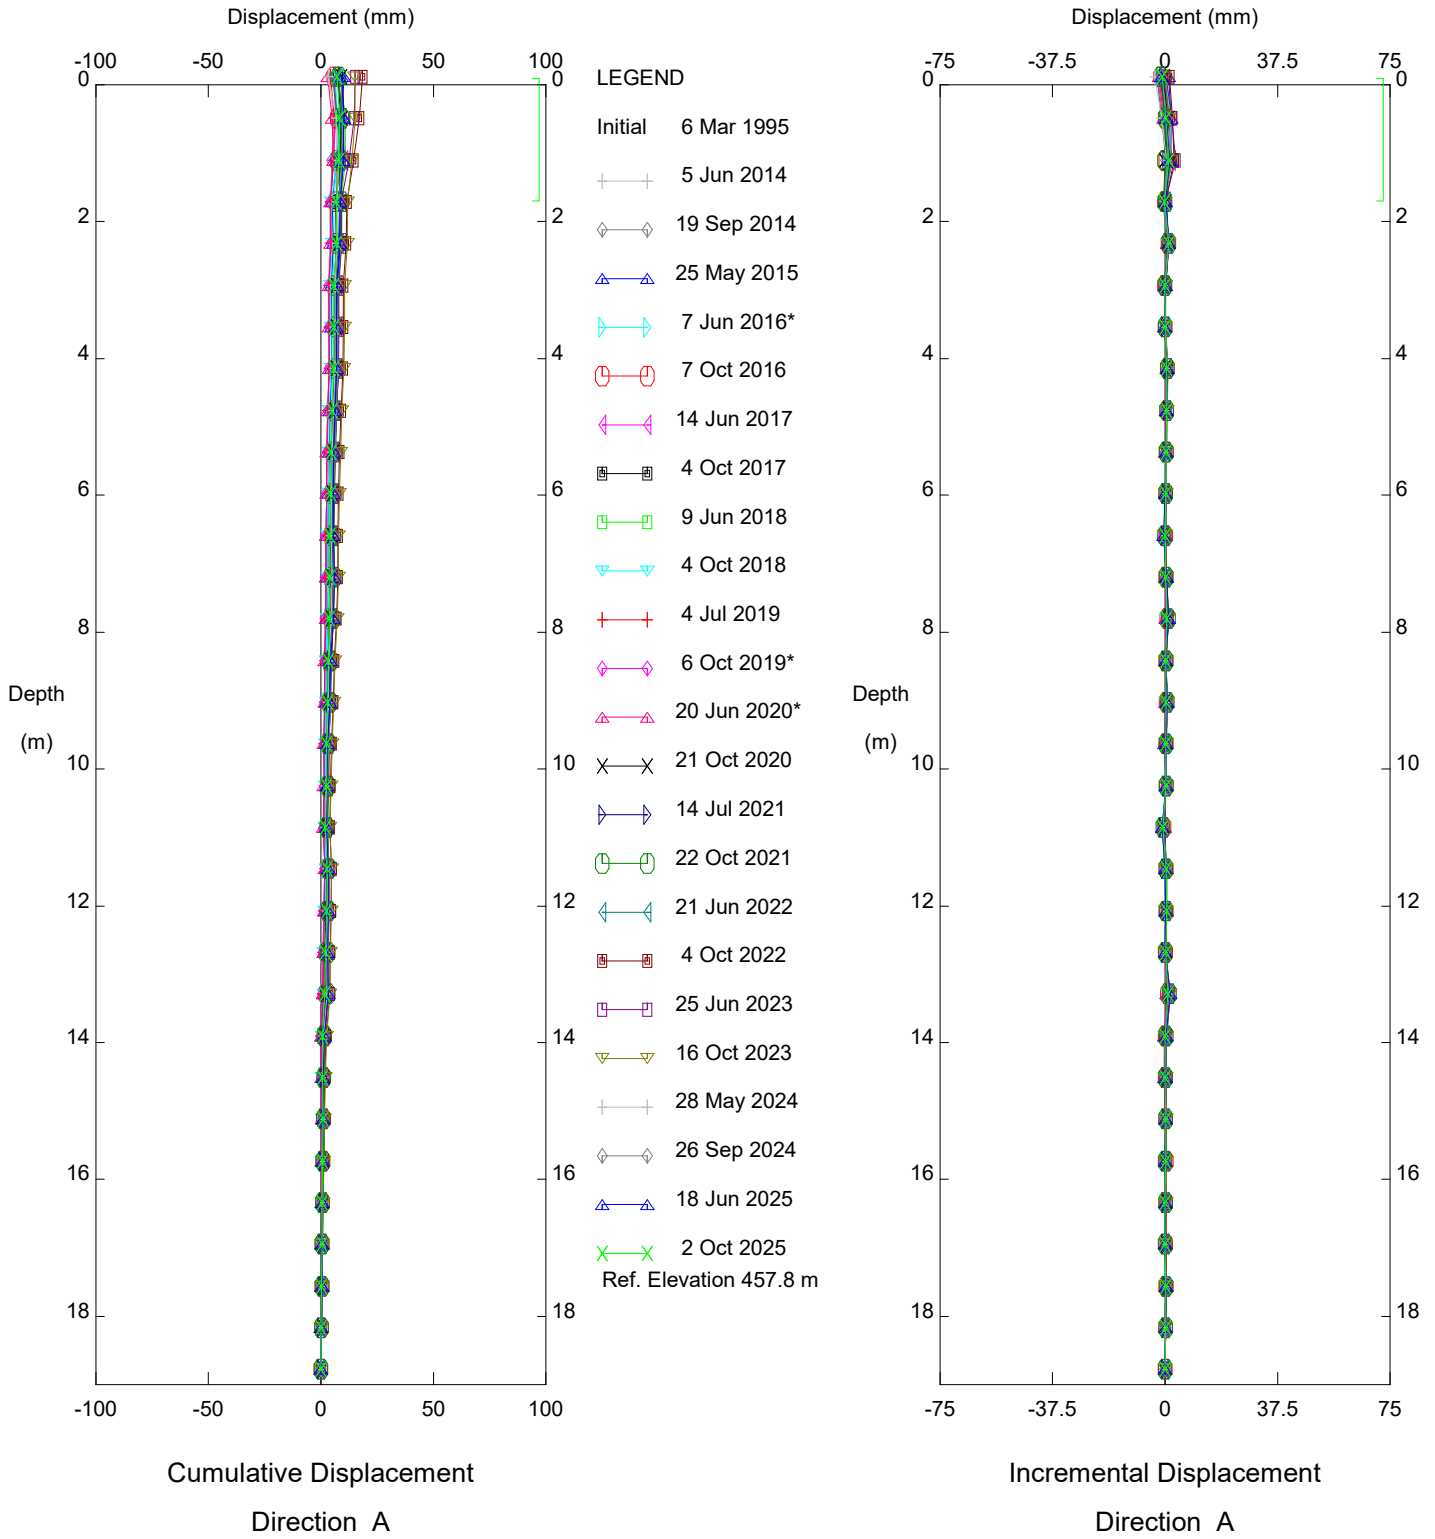
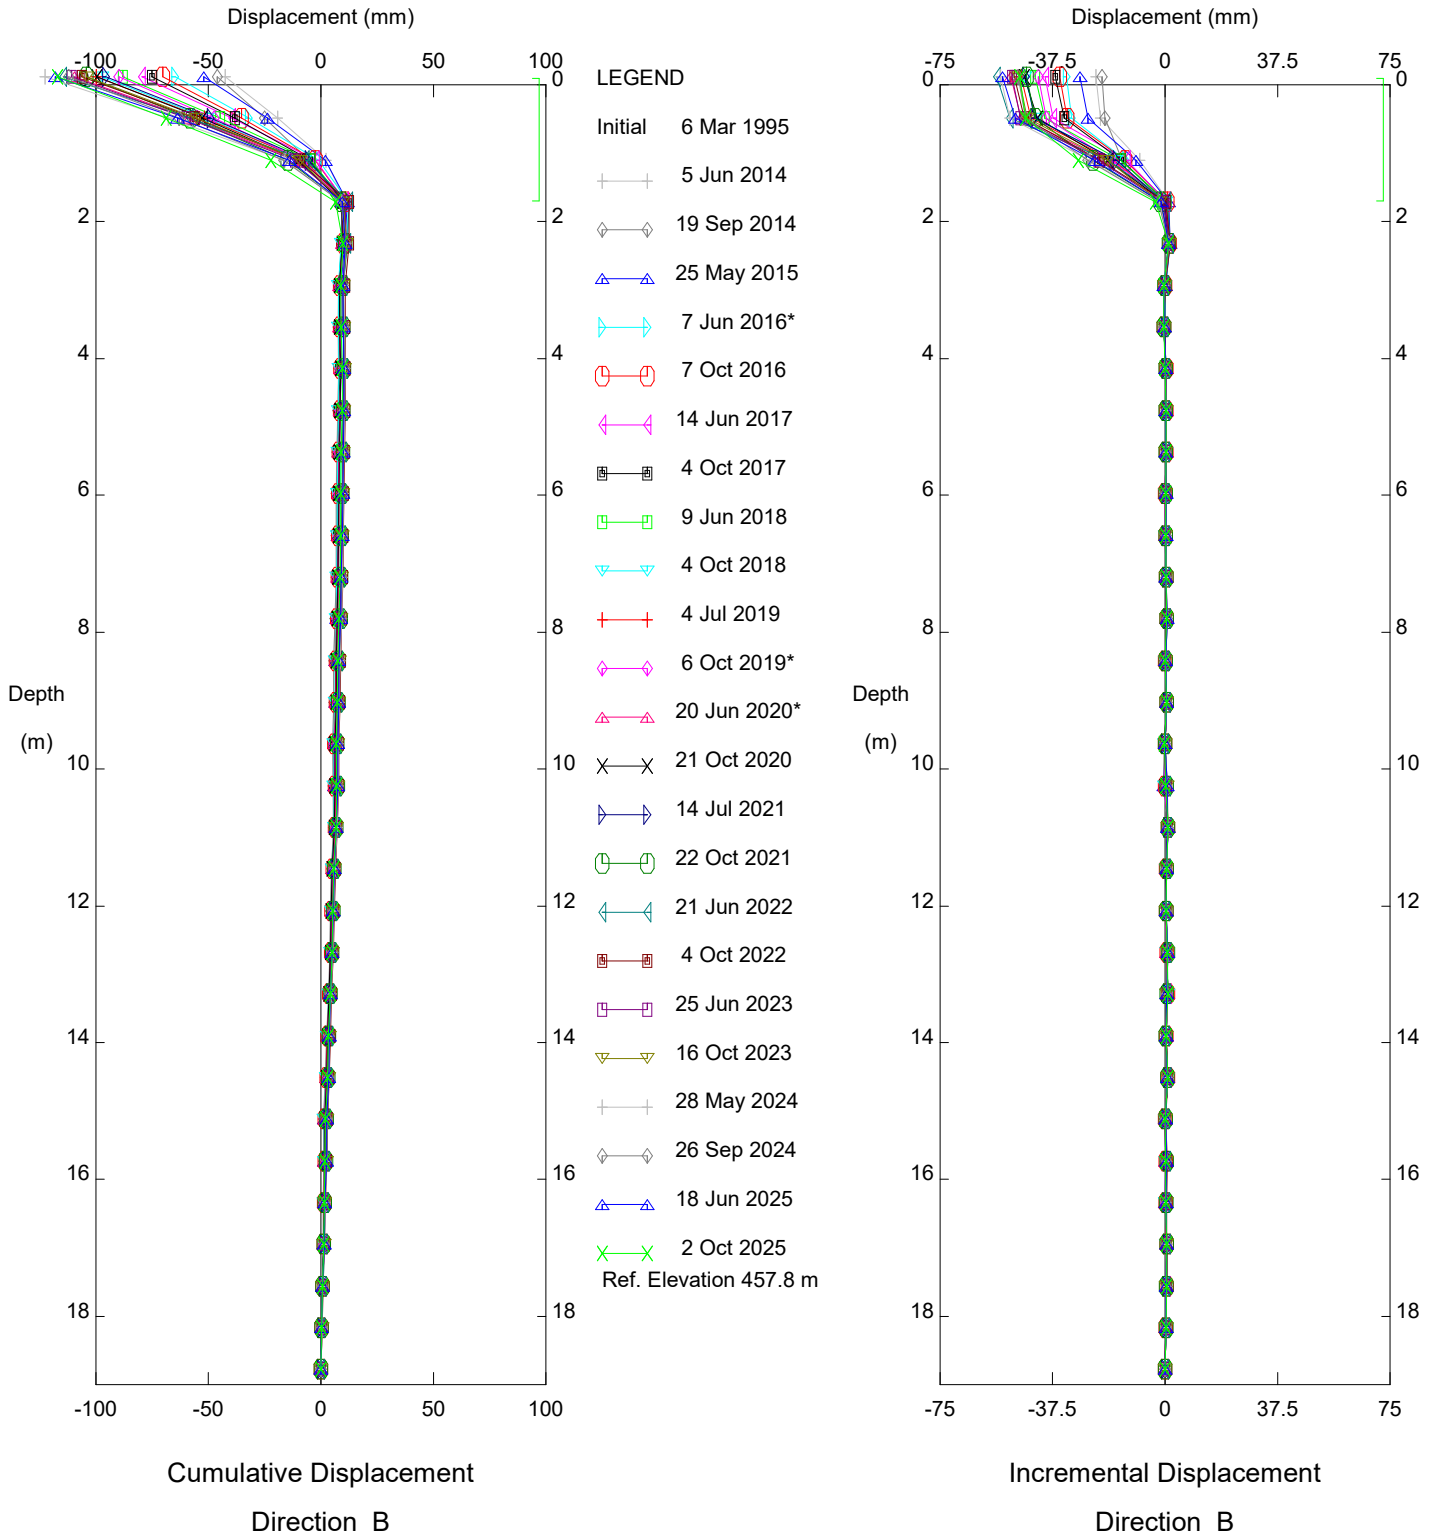
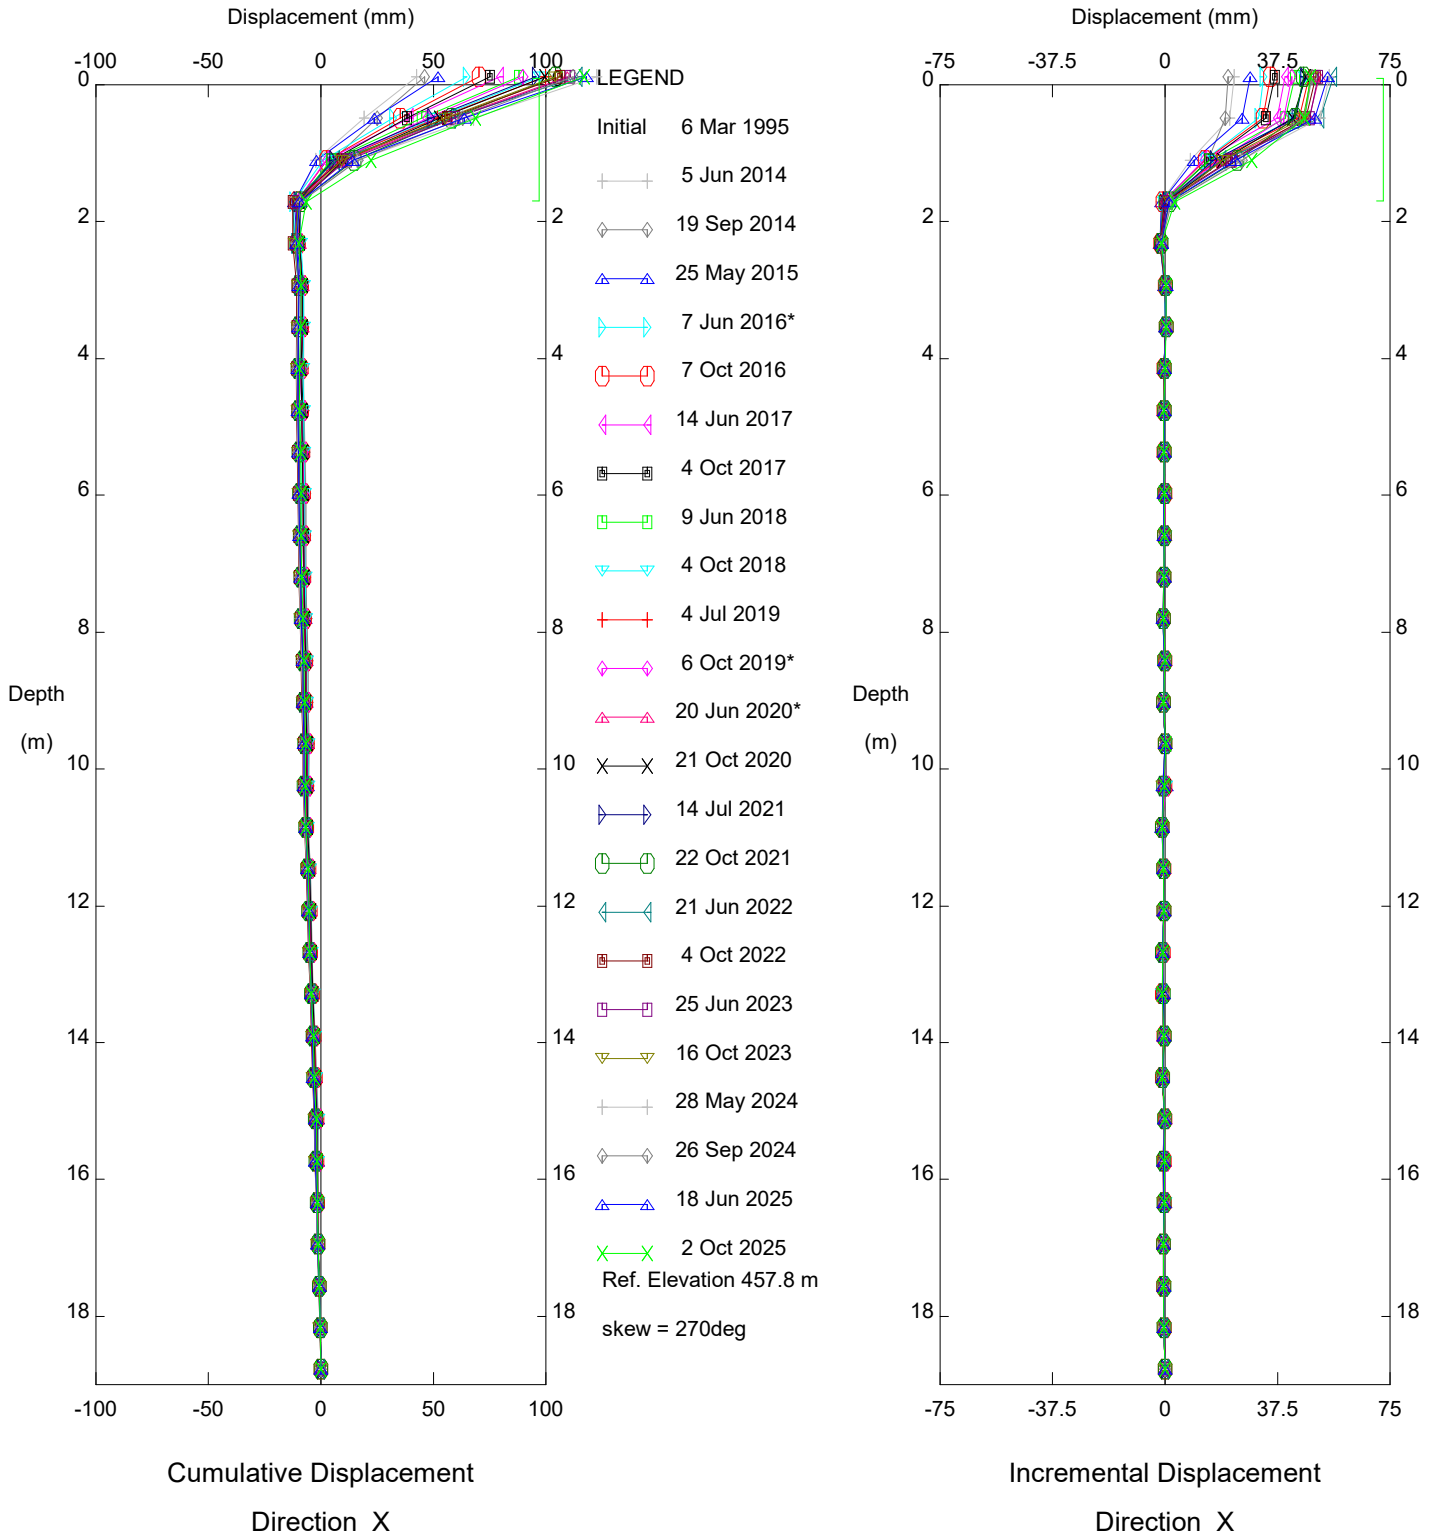
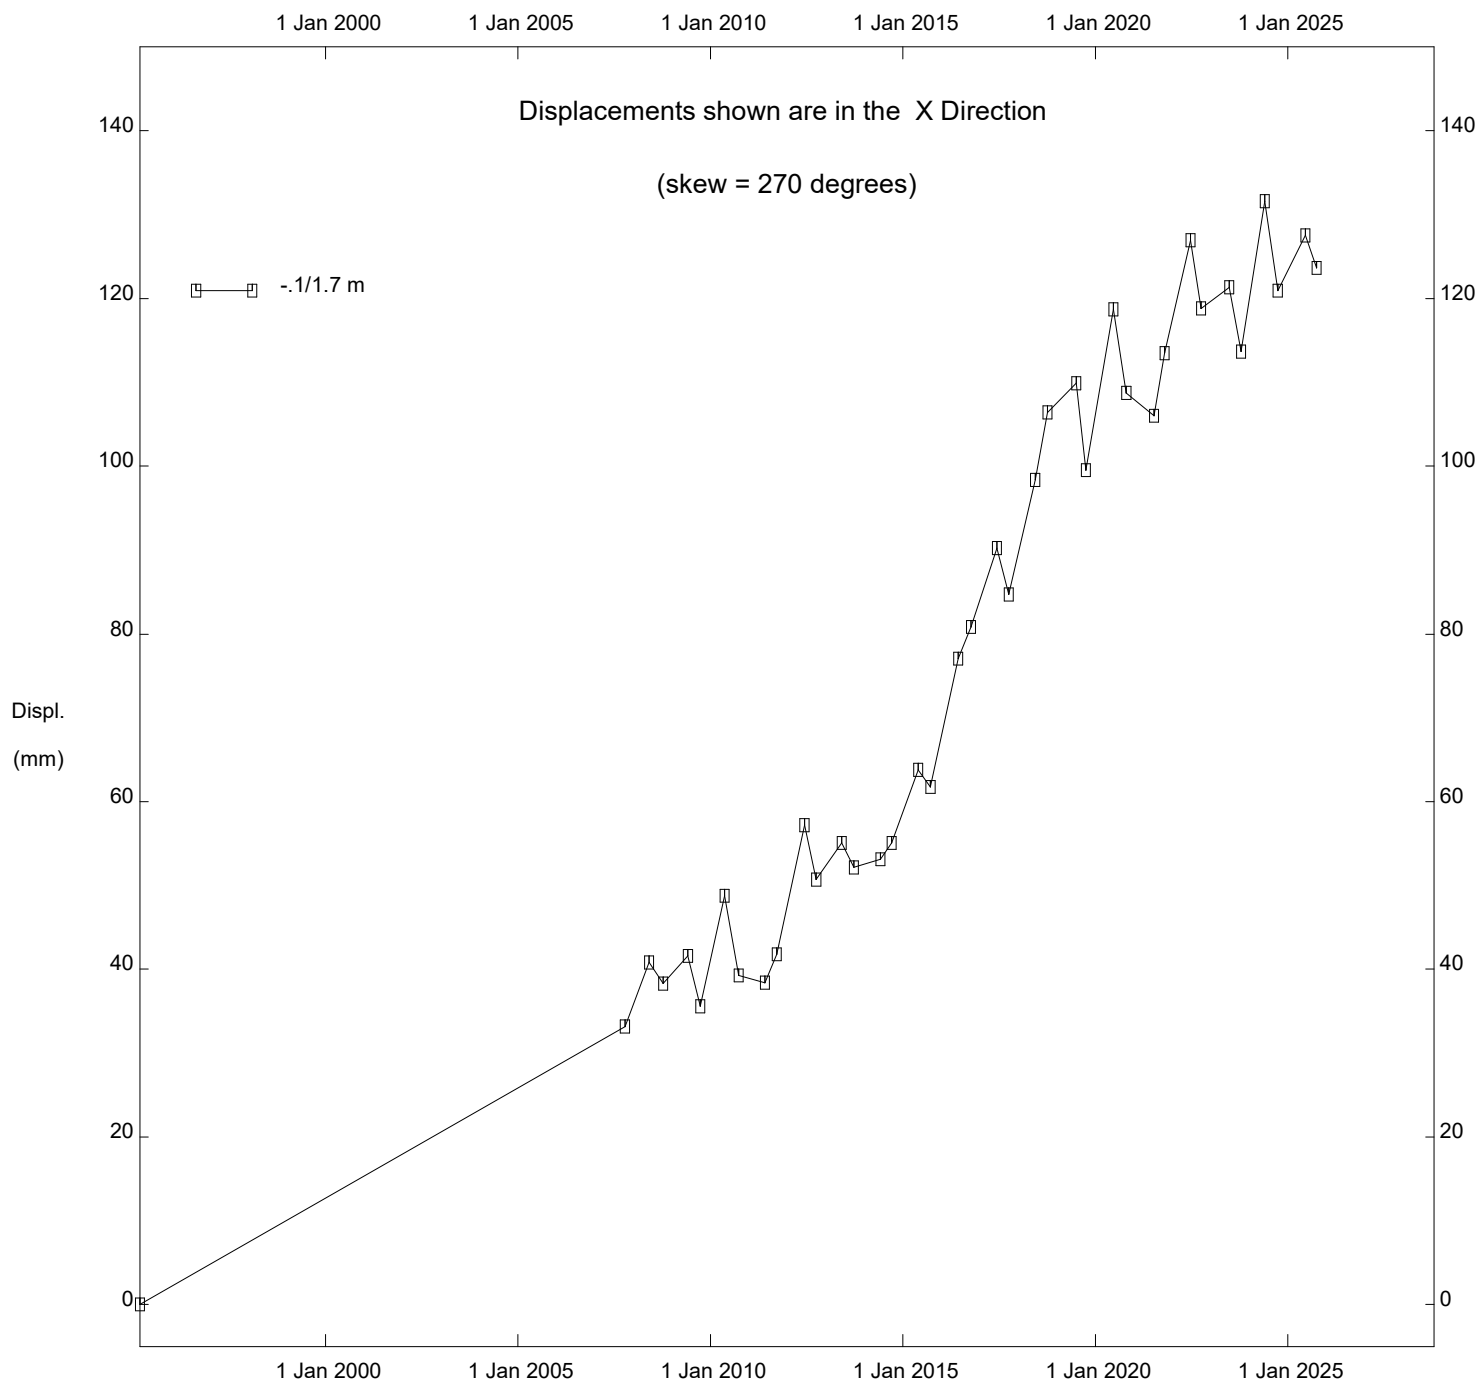
HWY 2:68 (PH037), Inclinometer SI-54

| INSTRUMENT # | DATE INITIALIZED | TOTAL CUMULATIVE RESULTANT MOVEMENT AT NOTED DEPTH SINCE INITIAL READING (mm) | MAXIMUM RATE OF MOVEMENT (mm/yr) | CURRENT STATUS | DATE OF PREVIOUS READING | INCREMENTAL MOVEMENT SINCE PREVIOUS READING (mm) | RATE OF MOVEMENT (mm/yr) | CHANGE IN RATE OF MOVEMENT SINCE PREVIOUS READING (mm/yr) |
|---|---|---|---|---|---|---|---|---|
| SI-54 | Mar. 6 1995 | 123.7 mm over 0.0 m to 1.7 m depth in 291° direction | 36.1 mm/yr in March 1995 | Operational | June 18, 2025 | -3.9 | -13.6 | -22.6 |

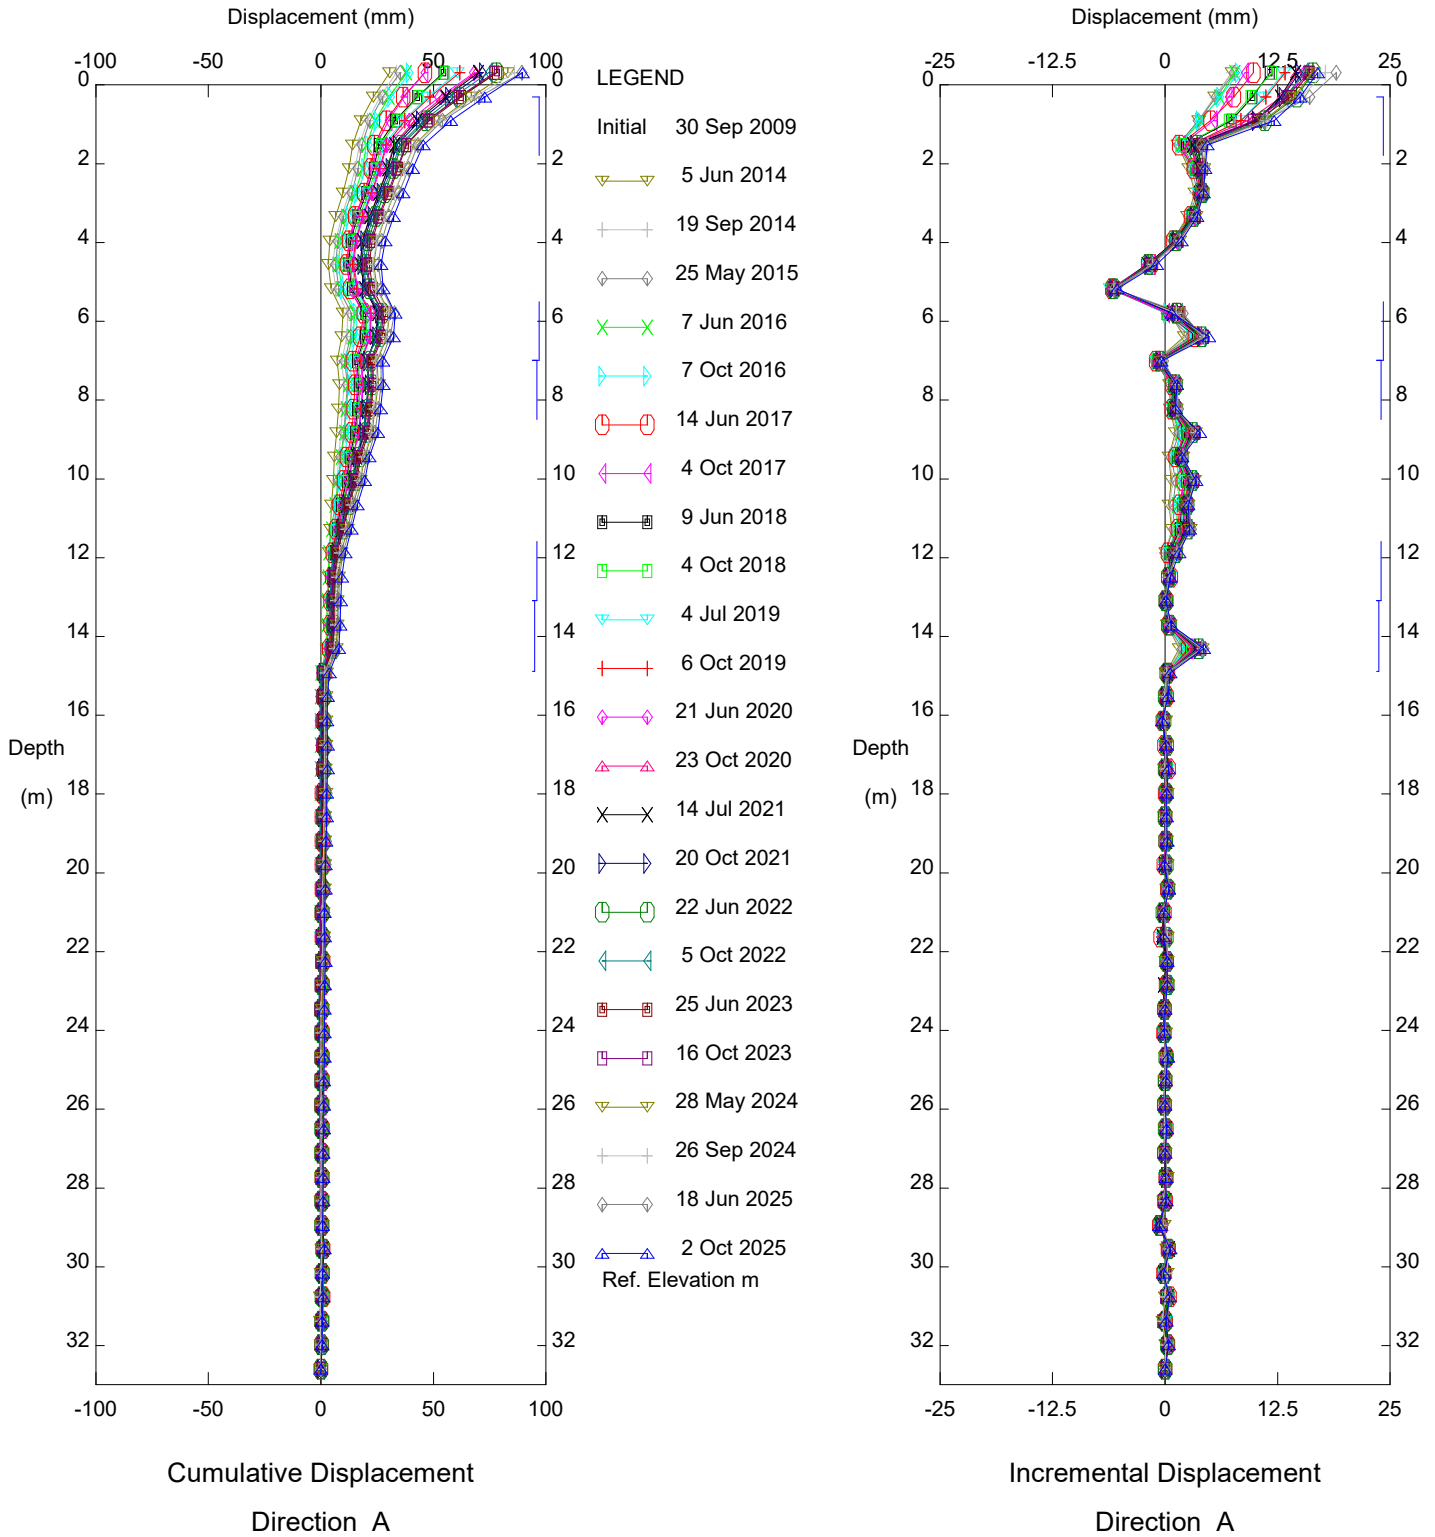
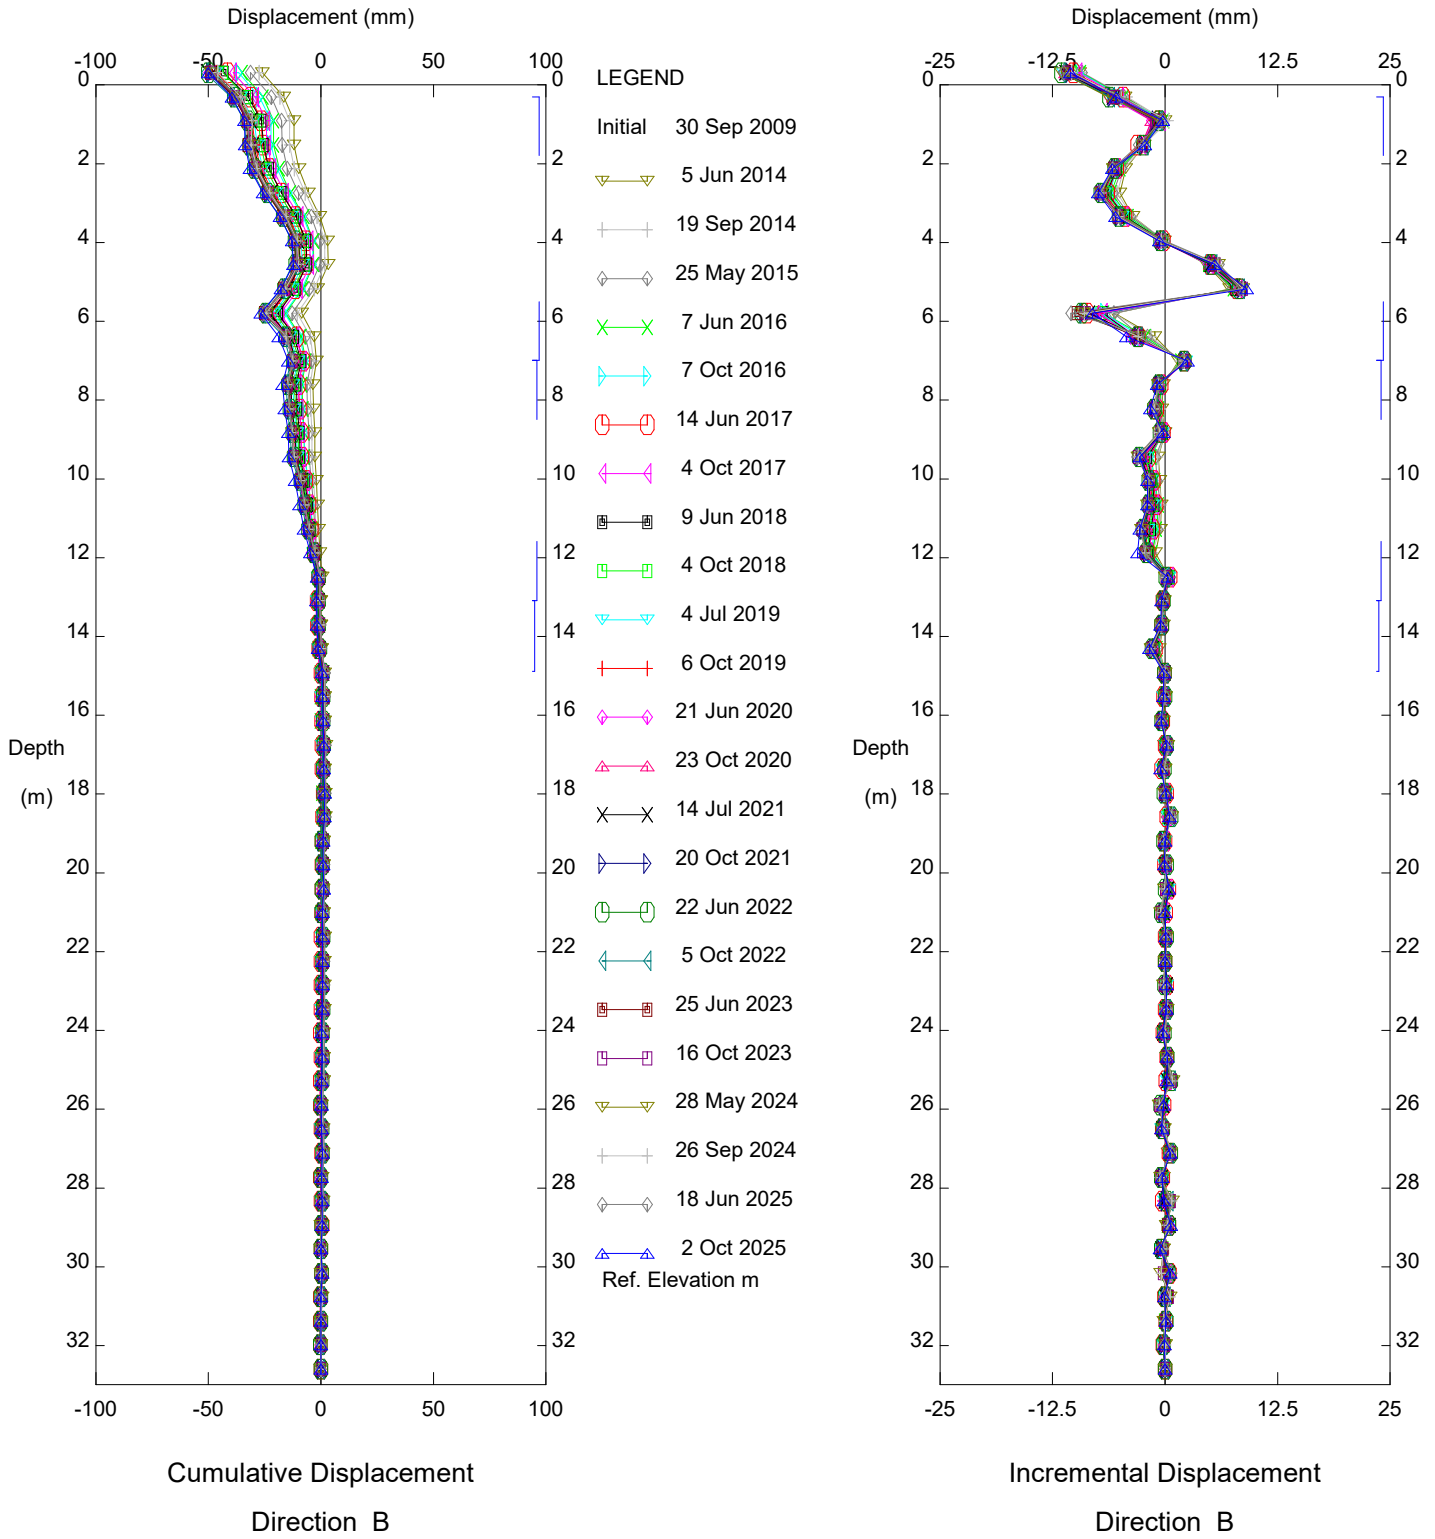
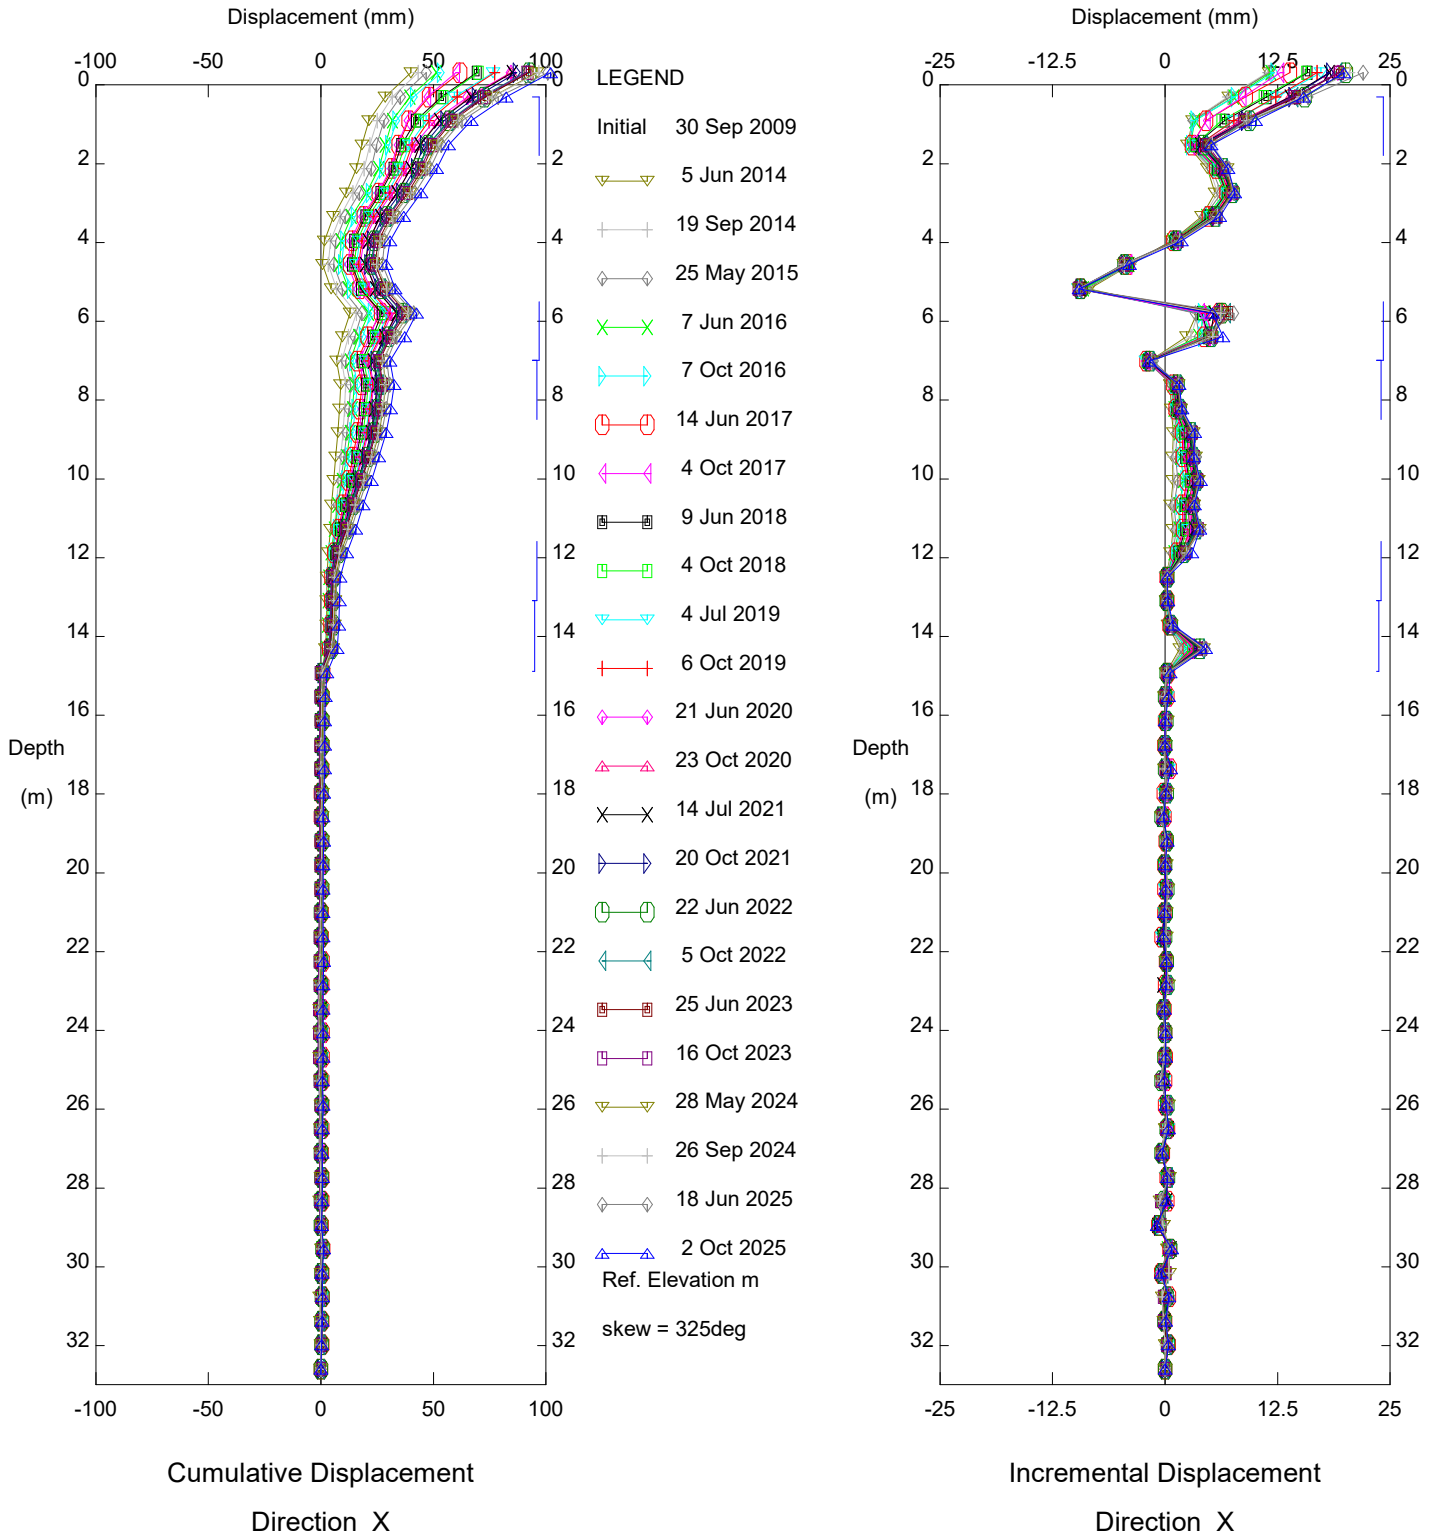
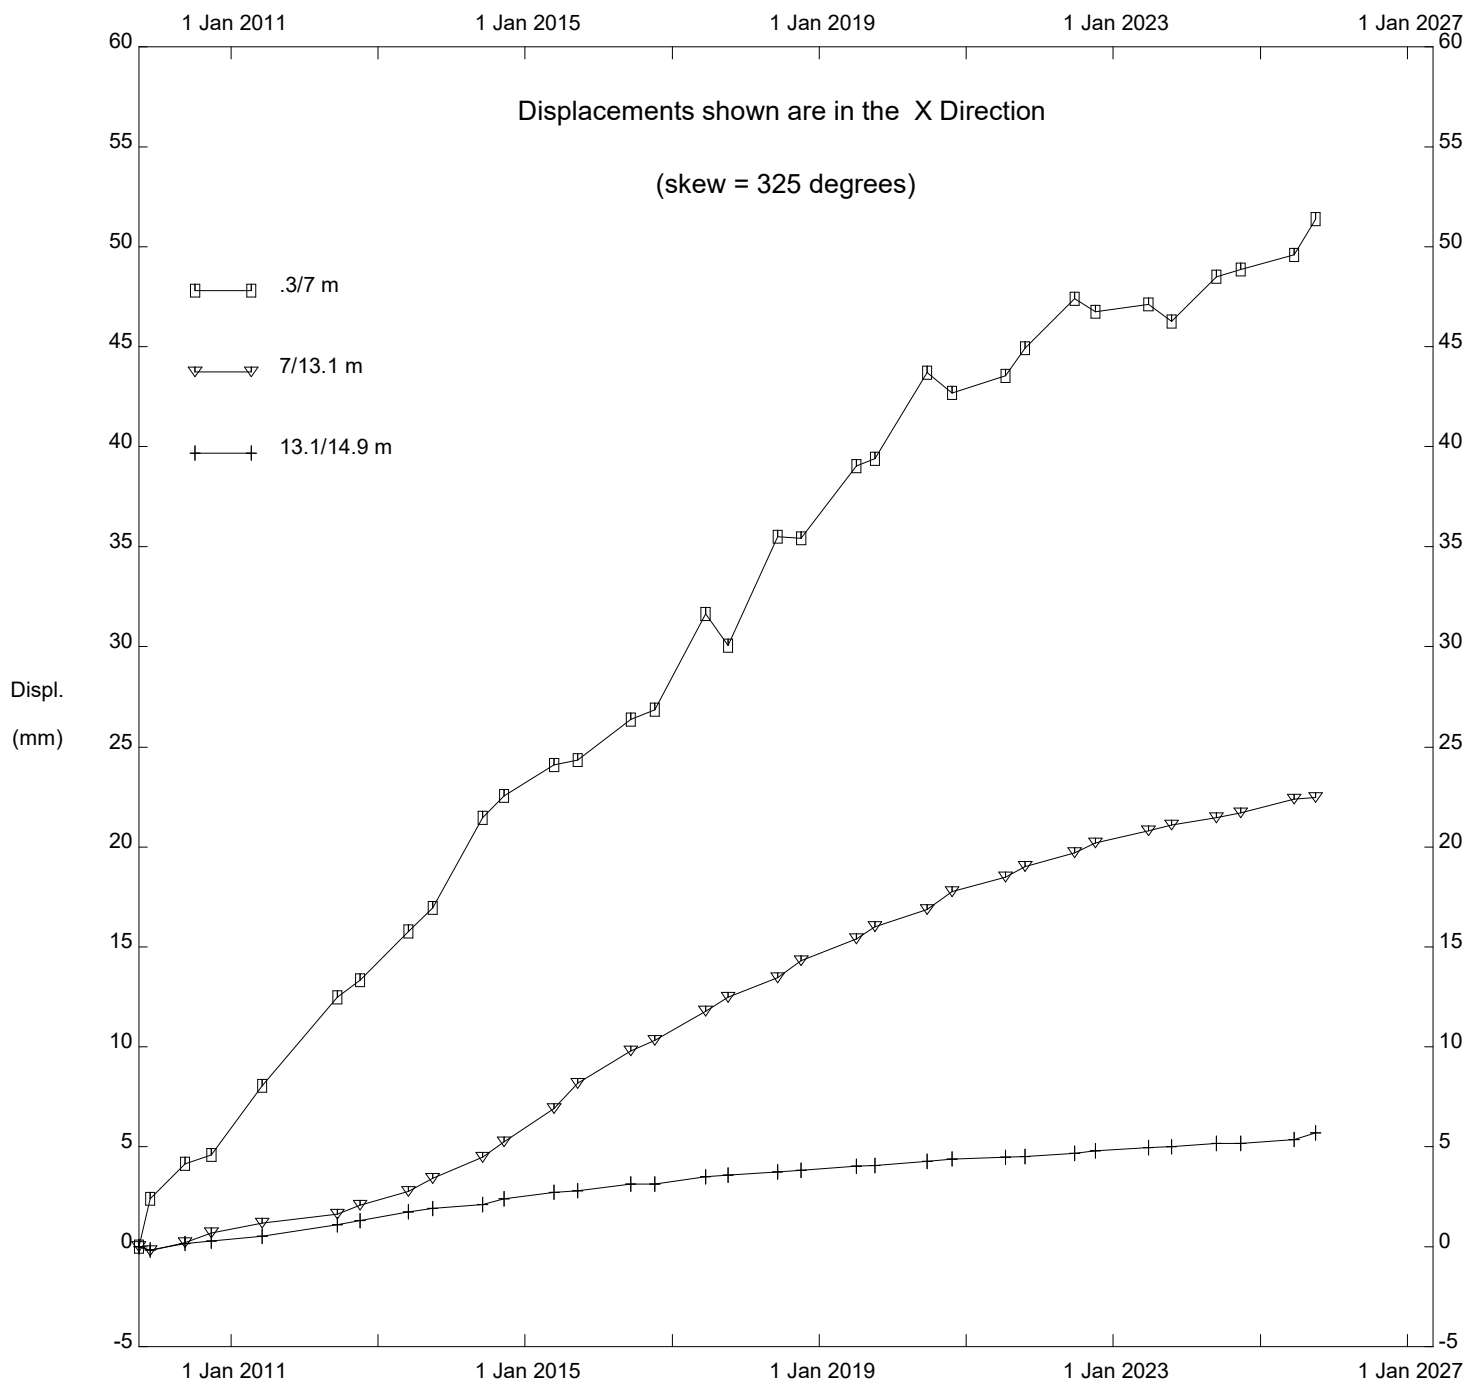
HWY 2:68 (PH037), Inclinometer SI09-1

| INSTRUMENT # | DATE INITIALIZED | TOTAL CUMULATIVE RESULTANT MOVEMENT AT NOTED DEPTH SINCE INITIAL READING (mm) | MAXIMUM RATE OF MOVEMENT (mm/yr) | CURRENT STATUS | DATE OF PREVIOUS READING | INCREMENTAL MOVEMENT SINCE PREVIOUS READING (mm) | RATE OF MOVEMENT (mm/yr) | CHANGE IN RATE OF MOVEMENT SINCE PREVIOUS READING (mm/yr) |
|---|---|---|---|---|---|---|---|---|
| SI09-1 | Sept. 30, 2009 | 51.4 mm over 0.3 m to 7.0 m depth in 216° direction | 15.7 mm/yr in November 2009 | Operational | June 18, 2025 | 1.8 | 6.2 | 5.2 |
| | | 22.4 mm over 7.0 m to 13.1 m depth in 216° direction | 4.0 mm/yr in September 2015 | | | 0.1 | 0.3 | -0.7 |
| | | 5.7 mm over 13.1 m to 14.9 m depth in 216° direction | 1.0 mm/yr in September 2014 | | | 0.3 | 1.0 | 0.8 |
