ALBERTA TRANSPORTATION AND  
ECONOMIC CORRIDORS GRMP  
PEACE REGION  
(GRANDE PRAIRIE DISTRICT - NORTH)  
INSTRUMENTATION MONITORING - FALL 2025

| Site Number | Location | Name | Hwy | km |
|---|---|---|---|---|
| PH037 | Station 1+250 to 2+000 | Dunvegan South | 2:68 | Km 15.7 |

| <b>Current Monitoring:</b> | 02-Oct-2025 | <b>Previous Monitoring</b> | 18~19-June-2025 |

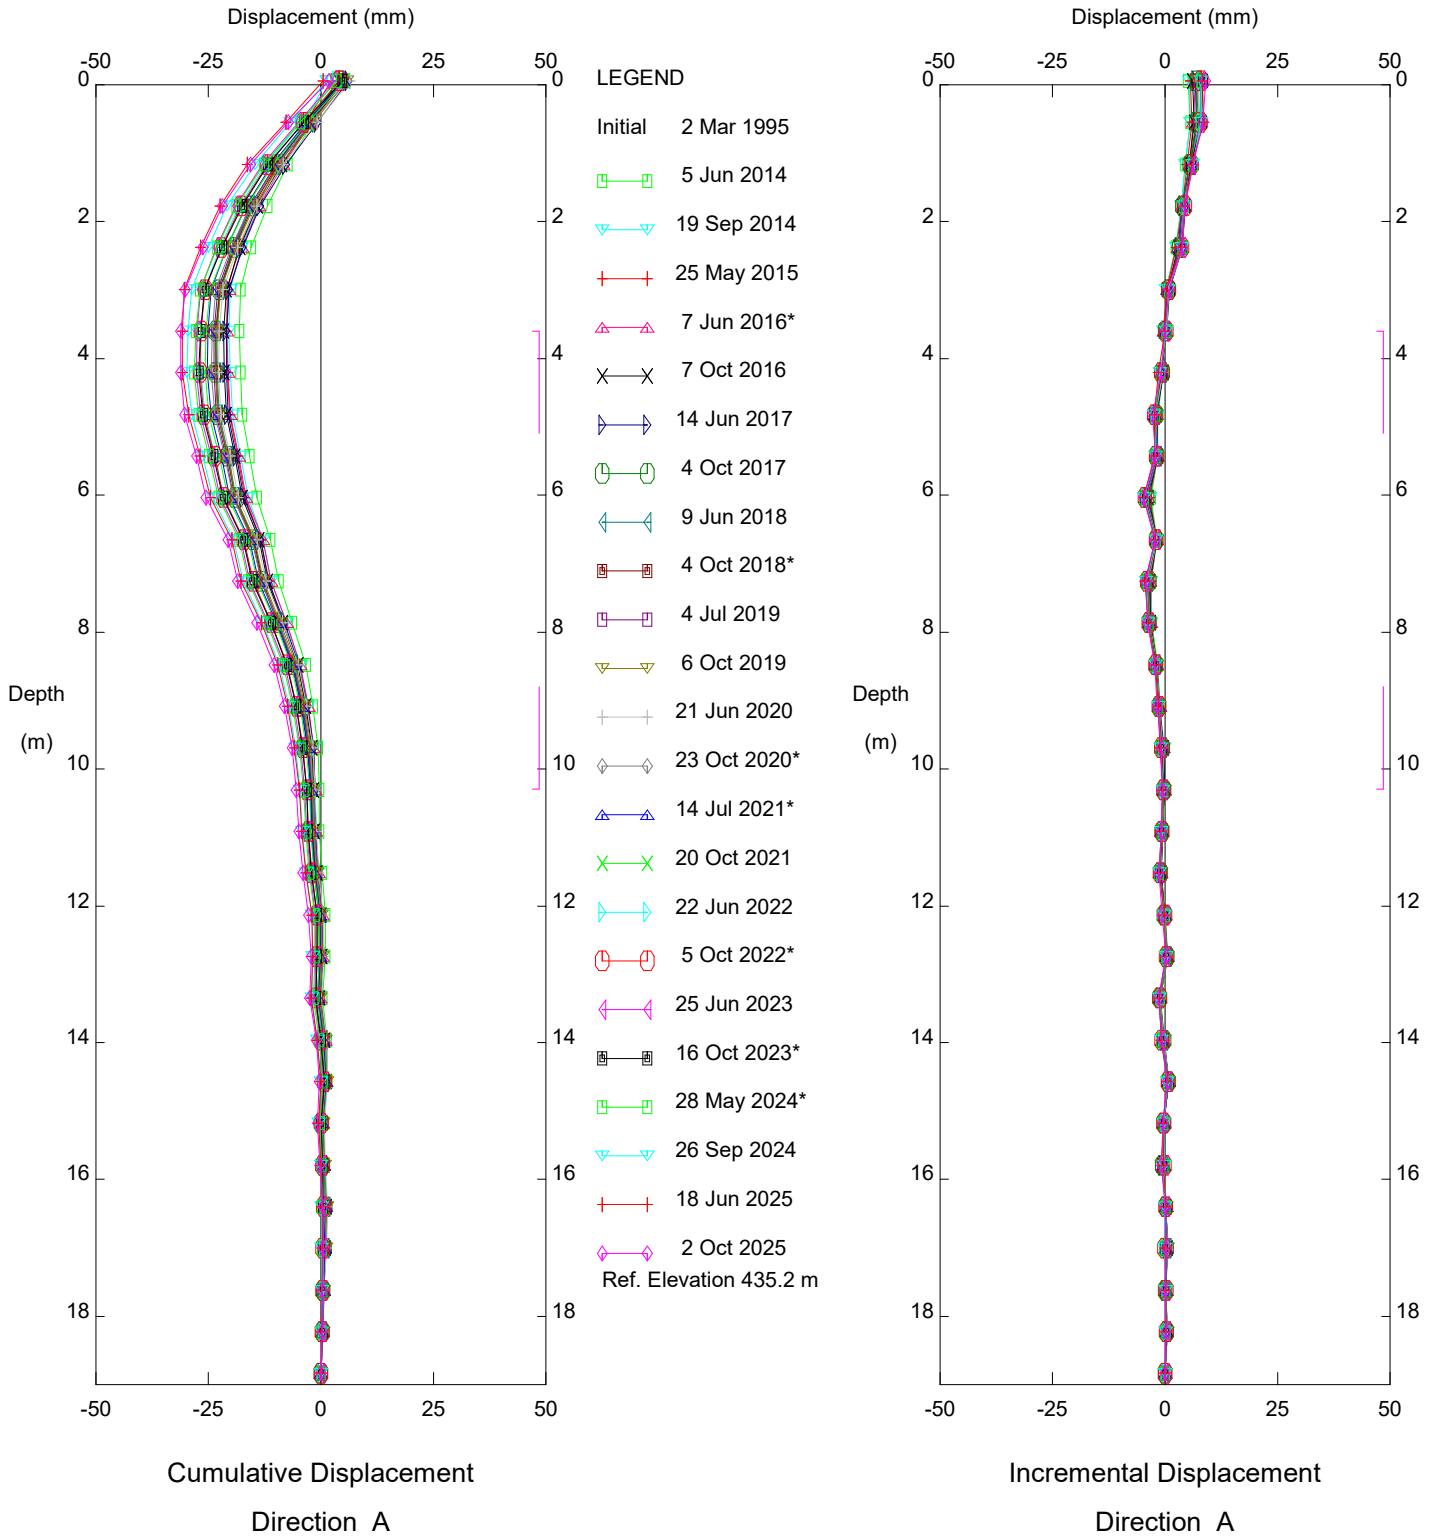
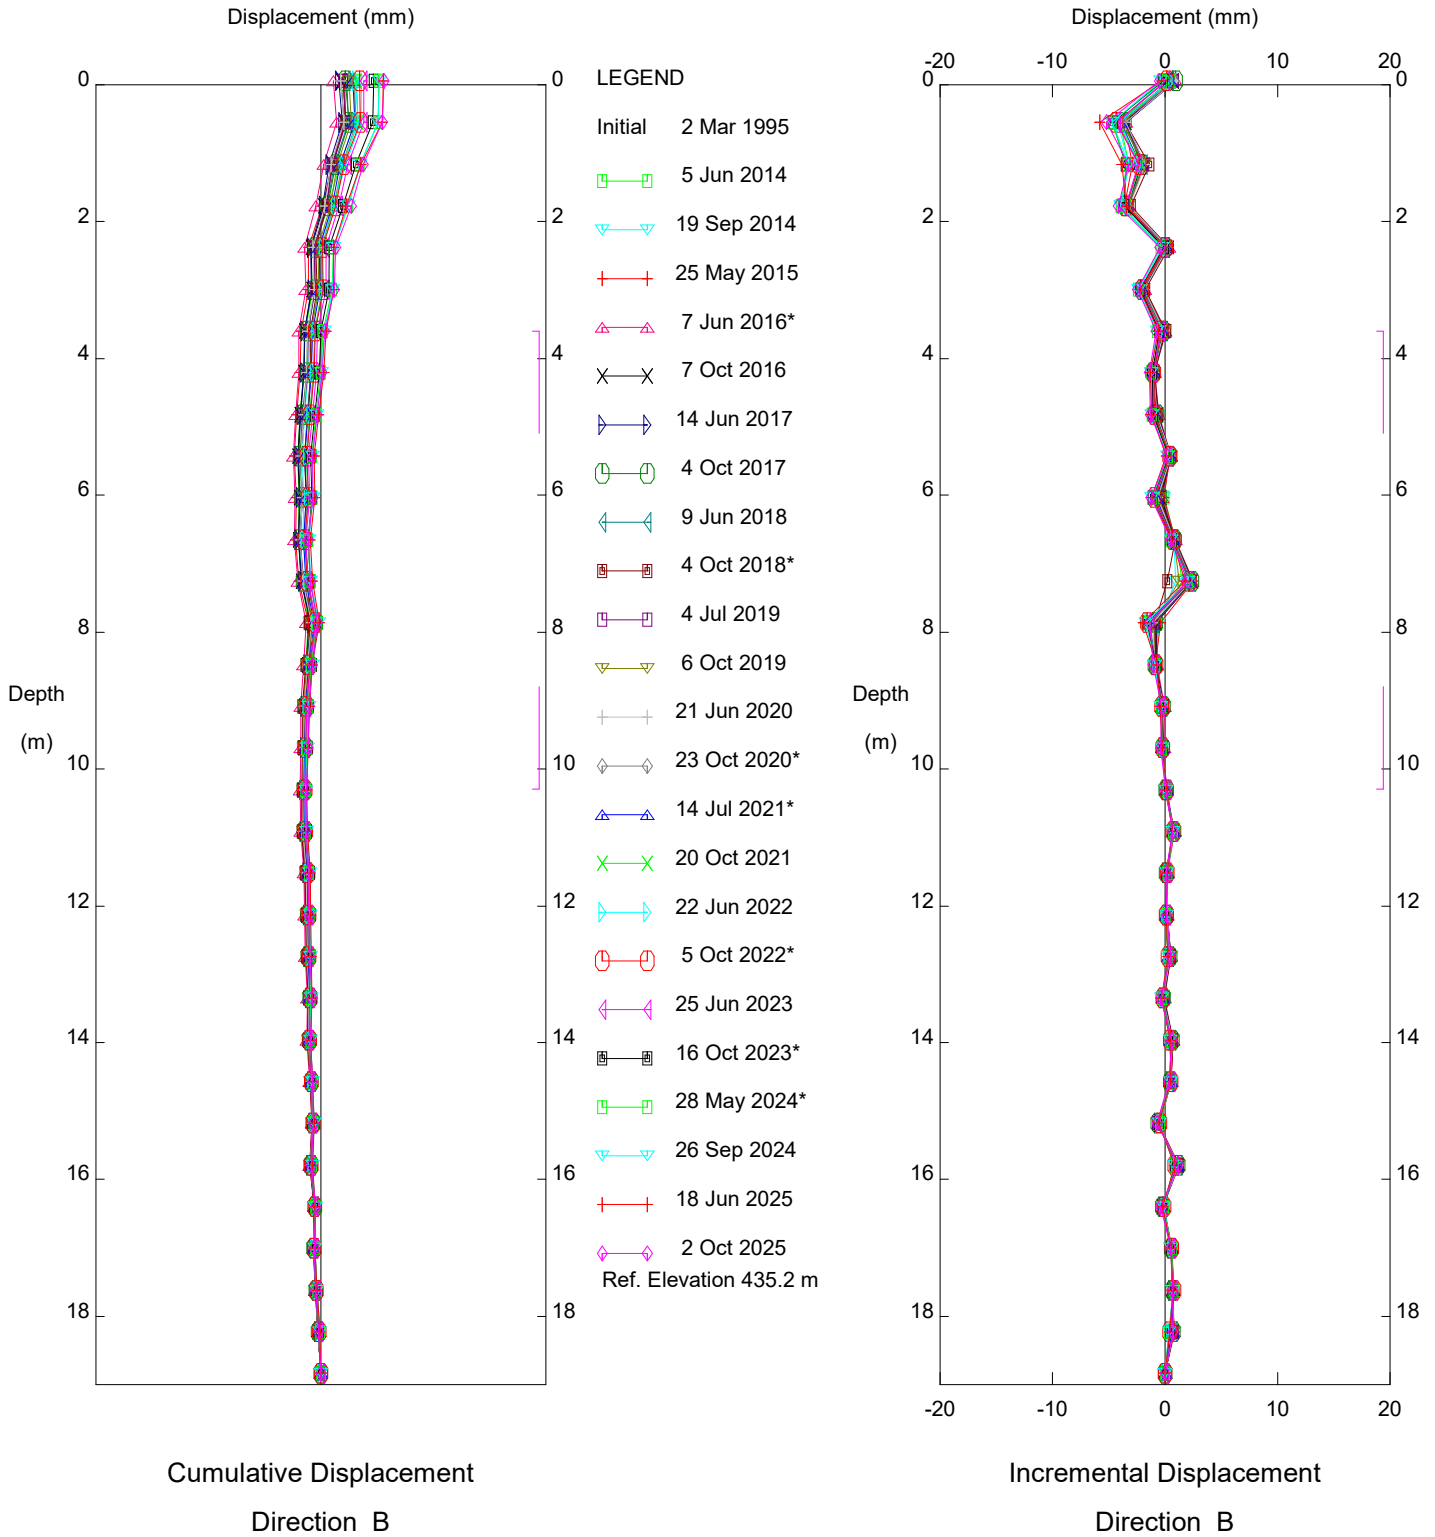
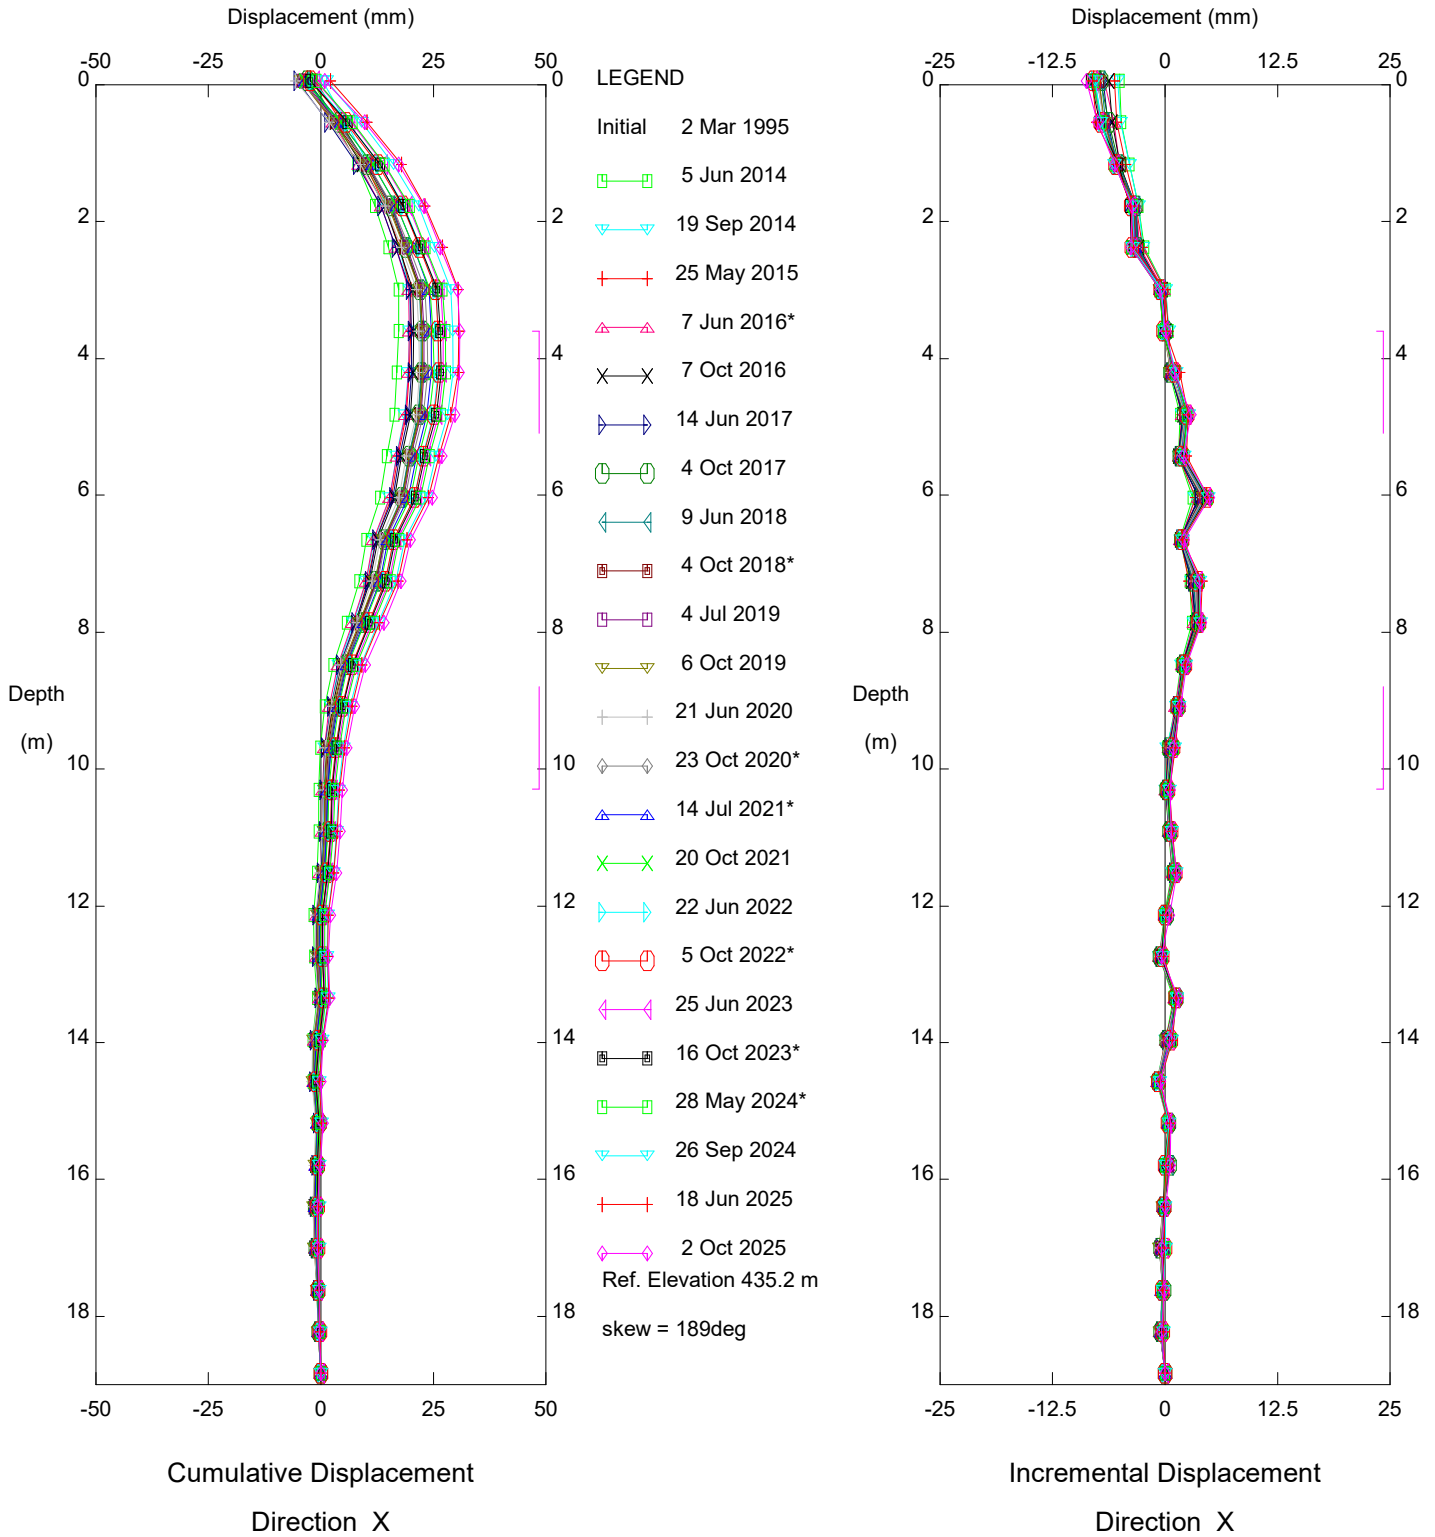
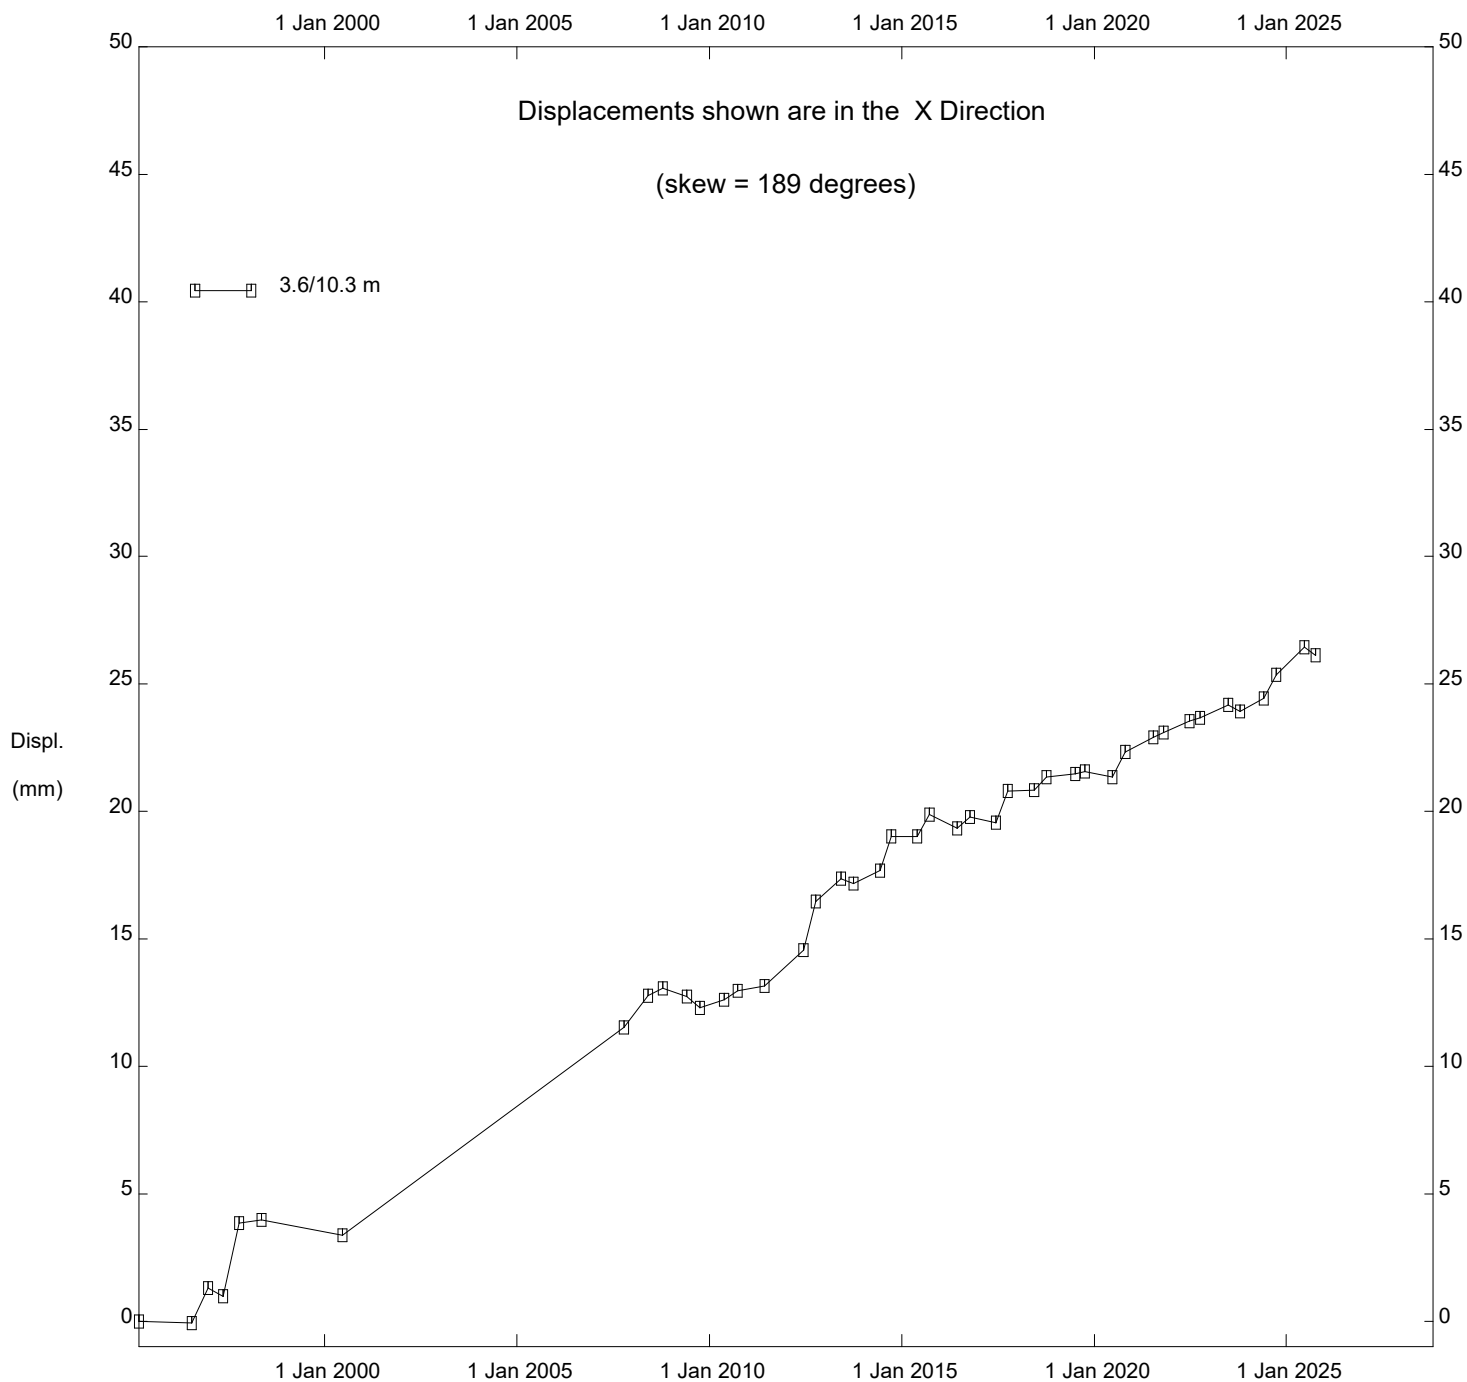
HWY 2:68 (PH037), Inclinometer SI-61

| INSTRUMENT # | DATE INITIALIZED | TOTAL CUMULATIVE RESULTANT MOVEMENT AT NOTED DEPTH SINCE INITIAL READING (mm) | MAXIMUM RATE OF MOVEMENT (mm/yr) | CURRENT STATUS | DATE OF PREVIOUS READING | INCREMENTAL MOVEMENT SINCE PREVIOUS READING (mm) | RATE OF MOVEMENT (mm/yr) | CHANGE IN RATE OF MOVEMENT SINCE PREVIOUS READING (mm/yr) |
|---|---|---|---|---|---|---|---|---|
| SI-61 | Mar. 2, 1995 | 26.5 mm over 3.6 m to 10.3 m depth in 190° direction | 7.2 mm/yr in October 1997 | Operational | June 18, 2025 | No discernible movement | No discernible movement | -2.7 |
