**ALBERTA TRANSPORTATION AND
ECONOMIC CORRIDORS
GEOHAZARD ASSESSMENT PROGRAM
PEACE REGION (GRANDE PRAIRIE DISTRICT - NORTH)
2025 INSPECTION**

Site Number	Location	Name	Hwy	km
PH037	Dunvegan	Dunvegan South 1+250 to 2+000	2:68	15.674
Legal Description		UTM Co-ordinates (NAD 83)		
NW¼ 06-080-04 W6M		11U E 398514	N 6197340

2025 PH037 INSPECTION PLAN

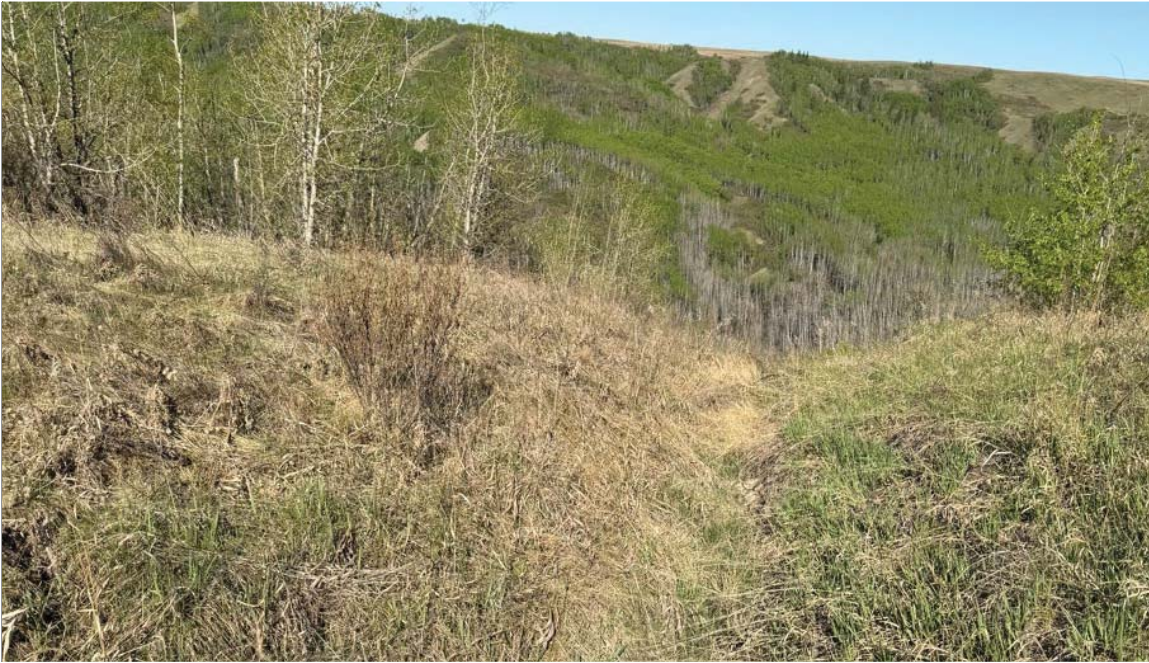
Erosion and slope movement downslope of the highway near Sta. 2+000 are a function of water flows in the ditch and are expected to worsen.

Photo 1: Looking northwest from Sta. 2+000 at erosion gully in SBL ditch south of ditch block

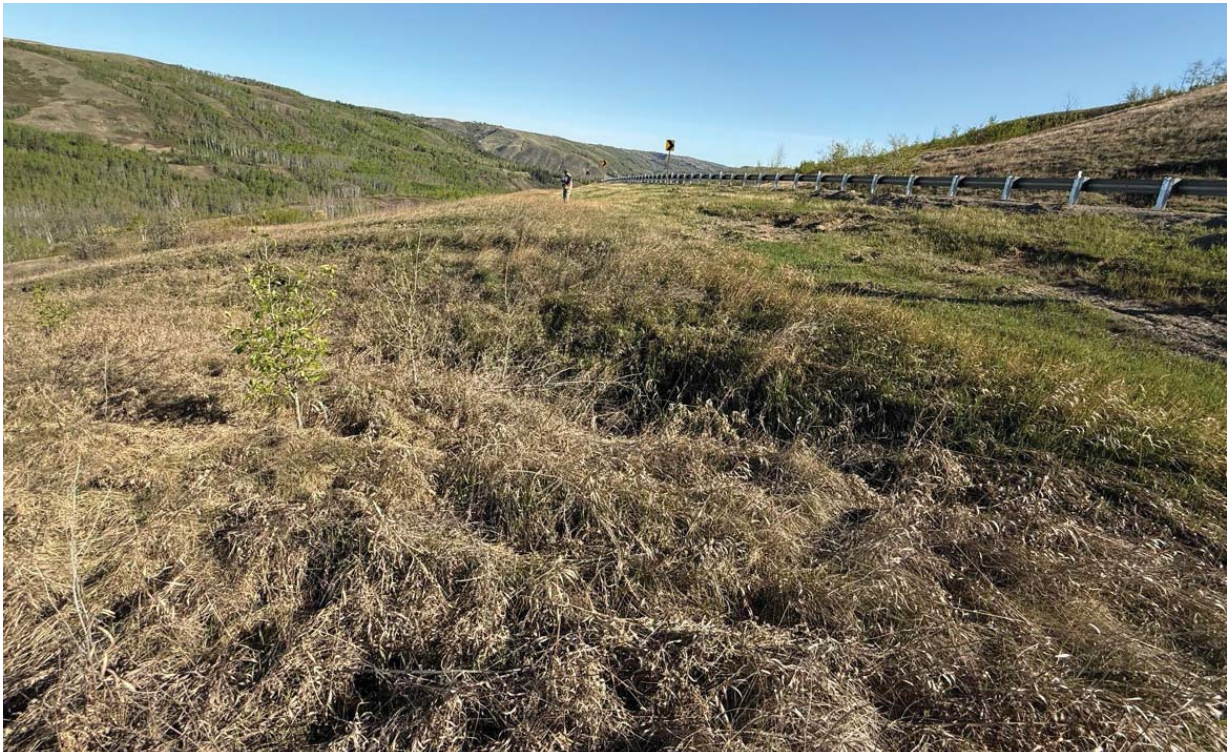
Photo 2: Looking north from Sta. 1+980 below the SBL highway. More movement noted in 2025

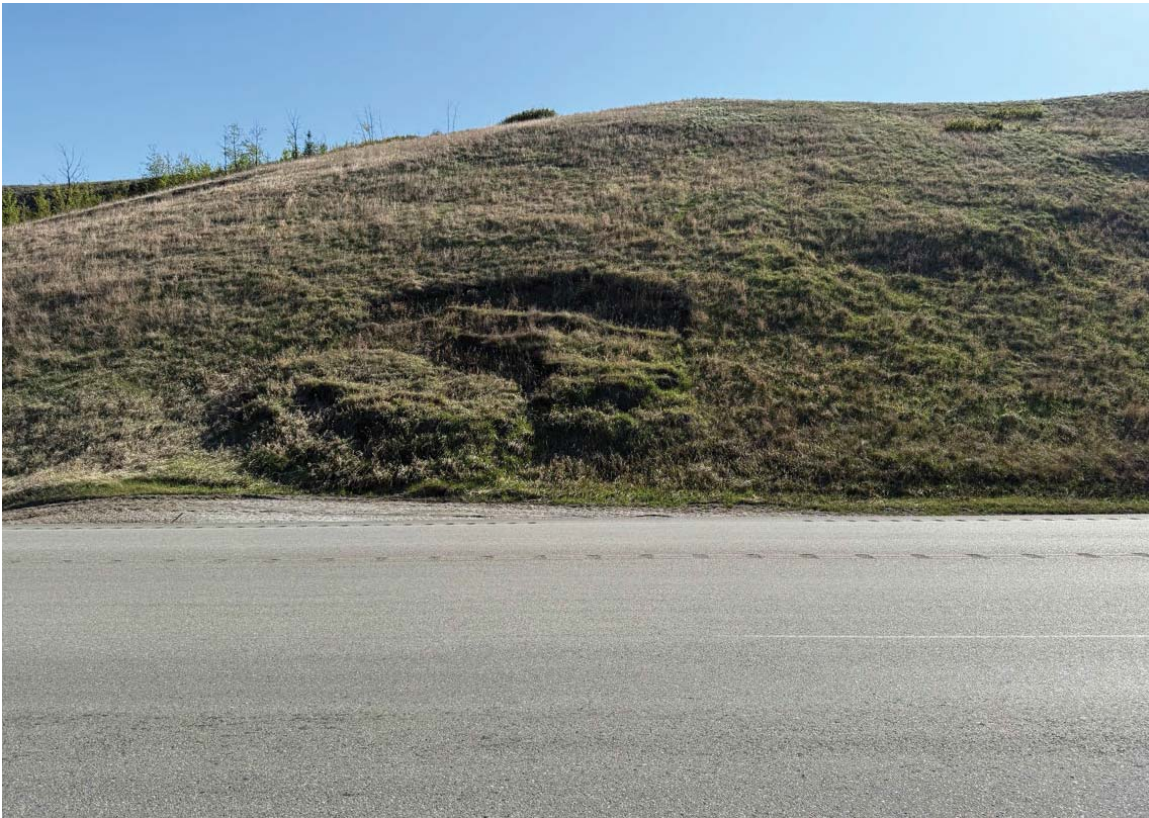
Photo 3: Looking east at backslope skin failure at Sta. 1+950. More active in 2025

The toe of the slumps located on the highway back slope between Sta. 2+000 to 2+100 should be graded, topsoiled and seeded to promote controlled drainage in this zone. As, grass has not grown in the ditch between 1+700 to 1+900, TEC should consider placement of seed and TRM in this zone.

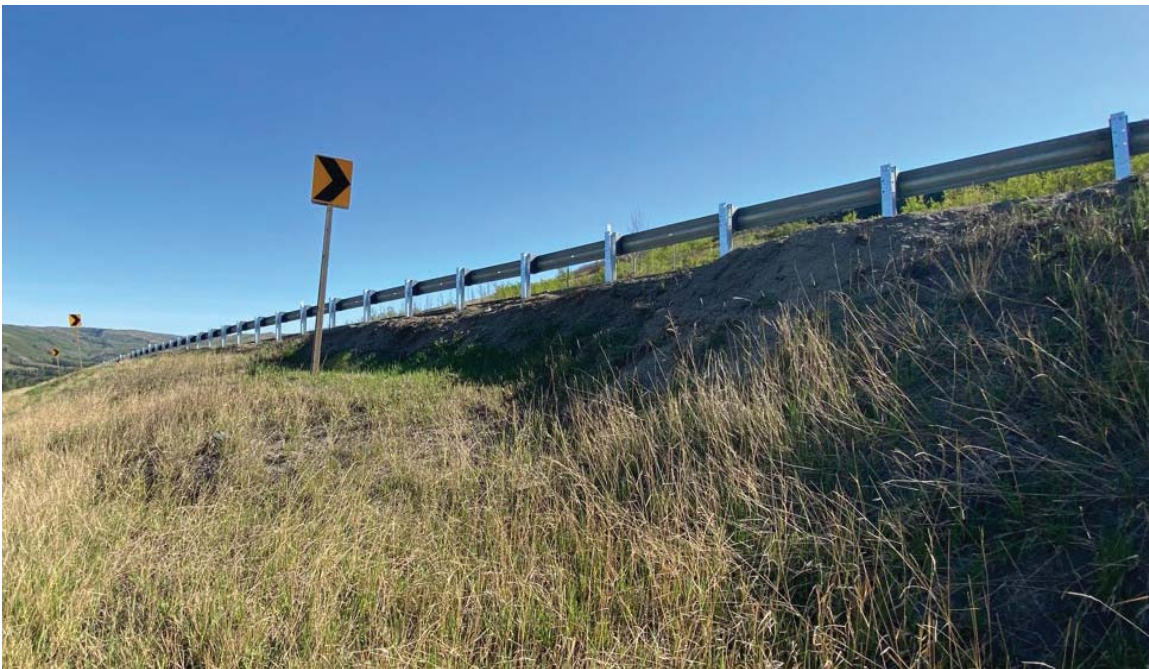
Photo 4: Looking north from Sta. 1+890 at the slump in the sideslope of the SBL. More movement in 2025. The scarp is 1.8 m high and 1.0 m from the guardrail.

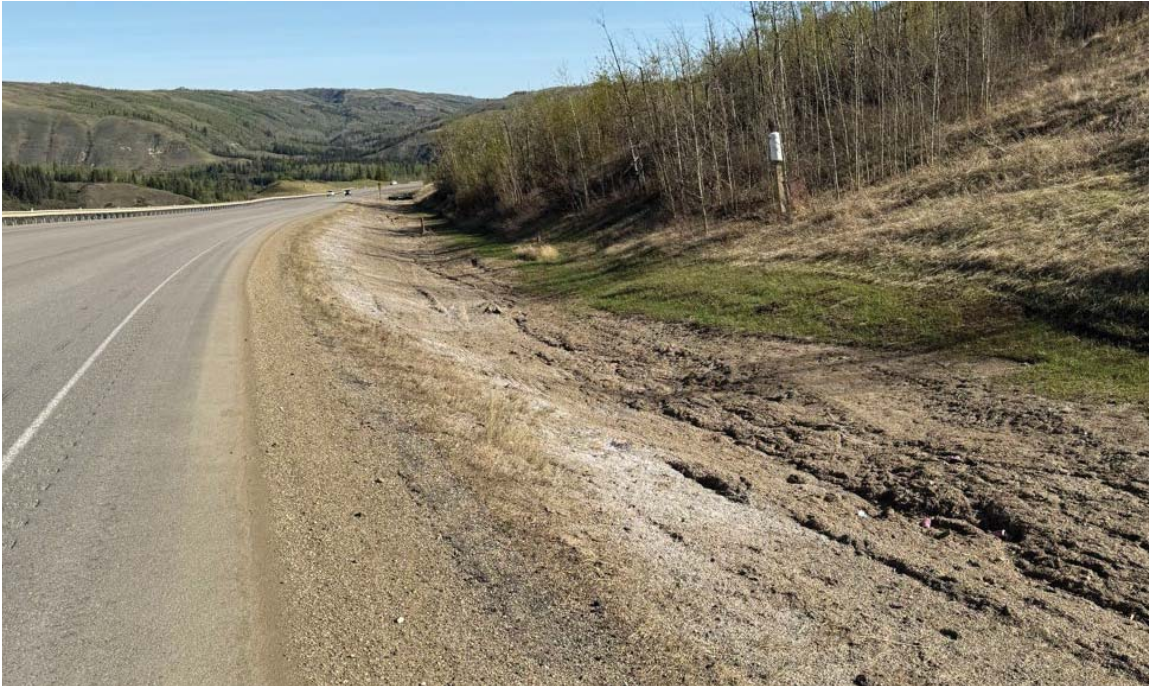
Photo 5: Looking north from Sta. 1+800. The erosion gully noted on the ditch up to 1.7 m wide and 0.7 m deep in 2024 was regraded. Currently rills are less than 200 mm wide by 200 mm deep.

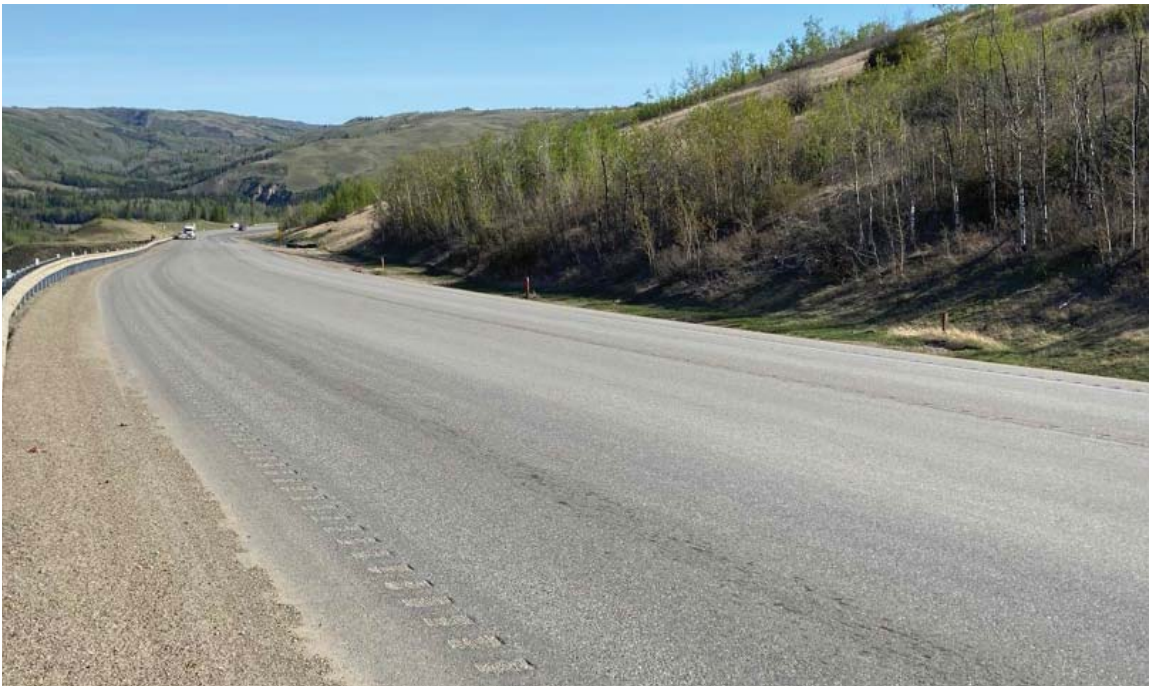
The 1+800 slide is a deep-seated slide that is currently affecting all three lanes of the highway over a 200 m length with the backscarp likely within the NBL ditch bottom. Based on the ongoing slope inclinometer monitoring, the 1+800 slide plane depth varies within the embankment of the highway from about 18 m near the SBL shoulder to a depth of 28 m below the NBL shoulder with the toe of the landslide is likely situated some 300 m further downslope towards Dunvegan Creek. Rates of movement in the 1+800 slide typically vary from small creep movements to 17 mm/yr. The 1+800 slide continues to exhibit moderate rates of movement; however, its footprint currently affects the entire highway embankment whereby a complete closure of the highway could result from a sudden increase in slide activity.

Photo 6: Looking north across the former dip in the highway at the south end of the 1+800 slide. No slide cracks or dips visible in the recently (2024) paved highway surface.

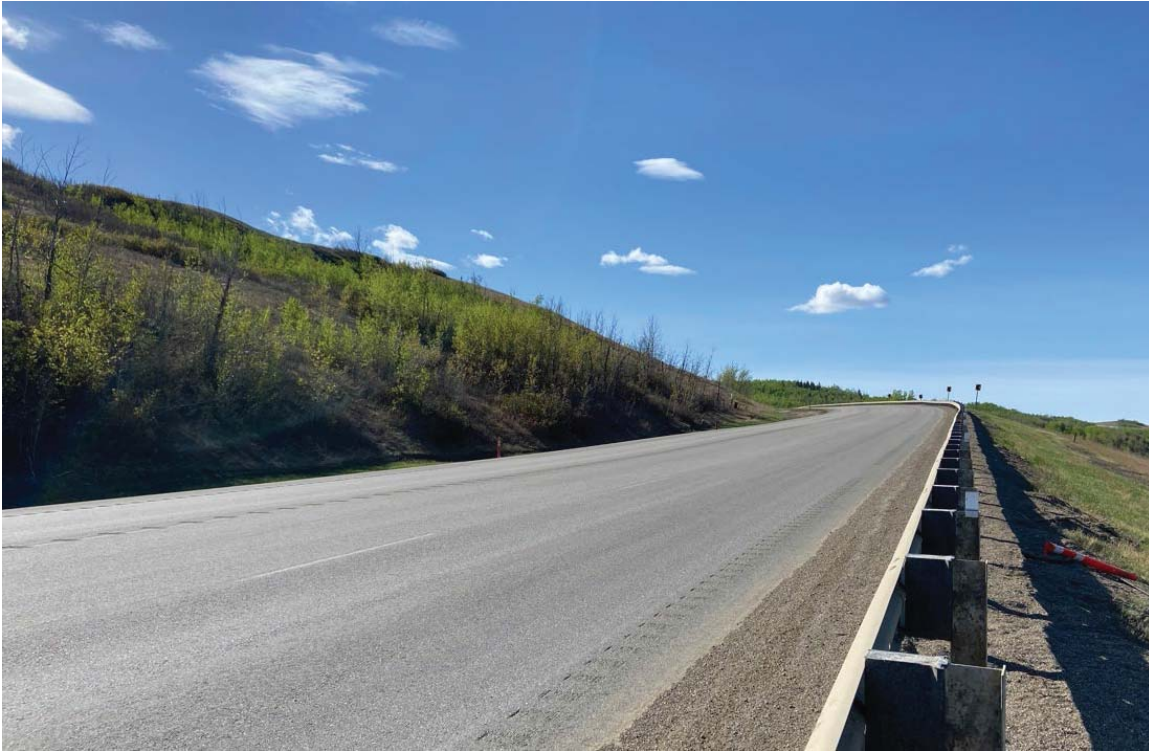
Photo 7: Looking south at the north end of the 1+800 slide. No slide cracks or dips visible on the recently (2024) paved highway surface.

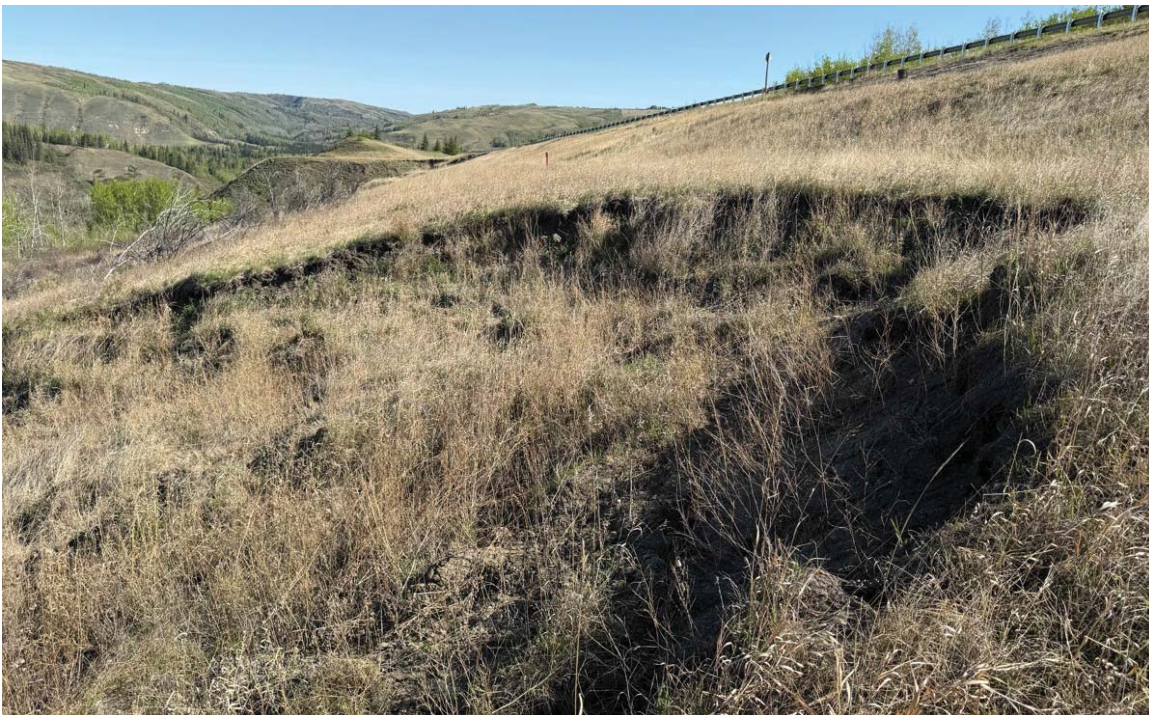
Photo 8: Looking north near Sta. 1+670 at slumping occurring on the highway side slope approximately 20 m from the edge of pavement. More movement noted in 2025

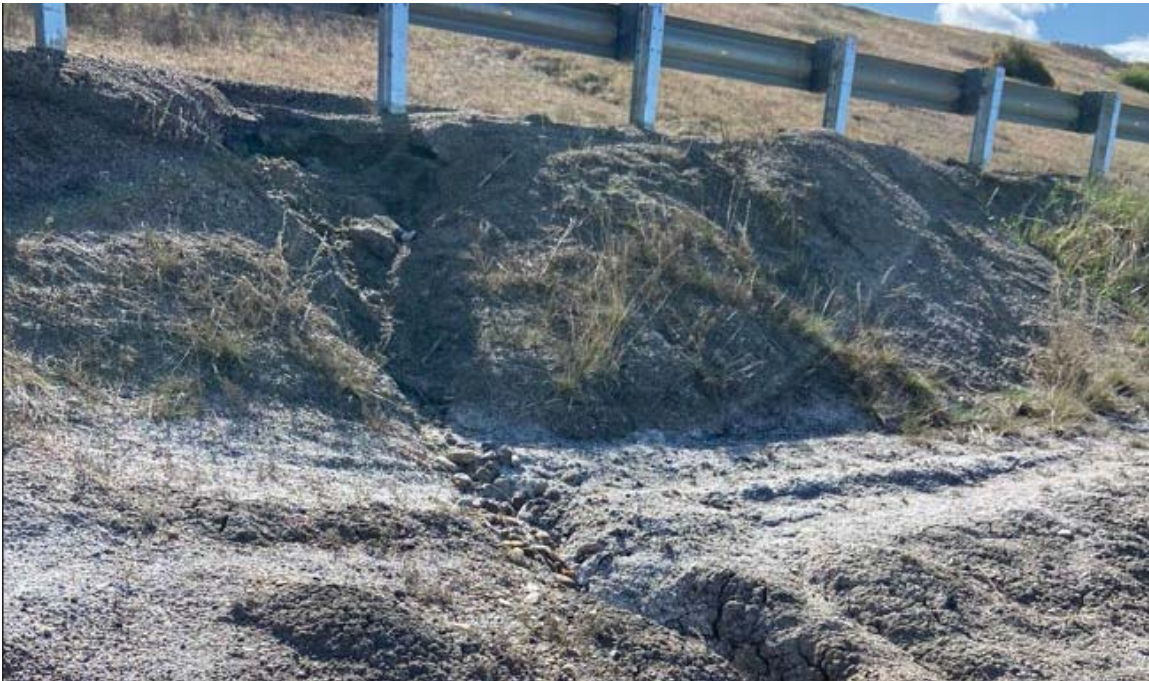
Photo 9: Looking north near Sta. 1+550 at erosion rills and gullies on the highway side slope becoming worse.

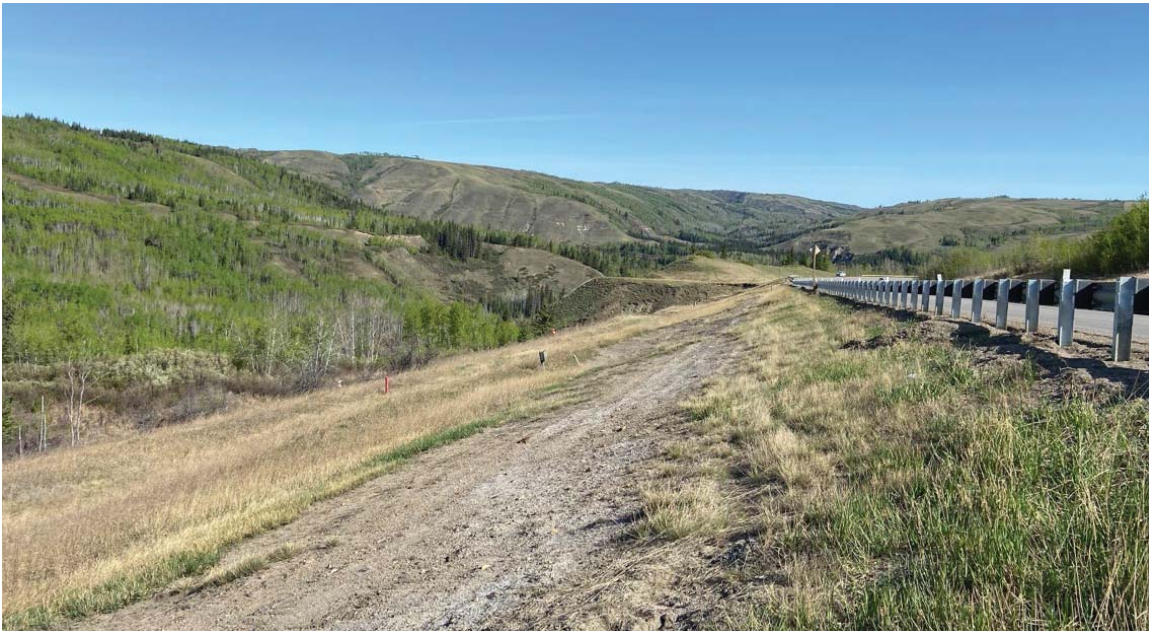
Photo 10: Looking north near Sta. 1+560 at rough area (drill access bench) with some seepage and tension cracks. Access bench was damp in 2025

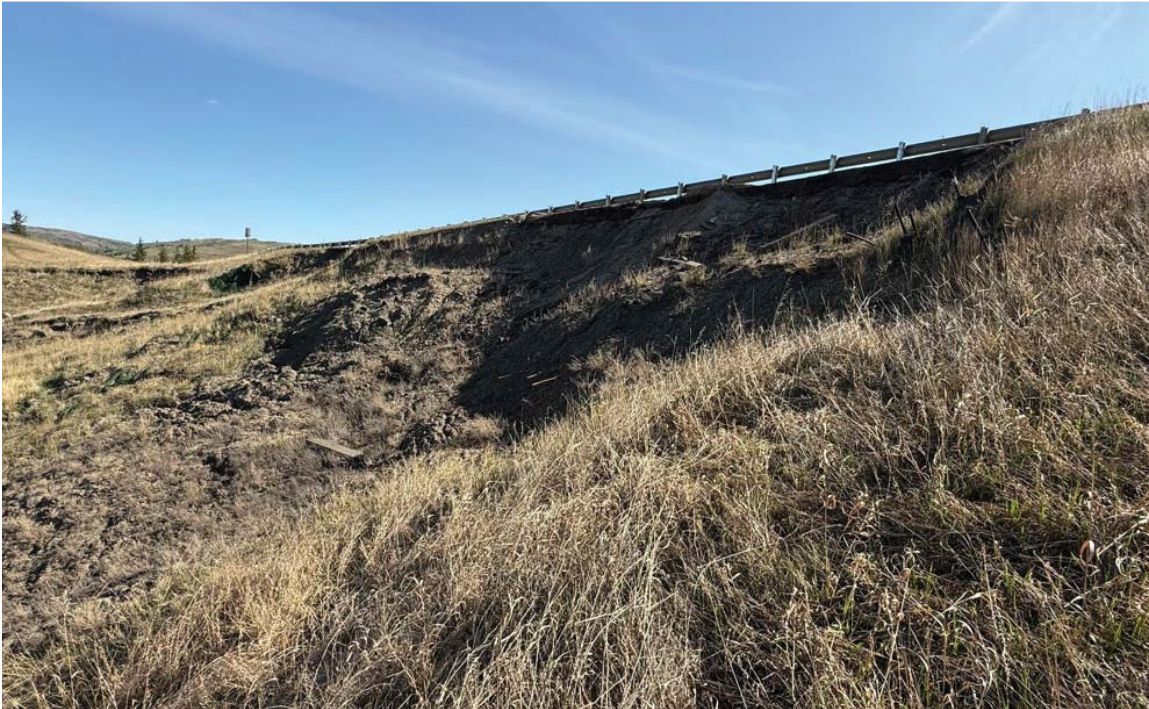
Ongoing slide activity was observed at the Sta. 1+400 slide in 2016 right through 2025. Soil below the matting and around the soil nails, installed in 2010, has failed superficially, with more substantial failure extents below the surface treated area. It is anticipated that the rate of retrogression will likely accelerate above the areas where the soil nails have been bent downward due to a combination of confining soil loss and slope movement. The backscarp located at the shoulder of the SBL ranges between 5 to 7 m high. The SI's installed within the footprint of the 1+400 slide had rapid rates of movement in the spring and summer of 2018 (50 to 700 mm/yr.) and sheared off at a depth of 2 m as a result of a mud flow after the fall of 2018. Although the highway realignment completed in the fall of 2024 has moved the highway lanes further from the slide backscarp cracks, the 1+400 slide continues to retrogress rapidly. This minor road realignment was intended to extend the service life of the highway for some time while the long-term realignment construction is completed.

Photo 11: Looking east at failed soil matting and soil nails which were installed in August 2010 at Sta. 1+450 slide. Backscarp (5 m to 7.5 m high) continues retrogressing and impacting the highway embankment.

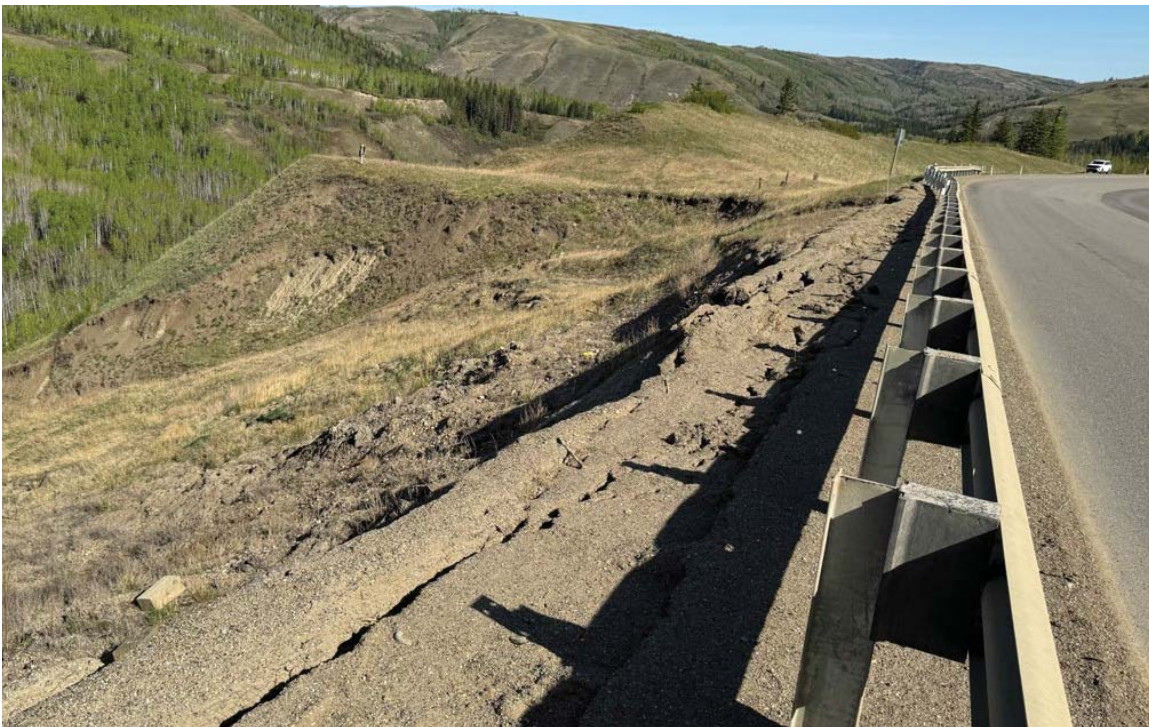
Photo 12: Looking north from Sta. 1+450 backscarp.

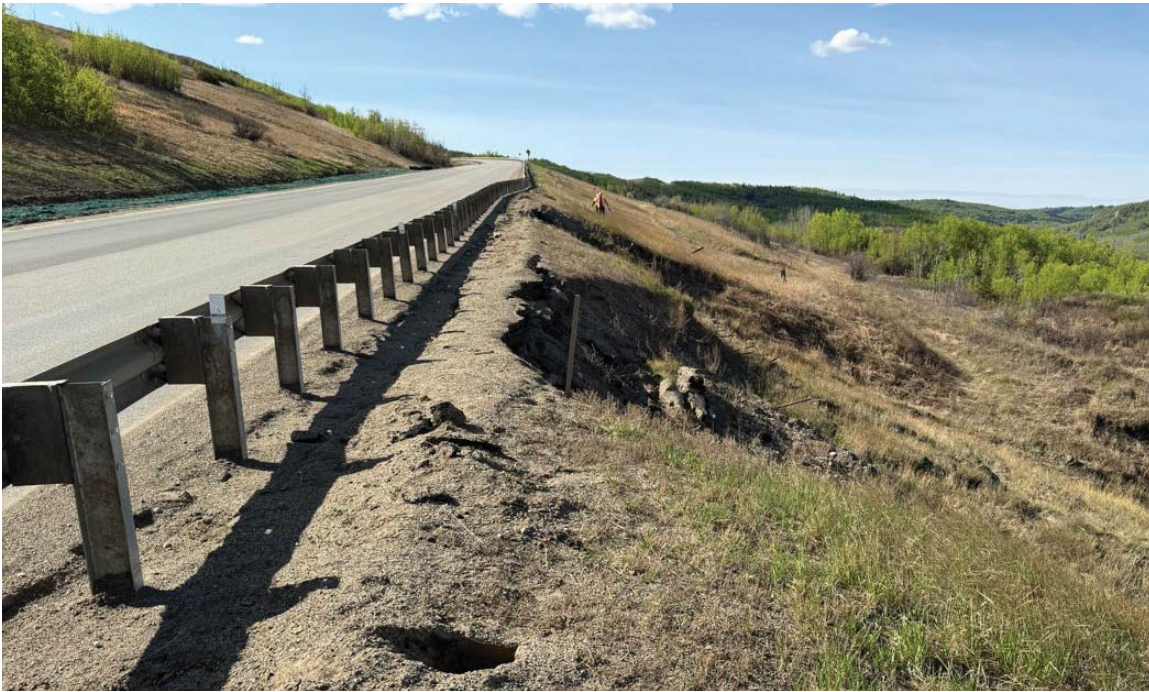
Photo 13: Looking south from Sta. 1+390 at the backscarp of the 1+400 slide.

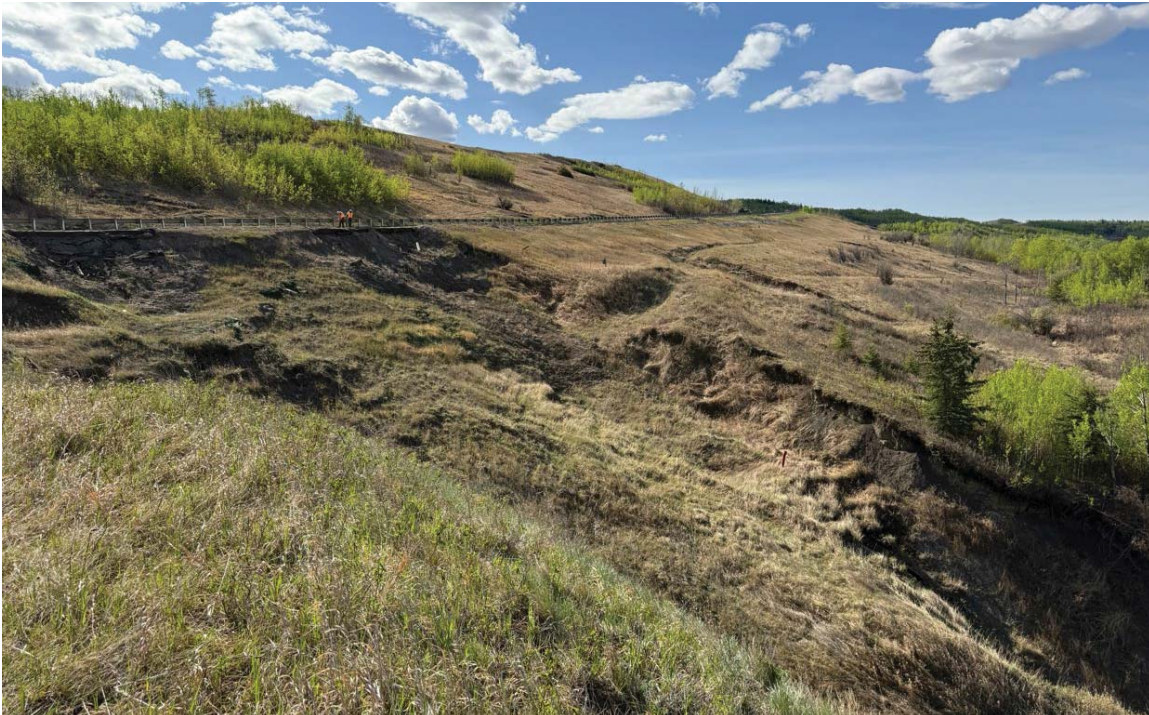
Photo 14: Looking south towards the 1+400 slide. There is a 5 m to 7.5 m drop below the guardrail.

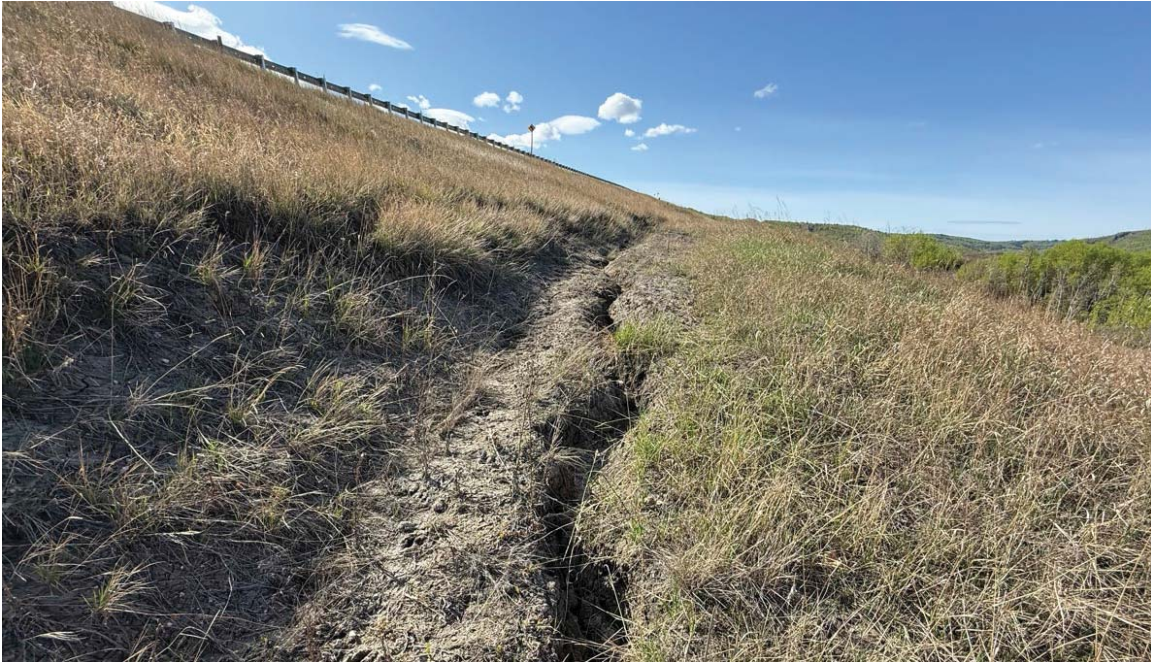
Photo 15: Looking south at slumping occurring from Sta. 1+480. Scarp measured 1.3 m deep in 2025

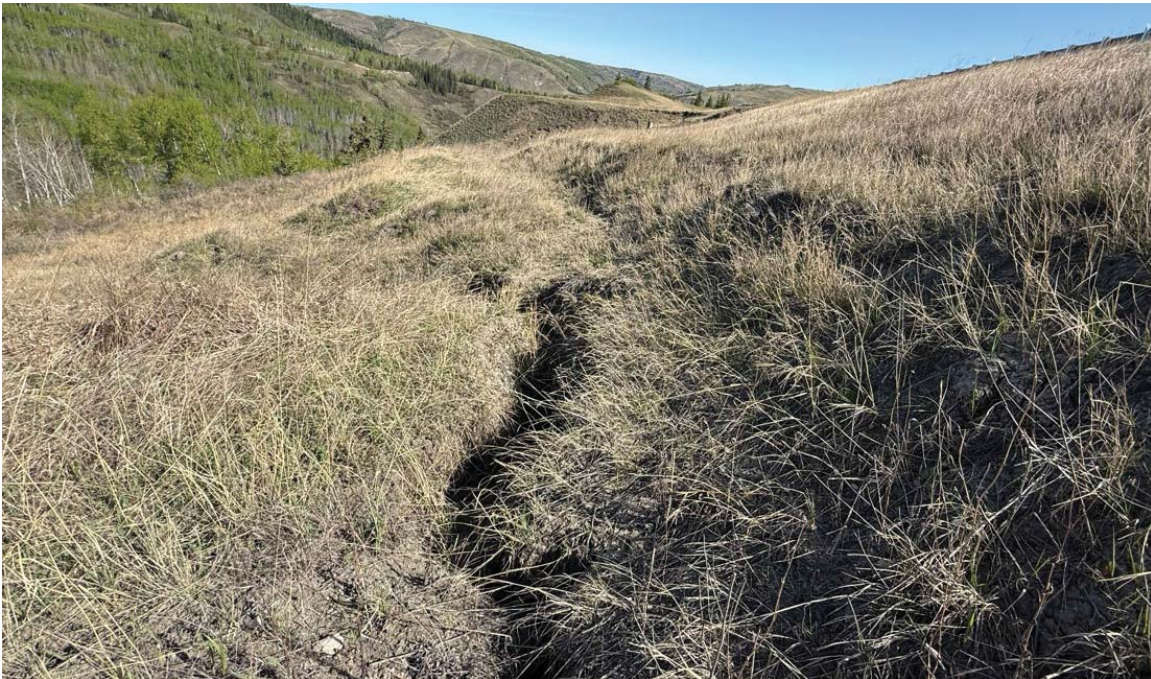
Photo 16: Looking north at slumping occurring from Sta. 1+500..

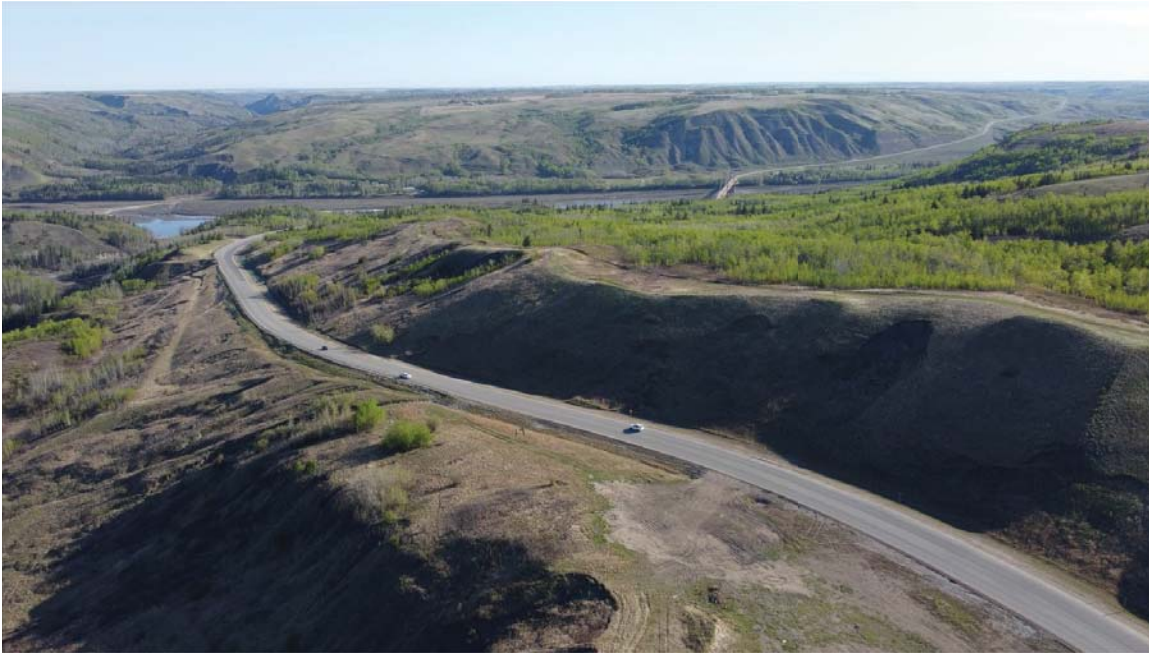
Photo 17: Drone view showing slumps along the highway sideslope and backslope. Overall backslope slumps are more active and partially blocking the upslope ditch.

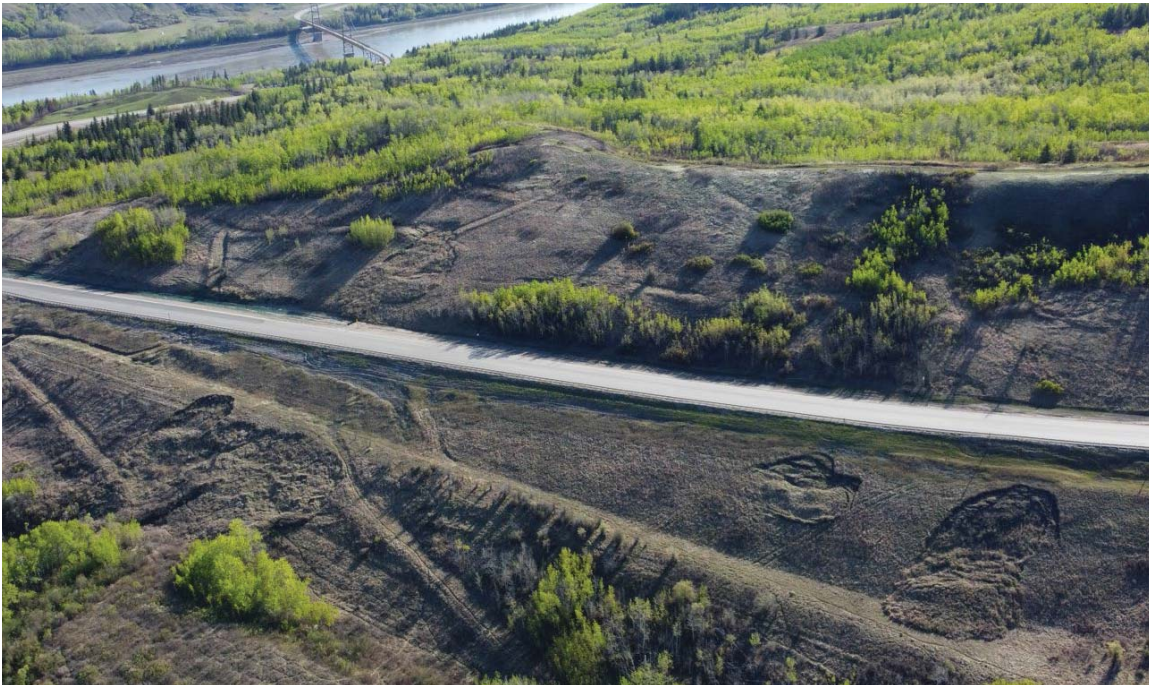
Photo 18: Drone view showing the area of the deep slide at Station 1+800

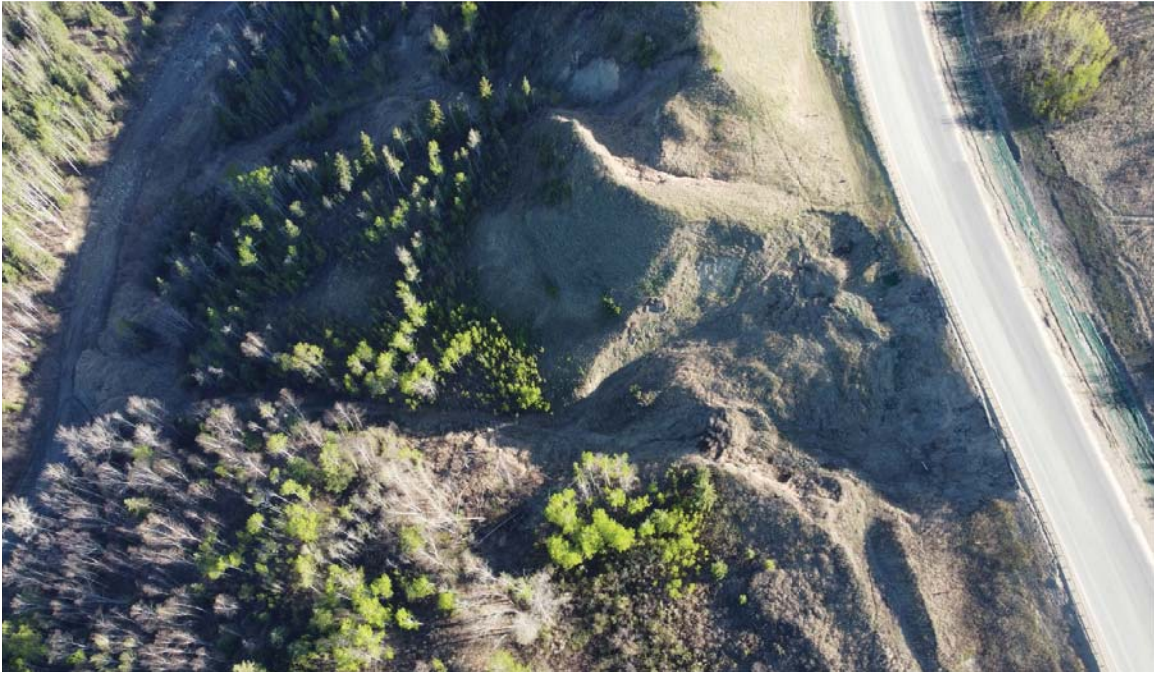
Photo 19: Drone view showing slide at Station 1+400

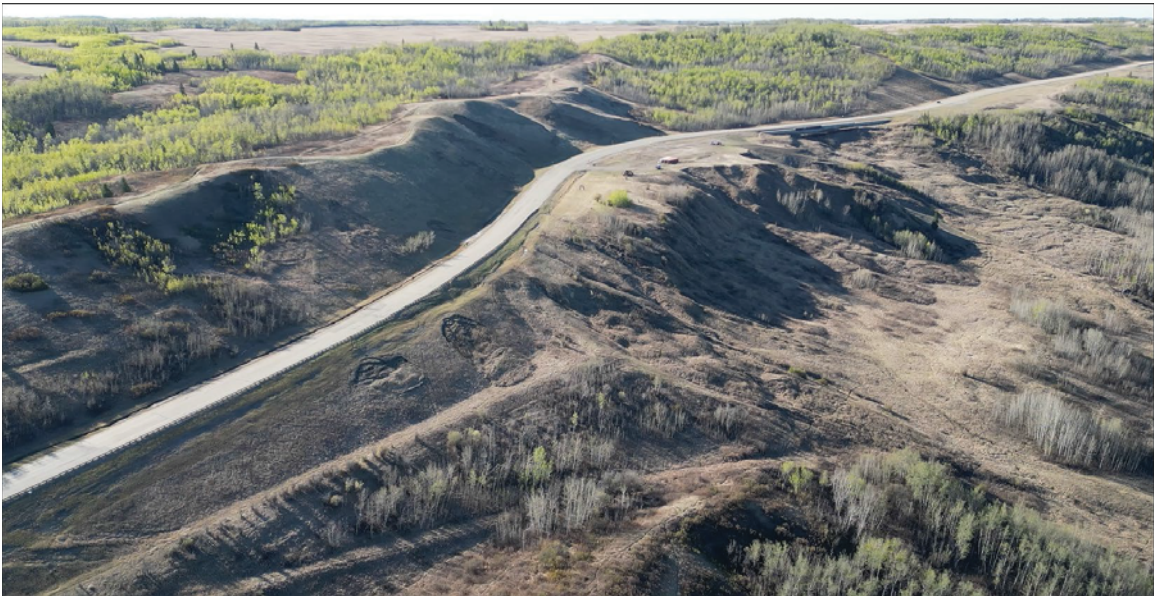
Photo 20: Drone view looking at south half of the site showing backslope slumps located north of Pile Wall at PH035
