ALBERTA TRANSPORTATION AND
ECONOMIC CORRIDORS GRMP
PEACE REGION
(GRANDE PRAIRIE DISTRICT - NORTH)
INSTRUMENTATION MONITORING - SPRING 2025

Site Number	Location	Name	Hwy	km
PH037	Station 1+250 to 2+000	Dunvegan South	2:68	Km 15.7
Legal Description: 4-7-80-4 W6		UTM Co-ordinates		
		11U E 398593.62	N	6197597.09

Current Monitoring:	18~19-June-2025	Previous Monitoring	26-Sep-2024
Instruments Read By:	Mr. Niraj Regmi, G.I.T and Mr. Godfred Etiendem, of Thurber

SITE PH037: HWY 2:68, DUNVEGAN SOUTH

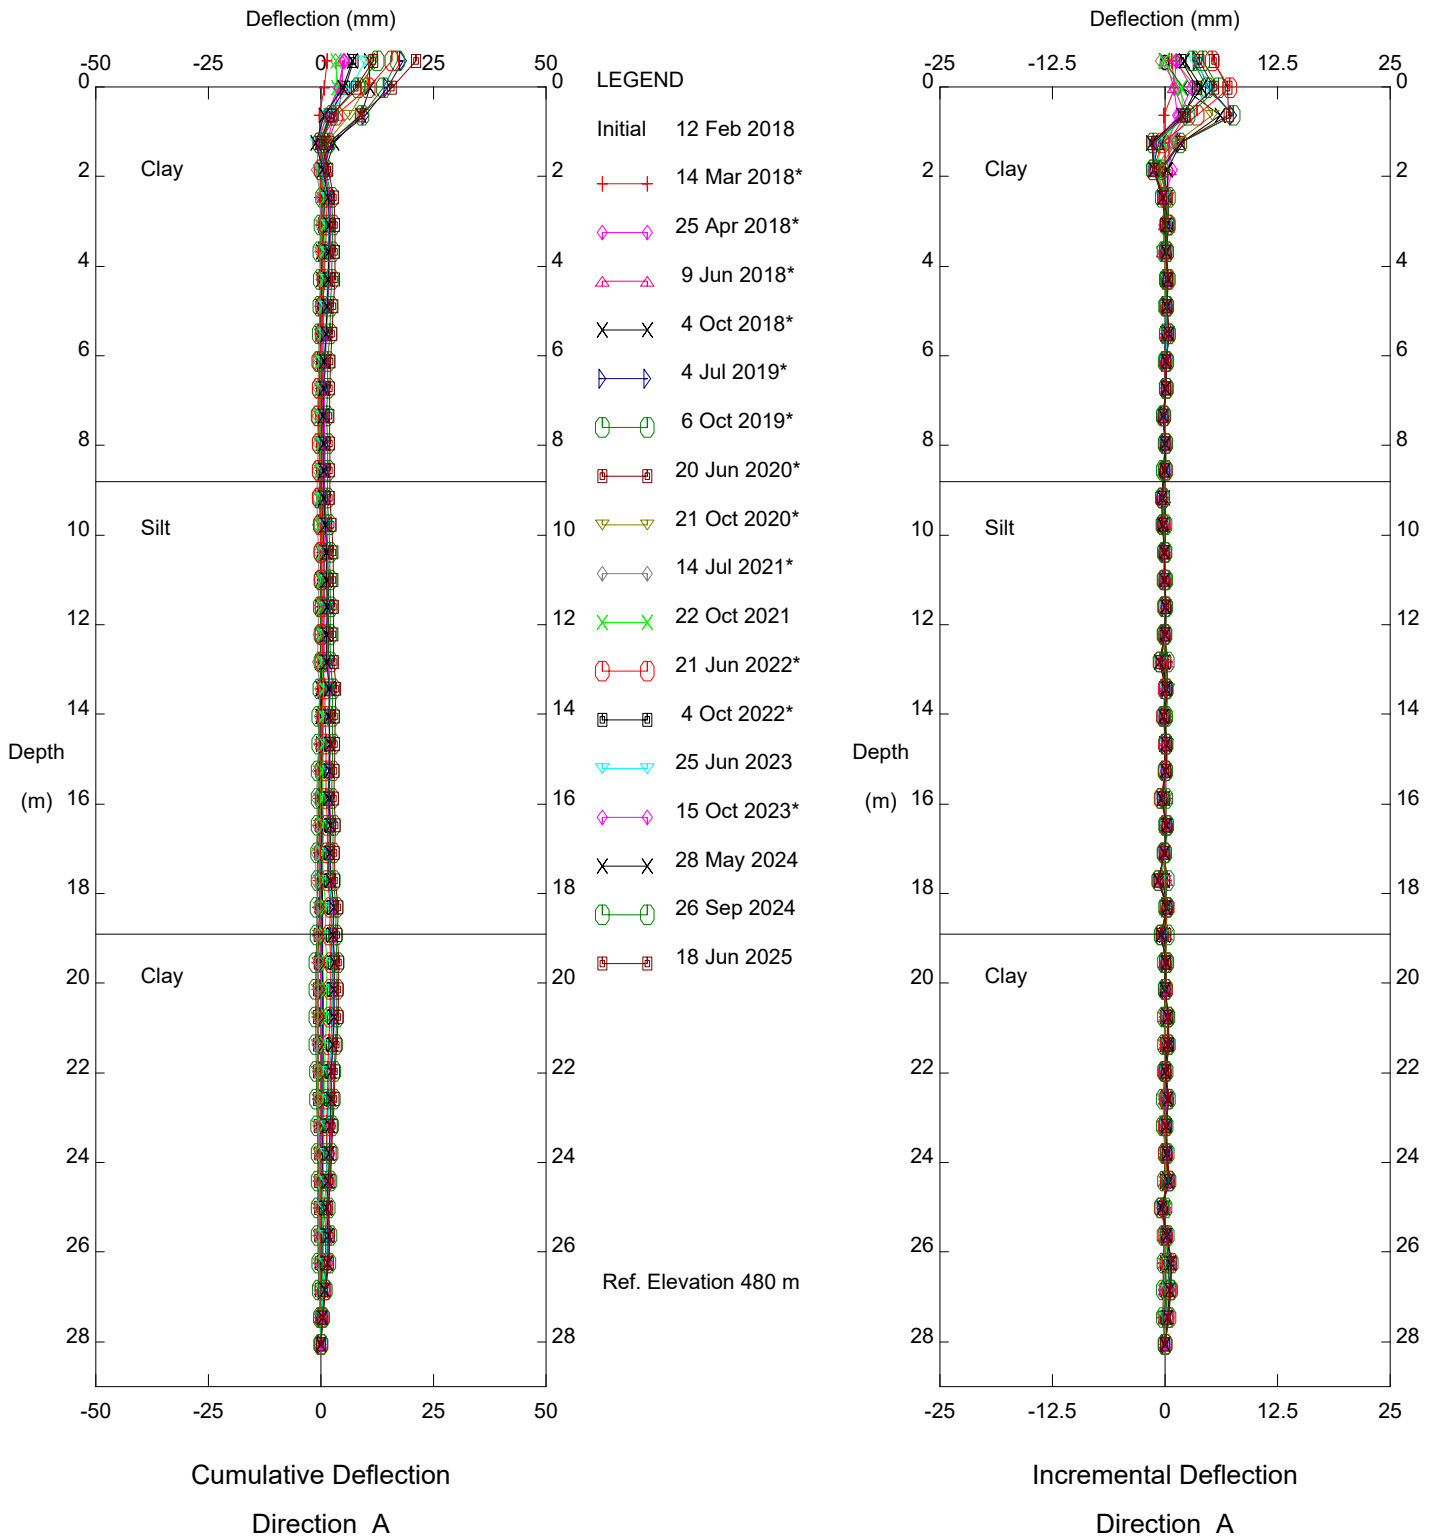
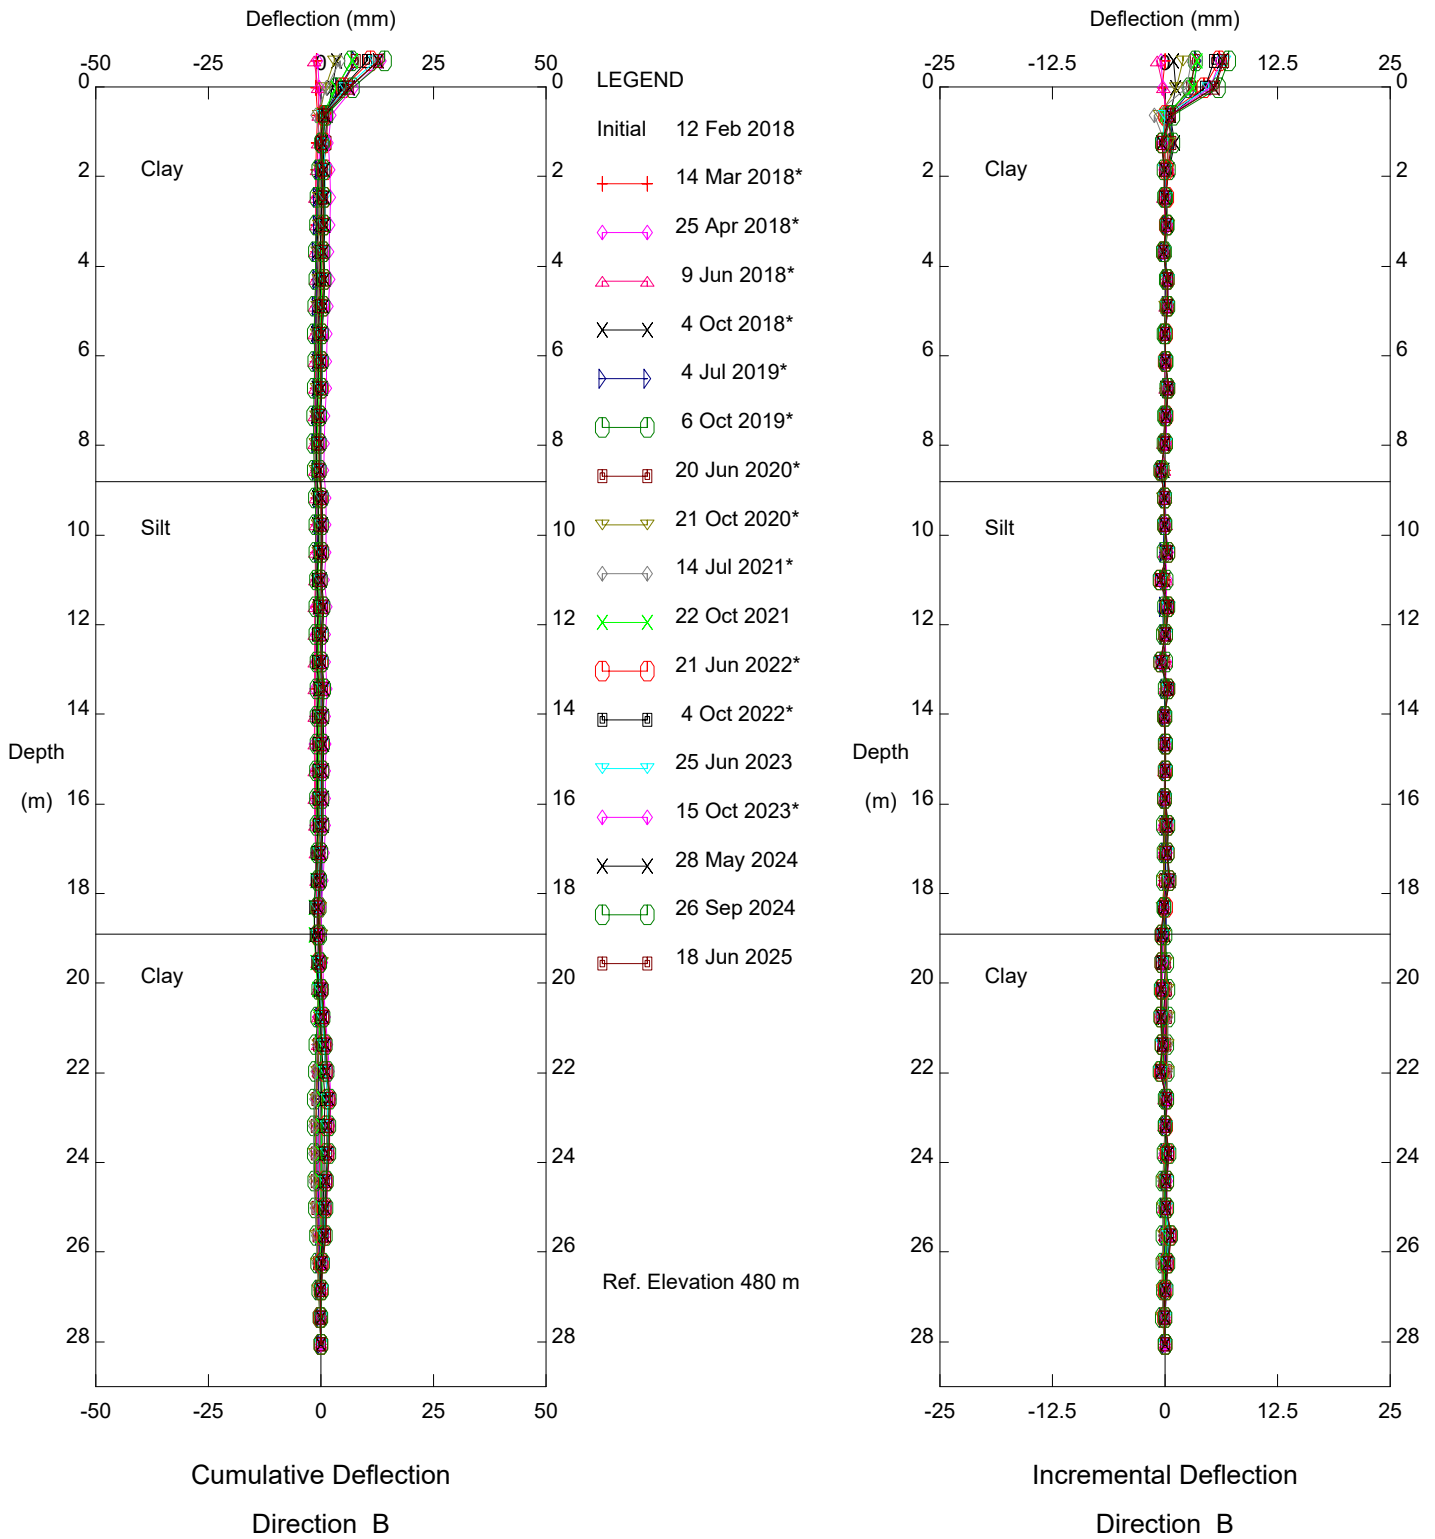
HWY 2:68 (PH037), Inclinometer SI18-4

<p>SI18-4 is in the cut slope above the highway and shows no discernible movement throughout the 28 m length of the slope inclinometer pipe.</p> <p>SI18-5 is just east of the highway and shows a rate of movement of 6.3 mm/yr over a distinct shear zone between 17.2 m to 20.3 m depth within a clay layer. This movement rate has been steady since the SI was installed in 2018.</p> <p>SI09-7 is about 90 m west of the highway and has several zones of movement. This instrument showed no discernible movement over the movement zone from 3.9 m to 6.3 m depth and the total movement since 2009 is about 8 mm. A rate of movement of 0.3 mm/yr was measured over 18.5 m to 20.3 m depth. This rate of movement has been steady since 2009 and total recorded movements are about 5.6 mm.</p> <p>SI-59 is in the highway east ditch near the assumed backscarp north flank of the landslide that is affecting the highway. It showed a rate of movement of 11.9 mm/yr over 1.0 m to 7.1 m depth. This SI has moved 186 mm over this depth zone, since it was first installed in 1994. A slower moving, subtle shear zone at 13 m depth may be present.</p> <p>Middle third of site:</p> <p>SI18-8 is just west of the highway and showed a rate of movement of 3.5 mm/yr along a distinct shear plane over 14.5 m to 16.3 m depth in a clay layer. This movement rate has held steady since 2018 and total movement to date is about 26 mm.</p> <p>SI-58 is about 100 m east of the highway and showed a rate of movement of 6.3 mm/yr over 0.5 m to 3.6 m depth. The movement pattern at SI-58 is bending with no well-defined shear zone.</p> <p>SI18-9 is about 35 m west of the highway and showed a rate of movement of 2.8 mm/yr along a well-defined shear plane over 20.1 m to 22.0 m depth in a clay till layer.</p> <p>North third of site:</p> <p>SI18-10 is just west of the highway and showed no discernible movement over 0 m to 3.0 m depth and a rate of movement of 2.0 mm/yr over 21.3 m to 23.2 m depth. The upper movement is tilting within a clay layer while the lower zone is a slowly developing distinct shear within a different clay layer.</p> <p>Slope inclinometer SI-54 is about 70 m east of the highway and showed a rate of movement of 9.1 mm/yr over 0 m to 1.7 m depth since the fall of 2024 readings. Of more significance with this slope inclinometer is the lack of observed shear zones below the near ground surface movement zone.</p> <p>SI09-1 is just west of the highway and showed a rate of movement of 1.0 mm/yr over 0.3 m to 7.0 m, and rates of movement of 1.0 mm/yr, and 0.3 mm/yr at depths between 7.0 m to 13.1 m, and 13.1 m to 14.9 m, respectively, since the fall of 2024 readings.</p> <p>SI-61 is just west of the highway and just north of SI09-1; it showed a rate of movement of 1.5 mm/yr over 3.6 m to 10.3 m depth. The pattern of movement at SI-61 is best described as a bulge which is unusual for this site.</p> <p>Standpipe piezometers SP09-6 and SP09-8 continued to be dry.</p> <p>Most of the pneumatic piezometers generally showed relatively small changes in groundwater level compared to the fall of 2024, ranging from a decrease of 0.20 m in PN18-1 to an increase of 0.98 m in PN18-14A. PN18-4 showed a groundwater elevation of 453.90 m,</p>

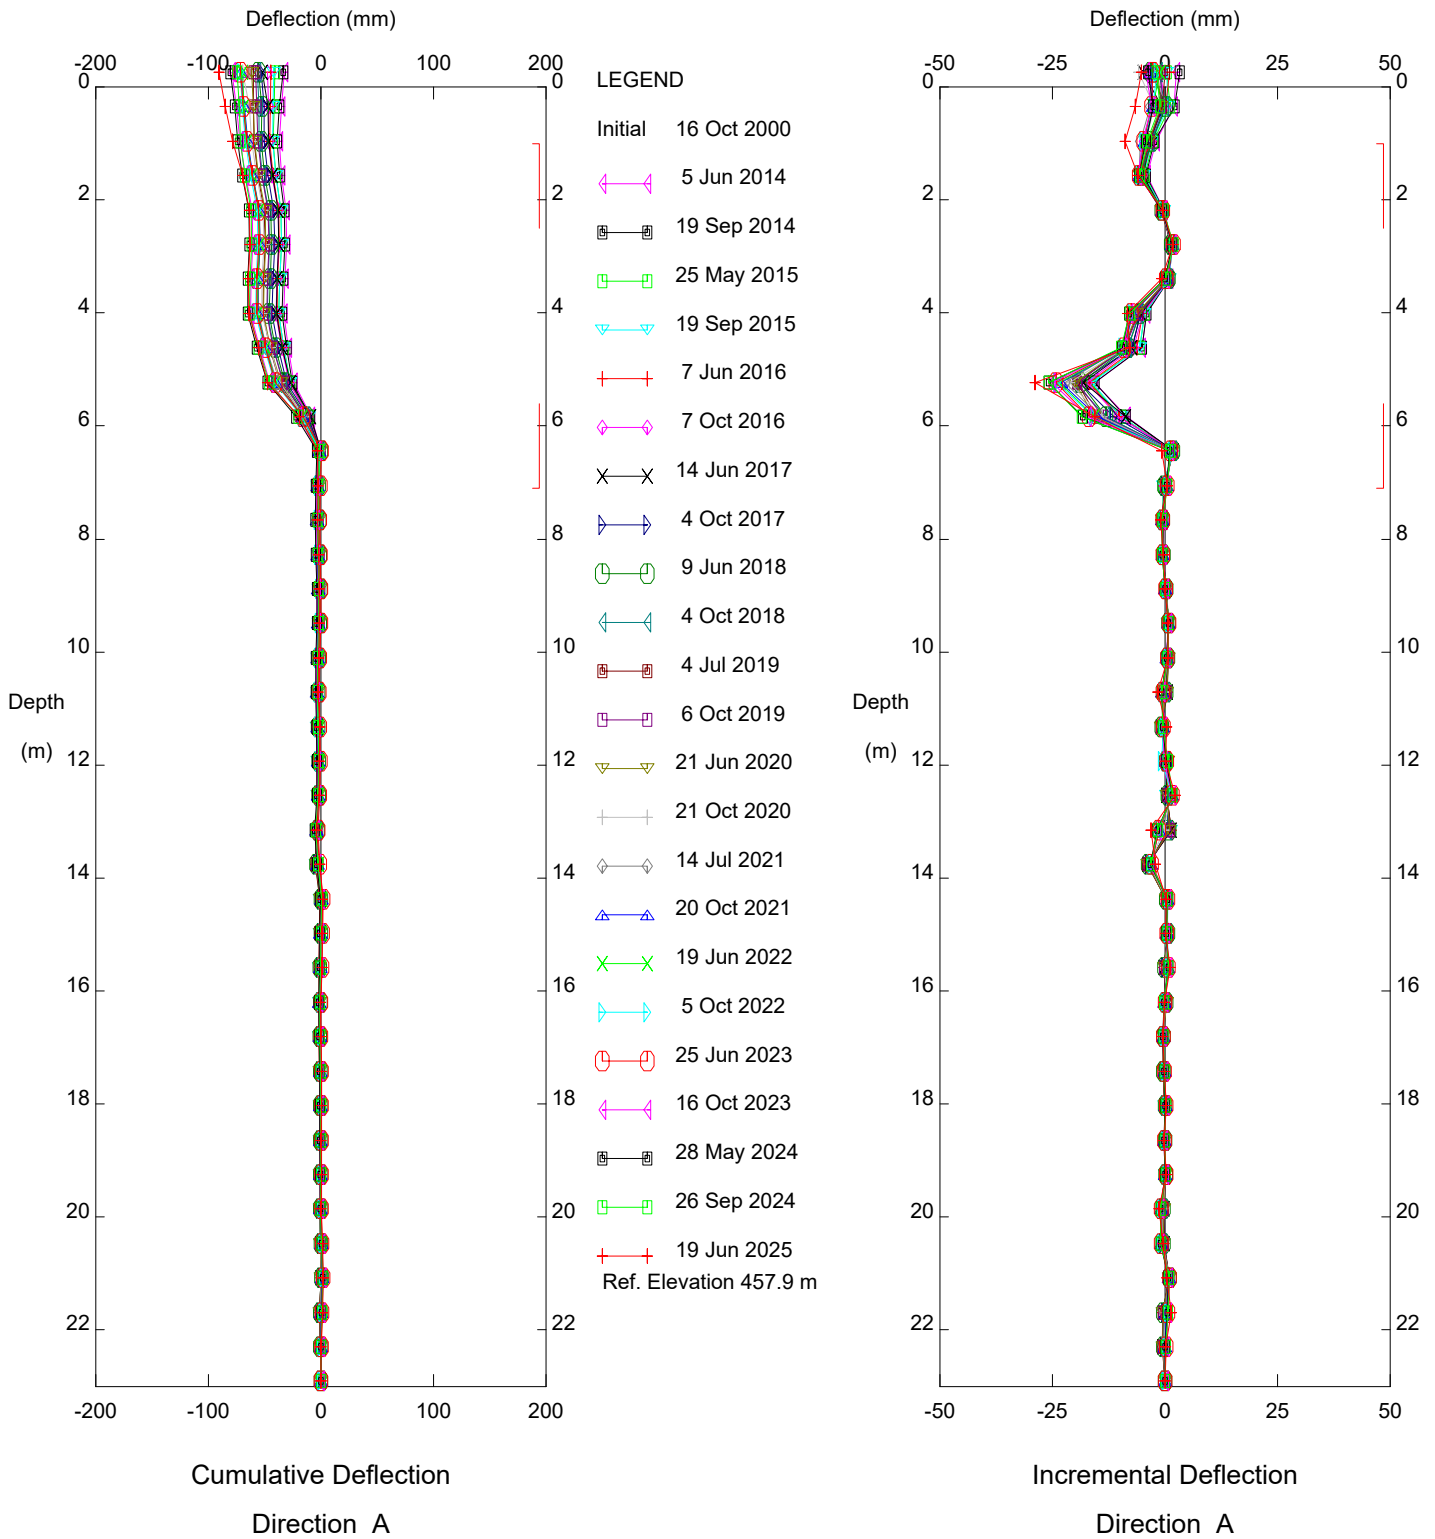
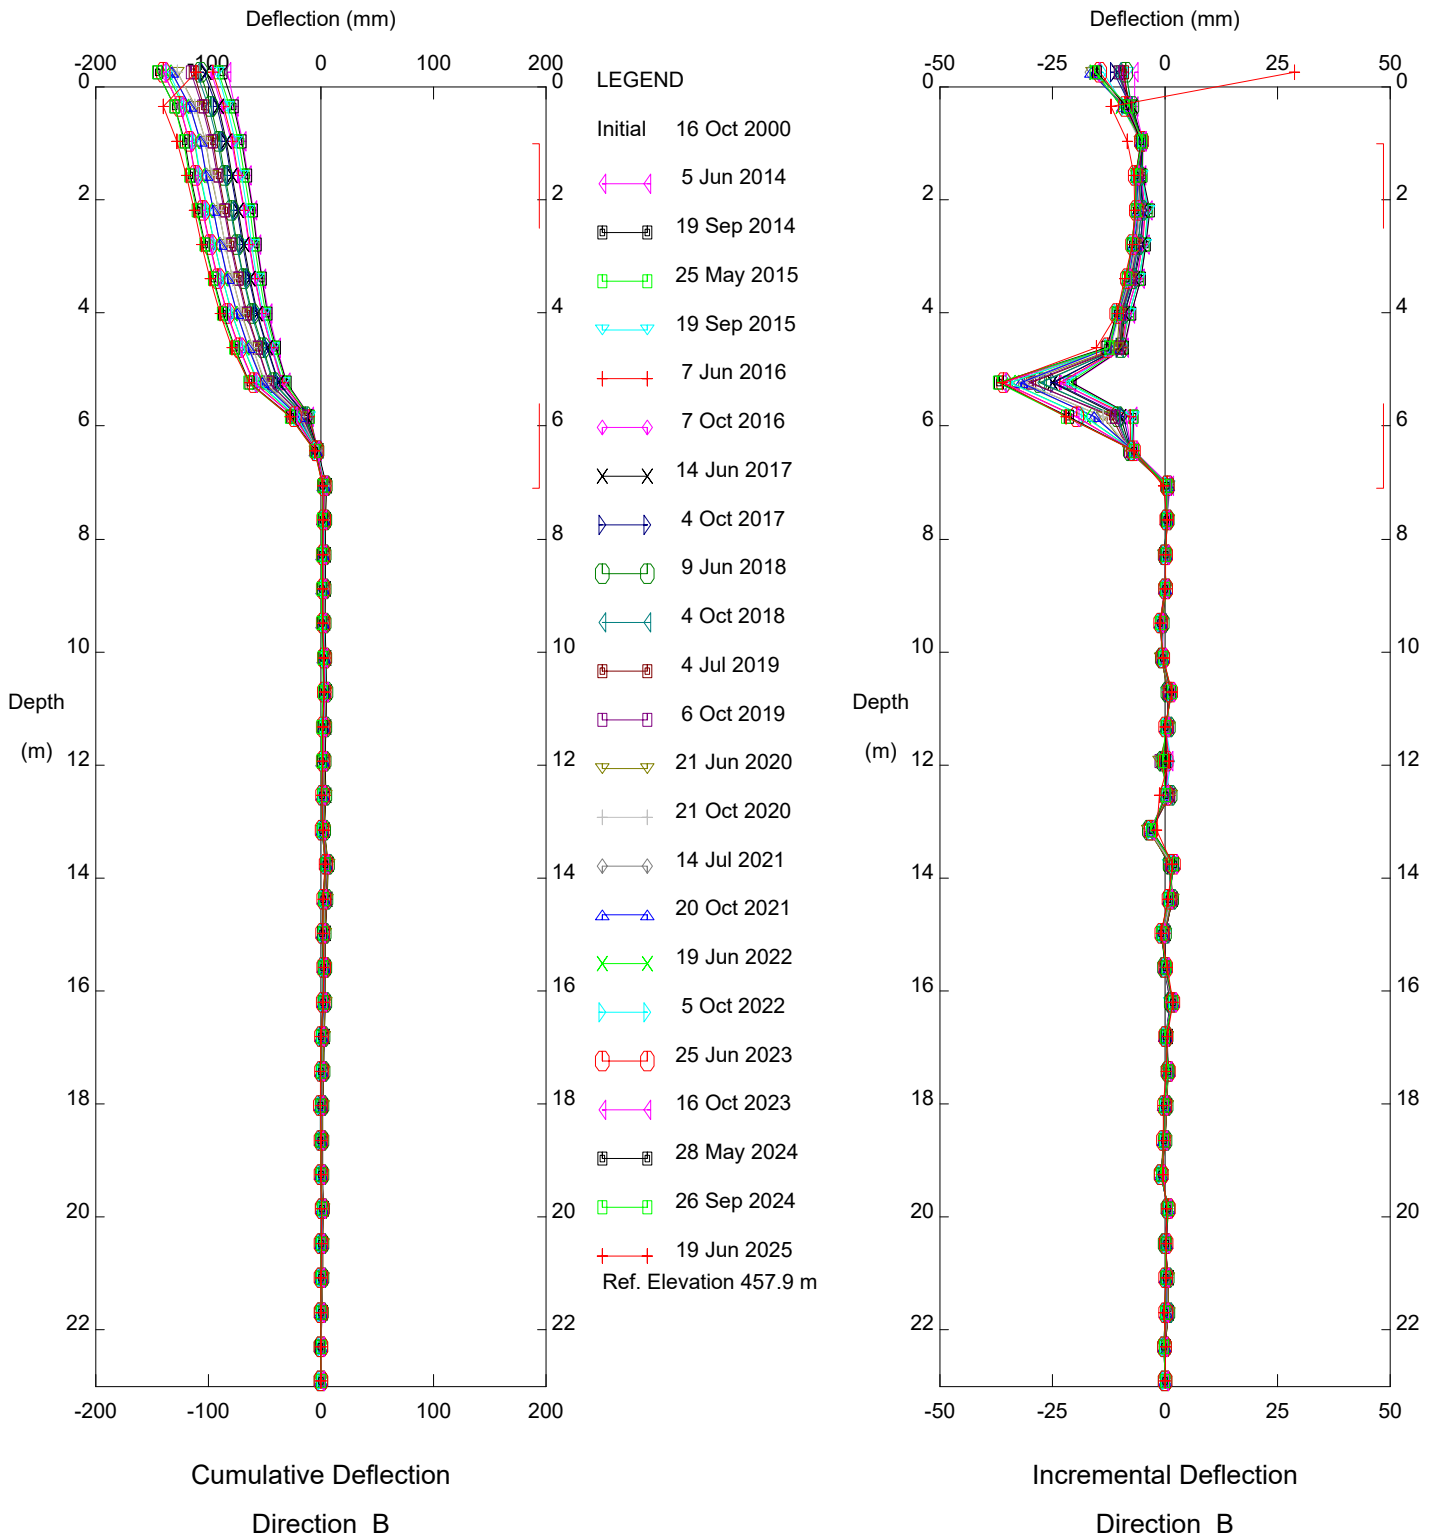
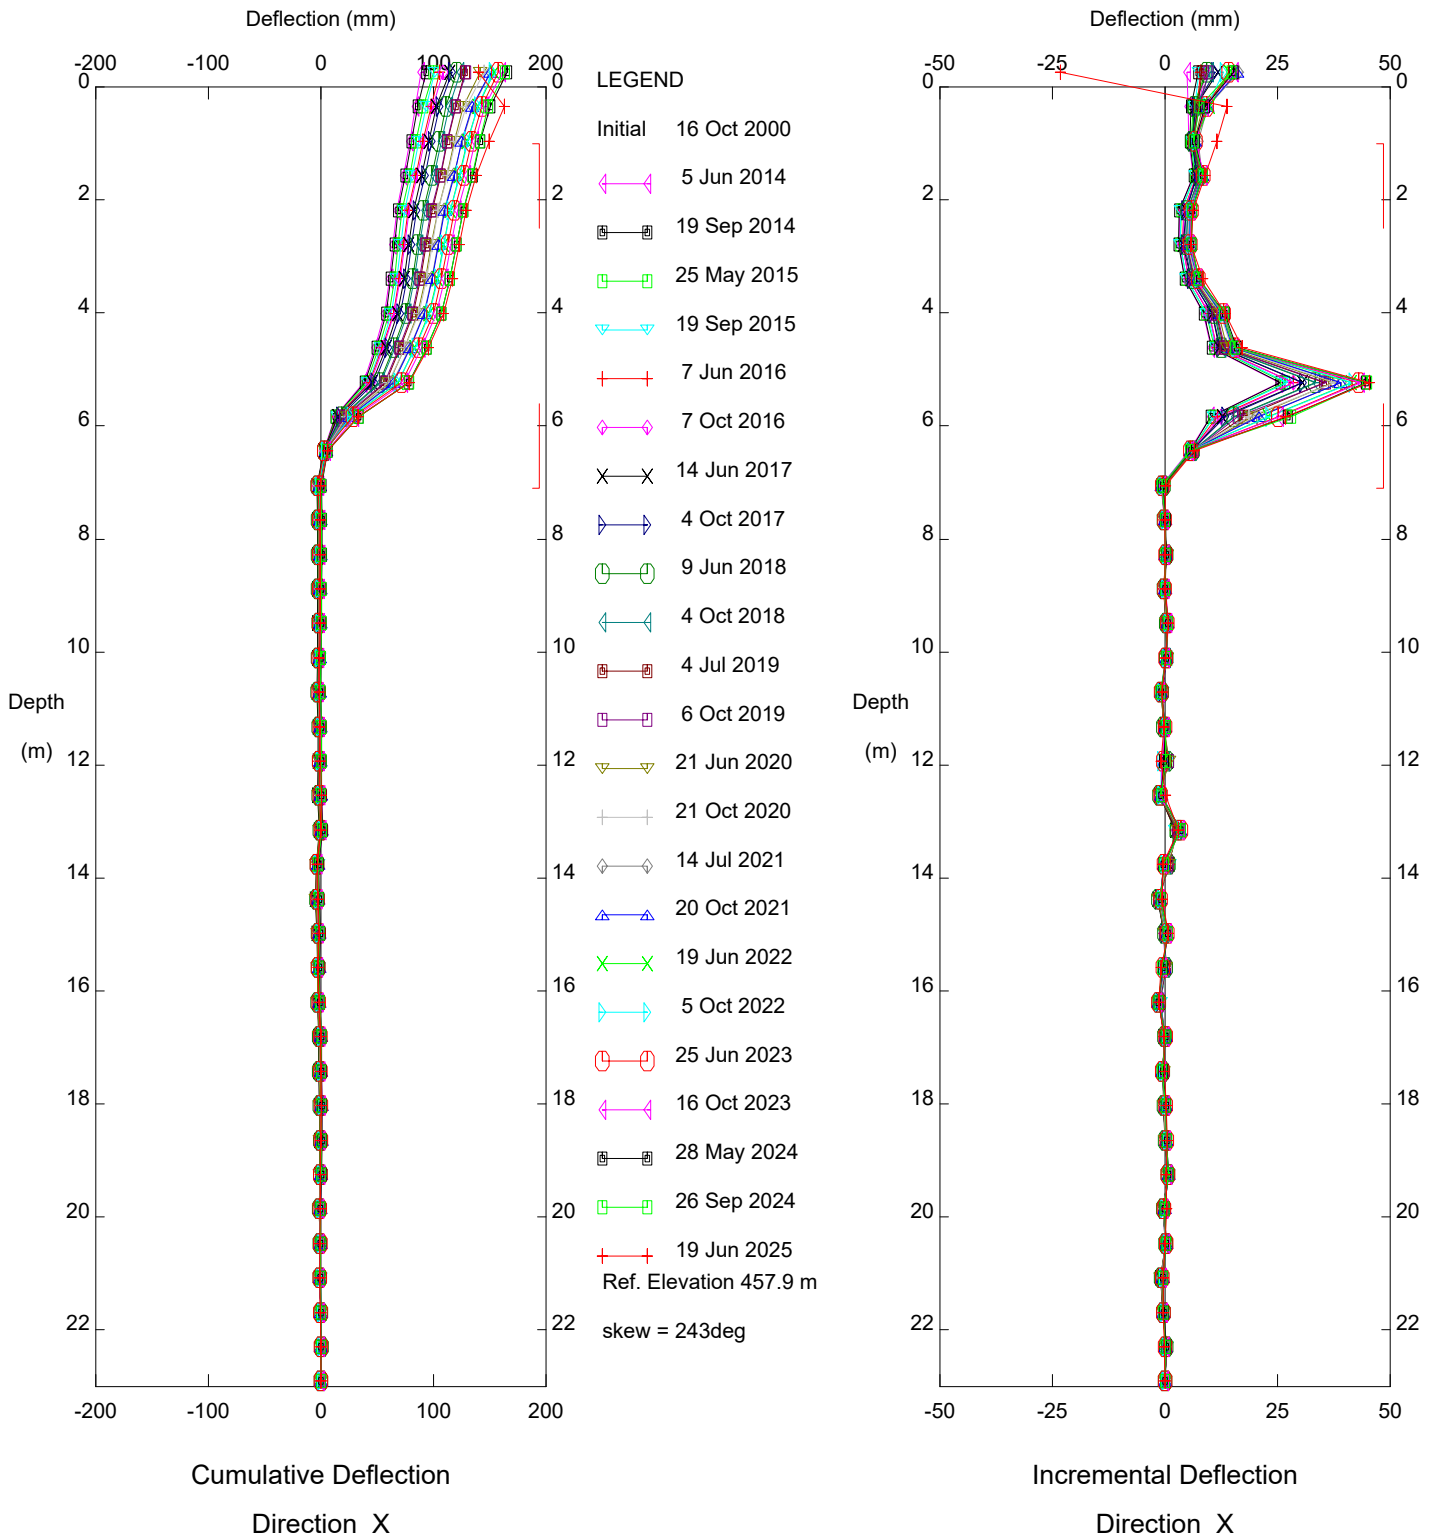
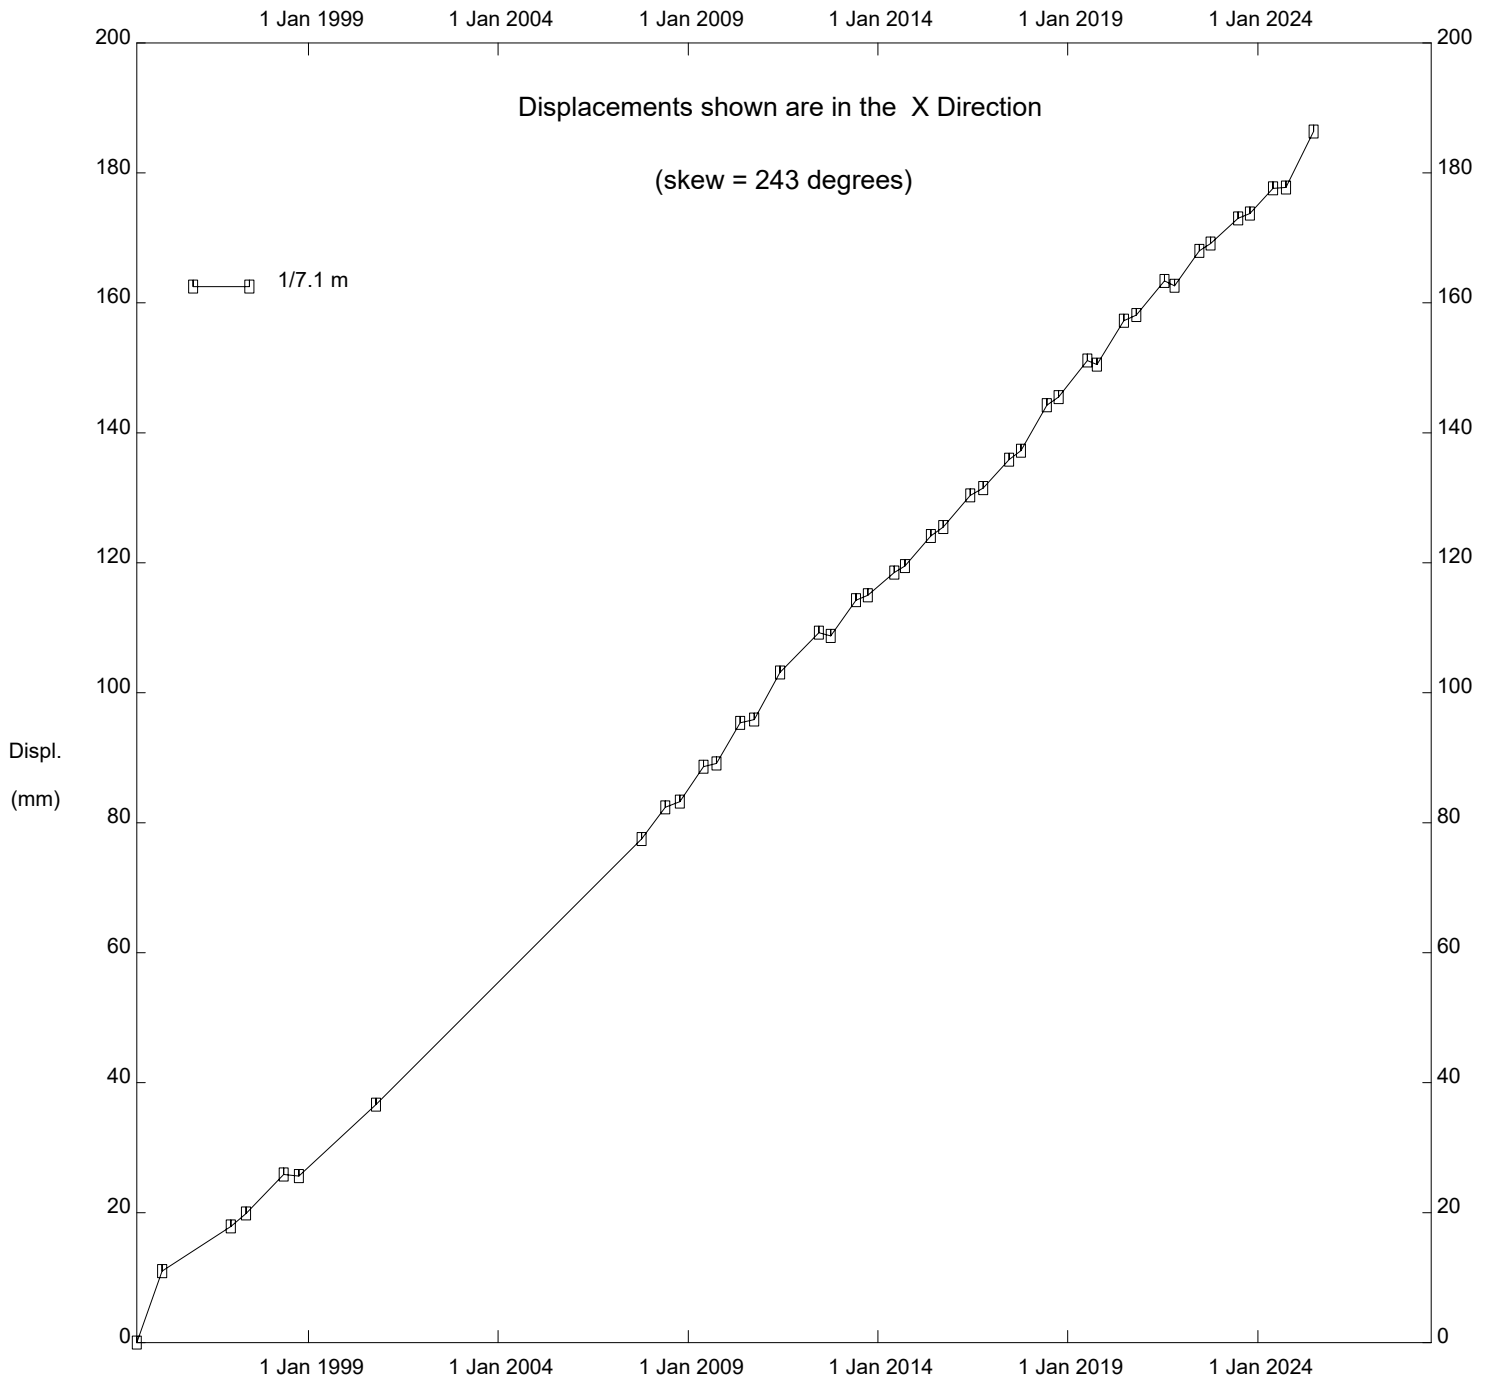
HWY 2:68 (PH037), Inclinometer SI-59

5.6 mm over 18.5 m to 20.3 m depth in 286° direction	1.1 mm/y in October 2017			0.2	0.3	0.2
SI-59	June 28, 1994	186.4 mm over 1.0 m to 7.1 m depth in 299° direction	16.4 mm/yr in March 1995	Operational	September 26, 2024	8.7	11.9	11.9

*SI-61 Hard to pull from 26-24 ft, use dummy probe
*** Slope Direction is 270 degree
SI -59 Damaged during construction broken about 2.0ft from top of casing, can be repaired without mechanical assistance, this time SI read from 74.0 ft
SI-55 DAMAGED can be repaired without mechanical excavation, its broken at 1 foot below ground surface see photo
SI-56 Wiped out during construction, no trace of SI in ditch see photo

which is the highest measured in the instrument since it was initialized in 2018.
Future Work:	The instruments should be read again in the fall of 2025. Another attempt should be made to read PN18-12B to confirm if it is not functioning.
Instrumentation Repairs:	SI-55 and SI-59 are both damaged and should be repaired. Both instruments are damaged near the ground surface and should be repairable by hand.
Additional Comments:
