ALBERTA TRANSPORTATION GEOHAZARD ASSESSMENT PROGRAM PART A: FILE REVIEW

PEACE REGION – PEACE-HIGH LEVEL

PH52 DUNVEGAN NORTH – 10+800

Legal Location:	SE¼16-080-04 W6M
Nearest Landmark:	3 km NE along Hwy 2 from the Dunvegan Bridge
Highway Control Section:	Hwy 2:68
Date of Initial Observation:	May 2007
Date of Last Inspection:	June 2008
Last Inspected By:	Thurber Engineering Ltd.
Instrumentation Installed:	None
Instrumentation Operational:	None
Risk Assessment:	PF = 11 CF = 3 Risk = 33

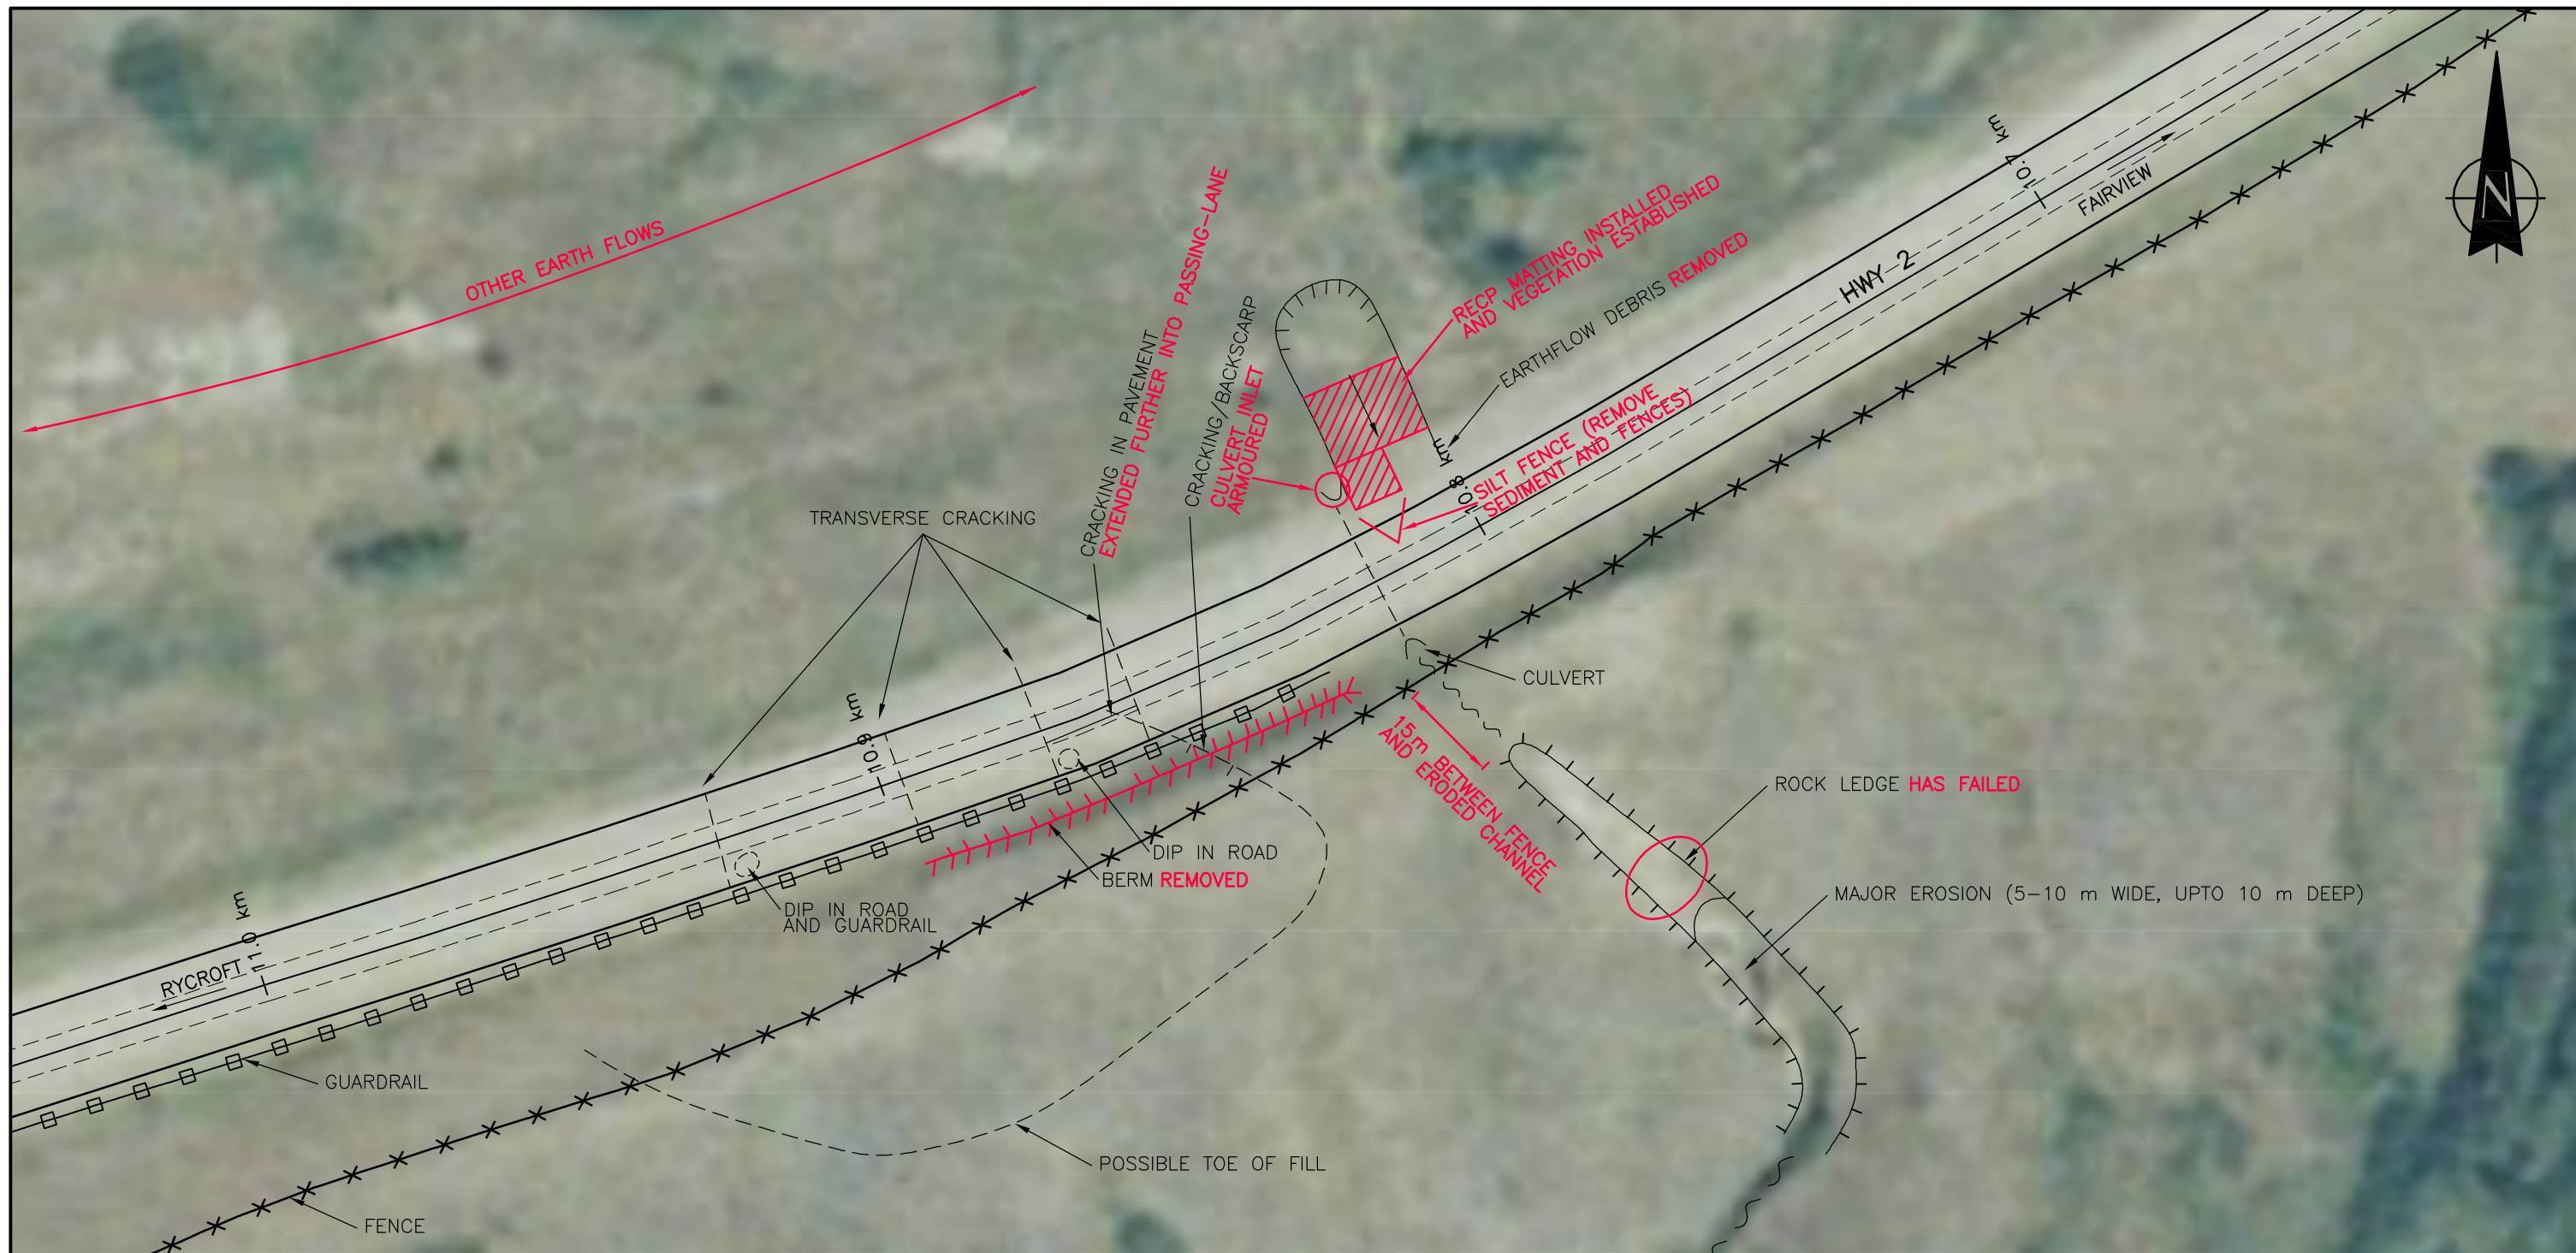
FIGURE 2

The site is located along Hwy 2, 3 km north and east from the Dunvegan Bridge, on the way to Fairview. The site is near the top of the climb out of the Peace River Valley, and covers a 200 m long section of the road. The site includes a roughly 20 m or potentially wider scarp which extends back into the uphill passing lane. The site also includes an up hill shallow soil failure that was repaired in 2007.

The site is in a cut and fill section of the road on the valley side, with exposures of rock downhill of the road at the east end of the site at the culvert outlet. Significant erosion has occurred downstream of the culvert outlet in rock, leaving a 5 m to 10 m wide channel eroded up to 10 m deep. West of this, the road appears to be in fill, with an apparent dip in the natural ground surface downhill of the road in this area. It is west of the culvert crossing that cracking and settlement in the road surface have been noted. However, no toe bulge has been mapped for this feature.

The slope uphill of the road is generally more uniform, suggesting a cutslope. There are a number of shallow slides that become earthflows on the slope above the road, including one that obstructed the ditch upstream of the culvert near km 10.8. Other earthflow features have been identified on the slope above the road to the west of the culvert.

Settlement of the pavement and cracking were first noted in the Spring of 2007, with a callout inspection conducted in May 2007 as part of the regular geohazard assessments. Local patching was conducted at the site and a pavement overlay done through the area during 2007. Cracking and settlement worsened prior to our 2008 inspection.

Spring 2007	Cracking and settlement first noted.
May 2007	Callout inspection. Earthflow plugging upslope ditch. Cracking and settlement noted in the climbing lane, extending across the shoulder at the east end of the site. Severe erosion of channel downstream of culvert at km 10.8.
Summer 2007	Debris removed from upslope ditch and slope repaired – erosion protection measures installed. Berm along downslope shoulder removed. Patching of cracks and pavement overlay.
June 2008	Pavement settlement and cracking has worsened and extended since repairs were conducted. Erosion downstream of the culvert has worsened.
