**ALBERTA TRANSPORTATION
GEOHAZARD ASSESSMENT PROGRAM
PEACE REGION – PEACE-HIGH LEVEL
2018 INSPECTION**

Site Number	Location	Name	Hwy	km
PH052-1	Dunvegan	Dunvegan North 10+800	2:68	10.80
Legal Description		UTM Co-ordinates		
SE¼ 16-080-04 W6M		11U E 402466	N 6199552

**PEACE REGION (PEACE RIVER/HIGH LEVEL)
PH052-1 DUNVEGAN NORTH - HIGHWAY 2:68**

2018 PH052-1 INSPECTION PLAN

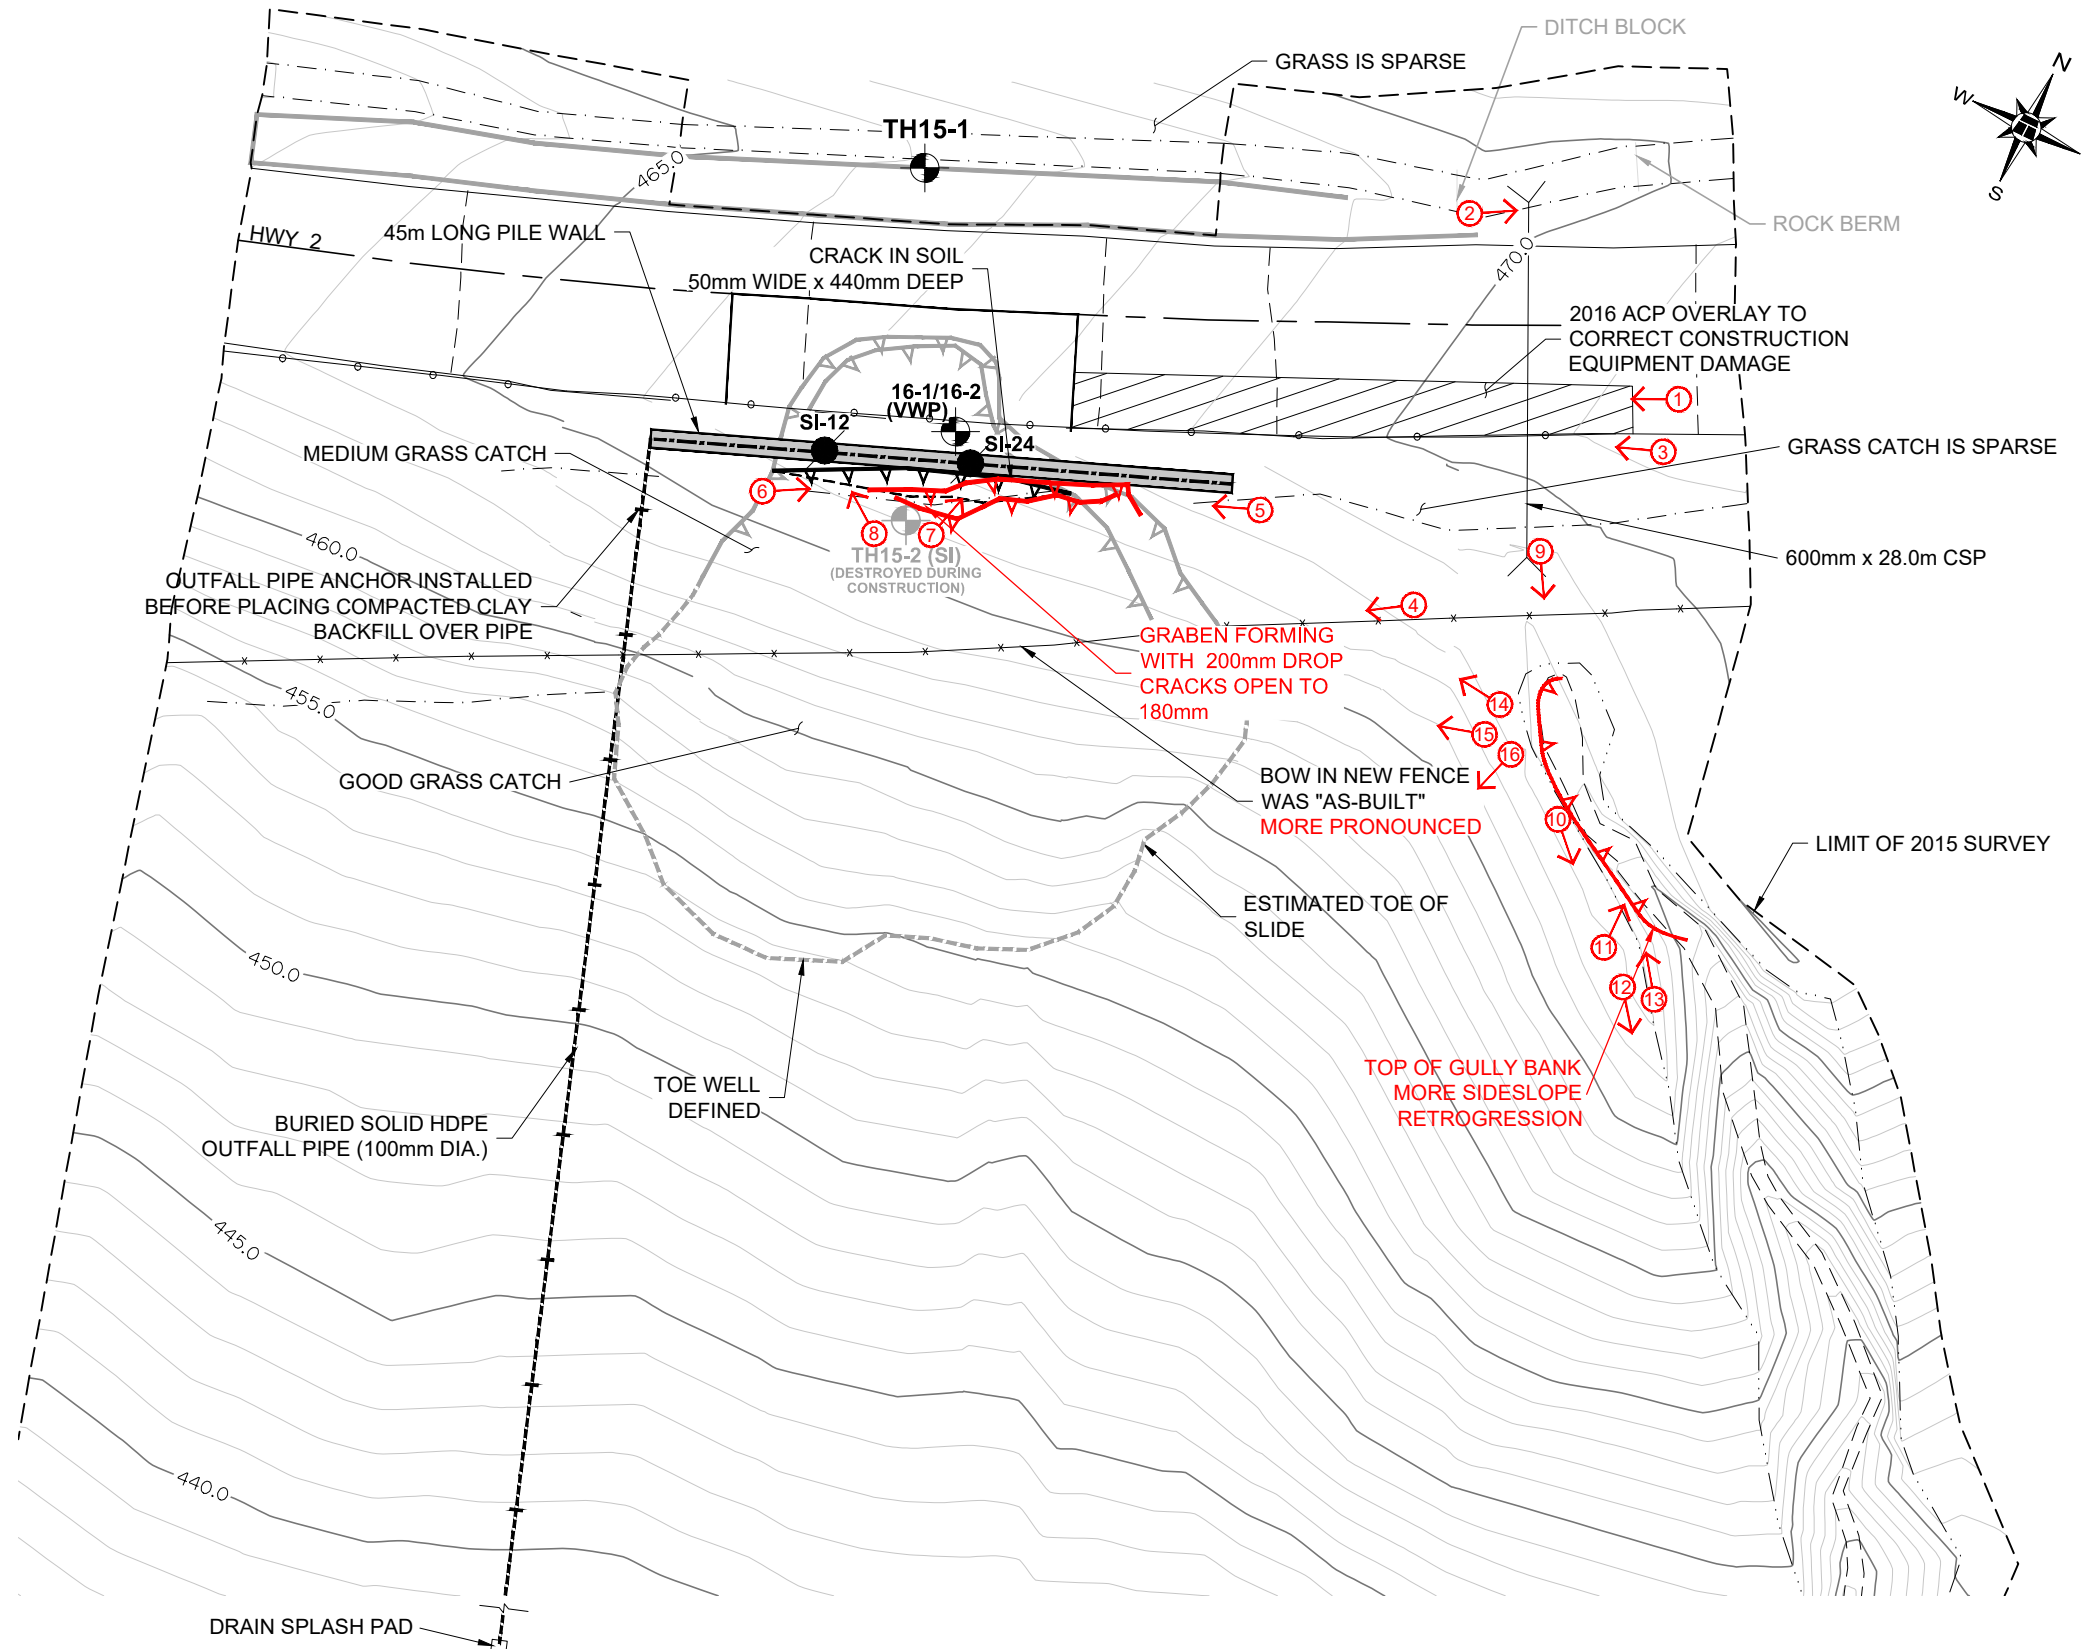
NOTE:
1 MAY 15, 2018 OBSERVATIONS SHOWN IN RED.

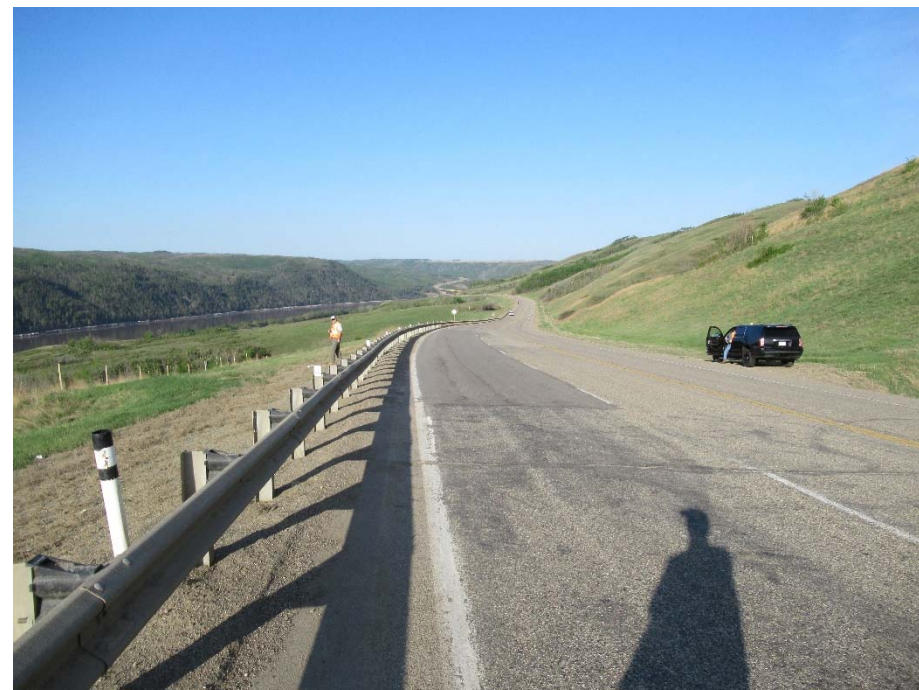
Photo 1.
Looking SW from the NBL of Hwy 2:68 towards the 2015/2016 landslide repair under Alberta Transportation Contract CON0017398. The ACP placed in 2016 is still smooth and there are no signs of cracks or dips.

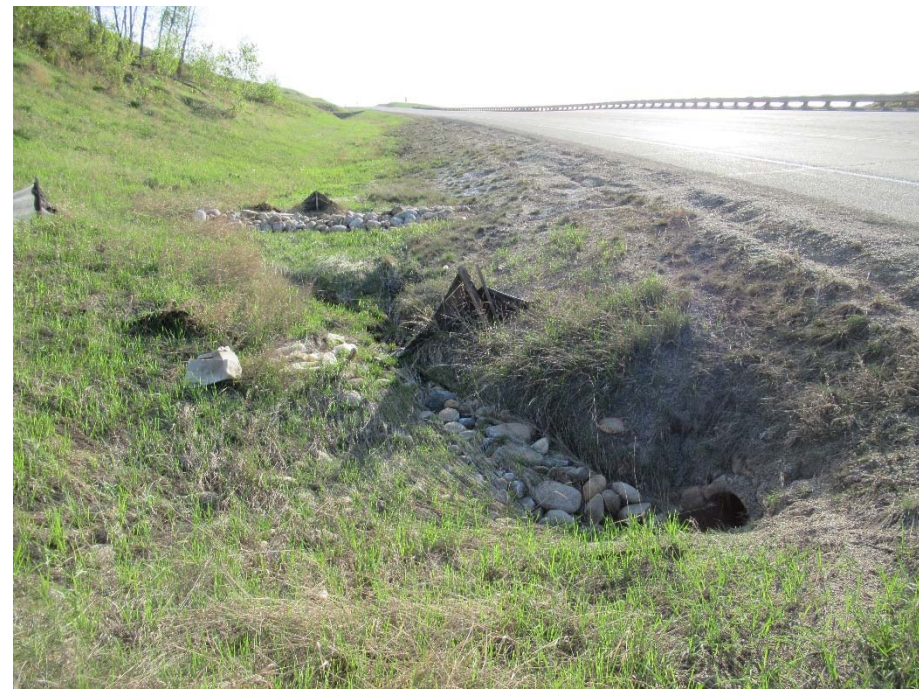
Photo 2.
Looking northeast at inlet to 600 mm diameter CSP and rock berm. No significant change since 2017.

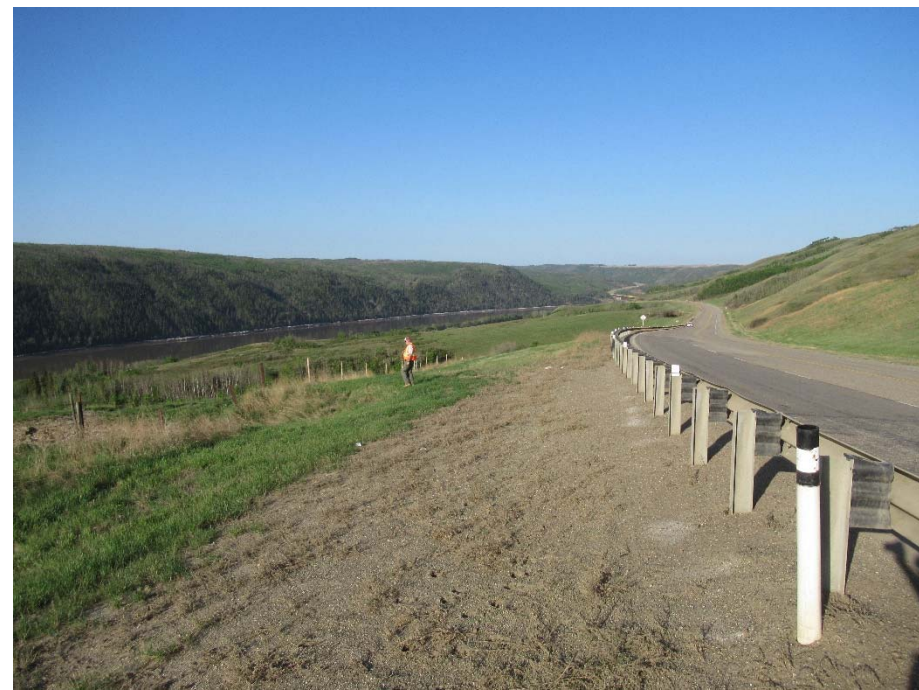
Photo 3.
Looking southwest from east of the new pile wall built in 2015/2016. The pile wall is buried below ground. Grass catch is sparse east of the pile wall (foreground).

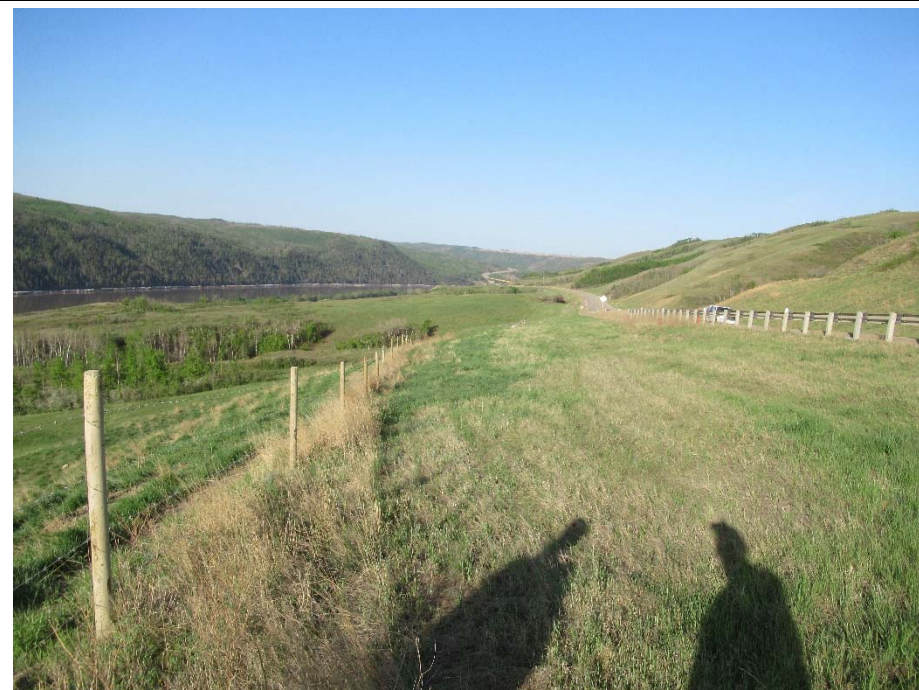
Photo 4.
Looking southwest along the new pile wall built in 2015/2016. The pile wall is buried below ground. The grass catch in the area seeded in the highway sideslope at the wall location is good. The bow in the new fence installed in 2016 is more pronounced than in 2017.

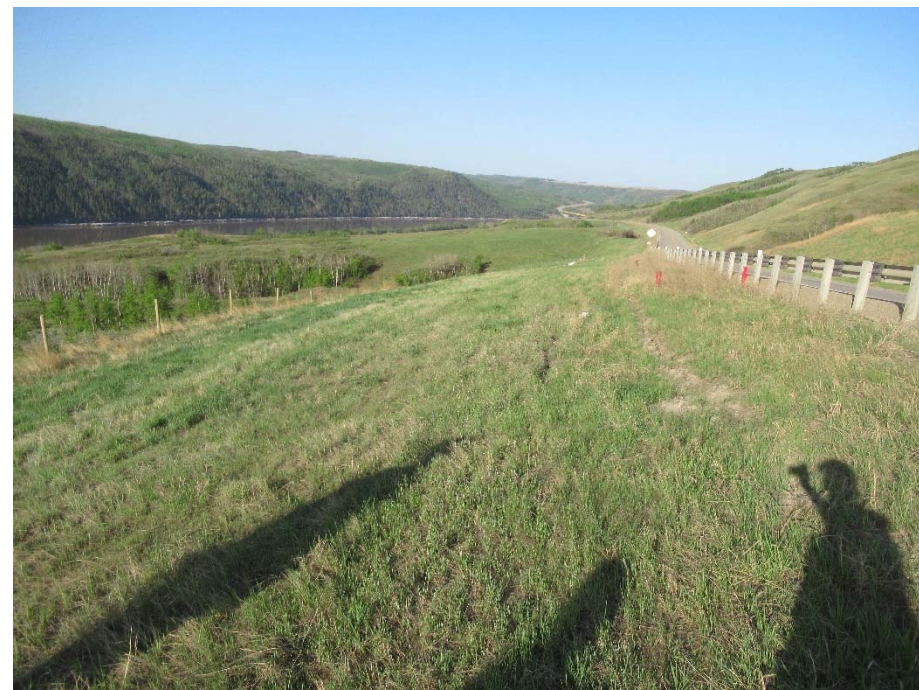
<input checked="" type="checkbox"/> Slope Movement	<p>The main landslide feature affecting the roadway was repaired in 2015/2016. There have been some cracks and a graben that have formed in the passive bench downslope of the pile wall since 2016. The openings in the cracks are up to 180 mm in width and the graben is 1.5 m to 4.5 m wide with an overall drop of 200 mm (Photos 5 and 6).</p> <p>There is bow in the new barbed wire fence below the highway (Photo 4).</p> <p>Slides above the highway were also noted in the backslope (Photos 7 and 8).</p>	<input checked="" type="checkbox"/>	
<input checked="" type="checkbox"/> Erosion	Runoff from both the roadway ditch and the scoured channel below the centerline culvert appears to be causing sediment to accumulate about 80 m downslope below the roadway. There has been some deepening of the scour channel	<input checked="" type="checkbox"/>

Assessment:		
<p>Following the two May 2015 call-outs, Thurber performed a geotechnical investigation and prepared tender drawings for the remediation work to repair the landslide. The landslide was repaired in 2015 and 2016 as part of TRANS Contract CON0017398 with the construction of a 46 m long cantilever cast-in-place concrete pile wall. The top of the pile wall was buried below ground and the original highway NBL and sideslope were reinstated as part of the repair. Two slope inclinometers were installed in selected piles in the wall and will be monitored twice annually for downslope movement as part of the annual geohazard instrument reading program.</p> <p>The new pile wall was built as cantilever pile wall with the capability of accommodating tie-back anchors in the eventuality that the passive soil bench support would become compromised.</p> <p>A 1.5 m to 4.5 m wide graben with a 0.2 m drop has formed since in the passive bench below the pile wall.</p>

Photo 5.
Looking southwest along the buried cantilever pile wall built in 2015. The graben in the passive bench below the wall is more apparent since 2017 with cracks open to 180 mm with a 200 mm drop.

Recommendations:		Cost
Bi-annual readings of the SI's in the wall and annual inspection of the cracks in the passive bench downslope of the pile wall are still required to monitor for any sign of downslope movement of the pile wall.		Monitoring
The graben that has formed in the passive bench below the pile wall should be backfilled, top soiled and seeded.		Maintenance
The existing centerline culvert that crosses the highway east of the landslide could be grouted and surface water should be directed along the existing southbound lane ditch to the existing bridge culvert further downslope to the southwest, if the downstream culvert and ditch can accommodate the extra flow. Alternatively, the culvert should be flushed out and the erosion gully repaired.		\$500,000

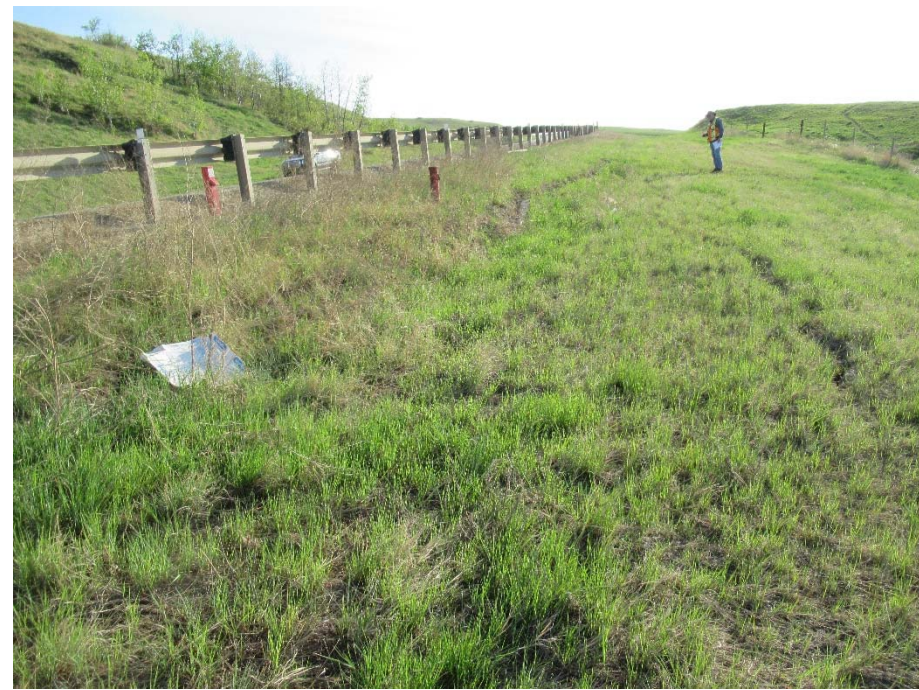
Photo 6.
Looking northeast along the graben forming in the passive bench below the pile wall. The graben varies in width from 4 m at the west end to 1.5 m at the east end of the pile wall.

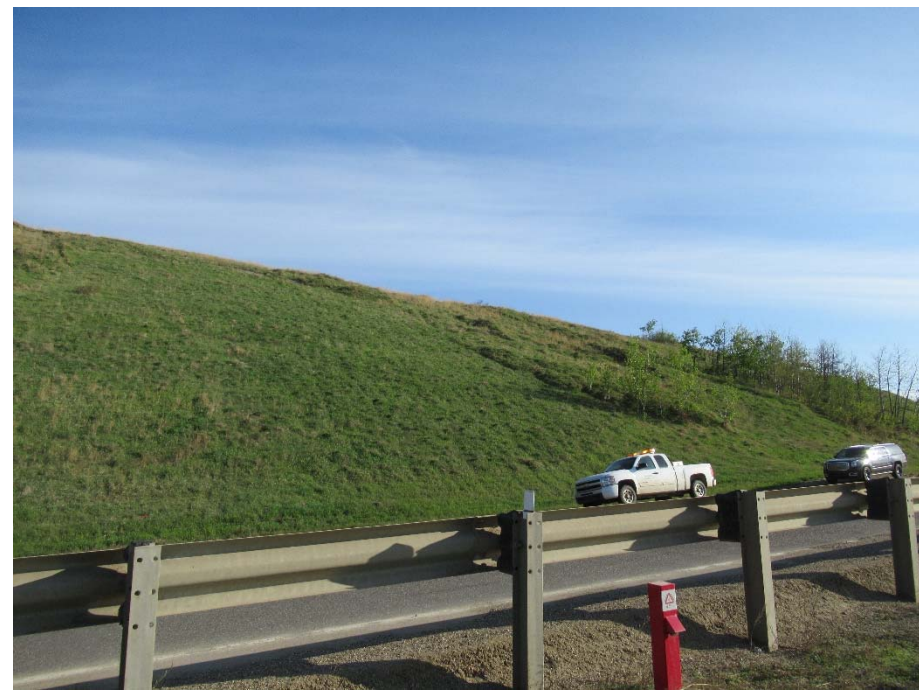
Photo 7.
Looking north from
the new pile wall at
the skin failures in the
backslope above the
highway.

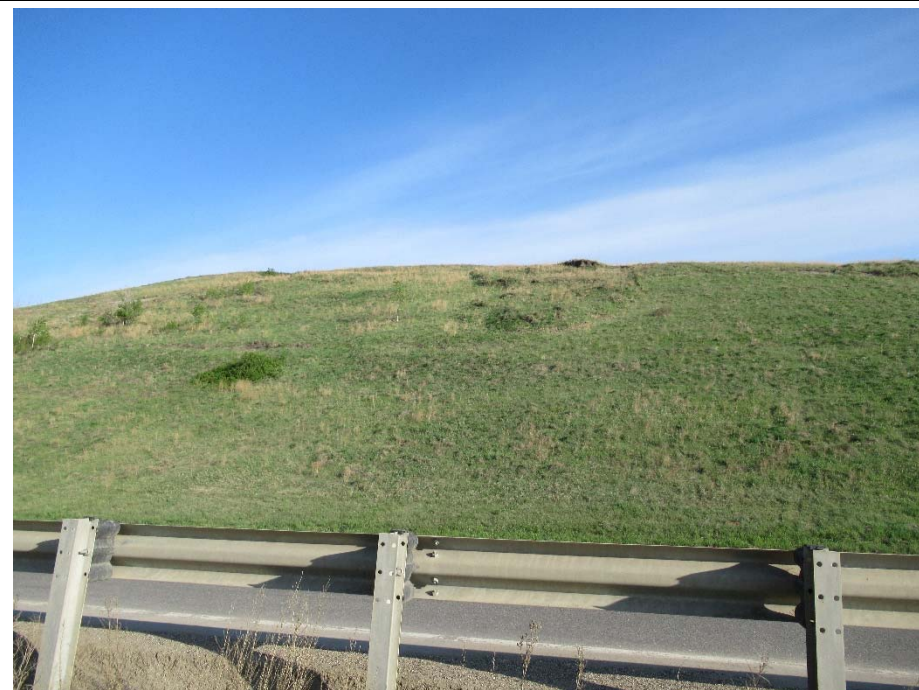
Photo 8.
Looking northwest
from the new pile wall
at the skin failures in
the backslope above
the highway.

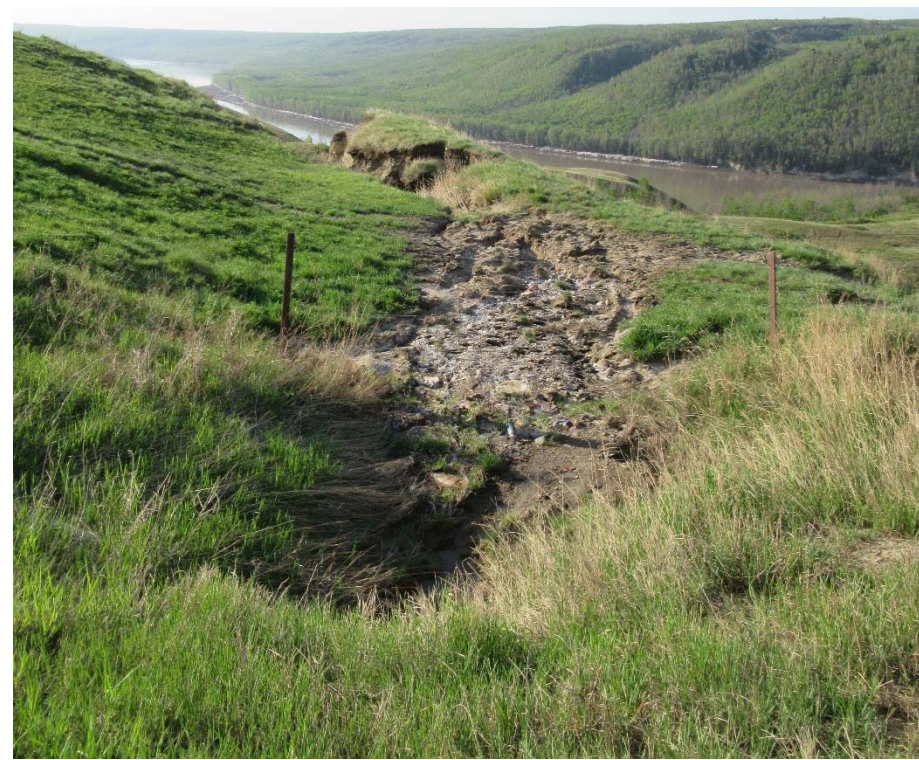
and some slight retrogressing on the scour channel sidewalls. There has been no retrogression of the scour channel upslope towards the outlet of the centerline culvert since 2017 (Photos 9, 10 and 13).	
<input type="checkbox"/> Seepage		<input type="checkbox"/>
<input checked="" type="checkbox"/> Bridge/Culvert Distress	There is a 600 mm diameter 28 m long CSP centerline culvert to the east of the pile wall (Photo 2).	<input type="checkbox"/>
<input type="checkbox"/> Other		<input type="checkbox"/>
Instrumentation:		
SI16-12 and SI16-24	Two slope inclinometers were installed in the cantilever retaining wall piles during construction and there has been no discernable movement observed since their initialization on July 4, 2016.	
VW16-1 and VW16-2	Two vibrating wire piezometers were installed upslope of the cantilever pile wall during construction at 9 m and at 16 m depths below the finished ground surface (BGS). VW16-1 (9 m BGS) showed a water level of 0.2 m above the tip and VW16-2 (16 m BGS) showed a water level of 2.1 m above the tip during the spring 2017 readings.

Photo 9.
Looking southeast from north of the centerline culvert outlet towards the scour channel. No significant change since 2017.

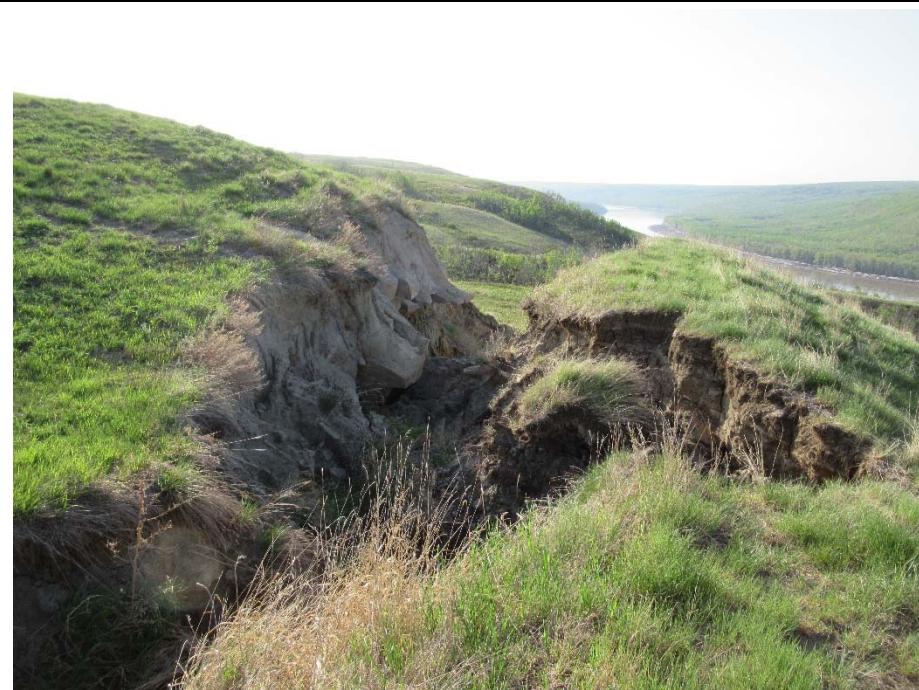
Photo 10.
Looking southeast from the north end of the scour channel that has developed below the outlet of the centerline culvert. The scour is slightly wider and there are no signs of retrogression towards the highway since 2017.

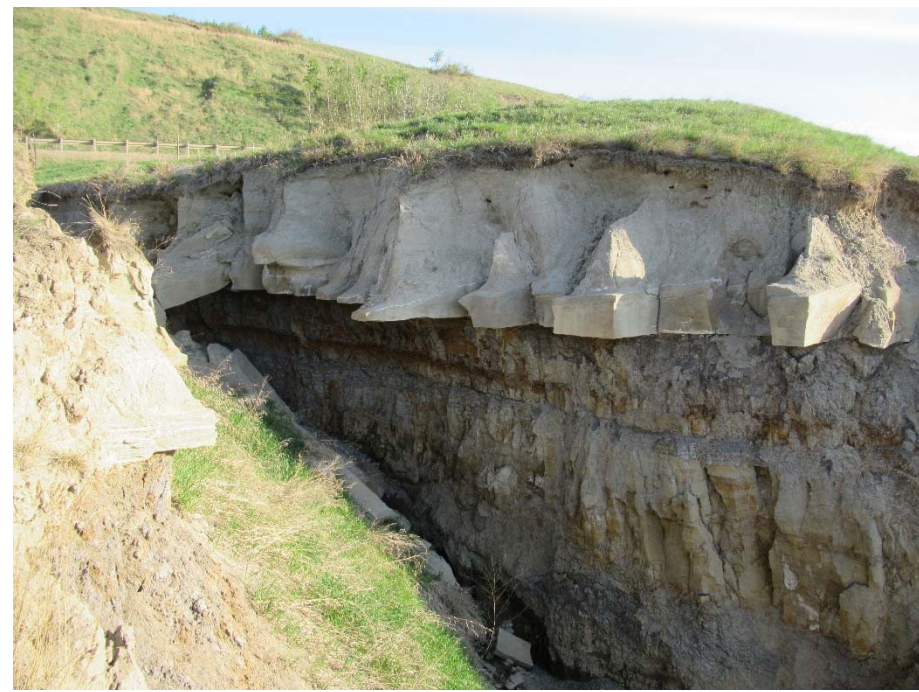
Photo 11.
Looking north from
the west side of the
scour channel that is
situated below the
outlet of the
centerline culvert.

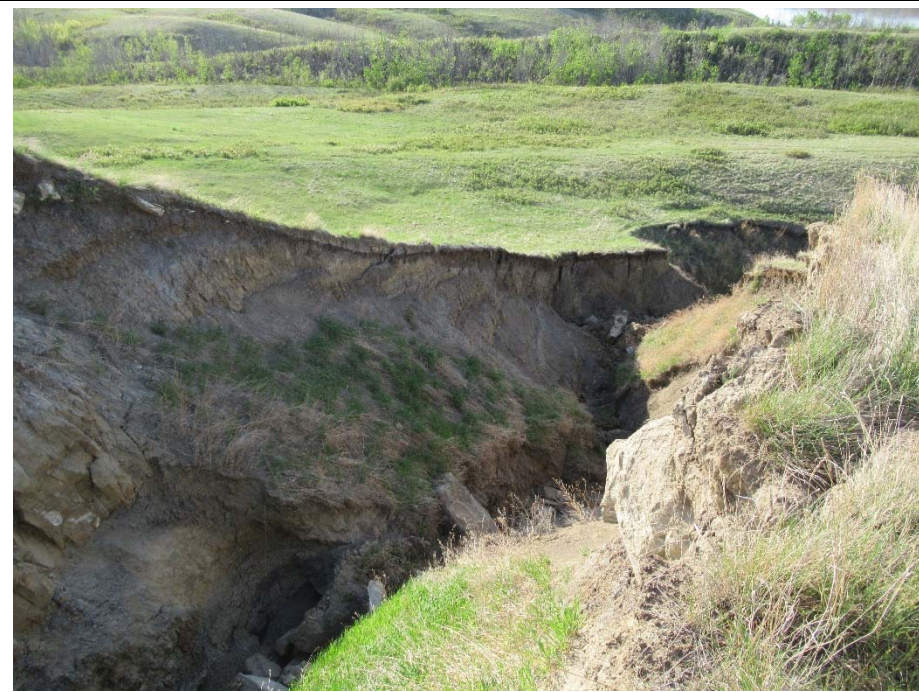
Photo 12.
Looking southeast
along the centerline
culvert scour channel
at mid-slope.

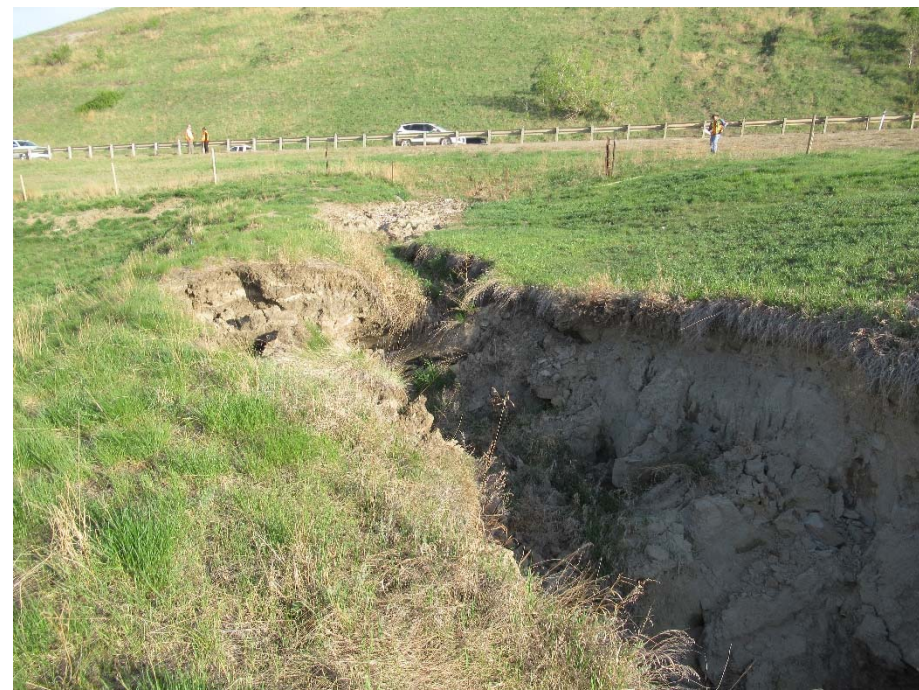
Photo 13.
Looking northwest
from the north end of
the scour channel
towards the outlet of
the centerline culvert.

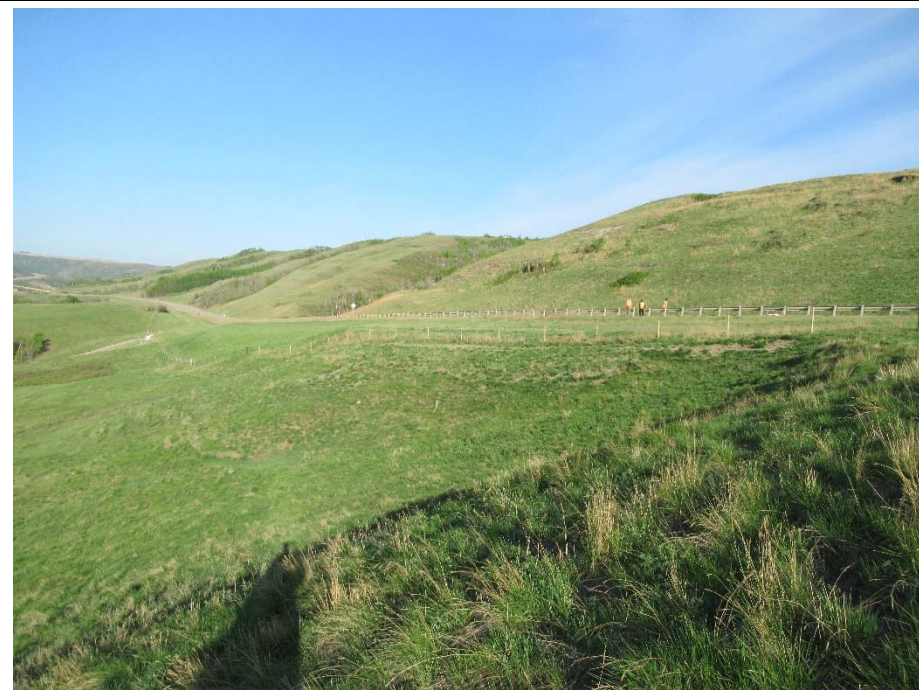
Photo 14.
Looking west towards
the Dunvegan North
landslide repair. The
grass catch is still
good downslope of
the repair.

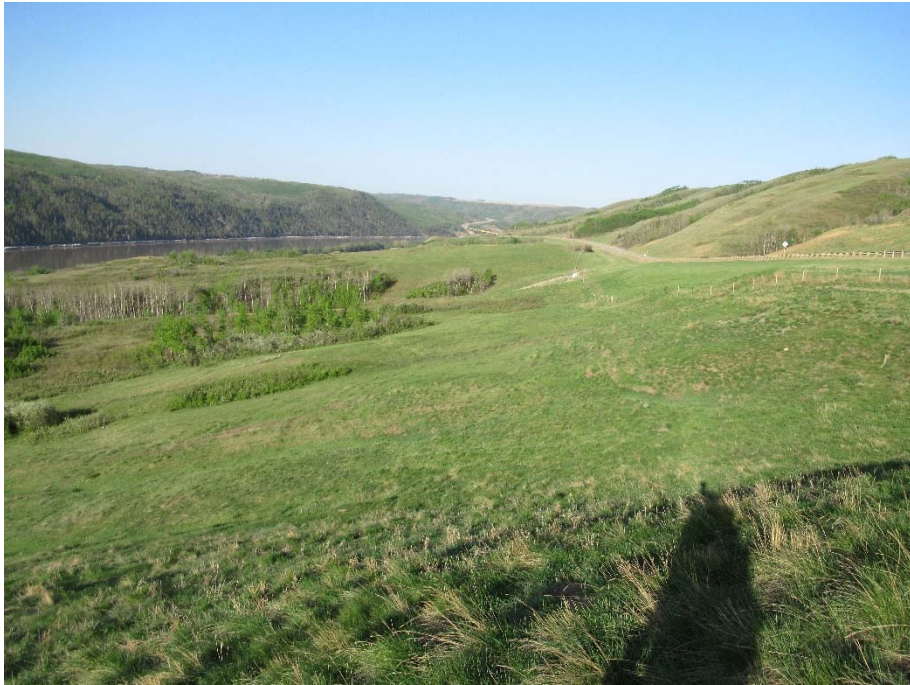
Photo 15.
Looking southwest towards the Dunvegan North landslide repair. The grass catch is good downslope of the repair. The old toe bulge is still distinct.

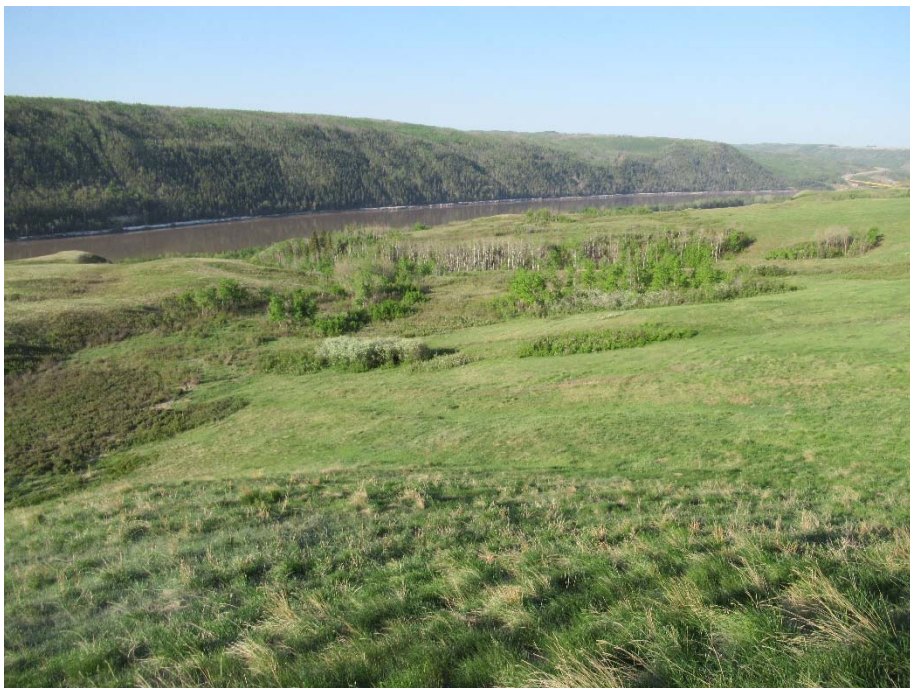
Photo 16.
Looking southwest downslope of the Dunvegan North landslide repair. The grass catch is still good downslope of the repair. No significant change since 2017.
