**ALBERTA TRANSPORTATION  
GEOHAZARD ASSESSMENT PROGRAM  
PEACE REGION – PEACE-HIGH LEVEL  
2020 INSPECTION**

Site Number	Location	Name	Hwy	km
PH052-1	Dunvegan	Dunvegan North 10+800	2:68	10.80
Legal Description		UTM Co-ordinates		
SE¼ 16-080-04 W6M		11U E 402466	N 6199552

**2020 PH052-1 INSPECTION PLAN**

**DWG No. 13351-PH052-1**

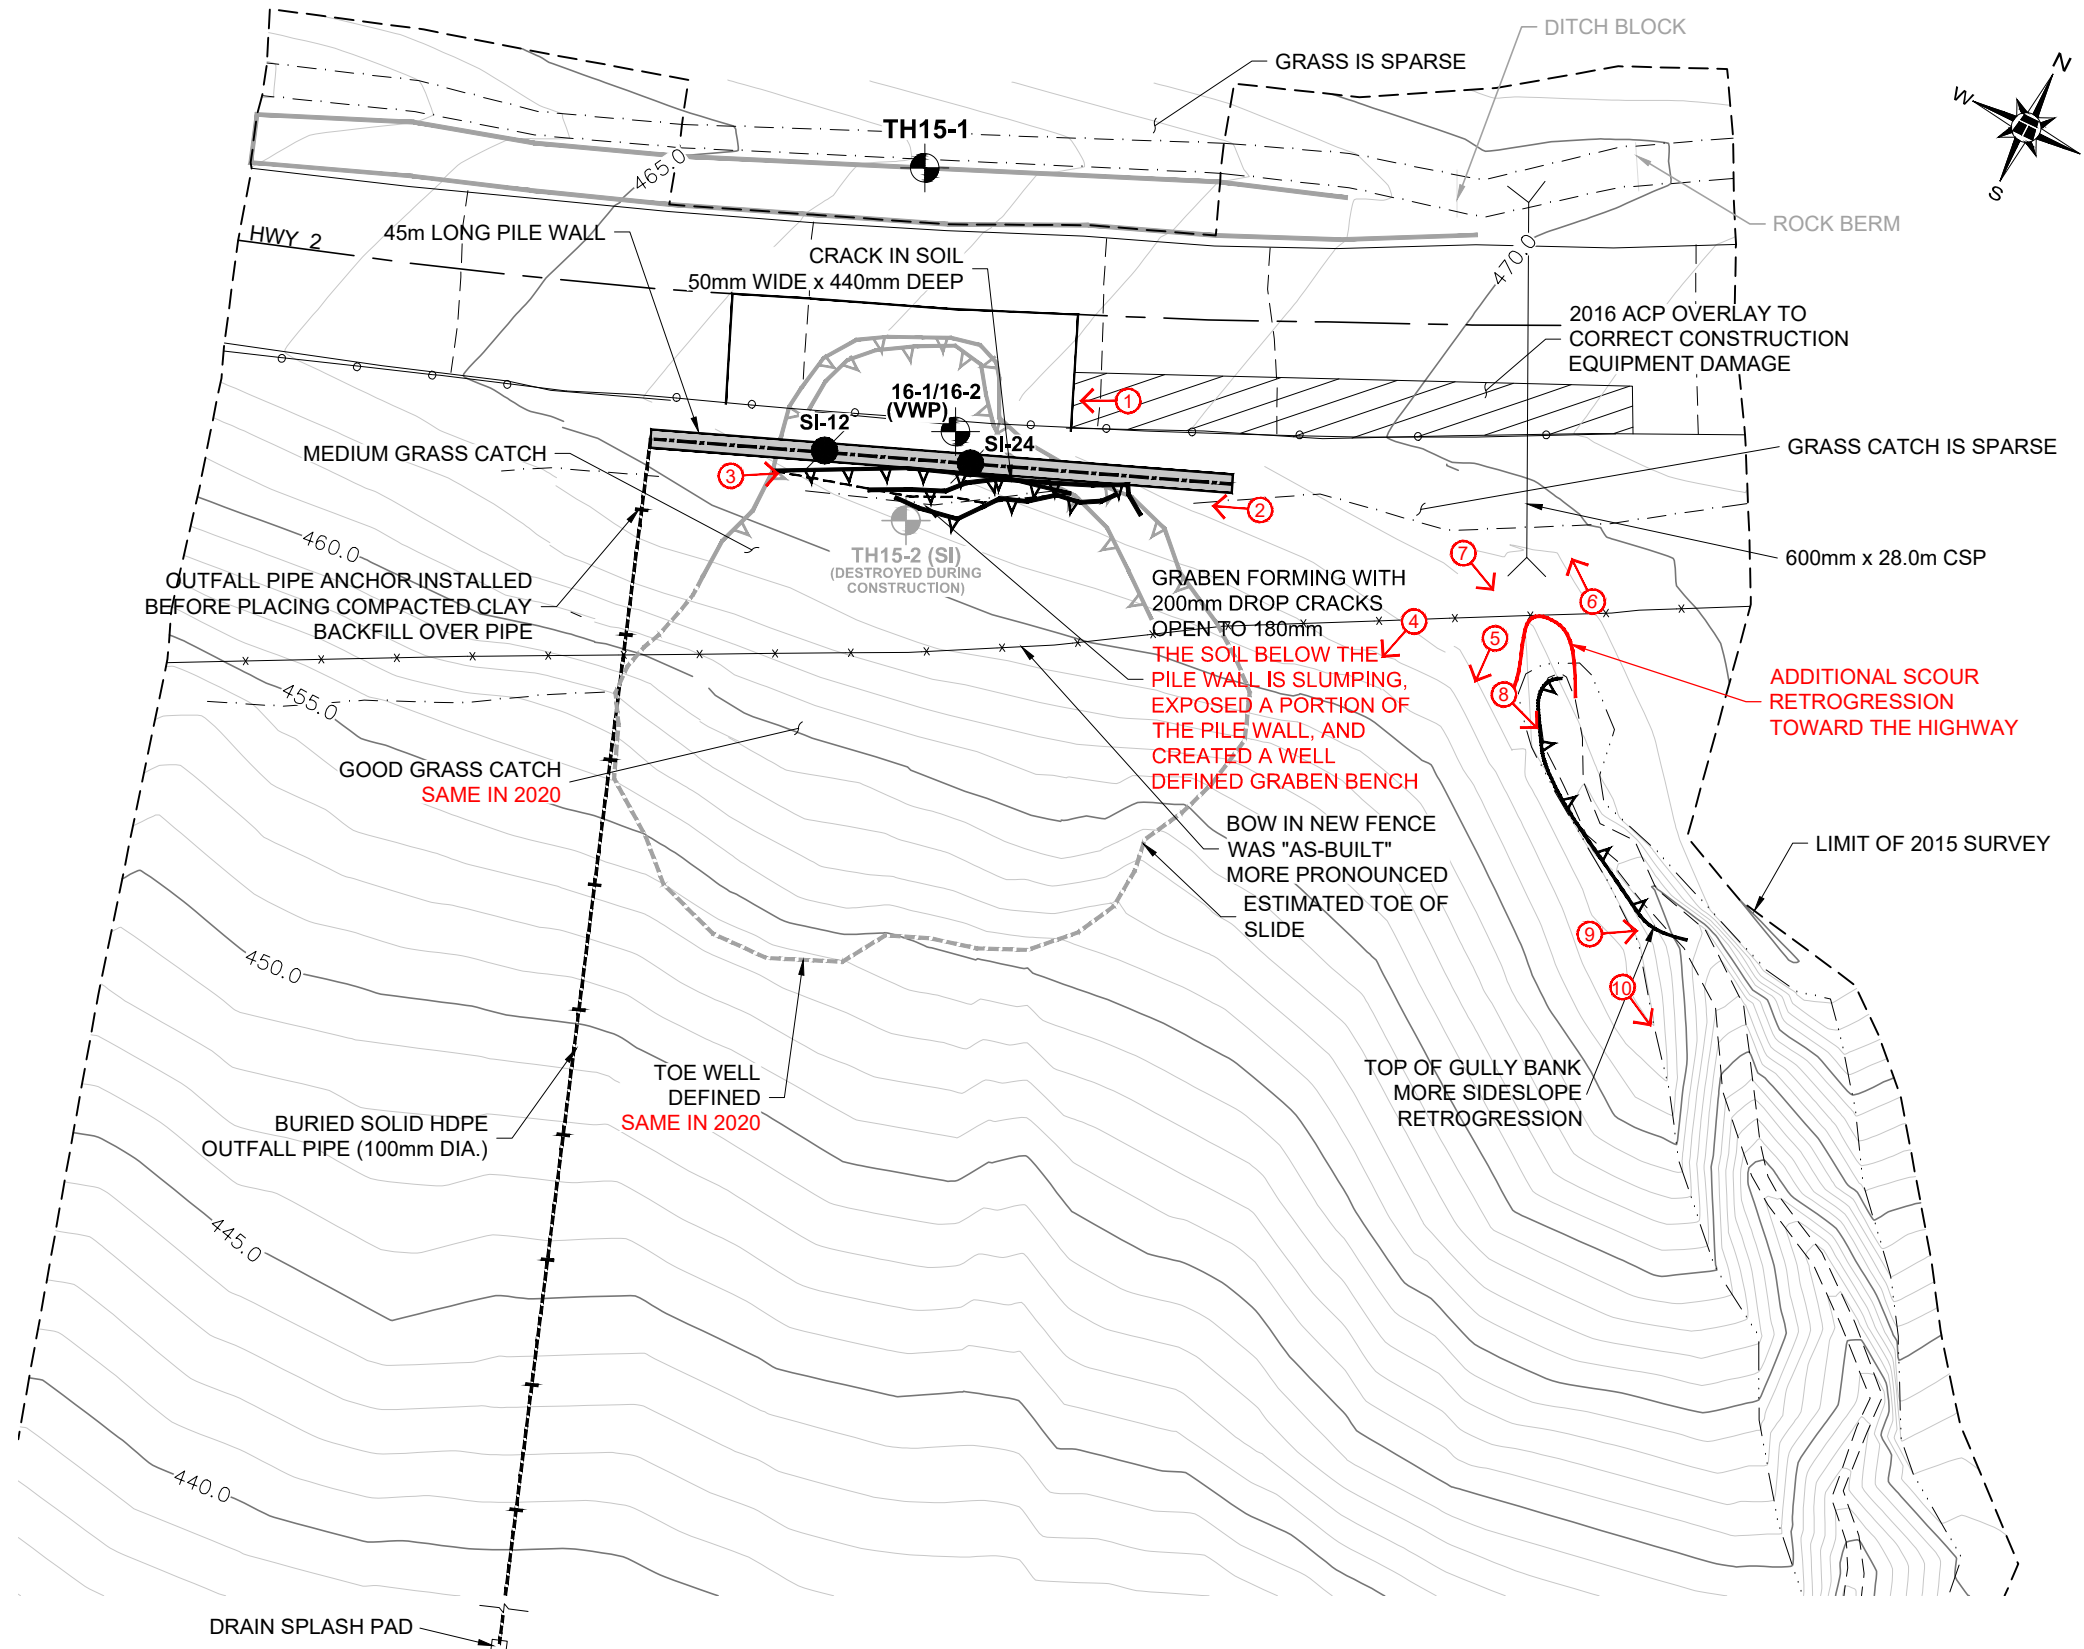
NOTE:  
1 JUNE 12, 2020 OBSERVATIONS SHOWN IN RED.

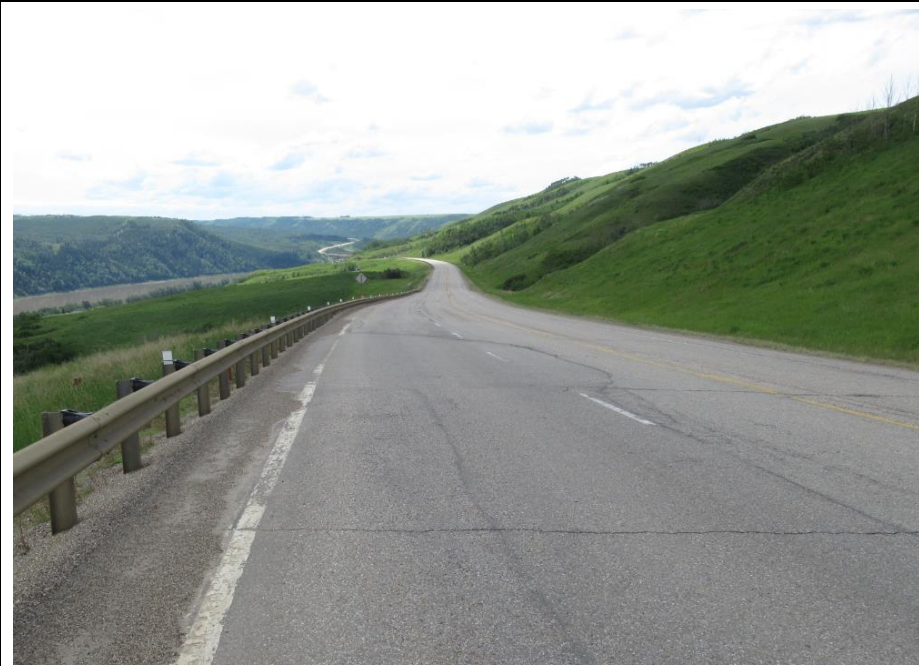
**Photo 1.**  
Looking SW from the NBL of Hwy 2:68 towards the 2015/2016 landslide repair under Alberta Transportation Contract CON0017398. Reflective cracks became visible.

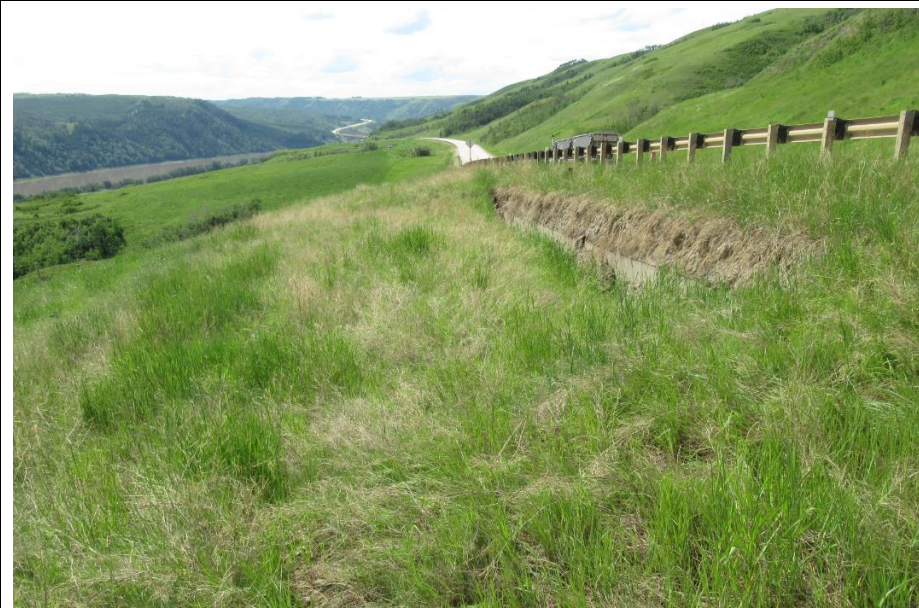
<input checked="" type="checkbox"/> Slope Movement	<p>The main landslide feature affecting the roadway was repaired in 2015/2016. There have been some cracks and subsequent profile drop and a graben formed in the passive bench downslope of the pile wall since 2016. The ground surface dropped 1.5 m at the downslope edge of the wall near the north SI in the pile wall (Photo 2).</p> <p>There is bow in the new barbed wire fence below the highway.</p> <p>Slides above the highway were also noted in the backslope in the 2018 inspection.</p>	<input checked="" type="checkbox"/>	
<input checked="" type="checkbox"/> Erosion	There has been some deepening of the scour channel and some slight retrogressing on the scour channel sidewalls. There has been slight retrogression of the scour channel upslope towards the outlet of the centerline culvert since 2018 (Photos 6 and 7).	<input checked="" type="checkbox"/>

**Photo 2.**  
Looking southwest along the pile wall built in 2015/2016. The soil below the pile wall is slumping, exposed a portion of the pile wall, and created a well-defined graben bench.

<b>Recommendations:</b>		
Bi-annual readings of the SI's in the wall and annual inspection of the cracks in the soil bench downslope of the pile wall are still required to monitor for any sign of downslope movement of the pile wall.		Monitoring
The graben that has formed in the passive bench below the pile wall should be backfilled, top soiled and seeded. The bowing zone in the barbed wire fence might also need to be straightened out.		Maintenance
The existing centerline culvert that crosses the highway east of the landslide could be grouted and surface water should be directed along the existing southbound lane ditch to the existing bridge culvert further downslope to the southwest, if the downstream culvert and ditch can accommodate the extra flow.		\$50,000

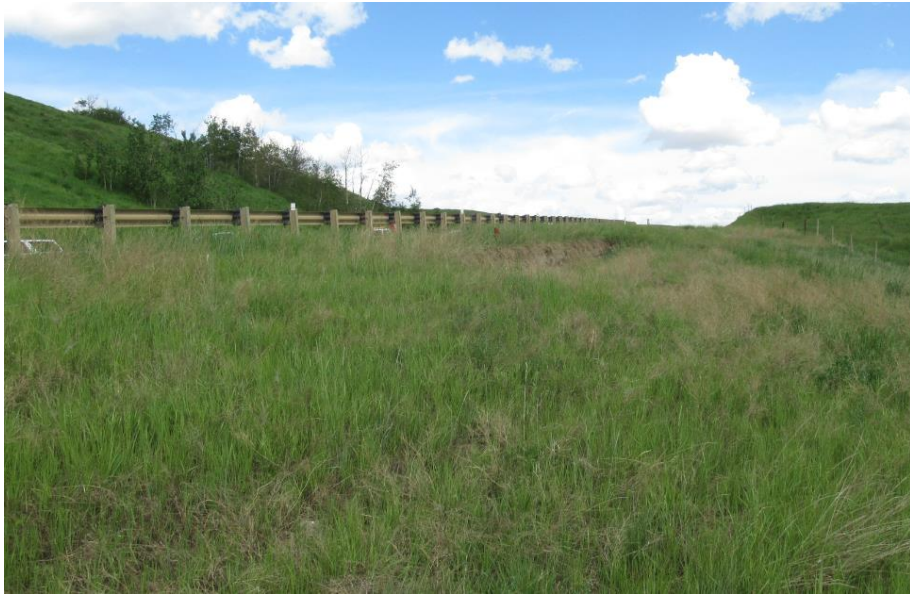
**Photo 3.**  
Looking northeast along the graben formed in the passive bench below the pile wall.

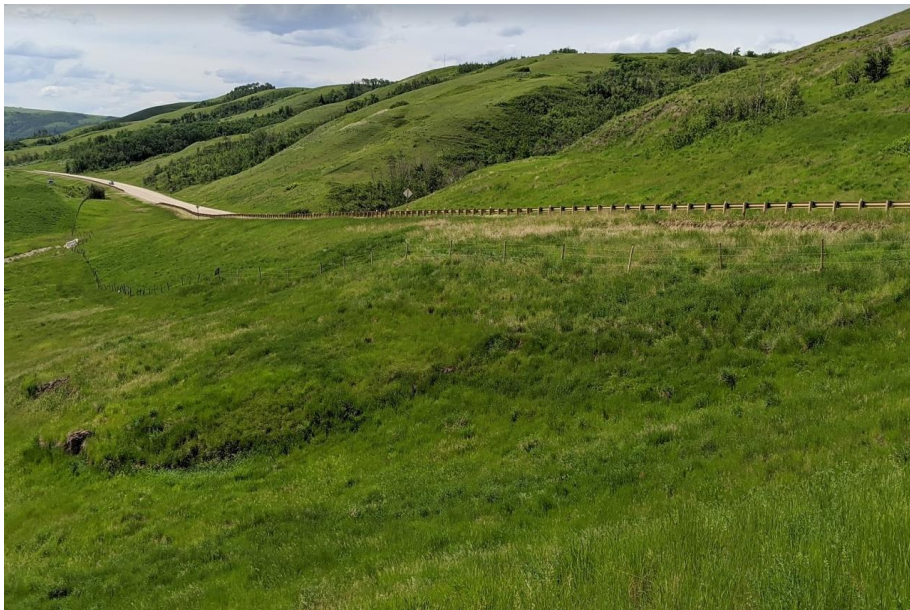
**Photo 4.**  
Looking southwest at landslide mass. Note the soil dropped up to 1.5 m below the pile wall and is now exposing the upper 0.5 m of the pile wall at the crest of the slide near the guardrail. The toe bulge is still well-defined at the bottom. The barbed wire fence is still being impacted by landslide movement. But, has not been broken yet.

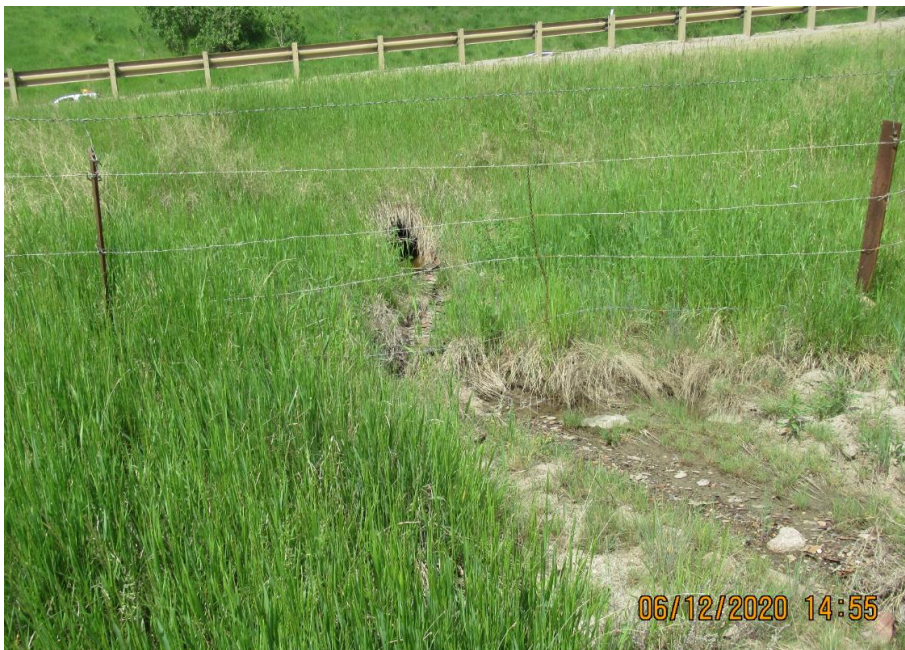
**Photo 6.**  
Looking at the 600 mm centre line culvert outlet. Erosion downstream of the outlet is still occurring

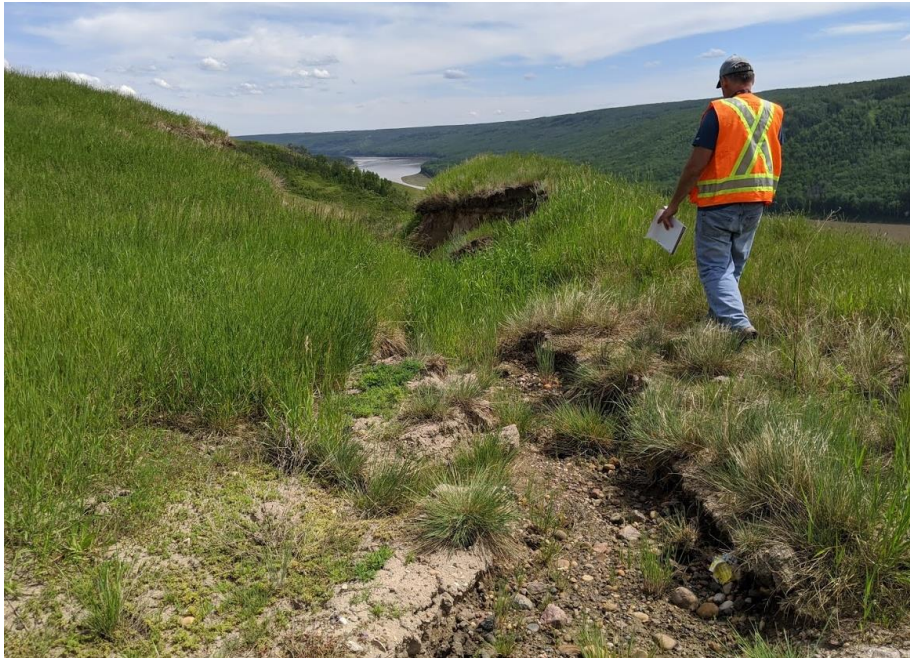
**Photo 7.**  
Looking southeast from north of the centerline culvert outlet towards the scour channel.

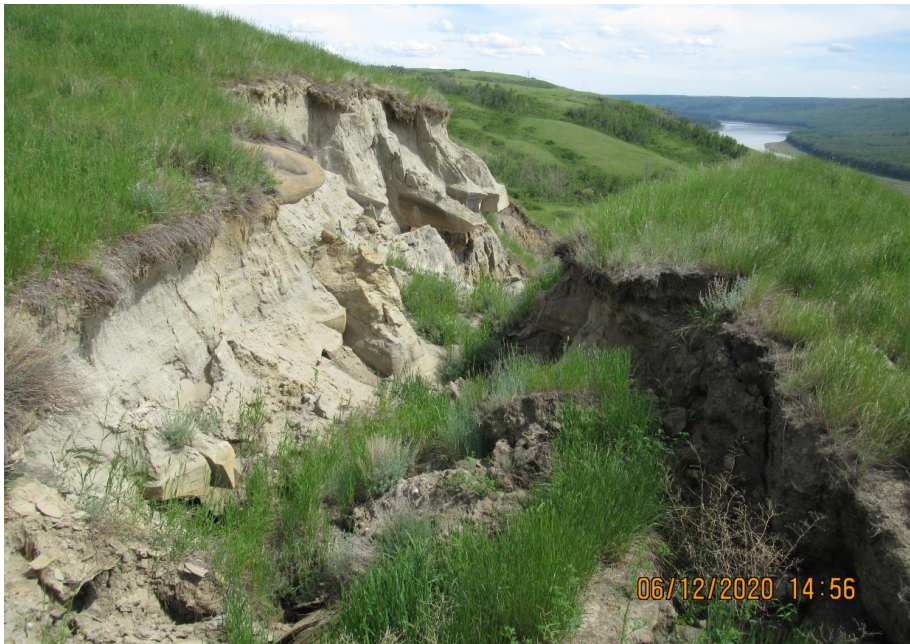
**Photo 8.**  
Looking southeast from the north end of the scour channel that has developed below the outlet of the centerline culvert. The scour is slightly wider and is retrogressing towards the highway since 2018.

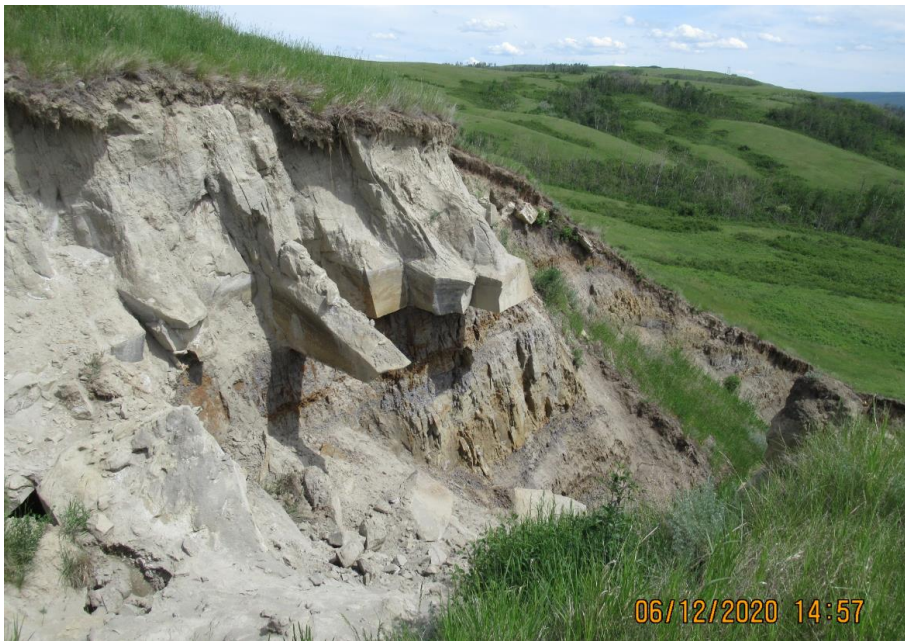
**Photo 9.**  
Looking north from  
the west side of the  
scour channel that is  
situated below the  
outlet of the  
centerline culvert.

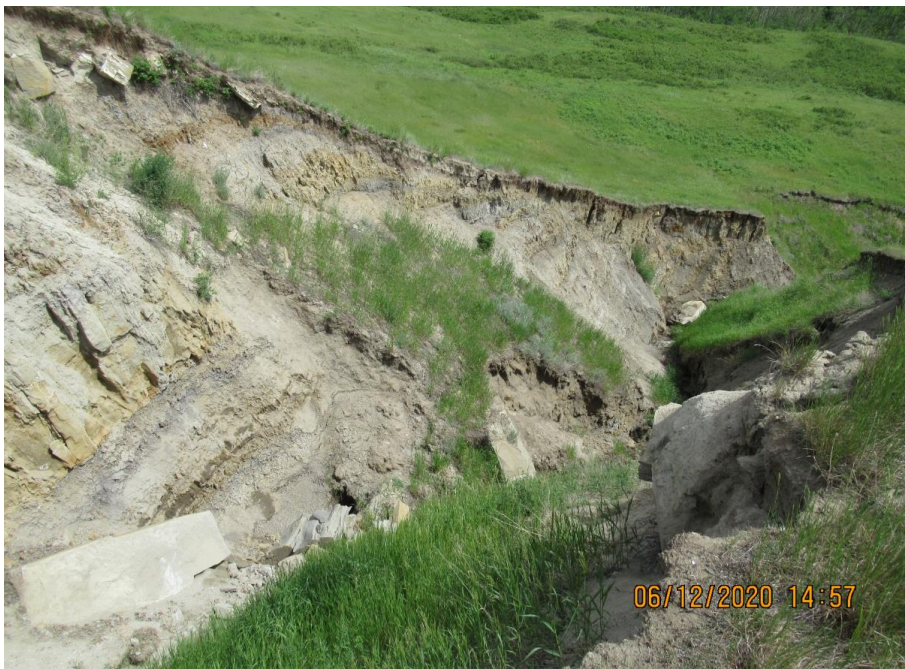
**Photo 10.**  
Looking southeast  
along the centerline  
culvert scour channel  
at mid-slope.

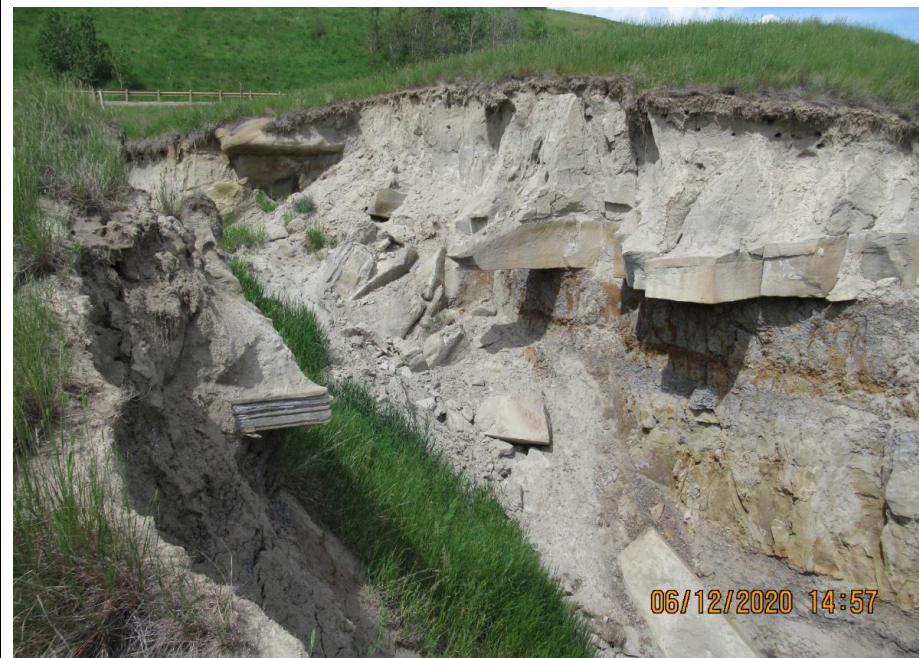
**Photo 11.**  
Looking northwest from the north end of the scour channel towards the outlet of the centerline culvert. Note grass growing at the bottom of the gully and bird burrows on the upper weathered sandstone layer
