August 4, 2022 File No.: 32123

# ALBERTA TRANSPORTATION GRMP (CON0022165) PEACE REGION (GRANDE PRAIRIE DISTRICT – NORTH) INSTRUMENTATION MONITORING RESULTS – SPRING 2022

SITE PH052: HWY 2:68 DUNVEGAN NORTH SLIDE AND EROSION

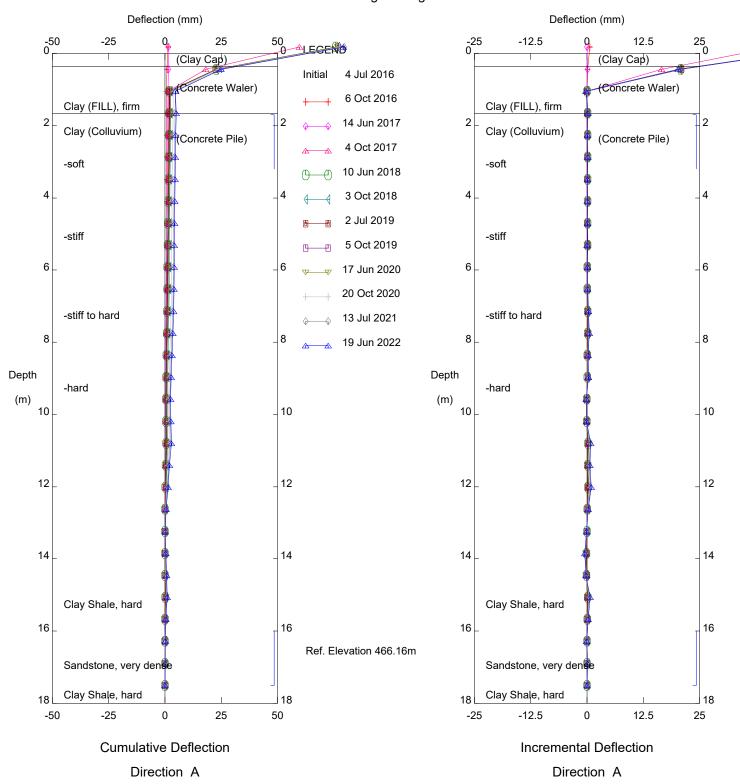
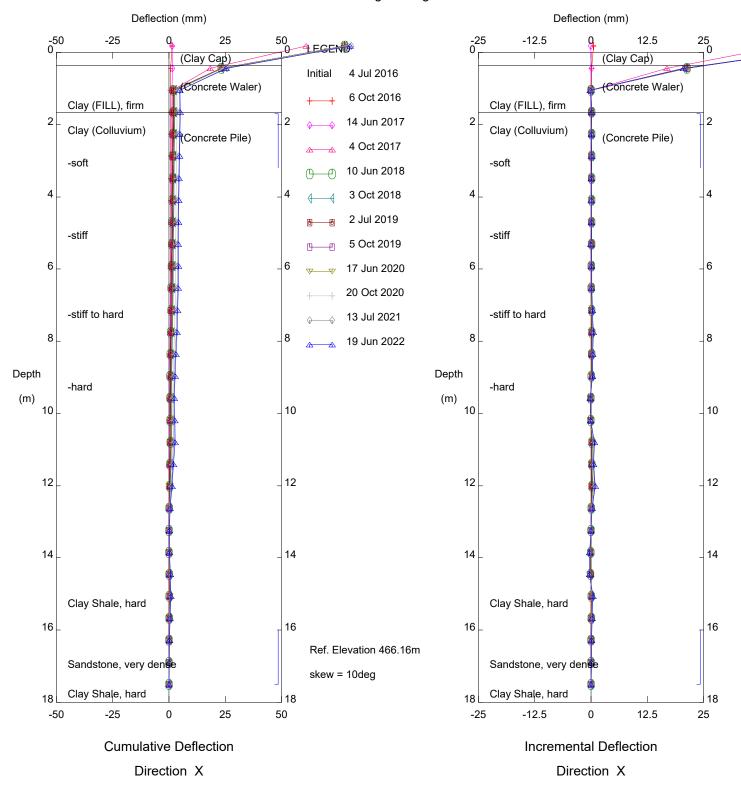
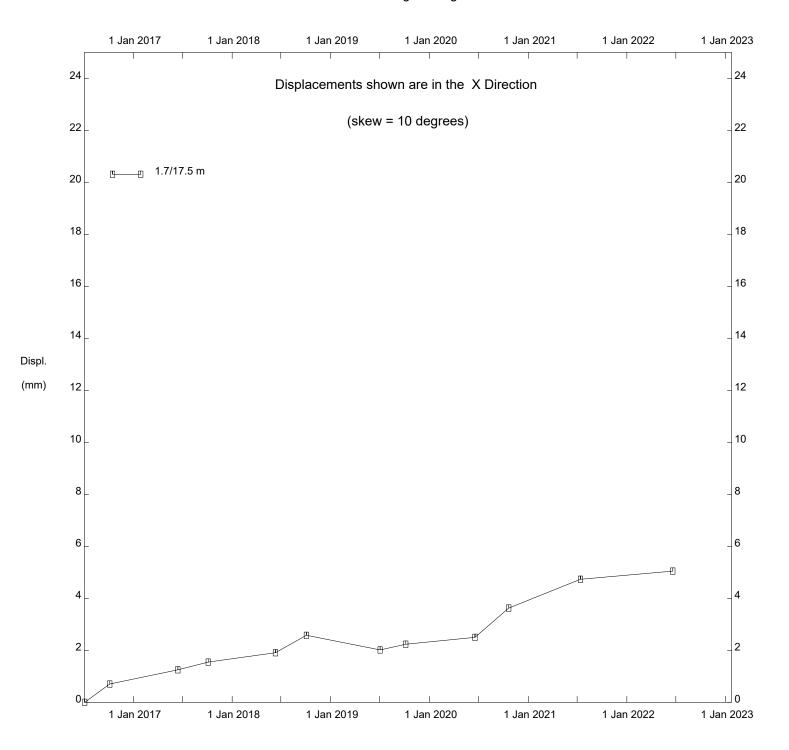
Dunvegan North Slide (PH052), Inclinometer SI16-P12

SI16-P12 showed a rate of movement of 0.3 mm/yr over the length of the pile from 1.7 m to 17.5 m depth since the spring of 2021 readings. The total pile head movement to date has been 5.0 mm.

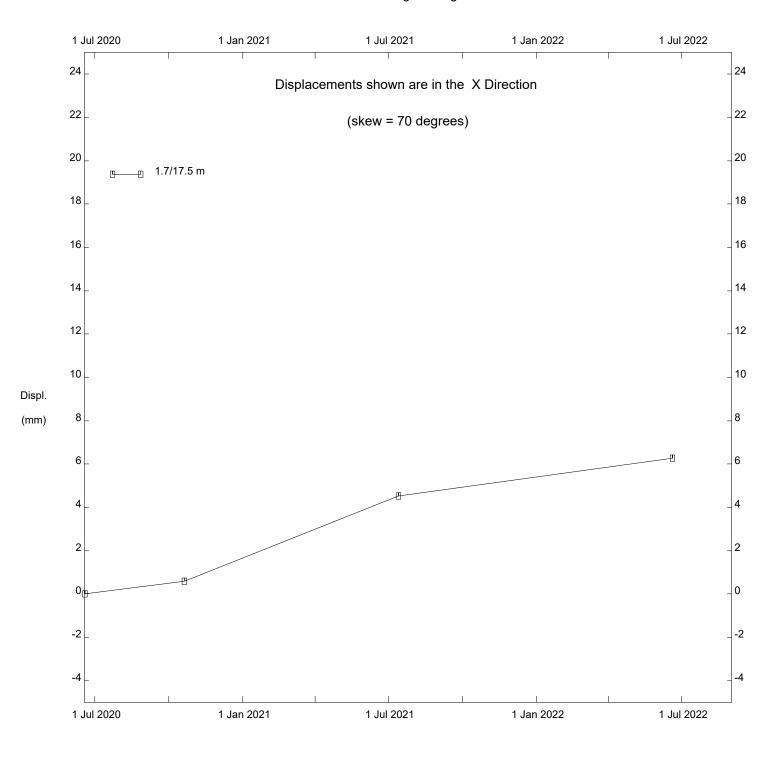
Dunvegan North Slide (PH052), Inclinometer SI16-P21

SI16-P21 showed a rate of movement of 1.9 mm/yr over the length of the pile from 1.7 m to 17.5 m depth compared to the spring of 2021 readings. SI16-P21 has shown a total pile head movement of 6.3 mm since it was reinitialized. However, the current calculated movement likely contains some reading error due to a tight bend in the new casing at approximately 12 m depth.

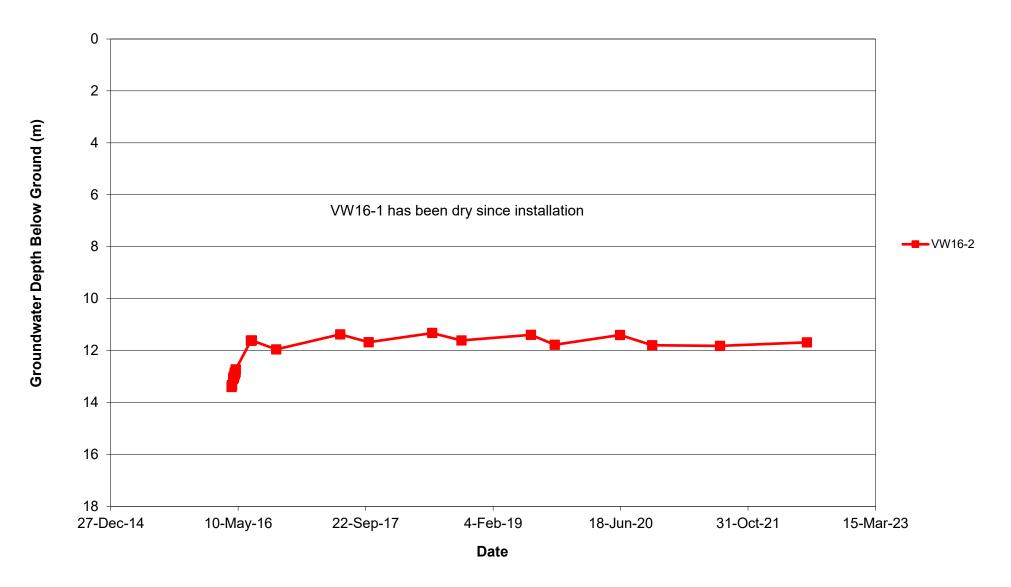
FIGURE PH052-1
PIEZOMETRIC DEPTHS FOR HWY 2:68 DUNVEGAN NORTH 10+800 SLIDE

Vibrating wire piezometer VW16-2 showed an increase in groundwater level of 0.13 m compared to the spring of 2021 readings. VW16-1 continued to be dry. The piezometer reading results are presented in Table PH052-2, and are plotted in Figures PH052-1 (by depth) and PH052-2 (by elevation) in Appendix A.
