**ALBERTA TRANSPORTATION
GEOHAZARD ASSESSMENT PROGRAM
PEACE REGION–GRANDE PRAIRIE
2020 INSPECTION REPORT**

Site Number	Location	Name	Hwy	km
GP029	Saddle (Burnt) River Crossing North Valley Slope	RR771 Slide (Church Camp)	2:70	11.881
Legal Description		UTM Co-ordinates		
NW¼4-077-05-W6M		11U E 393076	N 6168469

PEACE REGION (GRANDE PRAIRIE)
GP29-1: HWY 2:70 RR771 SLIDE

2020 INSPECTION FIGURE

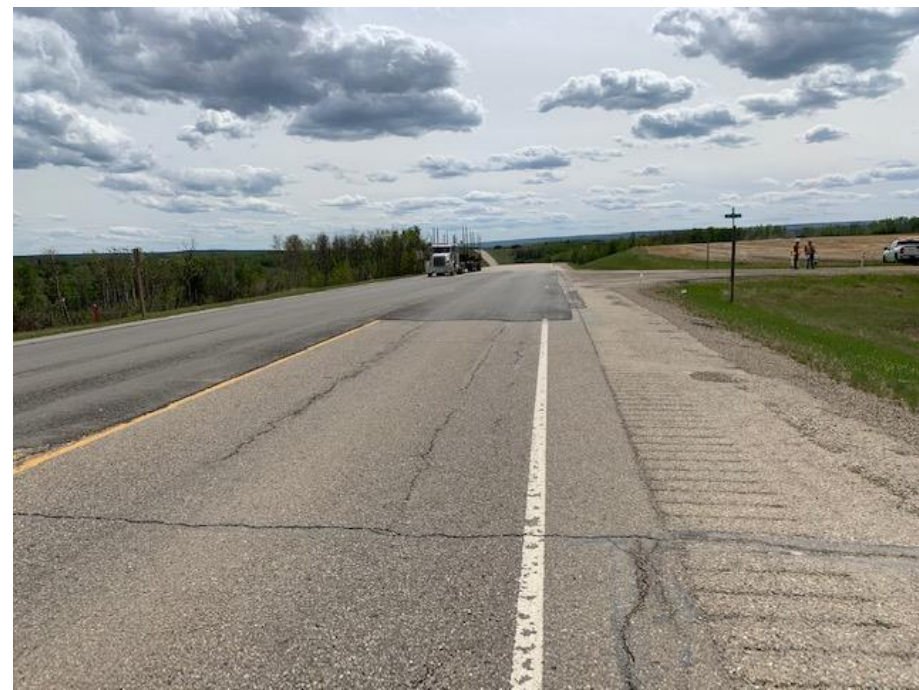
Photo 1.
Looking southwest from the SBL shoulder about 50 m north of the intersection between Hwy 2:70 and Township Road 771.

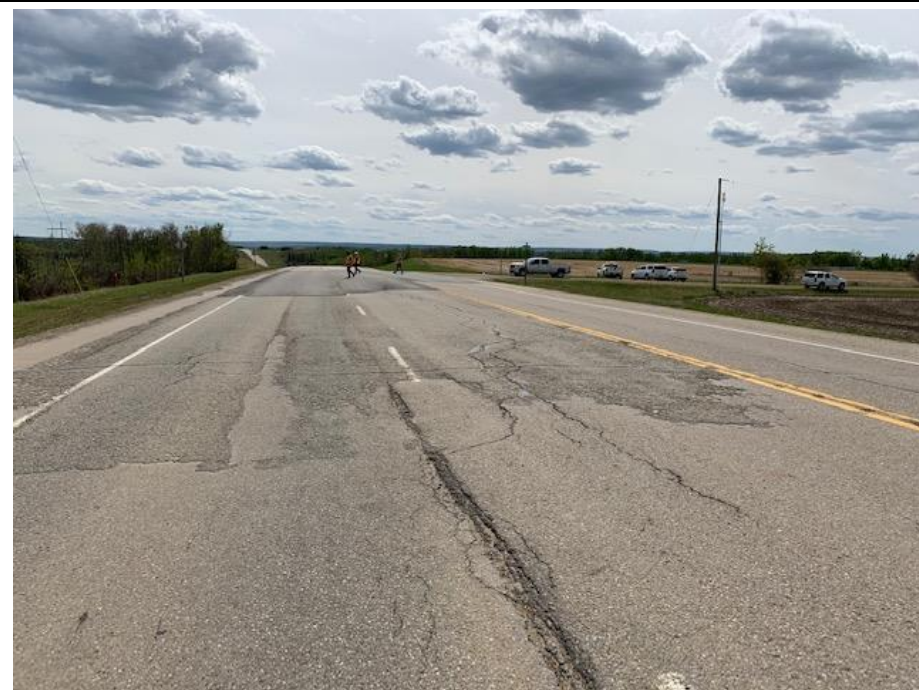
Observations:	Description	Worsened?	
<input checked="" type="checkbox"/> Pavement Distress	Cracks are showing through the new patch they placed in 2019 with opening width up to 10 mm were observed on the shoulder of SBL. The scarp crack observed in the pavement extended 200 m further south through all lanes and into the east shoulder. The cracks in the east shoulder are about 20 mm in width. A crack extended about 50 m further south running parallel to a crack directly east of the crack extension. There is also a dip in the road that is evident when cars drive over the surface.	<input checked="" type="checkbox"/>	
<input checked="" type="checkbox"/> Slope Movement	The readings of the SIs installed in 2017 indicated the presence of a deep slip surface at a depth about 45 m below the existing ground surface. There was	<input checked="" type="checkbox"/>

Photo 2.
Looking closer at cracks in northeast inner NB passing lane at cracks in ACP patch.

In the short term, the development of the cracks on in the ACP surface of the roadway should be regularly monitored. Cracks should be timely patched/sealed to prevent surface water infiltration into the landslide backscarp.

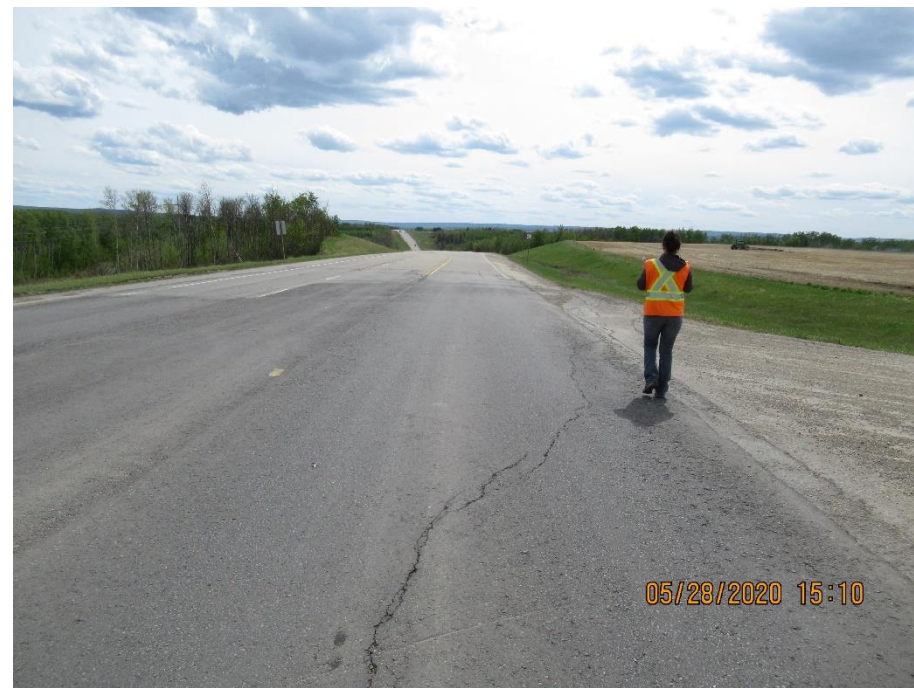
Photo 3.
Looking south
standing near
Township Road
771 looking at
crack in the SBL.

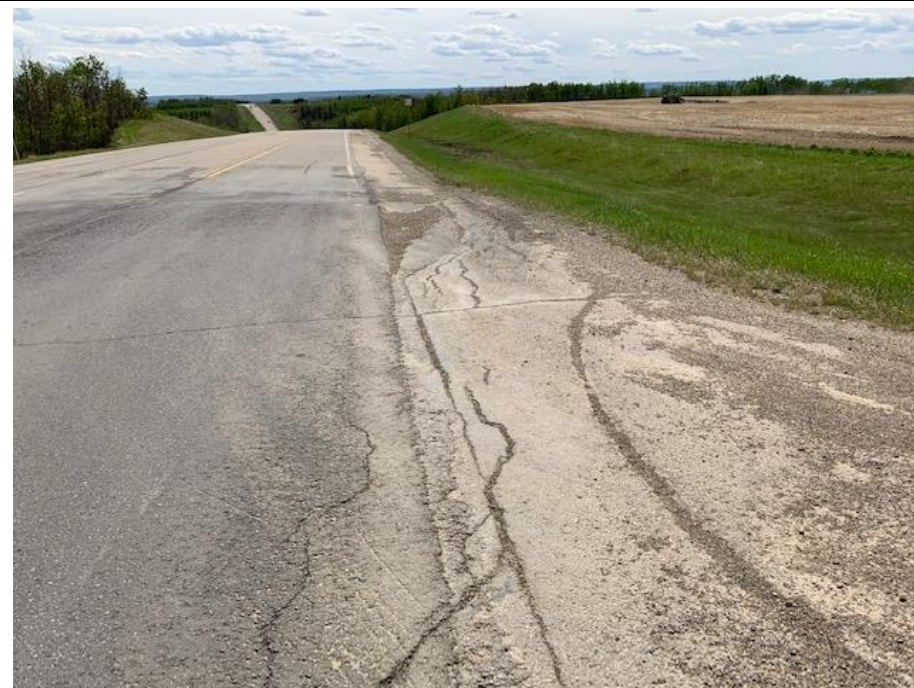
Photo 4.
Looking south at
the cracks in the
SBL shoulder just
south of Township
Road 771.

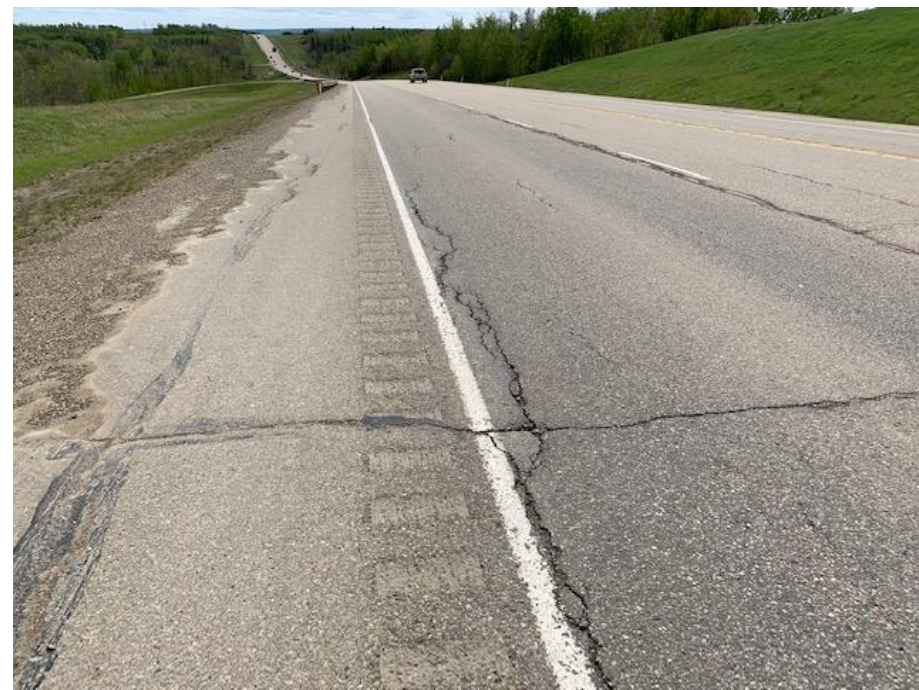
Photo 5.
New cracks
observed crossing
both NBL and
extending into the
shoulder.

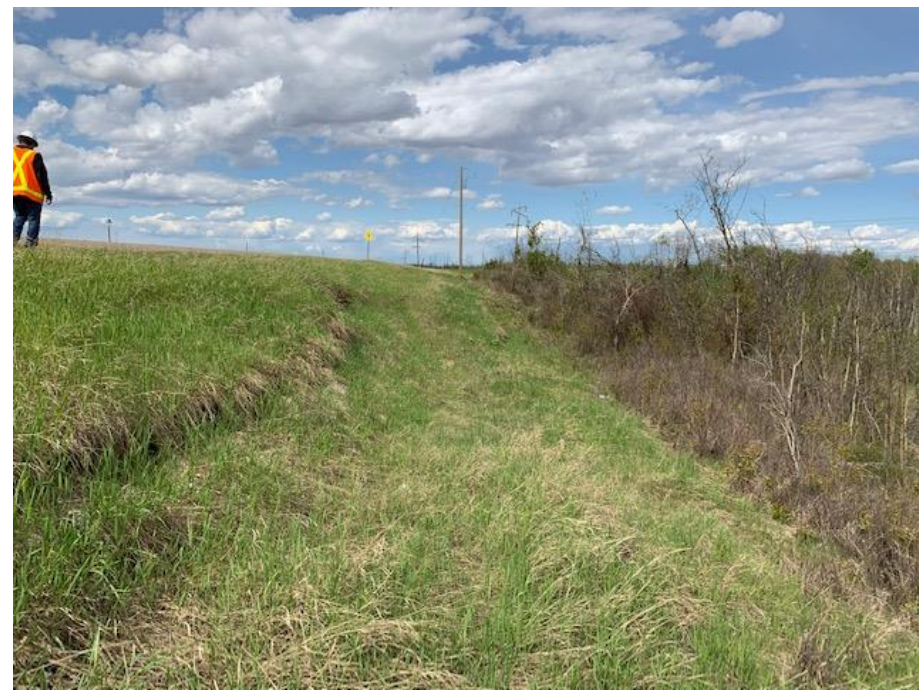
Photo 6.
Looking north from
highway
embankment to the
east where scarp
crack was
observed.

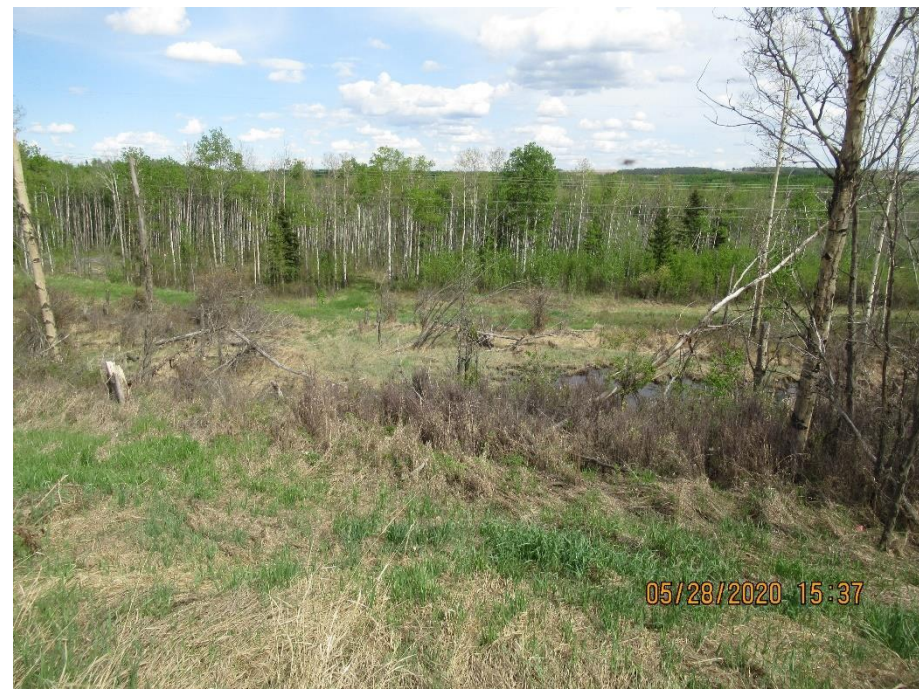
also a movement zones observed between 17 m and 33 m depth below ground surface. Only SI17-5 did not show movement; however, this may be installed too shallow.	
<input type="checkbox"/> Erosion		<input type="checkbox"/>
<input checked="" type="checkbox"/> Seepage	Ponded water observed mid-slope northeast of SI-2.	<input checked="" type="checkbox"/>
<input type="checkbox"/> Bridge/Culvert Distress		<input type="checkbox"/>
<input type="checkbox"/> Other		<input type="checkbox"/>
Instrumentation:		
SI-1 (Destroyed)	Installed at about 20 m downslope (east) of Hwy 2:70 as a part of the 2007 geotechnical investigation program. This SI was likely destroyed during the construction of northbound climbing lane in 2013. Readings of this SI indicated a slip surface at an approximate elevation of 622.6 m (about 22 m below ground surface).	
SI-2	Installed about 60 m downslope of the Hwy 2:70 NBL at approximately the middle of the Saddle (Burnt) River west valley slope. This SI showed a rate of slope movement of: 8.0 mm/yr within depths from 6.4 m to 9.5 m below the existing ground surface since the Spring 2020 readings. A movement zone within depths of 34.4 m to 35.1 m showed no discernible movement.

Photo 7.
Looking east at low lying wet land area where water was ponded.

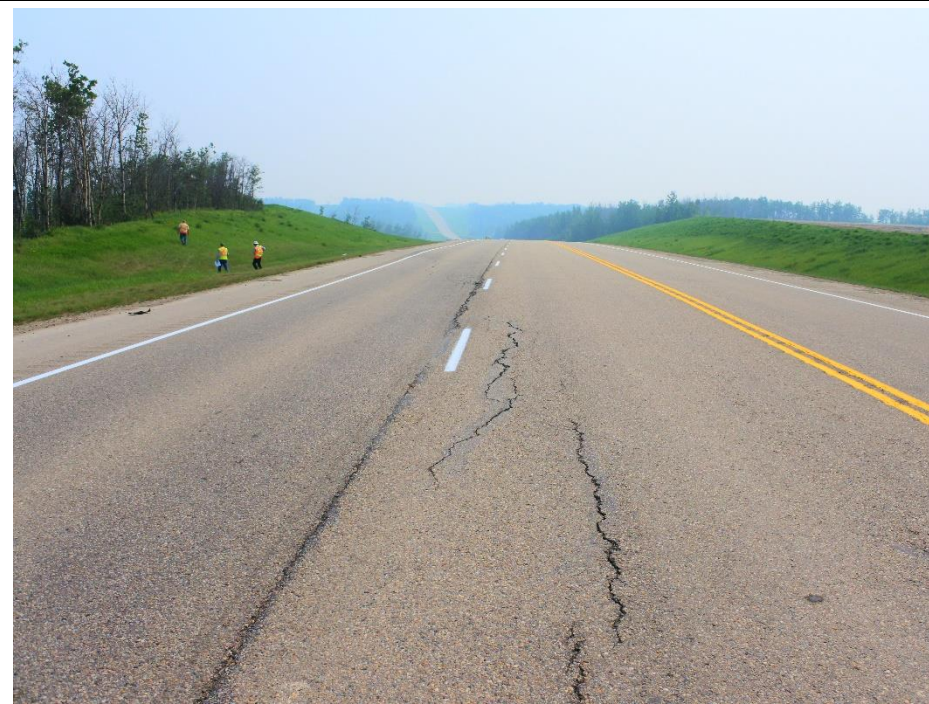
Photo 8.
New cracks observed crossing both NBL.
