THURBER ENGINEERING LTD.

November 22, 2022

**ALBERTA TRANSPORTATION GRMP (CON0022165)
PEACE REGION (GRANDE PRAIRIE DISTRICT – NORTH)
INSTRUMENTATION MONITORING RESULTS – FALL 2022**

SITE GP029: HWY 2:70, CHURCH CAMP SLIDE

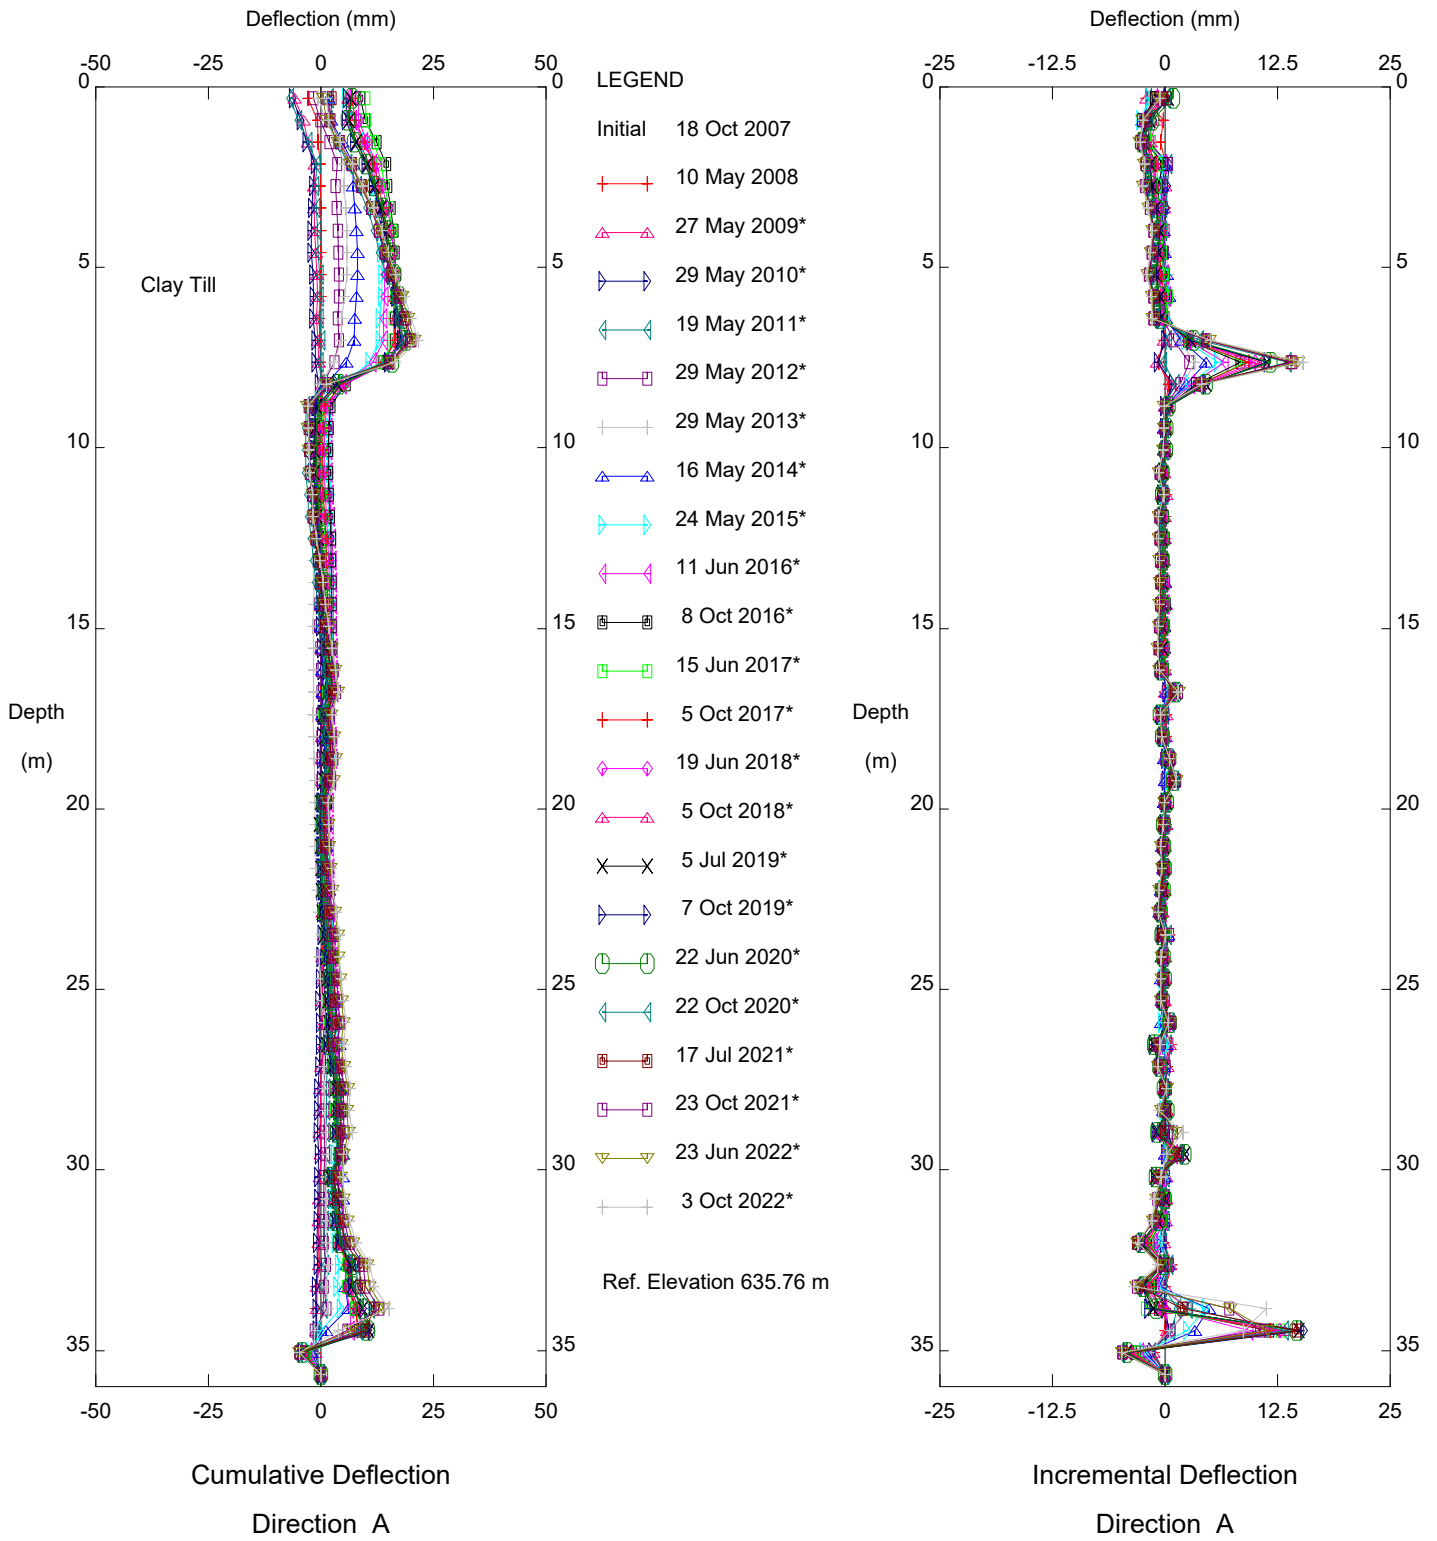
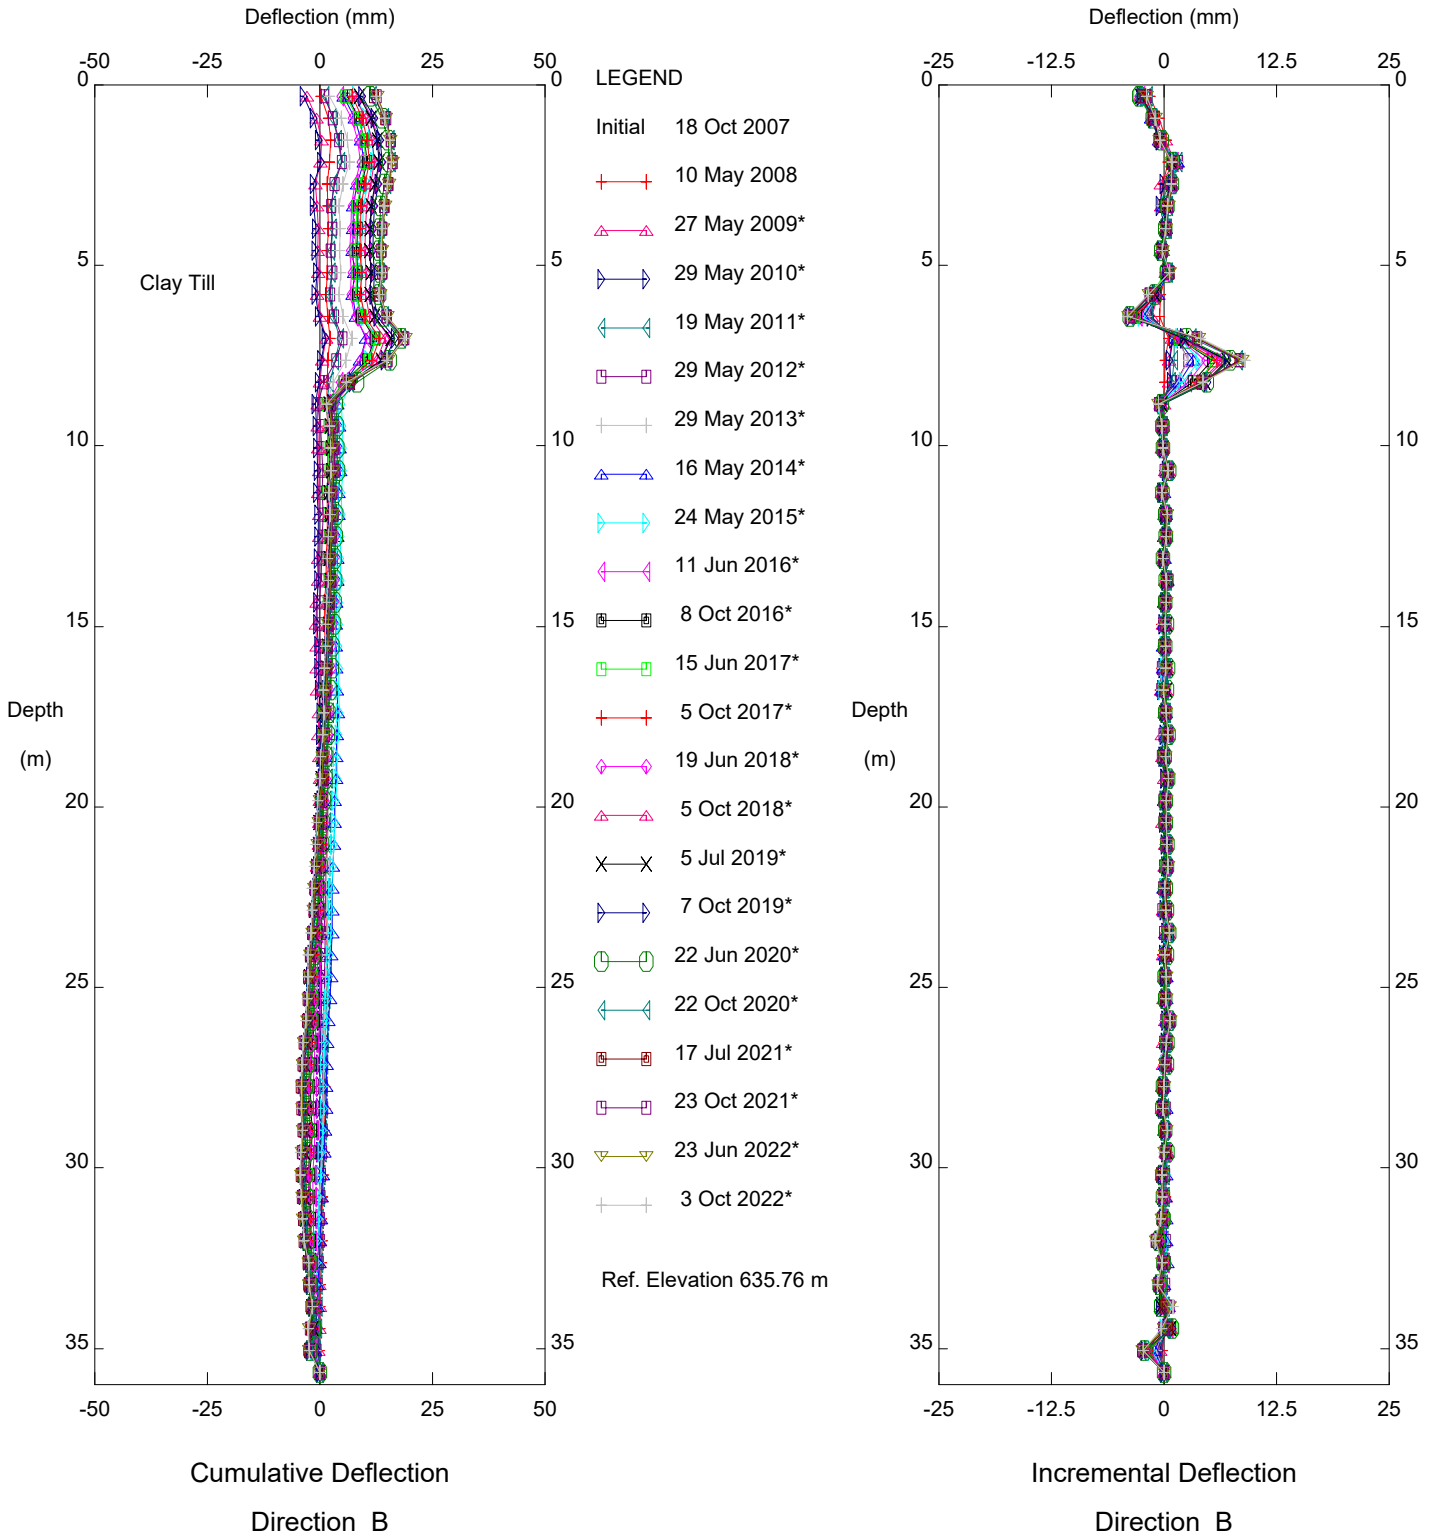
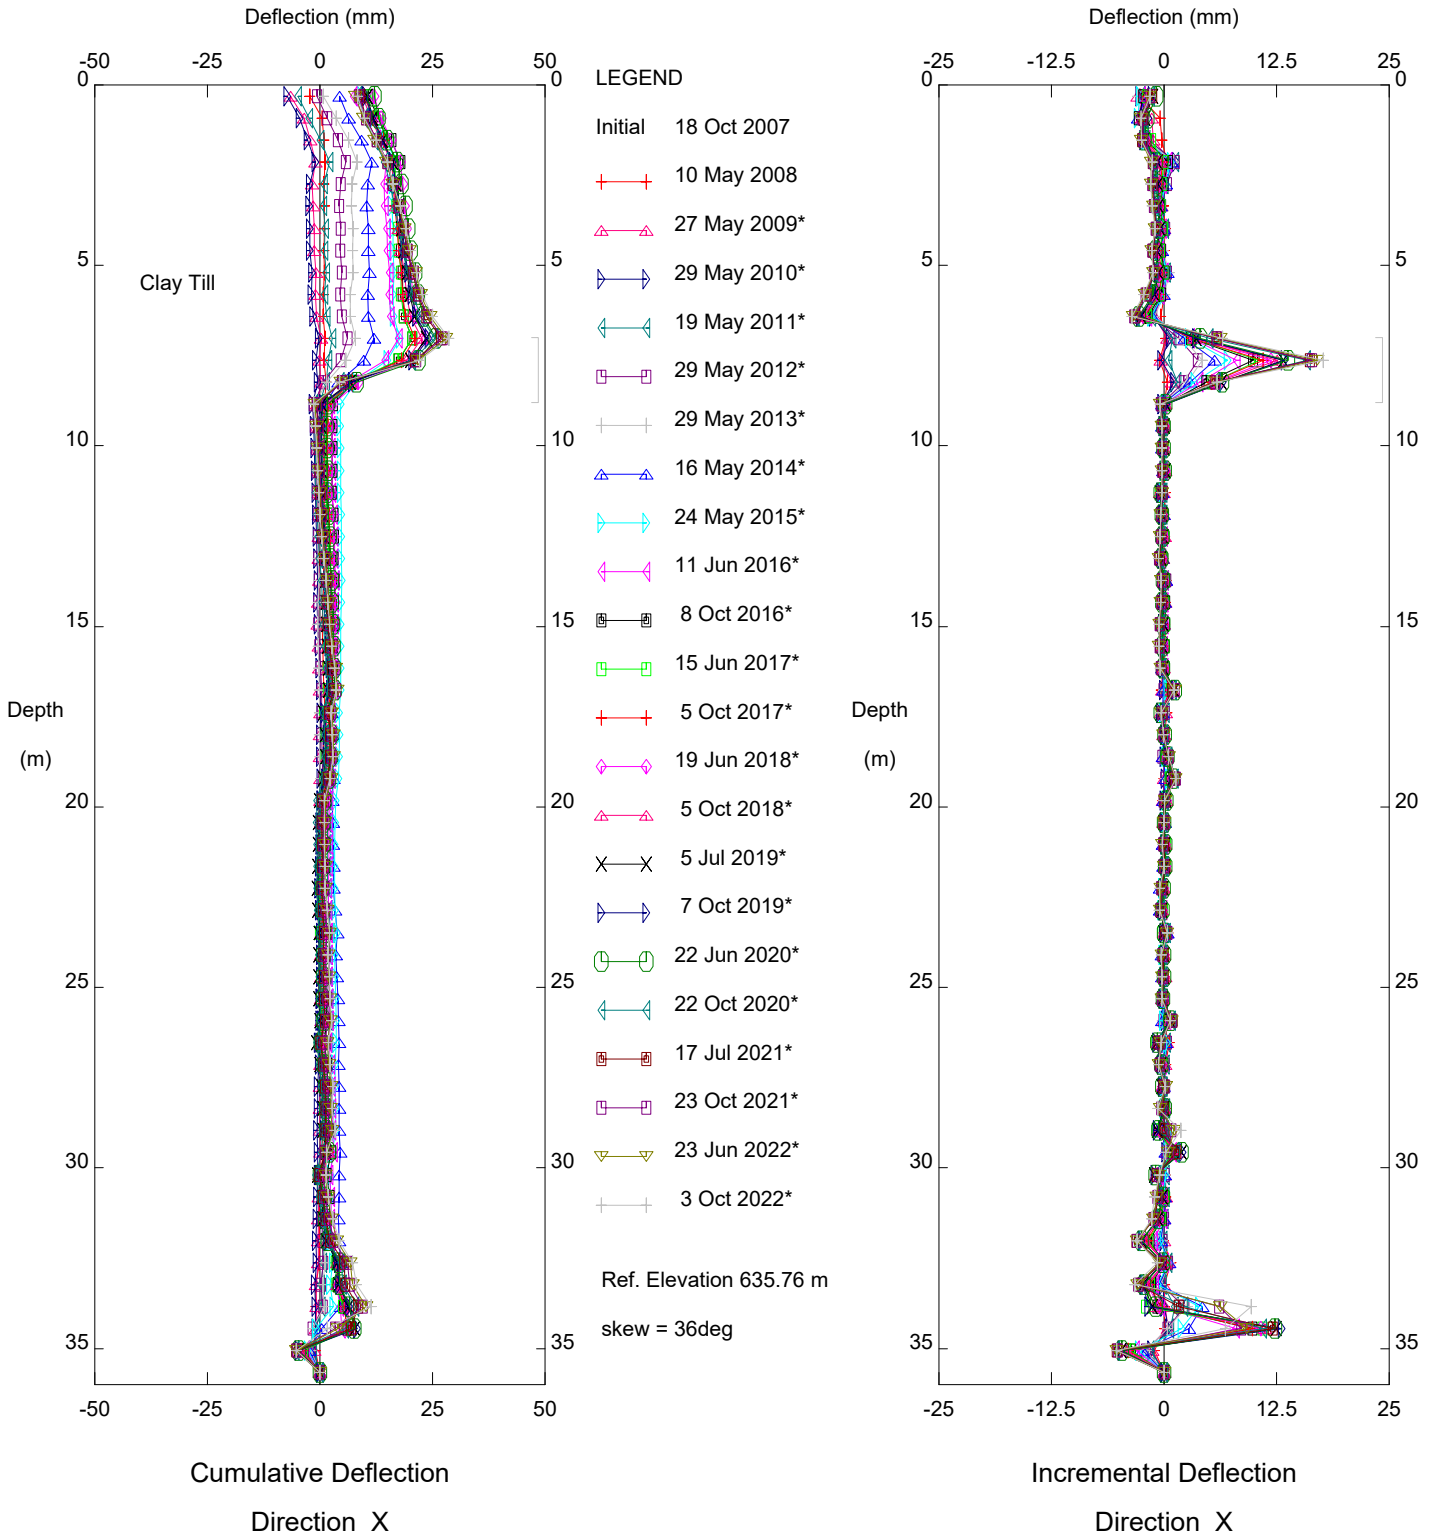
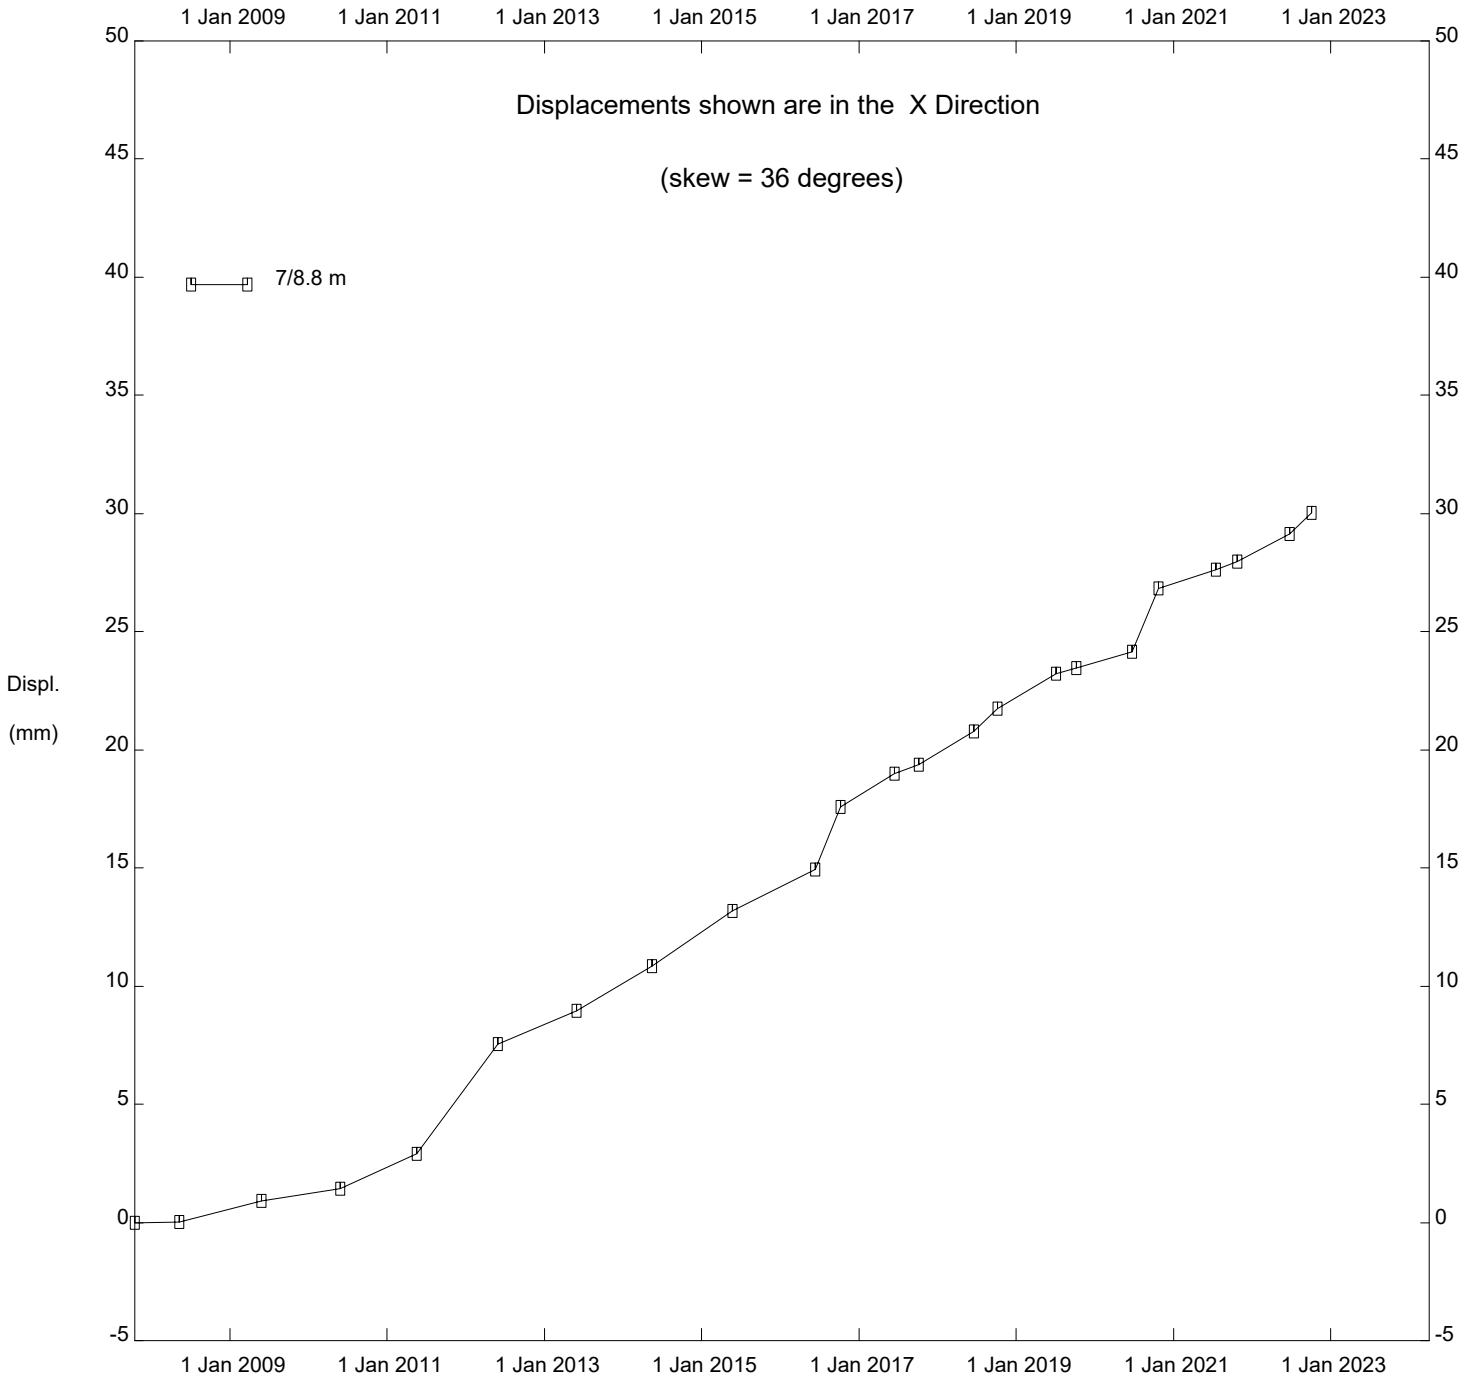
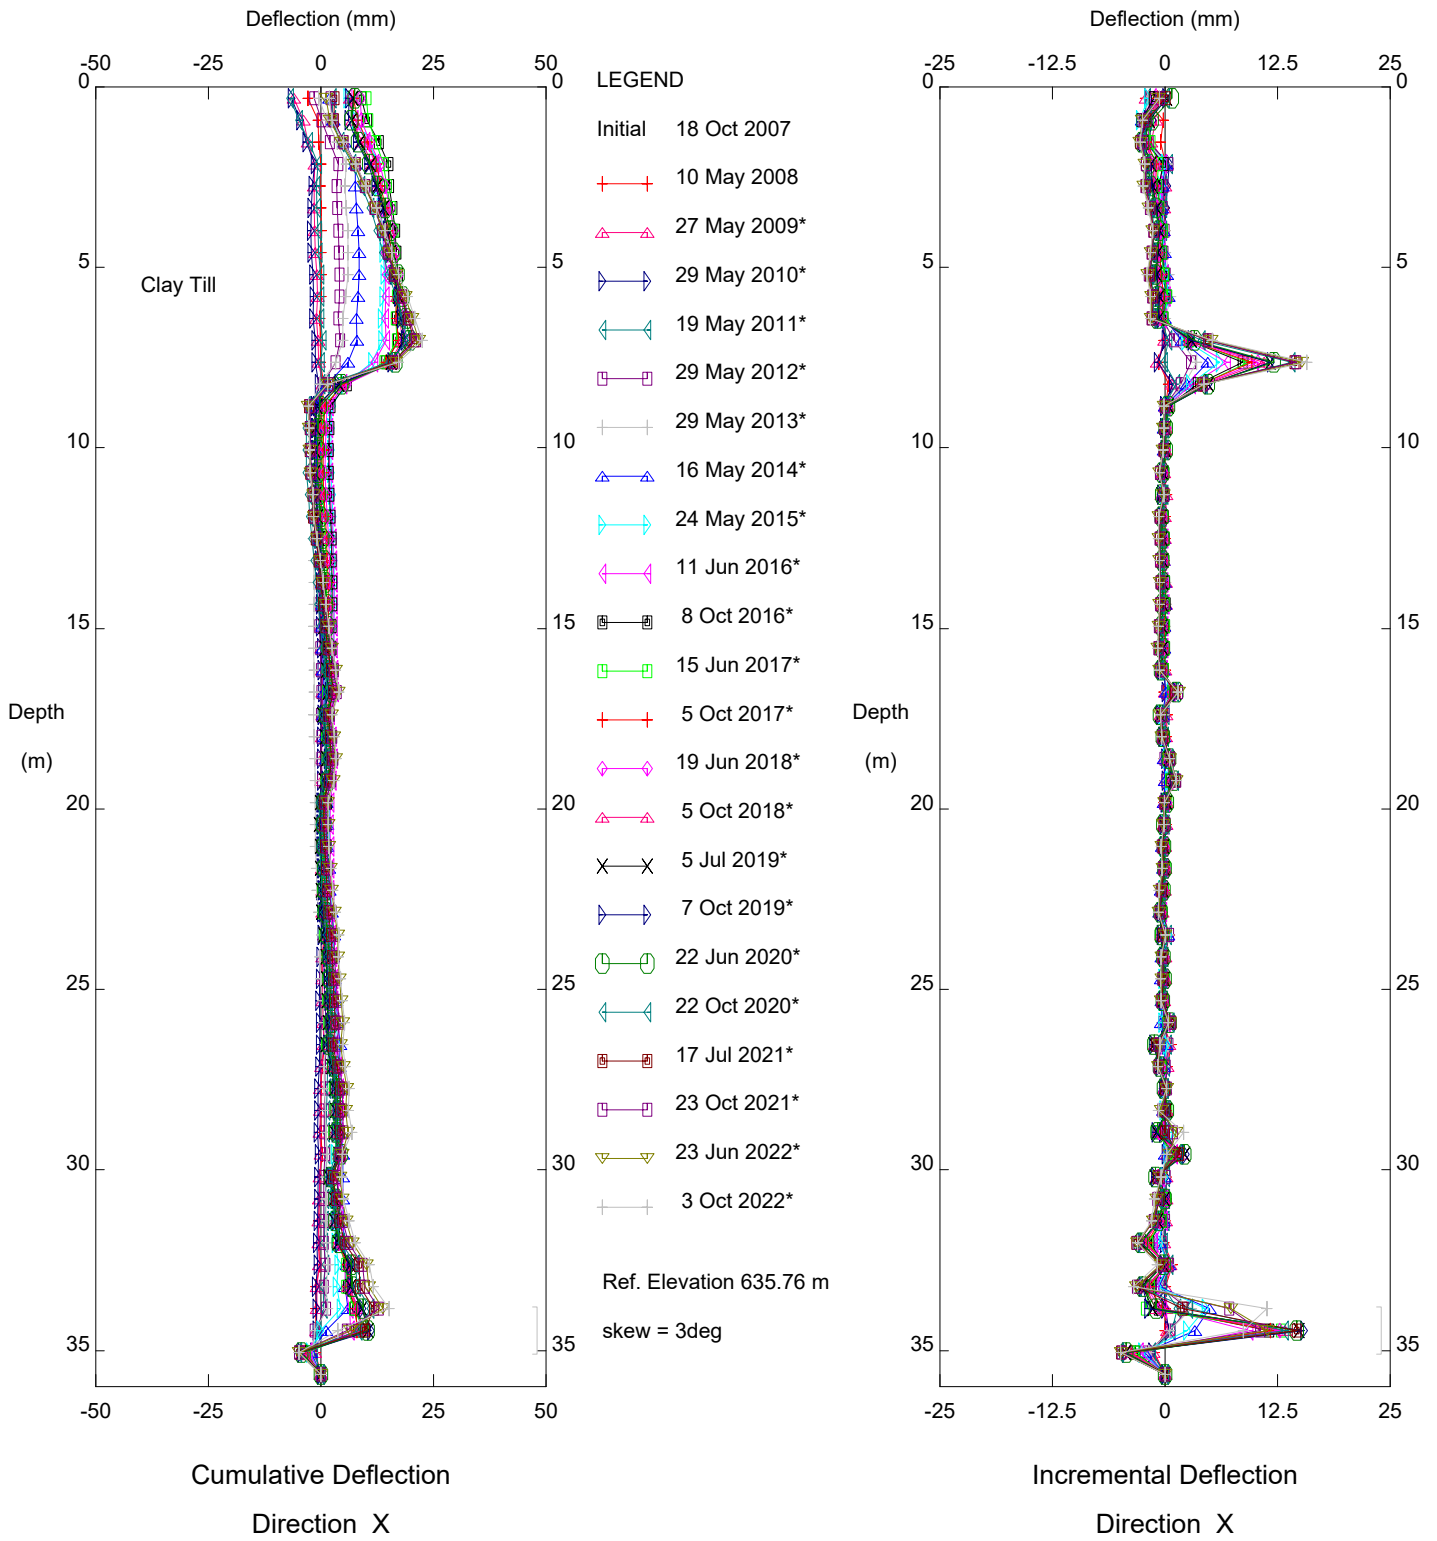
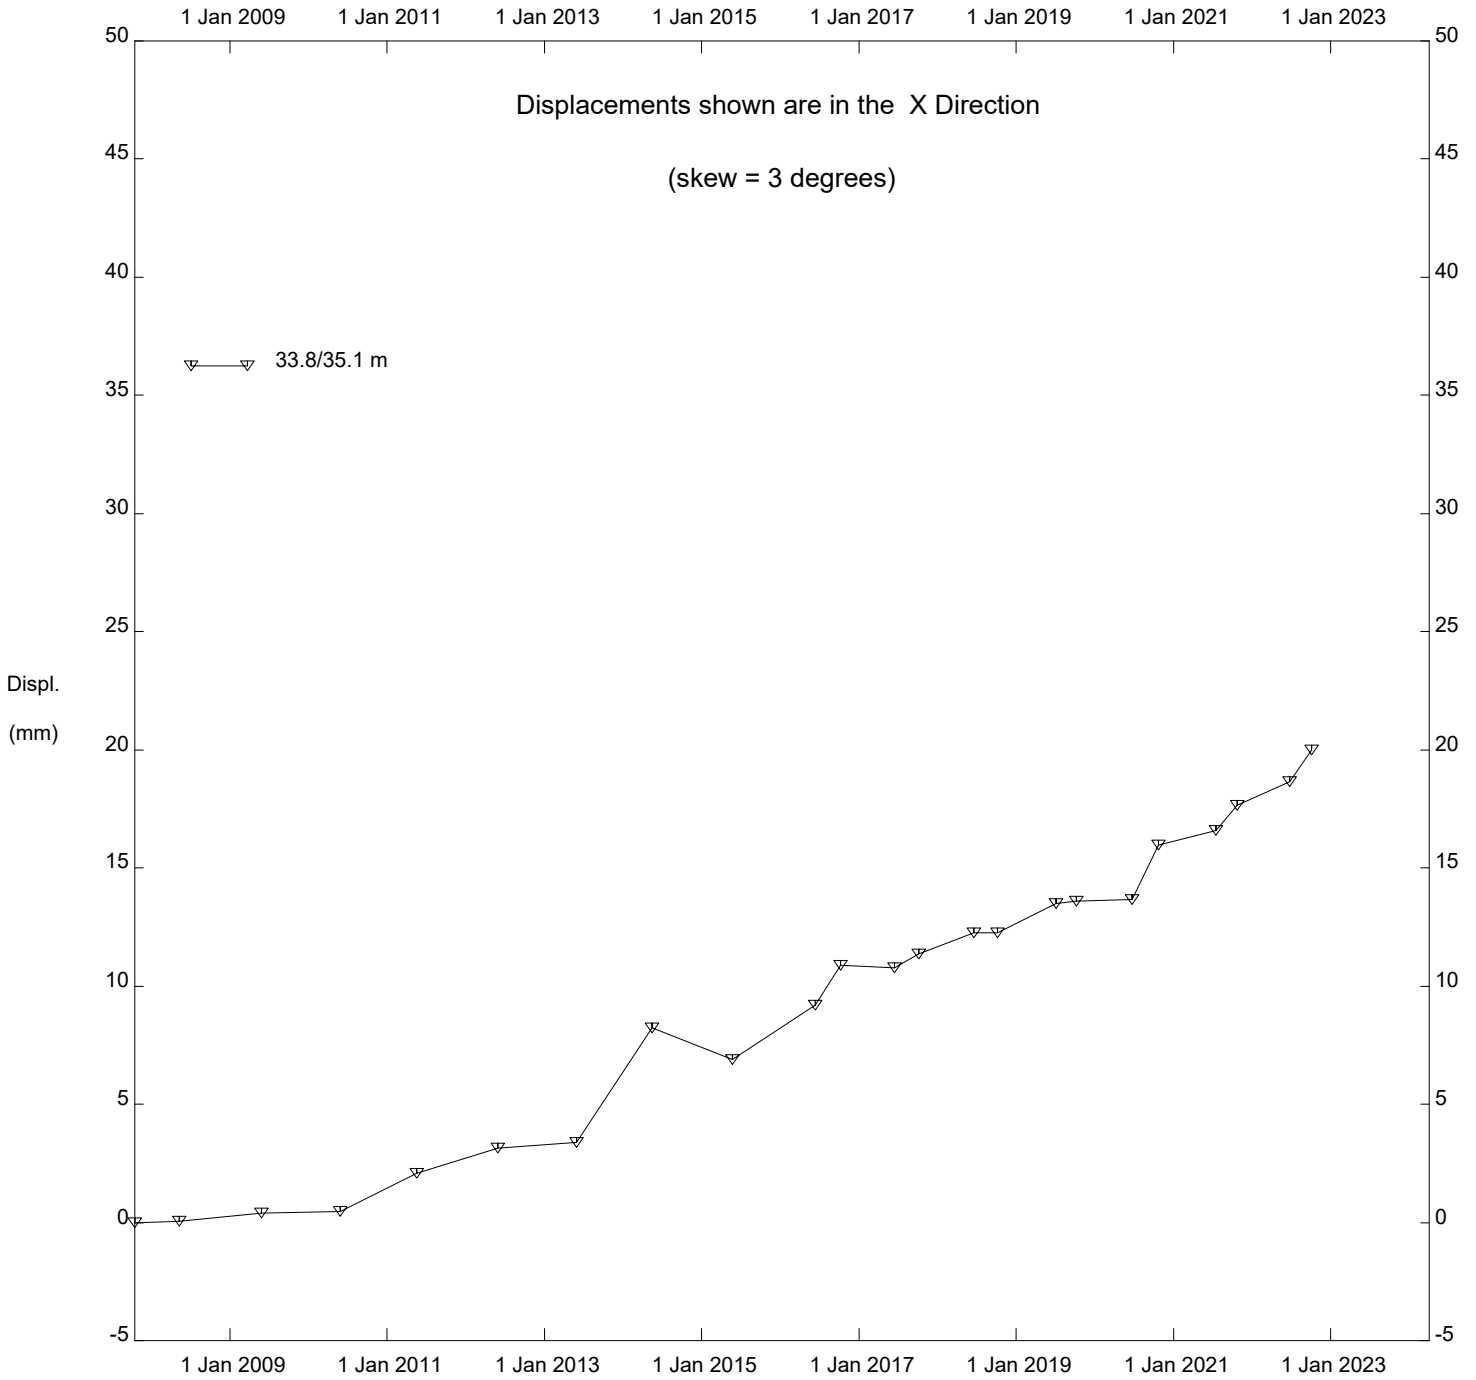
GP029 HWY 2:70 (Church Camp), Inclinometer SI-2

Slope inclinometer SI-2 showed a rate of movement of 3.1 mm/yr over 7.0 m to 8.8 m depth and a rate of movement of 4.8 mm/yr over 33.8 m to 35.1 m depth since the spring of 2022 readings. Both zones of movement in SI-2 show a slight acceleration of movement compared to the past several readings cycles. SI-3 showed a rate of movement of 1.2 mm/yr over 5.2 m to 7.0 m depth, a rate of movement of 3.8 mm/yr over 9.4 m to 10.6 m depth, a rate of movement of 0.2 mm/yr over 13.1 m to 14.3 m depth and a rate of movement of 0.3 mm/yr over 18.0 m to 19.2 m depth since the spring of 2022 readings. The zone of movement over 5.2 m to 7.0 m depth in SI-3 showed a noticeable deceleration in movement compared to the average rate of movement over the past several years, while the zone over 9.4 m to 10.6 m depth showed an acceleration in movement. The lower two movement zones in SI-3 show rates of movement similar to the historic average rates for these instruments. SI17-5 has shown no discernible movement since initialization as it is likely located just outside of the landslide.

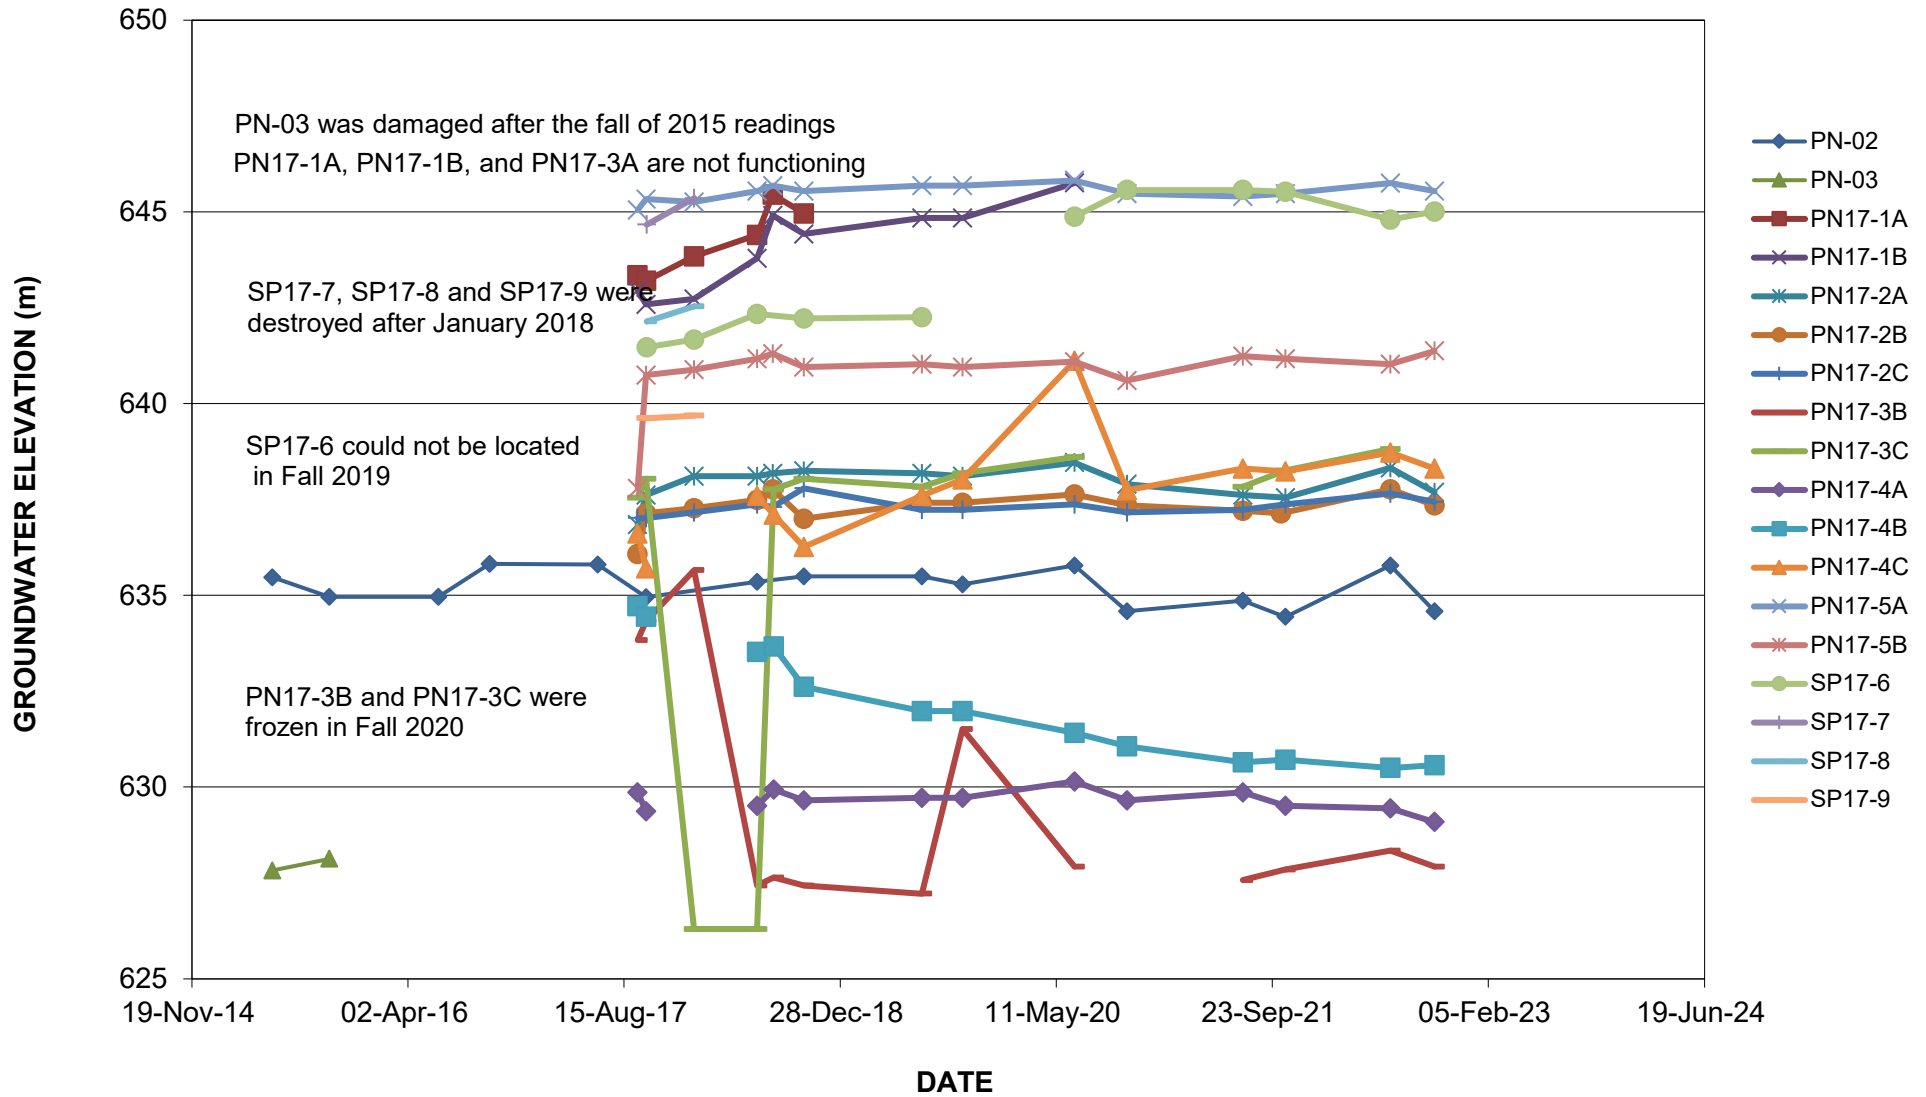
**FIGURE GP029-1
PIEZOMETRIC ELEVATIONS FOR HWY 2:70 CHURCH CAMP SLIDE**

Pneumatic piezometers PN-02, PN17-2A, PN17-2B, PN17-2C, PN17-3B, PN17-4A, PN17-4C and PN17-5A showed decreases in groundwater levels of 1.20 m, 0.63 m, 0.42 m, 0.21 m, 0.43 m, 0.35 m, 0.42 m, and 0.21 m, respectively, since the spring of 2022 readings. PN17-4B and PN17-5B showed increases in groundwater levels of 0.07 m, and 0.36 m, respectively, since the spring of 2022 readings. PN17-5B is currently showing the highest groundwater level measured in the instrument since it was initialized. PN17-3C showed no change in groundwater level since the spring of 2022 readings. PN17-3C and PN17-4C are currently showing above-ground (artesian) groundwater levels of 9.31 m and 7.11 m, respectively.

Overall, the pneumatic and standpipe piezometers are showing groundwater levels in line with historic groundwater level readings at the site. The piezometer readings are summarized in Tables GP029-2 and GP029-3 above and are plotted in Figures PH029-1 (by elevation) and PH029-2 (by depth) in Appendix A.
