**ALBERTA TRANSPORTATION
GEOHAZARD ASSESSMENT PROGRAM
PEACE REGION–GRANDE PRAIRIE
2022 INSPECTION REPORT**

Site Number	Location	Name	Hwy	km
GP029	Saddle (Burnt) River Crossing North Valley Slope	RR771 Slide (Church Camp)	2:70	11.881
Legal Description		UTM Co-ordinates		
NW¼4-077-05-W6M		11U E 393076	N 6168469

**PEACE REGION (GRANDE PRAIRIE)
GP29-1: HWY 2:70 RR771 SLIDE**

2022 INSPECTION FIGURE

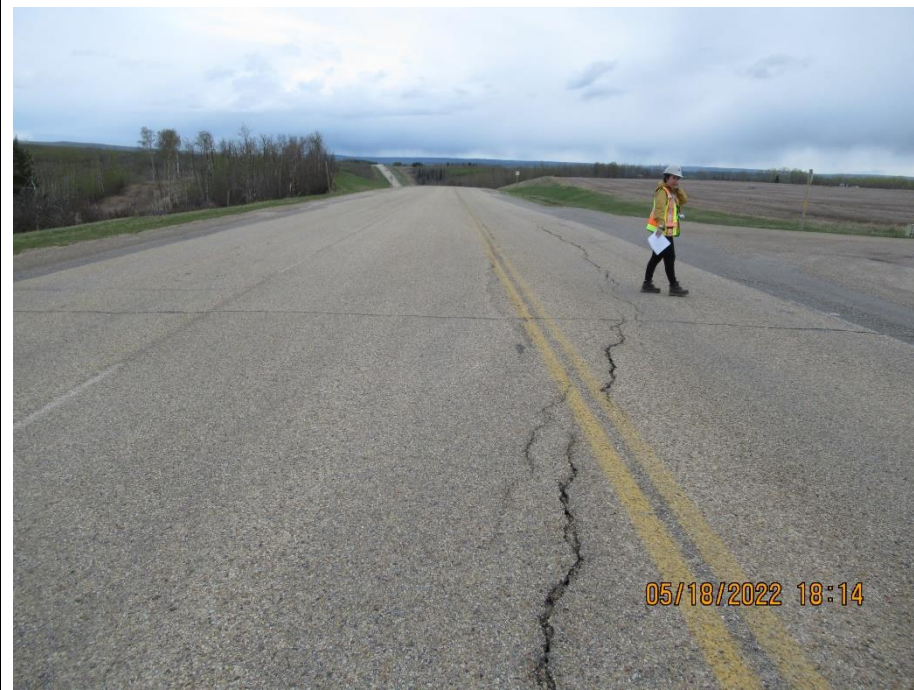
Photo 1.
Looking southwest from middle of highway about 50 m north of the intersection between Hwy 2:70 and Township Road 771.

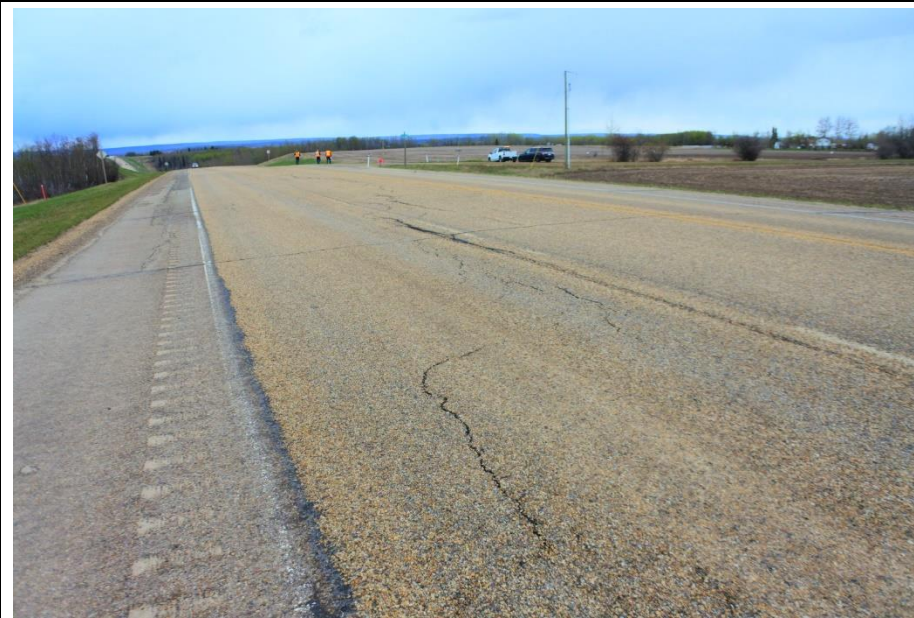
Photo 2.
Looking at cracks in ACP patch in the northeast outer NB passing lane.

In the short term, the development of the cracks on in the ACP surface of the roadway should be regularly monitored. Cracks should be timely patched/sealed to prevent surface water infiltration into the landslide backscarp.	Monitoring
---	------------

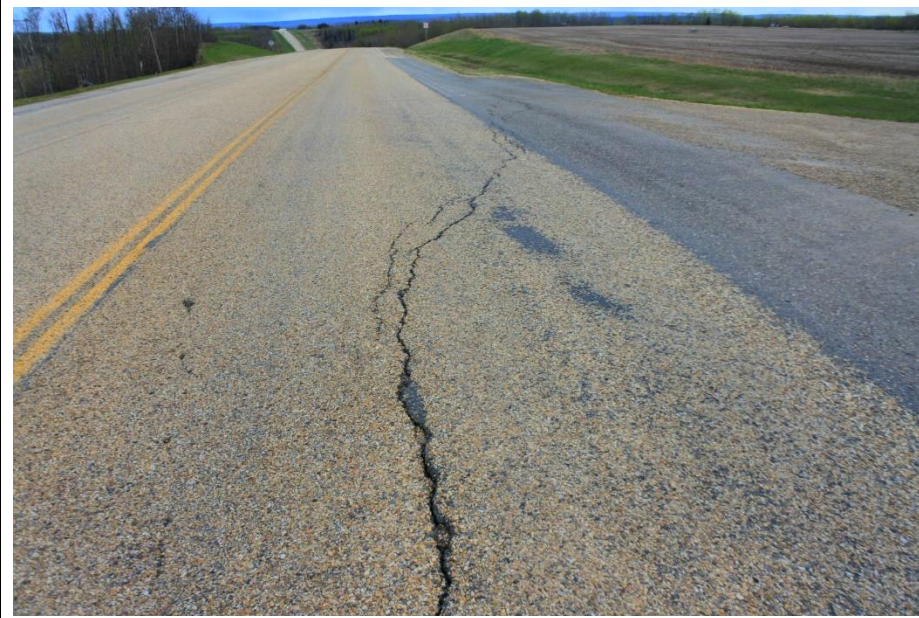
Photo 3.
Looking south
standing near
Township Road
771 looking at
crack in the SBL.

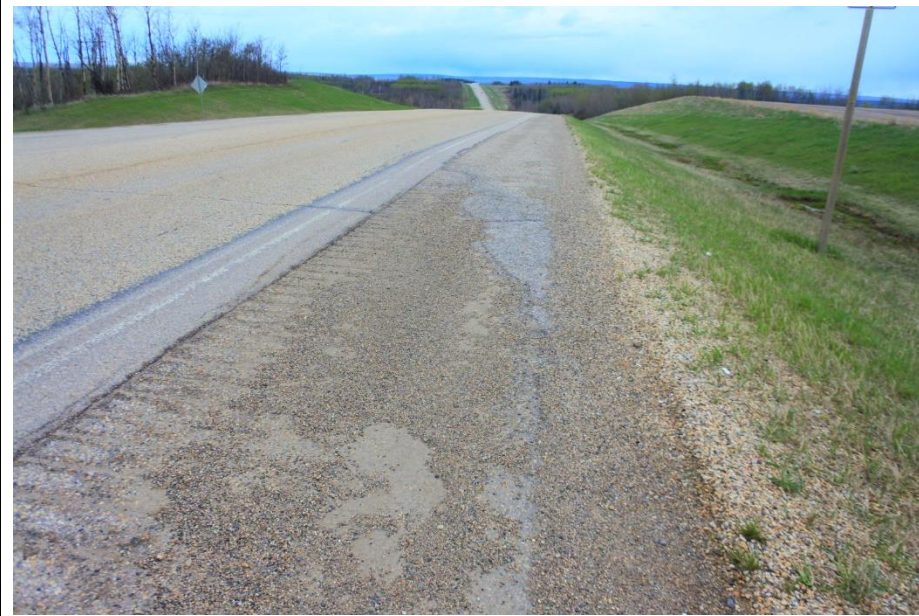
Observations:	Description	Worsened?
<input checked="" type="checkbox"/> Pavement Distress	<p>Cracks are showing through the chip seal that was placed in 2021 with opening width up to 80 mm were observed on the shoulder of SBL. The scarp crack observed in the pavement extended 200 m further south through all lanes and into the east shoulder. The cracks in the east shoulder are about 20 mm in width. A crack extended about 50 m further south running parallel to a crack directly east of the crack</p>	<input checked="" type="checkbox"/>

Photo 4.
Looking south at
the cracks in the
SBL shoulder just
south of Township
Road 771.

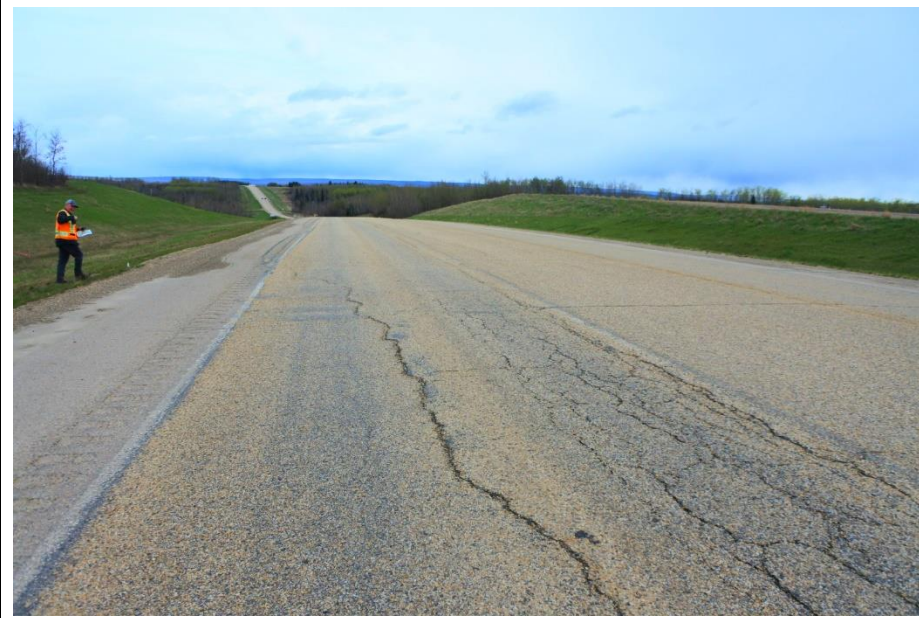
Photo 5.
Looking south at cracks observed crossing both NBL and extending into the shoulder.

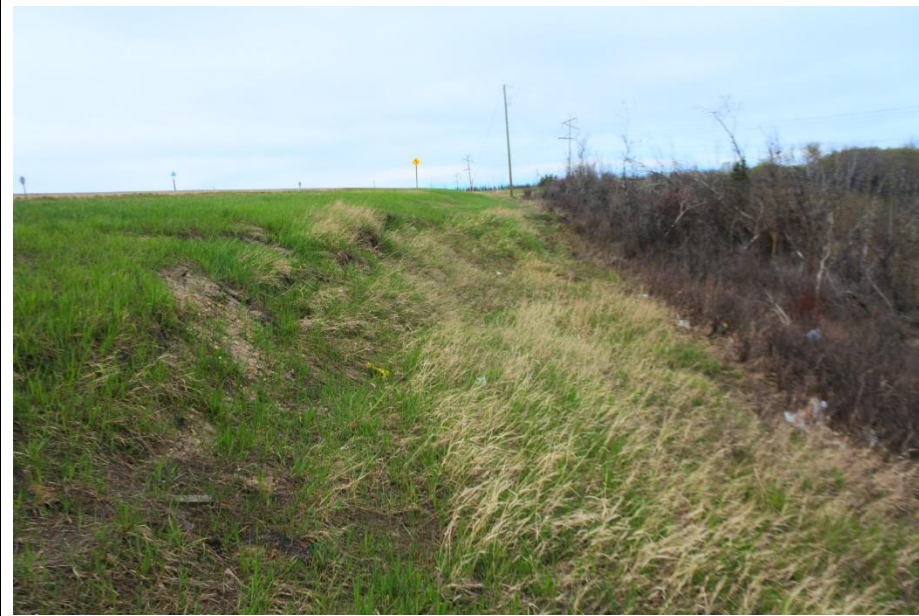
Photo 6.
Looking north from highway embankment to the east where scarp crack was observed and was slightly more grown over in 2022.

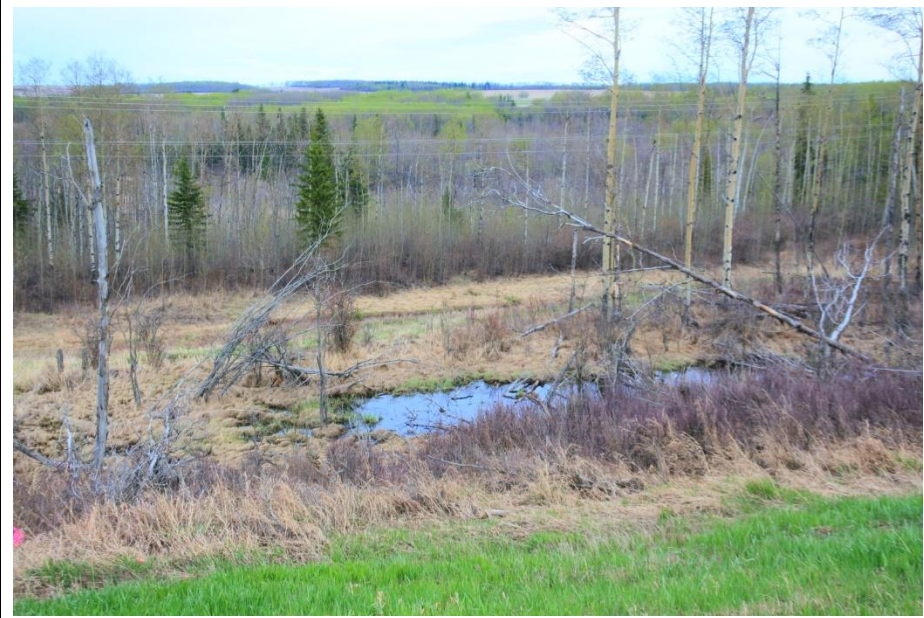
Photo 7.
Looking east at low lying wet land area where water was ponded.

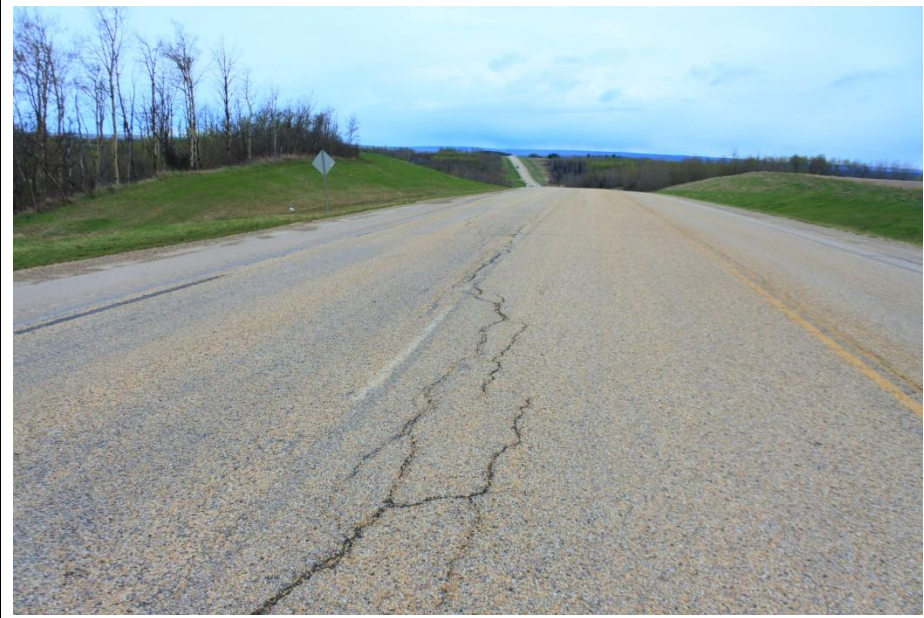
Photo 8.
Looking south at cracks observed crossing both NBL.
