ALBERTA TRANSPORTATION AND
ECONOMIC CORRIDORS GRMP
PEACE REGION
(GRANDE PRAIRIE DISTRICT - NORTH)
INSTRUMENTATION MONITORING - SPRING 2025

Site Number	Location	Name	Hwy	km
GP029	HWY 2:70 km 11.88	Church Camp Slide	2:70	Km 11.9
Legal Description:		UTM Co-ordinates		
16-4-77-5 W6		11U E 393096	N	6168377

Current Monitoring:	17-Jun-2025	Previous Monitoring	25-Sep-2024
Instruments Read By:	Mr. Niraj Regmi, G.I.T. and Mr. Godfred Etiendem, of Thurber

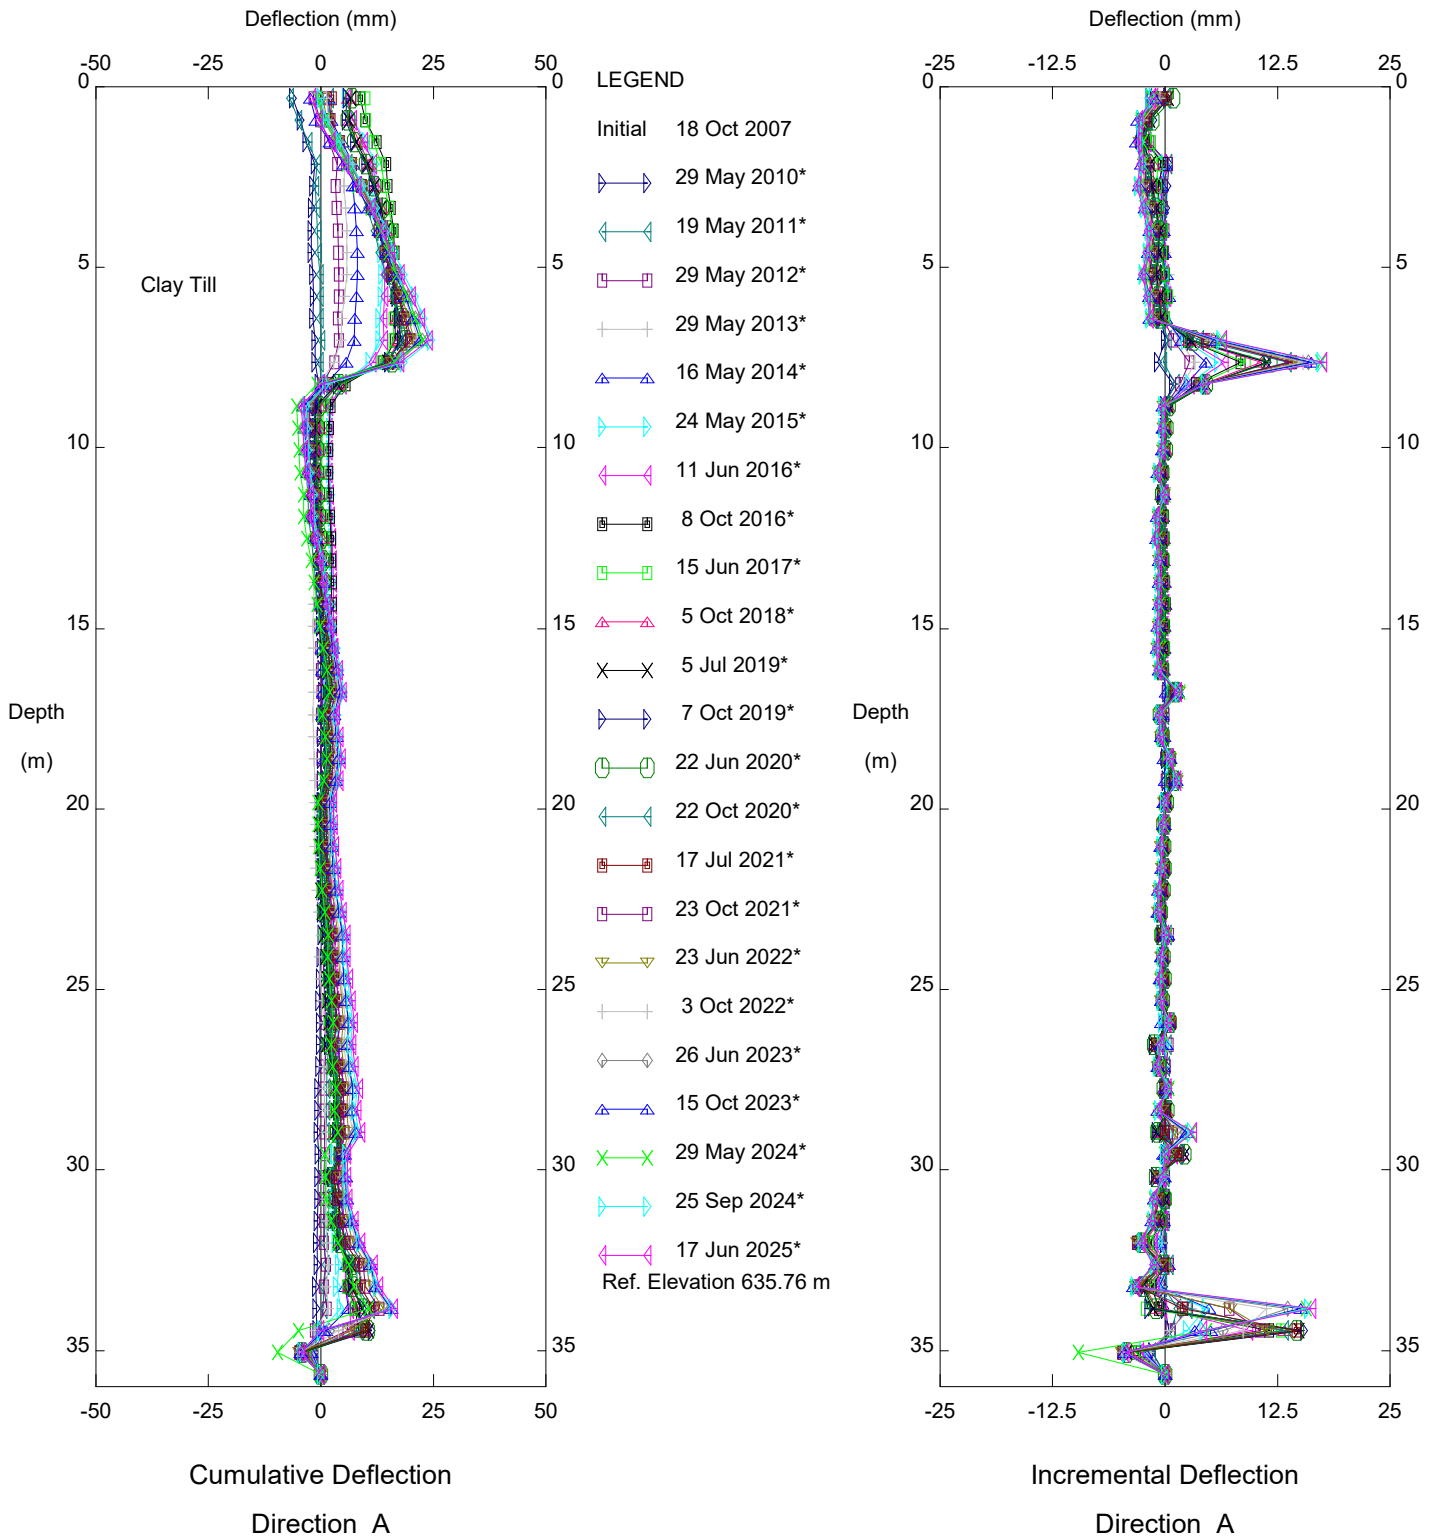
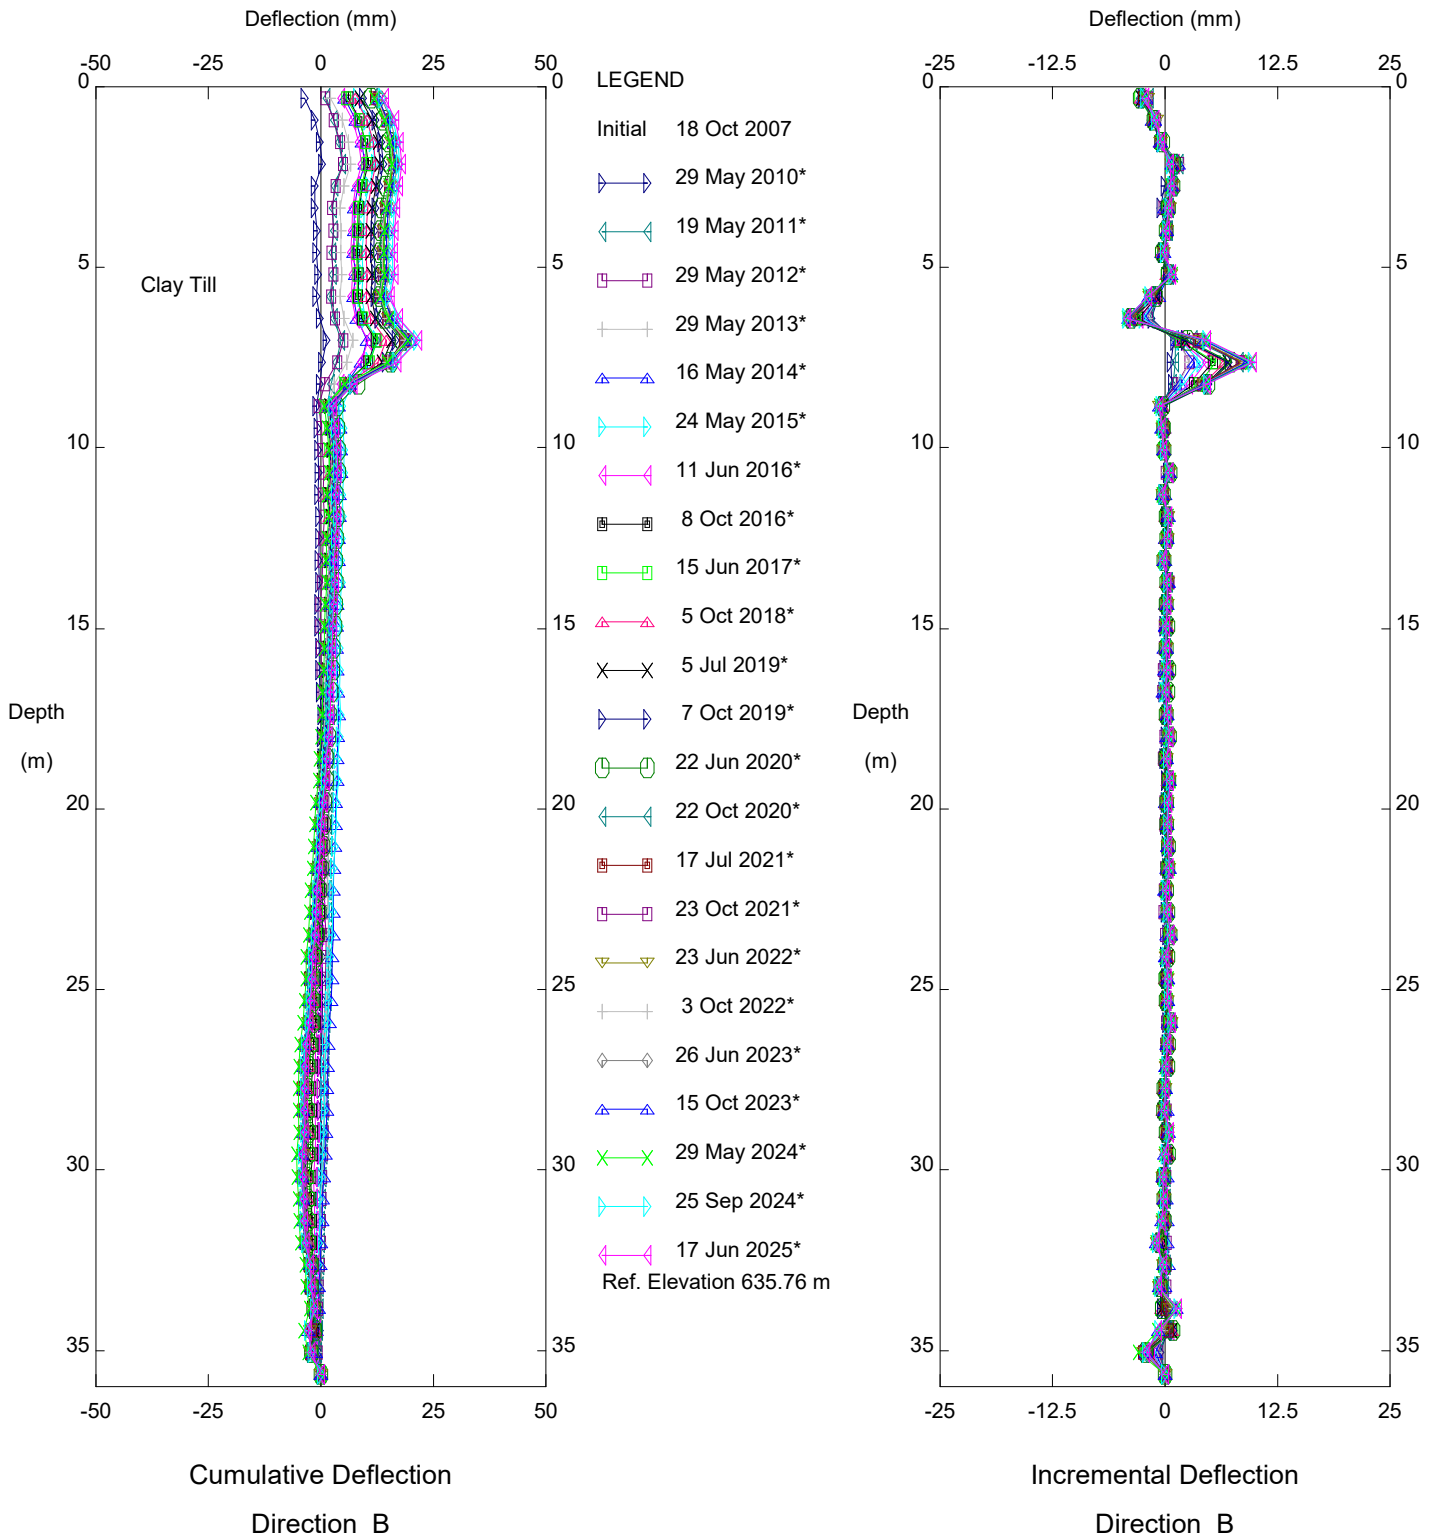
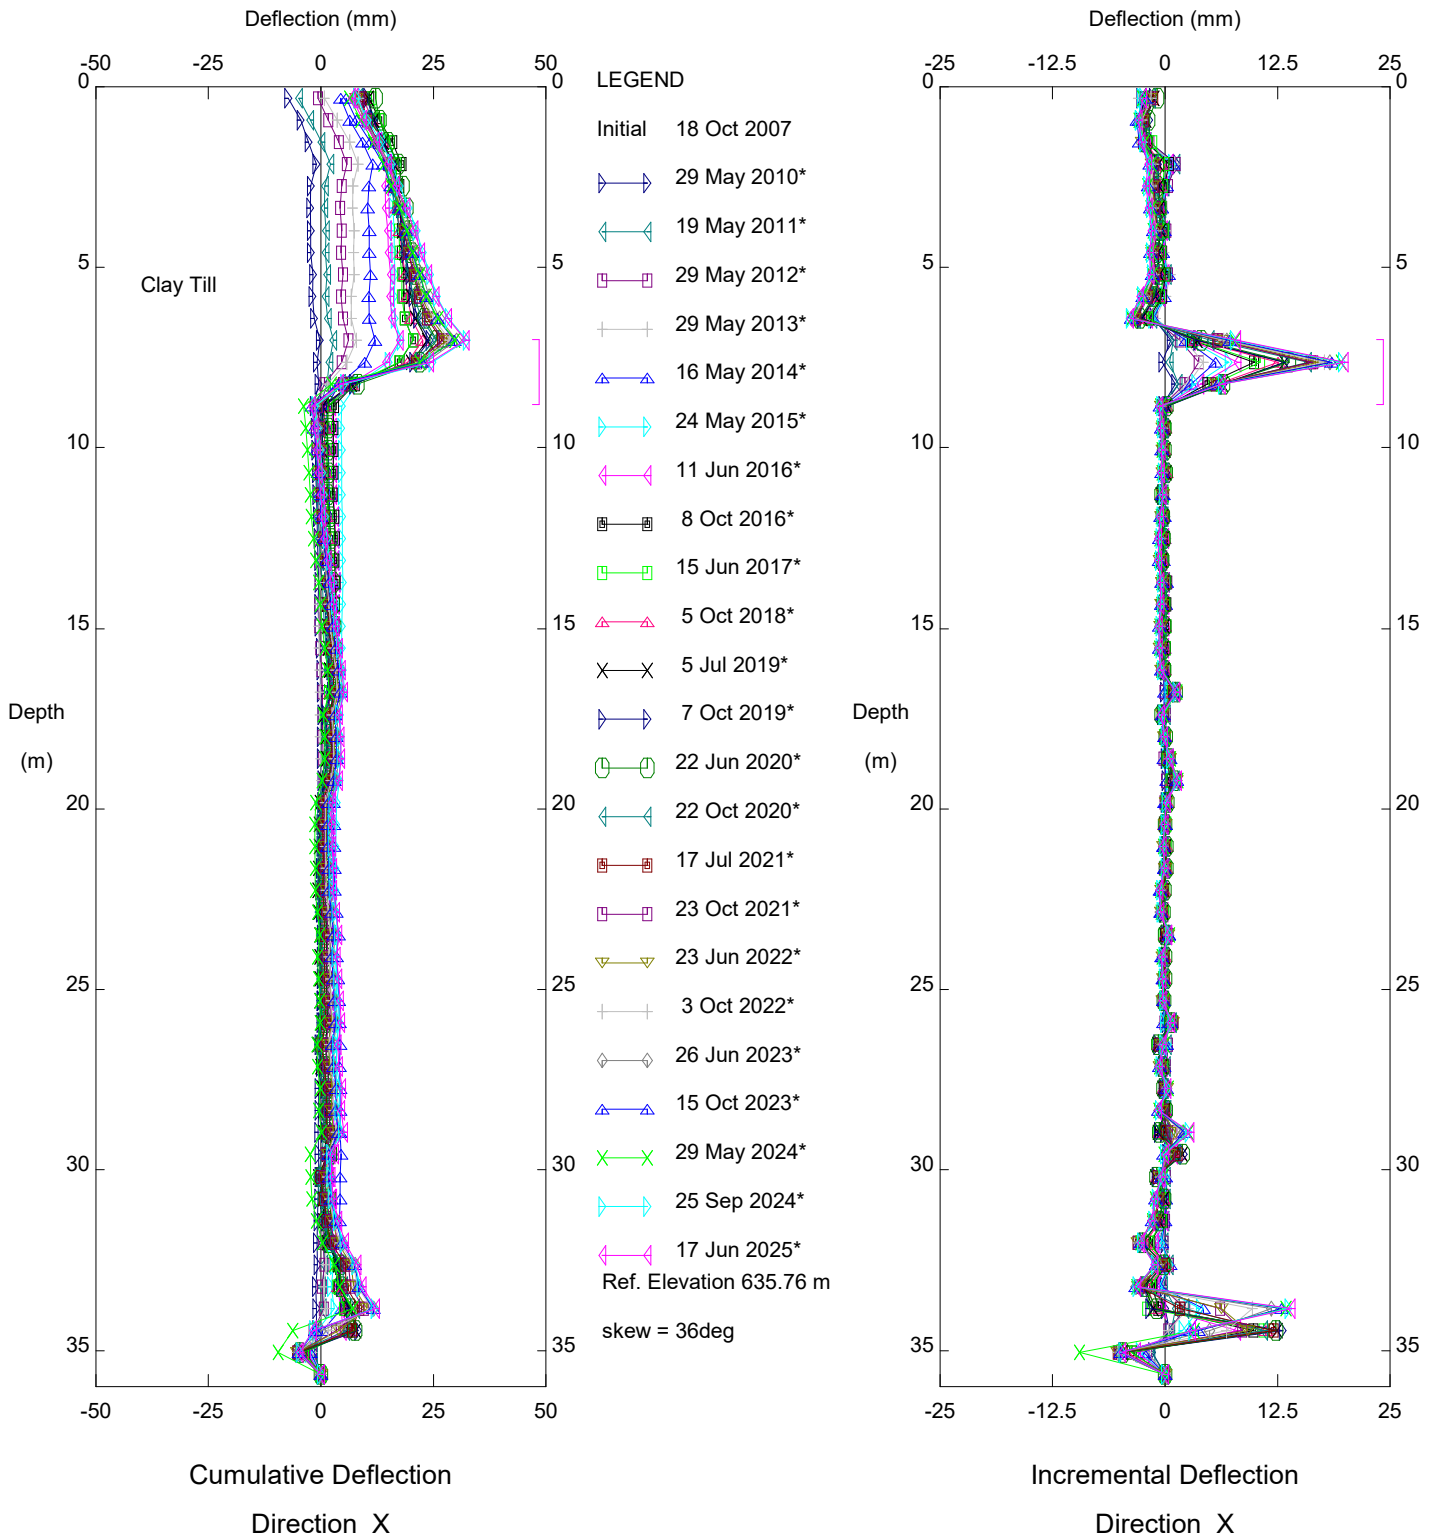
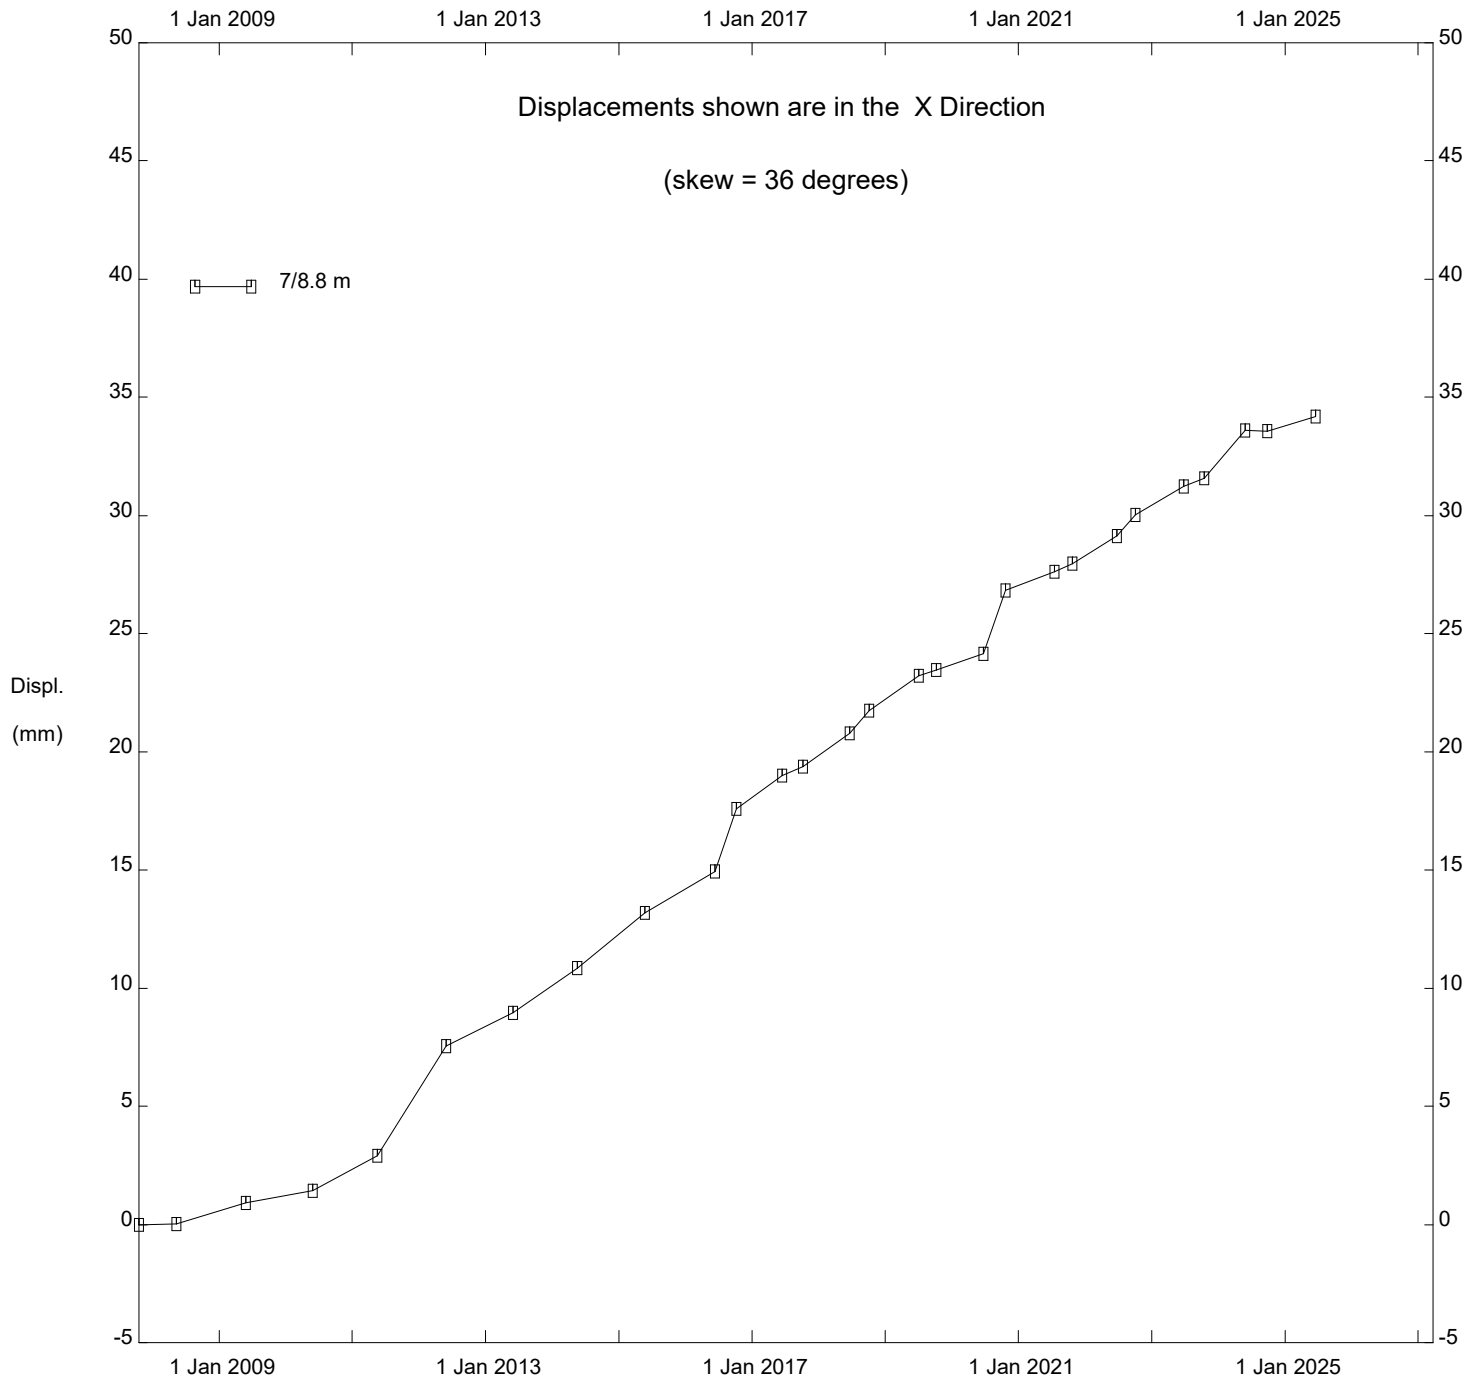
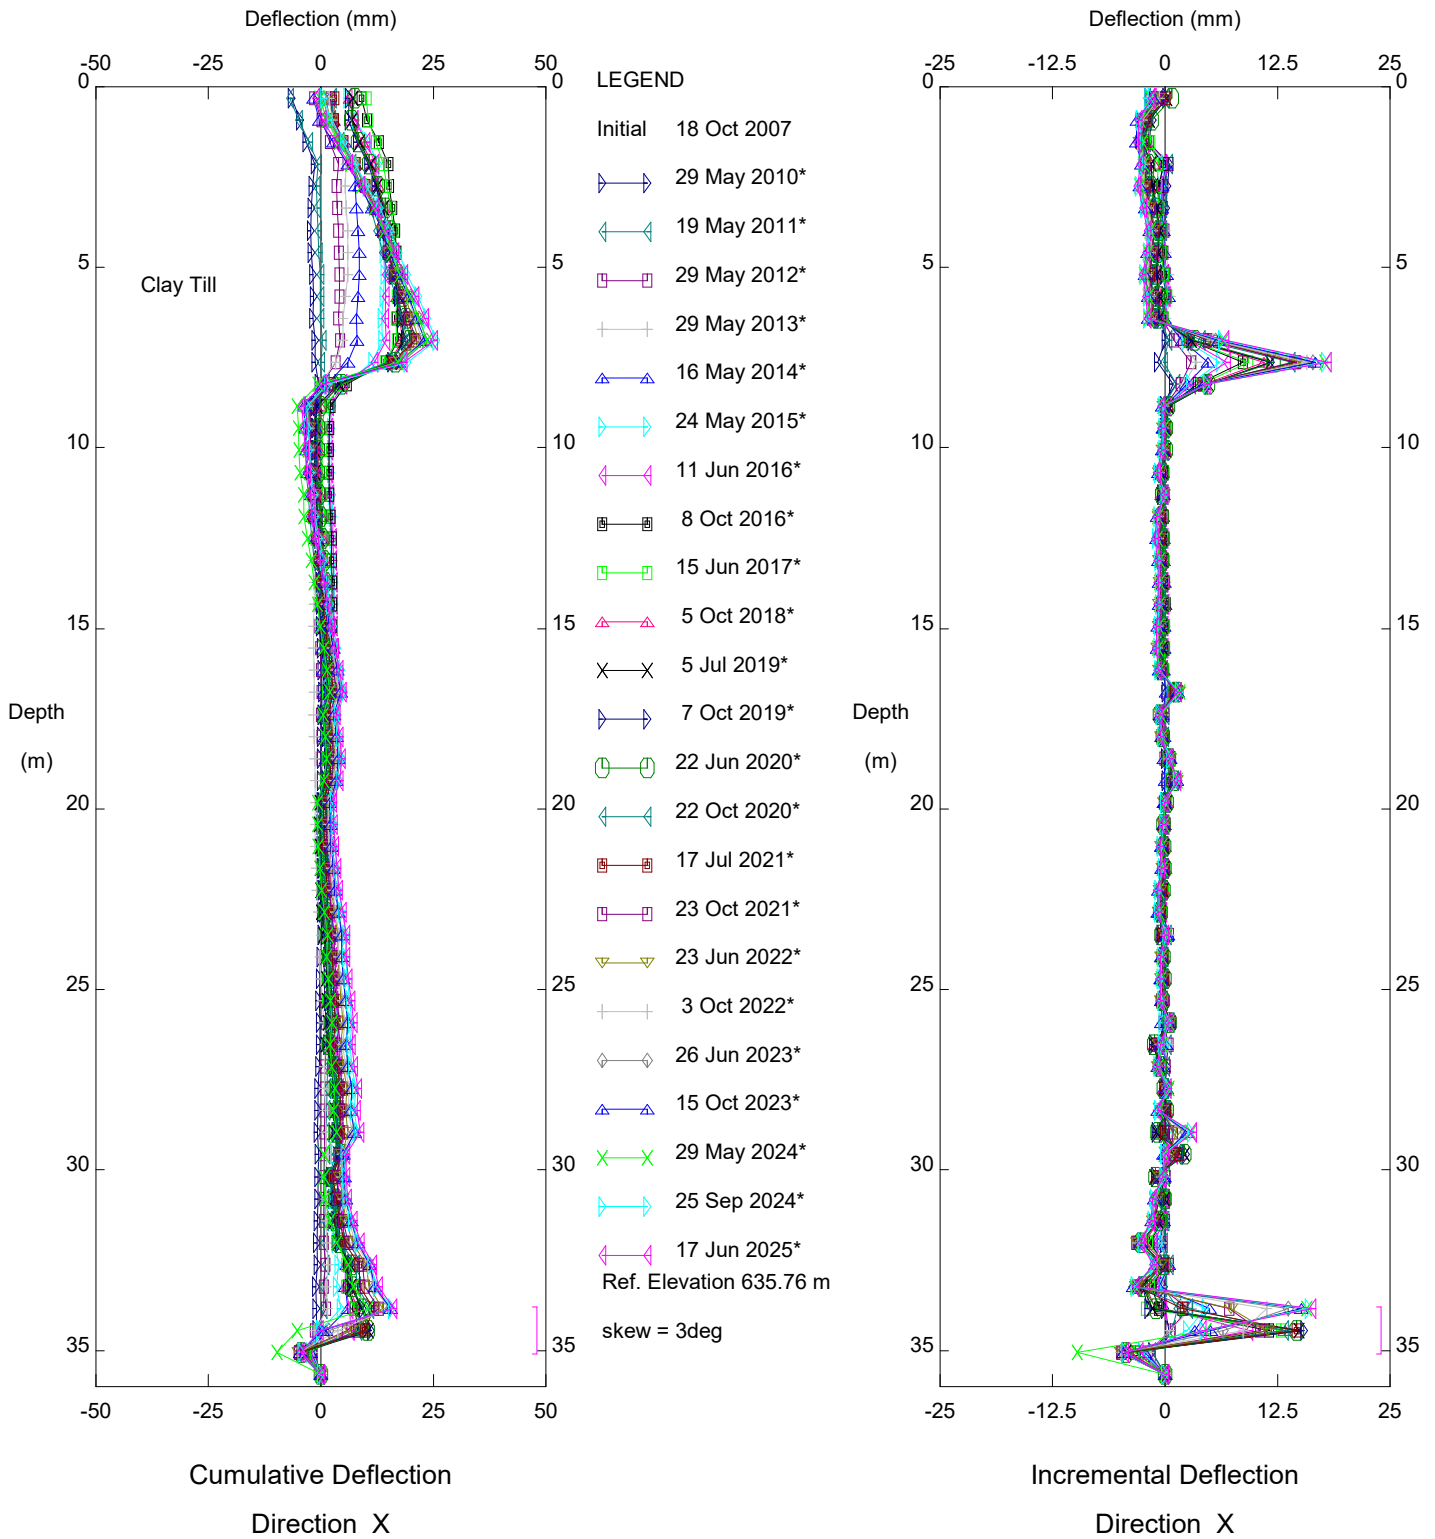
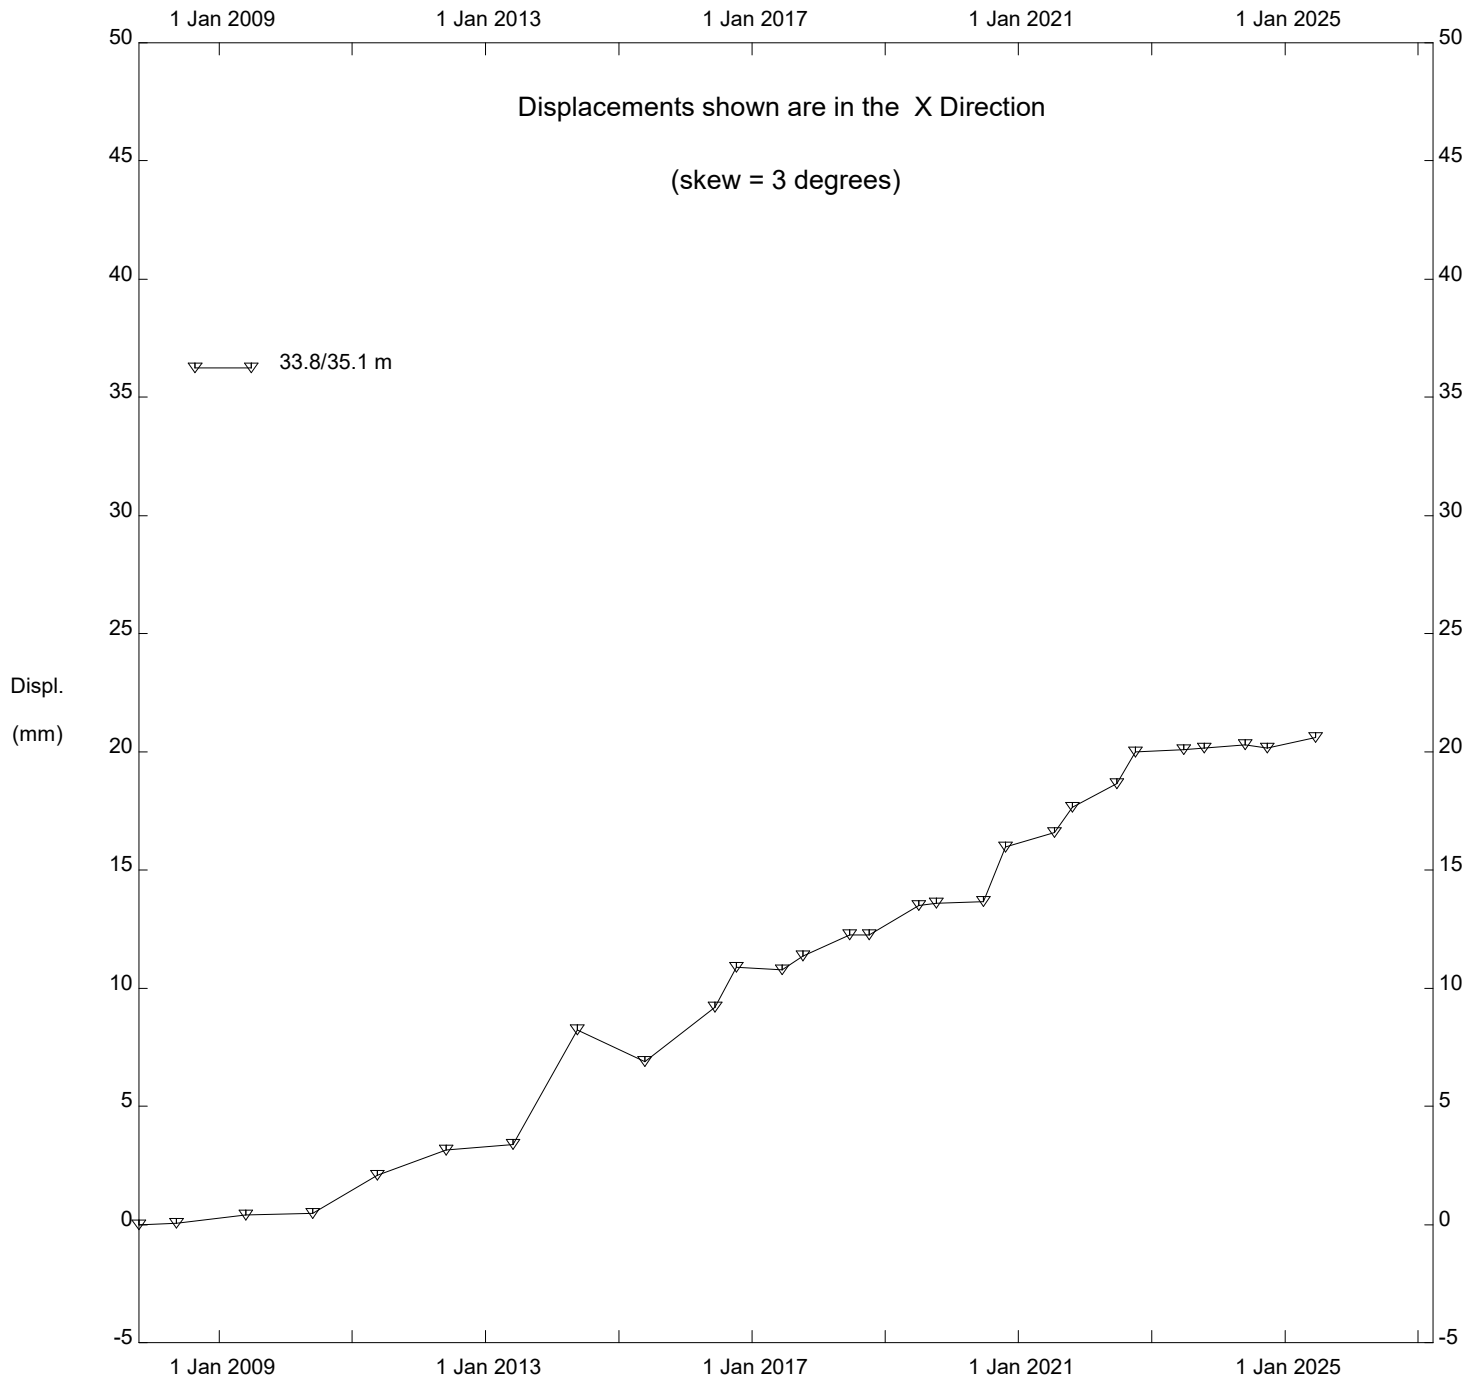
GP029 HWY 2:70 (Church Camp), Inclinometer SI-2

Discussion	
Zones of New Movement:	None
Interpretation of Monitoring Results:	<p>Slope inclinometer SI-2 showed a rate of movement of 0.9 mm/yr over 7.0 m to 8.8 m depth, and a rate of movement of 0.6 mm/yr over 33.8 m to 35.1 m depth since the fall of 2024 readings. Both zones of movement are very distinct and showed an increase in rate of movement since the previous readings. Of interest is the upper zone which has a movement vector skew angle of 36 degrees and the lower zone has a skew angle of 3 degrees.</p> <p>SI-3 has four known zones of movement. From top to bottom the movement rates since the fall of 2024 readings are: 0.9 mm/yr over 5.2 m to 7.0 m depth; no discernible movement over 9.4 m to 10.6 m depth; no discernible movement over 13.1 m to 14.3 m depth, and; less than 0.1 mm/yr over 18.0 m to 19.2 m depth. The cumulative movements are: 43.9 mm over 5.2 m to 7.0 m depth; 12.6 mm over 9.4 m to 10.6 m depth; 3.1 mm over 13.1 m to 14.3 m depth, and; 4.8 mm over 18.0 m to 19.2 m depth. The multitude of movement zones is indicative of the complexity of the slide at this site.</p>
