ALBERTA TRANSPORTATION AND
ECONOMIC CORRIDORS GRMP
PEACE REGION
(GRANDE PRAIRIE DISTRICT - NORTH)
INSTRUMENTATION MONITORING - SPRING 2025

Site Number	Location	Name	Hwy	km
GP029	HWY 2:70 km 11.88	Church Camp Slide	2:70	Km 11.9
Legal Description:		UTM Co-ordinates		
16-4-77-5 W6		11U E 393096	N	6168377

Current Monitoring:	17-Jun-2025	Previous Monitoring	25-Sep-2024
Instruments Read By:	Mr. Niraj Regmi, G.I.T. and Mr. Godfred Etiendem, of Thurber

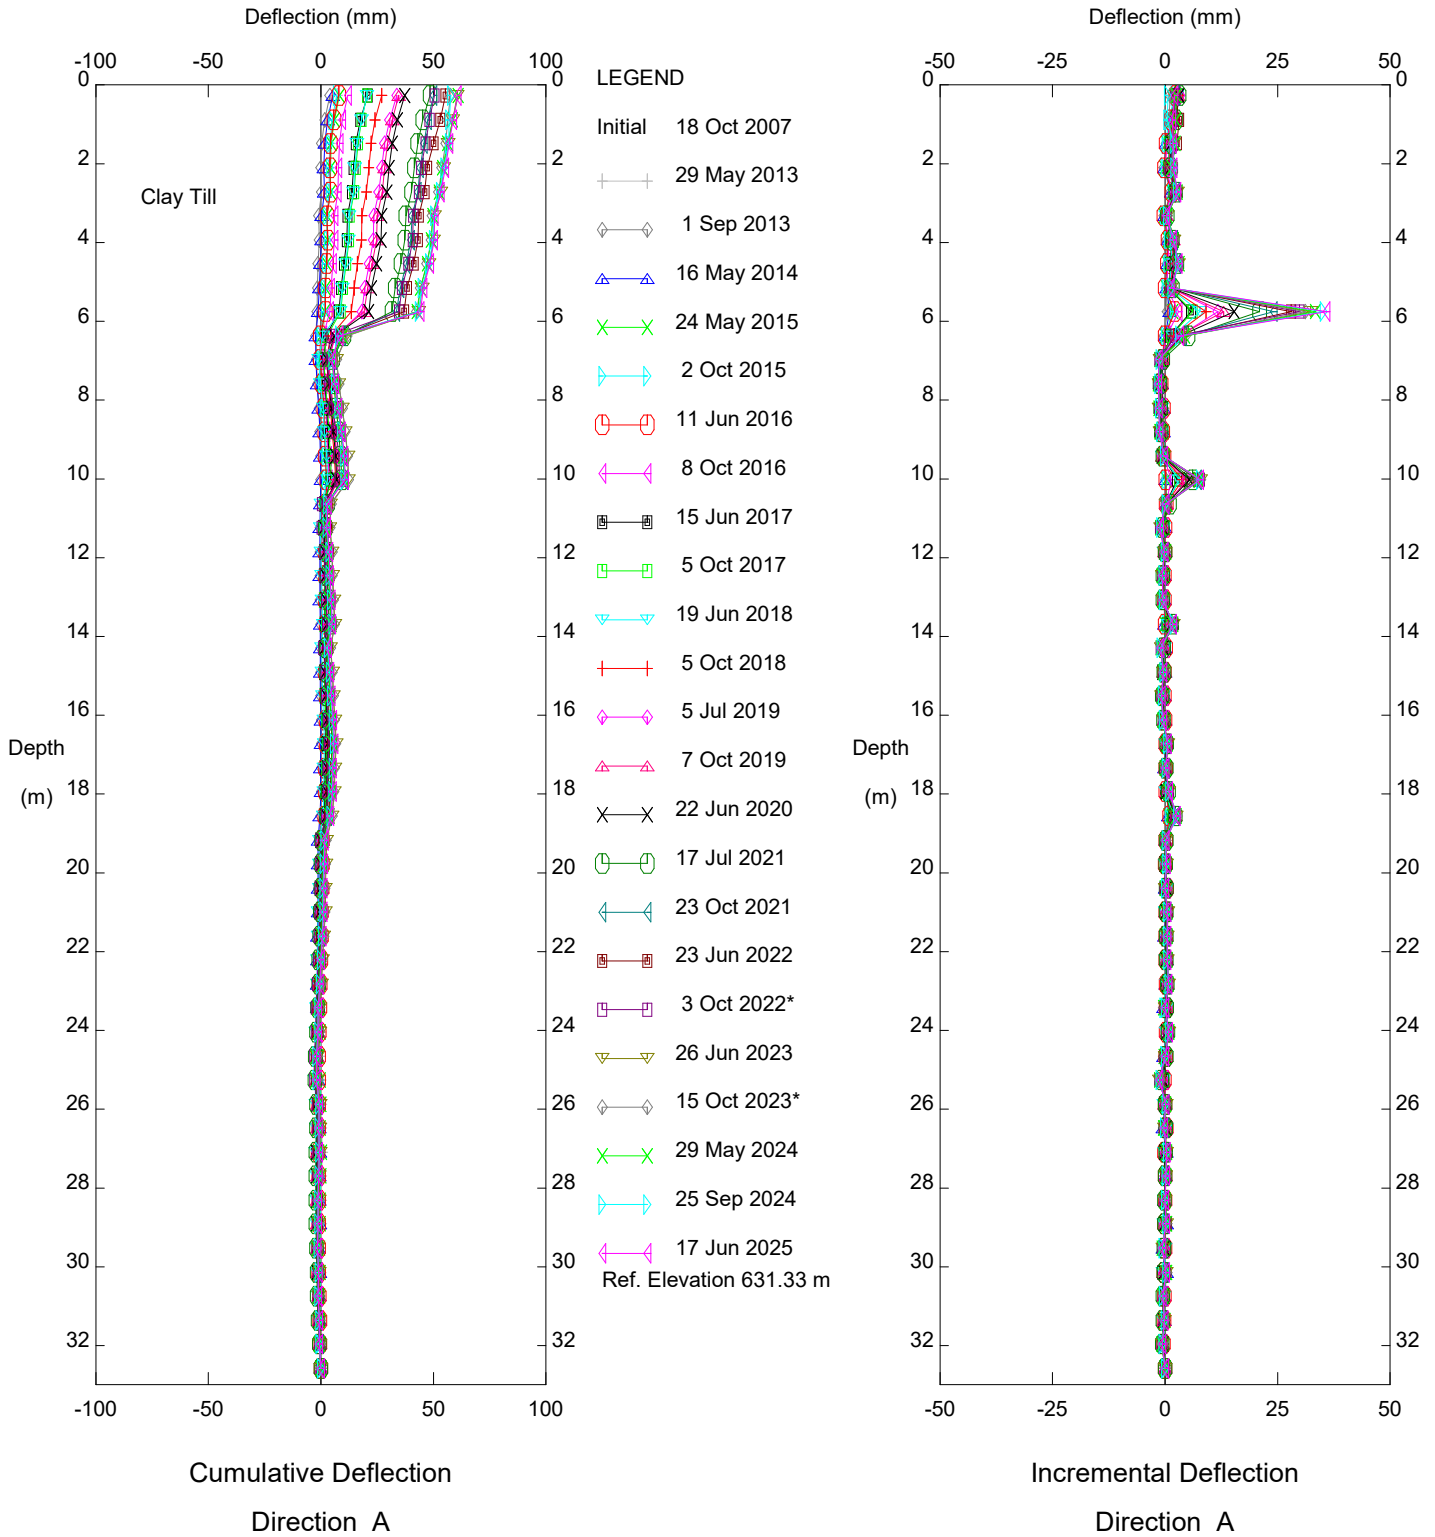
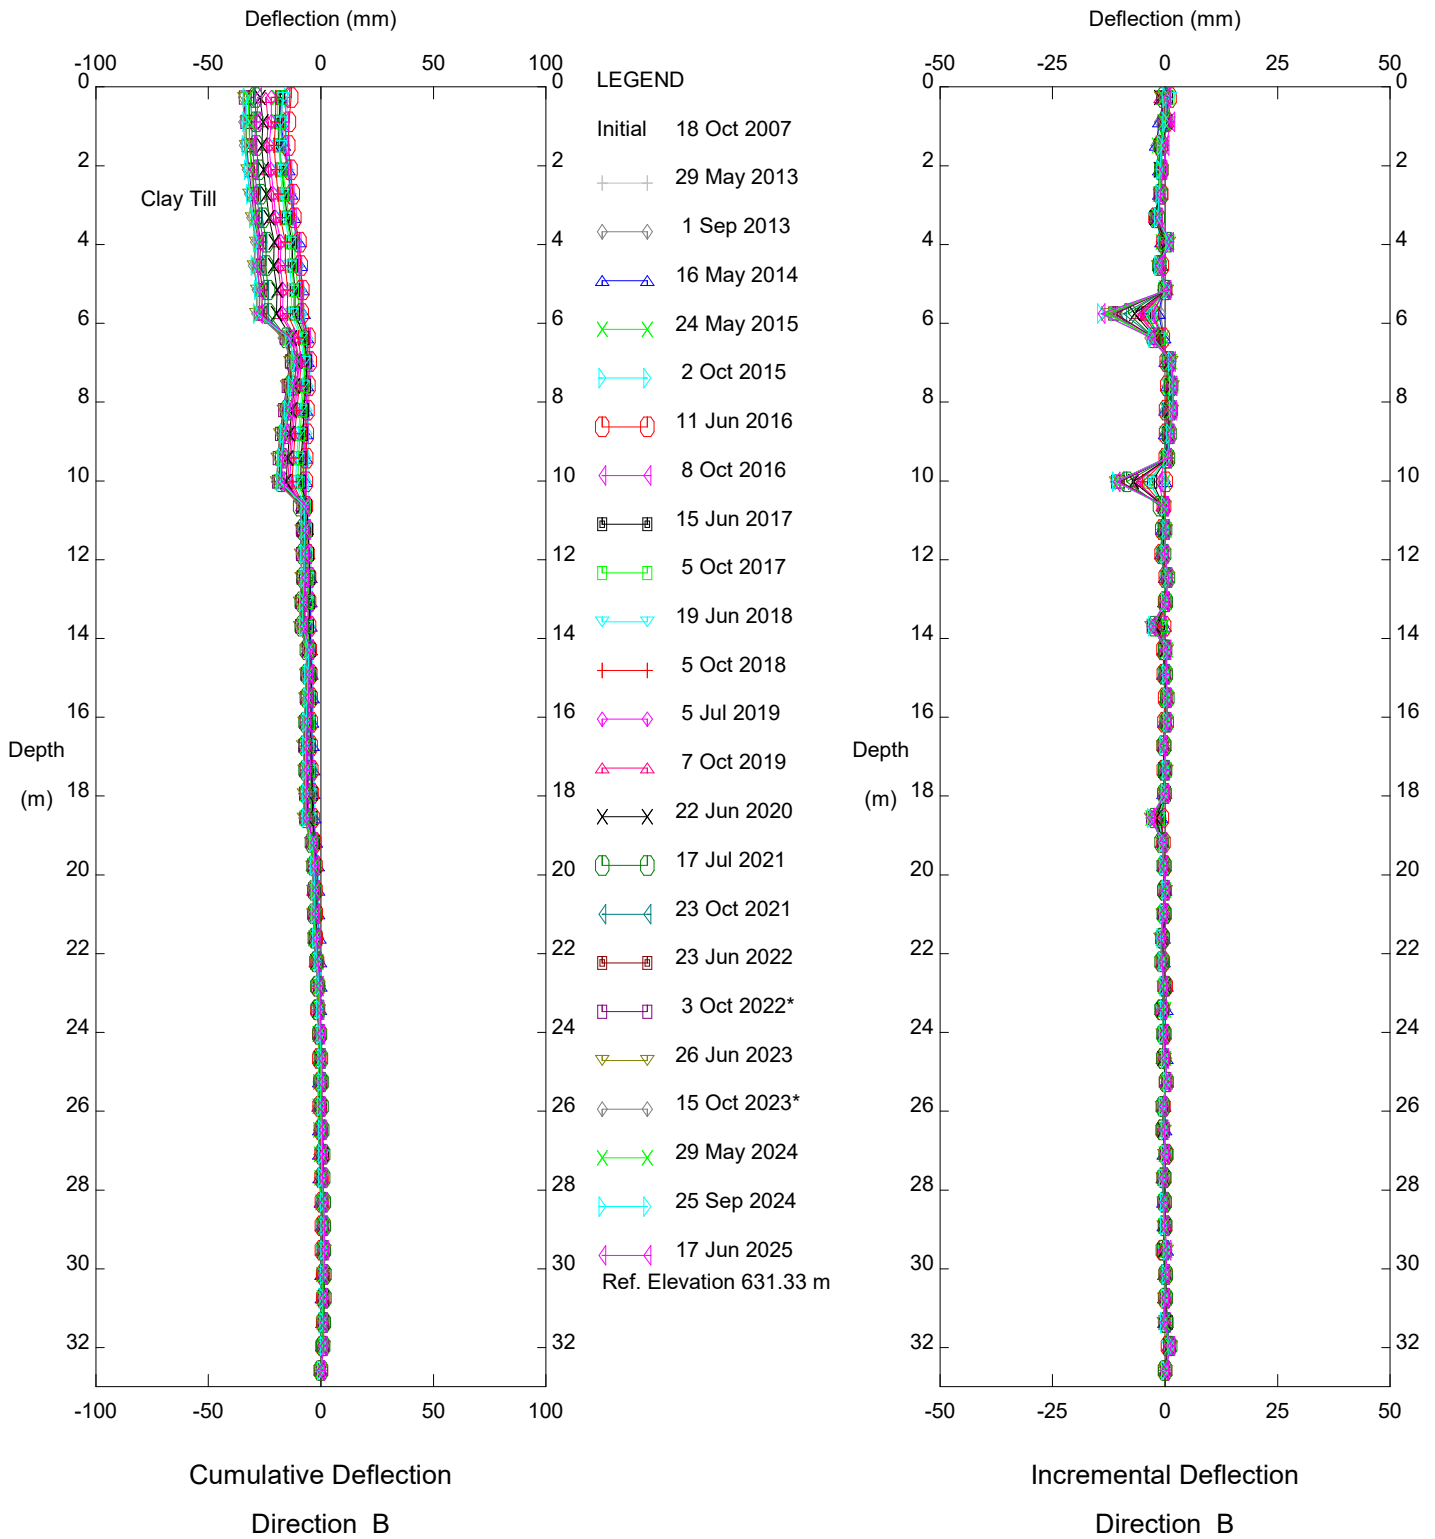
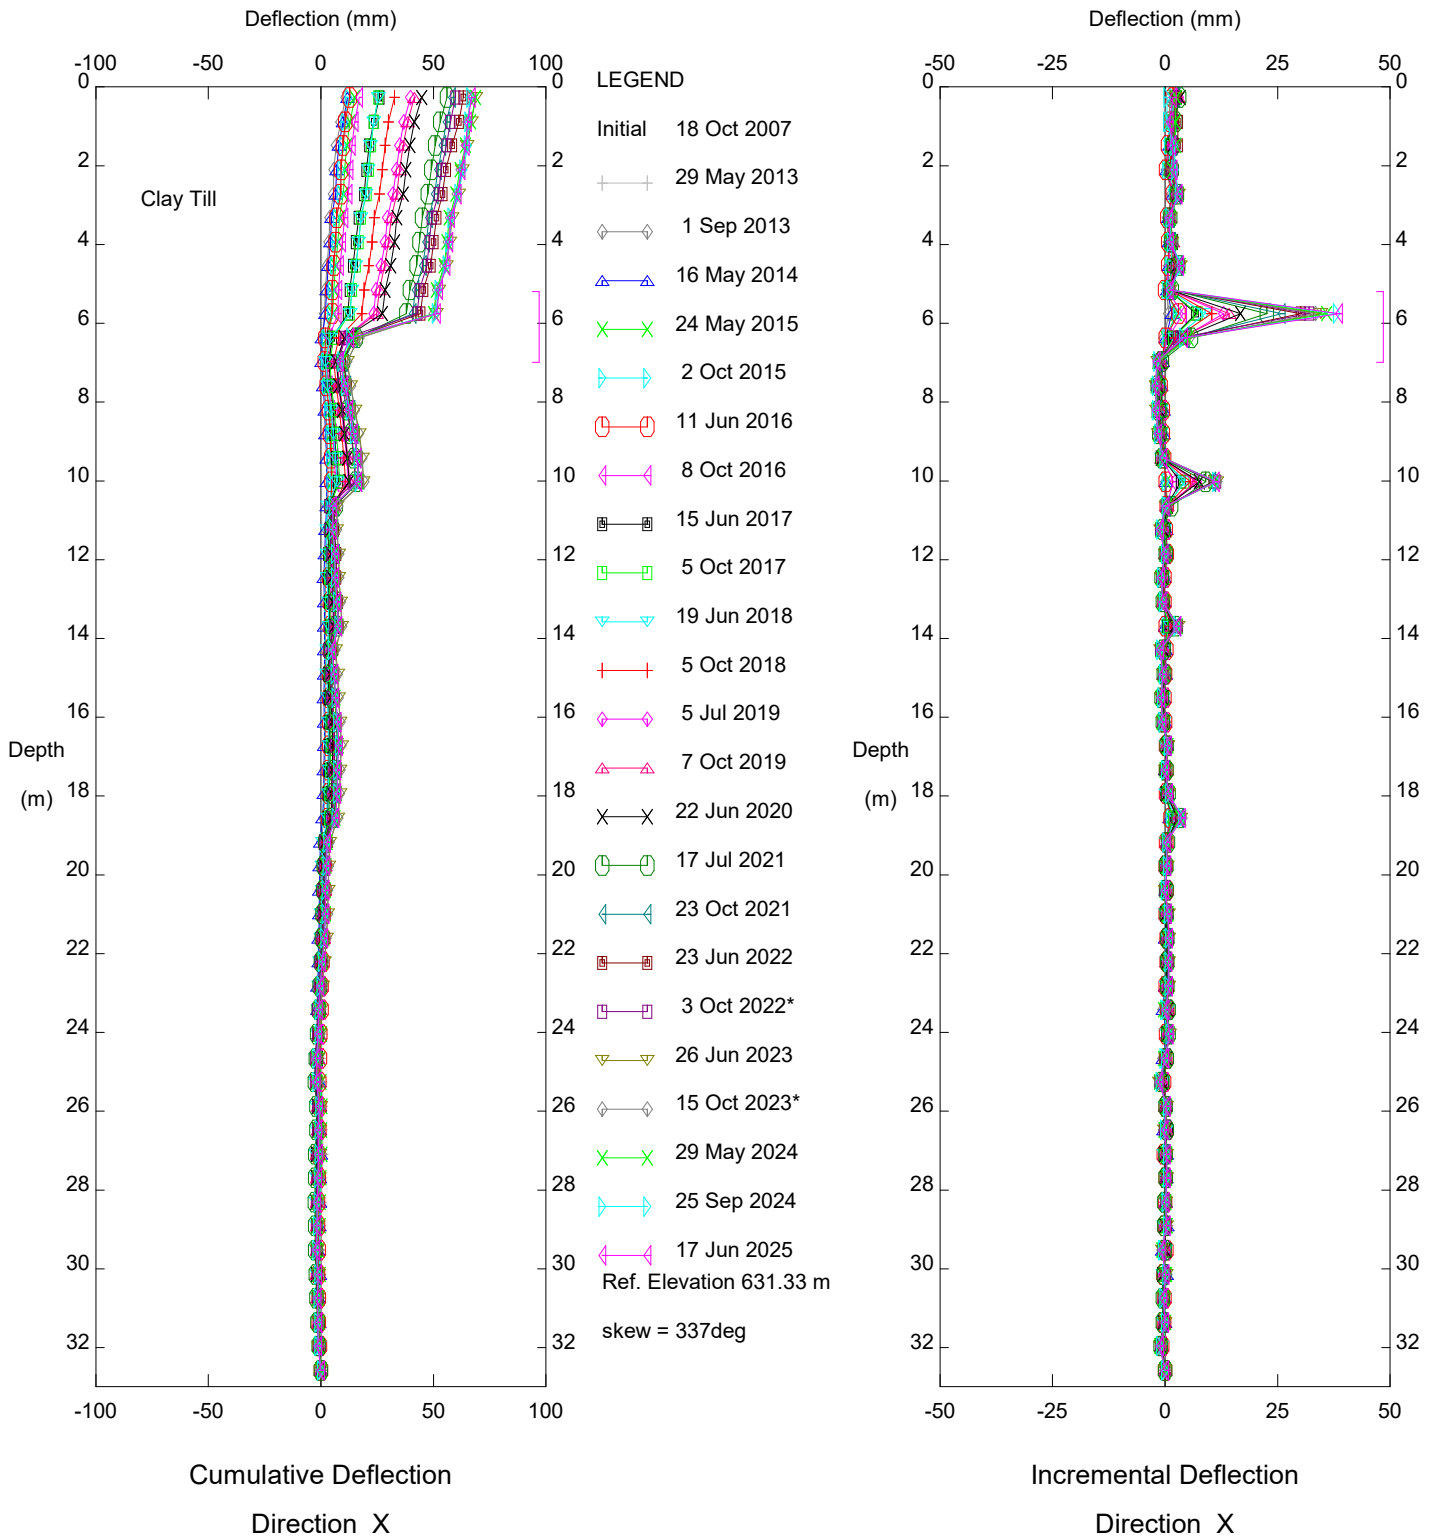
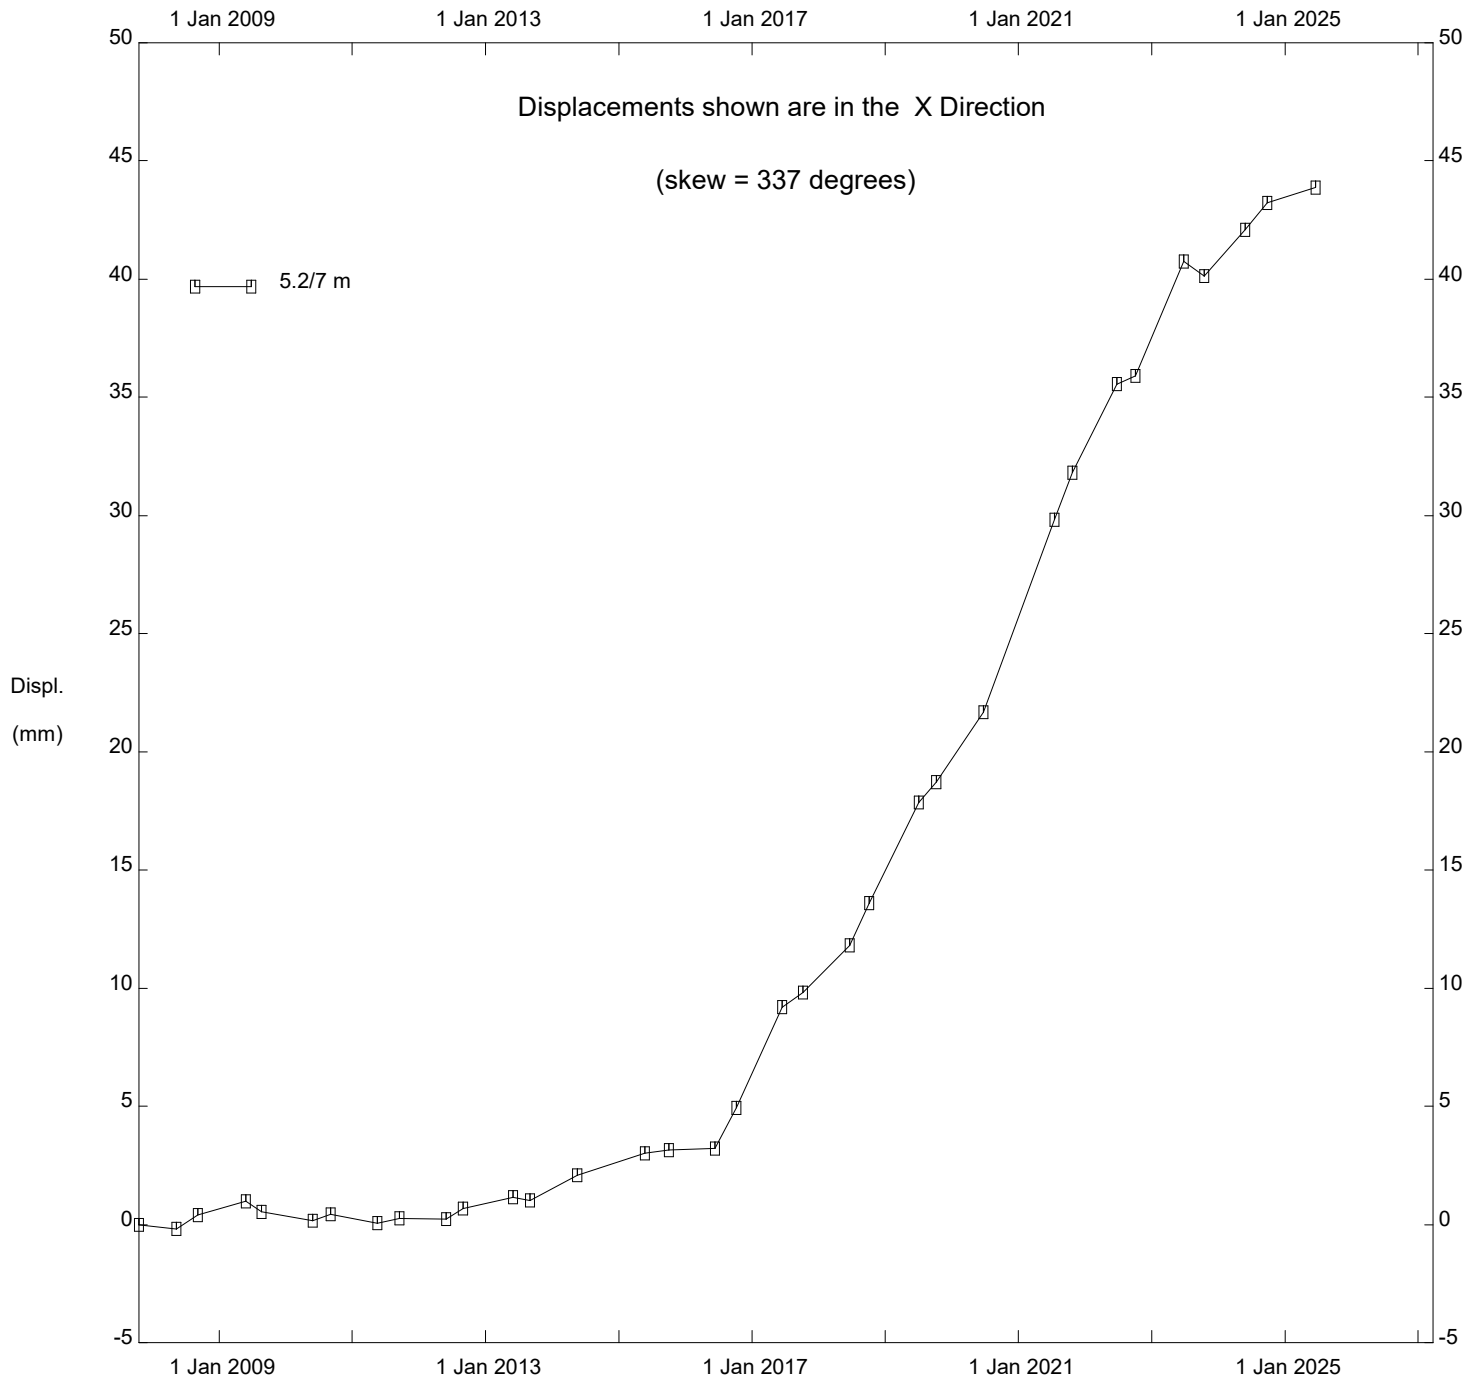
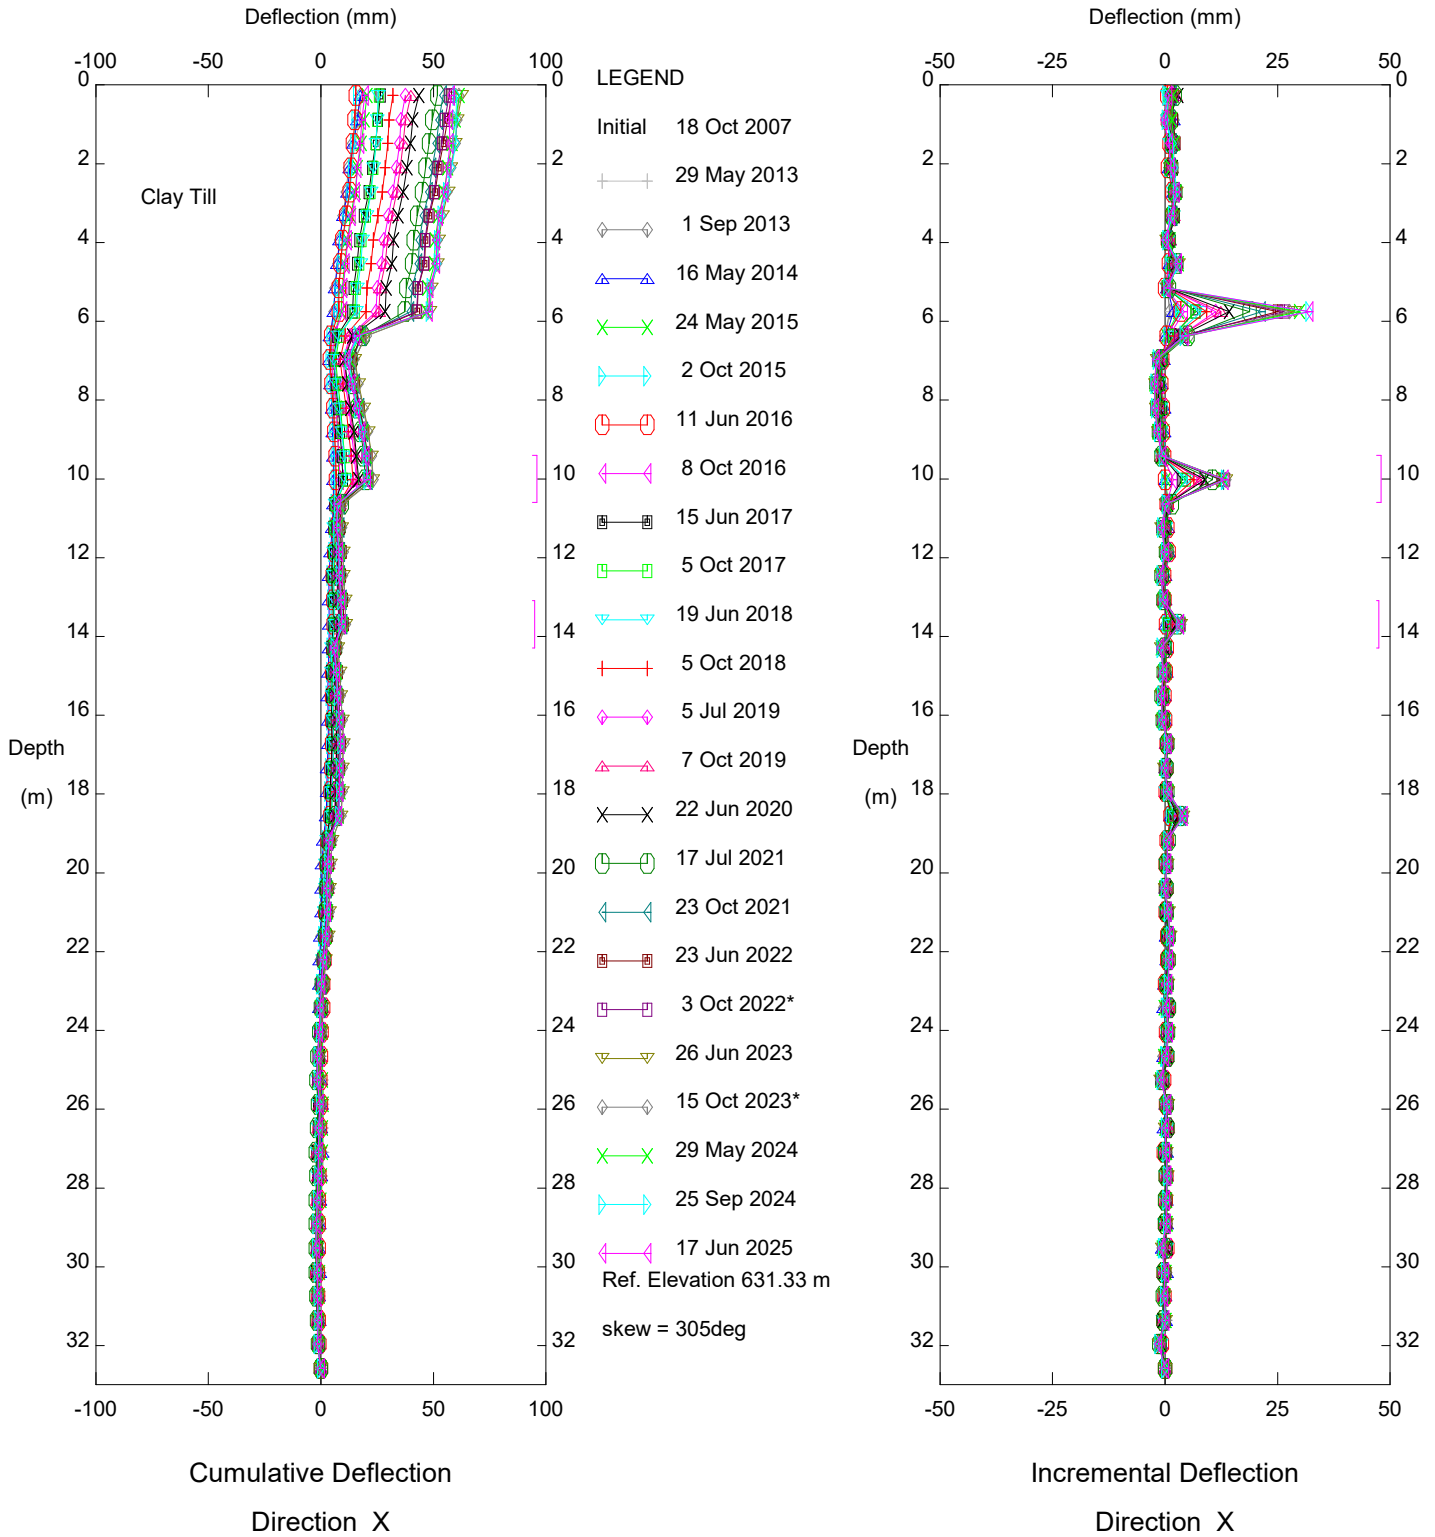
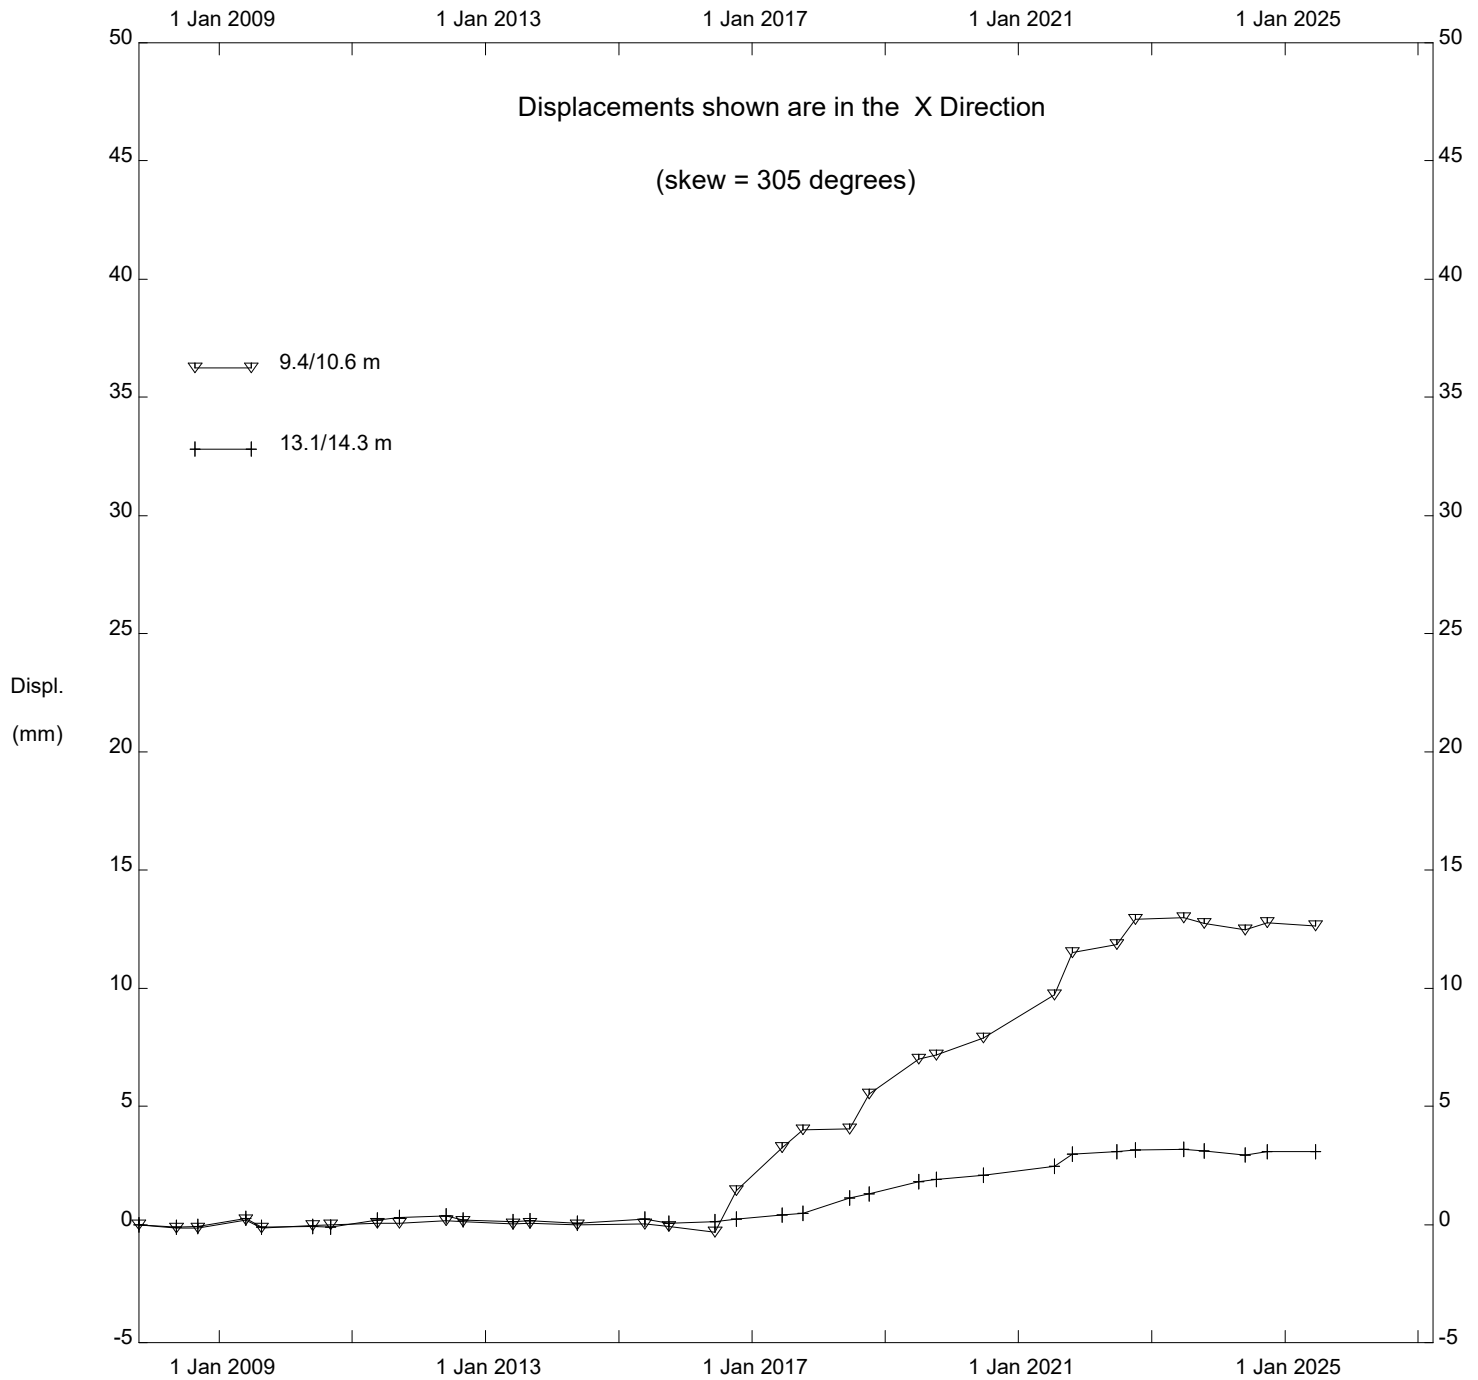
GP029 HWY 2:70 (Church Camp), Inclinometer SI-3

Discussion	
Zones of New Movement:	None
Interpretation of Monitoring Results:	<p>Slope inclinometer SI-2 showed a rate of movement of 0.9 mm/yr over 7.0 m to 8.8 m depth, and a rate of movement of 0.6 mm/yr over 33.8 m to 35.1 m depth since the fall of 2024 readings. Both zones of movement are very distinct and showed an increase in rate of movement since the previous readings. Of interest is the upper zone which has a movement vector skew angle of 36 degrees and the lower zone has a skew angle of 3 degrees.</p> <p>SI-3 has four known zones of movement. From top to bottom the movement rates since the fall of 2024 readings are: 0.9 mm/yr over 5.2 m to 7.0 m depth; no discernible movement over 9.4 m to 10.6 m depth; no discernible movement over 13.1 m to 14.3 m depth, and; less than 0.1 mm/yr over 18.0 m to 19.2 m depth. The cumulative movements are: 43.9 mm over 5.2 m to 7.0 m depth; 12.6 mm over 9.4 m to 10.6 m depth; 3.1 mm over 13.1 m to 14.3 m depth, and; 4.8 mm over 18.0 m to 19.2 m depth. The multitude of movement zones is indicative of the complexity of the slide at this site.</p>

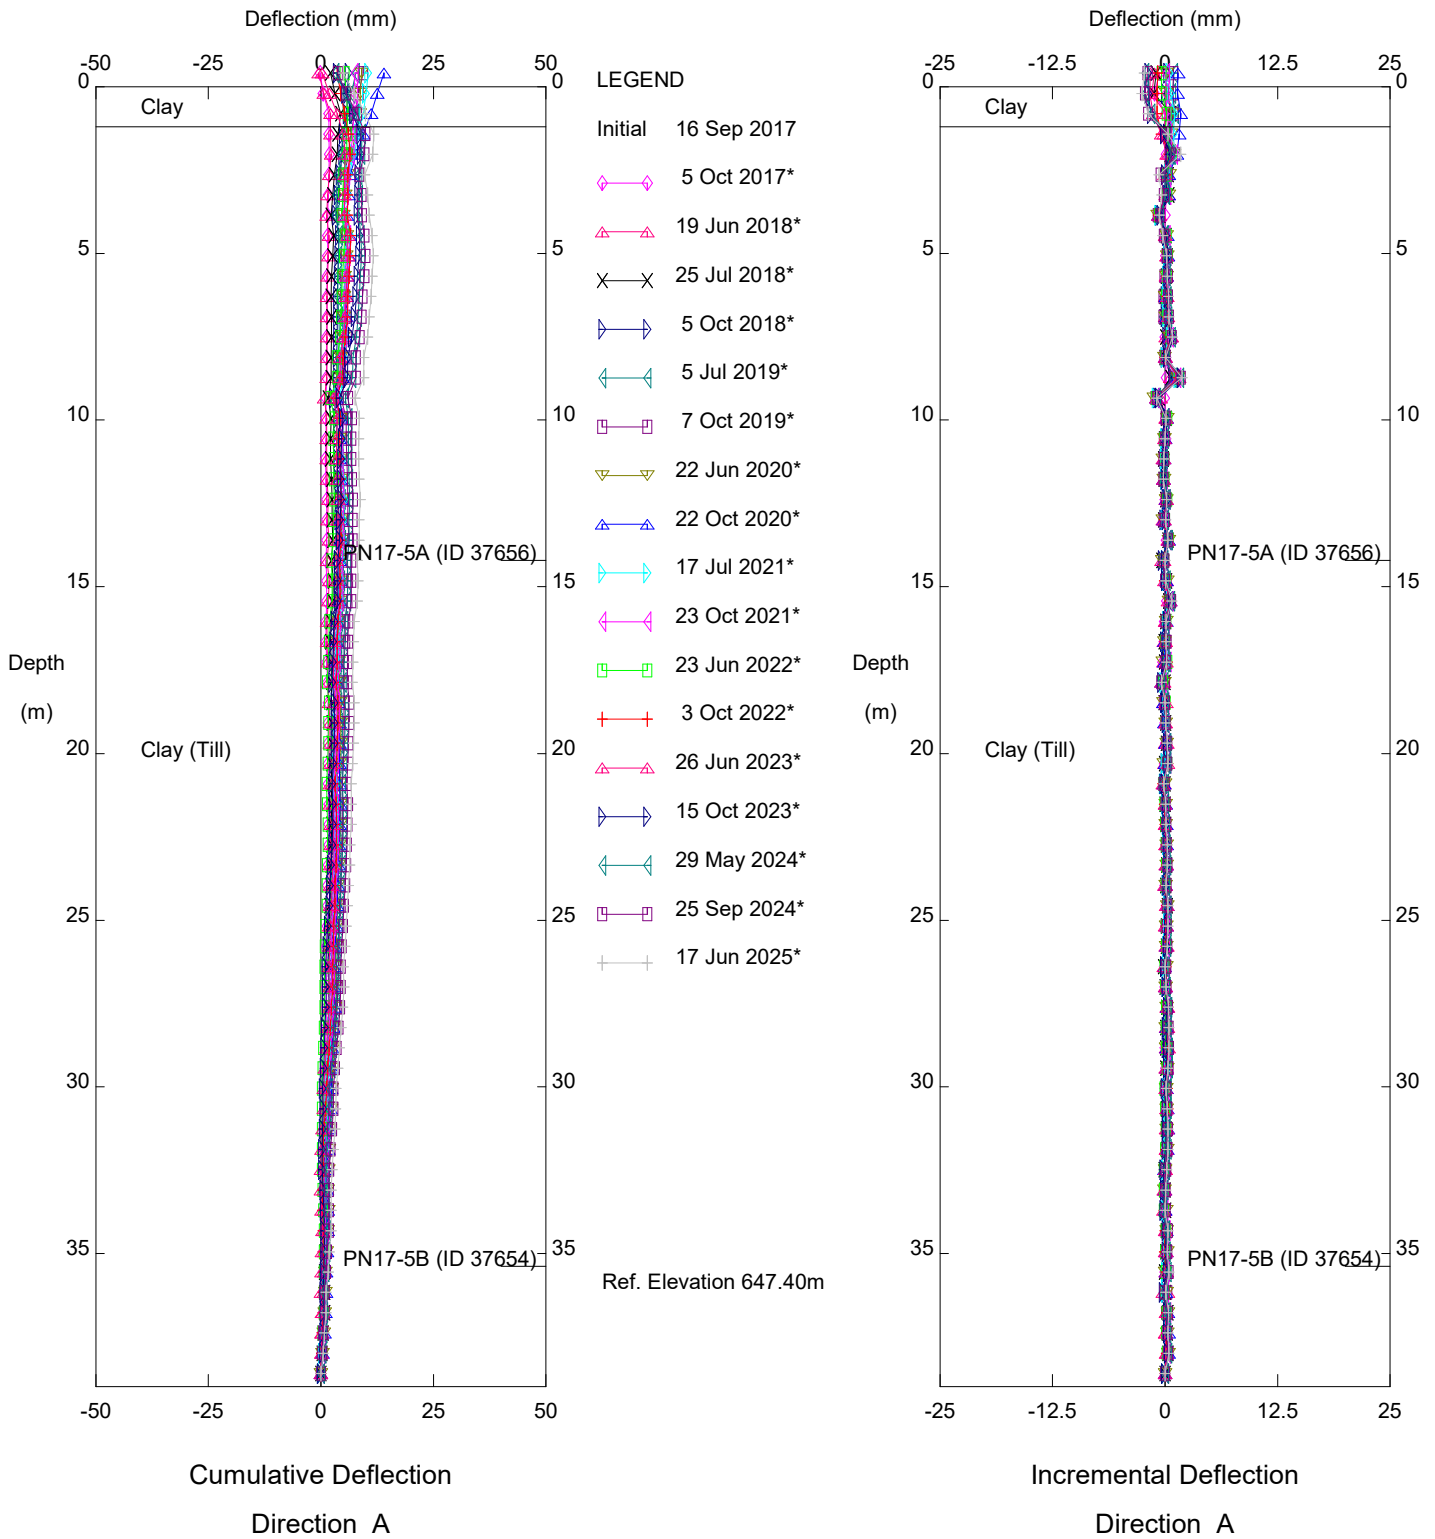
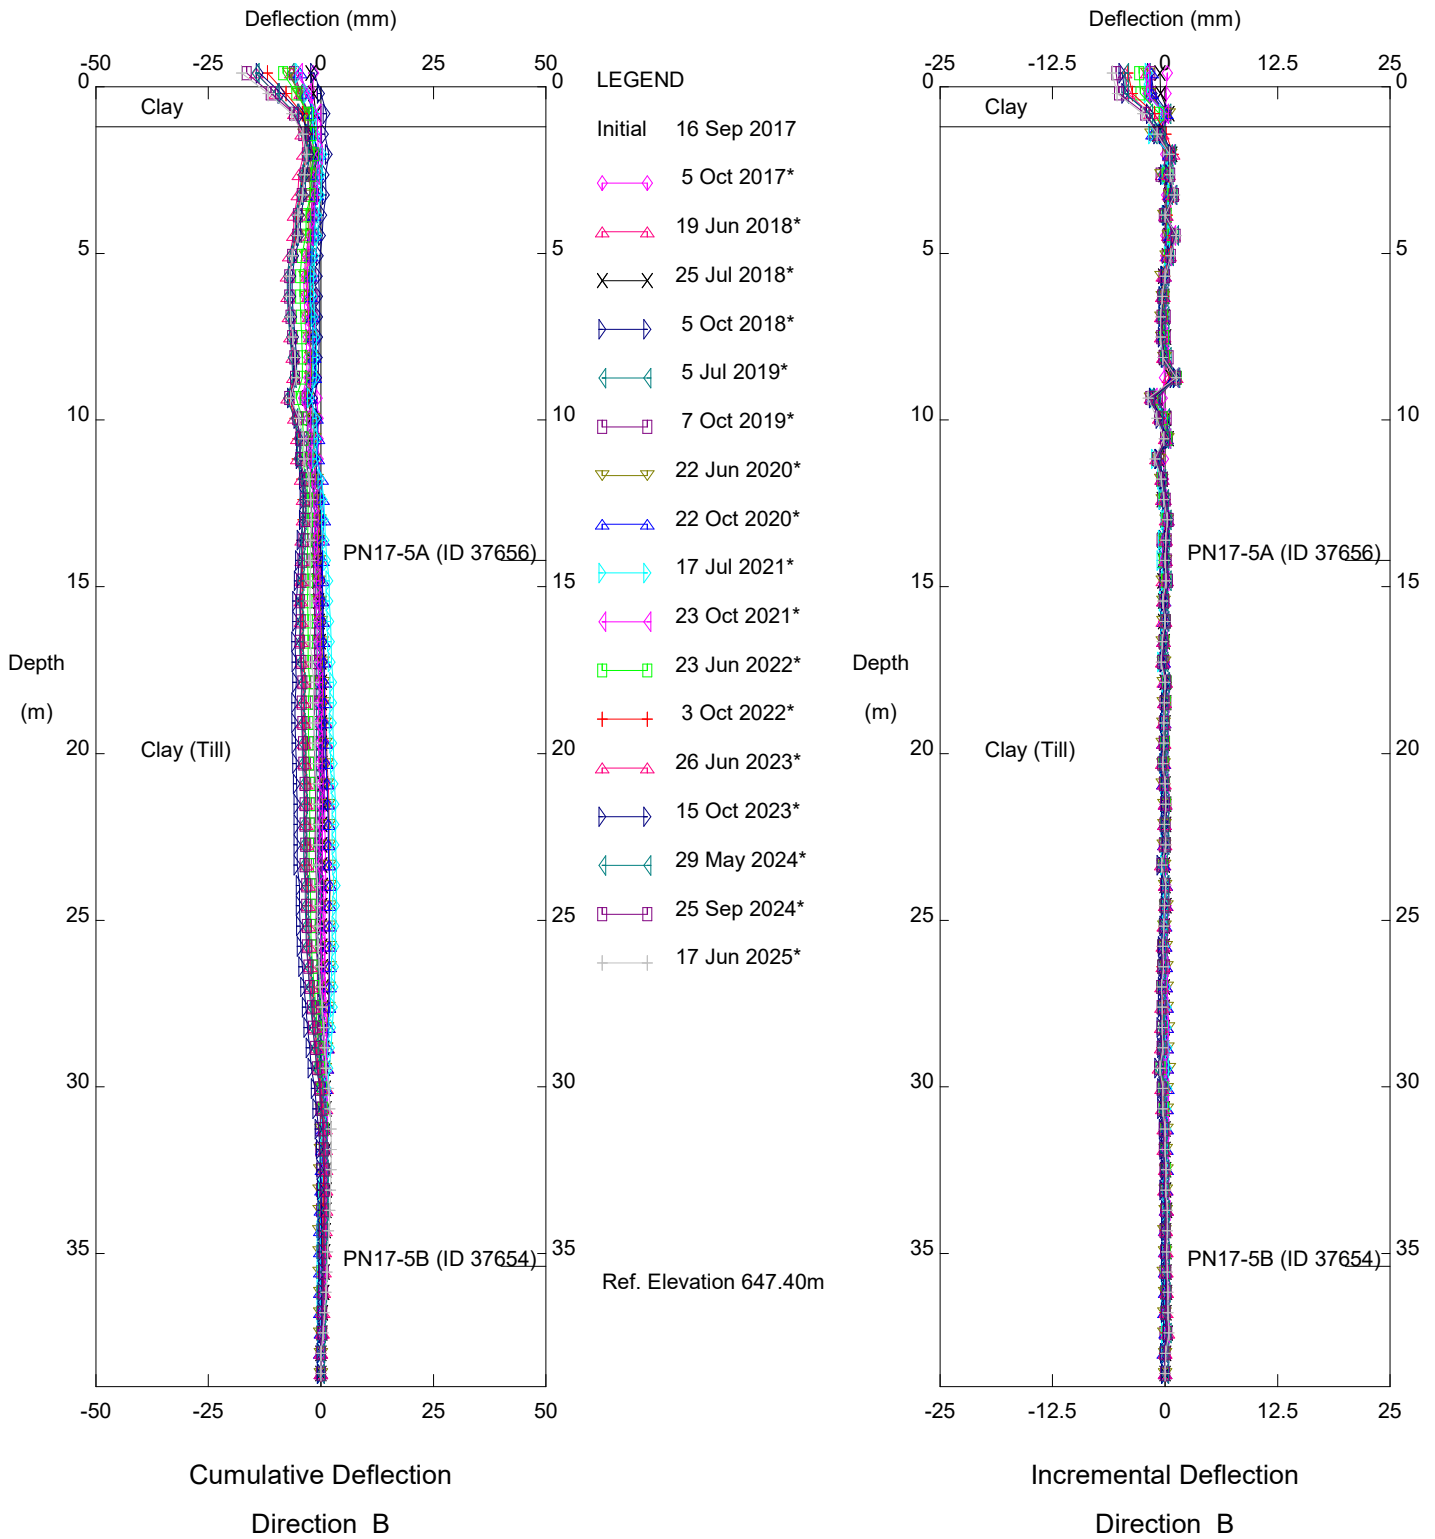
GP029 - Church Camp Slide, Inclinator SI17-5

<p>SI17-5 has shown no discernible movement since initialization as it is located on the opposite side of the highway just outside of the landslide influence zone.</p> <p>Pneumatic piezometers PN-02, PN17-2A, PN17-3B, PN17-3C, and PN17-4A showed increases in groundwater level of 0.49 m, 0.07 m, 0.28 m, 0.50 m, and 0.42 m, respectively, since the fall of 2024 readings. PN17-3C is currently showing significant above-ground (artesian) groundwater levels of 9.32 m. PN17-2B, PN17-5A, and PN17-5B showed decreases in groundwater level of 0.14 m, 0.35 m, and 0.35 m, respectively, since the fall of 2024 readings. Overall, the piezometers are generally showing groundwater levels in line with historic groundwater level readings at the site.</p>
Future Work:	<p>The road realignment work to bypass the landslide impacted area was completed this summer; therefore, there is no need to read these instruments anymore. However, the site inspection should still proceed for next year, when a decision should be made if further site inspection will still be needed.</p> <p>If TEC decide to read the instruments still, the following remarks should be noted.</p> <p>PN17-2C has malfunctioned for two reading cycles in a row and should be removed from future readings.</p>
