**ALBERTA TRANSPORTATION
GEOHAZARD ASSESSMENT PROGRAM
PEACE REGION–GRANDE PRAIRIE
2018 INSPECTION REPORT**

Site Number	Location	Name	Hwy	km
GP012B	Ksituan River West Valley Slope (east of Jct. with Hwy 725)	Ksituan Pile Wall	49:04	2.398
Legal Description		UTM Co-ordinates		
NW¼10-079-08-W6M		11U E 364030	N 6189796

GP012B-1: HWY 49:04 KSITUAN PILE WALL
2018 INSPECTION FIGURE

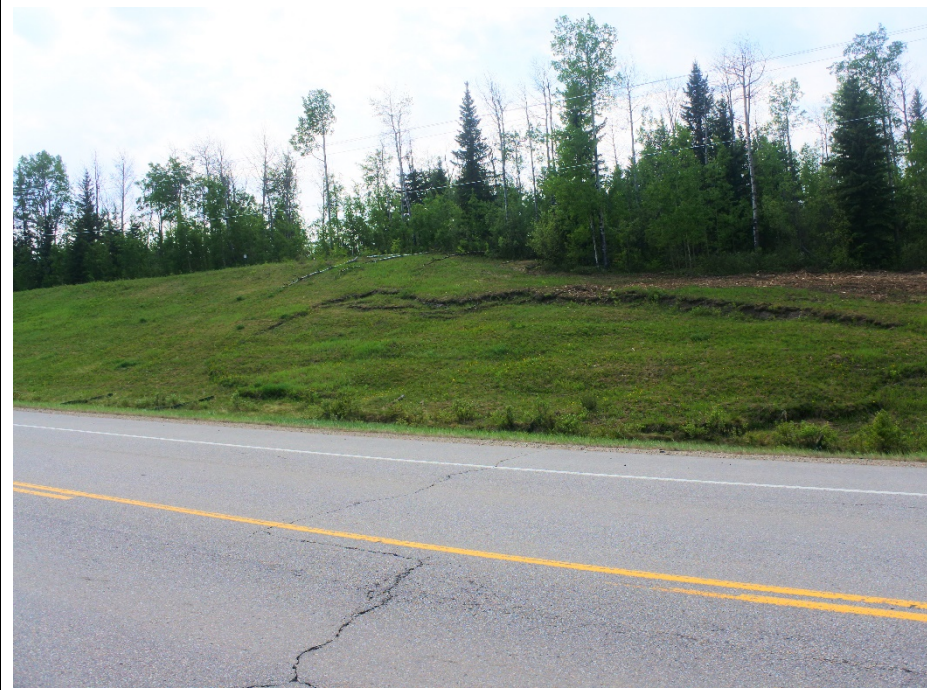
Photo 1.
Looking southwest
at backslope failure
on other side of
highway.

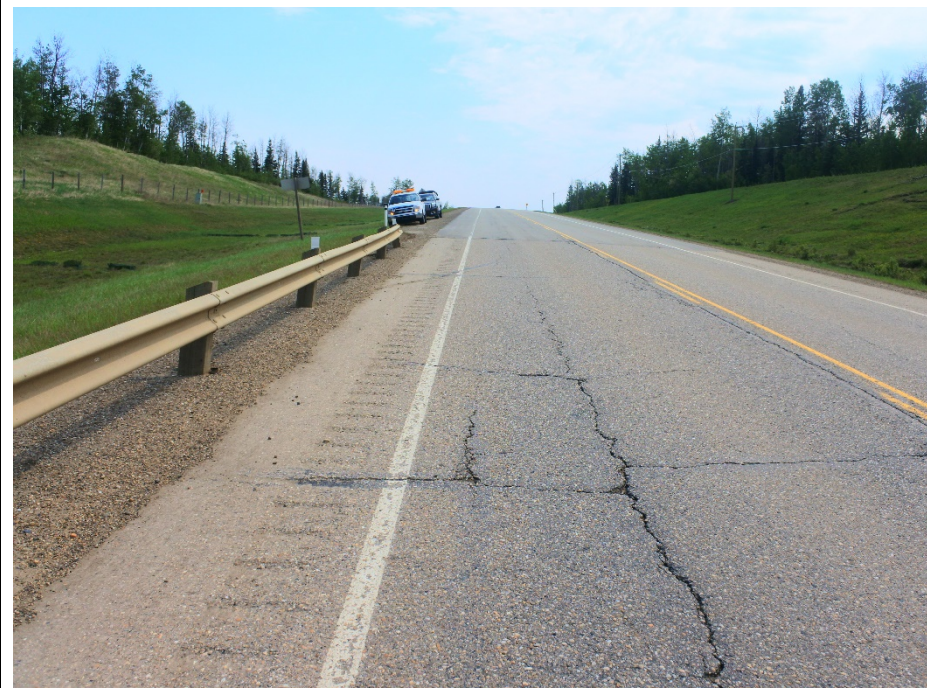
Photo 2.
Looking southeast
from the
northbound lane at
cracking in
pavement.

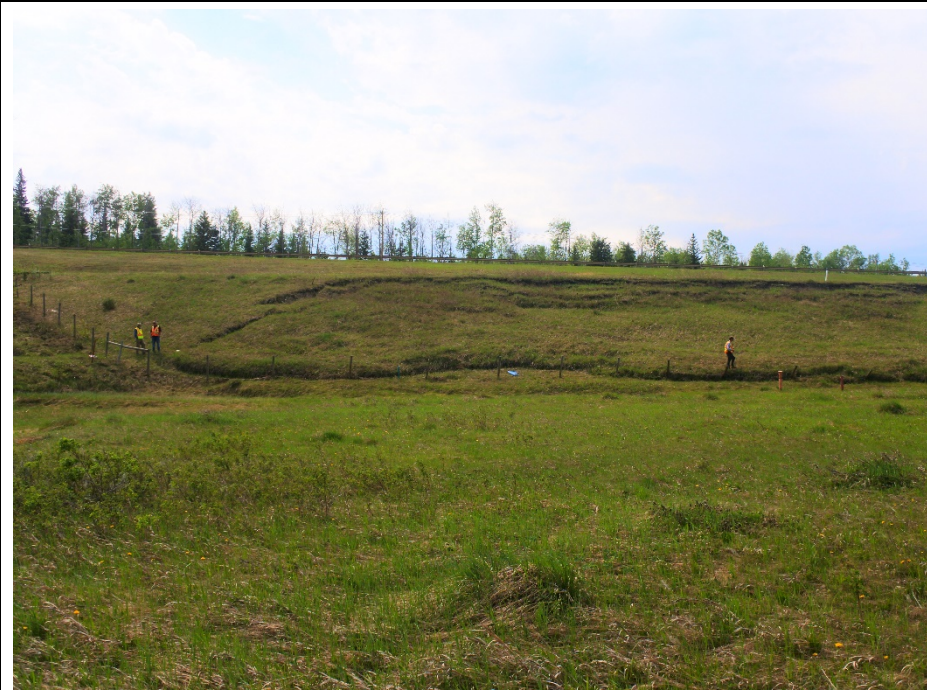
<input checked="" type="checkbox"/> Slope Movement	Failure of the 2H:1V sideslope of the toe berm located below the pile wall constructed in 2002. Fresh sloughing from recent movement was observed and the soil was moist in 2017; however, in 2018 it appeared to be slightly grown over. The fence posts at the bottom of the slope were pushed over from movement of the toe, it is in the same condition as last year.	<input type="checkbox"/>
<input type="checkbox"/> Erosion		<input type="checkbox"/>
<input type="checkbox"/> Seepage		<input type="checkbox"/>
<input type="checkbox"/> Bridge/Culvert Distress		<input type="checkbox"/>

Photo 3.
Looking southwest
towards the
landslide in the toe
berm.

Recommendations:		Ballpark Cost
<p>The site should be monitored annually. As displaced material from the landslide has been encroaching into the right-of-way of the sour natural gas pipeline, a dialog should be opened between AT and the pipeline owner/operator in order to implement remediation measure in the future.</p> <p>Consideration should be given to plant some deep rooted trees at the sliding area to help dewater the ground and improve its stability by developing a root system.</p>		Monitoring \$50,000

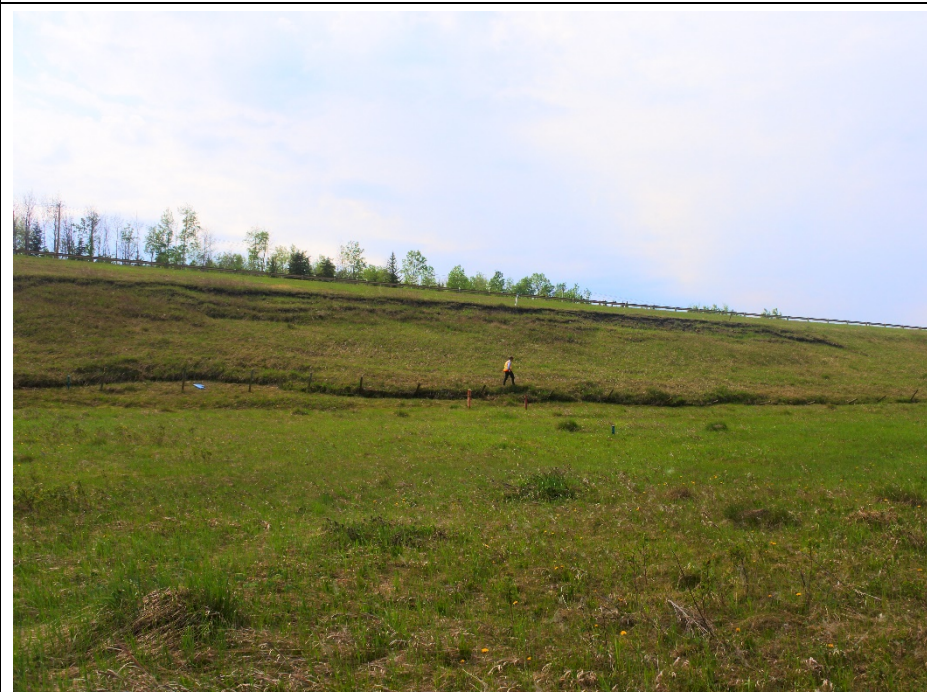
Photo 4.
Looking west
towards the
landslide in the toe
berm.

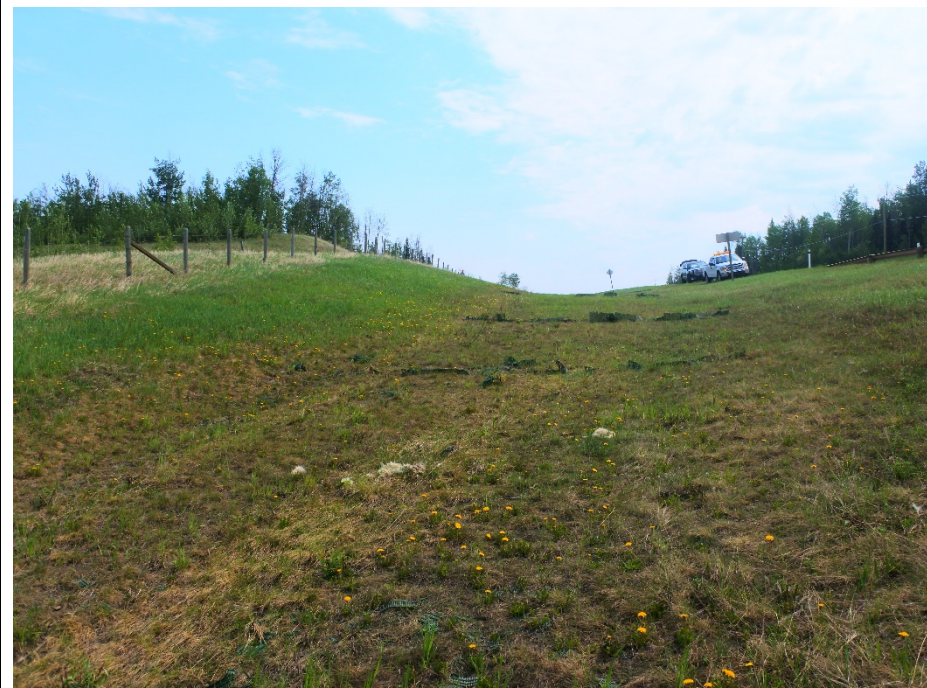
<input checked="" type="checkbox"/> Other	<p>As a result of the landslide in the toe berm, displaced mass has been accumulated at the toe and encroached into the right-of-way of the sour natural gas pipeline located adjacent to the highway.</p> <p>The water dissipation barriers were in noticeably worst condition than last year.</p>	<input checked="" type="checkbox"/>
Instrumentation:		
SI-1 SI-3	Installed in the 2002 slope stabilization piles. Small amount of movement has been detected in SI-1 and no discernable movement was detected in SI-3. The current rates are 2.1 mm/yr.	
SI-2	Installed 10 m downslope of the 2002 pile wall. This SI showed a decrease in the rate of slope movement in the upper zone and small movement in the lower; the current rates are: 22.9 mm/yr within depths from 1.1 m to 5.9 m and 0.4 mm/yr from 10.8 to 15.7 m below existing ground surface since the fall 2017 readings.

Photo 5.
Looking southeast
at water dissipation
barriers that are
tattered and in poor
condition.

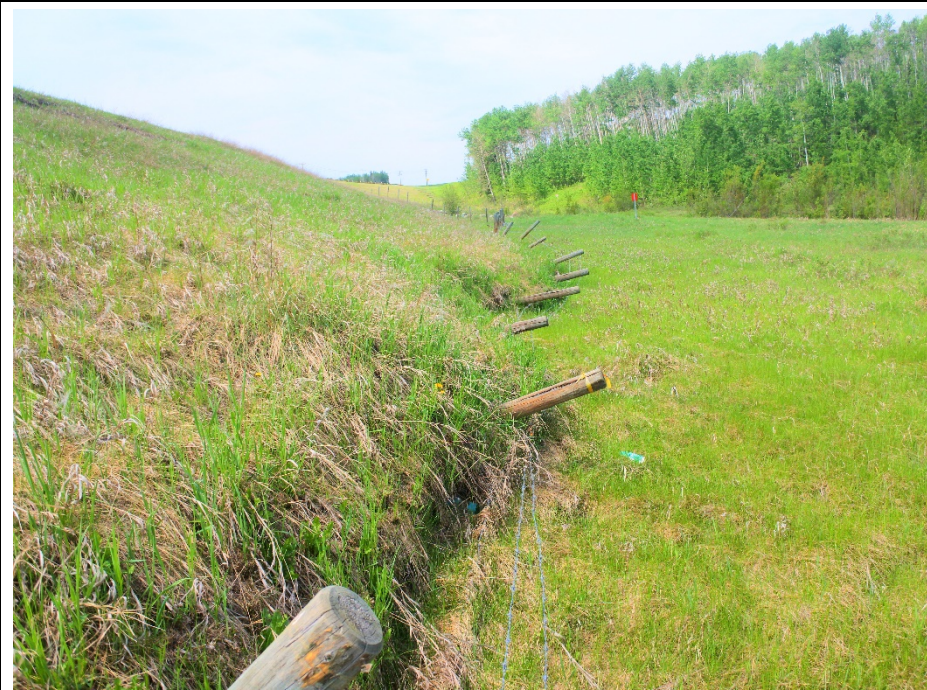
Photo 6.
Looking northwest
along the toe of the
landslide. The
fence posts are
bent over further
from movement of
the toe bulge.

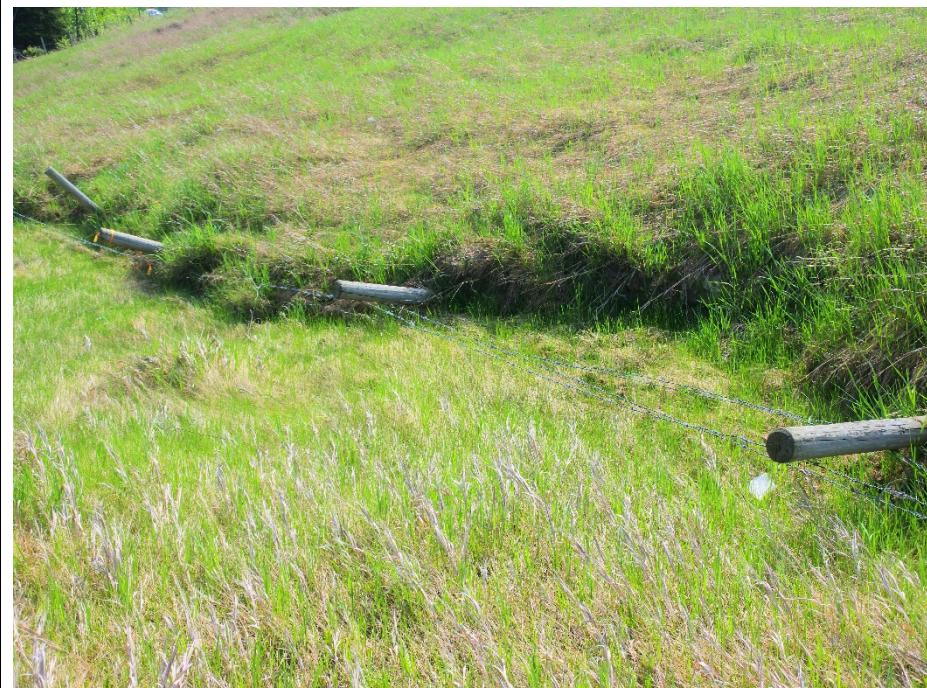
Photo 7.
Looking at the toe
bulge and bent
over posts

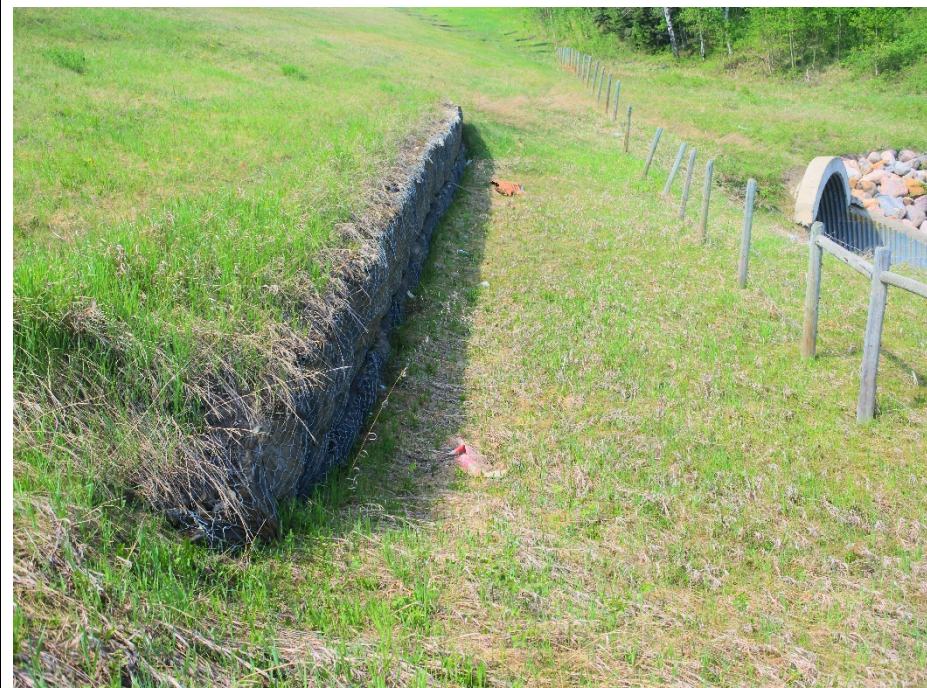
Photo 8.
Looking northwest
at gabion wall
above CSP culvert
outlet.

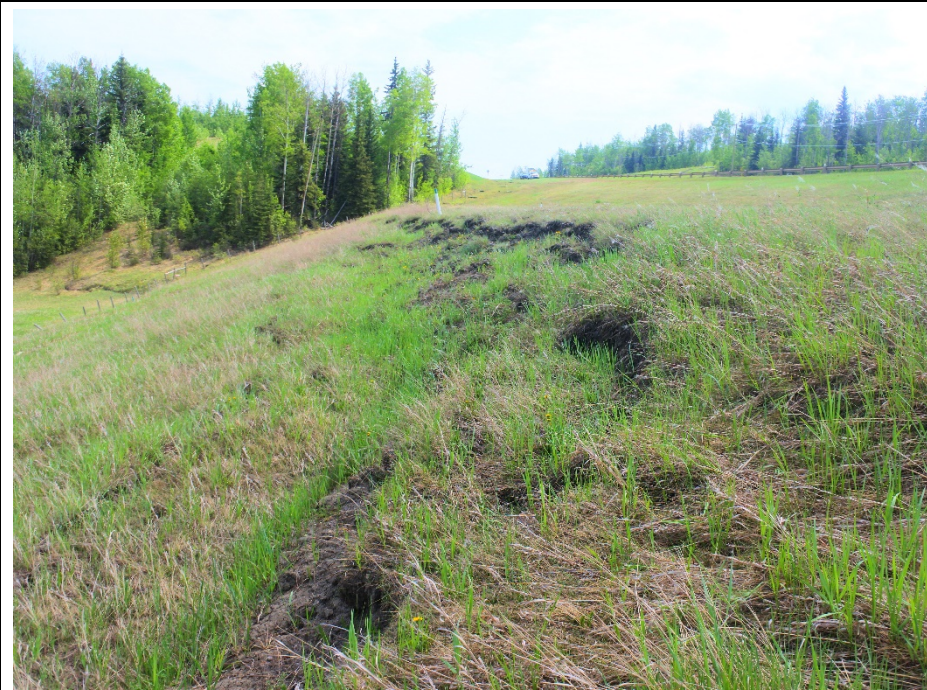
Photo 9.
Looking southeast
at relatively
grownover
slumping from head
scarp.

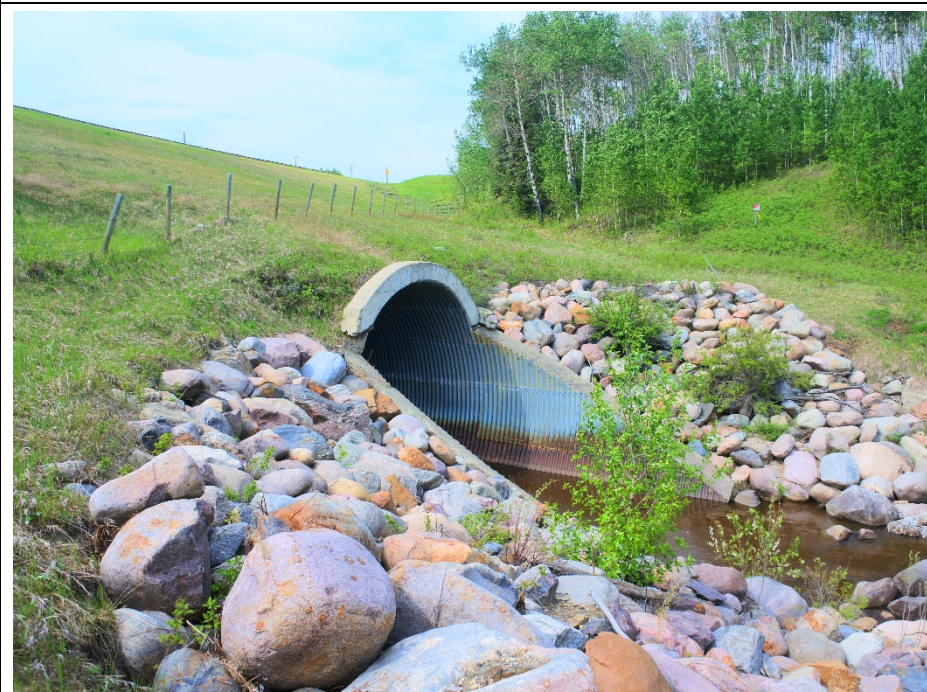
Photo 10.
Looking northwest
towards the 6.1 m
diameter SPCSP
centerline culvert.
