**ALBERTA TRANSPORTATION  
GEOHAZARD ASSESSMENT PROGRAM  
PEACE REGION–GRANDE PRAIRIE  
2020 INSPECTION REPORT**

Site Number	Location	Name	Hwy	km
GP012B	Ksituan River West Valley Slope (east of Jct. with Hwy 725)	Ksituan Pile Wall	49:04	2.398
Legal Description		UTM Co-ordinates		
NW¼10-079-08-W6M		11U E 364030	N 6189796

GP012B-1: HWY 49:04 KSITUAN PILE WALL  
2020 INSPECTION FIGURE

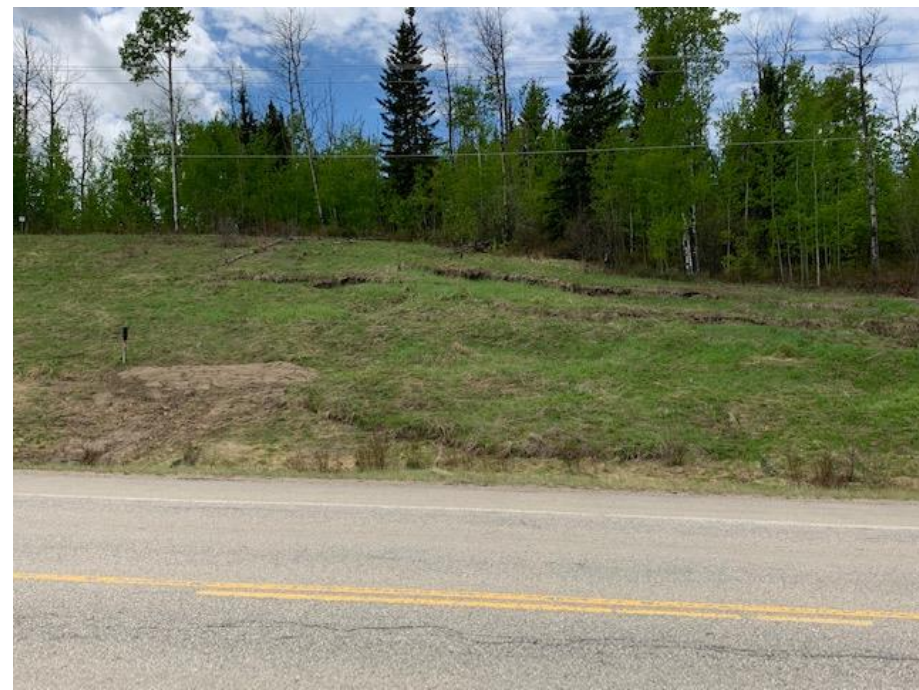
**Photo 1.**  
Looking southwest  
at backslope failure  
on other side of  
highway.

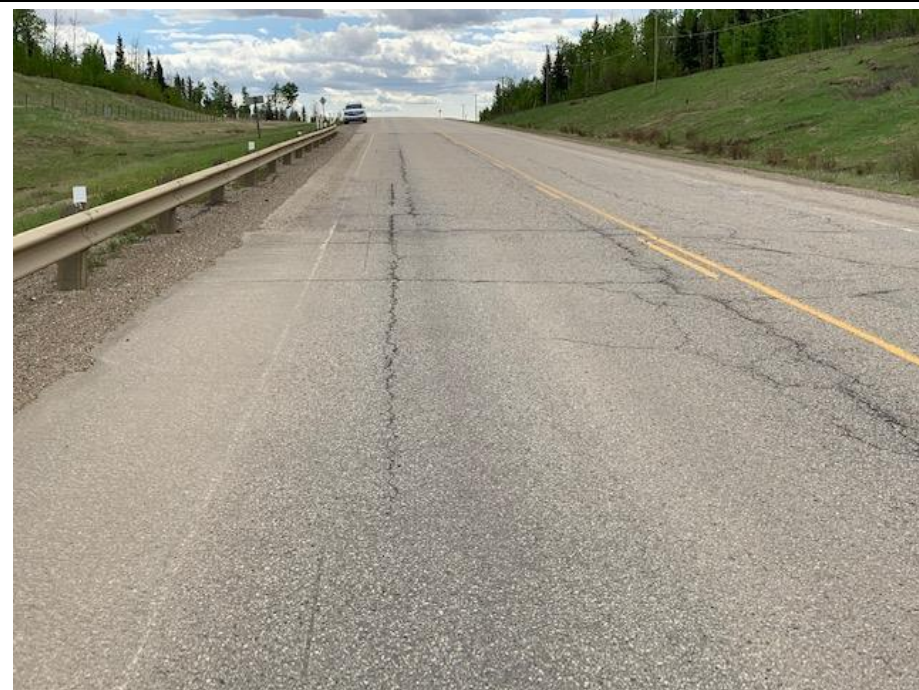
**Photo 2.**  
Looking southeast  
from the  
northbound lane at  
cracking in  
pavement.

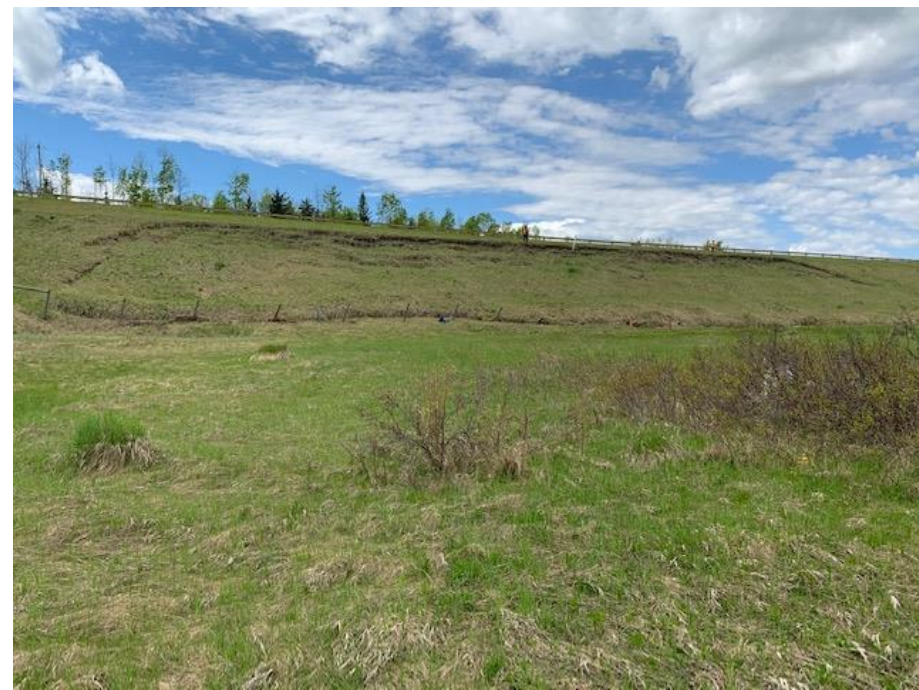
**Photo 3.**  
Looking southwest  
towards the  
landslide in the toe  
berm.

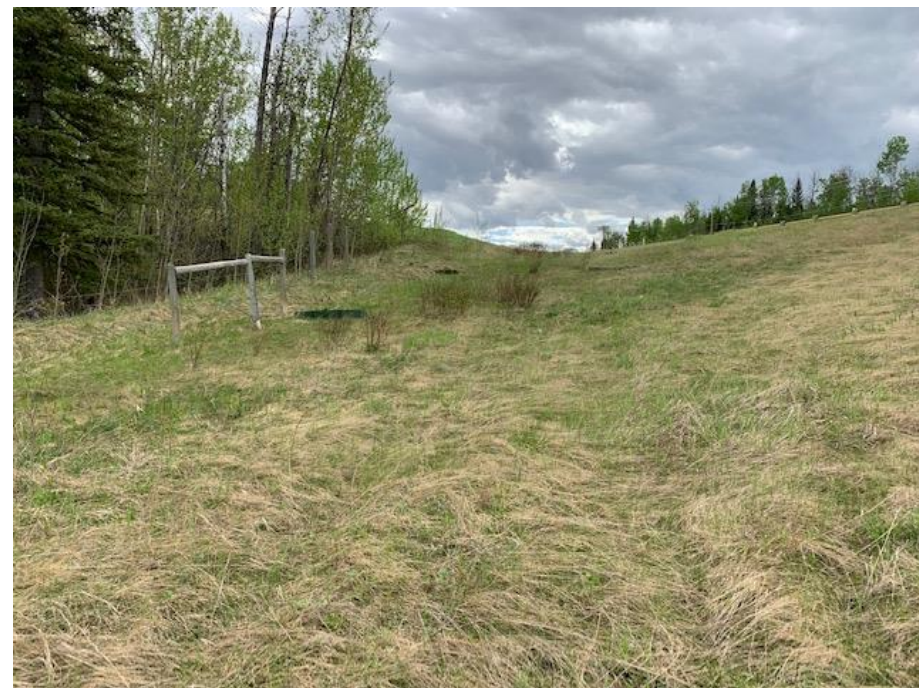
**Photo 4.**  
Looking southeast  
at water dissipation  
barriers that are  
tattered and in poor  
condition.

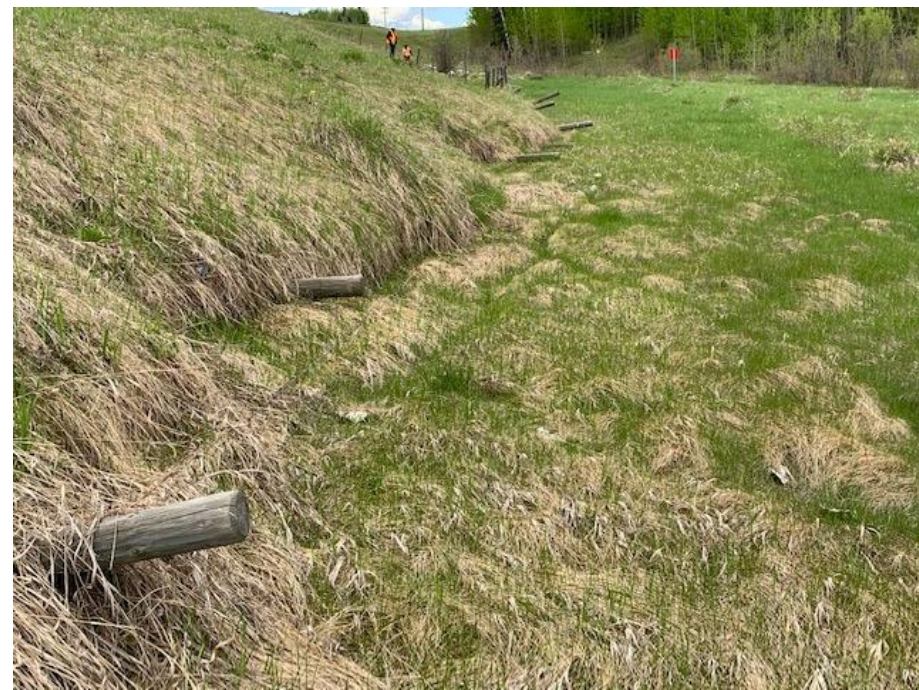
**Photo 5.**  
Looking northwest  
along the toe of the  
landslide. The  
fence posts are  
bent over further  
from movement of  
the toe bulge.

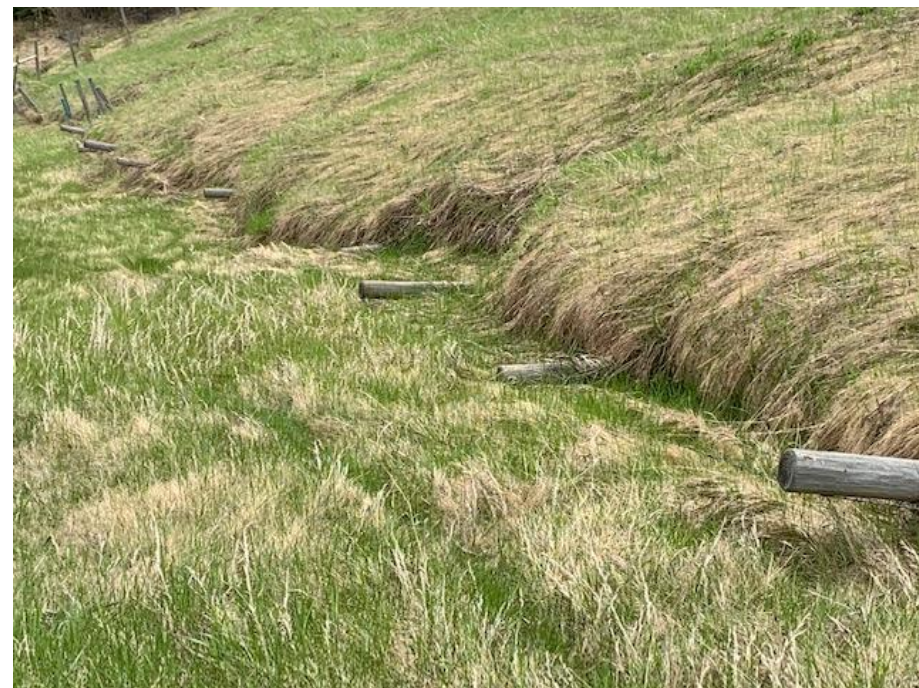
**Photo 6.**  
Looking at the toe  
bulge and bent  
over posts

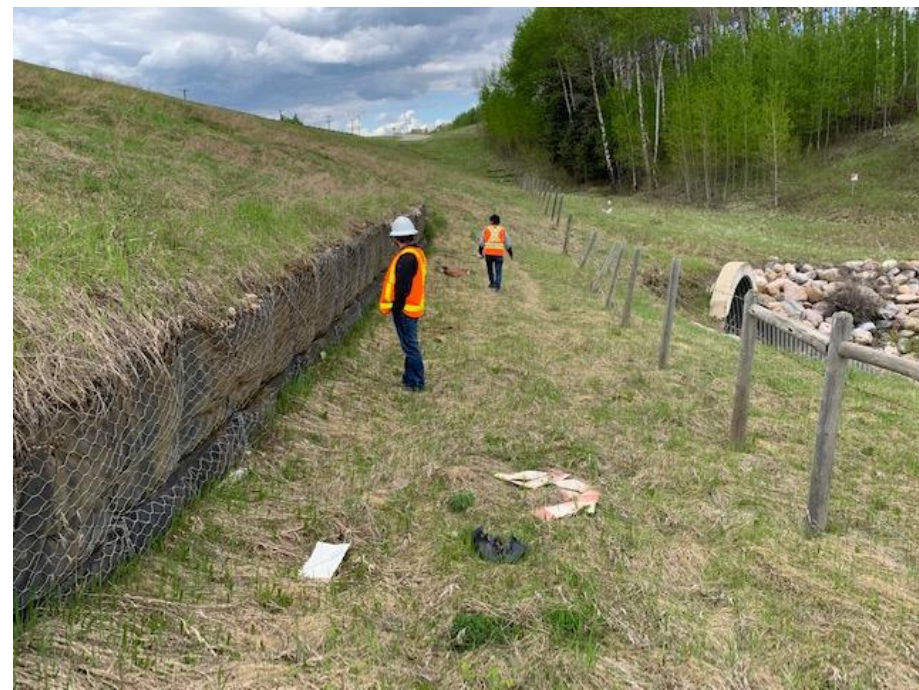
**Photo 7.**  
Looking northwest  
at gabion wall  
above CSP culvert  
outlet.

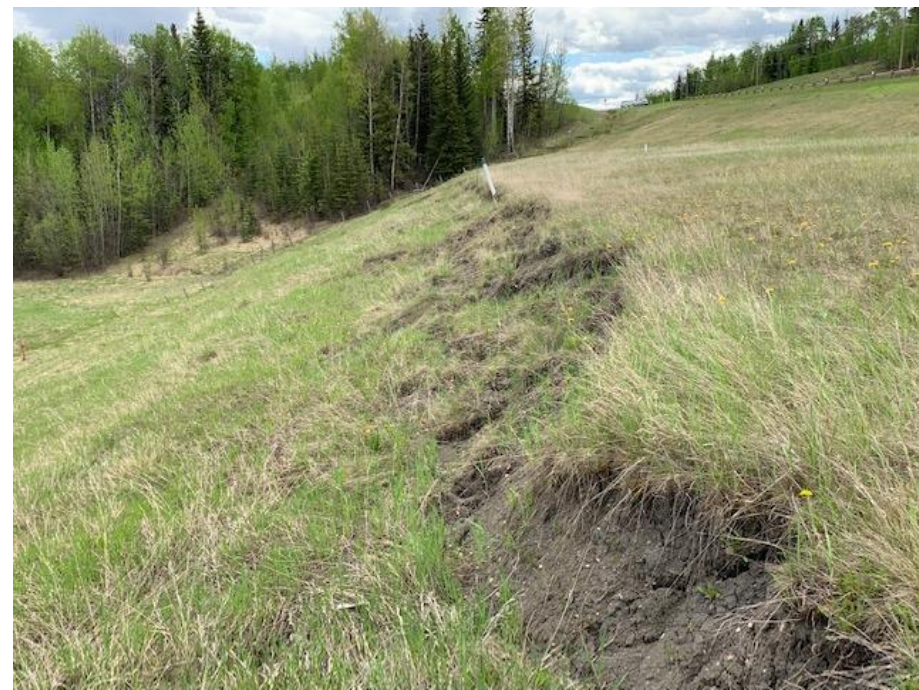
<input checked="" type="checkbox"/> Slope Movement	Failure of the 2H:1V sideslope of the toe berm located below the pile wall constructed in 2002. Fresh sloughing from recent movement was observed and the soil was moist in 2017. In 2020 it appeared to be slightly active (Photo 8). The fence posts at the bottom of the slope were pushed over from movement of the toe, and they were tilted over more with some posts now horizontal.	<input checked="" type="checkbox"/>
<input type="checkbox"/> Erosion		<input type="checkbox"/>
<input type="checkbox"/> Seepage		<input type="checkbox"/>
<input checked="" type="checkbox"/> Bridge/Culvert Distress	At the inlet of the 1.6 m SPCSP culvert, there has been some debris accumulation such as fall tree trunks, at the time on the inspection this	<input type="checkbox"/>

**Photo 8.**  
Looking southeast  
at relatively fresh  
slumping from head  
scarp.

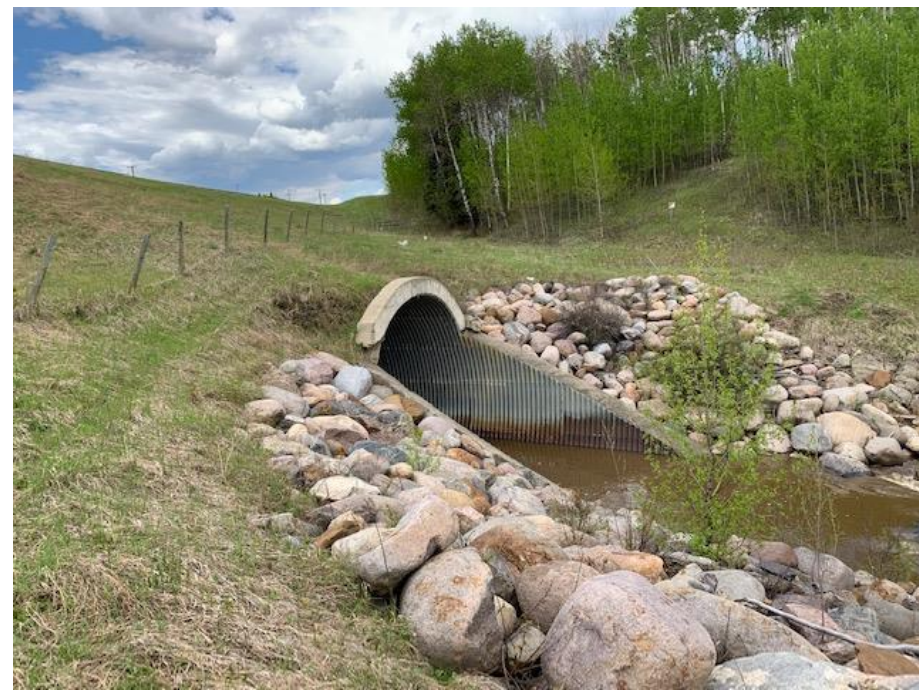
**Photo 9.**  
Looking northwest  
towards the 6.1 m  
diameter SPCSP  
centerline culvert  
outlet.

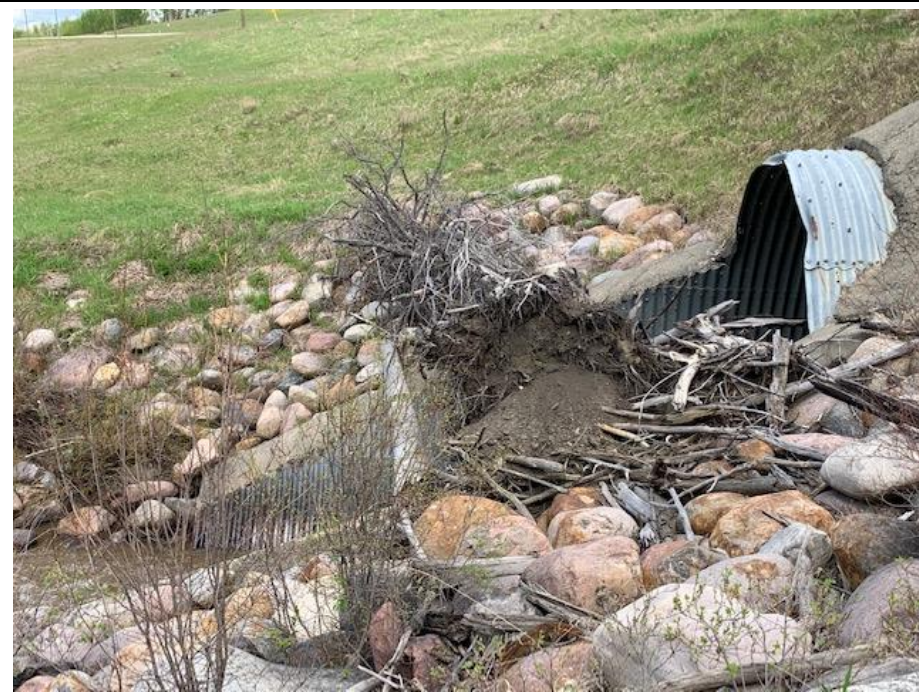
**Photo 10.**  
Looking northwest  
towards the 6.1 m  
diameter SPCSP  
centerline culvert  
inlet.

<b>Recommendations:</b>		<b>Ballpark Cost</b>
The site should be monitored annually. As displaced material from the landslide has been encroaching into the right-of-way of the sour natural gas pipeline, a dialog should be opened between AT and the pipeline owner/operator in order to implement remediation measure in the future.		Monitoring
Consideration should be given to plant some deep-rooted trees at the sliding area to help dewater the ground and improve its stability by developing a root system.		\$50,000
The inlet of the 1.6 m diameter culvert should be cleaned for the drift material that is currently blocking the inlet.		\$1,000
