**THURBER** ENGINEERING LTD.

August 4, 2022

**ALBERTA TRANSPORTATION GRMP (CON0022165)  
PEACE REGION (GRANDE PRAIRIE DISTRICT – NORTH)  
INSTRUMENTATION MONITORING RESULTS – SPRING 2022**

**SITE GP012B: HWY 49:04, KSITUAN PILE WALL**

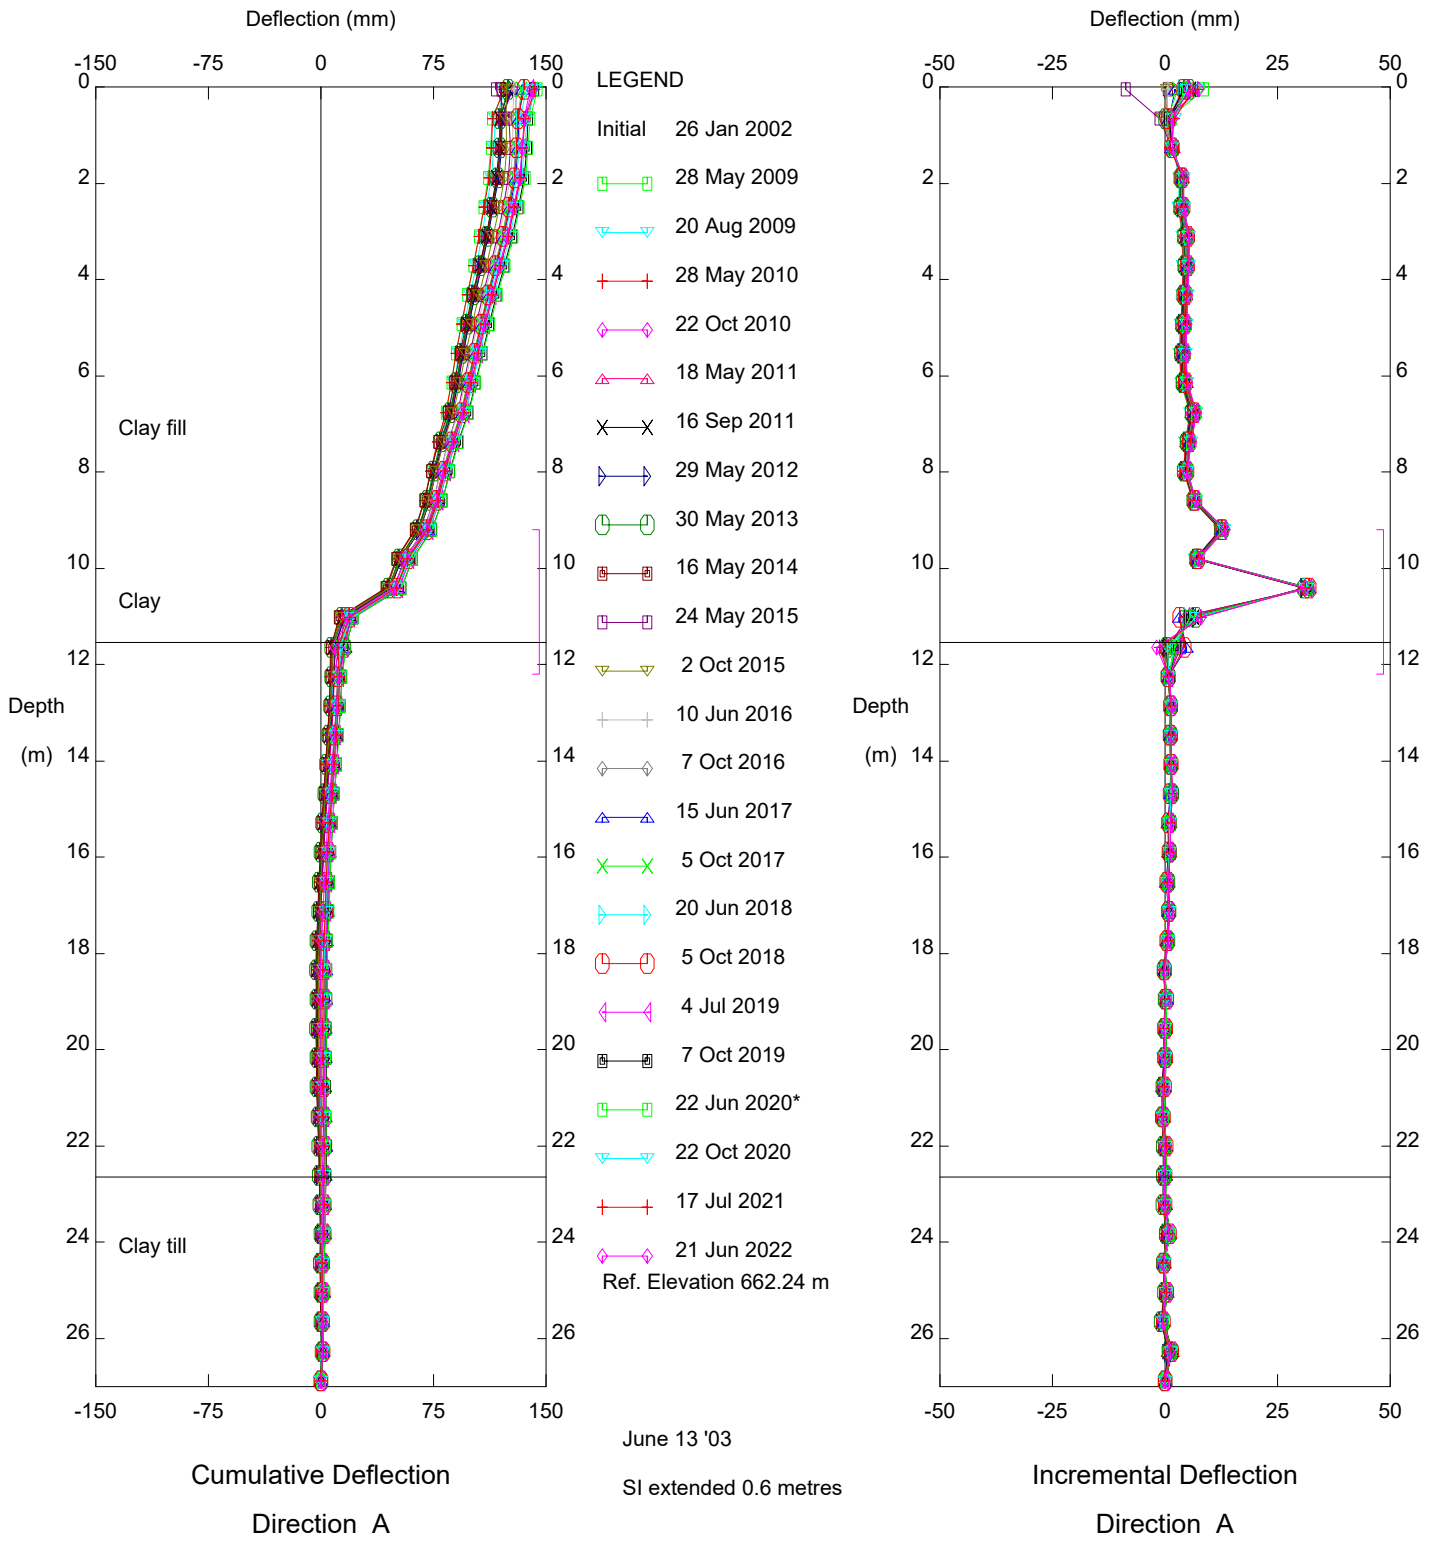
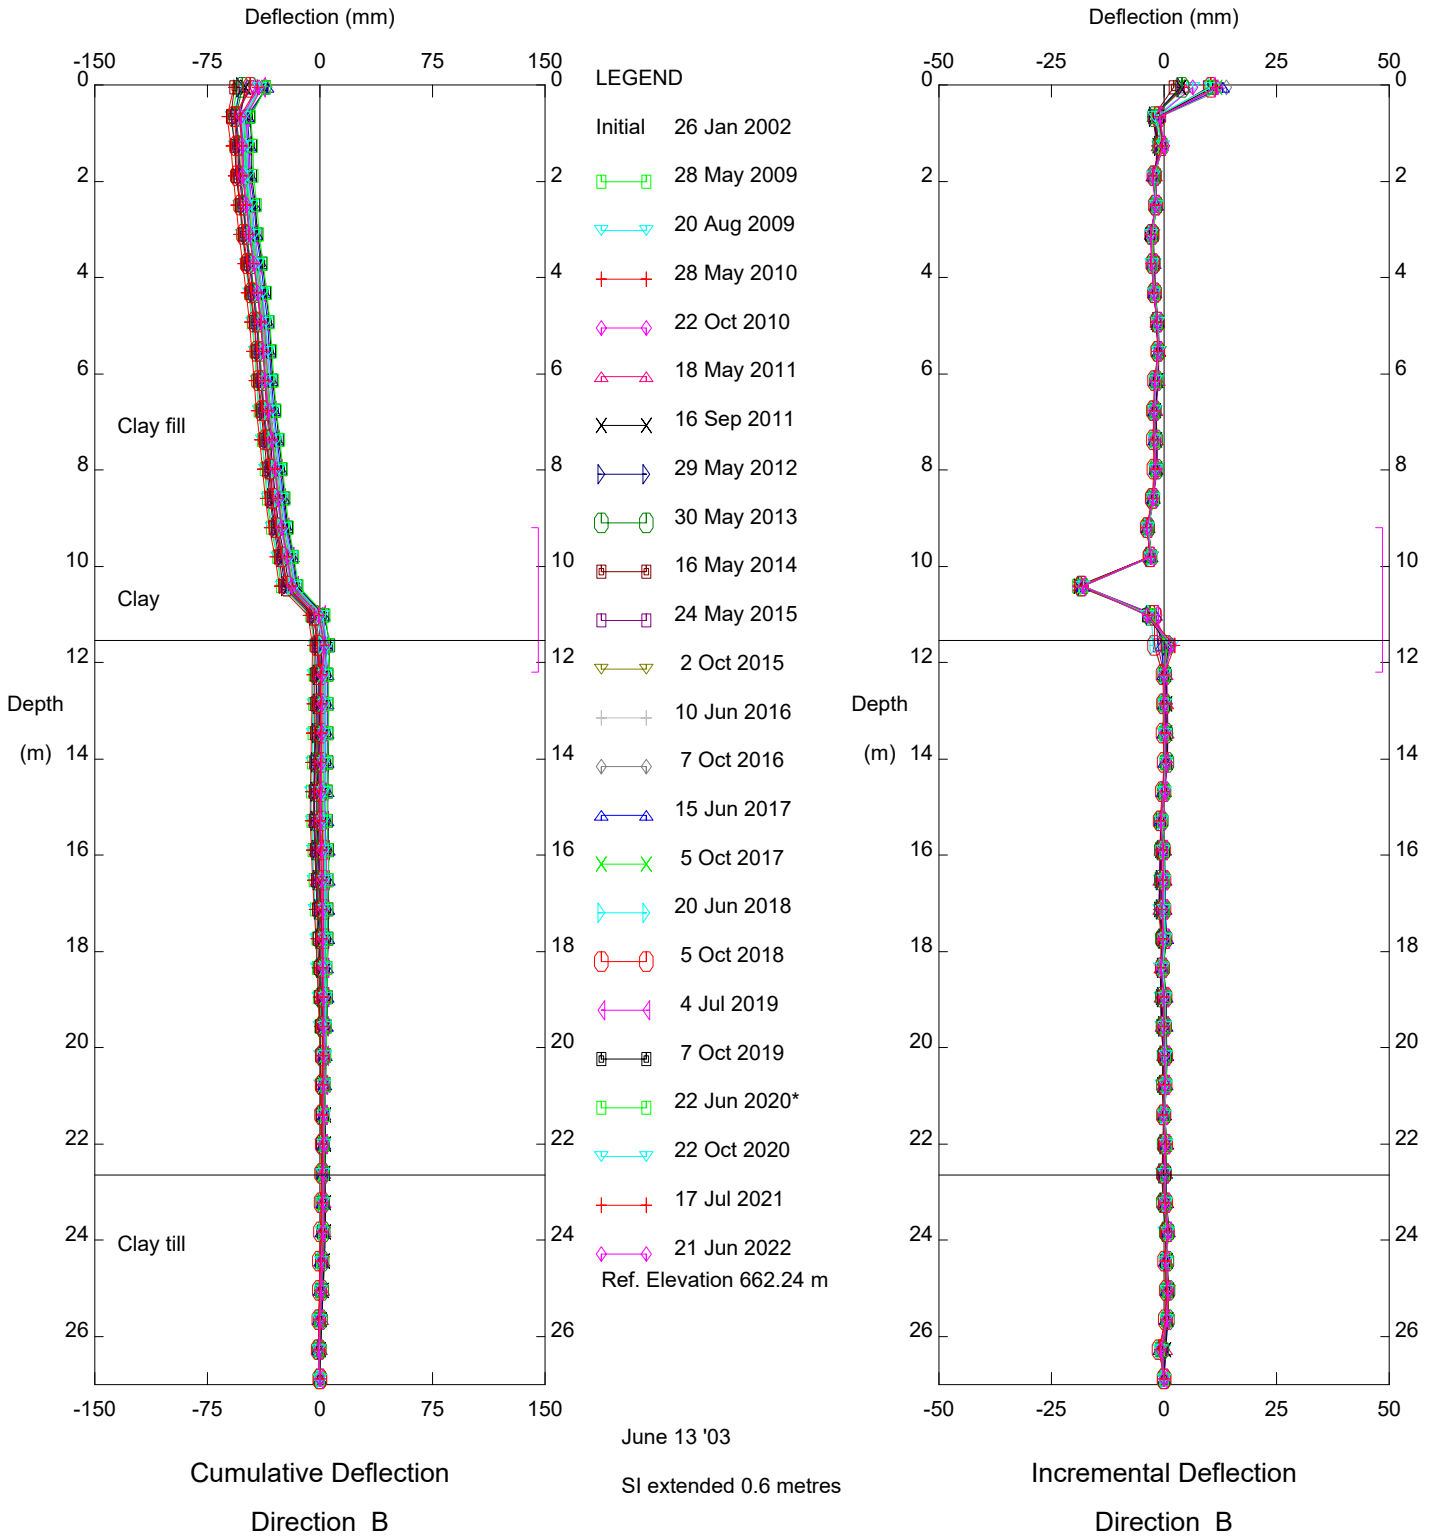
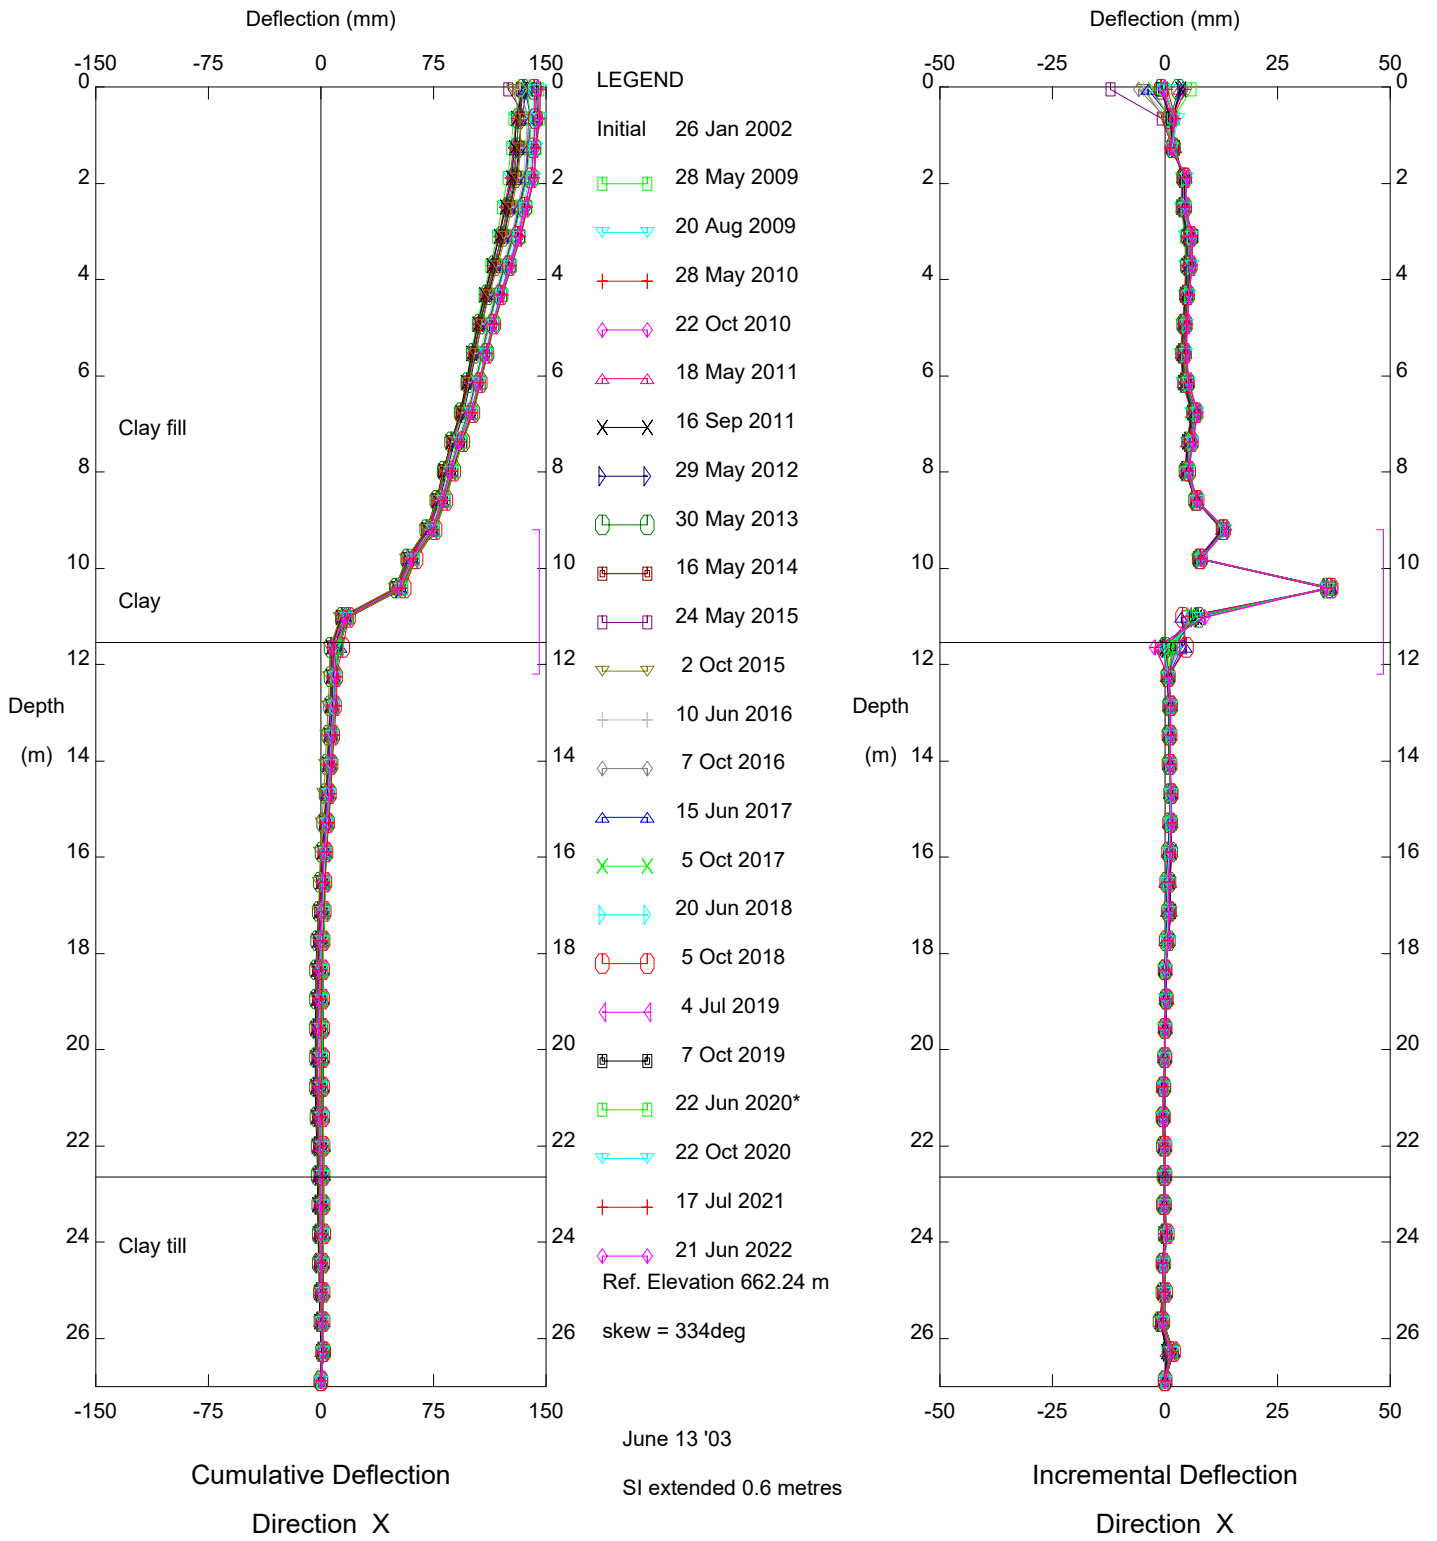
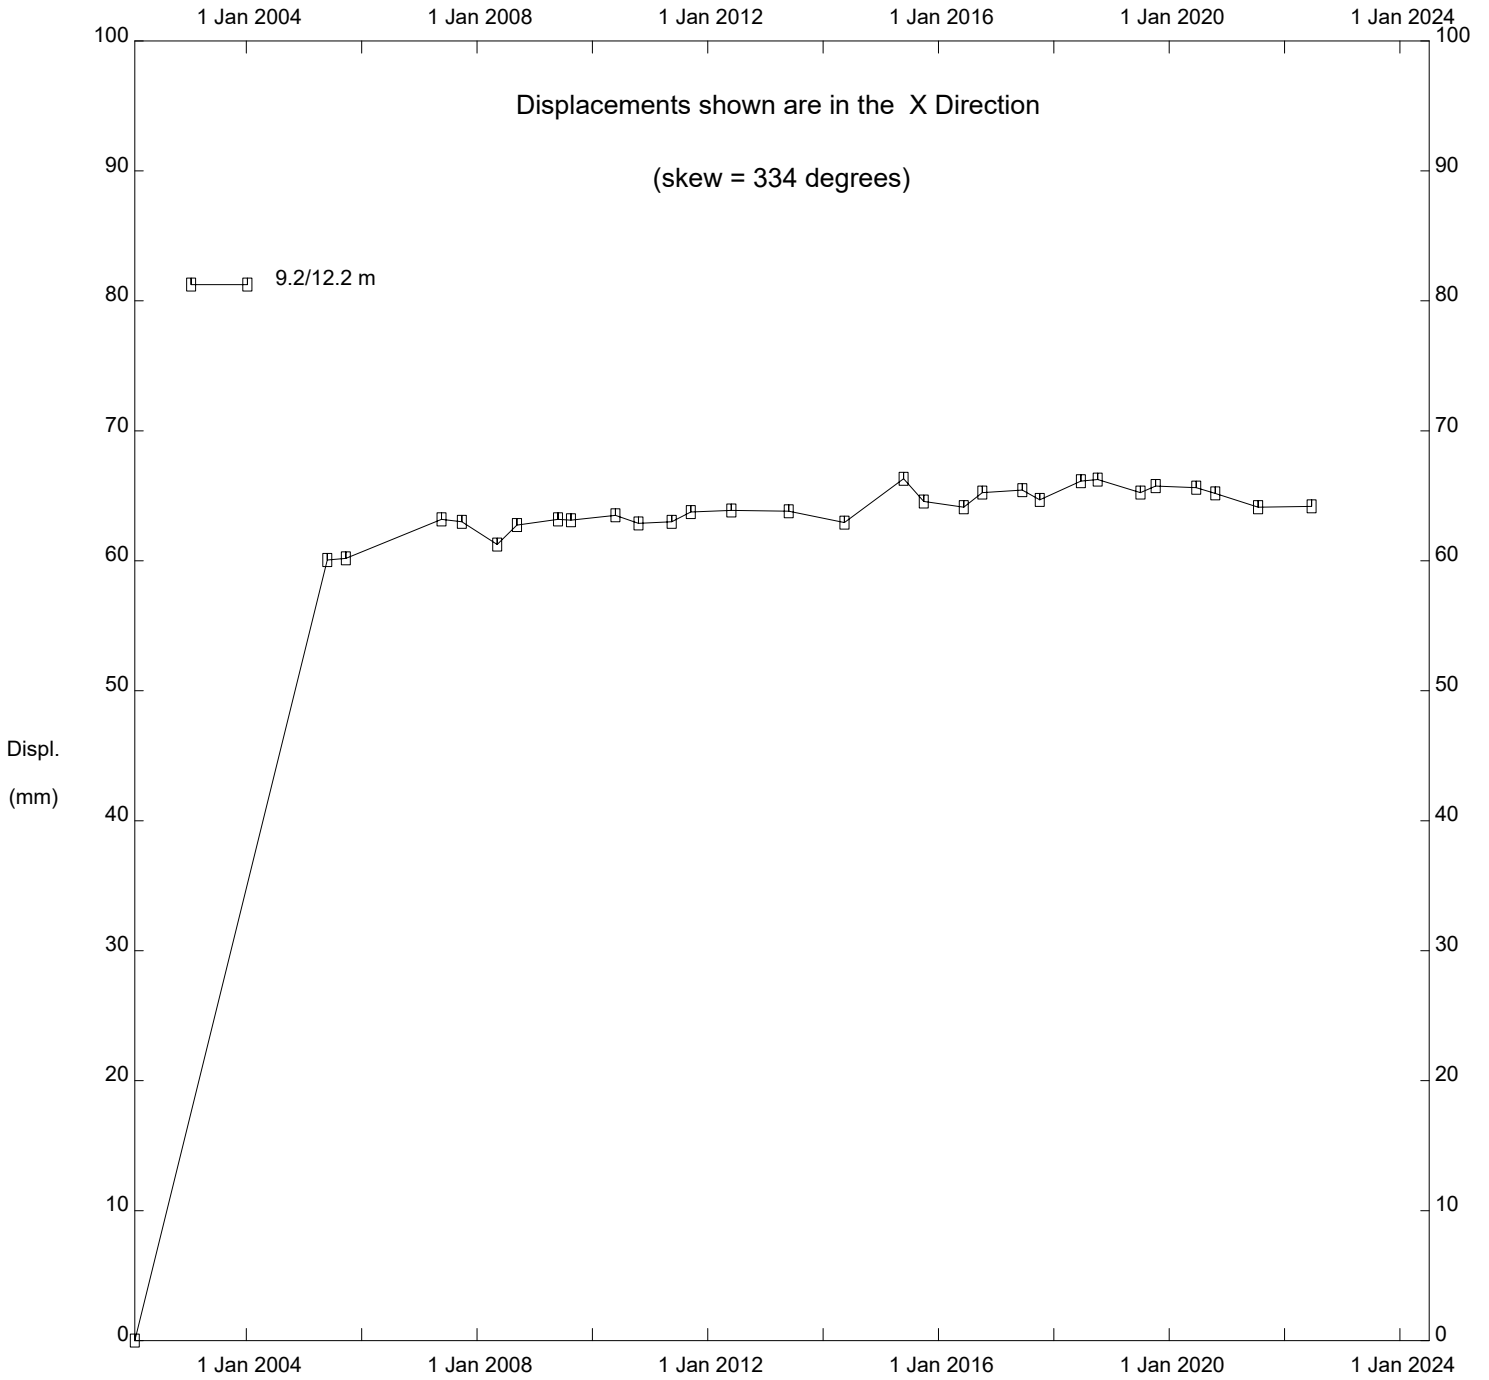
GP012B Ksituan River Crossing, Inclinometer SI-1

Slope inclinometer SI-1 showed a rate of movement of less than 0.1 mm/yr over 9.2 to 12.2 m since the spring of 2021 readings. SI-3 showed no discernible movement since the spring of 2021 readings. SI-6 showed a rate of movement of 0.9 mm/yr over 1.1 m to 2.3 m depth since the spring of 2021 readings. SI-8 showed a rate of movement of 2.0 mm/yr over 0.9 m to 19.2 m depth since the spring of 2021 readings. SI-8 has shown a total pile head movement of 58.3 mm to date.

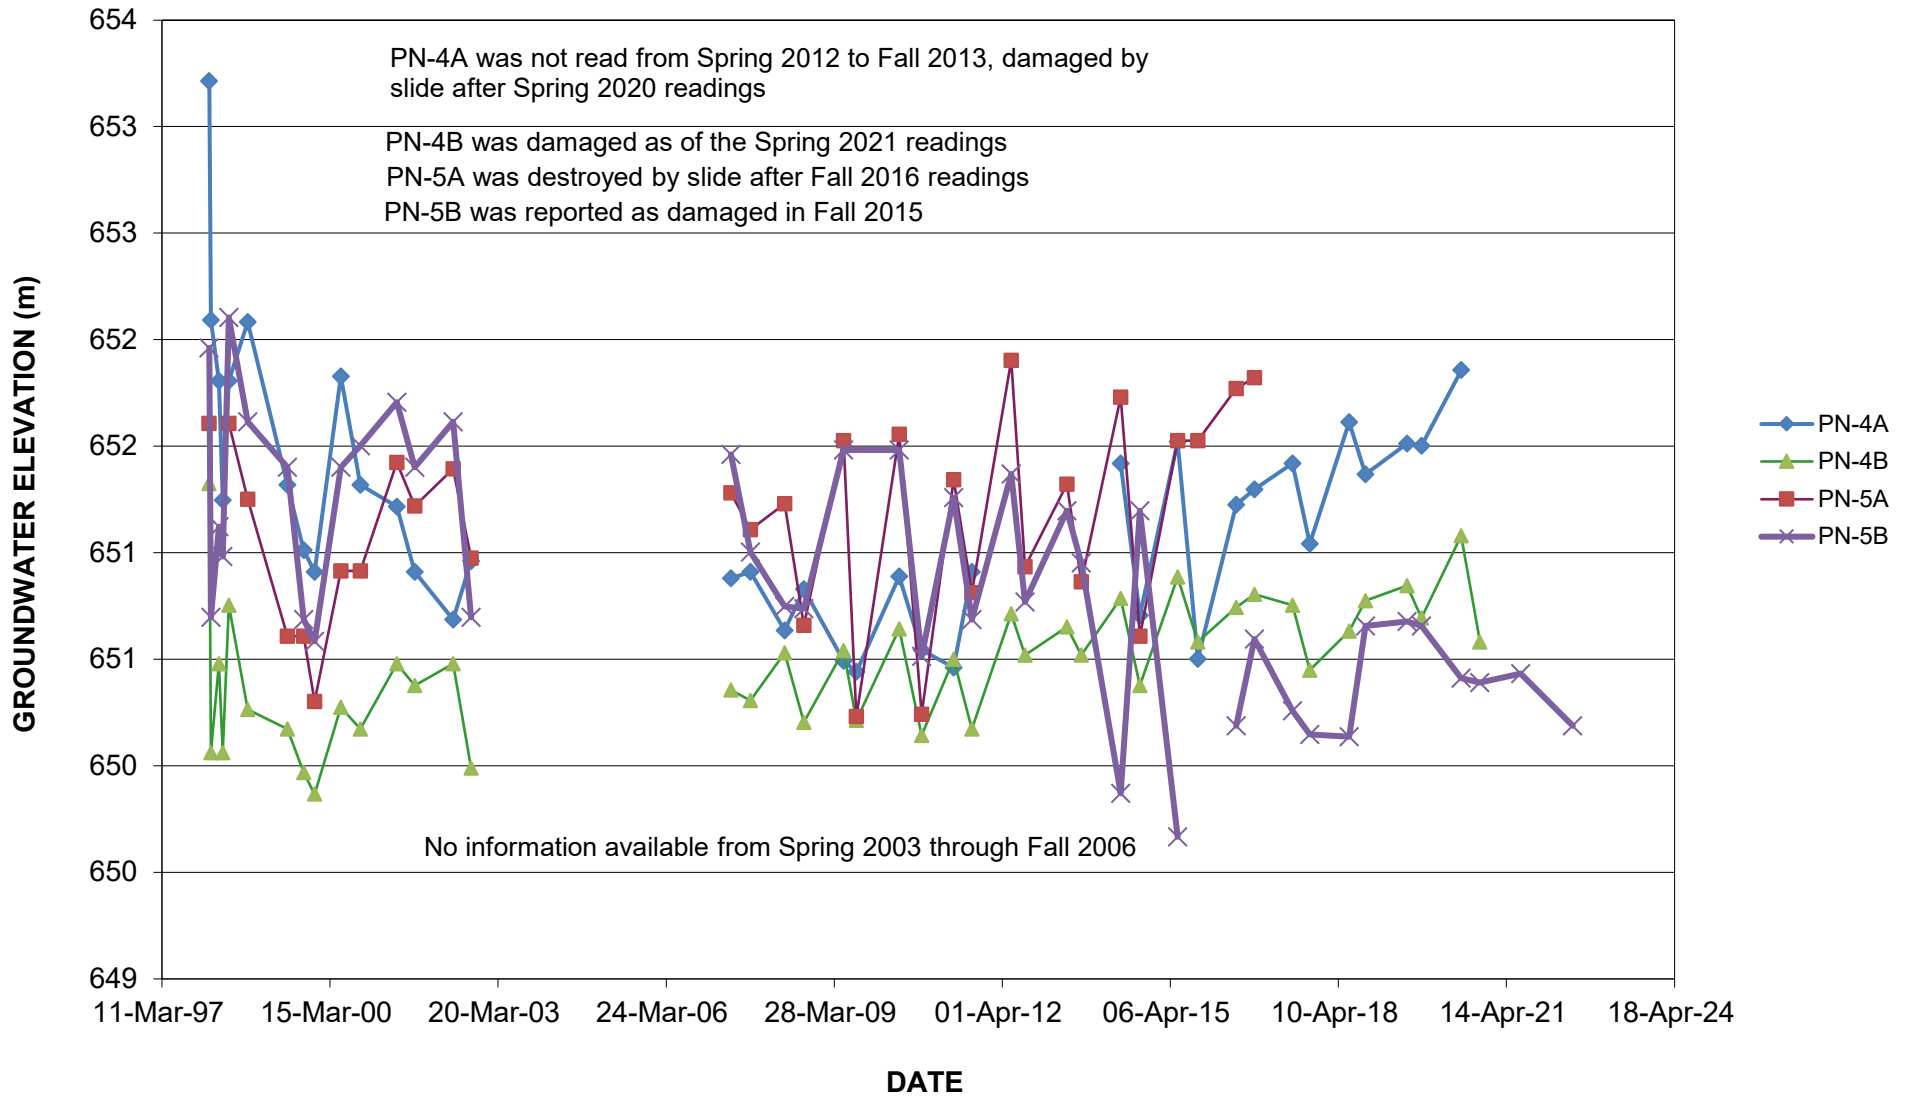
**FIGURE GP012B-1  
PIEZOMETRIC ELEVATIONS FOR HWY 49:04, KSITUAN PILE WALL**

The last two readings for pneumatic piezometer PN-4B do not match historical readings for this instrument and the readings show the groundwater level near the piezometer tip; in addition, the reading was not stable. It is, therefore, likely that the measured groundwater level can be attributed to the instrument being damaged. PN-5B showed a decrease in groundwater level of 0.24 m compared to the spring of 2021 readings. Pneumatic piezometer results are summarized in Table GP012B-2 below and are plotted in Figures GP012B-1 (by elevation) and GP012B-2 (by depth) in Appendix A.

The instruments should be read again in the spring of 2023. PN-4B will be removed from future readings cycles as it is likely that this instrument is damaged.
