ALBERTA TRANSPORTATION AND ECONOMIC CORRIDORS GRMP PEACE REGION – (GRANDE PRAIRIE DISTRICT - NORTH) INSTRUMENTATION MONITORING - SPRING 2025

Site Number	Location	Name			Hwy		km	
GP012B	HWY 49:04 C1 2.398	Ksitua	n Pi	le Wall	49.04		Km 2.4	
Legal Description: 12-10-79-8 W6			Co-c	ordinates		•		
		11U	Е	364166.28	N	618	9642.38

Current Monitoring:	13-Jun-2025	Previous Monitoring	29-May-2024				
Instruments Read By:	Mr. Niraj Regmi, G.	Mr. Niraj Regmi, G.I.T and Mr. Godfred Etiendem, of Thurber

SITE GP012B: HWY 49:04, KSITUAN PILE WALL

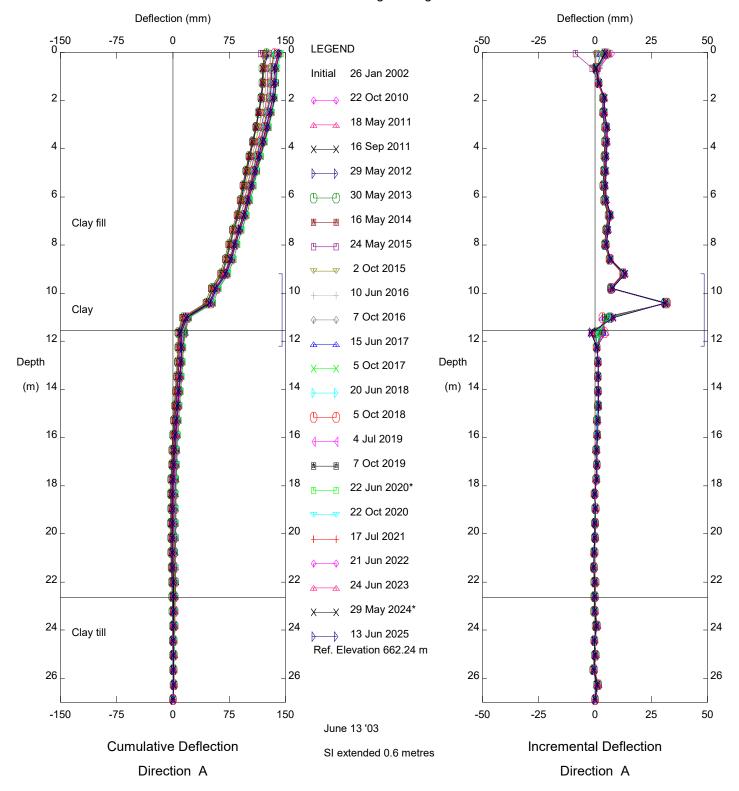
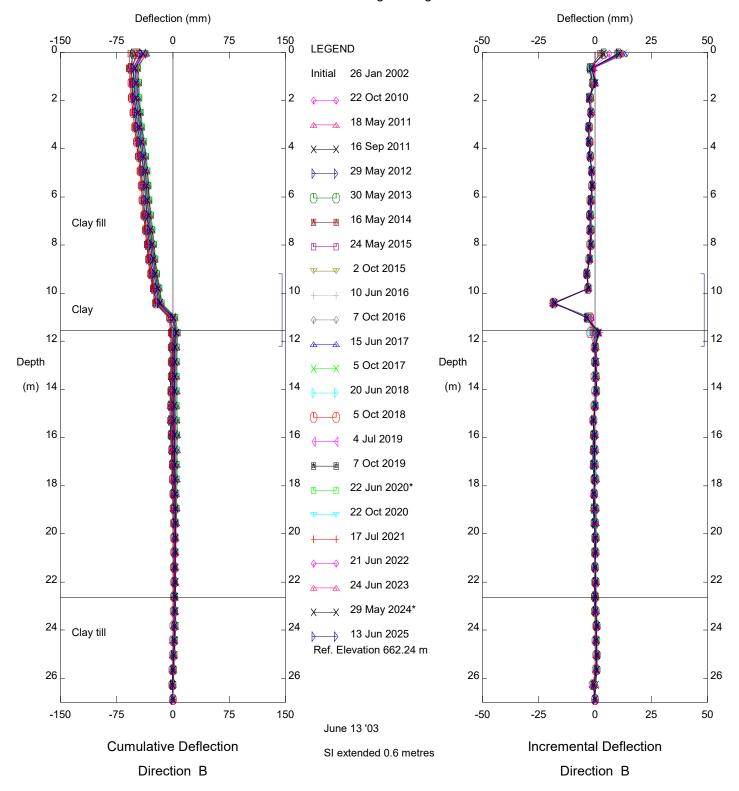
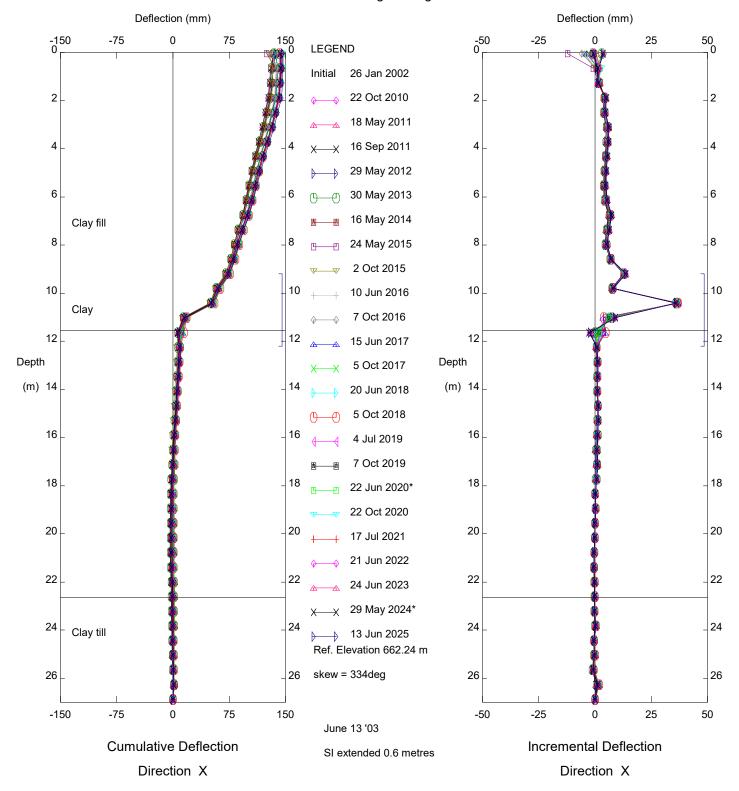
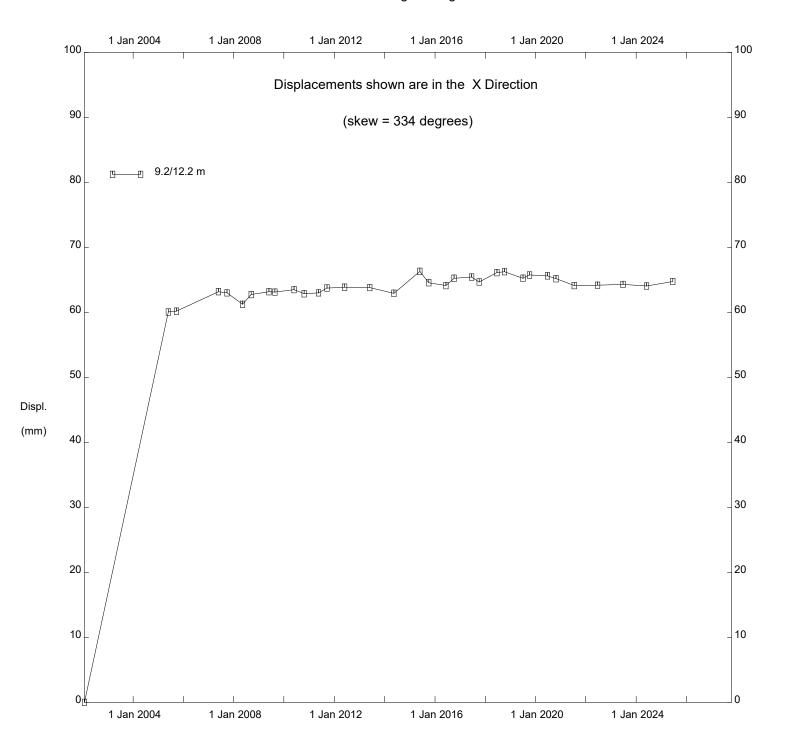
GP012B Ksituan River Crossing, Inclinometer SI-1

Discussion						
Zones of New Movement:	None					
	Slope inclinometer SI-1 showed a rate of movement of 0.7 mm/yr over 9.2 to 12.2 m since the spring of 2024 readings.					
	SI-3 showed no discernible movement over 11.2 m to 14.3 m since the spring of 2024 readings.					
Interpretation of Monitoring	SI-6 showed no discernible movement over 1.1 m to 2.3 m depth since the spring of 2024 readings.					
Results:	SI-8 showed no discernible movement of over 0.9 m to 19.2 m depth since the spring of 2024 readings. This rate of movement has been more or less consistent since 2008. SI-8 has shown a total pile head movement of 58.8 mm to date.					
	PN 5B showed an increase in groundwater level of 0.27 m compared to the spring of 2024 readings.					
Future Work:	The instruments should be read again in the spring of 2026.					
Instrumentation Repairs:	No instrument repairs are required at this time.					
Additional Comments:	A review of the pile wall design could be undertaken to determine how the measured pile head deflection compares to the design.
