ALBERTA TRANSPORTATION  
 GEOHAZARD ASSESSMENT PROGRAM  
 PEACE REGION - GRANDE PRAIRIE DISTRICT - NORTH  
 2021 INSPECTION REPORT

Site Number	Location	Name	Hwy	km
GP004a	Burnt River Bridge (BF73877)	Burnt River Bridge (West Approach Slide)	49:06	10.586
GP004d (Not Visited)		Burnt River Bridge (East Approach Slide)		11.000
<b>Legal Description</b>		<b>UTM Co-ordinates</b>		
NW¼10-078-04-W6M		11U E 403300	N 6178800

**2021 INSPECTION FIGURE**

DWG No. 32123-GP004A-1-1

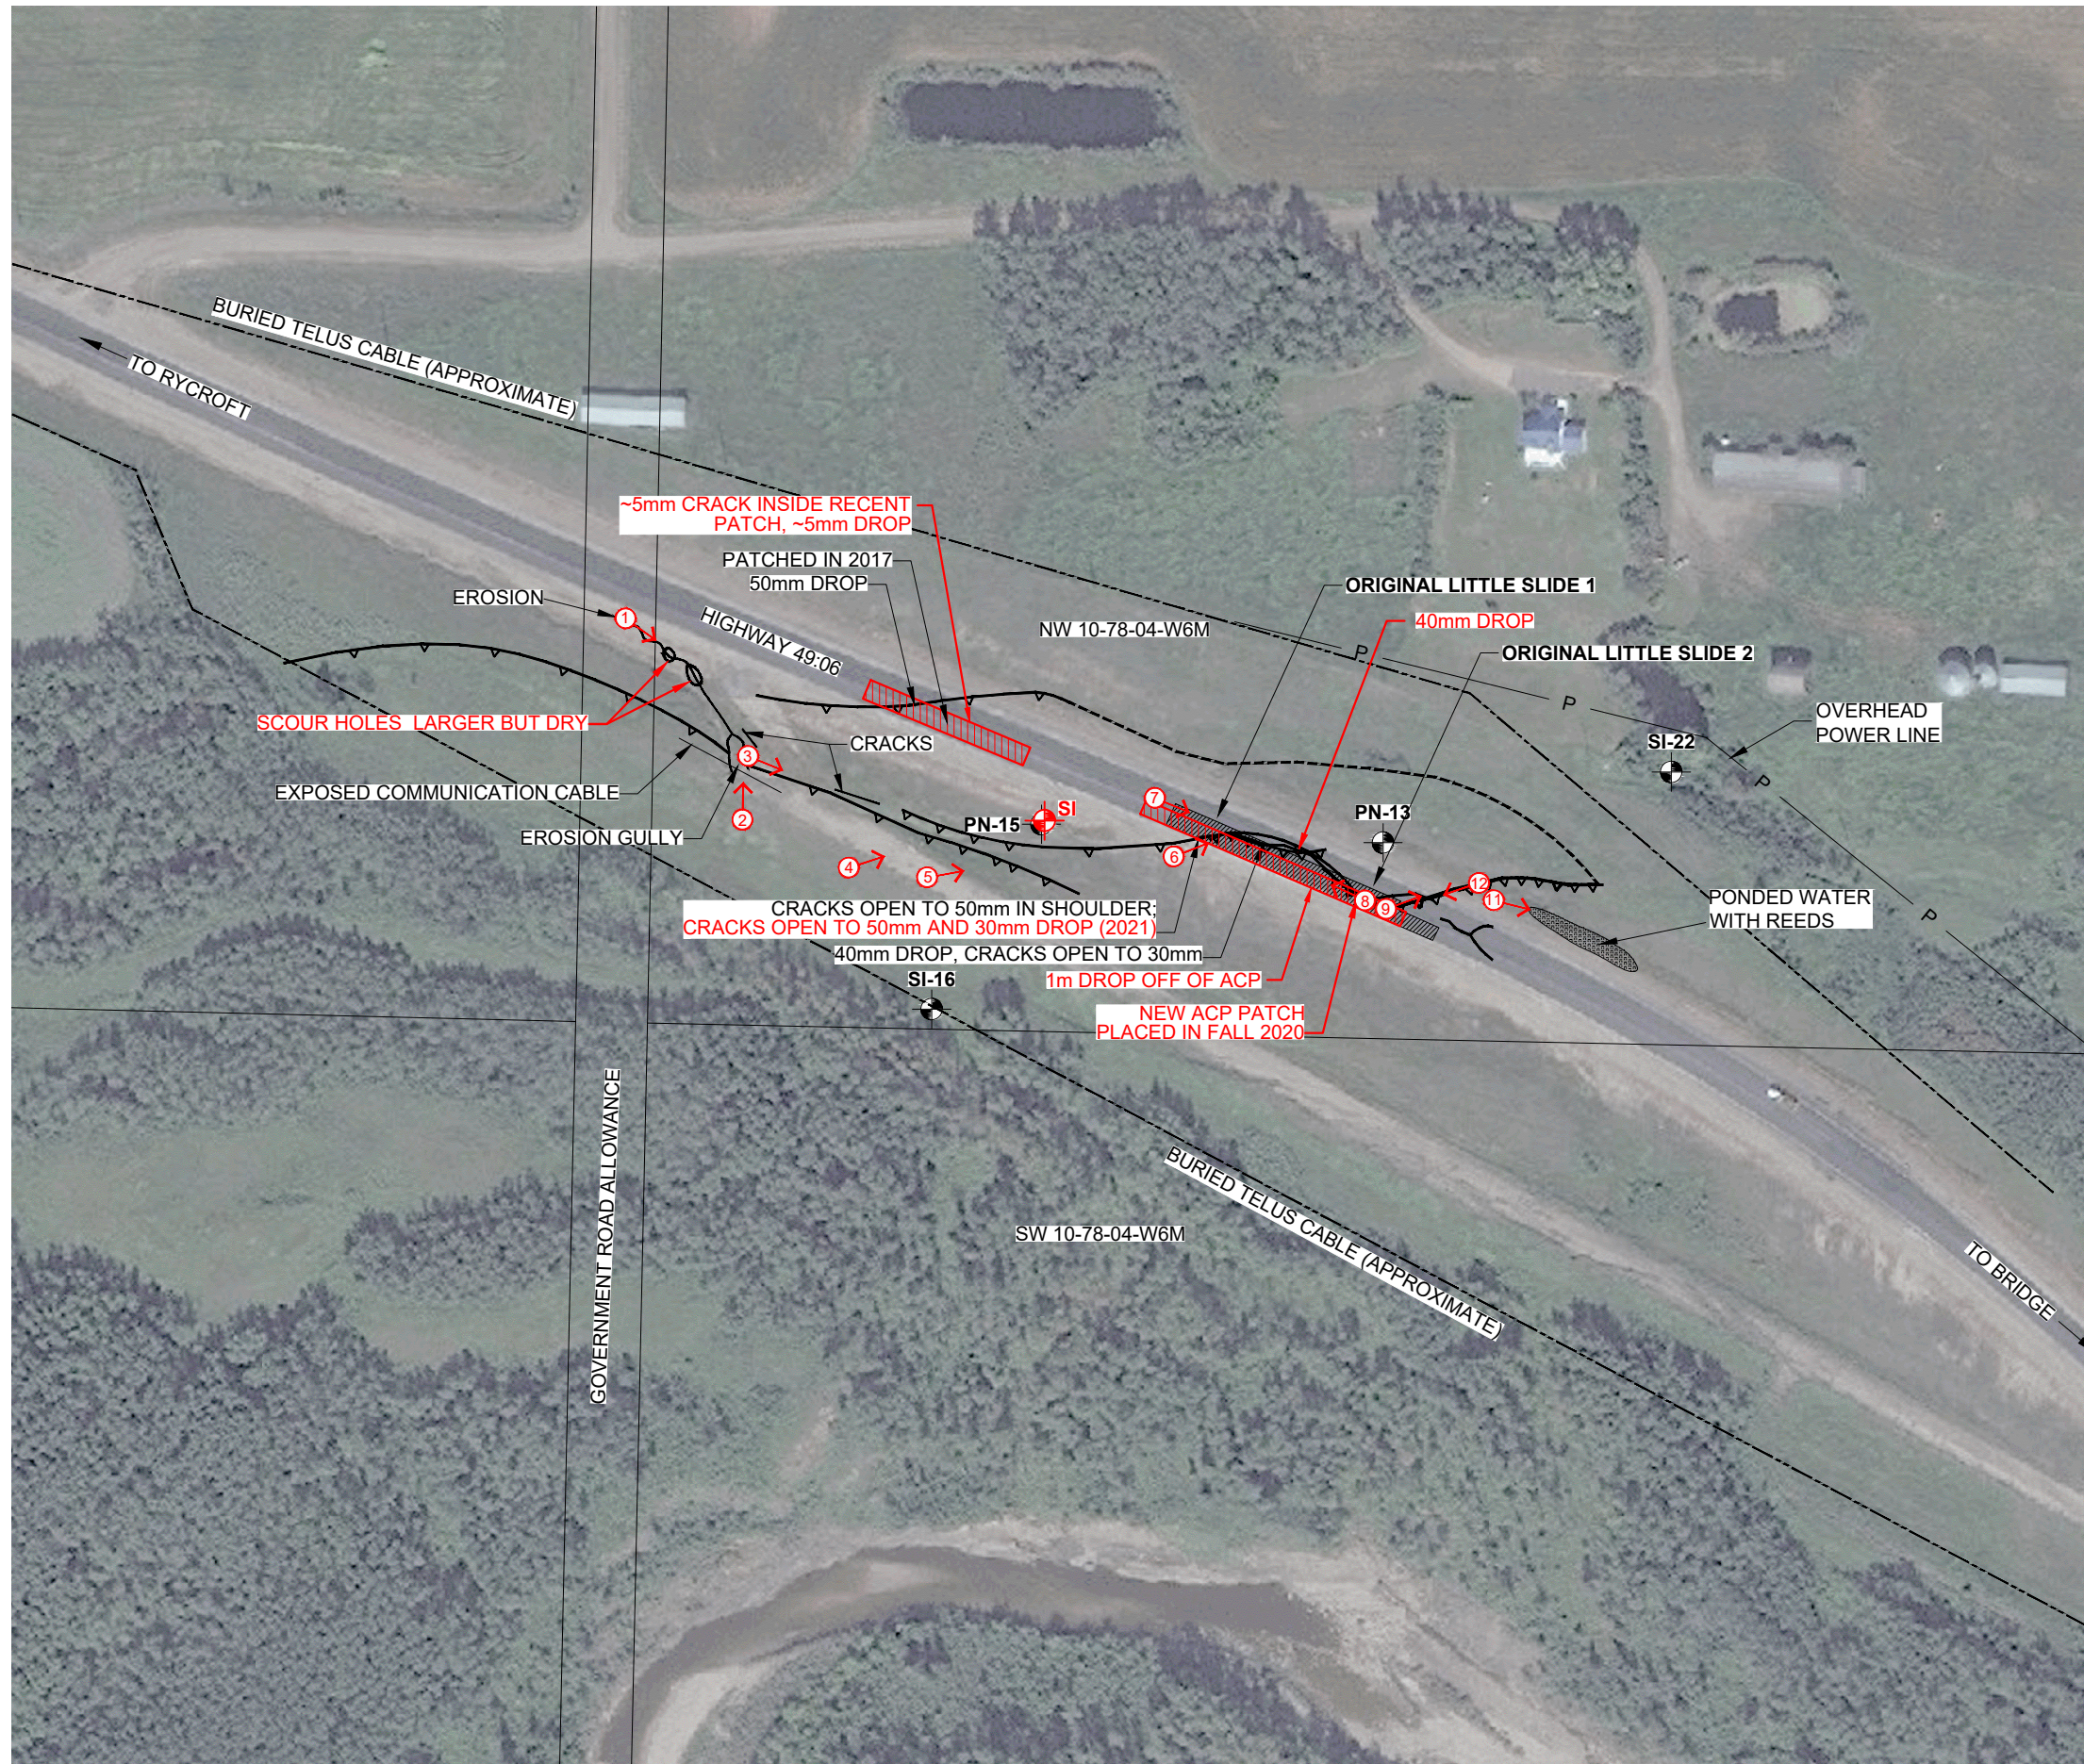
**PEACE REGION (GRANDE PRAIRIE DISTRICT - NORTH)  
GP004A-1: HWY 49:06 BURNT RIVER BRIDGE**

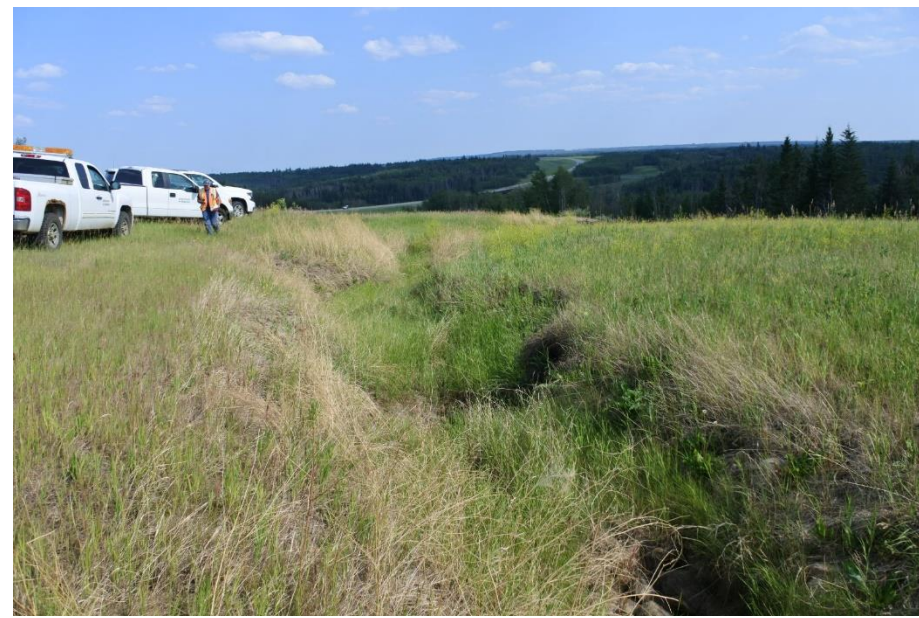
<input checked="" type="checkbox"/> Erosion	River erosion is ongoing at the toe of the larger deep-seated landslide on the west as the Burnt River continuously erodes the toe of the north valley slope. The scour holes in the erosion gully along the south ditch appeared a bit larger but were dry.	<input checked="" type="checkbox"/>
<input checked="" type="checkbox"/> Seepage	The previously ponded water area on the north side of the Highway was dry during the 2021 inspection, the reeds were present in the backslope ditch above the backscarp of the larger landslide at the West Approach Slide area. The two scour holes which were previously filled with water within the erosion gully formed to the northwest of the site were dry in 2021.	<input checked="" type="checkbox"/>
<input type="checkbox"/> Bridge/Culvert Distress		<input type="checkbox"/>
<input type="checkbox"/> Other		<input type="checkbox"/>

**Photo 1.**  
Looking south at erosion gully that has formed in the south ditch which was dry due to warm weather in 2021.

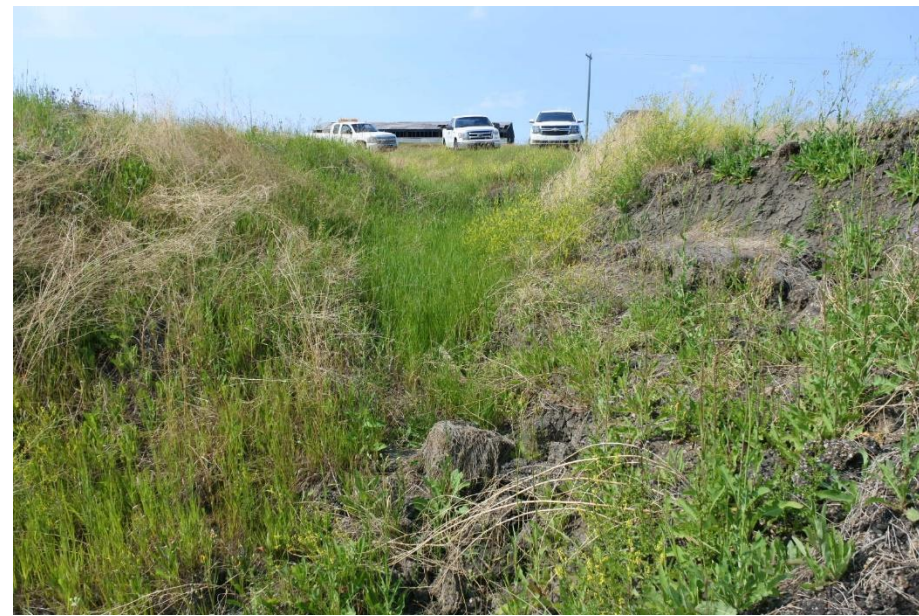
**Photo 2.**  
Looking northwest from edge of erosion gully. Note the ditch along east side of highway tails off and has been the contributor to this erosion.

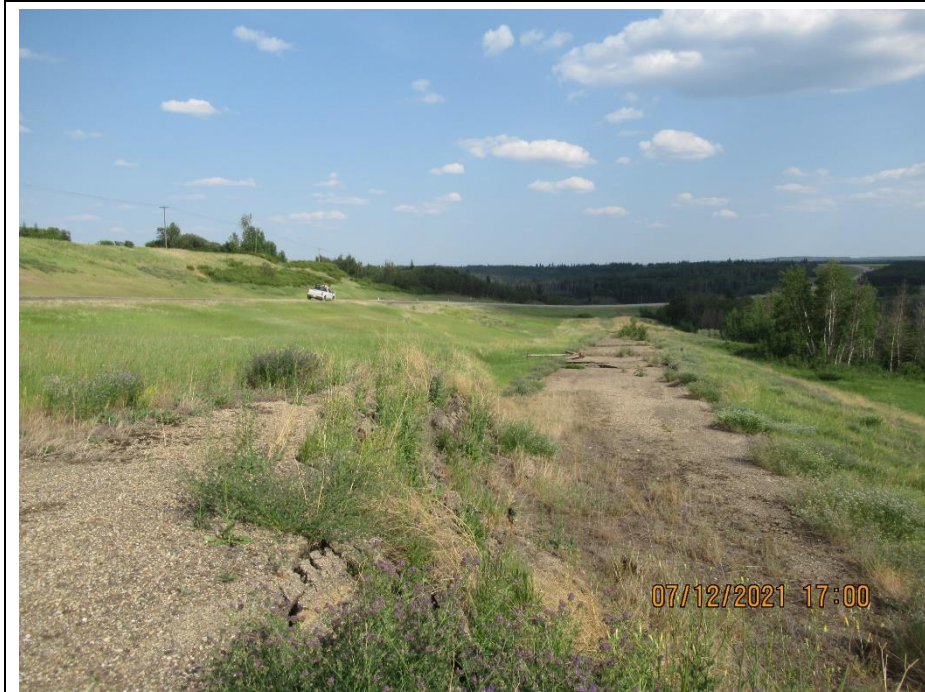
**Photo 3.**  
Looking southeast  
at where scarp  
crosses the old  
highway alignment.

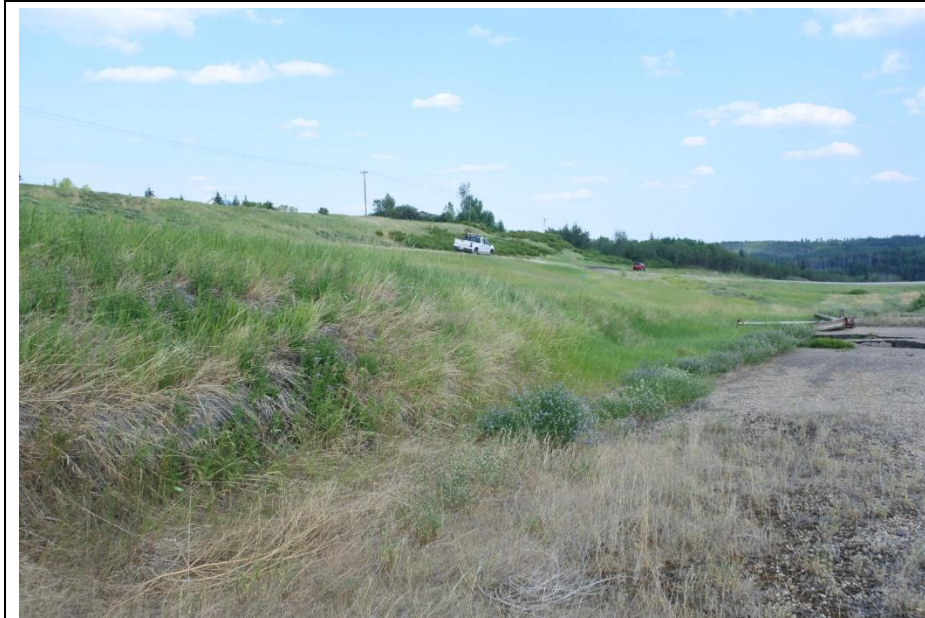
**Photo 4.**  
Looking northeast  
at southern slide  
scarp which  
crosses the old  
highway alignment.

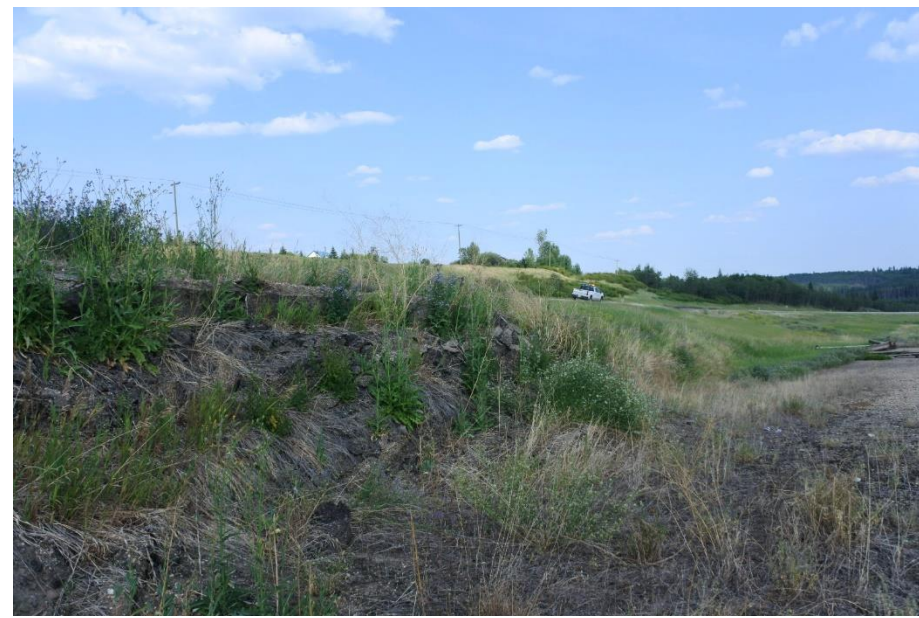
**Photo 5.**  
Looking southeast  
from old highway  
alignment at south  
slide scarp.

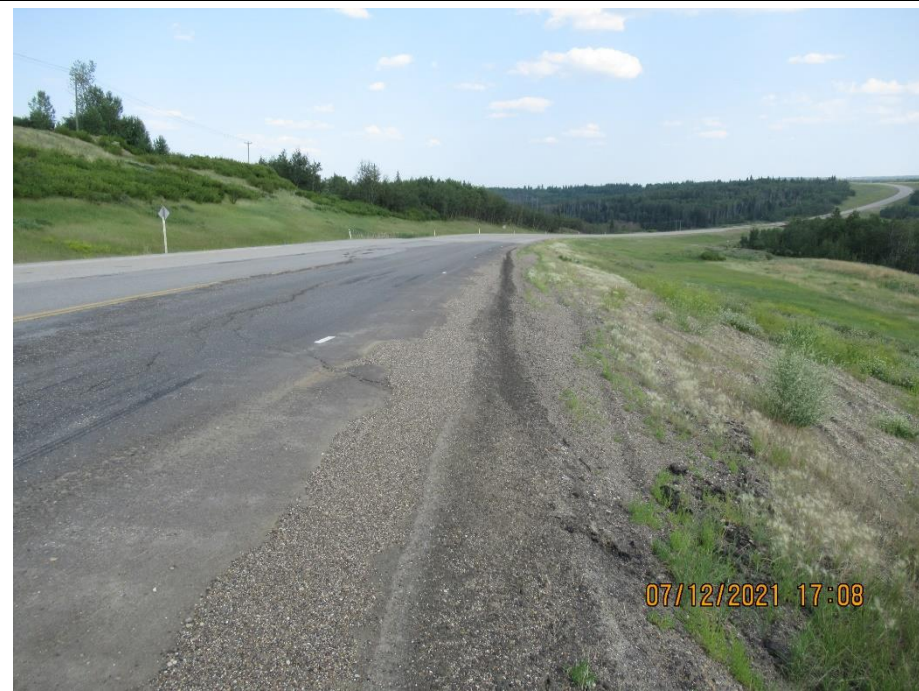
**Photo 6.**  
Looking east from  
the shoulder of the  
EBL of Hwy 49:06  
at the westmost dip  
in the fall 2020  
ACP patch. Note  
the scarp within the  
embankment

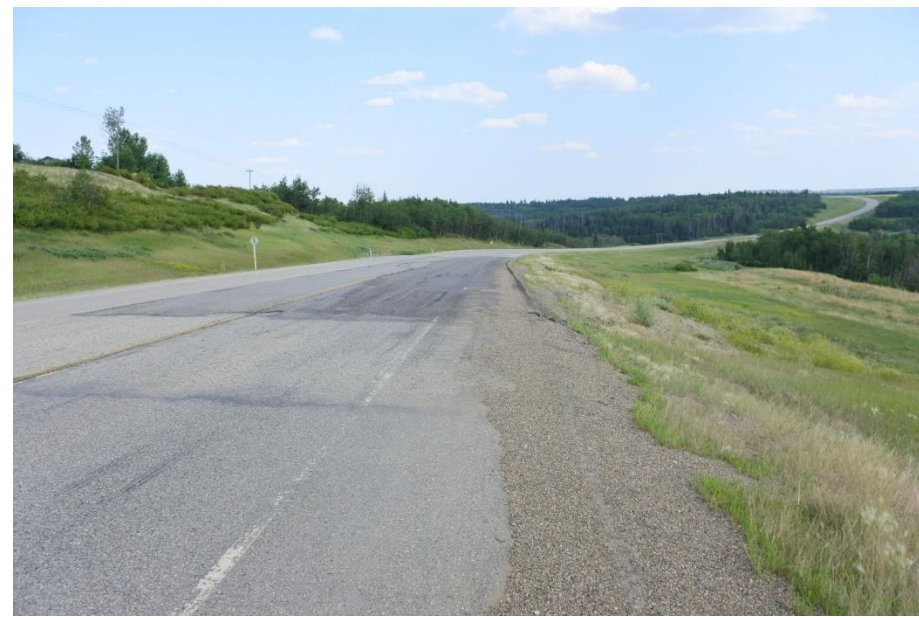
**Photo 7.**  
Looking east from the shoulder of the EBL of Hwy 49:06 across the inner crack feature and dip in the 2017 ACP patch.

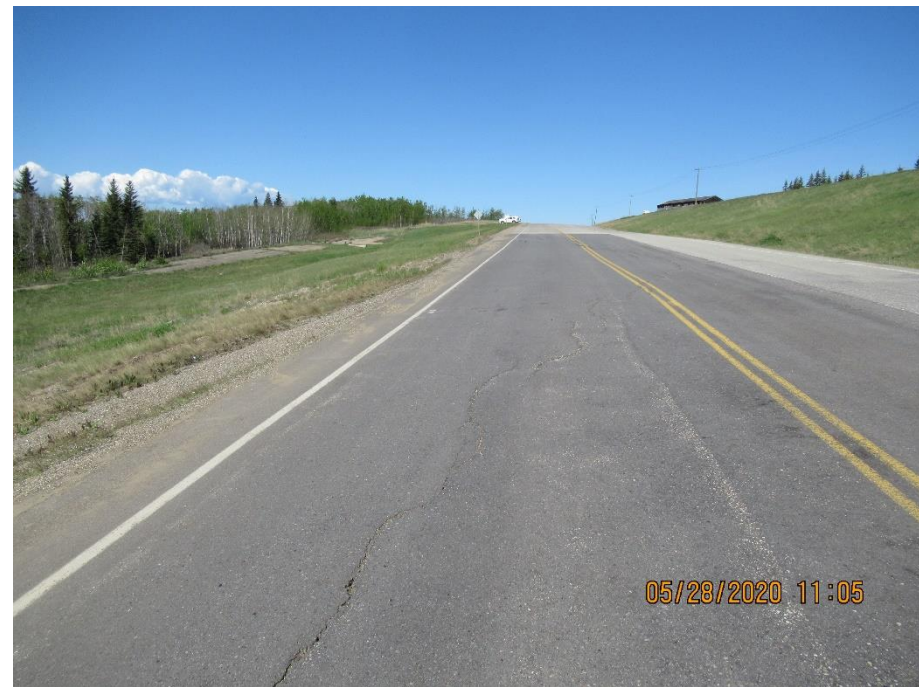
**Photo 8.**  
Looking northwest from the middle of Hwy 49:06 from the south end of the 2016 ACP patch.

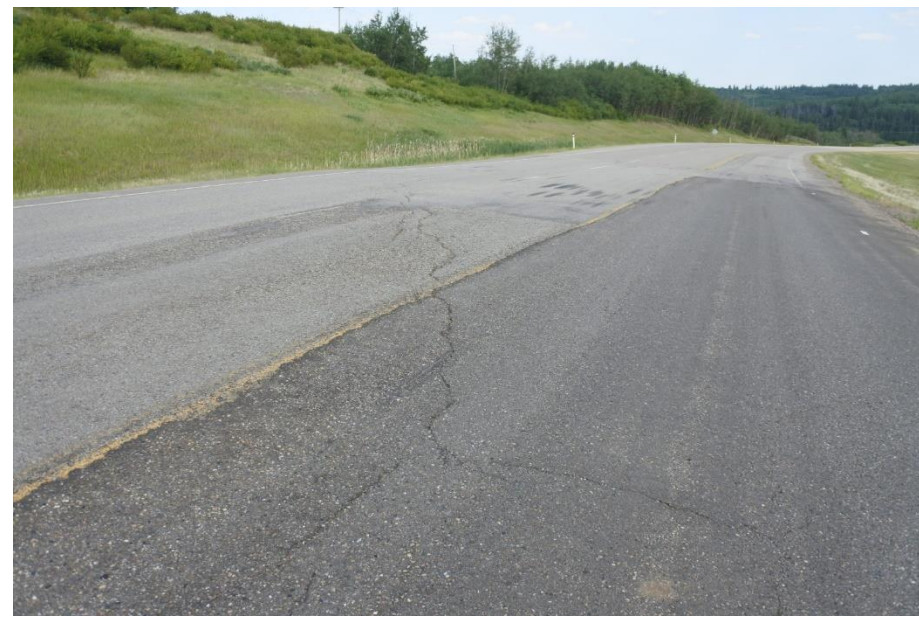
**Photo 9.**  
Looking east from near the middle of the 2017 ACP patch where crack continues into WBL.

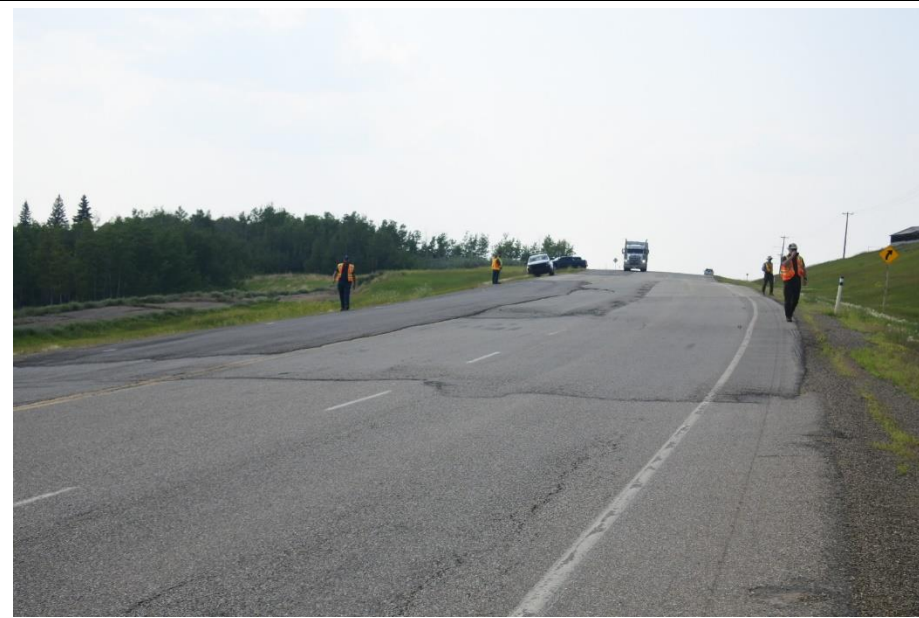
**Photo 10.**  
Looking northwest from the EBL of Hwy 49:06 at the south end of the site.

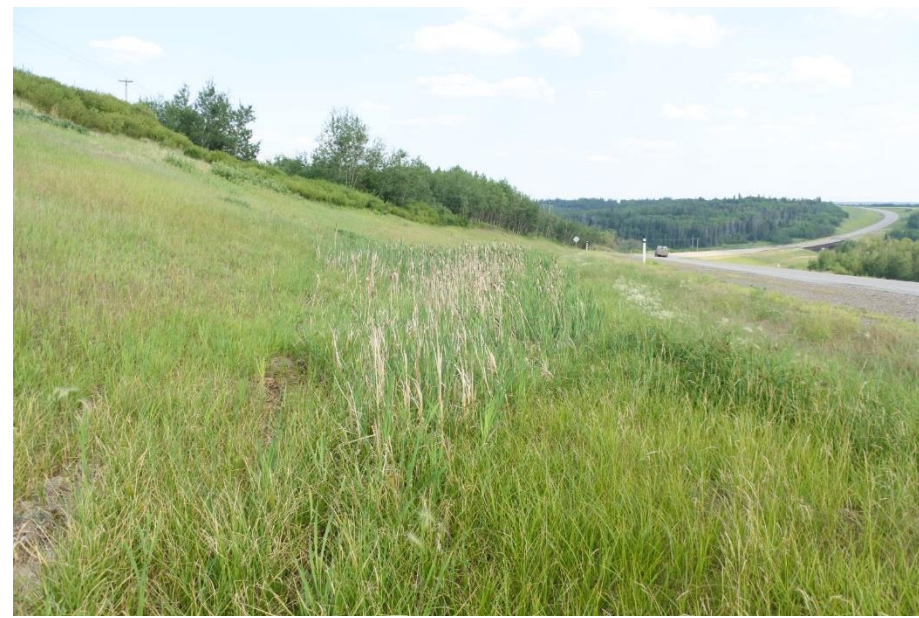
**Photo 11.**  
Looking southeast  
at ponded water  
and reeds on north  
side of highway.

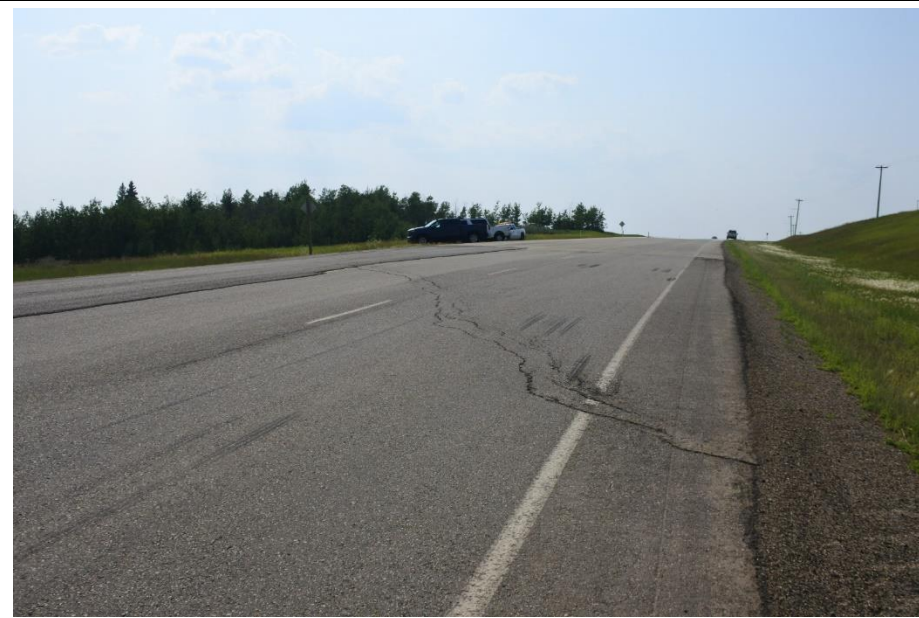
**Photo 12.**  
Looking northwest  
from the EBL  
shoulder of Hwy  
49:06 at scarp  
crack extending  
into shoulder at the  
south end of the  
site.
