November 22, 2022

### ALBERTA TRANSPORTATION GRMP (CON0022165) PEACE REGION (GRANDE PRAIRIE DISTRICT – NORTH) INSTRUMENTATION MONITORING RESULTS – FALL 2022

### SITE GP004A: HWY 49:06, BURNT RIVER BRIDGE

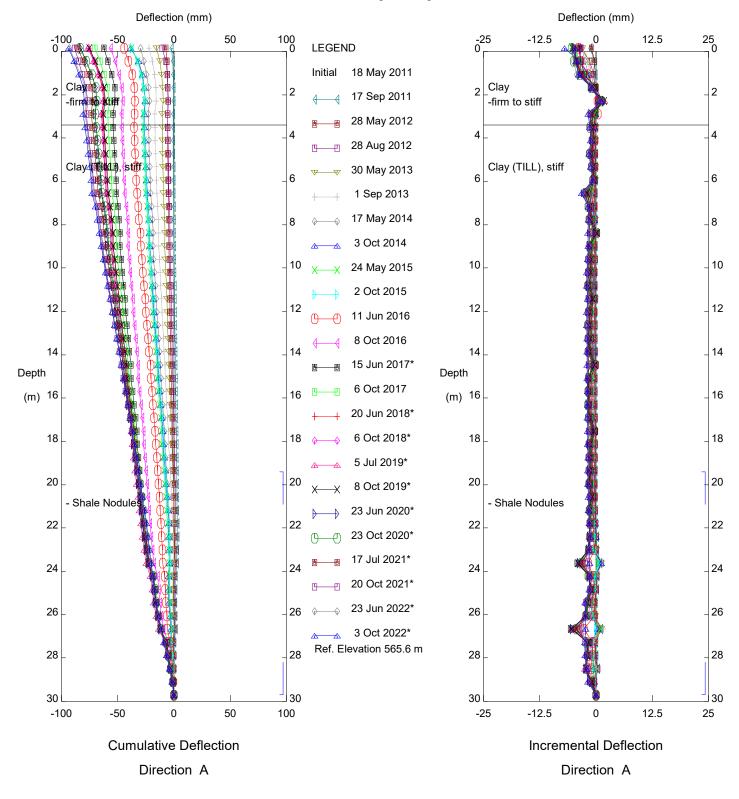
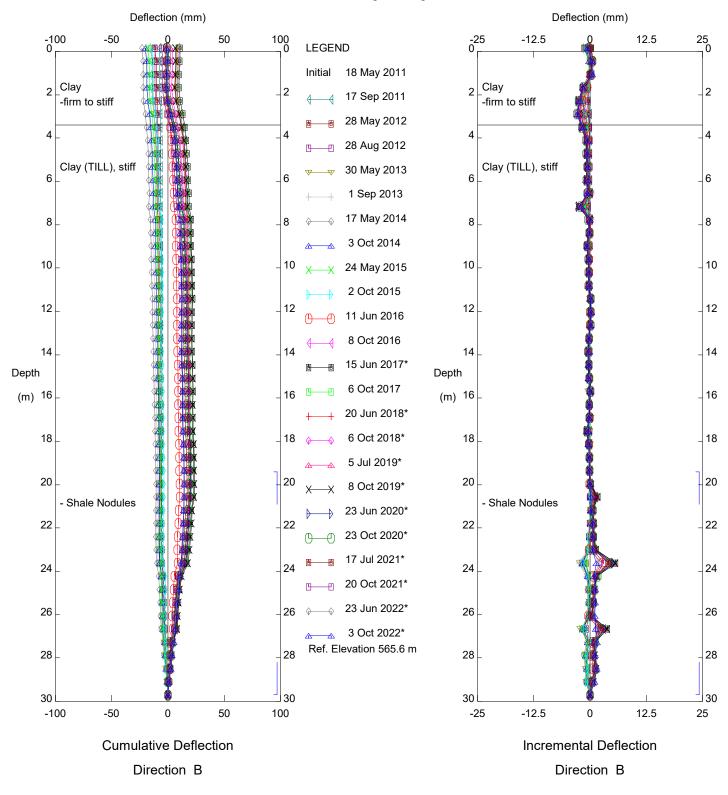
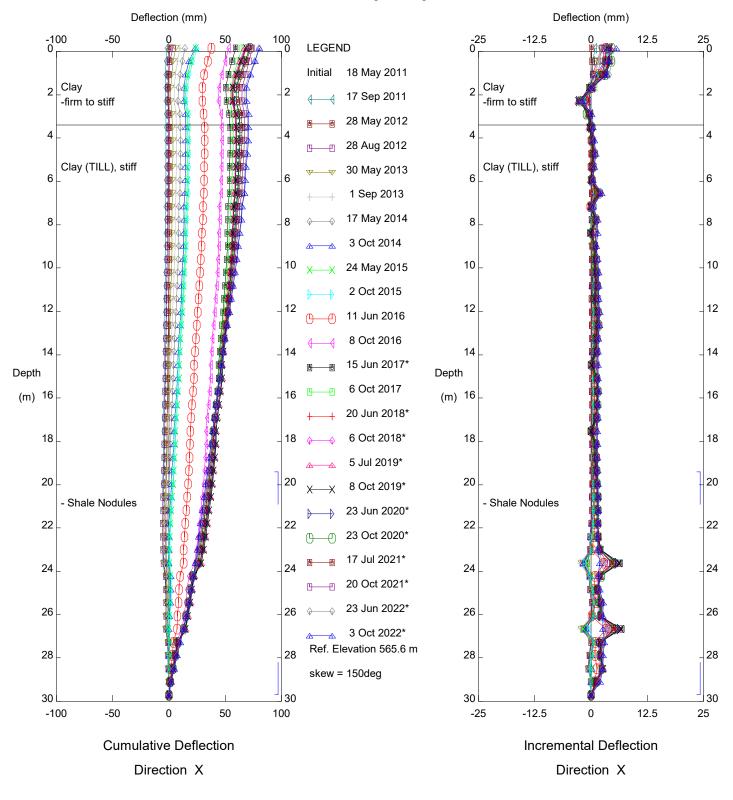
#### GP004A Burnt River West Approach, Inclinometer SI-16

Zones of new movement were not observed in SI-16 since the previous readings in the spring of 2022.

Slope inclinometer SI-16 showed no discernible movement since the spring of 2022 readings. SI-16 has shown movement in a northwest direction towards the slope over previous reading cycles. Based on the readings, it is possible that SI-16 is not installed deep enough to capture a deeper slide surface at the site.

The instruments should be read again in the spring of 2023.
