**ALBERTA TRANSPORTATION
GEOHAZARD ASSESSMENT PROGRAM
PEACE REGION–GRANDE PRAIRIE
2022 INSPECTION REPORT**

Site Number	Location	Name	Hwy	km
GP004a	Burnt River Bridge (BF73877)	Burnt River Bridge (West Approach Slide)	49:06	10.586
GP004d (Not Visited)		Burnt River Bridge (East Approach Slide)		11.000
Legal Description		UTM Co-ordinates		
NW¼10-078-04-W6M		11U E 403300	N 6178800

**PEACE REGION (GRANDE PRAIRIE DISTRICT - NORTH)
GP004A-1: HWY 49:06 BURNT RIVER BRIDGE**

2022 INSPECTION FIGURE

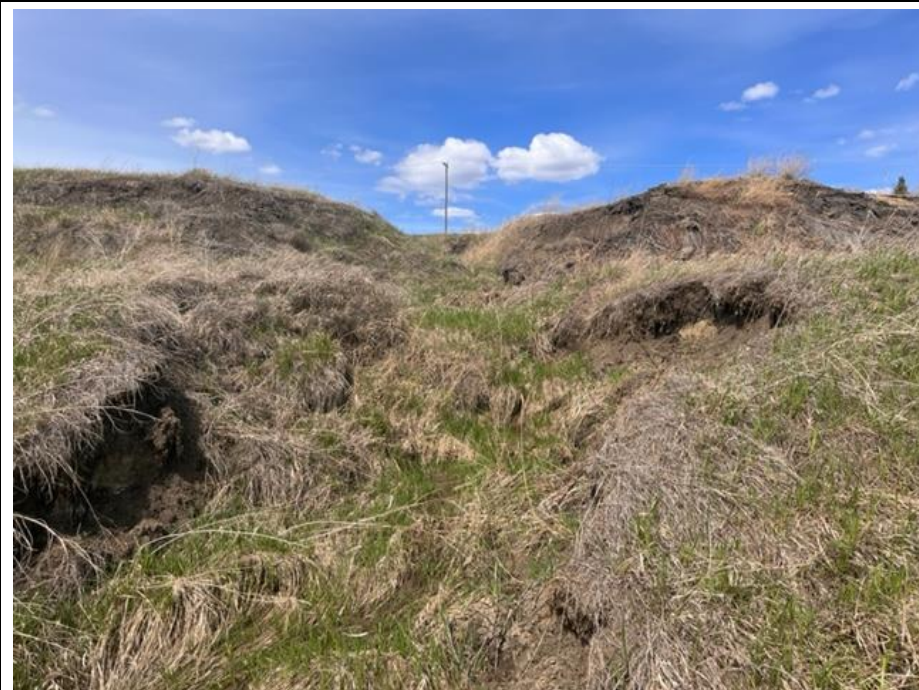
Photo 2.
Looking north from edge of erosion gully. Note the ditch along south side of highway tails off and has been the contributor to this erosion.

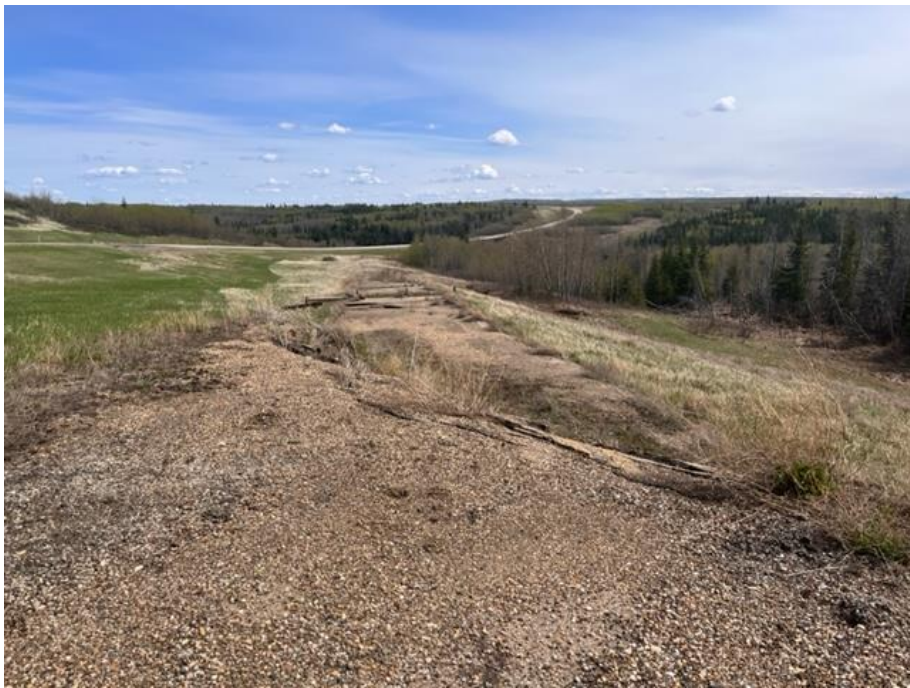
Photo 3.
Looking southeast
at where scarp
crosses the old
highway alignment.

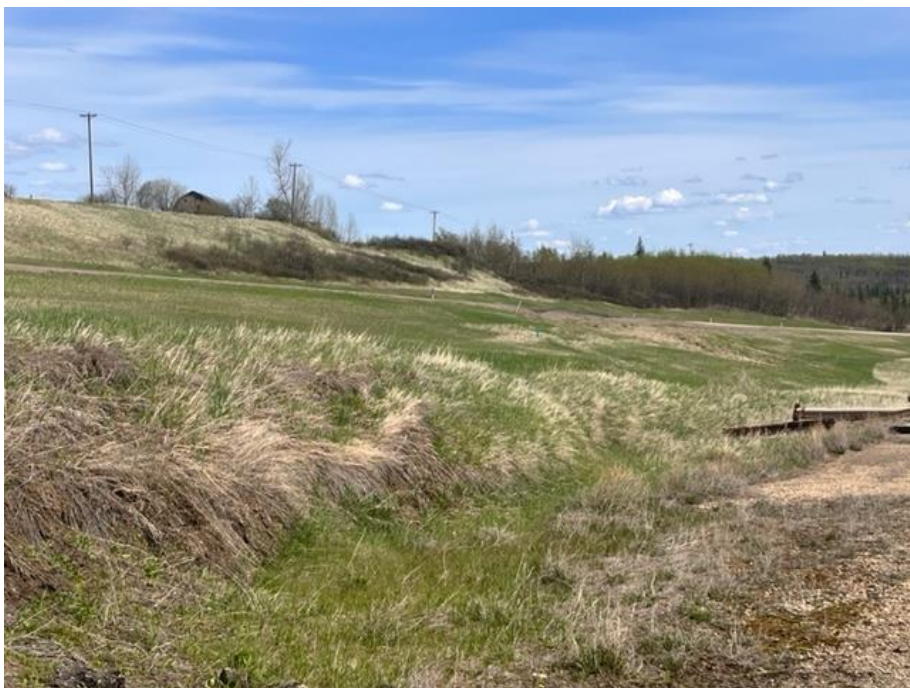
Photo 4.
Looking northeast
at southern slide
scarp which
crosses the old
highway alignment.

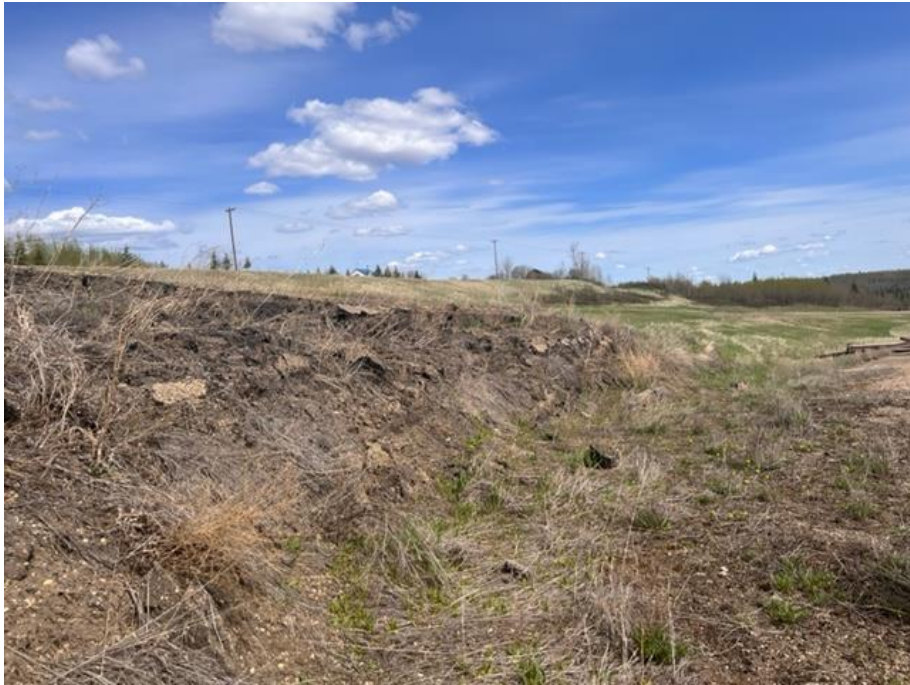
Photo 5.
Looking southeast
from old highway
alignment at south
slide scarp.

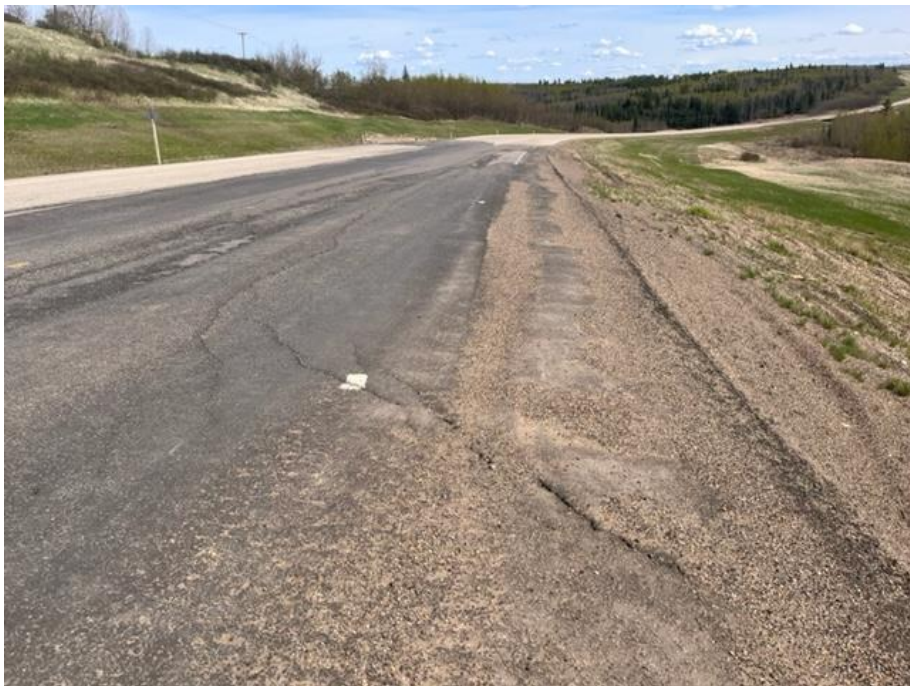
Photo 6.
Looking east from
the shoulder of the
EBL of Hwy 49:06
at the westmost dip
in the 2021 ACP
patch.

The aperture/extent of the cracks in the pavement affected by the West Approach Slides should be regularly monitored for signs of development and deterioration. Open cracks should be sealed or patched as soon as practical. A subdrain could be constructed in the north ditch, however we first recommend drilling a few test holes and installing piezometers to assess whether lowering of the water table is feasible with a subdrain below the ditch alignment.

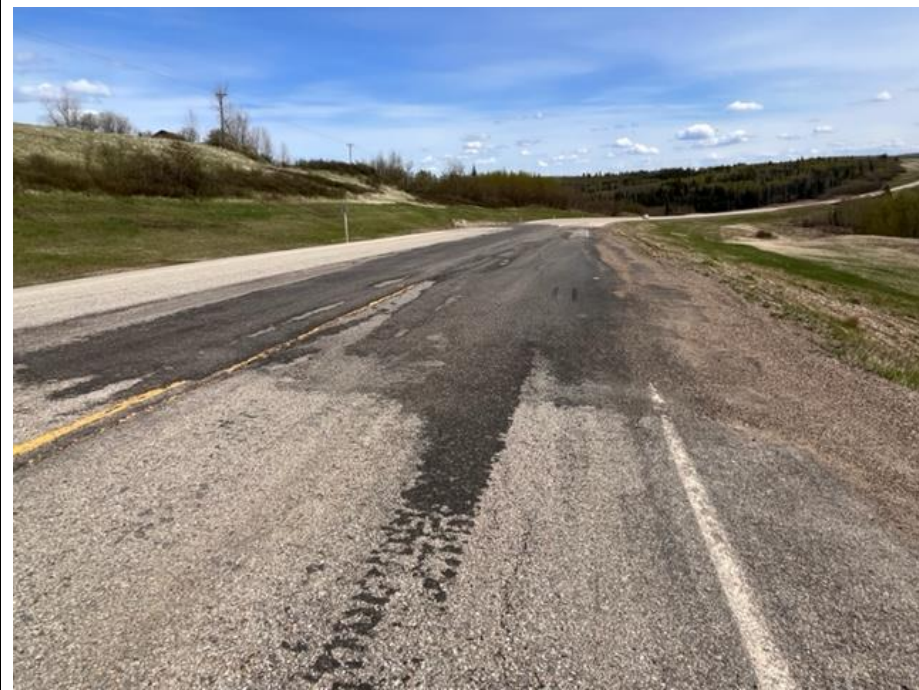
Photo 7.
Looking east from the shoulder of the EBL of Hwy 49:06 at the dip in the 2021 ACP patch.

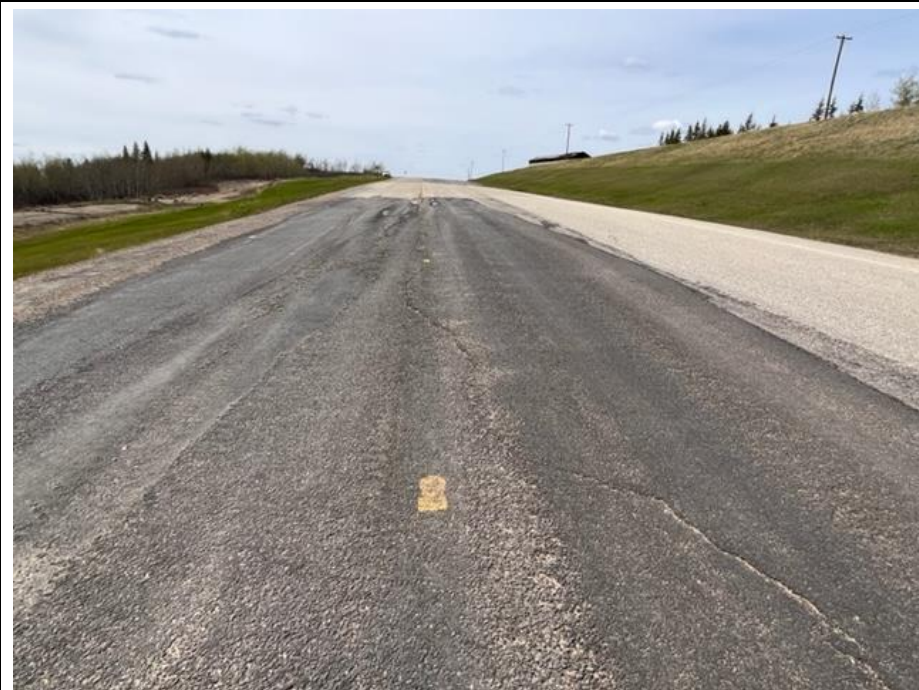
Photo 8.
Looking northwest from the middle of Hwy 49:06 from the south end of the 2021 ACP patch.

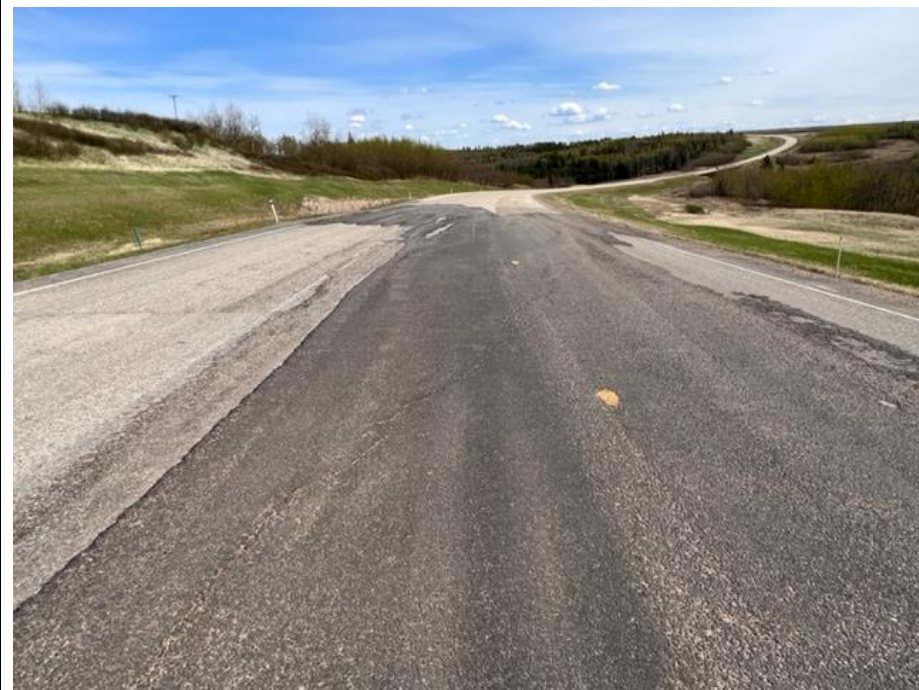
Photo 9.
Looking east from near the middle of the 2021 ACP patch where crack continues into WBL.

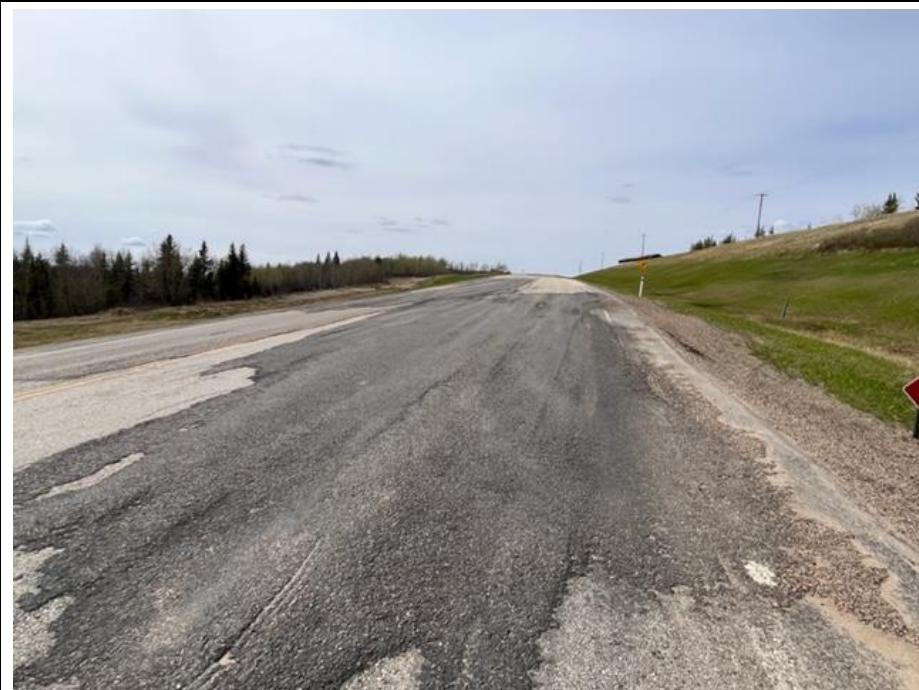
Photo 10.
Looking northwest from the EBL of Hwy 49:06 at the south end of the site.

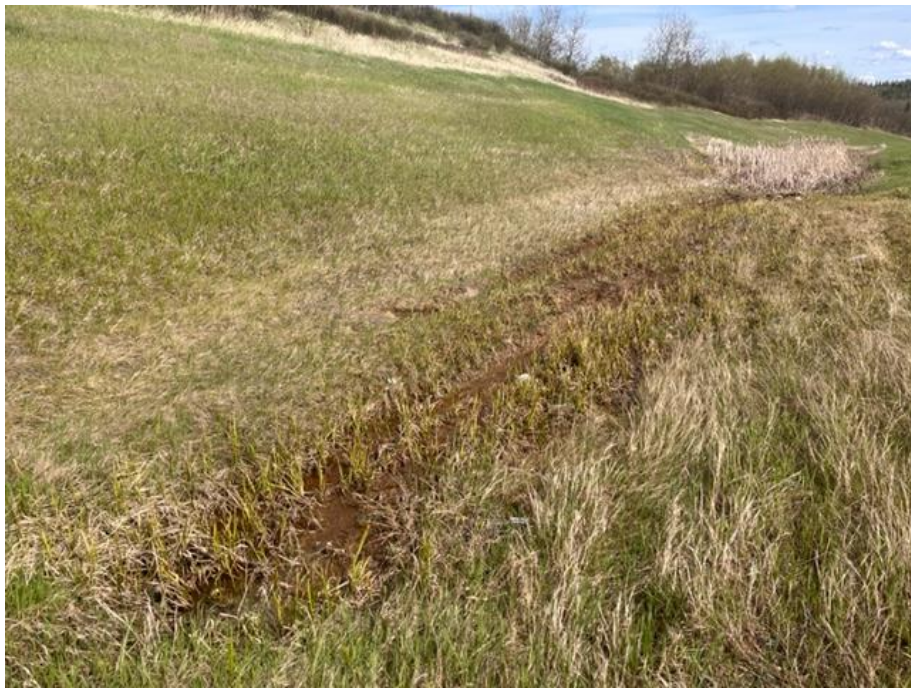
<input checked="" type="checkbox"/> Seepage	The previously ponded water area on the north side of the Highway was wet during the 2022 inspection, the reeds were present in the backslope ditch above the backscarp of the larger landslide at the West Approach Slide area. The two scour holes within the erosion gully formed to the northwest of the site were filled with water in 2022.	<input checked="" type="checkbox"/>
<input type="checkbox"/> Bridge/Culvert Distress		<input type="checkbox"/>
<input type="checkbox"/> Other		<input type="checkbox"/>
Instrumentation:		
SI-16	Installed about 70 m downslope of the Hwy 49:06 EBL at approximately the middle height of the Burnt River north valley slope. This SI showed no discernible movement since the fall 2021 readings. This SI was installed to a depth of 30 m; hence, it is possible that this SI was not installed deep enough to intercept the slide shear zone.

Photo 11.
Looking southeast
at ponded water
and reeds on north
side of highway.

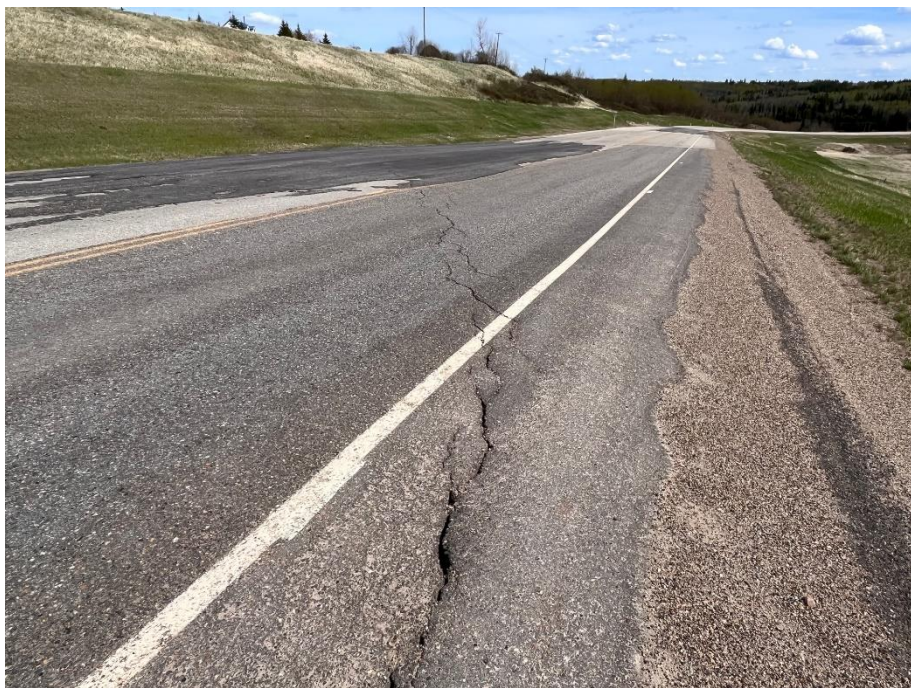
Photo 12.
Looking southeast
at the northwest
end of the site at
scarp crack open
on the SBL
shoulder.
