**ALBERTA TRANSPORTATION
AND ECONOMIC CORRIDORS
GEOHAZARD ASSESSMENT PROGRAM
PEACE REGION–GRANDE PRAIRIE DISTRICT - NORTH
2025 INSPECTION REPORT**

Site Number	Location	Name	Hwy	km
GP004a	Burnt River Bridge (BF73877)	Burnt River Bridge (West Approach Slide)	49:06	10.586
GP004d (Not Visited)		Burnt River Bridge (East Approach Slide)		11.000
Legal Description		UTM Co-ordinates		
NW¼10-078-04-W6M		11U E 403300

2025 INSPECTION FIGURE

DWG No. 32123-GP004A-1-1

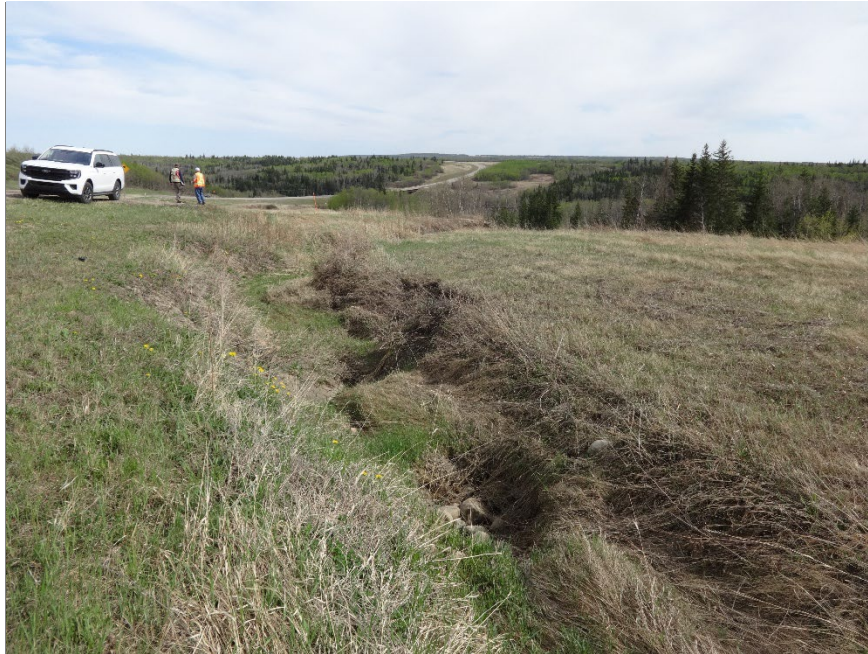
Photo 1. Looking southeast at erosion gully that had formed in the south ditch that had pooling water in it in 2022 but the scour holes were mainly dry with slight moisture in 2025.

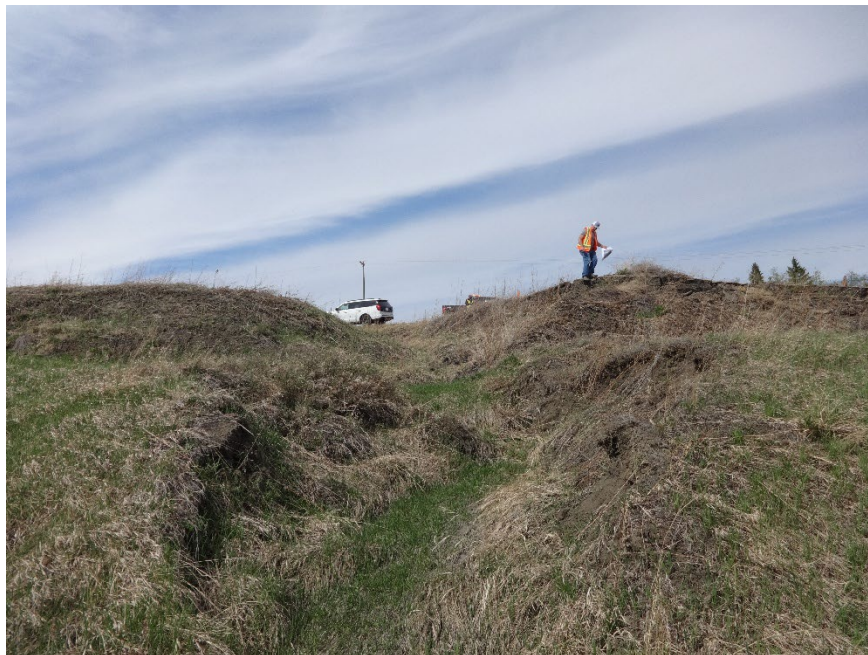
Photo 2. Looking north from edge of erosion gully. Note the ditch along south side of highway tails off and has been the contributor to this erosion.

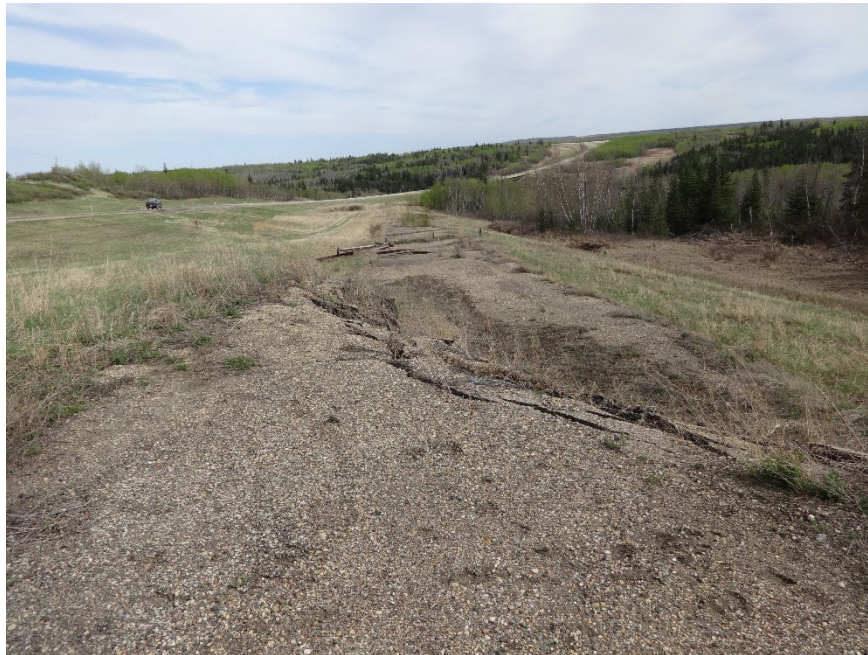
Photo 3. Looking southeast at where scarp crosses the old highway alignment.

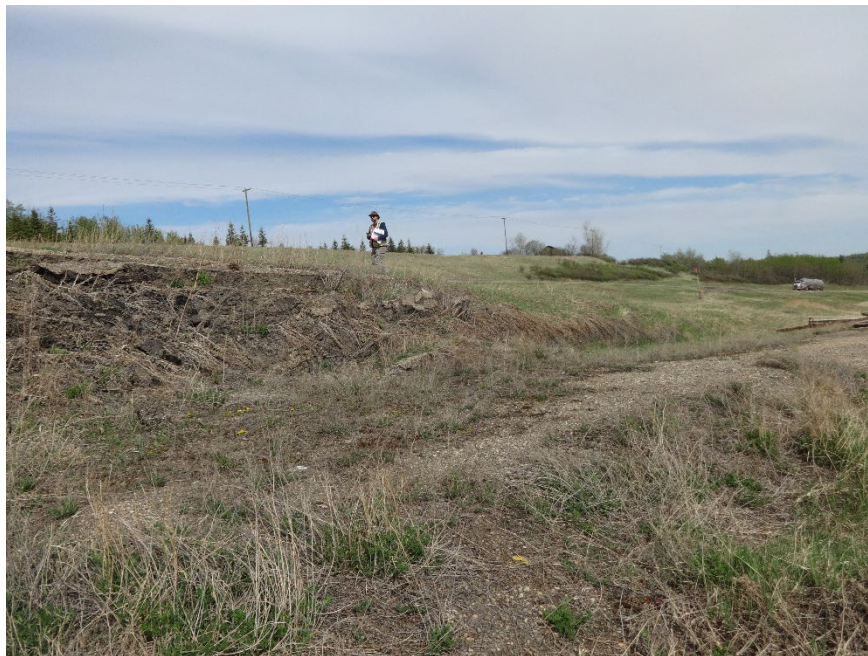
Photo 4. Looking northeast at southern slide scarp which crosses the old highway alignment.

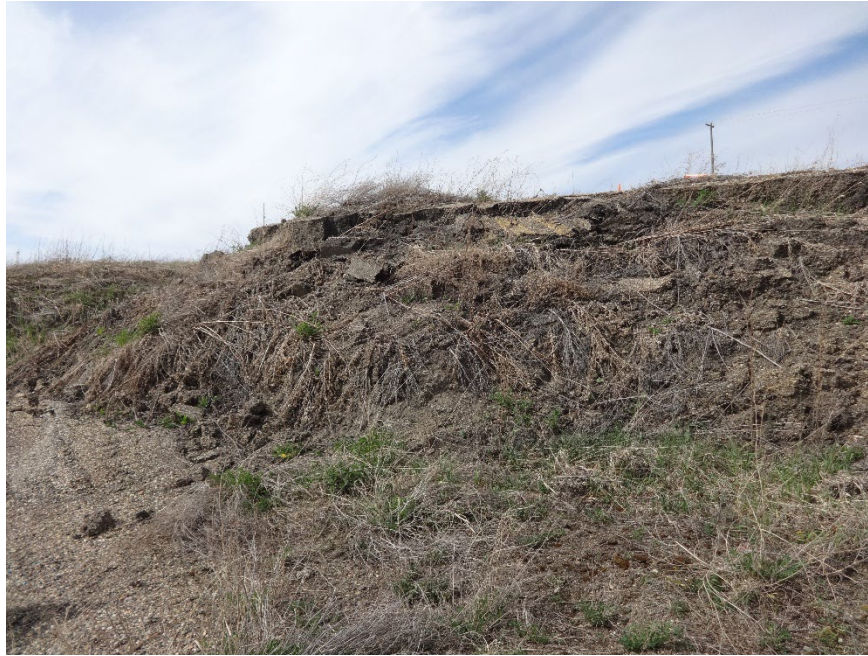
Photo 5. Looking north from old highway alignment at south slide scarp.

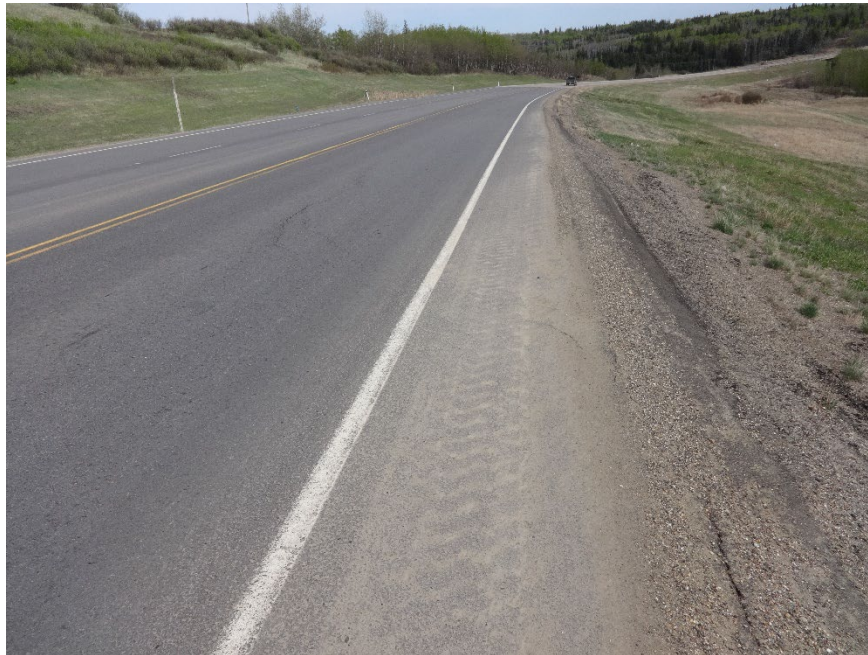
Photo 7. Looking east from the shoulder of the EBL of Hwy 49:06.

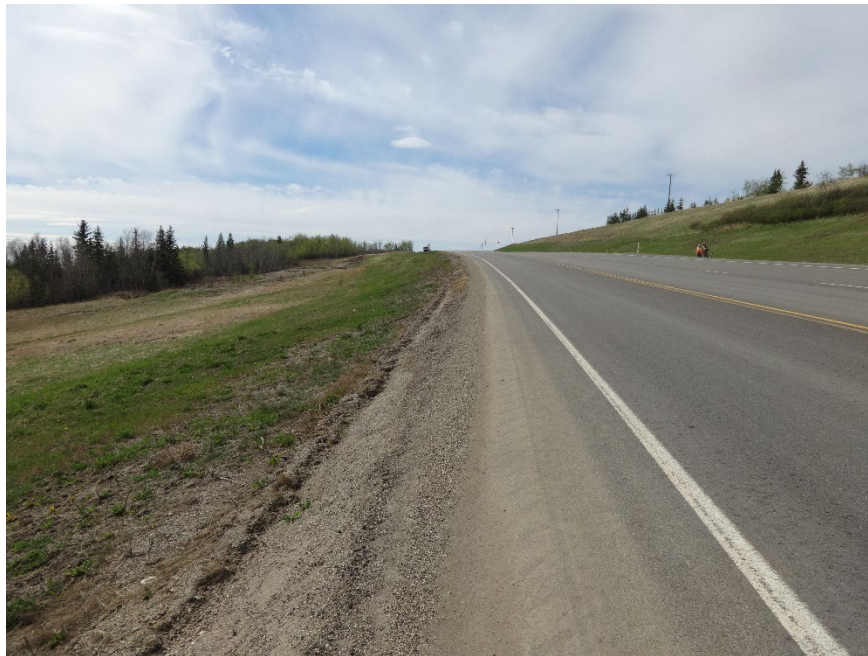
Photo 8. Looking northwest at south highway shoulder and drop off.

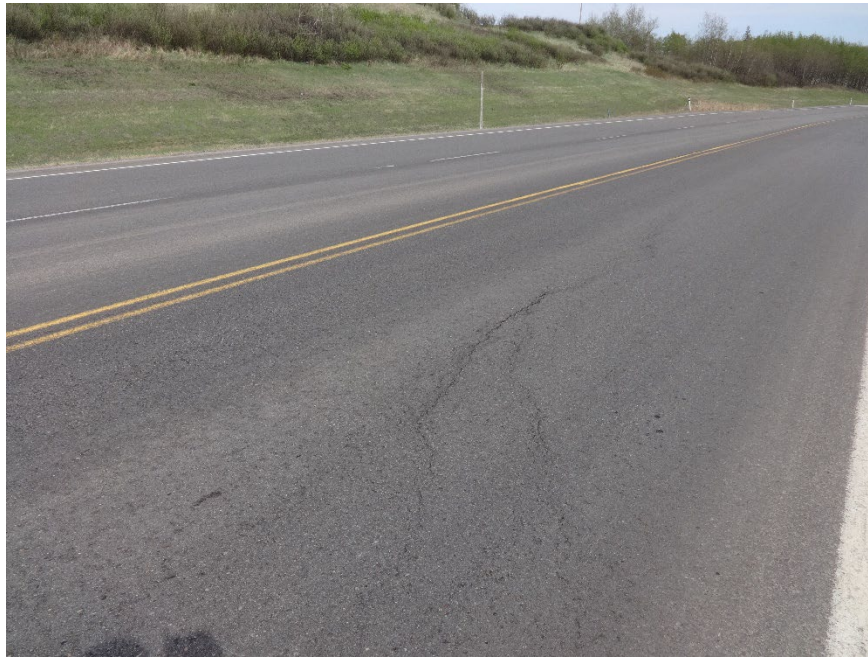
Photo 9. Looking east from near the middle of the site where crack is showing in EBL.

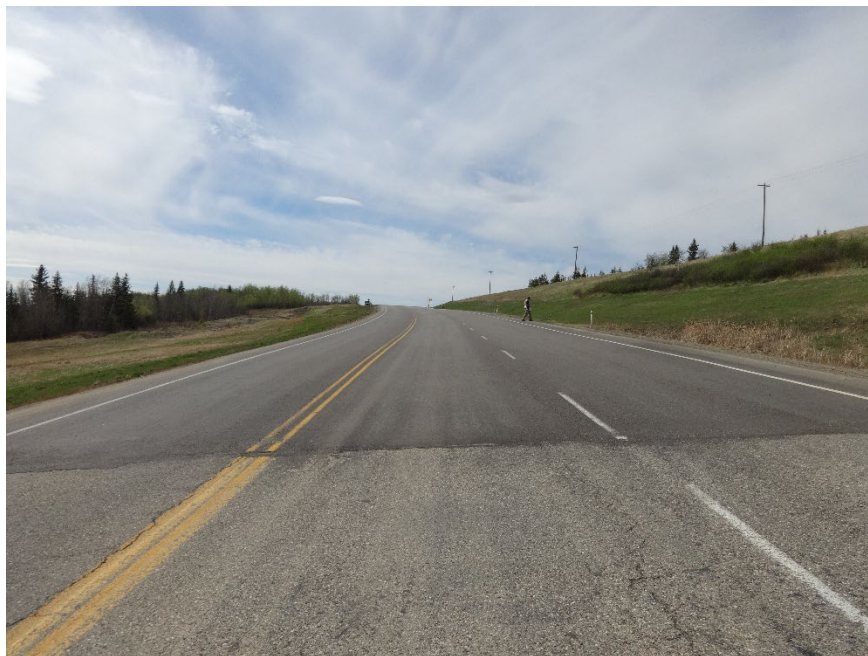
Photo 10. Looking northwest from the WBL of Hwy 49:06 at the south end of the site.

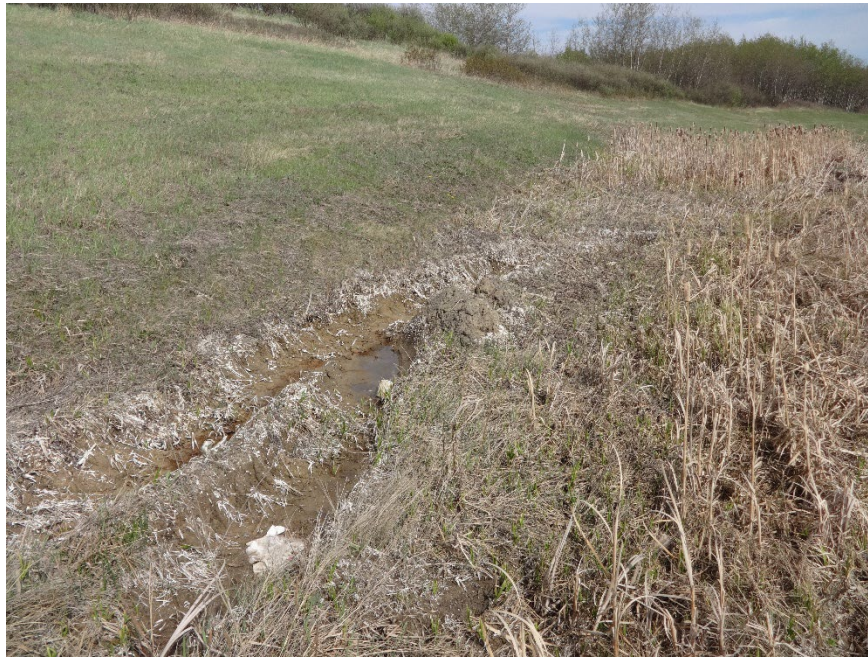
Photo 11. Looking southeast at ponded water and reeds on north side of highway.

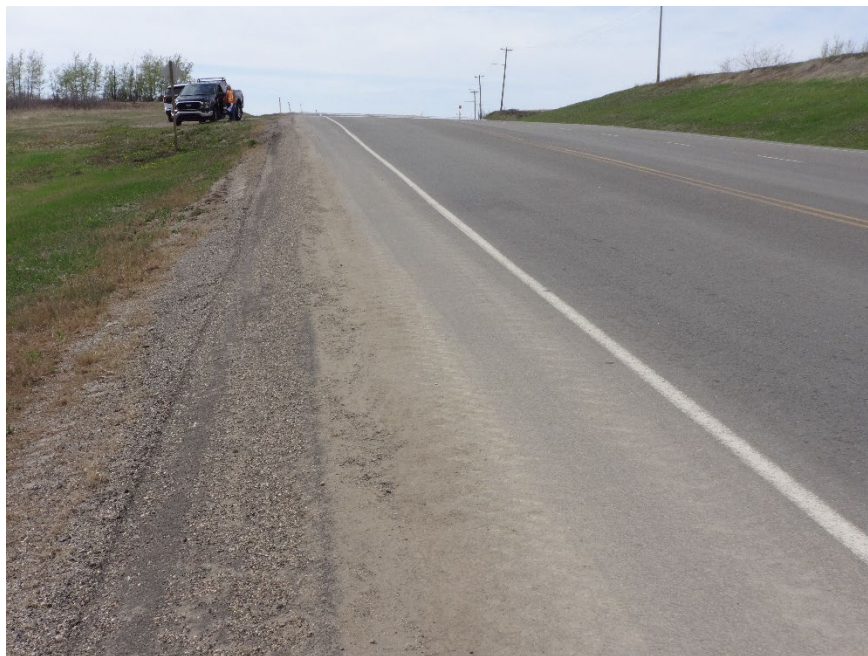
Photo 12. Looking northwest at the ACP overlay placed at the site.

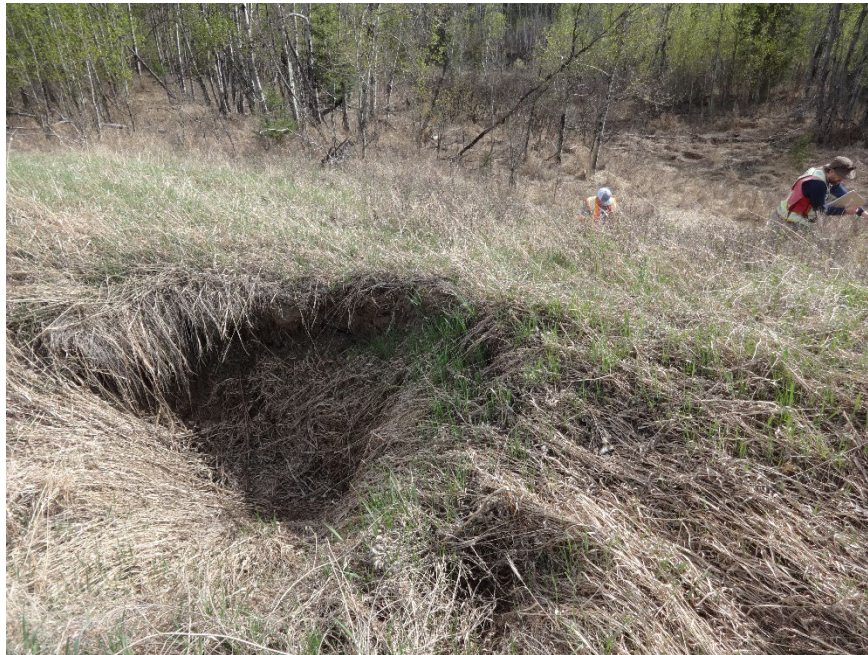
<input checked="" type="checkbox"/> Bridge/Culvert Distress		<input type="checkbox"/>
<input checked="" type="checkbox"/> Other	A 1.5 m diameter sinkhole was observed over an existing 800 mm diameter CSP culvert.	<input type="checkbox"/>

Photo 13. Looking south at sinkhole found south of the highway.

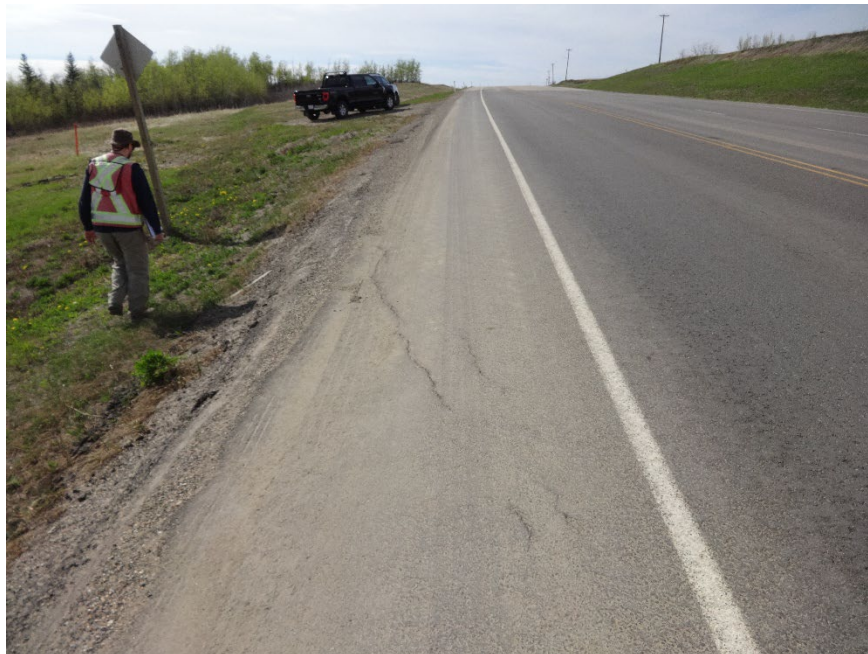
Photo 14. Looking northwest at hairline cracks showing in the eastbound lane shoulder at the northwest extent of the site.
