**ALBERTA TRANSPORTATION
GEOHAZARD ASSESSMENT PROGRAM
PEACE REGION (GRANDE PRAIRIE DISTRICT - NORTH)
2021 INSPECTION**

Site Number	Location	Name	Hwy	km
PH022	13 km W. Cleardale	Clear River East Hill-Site 6	64:02	22.8-23.1
Legal Description		UTM Co-ordinates (NAD 83)		
S28-84-11-W6		11 N 6243933	E 334702

2021 PH022 INSPECTION PLAN

2021 PH022 CONTOUR PLAN

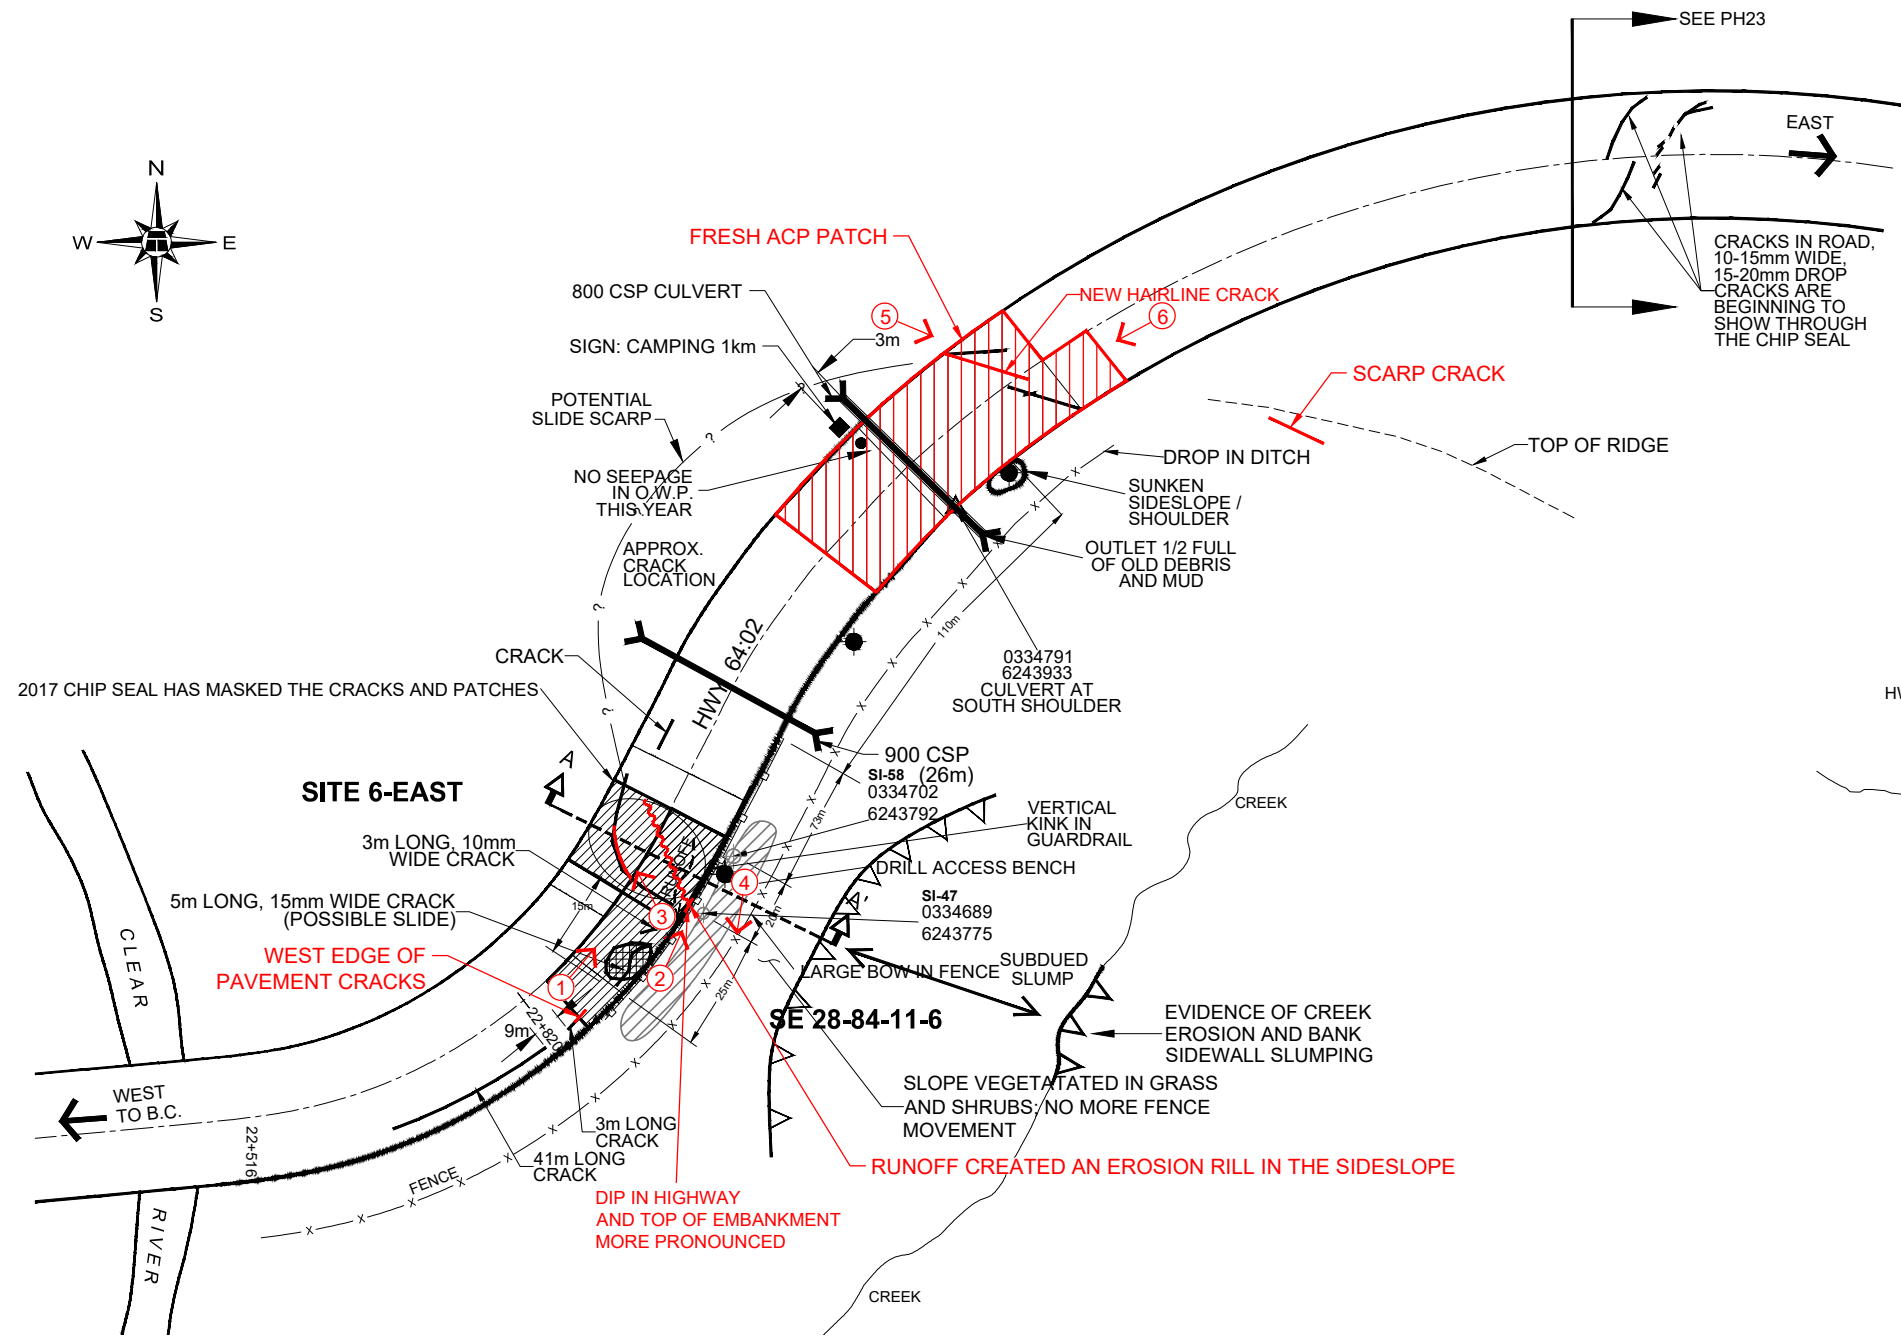
FIGURE PH022-1

It was concluded in 2011 that the drains mentioned in the old road files 50 m downslope of hwy may not have been installed, since they could not be located. Movements that were previously monitored in SI58 appear to be ongoing (but slow) based on a kink in the south guardrail, and a dip and bow in the fence on the south embankment at this location. It appears that a large slide scarp circles north of highway and joins the two observed dips spaced 200 m apart along the highway.

The west dip appears to be enlarging westwards, based on cracks first found in 2013 a distance of 15 m west of the west dip and which were observed to extend about 50 m west in 2017, and also a more apparent dip in the embankment in 2021. These cracks, and the fact that cracking has reflected through the freshly patched east dip in 2021 with a scarp crack observed south of the highway, in conjunction with the sunken shoulder in the pavement and south embankment at the west dip, suggests some on-going creep. Seepage traces in the pavement in previous years also indicates a high water table.

Perform a geotechnical Investigation to define the slide plane at this site, consisting of 3 test holes containing SI's and Piezometers (as shown on Figure PH22-1) to depths of at least 40 m.

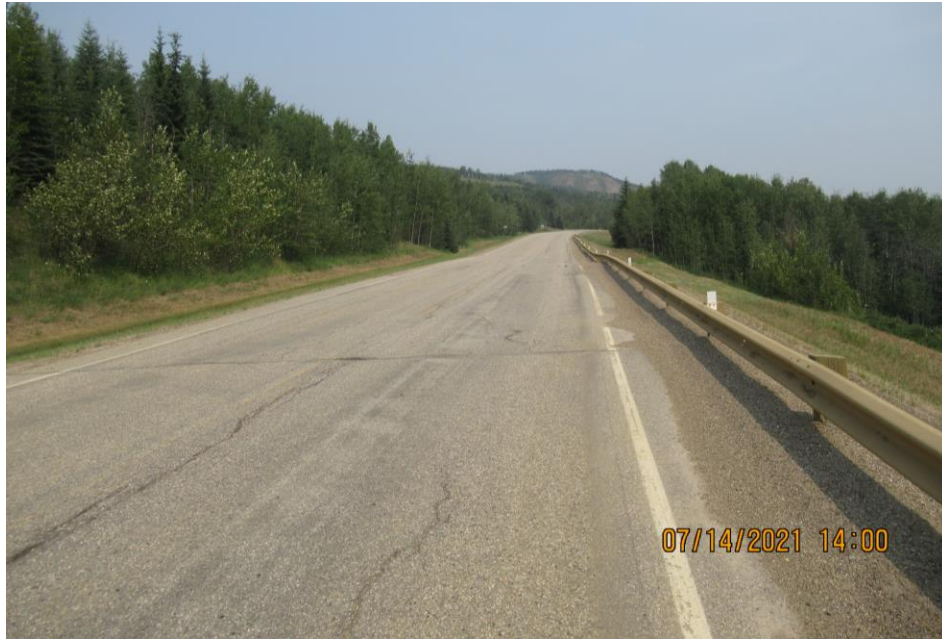
Photo 1 – Looking east along the cracked highway surface from the west end of the site. Note the west dip in the road/guardrail in the background.

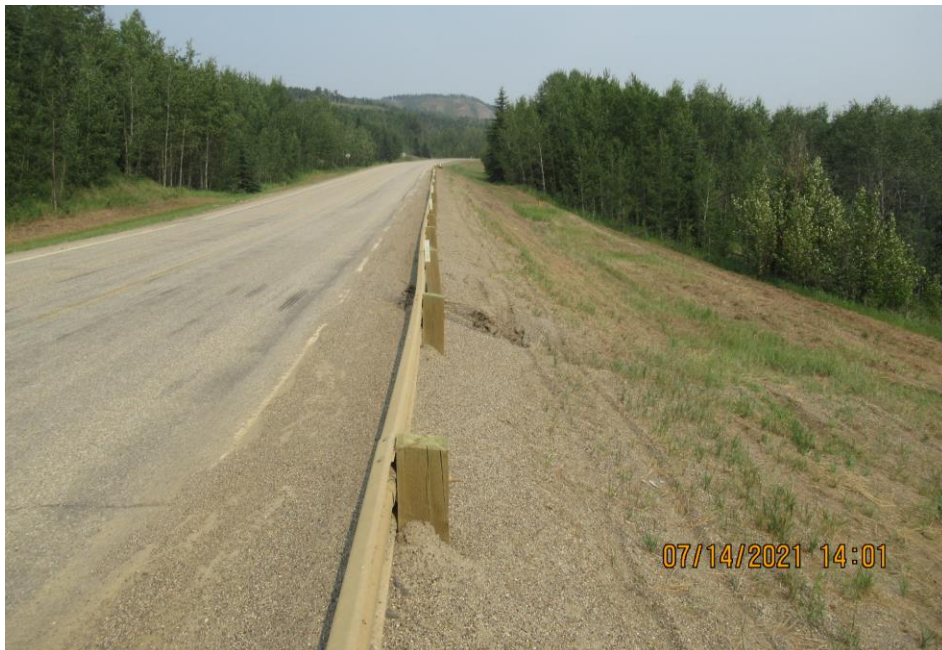
Photo 2 - Looking east at the guardrail at the west highway dip. Note the erosion rill in the embankment slope that formed from channelized runoff flowing along the dip in the highway.

- a) Clean the accumulated sand from the east highway shoulder and from underneath the guardrail for safety and to prevent formation of surface water concentration rilling.
- b) Place crushed gravel in the runoff channel that has formed on the embankment below the guardrail at the west dip.
- c) Monitor the pavement cracks in the two dipped areas for future subsidence/movement and progression of the circular slide scarp affecting the pavement at this location, and crack seal and patch as necessary.

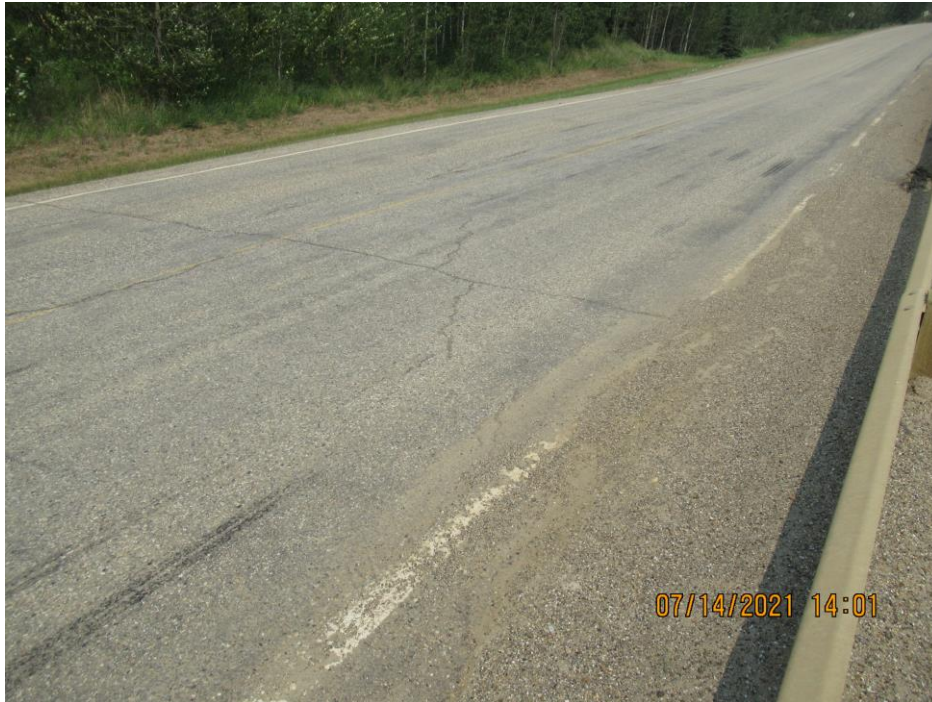
Photo 3 - Looking northeast along the scarp crack at the west end of the site. Note the highway dip to the east of the crack.

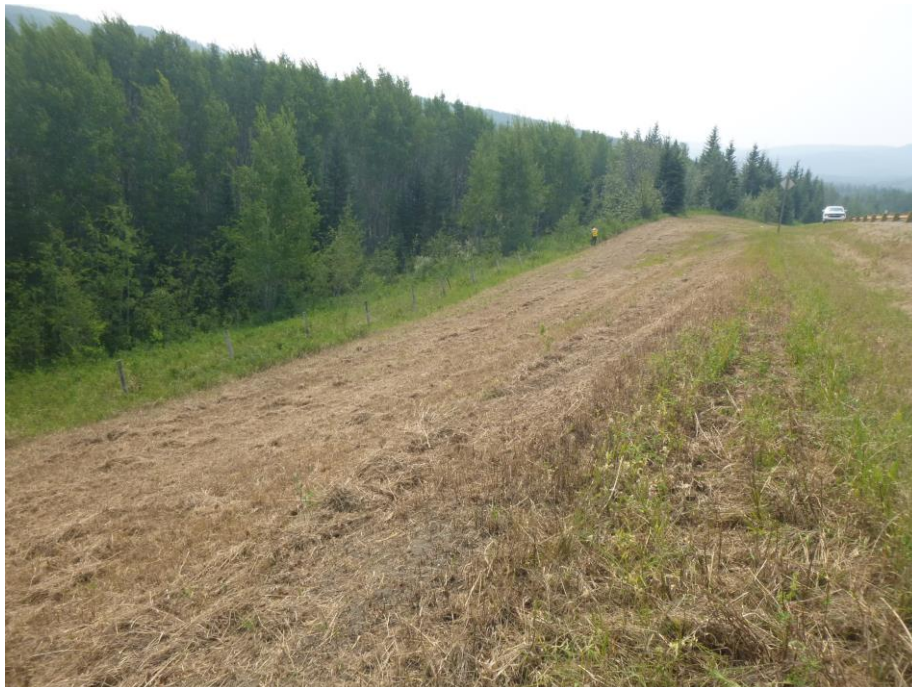
Photo 4 - Looking southwest at the dip/sunken south highway embankment located at the west end of the site below the hwy scarp crack area. There is also a bow in the fence.

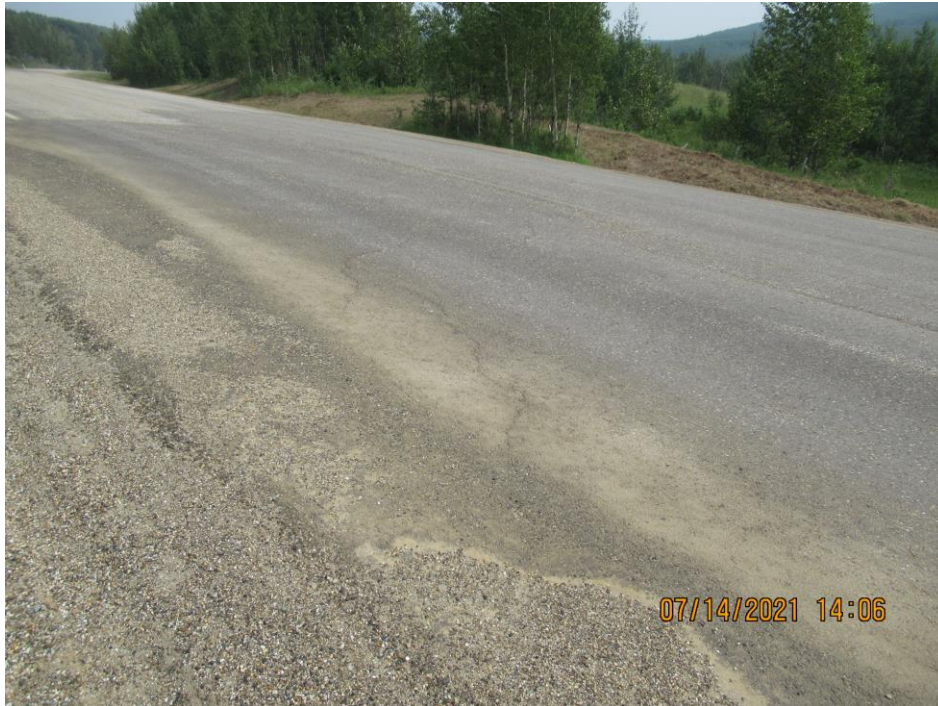
Photo 5 – Looking southeast across the east end of the site at the scarp crack reflecting through the fresh ACP patch.

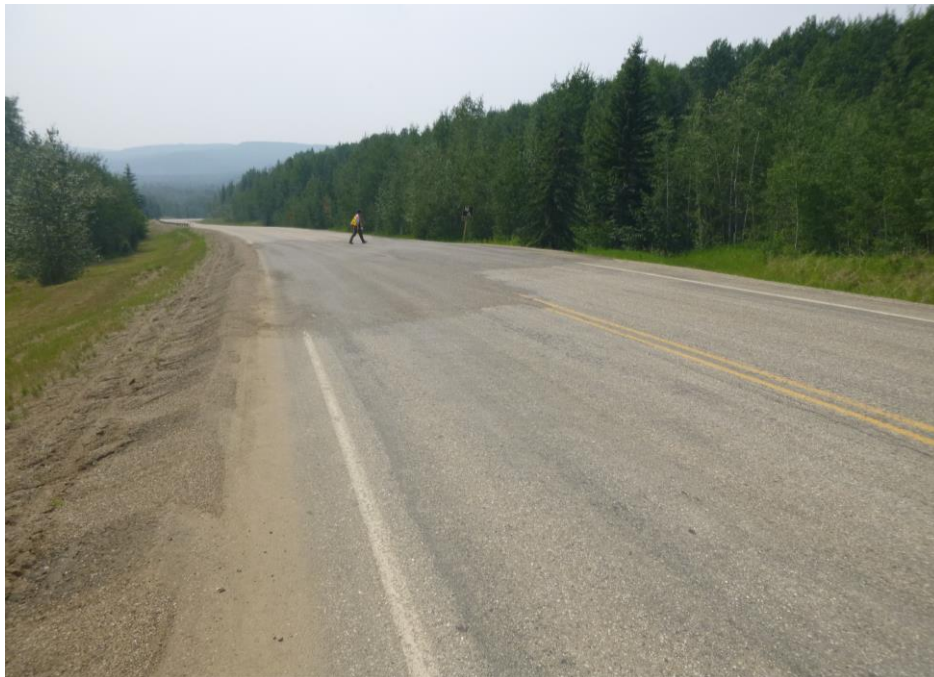
Photo 6 – Looking west at the fresh ACP patch placed over the east end of the site.
