**ALBERTA TRANSPORTATION AND
ECONOMIC CORRIDORS
GEOHAZARD ASSESSMENT PROGRAM
PEACE REGION (GRANDE PRAIRIE DISTRICT - NORTH)
2025 INSPECTION**

Site Number	Location	Name	Hwy	km
PH022	13 km W. Cleardale	Clear River East Hill-Site 6	64:02	22.8-23.1
Legal Description		UTM Co-ordinates (NAD 83)		
S28-84-11-W6		11 N 6243933	E 334702

2025 PH022 INSPECTION PLAN

2025 PH022 CONTOUR PLAN

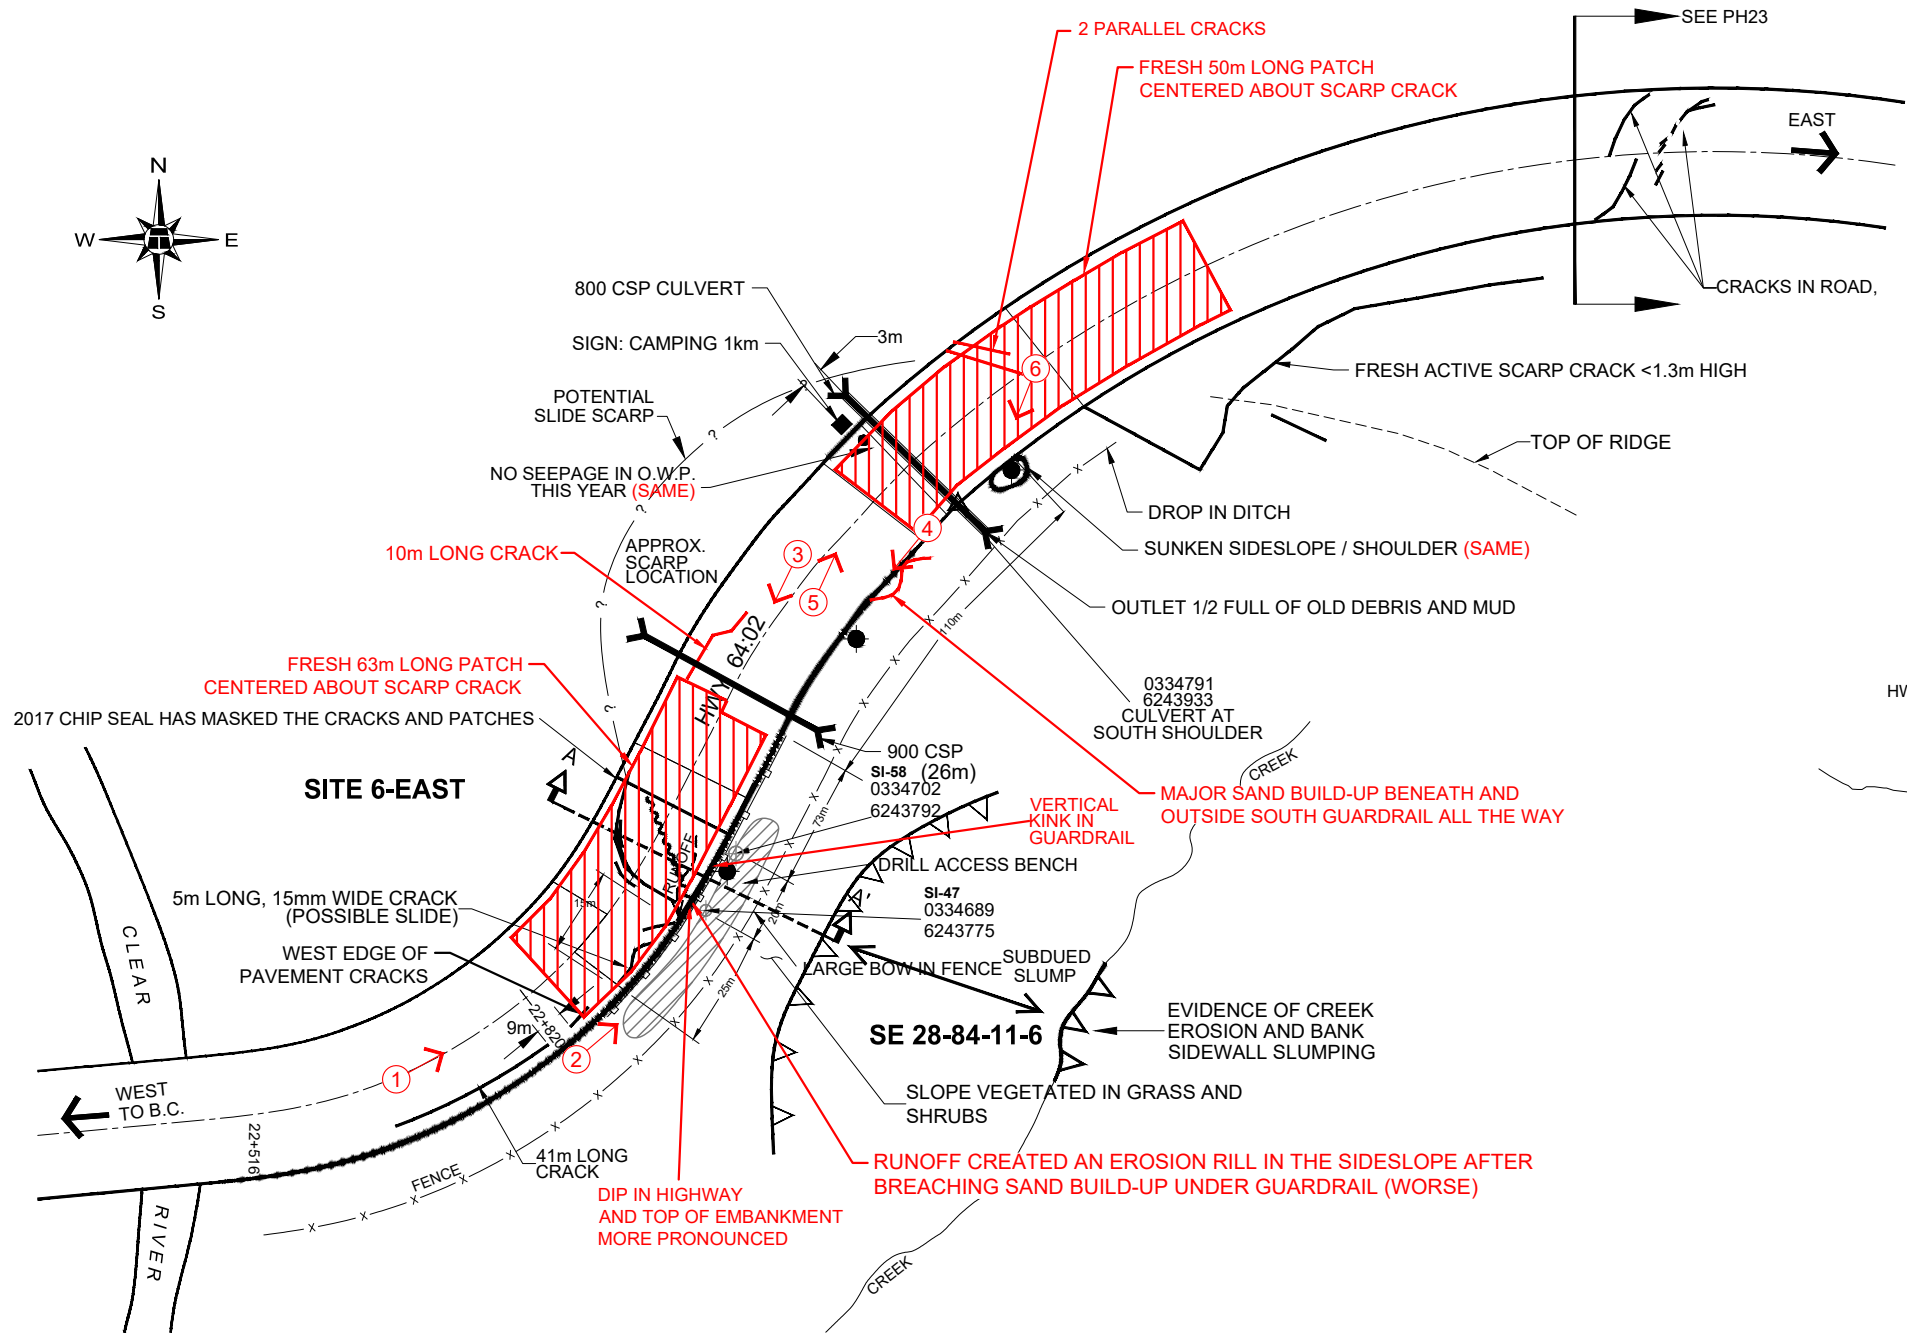
FIGURE PH022-1

Instrumentation:
Nonoperational. Previous Movements in SI-58 was 10 mm/yr at 21 m to 26 m deep.
Assessment (Refer to Figures PH022-1 and -2):
It was concluded in 2011 that the drains mentioned in the old road files 50 m downslope of hwy may not have been installed, since they could not be located – instead they may have been installed at a site closer to the east bridge abutment where some old test hole locations were recently found in the files.
Movements that were previously monitored in SI58 appear to be ongoing (but slow) based on a kink in the south guardrail, and a dip and bow in the fence on the south embankment at this location. It appears that a large slide scarp circles north of highway and joins the two observed dips spaced 200 m apart

along the highway. A fresh slide scarp extension south of the highway appears to link this site with the site further east (PH023) by a continuous scarp.

The west dip appears to be enlarging westwards, based on cracks first found in 2013 a distance of 15 m west of the west dip and, which were observed to extend about 50 m west in 2017, and also an increasingly more apparent dip in the embankment with time. These cracks, and the fact that cracking has reflected through the fresh 202 patched east dip, and with the fresh scarp crack observed south of the highway, in conjunction with the sunken shoulder in the pavement and south embankment at the west dip, suggest some on-going creep. Seepage traces in the pavement in previous years also indicate a high water table.

Perform a geotechnical Investigation to define the slide plane at this site, consisting of 3 test holes, each containing an SI and two Piezometers (as shown on Figure PH22-1) to depths of at least 40 m.

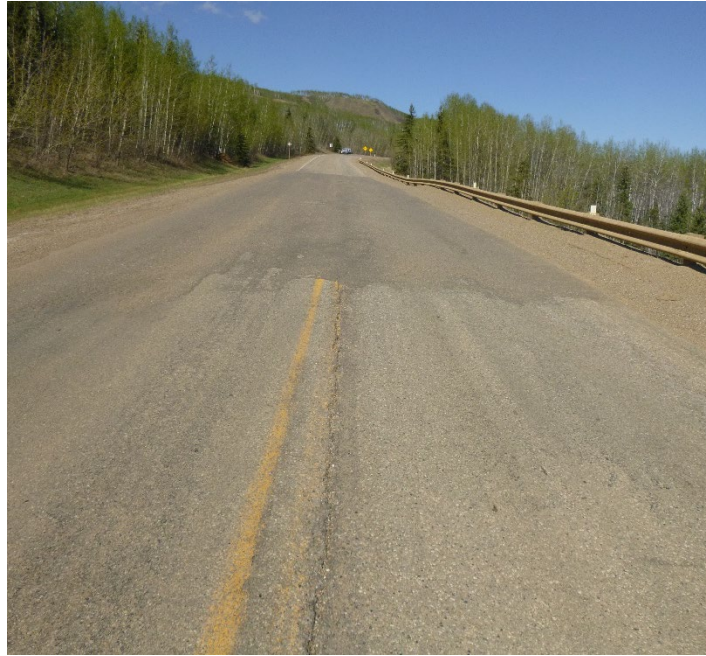
Photo 1 – Looking east along the cracked highway surface from the west end of the site. Note the fresh patch over the west end scarp crack and the dip in the south guardrail.

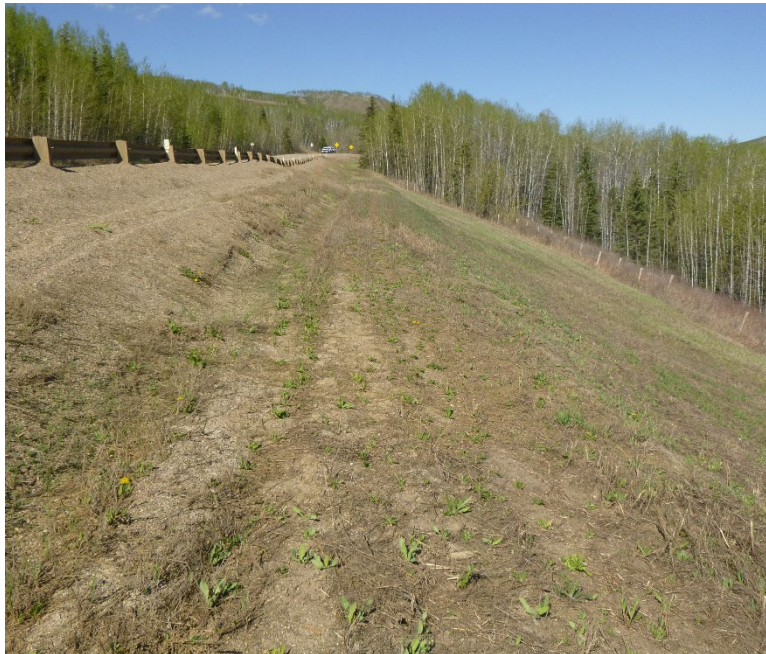
Photo 2 - Looking east along the south embankment and the bowed fenceline from the west end of the site. Note the dip in the embankment below the patched west scarp crack area.

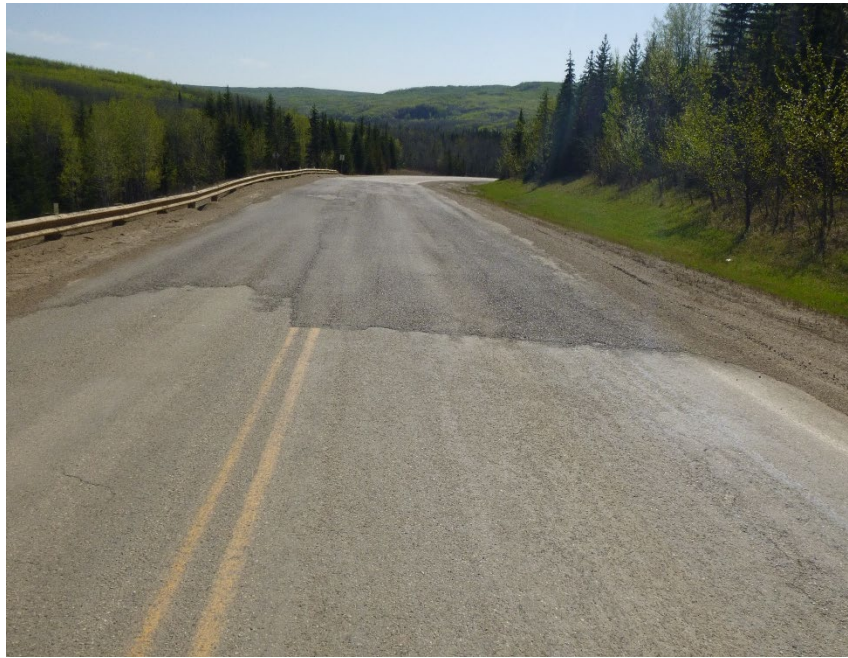
Photo 3 - Looking west at the fresh patch and the dip/sunken highway where the slide scarp crosses the west end of the site.

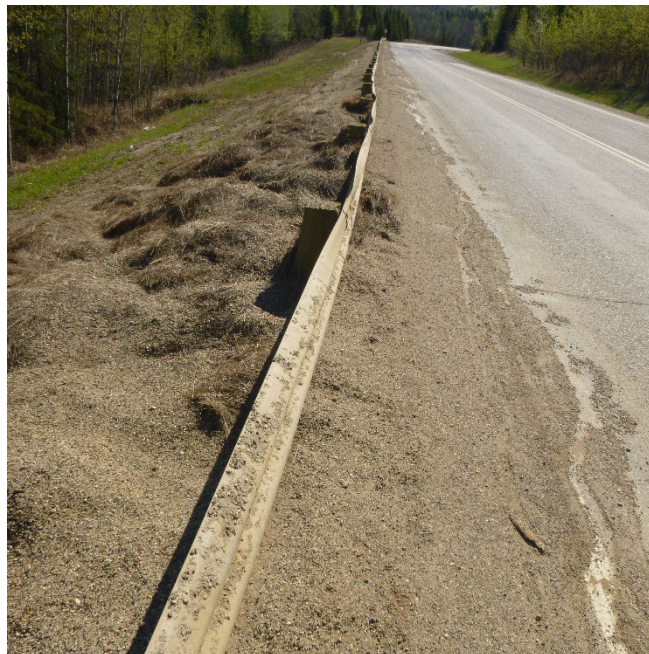
<input checked="" type="checkbox"/> Erosion	Channelized runoff from the highway along the low point in the west dip has formed an erosion rill in the EB shoulder/embankment.	<input checked="" type="checkbox"/>	<input type="checkbox"/>
<input checked="" type="checkbox"/> Seepage	Trace in OWP of WB lane east of east dip.	<input type="checkbox"/>	<input checked="" type="checkbox"/>
<input checked="" type="checkbox"/> Bridge/Culvert Distress	Two CSP culverts exist - one at the east dip, and another between the two dips.	<input type="checkbox"/>	<input checked="" type="checkbox"/>
<input checked="" type="checkbox"/> Other	There is major sand build-up beneath/outside the south guardrail, with a broken hay bale trapping additional sand near the G/R east end.	<input checked="" type="checkbox"/>	<input type="checkbox"/>

Photo 4 - Looking west along the south guardrail at the location where a broken hay bale is trapping sand along the edge of the highway between the east and west scarp cracks. Note the channelized surface runoff that has been created, and it has breached the sand build-up underneath the south guardrail and created an erosion gully in the hwy embankment slope below the dip in the highway further west.

- a) Clean the accumulated sand from the east highway shoulder and from underneath/outside the south guardrail and remove the broken hay bale, for safety and to prevent deepening gulying caused by surface water concentration runoff.
- b) Place crushed gravel in the runoff gully channel that has formed on the embankment below the guardrail at the west dip.
- c) Monitor the pavement cracks in the two dipped areas for future subsidence/movement and progression of the circular slide scarp affecting the pavement at this location, and crack seal and patch as necessary.

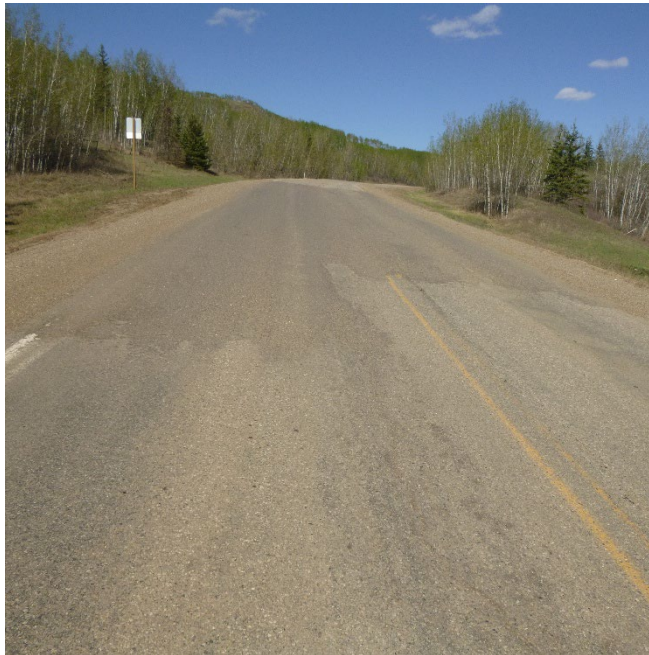
Photo 5 – Looking east at a fresh ACP patch over where the east slide scarp crosses the highway at the east end of the site.

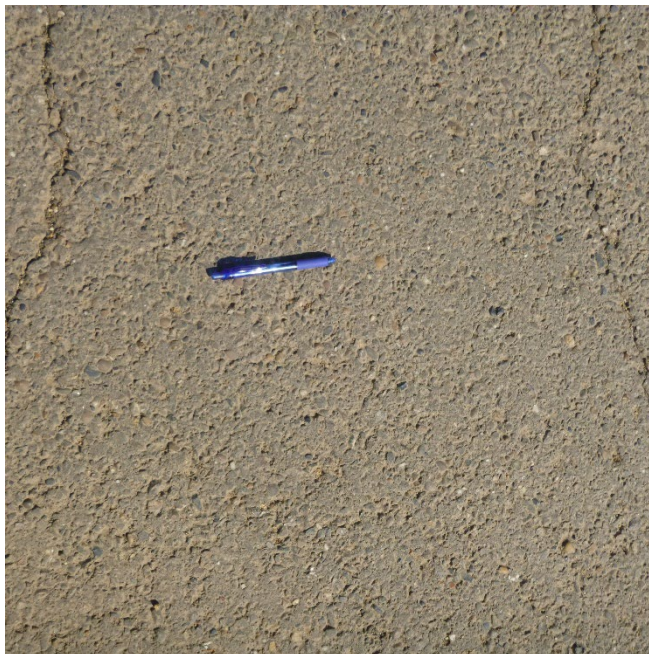
Photo 6 – Close-Up view of the two WB lane cracks reflecting through the east end scarp crack patch shown in Photo 5.
