**ALBERTA TRANSPORTATION
GEOHAZARD ASSESSMENT PROGRAM
PEACE REGION (GRANDE PRAIRIE DISTRICT-NORTH)
2021 INSPECTION**

Site Number	Location	Name (Old Site 5)	Hwy	km
PH023	12 km W. Cleardale	Clear River East Hill-Twin Pipes	64:02	23.4-24.1
Legal Description		UTM Co-ordinates (NAD 83)		
NE28/NW27-84-11-W6		11 N 6244273	E 335460

**PEACE REGION (GRANDE PRAIRIE DISTRICT - NORTH)
PH023: HWY 64:02 CLEAR RIVER EAST HILL**

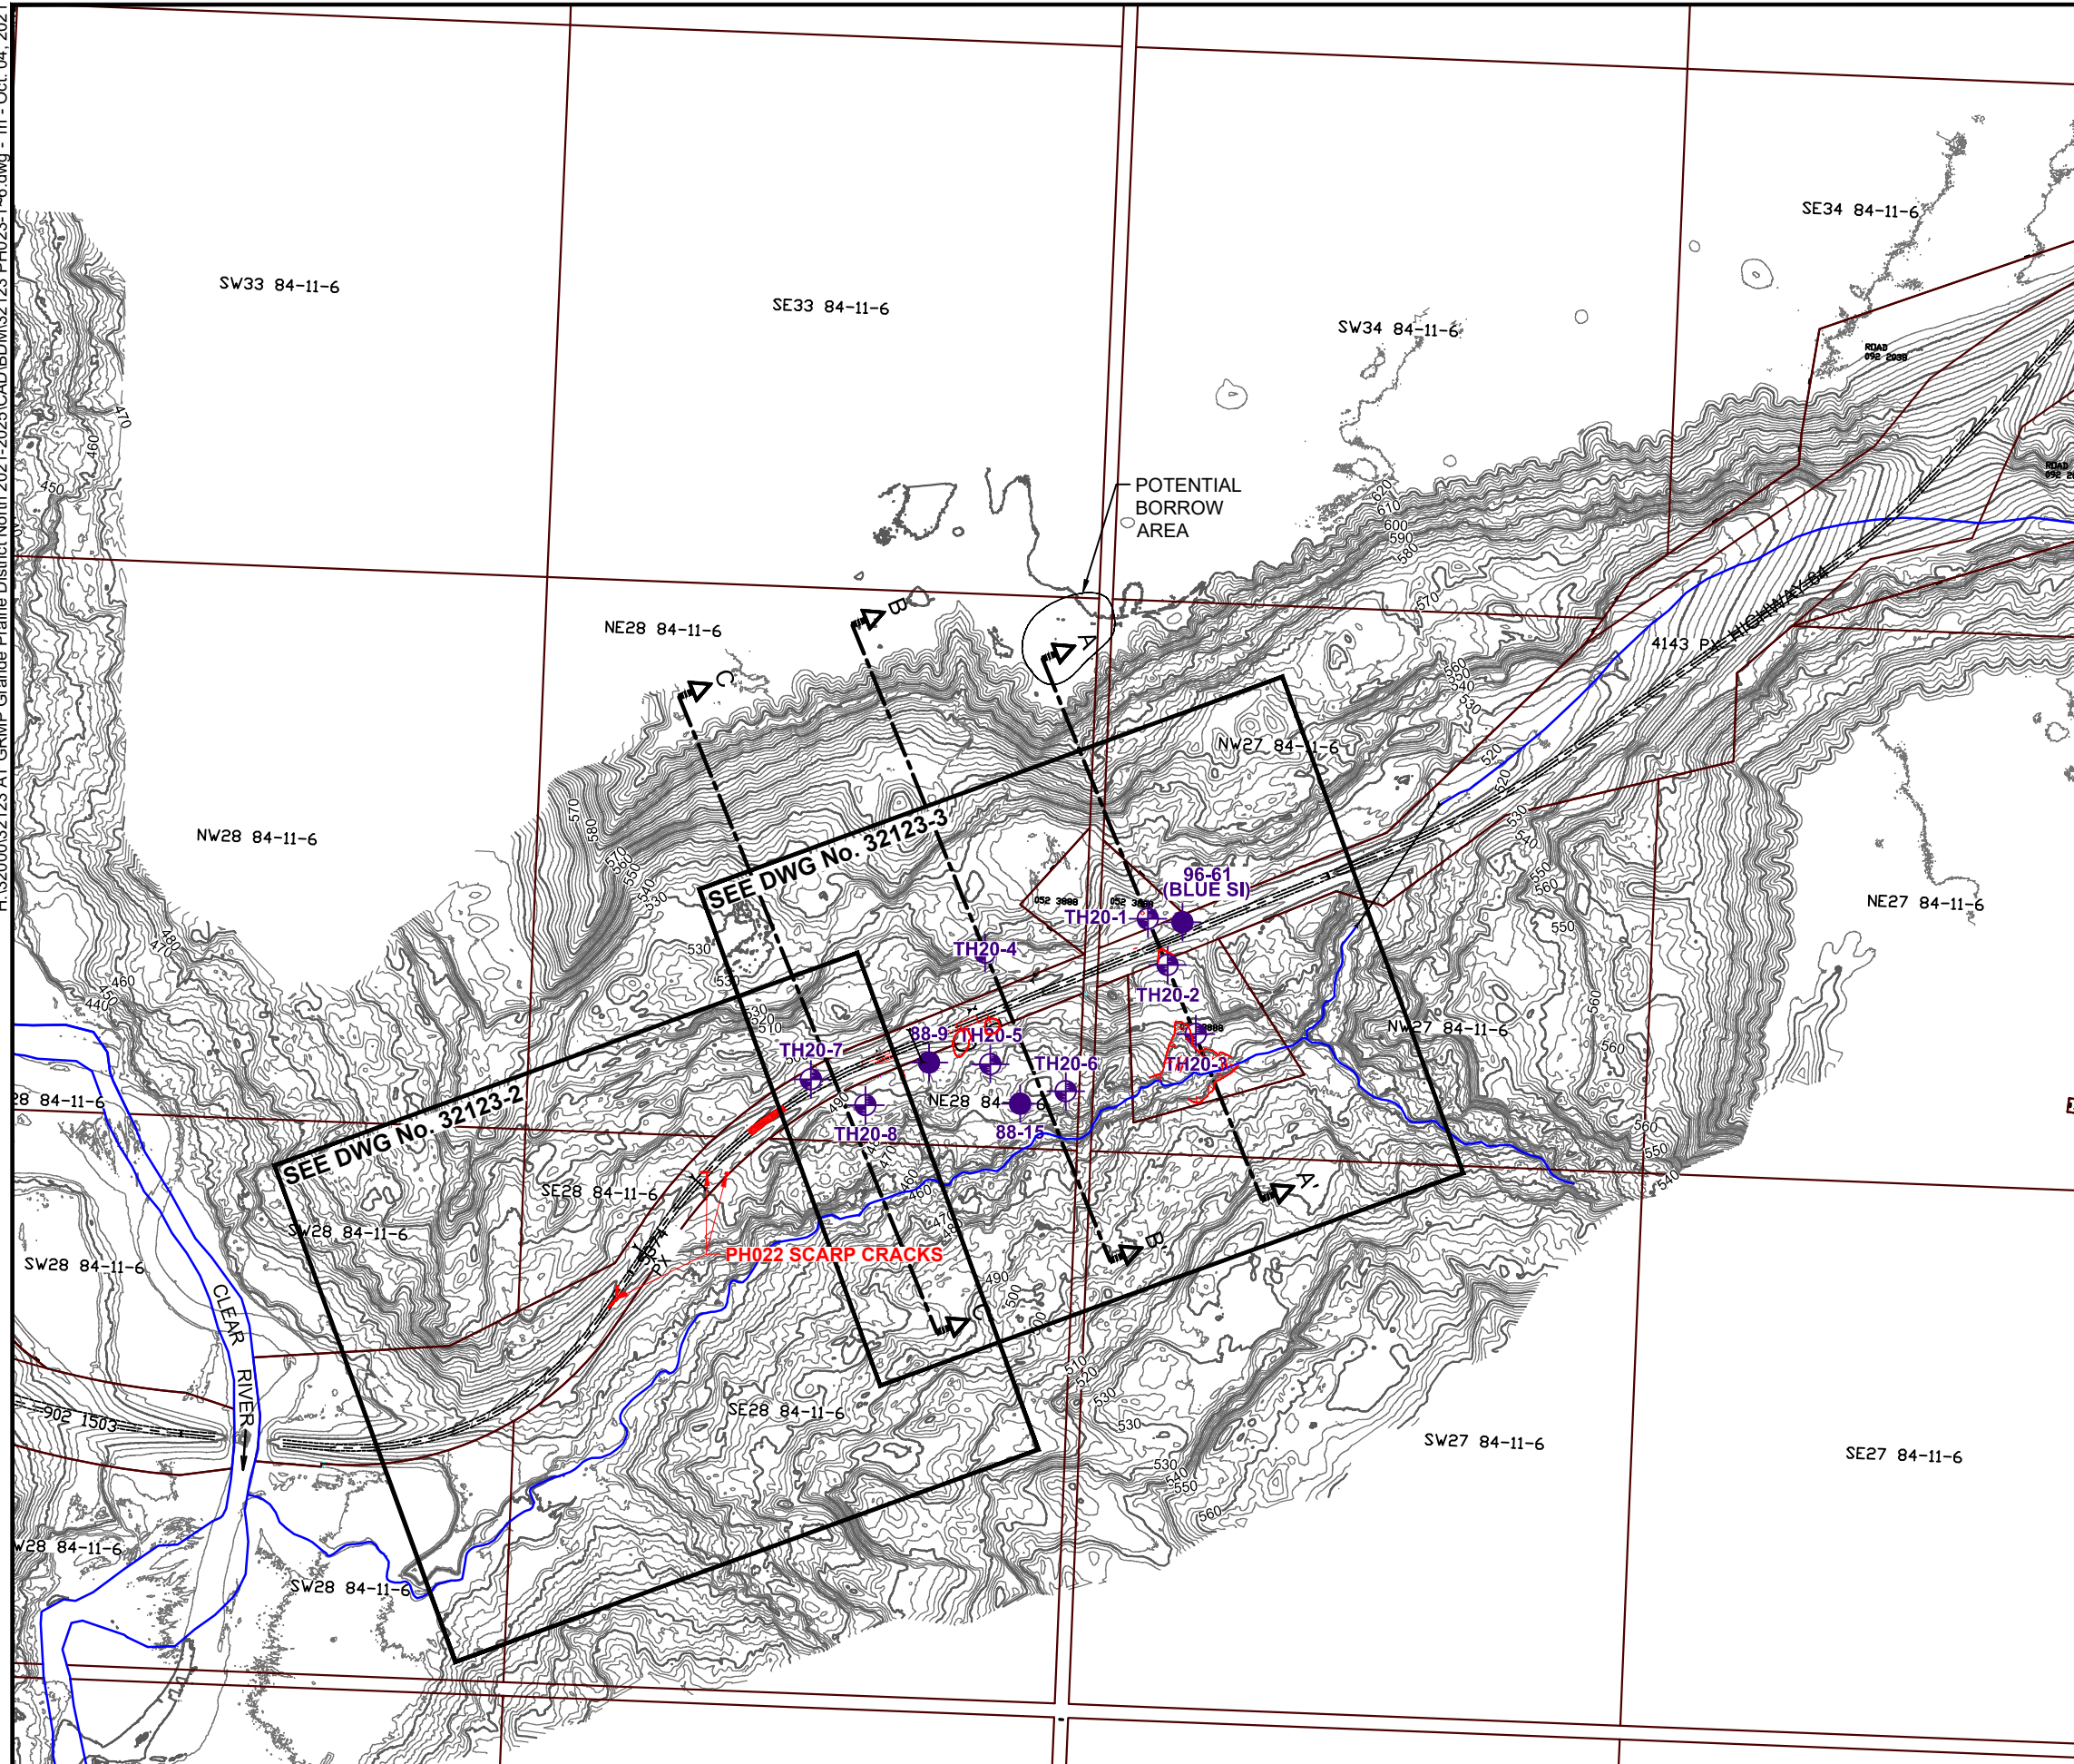
DWG No. 32123-PH023-1

NOTE:
1. JULY 14, 2021 OBSERVATIONS SHOWN IN RED

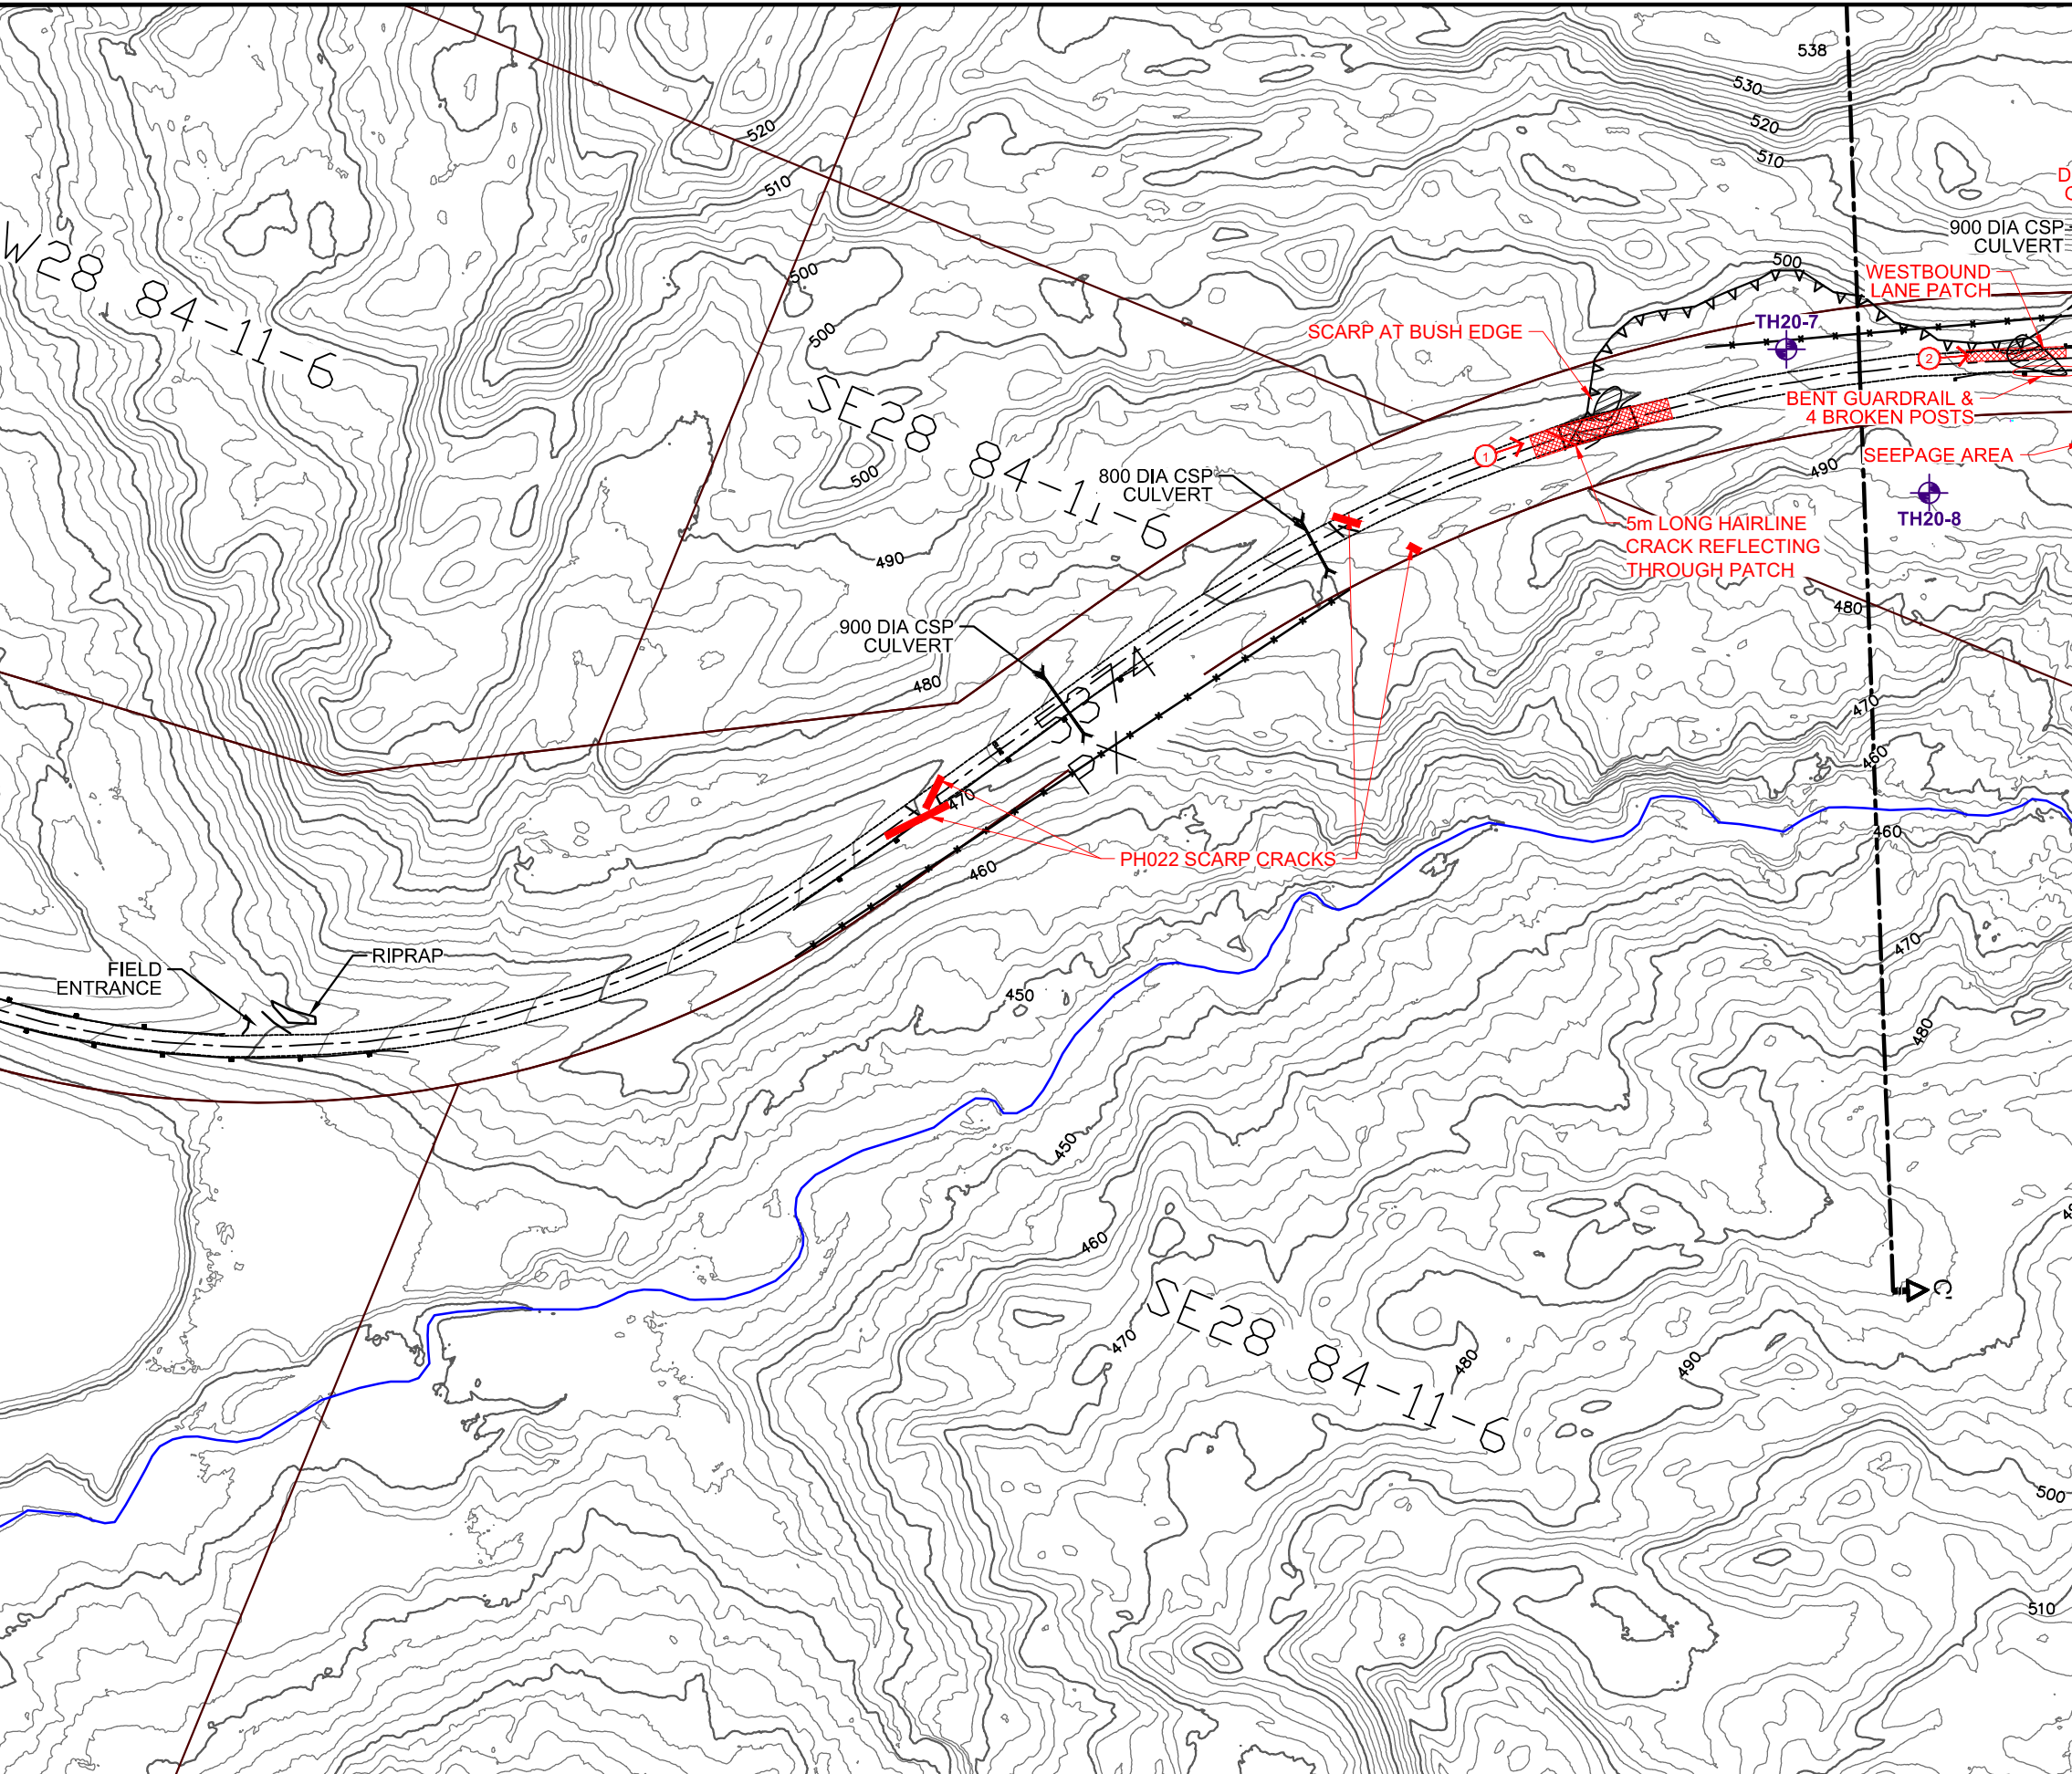
DWG No. 32123-PH023-2

NOTE:
1. JULY 14, 2021 OBSERVATIONS SHOWN IN RED

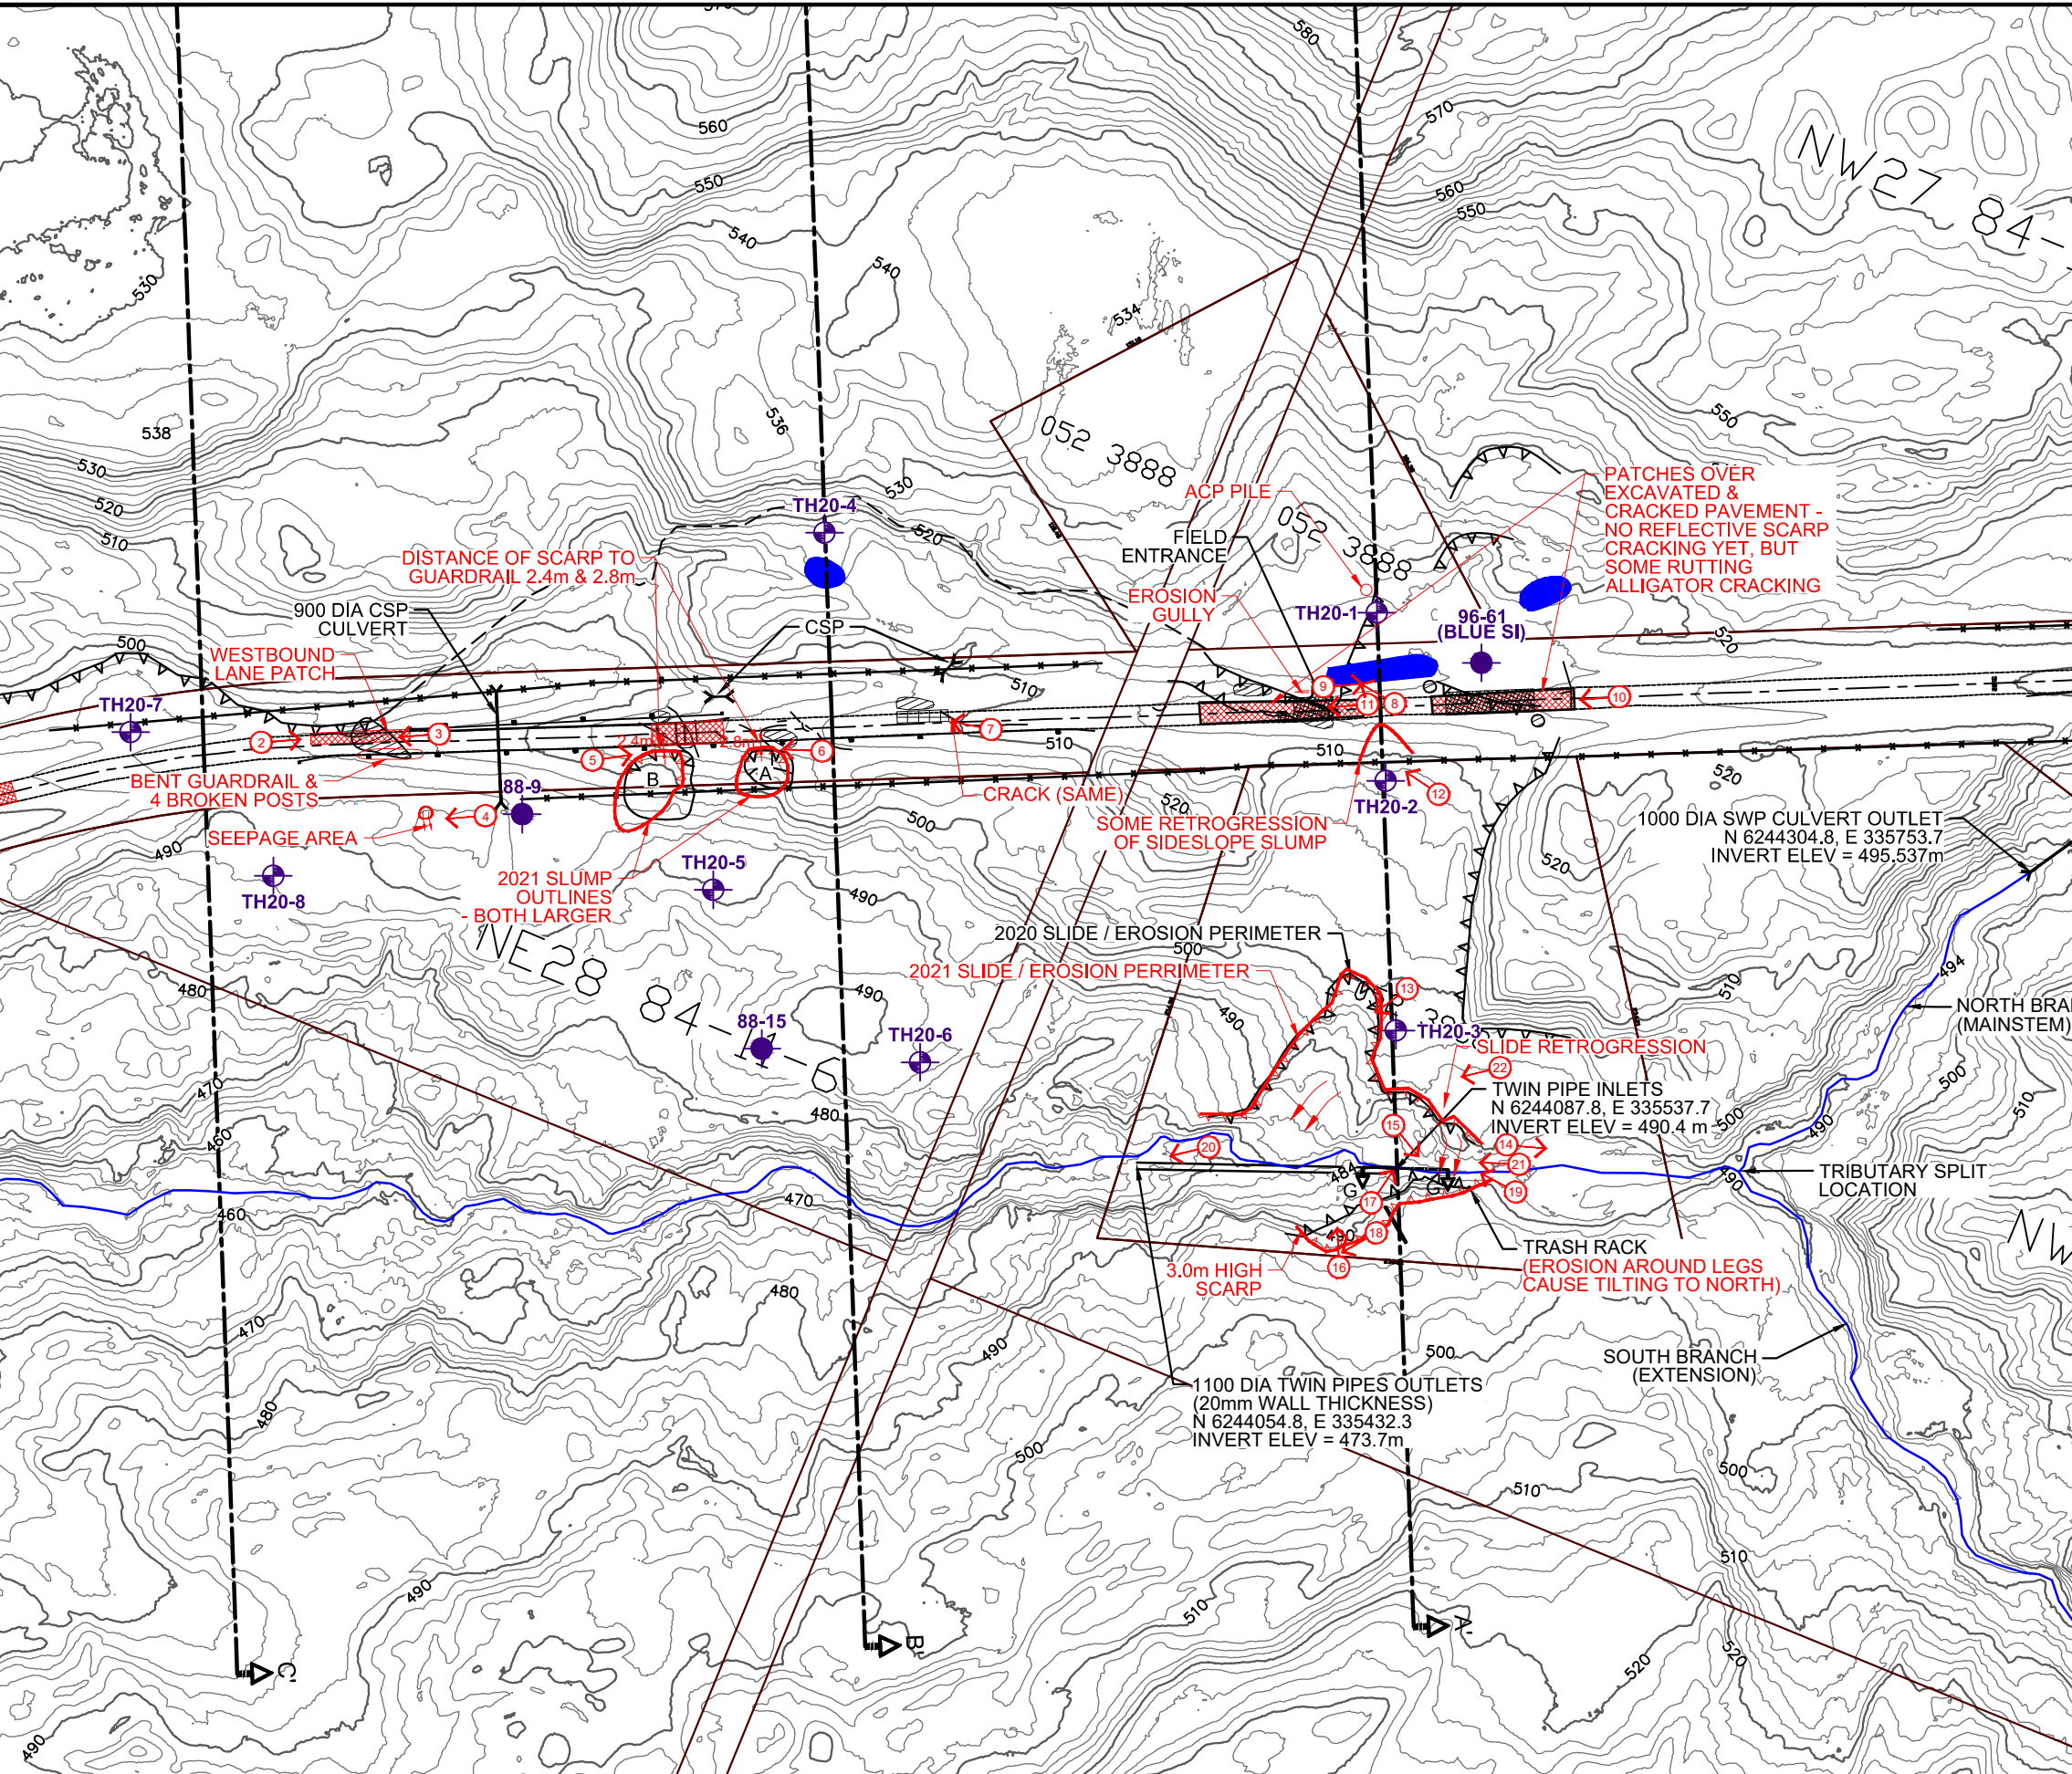
DWG No. 32123-PH023-3

- NOTES:**
1. JULY 14, 2021 OBSERVATIONS SHOWN IN RED
 2. DRY CONDITIONS & LOW FLOW IN TRIBUTARY IN 2021 CAUSED SLOWER SLIDE MOVEMENTS

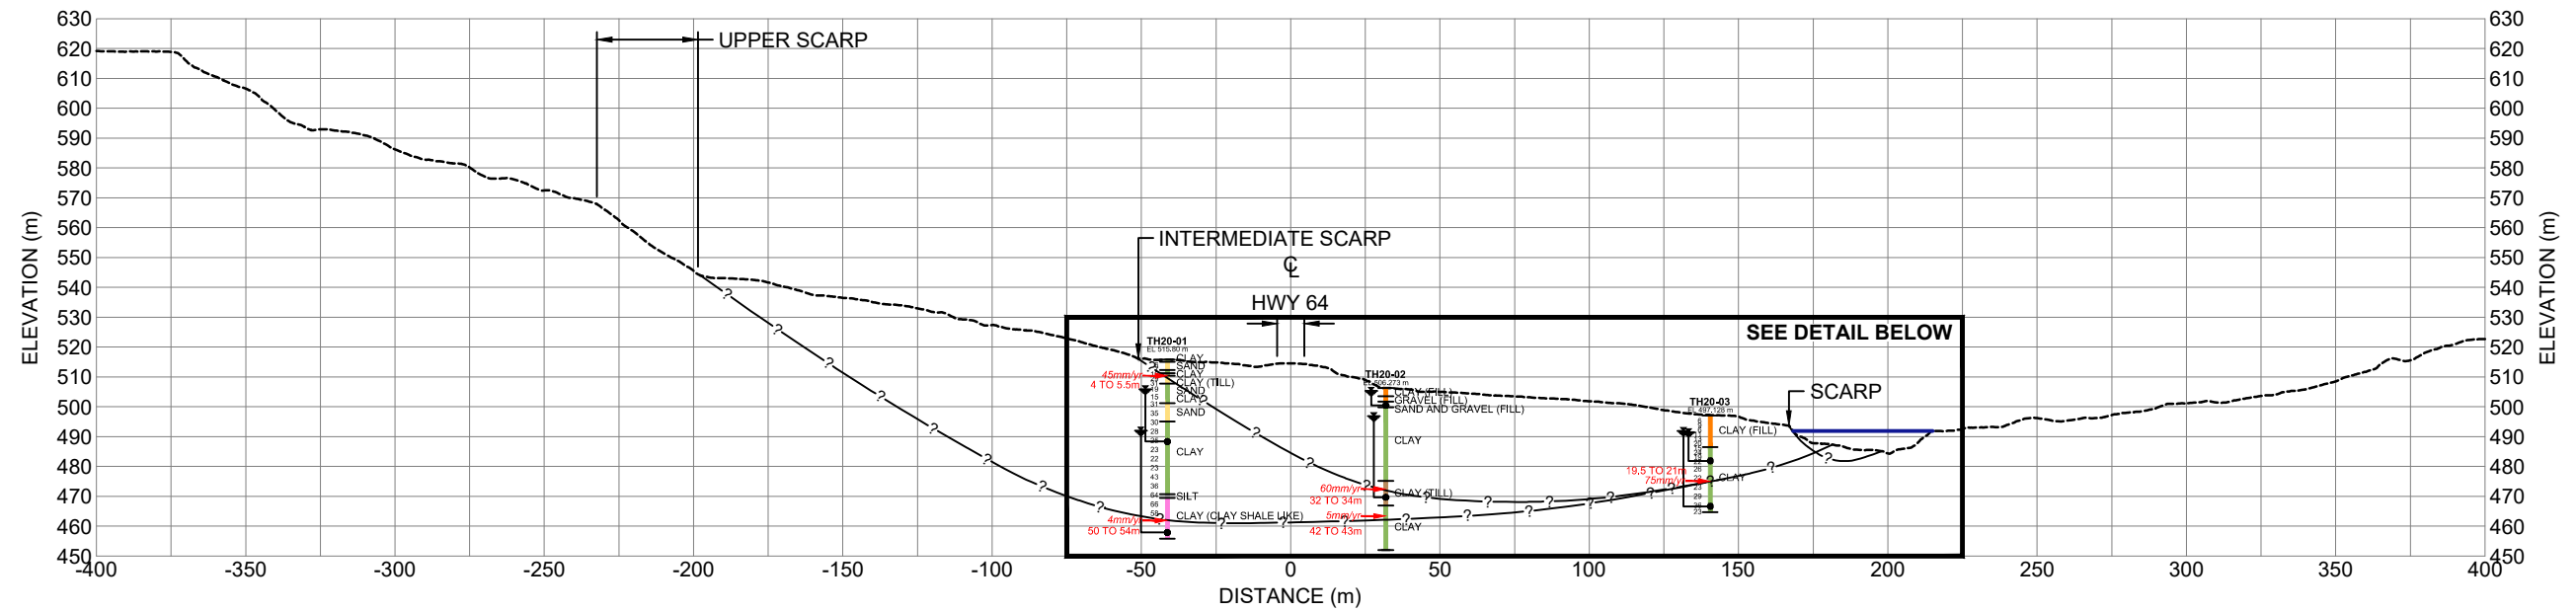
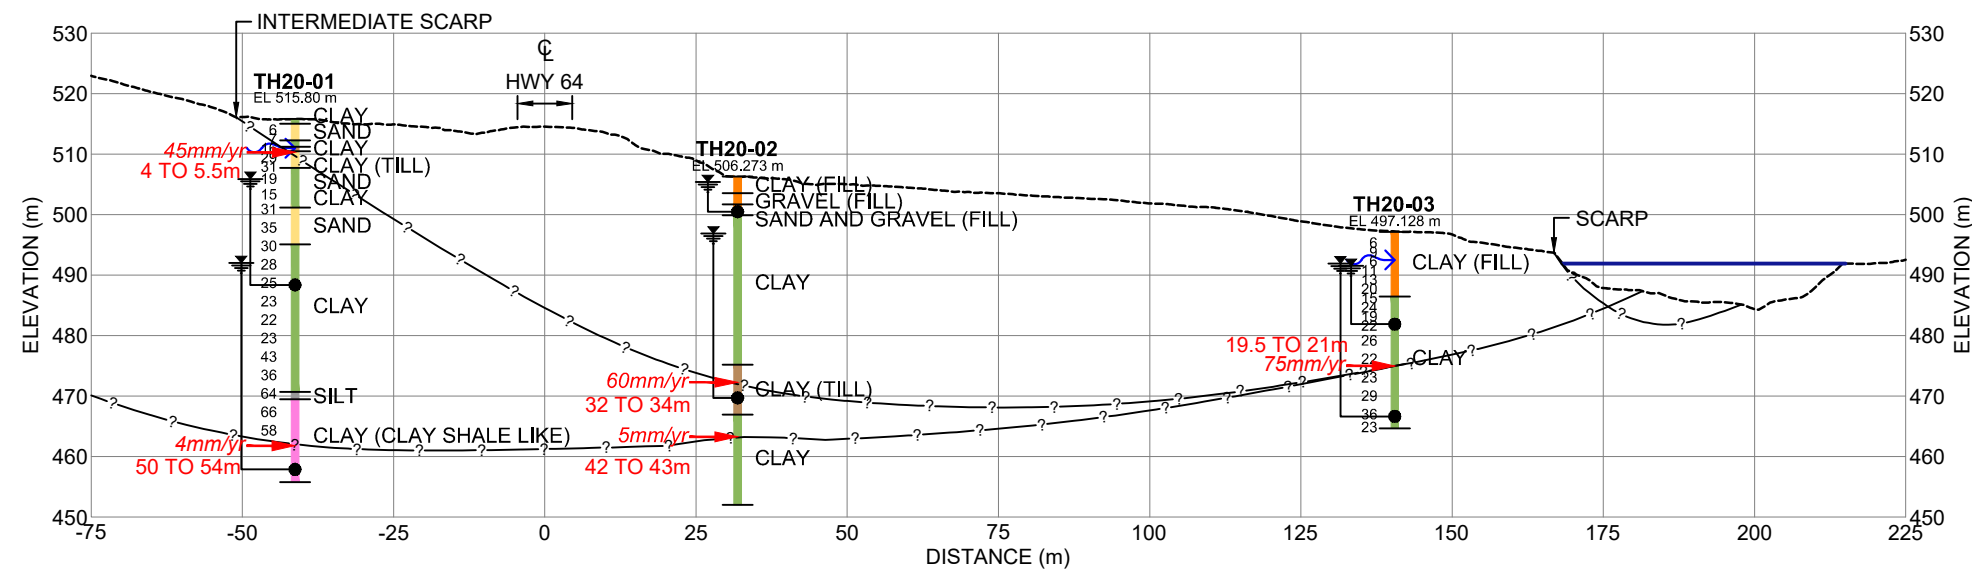
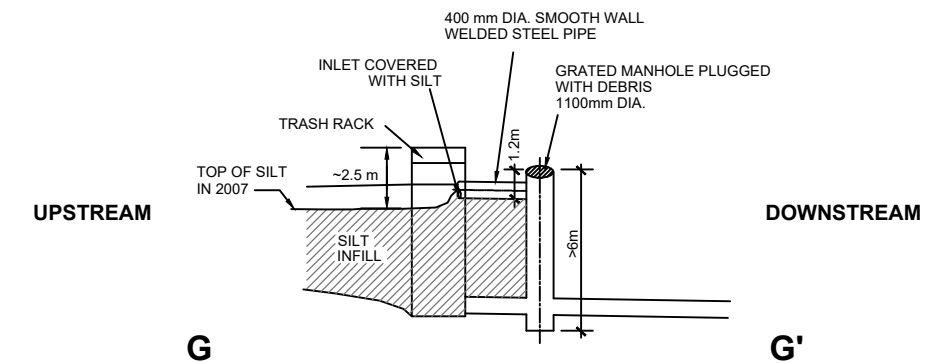
DWG No. 32123-PH023-4

20-1: 45mm/yr @ 4 to 5.5m; & 4mm/yr @ 50 to 54m. 20-2: 60mm/yr @ 32 to 34m; & 5mm/yr @ 42 to 43m. 20-3: 75mm/yr @ 19.5 to 21m. 20-4: 34mm/yr @ 6 to 8m; & 5mm/yr @ 60 to 62m. 20-5: 82mm/yr @ 9 to 12m; & 55mm/yr @ 31 to 36m. 20-6: 73mm/yr @ 18 to 20m; & 63mm/yr @ 28 to 31m. 20-7: 2mm/yr @ 18 to 20m; & 6mm/yr @ 32 to 34m. 20-8: 24mm/yr @ 34 to 37m.

PIEZOMETERS - 2 Pneumatic Tips were installed in each of the eight 2020 test holes, taped to the outside of the inclinometer casing. The tip depths and latest measurements are shown on the cross-section drawings attached (Drawings PH023-4 to -6). All of the piezometers had small fluctuations of <1m in height since the last reading date of Feb. 18, 2021, except for the lower tips in 20-7 (dropped 2.4m) and 20-8 (dropped 1.1m). The lower tip in TH20-4 has malfunctioned and will not be read any more.

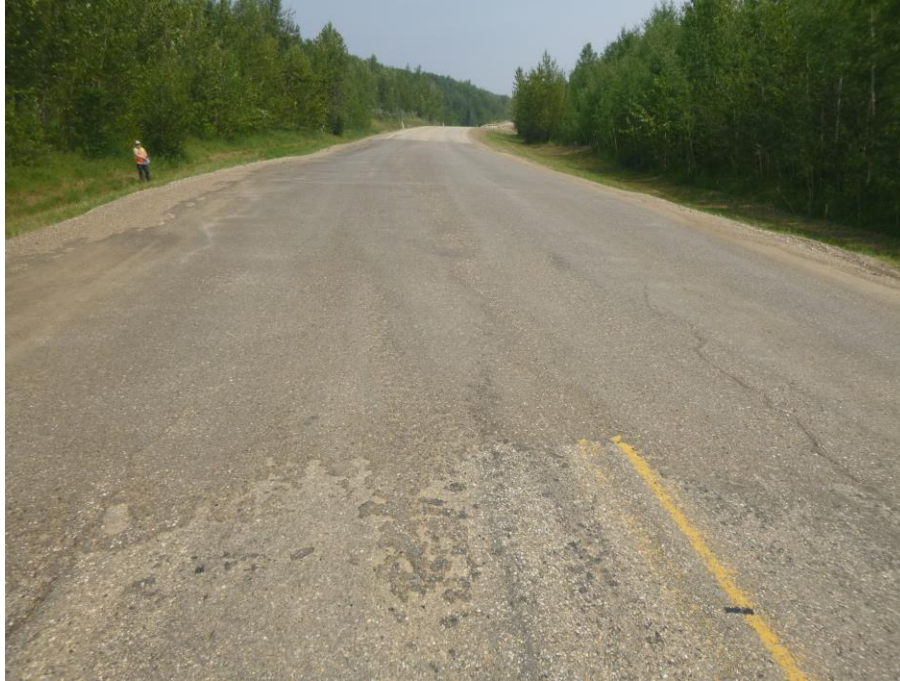
Photo 1 - Looking east along the highway at the milled/patched area over the two cracks first observed in 2013 that mark the west boundary of the slide on the highway.

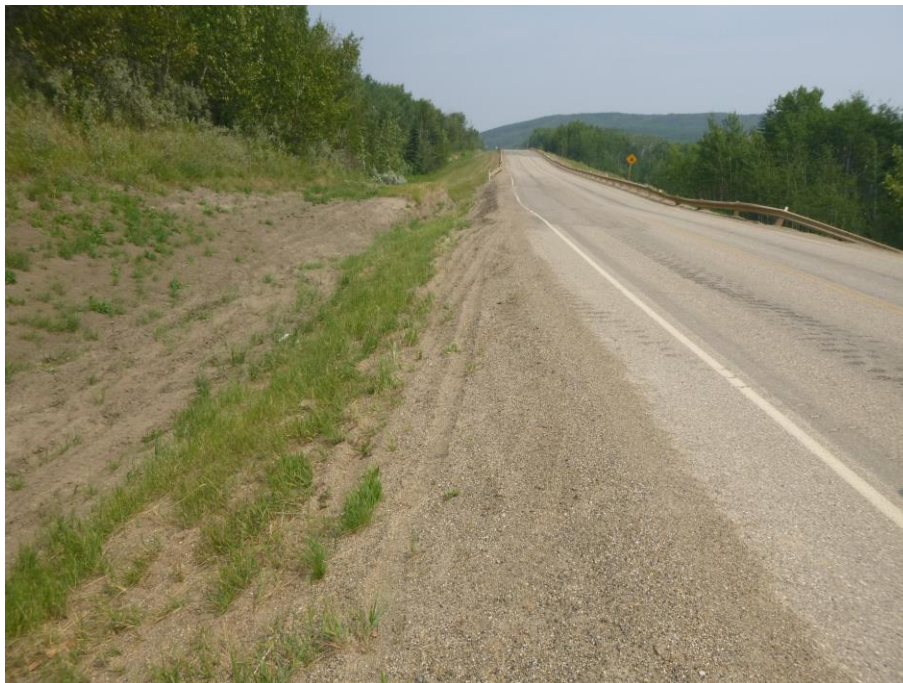
Photo 2 – Looking east along the recent WB lane patch over the highway cracks and large dip that extends across the highway near the west end of the site.

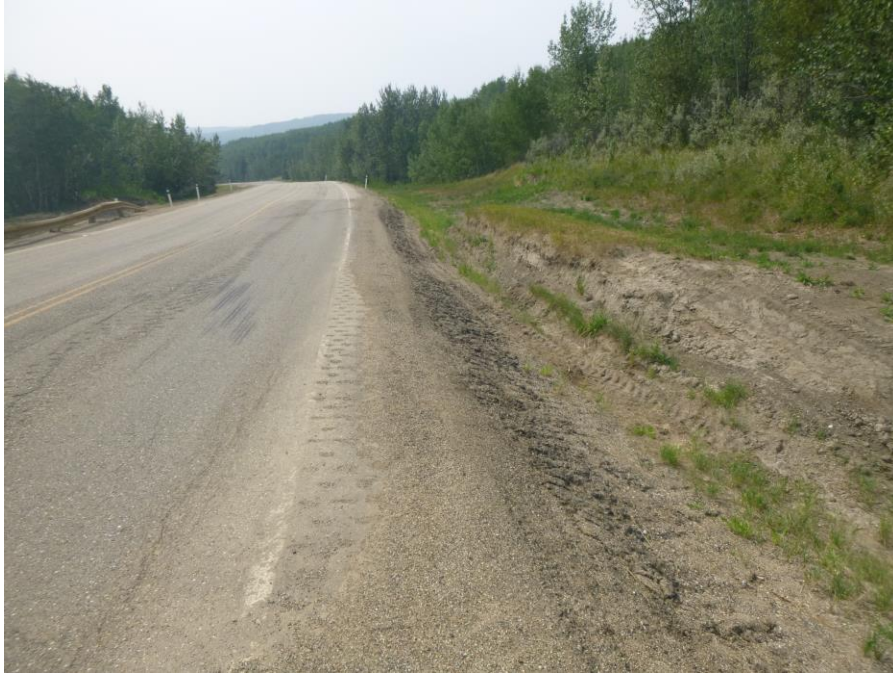
Photo 3 – Looking west from near the west end of the guardrails along the fresh scarp that extends along the north highway ditch.

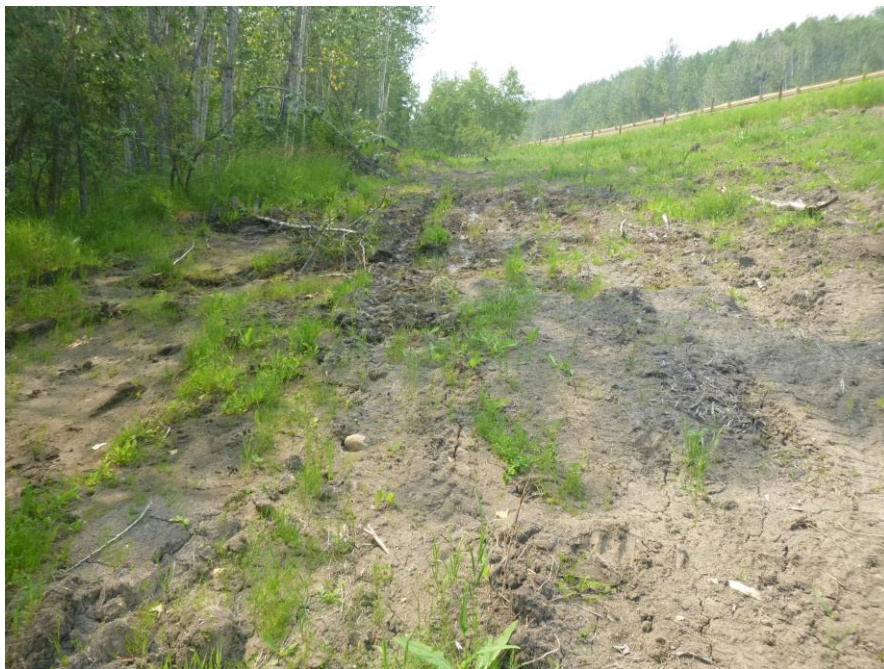
Photo 4 – Looking west along the Test Holes 20-5/20-6 access trail south of the highway at an active seepage area. This caused the tracked water truck to get stuck in Sept, 2020.

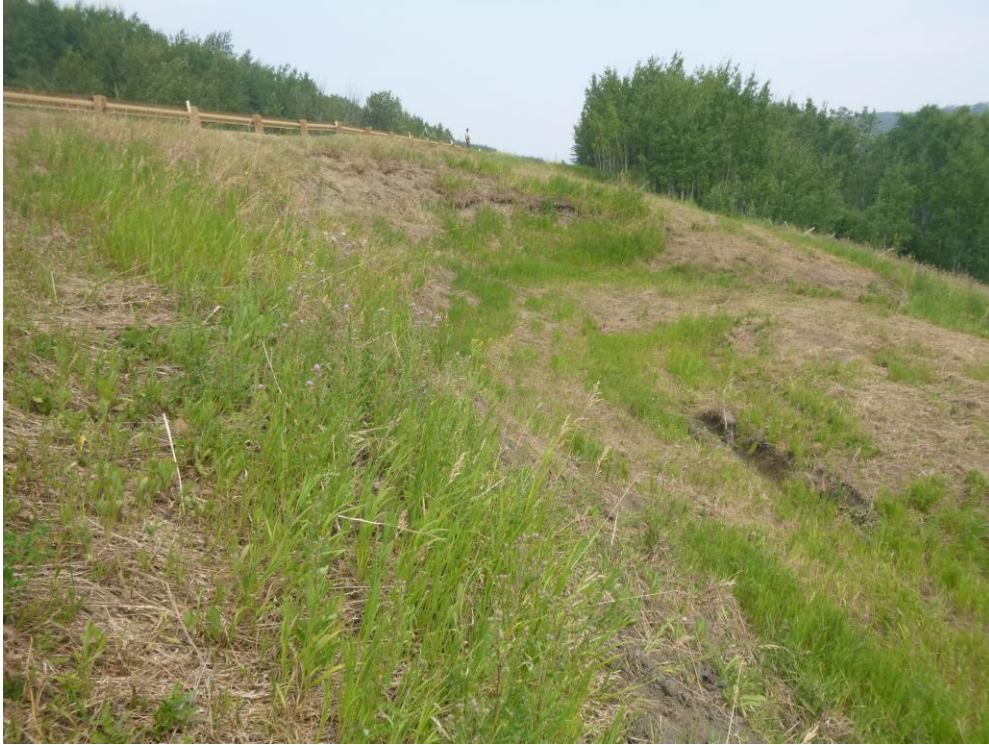
Photo 5 – Looking east along the south highway Embankment Slump B.

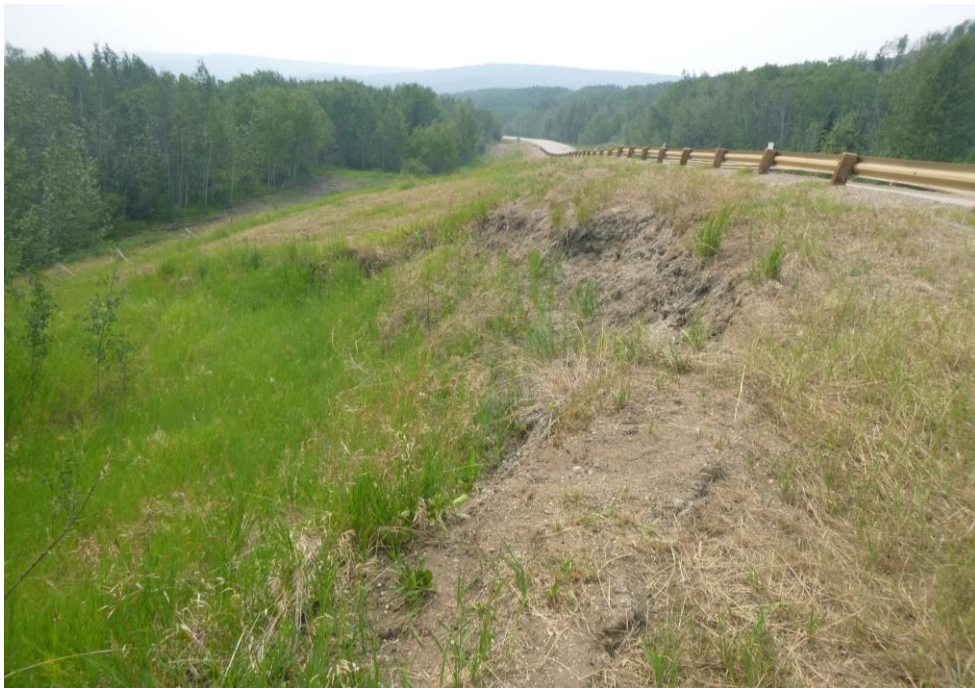
Photo 6 – Looking west at Embankment Slump A on the south side of the hwy.

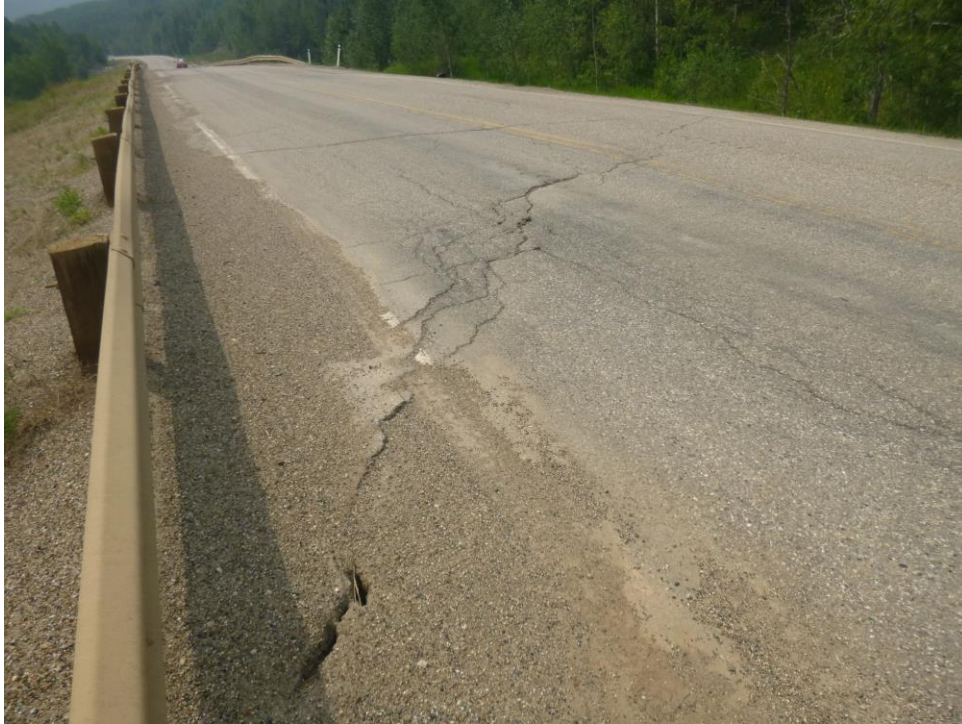
Photo 7 – Looking northwest across the highway at last years unrepaired slide cracks east of the northeast guardrail end.

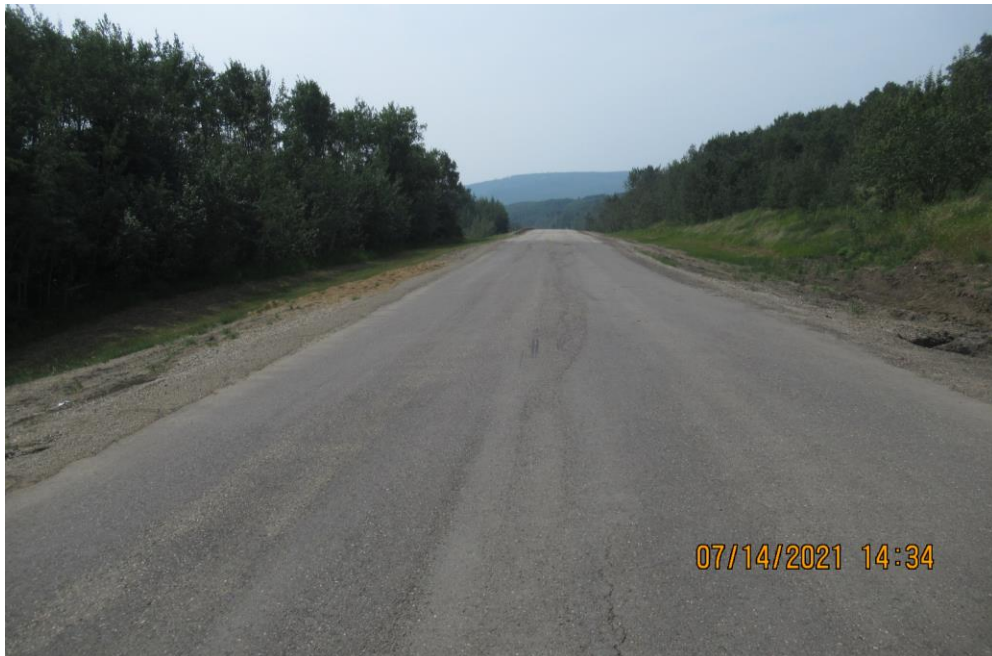
Photo 8 – Looking west at the west milled/patched area over the east slide crack.

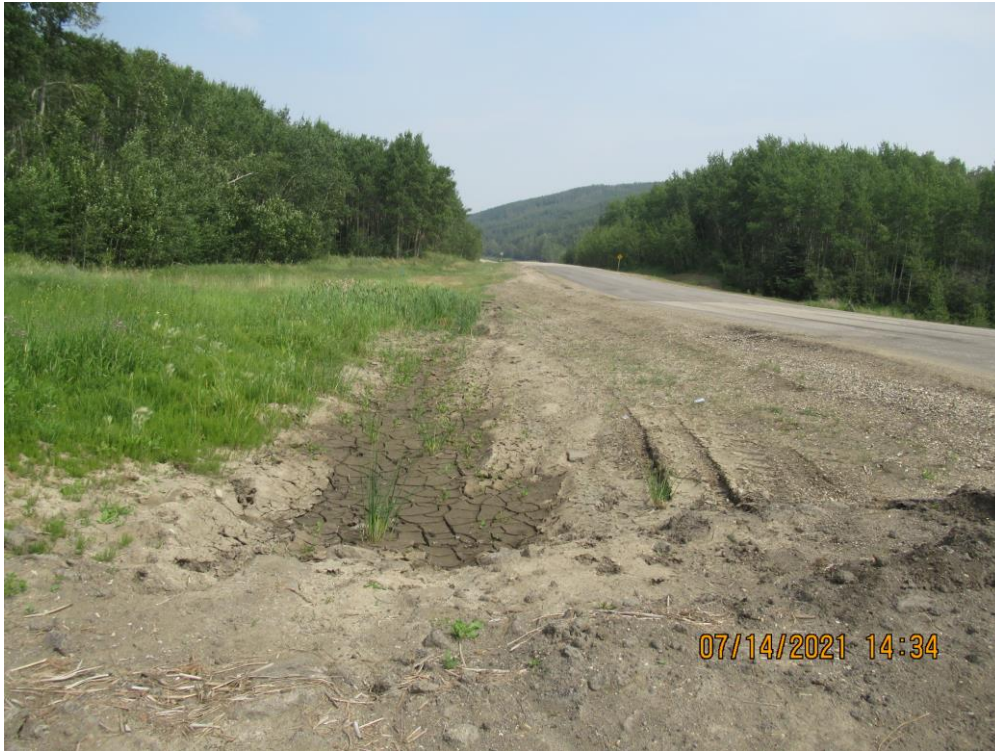
Photo 9 – Looking east along the north highway ditch at the dipped hwy and sagged cattail area (no ponded water this year).

1. Grade the north ditch at the east end of the site to eliminate the water ponding in the sag pond. If water does accumulate, it could be drained by installing a small diameter pipe through the road that outlets beyond the toe of the highway embankment (joined by a hose that directs water away from the crest of the erosion slide further downslope).
2. Locate the seepage sources in the large slump below the east end of the site, cover with 0.5 m of clean gravel, and drain to the creek via a 400 mm subdrain, connected with additional lateral perforated subdrains as required, then reconstruct the toe fill overtop.
3. Lower the highway over the large humps and cracks at both the east and west ends of the site and maintain these sections with a regularly graded gravel surface if required.

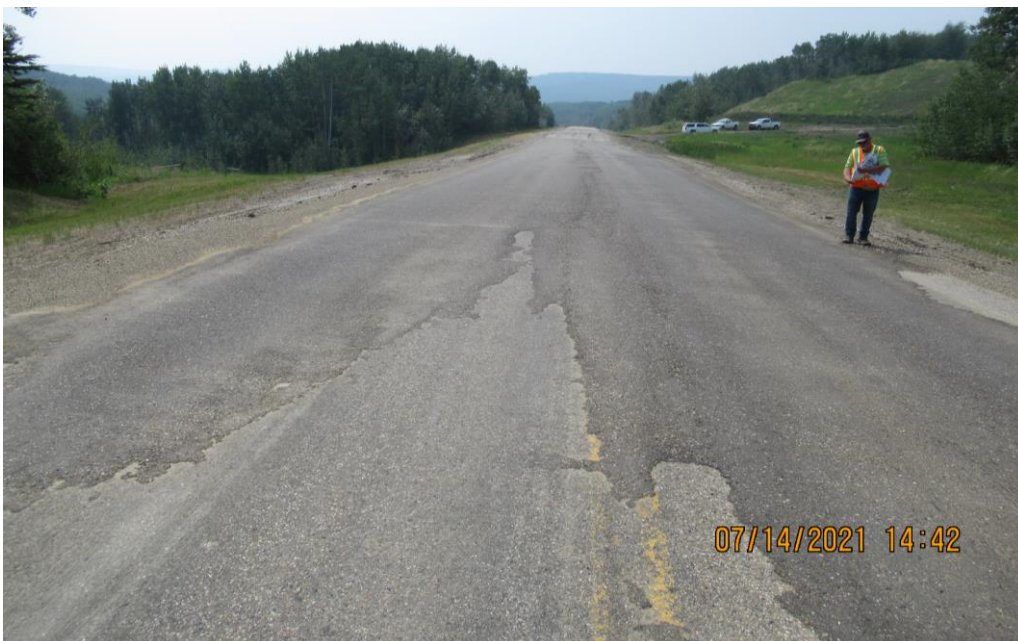
Photo 10 – Looking west along the highway at the east milled/patch over the east scarp cracked area at the east end of the site.

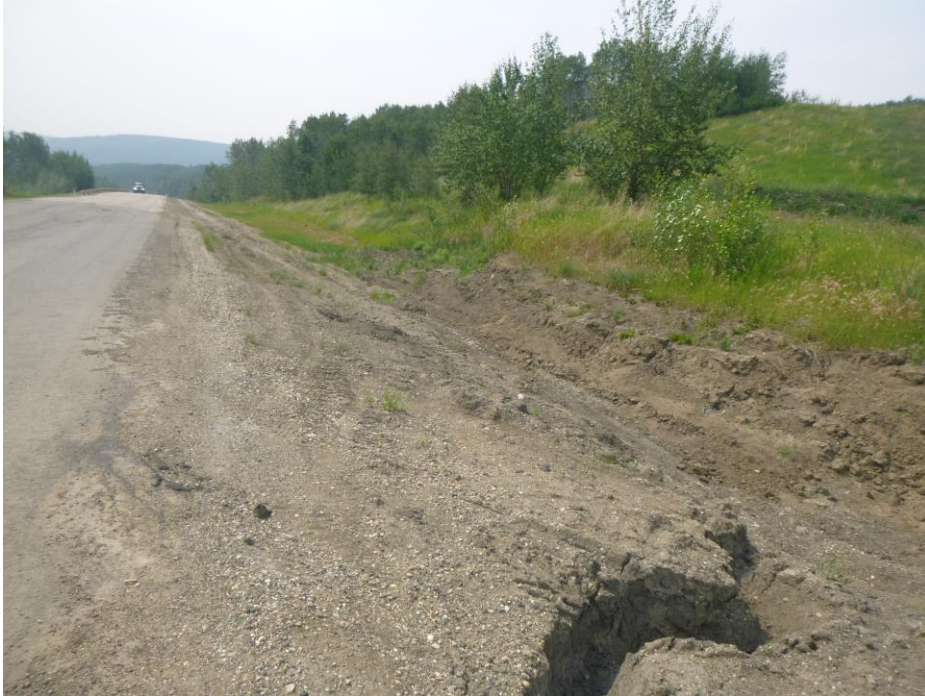
Photo 11 - Looking northwest along the main scarp from near the east edge of the highway. Note the erosion gully in the foreground.

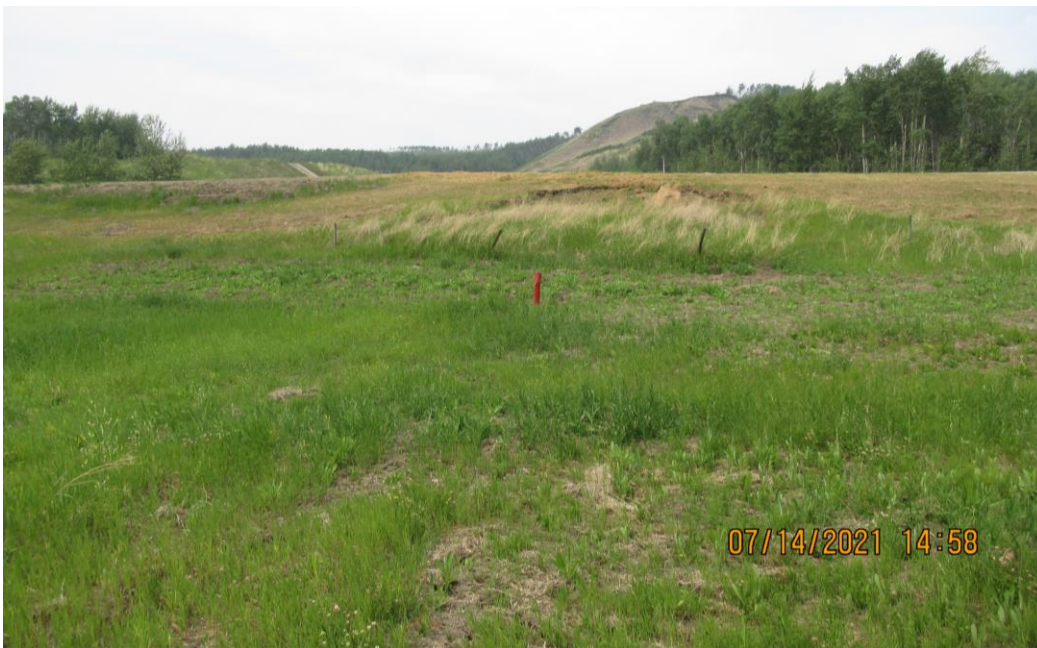
Photo 12 – Looking north towards the highway at the enlarged south hwy embankment slump below the east hwy scarp cracked area.
