**ALBERTA TRANSPORTATION
GEOHAZARD ASSESSMENT PROGRAM
PEACE REGION (GRANDE PRAIRIE DISTRICT-NORTH)
2021 INSPECTION**

Site Number	Location	Name (Old Site 5)	Hwy	km
PH023	12 km W. Cleardale	Clear River East Hill-Twin Pipes	64:02	23.4-24.1
Legal Description		UTM Co-ordinates (NAD 83)		
NE28/NW27-84-11-W6		11 N 6244273	E 335460

**PEACE REGION (GRANDE PRAIRIE DISTRICT - NORTH)
PH023: HWY 64:02 CLEAR RIVER EAST HILL**

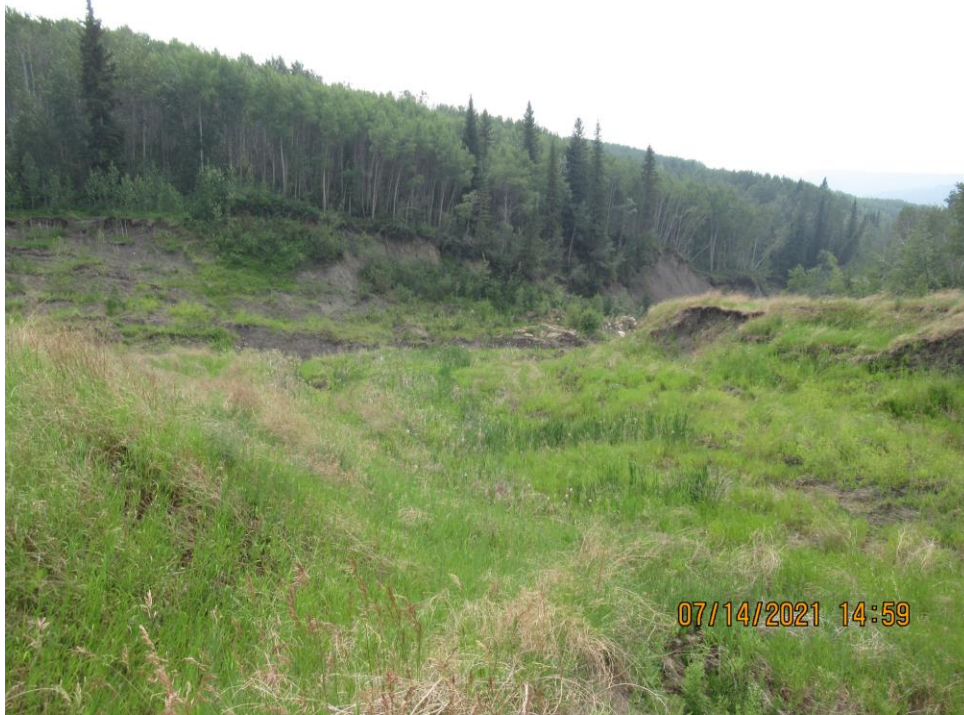
Photo 13 – Looking southwest at the eroded tributary channel from the north side of the eroded piping area. Significant seepage was emanating from the drains in the base.

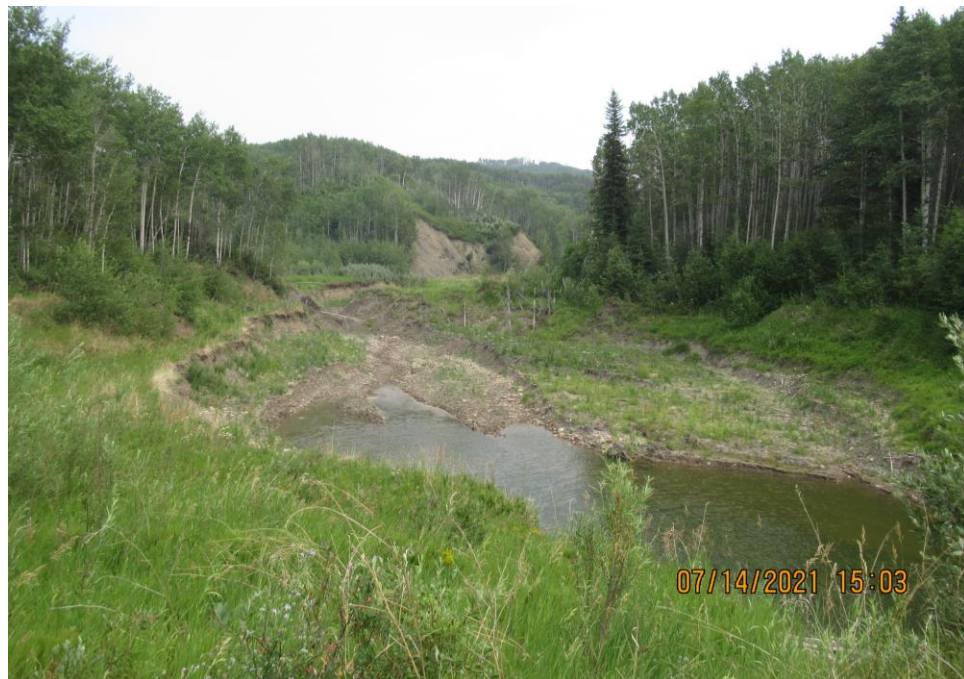
Photo 14 - Looking east at the upstream end of the eroded and silted in channel.

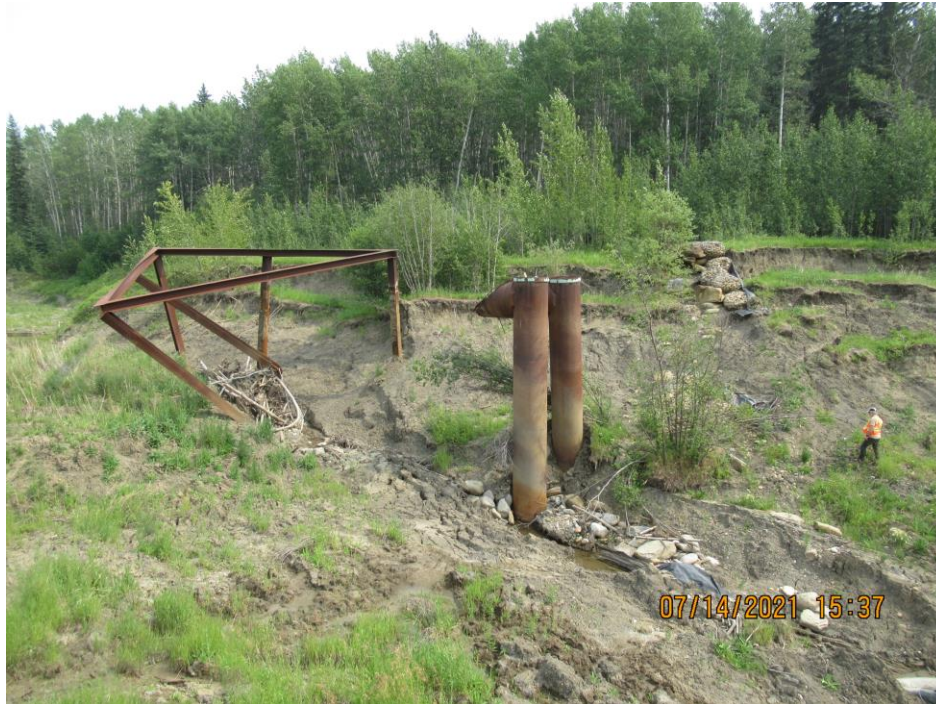
Sliding has also been aggravated by severe creek erosion at the toe of the valley slope over the years. There appears to be a recent large slide block that has moved towards the creek on the north side, centered about 300 m west of the drainage trench erosion area at the east end of the site. The large slump below the east end of the site is a result of the toe buttress fill blocking off the drainage trenches, causing erosion and earth flows that are retrogressing back towards the highway. The original twin culverts in the creek were not big enough to pass storm flows and to handle large amounts of silt and debris coming into the channel. As a result, channel lining/gabions below the east end of the site have eroded away and are ineffective. Recent creek erosion has completely eroded the gabion weirs, exposed the twin pipe outlets rendering them ineffective, displaced the large riprap, and has caused some of the trash rack piles to lean and bend.

Photo 15 – Looking southeast at the tilted trash rack and twin pipe inlet risers in the eroded (and now partially silted in) channel.

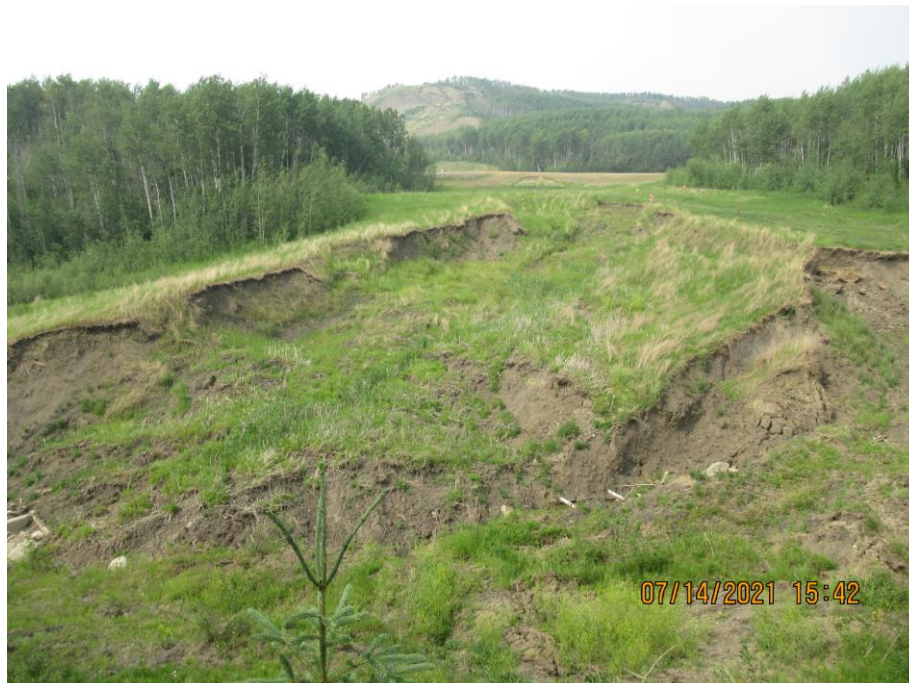
Photo 16 – Looking north at the piping erosion area shown in Photo 13, on the north edge of the channel.

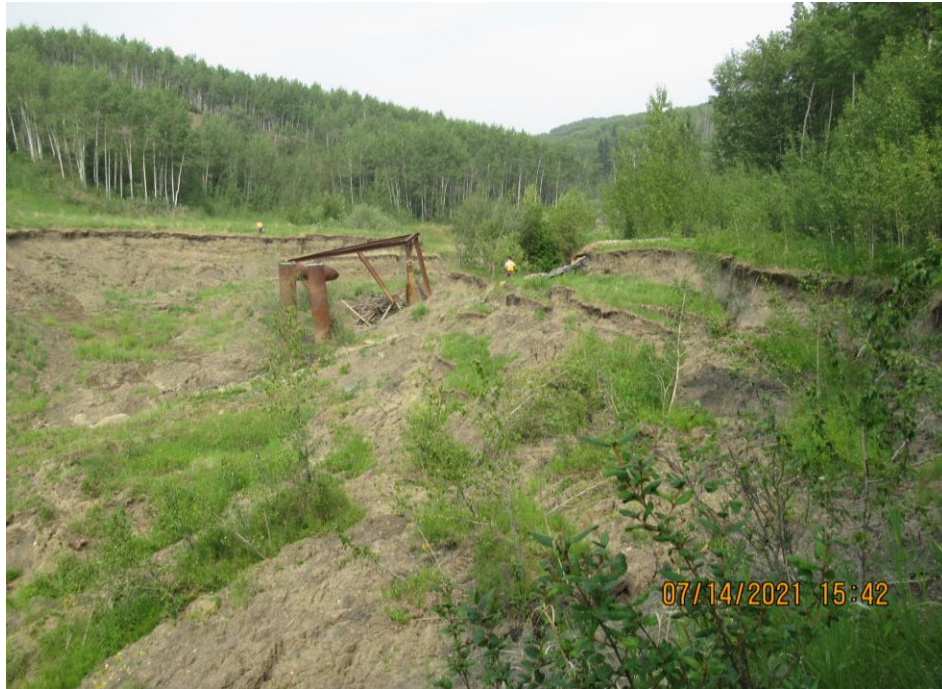
Photo 17 – Looking northeast at the trash rack and pipe inlets in the eroded channel. Note the enlarged south bank perimeter slumping.

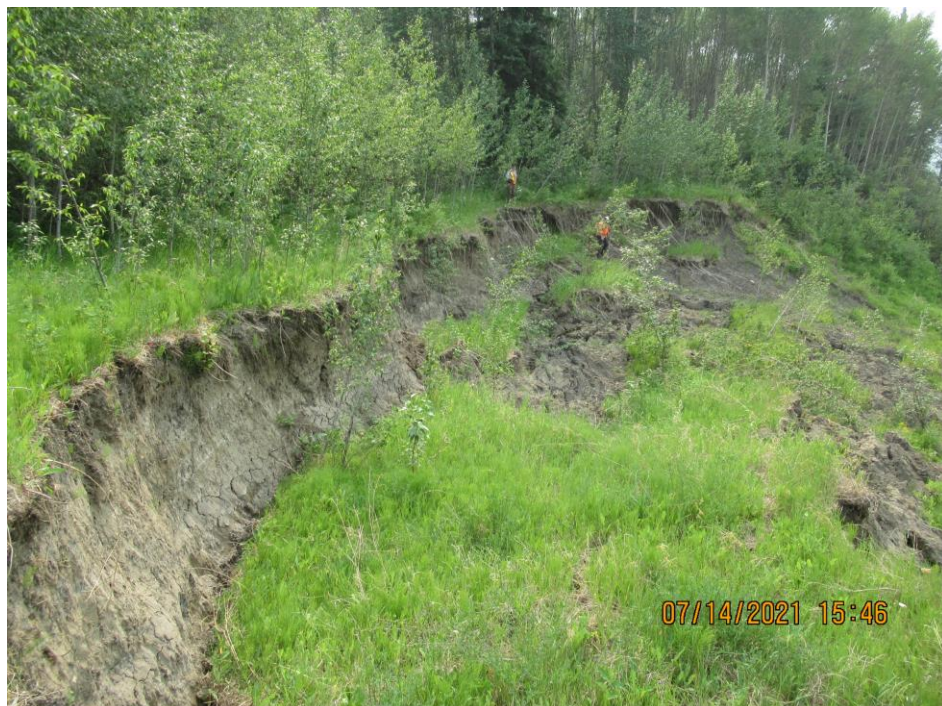
Photo 18 – Looking west at the fresh 3 m high slump scarp along the south edge of the channel.

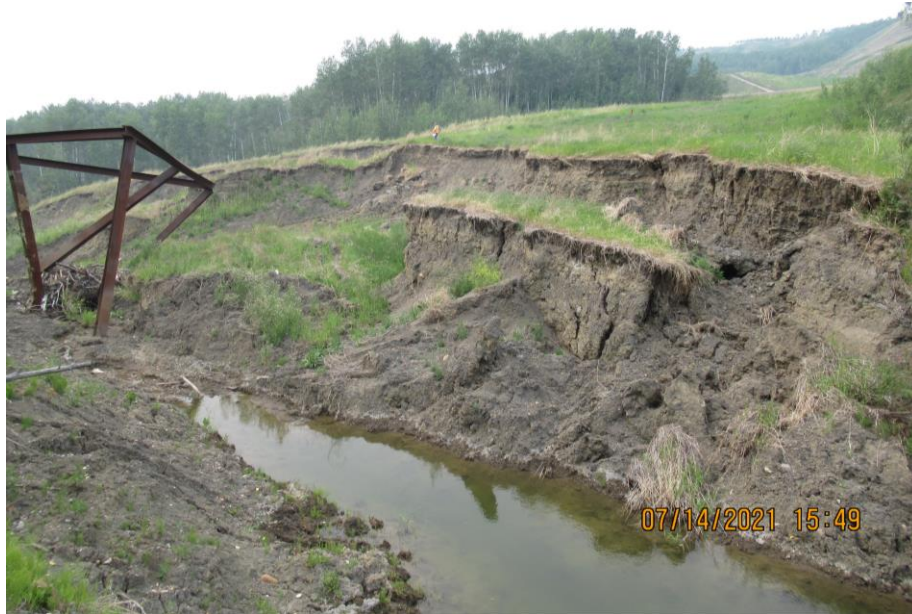
Photo 19 – Looking northwest at the extensive and continued slumping/erosion along the north channel banks adjacent to the trash rack.

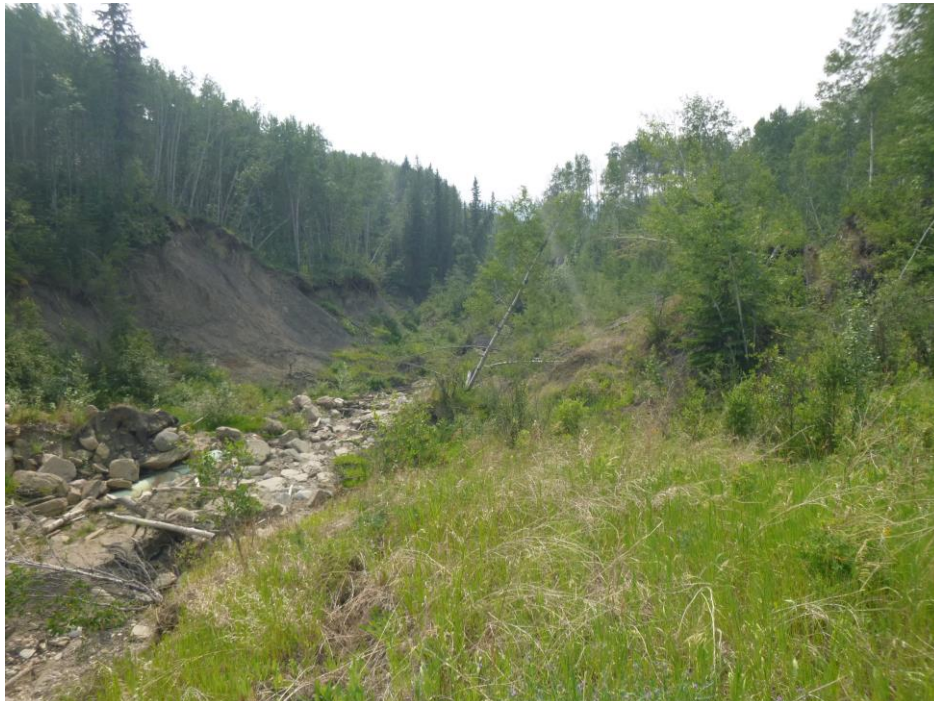
Photo 20 – Looking west along the creek channel at the twin pipes outlets.

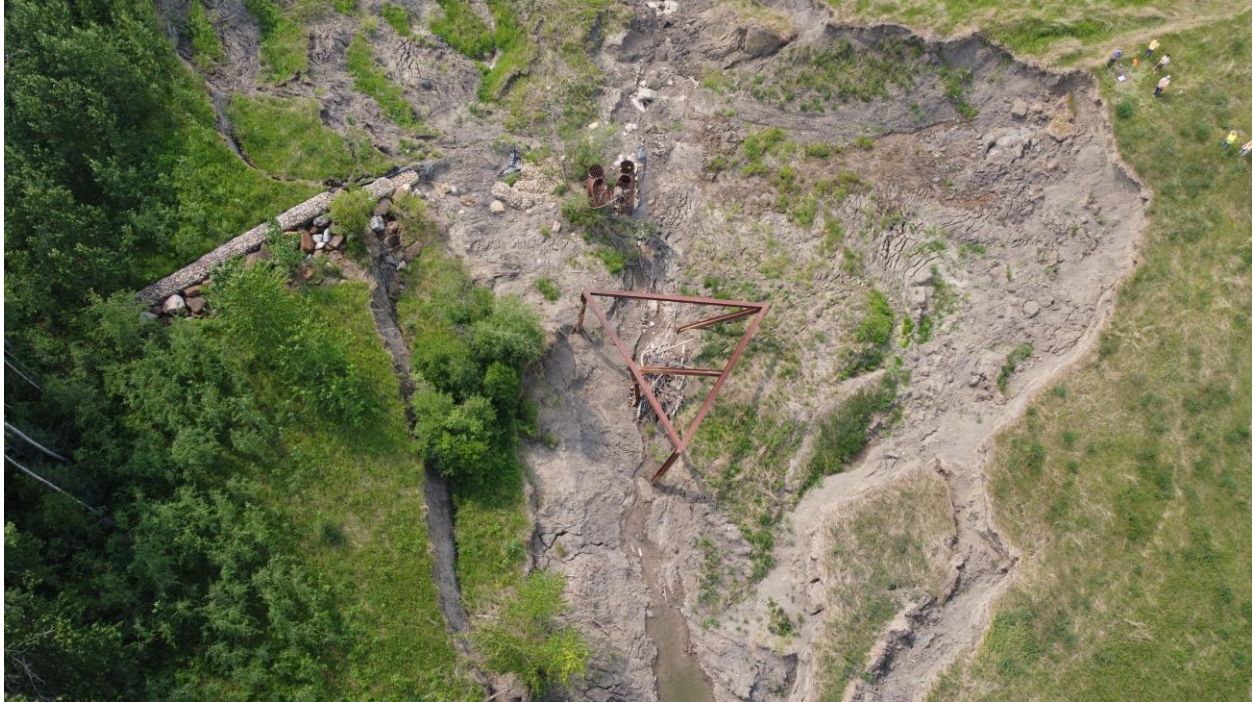
Photo 21 – UAV view looking west overtop the trash rack and twin pipe riser inlets in the eroded channel.

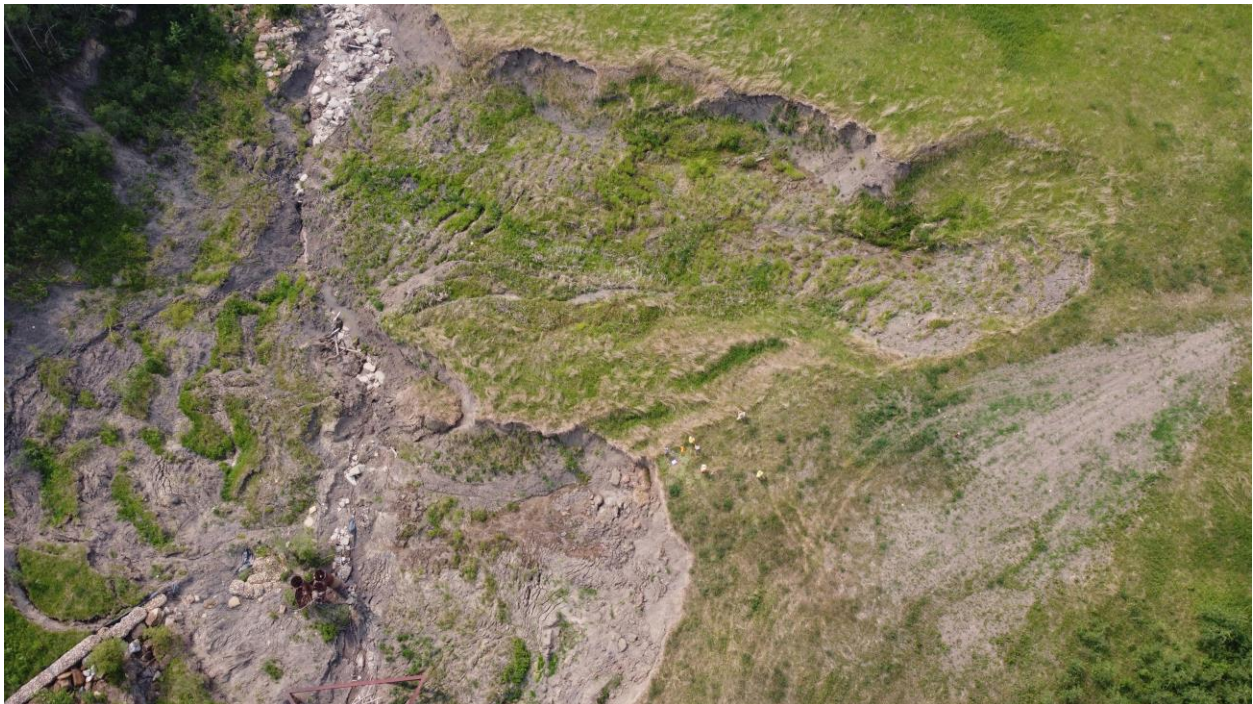
Photo 22 – UAV view looking west at the piping erosion area on the north edge of the eroded channel.
