November 22, 2022

**ALBERTA TRANSPORTATION GRMP (CON0022165)  
PEACE REGION (GRANDE PRAIRIE DISTRICT – NORTH)  
INSTRUMENTATION MONITORING RESULTS – FALL 2022**

**SITE PH023: HWY 64:02, CLEAR RIVER EAST HILL (SITE 5 – TWIN PIPES LANDSLIDE)**

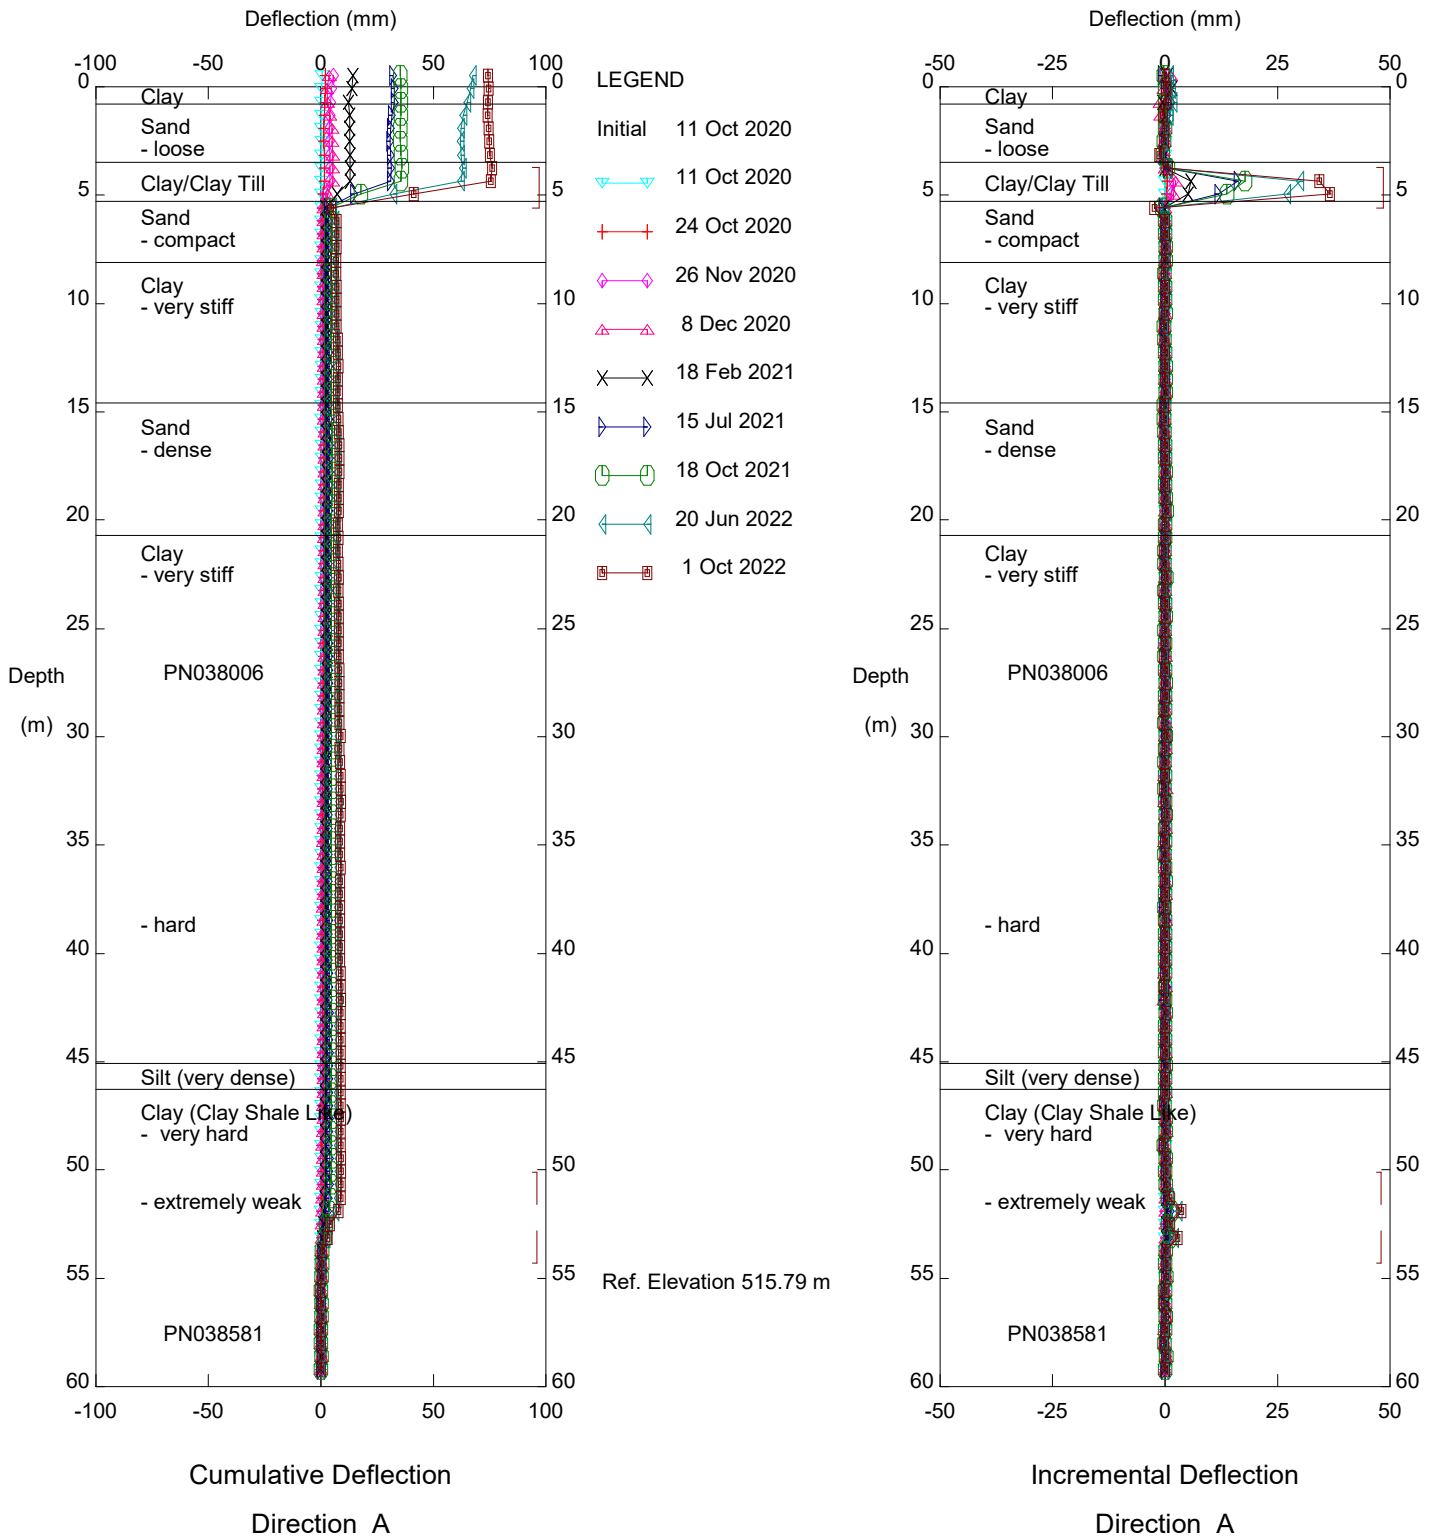
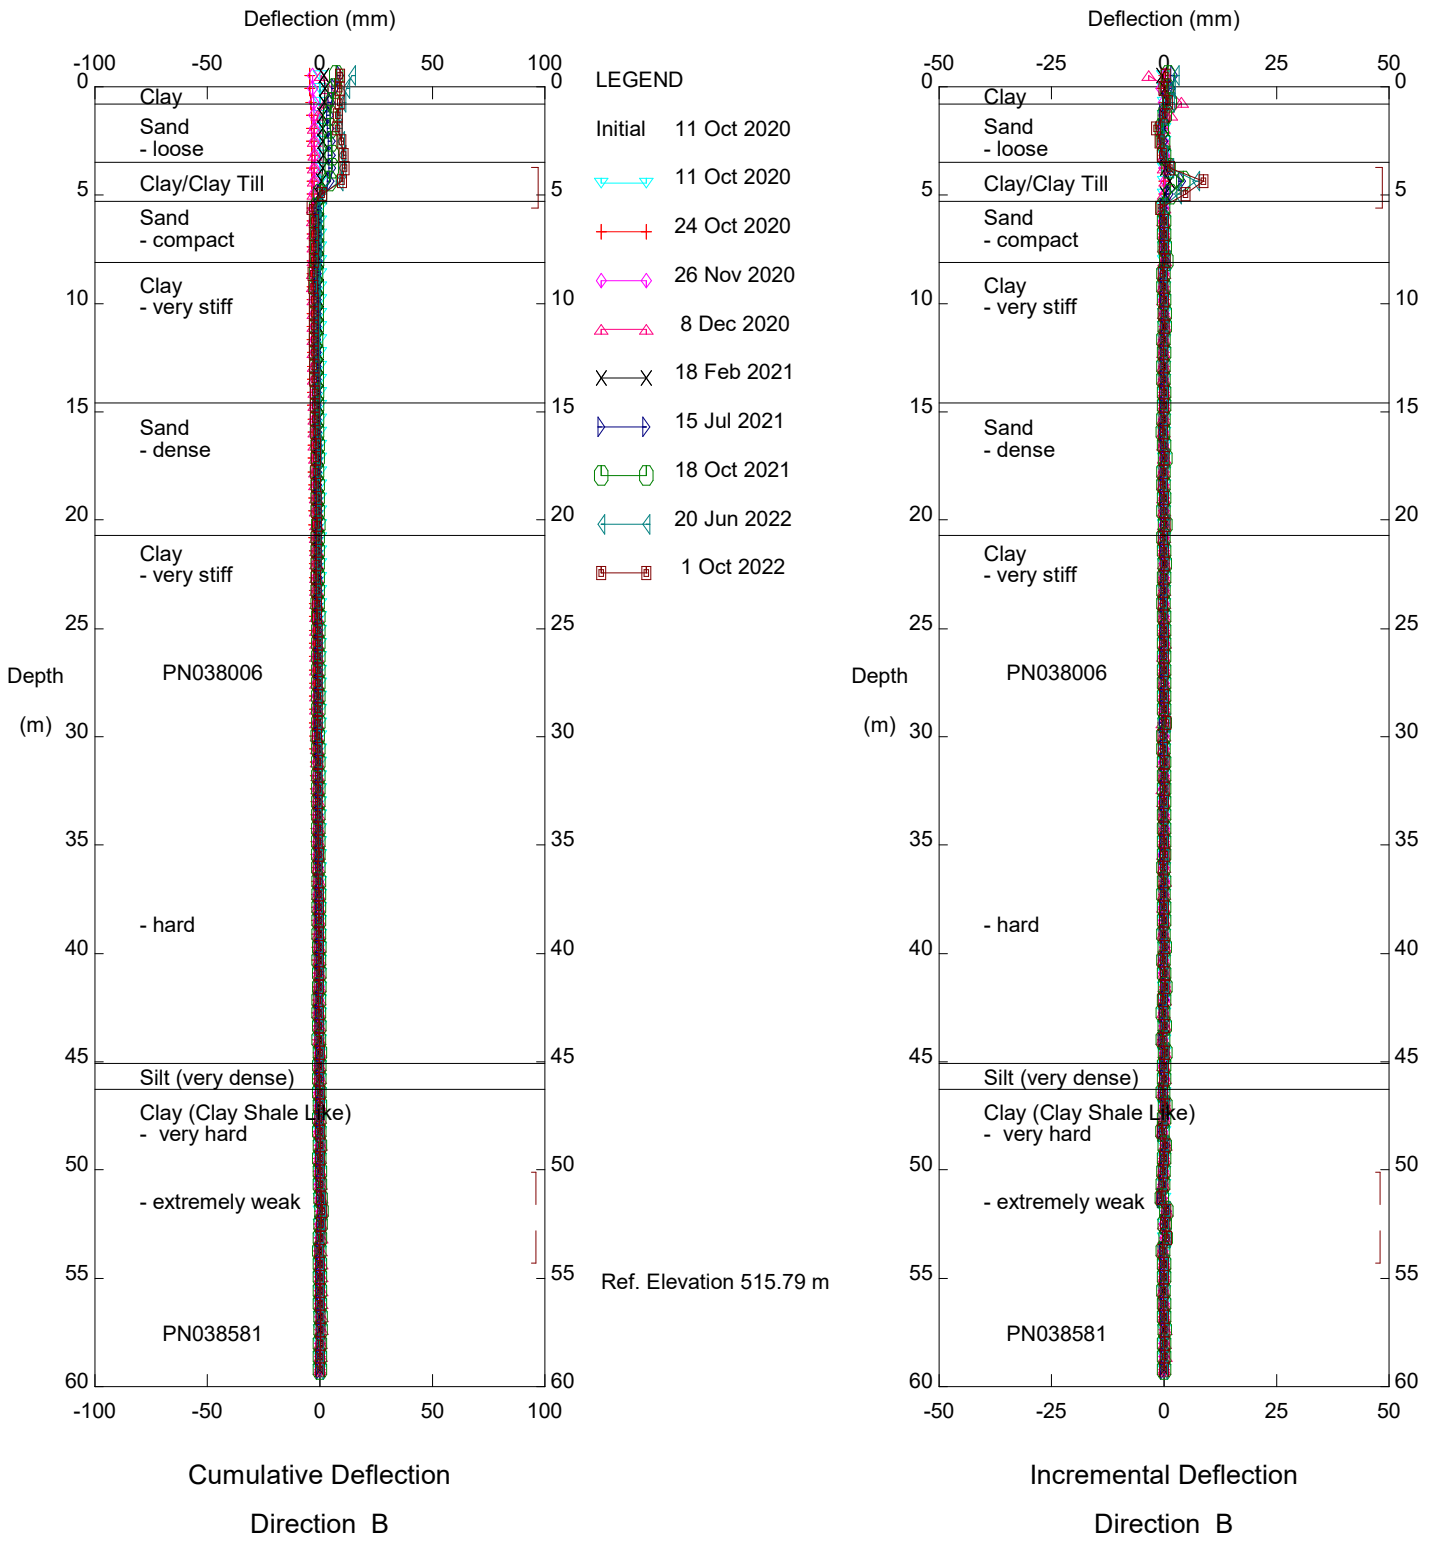
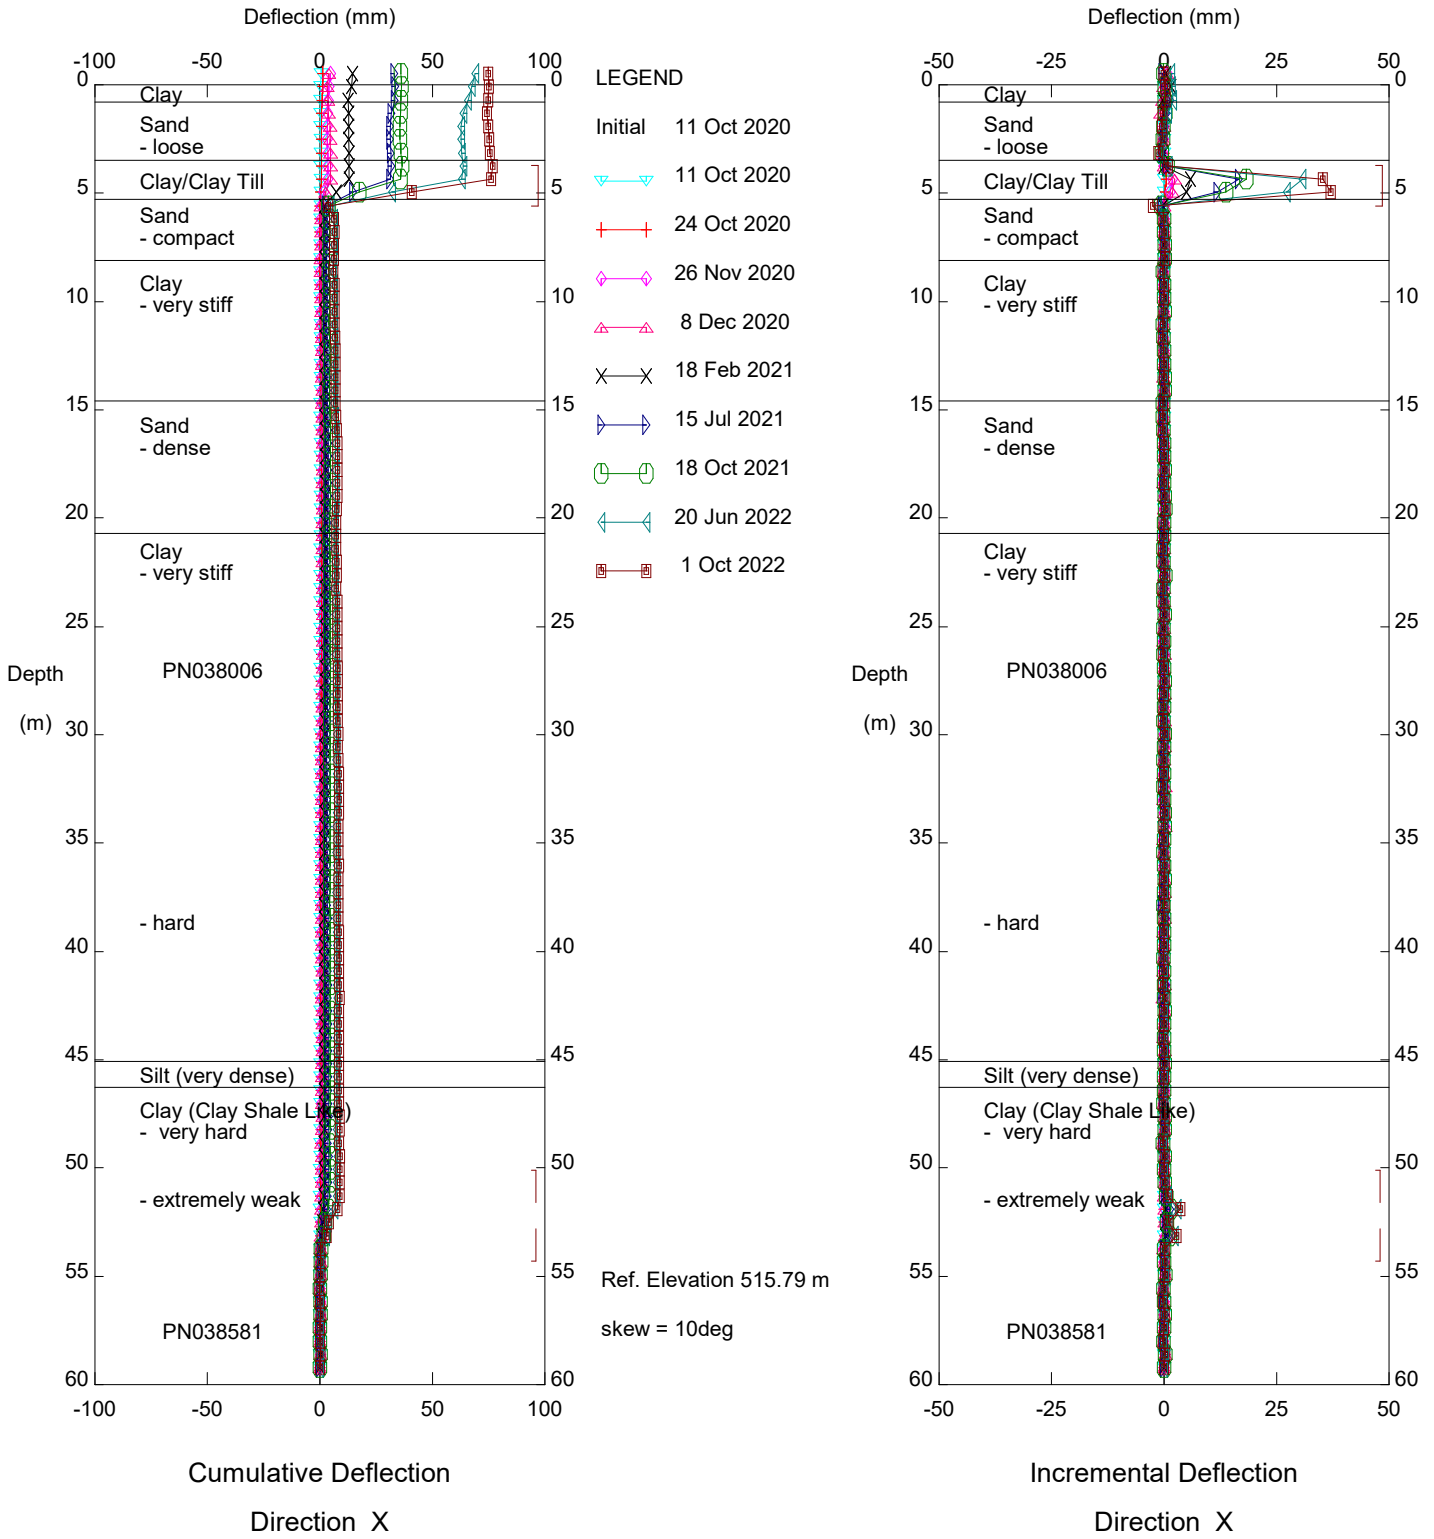
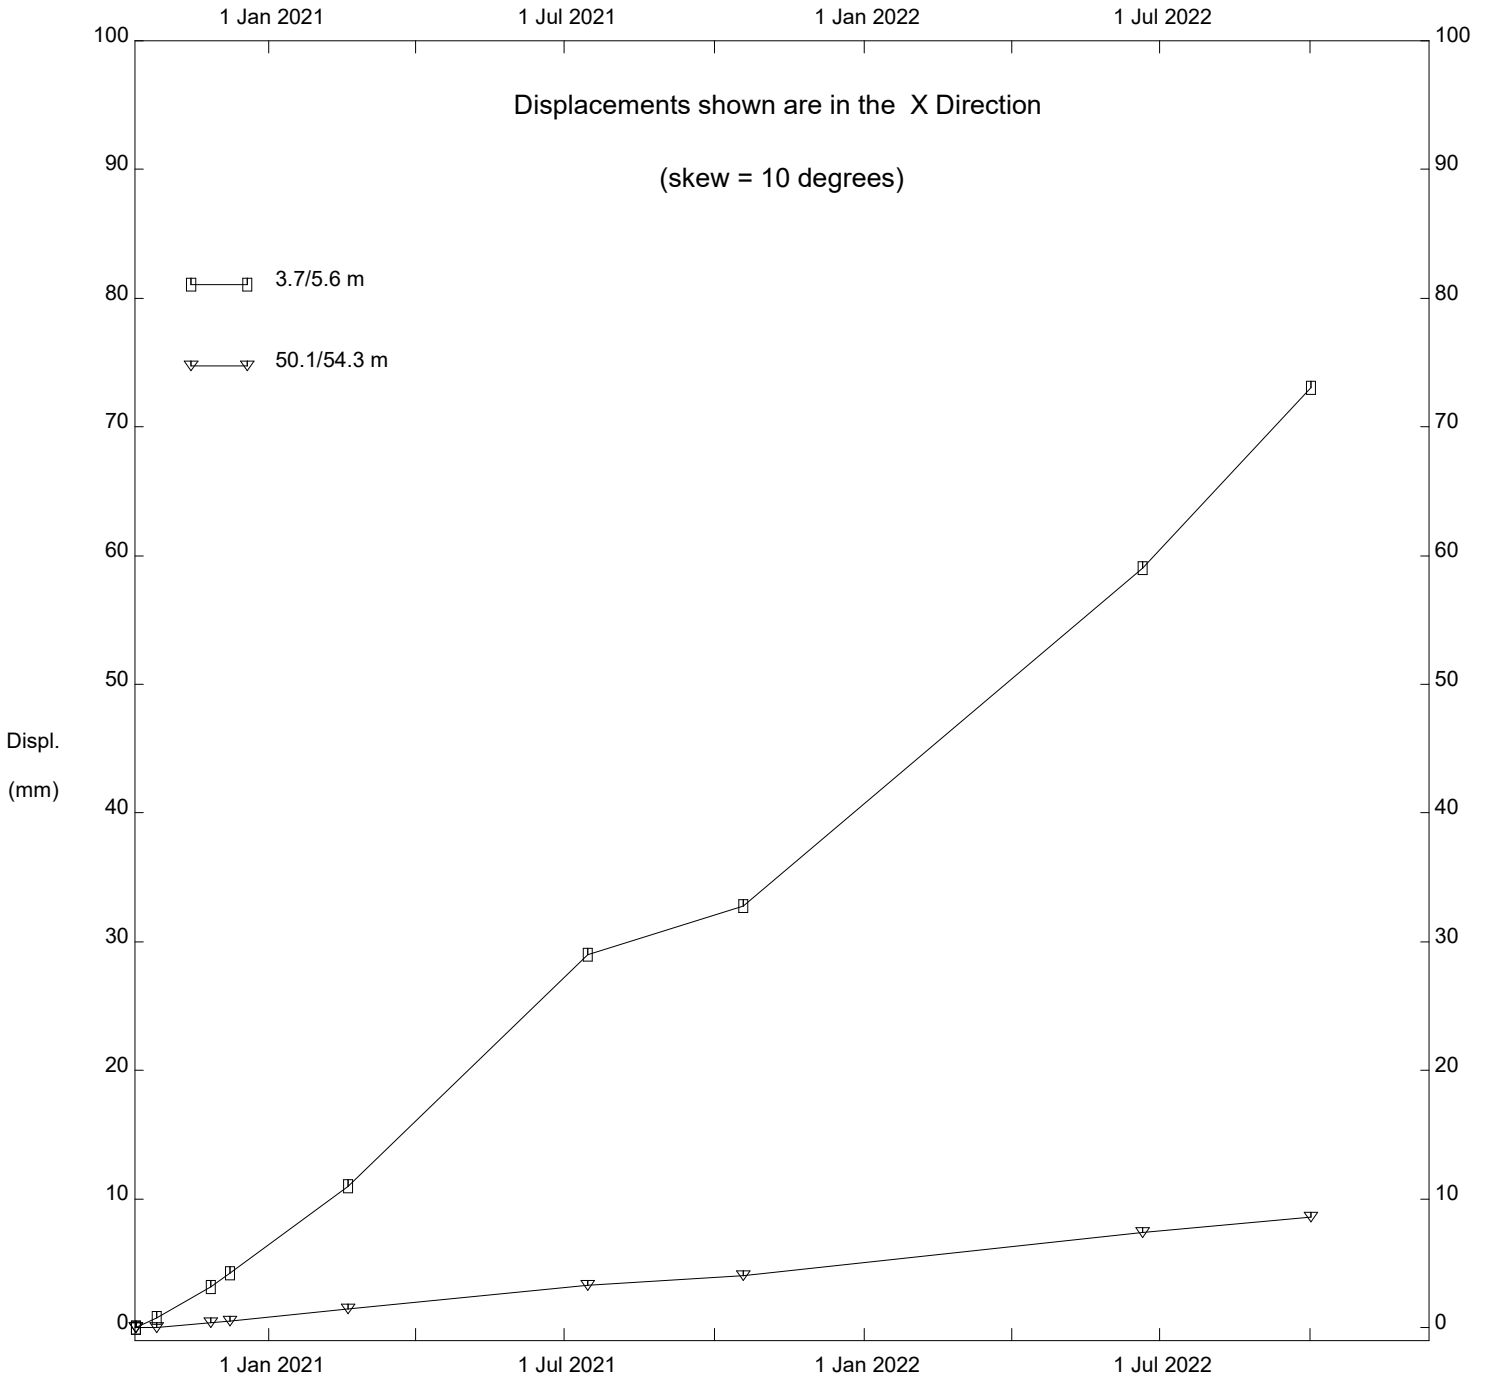
Hwy 64:02 Twin Pipes Landslide (PH023), Inclinometer SI20-1

SI20-1 showed current movement rates of 49.6 mm/yr and 4.2 mm/yr over 3.7 m to 5.6 m depth and 50.1 m to 54.3 m depth, respectively. SI20-7 showed rates of movement of 52.3 mm/yr and 6.4 mm/yr over 17.8 m to 19.6 m and 31.8 m to 33.6 m depth, respectively. The current rates of movement in SI20-1 (upper zone), and SI20-7 (upper zone) are the highest recorded since these instruments were initialized.

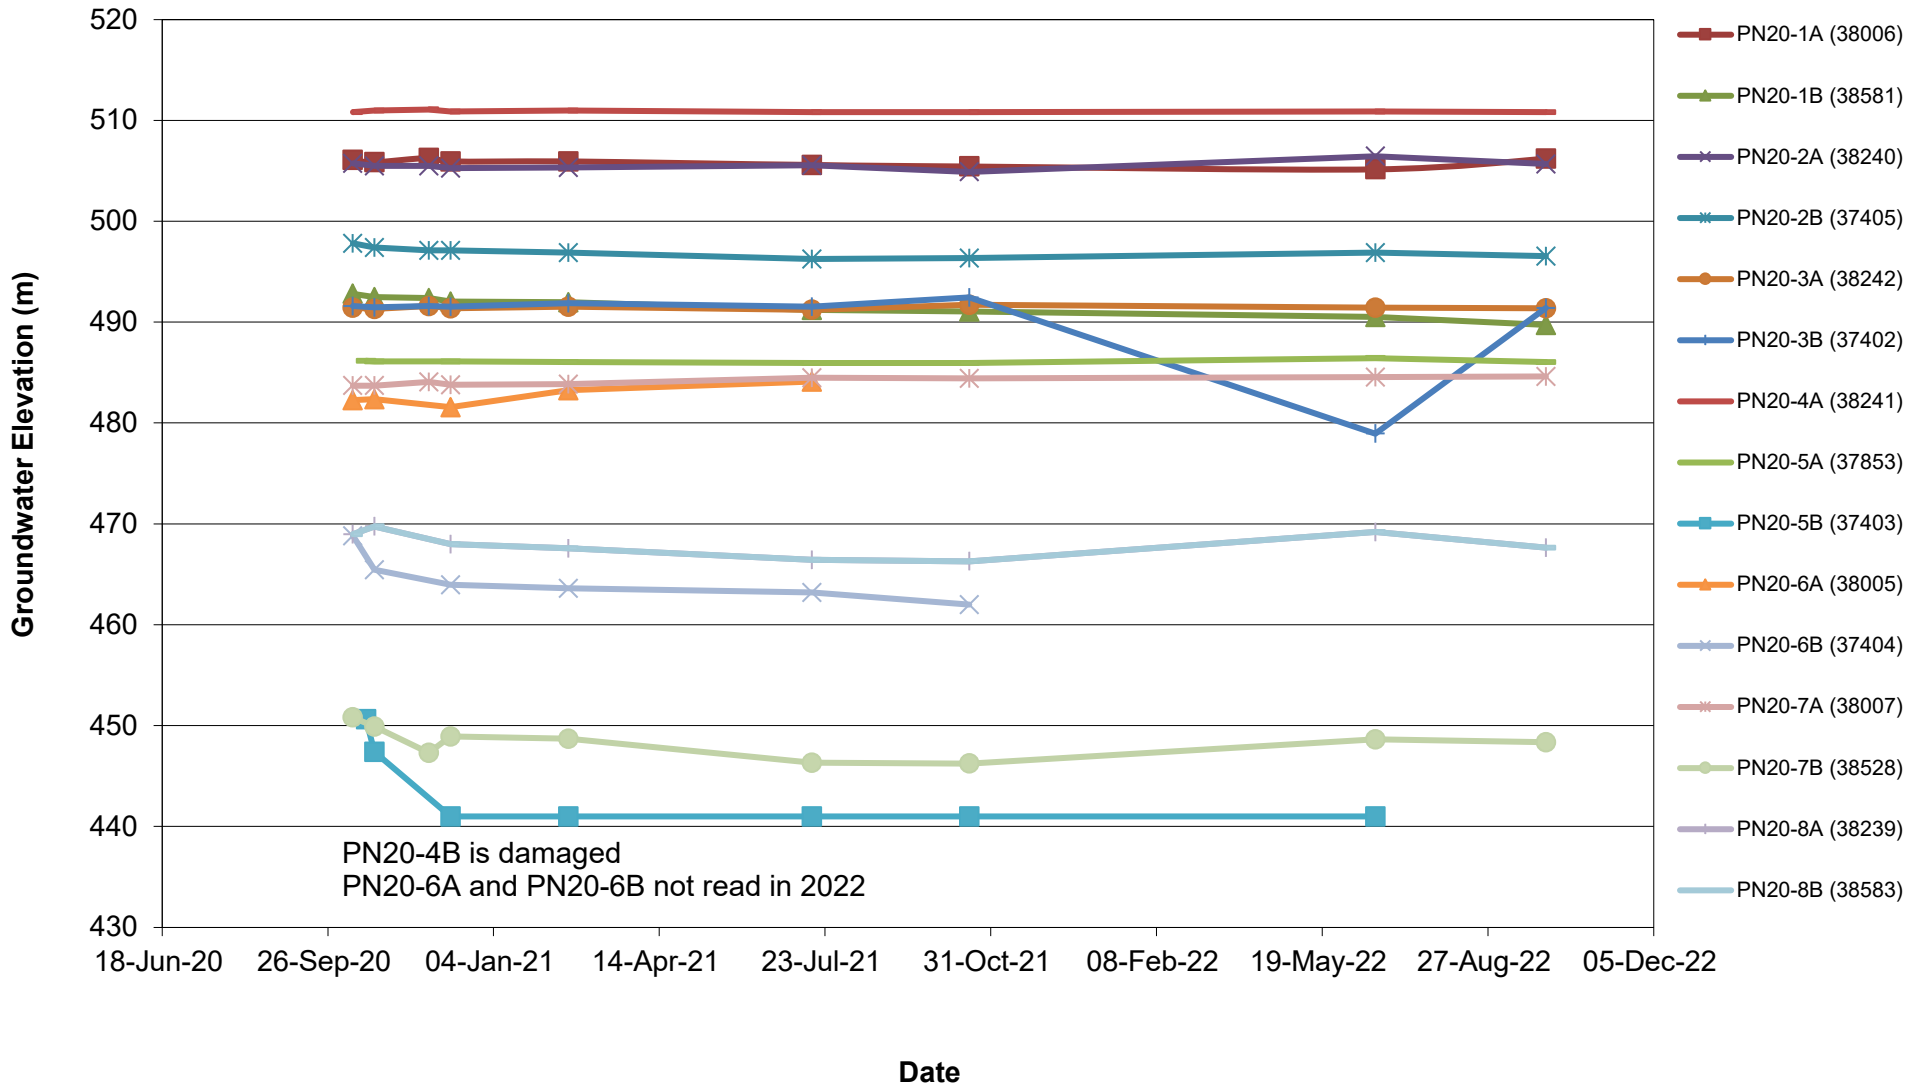
**FIGURE PH023-1  
HWY 64:02 - CLEAR RIVER EAST HILL - (SITE #5)  
PIEZOMETRIC ELEVATIONS**

The groundwater levels in pneumatic piezometers PN20-1A, PN20-3B, PN20-5A, and PN20-8A showed increases in water levels of 1.06 m, 12.45 m, 0.47 m, and 0.14 m, respectively, since the spring of 2022 readings. This large rise in PN20-3B is bringing it back to historical levels. PN20-8A showed the highest recorded water level measured in the instrument since it was initialized. The groundwater levels in pneumatic piezometers PN20-1B, PN20-2A, PN20-2B, PN20-3A, PN20-4A, PN20-7B and PN20-8B showed decreases in water levels 0.77 m, 0.77 m, 0.35 m, 0.07 m, 0.07 m, 0.28 m, and 1.55 m, respectively, since the spring of 2022 readings. The pneumatic piezometer readings are summarized in Table PH023-2 and are plotted in Figure PH023-1 (by elevation) and Figure PH023-2 (by depth) in Appendix A.

The instruments should be read again in the spring of 2023. The reading of PN20-3B should be checked to confirm if this instrument is functioning properly. A third party wildlife escort should be considered to read SI20-6, PN20-6A and PN20-6B due to the presence of a bear den near the instrument location.
