**ALBERTA TRANSPORTATION
GEOHAZARD ASSESSMENT PROGRAM
PEACE REGION (GRANDE PRAIRIE DISTRICT-
NORTH)
2022 INSPECTION**

Site Number	Location	Name (Old Site 5)	Hwy	km
PH023	12 km W. Cleardale	Clear River East Hill-Twin Pipes	64:02	23.4-24.1
Legal Description		UTM Co-ordinates (NAD 83)		
NE28/NW27-84-11-W6		11 N 6244273	E 335460

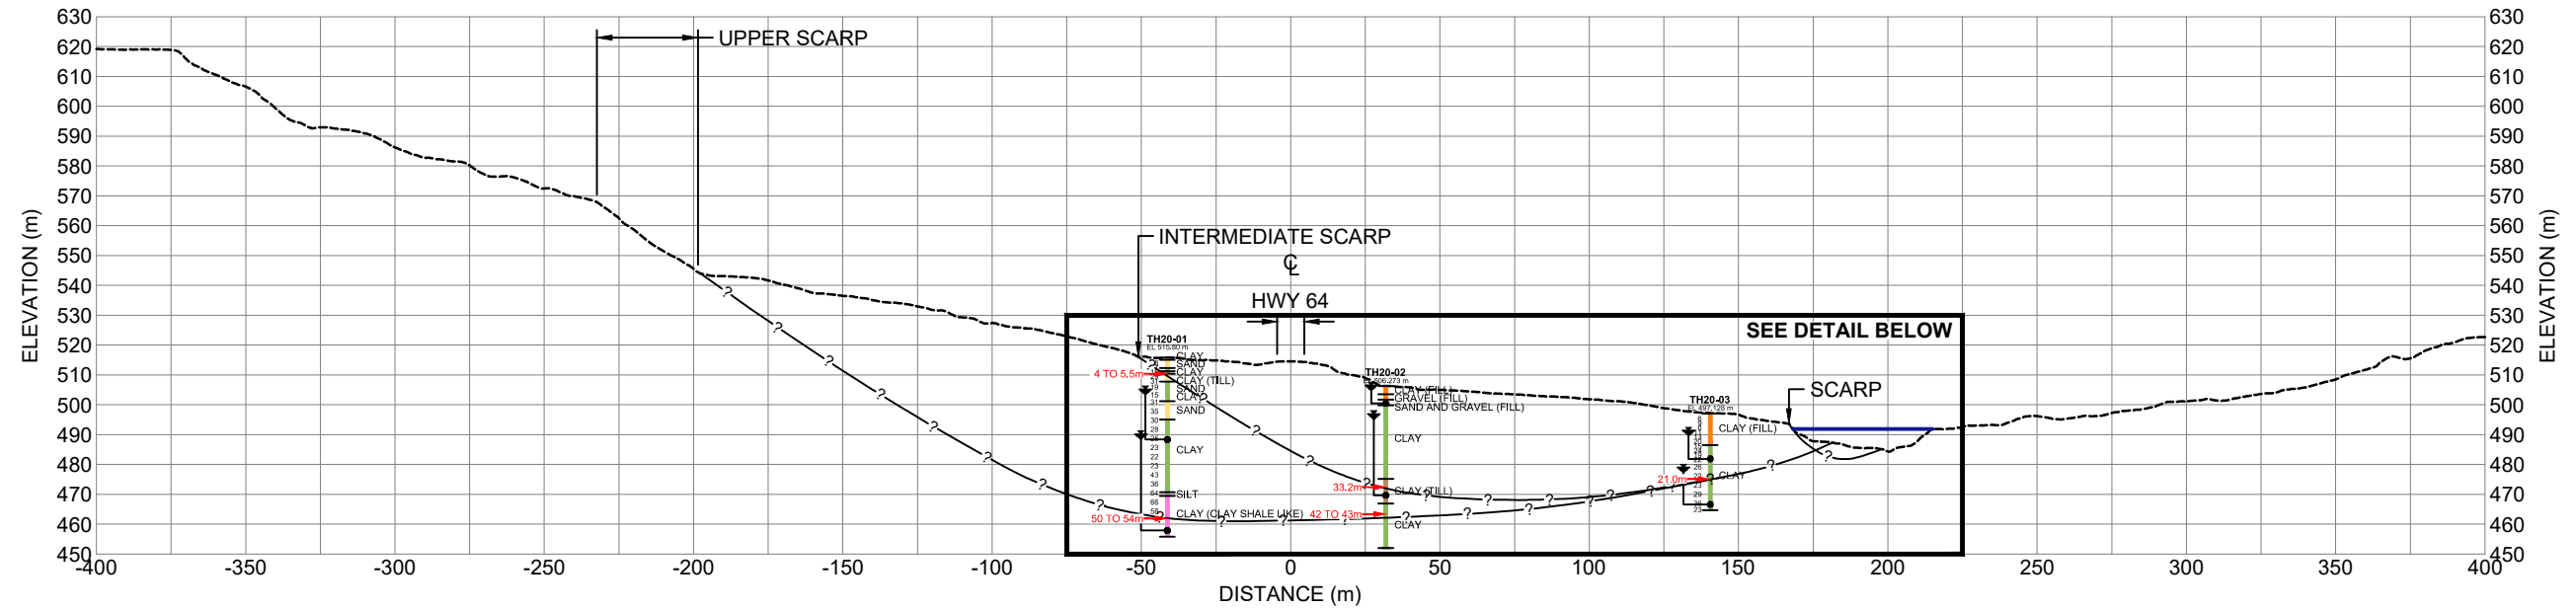
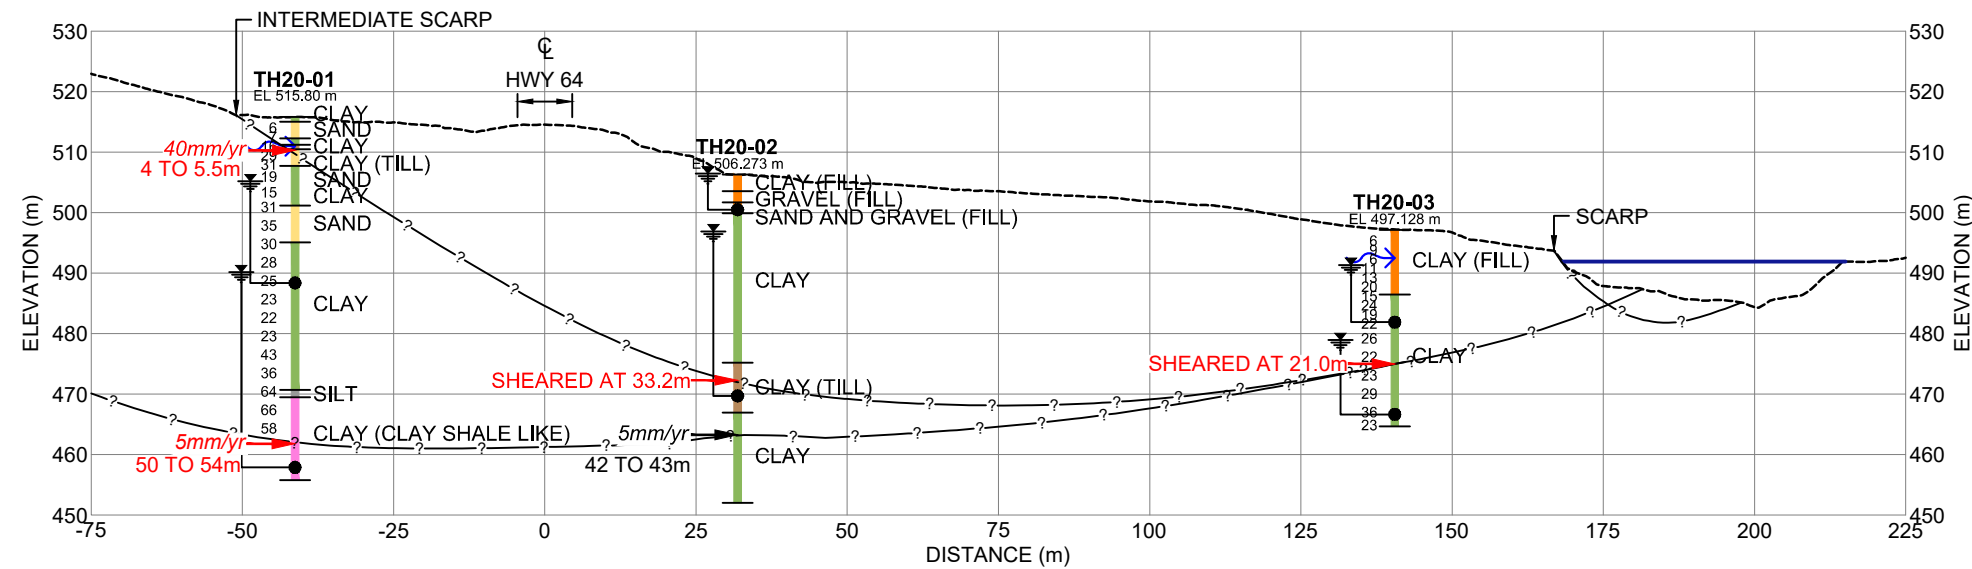
CROSS-SECTION A-A'

Instrumentation: Last read June 20, 2022 - The inclinometer movement zones, and piezometer tip depth measurements are shown on the cross-sections attached (Drawings PH023-4 to -6).

20-1: 40mm/yr @ 4 to 5.5m; & 5mm/yr @ 50 to 54m. **20-2:** Sheared off at 33.2m (but former movement zones @ 32 to 34m & 42 to 43m). **20-3:** Sheared off at 21.0m (former movement zone @ 19.5 to 21m). **20-4:** 42mm/yr @ 6 to 8m; & 4mm/yr @ 60 to 62m. **20-5:** 48mm/yr @ 9 to 12m; & 64mm/yr @ 31 to 36m. **20-6:** Not Read due to bear activity, (but previously 73mm/yr @ 18 to 20m; & 63mm/yr @ 28 to 31m). **20-7:** 17mm/yr @ 18 to 20m; & 7mm/yr @ 32 to 34m. **20-8:** 53mm/yr @ 34 to 37m.

- At Section A (near the east end), two additional measures include: a) Lowering the water table by 2 to 3 m over a 100 m wide x 250 area long area by installing a series of closely spaced trench (slot) drains that drain into the base of the tributary fill; and b) Reconstructing a 200 m length of slide compromised highway with lightweight fill by excavating a 5 m thickness of ACP, GBC, and clay fill.

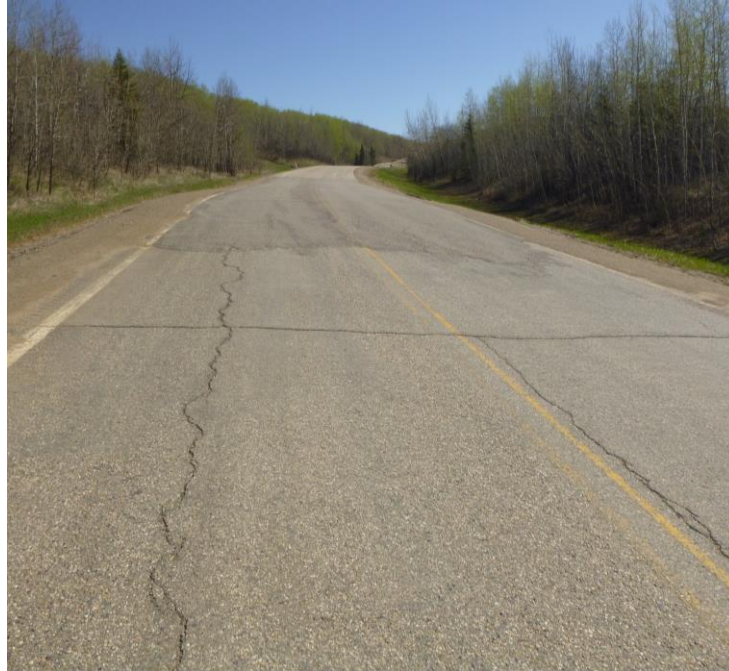
Photo 1 - Looking east along the highway at the milled/patched area over the two cracks first observed in 2013 that mark the west boundary of the slide on the highway.

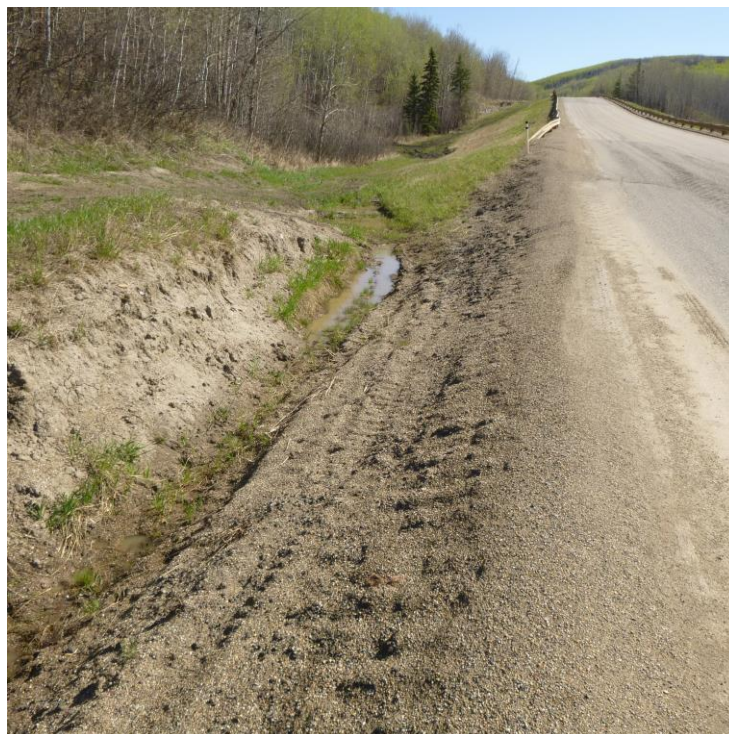
Photo 2 – Looking east along the slide scarp in the south ditch, and large dip that extends across the highway near the west end of the site.

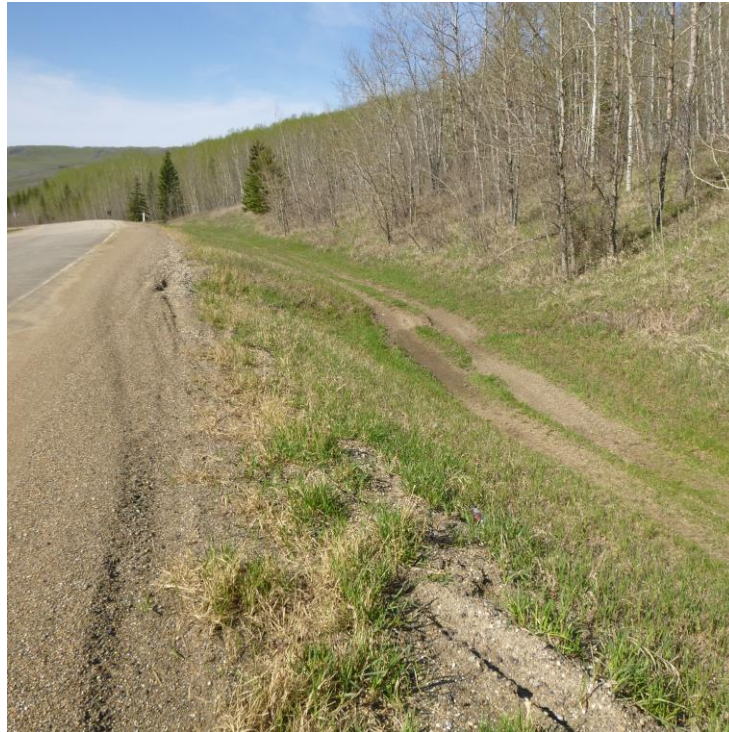
Photo 3 – Looking west from near the west end of the guardrails along the slide scarp that extends along the north highway ditch.

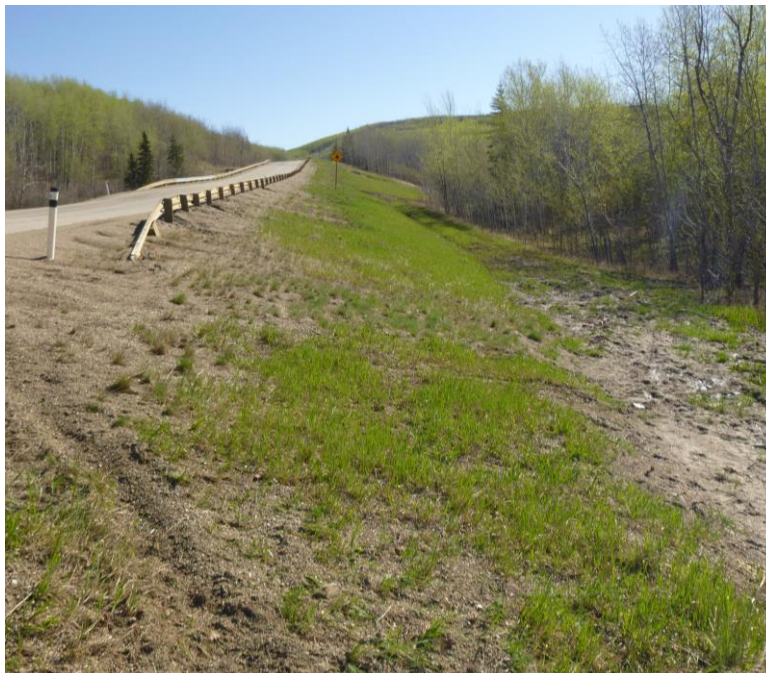
Photo 4 – Looking east along the south side of the highway at an active seepage area below the west end of the south guardrail.

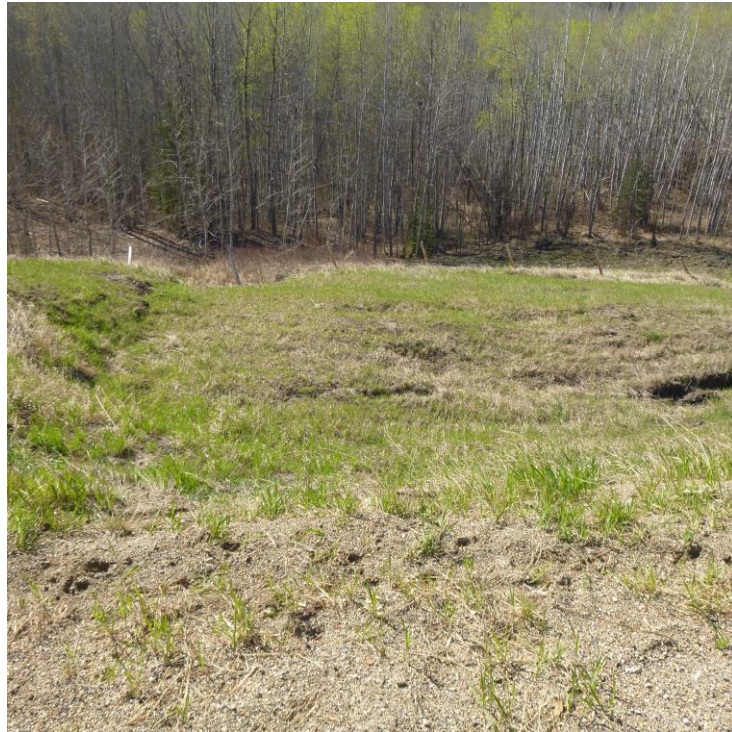
Photo 5 – Looking south along the south highway Embankment Slump B.

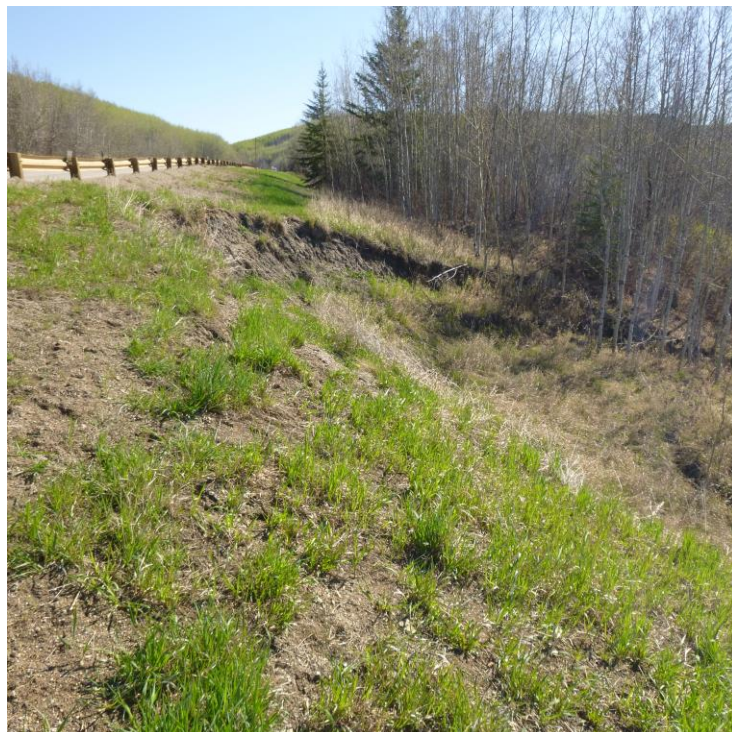
Photo 6 – Looking east at Embankment Slump A on the south side of the hwy.

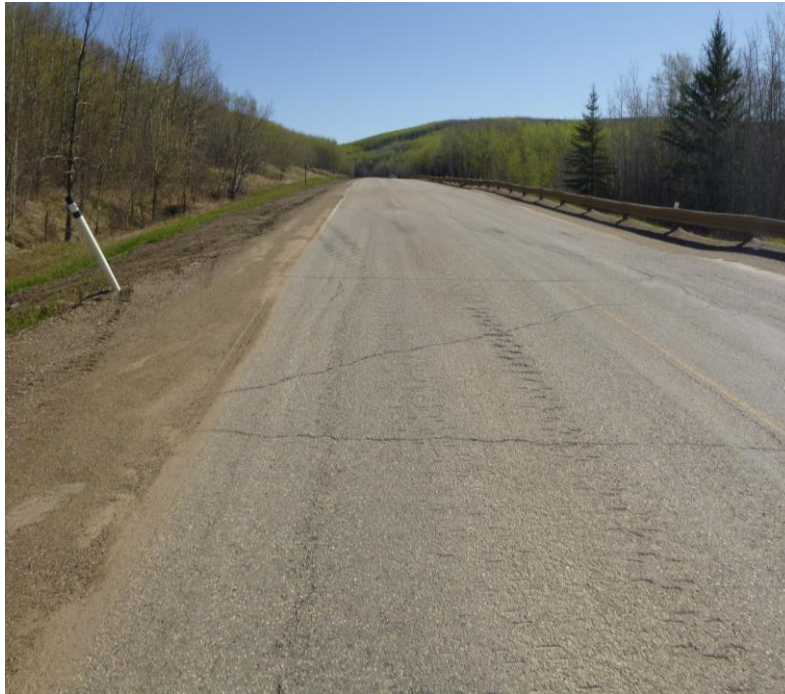
Photo 7 – Looking east along the highway at last years unrepaired slide cracks east of the northeast guardrail end.

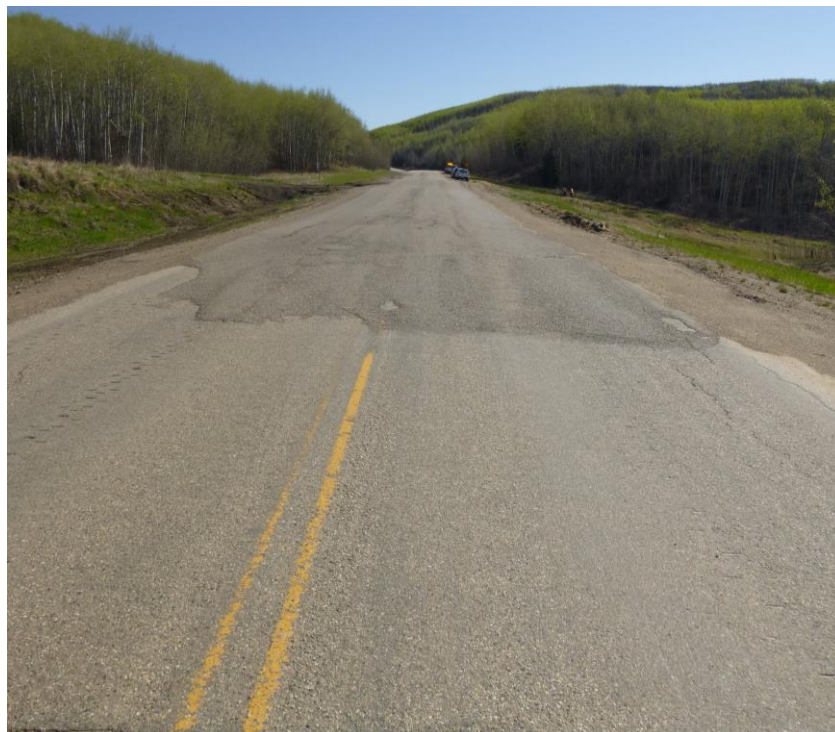
Photo 8 – Looking east at the west milled/patched area over the east slide crack.

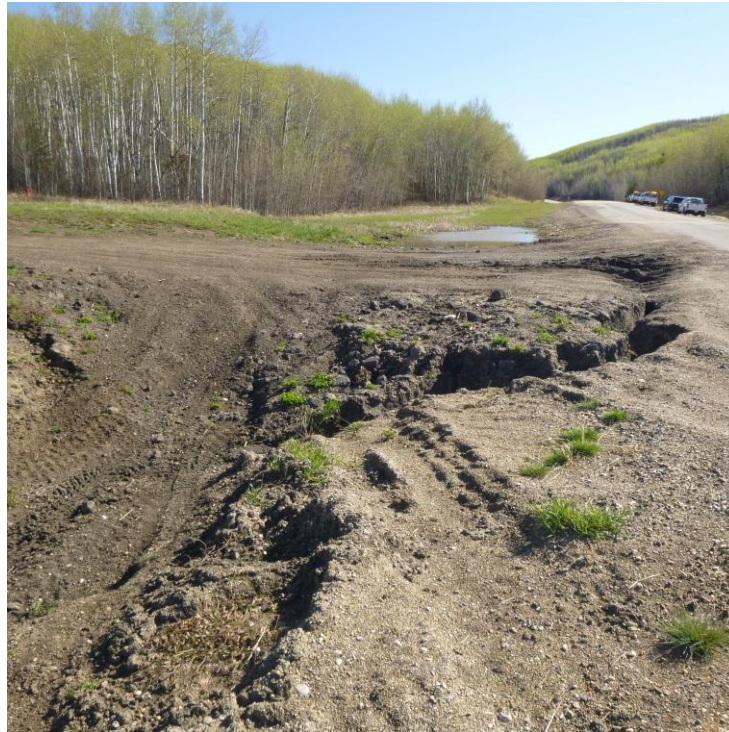
Photo 9 – Looking east along the north highway ditch at the erosion gully across the access, the dipped hwy, and sagged area with ponded water.

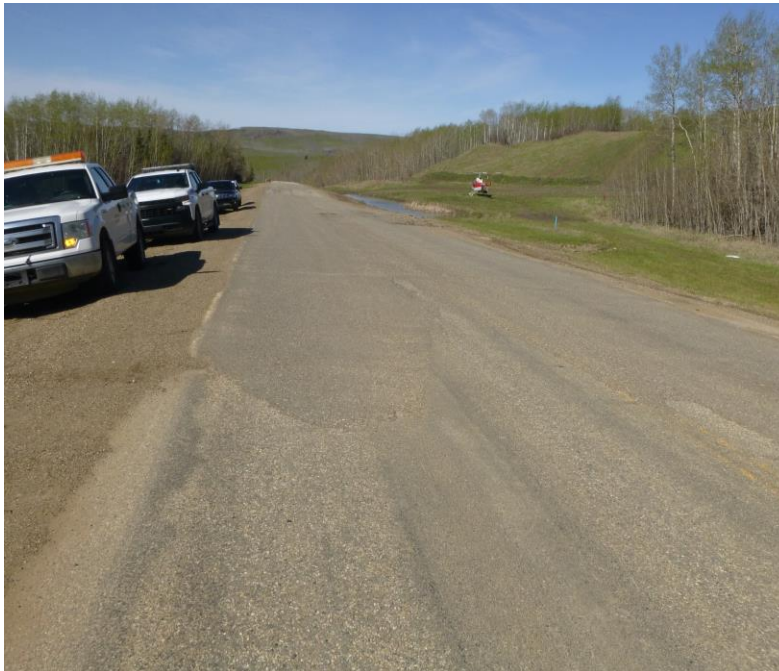
Photo 10 - Looking west along the highway at the east milled/patch over the east scarp cracked area at the east end of the site.

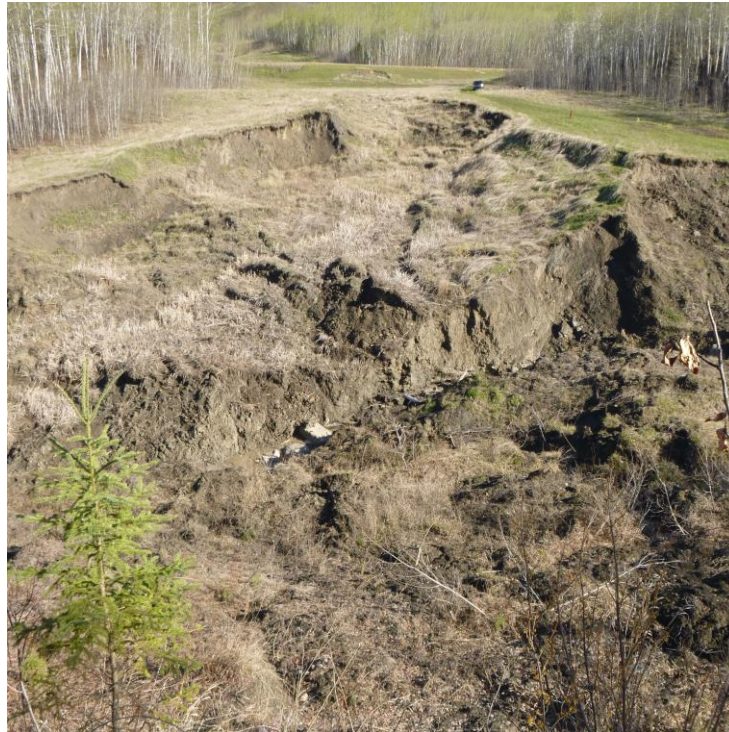
Photo 11 – Looking north towards the highway at the piping erosion area. Note the south hwy embankment slump below the east hwy scarp cracked area.

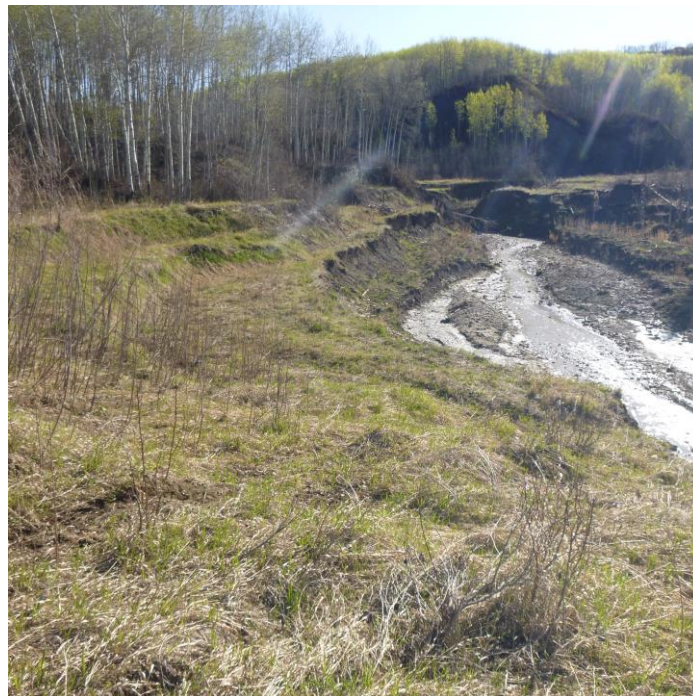
Photo 12 – Looking east at the upstream end of the eroded and silted in channel.

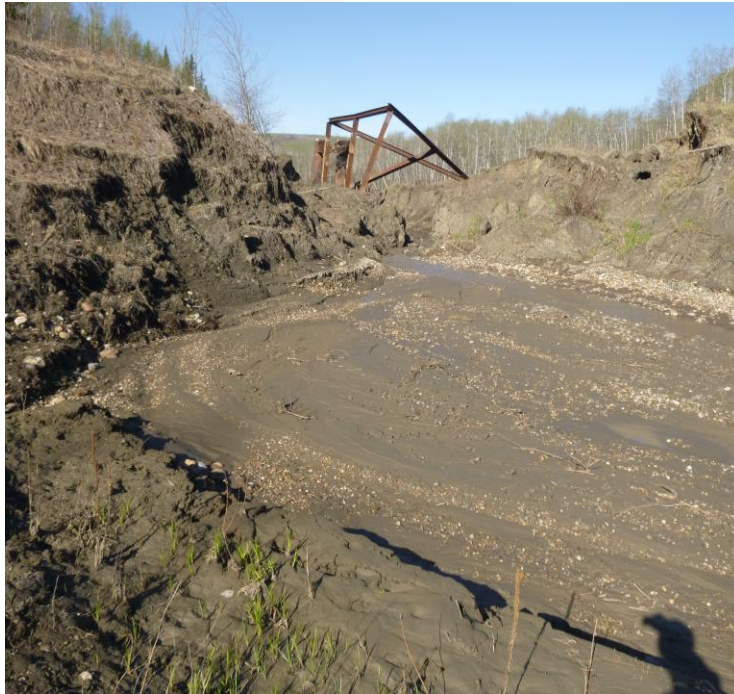
Photo 13 - Looking west at the eroded tributary channel from east of the eroded piping area. Note the fresh silt deposition in the foreground.

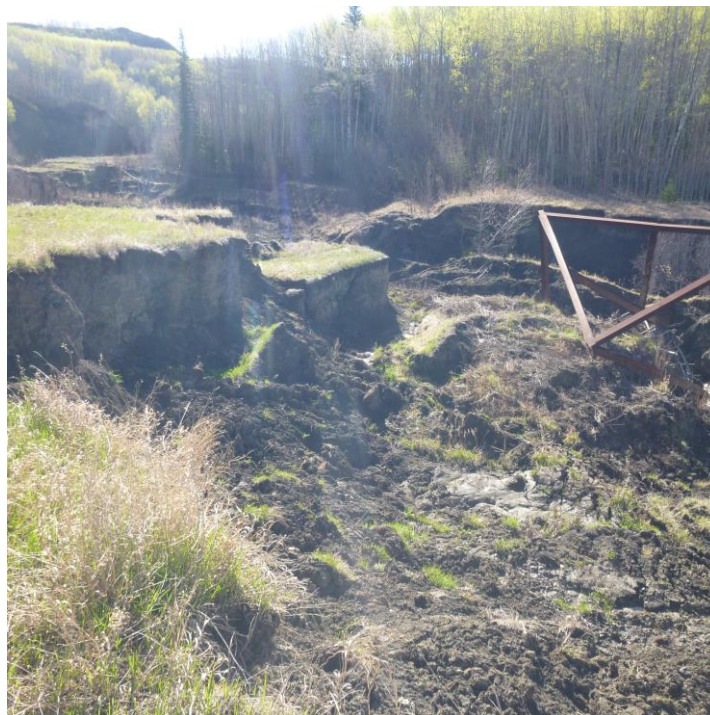
Photo 14 – Looking southeast along the eroded channel where it meets the eroded piping area, with the trash rack on the RHS.

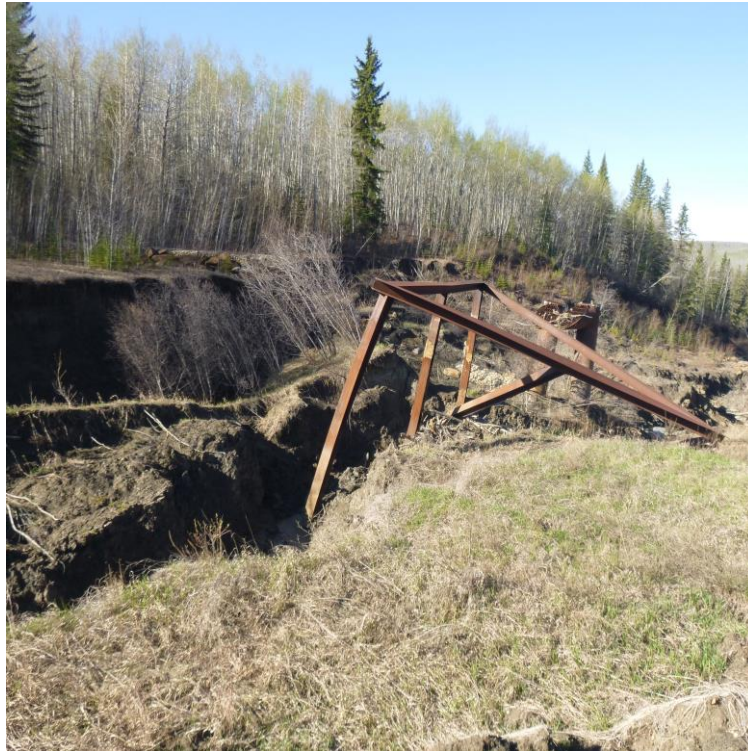
Photo 15 – Looking west at the twin pipe inlet risers, and the eroded trash rack.

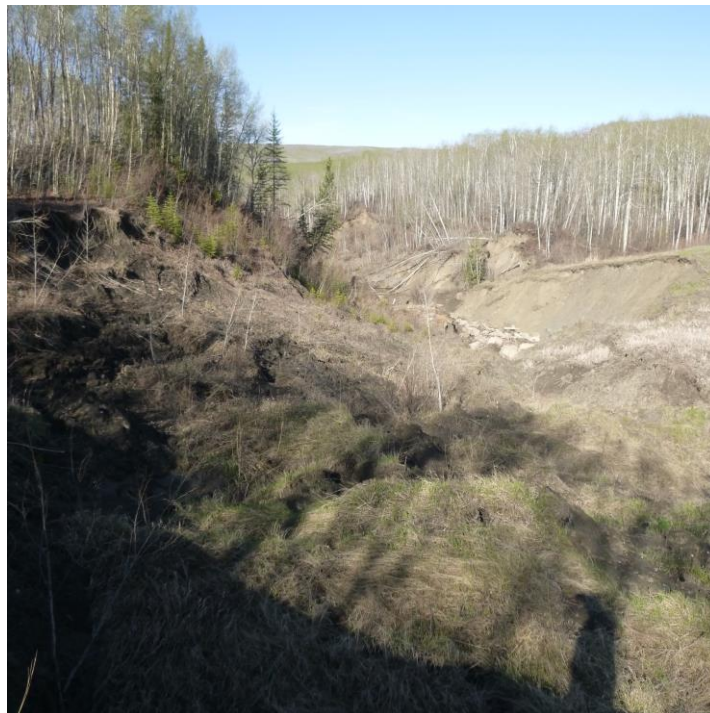
Photo 16 – Looking west along the eroded creek channel from near the twin pipes outlets.

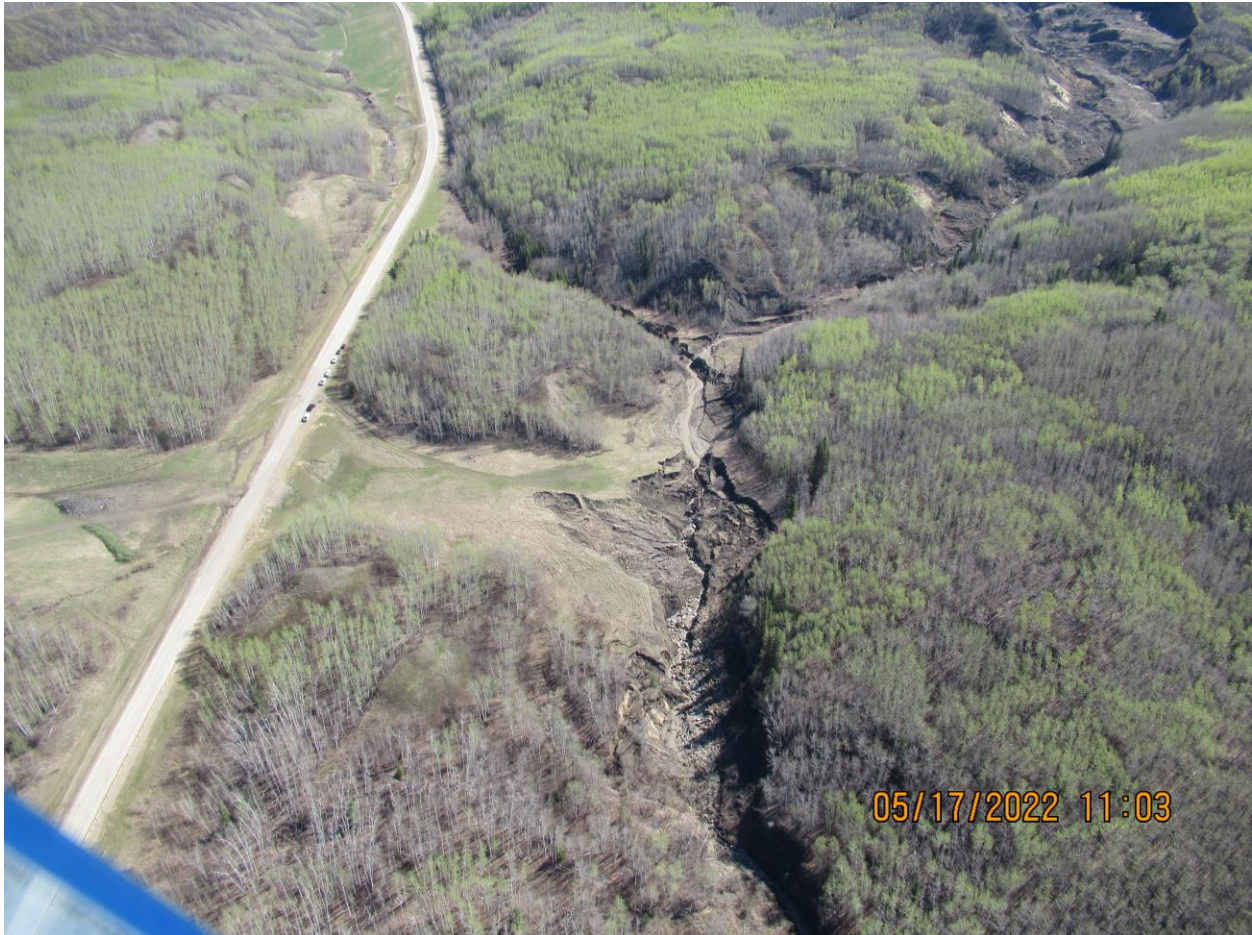
Photo 17 – Looking east at the site (Chopper Photo).
