**ALBERTA TRANSPORTATION AND  
ECONOMIC CORRIDORS  
GEOHAZARD ASSESSMENT PROGRAM  
PEACE REGION (GRANDE PRAIRIE DISTRICT - NORTH)  
2025 INSPECTION**

Site Number	Location	Name (Old Site 5)	Hwy	km
PH023	12 km W. Cleardale	Clear River East Hill-Twin Pipes	64:02	23.4-24.1
Legal Description		UTM Co-ordinates (NAD 83)		
NE28/NW27-84-11-W6		11 N 6244273	E 335460

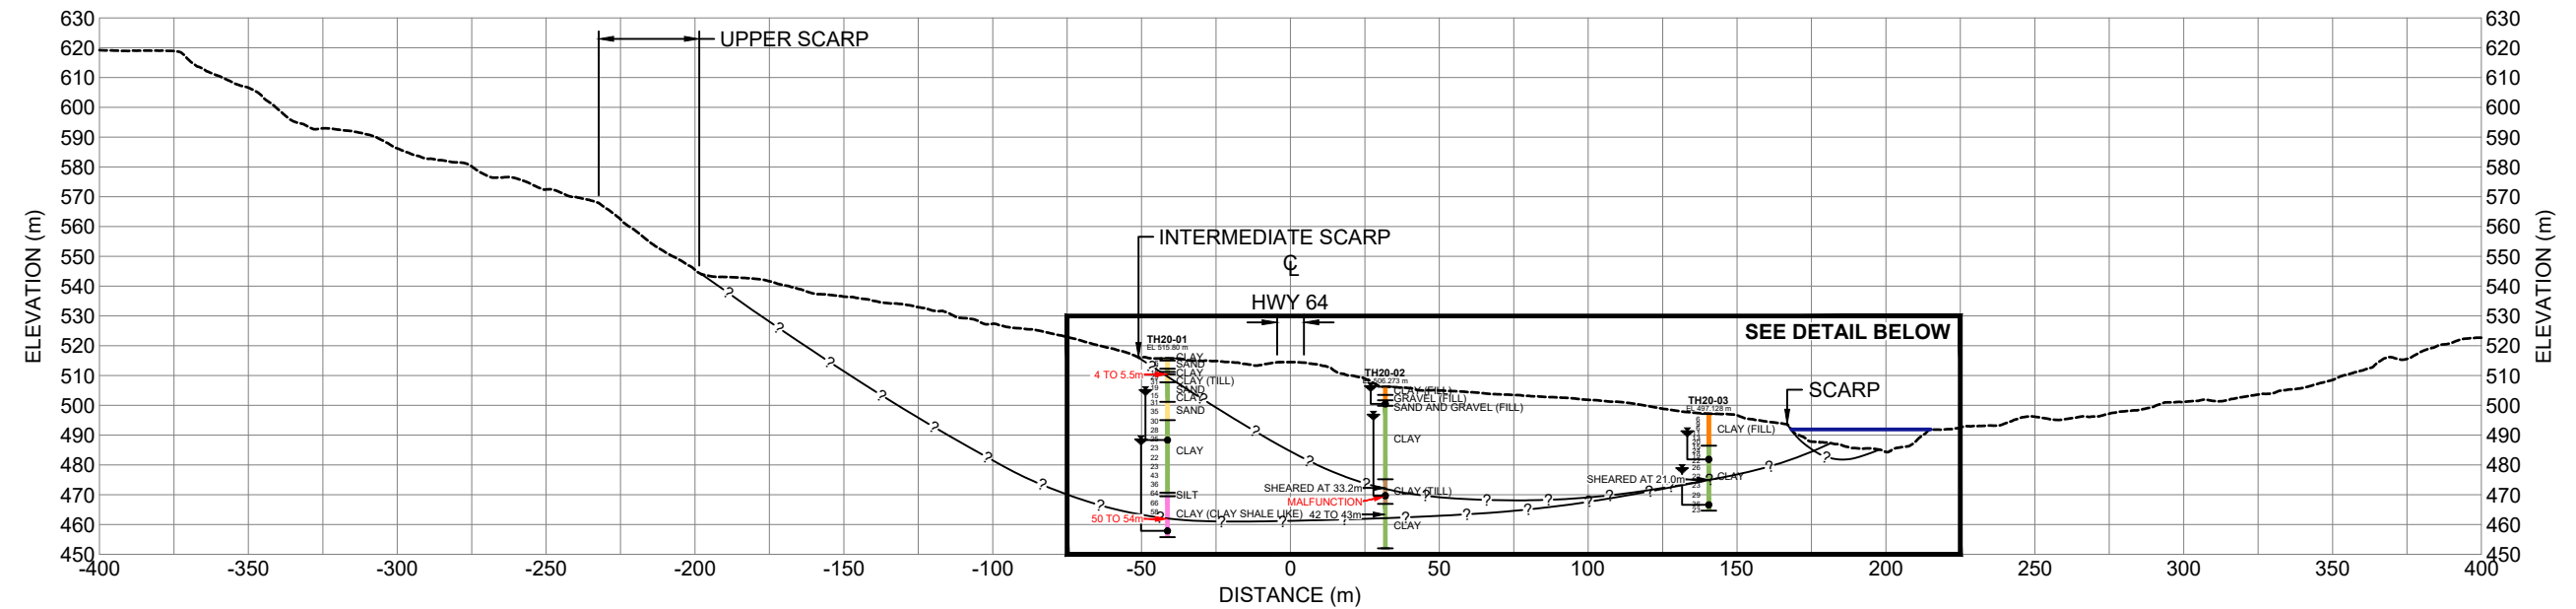
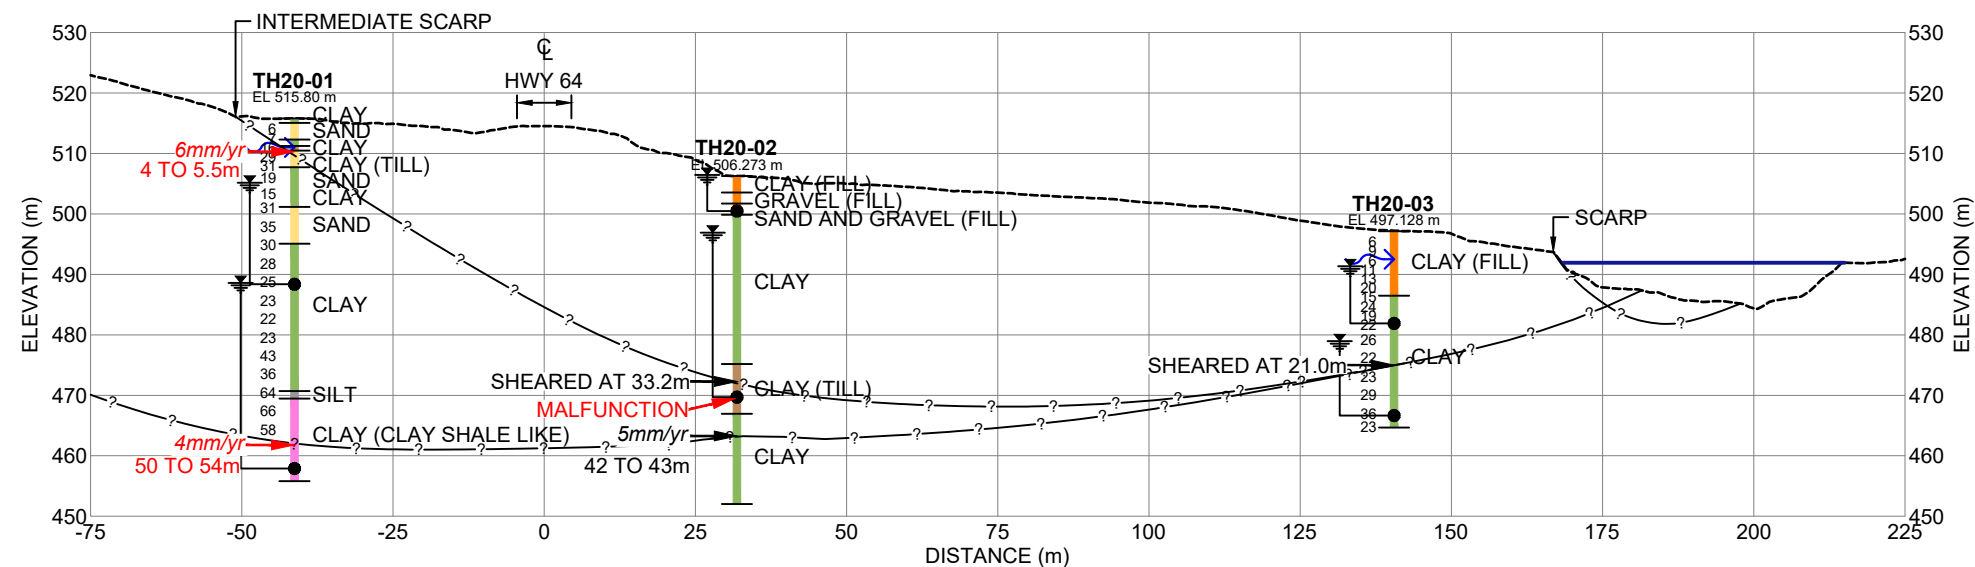
**DWG No. 32123-PH023-4**

**Instrumentation:** Last read June 15, 2025 - The inclinometer movement zones, and piezometer tip depth measurements are shown on the cross-sections attached (Drawings PH023-4 to -6).

**88-09:** Sheared at 5.5m. **20-1:** 6mm/yr @ 4 to 5.5m; & 4mm/yr @ 50 to 54m. **20-2:** Sheared off at 33.2m (but former movement zones @ 32 to 34m & 42 to 43m). **20-3:** Sheared off at 21.0m (former movement zone @ 19.5 to 21m). **20-4:** Sheared off at 7.6m (but former movement zones @ 6 to 8m & 60 to 62m). **20-5:** Sheared off at 11.6m (but former movement zones @ 9 to 12m & 31 to 36m). **20-6:** Sheared off at 20.1m, (but former movement zones @ 18 to 20m & 28 to 31m). **20-7:** 2mm/yr @ 18 to 20m; & 3mm/yr @ 32 to 34m. **20-8:** Sheared off at 36.2m (former movement zone @ 34 to 37m).

- At Section A (near the east end), two additional measures include: a) Lowering the water table by 2 to 3 m over a 100 m wide x 250 area long area by installing a series of closely spaced trench (slot) drains that drain into the base of the tributary fill; and b) Reconstructing a 200 m length of slide compromised highway with lightweight fill by excavating a 5 m thickness of ACP, GBC, and clay fill.

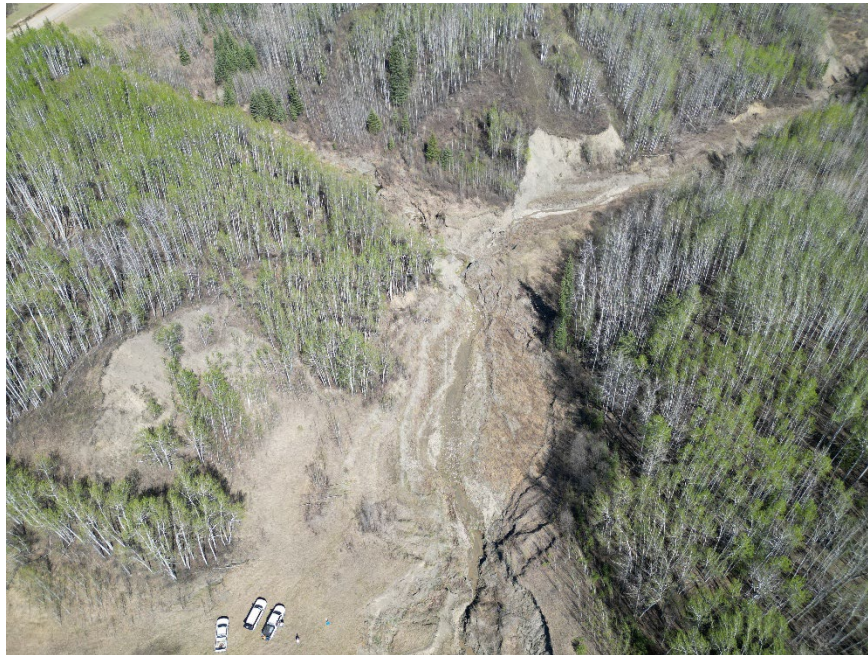
**Photo 1 – UAV Looking east at the east end of the site where the tributary channels merge.**

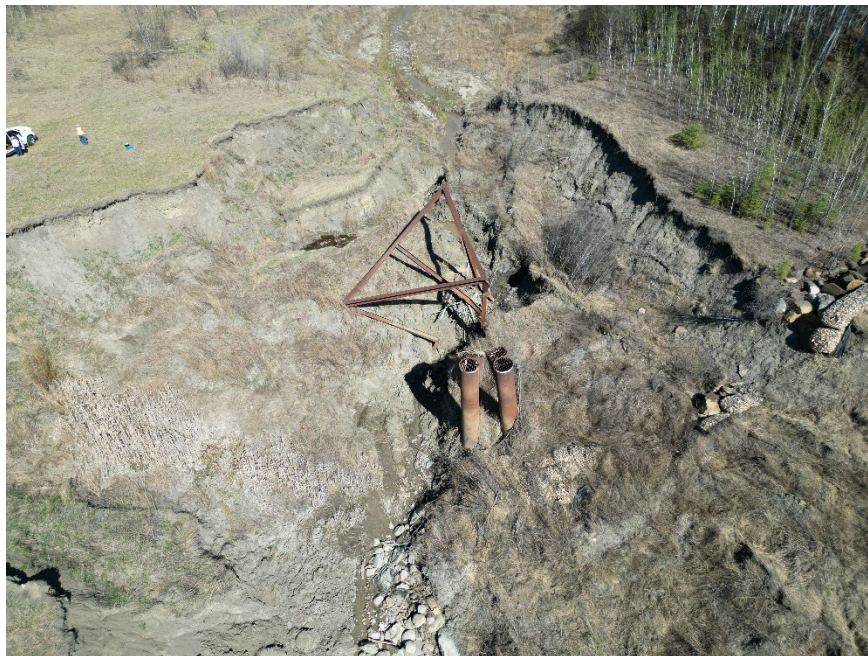
<input checked="" type="checkbox"/> Bridge/Culvert	The twin culverts installed in the creek below the toe berm are ineffective due to silt build-up and channel erosion. The trash rack is toppling due to loss of support.	<input checked="" type="checkbox"/>	<input type="checkbox"/>

**Photo 2 – UAV Looking east at the trash rack, twin culvert riser pipes, and remaining gabion remnants.**

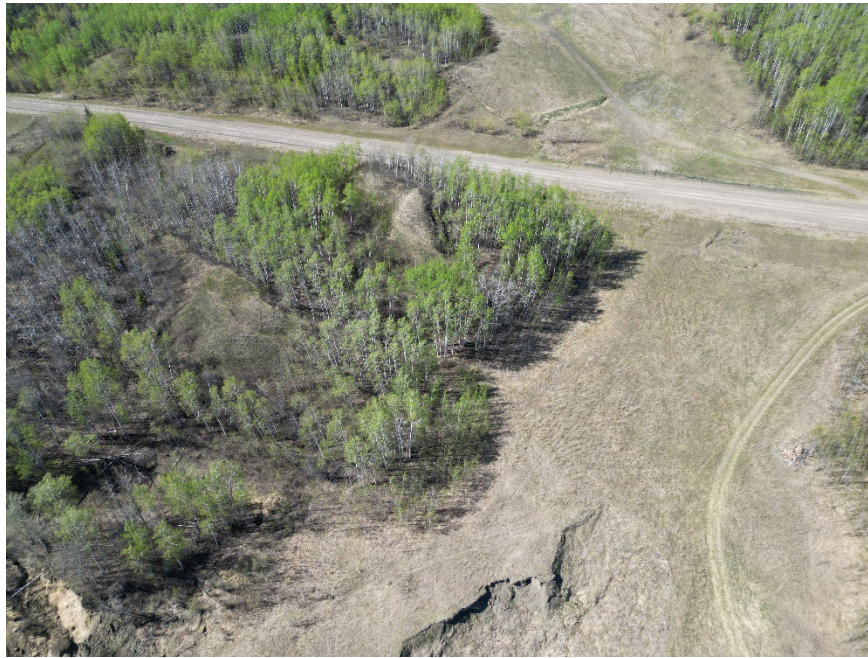
**Photo 3 – UAV Looking north across the highway at the east end of the site.**

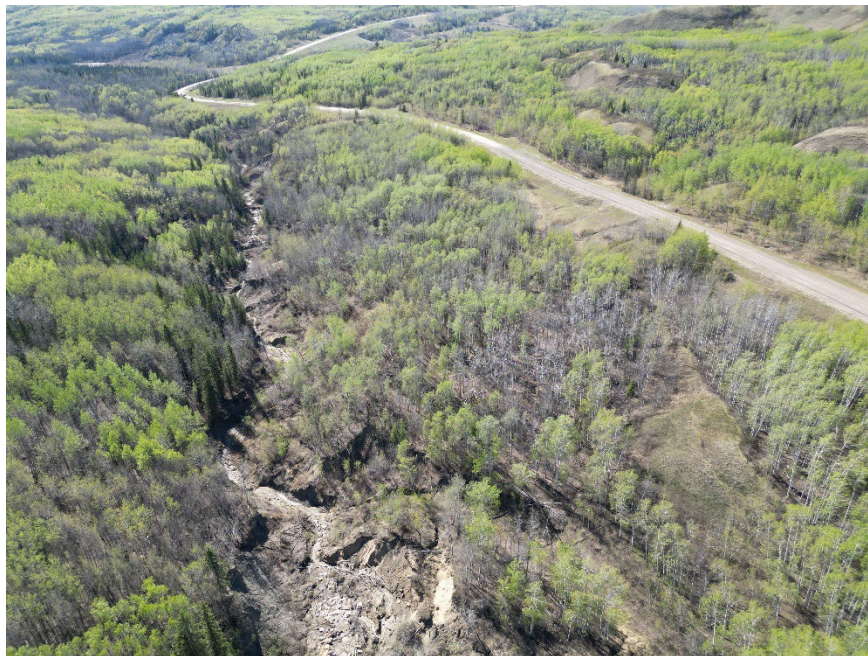
**Photo 4 – UAV Looking west along the highway and tributary.**

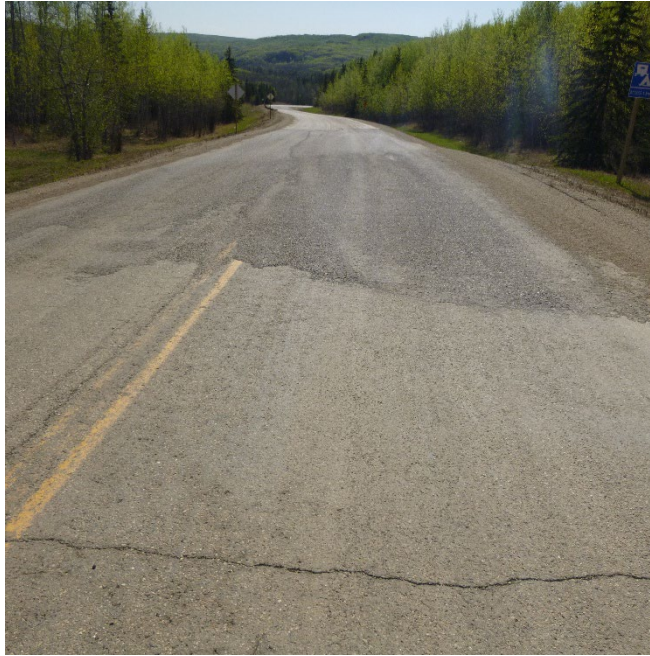
**Photo 5 - Looking west at the milled/patched area over the two slide cracks first observed in 2013 that mark the west boundary of the slide on the highway.**

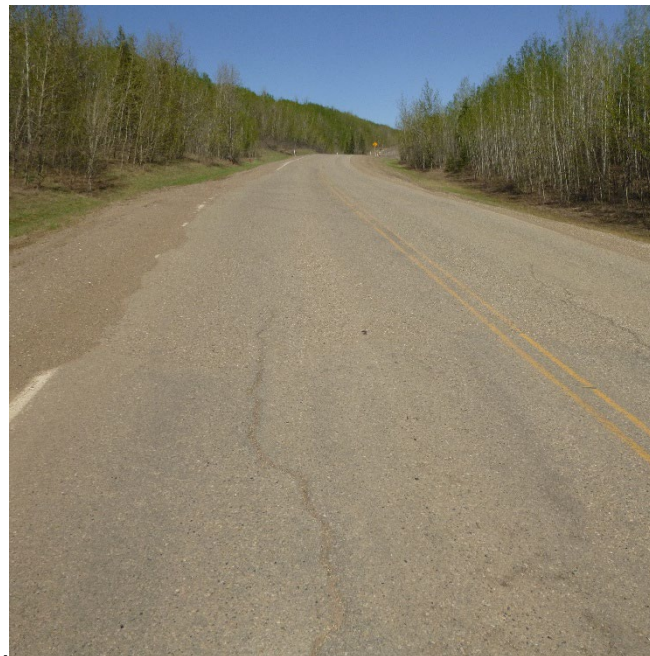
**Photo 6 – Looking east at the same slide crack and scarp as Photo 5 that extends into the north ditch. Note the two settled areas along the north edge of the highway embankment.**

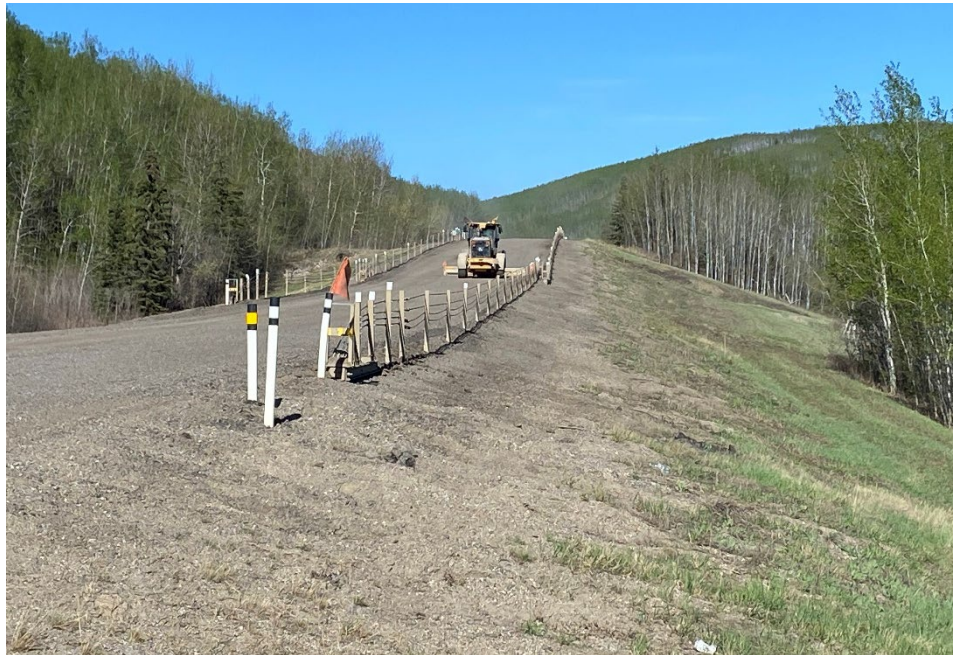
**Photo 7 – Looking east just east of where a landslide crack and large dip used to be visible in the road surface and north ditch before the road surfacing was converted to gravel in 2023.**

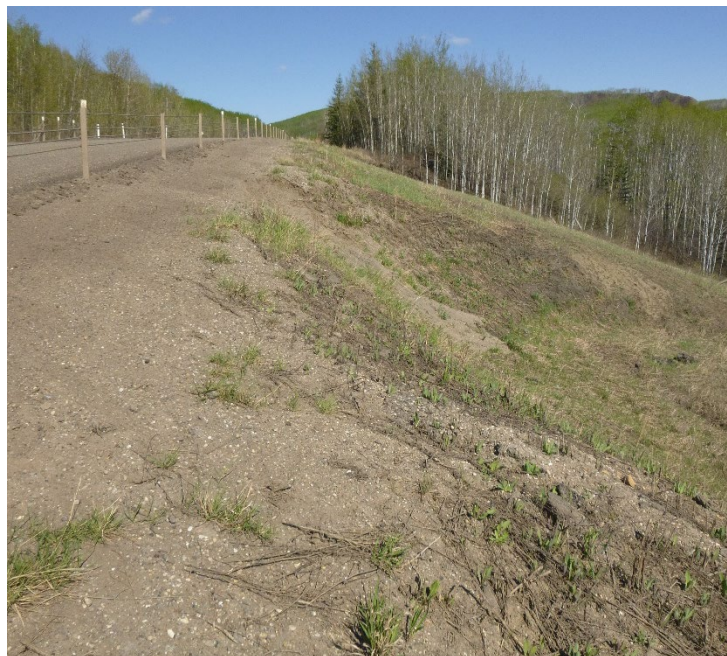
**Photo 8 – Looking east at Embankment Slump B on the south side of the hwy.**

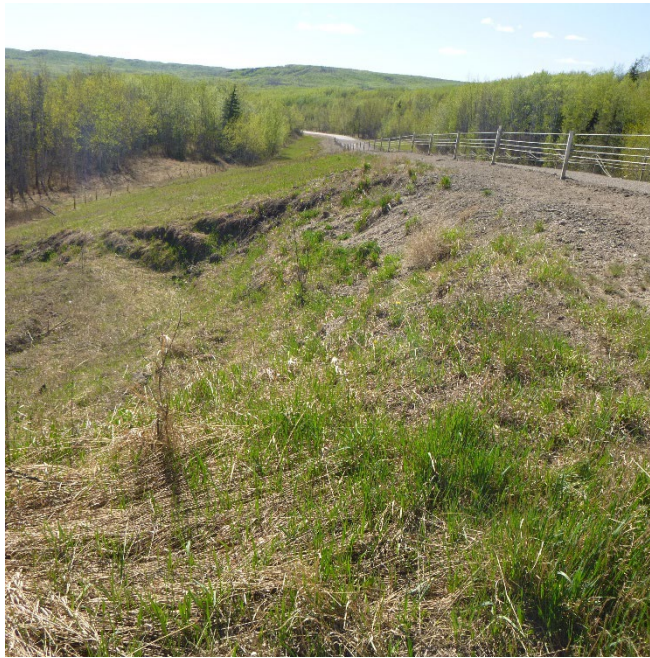
**Photo 9 – Looking west along the south edge of the highway at Embankment Slump A.**

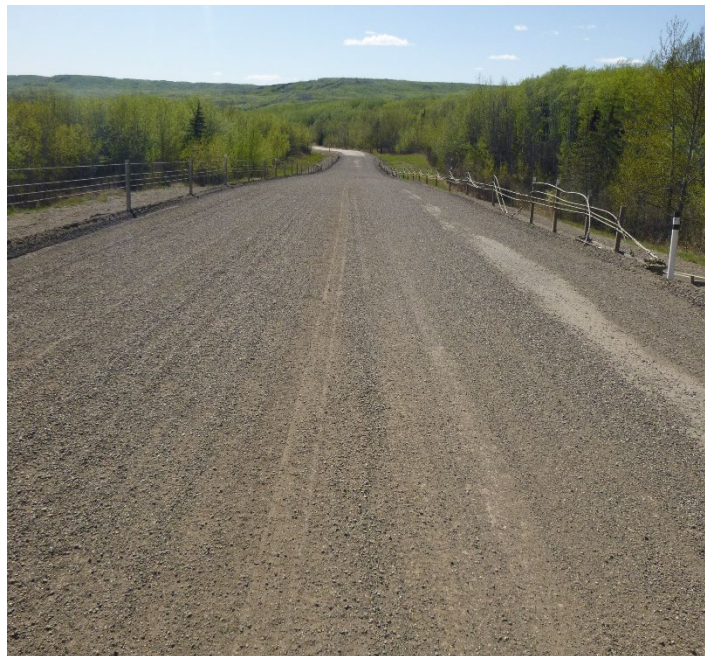
**Photo 10 – Looking west along the road. Note the damaged and loose north HTCB.**

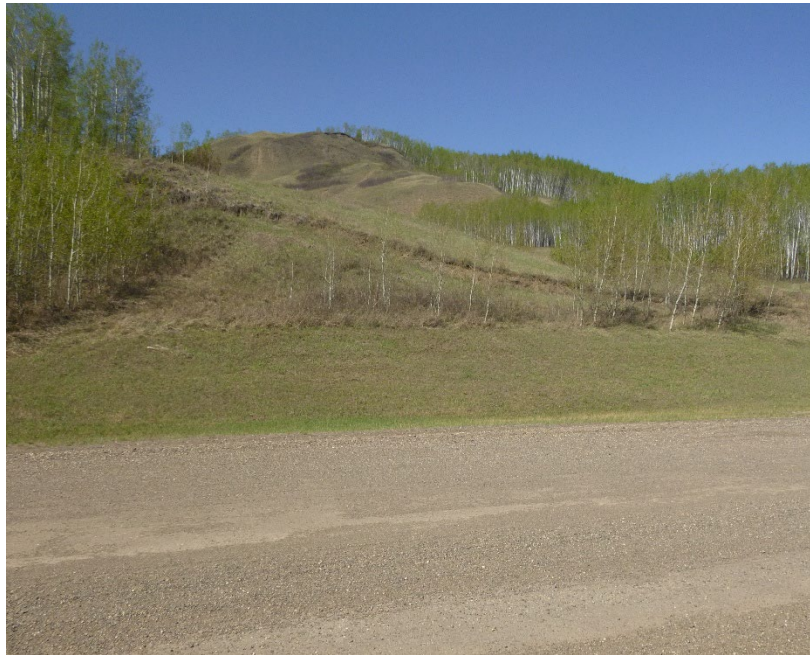
**Photo 11 – Looking north at the slide scarp running along the hill above and to the west of the east end of the site.**

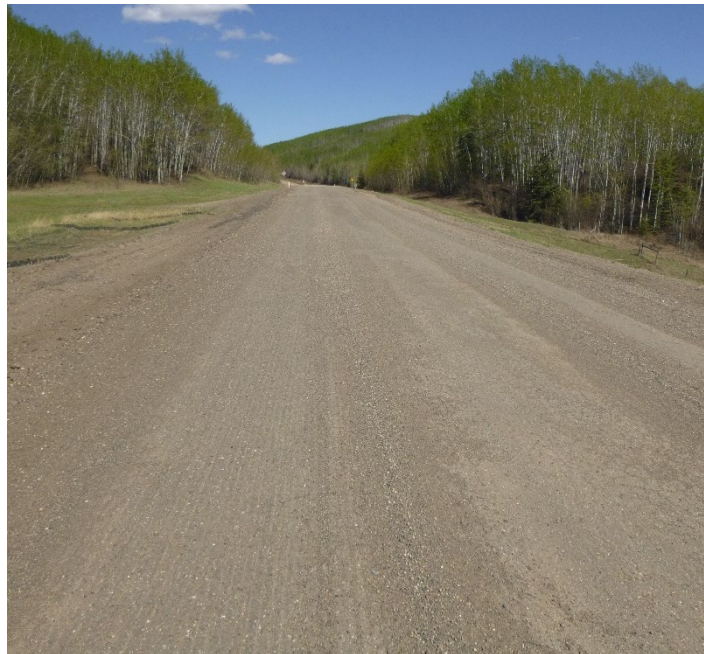
**Photo 12 – Looking east along the north ditch that was re-graded and lined with TRM, across the area where the east slide crack was affecting the highway.**

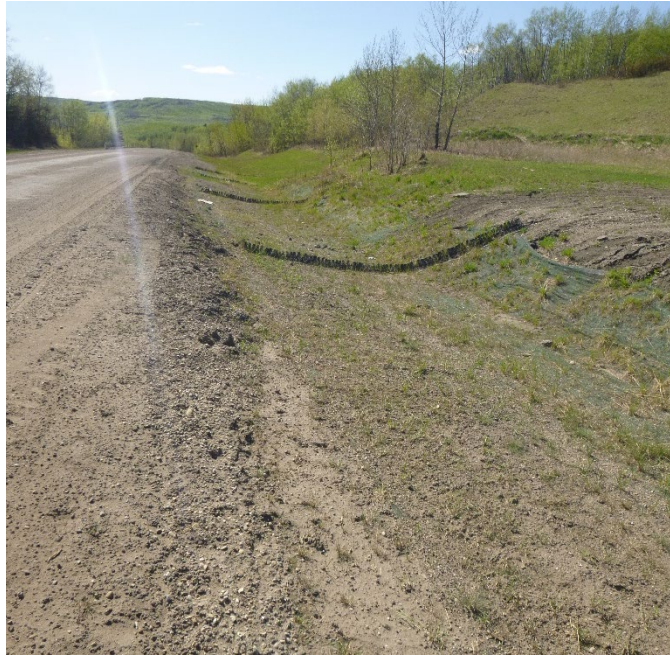
**Photo 13 – Looking west along the north highway ditch at the former sagged area that had ponded water. Water was drained, the former north approach was removed and the ditch was graded and lined with TRM as part of the 2023 road surface gravel conversion project.**

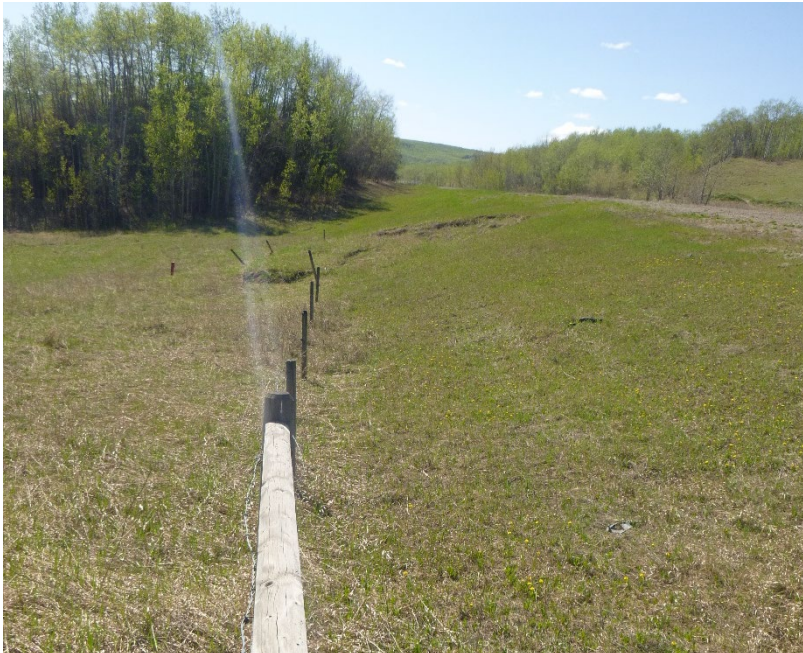
**Photo 14 – Looking west at the slump in the south highway embankment sideslope at the east end of the site. Note how the toe has pushed the fence downslope.**

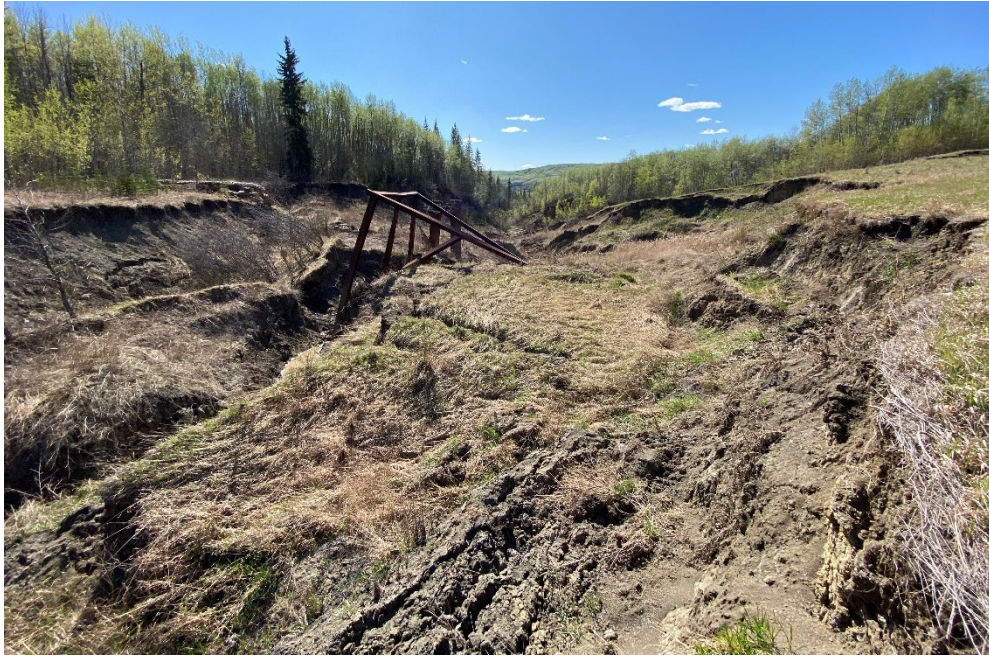
**Photo 15 – Looking west along the eroded channel at the twin pipe riser inlets, eroded trash rack, and gabion remnants.**

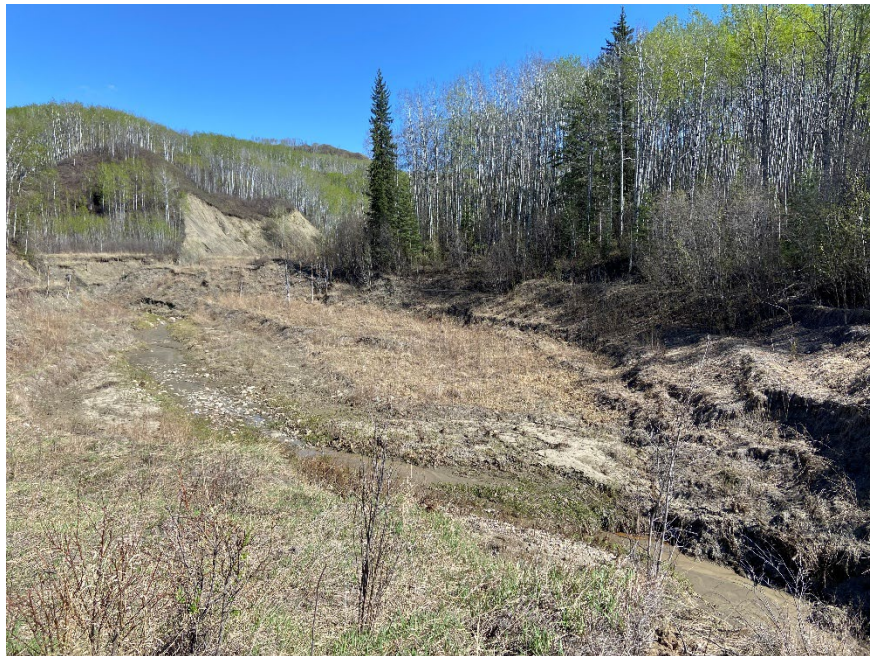
**Photo 16 – Looking east at the upstream end of the eroded and silted in tributary channel.**

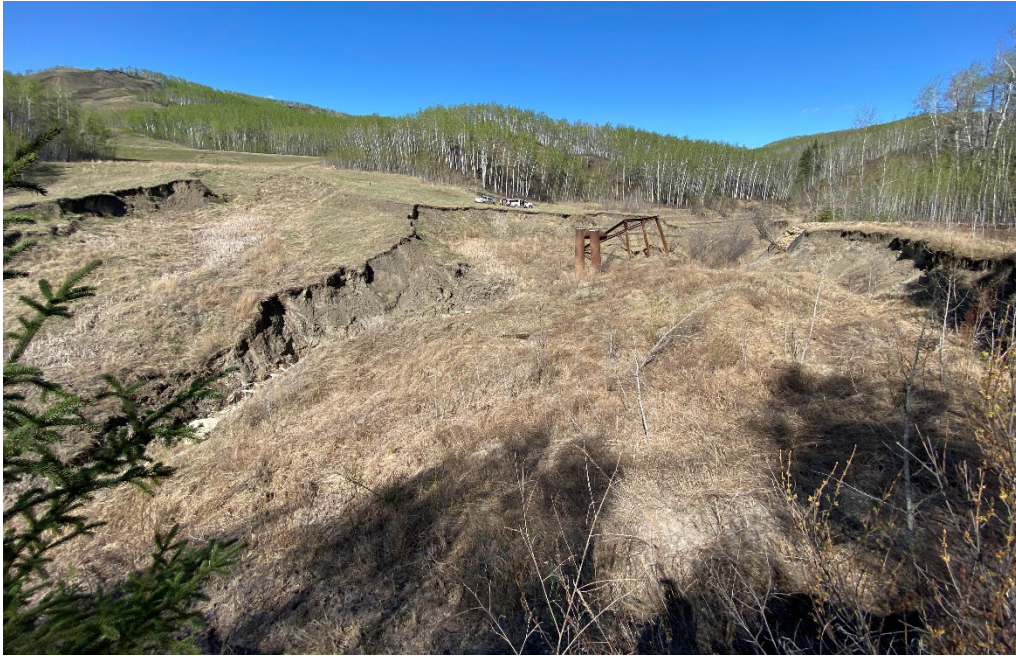
**Photo 17 – Looking north across the eroded tributary channel towards the highway, at the eroded piping area (LHS), twin pipe inlets and trash rack (Center), and eroded gabion weir (RHS).**

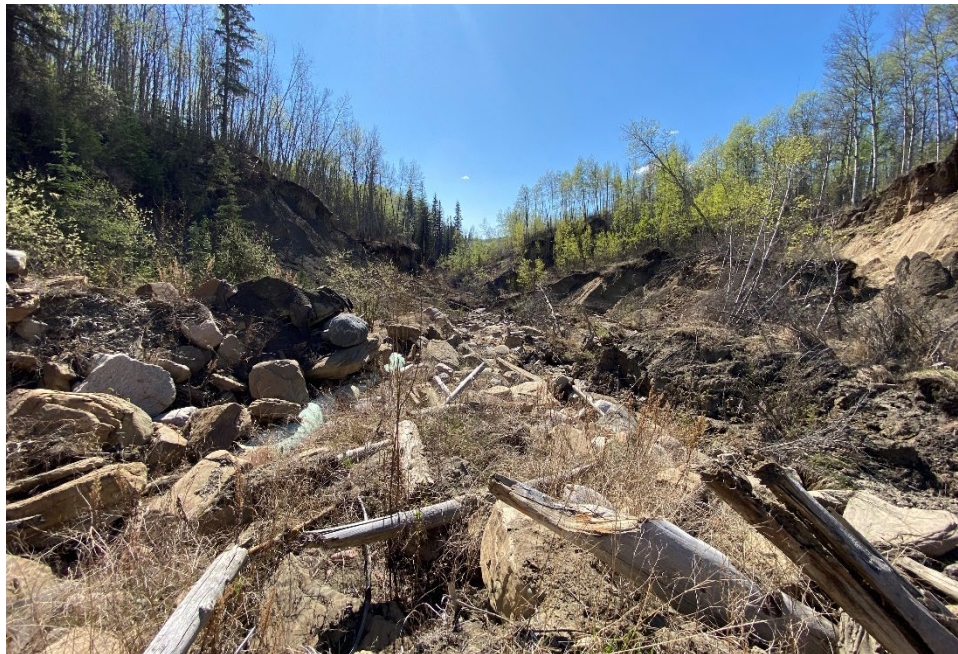
**Photo 18 – Looking west along the eroded creek channel at the twin pipe outlets.**

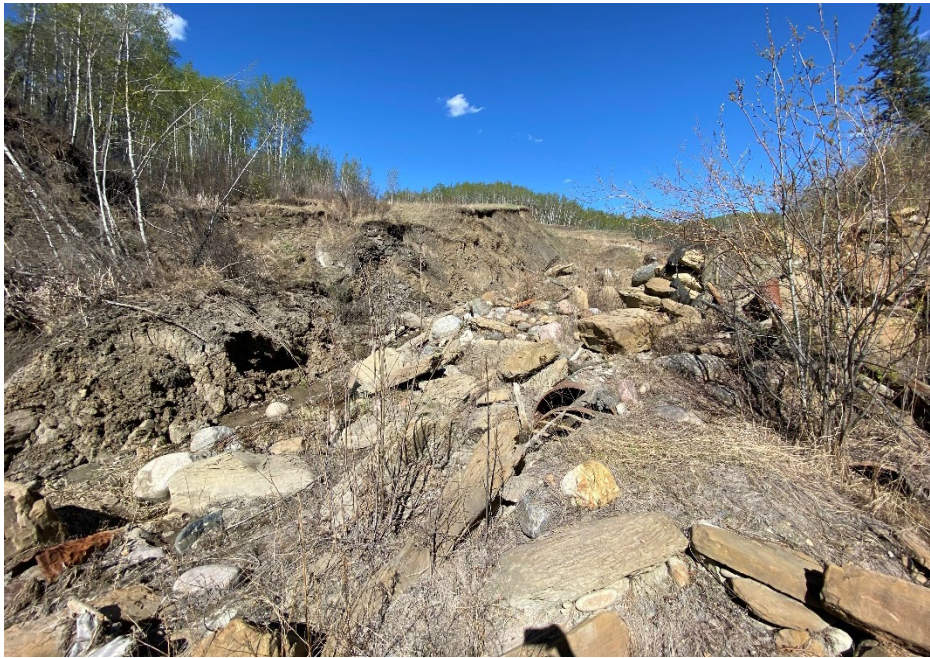
**Photo 19 – Looking east along the channel at the twin pipe outlets.**

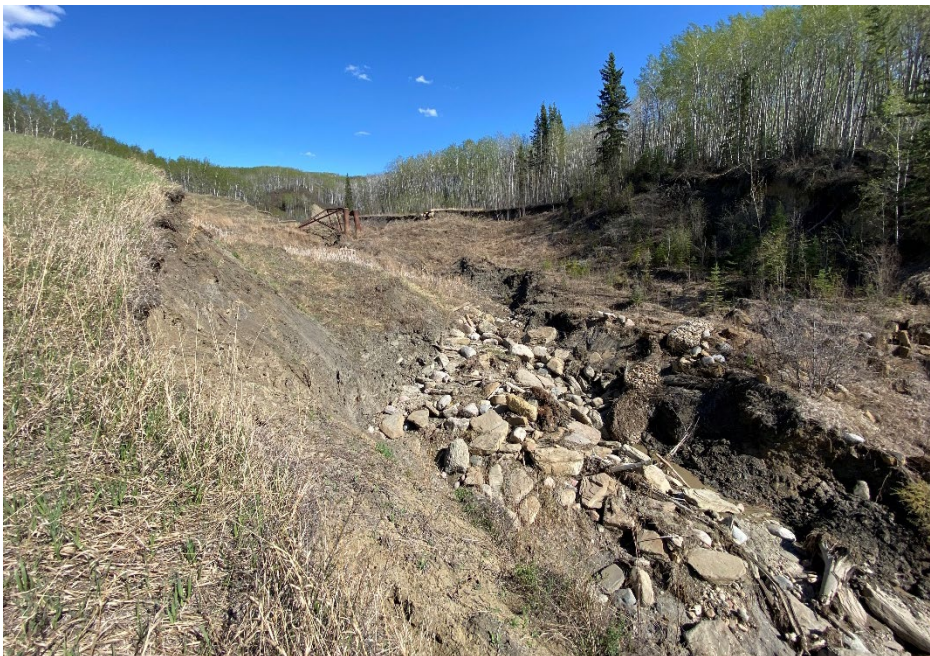
**Photo 20 – Looking east along the eroded channel from the site center.**
