ALBERTA TRANSPORTATION AND  
ECONOMIC CORRIDORS GRMP  
PEACE REGION  
(GRANDE PRAIRIE DISTRICT - NORTH)  
INSTRUMENTATION MONITORING - SPRING 2025

Site Number	Location	Name	Hwy	km
PH023	HWY 64:02 km 24.10	Clear River East Hill (Site 5- Twin Pipes Landslide)	64:02	Km 24.1
<b>Legal Description:</b> 12-27-84-11 W6		<b>UTM Co-ordinates</b>		
		11U E 335453	N	6244315

<b>Current Monitoring:</b>	15-June-2025	<b>Previous Monitoring</b>	24-Sep-2024
<b>Instruments Read By:</b>	Mr. Niraj Regmi, G.IT. and Mr. Godfred Etiendem of Thurber

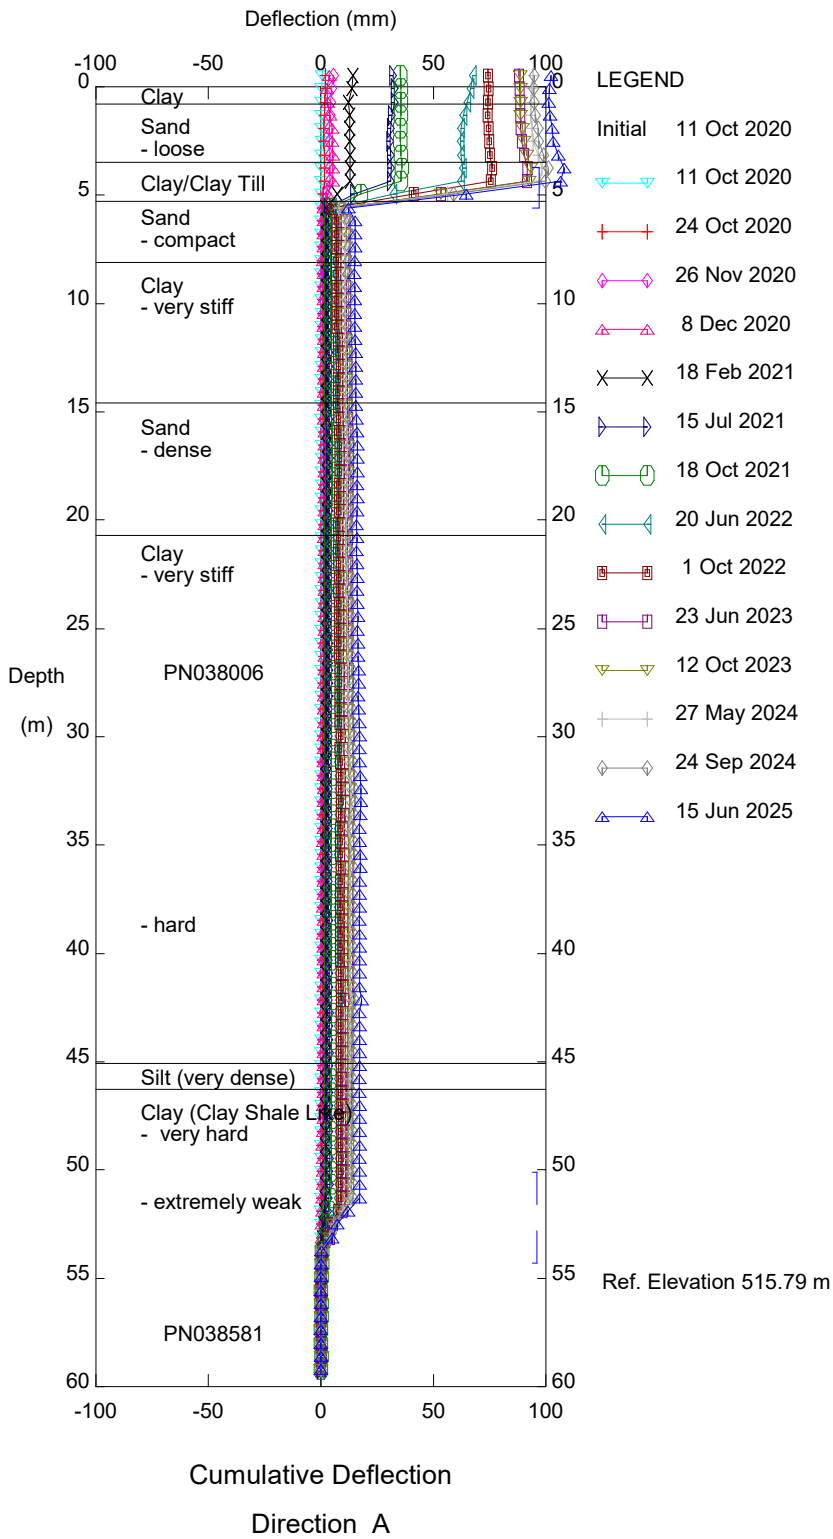
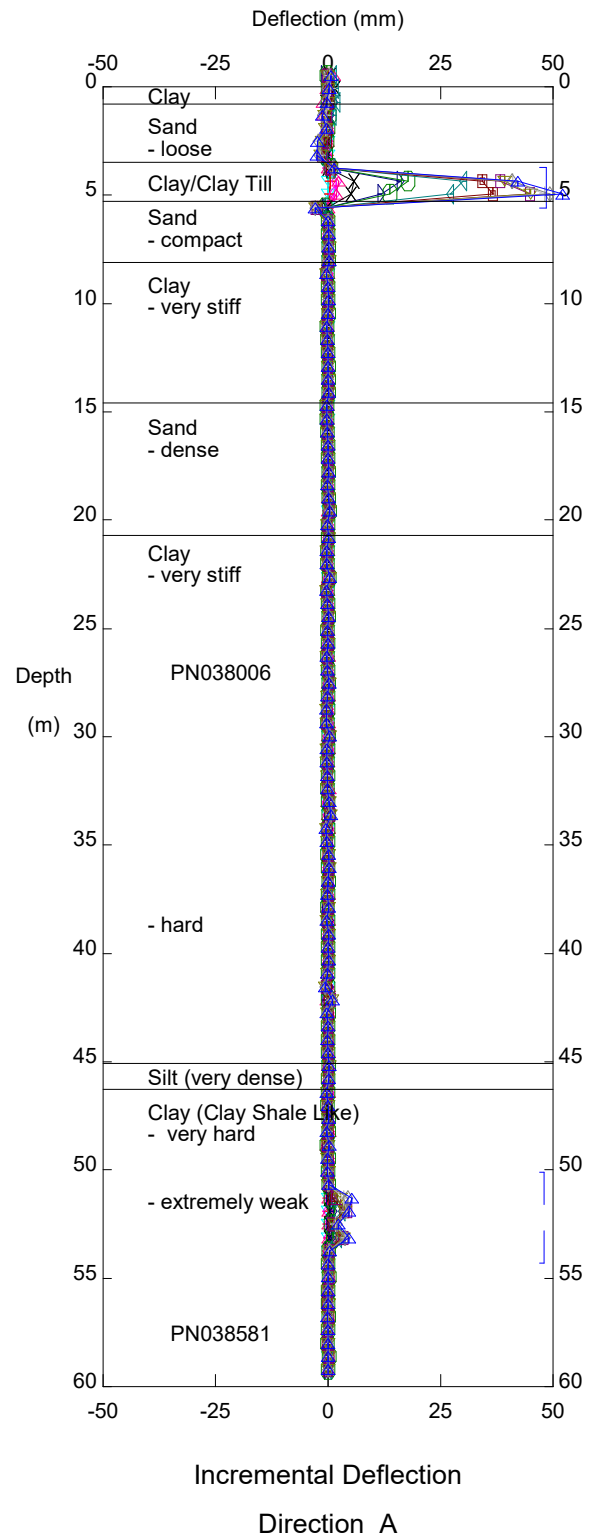
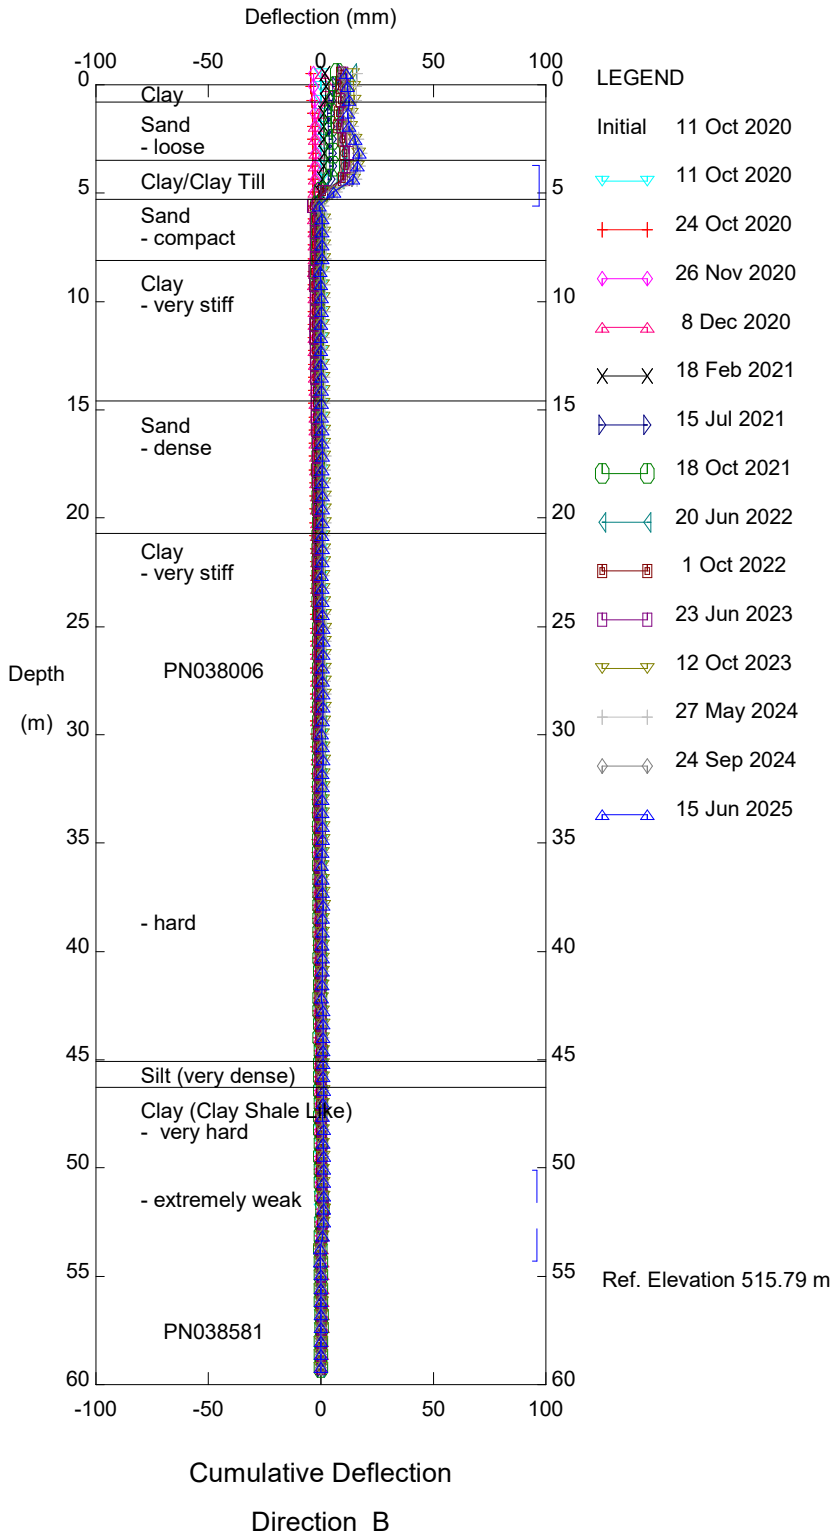
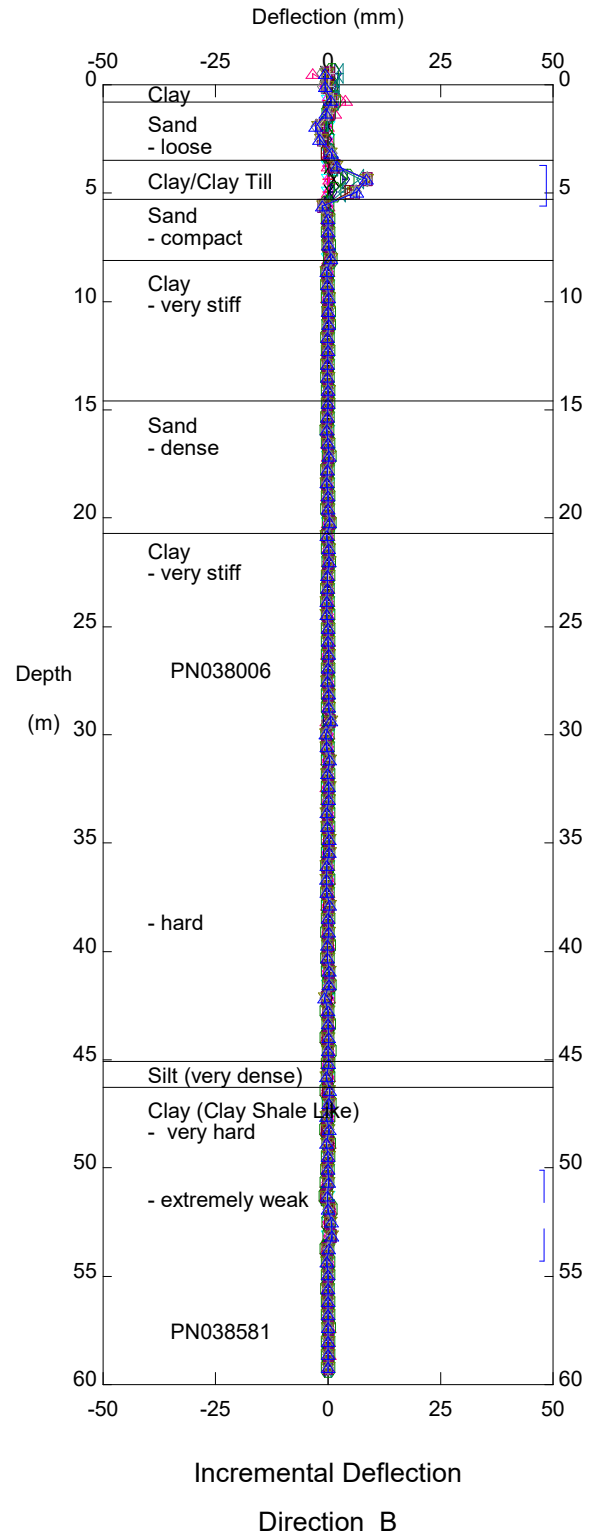
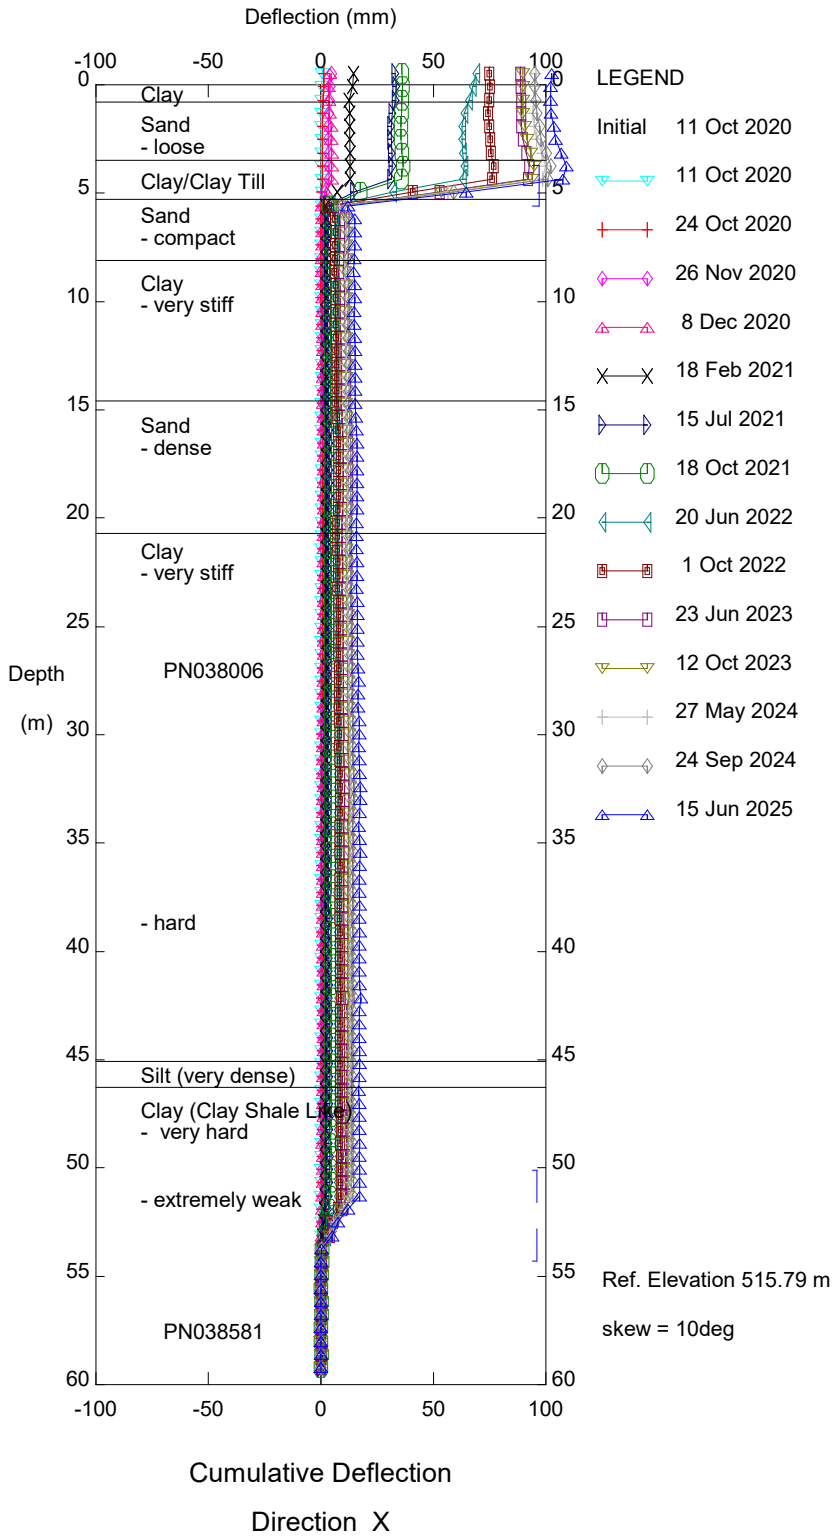
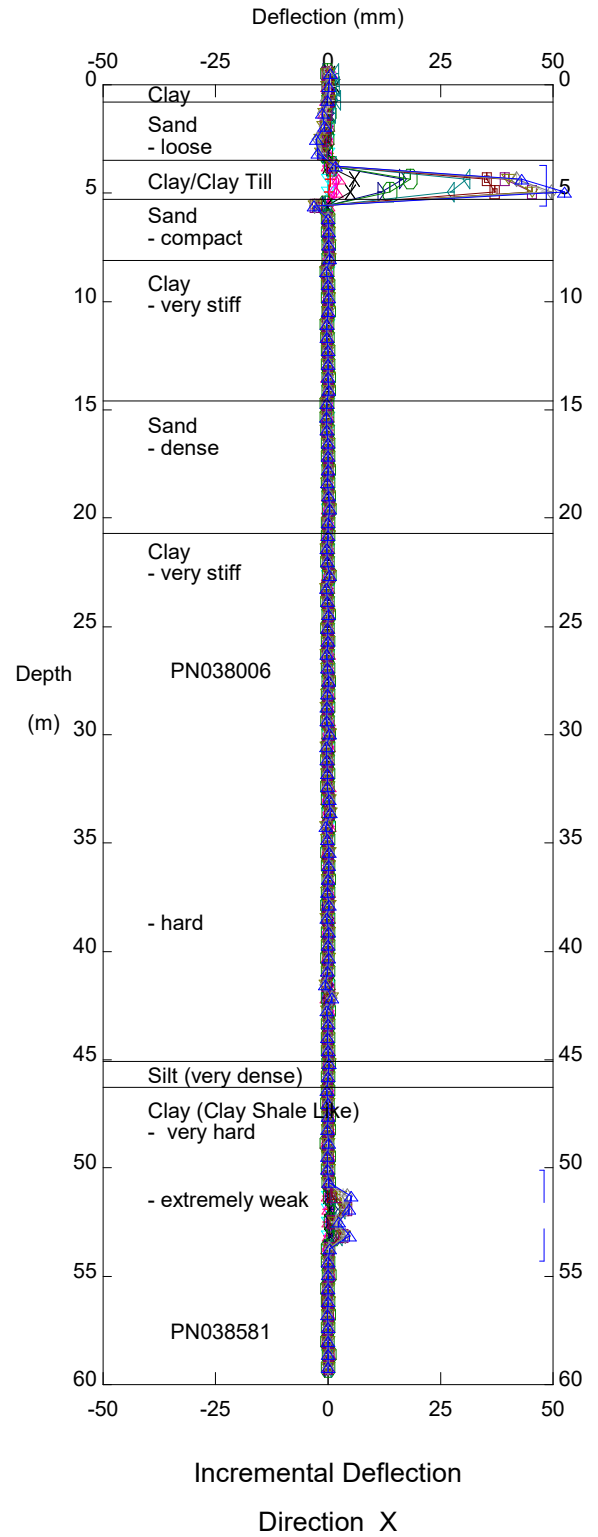
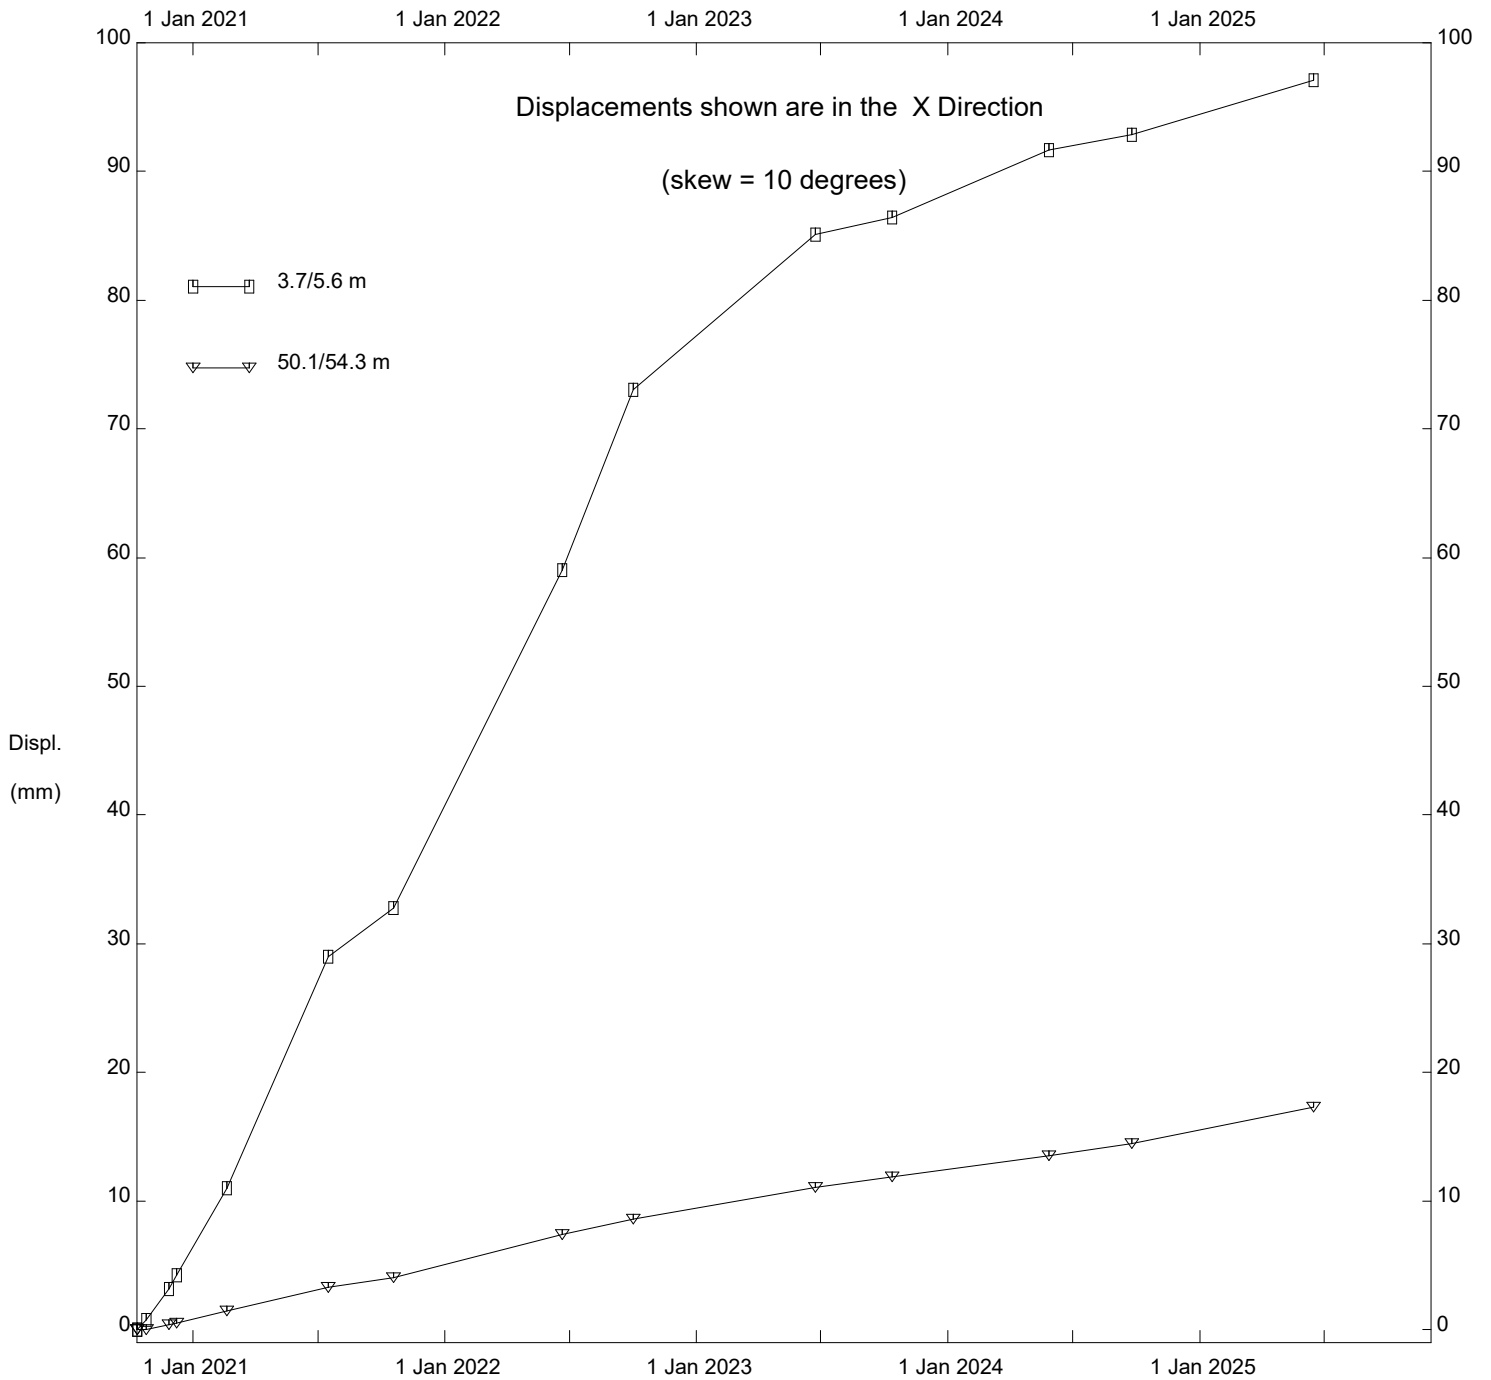
Hwy 64:02 Twin Pipes Landslide (PH023), Inclinometer SI20-1

Discussion	
<b>Zones of New Movement:</b>	None
<b>Interpretation of Monitoring Results:</b>	<p>Overall, the SIs showed slightly accelerated rates of movement compared to the previous readings in the fall of 2024.</p> <p>SI20-1 showed current movement rates of 5.8 mm/yr over 3.7 m to 5.6 m depth and 4.0 mm/yr over 50.1 m to 54.3 m depth. SI20-7 showed rates of movement of 1.8 mm/yr over 17.8 m to 19.6 m and 2.6 mm/yr over 31.8 m to 33.6 m depth. SI 20-1 and 20-7 are about 600 m apart but both show comparable movement rates and elevation of the deeper movement zones (both SI are moving at about elevation 460 m in a weak clay strata) which is a confirmation of a very large and deeply seated movement mass.</p> <p>The groundwater levels in piezometers PN20-1A, PN20-1B, PN20-4A, PN20-7A, PN20-8A, and PN20-8B showed decreases in groundwater levels of 0.63 m, 0.70 m, 0.07 m, 0.28 m, 0.07 m and 1.13 m, respectively, since the fall of 2024 readings. PN20-2A, PN20-3A,</p>

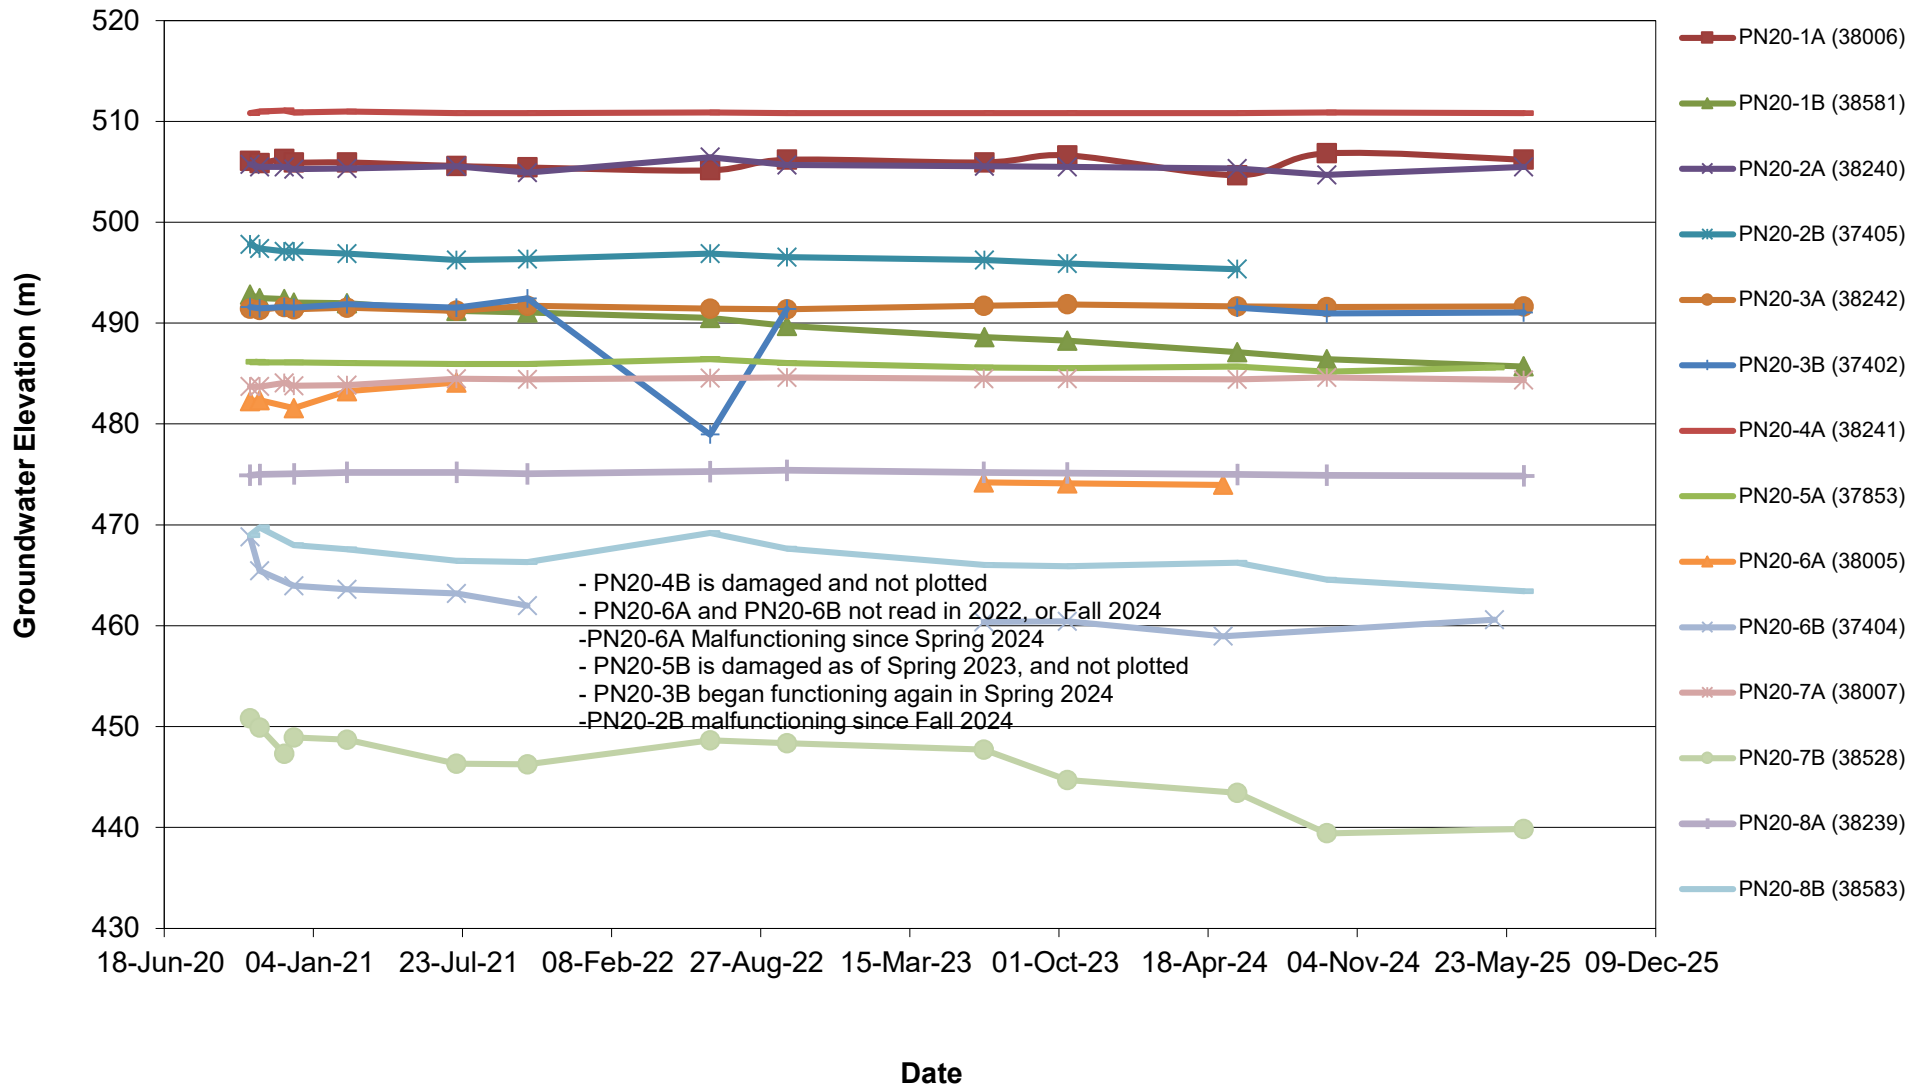
**FIGURE PH023-1**  
**HWY 64:02 - CLEAR RIVER EAST HILL - (SITE #5)**  
**PIEZOMETRIC ELEVATIONS**

<p>PN20-3B, and PN20-7B showed increases in groundwater level of 0.77 m, 0.07 m, 0.07 m, and 0.43 m, respectively, since the fall of 2024 readings.</p> <p>PN20-5A and PN20-6B were read during the annual site inspections on May 7, 2025. PN20-5A and PN20-6B showed increases in groundwater level of 0.42 m and 1.61 m, respectively, since their last readings in May 2024.</p> <p>PN20-2B appears to be malfunctioning and the reading wasn't tabulated this cycle. PN20-7B has shown a trend of decreasing pressures and readings over the last few reading cycles to near 0 PSI and may be malfunctioning; this pattern should be confirmed during the next reading.</p>
<b>Future Work:</b>	<p>The instruments should be read again in the fall of 2025. PN20-2B and PN20-7B are still malfunctioning and should be removed from future reading cycles. PN20-2B, 20-4B, 20-5B &amp; 20-6A are inoperable and will not be read any more.</p> <p>Since TH 20-5 and 20-6 require bear scare escort personnel and these SI's have sheared, the two remaining operable piezometers (20-5A and 20-6B) where good base readings have been established, will not be read any more in the interest of cost effectiveness.</p>
