**ALBERTA TRANSPORTATION  
GEOHAZARD ASSESSMENT PROGRAM  
PEACE REGION (GRANDE PRAIRIE DISTRICT- NORTH)  
2021 INSPECTION**

Site Number	Location	Name	Hwy	km
PH024	11 km W. Cleardale	Clear River East Hill-(Old Site 8)	64:02	24.2-25.5
Legal Description		UTM Co-ordinates (NAD 83)		
NE27/SE34-84-11-W6		11 N 6244830	E 336445

Date	PF	CF	Total
<b>Previous Inspection:</b>	June 16, 2020	12	4	48 (Risk Eros. Scale)
<b>Current Inspection:</b>	July 14, 2021	9	4	36 (Risk Eros. Scale)
<b>Road AADT:</b>	260		<b>Year:</b>	2020
<b>Inspected By:</b>	Don Proudfoot, Barry Meays (Thurber). Ed Szmata, Roger Skirrow, Rocky Wang, Ken Szmata, Max Shannon (AT)			
<b>Report Attachments:</b>	<input checked="" type="checkbox"/> Photographs <input checked="" type="checkbox"/> Plans <input checked="" type="checkbox"/> Maintenance Items

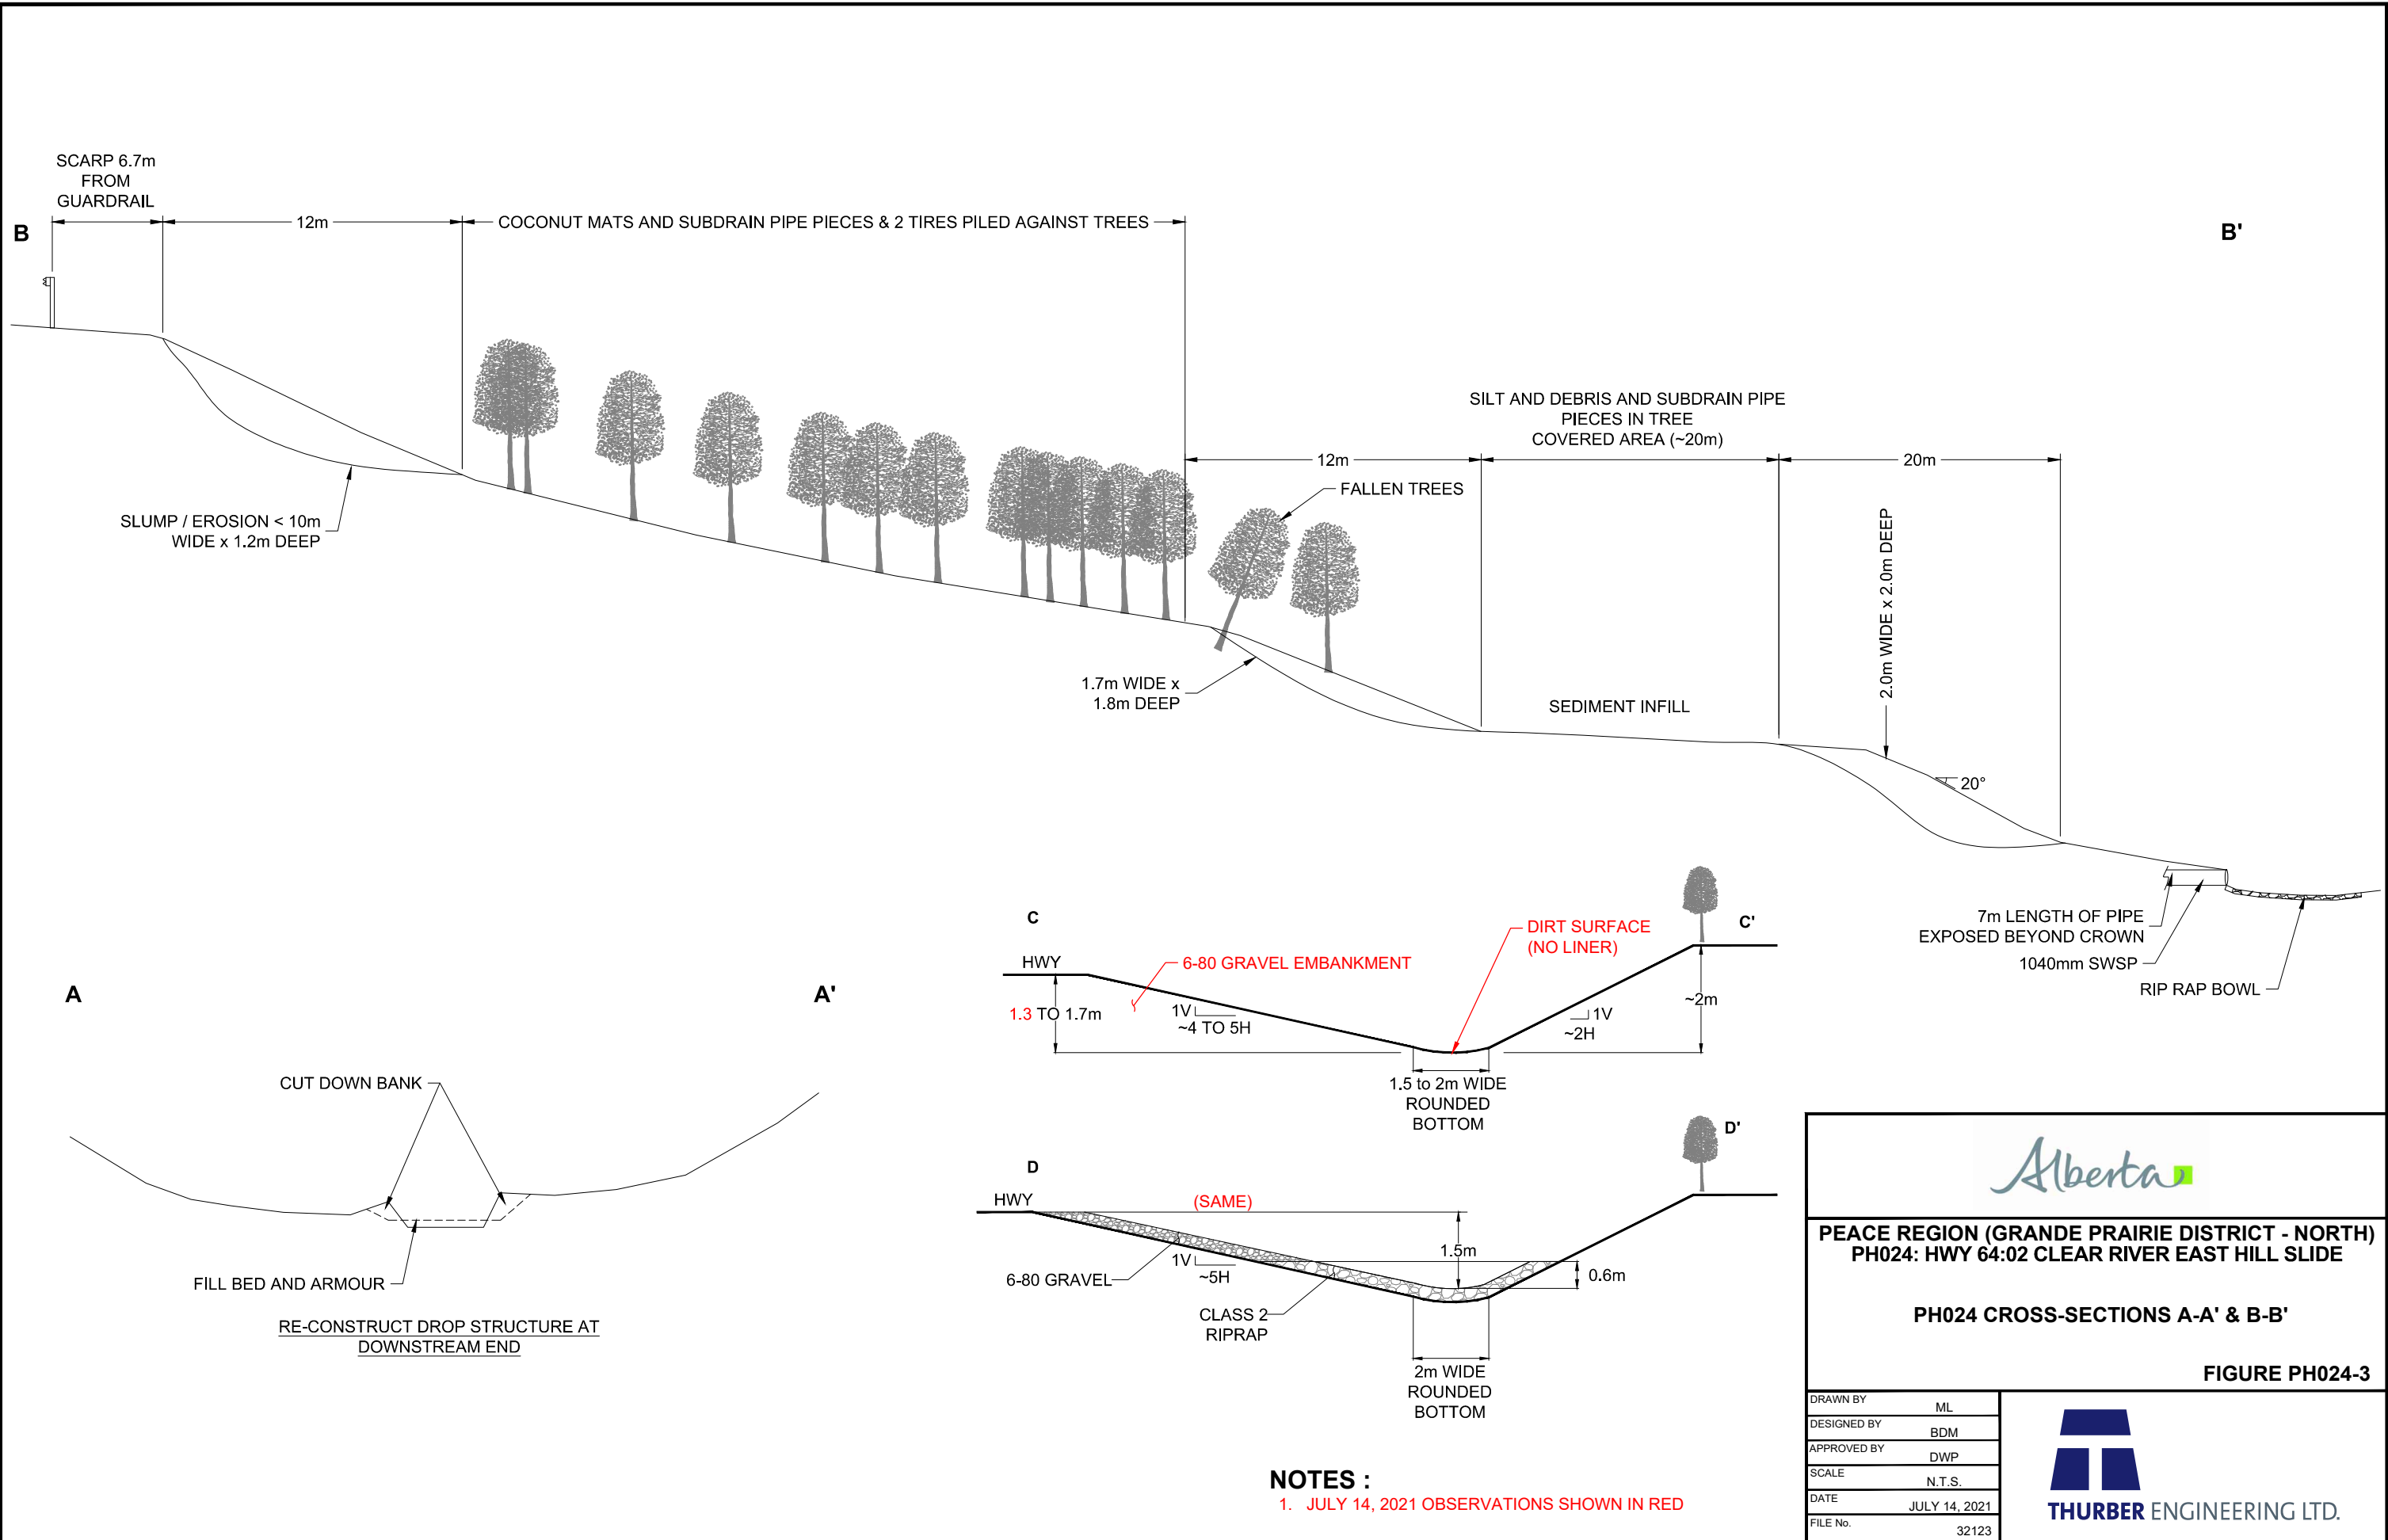
**FIGURE PH024-3**

The pitrun gravel that was used to fill 2018's erosion event was eroded and washed downslope, filling the south ditch near the west end, and water also ran overtop the highway and down the north embankment at one location. LaPrairie used a backhoe to dig part of the ditch out and swept the excess pitrun off the road. Similar south ditch erosion occurred in spring, 2020 after the 2019 installation of pitrun with TRM cover. The 2020 repairs involved grading the south embankment with 6-80 gravel, and installing a south ditch liner consisting of: 6-80 gravel over a 130 m length where the gradient was ~7 percent; then Class 2 riprap along the bottom portion of the channel over a 110 m length extending up to the 760 mm SWSP culvert where the gradient was ~9 percent, as shown on Section D-D' on Drawings PH024-1-2 and -3; and left the ditch bottom unlined west of the 760 SWSP (where a modest ditch block was constructed), as shown on Section C-C'.

The damaged gabion structures on the north side of the highway need to be reconstructed to their original condition. The downstream end of the damaged gabion drop structure furthest west (Section A-A' on Drawings PH24-1-1 and -3) should have the sideslopes trimmed back flatter, and then use some of this material to build up the bed, before armouring the bottom and sideslopes. Consideration could be given to lining the replacement structures with Class 2 riprap instead of gabion mattress. **Ballpark Cost \$100,000**

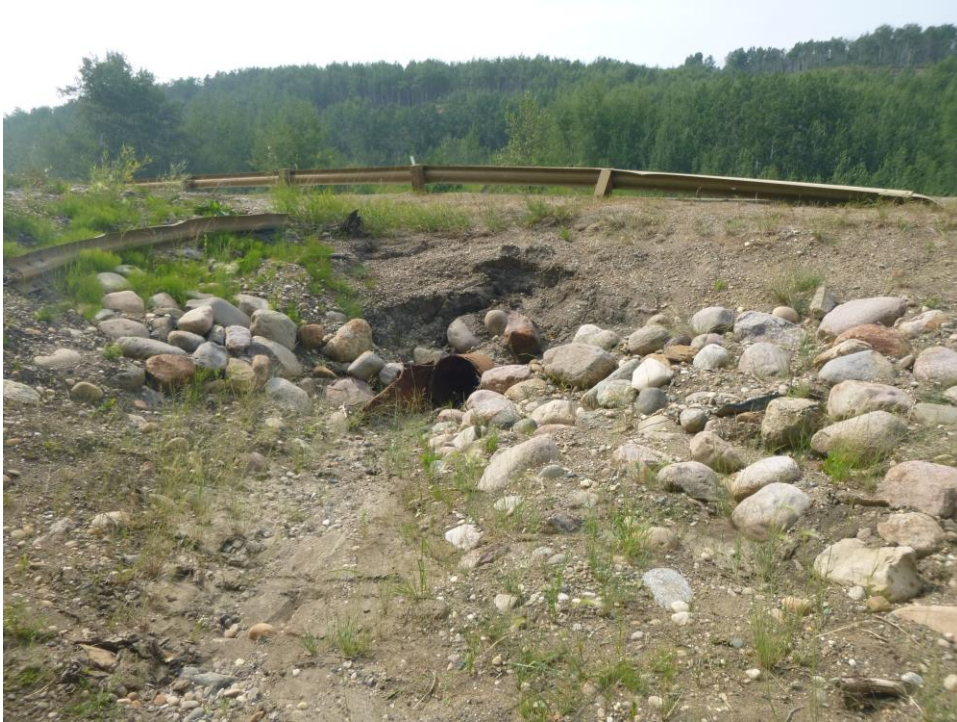
The 810 mm diameter culvert had been half full of sediment for several years. This culvert appears to have been originally installed to bring water from the south ditch across to the north side of the highway for discharge via the 1.04 m dia. SWSP centreline pipe down into the dissipation pool on the south side of the highway. It appeared that this pipe had not been allowing flow to the north side either due to lack of maintenance or after it was purposely blocked. This culvert was cleaned out in 2020, and the inlet was formed with a riprap covered inlet bowl and a downstream ditch block that grades downwards to the south which would appear to let flood water overflow to the west through the bush if this culvert backs up flow.

Photo 1 – Looking north at the inlet of the 810 CSP on the south side of the hwy embankment.

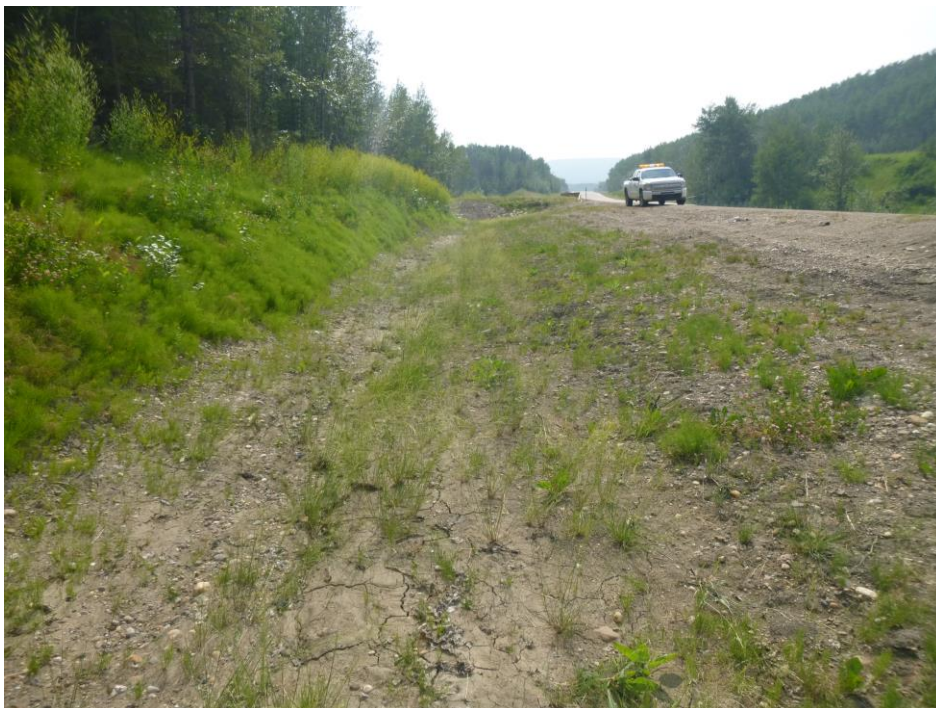
Photo 2 – Looking west along the unlined south ditch from near the west end, at the 2020 grading that took place along the south highway embankment and ditch.

As a minimum, the ~330 m long segment of the currently unlined south ditch bottom extending west of the riprap lined segment up to the 810 CSP culvert, should be topsoiled, seeded, and covered with TRM. **\$10,000**

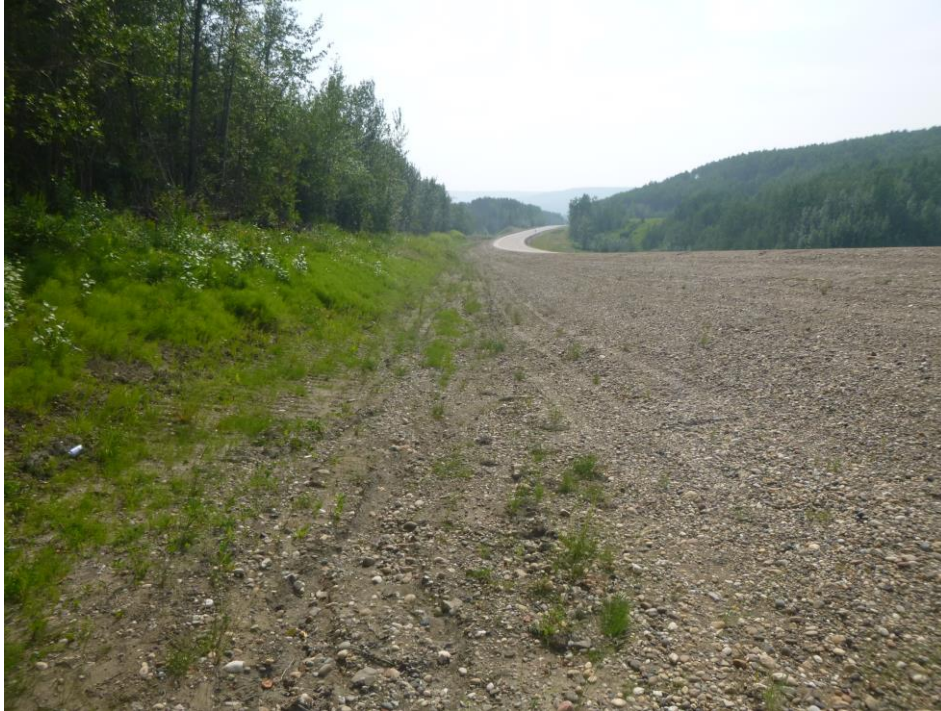
Photo 3 – Looking west along the south ditch and hwy embankment.

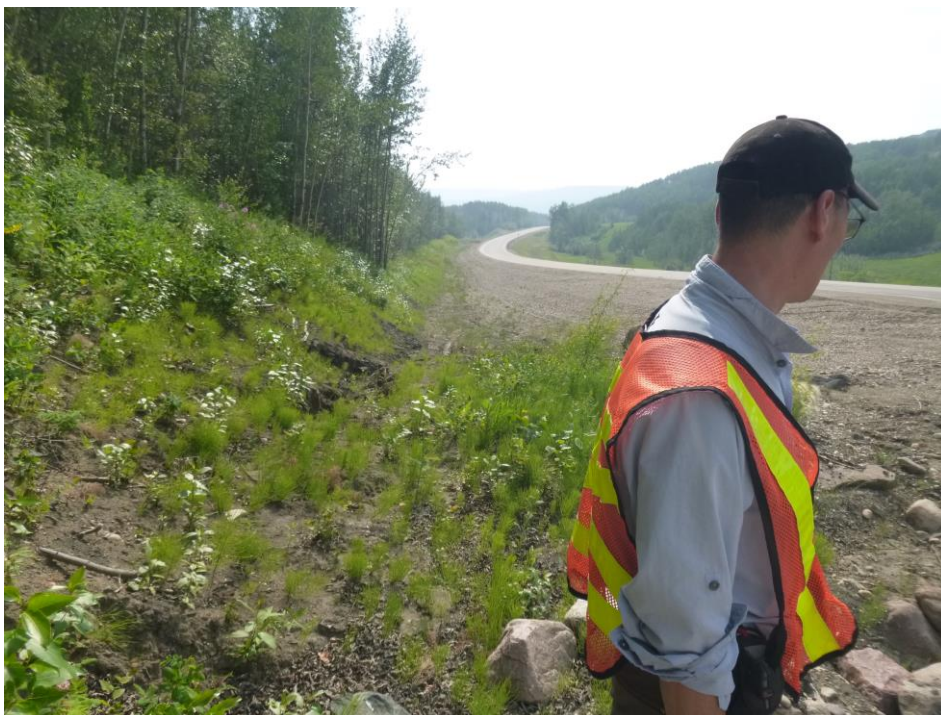
Photo 4 – Looking west along the unlined south highway ditch from the inlet of the 760 mm dia. SWSP.

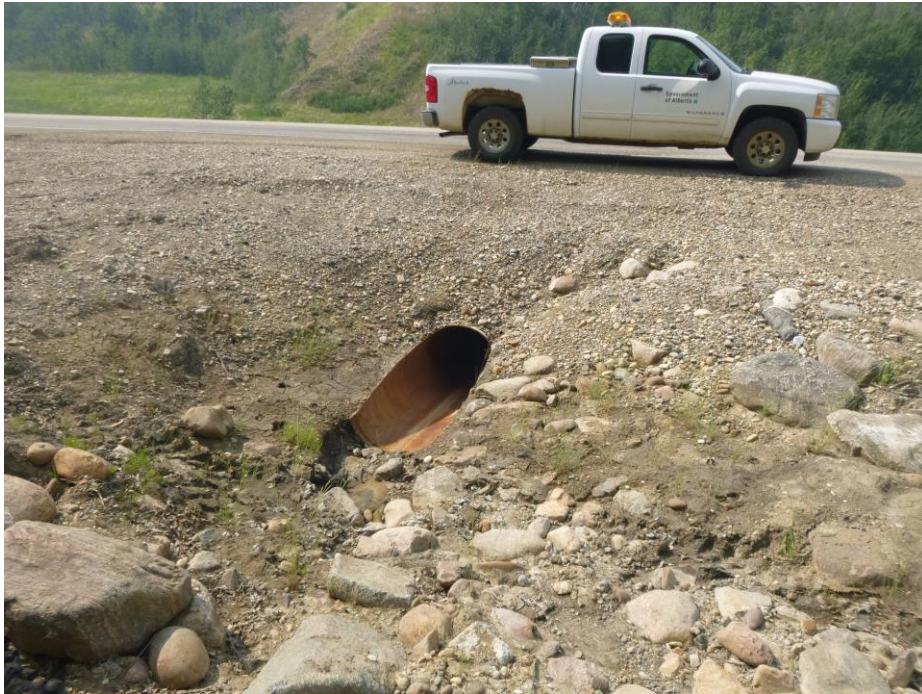
Photo 5 – Looking north at the inlet of the clean 760 mm dia. SWSP.

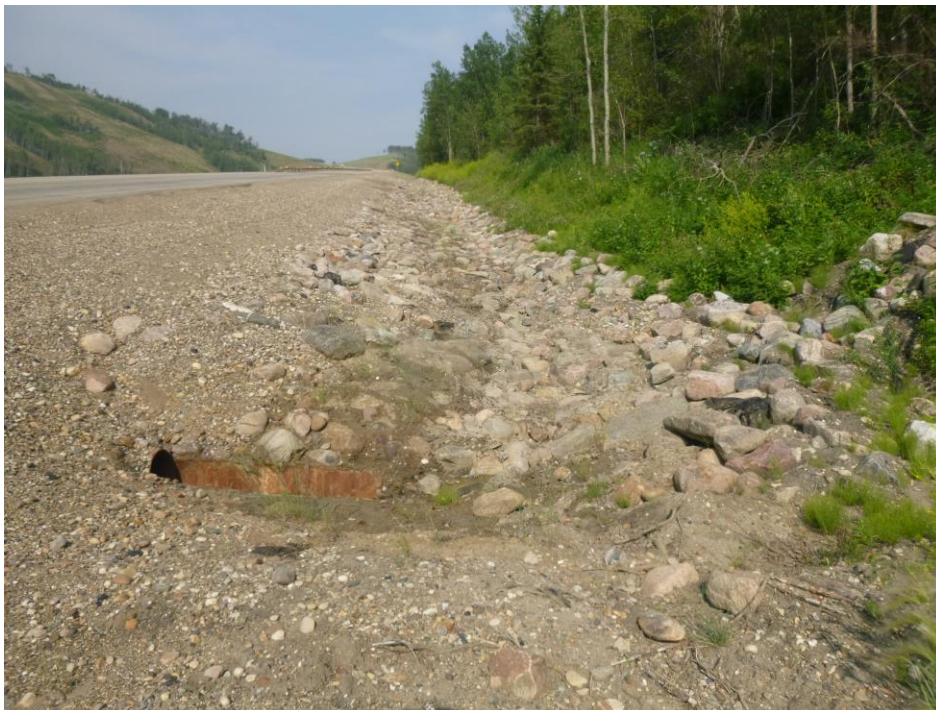
Photo 6 – Looking east from the ditch block along the riprapped south ditch channel from the inlet of the 760 mm dia. SWSP.

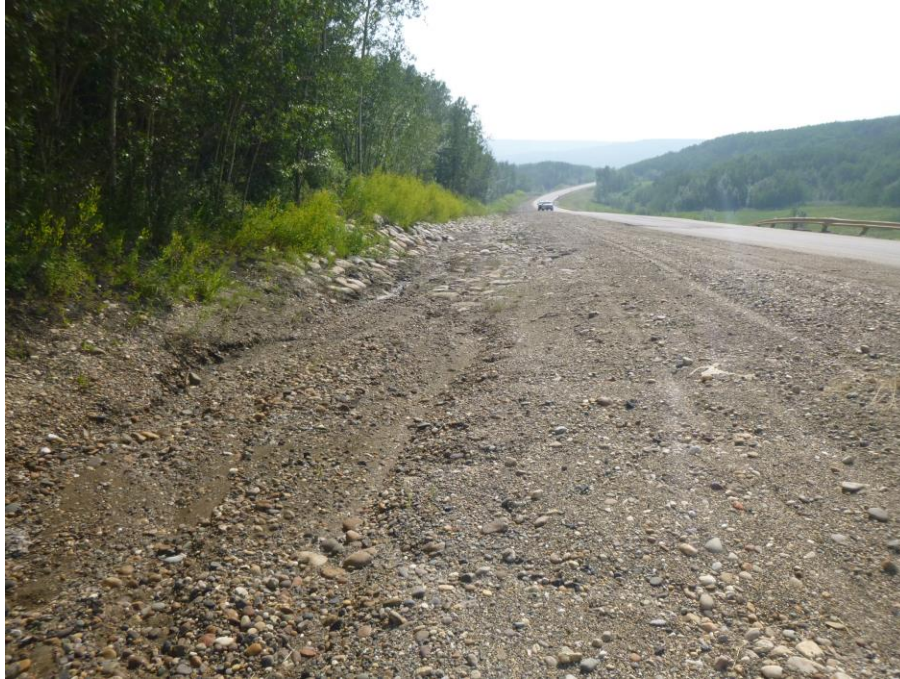
Photo 7 - Looking west along the recently lined south ditch channel and highway embankment, at the point where the riprap (west) and gravel (east) merge.

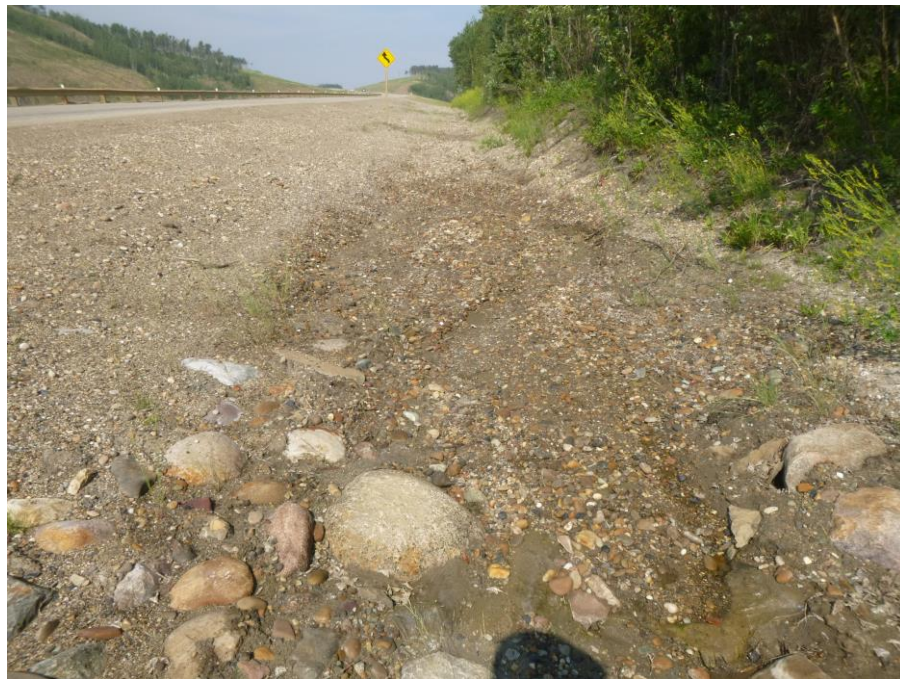
Photo 8 – Looking east along the south ditch channel and hwy embankment that was lined with 6-80 gravel.

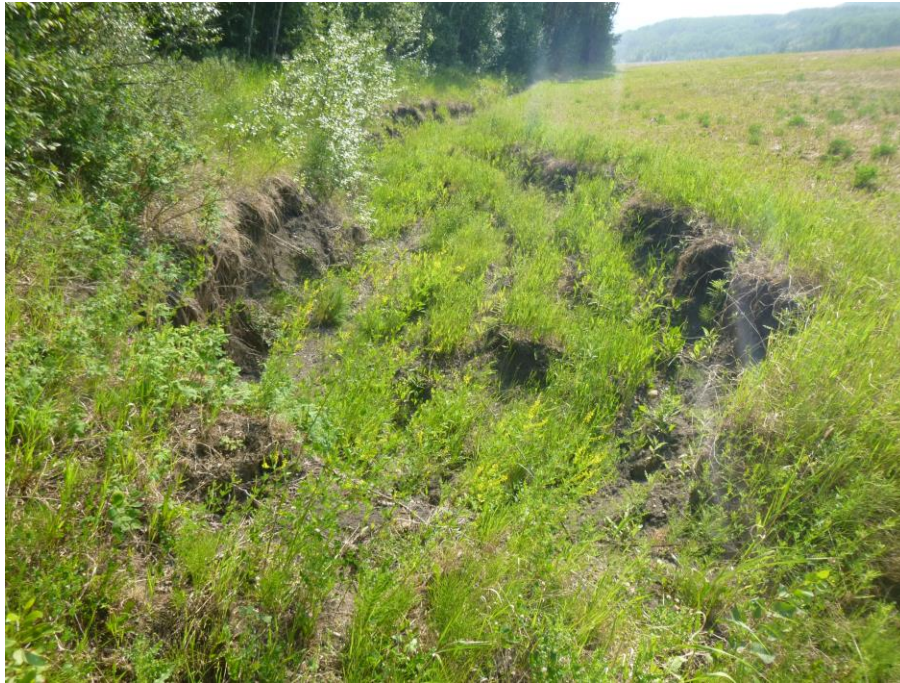
Photo 9 – Looking northwest at the erosion that formed in 2020 along the boundary of the south embankment fill and the bush line.

**a)** The 150 m length of the south ditch away from the highway in the bush near the west end, should also be repaired. Even if the now cleaned and flushed 810 mm and 760 mm diameter centreline culverts (and a proposed new centerline bore, discussed below) take some flow to the north there may still be some flow extending down the south bank through this eroded area. A more durable fix for this section would be to infill the eroded areas with clay compacted in thin lifts using a sheepsfoot compactor, grading the surface and then covering it with gabion mattress all the way down to the stilling pool.

**b)** A cheaper stop gap approach for the 150 m length away from the highway would be to fill the eroded areas with class 1 riprap placed over non-woven geotextile in the upper slope area and construct a riprap lined drop structure on the lower 20° slope above the 1040 mm SWSP outlet (1.9 m headscarp area) to dissipate flows upslope of the stilling basin.

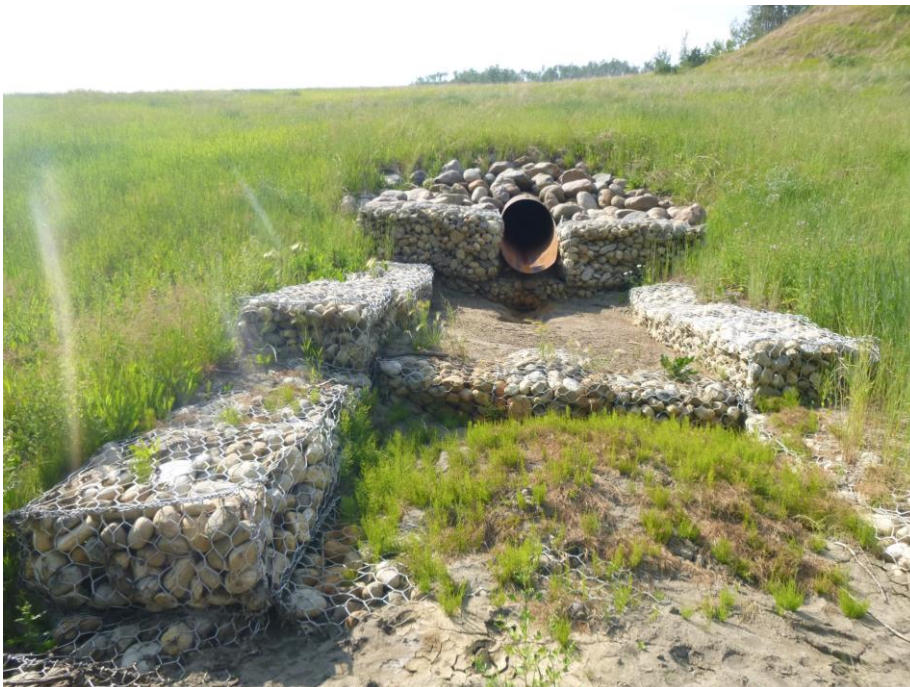
Photo 10 - Looking north at the 900 SWSP outlet and gabion outlet structure.

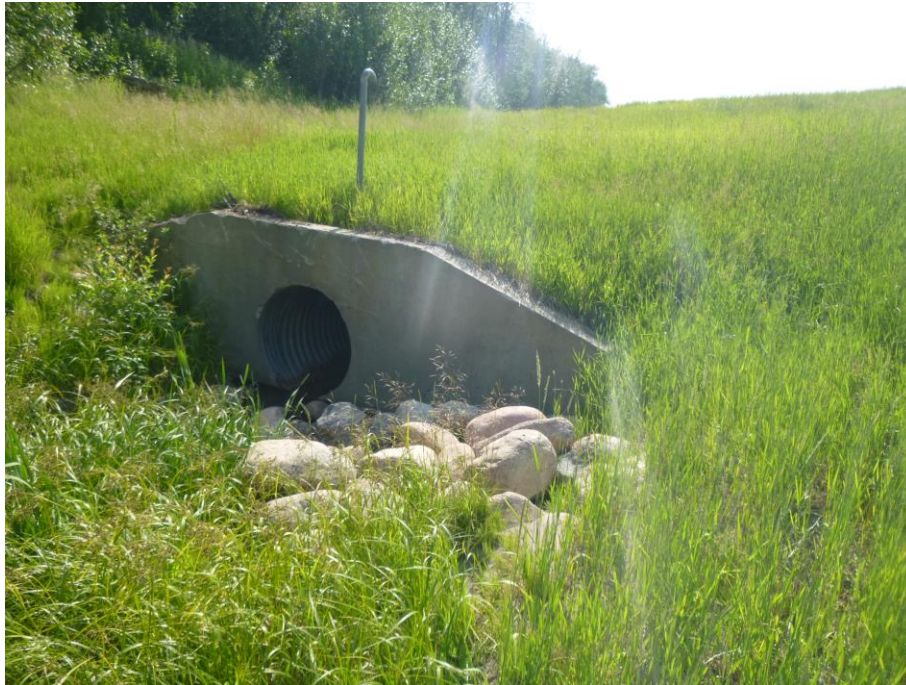
Photo 11 – Looking west at the 1200 mm CSP inlet headwall.

The 1200 mm dia. CSP inlet should be inspected and steamed each spring (if required) to remove ice build-up with a backhoe and establish unrestricted flow. We recommend that this late winter/early spring check and steaming be formally added to the maintenance contractor's annual maintenance work requirements. **\$5,000 annually**

The main 1200 mm dia. CSP should be inspected with a camera inserted along the pipe to see if it is restricted or damaged in any way, or if the joints are compromised which could lead to water leaking out and creating erosion around the outside of the pipe. To prevent future icing of the culvert inlet, perhaps a permanent heat system consisting of heat wires inside small metal tubing attached to the inside of the culvert inlet over a 10 m length and powered by a solar cell mounted on a post with a battery backup could be employed. **\$75,000**

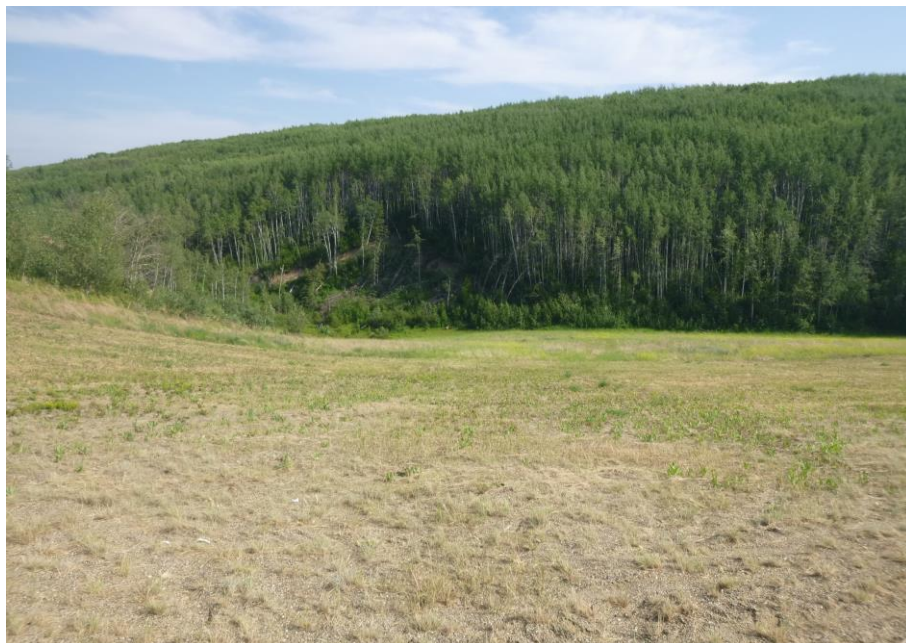
The backed-up water from the flood surges nearer the inlet of the 1200 mm dia. culvert saturated the native soil along the toe of the natural valley slope and combined with toe erosion from flowing water and a likely sudden drawdown scenario, caused toe slumping of the natural tree covered slope. This has gotten worse the last couple of years but is not currently affecting the functionality of the site, although some slide debris was observed beyond the toe of the slope in 2021.

Photo 12 – Looking south at the valley slope slumping above the 1200 culvert inlet and gabion outlet area, caused by rapid drawdown of built-up floodwater.

Clean out future slide toe debris accumulations from in front of the 1200 culvert inlet area if required.

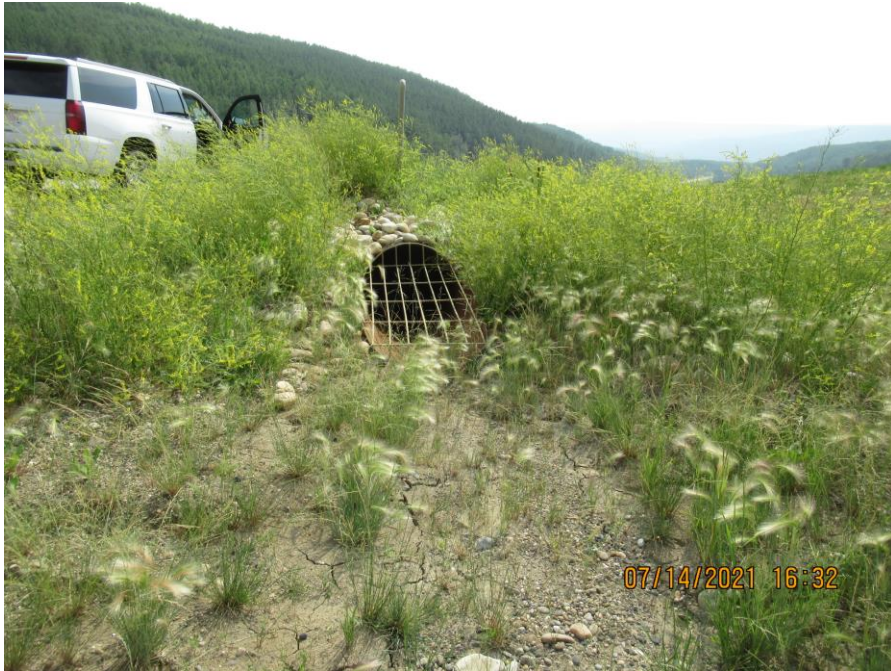
In 2015, an erosion gully was observed overtop of the ditch block at the inlet to the 900 mm dia. SWSP in the north ditch, which was likely formed by surface runoff overtopping the 900 mm dia. SWSP entrance during a high flow event and became larger in 2019. The inlet of this SWSP also appeared to be getting jacked up into the air by frost action the last few years, as the void beneath was getting larger. In 2020, the erosion was repaired with 6-80 gravel fill, and the void was repaired with the addition of riprap, and both appear OK in 2021.

Photo 13 – Looking west at the repaired erosion area around the north 900 mm SWSP entrance.

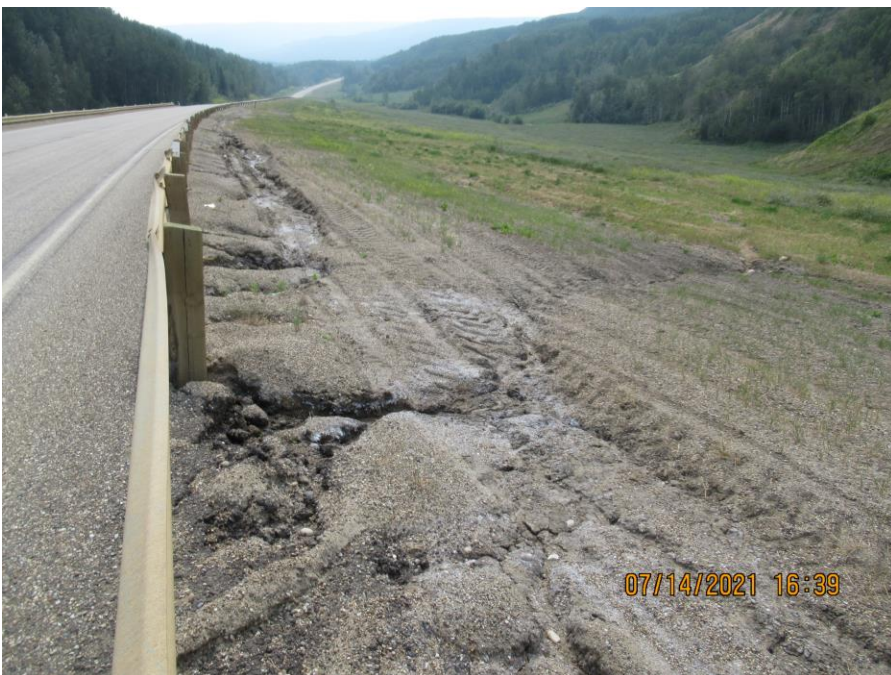
Photo 14 – Looking west at the rilling adjacent to the north guardrail (just west of the repaired rilling on the north embankment).

Some of the rilling erosion had been graded/smoothened. Repair the remaining rill erosion outside the north edge of the guardrail and along the edge of the eroded ACP north shoulder by first grading the existing surface, then adding/track-packing/shaping a few loads of gravel infill (Photo 14), and then covering with topsoil and TRM. **\$5,000**

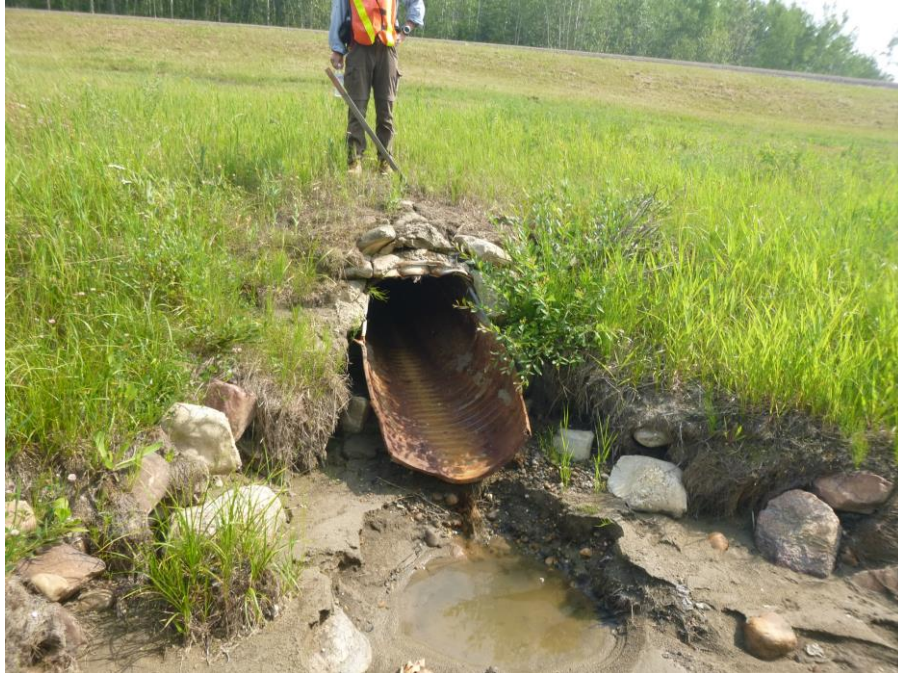
Photo 15 - Looking south at the 810 CSP outlet along the north ditch channel that was cleaned in 2020. Note the erosion scour bowl forming.

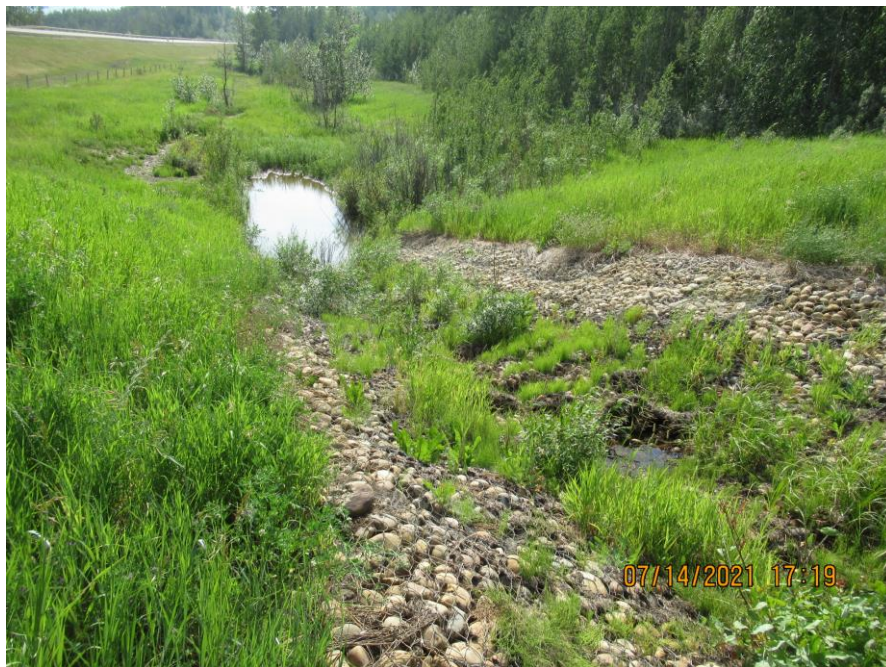
Photo 16 - Looking west (downstream) along the north ditch channel just upstream of the 810 CSP outlet and 1040 SWSP inlet. Note the gabions are still intact here.

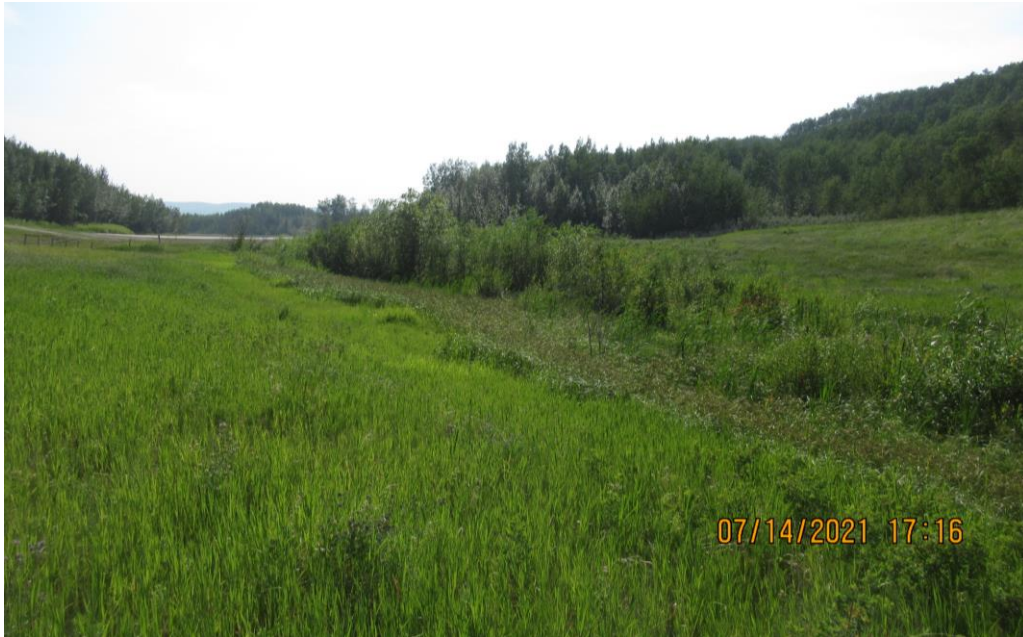
Photo 17 – Looking west along the north ditch channel.

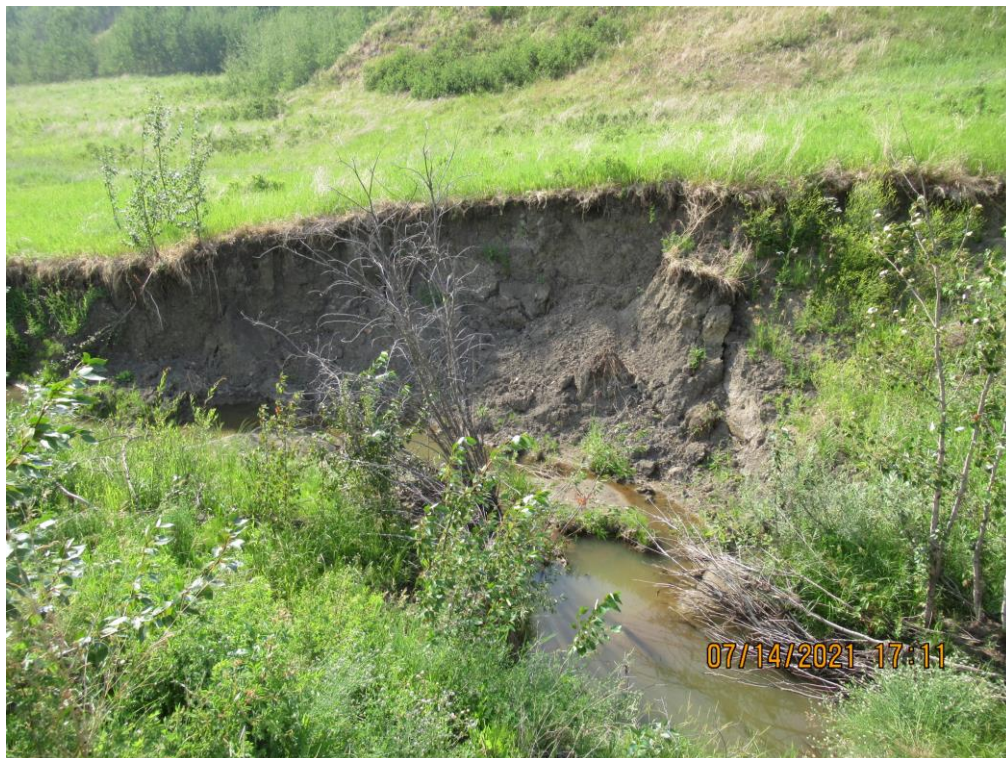
On the north side of the highway, the 1200 mm dia. CSP flowing full was also likely combined with runoff from the area/slopes to the north, which caused damage to one of the steeper sloping gabion lined channel sections further west and created a scour hole in the channel further west of this. The channel was overgrown with trees which reduced the flow capacity causing water to flow around and erode the sides of the gabion structure. In the 2013 event, there was also an erosion scour around the outlet of the 760 mm dia. SWSP in the north ditch, resulting from runoff originating from the south ditch flowing beneath the highway, which may have also contributed to the large erosion feature around the gabions immediately west (downslope) of this outlet. Both the inlet and outlet of this pipe were covered with pitrun in 2019, but this culvert was flushed/cleaned in 2020. A runoff gully has since formed beyond this culvert outlet and joined the gully that exists around the channel gabion.

Photo 18 – Looking east (upstream) along the north ditch channel at the ongoing erosion and eroded gabion liner between the 760 SWSP and 810 CSP outlets.

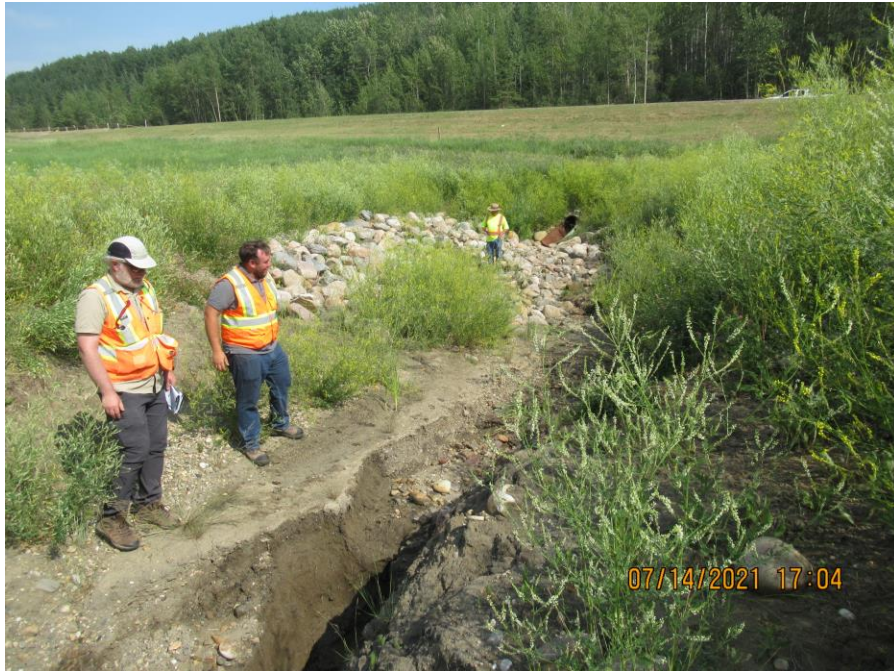
Photo 19 - Looking south at the 760 mm SWSP outlet. Note the erosion gully along the west side of the riprap that was added downslope of the culvert in 2020.

The erosion gully between the outlet of the recently opened 760 mm diameter SWSP and north channel should be repaired by grading a trapezoidal channel and lining it with Class 1 riprap over non-woven geotextile. **Ballpark Cost \$20,000**

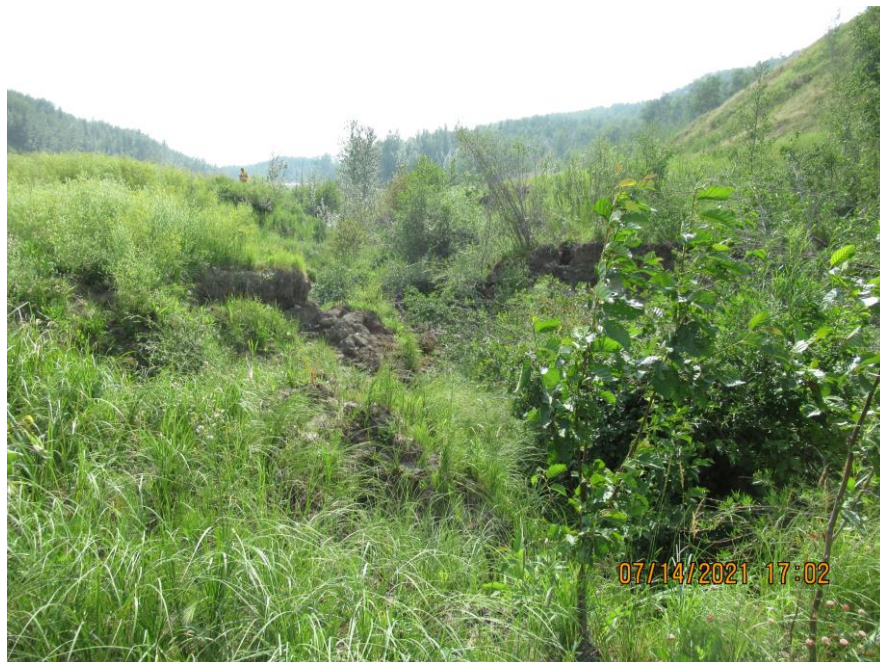
Photo 20 - Looking west at the erosion in the north ditch channel at the completely eroded gabion liner east (upslope) of the 760 SWSP outlet.

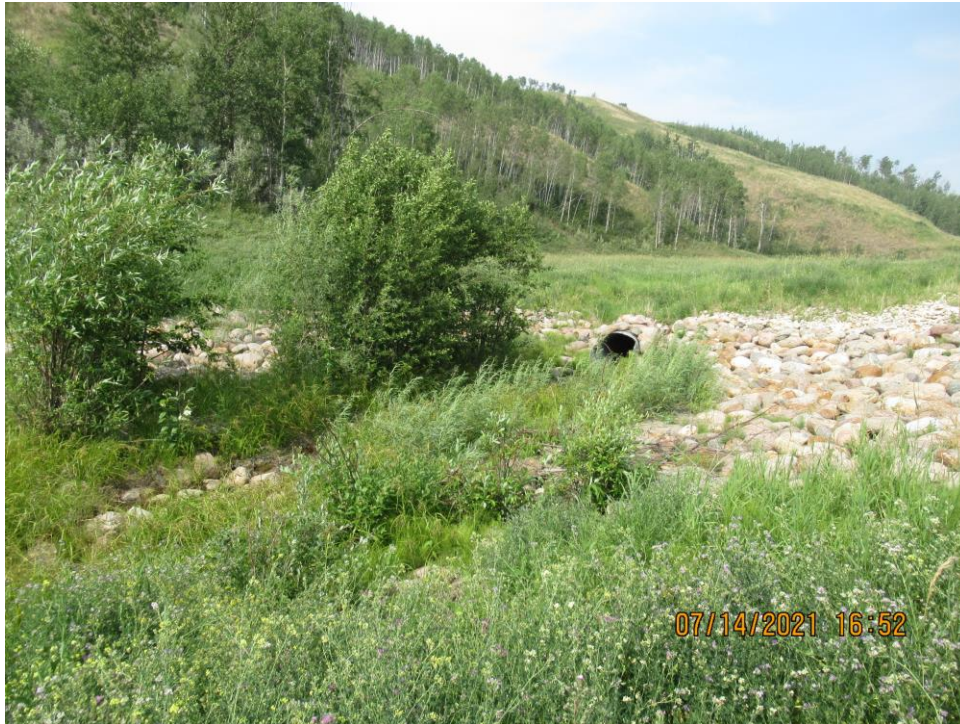
Photo 21 - Looking east at the 1200 CSP outlet area in the north channel.

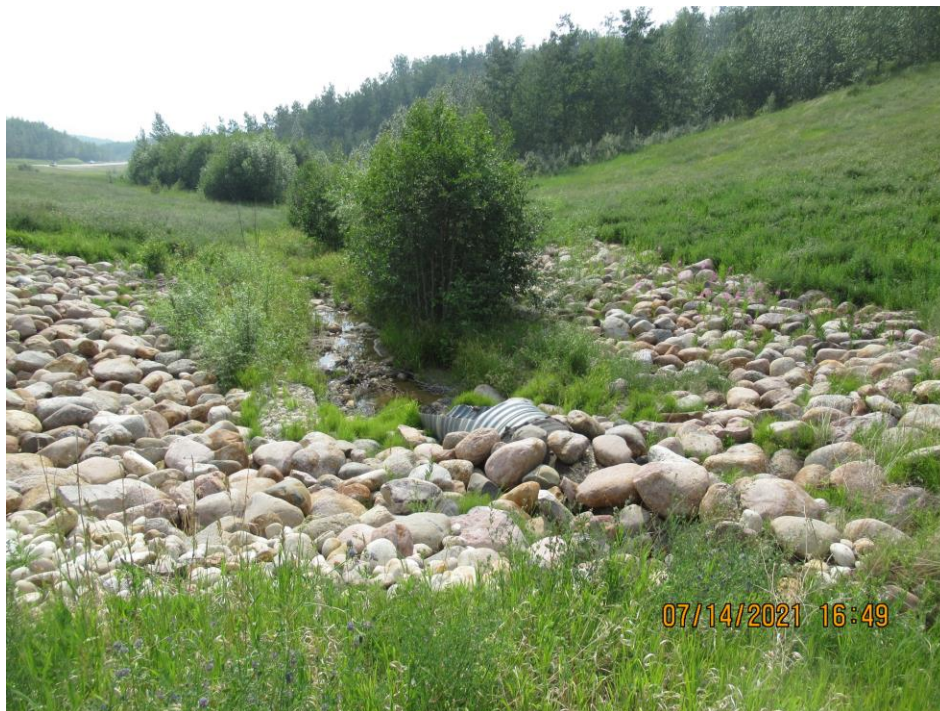
Photo 22 – Close-up view of culvert outlet, looking west.
