**ALBERTA TRANSPORTATION  
GEOHAZARD ASSESSMENT PROGRAM  
PEACE REGION (GRANDE PRAIRIE DISTRICT- NORTH)  
2022 INSPECTION**

Site Number	Location	Name	Hwy	km
PH024	11 km W. Cleardale	Clear River East Hill-(Old Site 8)	64:02	24.2-25.5
Legal Description		UTM Co-ordinates (NAD 83)		
NE27/SE34-84-11-W6		11 N 6244830	E 336445

Date	PF	CF	Total
<b>Previous Inspection:</b>	July 14, 2021	9	4	36 (Risk Eros. Scale)
<b>Current Inspection:</b>	May 17, 2022	9	4	36 (Risk Eros. Scale)
<b>Road AADT:</b>	290		<b>Year:</b>	2021
<b>Inspected By:</b>	Don Proudfoot, Barry Meays (Thurber). Ed Szmata, Kristin Tappenden, Austin Dillman, Ken Szmata, Max Shannon (AT)			
<b>Report Attachments:</b>	<input checked="" type="checkbox"/> Photographs <input checked="" type="checkbox"/> Plans <input checked="" type="checkbox"/> Maintenance Items

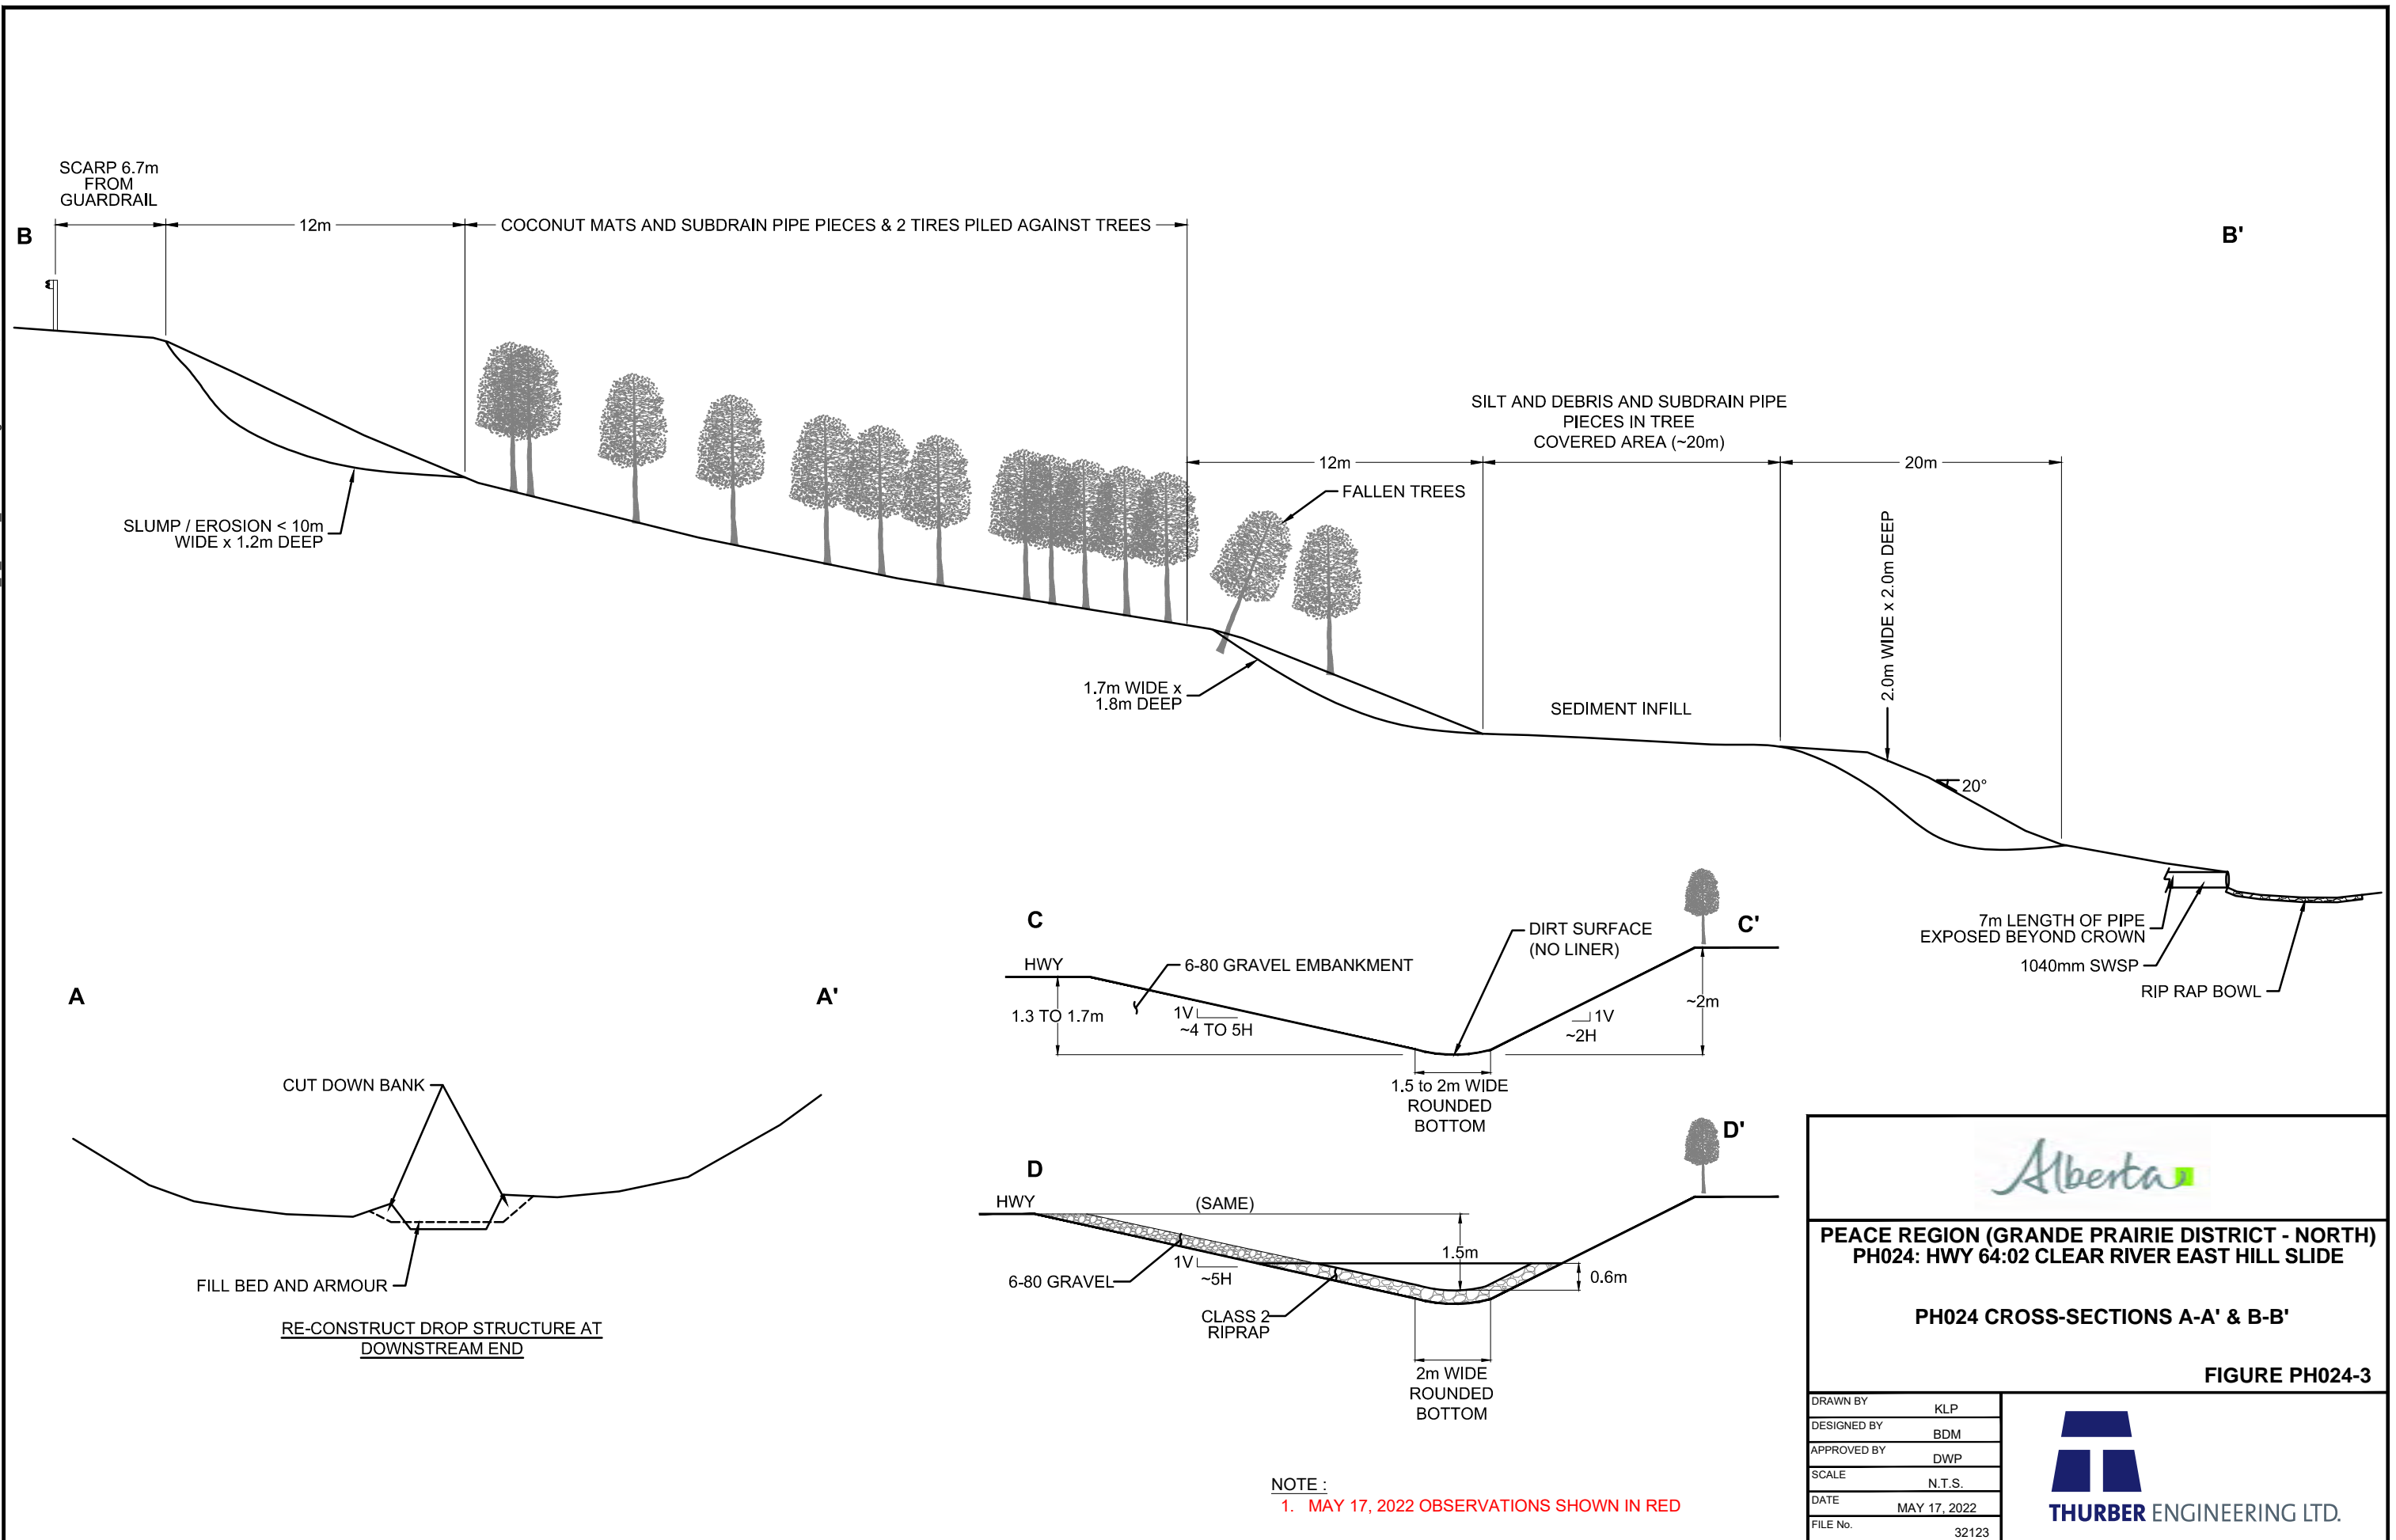
**FIGURE PH024-3**

**PH024 CROSS-SECTIONS A-A' & B-B'**

The damaged gabion structures on the north side of the highway need to be reconstructed to their original condition. The downstream end of the damaged gabion drop structure furthest west (Section A-A' on Drawings PH24-1-1 and -3) should have the sideslopes trimmed back flatter, and then use some of this material to build up the bed, before armouring the bottom and sideslopes. Consideration could be given to lining the replacement structures with Class 2 riprap instead of gabion mattress.

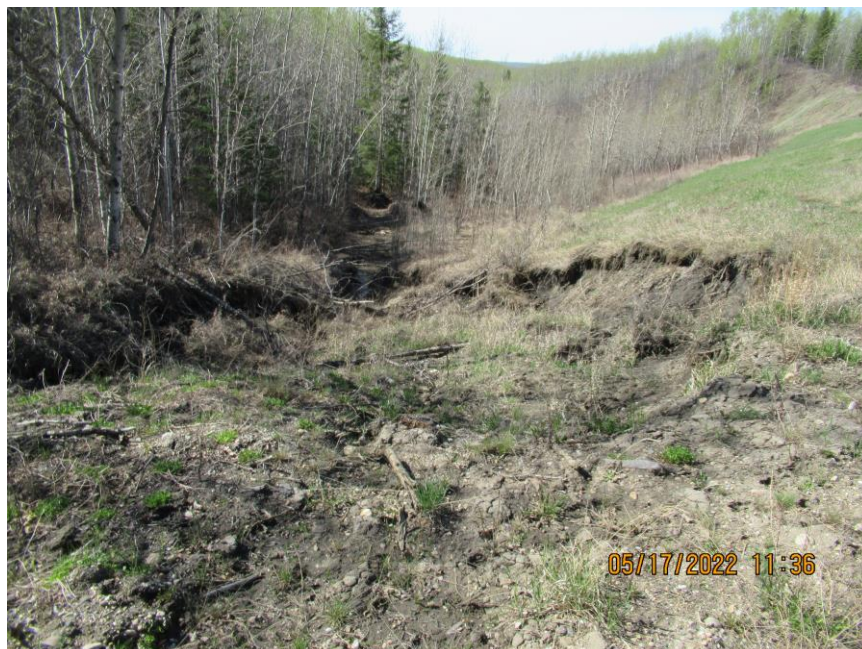
Photo 2 – Looking south along the eroded bush channel at the west end of the site.

The 150 m length of the south ditch away from the highway in the bush near the west end, should also be repaired. Even if the now cleaned and flushed 810 mm and 760 mm diameter centreline culverts (and a proposed new centerline bore, discussed below) take some flow to the north and then through the 1.04 SWSP beneath the hwy, there may still be some flow extending down the south bank through this eroded area. A more durable fix for this section would be to **a)** infill the eroded areas with clay compacted in thin lifts using a sheepsfoot compactor, grading the surface and then covering it with gabion mattress all the way down to the stilling pool.

**b)** A cheaper stop gap approach for the 150 m length away from the highway would be to fill the eroded areas with Class 1 riprap placed over non-woven geotextile in the upper slope area and construct a riprap lined drop structure on the lower 20° slope above the 1040 mm SWSP outlet (1.9 m headscarp area) to dissipate flows upslope of the stilling basin.

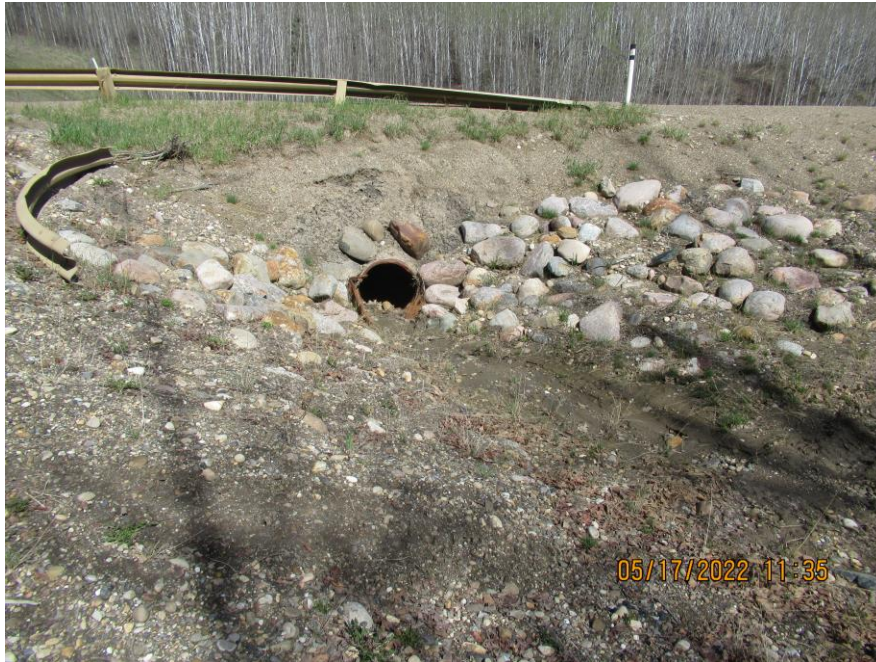
The 810 mm diameter culvert had been half full of sediment for several years. This culvert appears to have been originally installed to bring water from the south ditch across to the north side of the highway for discharge via the 1.04 m dia. SWSP centreline pipe down into the dissipation pool on the south side of the highway. It appeared that this pipe had not been allowing flow to the north side either due to lack of maintenance or after it was purposely blocked. This culvert was cleaned out in 2020, and the inlet was formed with a riprap covered inlet bowl and a downstream ditch block that grades downwards to the south which would appear to let flood water overflow to the west through the bush if this culvert backs up flow.

Photo 3 – Looking north at the inlet of the 810 CSP on the south side of the hwy embankment.

Grade/shape the downstream banks of the ditch blocks at the inlets of the 760mm SWSP and the 810mm CSP, and then add some Class 2 riprap over non-woven geotextile to induce more flow into these culverts. **\$5,000**

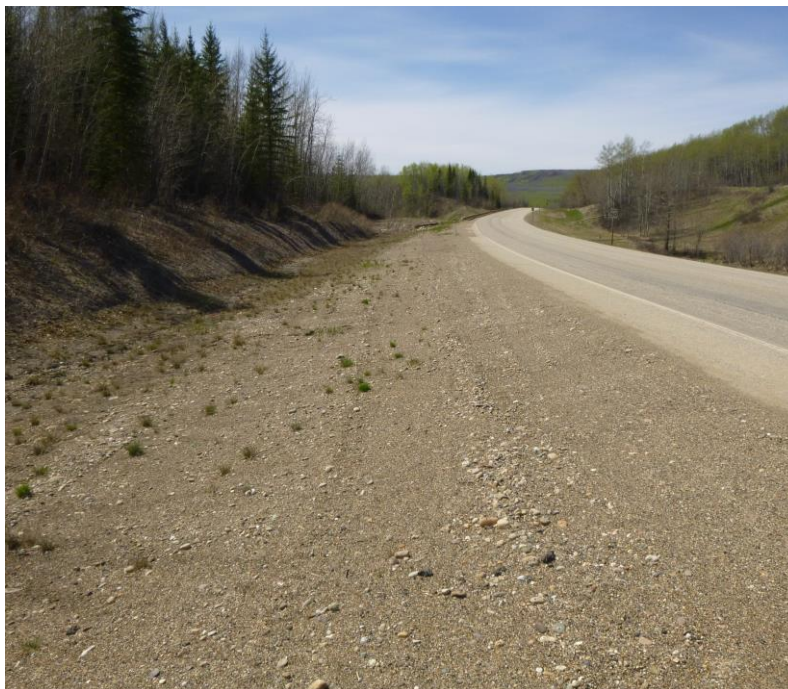
Photo 4 – Looking west along the unlined south ditch from near the west end, at the 2020 grading that took place along the south highway embankment and ditch.

As a minimum, the ~330 m long segment of the currently unlined south ditch bottom extending west of the riprap lined segment up to the 810 CSP culvert, should be topsoiled, seeded, and covered with TRM. **\$10,000**

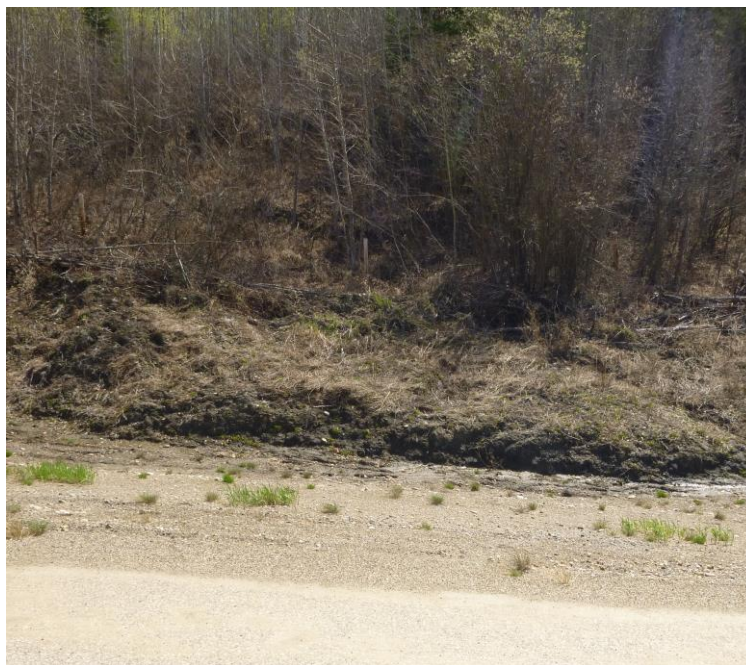
Photo 6 – Looking at a 12m wide x 3m high toe slump into the south edge of the south ditch.

Clean out future slide toe debris accumulations from in front of the 1200 culvert inlet area, and along the south ditch, if required.

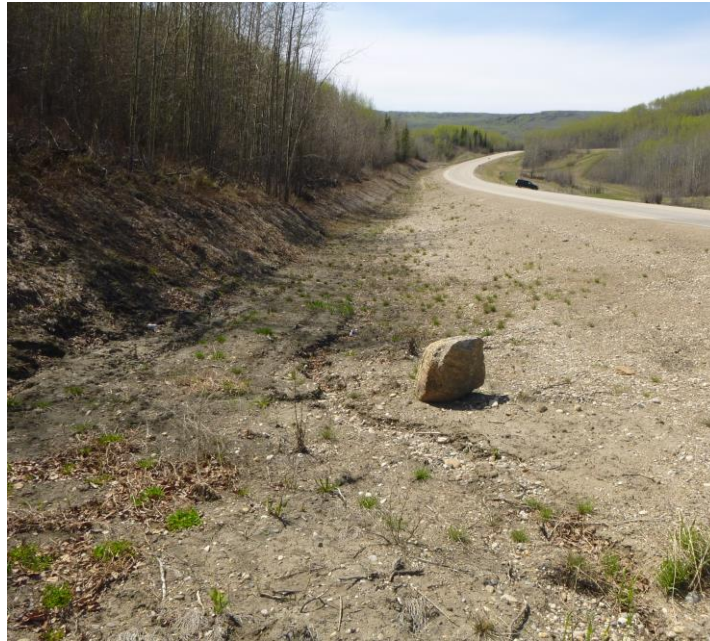
Photo 7 - Looking west along the unlined south highway ditch from the inlet of the 760 mm dia. SWSP.

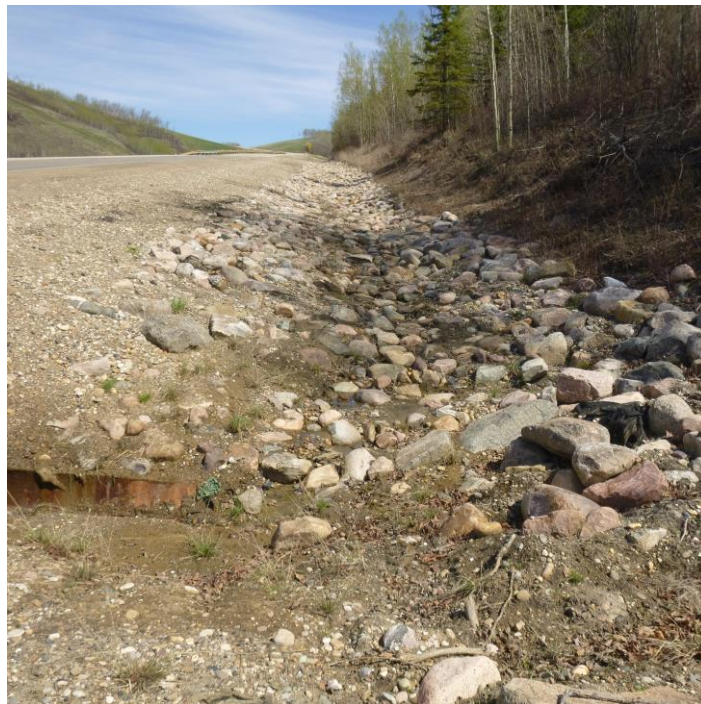
Photo 8 – Looking east from the ditch block along the riprapped south ditch channel from the inlet of the 760 mm dia. SWSP.

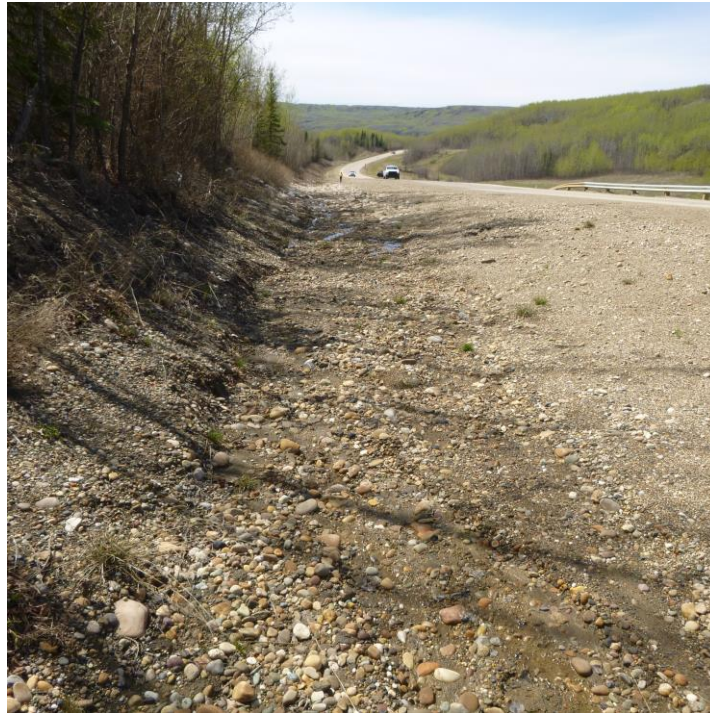
Photo 9 – Looking west along the south ditch channel and hwy embankment that was lined with 6-80 gravel.

Future erosion along the toe of the south highway embankment and ditch is still a potential threat to the highway and although some repairs were performed in 2020, supplementary repairs might still be needed. A Class 2 riprap south ditch bottom segment ~110 m long was installed in 2020, but a hard armour liner (such as riprap or gabion mattress) should extend over the entire ditch that has a ~9 % gradient (to the 810 CSP inlet at the west end) and may also need to be extended further east over the present 130 m long ~7% gravelled ditch segment (also installed in 2020).

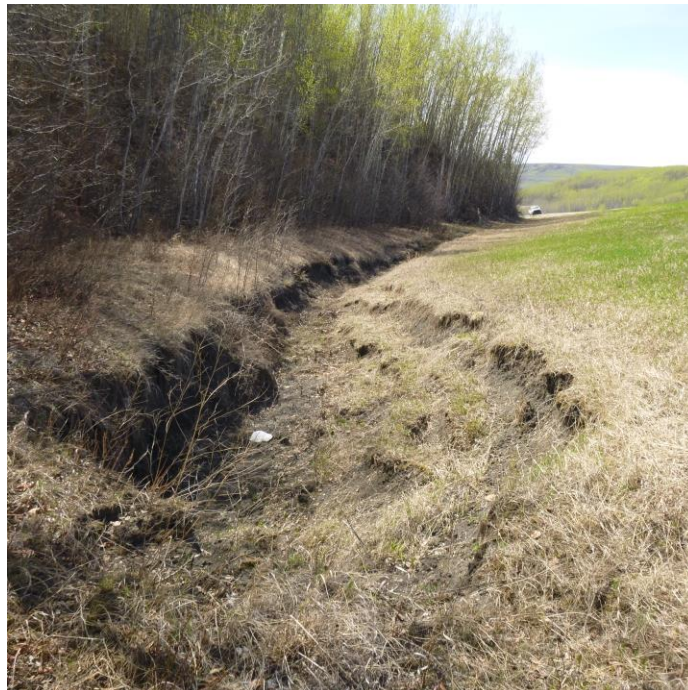
Photo 10 – Looking west at the erosion that formed in 2020 along the boundary of the south embankment fill and the bush line.

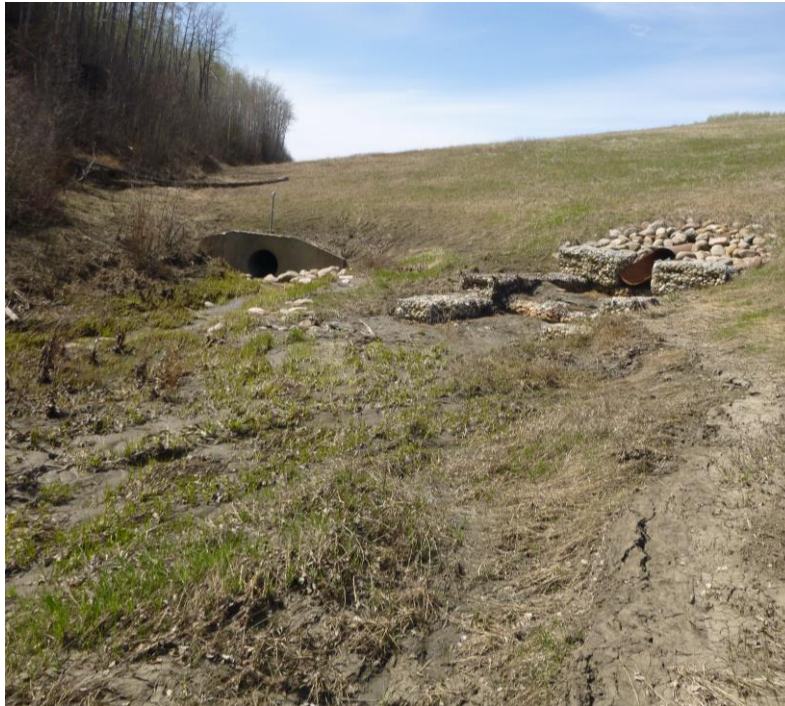
Photo 11 - Looking northwest at the 1200 CSP inlet headwall (left), and the 900 SWSP outlet and gabion outlet structure (right).

The 1200 mm dia. CSP inlet should be inspected and steamed each spring (if required) to remove ice build-up with a backhoe and establish unrestricted flow. We recommend that this late winter/early spring

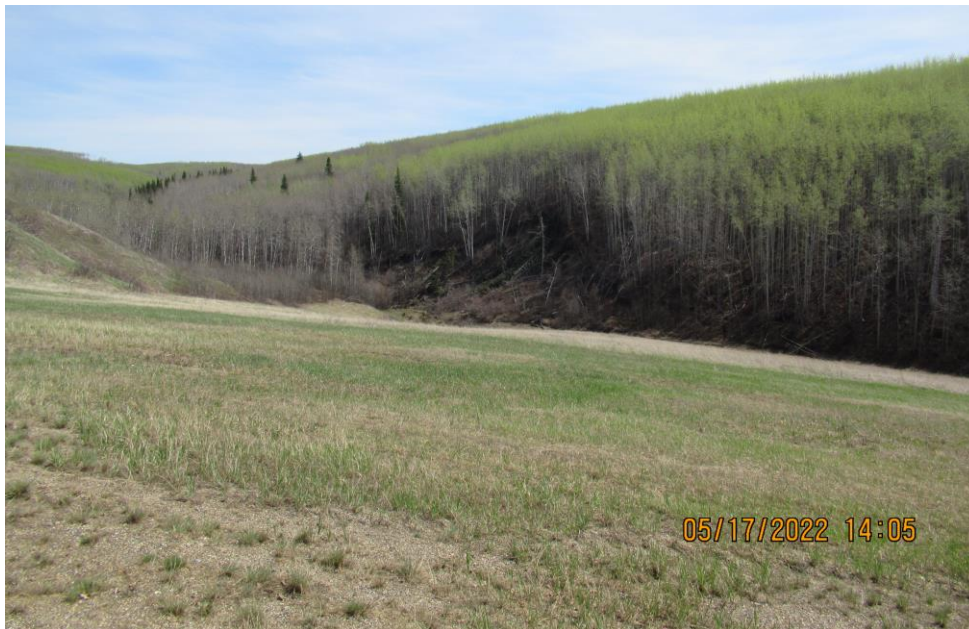
The backed-up water from the flood surges nearer the inlet of the 1200 mm dia. culvert saturated the native soil along the toe of the natural valley slope and combined with toe erosion from flowing water and a likely sudden drawdown scenario, caused toe slumping of the natural tree covered slope. This has gotten worse the last couple of years but is not currently affecting the functionality of the site, although some slide debris was observed beyond the toe of the slope in 2021.

Photo 12 – Looking south at the valley slope slumping above the 1200 culvert inlet and gabion outlet area, caused by rapid drawdown of built-up floodwater.

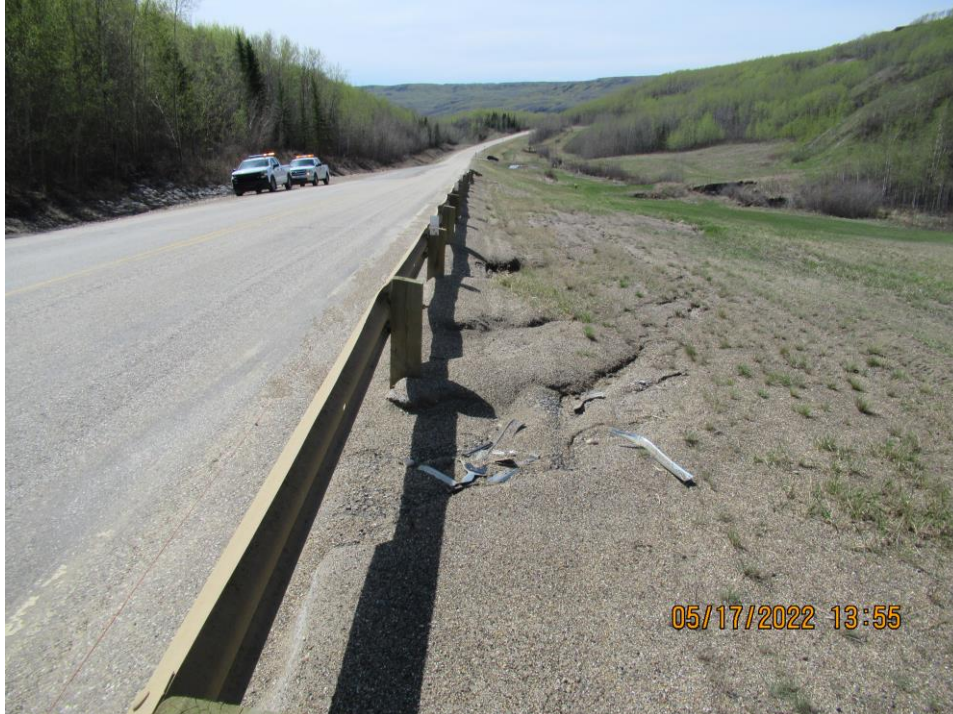
Photo 14 – Looking west at the rilling adjacent to the north guardrail (just west of the repaired rilling on the north embankment).

Some of the rilling erosion near the north hwy embankment guardrail had been graded/smoothened. Repair the remaining rill erosion outside the north edge of the guardrail and along the edge of the eroded ACP north shoulder by first grading the existing surface, then adding/track-packing/shaping a few loads of gravel infill (Photo 14), and then covering with topsoil and TRM. **\$5,000**

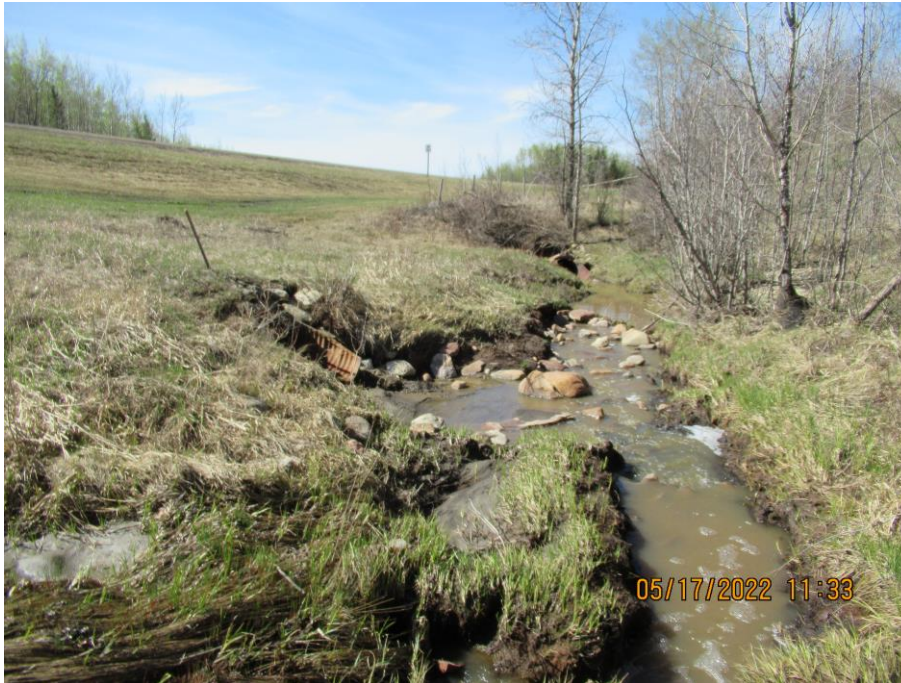
Photo 15 - Looking southwest at the 810 CSP outlet (left), and the 1040 SWSP inlet (right), at the west end of the north ditch channel.

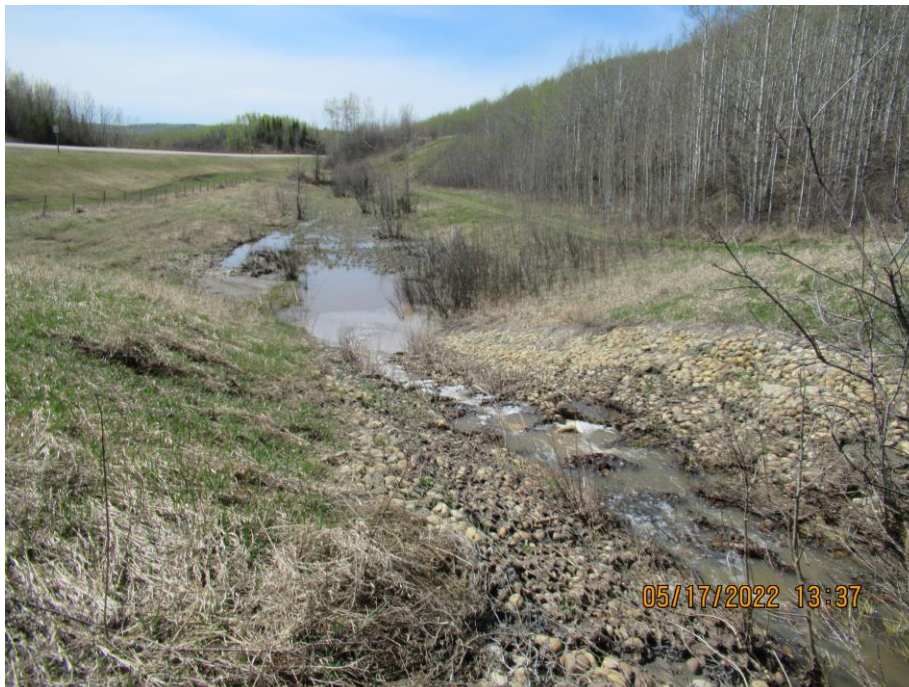
Photo 16 - Looking west (downstream) along the north ditch channel upstream of the 810 CSP outlet. Note the gabions are still intact here.

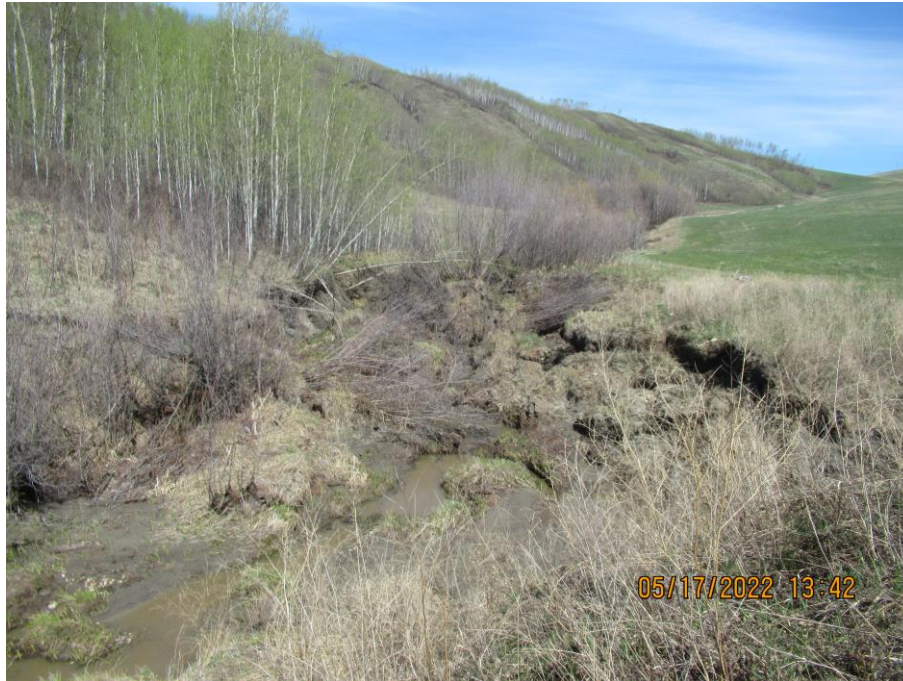
On the north side of the highway, the 1200 mm dia. CSP flowing full was also likely combined with runoff from the area/slopes to the north, which caused damage to two of the steeper sloping gabion lined channel sections further west and created a scour hole in the channel further west of this. The channel was overgrown with trees which reduced the flow capacity causing water to flow around and erode the sides of the gabion structure. In the 2013 event, there was also an erosion scour around the outlet of the 760 mm dia. SWSP in the north ditch, resulting from runoff originating from the south ditch flowing beneath the highway, which may have also contributed to the large erosion feature around the gabions immediately west (downslope) of this outlet. Both the inlet and outlet of this pipe were covered with pitrun in 2019, but this culvert was flushed/cleaned in 2020. A runoff gully has since formed beyond this culvert outlet and joined the gully that exists around the channel gabion.

Photo 17 – Looking east (upstream) along the north ditch channel at the ongoing erosion and eroded gabion liner just downstream of the 760 SWSP outlet.

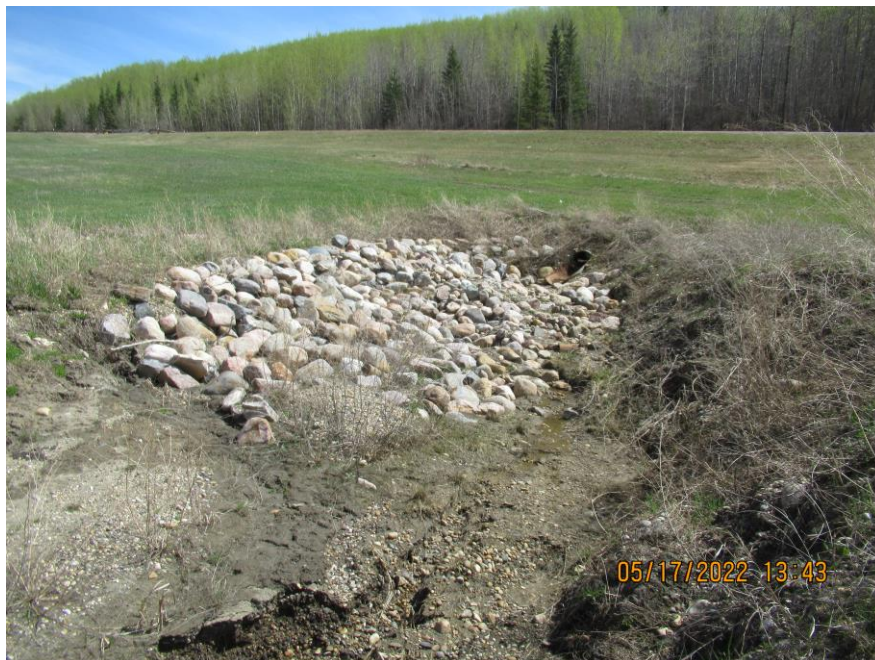
Photo 18 - Looking south at the 760 mm SWSP outlet. Note the erosion gully along the west side of the riprap that was added downslope of the culvert in 2020.

The erosion gully between the outlet of the recently opened 760 mm diameter SWSP and north channel should be repaired by grading a trapezoidal channel and lining it with Class 1 riprap over non-woven geotextile. **Ballpark Cost \$20,000**

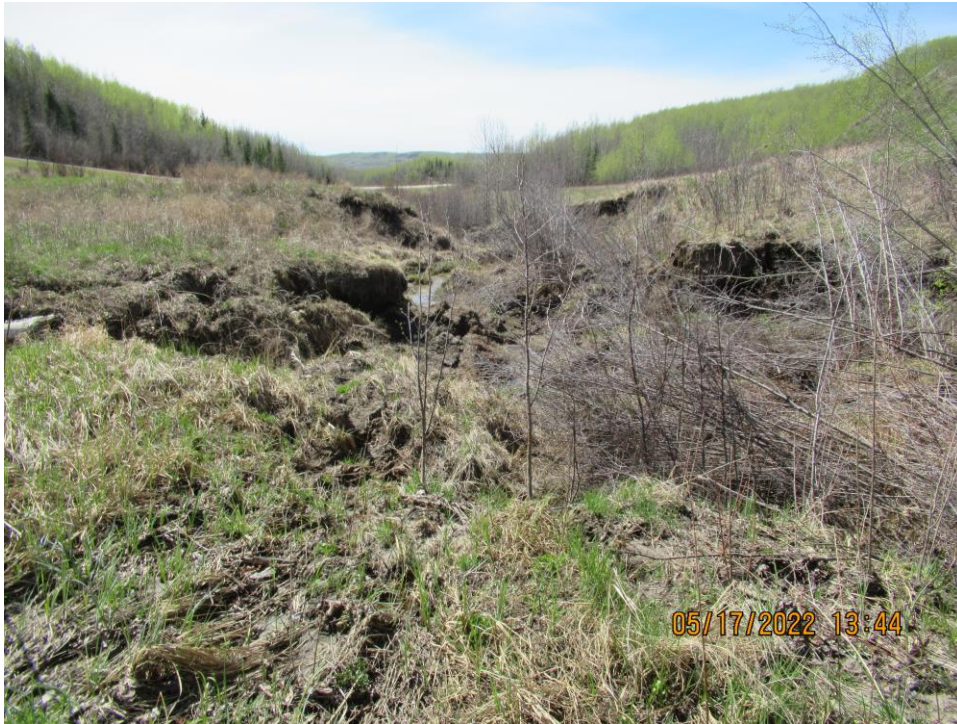
Photo 19 – Looking west (downstream) at the erosion just upstream of the 760 SWSP outlet.

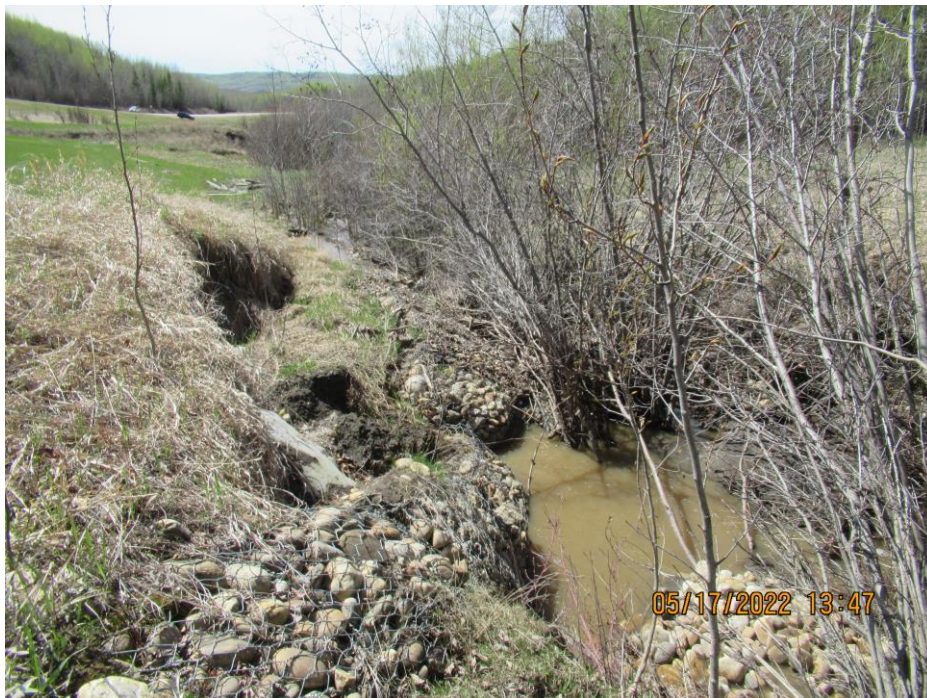
Photo 20 - Looking east at the erosion in the north ditch channel at the completely eroded gabion liner between the 760 SWSP and 1200 CSP outlets.

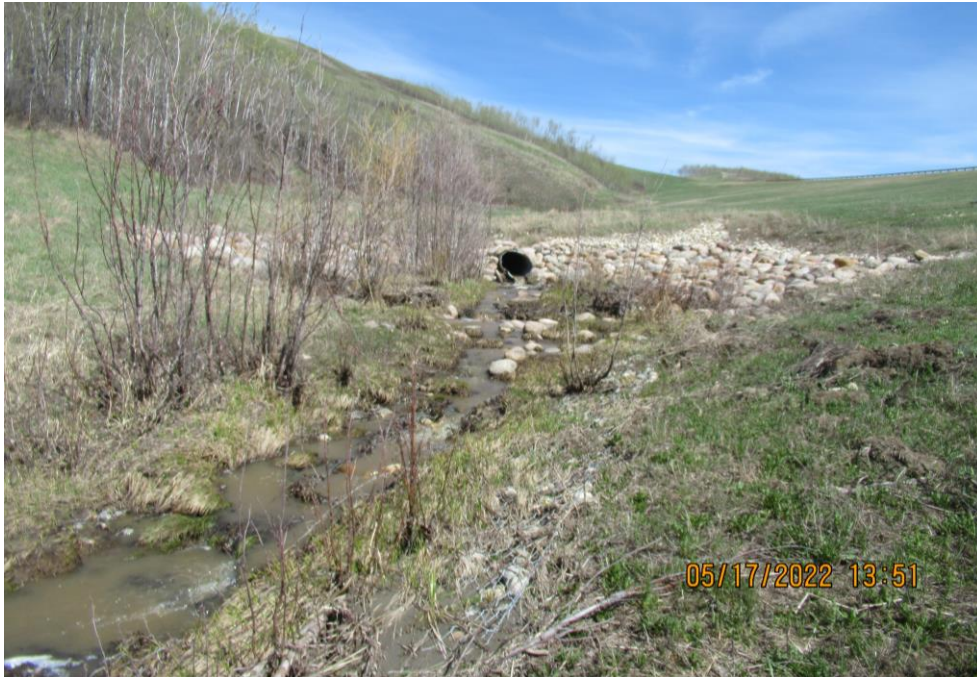
Photo 21 - Looking east at the 1200 CSP outlet area in the north channel.

The main 1200 mm dia. CSP should be inspected with a camera inserted along the pipe to see if it is restricted or damaged in any way, or if the joints are compromised which could lead to water leaking out and creating erosion around the outside of the pipe. To prevent future icing of the culvert inlet, perhaps a permanent heat system consisting of heat wires inside small metal tubing attached to the inside of the culvert inlet over a 10 m length and powered by a solar cell mounted on a post with a battery backup could be employed. **\$75,000**
