**ALBERTA TRANSPORTATION  
GEOHAZARD ASSESSMENT PROGRAM  
PEACE REGION – PEACE RIVER/HIGH LEVEL  
2020 INSPECTION**

<b>Site Number</b>	<b>Location</b>	<b>Name</b>	<b>Hwy</b>	<b>km</b>
PH8	Clear River West Hill	Old Site 7	64:02	19.4-20.1
<b>Legal Description</b>		<b>UTM Co-ordinates (NAD 83)</b>		
SW32-84-11-W6		11 N 6245420	E 332480

**2020 PH008-1 INSPECTION PLAN**

**DWG No. 13351-PH008-1**

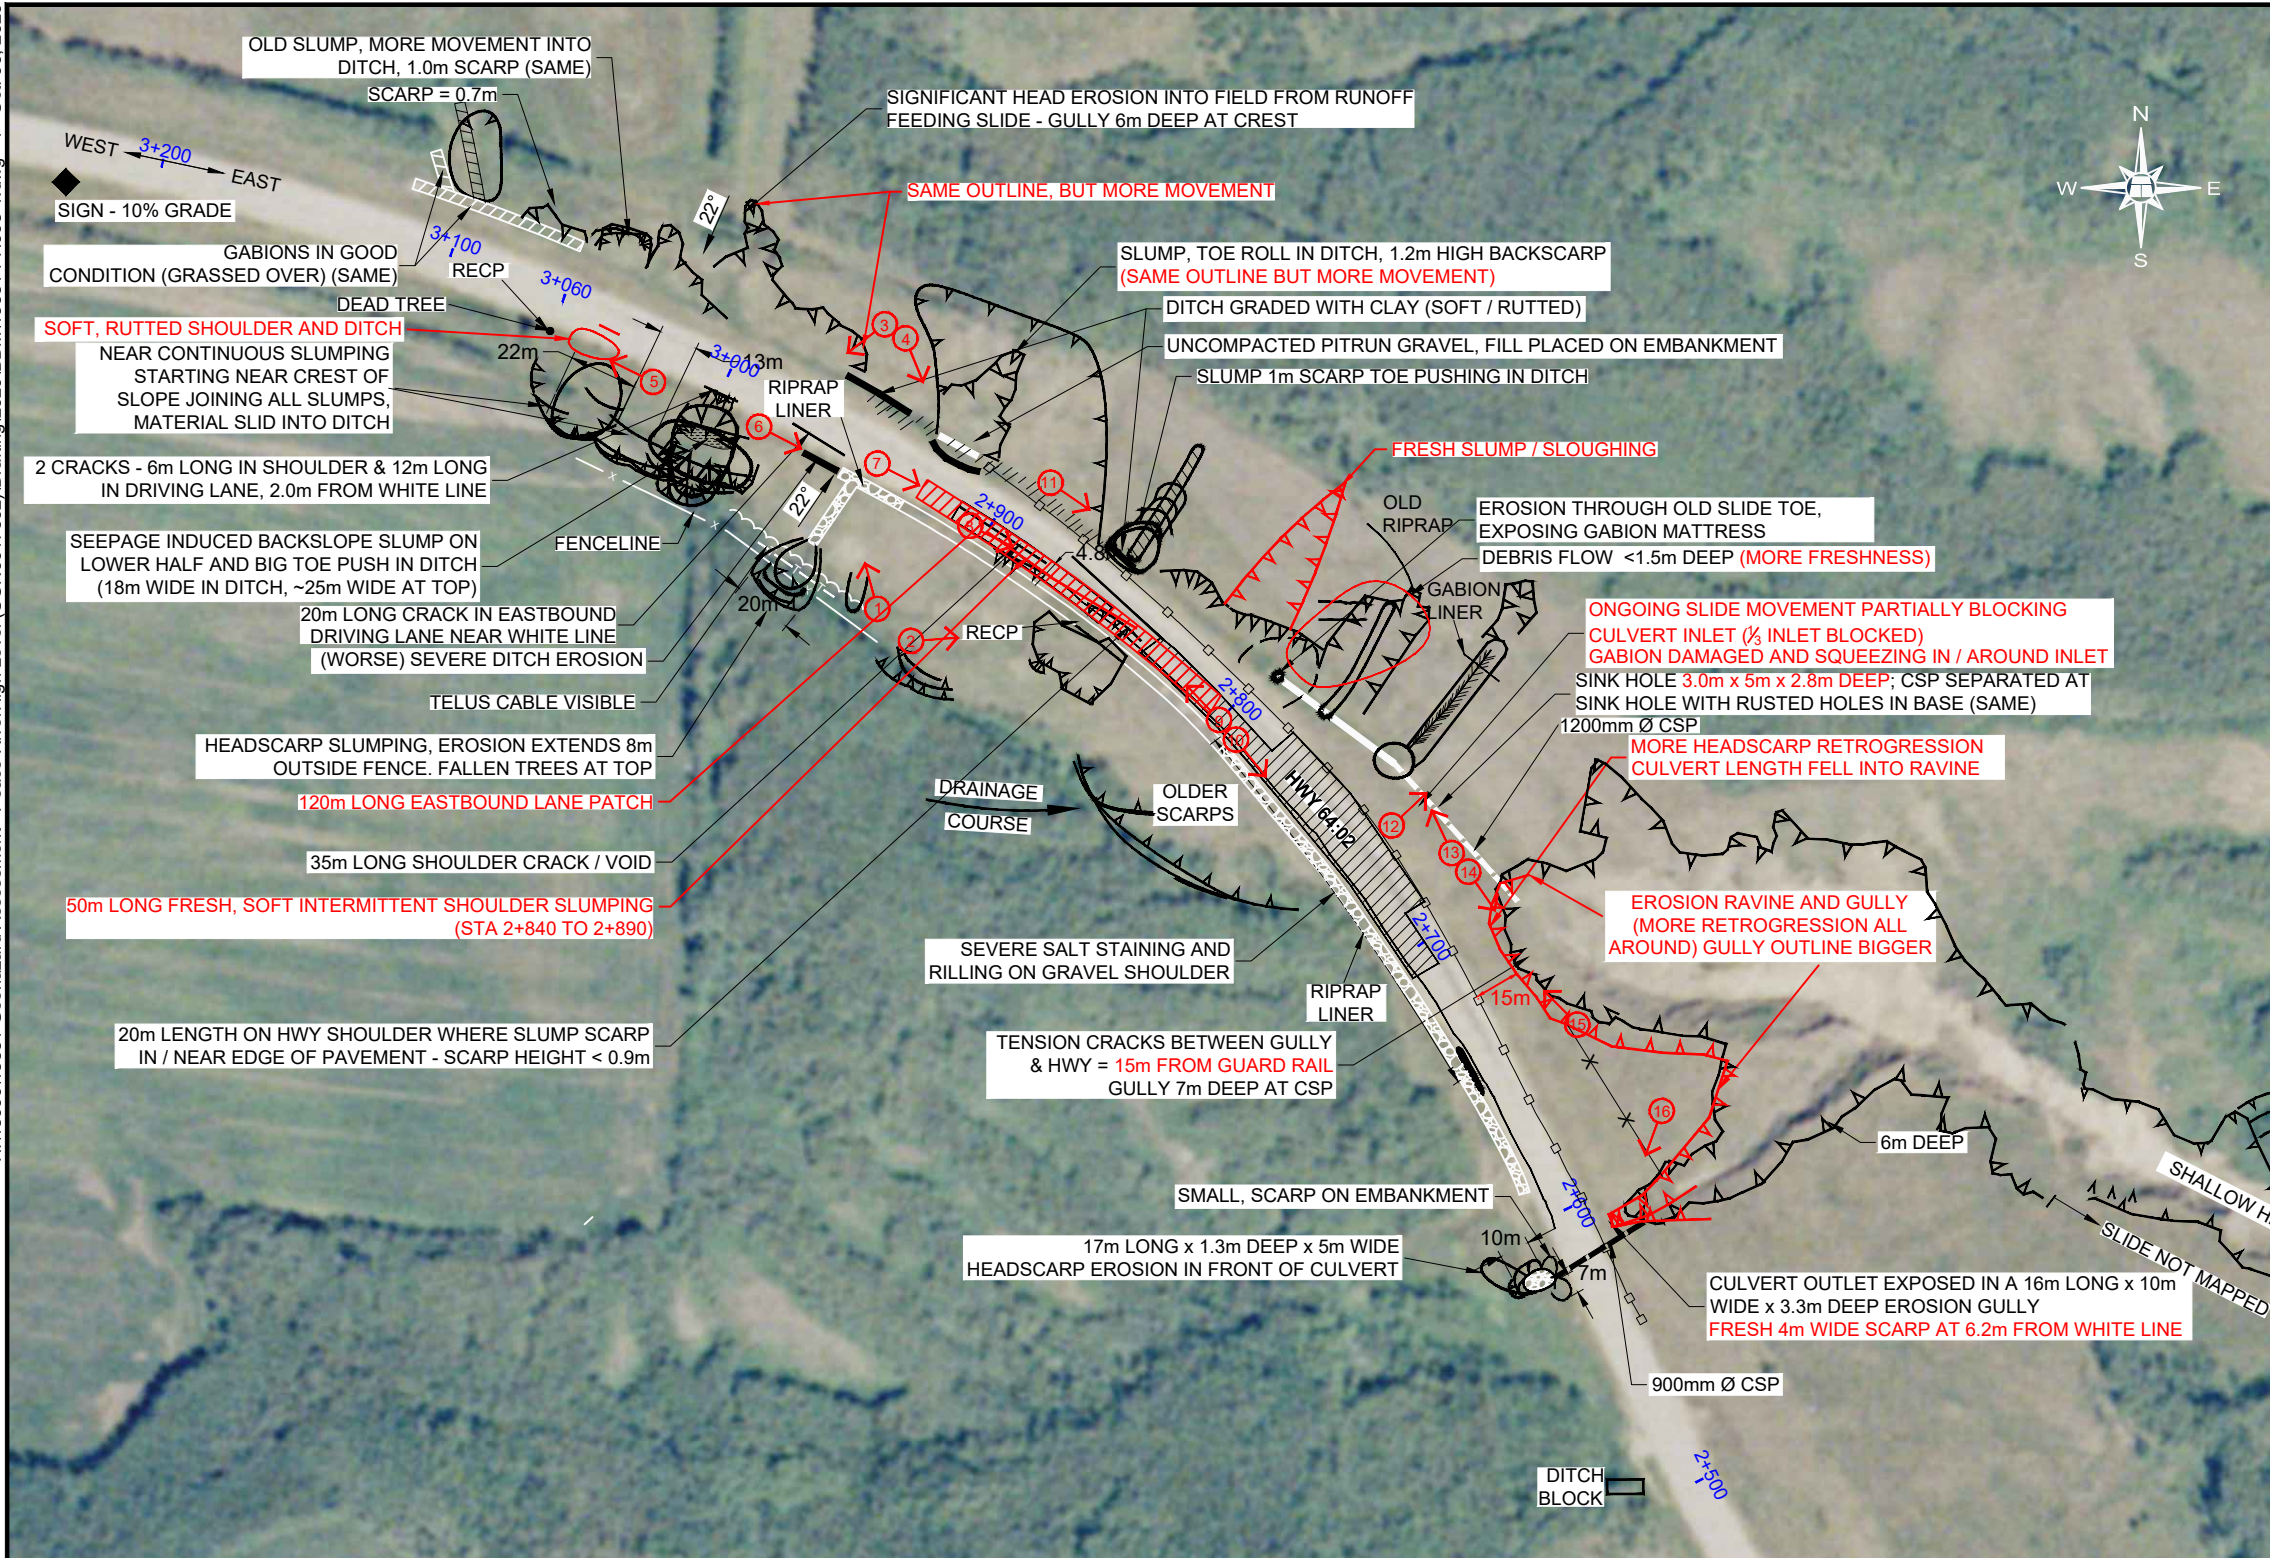
The 140 m long 2017 patched/overlayed area from ~Sta 2+690 to 2+830 (and the previous rutted, sunken, alligator crack-sealed segments further west), along the eastbound lane and south highway shoulder of the highway adjacent to the south ditch, is thought to be attributed to a soft/wet subgrade. The worst 40 m long segment (centered at Sta 2+850) contains a crack along the center of the EBDL and a slump into the south edge of the pavement & embankment, but the pavement and embankment are quite soft and contain shoulder slumped areas over a 130 m length extending between ~Sta 2+800 to 2+930. Cracks and shoulder slumps have since formed over intermittent segments extending 130 m further west of this area (~Sta 2+930 to 3+060) along the center or edge of the eastbound driving lane/shoulder (shown on Drawing 13351-PH8-1 and Photos 5 to 10).

- NOTES:
1. LOCATION DATA RECORDED USING HAND HELD GPS RECEIVER. ALL LOCATIONS ARE APPROXIMATE AND ARE FOR ILLUSTRATIVE PURPOSES ONLY.
  2. JUNE 16, 2020 OBSERVATIONS SHOWN IN RED.
  3. ALL GEORIDGE EROSION CONTROL BARRIERS ARE DESTROYED IN SOUTH DITCH.
  4. HIGHWAY WAS CHIP SEALED IN 2017
  5. PITRUN GRAVEL ON HIGHWAY EMBANKMENT AND DITCH GRADING DONE IN 2017.
  6. BACKSLOPE SLUMPING, DITCH EROSION, AND SOUTH SHOULDER SLUMPING ALL WORSE IN 2020.

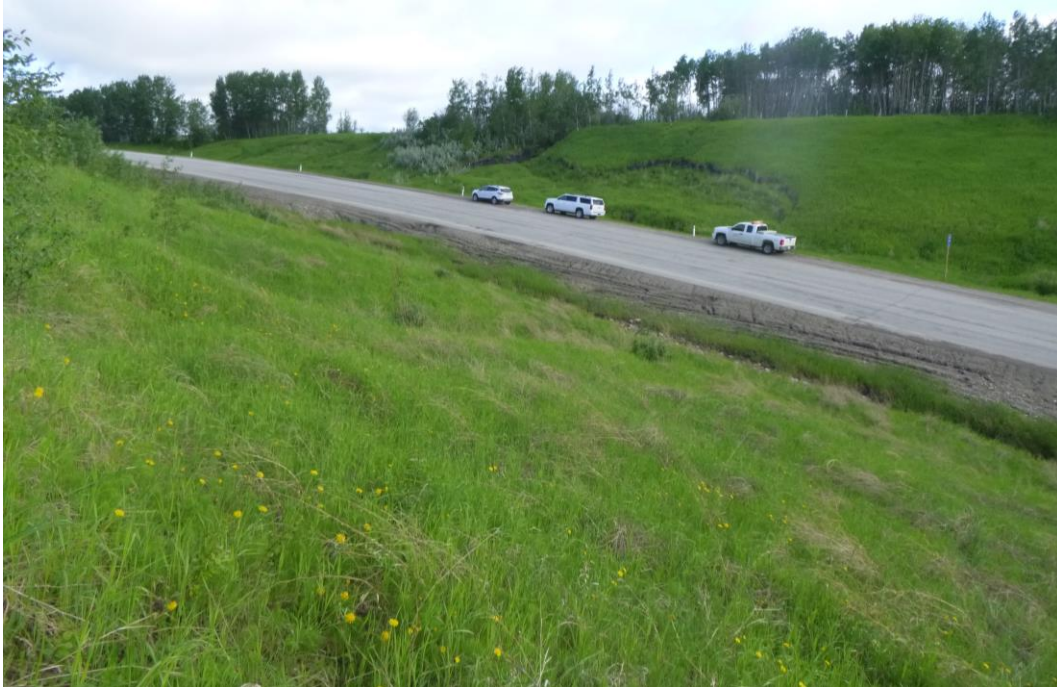
Photo 1 - Looking northwest at the west end of the north cut backslope.

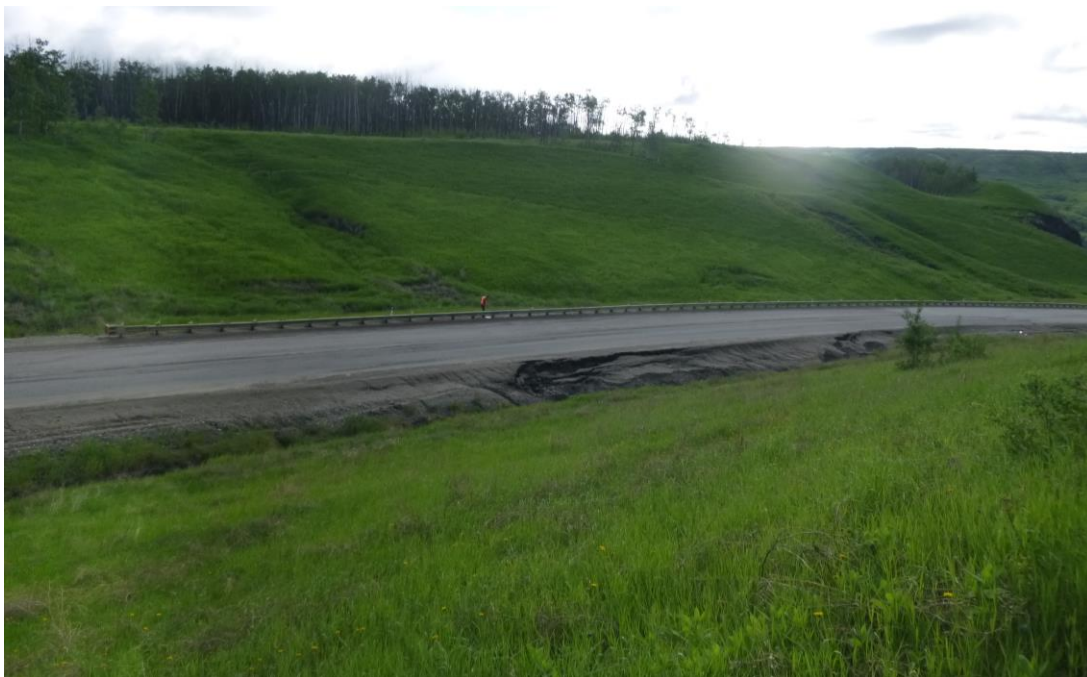
Photo 2 – Looking northeast at the east end of the north backslope erosion and slumps. Also note the south highway embankment slumping and ditch erosion formed from concentrated surface runoff.

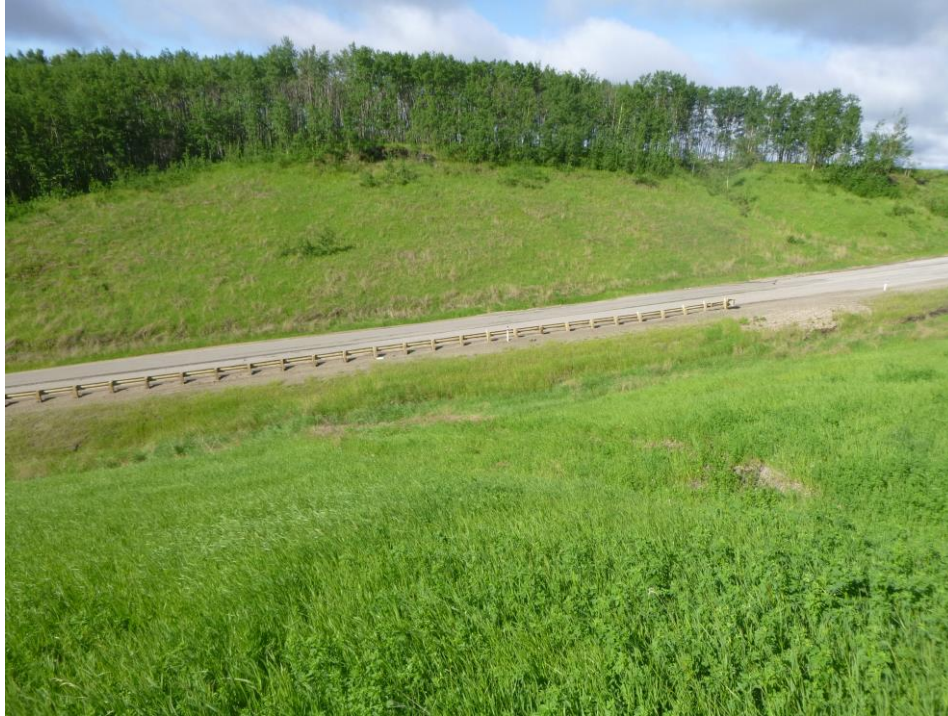
Photo 3 – Looking south at the slumping in the west end of the south highway cut backslope. Note the north guardrail, shoulder pitrun, and ditch grading that took place in 2017.

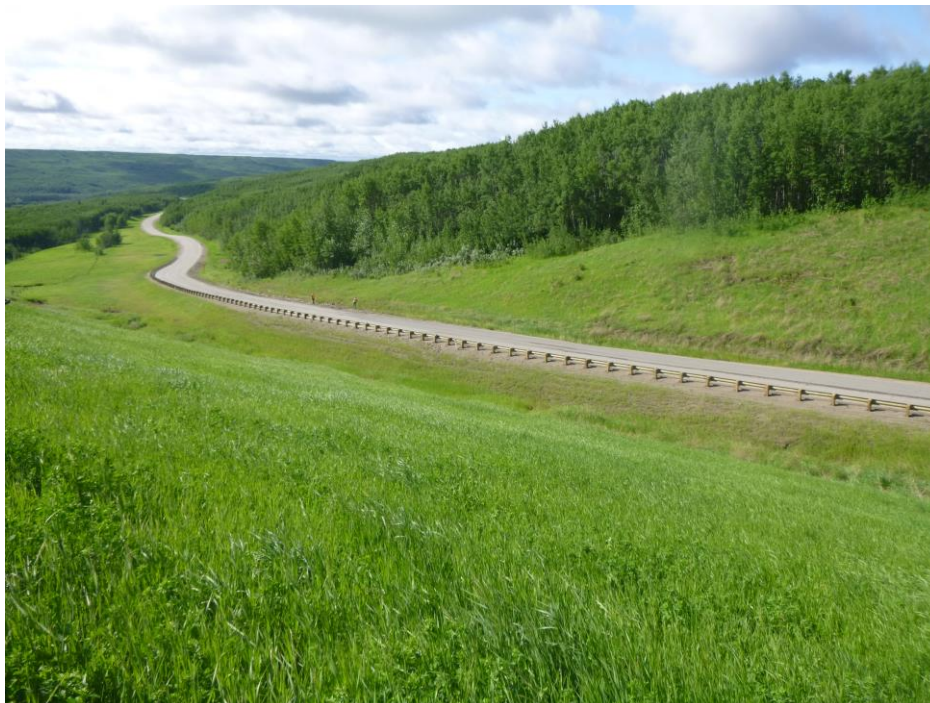
Photo 4 – Looking southeast at the east end of the south cut backslope.

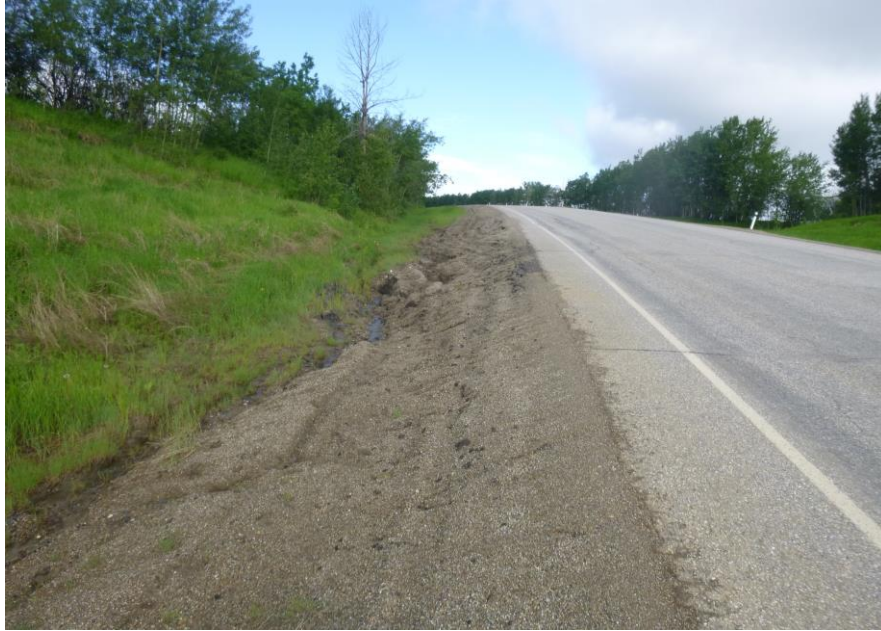
Photo 5 – Looking west along the south ditch from ~STA 3+020. Note the wet, soft, rilled shoulder and slumping highway embankment adjacent to the ditch which was graded in 2017. The tall dead tree beside the south ditch marks the start of the proposed repair (~STA 3+060).

Reconstruct the slumping south embankment sideslope of the highway and ditch by: Excavating to a depth of about 1.5 m below the pavement surface just north of the crack and extending into the south ditch (~12 m horizontally); Install non-woven geotextile over the entire base and sides of the excavation; Place and compact well graded pitrun gravel in the excavation (adding a layer of geogrid over non-woven geotextile near the base); Re-instate the GBC and ACP pavement structure; Line the ditch with Class 1 riprap over non-woven geotextile. AT requested that Thurber prepare detailed design sketches, instructions, and quantity estimates for the areas requiring repairs.

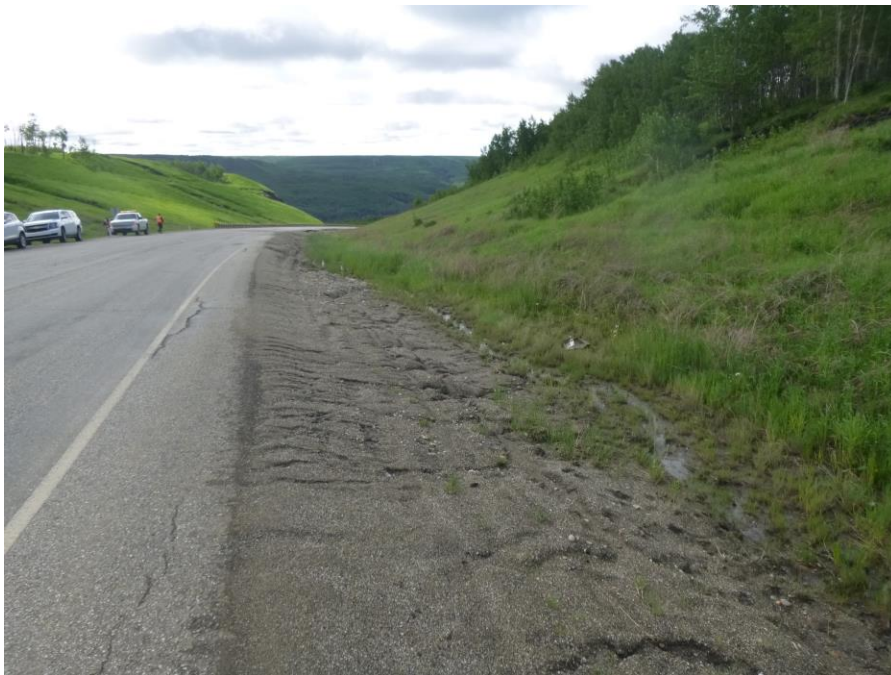
Along the 2008 RECP lining, the base of the ditch is soft and was likely not compacted well before lining installation. Continued erosion occurred under, or around the edges of, the silted-up, georidge barriers along the center of the ditch, and they were all damaged or non-functional, and were removed/destroyed

Photo 6 – Looking east along the south soft embankment and ditch from ~STA 2+980. The georidge ditch barriers installed as part of 2008 repairs are now gone.

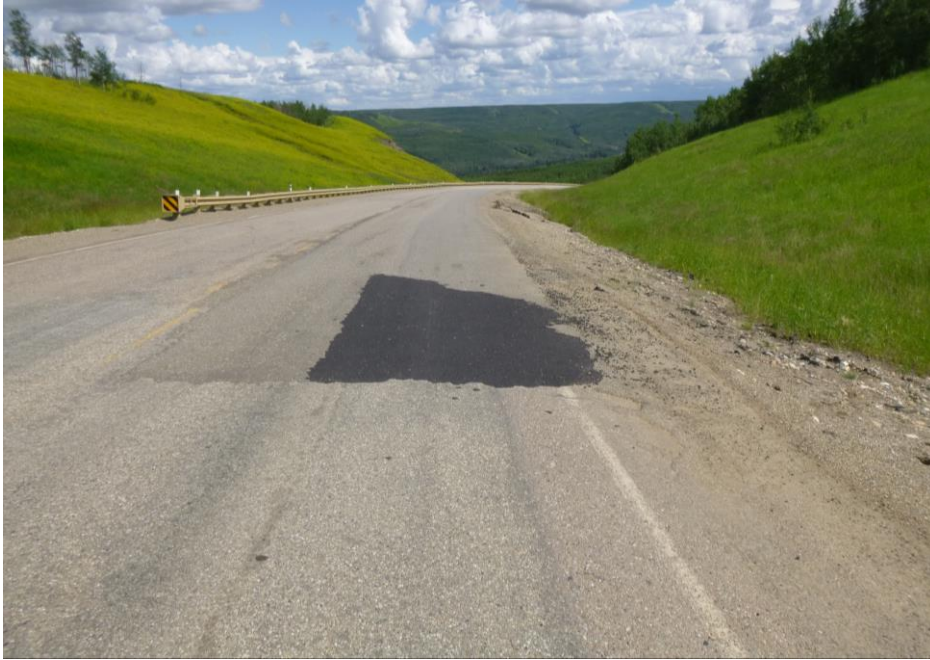
Photo 7 – Looking east along the south edge of the highway at the west end of the patched, cracked and slumping south highway surface and embankment (~STA 2+930).

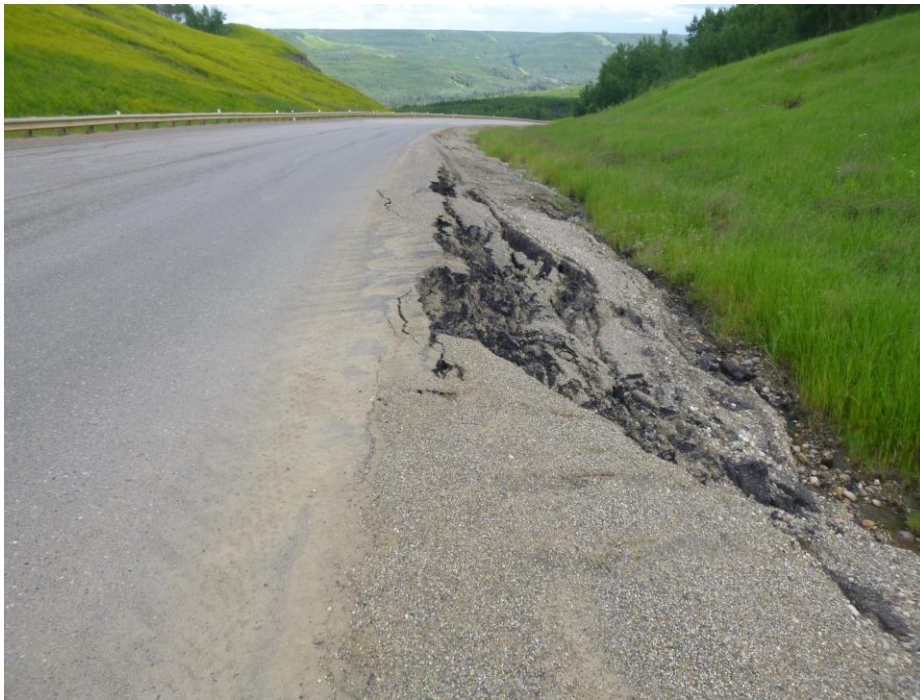
Photo 8 – Looking east along the highway from ~STA 2+900 at the area of the 20 m long slump in the edge of the eastbound driving lane pavement and a crack along the center of the EB driving lane pavement spanning beyond this slump.

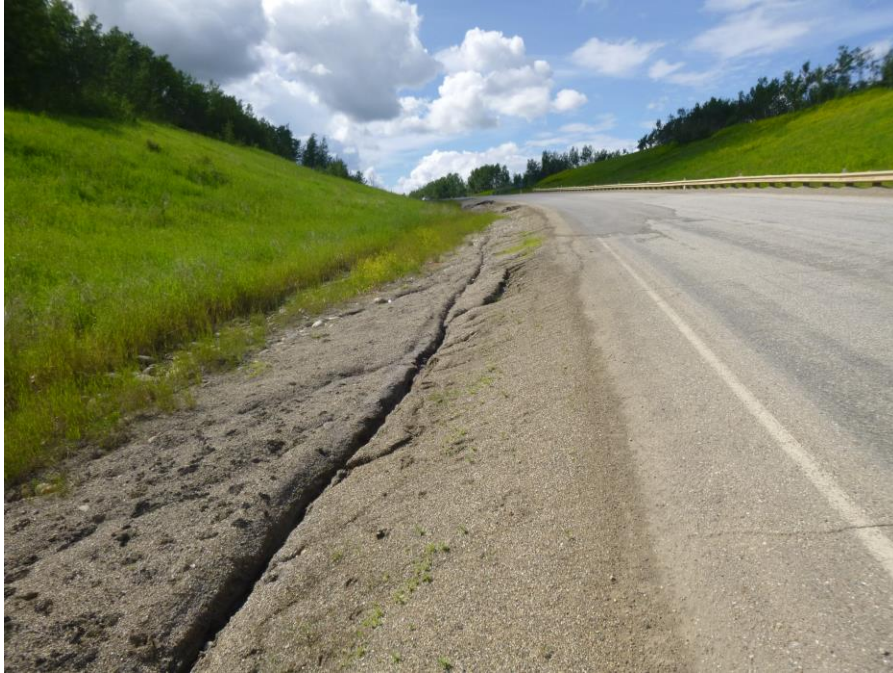
Photo 9 - Looking west along the soft south highway embankment and ditch at ~STA 2+790, showing the patched EB lane and the south embankment slumps in the background.

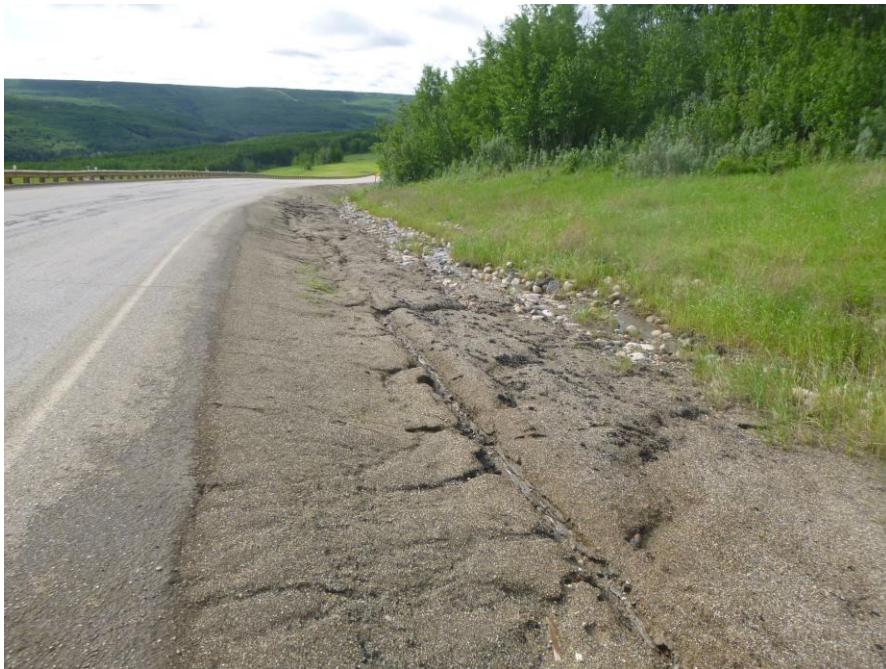
Photo 10 – Looking east at the riprap lined portion of south ditch, and the soft, distorted shoulder/highway embankment above it (~STA 2+790).

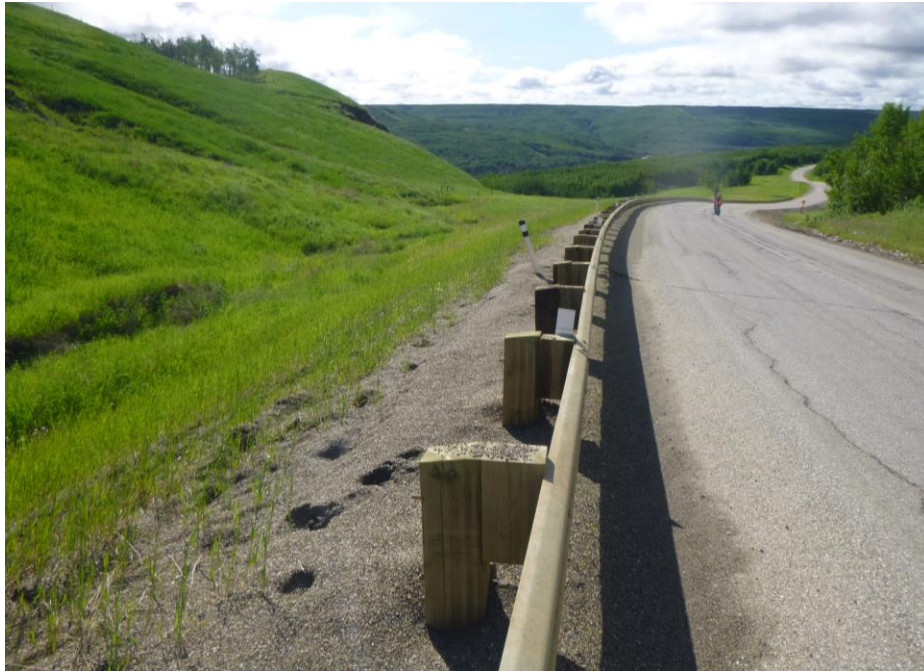
Photo 11 – Looking east along the cracked pavement and soft north shoulder and embankment (~STA 2+880). Note the slide debris that has pushed into the north ditch.

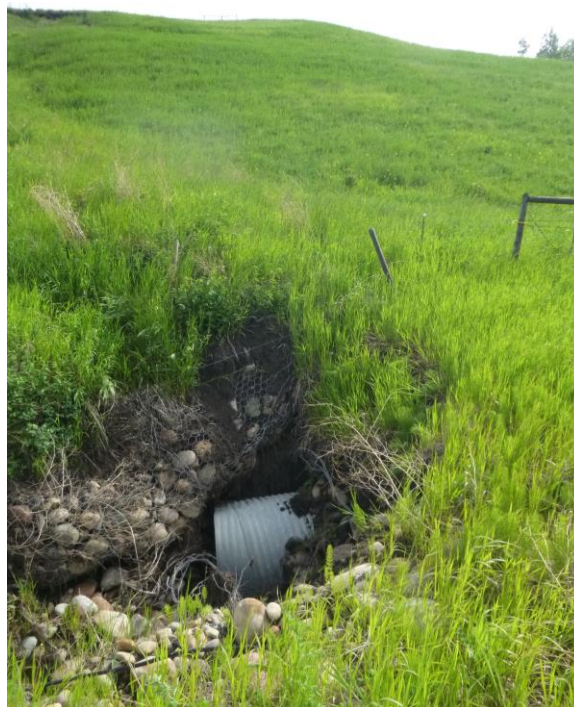
Photo 12 – Looking north at the damaged gabions squeezing in around the culvert inlet caused by slide movement from above (~STA 2+740).

Extend the west end of the north ditch culvert (~Sta 2+800) about 40 m west (upslope of the active backslope slump) to sit on gabions, then mound or berm compacted soil to funnel flow into the pipe and line the inlet area with riprap over non-woven geotextile. Repair the separated culvert area (~2+750) by excavating, cleaning the debris inside it, adding a new length of culvert to join the separated ends, and then neatly backfilling clay around and overtop the excavation and sinkhole area.

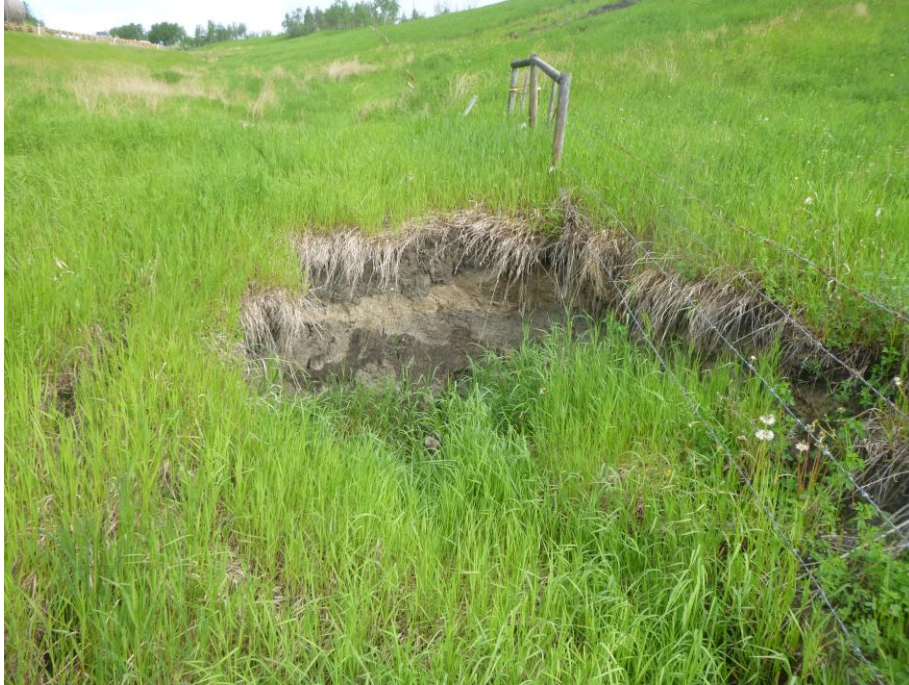
During the 2018 inspection, prior north ditch runoff flow caused a new sinkhole to form overtop of the buried 1200 mm dia. CSP culvert upstream of the outlet, which separated it. The culvert is half full of debris at this separated opening.

Photo 13 – Looking west along the north ditch at the 3m x 5m x 2.8m deep sinkhole overtop the culvert a short distance east of the inlet (~STA 2+730).

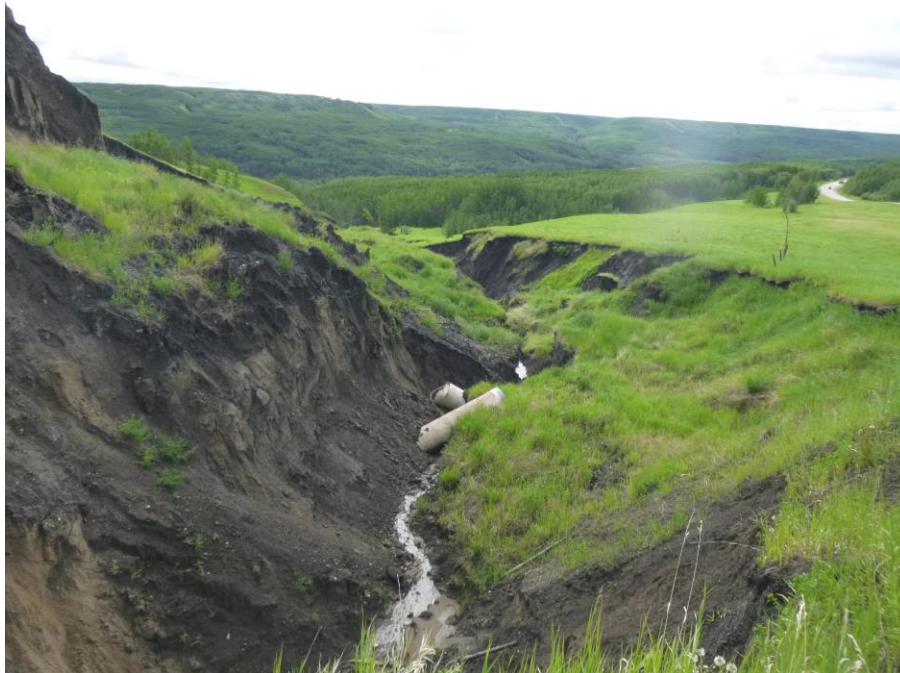
The large erosion ravine and culvert outlet gully have gotten worse again this year. The concentrated runoff flows in the ravine are too fast for the unprotected clay soils.

Photo 14 - Looking east along the large erosion ravine and fence line from the north ditch culvert outlet. Note the slide blocks that have slid down and broken off pieces of culvert.

Perform Lidar (TRANS does have older 2005 coverage of this site), hydrology and geotechnical studies to assess flows, & prepare a design to control and stabilize the severe erosion of the culvert outlet gully and the north ravine.

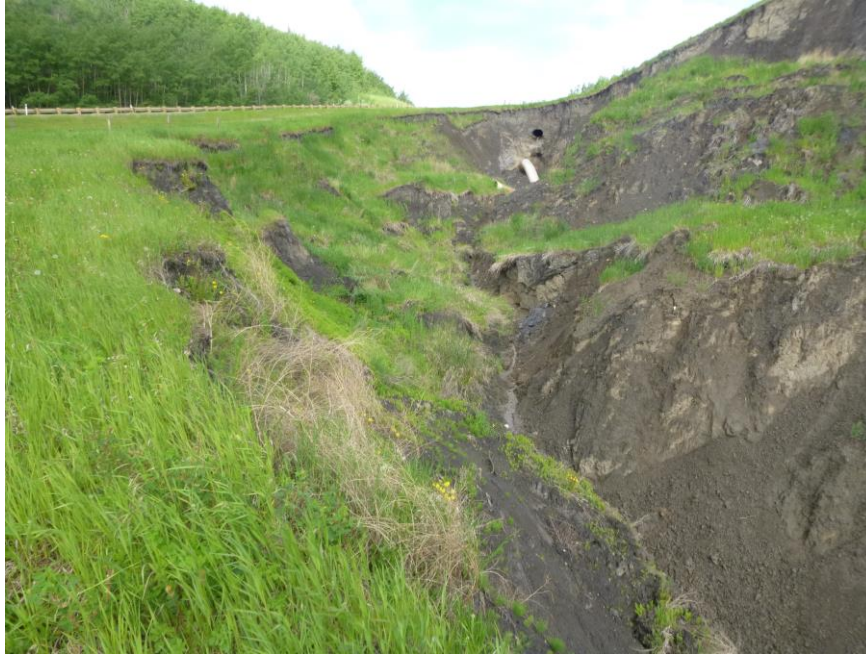
Photo 15 - Looking west parallel to the highway at the 7 m deep erosion ravine headscarp caused by runoff from the north ditch culvert outlet. The erosion/slumping has again encroached closer to the pavement white line.

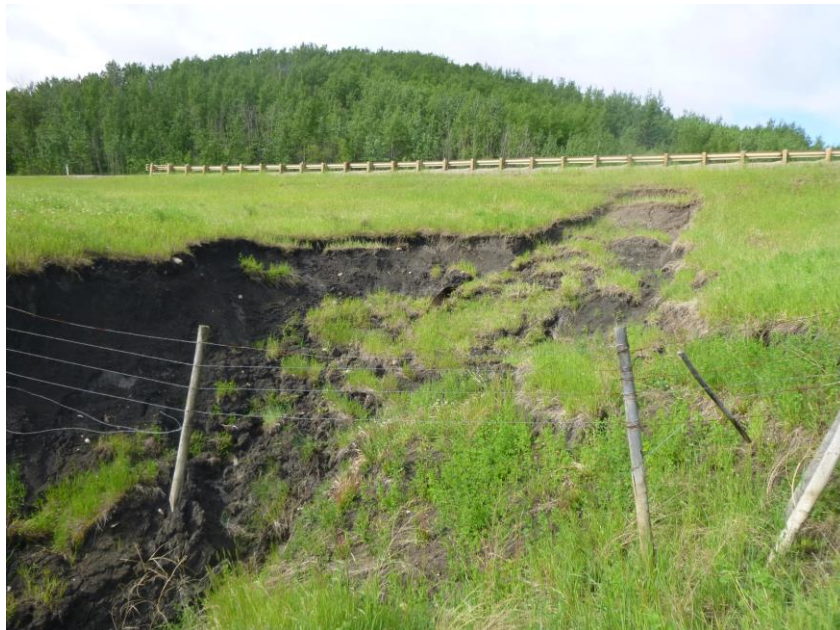
Photo 16 – Looking south along the erosion gully formed downstream of the cross-culvert outlet. The headscarp of this erosion has encroached to 6.2m from the white line.

Check the highway cross culvert (at Station 2+580) to see if cleaning it of mud/debris is still required to allow more unrestricted flow. In 2016 the culvert outlet was 1/3 full, but gully erosion has encroached back behind the outlet and it appears to have self-cleaned itself.

Add some more riprap (sized to suit the condition) along the south ditch where it is required, and at the cross culvert inlet and outlet, and the north ditch culvert outlet (after re-establishing the eroded grades
