**ALBERTA TRANSPORTATION  
GEOHAZARD ASSESSMENT PROGRAM  
PEACE REGION – GRANDE PRAIRIE NORTH  
2021 INSPECTION**

<b>Site Number</b>	<b>Location</b>	<b>Name</b>	<b>Hwy</b>	<b>km</b>
PH008	Clear River West Hill	Old Site 7	64:02	19.4-20.1
<b>Legal Description</b>		<b>UTM Co-ordinates (NAD 83)</b>		
SW32-84-11-W6		11 N 6245420	E 332480

<b>Date</b>	<b>PF</b>	<b>CF</b>	<b>Total</b>
<b>Previous Inspection:</b>	June 16, 2020	14	4	56
<b>Current Inspection:</b>	July 14, 2021	12	4	48 (Road/Ditch only)
<b>Road AADT:</b>	260	<b>Year:</b>		2020
<b>Inspected By:</b>	Don Proudfoot, Barry Meays (Thurber), Ed Szmata, Roger Skirrow, Rocky Wang, Ken Szmata (AT)			
<b>Report Attachments:</b>	<input checked="" type="checkbox"/> Photographs <input checked="" type="checkbox"/> Plans <input type="checkbox"/> Maintenance Items

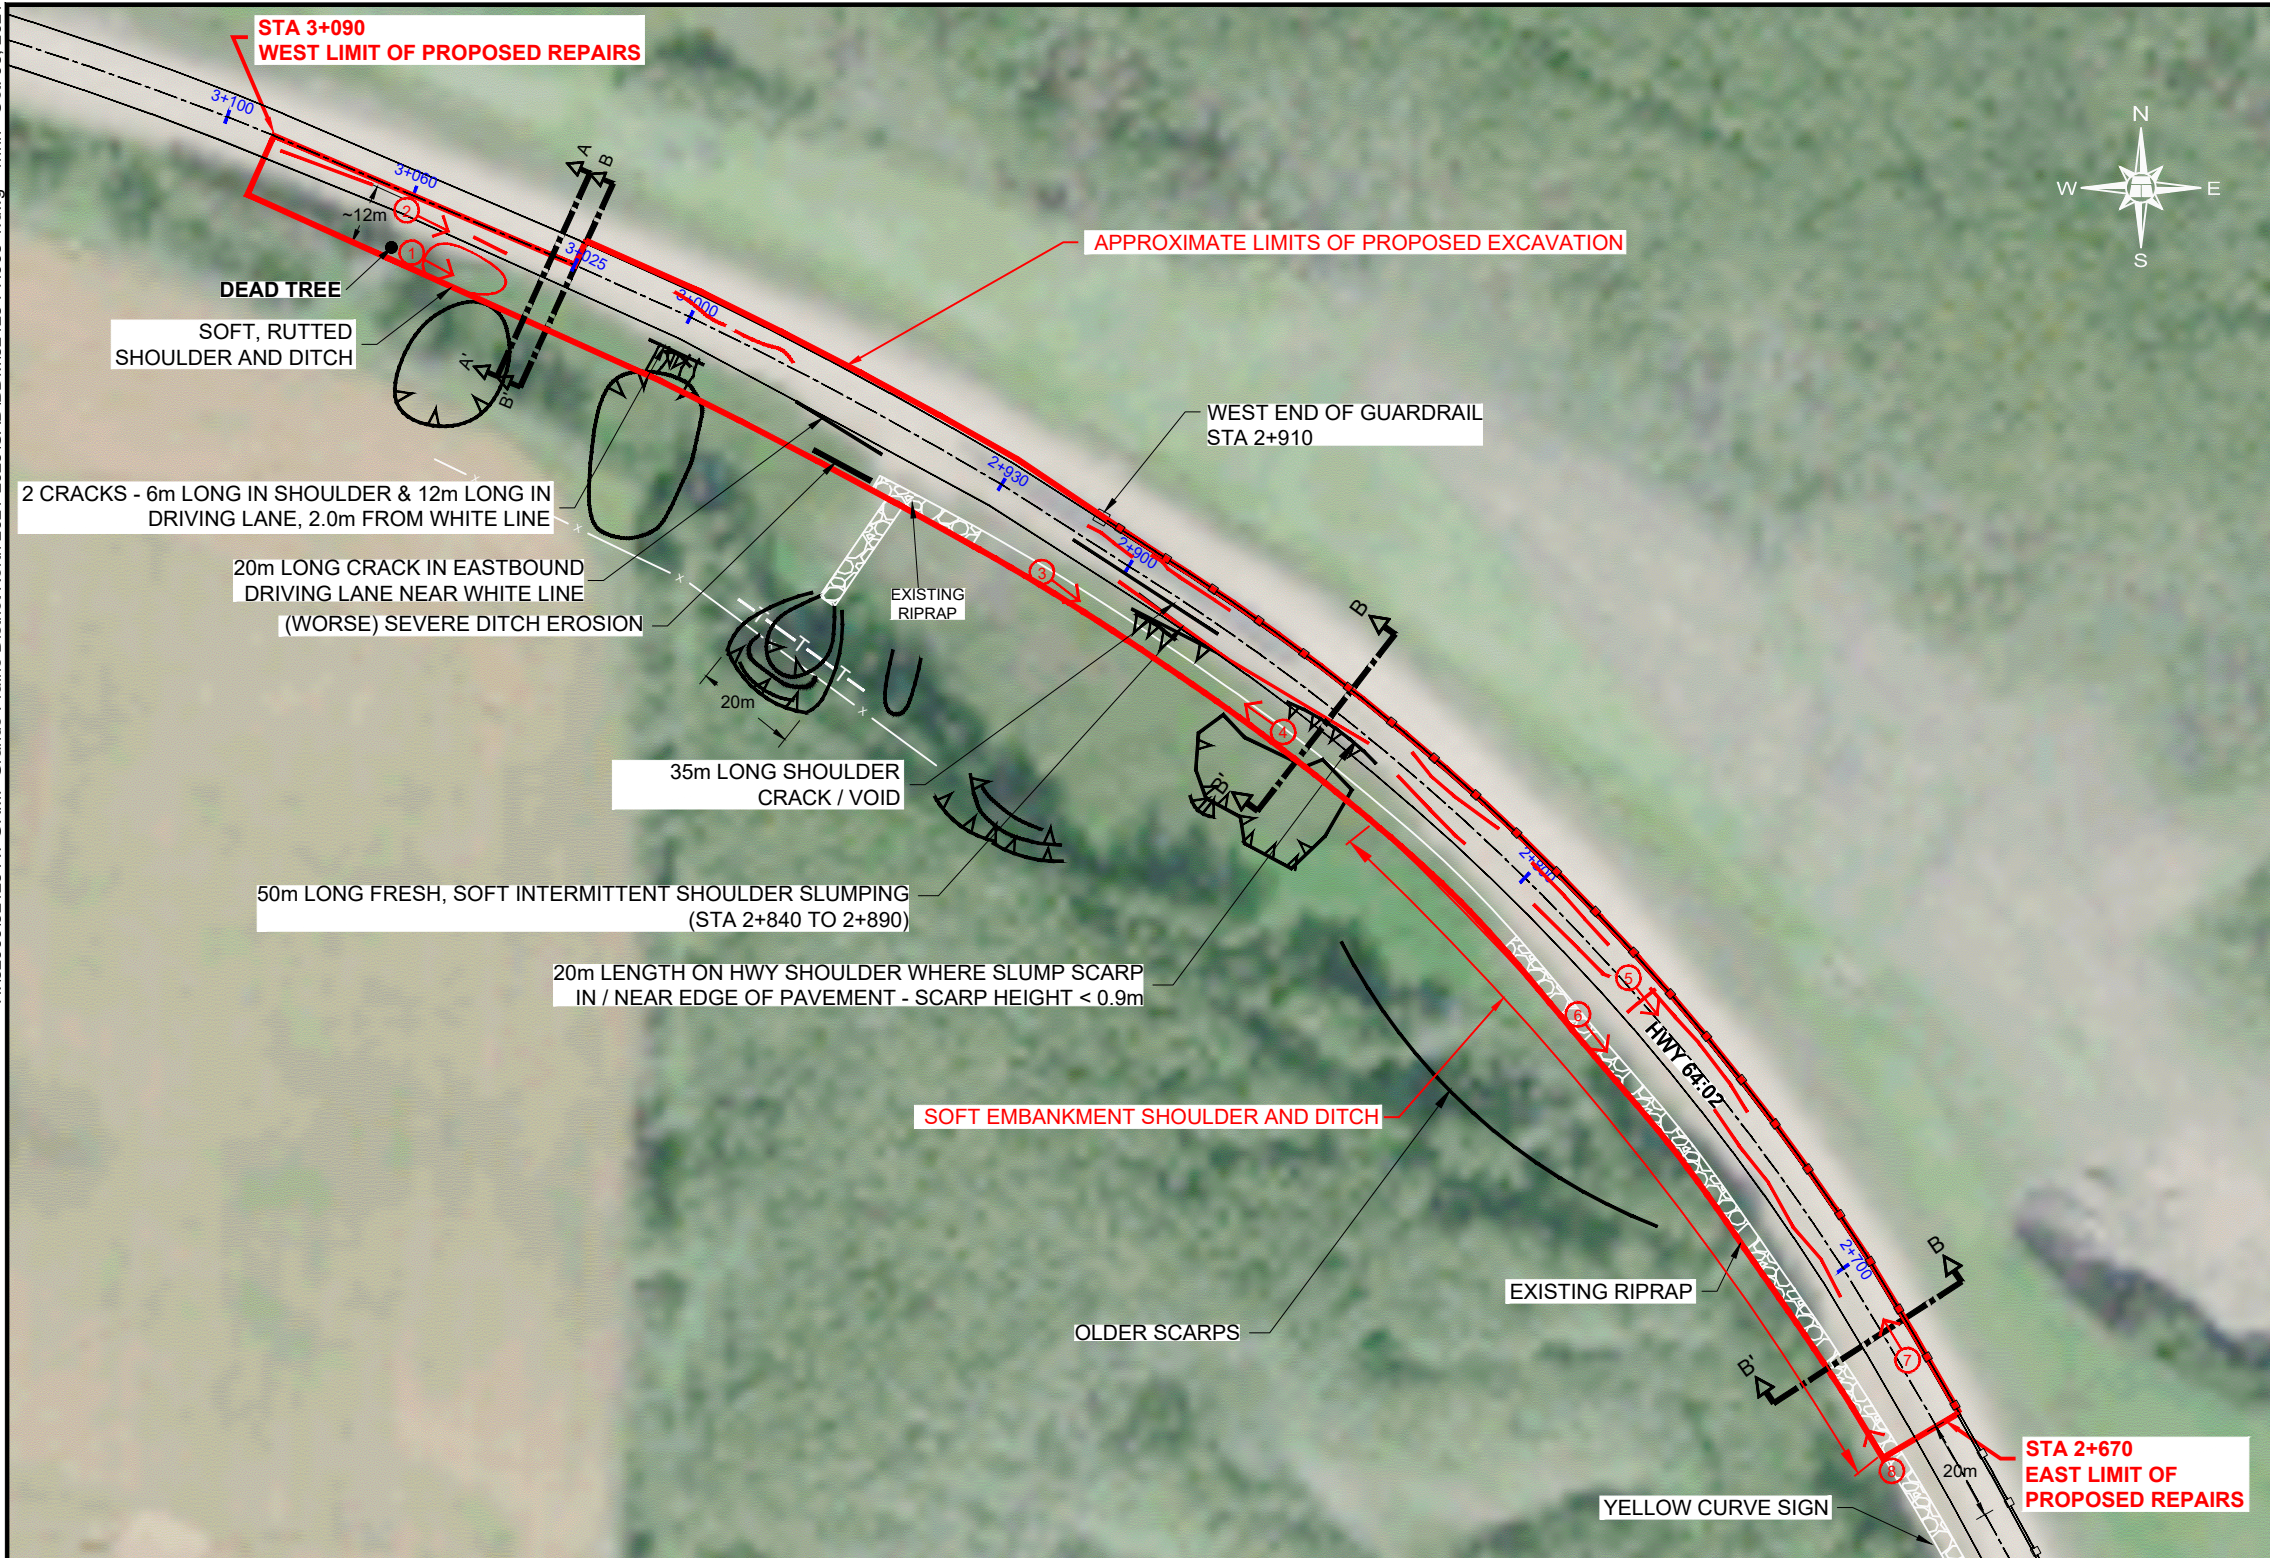
DWG NO. 32123-PH008-1

The 140 m long 2017 patched/overlayed area from ~Sta 2+690 to 2+830 (and the previous rutted, sunken, alligator crack-sealed segments further west), along the eastbound lane and south shoulder of the highway adjacent to the south ditch, is thought to be attributed to a soft/wet subgrade. This has now enlarged to include semi-continuous areas over an approximate 420 m length of highway, in both the eastbound and westbound driving surfaces. The worst 40 m long segment (centered at Sta 2+850) contains a crack along the center of the EBDL and a slump into the south edge of the pavement & embankment, but the pavement and embankment are quite soft and contain shoulder slumped areas over a 130 m length extending between ~Sta 2+800 to 2+930. Cracks and shoulder slumps have since formed over intermittent segments extending 160 m further west of this area (~Sta 2+930 to 3+090) along the center or edge of the eastbound driving lane/shoulder, along with rutting/cracking/patching and a soft east embankment/ditch extending further east up to ~Sta 2+670, spanning a total highway length of about 420 m (shown on Drawing 32123-PH008-1 and the Photos).

As an interim measure to control and stabilize only the ~420 m length of pavement deterioration and ditch erosion at this site (as shown on Drawings 1 and 3): Reconstruct the slumping south (eastbound) embankment sideslope of the highway and ditch, and the north (westbound driving lane) by: Excavating to a depth of 1.0 m below the pavement surface from hwy centerline northwards up to near the guardrail (where it exists), and 1.5 m below the pavement surface from hwy centerline and extending southwards into the ditch (~14 m horizontally); Install non-woven geotextile over the entire base and sides of the excavation; Place and compact well graded pitrun gravel in the excavation (0.5m north of centerline and 1.0m south of centerline), adding a layer of geogrid overtop the non-woven geotextile near the base); Re-instate the GBC and ACP pavement structure; Line the south ditch with Class 1 riprap over non-woven geotextile. AT is currently considering preparation of a detailed design and tender for these specific areas requiring repairs, and also to address/include the local repair of the cross-culvert outlet erosion north of the highway (which would likely include rebuilding the sideslopes with compacted clay, reshaping the channel, and placing riprap armour to the fence or property line).

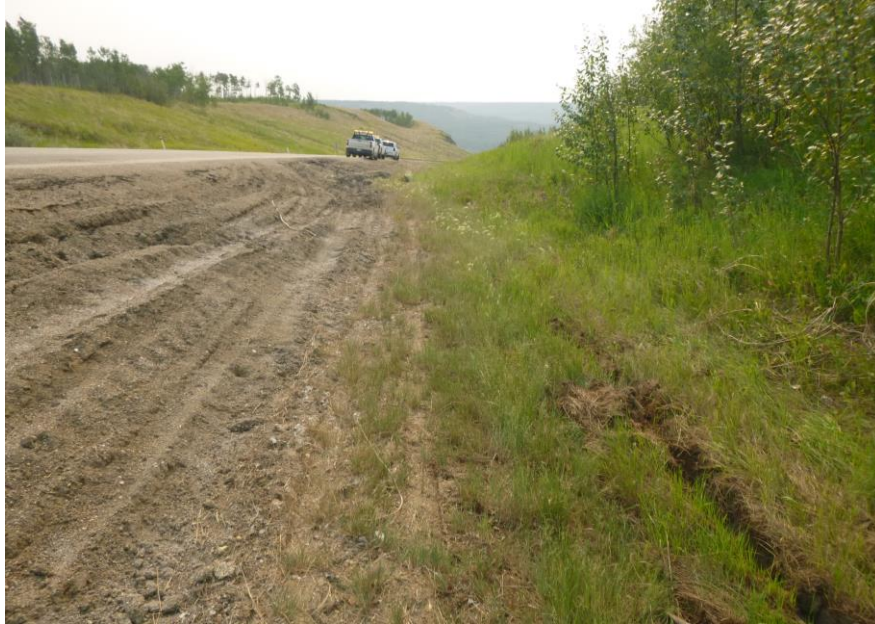
Photo 1 – Looking east along the south ditch from the tall dead tree landmark (~STA 3+060). Note the wet, soft, rilled shoulder and slumping highway embankment adjacent to the ditch which was graded in 2017. Also note the toe of a backslope slump encroaching into the ditch on this side of the vehicles.

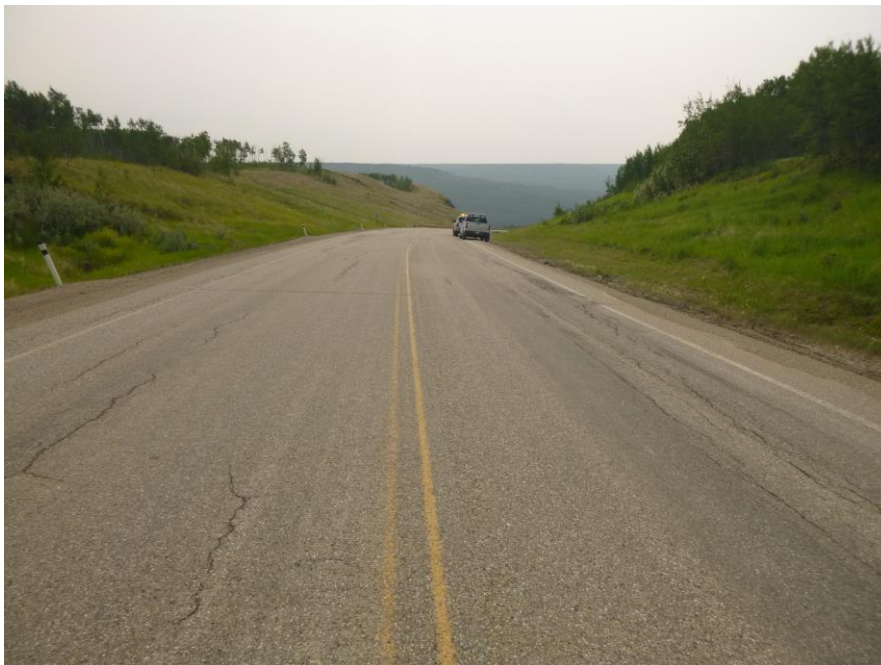
Photo 2 – Looking east along the center of the hwy from ~STA 3+060. The north half of the hwy (WB lane) was deemed to not require repairs at this location. Note the rutted outside wheel path in the EB lane.

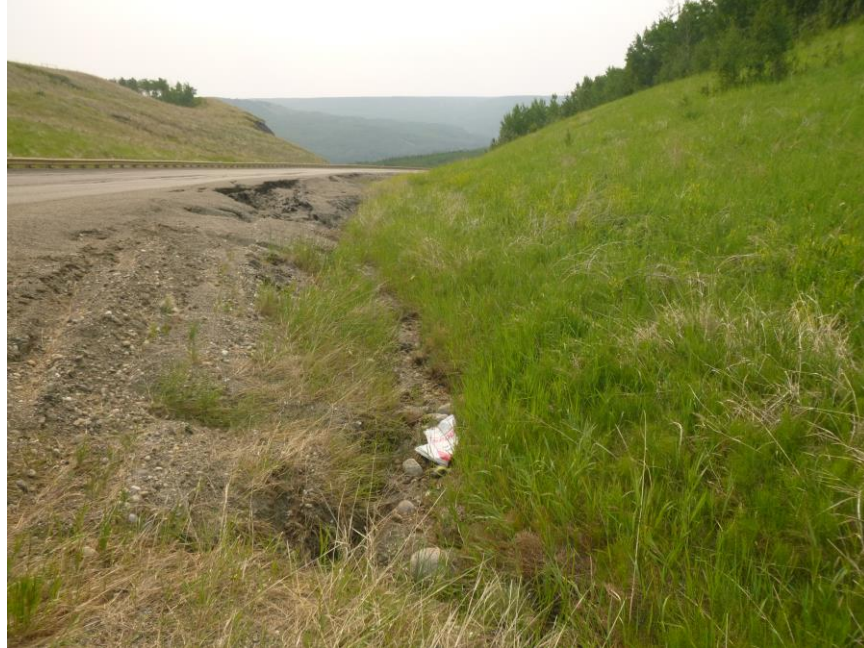
Photo 3 – Looking east along the south highway ditch from the west end of the guardrail (~STA 2+910). Note the patched, cracked and slumping south highway shoulder and embankment.

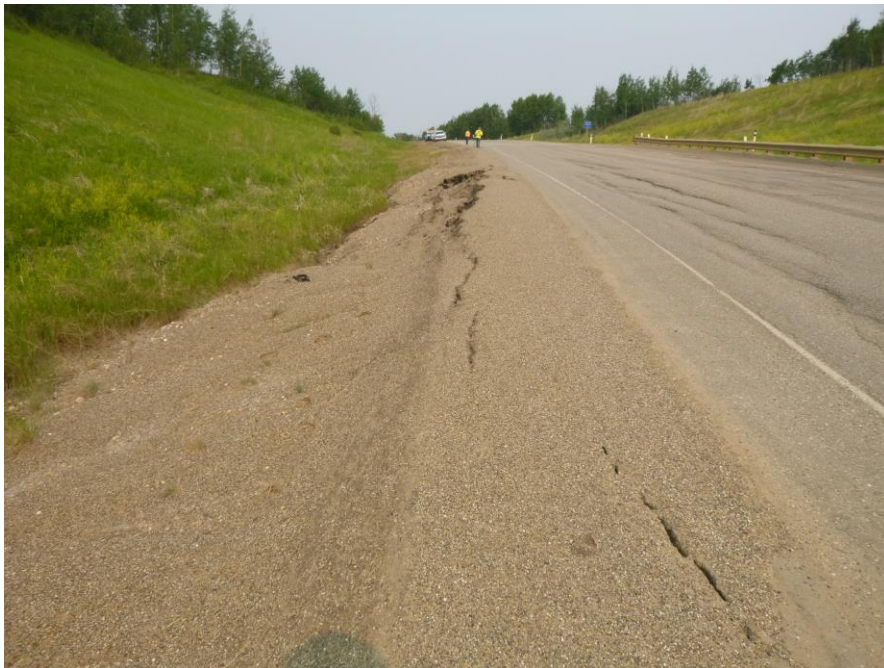
Photo 4 – Looking west along the south edge of the highway from ~STA 2+860 at the area of the 20 m long slump in the edge of the eastbound driving lane pavement and a crack along the center of the EB driving lane pavement spanning beyond this slump.

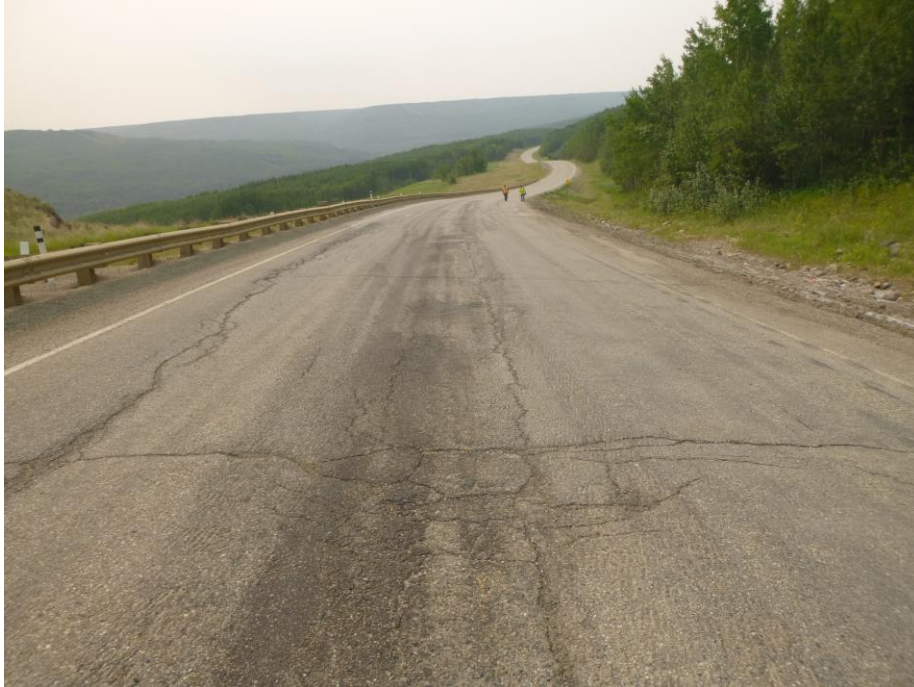
Photo 5 - Looking east along the center of the highway at ~STA 2+760, showing the cracking and rutting occurring in this previously patched area.

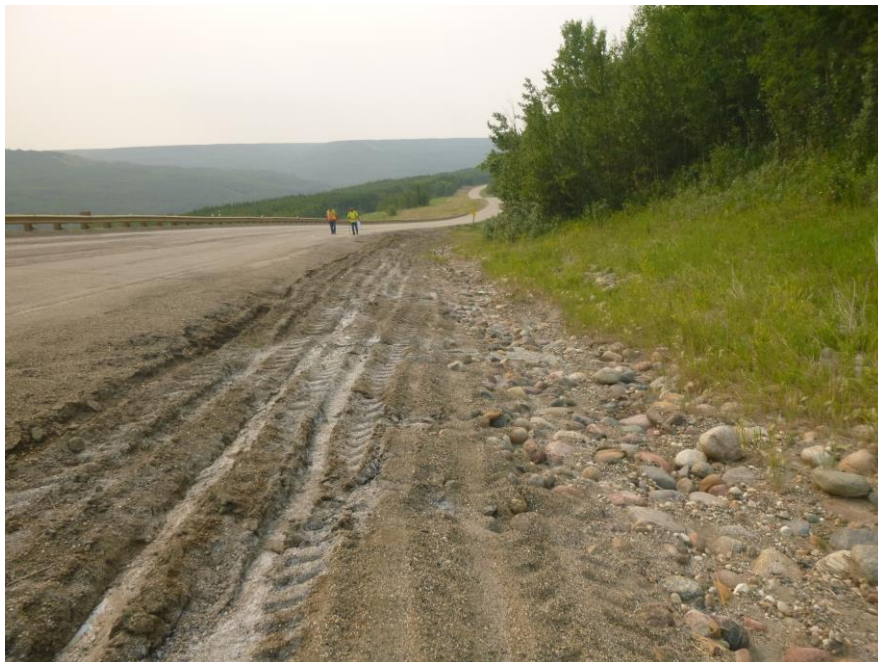
Photo 6 – Looking east along the riprap lined portion of south ditch, and the soft, distorted shoulder/highway embankment above it (~STA 2+760).

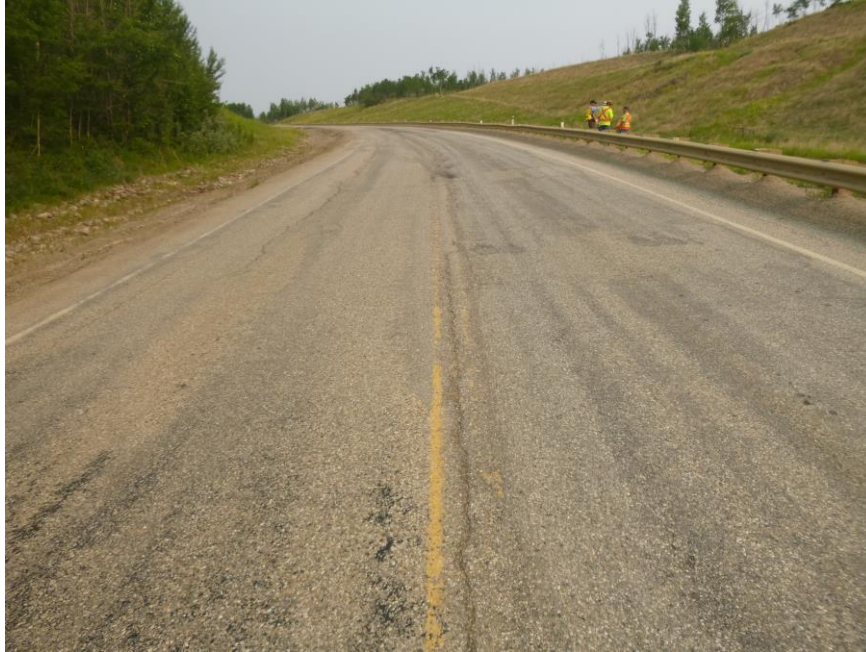
Photo 7 – Looking west along the cracked and deformed pavement from the east end of the proposed repair area (~STA 2+670, ~ 20 m west of the yellow curve sign). Note this area was also previously patched.

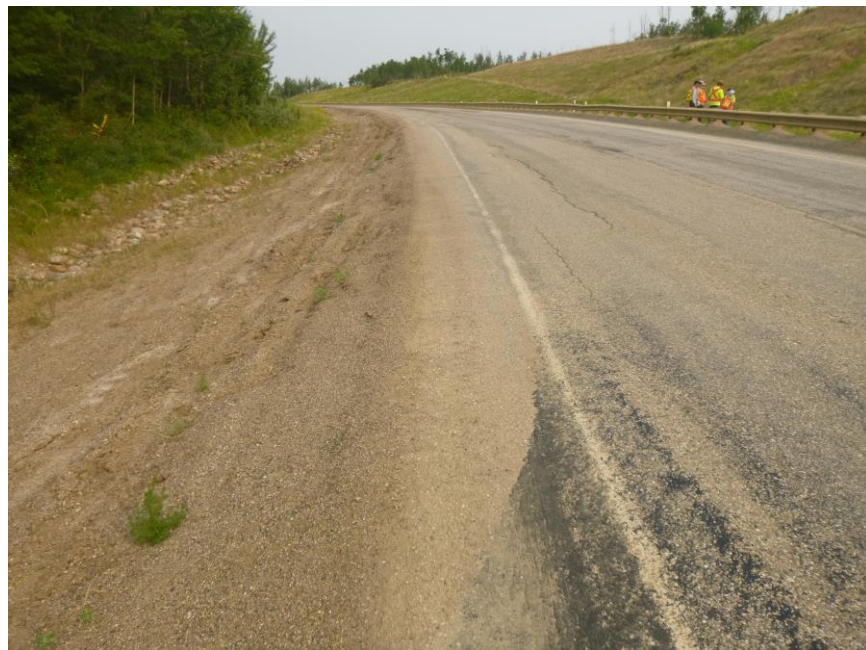
Photo 8 – Looking west along the south edge of the highway from the west end of the proposed repair area (~STA 2+670).

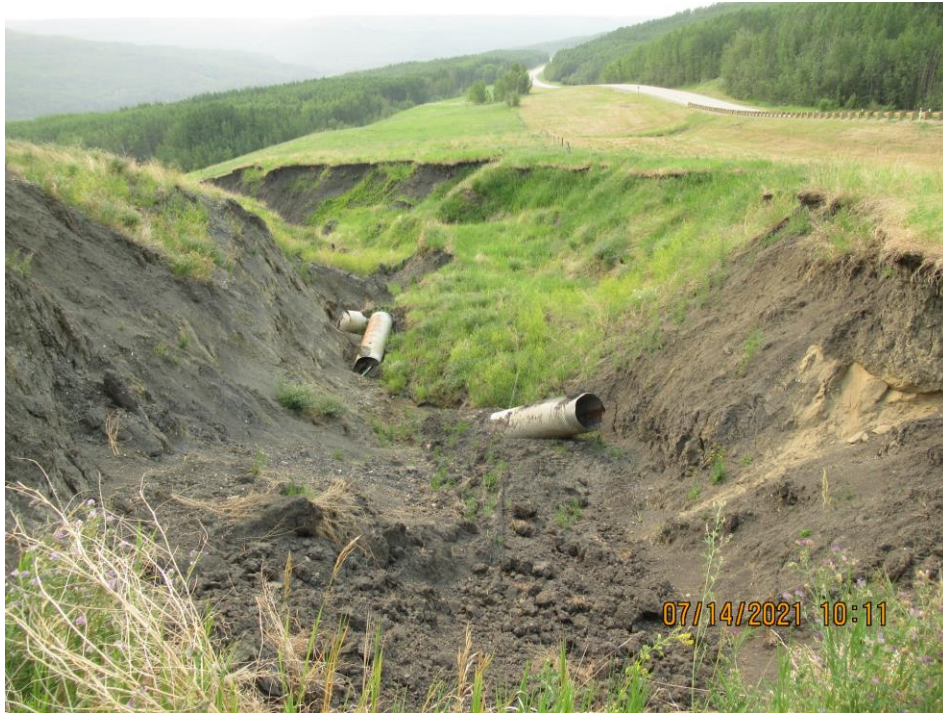
The large erosion ravine and culvert outlet gully have gotten worse again this year. The concentrated runoff flows in the ravine are too fast for the unprotected clay soils.

Photo 9 - Looking east along the large erosion ravine and fence line from the north ditch culvert outlet. Note the slide blocks that have slid down and broken off pieces of culvert.

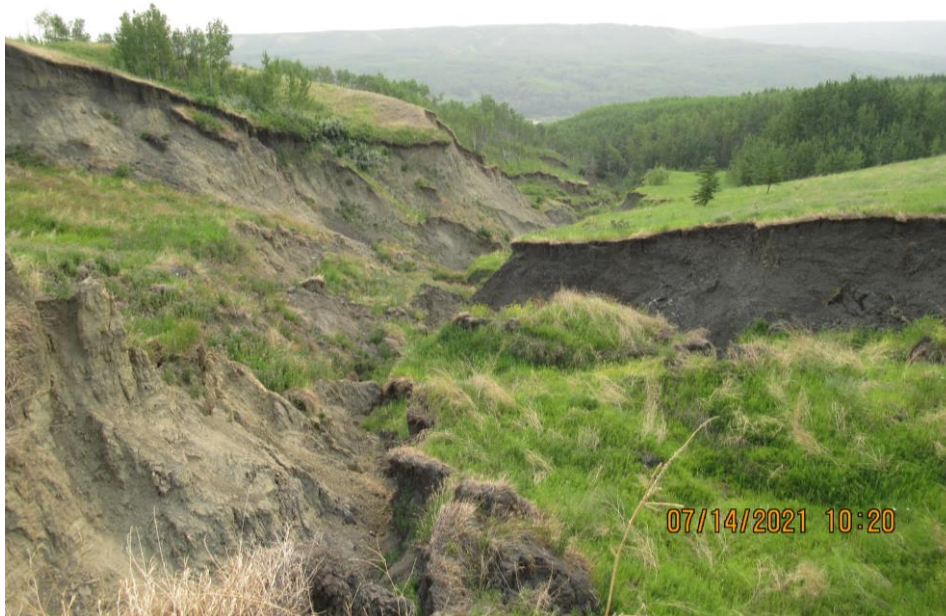
Photo 10 – Looking northeast along the large erosion ravine where the cross-culvert outlet erosion merges into it.

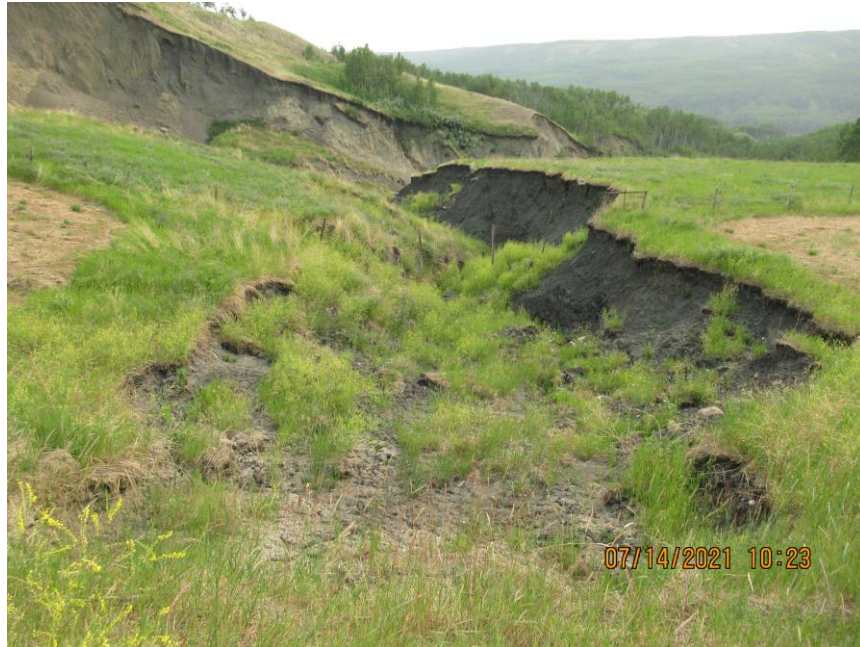
Photo 11 - Looking north from the highway at the 7 m deep erosion ravine headscarp caused by runoff from the north ditch culvert outlet. The erosion/slumping has again encroached closer to the pavement white line.

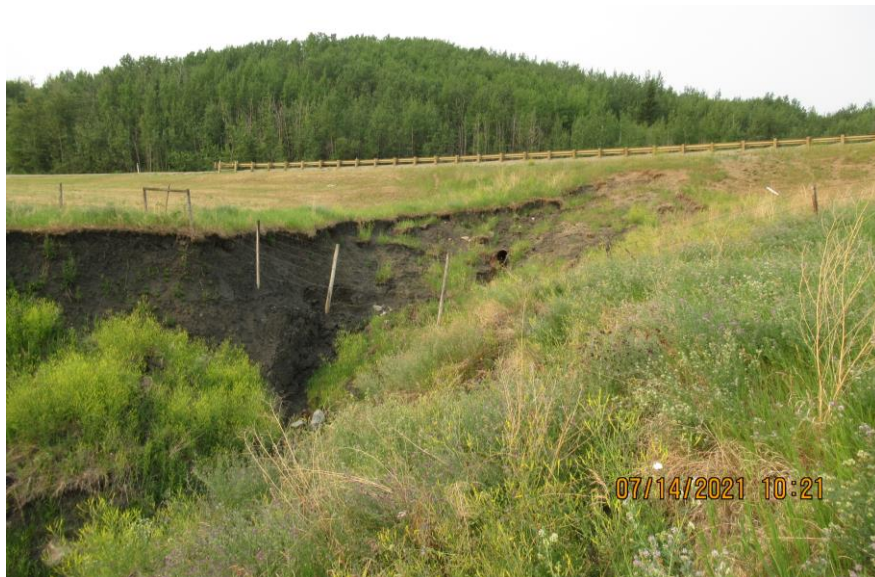
Photo 12 – Looking southeast at the erosion gully formed downstream of the cross-culvert outlet. The headscarp of this erosion has encroached to 5.3 m from the white line (from 6.2 m last year).
