THURBER ENGINEERING LTD.

August 15, 2017

File: 13351

**GEOHAZARD ASSESSMENT PROGRAM
CALL-OUT INSPECTION
HWY 64:2 GOLF COURSE SLIDES – 6.1 km WEST OF CLEARDALE**

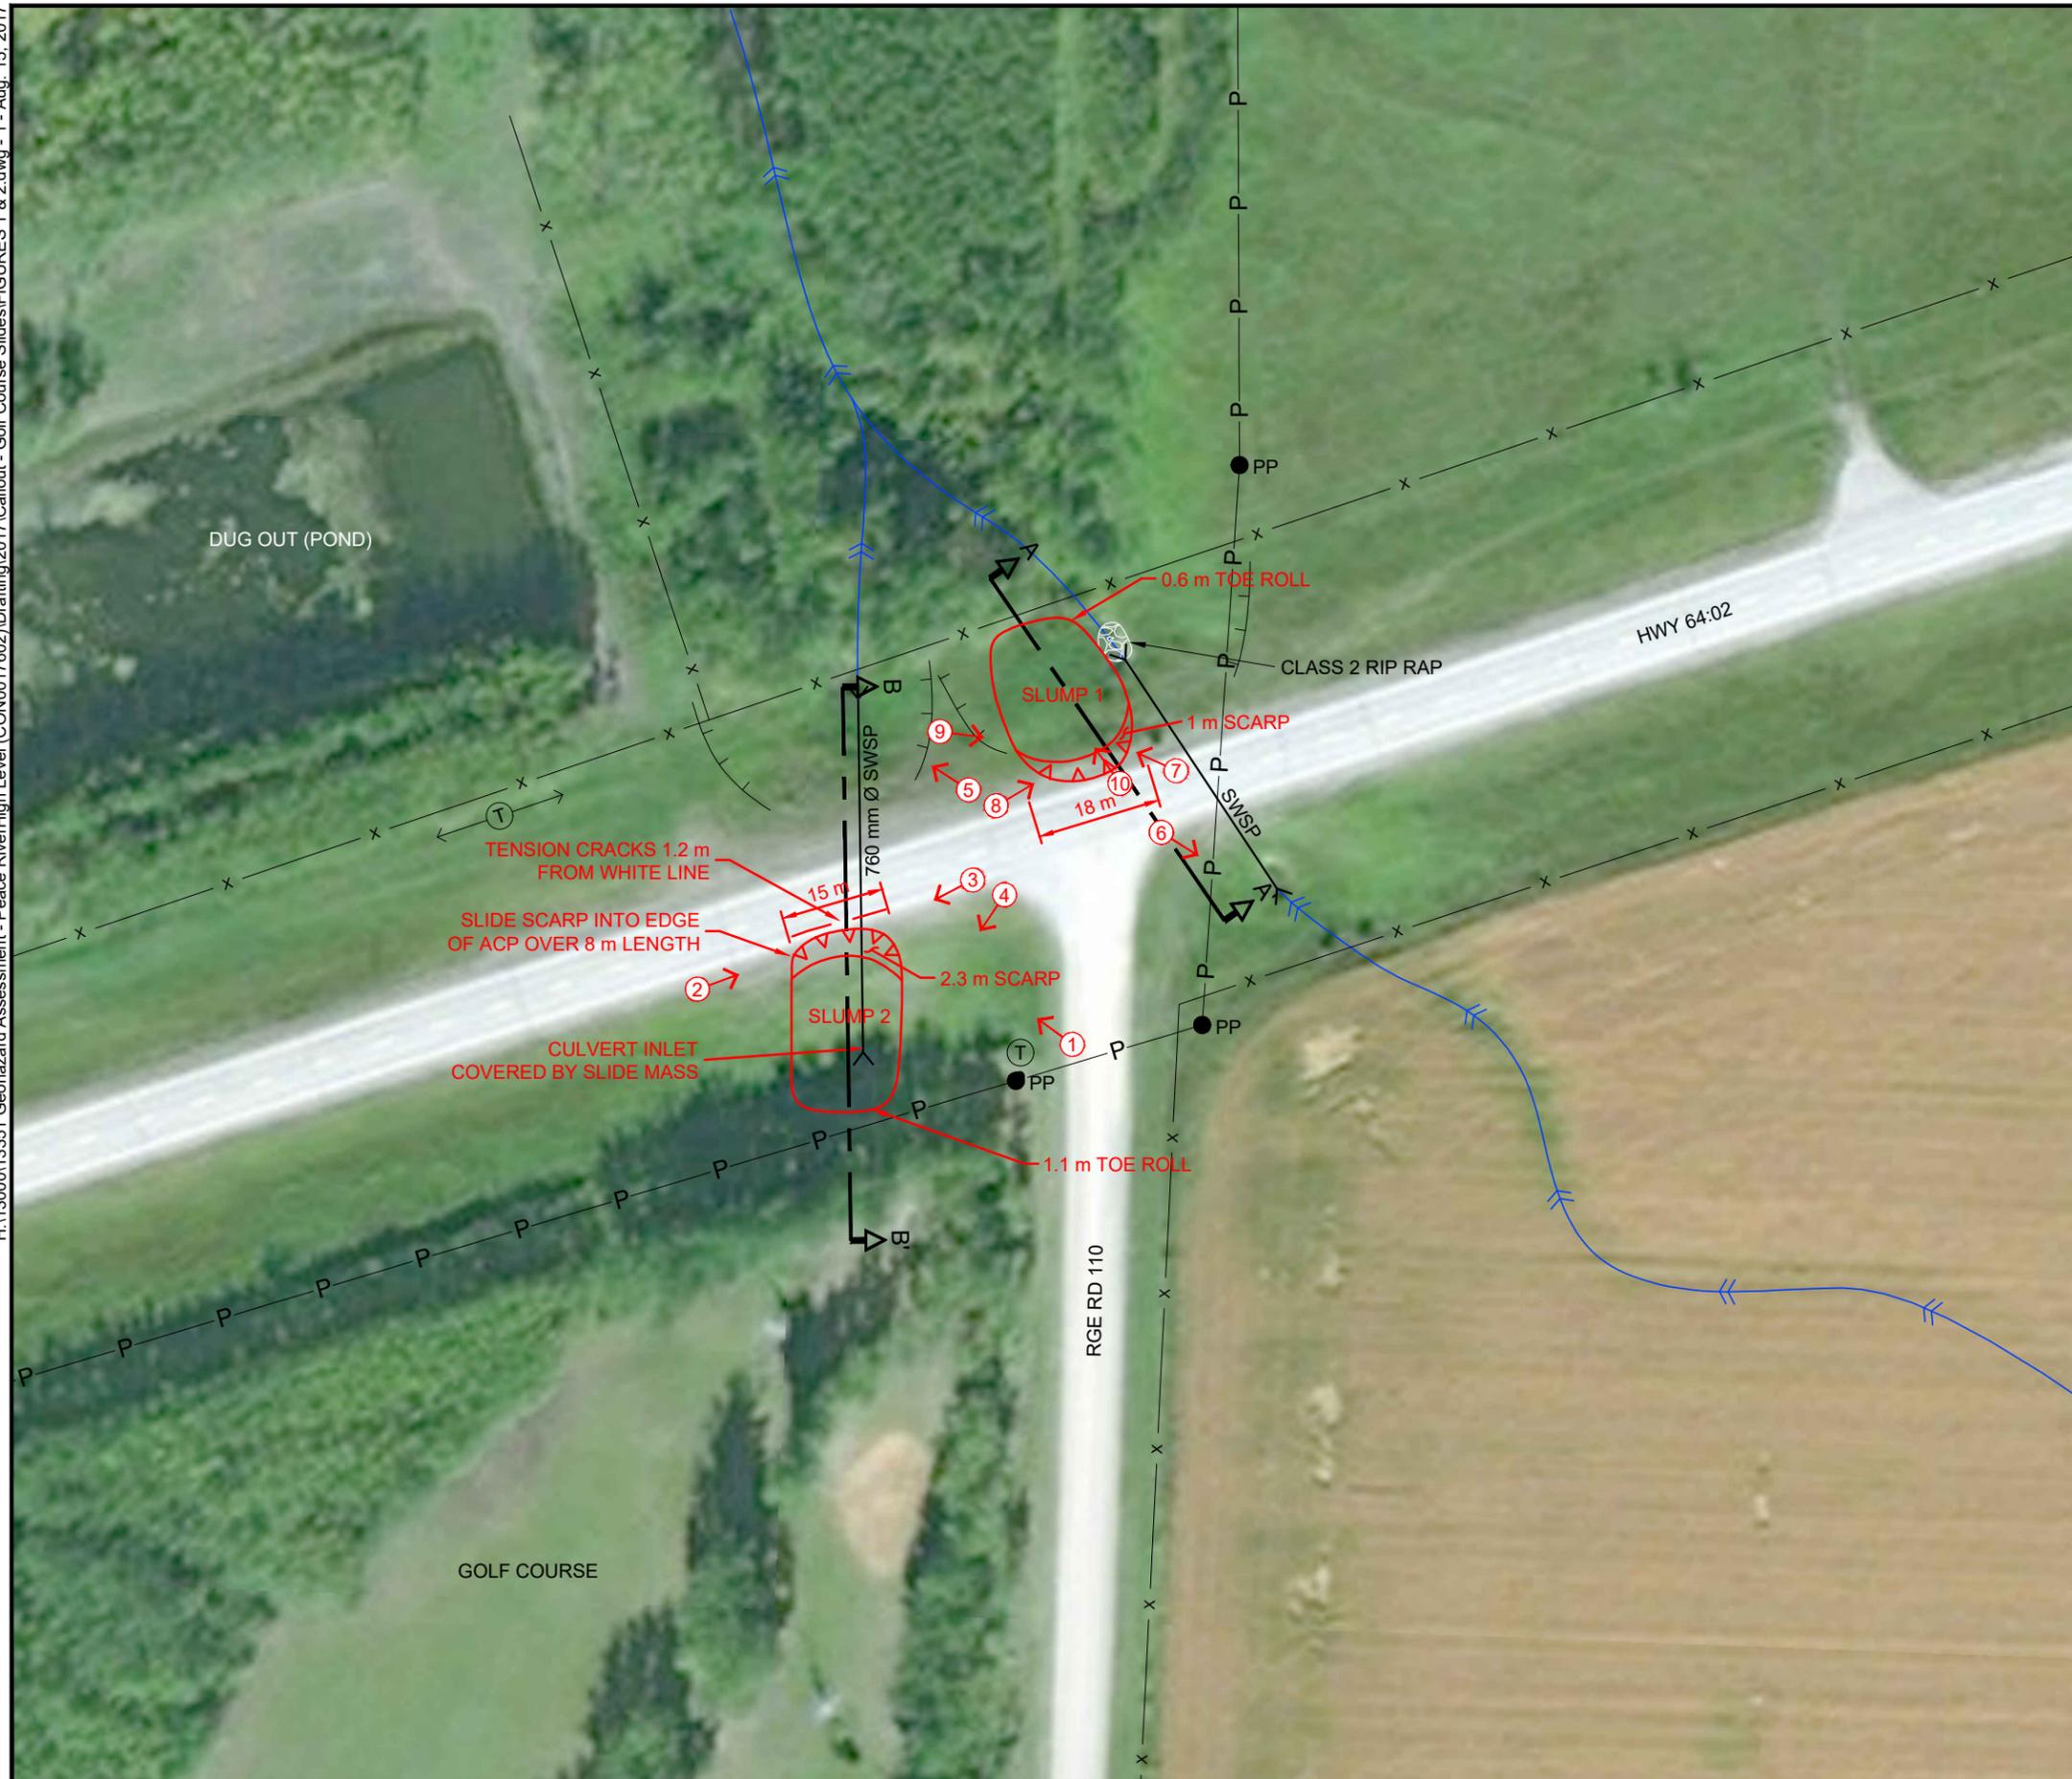
FIGURE 1

JULY 26, 2017 CALLOUT INSPECTION PLAN

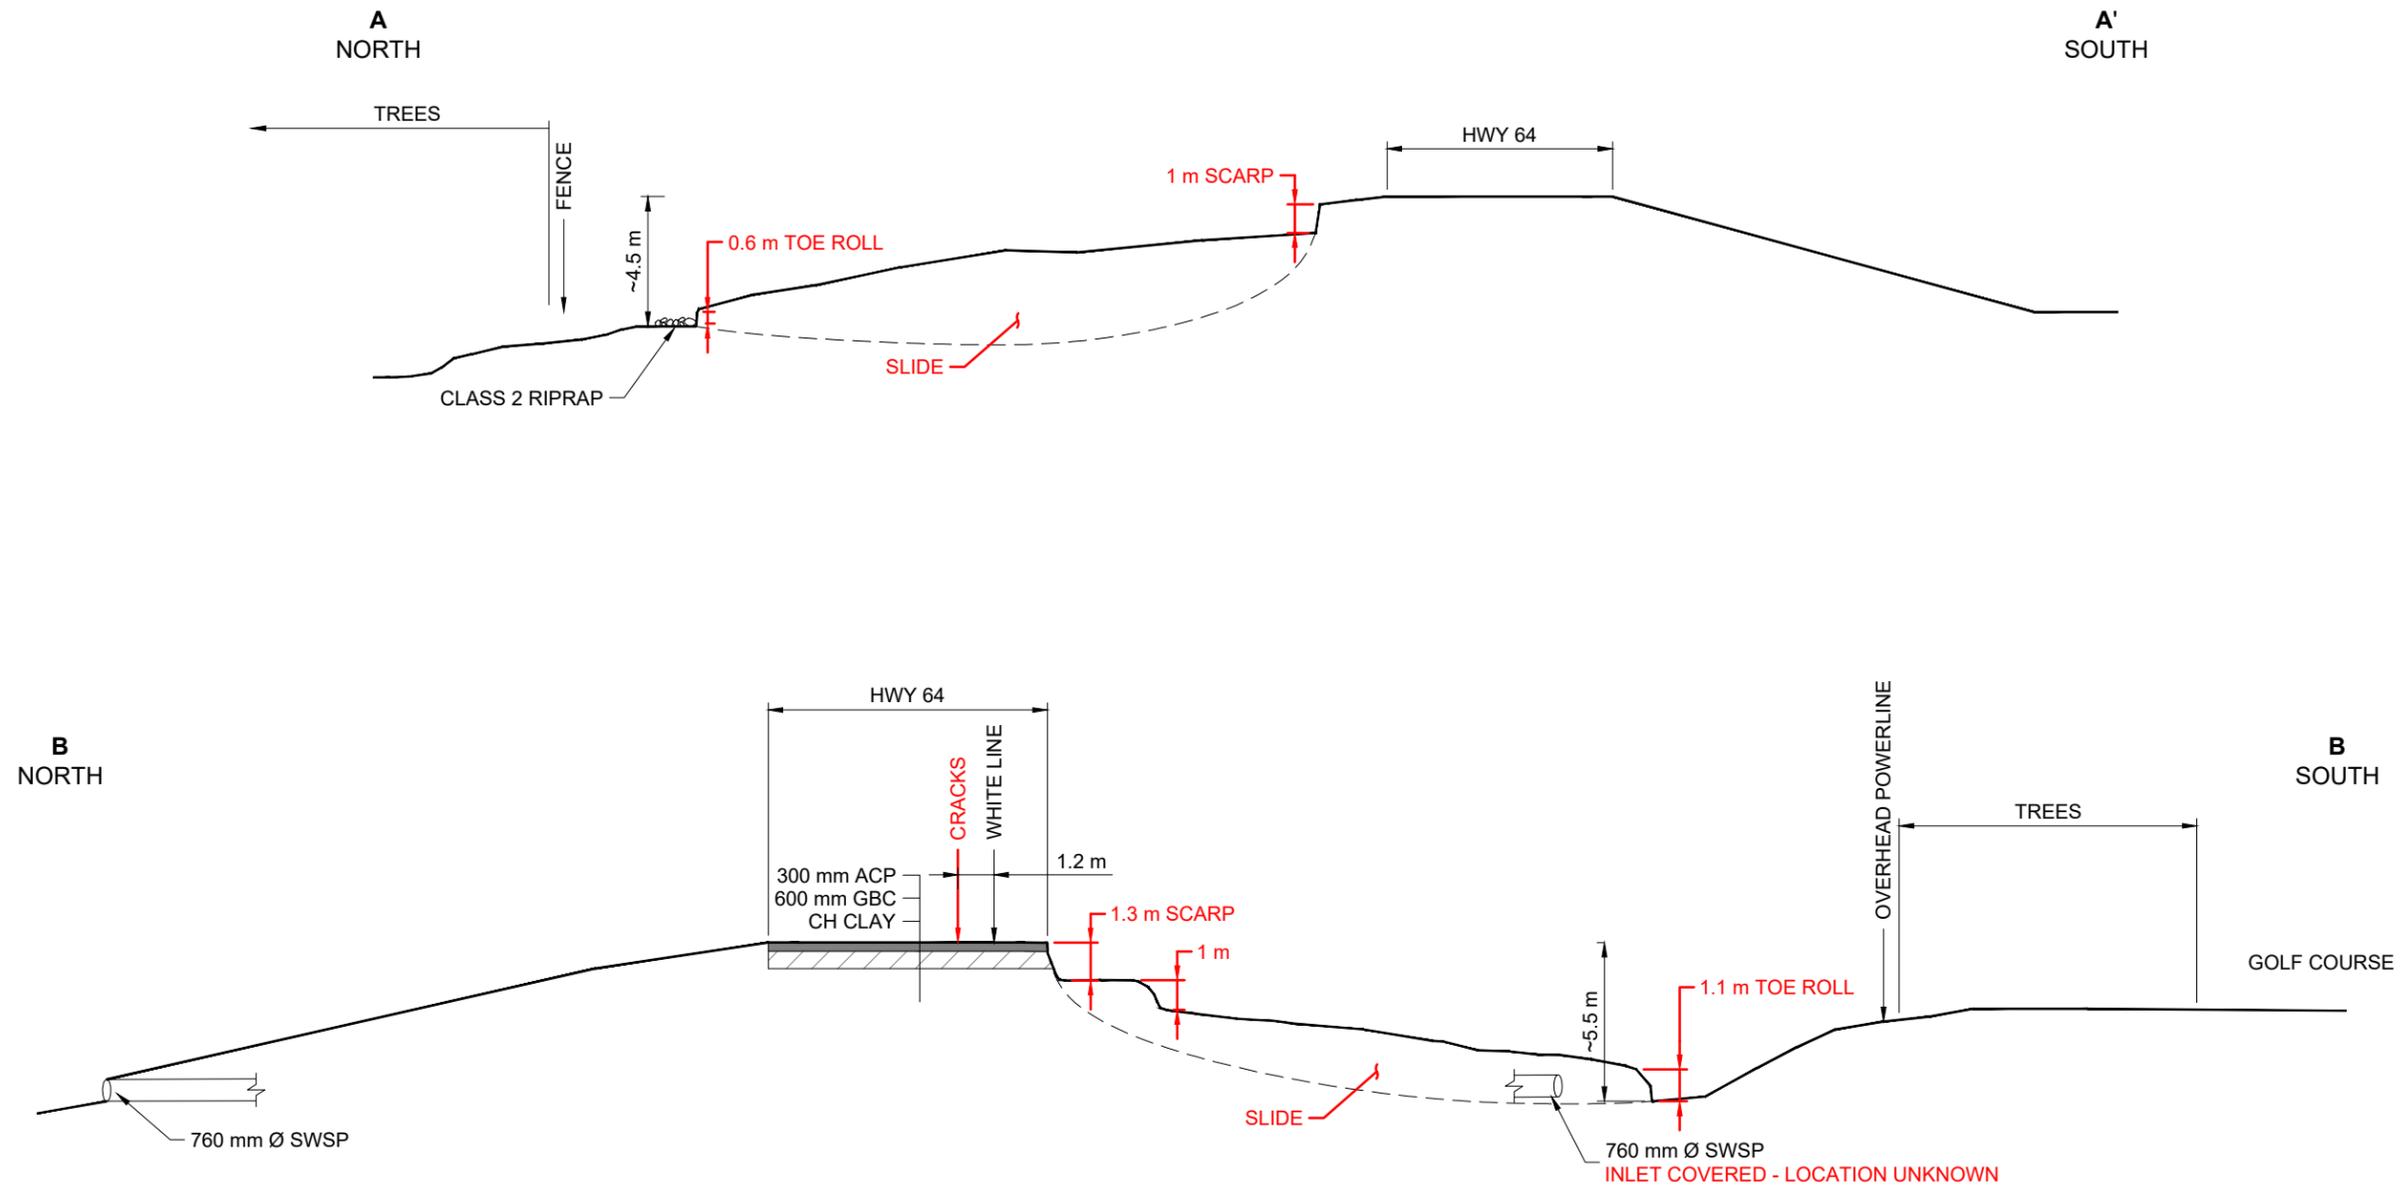
The inferred slip surfaces of the landslides are shown on the attached cross-sections. These cross-sections are approximate, based on pacing and estimated heights.

Alberta Transportation	
HWY 64:02 GOLF COURSE SLIDES 6.1 km WEST OF CLEARDALE	
JULY 26, 2017 CALLOUT CROSS-SECTIONS A-A' & B-B'	
FIGURE 2	
DRAWN BY: K LW DESIGNED BY: T ME APPROVED BY: D WP SCALE: 1:250 DATE: AUGUST 2017 FILE No.: 13351

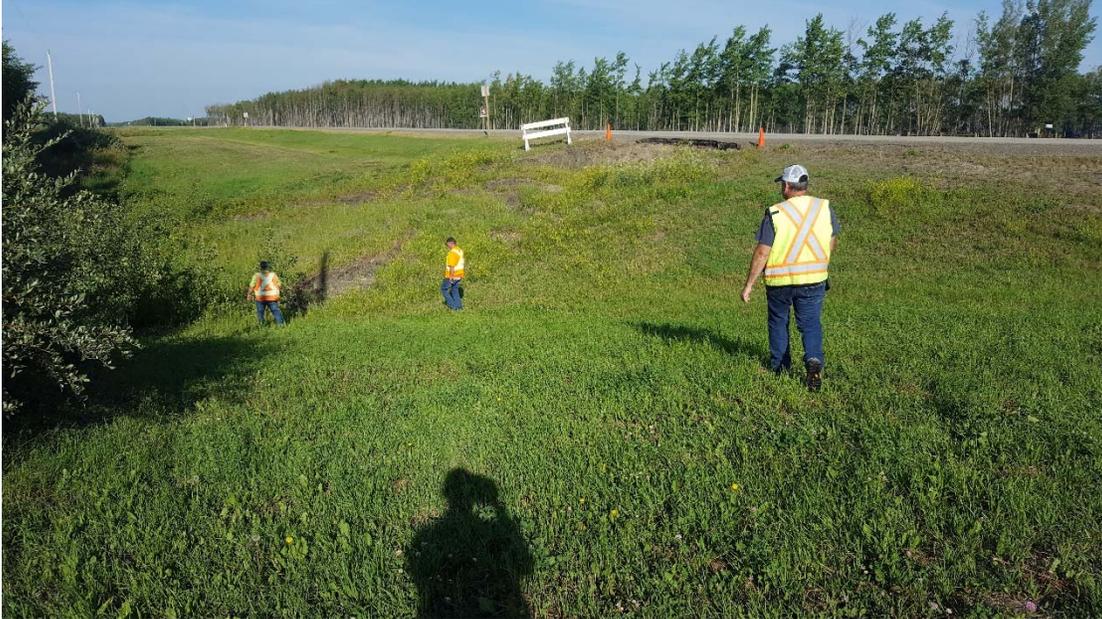
Landslide S2 is about 15 m in width and is currently affecting about an 8 m length of the paved shoulder of the highway. There are also tension cracks located in the EB Lane about 1.2 m from the white line. The backscarp of the slide is about 2.3 m deep and the toe roll is about 1.1 m high. The slide mass has blocked the ditch and covered the inlet of a 0.76 m diameter SWSP. It appears that the culvert drains the south highway ditch as well as a swale draining from the golf course.

Photo 1: Slide 2 (S2) looking NW.

Option a) – Excavate the slide and rebuild the slope with clay and a toe berm

Option b) – Over-excavate the slide and rebuild the slope with granular fill

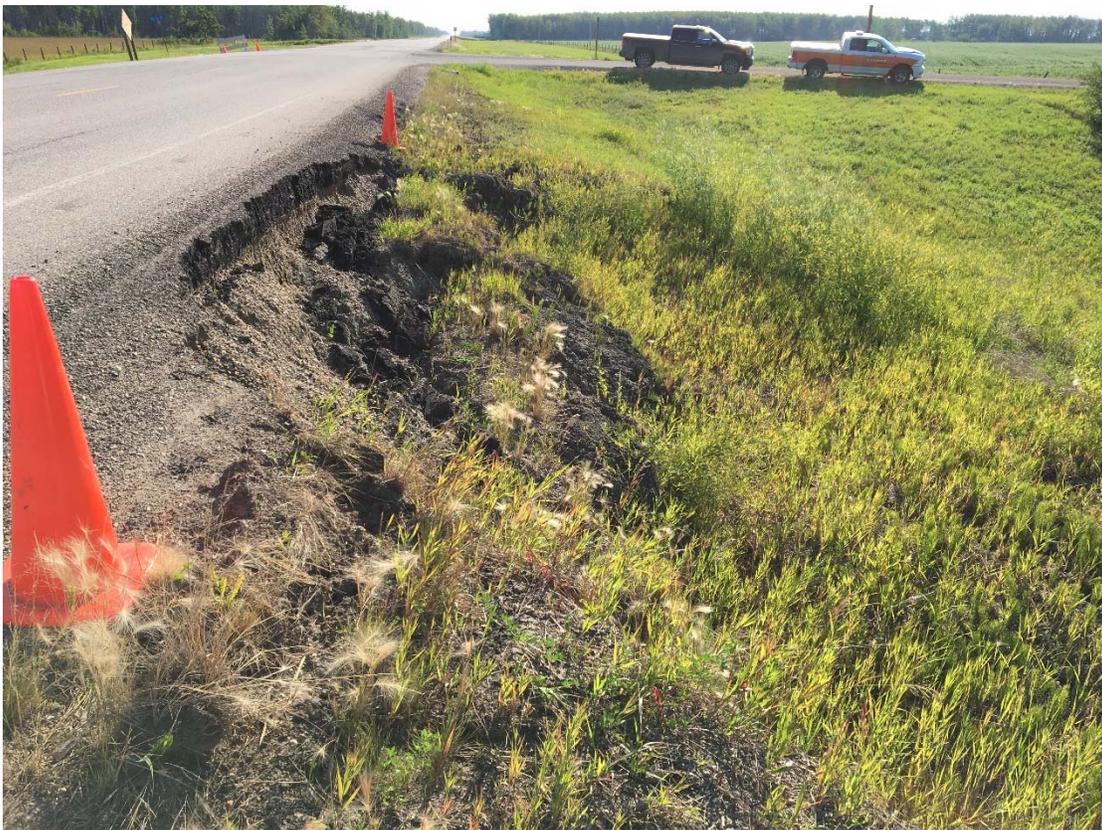
AT Photo 2: S2 looking east at backscarp

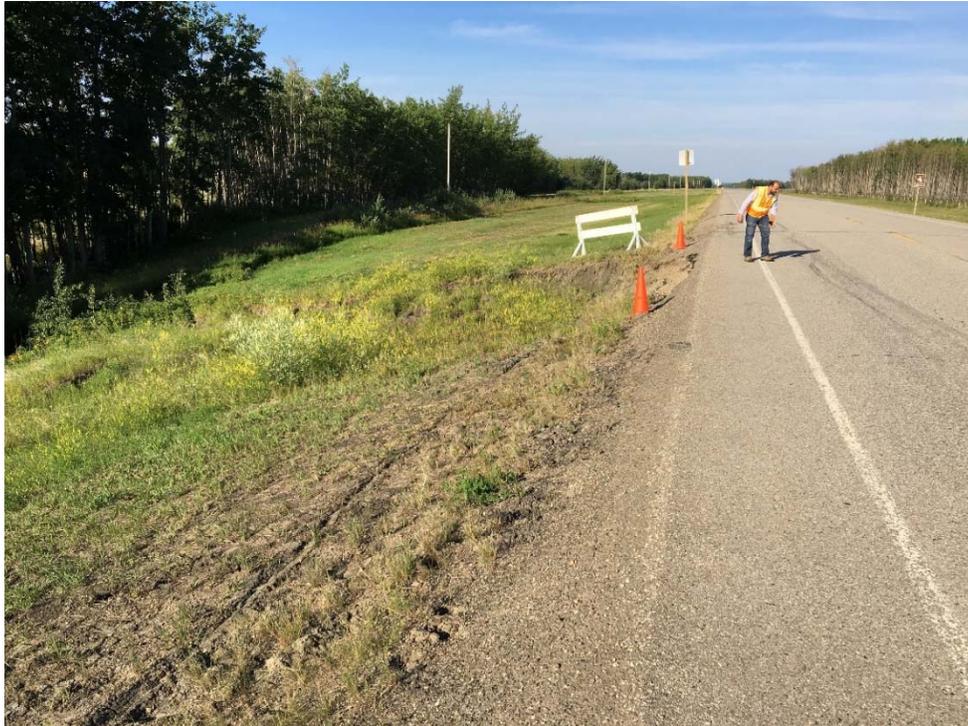
Photo 3: S2 looking west

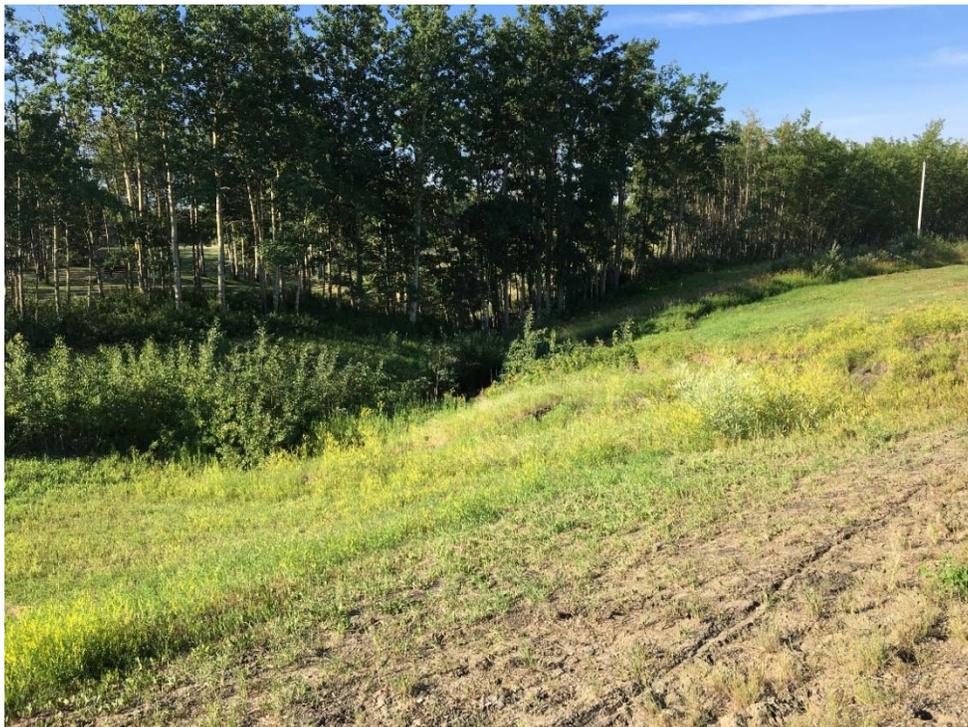
Photo 4: S2 looking SW at gully that leads to culvert from golf course

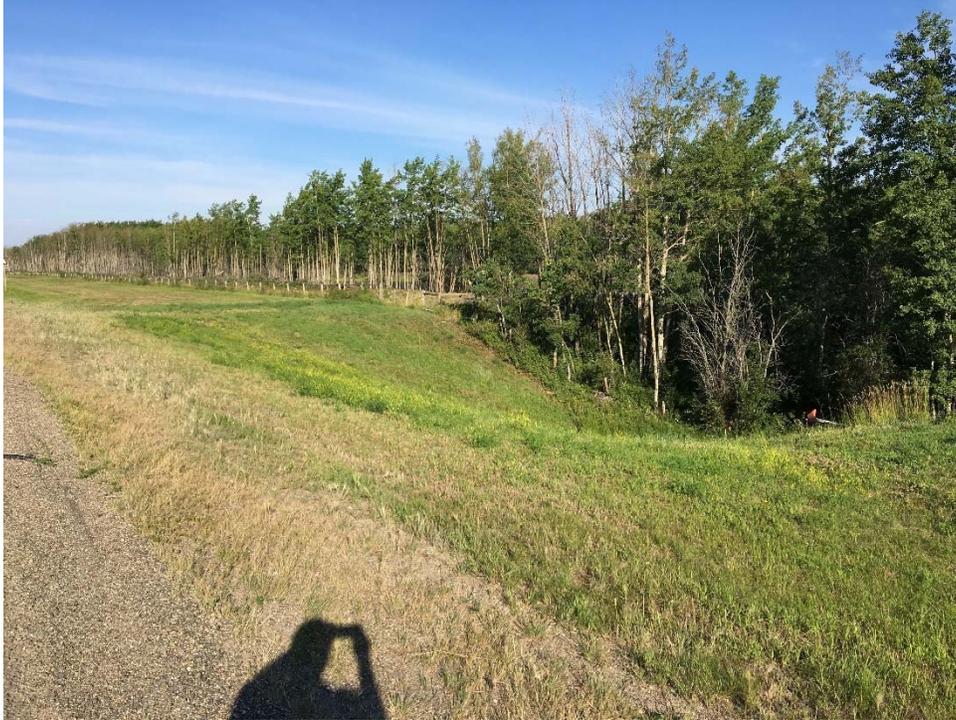
Photo 5: Looking NW at gully that S2 culvert drains into. A dugout pond is present NW of the gully

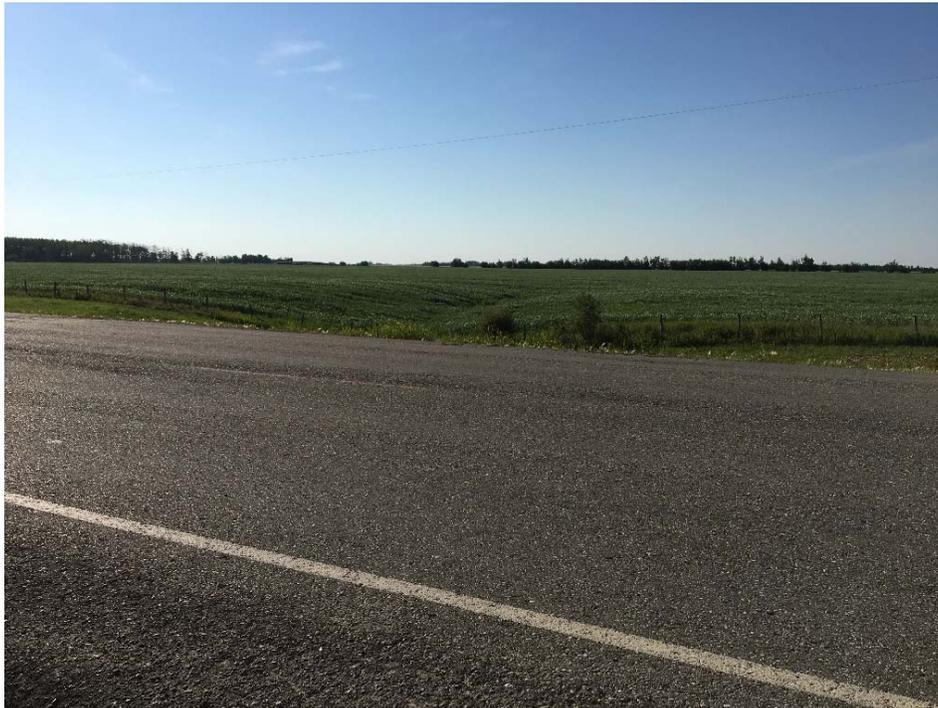
Photo 6: Looking SE at drainage swale that drains into culvert near S1.

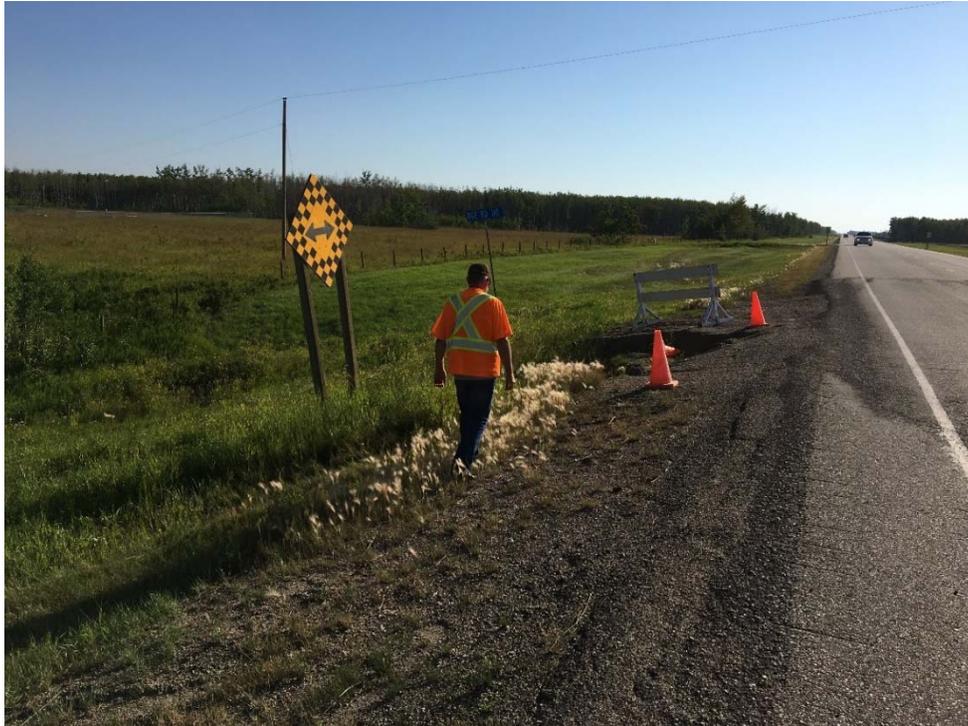
Landslide S1 is located beside the outlet of a smooth wall steel pipe (SWSP) culvert that drains water in an intermittent draw from a farm field into a wooded gully located north of the highway. The embankment is about 4.5 m high at the landslide location. The slide is about 18 m wide, has a backscarp drop of about 1 m and a toe roll of about 0.6 m in height. The slope has an overall inclination of about 5H:1V. The backscarp of S1 is located a short distance downslope of the edge of asphalt.

Photo 7: Looking east at Slide 1 (S1)

Similar options could be considered for S1 however extra right of way would be needed for Option a). The prices are expected to be of a similar magnitude as for S2. Hence, the total cost to fix both landslides at the same time could vary from about \$350,000 to \$500,000.

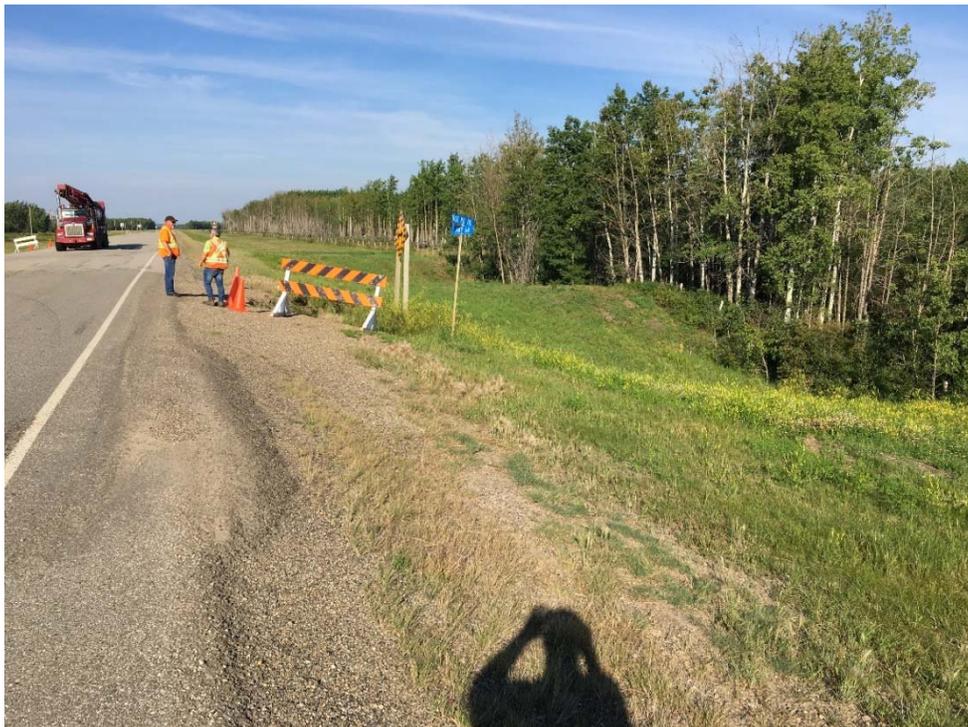
Photo 8: Looking west at S1.

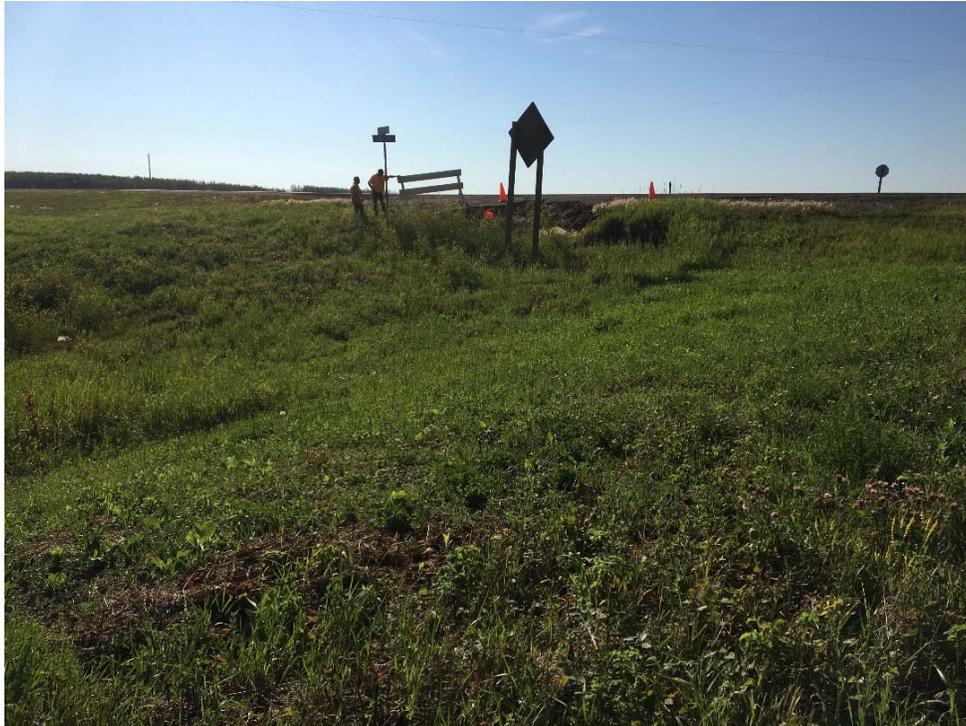
Photo 9: Looking SE at S1

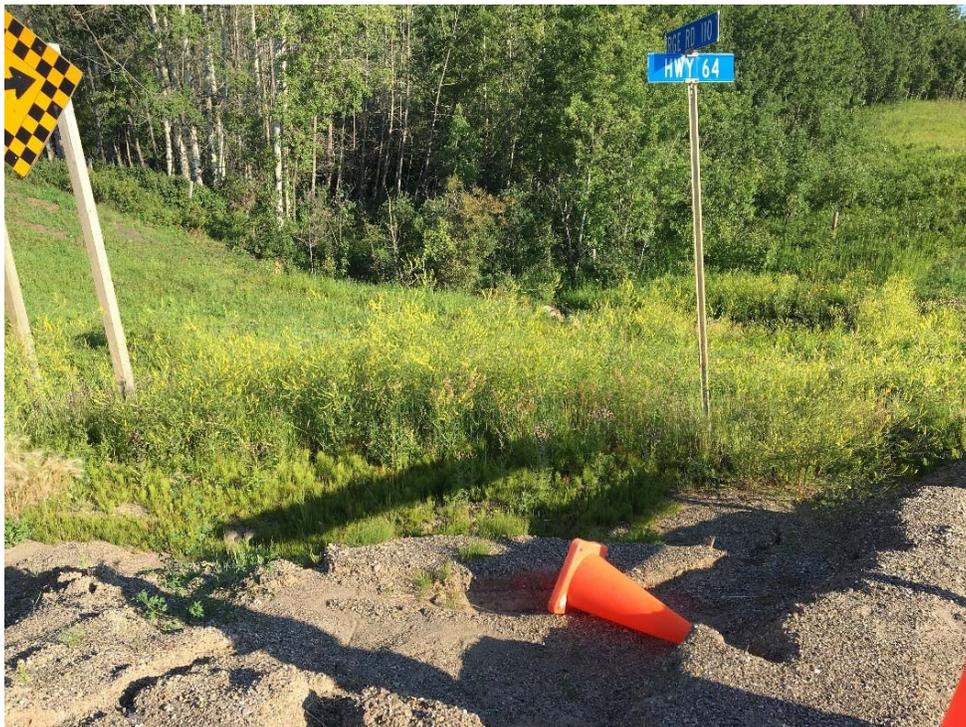
Photo 10: Looking north down S1 to gully into which the culvert drains
