**ALBERTA TRANSPORTATION  
GEOHAZARD ASSESSMENT PROGRAM  
PEACE REGION – PEACE RIVER/HIGH LEVEL  
2020 INSPECTION**

<b>Site Number</b>	<b>Location</b>	<b>Name</b>	<b>Hwy</b>	<b>km</b>
PH83	6.1 km W Cleardale	Golf Course Slides	64:02	29.0
<b>Legal Description</b>		<b>UTM Co-ordinates (NAD 83)</b>		
SE1-1-85-11-W6		11V N 6246600	E 340300

<b>Date</b>	<b>PF</b>	<b>CF</b>	<b>Total</b>
<b>Previous Call Out:</b>	May 13, 2019	10	3	30
<b>Current Inspection:</b>	June 16, 2020	10	3	30
<b>Road AADT:</b>	320		<b>Year:</b>	2019
<b>Inspected By:</b>	Barry Meays (Thurber) Ed Szmata, Roger Skirrow (AT)			
<b>Report Attachments:</b>	<input checked="" type="checkbox"/> Photographs		<input checked="" type="checkbox"/> Plans	<input checked="" type="checkbox"/> Maintenance Items

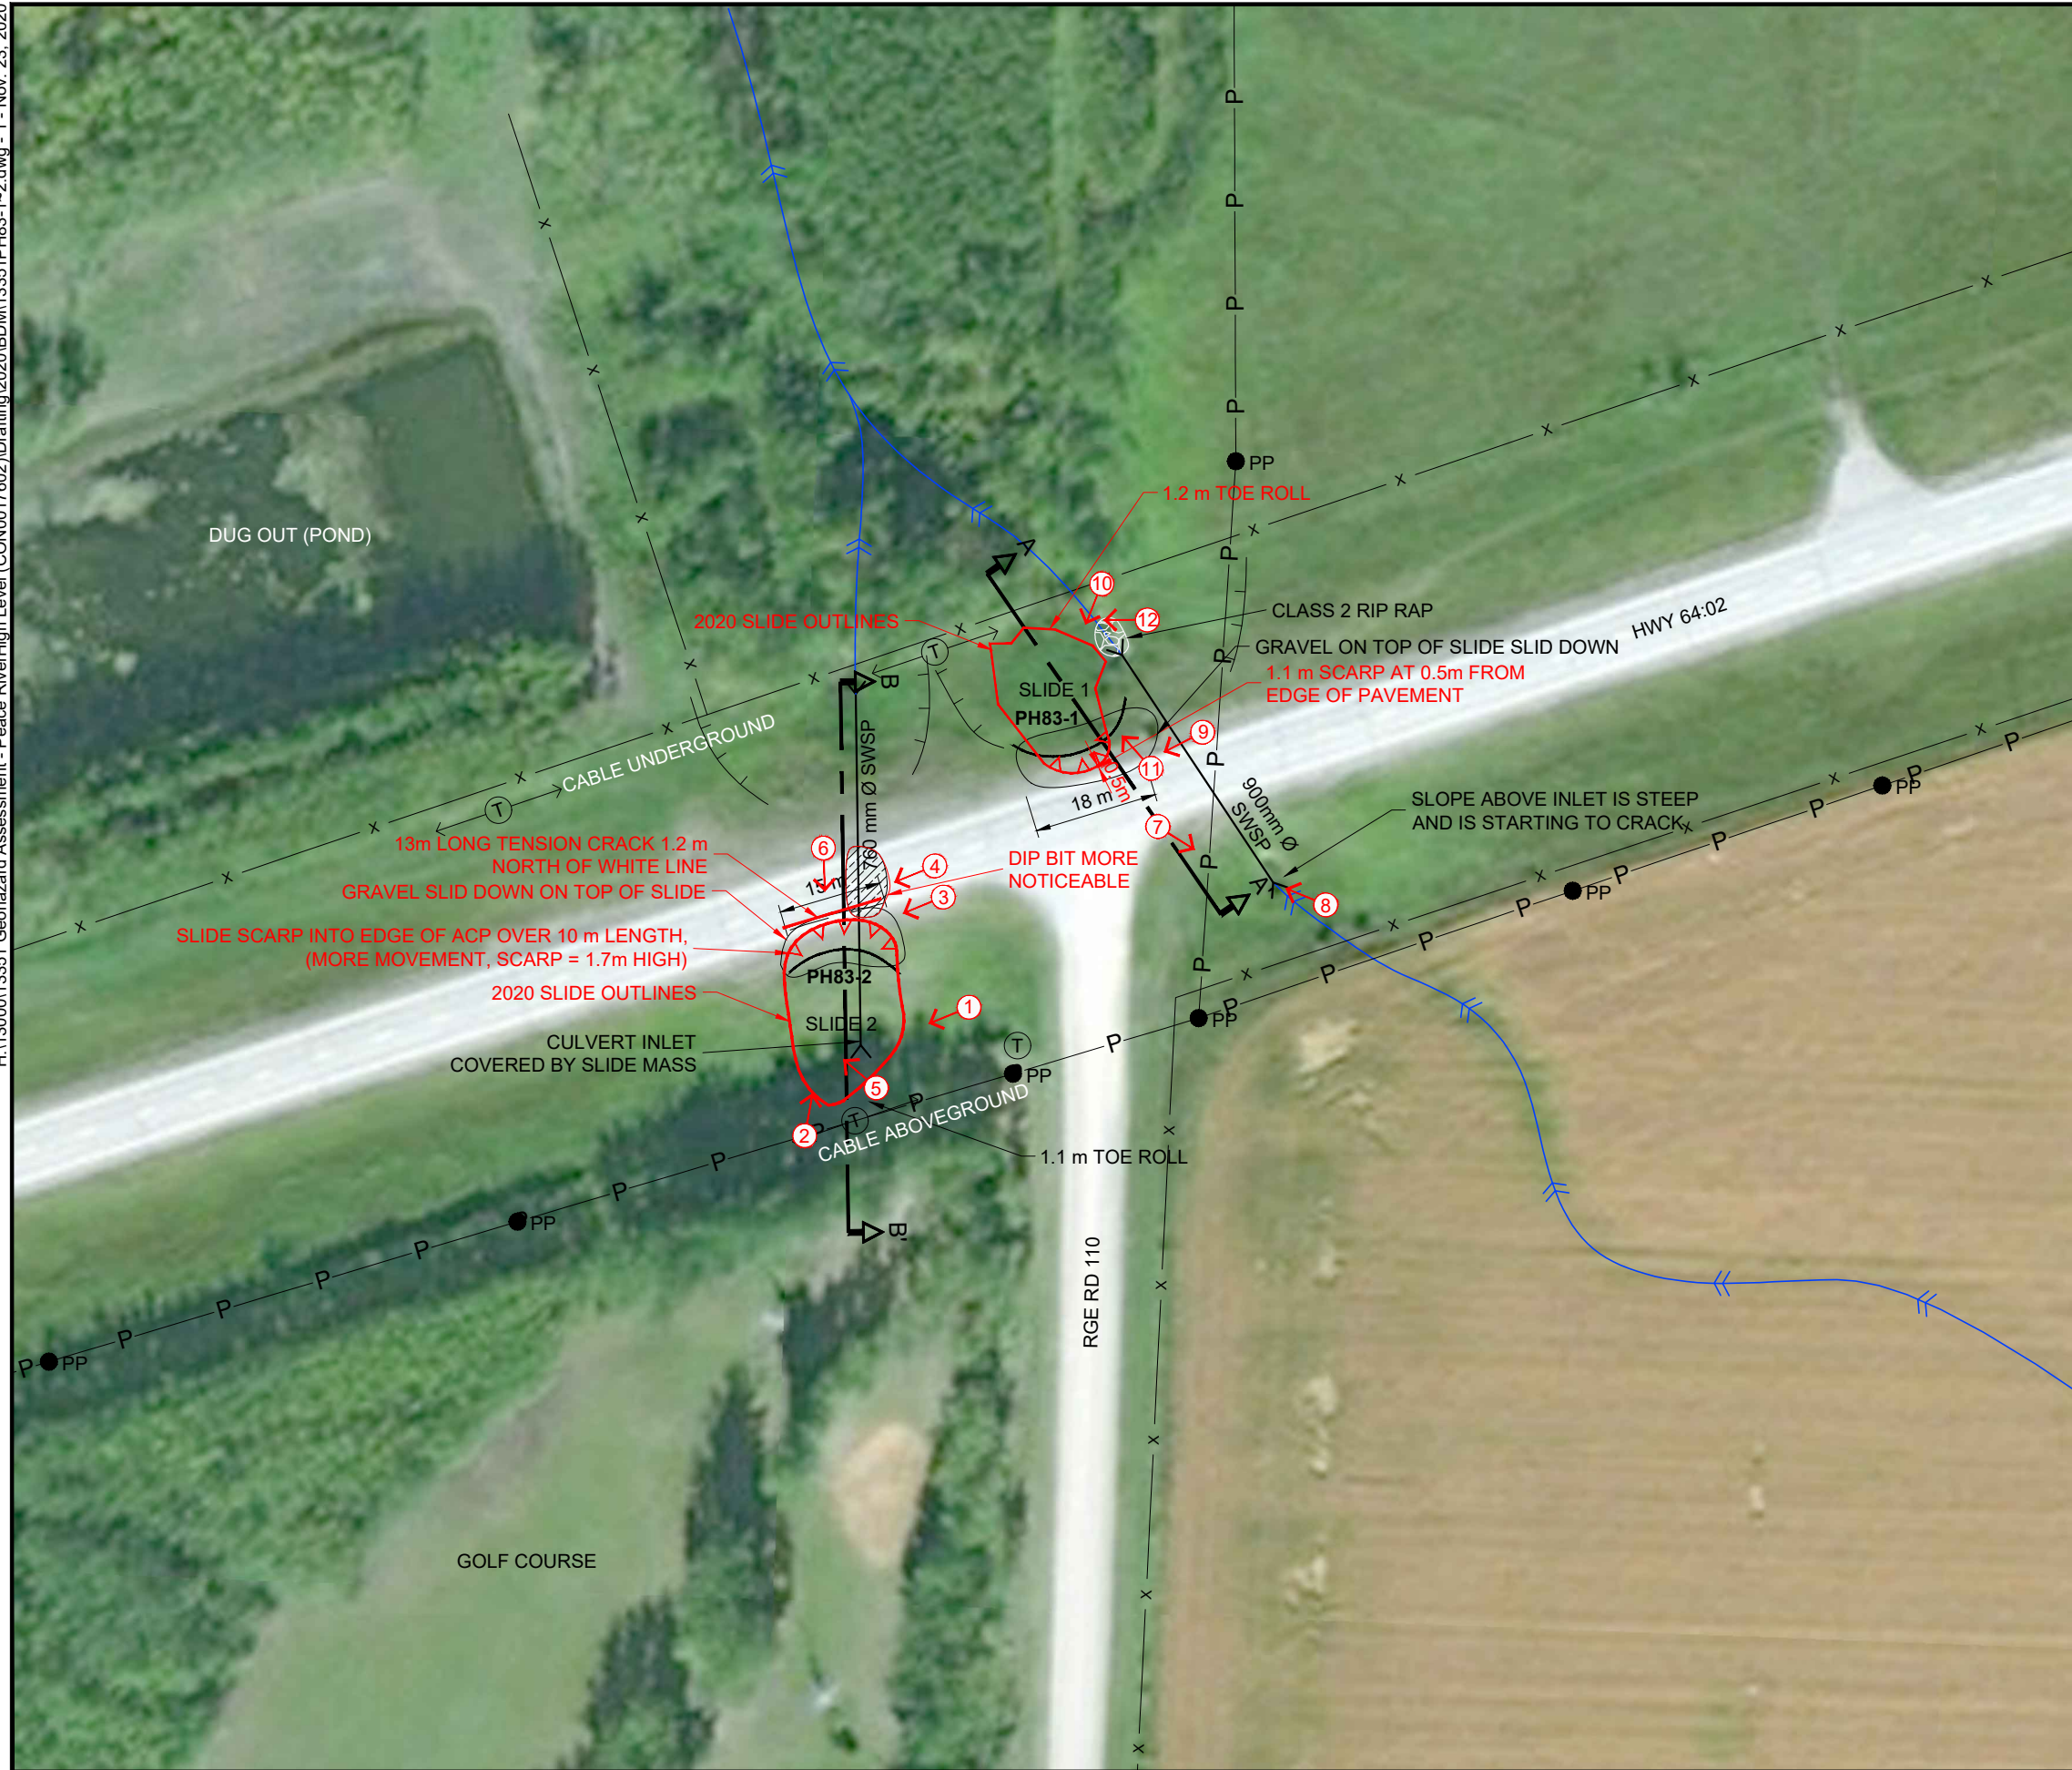
**FIGURE PH83-1**

**2020 INSPECTION PLAN**

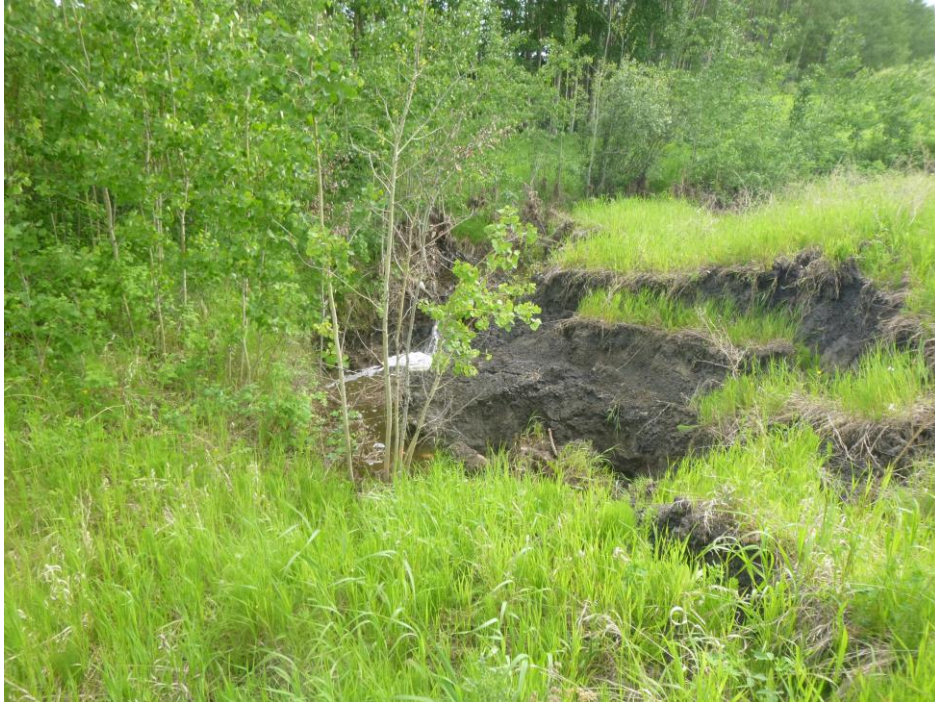
Photo 1 – Looking west across the toe and body of Slide 2. There is an overhead power line running east-west a short distance from the tree line.

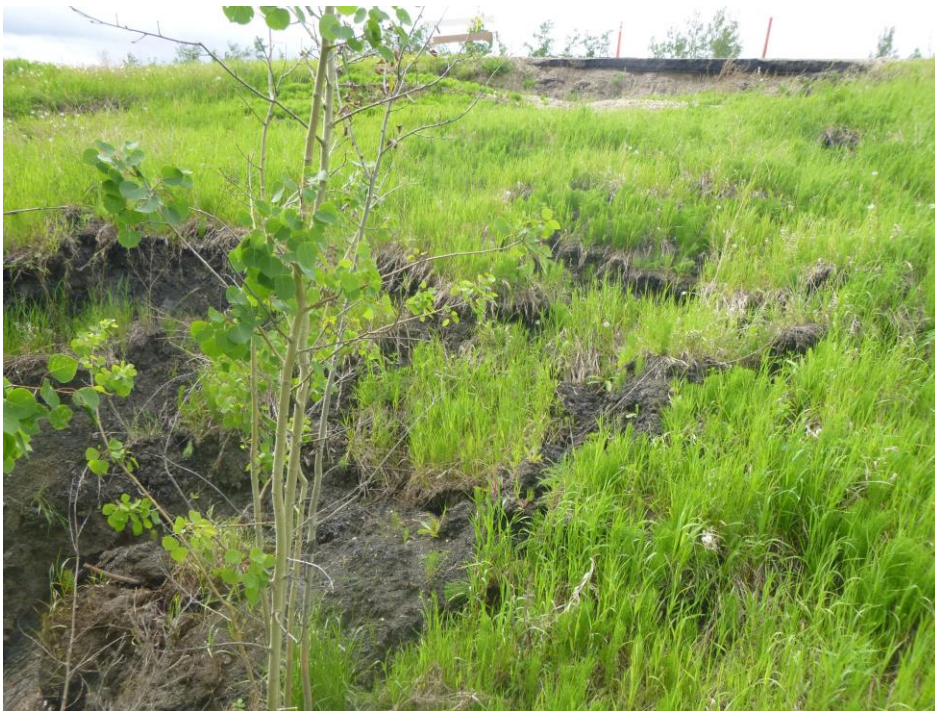
Photo 2 – Looking north (upslope) at Slide 2.

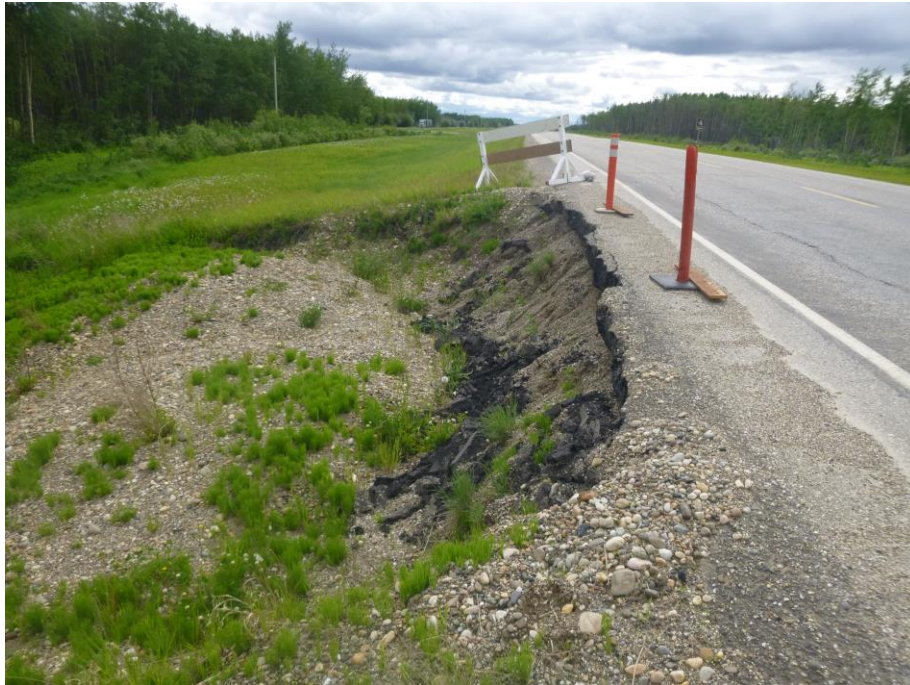
The slides were relatively unchanged in size this year, however there were some additional movements. The scarp height dropped through the previously placed gravel to 1.7 m (from 1.3 m last year) at Slide 2, and was about the same as last year (1.3 m) at Slide 1. This translated to some additional slide body movements and increased toe roll distances (the inlet of Slide 1 was again covered this year). The previously placed gravel overtop of the slide scarp portions is likely adding a surcharge to the top of the slide and causing additional movements.

Photo 3 – Looking west along the highway embankment and scarp of Slide 2. Note the pitrun gravel that was placed overtop of the slide scarp adjacent to the highway continues to settle and move downslope.

Spread out the existing gravel that was placed over the slide headscarps more evenly and level with the outside ground to reduce the load on top of the slide.

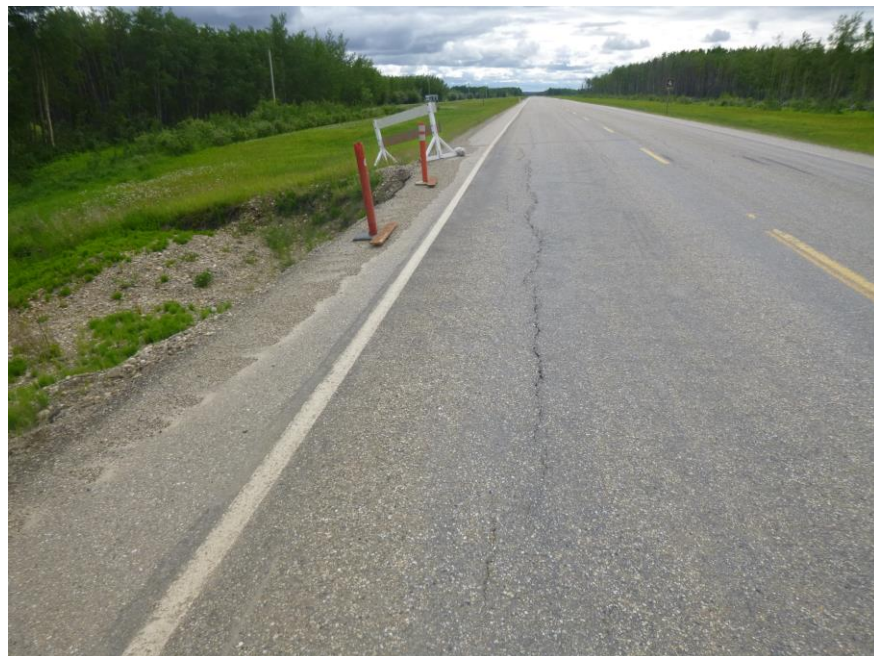
The landslides will continue to grow in size if not dealt with. In particular, Slide 2 has a 13 m long tension crack located near the center of the EBDL, which suggests that it could retrogress further into the driving lane in the future. The blocked Slide 2 inlet with toe debris has the potential for water to pond at the landslide mass and accelerate movements.

Photo 4 – Looking west at the crack in the highway EB lane OWP adjacent to the Slide 2 scarp.

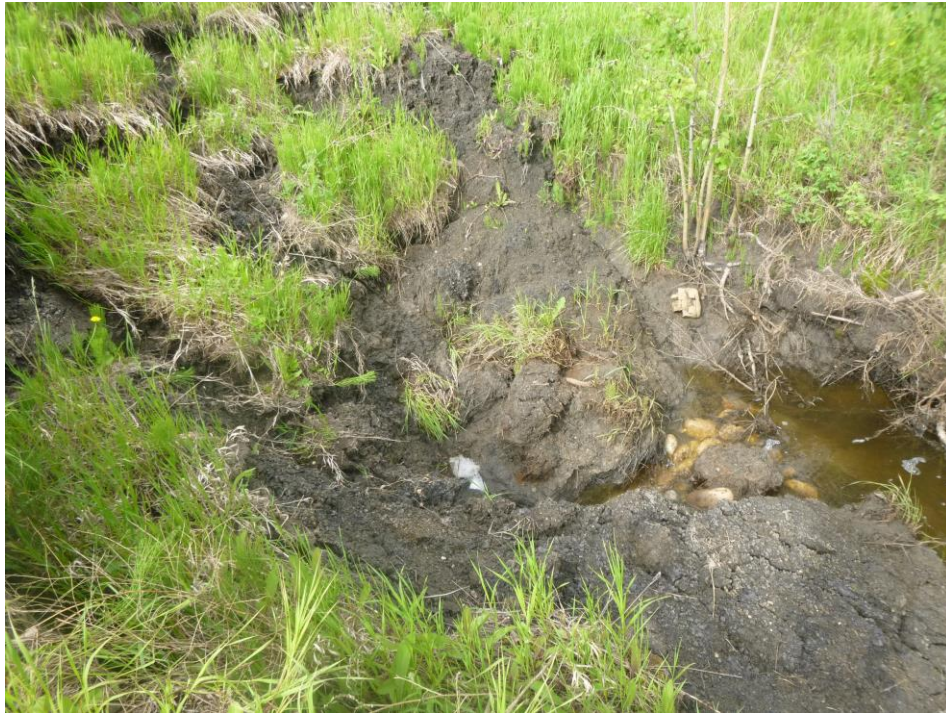
The 760 mm diameter SWSP culvert at Slide 2 appears to drain south highway ditch runoff, as well as a swale draining from the golf course. The inlet was covered with slide material similar to last year.

Photo 5 – Close-up view of the culvert inlet, where Slide 2 debris squeezed around and covered it.

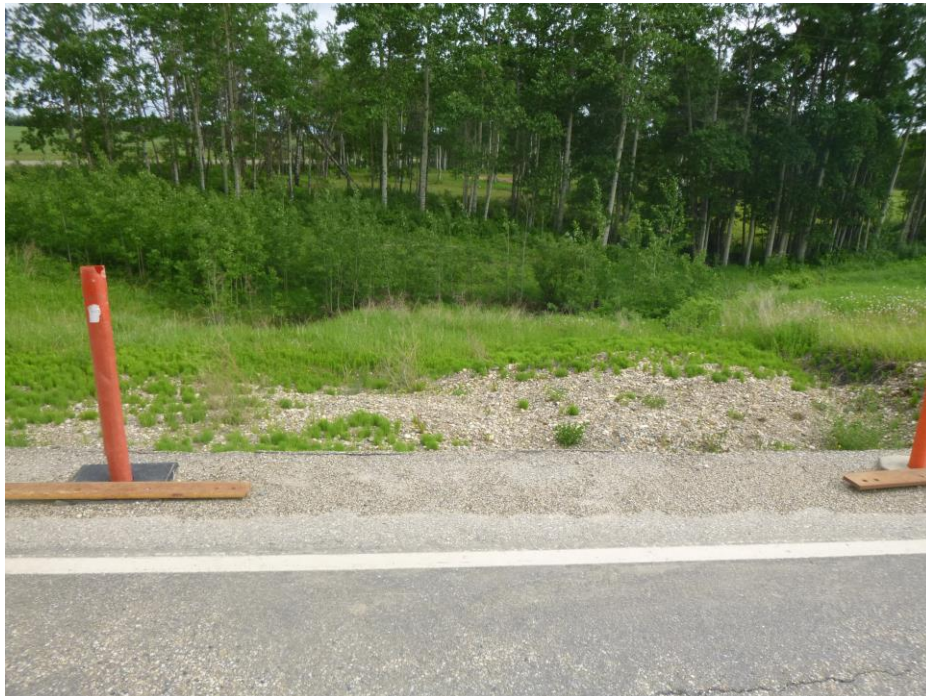
Photo 6 – Looking south from the highway over Slide 2.

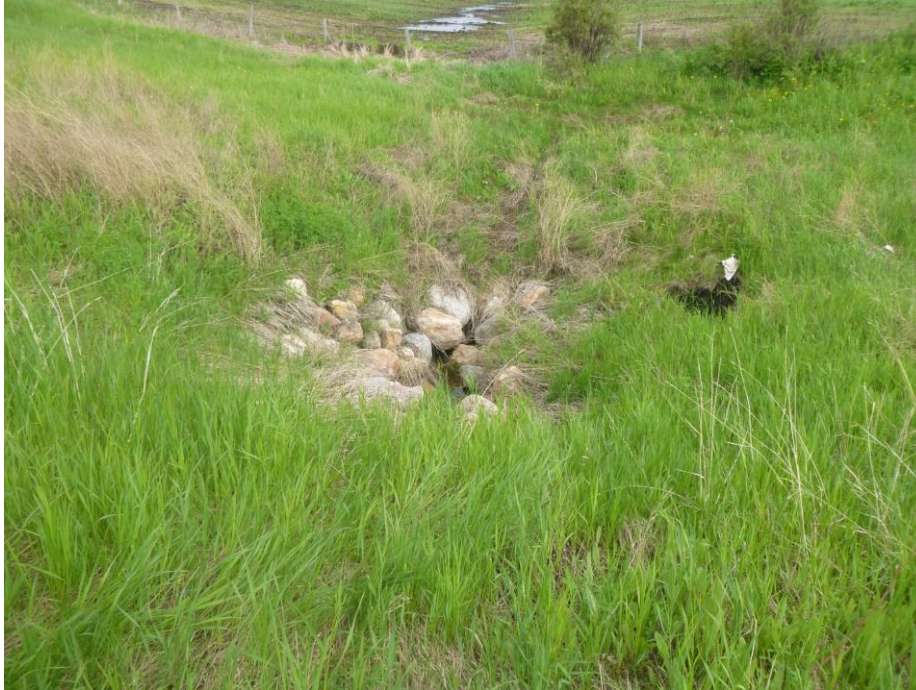
Photo 7 – Looking southeast at the drainage gully leading into the culvert inlet area on the opposite (south) side of the highway from Slide 1.

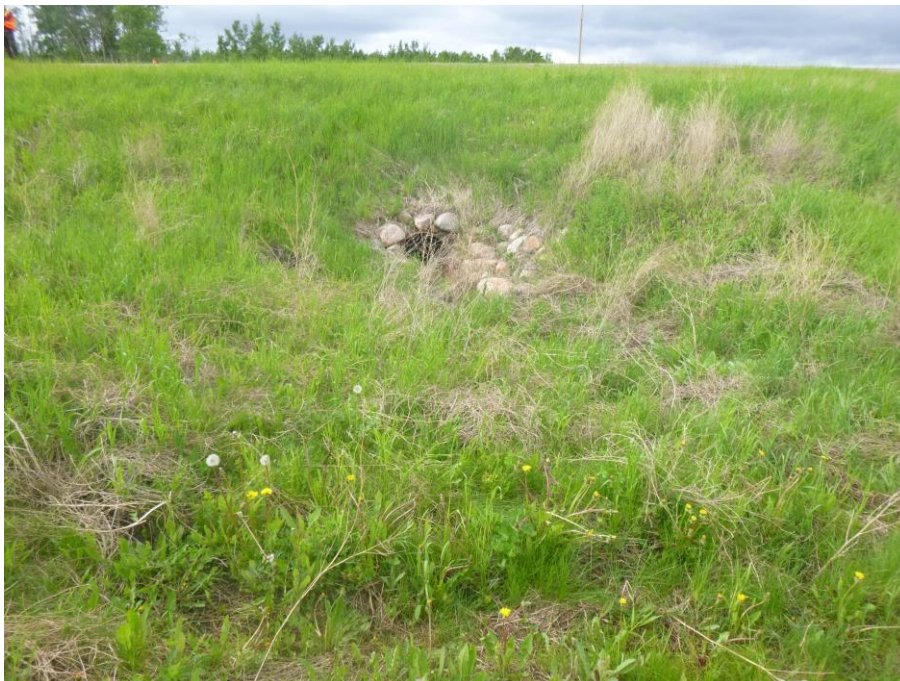
Information from the MCI indicated there used to be a 1.2 m diameter CSP culvert located under the Slide 1 area, which had apparently separated and created a sink hole. This culvert was attempted to be lined, but debris infill prevented success. Subsequently, a bored 900 mm SWSP was installed (located on the east side of the slide). There were a few cracks observed on the steeper sloping ground around the inlet to this new SWSP (a longer inlet would have allowed flatter sloping ground to be formed around the inlet).

Photo 8 – Looking north at the inlet of the 900 mm dia. SWSP of Slide 1. A few cracks formed around the steeply sloping embankment surface around the inlet.

If the cracking around the slopes of the new 900 mm SWSP culvert begin to threaten the integrity of the upstream highway embankment, the existing bevelled end of SWSP could be cut off, an additional length of SWSP with a bevelled end welded onto the cut, and new, flatter slopes constructed with compacted clay around the new inlet.

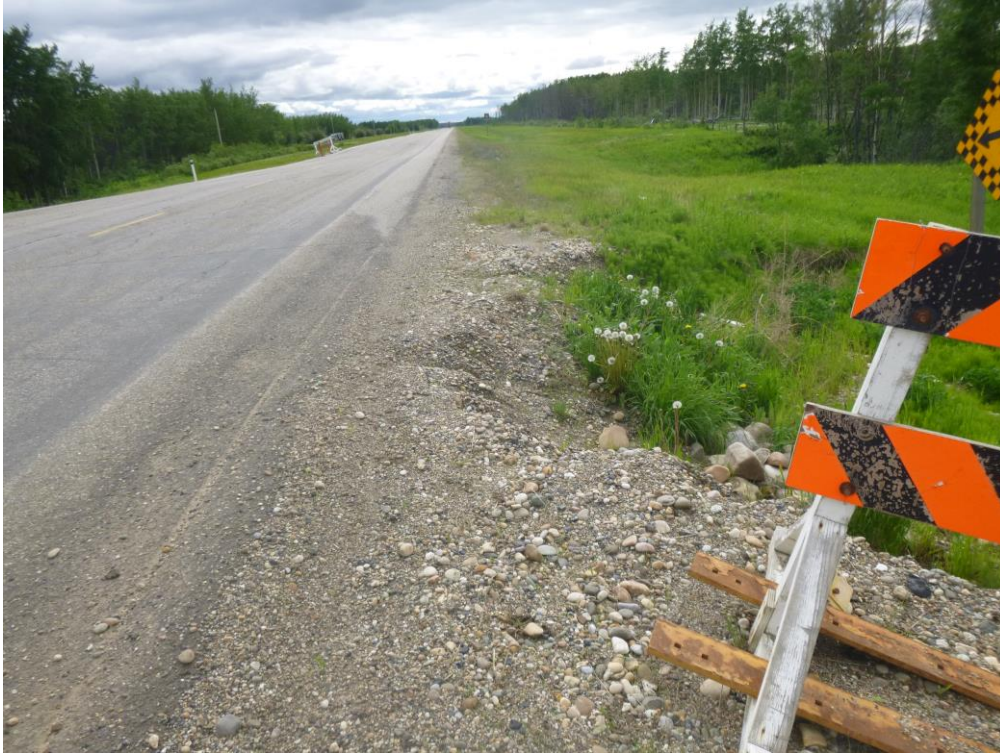
Photo 9 – Looking west adjacent to the hwy at the Slide 1 slide scarp. Note the dip in the hwy ovetop the culvert crossing at Slide 2 (in the background).

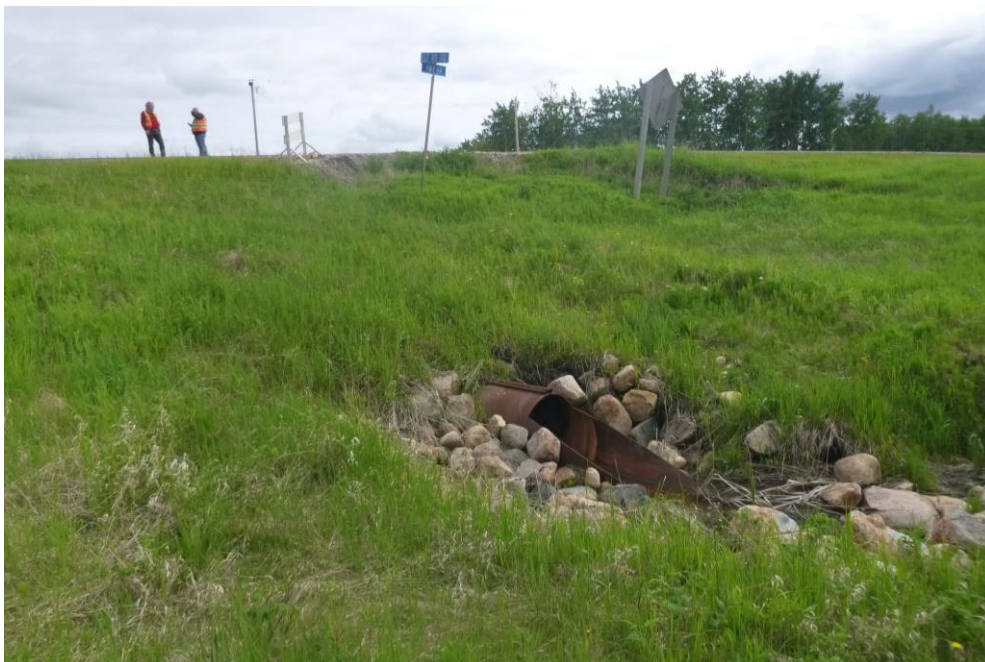
Photo 10 – Looking south across Slide 1 at the north highway embankment and the 900 mm dia. SWSP outlet.

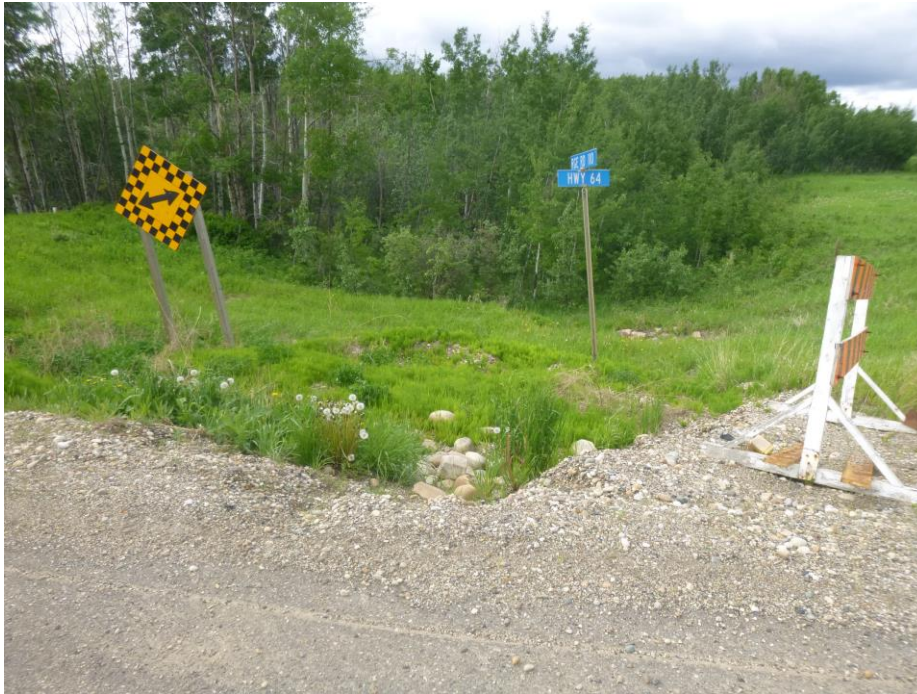
Photo 11 – Looking north from the highway overtop Slide 1.

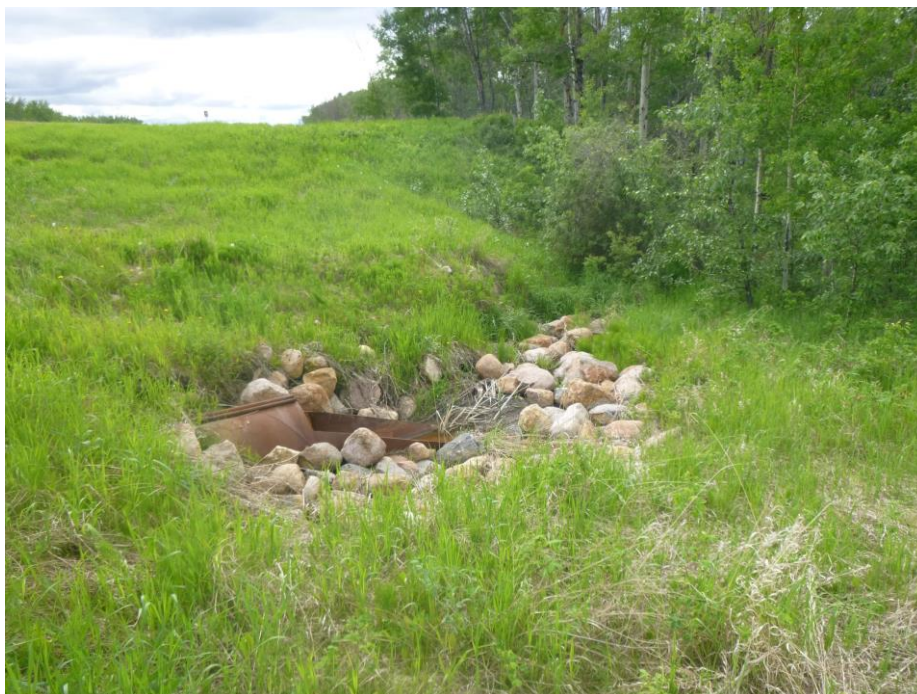
Photo 12 – Looking northwest at the outlet and downstream erosion gully of Slide 1.
