**ALBERTA TRANSPORTATION
GEOHAZARD ASSESSMENT PROGRAM
PEACE REGION – GRANDE PRAIRIE DISTRICT NORTH
2021 INSPECTION**

Site Number	Location	Name	Hwy	km
PH083	6.1 km W Cleardale	Golf Course Slides	64:02	29.0
Legal Description		UTM Co-ordinates (NAD 83)		
SE1-85-11-W6		11V N 6246600	E 340300

**PEACE REGION (GRANDE PRAIRIE DISTRICT - NORTH)
PH083: HWY 64:02 GOLF COURSE SLIDES, 6.1km
WEST OF CLEARDALE**

2021 INSPECTION PLAN

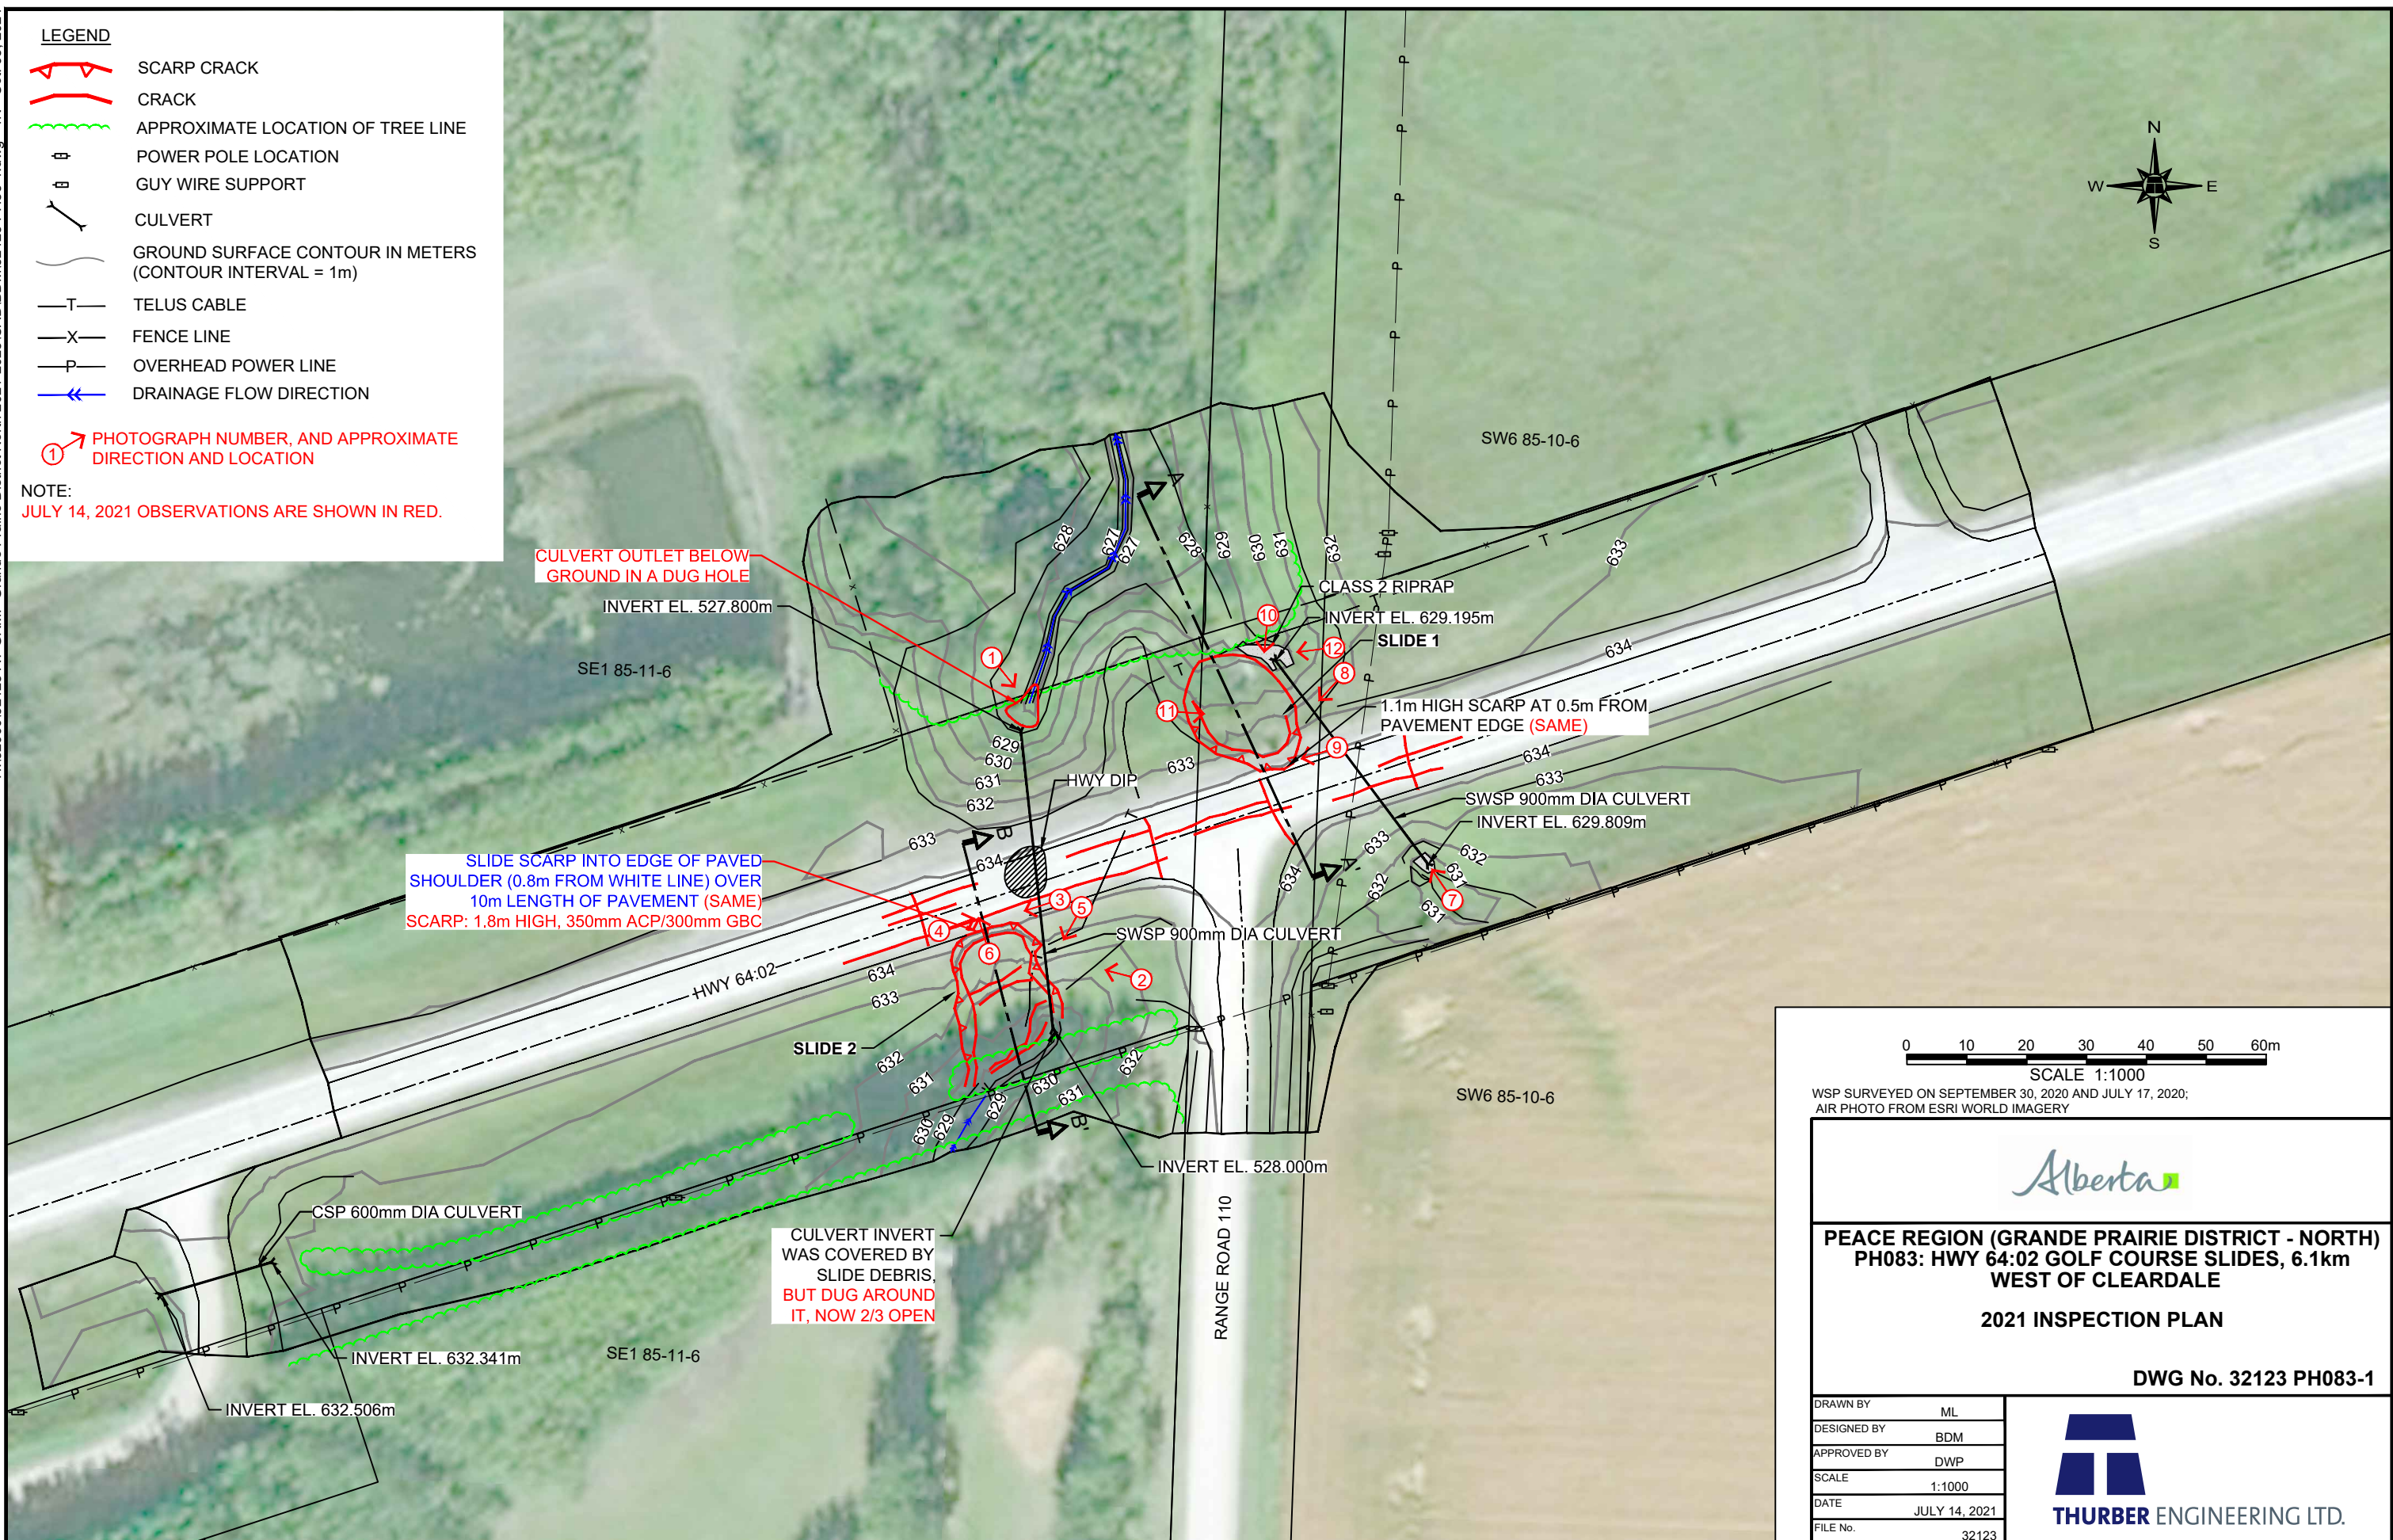
DWG No. 32123 PH083-1

CULVERT OUTLET BELOW GROUND IN A DUG HOLE
INVERT EL. 527.800m

1.1m HIGH SCARP AT 0.5m FROM PAVEMENT EDGE (SAME)

SLIDE SCARP INTO EDGE OF PAVED SHOULDER (0.8m FROM WHITE LINE) OVER 10m LENGTH OF PAVEMENT (SAME)
SCARP: 1.8m HIGH, 350mm ACP/300mm GBC

CULVERT INVERT WAS COVERED BY SLIDE DEBRIS, BUT DUG AROUND IT, NOW 2/3 OPEN

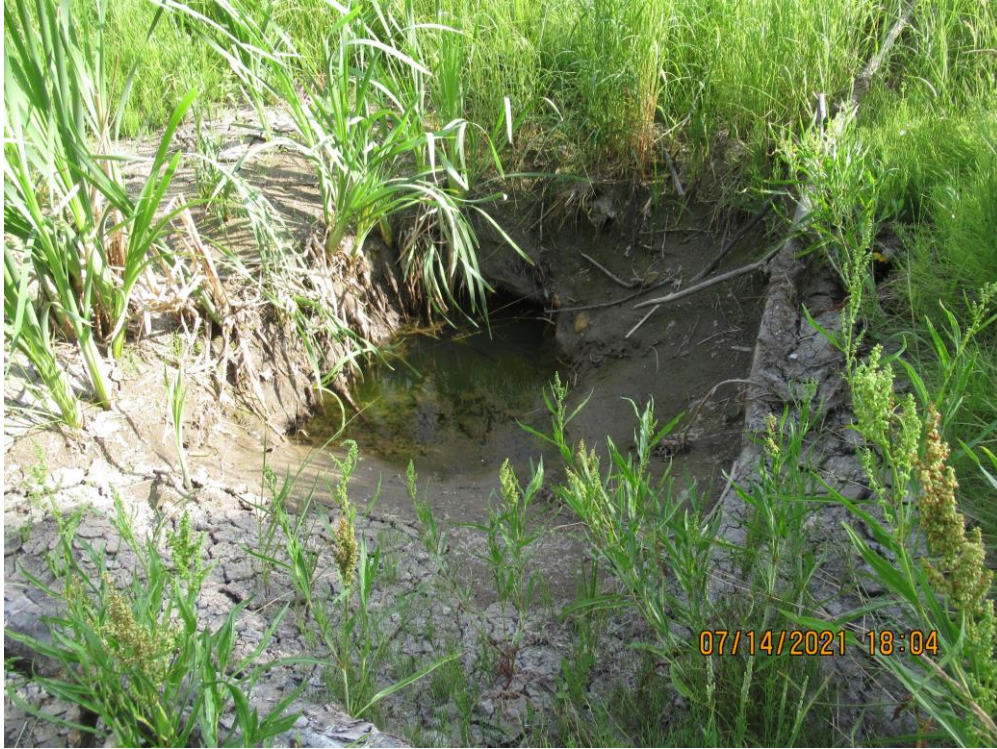
Photo 1 – Looking south at the outlet of the 900 mm diameter SWSP culvert of Slide 2 north of the hwy. The outlet is below ground, and somebody had dug around it to open it up.

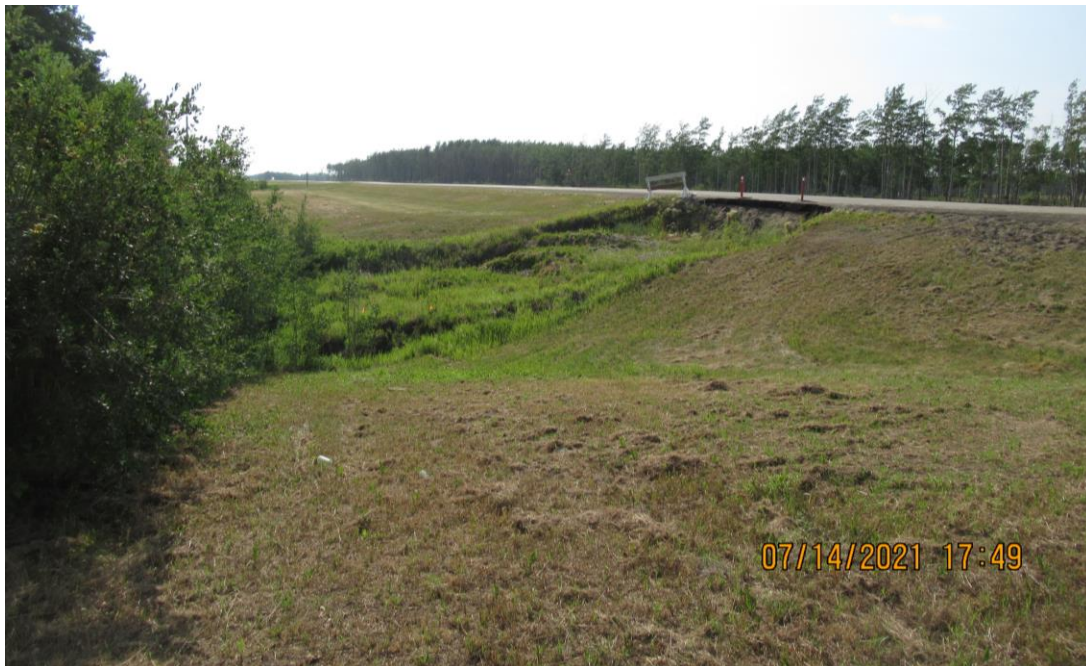
Photo 2 – Looking northwest across Slide 2.

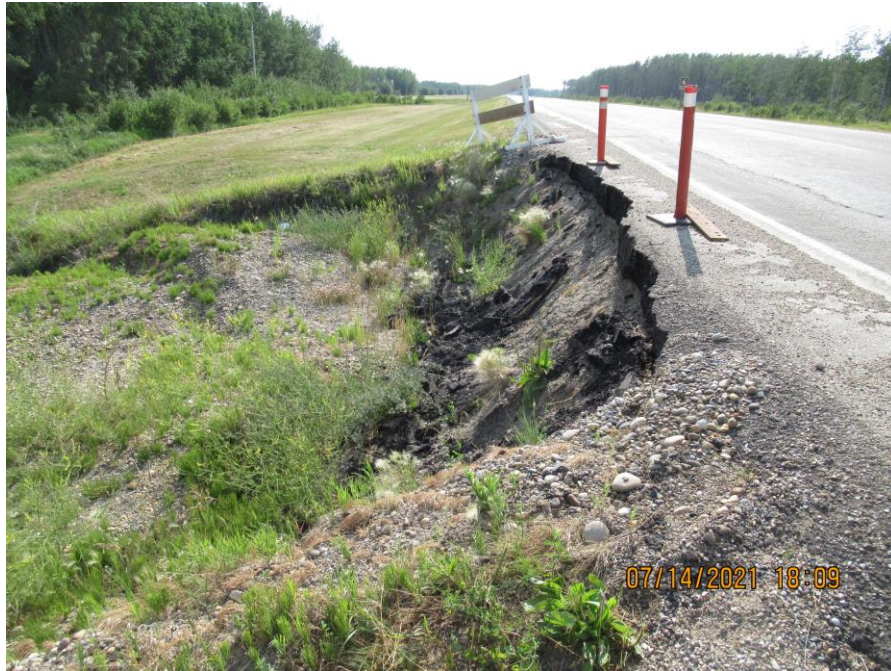
Photo 3 – Looking west along the highway embankment and scarp of Slide 2. Note the pitrun gravel that was placed overtop of the slide scarp adjacent to the highway continues to settle and move downslope.

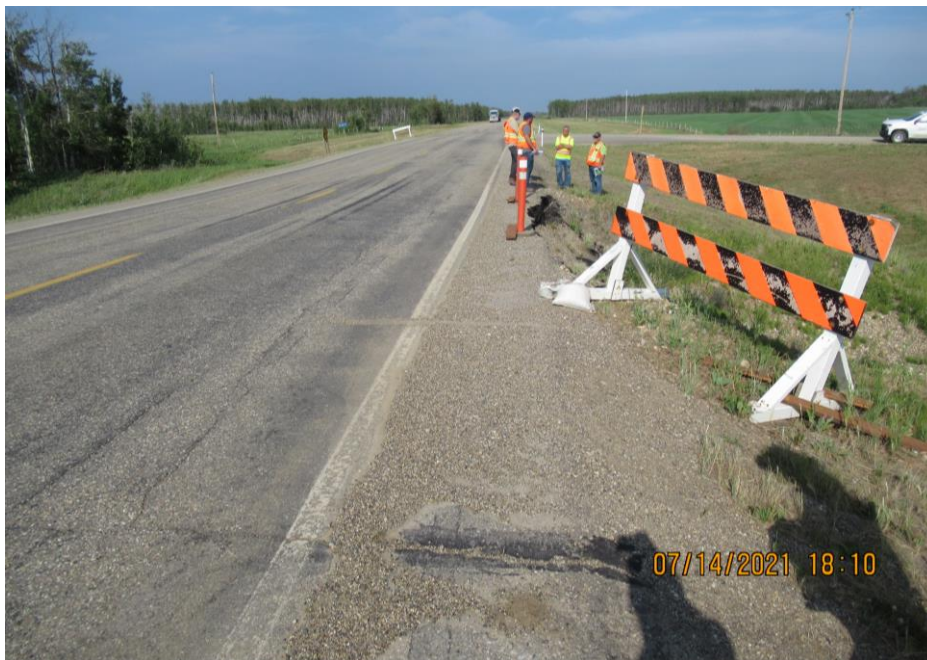
Photo 4 – Looking east along the crack in the highway EB lane OWP adjacent to the Slide 2 scarp.

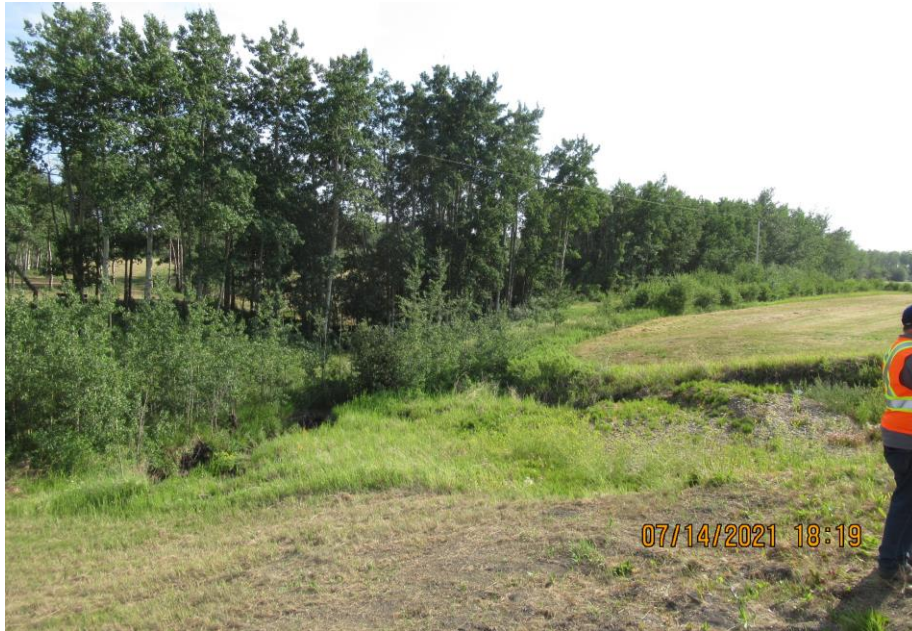
Photo 5 – Looking west across the culvert inlet area, where Slide 2 debris squeezed around and covered it, before it was excavated and partially opened.

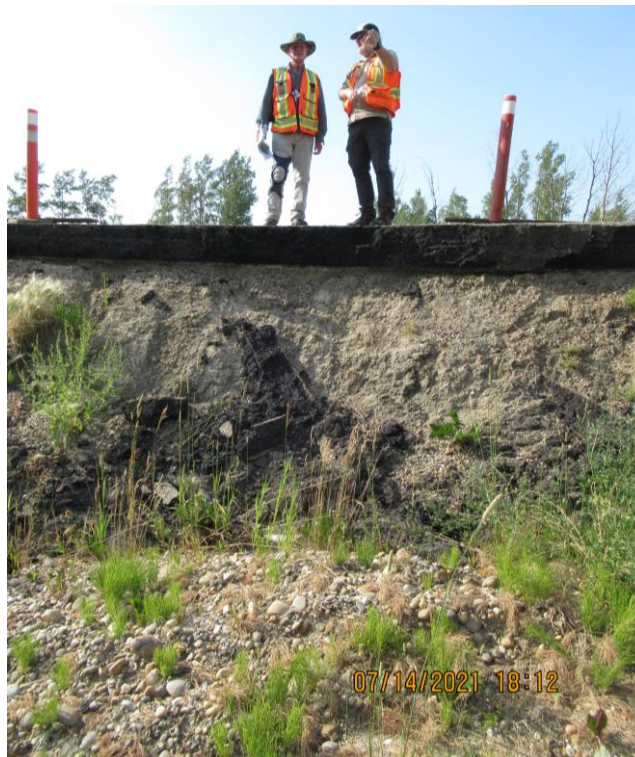
Photo 6 – Looking north at the slide scarp that has bit into the highway shoulder over Slide 2.

Recommendations		
Maintenance: Monitor further movements or enlargement at both slide locations. A barricade and delineators were set up to mark the scarp retrogression into the paved shoulder at Slide 2, but it should be enhanced with warning signage until highway repairs are undertaken. A barricade was also placed at slide 1, but if it encroaches further into the edge of the highway pavement, it should similarly be marked with additional warning signage. Short Term: Spread out the existing gravel that was placed over the slide headscarps more evenly and level with the outside ground to reduce the load on top of the slide. If the cracking around the slopes of the new 900 mm SWSP culvert at Site 1 begin to threaten the integrity of the upstream highway embankment, the existing bevelled end of SWSP could be cut off, an additional length of SWSP with a bevelled end welded onto the cut, and new, flatter slopes constructed with compacted clay around the new inlet. Consideration could also be given to training all of the south highway ditch runoff across the south approach road, so that all of this water is concentrated into one culvert instead of two (effectively eliminating the east culvert). Medium to Long Term: A preliminary engineering assessment was performed by Thurber for repair of these two landslides (File #29186 dated March 23, 2021), and two options were presented for mitigating each of the slides: <ol style="list-style-type: none"> 1) Excavate each slide and rebuild the slope with compacted clay and a toe berm, or 2) Over-excavate each slide and rebuild the slope with granular fill.

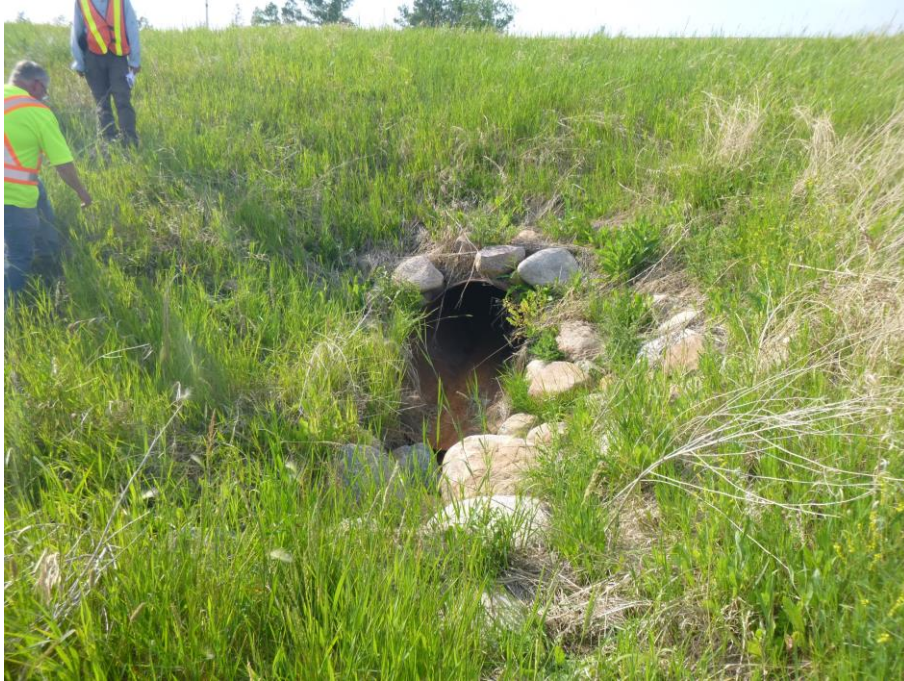
Photo 7 – Looking north at the 900 mm culvert inlet area on the opposite (south) side of the highway from Slide 1. A few cracks formed around the steeply sloping embankment surface around the inlet.

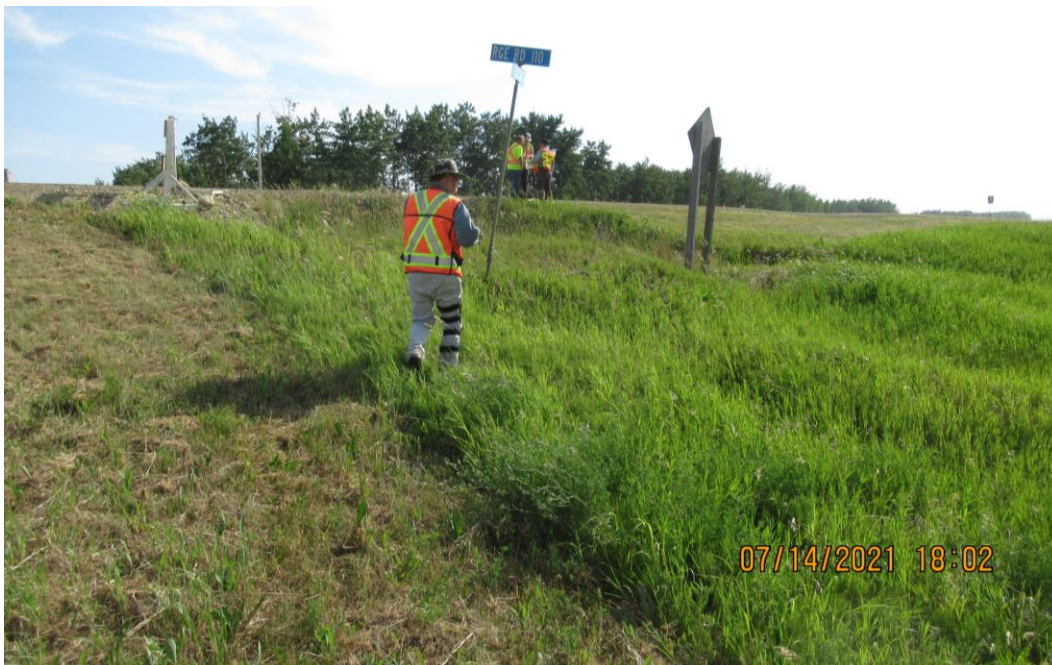
Photo 8 – Looking southwest towards the highway across Slide 1.

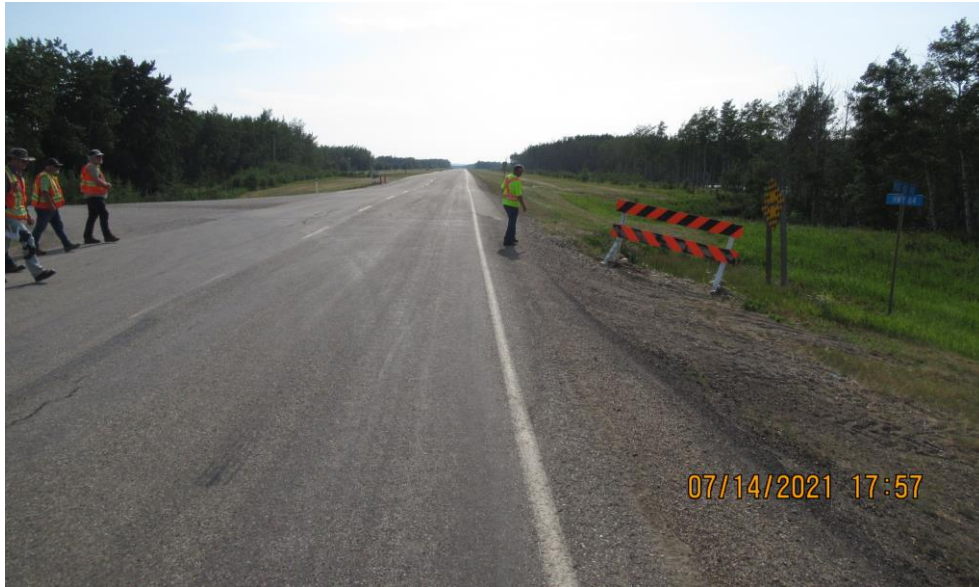
Photo 9 – Looking west adjacent to the hwy at the Slide 1 slide scarp. Note the dip in the hwy overtop the culvert crossing at Slide 2 (in the background).

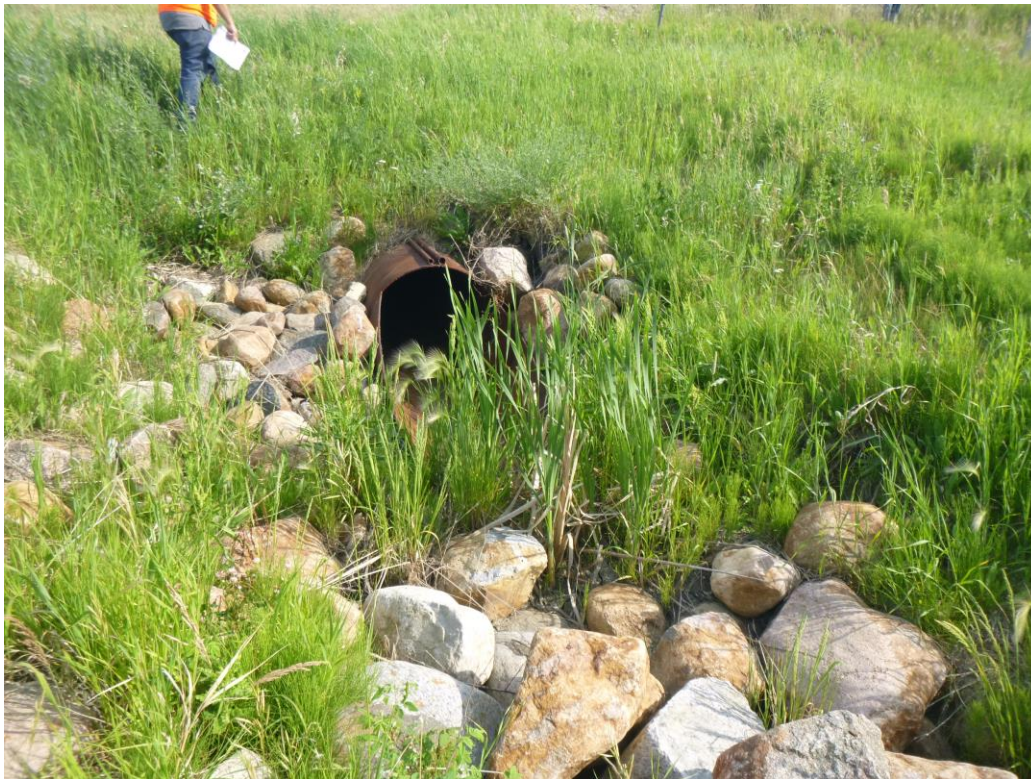
Photo 10 – Looking south at the 900 mm dia. SWSP outlet of Slide 1. Note the edge of the slide has moved right up to the edge of the culvert.

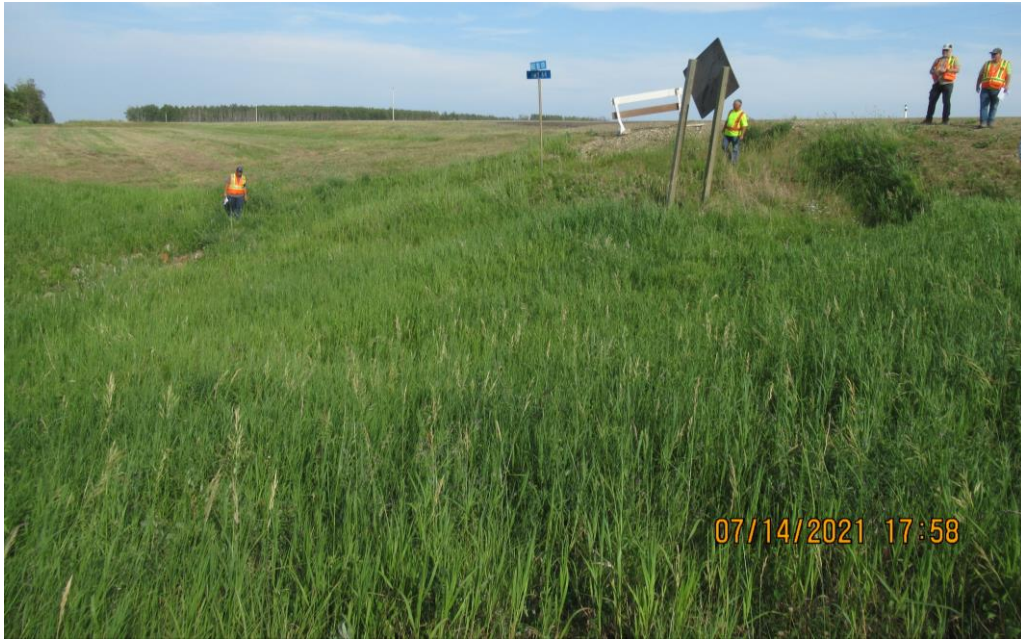
Photo 11 – Looking southeast across the Slide 1 body towards the highway.

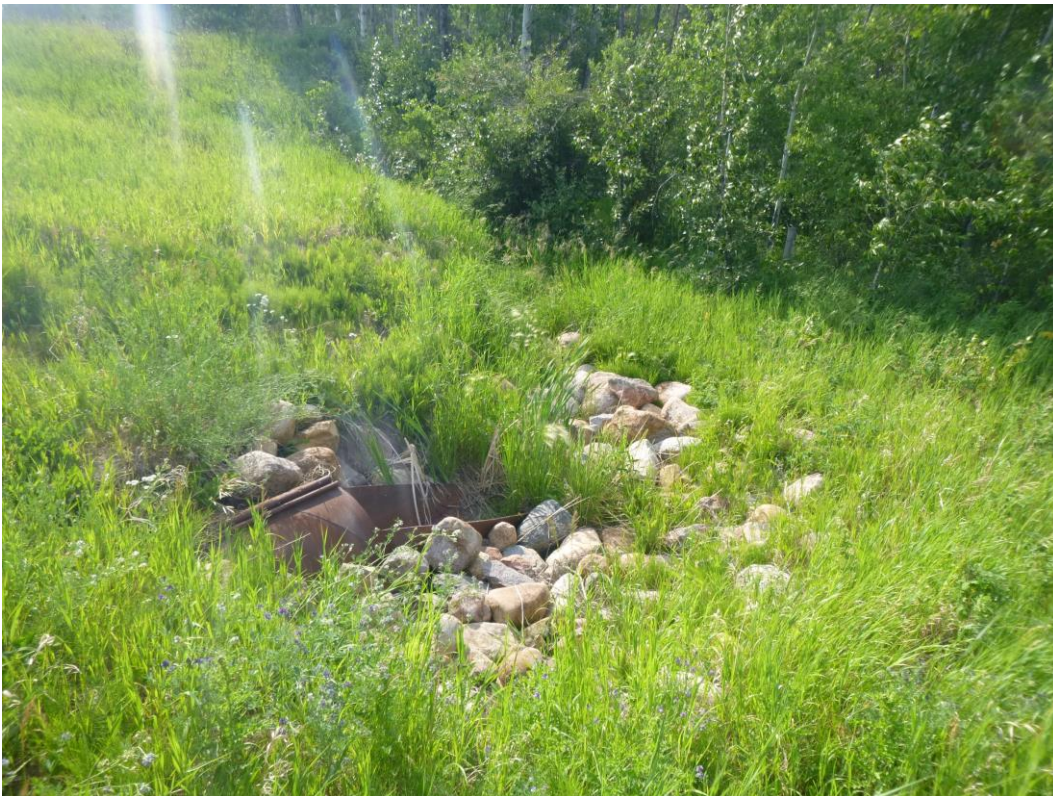
Photo 12 – Looking northwest at the outlet and downstream erosion gully of Slide 1.
