**ALBERTA TRANSPORTATION AND ECONOMIC
CORRIDORS
GEOHAZARD ASSESSMENT PROGRAM
PEACE REGION – GRANDE PRAIRIE DISTRICT NORTH
2024 INSPECTION**

Site Number	Location	Name	Hwy	km
PH083	6.1 km W Cleardale	Golf Course Slides	64:02	29.0
Legal Description		UTM Co-ordinates (NAD 83)		
SE1-85-11-W6		11V N 6246600	E 340300

**HWY 64:02 km 29.500 TO 29.650
PH083 INSPECTION PLAN**

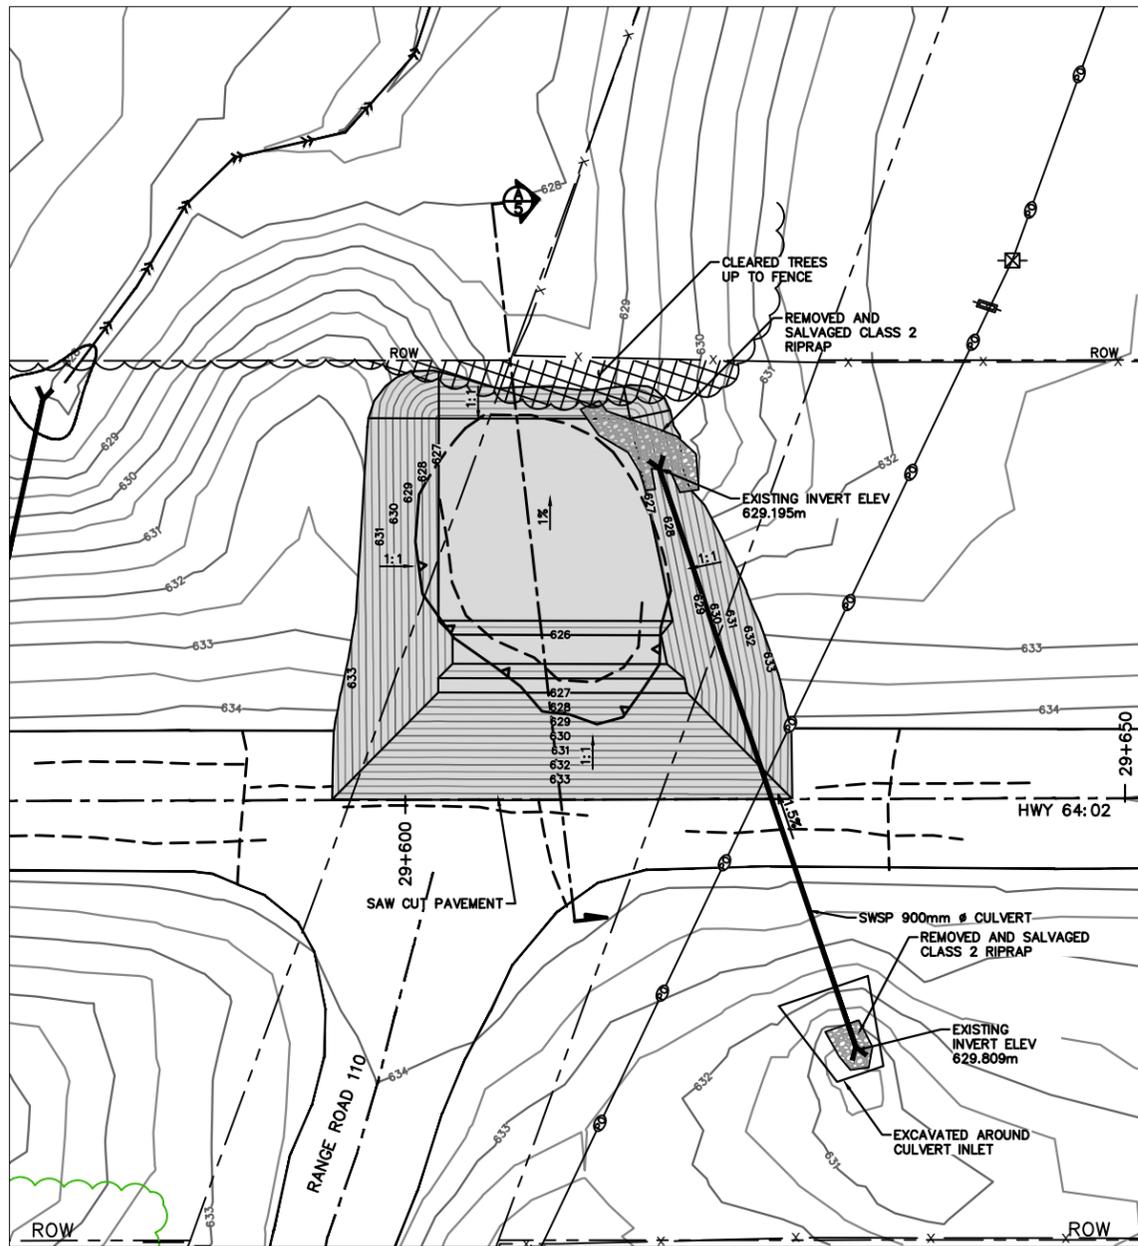
EAST SLIDE 1 EXCAVATION PLAN
1:250

The East Slide repairs consisted of excavation of the entire slide mass up to the Hwy C/Line, removing and then extending a 4 m length of the outlet section of the 900 SWSP and surrounding it with Class 2 riprap, re-constructing the north hwy. embankment slope with 6-80 gravel that included a 2 m wide bottom shear key, before re-constructing the highway surface, and also extending the 900 SWSP outlet by 3 m and placing Class 1 riprap around it.

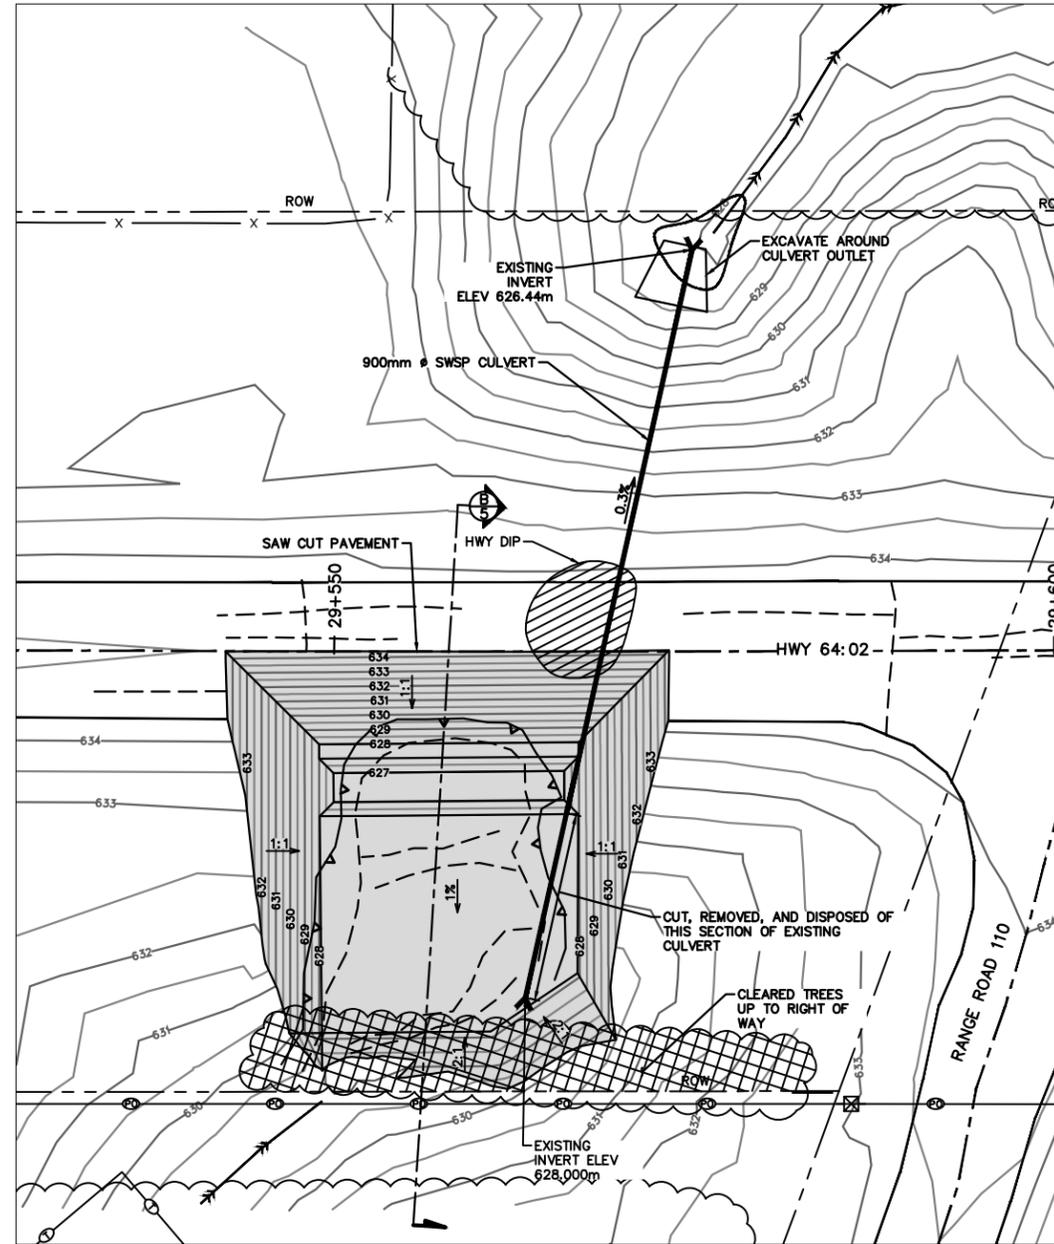
WEST SLIDE 2 EXCAVATION PLAN
1:250

The West Slide repairs consisted of excavation of the entire slide mass up to the Hwy C/Line, removing and then extending a 19 m length of the inlet section of the 900 SWSP and surrounding it and lining a portion of the ditch channel with Class 1 riprap, re-constructing the south hwy. embankment slope with 6-80 gravel that included a 2 m wide bottom shear key, before re-constructing the highway surface, and also placing Class 2 riprap around the outlet and forming an extended channel downstream of it.

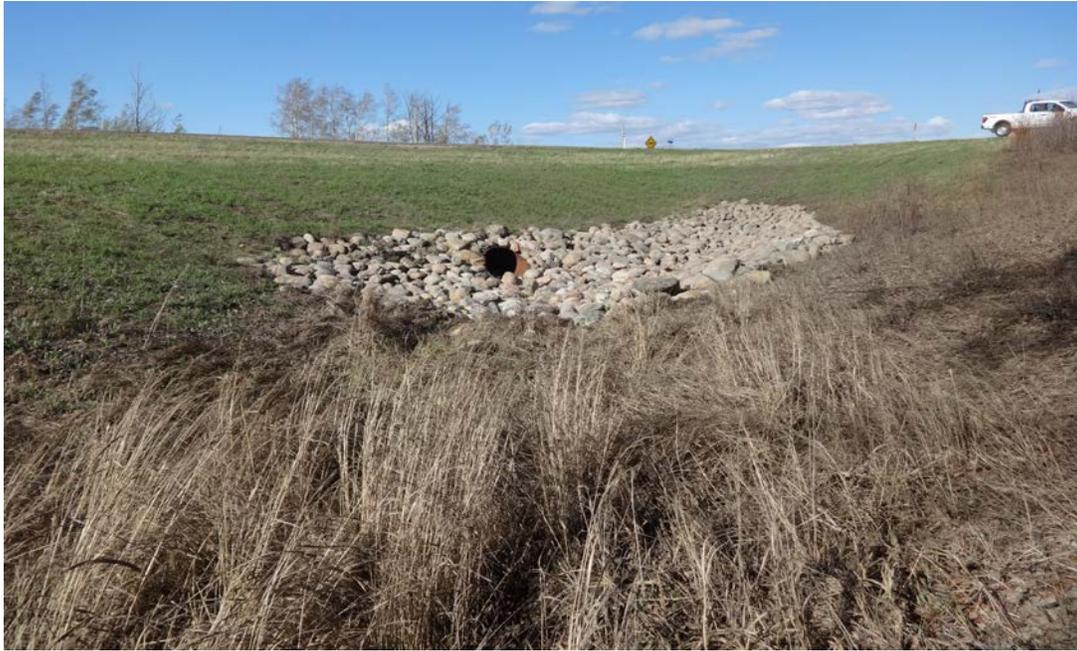
Photo 1 – Looking northeast across the culvert inlet area and channel riprap of the West Slide.

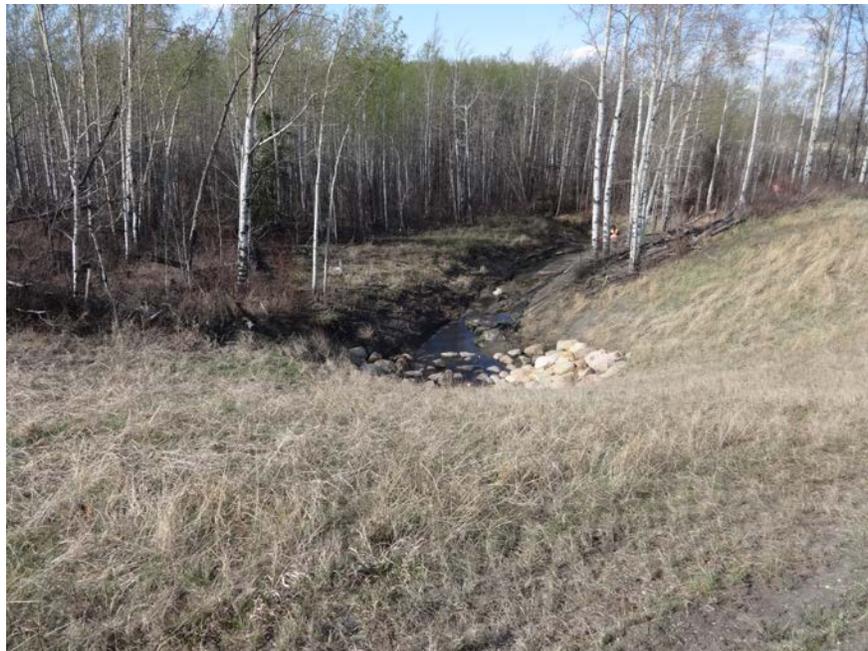
Photo 2 – Looking northeast at the highway embankment, culvert outlet and extended channel over/beyond the West Slide.

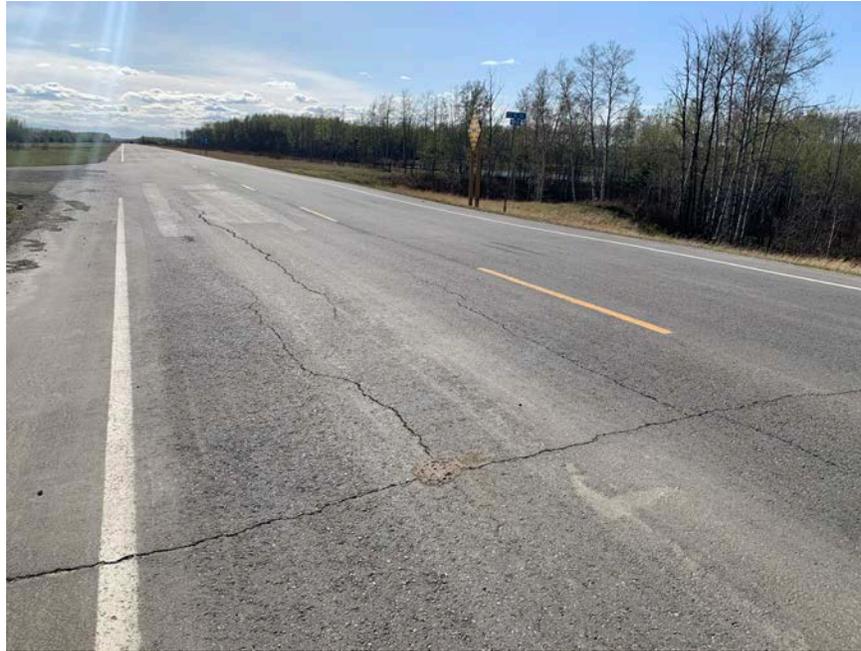
Photo 3 – Looking west along the highway from the 900 mm SWSP culvert crossing the highway of the East Slide. A few cracks have formed through the new pavement surface placed in 2022, west of and overtop of this culvert.

Monitor any crack enlargements at the East Slide location.

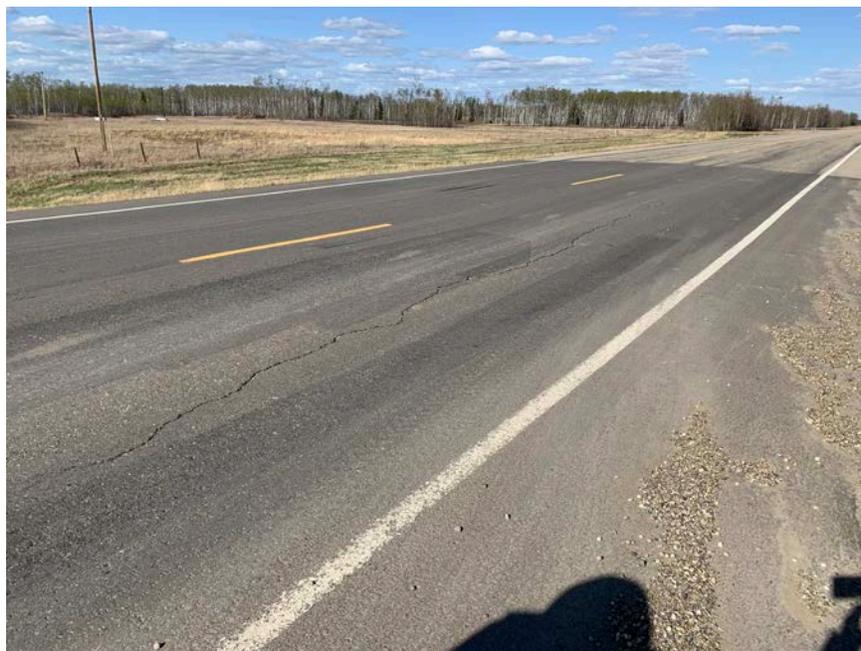
Photo 4 – Looking northeast along the highway at the cracks west of and over the culvert adjacent to the East Slide.

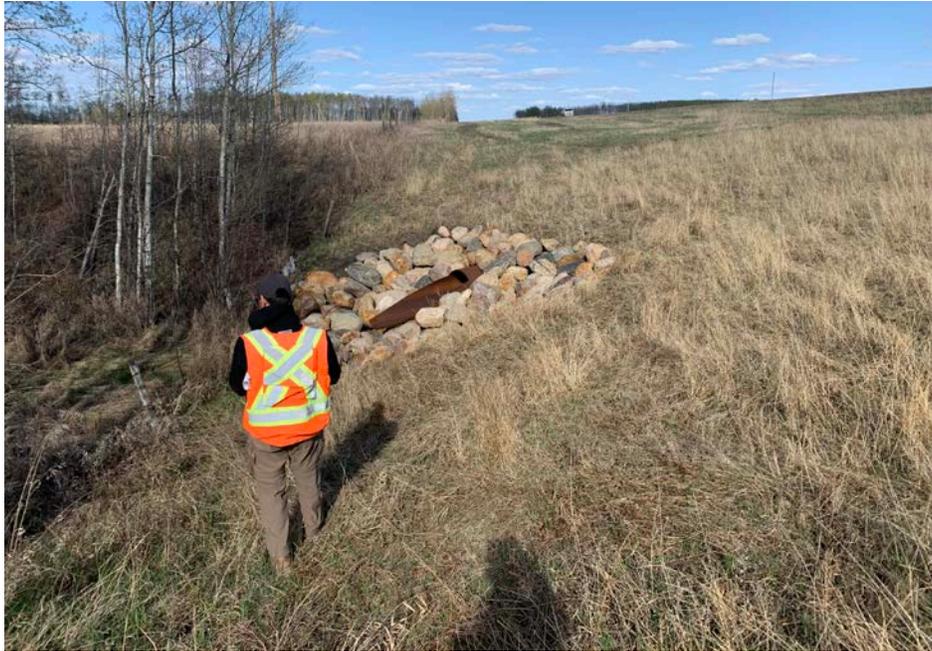
Photo 5 – Looking east at the 900 mm dia. SWSP outlet and north downstream embankment of the East Slide.

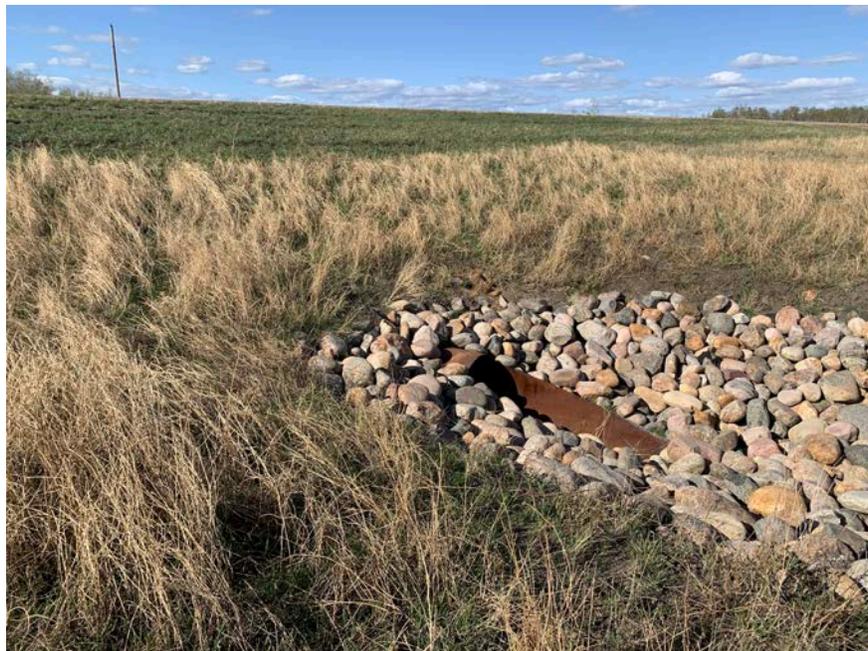
Photo 6 – Looking southeast across the 900 mm SWSP inlet of the East Slide.
