**ALBERTA TRANSPORTATION
GEOHAZARD ASSESSMENT PROGRAM
PEACE REGION (GRANDE PRAIRIE DISTRICT- NORTH)
2021 INSPECTION**

Site Number	Location	Name	Hwy	km
PH067	West of Fairview	East Hill Ditch Erosion Section	682:02	13.8-14.1
Legal Description		UTM Co-ordinates (NAD 83)		
Centre 36-81-5-W6		11 N 6214450	E 398000

**PH067-1: HWY 682:02 - HINES CREEK
 2021 INSPECTION PLAN**

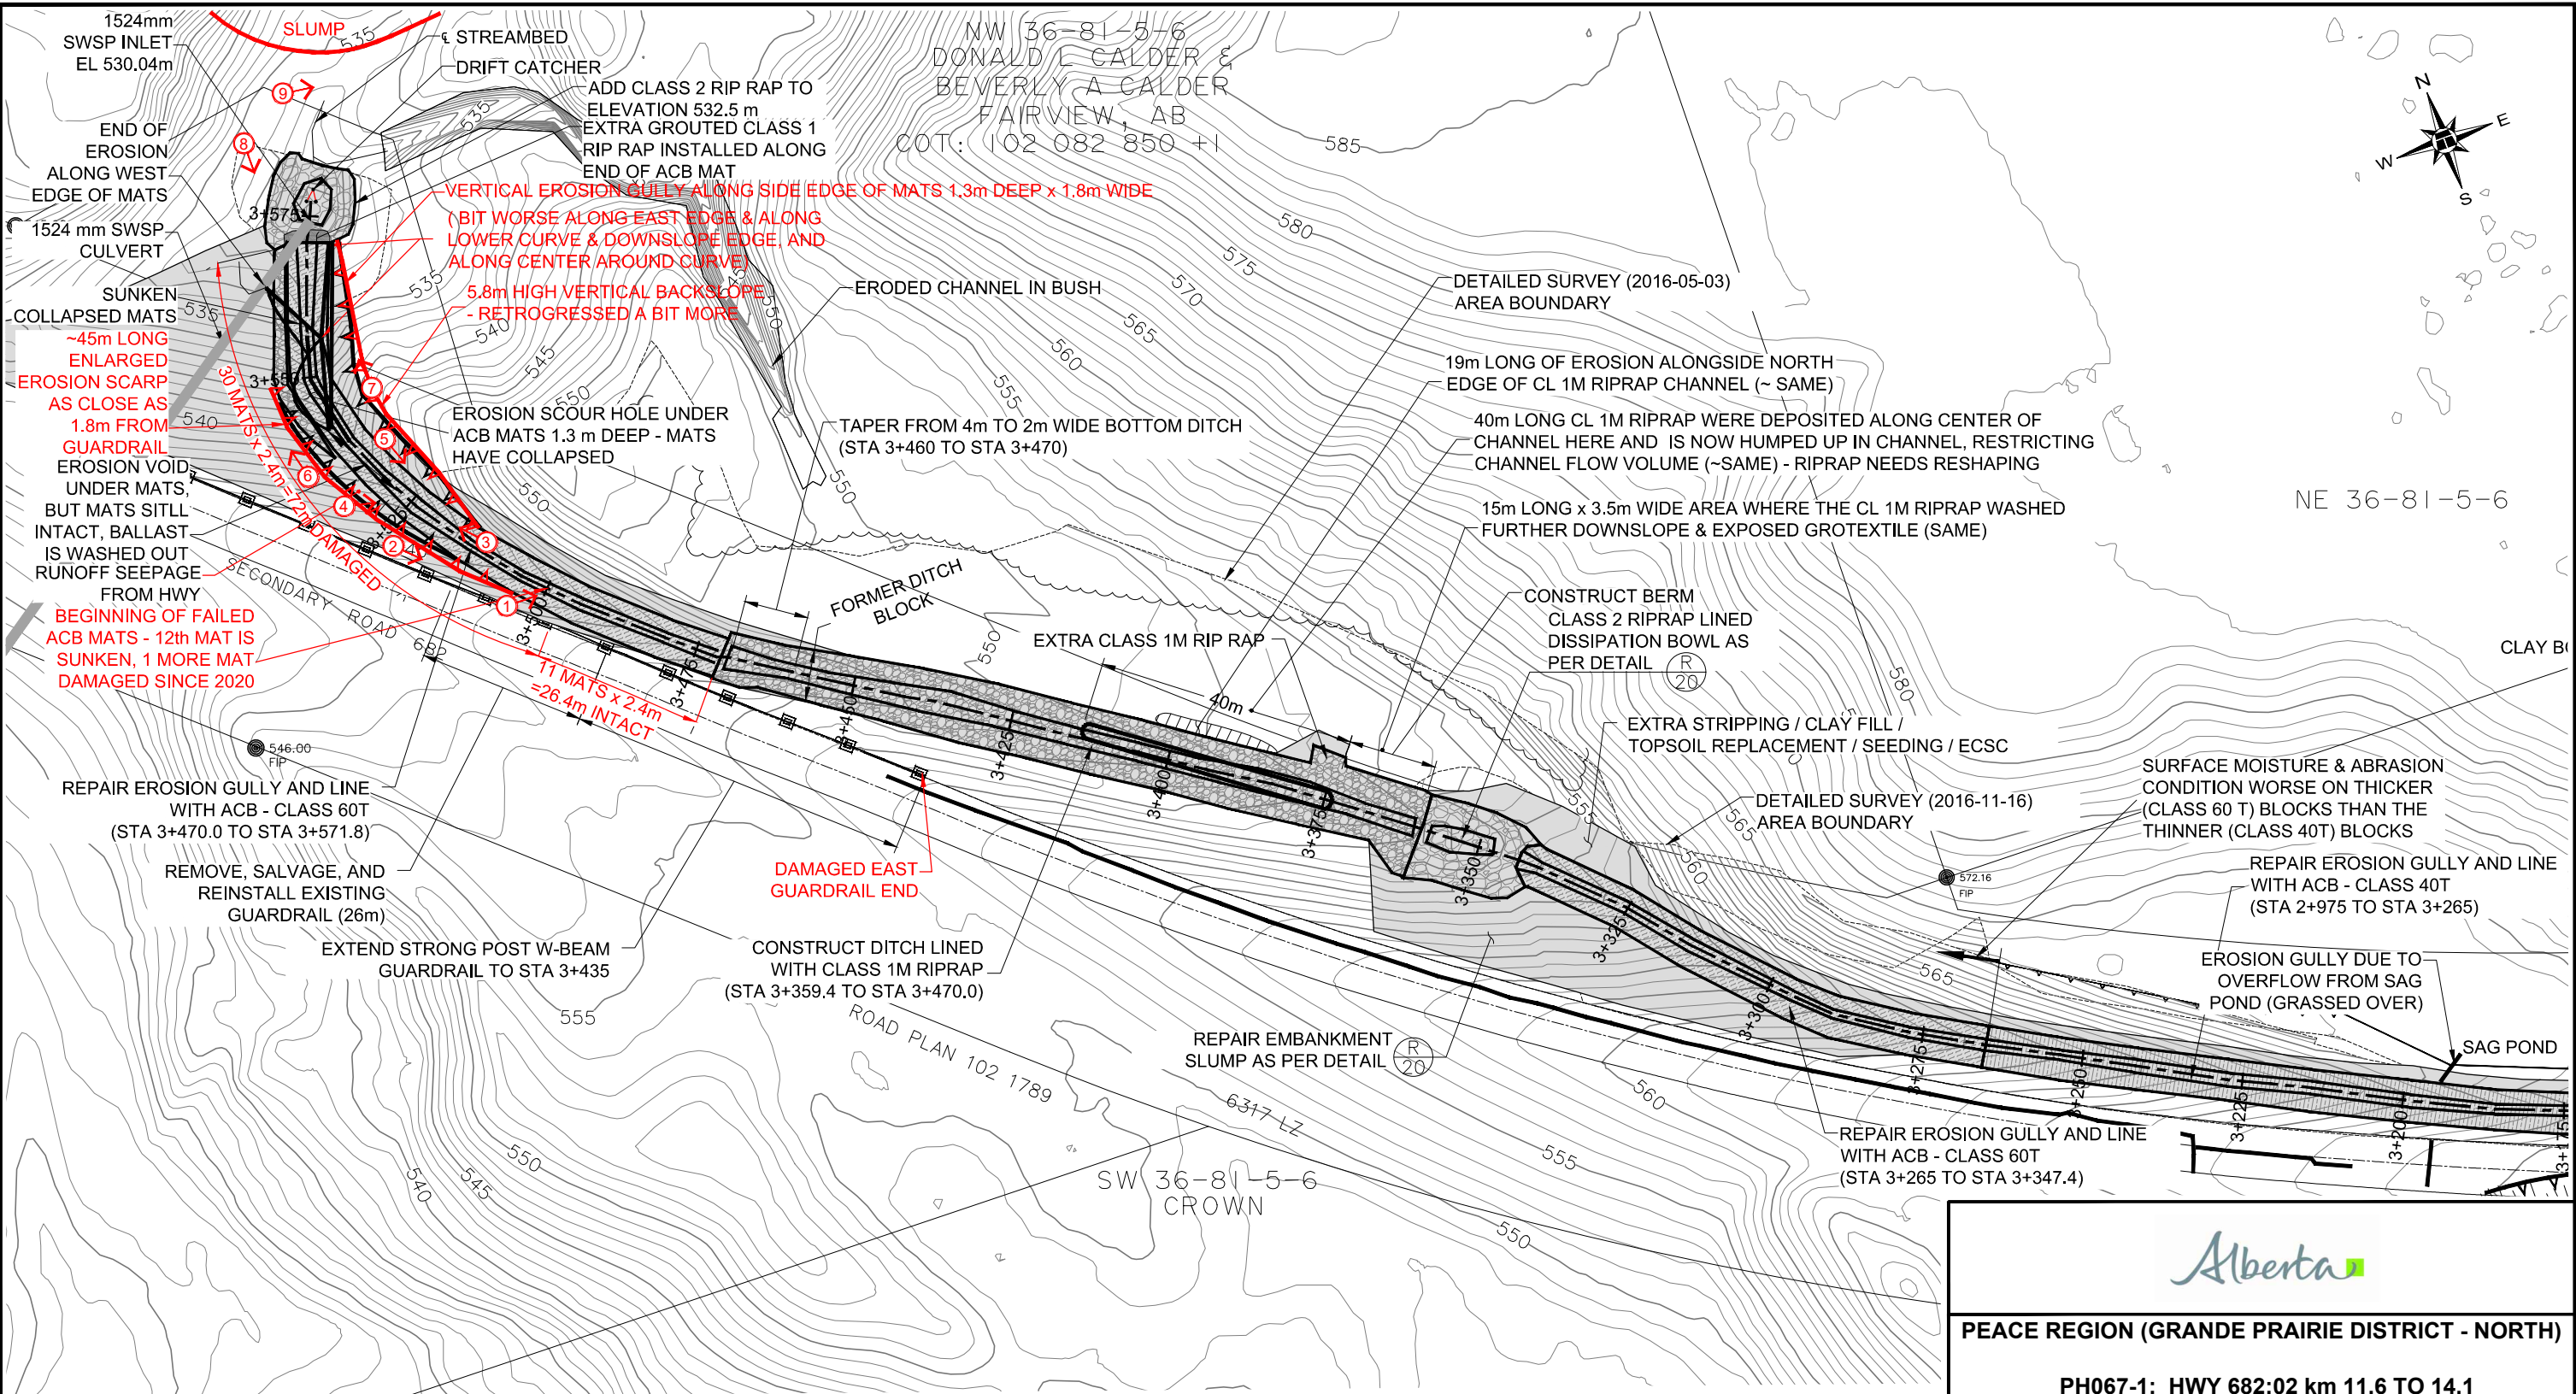
DWG No. 32123-PH067-1-2

- NOTES :**
1. FEATURE LOCATIONS ARE APPROXIMATE
 2. PREVIOUS OBSERVATIONS SHOWN IN BLACK
 3. **JULY 13, 2021 FEATURES SHOWN IN RED**
 4. ADVANCED ABRASION & SPALLING OF ACB MAT BLOCKS AND MANY BROKEN BLOCKS ALONG CENTER BASE OF CHANNEL; SOME MATS WORSE THAN OTHERS.
 5. HIGHWAY SAND / SALT STAINING ALONG BASE & HIGHWAY SIDE OF ACB MATS IN CHANNEL.

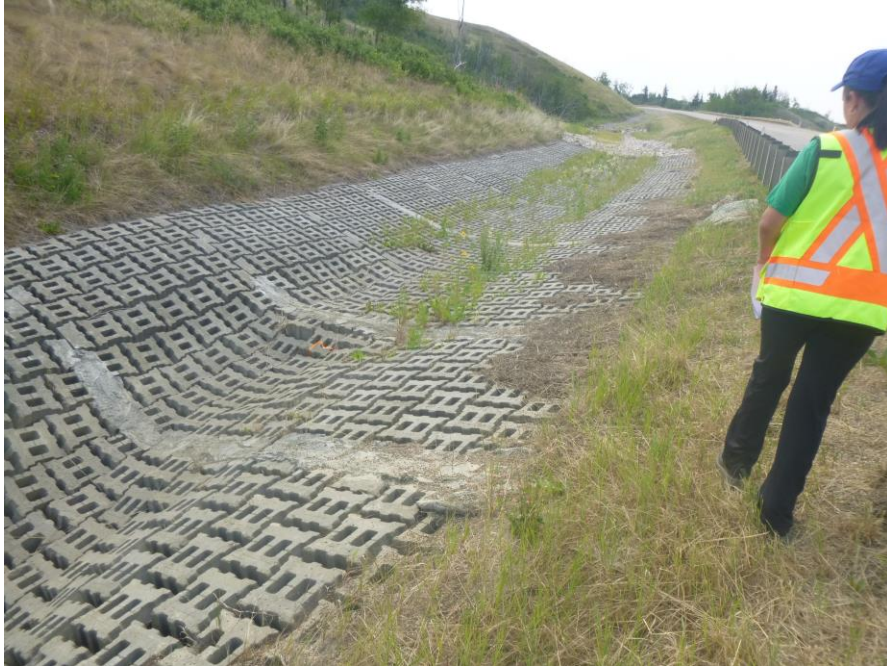
Photo 1 – Looking east along the beginning of the eroded ACB mat area north of the highway. The first 11 mats are still intact (1 east of the ribbon).

- 1) Sta 3+500 to Grimms Creek, installing more robust Class 70T (= 230 mm high blocks compared to existing 190 mm) ACB mats with anchors over a thicker minimum 0.5 m compacted clay, in a wider 3 m channel bottom, on uniform vertical (24 percent) and horizontal gradients which requires cutting the hillside back in the cut area and constructing berms in the fill area, incorporating a super-elevated cross-section, two concrete grout cut-offs across the channel at the upstream end (one at the end of

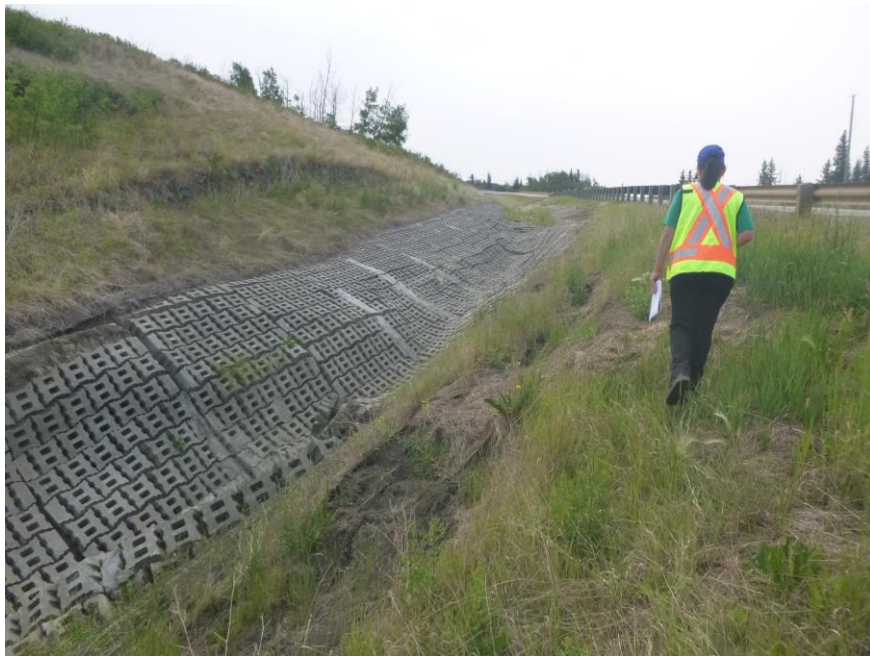
Photo 2 – Looking southeast along the edge of the eroded ACB mat area. Note the recent scarp extension along the south edge of the mats.

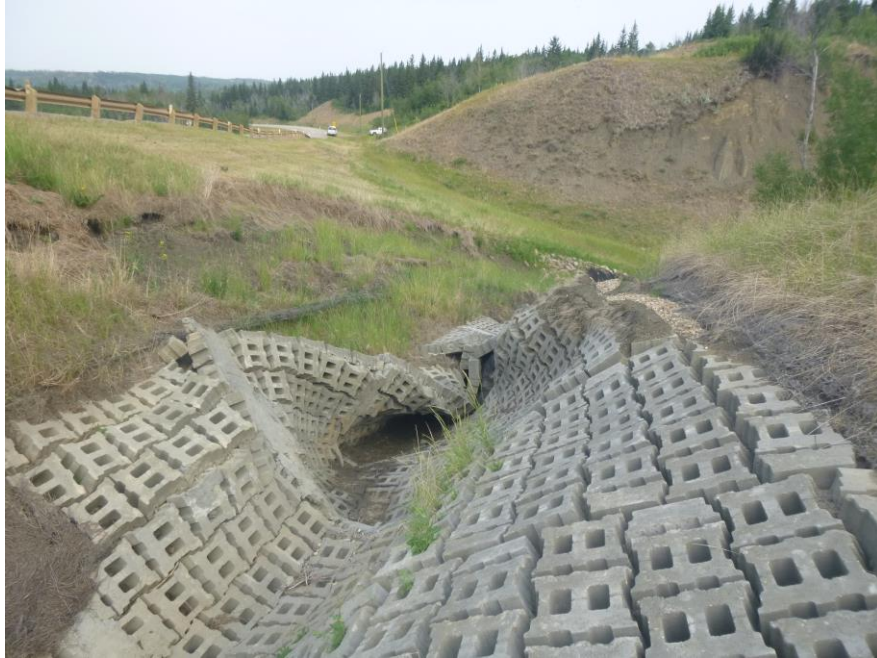
Photo 3 – Looking northwest along the severely damaged ACB mat area and enlarged slide scarp area.

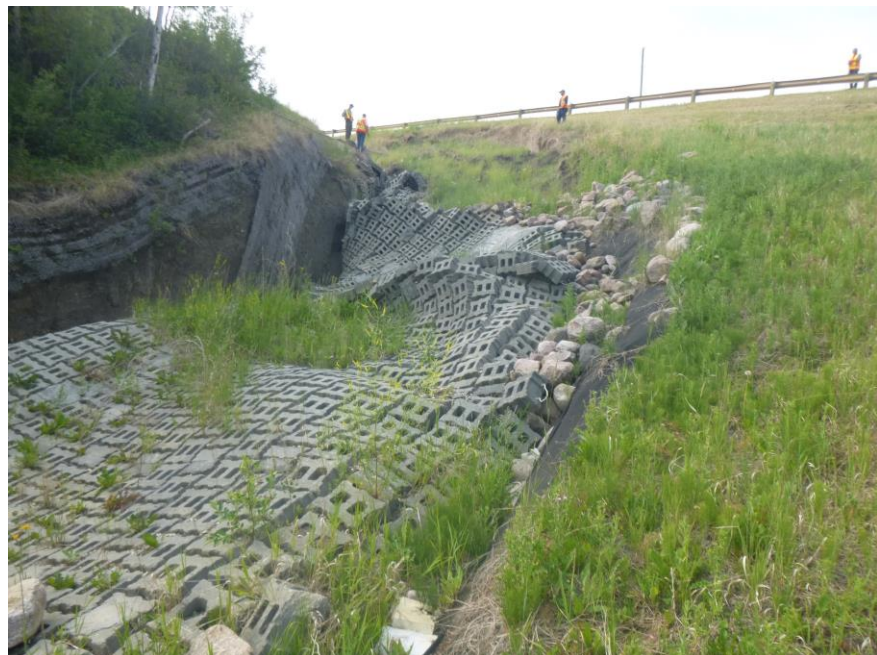
Photo 4 – Looking southeast at the severe erosion through the ACB mat and peripheral riprap areas. Note the enlarged erosion and slide developing south of the mats.

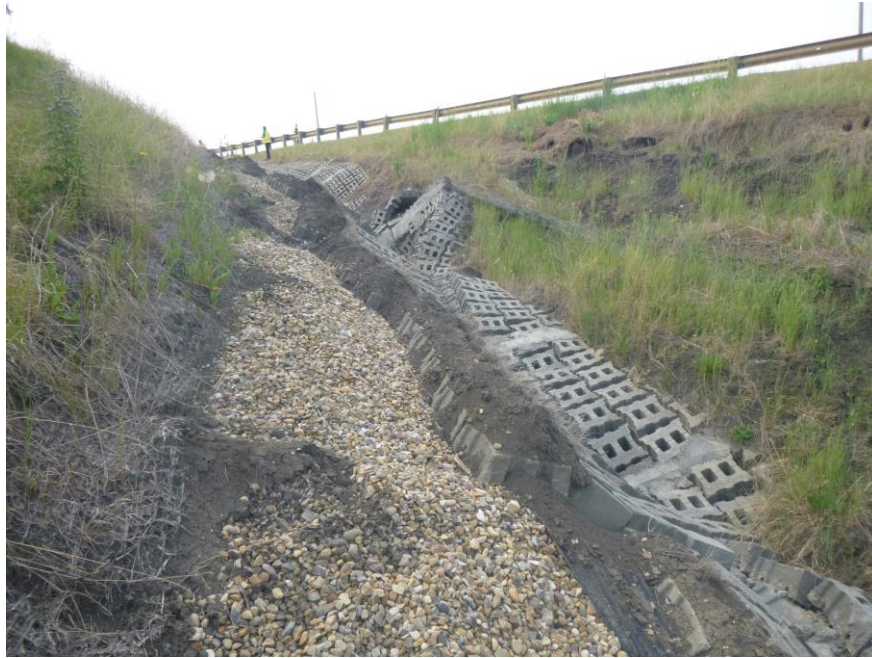
Photo 5 – Looking southeast along the north edge of the eroded ACB mats. Here the mats have slid down into the deeply eroded channel, exposing the underlying gravel.

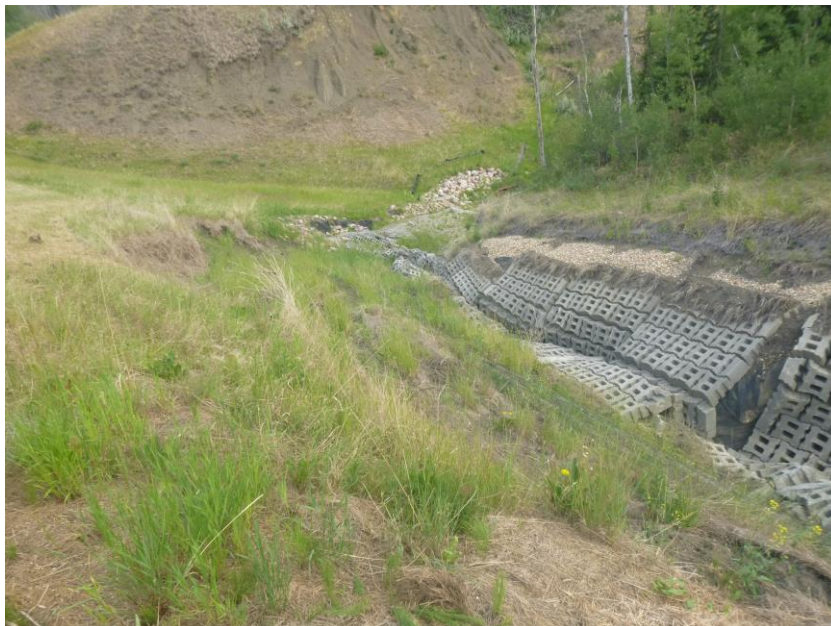
Photo 6 – Looking north along the southwest side of the damaged and eroded ACB mats.

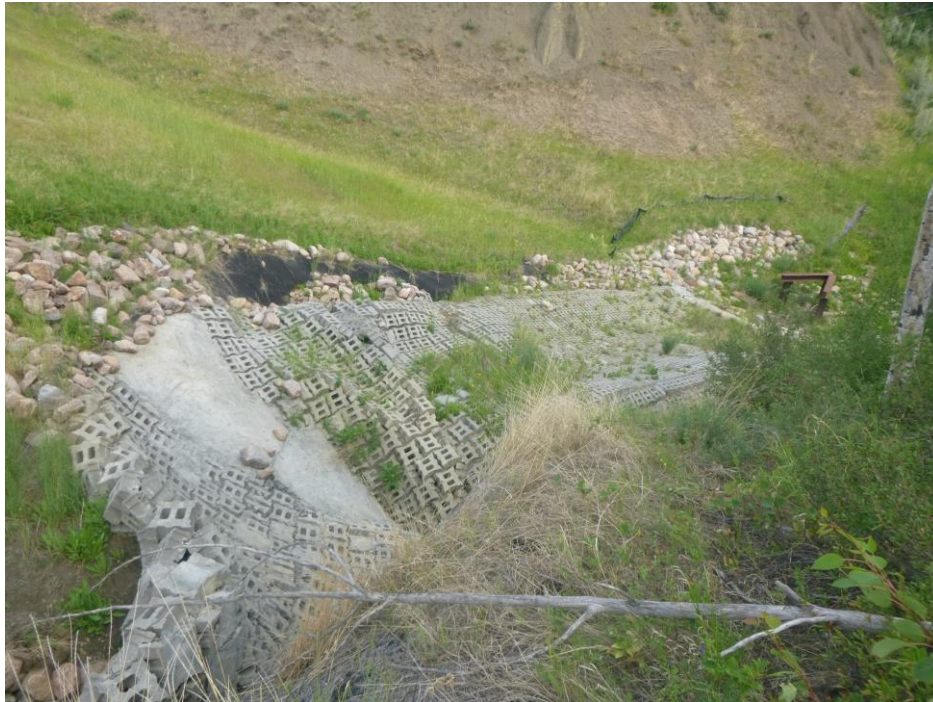
Photo 7 – Looking northwest across the eroded mat area from about halfway down the slope.

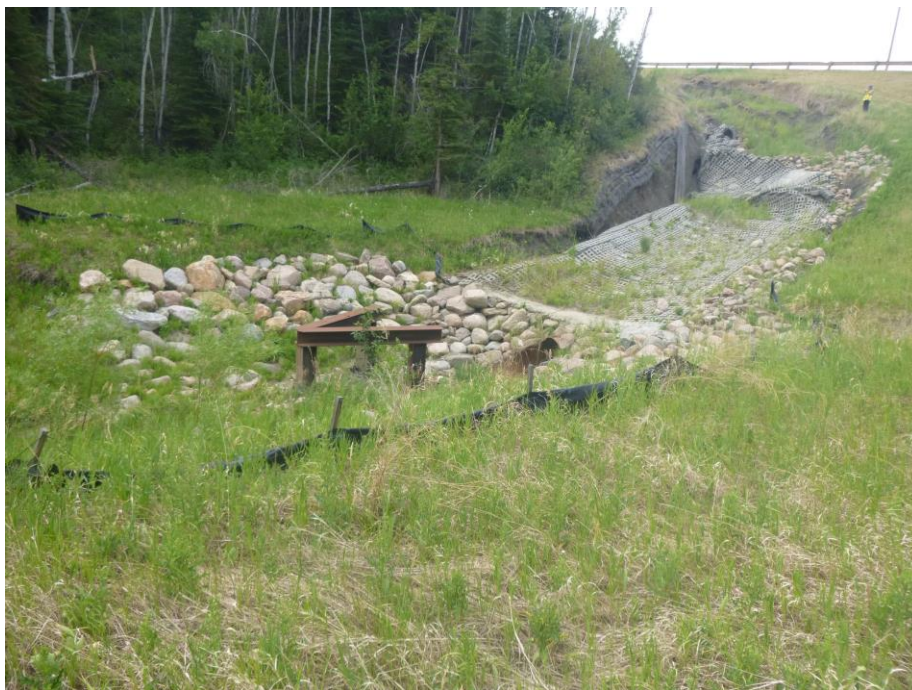
Photo 8 – Looking southeast at the culvert inlet and eroded ACB mat area leading to it.

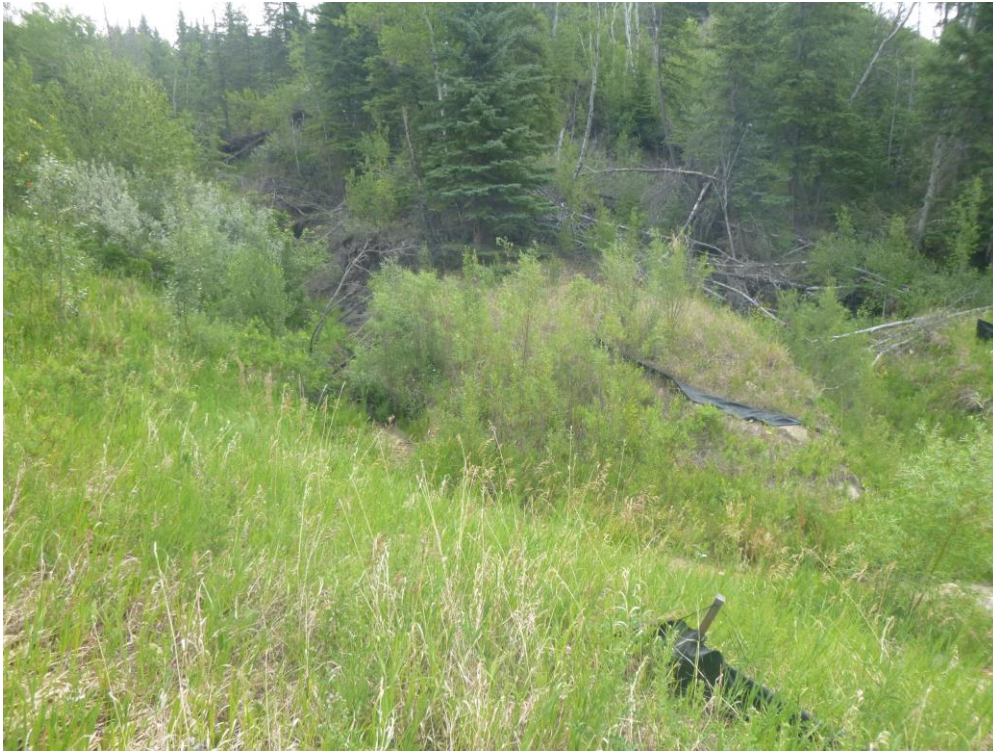
Photo 9 – Looking north at the slumping and infill occurring into the channel upstream of the 1524 SWSP culvert entrance.

Consider installing culverts (900 or 1200 mm diameter) in the slumping channel areas upstream of the existing 1524 mm diameter culvert inlet, to allow flow to the existing culvert while minimizing debris and potential blockage.
